**11 YEAR EVALUATION OF FABRIC FORM  
WITH CEMENT FLY ASH MIXTURE FOR  
EROSION AND SEDIMENT CONTROL**

**Construction Final Report Addendum  
June 1998**

**Research, Development & Technology Transfer  
Oklahoma Department of Transportation  
200 N.E. 21st Street, Room 2A2  
Oklahoma City, Oklahoma 73105  
(405) 521-2671  
FAX (405) 521-6528**

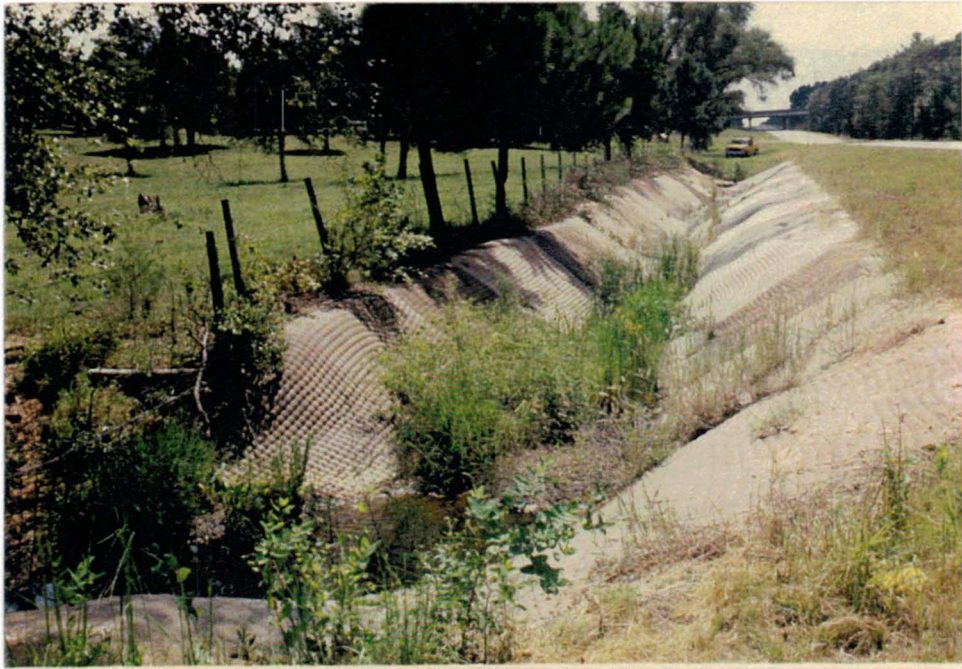
Illustration 1 Overall view looking south

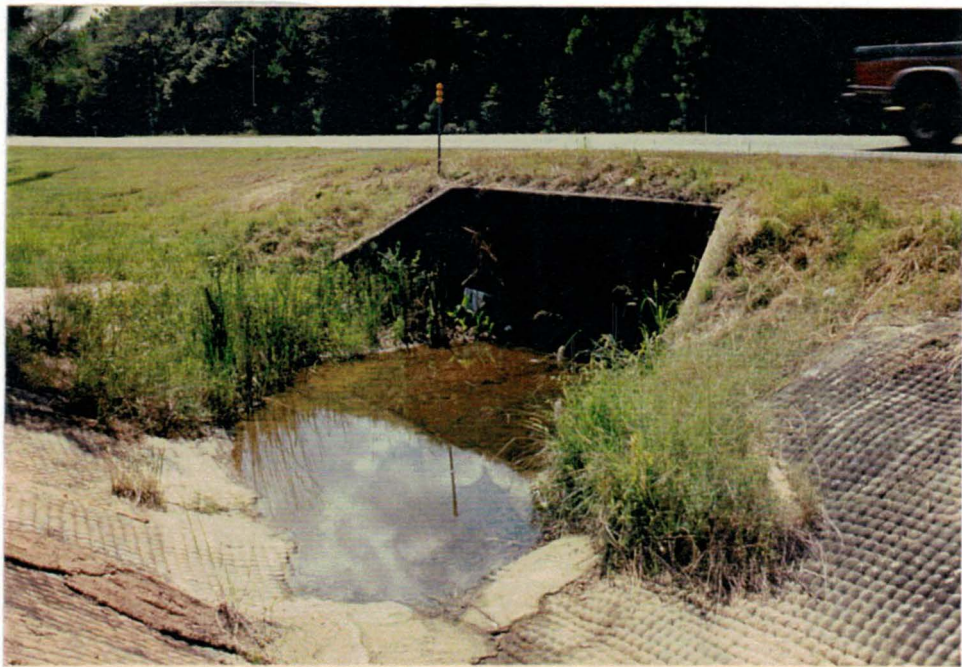
Illustration 2 Culvert at south end of ditch

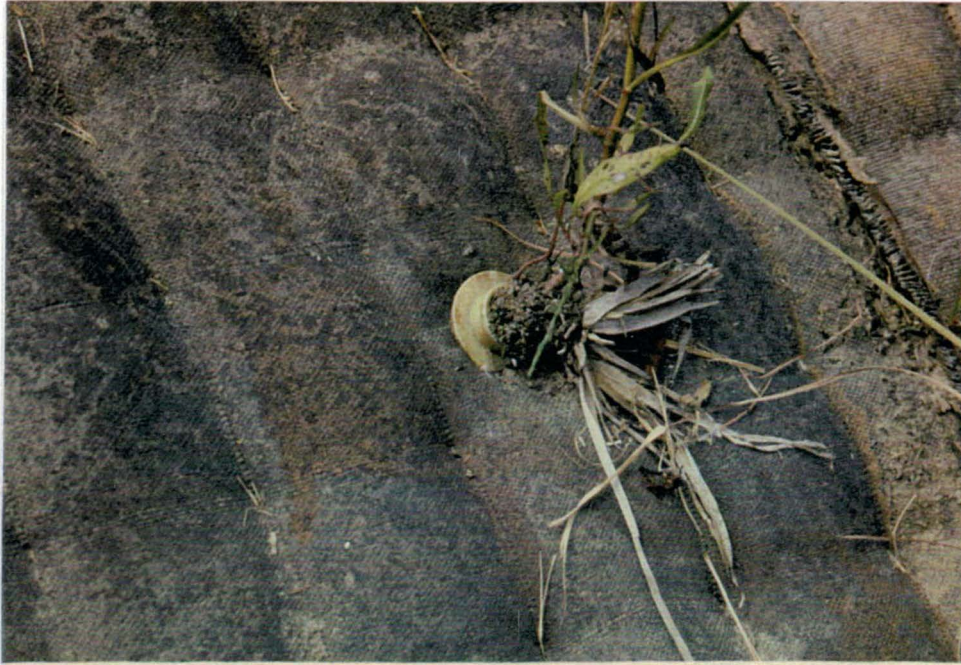
11. The weep holes provided a protective growing area for vegetation. There is greater vegetative growth in the areas where the nylon bags were placed, regardless of the different mortar mixes.
12. Vegetative growth was found in some longitudinal cracks in the lower 1/3 of the slopes.
13. Most of the vegetation is growing in soil accumulations gathered at the stitch-lines of the matting and in the ditch bottom.
14. Voids were found under the upper 1/4 to 1/3 of the inslope, ranging from 6.4 mm (1/2 in) upwards to 101.6 mm (4 in).

Illustration 3 Weep hole

Future projects utilizing weep holes should use a fabric cover on both the embedded and exposed ends to reduce soil collection and thus retard vegetative growth.

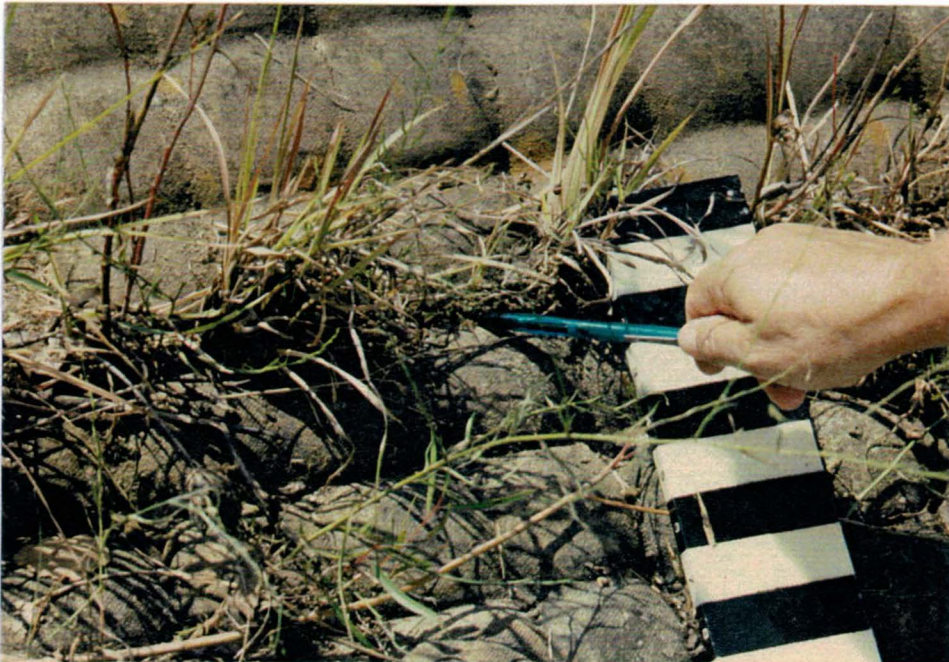
The longitudinal cracking is the most probable cause for the vegetative growth along the side-slopes of the ditch. This type of problem could be corrected by an annual or semiannual maintenance program where cracks are routed, cleaned and sealed; or use of an appropriate herbicide.

Illustration 4 Vegetative growth in longitudinal cracks

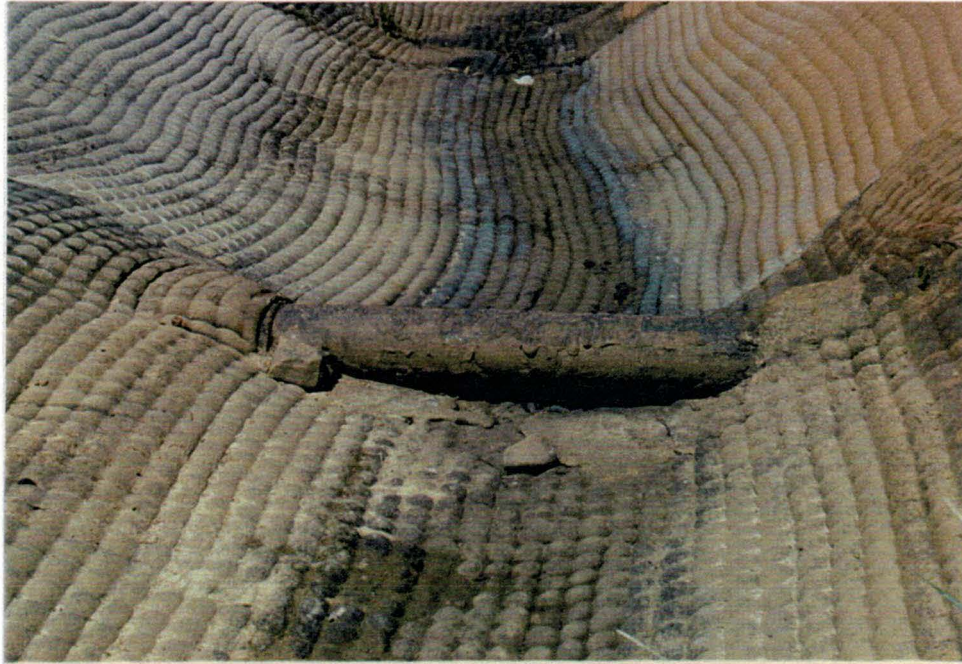
Illustration 5 Placement around pipe (Shows discoloration)

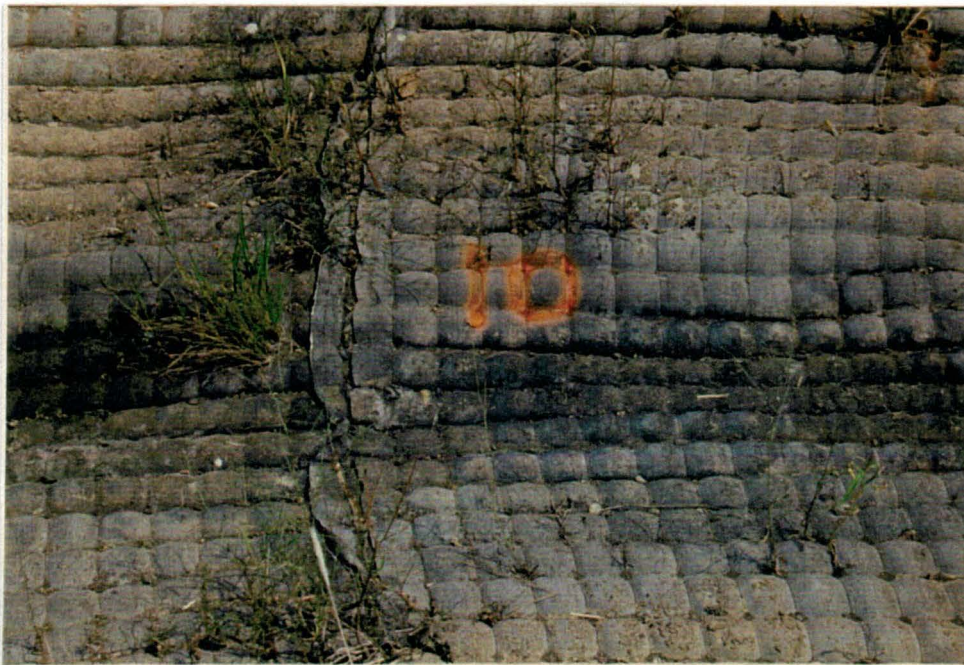
Illustration 6 Section 10 - Showing seam separation

**Fabric Condition:** This fabric is shredding like the other polypropylene fabrics.

**Seam Condition:** These seams are showing signs of stress and wear.

Considerations should be made for a joint sealant, such as silicone or an asphaltic tape in addition to sewing for increased durability.

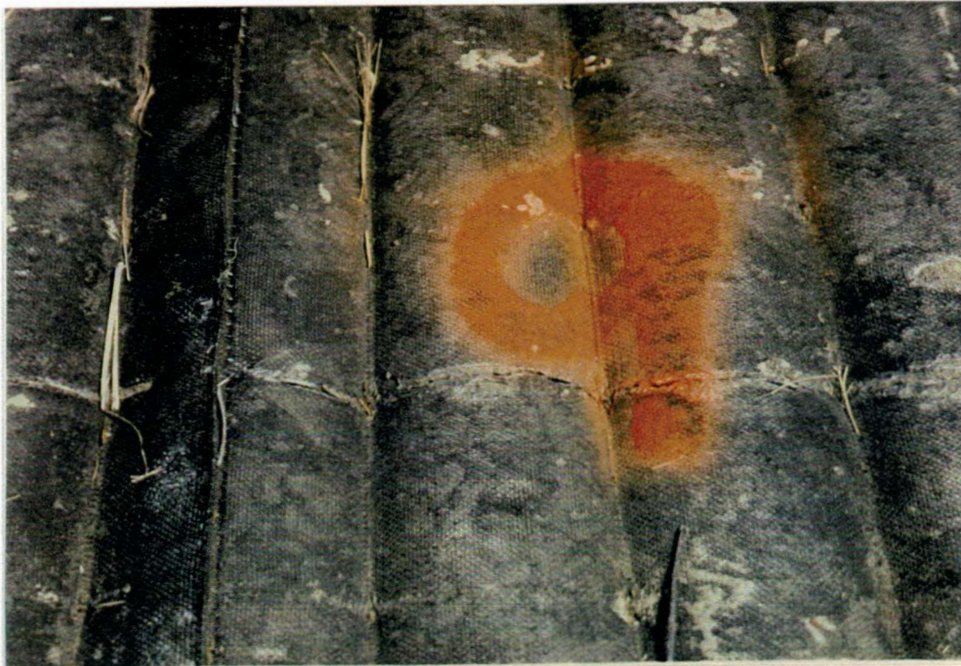
Illustration 7 Section 9 - Showing cracking at seam line

**Fabric Condition:** The fabric shows only minor wear.

**Grout Condition:** The grout is in good condition except for two cracks. The first is located approximately 1.83 meters (6 ft) down from the upper side and extends the length of the mat. The second crack is a small one, approximately 0.61 meters (2 ft) long and is located in the middle of the section.

**Voids:** There are no visual voids at this time. However, the cracks mentioned earlier may be caused by voids under this section.

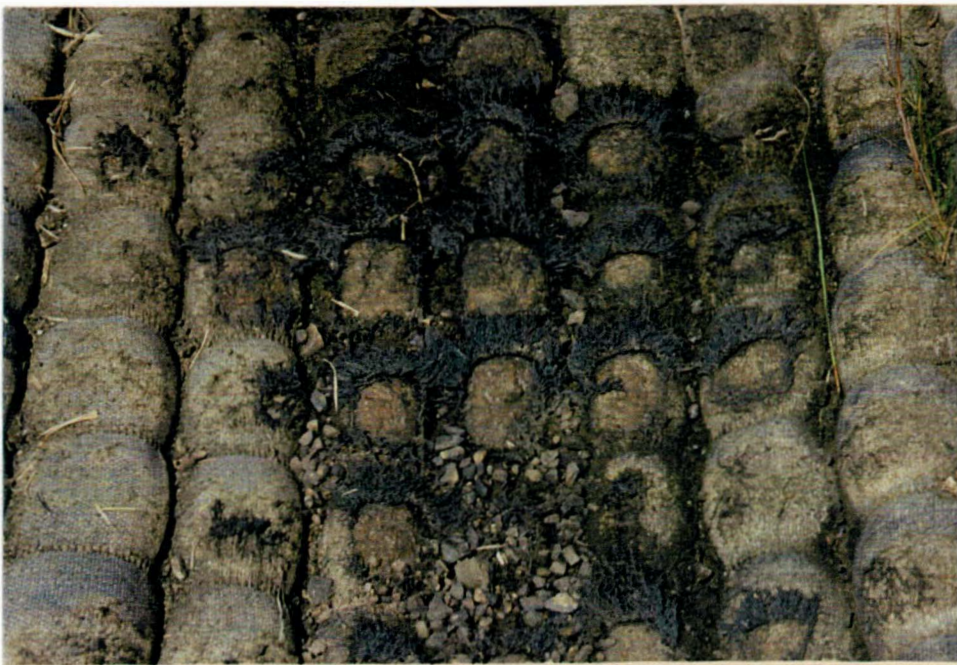
5. Surfaces of the polypropylene type mats exhibited separation and shredding of the exposed fibers.
6. Surfaces of the nylon mats displayed abrasion and wear.

Long term exposure to ultraviolet radiation has a high impact on polypropylene fiber decomposition. The reduced bonding of the polypropylene mat with the mortar mixes is felt to have amplified the deterioration.

Illustration 8 Showing wear (Polypropylene type)

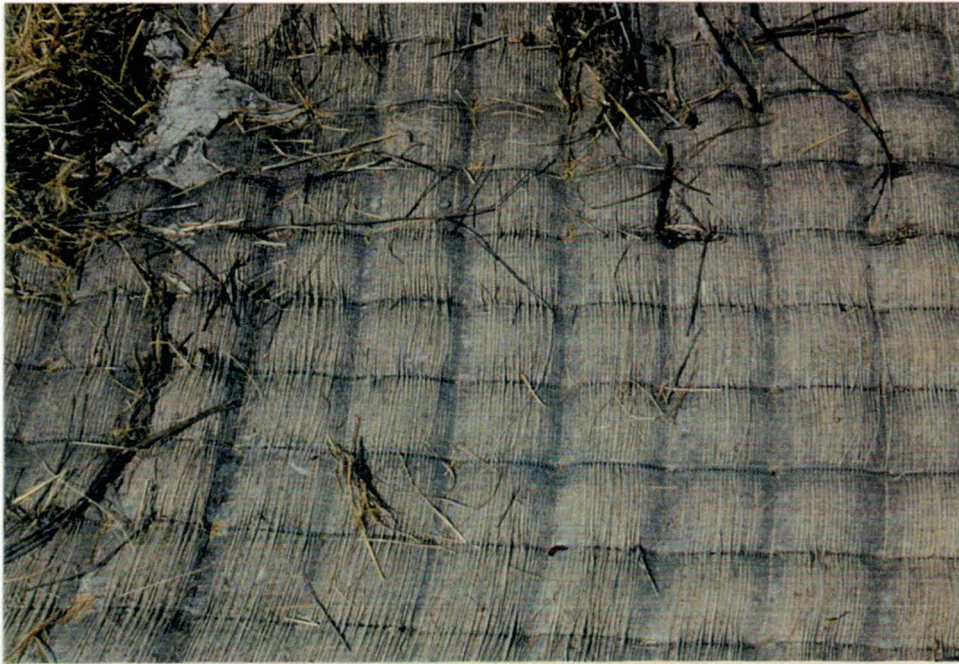
2. The nylon mats adhered to the mortar better than the polypropylene type mats.
3. The polypropylene type mats tend to separate at the sewed joints.
4. The nylon type mats bonded better at the sewed joints.

Illustration 9 Showing separation (Polypropylene type)

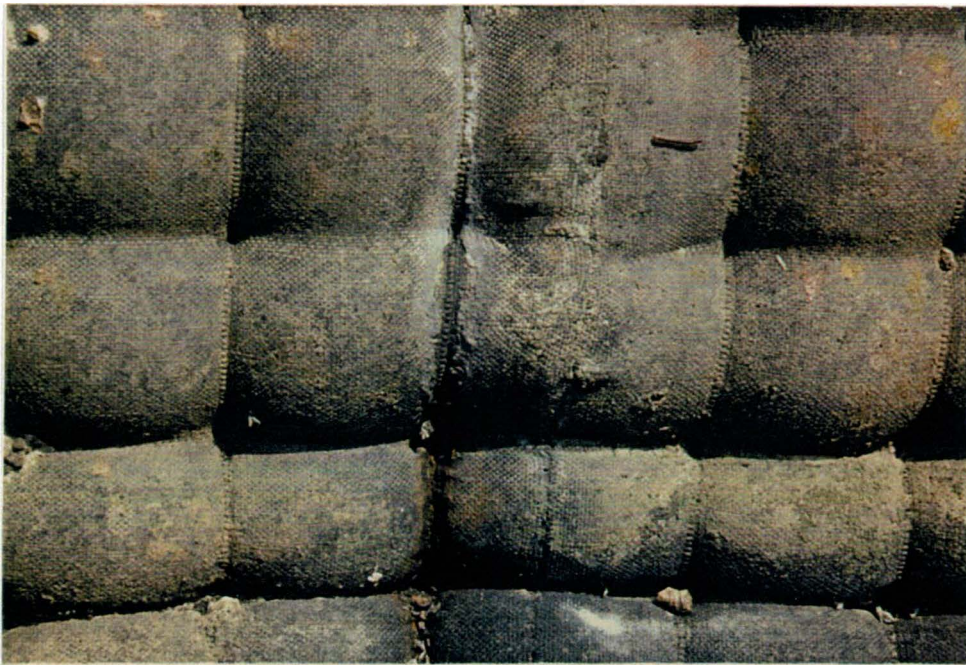
Illustration 10 Showing Bond (Nylon type)
