EVALUATION OF AN EXPERIMENTAL
PROTECTIVE COATING FOR BRIDGE STEEL

David C. Streb
Project Manager

Oklahoma Department of Transportation
Oklahoma City, Oklahoma

October 1989

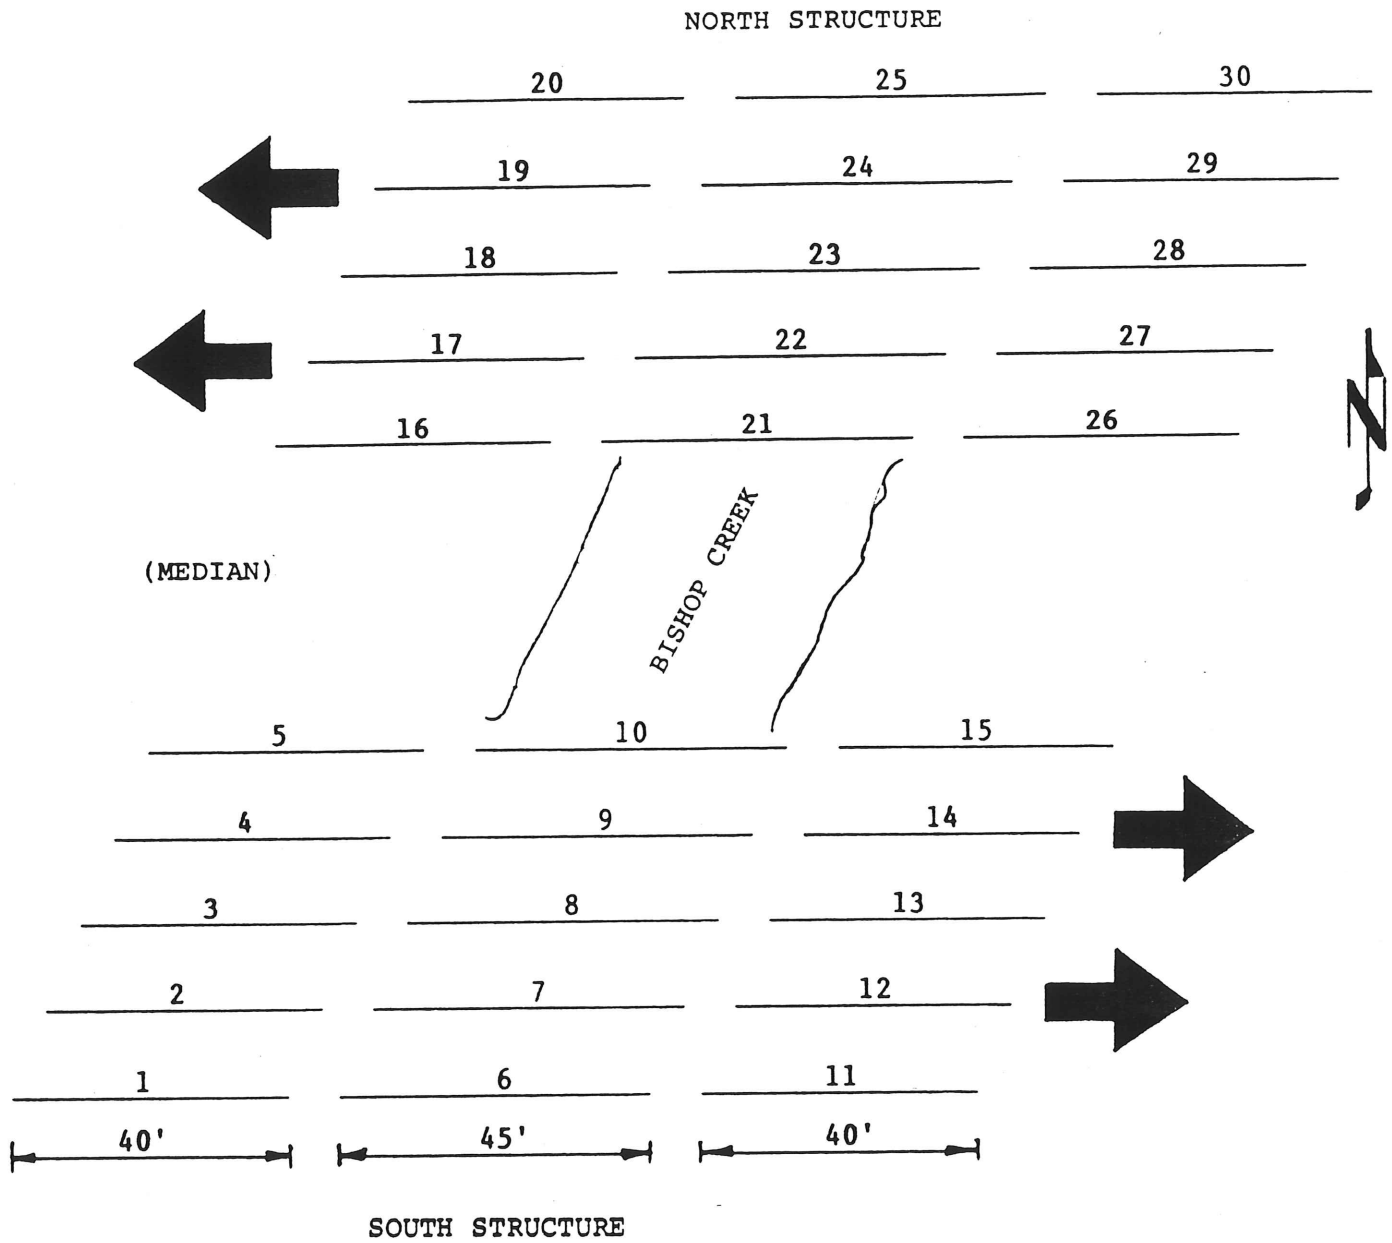
Figure 2. Identification of Bridge Beams.

view of the two bridges with a number assigned to each bridge beam. Table 1 is a table which identifies the condition of each beam prior to repainting and identifies whether the beam had one or two coats applied. The south structure received only a coat of the metal sealer so that the sealer's performance could be monitored. In summary, the beams were in excellent condition with minor scaling and corrosion present on a few beams. The corrosion found on these beams was in the form of light rust with no pitting. One observation of significant interest was that the beams on the east span of the south structure appeared to have been scraped by a bulldozer performing dirt work along the east slope. The scrapes were approximately 1/2 inch wide by 1/8 inch deep extending the width of the bottom face of the bottom flange on beams #11, 12, 13, 14, and 15. These scrapes had light rust developing and should be monitored for signs of corrosion coming through the Black Gold sealer in the future.

1. Monitor the performance of the metal sealer and armor coat paying special attention to the locations where corrosion existed prior to application.
2. Continue to monitor the performance of the bridges painted in 1962 in Western Oklahoma.

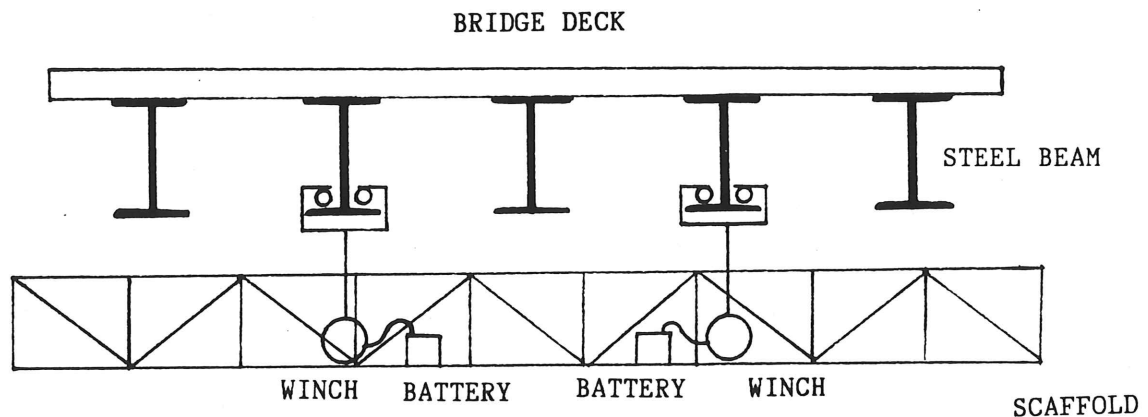
Figure 3. Scaffold Setup.

The painting contractor erected a steel scaffold which attached rollers to the second and fourth beams of a five beam wide bridge. The scaffold could be raised and lowered by two battery powered winches each attached to a beam above. The scaffold could then be moved laterally within each bay simply by rolling on the beams bottom flanges. Figure 3 depicts the scaffold erected and ready for use by painters. This scaffold setup was used for cleaning as well as paint application.
