STRESS WAVE TIMING, A SIMPLISTIC AND COST
EFFECTIVE METHOD TO EVALUATE
DETERIORATED AND REPAIRED
TIMBER BRIDGE PILES

Submitted to the Faculty of the Graduate College
of the Oklahoma State University in
partial fulfillment of the Degree of
MASTER OF SCIENCE
July, 2007

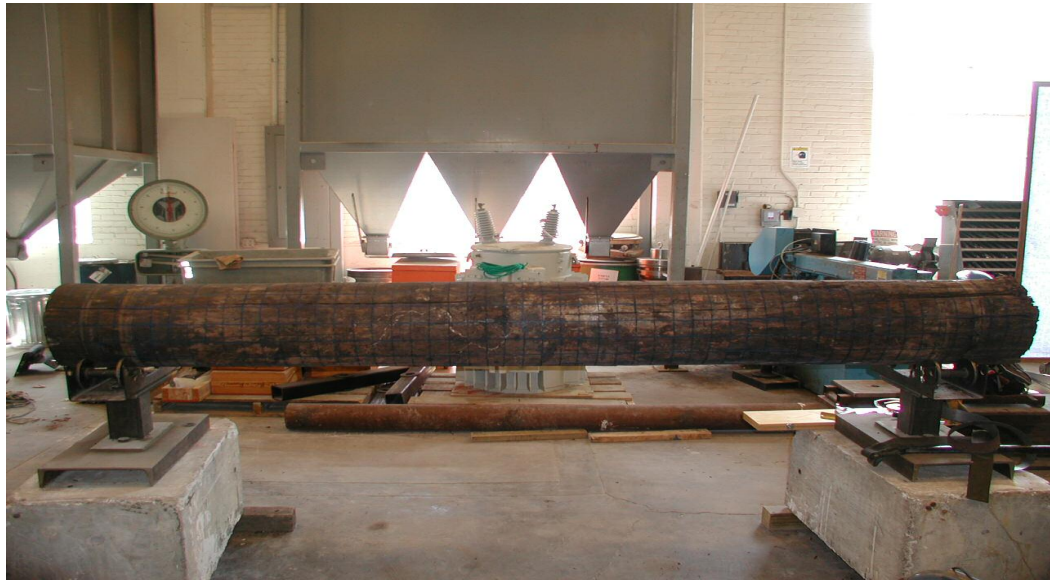
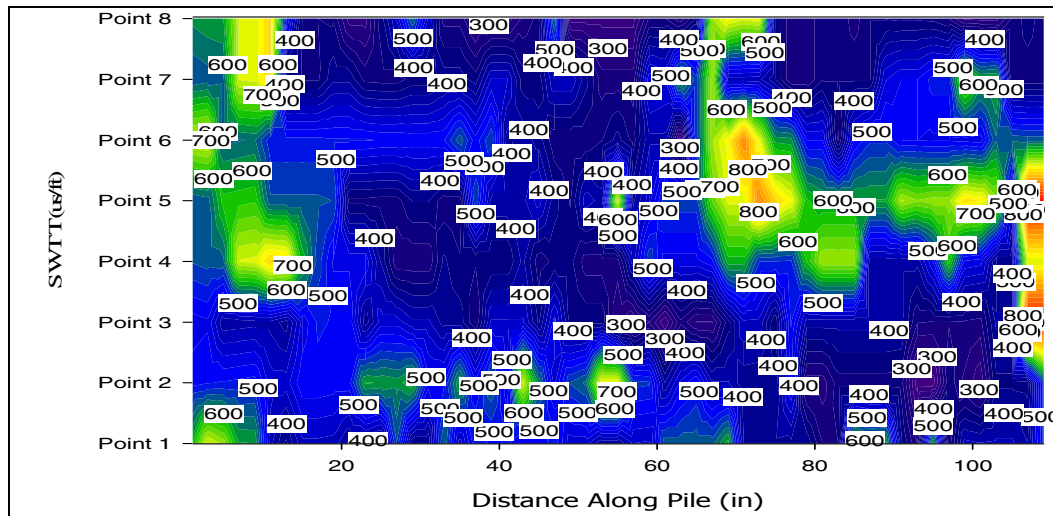
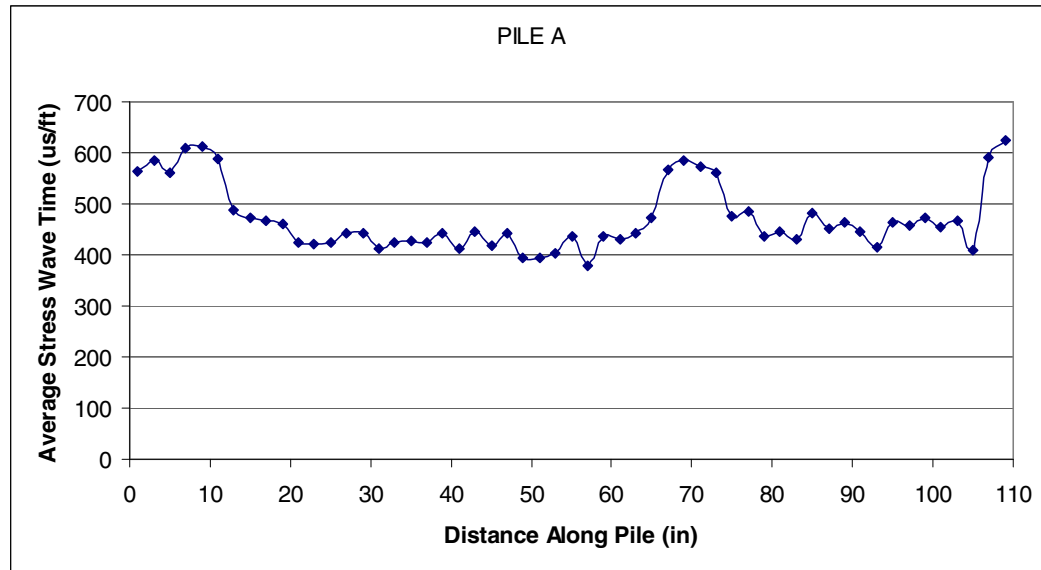
Figure 4.1. Photo of Pile A

the results from Table 2.1 for sound wood are in the 200-400 μ s/ft region. The values of 200-400 μ s/ft was considered the upper boundary for sound wood for this project. The boundaries for early decay were considered to be 400-500 μ s/ft. The boundaries for moderate decay were considered to be 400-800 μ s/ft. Any values above 800 μ s/ft were considered severe decay.

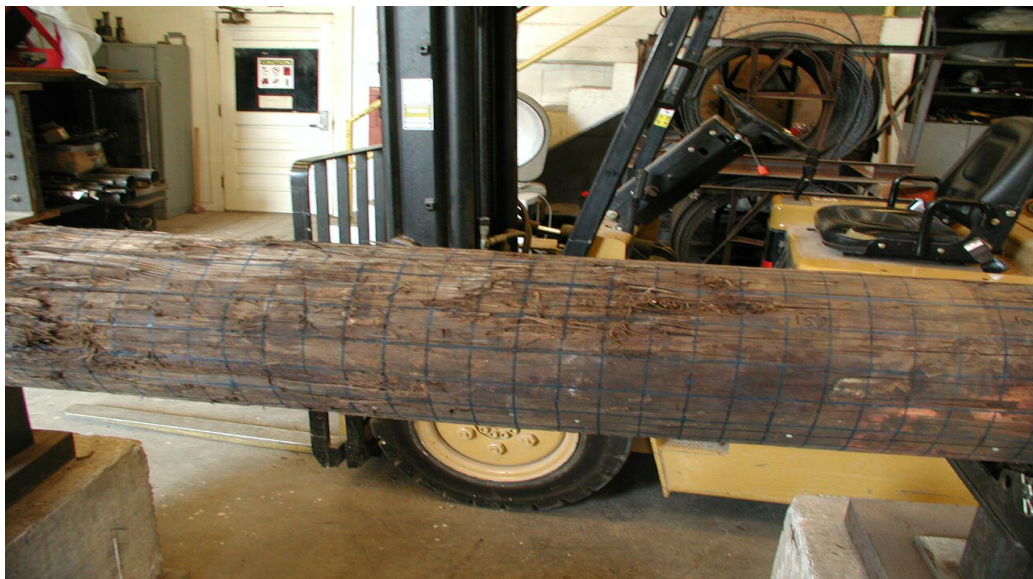
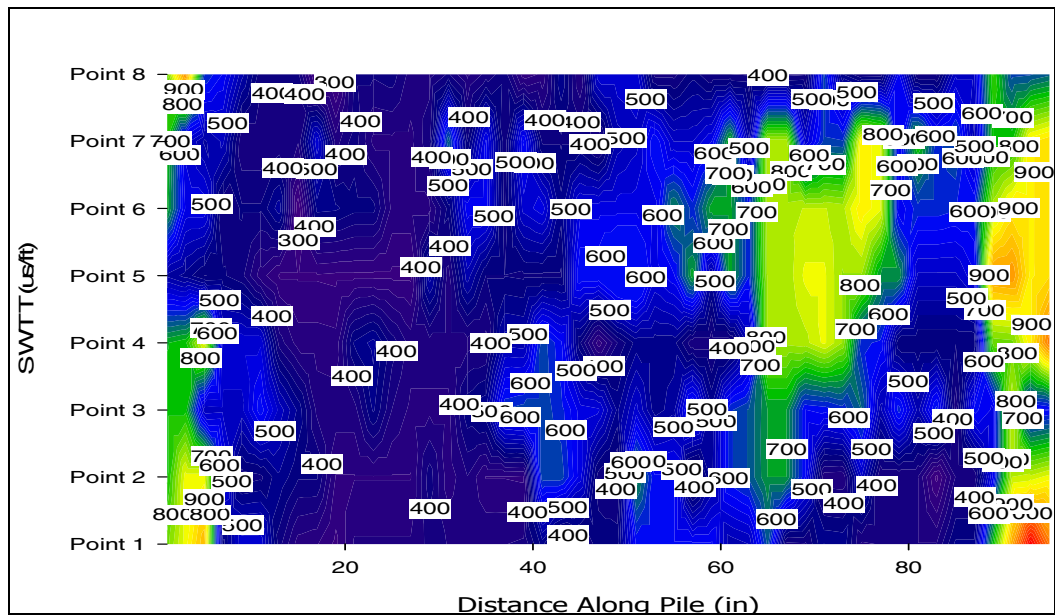
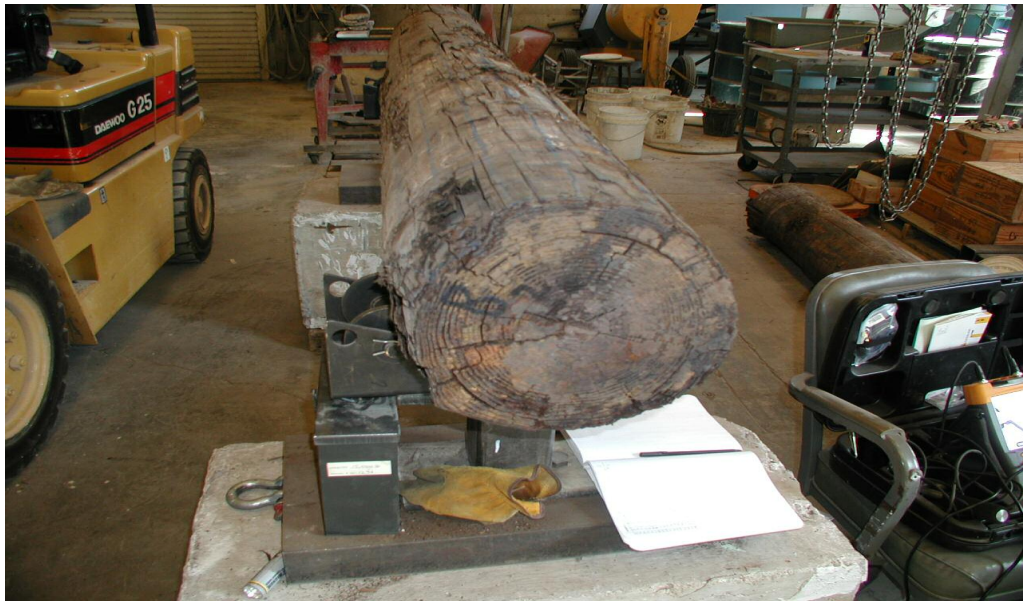
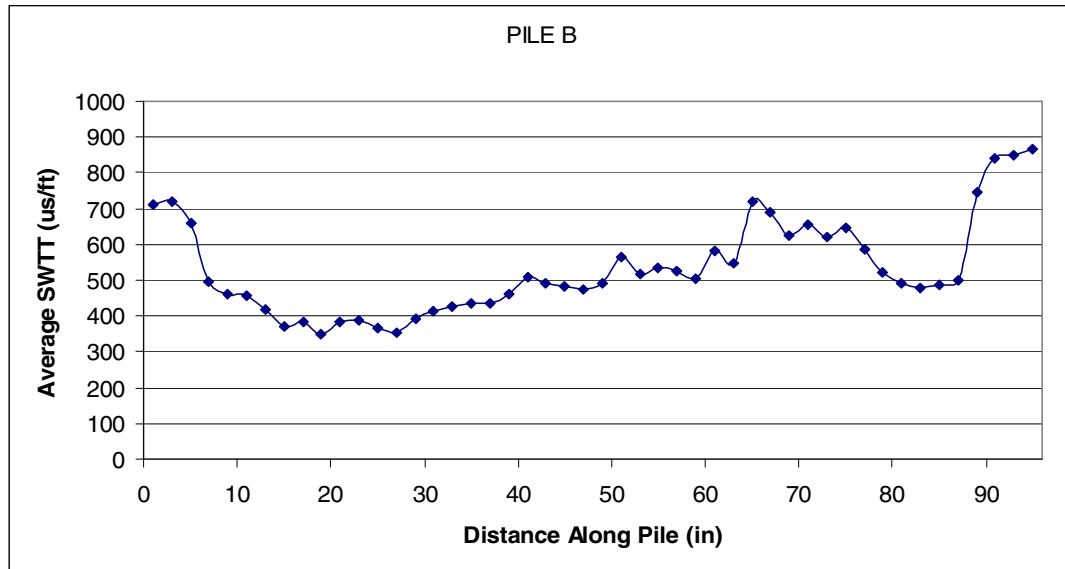
Figure 4.6. Photo of Pile B

Pile B was a length of 98 inches and the largest diameter recorded was 12.2 inches before repair. Figure 4.6 displays a photo of Pile B. From visual inspection Pile B is well intact but has certain sections where the outer surface was damaged, most likely during extraction. Figure 4.7 shows a map of the stress wave transmission time throughout Pile B. The highest recorded SWTT was over $1000\mu\text{s}/\text{ft}$ and the readings were taken at the ends. Visually the ends have a lot of cracks. Figure 4.8 illustrates an end view of Pile B. Most of SWTT for Pile B are between $400\text{--}600\mu\text{s}/\text{ft}$. The region between 60-80 inches has high SWTT.

Figure 4.9 displays the average SWTT. Pile B is also at the stage of early to moderate decay because most of the values are above 200-400 $\mu\text{s/ft}$. The region around twenty inches can be considered to be sound wood.

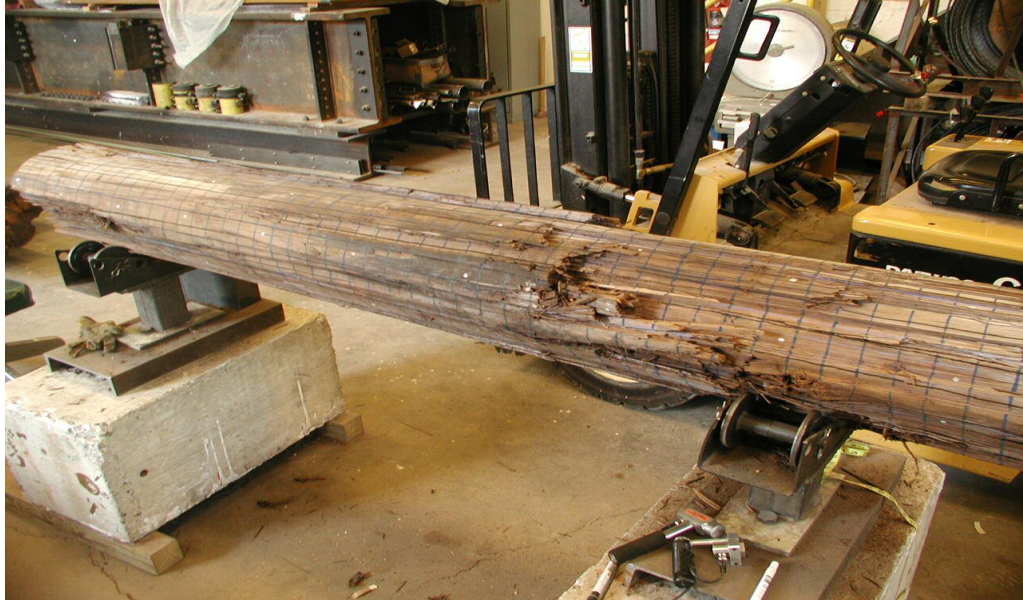
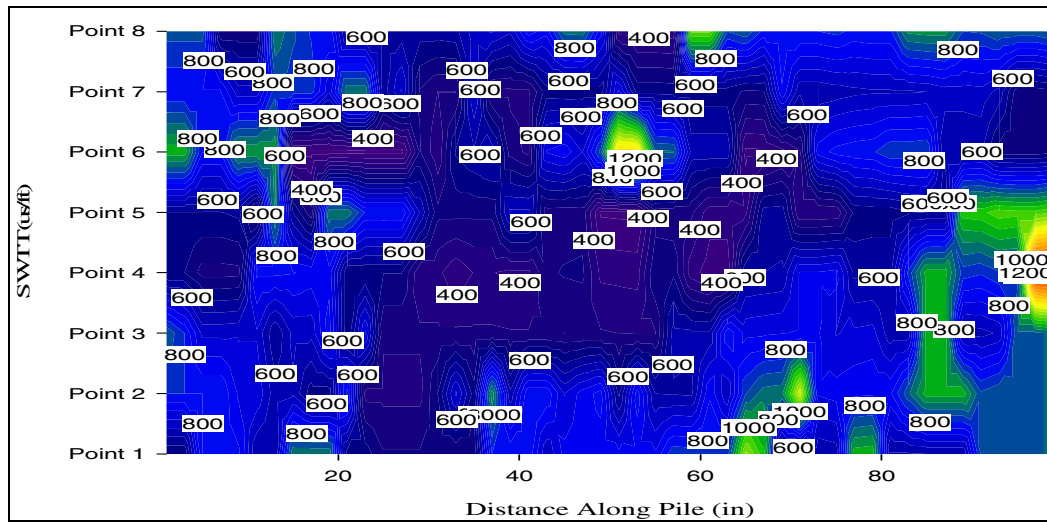
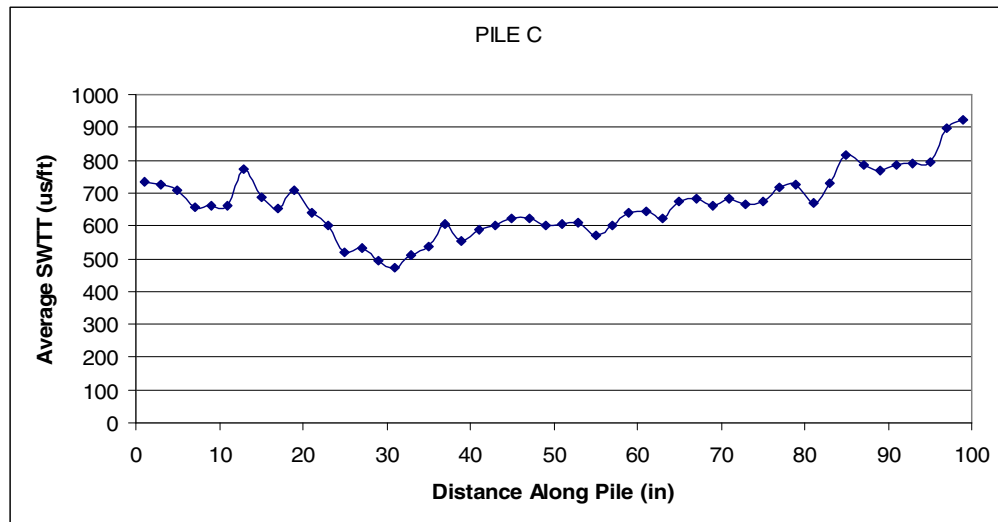
Figure 4.12. Photo of Pile C

Figure 4.13 shows a map of the stress wave transmission time throughout Pile C. The highest recorded SWTT was over $1600\mu\text{s}/\text{ft}$ and the readings were taken at the right end. Also, at 50 inches along the pile there were SWTT measured to be over $1300\mu\text{s}/\text{ft}$. Most of the SWTT for Pile C are between $400\text{--}700\mu\text{s}/\text{ft}$. All the values are above the $200\text{--}400\mu\text{s}/\text{ft}$ so this pile has early to moderate decay with some areas with advance decay.

Figure 4.14 displays the average SWTT. All the average values are well above the sound wood criteria of 200-400 μ s/ft.

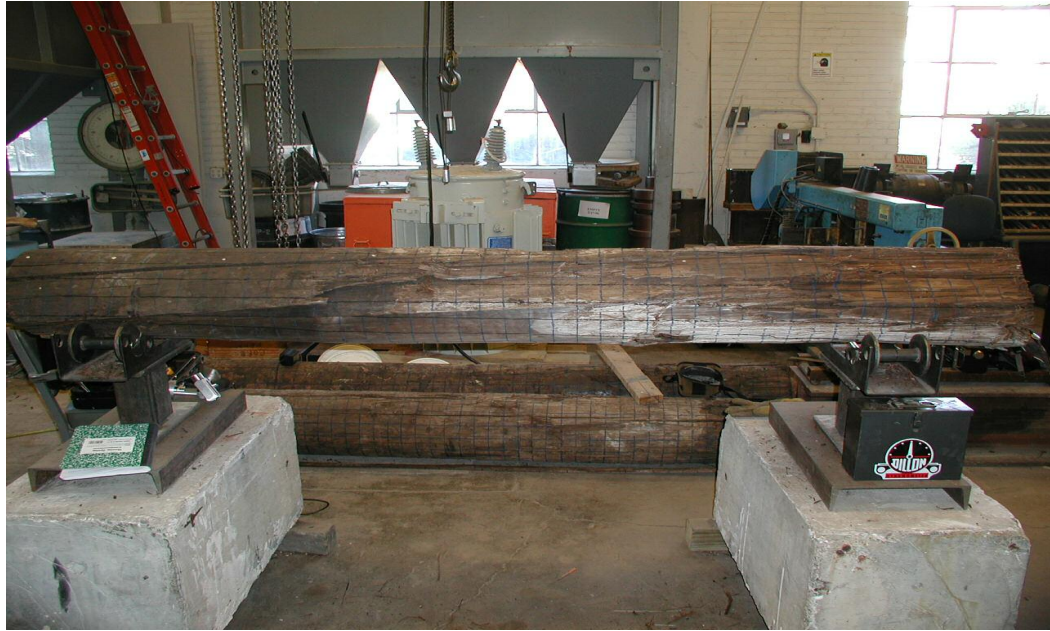
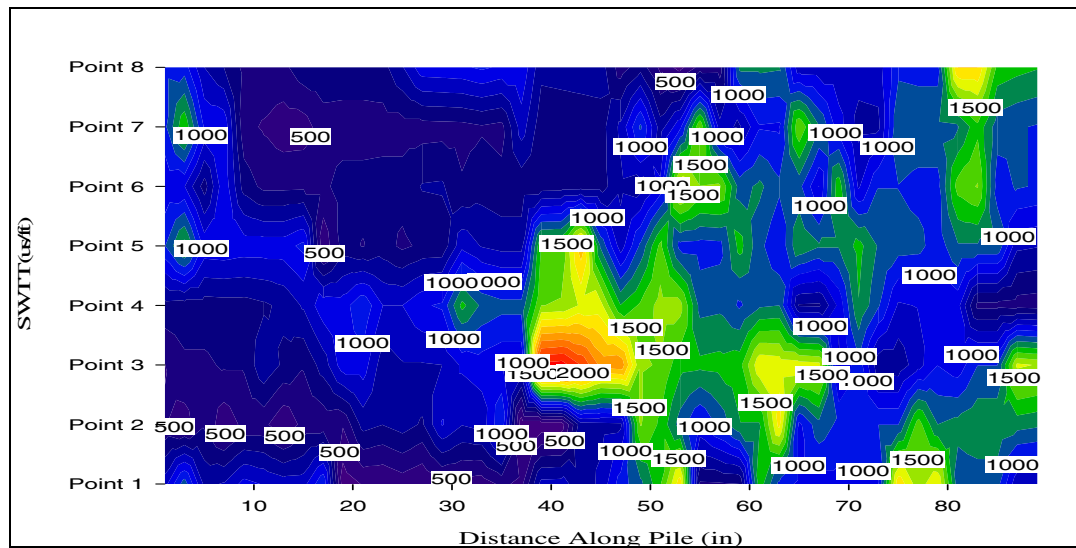
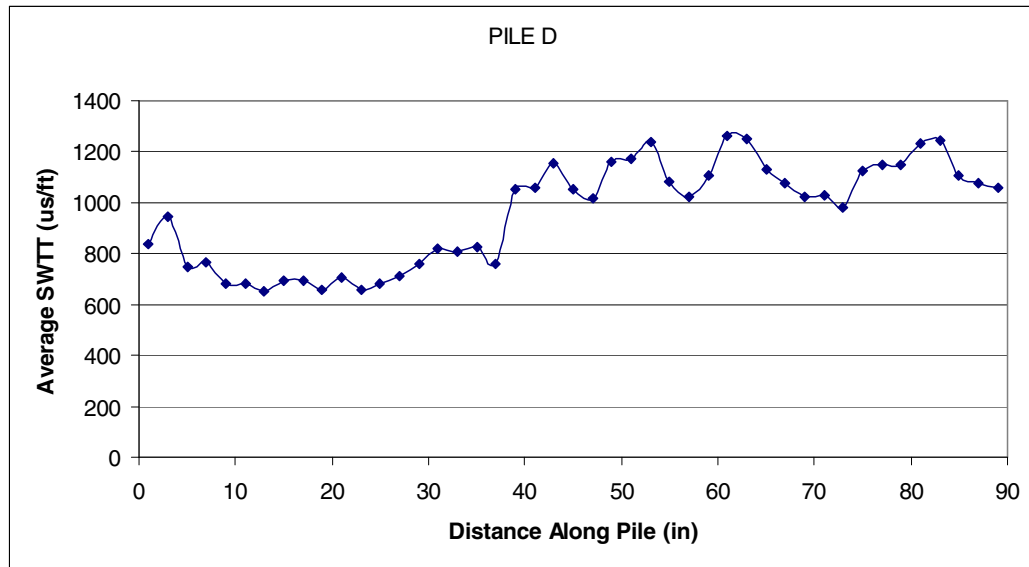
Figure 4.16. Photo of Pile D

Pile D was the shortest and lightest pile of the nine piles. Figure 4.16 displays a photo of Pile D. From visual inspection it can be seen that there is decay present on the outside of Pile D. The figure shows the decay on the pile which is the white area. The outer surface was severely damaged with much of the outer shell missing. Figure 4.17 shows a map of the stress wave transmission time throughout Pile D. The highest recorded SWTT was over 1700 μ s/ft. Most of the SWTT for Pile D is above 1000 μ s/ft. The regions from 40 inches to 90 inches have the highest SWTT values, and this is the area where the decay can be seen on the surface. Pile D at 30 inches to 91 inches is at the stage of severe decay. The rest of the pile is at moderate decay.

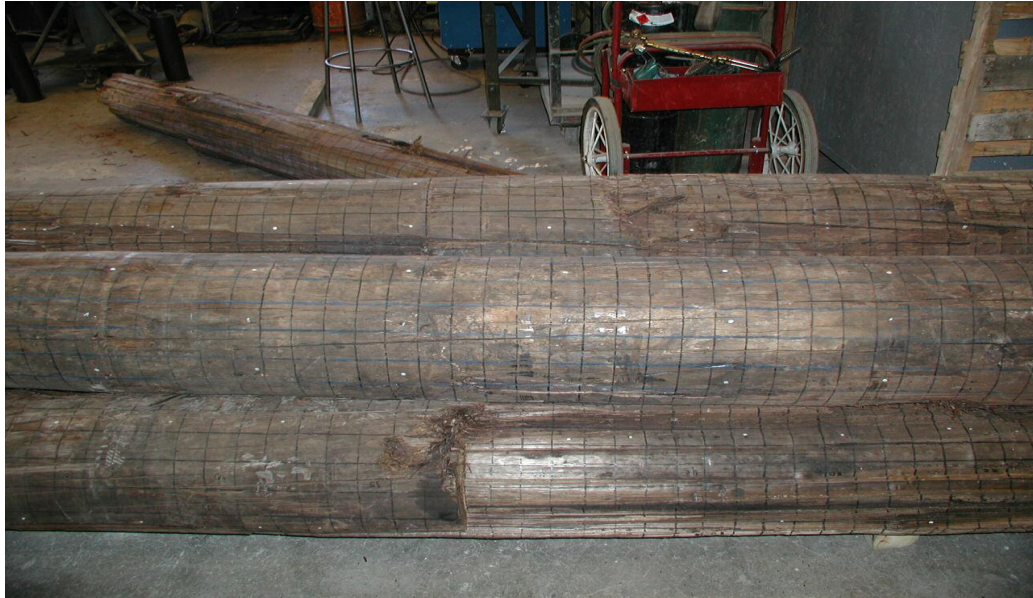
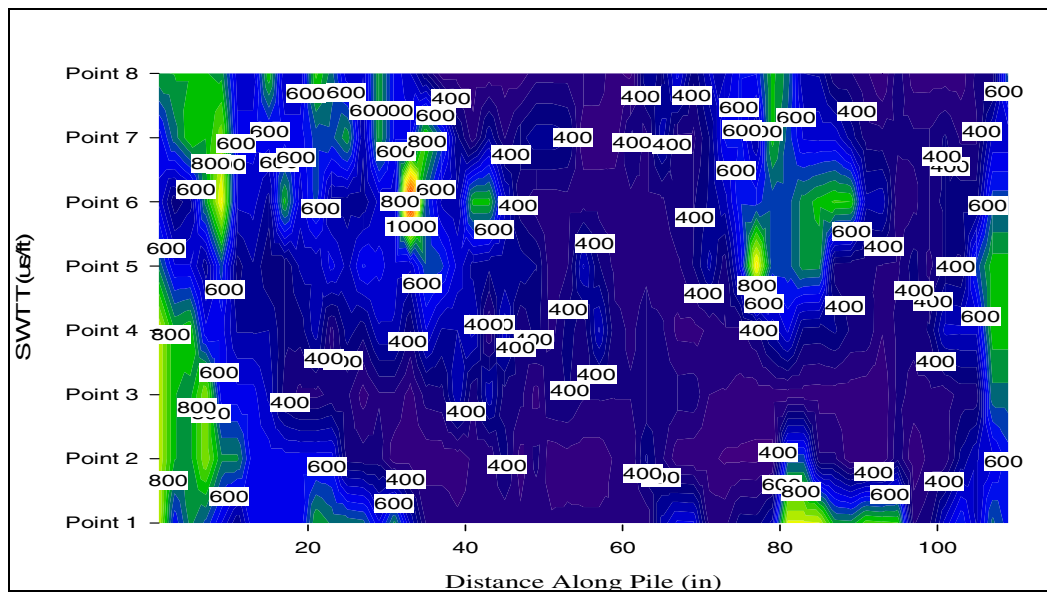
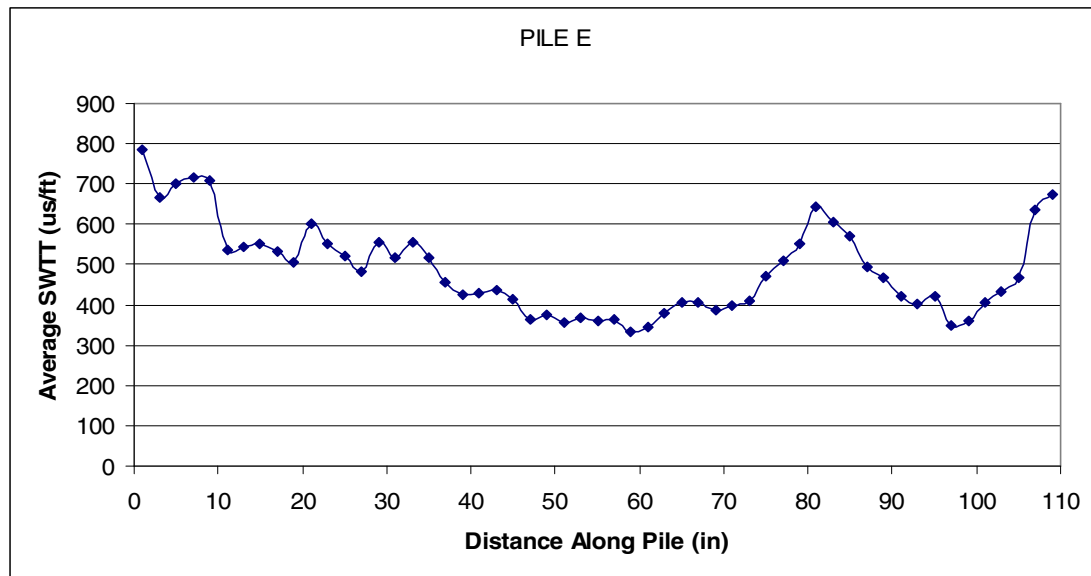
Figure 4.20. Photo of Pile E

extraction. Pile E was a length of 111.5 inches and the largest diameter recorded was 13.6 inches before repair. Figure 4.21 shows a map of the stress wave transmission time throughout Pile E. The highest recorded SWTT was over 1300 μ s/ft. The left end has a lot of cracks; this is why the SWTT values are high. Most of SWTT for Pile E are between 400-500 μ s/ft.

Figure 4.22 illustrates the average SWTT values. The ends have the highest stress wave times, and the middle from 45 inches to 75 inches seems to be sound wood.

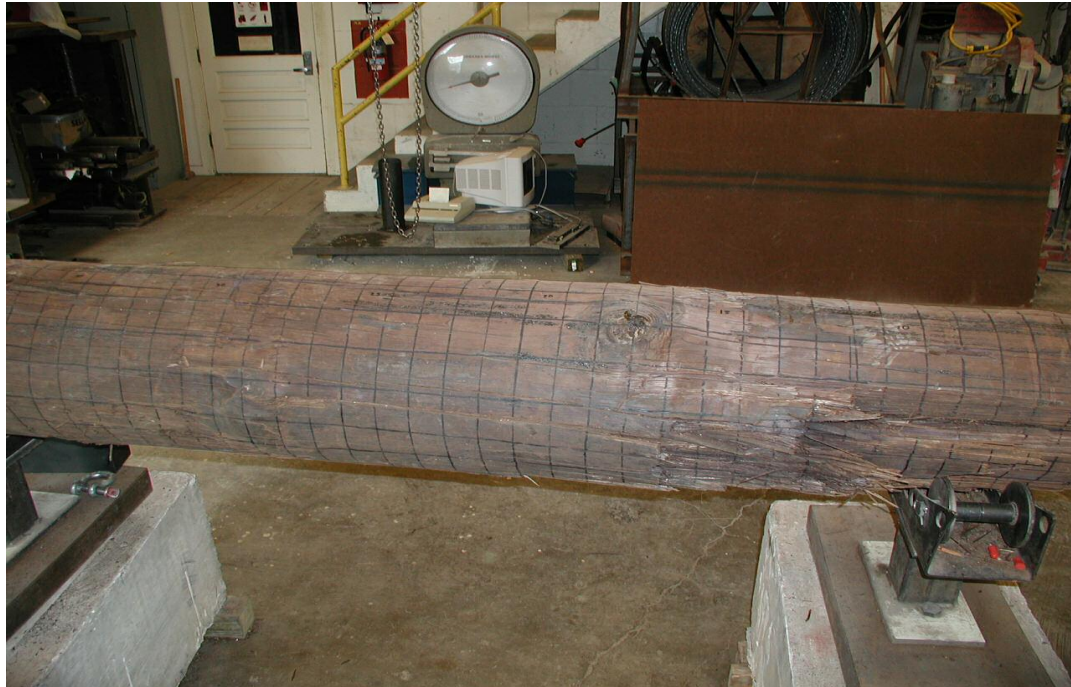
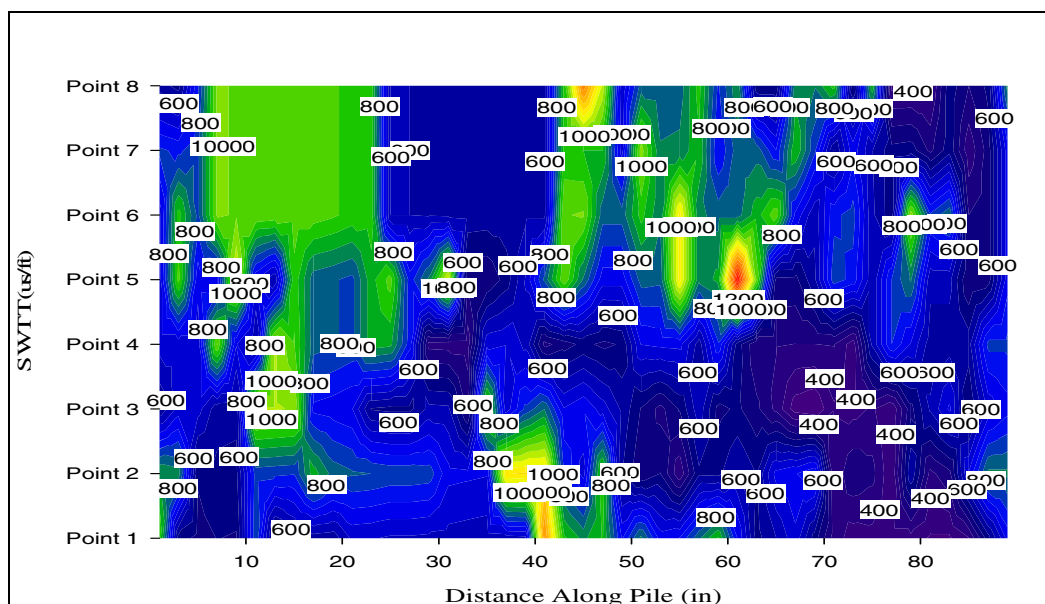
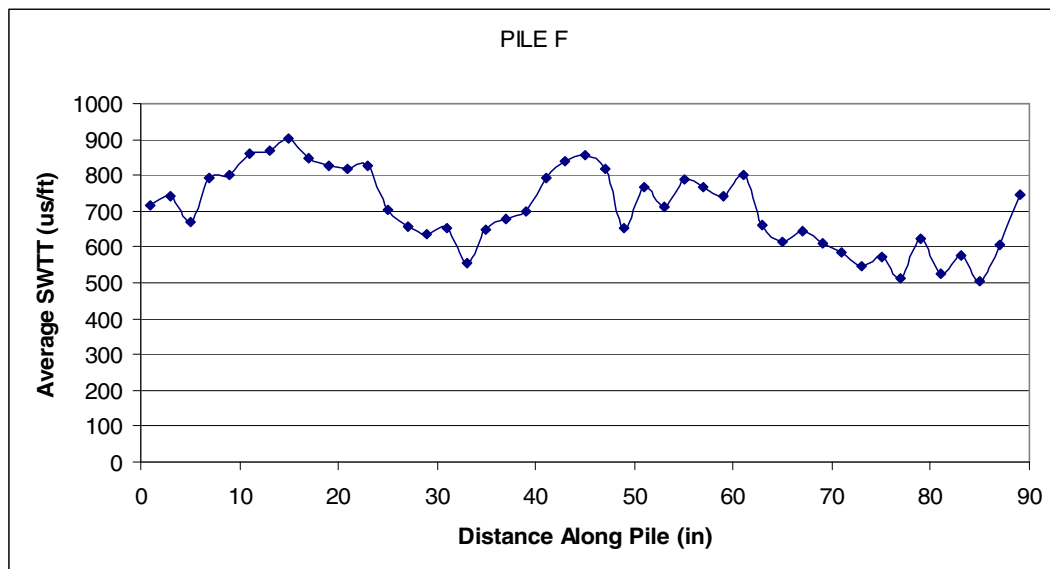
Figure 4.25. Photo of Pile F

wave transmission times. The end that was badly damaged has high SWTT values. The highest SWTT recorded was over 1600 μ s/ft. The pile has moderate decay with some regions of advance decay.

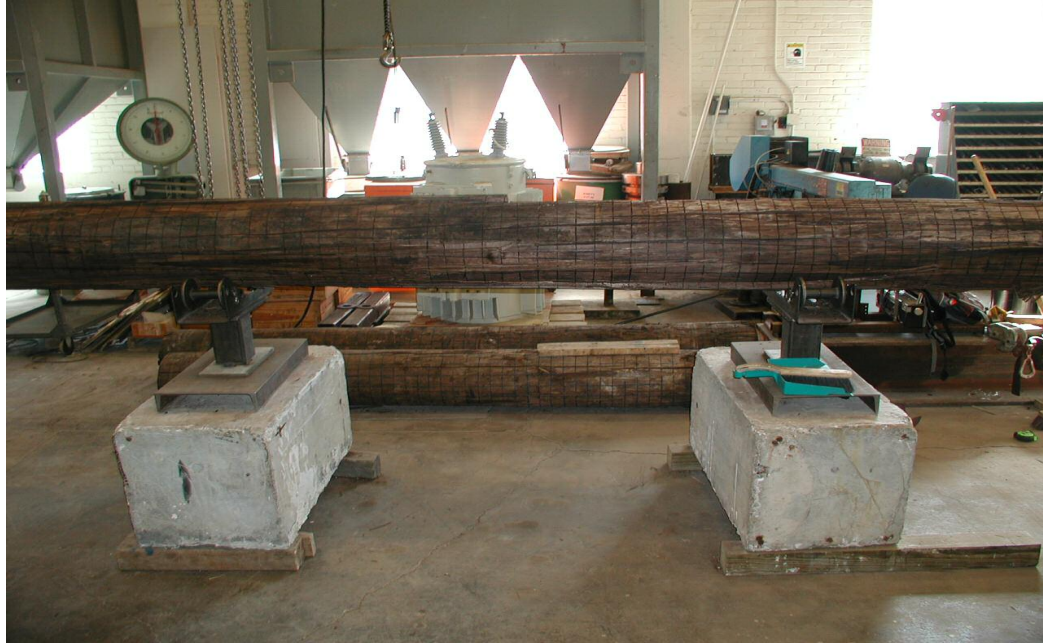
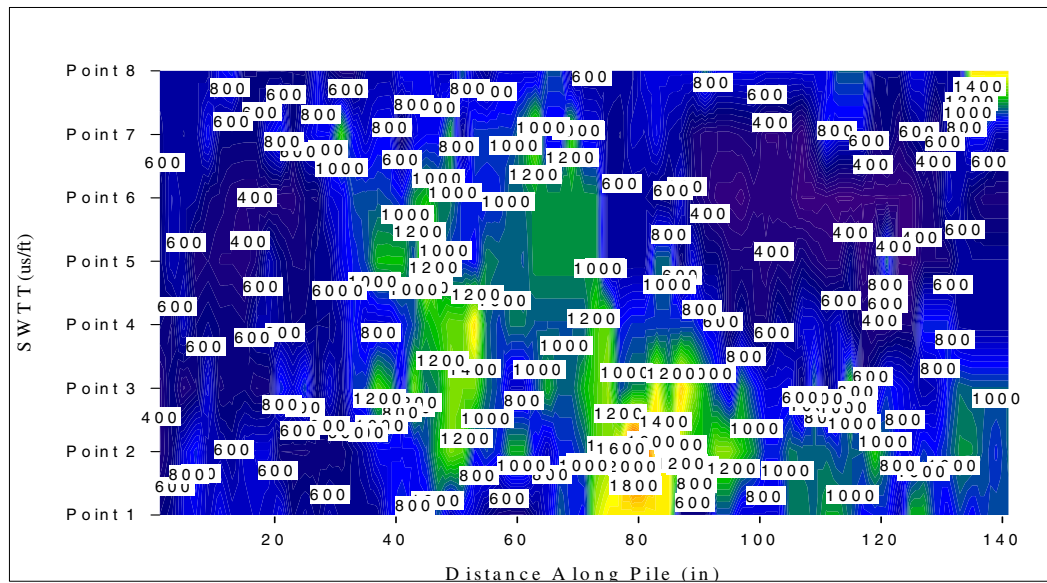
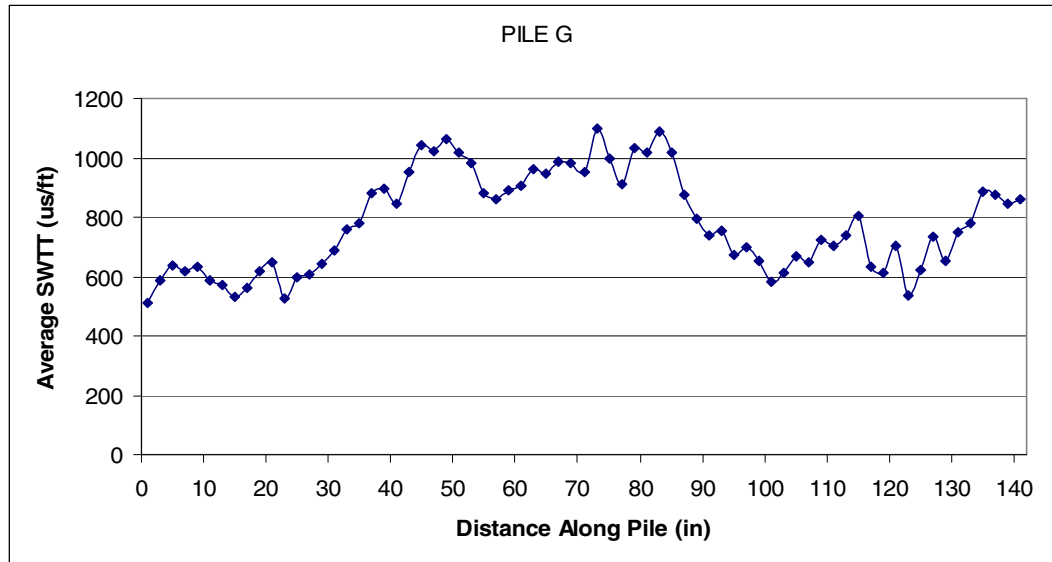
Figure 4.29. Photo of Pile G

The final three piles are the longest in length. The longest piles were damaged the most during removal from the bridge in Oklahoma. Pile G was measured to be 142.5 inches. A photo of Pile G is in Figure 4.29. Pile G was extremely damaged during extraction. Cracks can be seen all around the perimeter of the specimen. Most of the outer shell is weak and could be easily torn apart by hand. No visible decay is present on the outer surface. Figure 4.30 illustrates a layout of the stress wave transmission time throughout Pile G. There are some areas in the pile that has early decay. The early decay is present where the darker shade of blue can be seen in the figure. Around the regions of early decay are higher SWTT values, this seems to be moderate decay. The green, yellow and red regions seem to signify advance decay. The red region is at Point 2 and 80 inches in the figure.

The average SWTT for Pile G are in Figure 4.31. There is no clear trendline for the stress waves in pile G. The SWTT for Pile G is scattered probably due to the damaged suffered during extraction. The results are as low as 500 μ s/ft to as high as 1100 μ s/ft. It is clear though that the pile has moderate to advance decay.

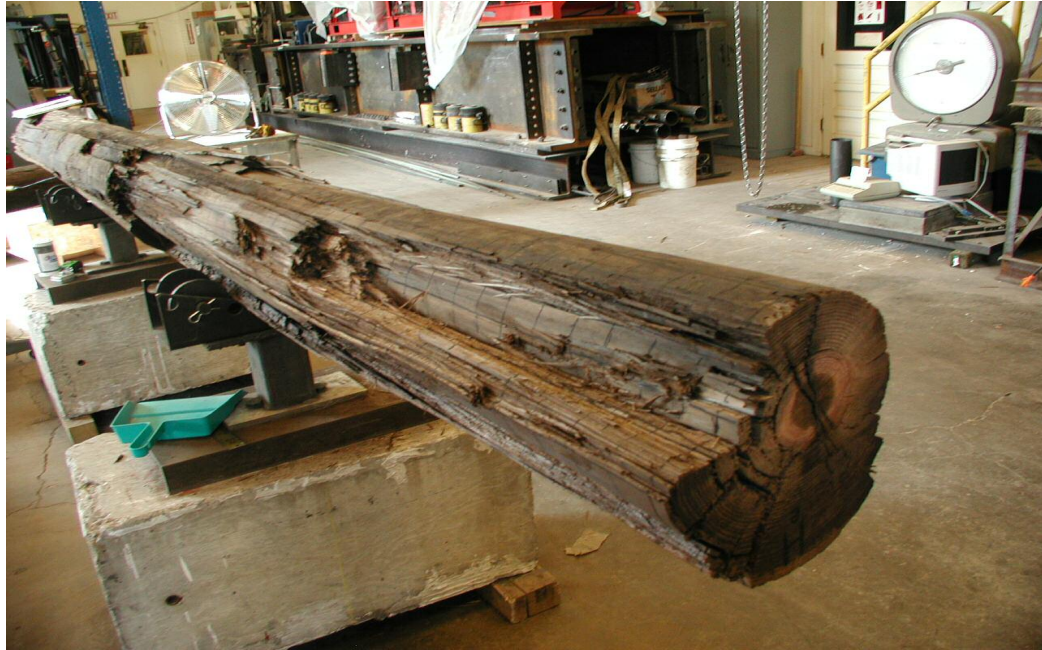
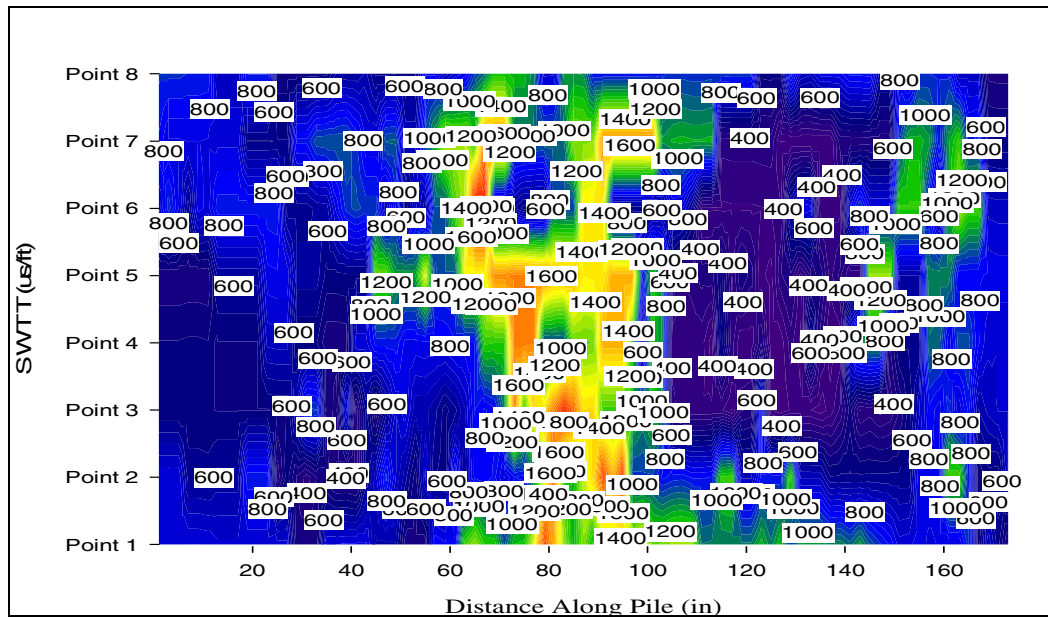
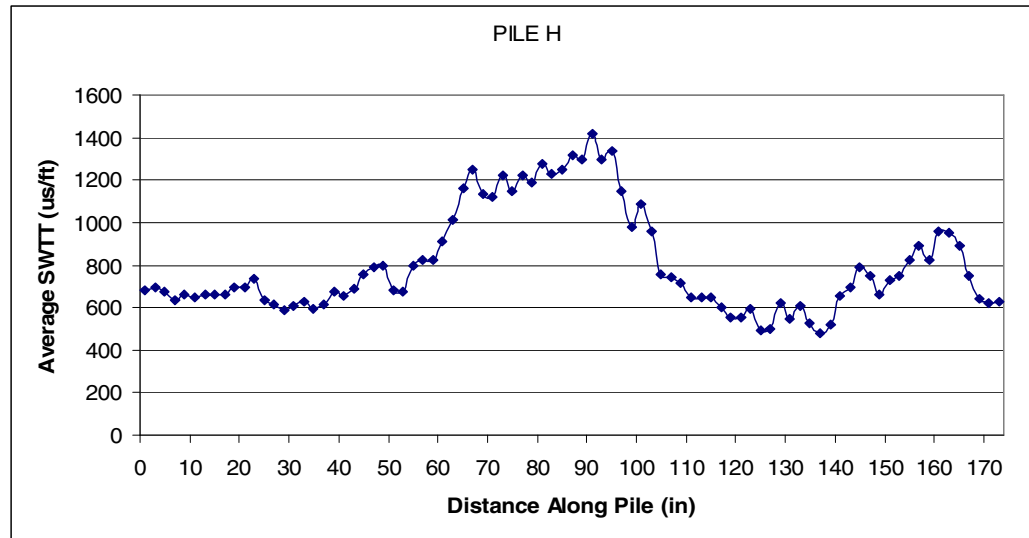
Figure 4.33. Photo of Pile H

As seen in the Figure 4.33, Pile H was severely damaged. Cracks and splits can be seen all around the perimeter of the pile. The right end was the area that was most severely damaged. The stress waves recorded from the middle to the right end were difficult to record. Perpendicular strikes to the wood were almost impossible due to the extent of the damaged on Pile H. Figure 4.34 illustrates that the highest SWTT for Pile H are in the middle of the pile. The right end also has high SWTT values even though the diameter was smallest in that region. The middle of the pile has advance decay. To the right of the advance decay seems to be early decay. The rest of the pile has moderate decay.

Figure 4.35 also illustrate that the highest SWTT of Pile H are in the middle. It is clearly seen that all of the pile has some type of decay.

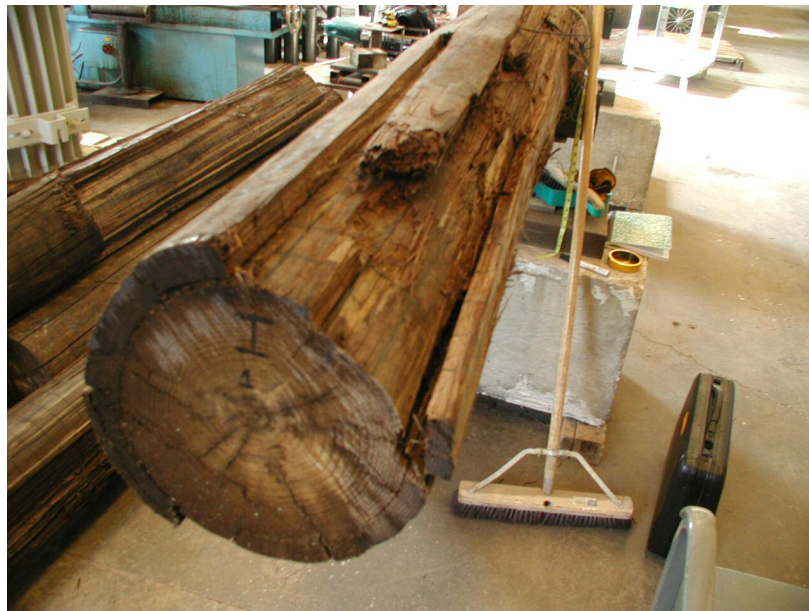
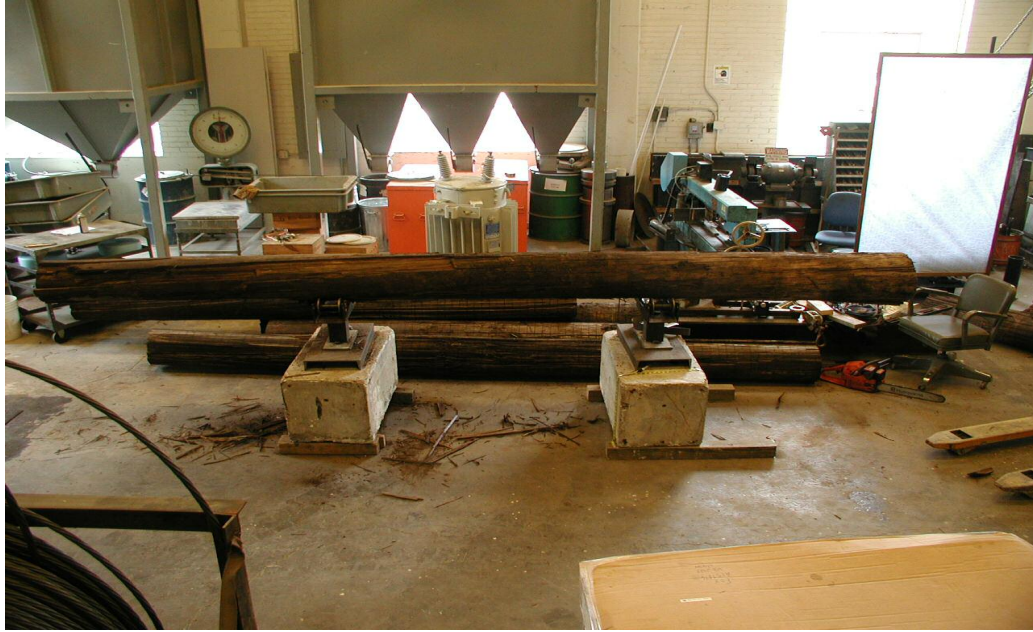
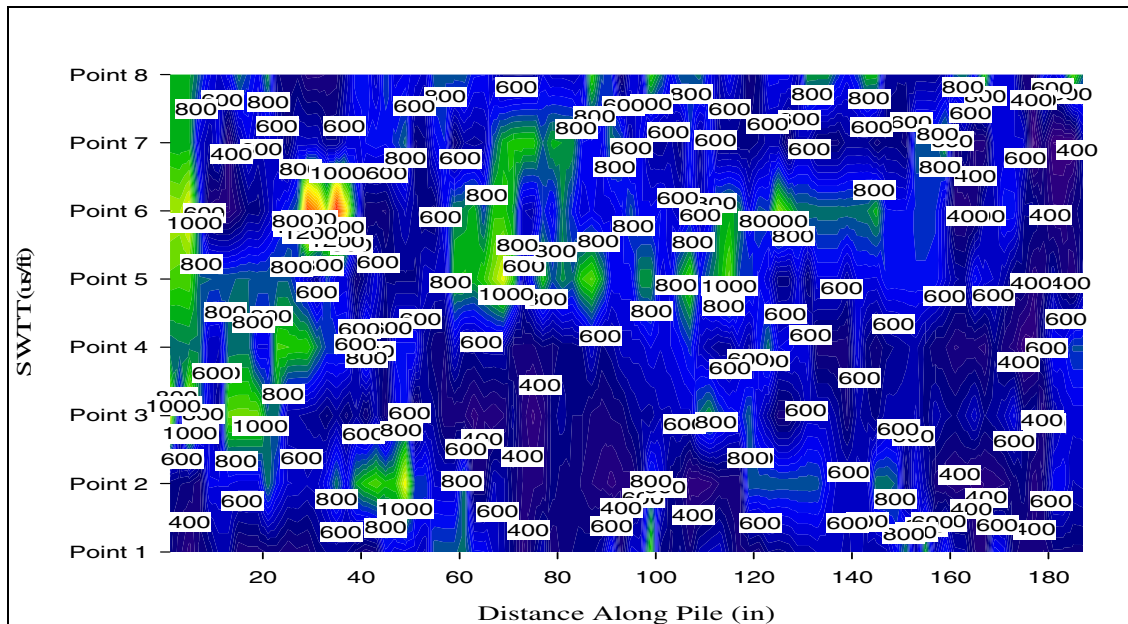
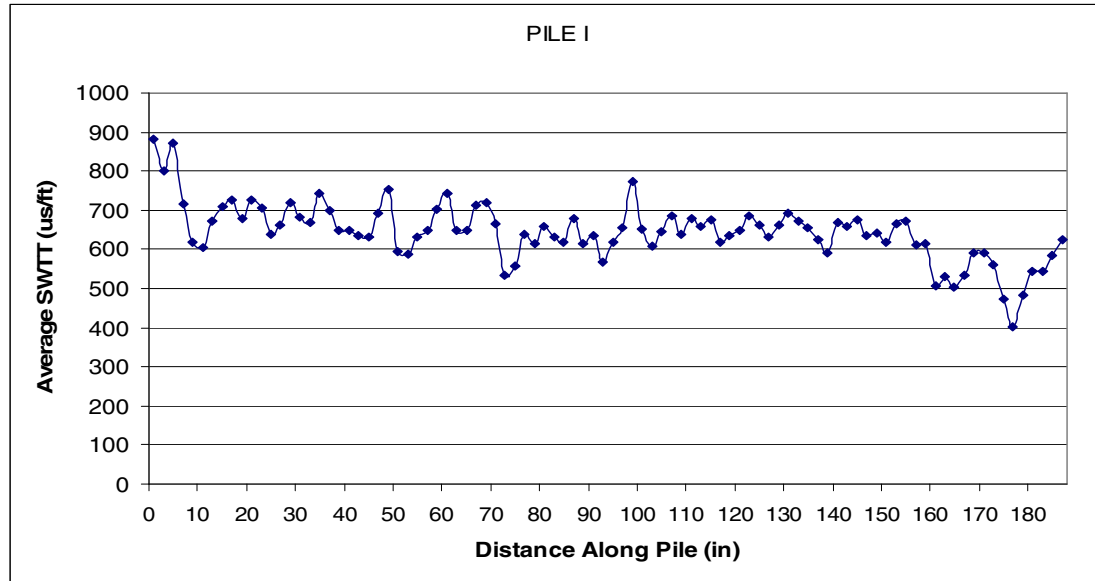
Figure 4.39. Photos of Pile I

Pile I is very similar to Pile H on the exterior. Photo of Pile I are in Figure 4.38 and in Figure 4.39. Pile I has lost a lot of its' outer shell. Figure 4.38 displays the damage the pile has endured on the left side. Even though the outer shell seems to be weak, the inner area seems well intact. The length of Pile I was the greatest at nearly 190 inches. The diameter of the pile ranges from 11.2 inches to 14.0 inches. Figure 4.40 illustrates the layout of the stress waves through Pile I. The left end of the pile has the slowest stress wave velocity and this is shown by the shades of green. The yellow/orange area has the highest values of stress waves recorded. The rest of the pile is in the blue region which signifies early decay.

If a trend line is to be placed in Figure 4.41, it would approximately be between 600-700 μ s/ft. These are the values for moderate decay. The whole pile is above the sound wood criteria of 200-400 μ s/ft.

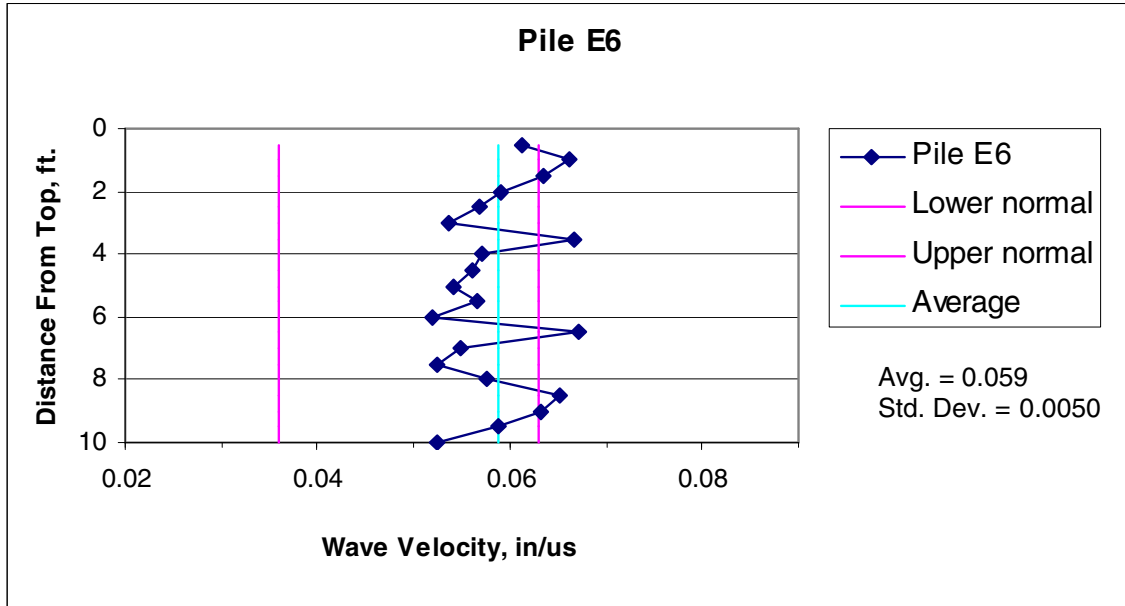
Figure 5.15. Stress Wave Velocity through Timber Pile, E6

of the pile should probably be rechecked at regular intervals to ensure no further deterioration occurs.
