PERFORMANCE OF ULTRA THIN WHITE TOPPING
IN OKLAHOMA

Submitted to the Faculty of the
Graduate College of the
Oklahoma State University
in partial fulfillment of
the requirements for
the Degree of
MASTER OF SCIENCE
July, 2011

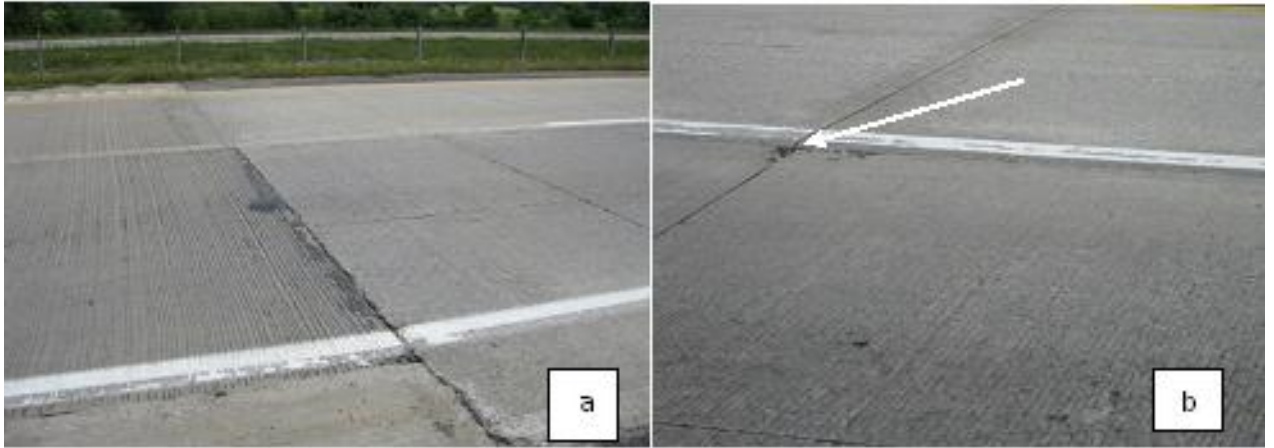
The overall condition of this overlay looks excellent. However, a few problems were observed. Joint raveling was a common problem which was observed as shown in Fig. 2.6 b. Some longitudinal cracks were seen covering multiple panels from 2 panels to 9 panels long. In total, 38 panels had visible cracks, which is about 1% of the total number of panels. Some examples of the longitudinal cracks are shown in Fig. 2.7. The passing lane was in better shape as compared to the driving lane. This is as anticipated as the travel lane would be expected to see significantly more traffic than the passing lane. Also in the driving lane the right wheel path showed more wear when compared to left wheel path. This may be due to the presence of an asphalt shoulder for this overlay. An asphalt shoulder would not provide as much support as the adjacent concrete lane. At about 0.2 miles from the start of the overlay a core had been taken for previous testing. However, it was not refilled well; the filler material has been removed over time, as shown in Fig. 2.8. The drainage for this system was excellent.

Figure 2.6 - Photo a showing the start of the overlay at north end. Photo b shows typical joint raveling seen.

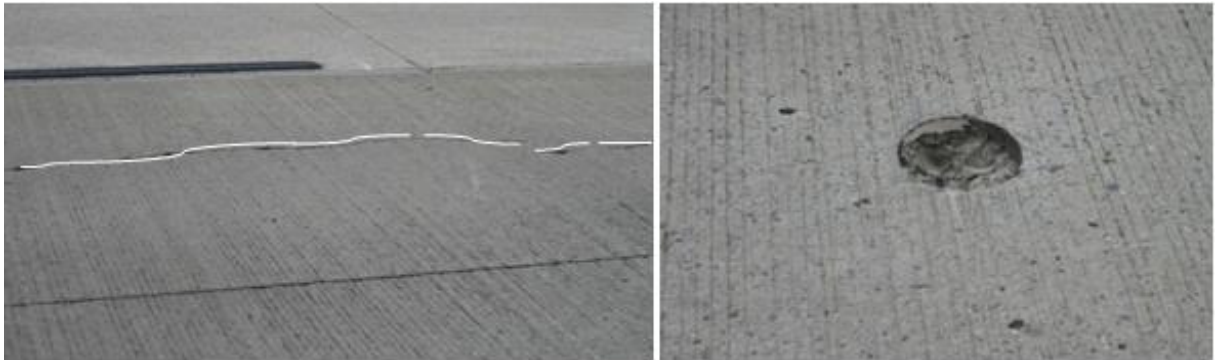
Figure 2.7 - Longitudinal Cracking spanning over panels **Figure 2.8** -Testing core not refilled well.

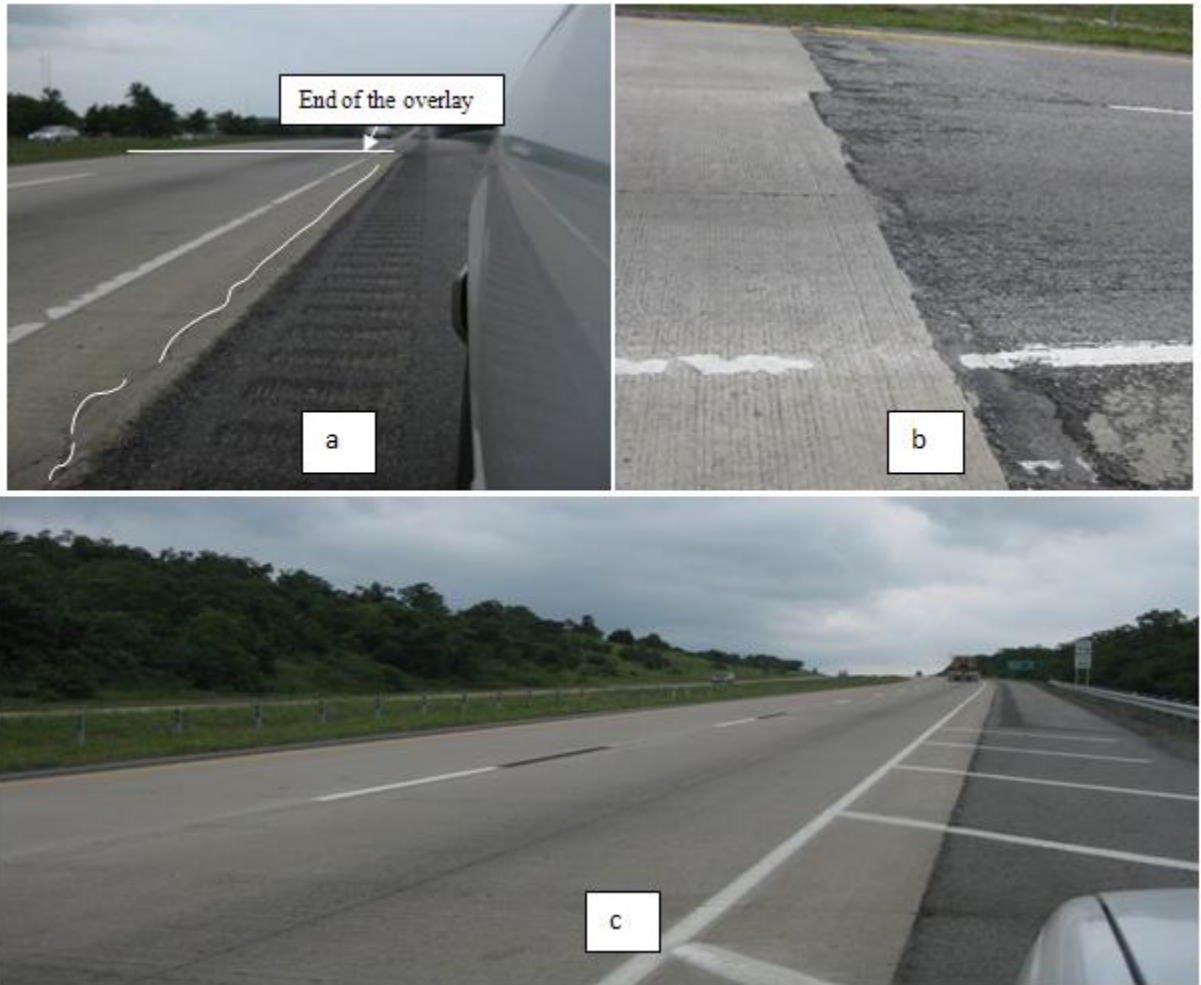
A longitudinal crack that covered 13 panels on the outside of the pavement was seen, as shown in Fig. 2.9 a. Faulting was seen at the end of the overlay. The last seven panels had problems with faulting. Occasional grinding on the surface was seen on these panels. This south bound overlay ended at an asphalt pavement as shown in Fig. 2.9 b. The end was also the top of a hill as shown in Fig. 2.9a.

Figure 2.9 - Photo a shows the 13 panel long longitudinal crack at the end of the overlay. Photo b shows the transition of concrete into asphalt at the end of the overlay. Photo c shows overall good condition of the overlay.

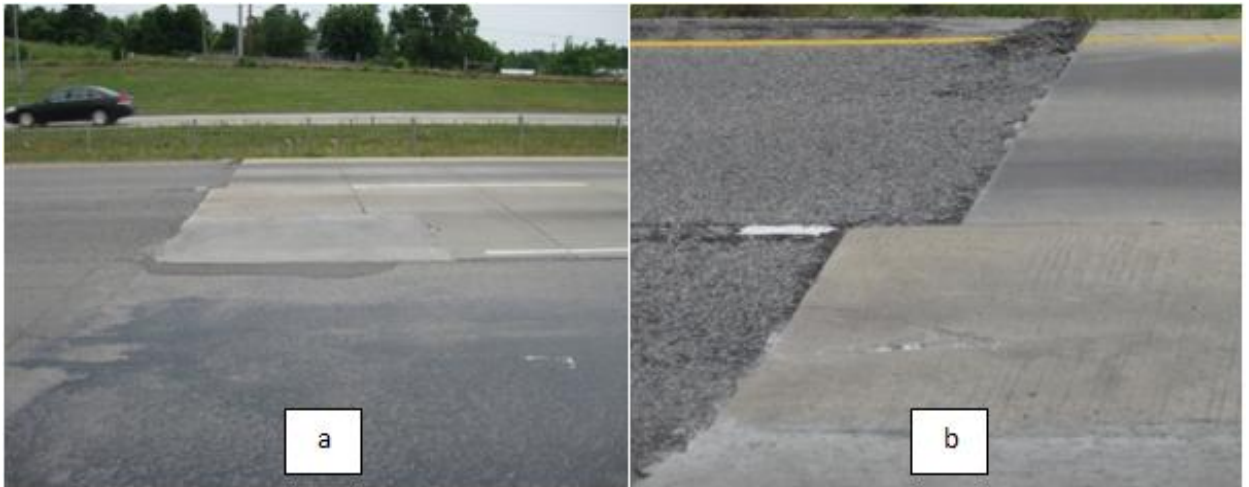
The overall condition of this overlay looked very good. However, there were some problems observed. The initial panels had been replaced with a new concrete panel (Fig. 2.10 a). A definite elevation difference was seen between the asphalt pavement and the approach thin white-topping panel at the beginning of the project. The elevation difference was very significant, with some cracking observed in the approach panels even after the replacement (Fig. 2.10 b). Some heavy polishing was seen in both driving and passing lanes of the overlay, stretching to over 30 panels in length. Longitudinal cracking was also seen, but it was insignificant as it was just at a couple of places over the overlay and also spanned only for two panels. At about 0.7 miles after the start of the overlay (at exit for US 270 west on the highway), two punch outs were seen, as shown in Fig. 2.11. Some corner cracking was also observed where the approach ramp meets the overlay after this exit. None of the problems stated above were extensive, but they should be monitored for future deterioration. The end of the overlay looked good without any sign of distress, as shown in Fig. 2.12, as it ends in a concrete bridge. Also, drainage of this overlay looked quite good and satisfactory.

Figure 2.10 - Initial panel replacement at the start of overlay as seen in photo a, and in photo b we see how there is an elevation difference between the leaving asphalt panel and approaching concrete panel.

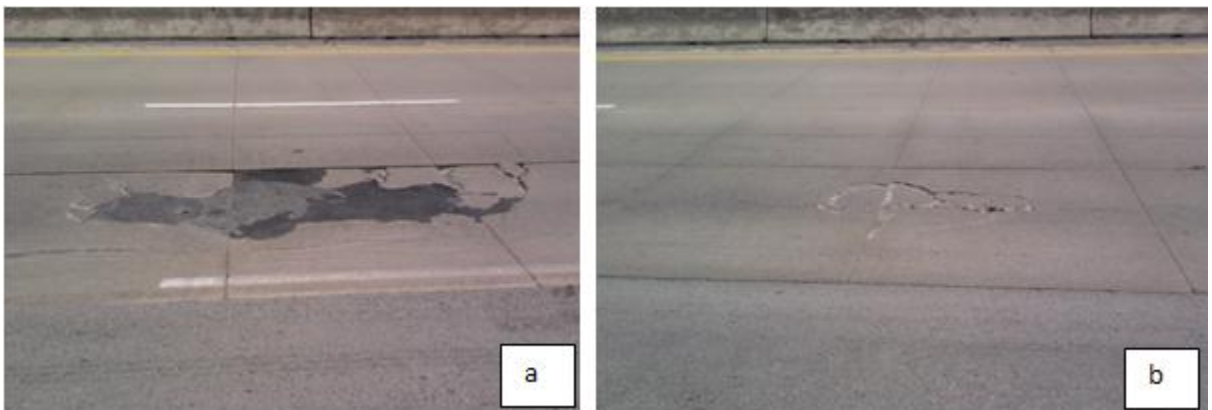
Figure 2.11 - Punch outs at the exit for US 270 west. These two punch (photos a and b) outs are about ten panels apart from each other.

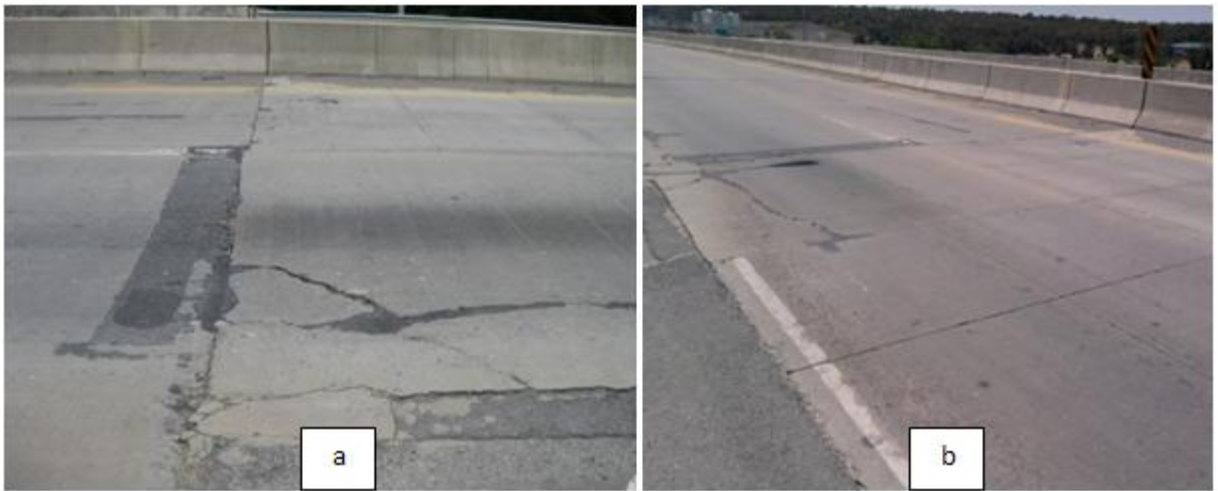
This overlay starts at the end of a concrete bridge in McAlester. The overlay has shown good performance apart from the initial panels. The initial panels have heavy block cracking, as shown in Fig. 2.13 a. The driving lane of the overlay has a continuous replacement panel and not the thin white-topping overlay seen in the passing lane, as shown in Fig. 2.13 b. The reason for these failed initial panels could not be determined. Some minor longitudinal cracking, scaling and polishing were observed in the passing lane. However, they probably are caused by normal wear. At about 0.2 miles from the south end of the overlay, heavy surface scaling and corner cracks were observed in the driving lane. Similar heavy abrasion and scaling was again observed in the passing lane about 0.8 miles from the south end of the overlay.

Figure 2.13 - Initial panels facing block cracking as shown in photo a. The first panel is replaced after initial failures with a full size panel as shown in photo b.

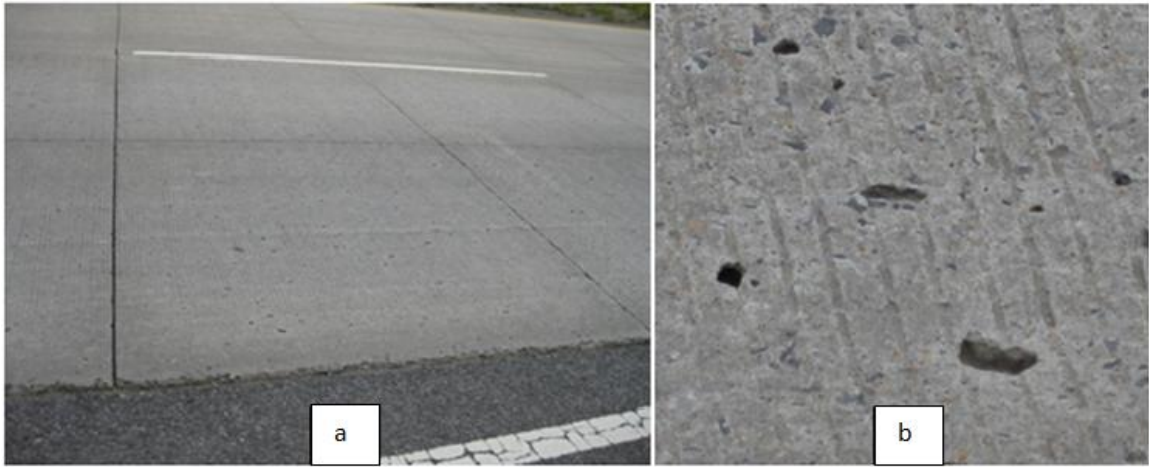
Some pop outs were seen about 0.5 miles from the south end of the overlay. About 24 panels showed pop outs with approximately 20 per panel, as shown in Fig. 2.14. This is likely caused by an unsound aggregate being used in these panels. The overlay ended in a jointed concrete pavement. Significant scaling and faulting were observed where the overlay ends. However, repairs have been done for both panels, as shown in Fig. 2.15.

Figure 2.14 - Photo a showing pop outs (about 20 pop outs/panel) of larger aggregates (on about 24 panels) at about 0.5 miles from the south end of the overlay. Photo b is just the closer view of photo a.

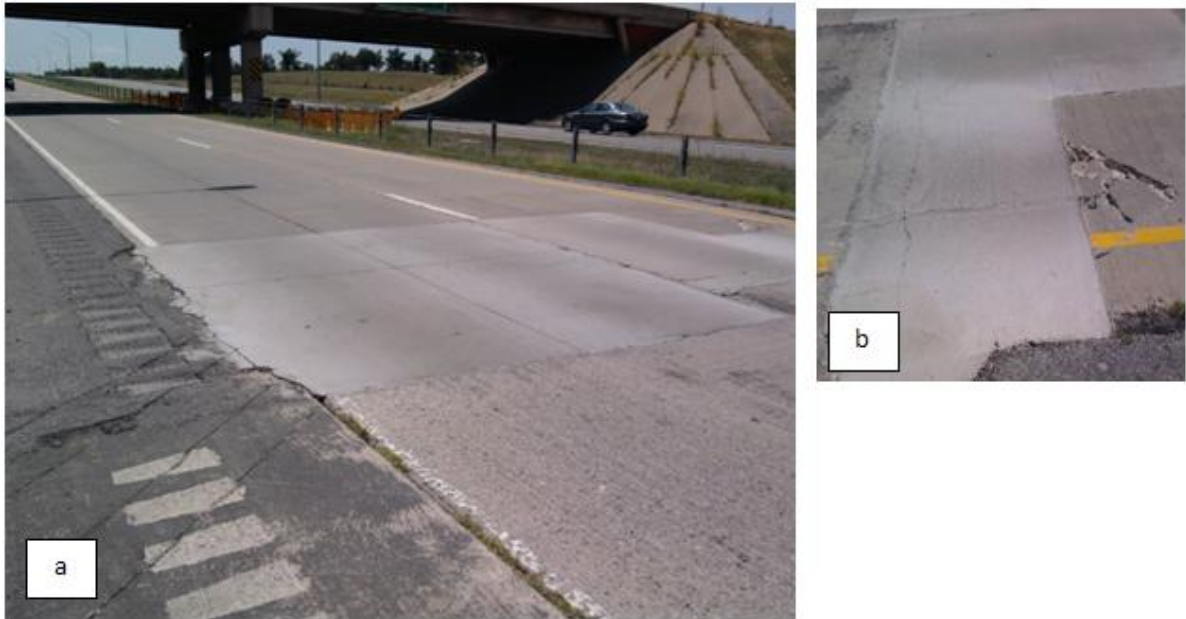
Figure 2.15 – Photo a shows the repaired panels at the north end of the overlay. Photo b shows a cracked panel at the west end of the overlay.

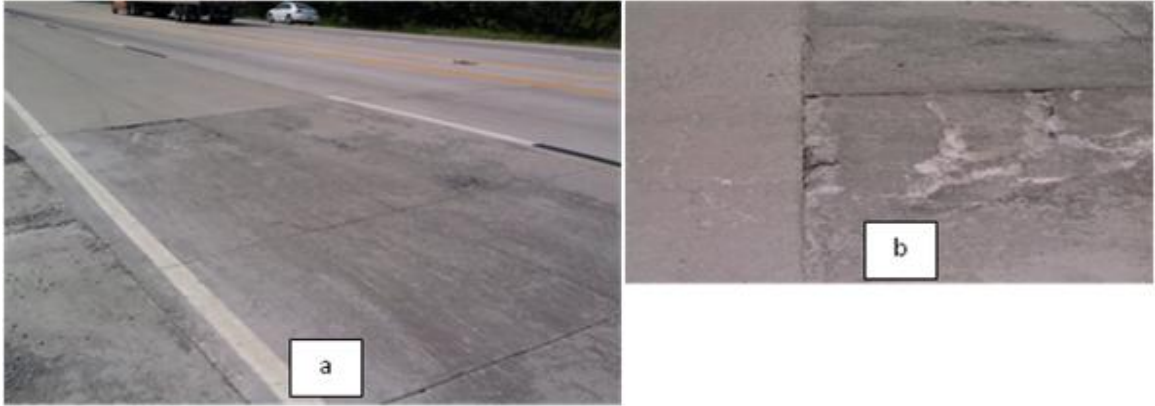
Figure 2.17 shows the start of the north bound overlay. The initial panel has block cracking, as shown in the photo. The reason for this block cracking could not be determined. This is surprising, as the overlay is just one year old.

Figure 2.17 – Photo a shows a cracked panel at the start of an overlay. Photo b shows a closer view of that panel.

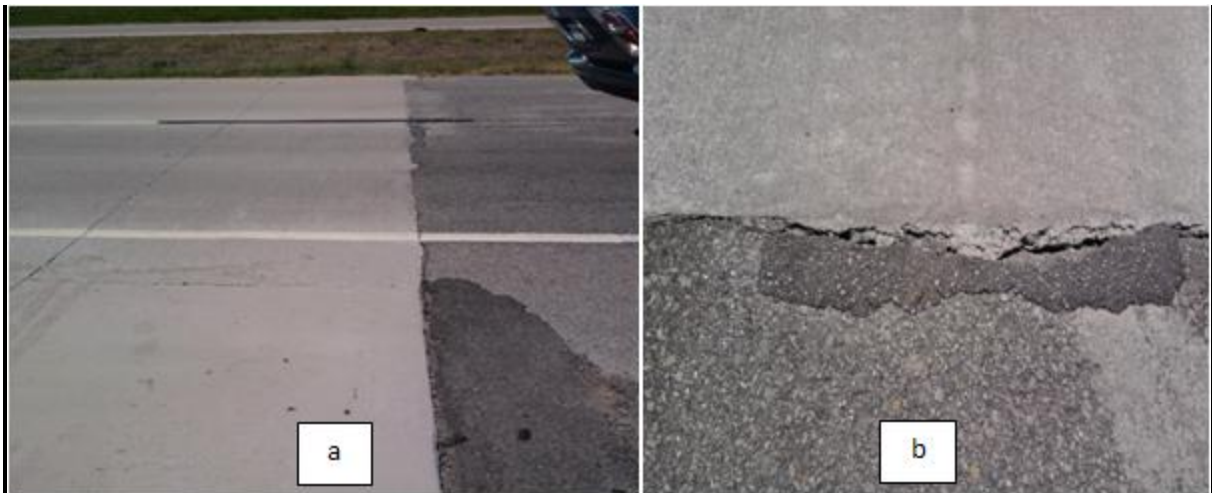
Figure 2.18 - Photo a shows the end of the overlay. The asphalt pavement looks good where it starts. But there is a small amount of distress initiation as shown in photo b.

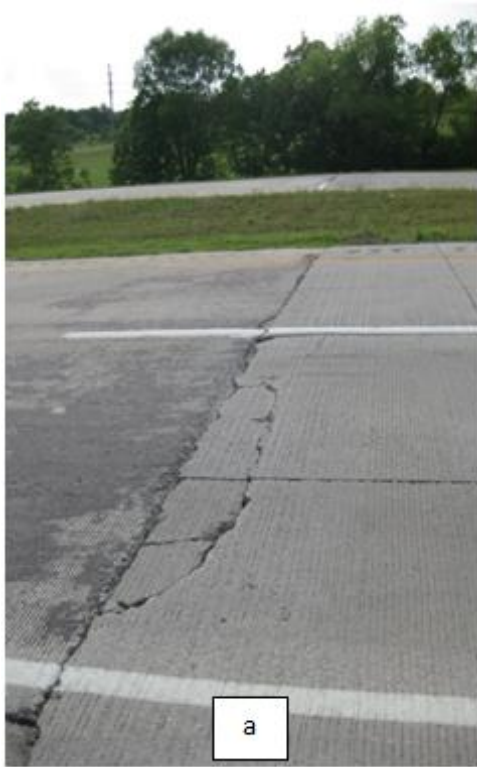
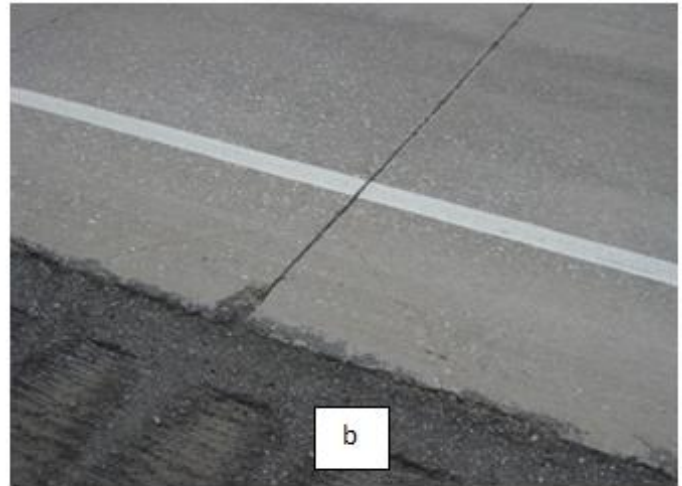
This overlay showed some distress where it was adjacent to a continuously reinforced concrete pavement (CRCP). This distress included corner cracking and some initial cracking at the interface between the two systems, as shown in Fig. 2.19 a and b. But all of those remain at a very rudimentary level and pose no issue of concern. The overlay otherwise was in good shape. The end of the overlay is shown in Fig. 2.20. Some polishing was seen in the intermediate stage of the overlay, but it looked like mechanical polishing done for smoothing the surface and not the wear of the overlay. Fig. 2.21 shows one of these areas.

Figure 2.19 – Photo a shows the cracked panels at the junction of the overlay and the existing asphalt pavement. Photo b shows a rare corner crack on the overlay.

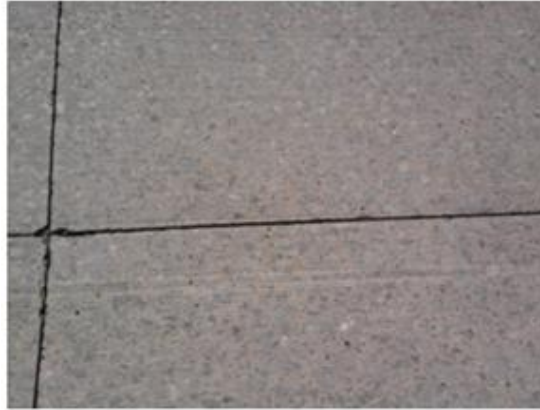
Figure 2.21 – Polishing of the overlay surface.

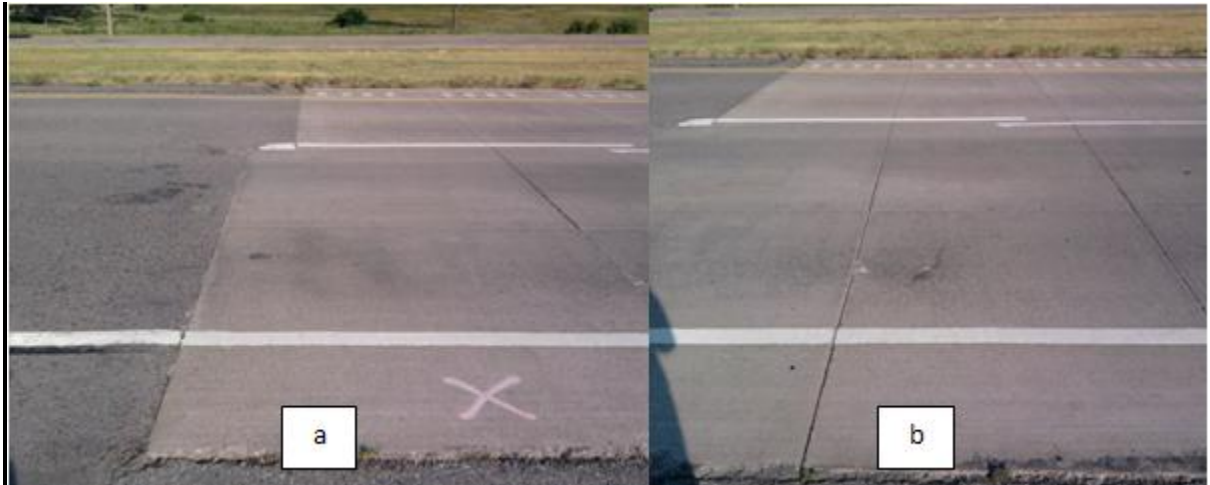
Figure 2.22 - Photo a showing start of the overlay where the asphalt pavement ends. A corner crack was seen on the second panel right after the start of the overlay as shown in photo b.

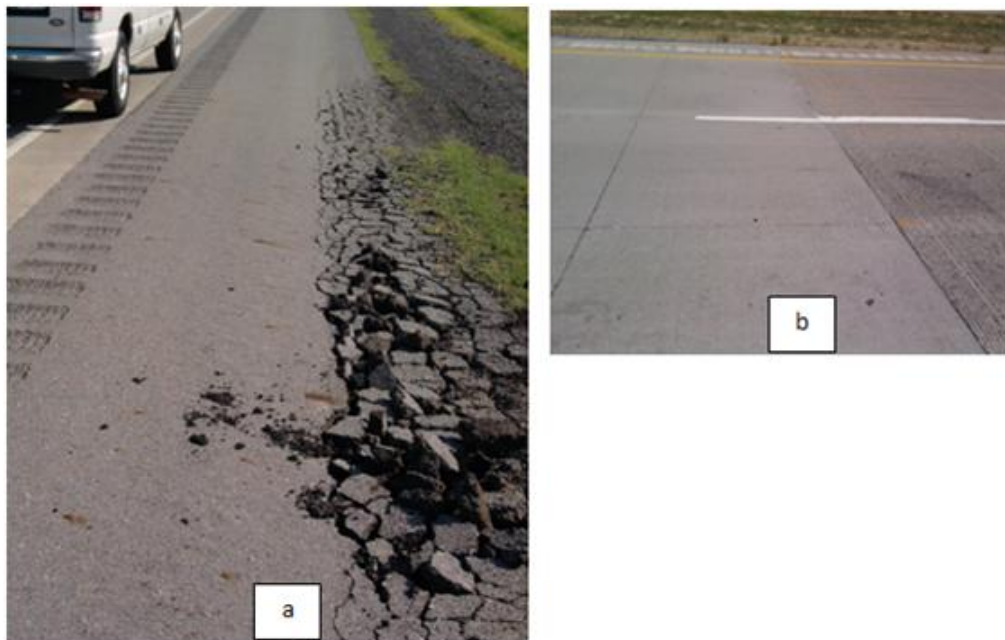
Figure 2.23 – Photo a shows the deterioration of the asphalt shoulders. Photo b shows the interface of the overlay with a CRCP. The end of the overlay was in excellent condition.

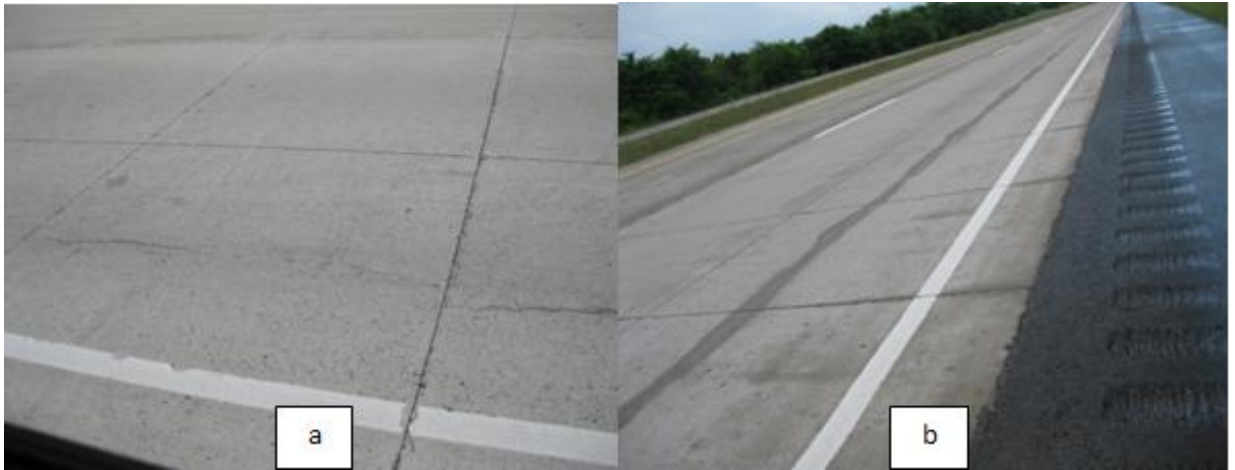
Most of the problems on this overlay were in the right wheel path of the driving lane. The passing lane did not show significant deterioration. Longitudinal cracks extending through two panels on average were seen all along the overlay; some cracks extended through up to 4 panels in a row. The number of cracked panels was significant, as shown in Fig. 2.24. About 200 panels (about 6%) were cracked per mile for the initial two miles. Then this crack pattern stopped abruptly.

Figure 2.24 - Photo a showing the type of longitudinal cracking pattern. Photo b shows the cracks after heavy rains overnight. The seepage of water through the cracks is clearly visible.

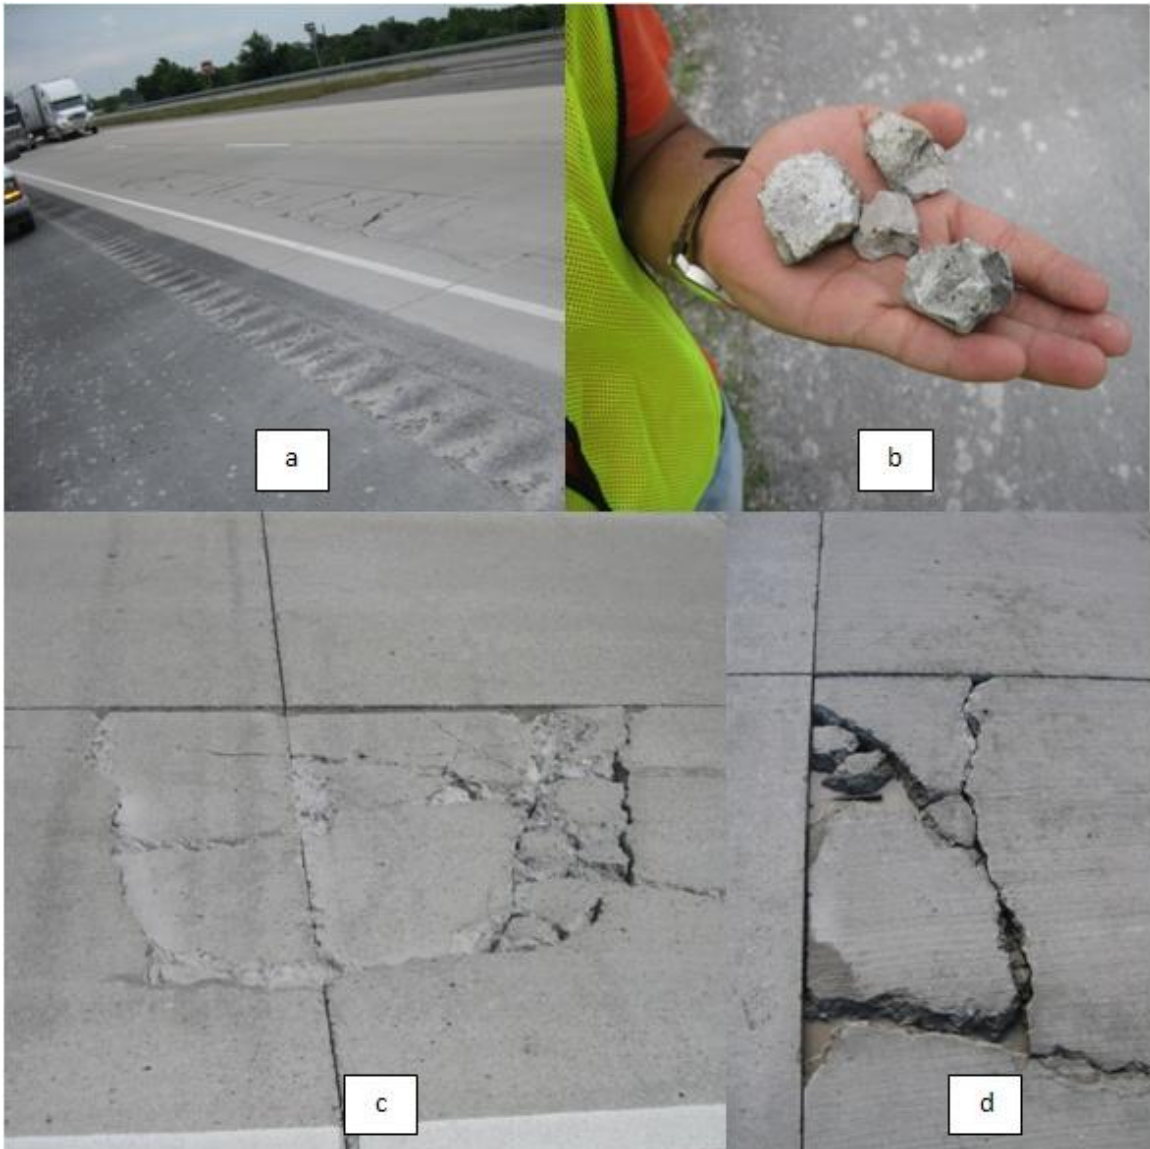
It was noticed that the deterioration of the overlay seemed to correlate with the intersections. Sometimes the failure was seen just as an individual panel failure. Sometimes it was seen as a series of panel failures covering up to seven panel failures in a single stretch. There were also large pieces of concrete that were from the failed panels. The drainage for this overlay was not good. Several places were seen to retain water instead of letting it flow through the system. However, it is unclear how much of an effect this poor drainage has on the failures. A total of 19 such individual or series panel failures were seen along the 5 mile stretch of the overlay, some of them are shown in Fig. 2.25.

Figure 2.25 - Photos showing the failures of panels in the right wheel path of driving lane of the overlay. Photo a shows failures observed in continuous panels. Photo b shows the pieces of concrete that came from the failed panels. Photo c shows individual panel failures, typically seen at the intersections. Photo d shows drainage problems in the pavement and also the damage resulted because of it.

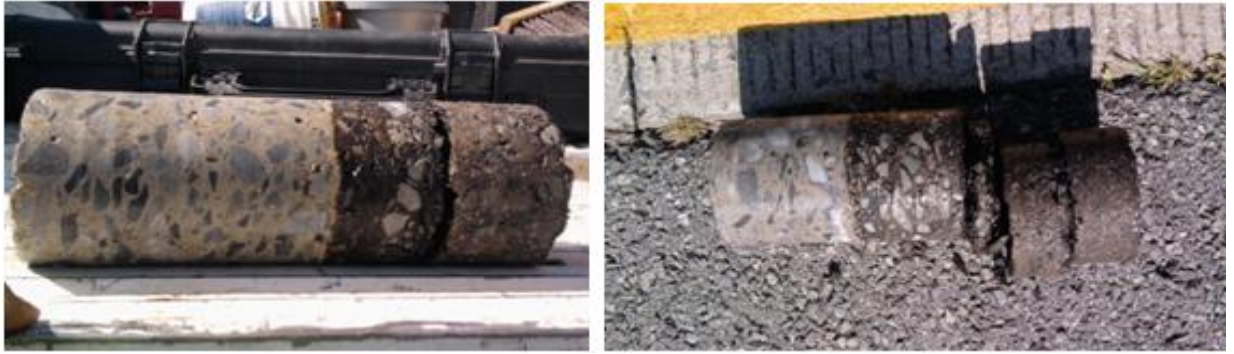
Fig. 2.26 shows the cores extracted from Oldest McAlester Whitetopping. The thickness of asphalt was found to be, at minimum, 9” and was on an average 11”. This is likely one contributing factor into the positive performance of the overlay. Four cores were taken at the locations 1 and 5 from the driving lane and 3 and 7 from the passing lane as described in Table 2.9.

Figure 2.26 - Cores extracted on the oldest McAlester Overlay.

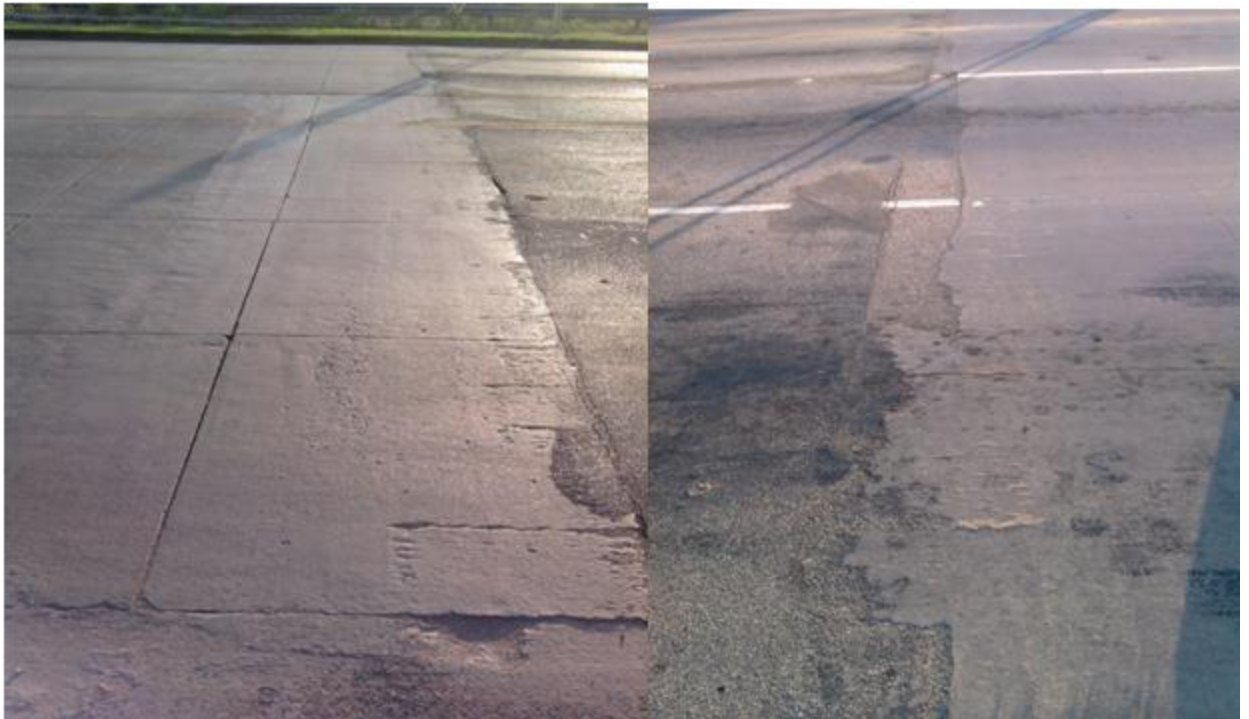
Figure 2.35 - Approach on US 177 from north showing absence in panel failures. Note the small difference in the elevation between the approach and leave pavements.

Maintaining close elevation difference at the approach panels may reduce the possibility of initial panel failures due to impact loading.

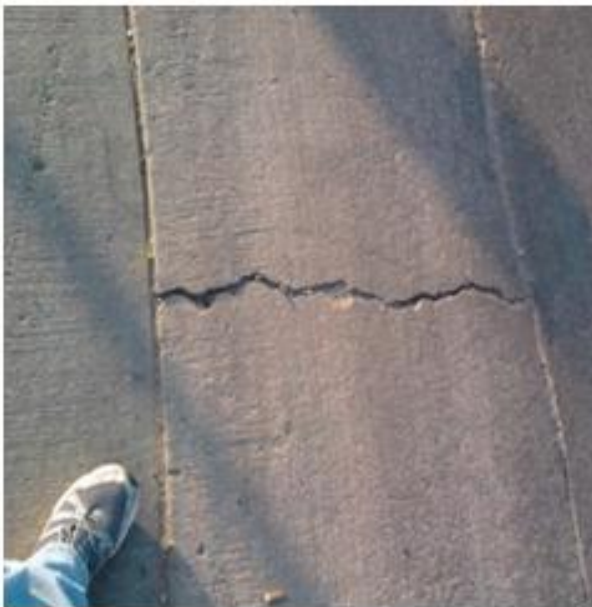
Figures 2.36 through 2.40 show the problems observed primarily at the west approach on SH – 51. The problems observed were cracking in the shoulder, approach panel failures, fines movements, and abutment cracking. Figure 2.36 shows the cracking in the shoulder on the US – 177 south side turn from west SH – 51. Figure 2.37 shows the approach panel failures from west SH – 51. The first panel is longer (6' x 9') than all of the other overlay panel dimensions. The 9' dimension is in the east-west direction, the same direction as the traffic. Also, there is considerable rutting (refer Fig. 2.37 b) on the adjacent concrete leave slab on the east side of the concrete bridge connecting to the intersection (refer Fig. 2.29 for layout of bridge and overlay). This rutting has induced an elevation difference which may have decreased the performance of the approach panel. In addition, since this panel is longer, one would expect the length to increase the bending stresses in the panel from center loadings as well as the curling of the panel. Severe cracking of the panel can be seen in Fig. 2.37.

Figure 2.36 – Distress cracking in the shoulder.

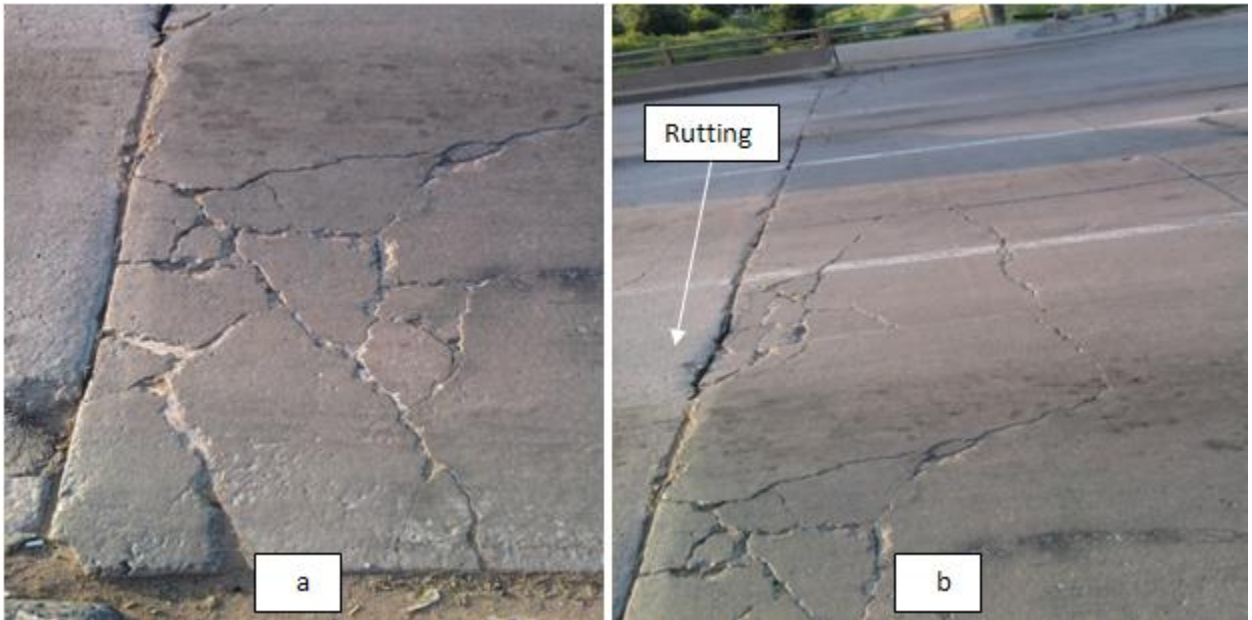
Figure 2.37 - Photos from west side of intersection on SH – 51. Photo a is at the intersection of the overlay and the concrete bridge. Rutting can be clearly seen in photo b.

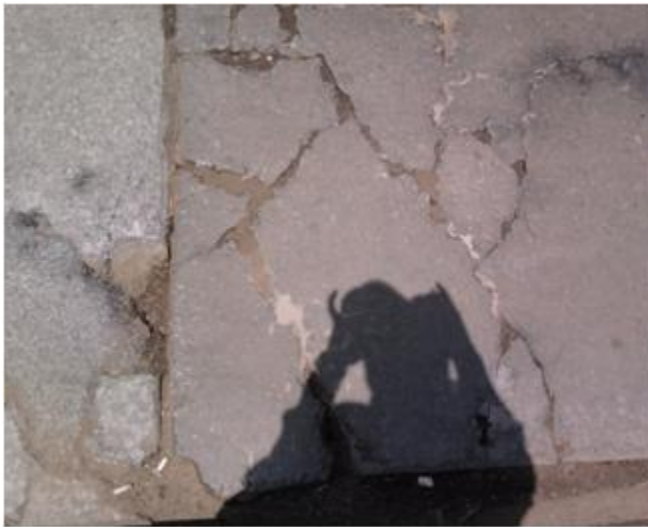
Figures 2.38, 2.39 and 2.40 show the fines movement seen on the pavements, the abutment cracking and the impact loading due to an insufficient turning radius for large trucks. Figure 2.39 shows the abutment cracking which may have been caused by thermal movements of the pavement or perhaps settlement of the compacted soil behind the bridge abutment. However, it is not clear when the cracking occurred. It is also not clear whether there is any type of relation between the fines movement and the bridge abutment. Figure 2.40 is really interesting as it shows how the tire impacts the ground as it leaves the curb and creates stresses on the surface of the pavement.

Figure 2.38 - Fines movement in first panels of intersection.

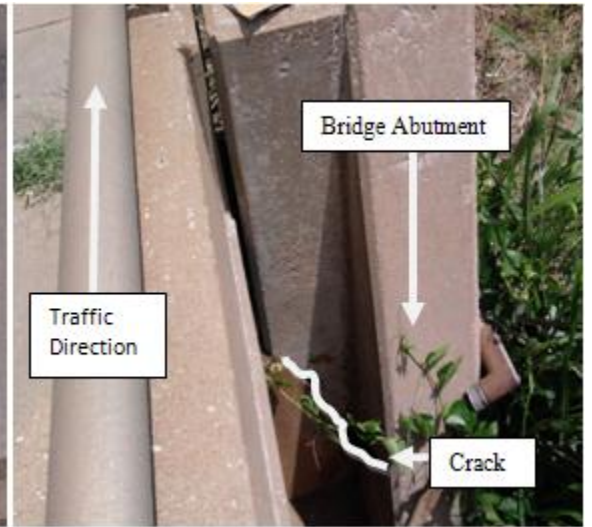
Figure 2.39 - Cracking in abutments of the bridge.

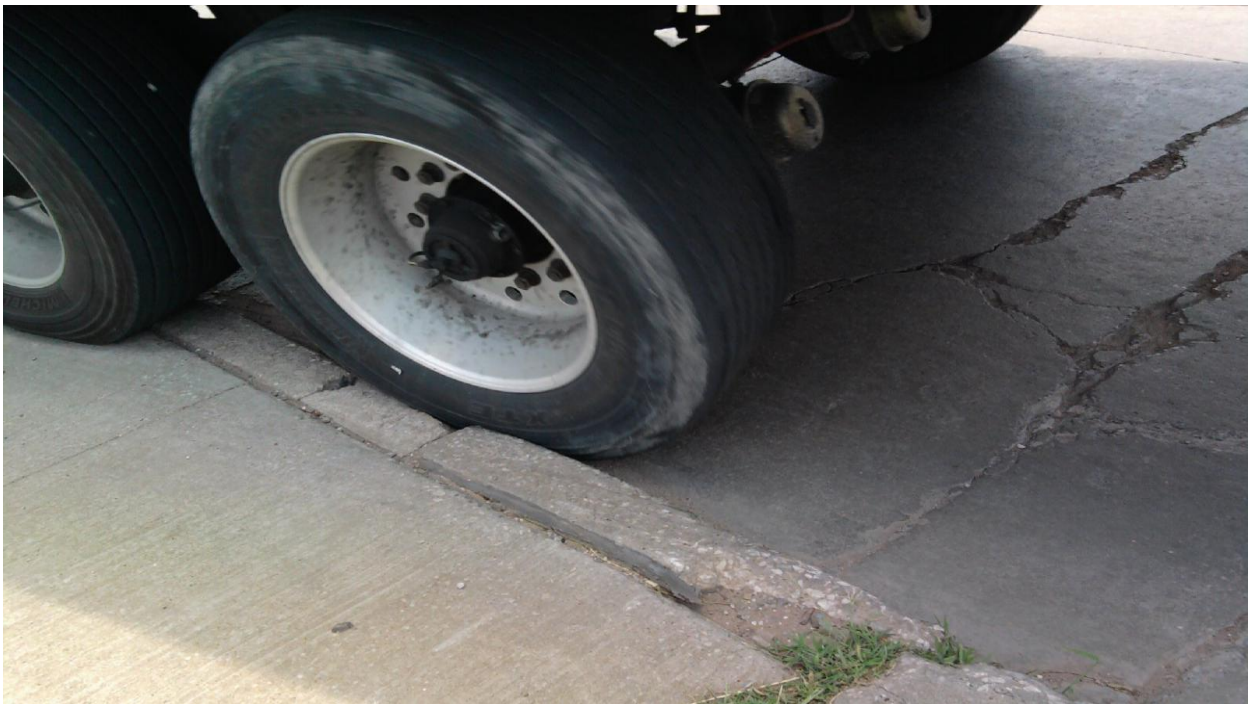
Figure 2.40 - Photo showing the impact loading due to lack of radius of curvature for large trucks.

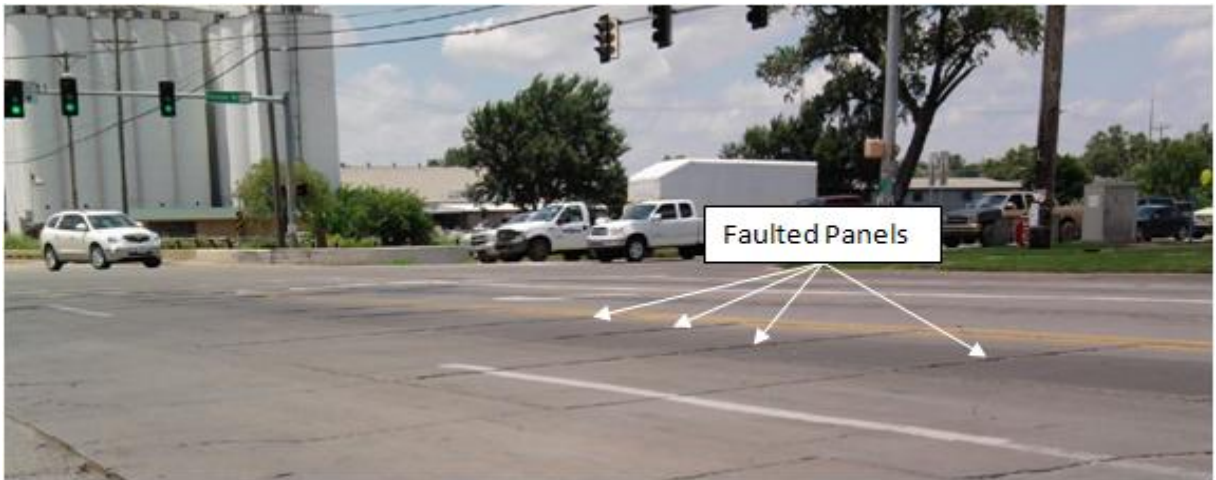
Figures 2.41 through 2.44 show the problems with the east end of the intersection. Again, this is also on SH – 51. Some of the problems observed were faulting and panel cracking where the concrete overlay interfaced the asphalt shoulder. Figures 2.41 through 2.42 show the faulting which is taking place on the eastern end of the overlay. Predominantly, faulting was seen only in

Figure 2.41 - Photo showing faulting as seen from east end of the intersection. A repetitive noise was heard from the tires of the vehicles when they passed on the faulted panels.

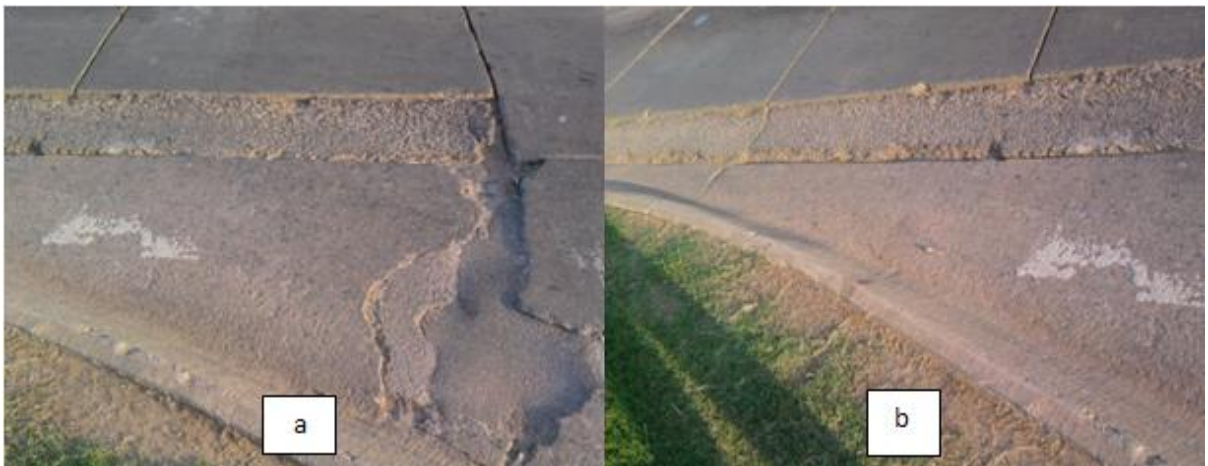
Figure 2.42 - Photos a and b showing faulting as overlay turns from west SH 51 to north US 177.

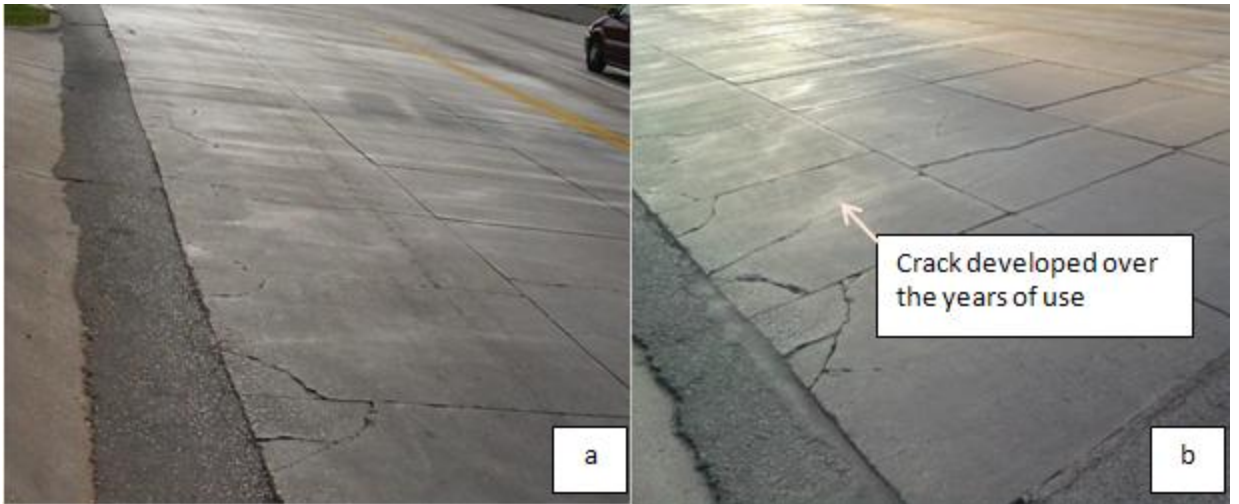
Figures 2.43 through 2.44 show how the cracking has increased. This increase in damage is apparent at the interface of concrete and asphalt. Figure 2.43 shows a crack that has extended from the shoulder since 2004. It is in the know that, this crack has extended as we have photographs taken by MacArthur and Associates from 2004. Some sections were seen in which some parts of panels have been elevated, as shown in Fig.2.44.

Figure 2.43 - Photos at the entrance to the gas station showing how the cracking has changed between 2004 and 2010. Photo a was taken in 2004 (David Cline, MacArthur Associated Consultants) and photo b is taken by the research team in 2010.

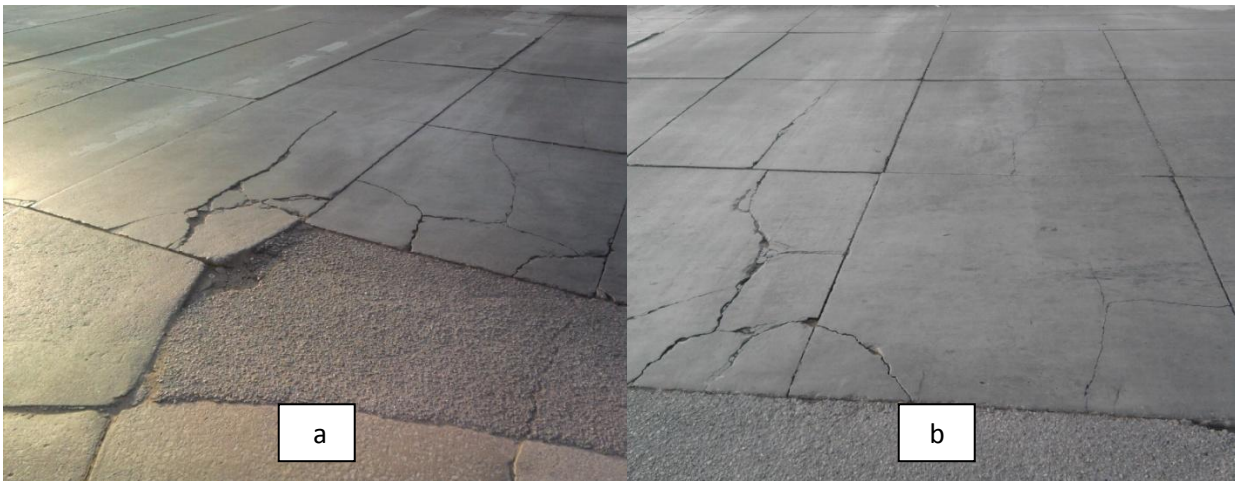
Figure 2.44 - Large block cracking at the east end of the intersection where the overlay is adjacent to the gas stations. The shadows shown in photo a show the difference in height between to the overlay and the adjacent asphalt. Additional block cracking can be seen in photo b.
