ASSESSMENT OF CONTINUOUSLY REINFORCED
CONCRETE PAVEMENT DESIGN AND
BEHAVIOR IN OKLAHOMA

Submitted to the Faculty of the
Graduate College of the
Oklahoma State University
in partial fulfillment of
the requirements for
the Degree of
MASTER OF SCIENCE
May, 1999

OKLAHOMA STATE UNIVERSITY

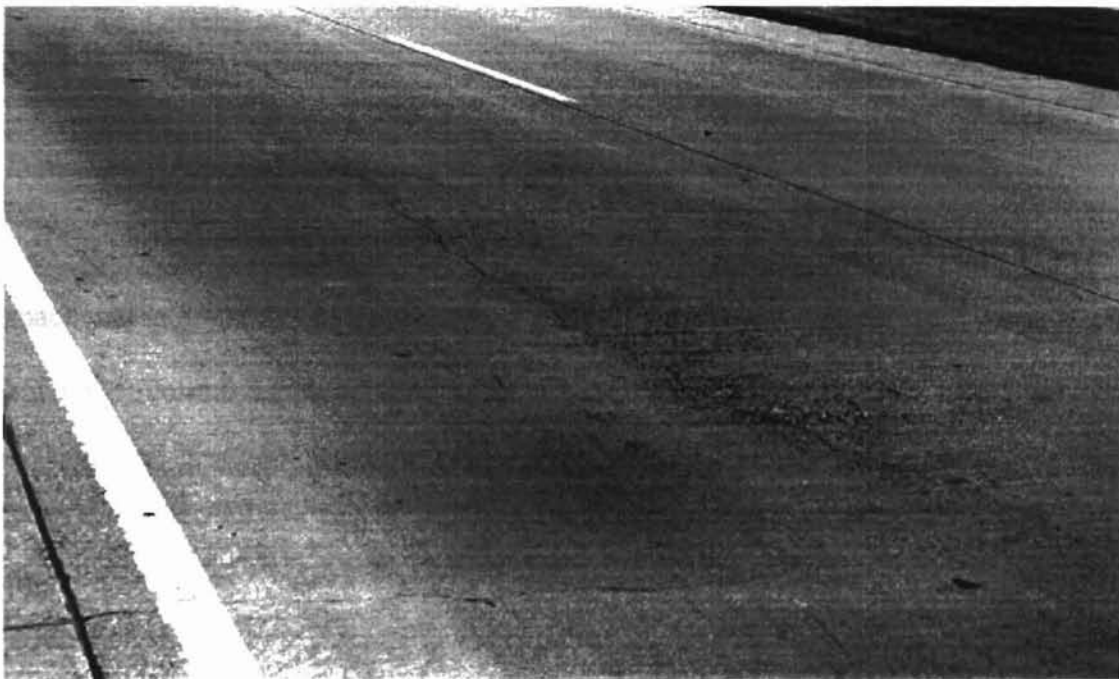
Figure A3. The longitudinal crack in MABRF-53(141)

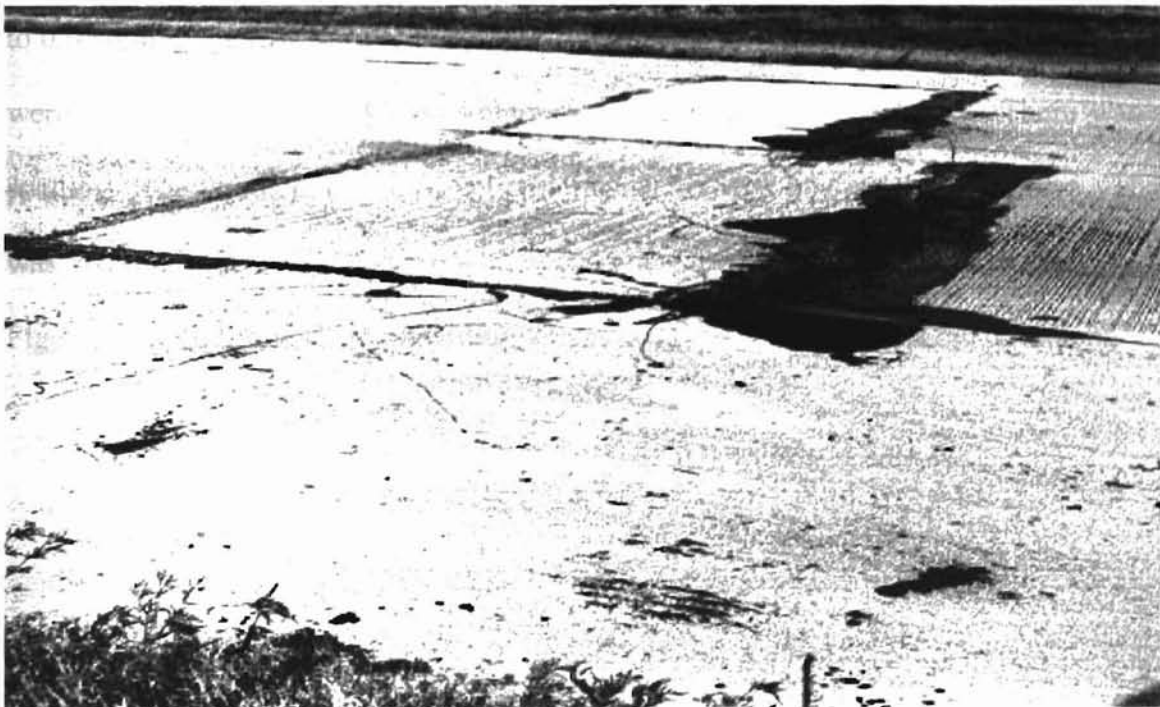
sum of the area of patches, including those at the joints, was about 20 m². Faulting had occurred at some joints. See Figure A23.

Figure A23. Patch next to repair westbound

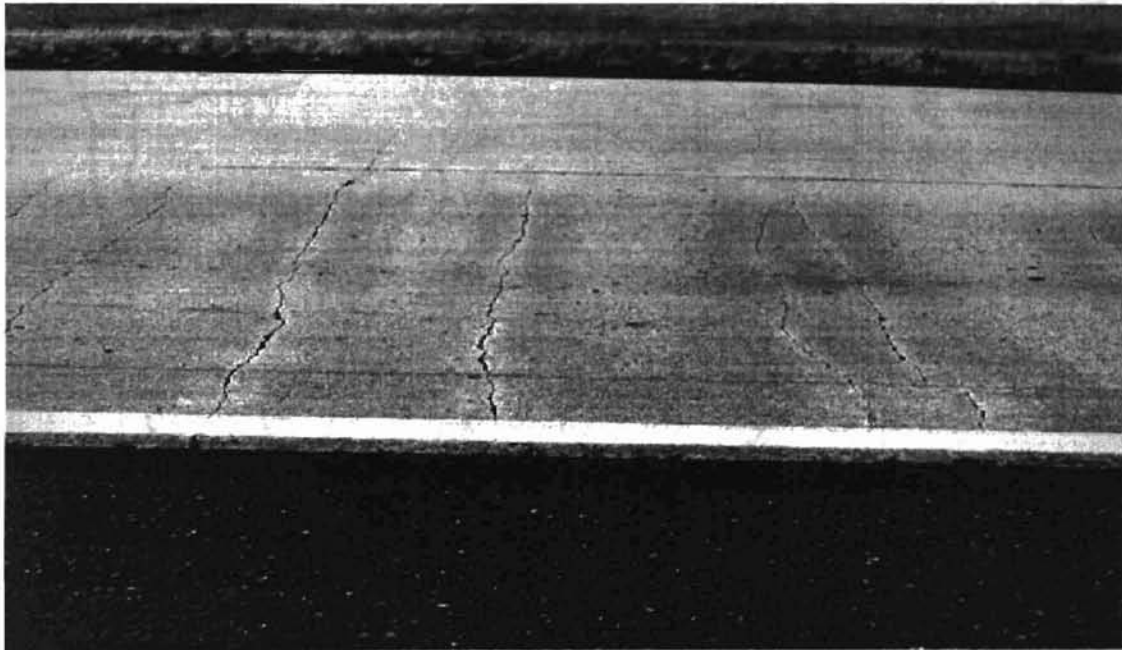
10 m long. There was spalling, punchouts, and repairs. There were, in general, more than six patches per mile. Some patches were as big as 10 m by 3.6 m lane, others as much as about one-fifth km long by the 3.6 m lane width. See Figure A32. The numerous repairs and punchouts did not affect the smoothness of the ride

Figure A31. Wide transverse crack widths on I-40-6(86) eastbound.

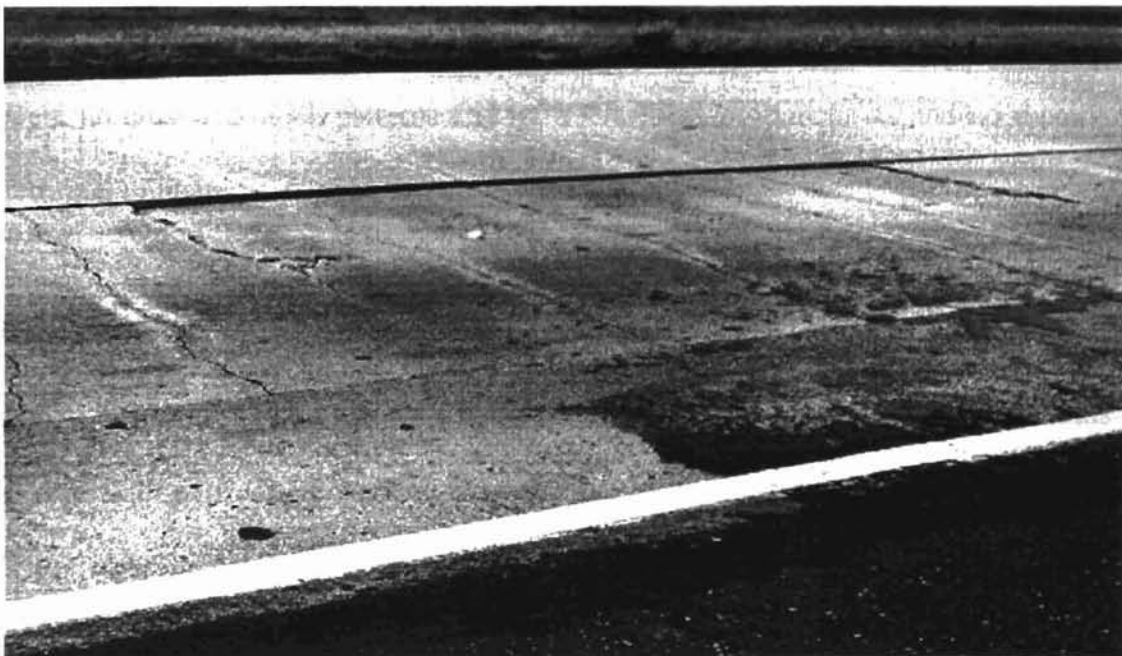
Figure A32. Wide crack widths and faulting westbound.

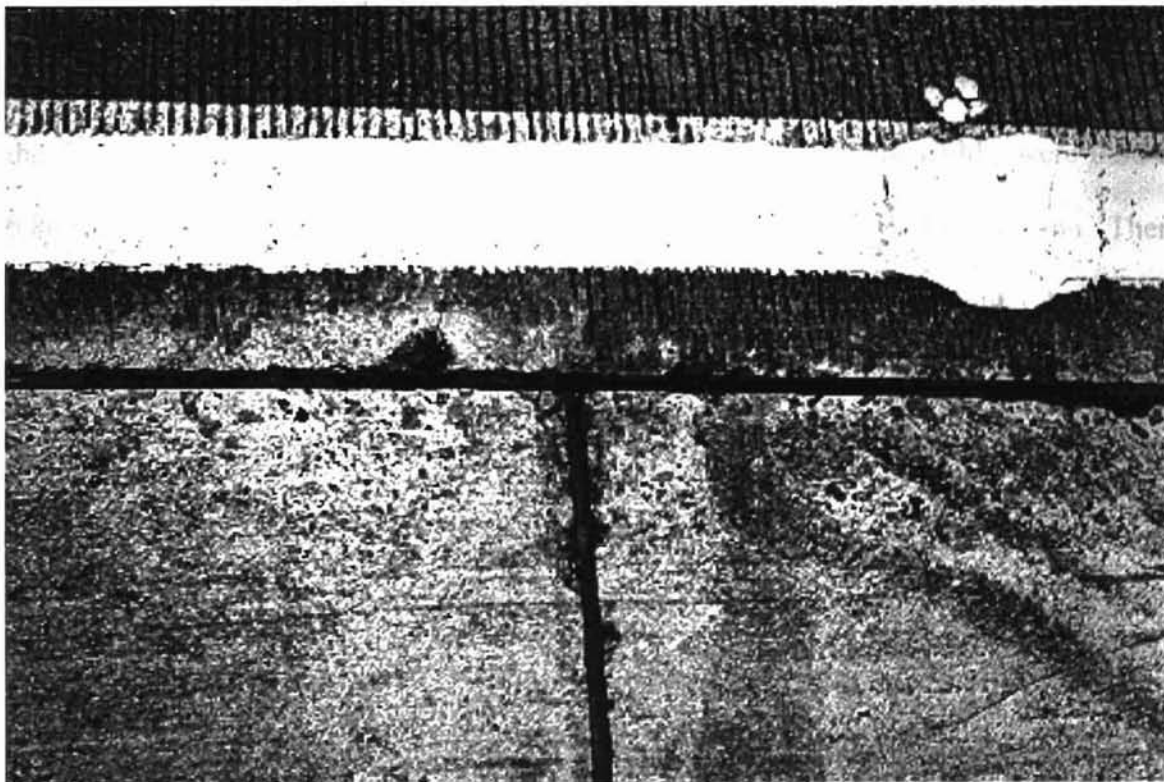
Figure A44. Relative movement between CRC slab and shoulders near terminal joint.

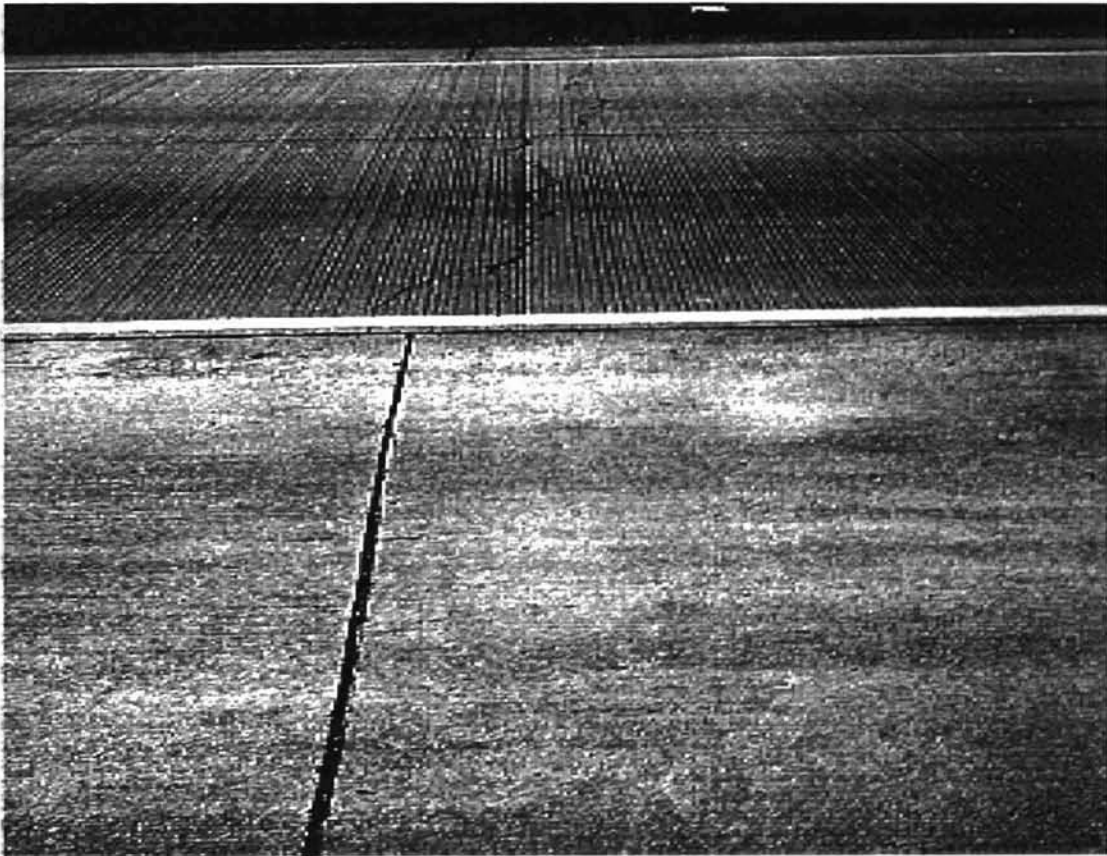
Transverse crack spacings were 1.8 to 4.5 m for this direction. Crack widths were 0.50 to 0.80 mm for the first third along the length, and 0.70 to 1.20 mm for the rest of the pavement. There was spalling along the cracks. Punchouts and repairs were over fifty in the 11.88-km stretch. See Figure A47.

Figure A47. Typical shoulder and pavement condition of F-299(45) southbound.

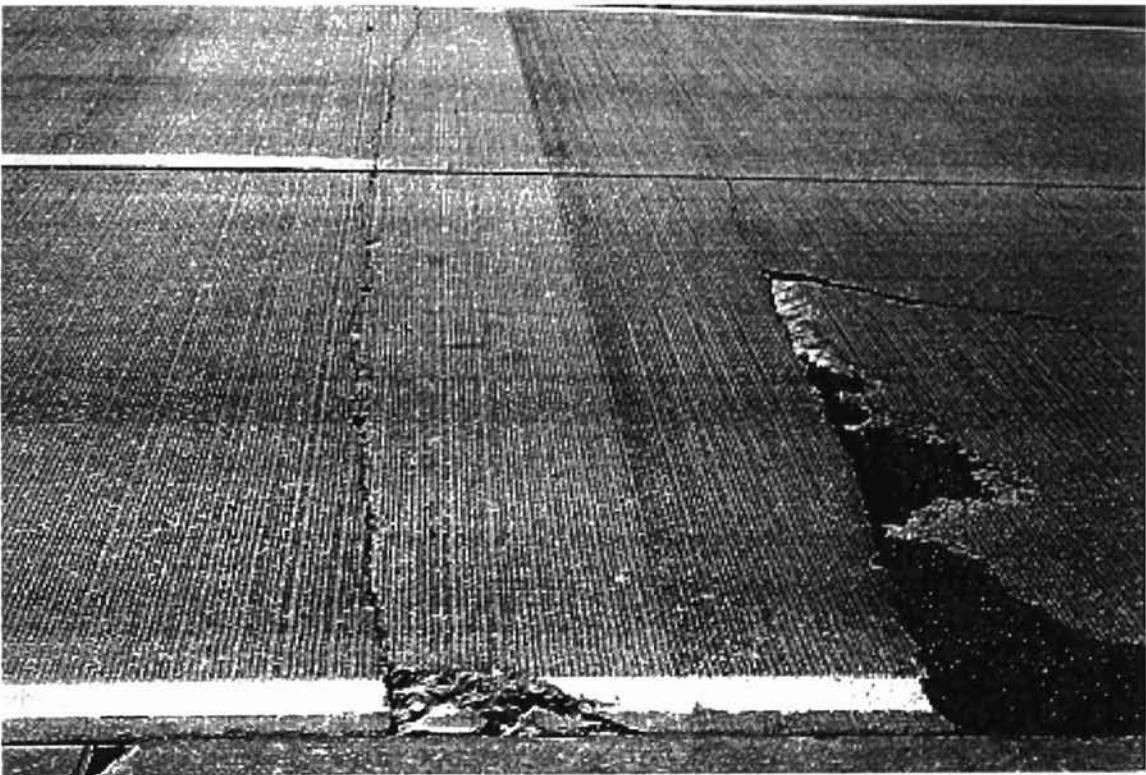
Transverse crack spacings were 1.8 to 4.5 m in the first third and 1.2 to 2.0 m in the rest of the pavement in this direction. Crack widths were about 0.60 mm. The length of CRCP is about 12 km. More than ninety punchouts and repairs of various sizes counted in this stretch. See Figure A50.

Figure A50. Punchout and deteriorated patch on F-299(35) southbound.

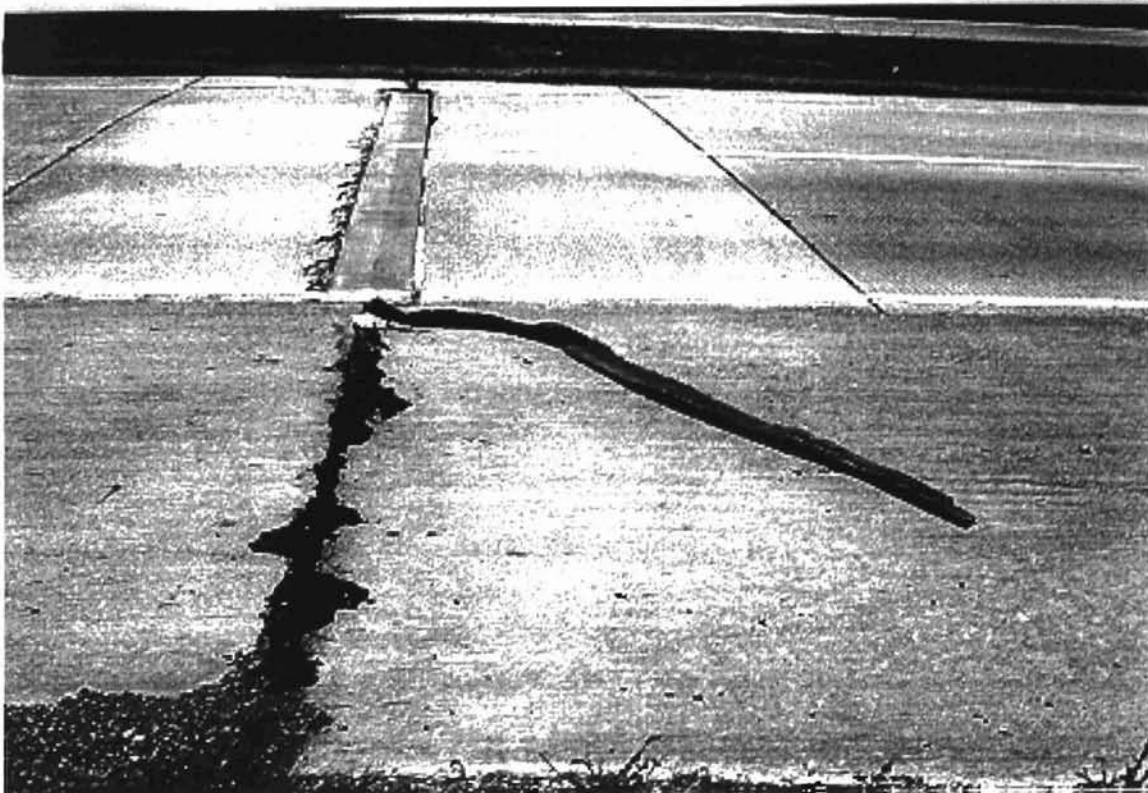
Figure A53. Structural steel beam in terminal joints of F-299(99). Extruded joint filler on shoulder

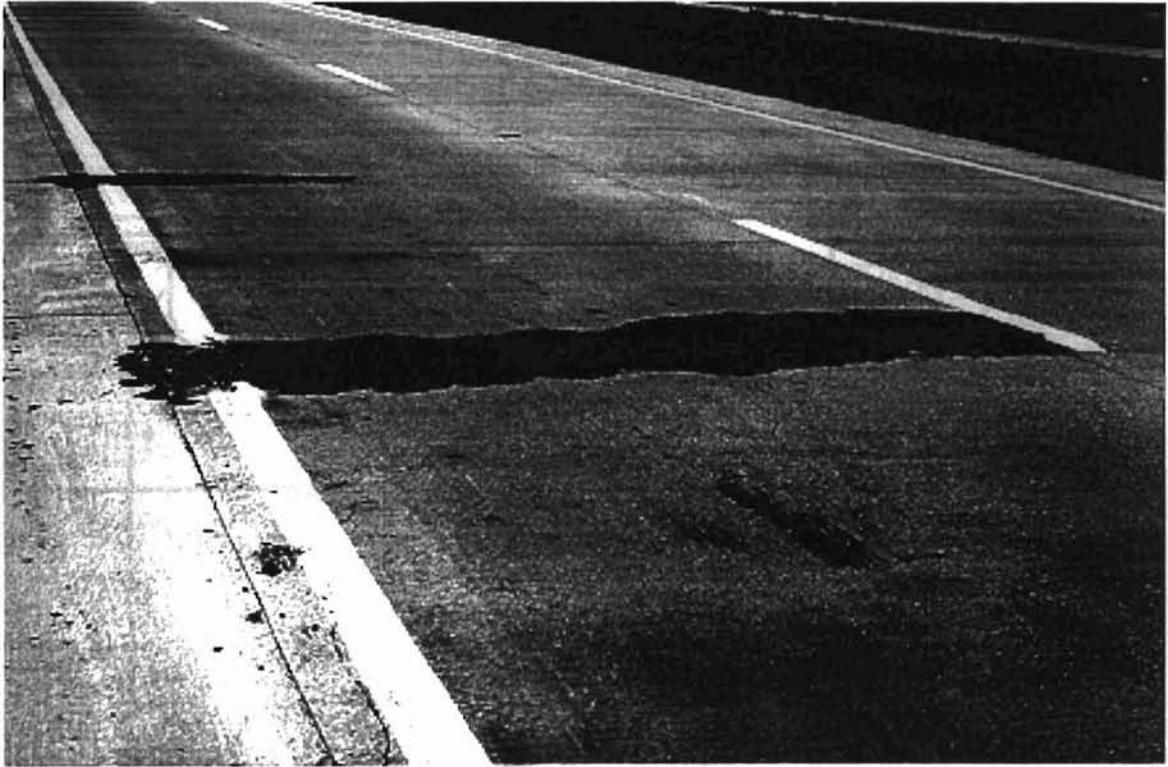
Figure A55. Patch on F-219(35) northbound.

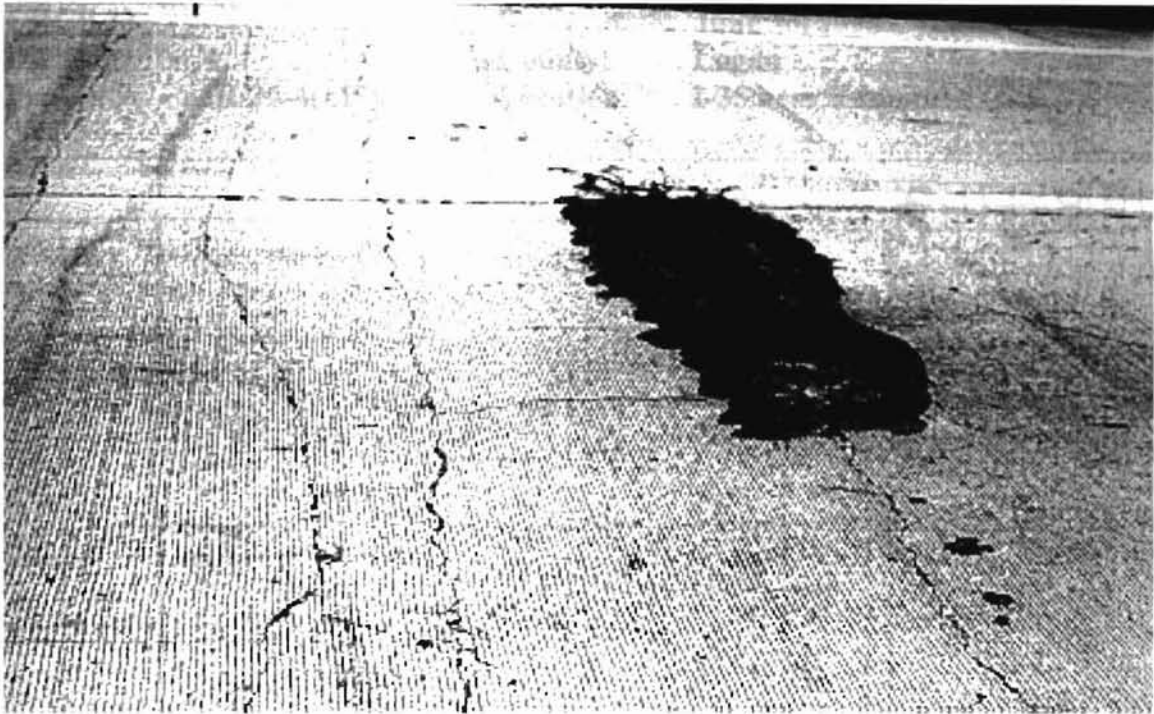
Figure A61. Repair of punchout on I-40 using asphalt concrete patching.

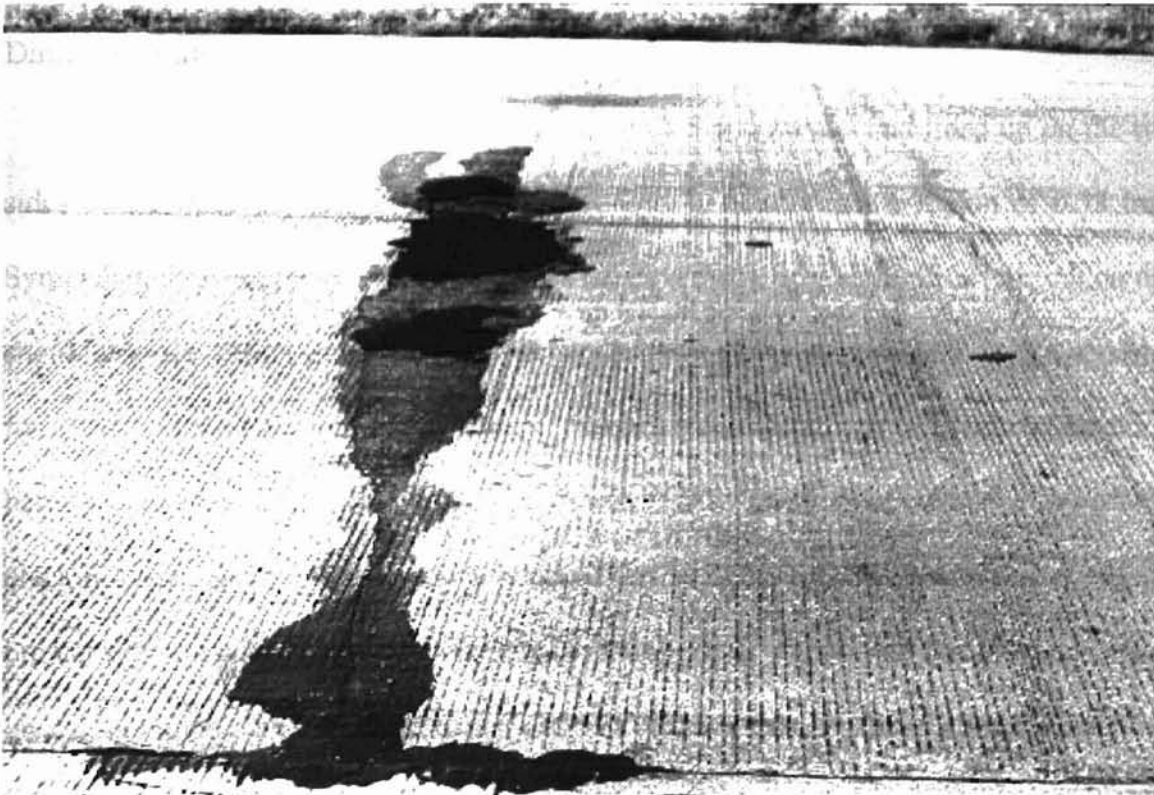
Figure A62. Patch on IR-40-5(169) westbound.

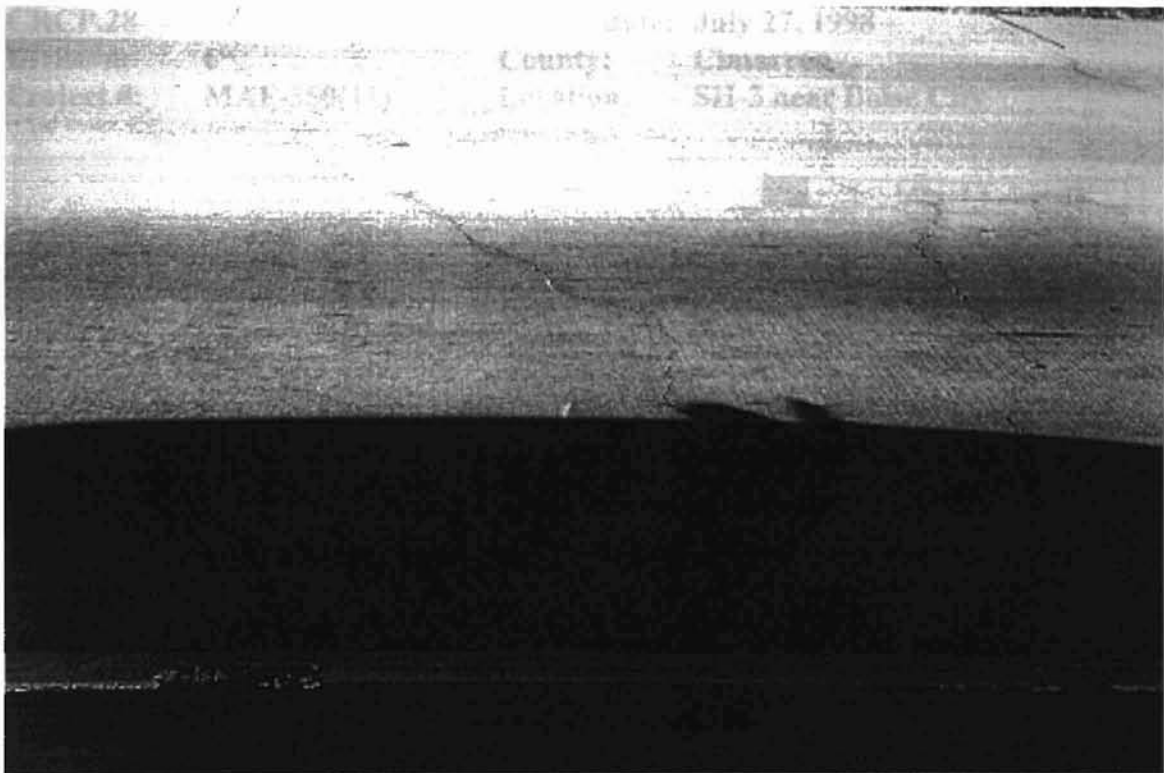
Figure A75. Curved cracks typical on IM-40-2(119) eastbound.

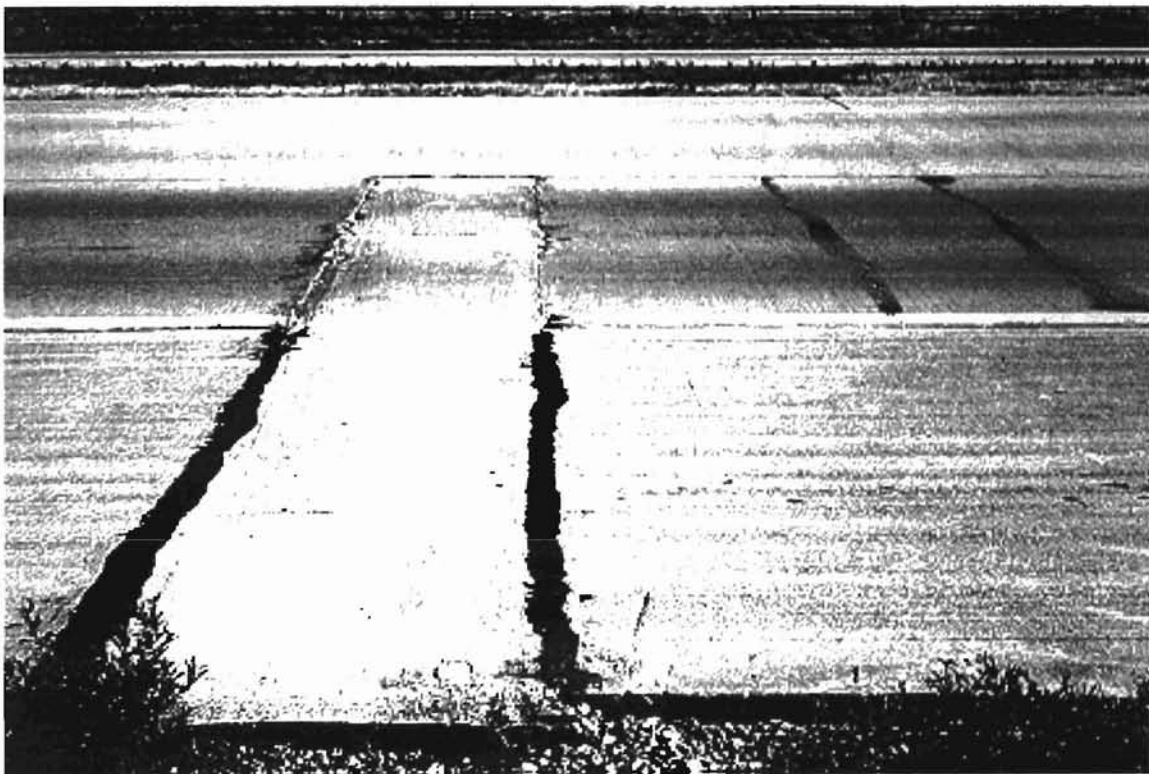
Fig. A76. Repair of punchout. Drain constructed to increase drainage under pavement.

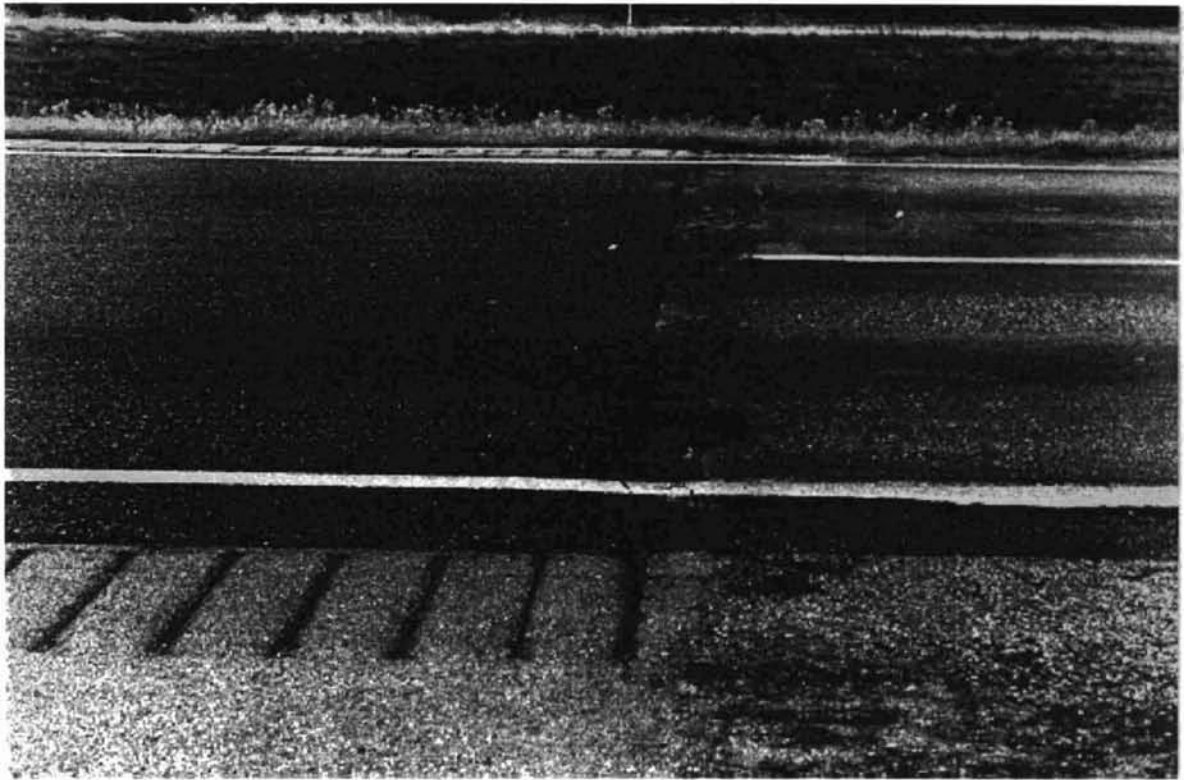
Figure A85. Asphalt overlay on CRCP.

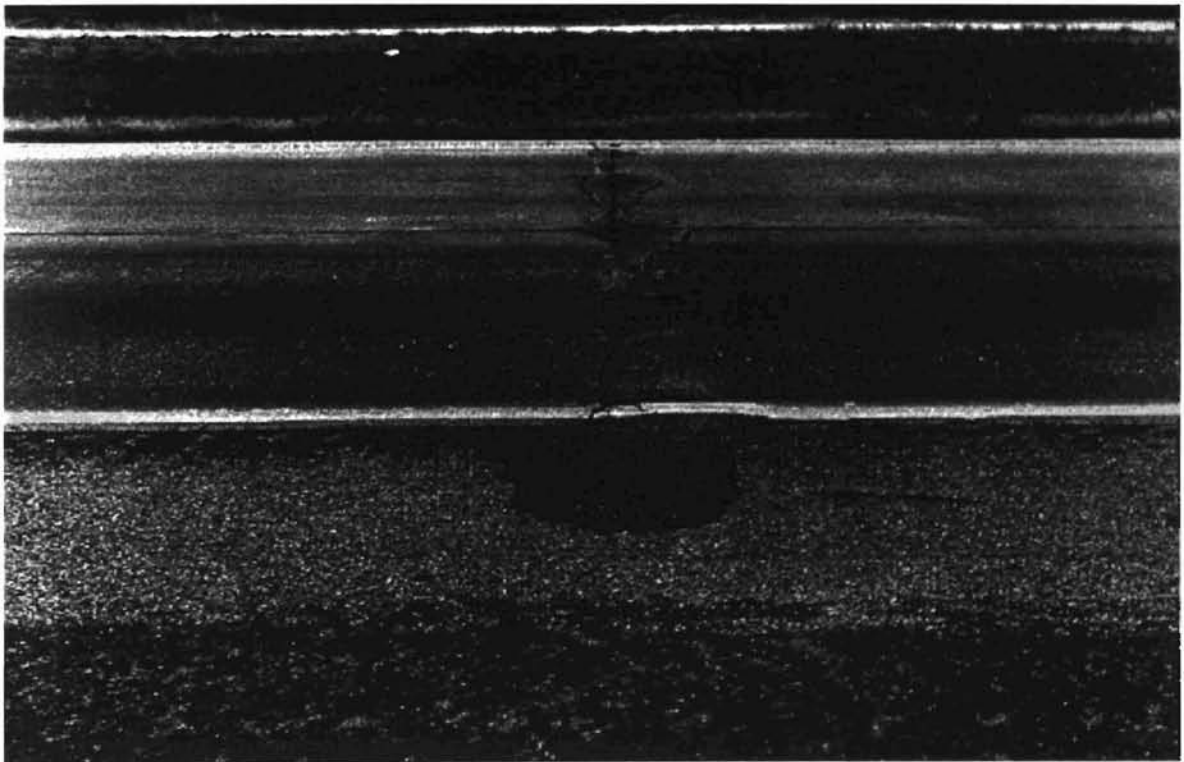
Figure A86. Joint deterioration and patching.

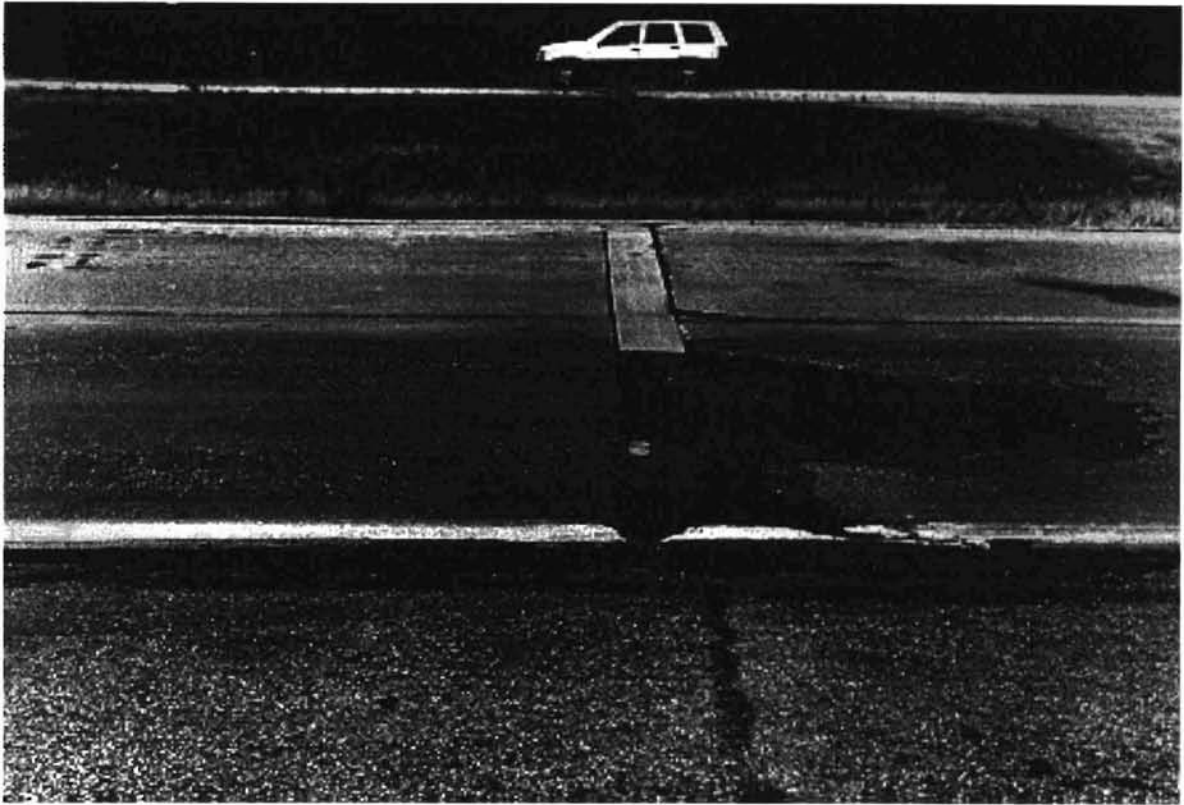
Figure A87. Terminal joint deterioration.

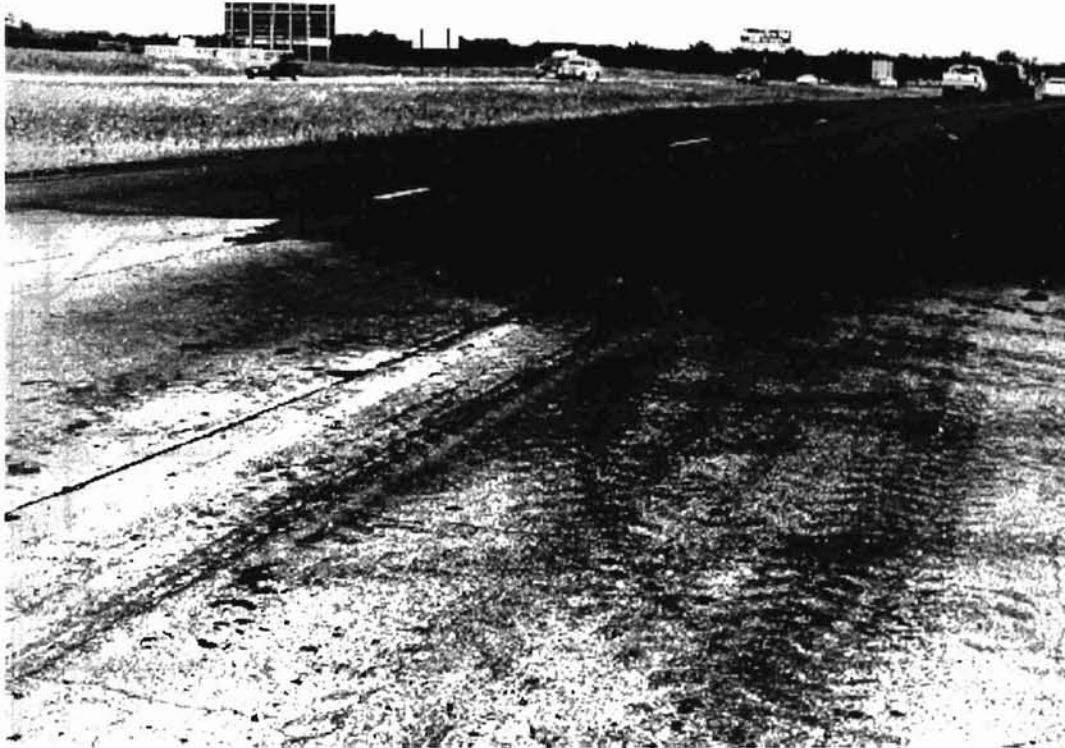
Transverse crack spacings were very regular in this section; at 1.2 to 1.8 m centers. Crack widths were 0.90 to 3.00 mm. There was some longitudinal cracking punchouts and patches at a number of places. This is one of the first CRCPs in the state and, though past its design life, could still provide some useful service.

Figure A90. Asphalt overlay typical on I-35 CRCPs in Murray and Carter counties.

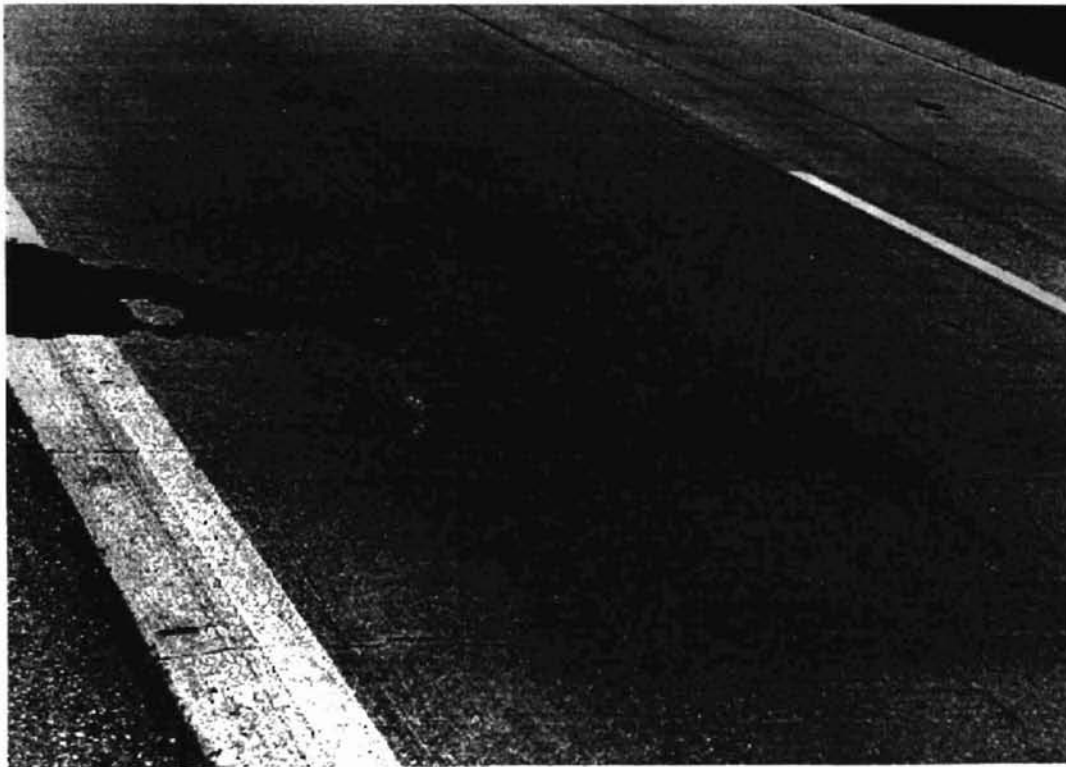
Figure A92. Patch at edge of pavement. Transverse and longitudinal cracks intersecting create conditions for punchout.

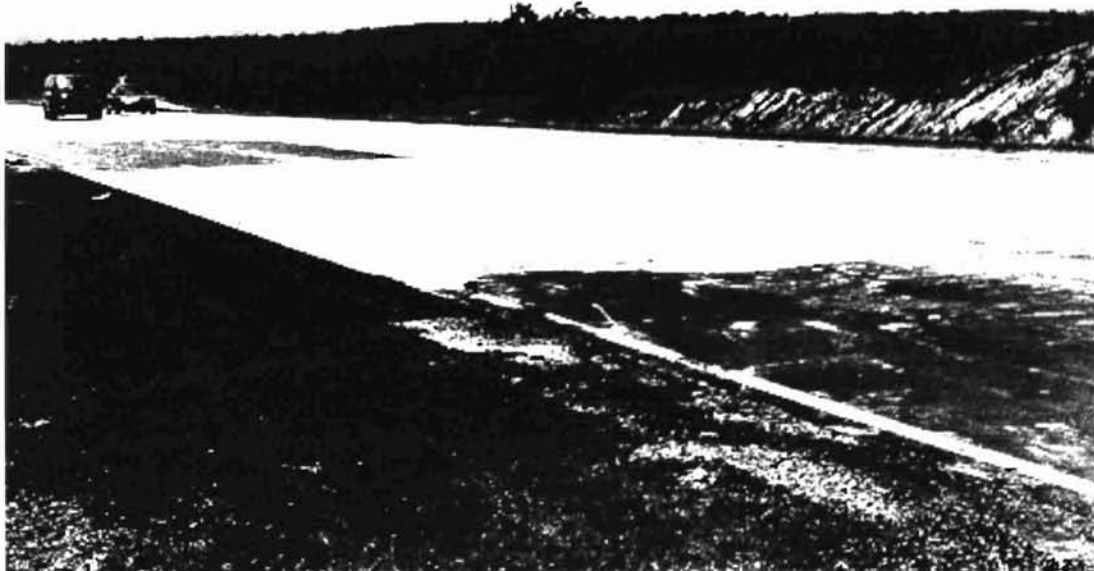
Figure A93. Full-depth full-width repair on northbound lanes of I-35-I(48) near Arbuckle.

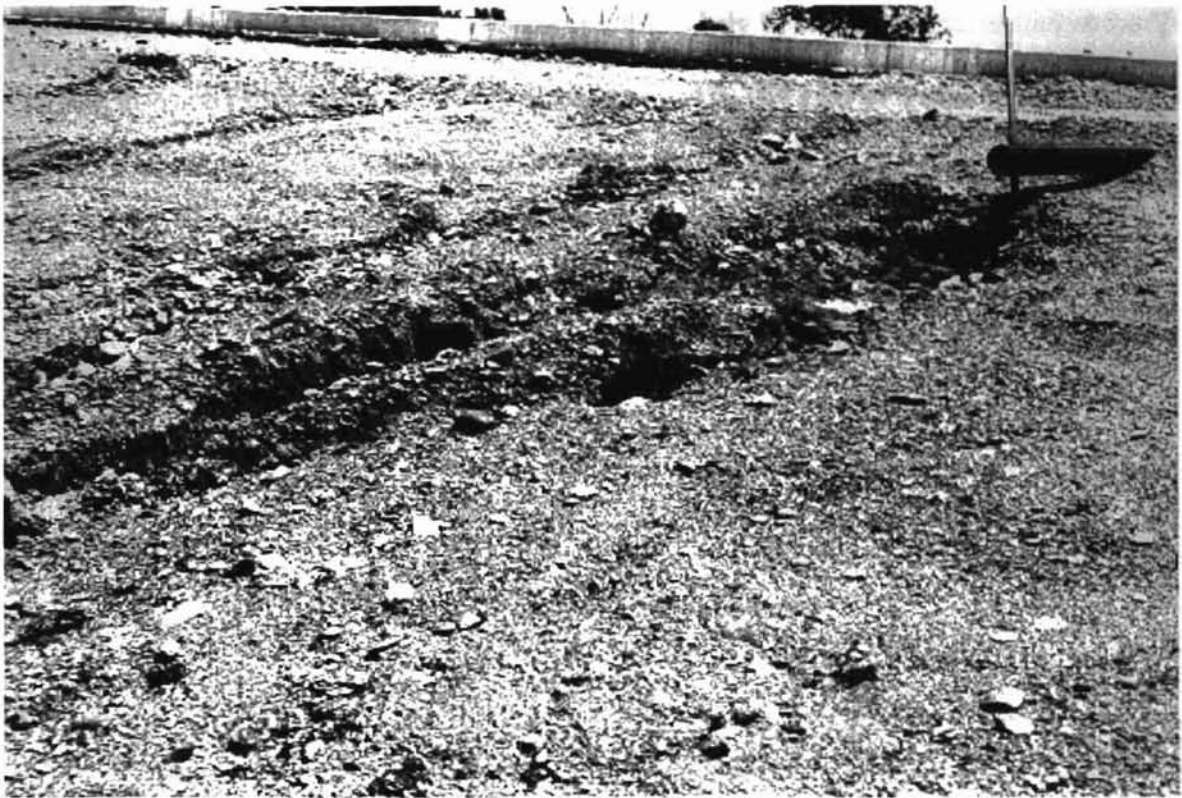
Figure A95. Outlet of drainage under pavement and erosion of embankment.

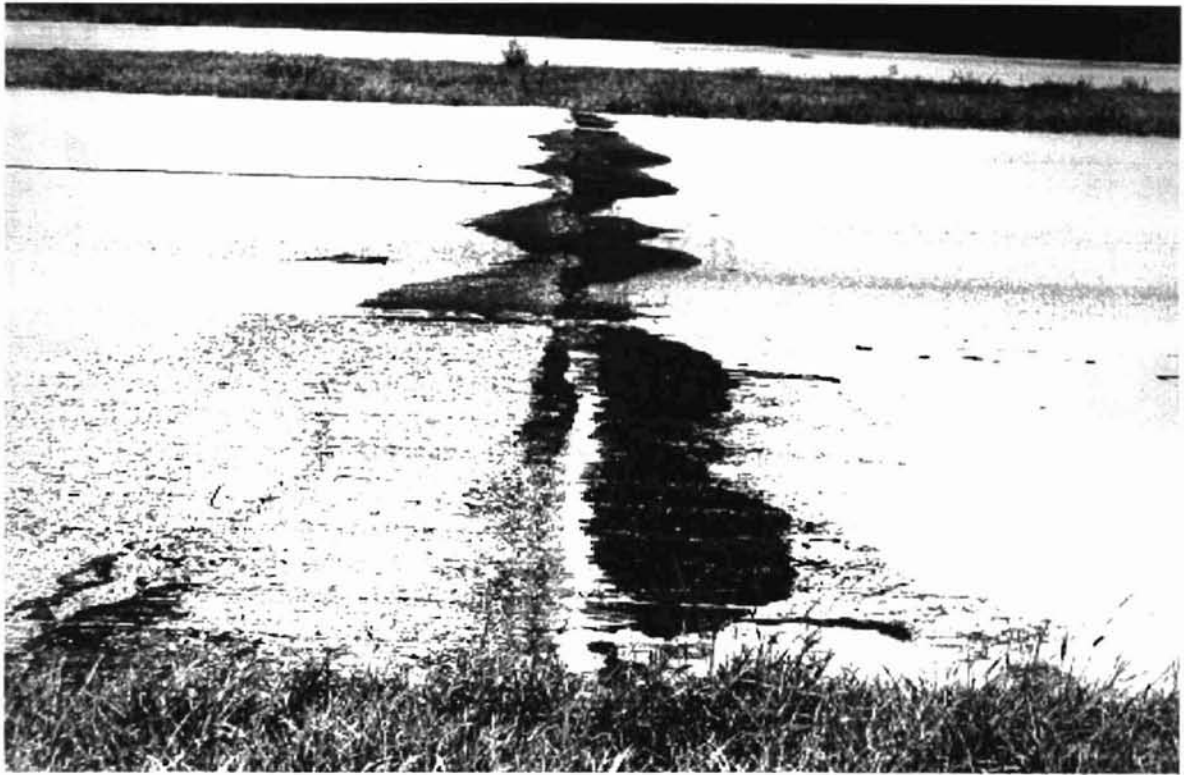
Figure A120. Patch at joint of CRC and asphalt pavements.

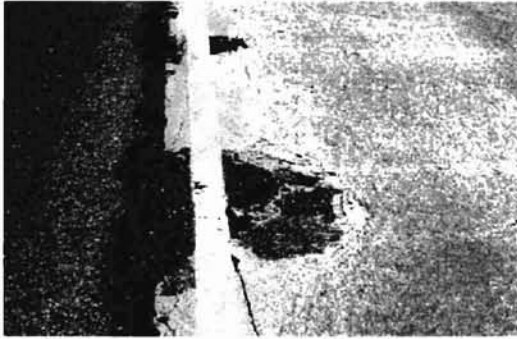
1. Punchout of repair. Typical around this location
