FACTORS RELATING TO SUBGRADE MOISTURE VARIATIONS
BENEATH OKLAHOMA HIGHWAYS

Submitted to the Faculty of the Graduate College
of the Oklahoma State University
in partial fulfillment of the requirements
for the Degree of
MASTER OF SCIENCE
May, 1970

The School of Civil Engineering at Oklahoma State University is presently engaged in a six-year Subgrade Moisture Variations research project, which began in June, 1964. The project is sponsored by the Oklahoma Department of Highways and the U. S. Department of Transportation, Federal Highway Administration, Bureau of Public Roads.

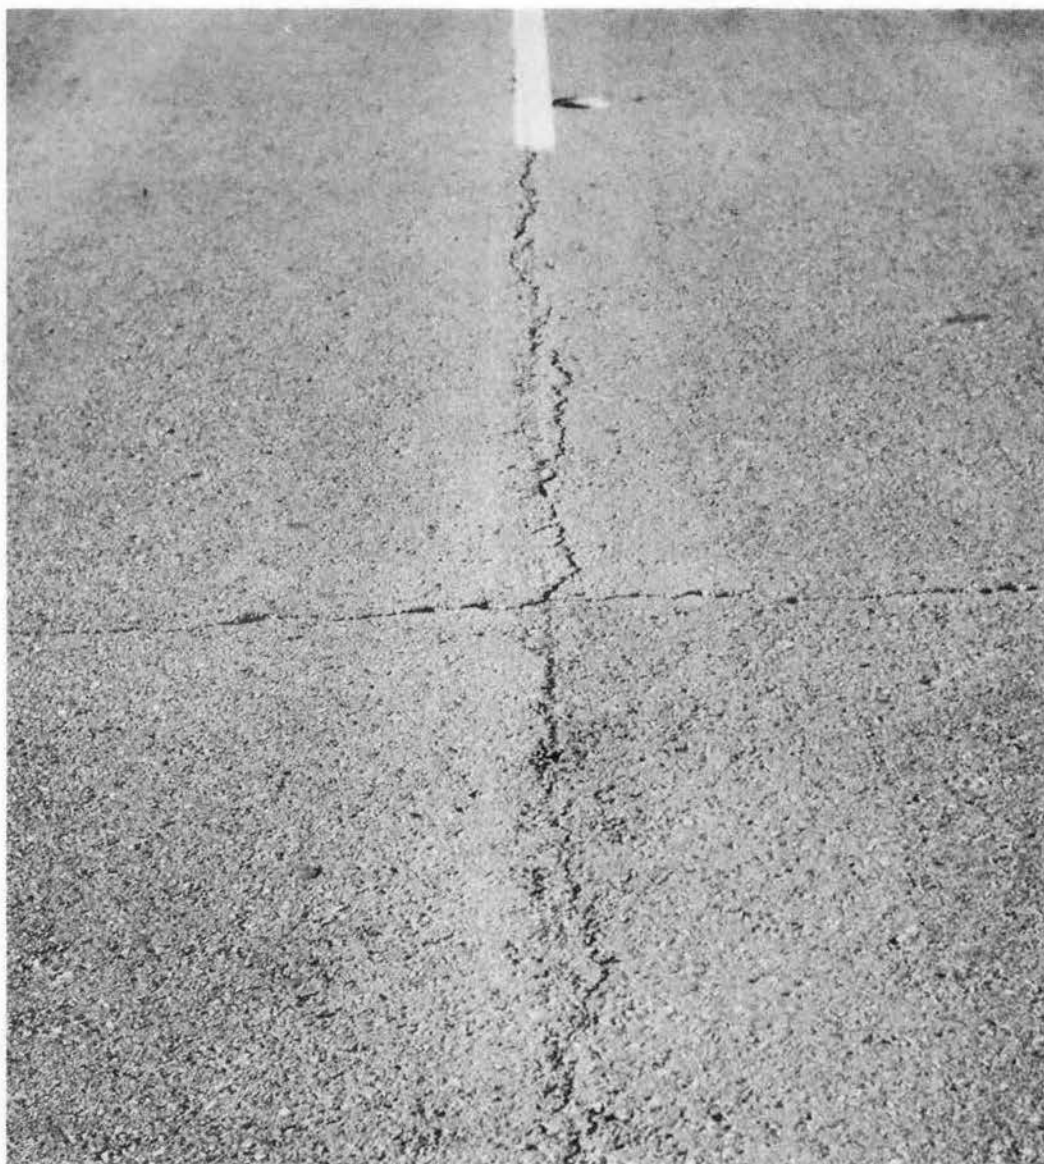
Figure 5.11 shows moisture variations and rainfall at Site No. 4, installed in July 1966. Moisture contents decrease with depth and some levels are above the subgrade liquid limit. Moisture contents had decreased when the second overlay was applied and heavy precipitation in the winter of 1967-68 caused a sharp increase in moisture contents, particularly at the 2.5 foot level. The bearing capacity was greatly reduced and in the early spring of 1968 the new overlay cracked. Since the old overlay was already cracked, infiltration occurred. Research personnel reported a "thumping" noise whenever traffic crossed the transverse joints before and after the second overlay. Much of the subgrade support was evidently lost long before 1966 when first observations were made. Figure 5.12 shows a photograph of the

Figure 5.12. Transverse and Longitudinal Cracks in Overlay at Site No. 4

reappearance of centerline and transverse joints adjacent to Site No. 4. Details of the cracking are shown by a photograph in Fig 5.13, where the size of the transverse joint in the underlying PCC pavement is indicated by the size of the AC chunks from the new overlay. Also evident is longitudinal cracking between the pavement and the widened portion. Figure 5.14 shows the subgrade soil profile at Site No. 4. The silty layer under the pavement probably acts as a "holding basin" for infiltration into the subgrade below.

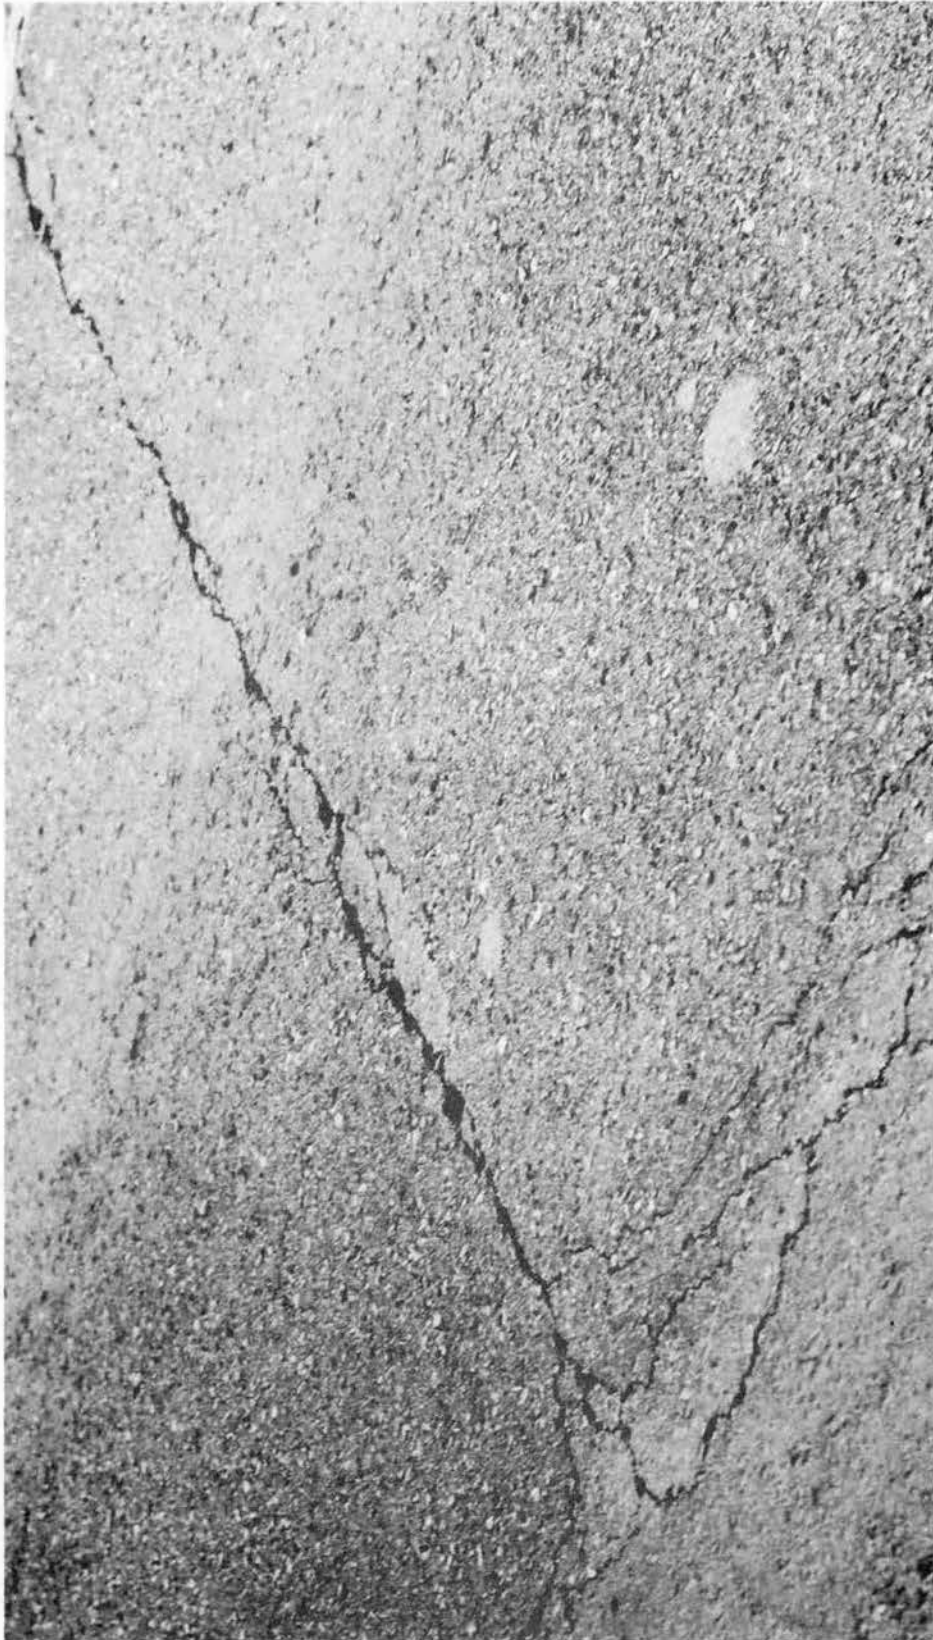
Figure 5.13. Close-up of Transverse and Longitudinal Crack Along Pavement
Edge at Site No. 4

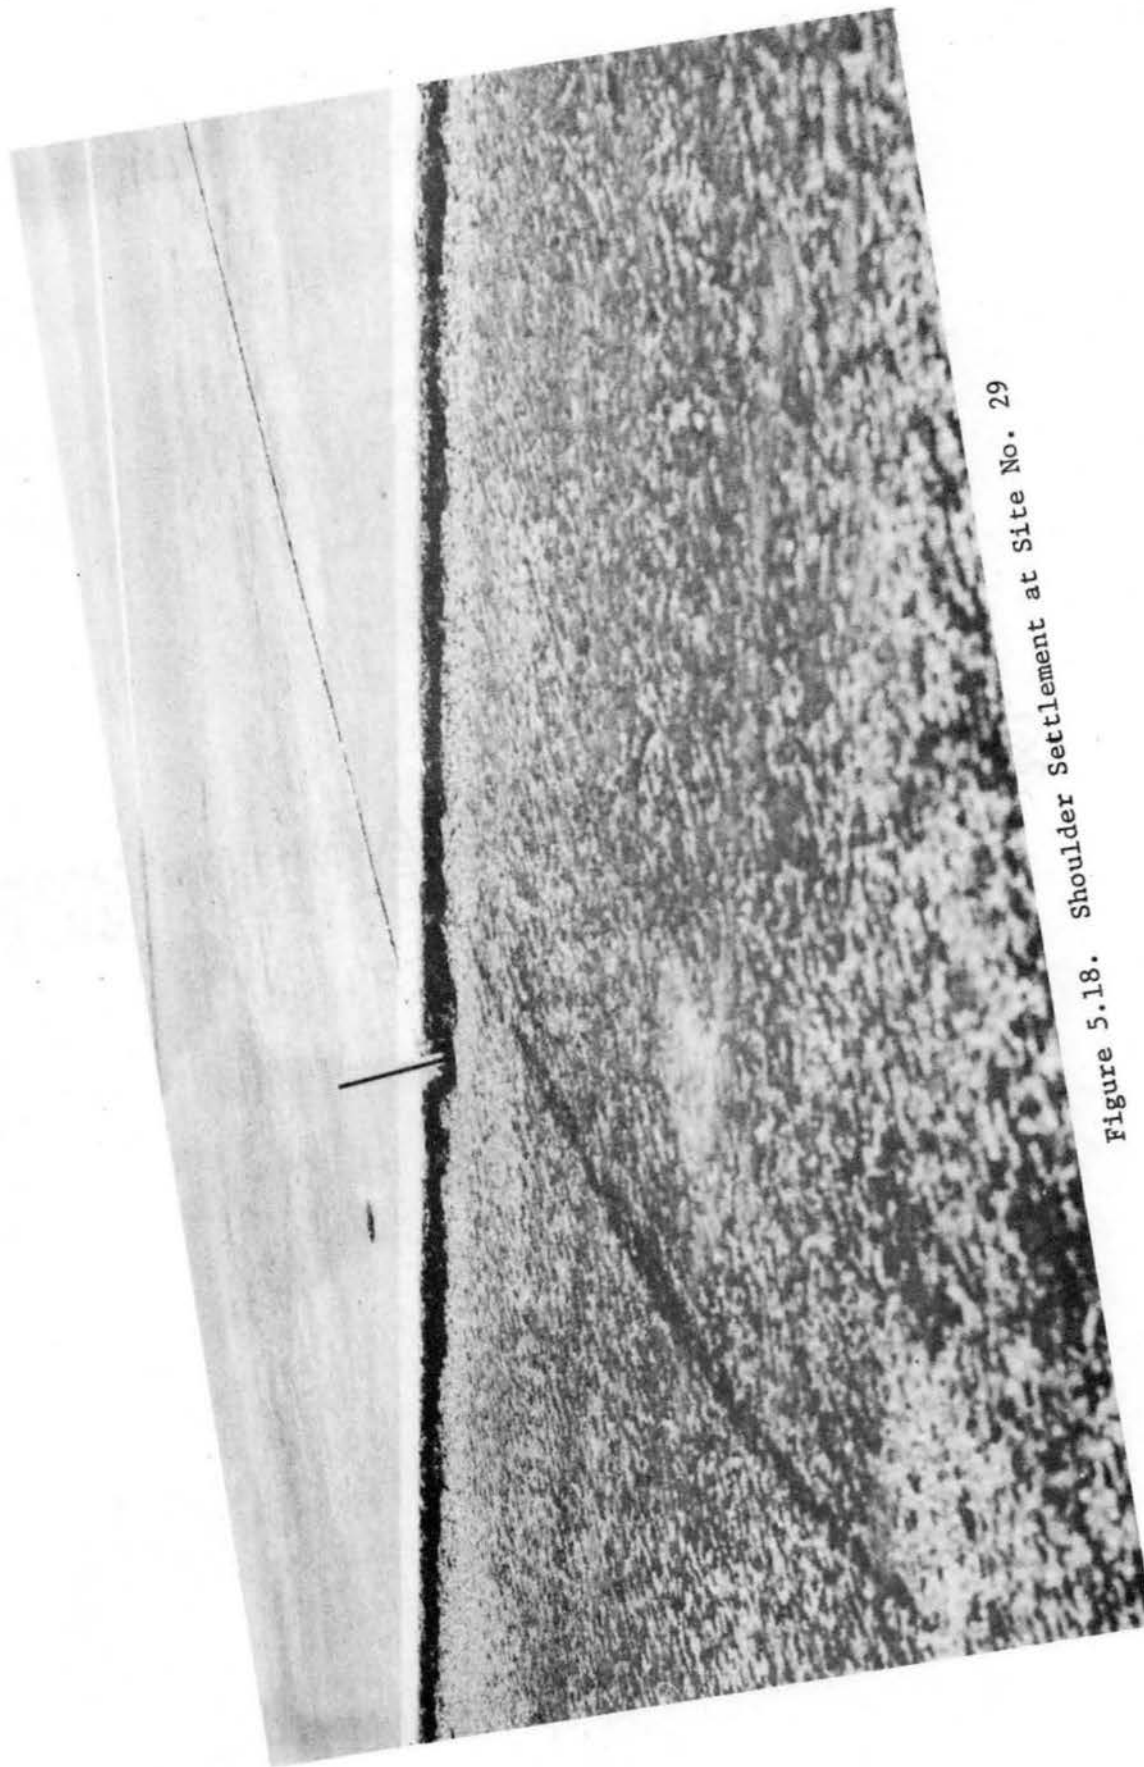
Site No. 29 is a relatively high fill section on US 64 in Tulsa County. The two-lane highway has PCC pavement with improved shoulders and was constructed in 1960 on a uniform A-7 clay subgrade with a plastic limit range of 20-28% and an average lineal shrinkage of 20%. Capillary water accumulates under the pavement centerline, but probably evaporates near the edge of the shoulders because of greater surface area on the embankment sides. A photograph of one shoulder at Site No. 29 is shown in Fig 5.18. This shoulder has settled 2 to 3 inches, as has the other shoulder, because of generally dryer conditions under the shoulders. Figure 5.19 is a photograph of the pavement edge at Site No. 29. The ripples in the pavement edge are probably joints, since a transverse joint usually coincides with

Figure 5.18. Shoulder Settlement at Site No. 29

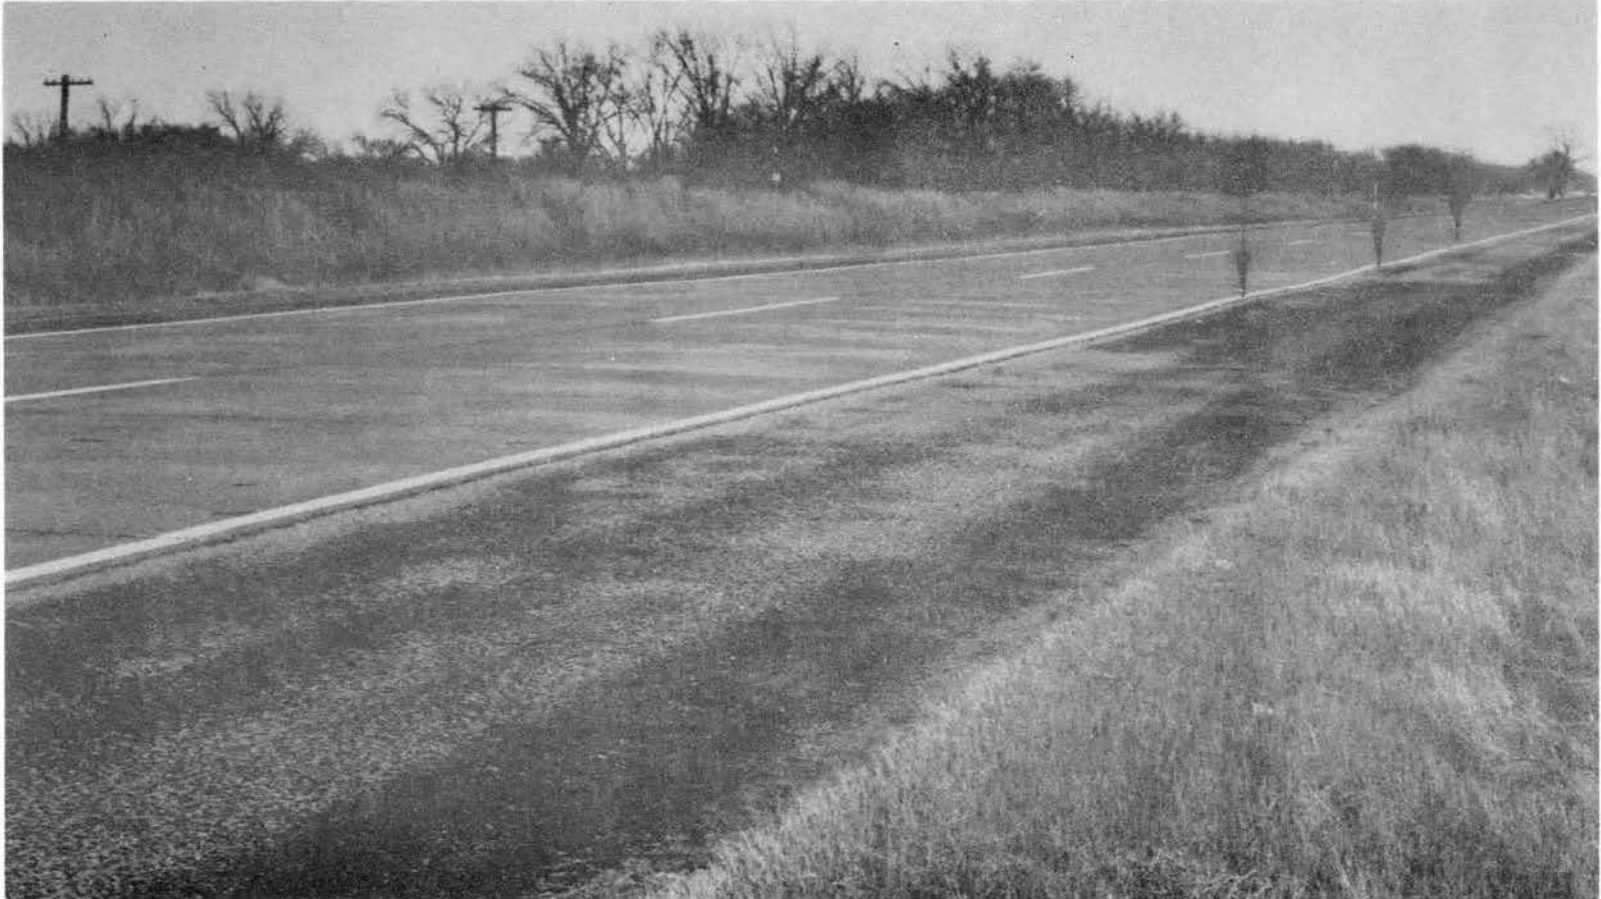
Figure 5.19. Ripples in Pavement Edge at Site No. 29

the peak of a ripple. Pavement and shoulder ratings at Site No. 29 are good.

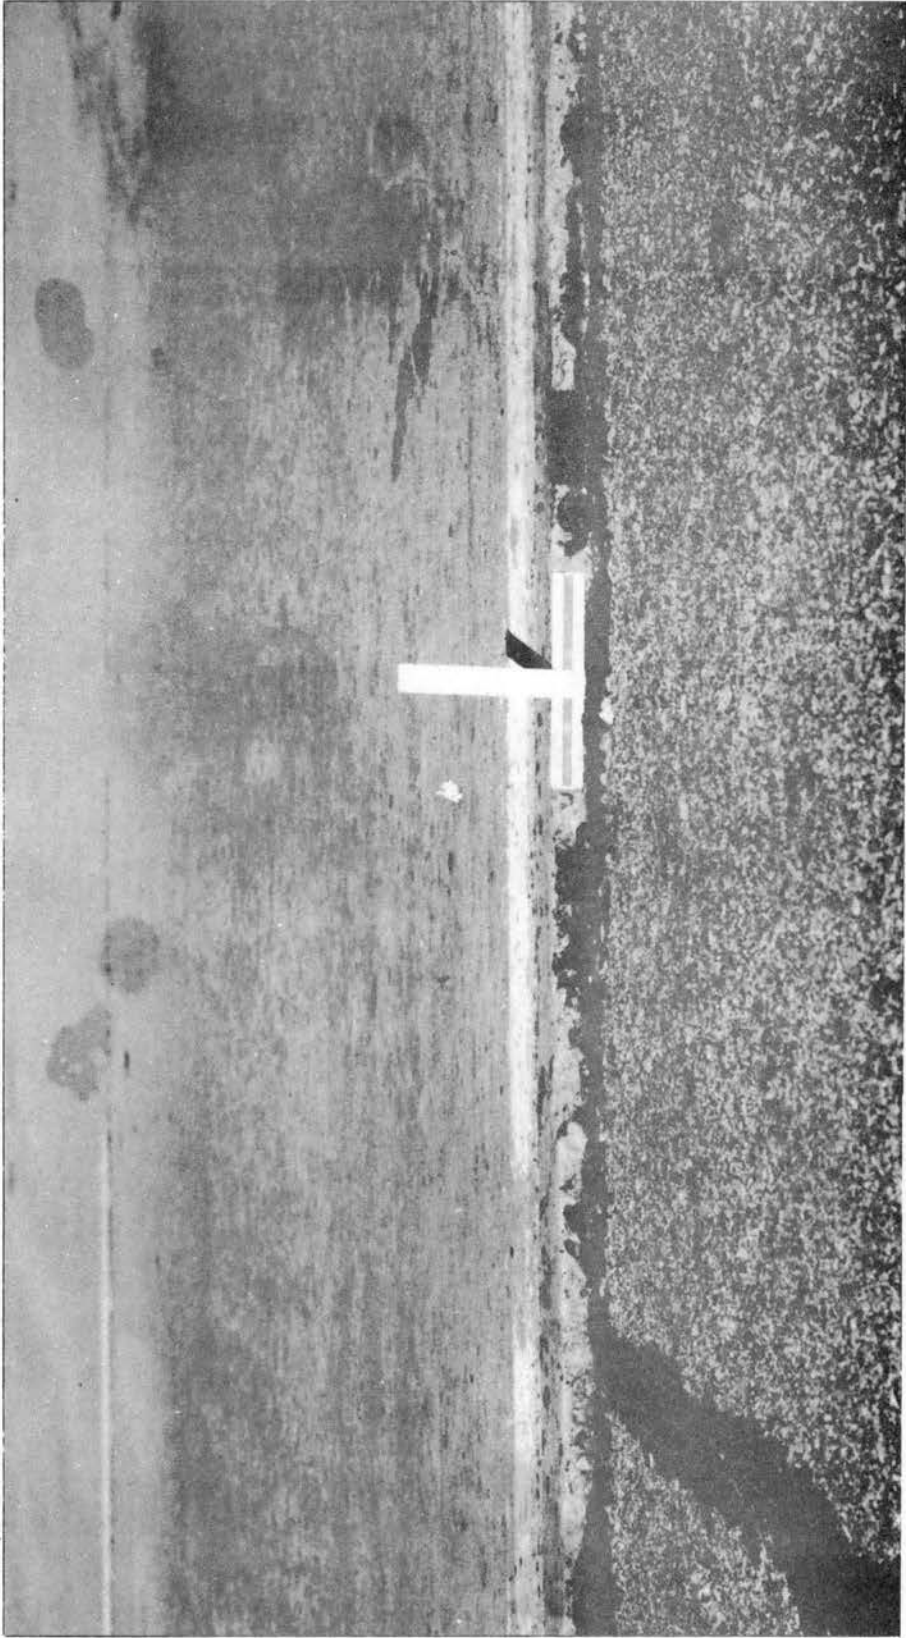
Subgrade soil type was found to be related to subgrade moisture behavior. Data from sites with bench marks indicates plastic and non-plastic subgrade soils swelled with increasing moisture content, although the plastic subgrade soils swelled more. Most plastic subgrade soils exhibited an average heave/moisture content increase ratio of 1/12 in./% as compared to less than 1/16 in./% for "good" non-plastic subgrade soils. Figure 5.21 is a picture of the shoulder adjacent to Sites No. 49 and 50. As mentioned previously, Site No. 49 is AC pavement with a sand-asphalt base under the shoulders, while Site No. 50 has PCC pavement and soil-cement base under the shoulders. The sites are within 50 yds of each other, though they have different subgrades. The plastic subgrade soil at Site No. 50 heaved four times as much as the "good" subgrade at Site No. 49. It is readily apparent that the soil-cement base has been cracked as a result of this swelling while the sand-asphalt base did not crack. Before the cracks were sealed moisture content increased considerably under the shoulder at Site No. 50. Close scrutiny of Fig 5.21 will show longitudinal cracking near the shoulder edge of the section with soil-cement base, which

Figure 5.20. Shoulder Settlement at Site No. 42

was probably caused by development of a wet-dry interface.

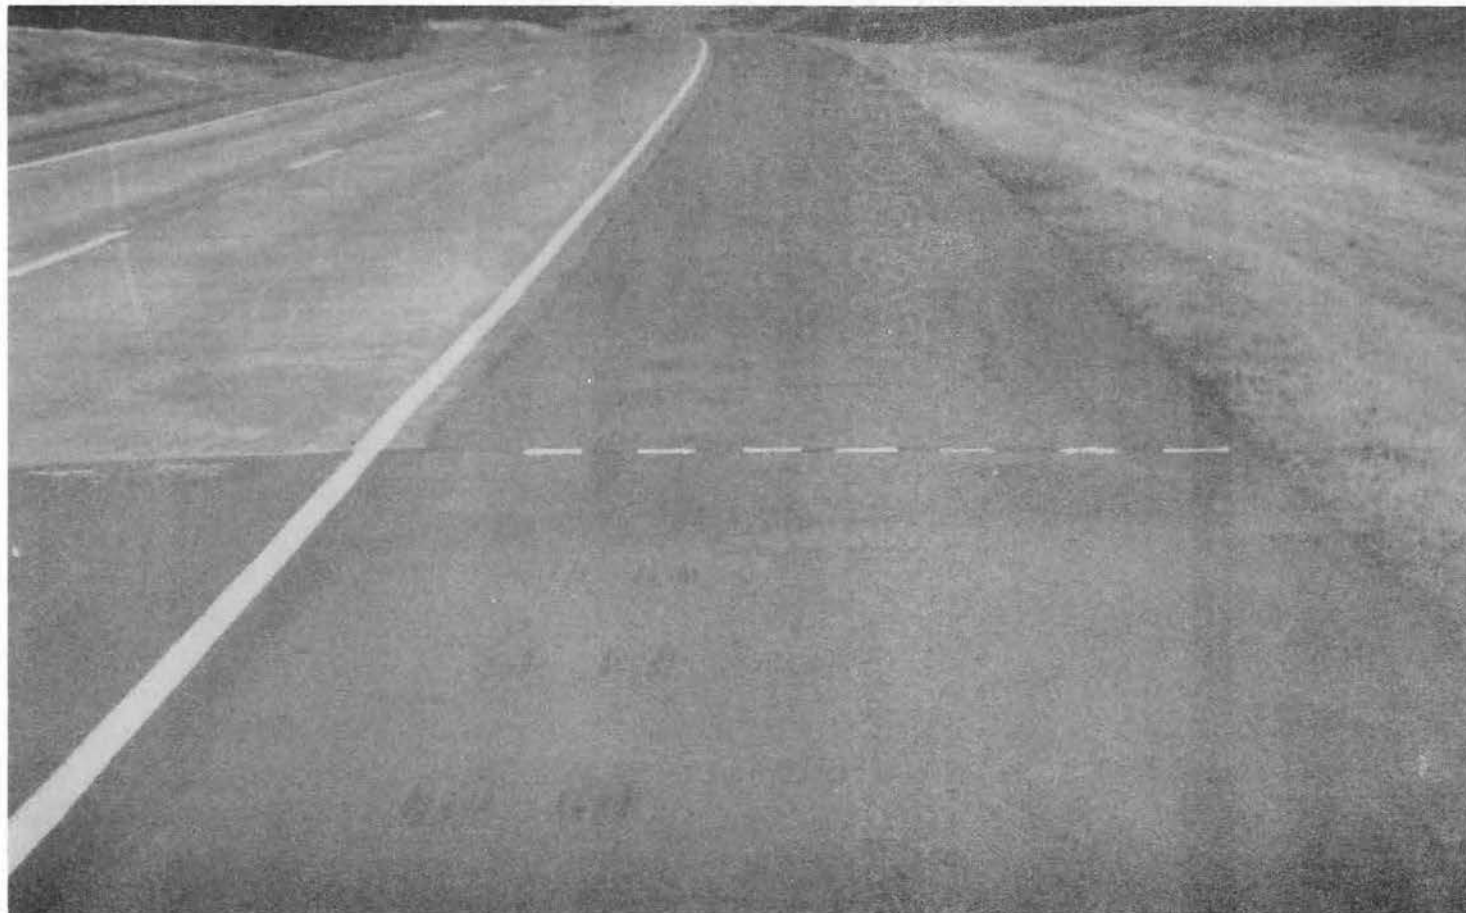
Figure 5.21. Shoulder Cracks Adjacent to Site Nos. 49 and 50

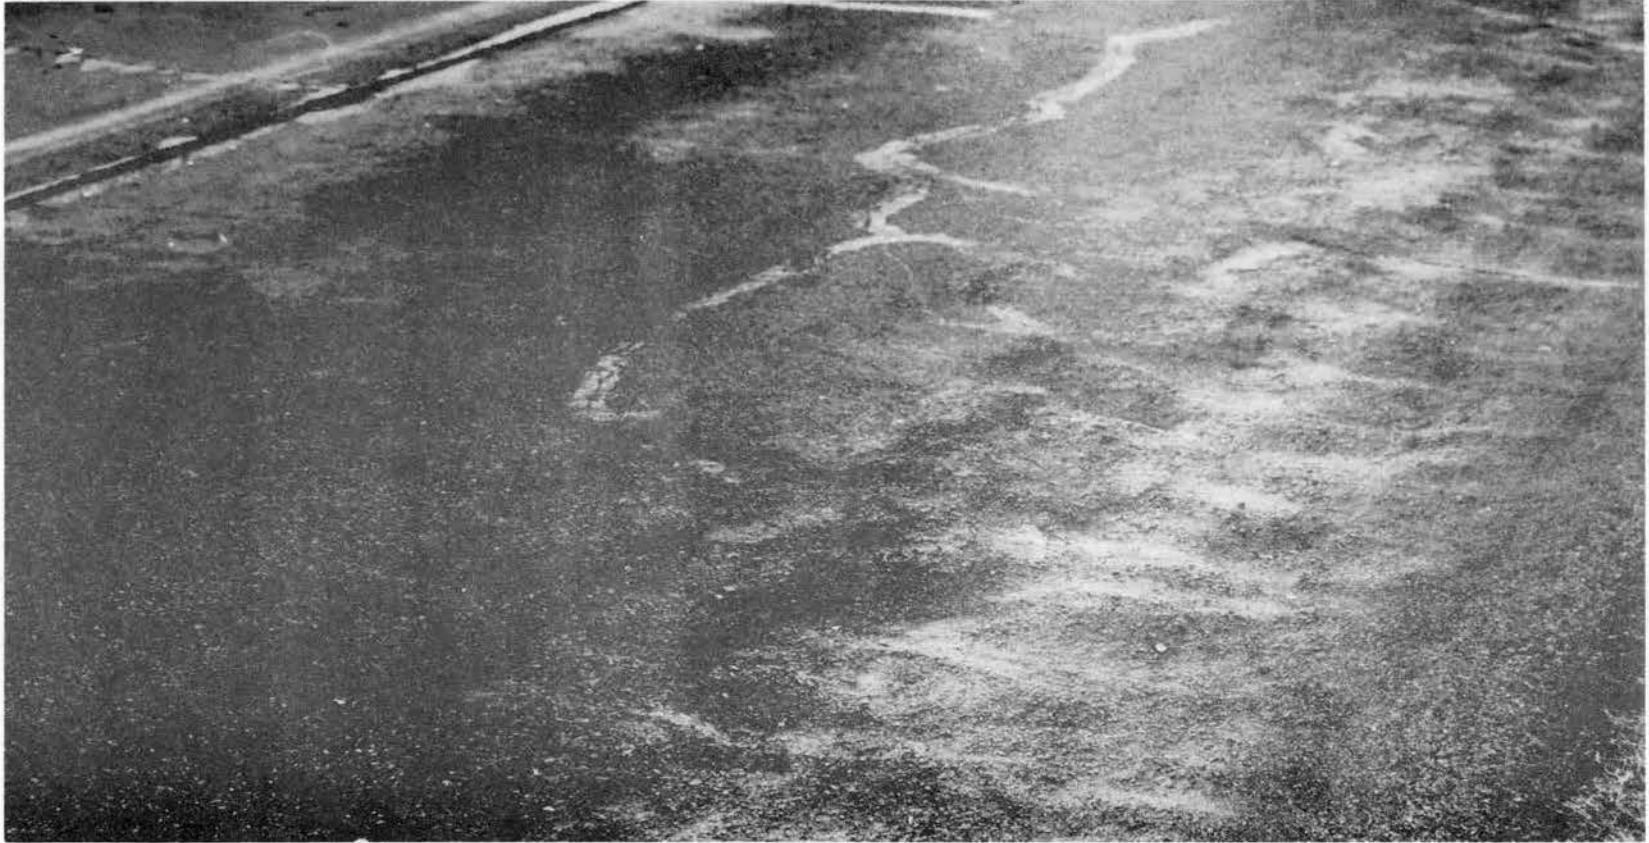
Figure 5.23. Shoulder Failure Because of Heavy Traffic

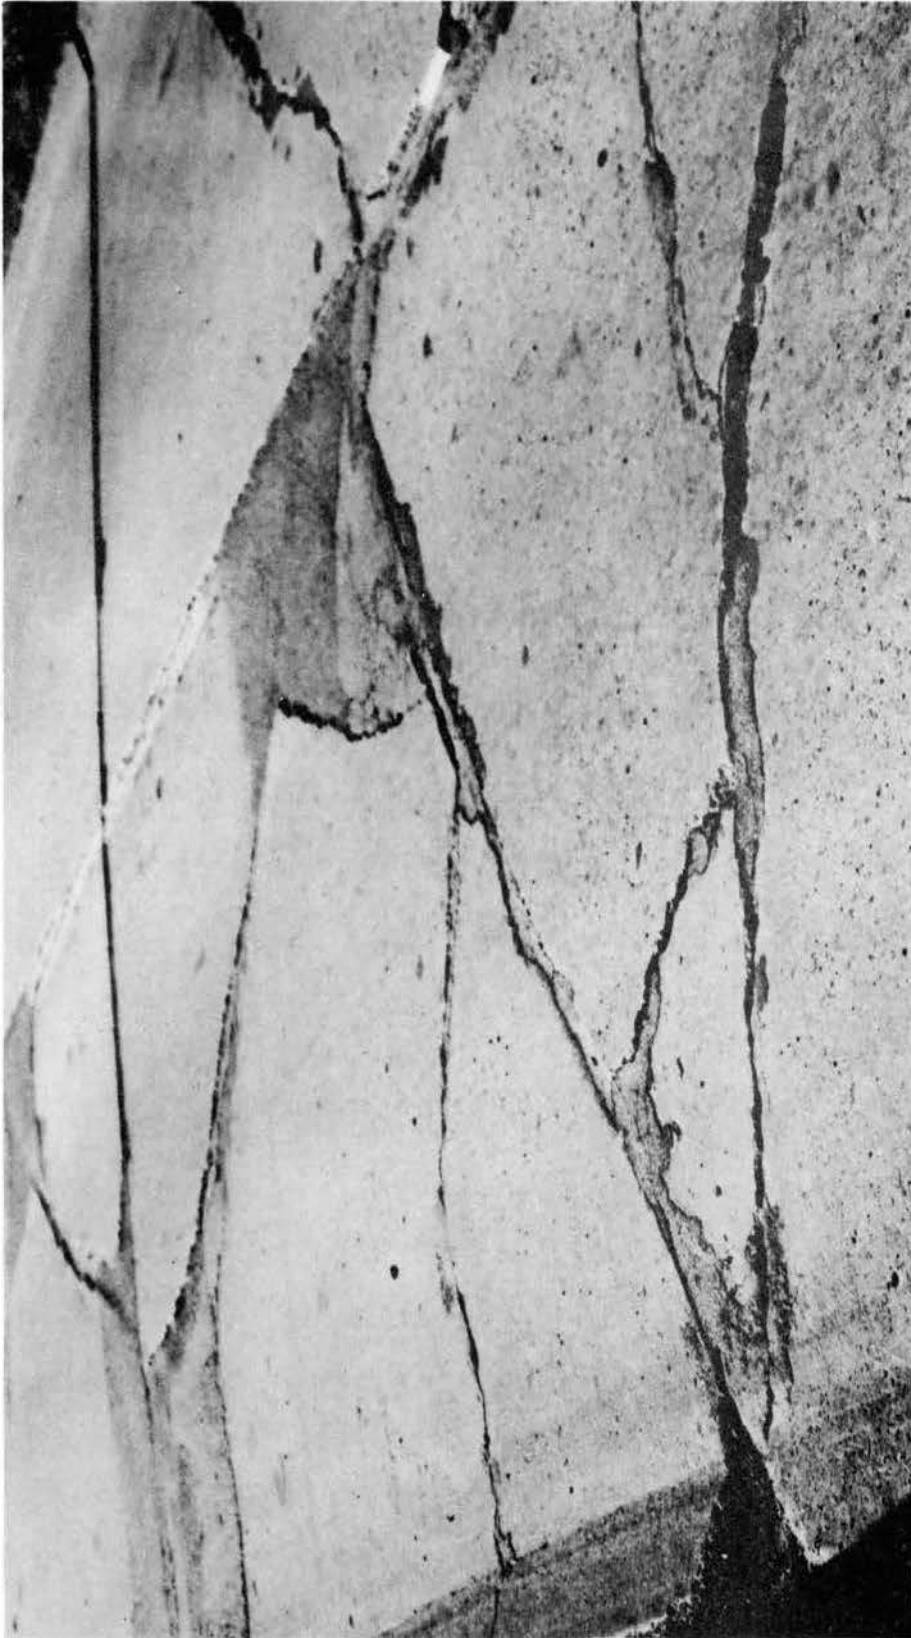
As noted previously, concrete pavements grow because of thermal expansion. Upon contraction, joints are wider since only each slab contracts. If the widened joint is not sealed, solid material fills the joint. Upon the next expansion/contraction cycle, the total "growth" is greater because the joints have been filled. As the joints become wider, greater amounts of infiltration occur, causing the subgrade soil to swell and this swelling opens the joints still further. When subgrade moisture contents are high enough, pumping may occur, and the pavement fails because of reduced bearing capacity and loss of subgrade support. Figure 5.24 shows a pavement which has failed completely because of swelling soils and improper maintenance of the joints. Figures 5.25 and 5.26 show details of wide joints, differential movement along the pavement centerline, and pavement cracking. Nearby is the subgrade for the new replacement highway, which has

Figure 5.24. Overall View of Complete Pavement Failure

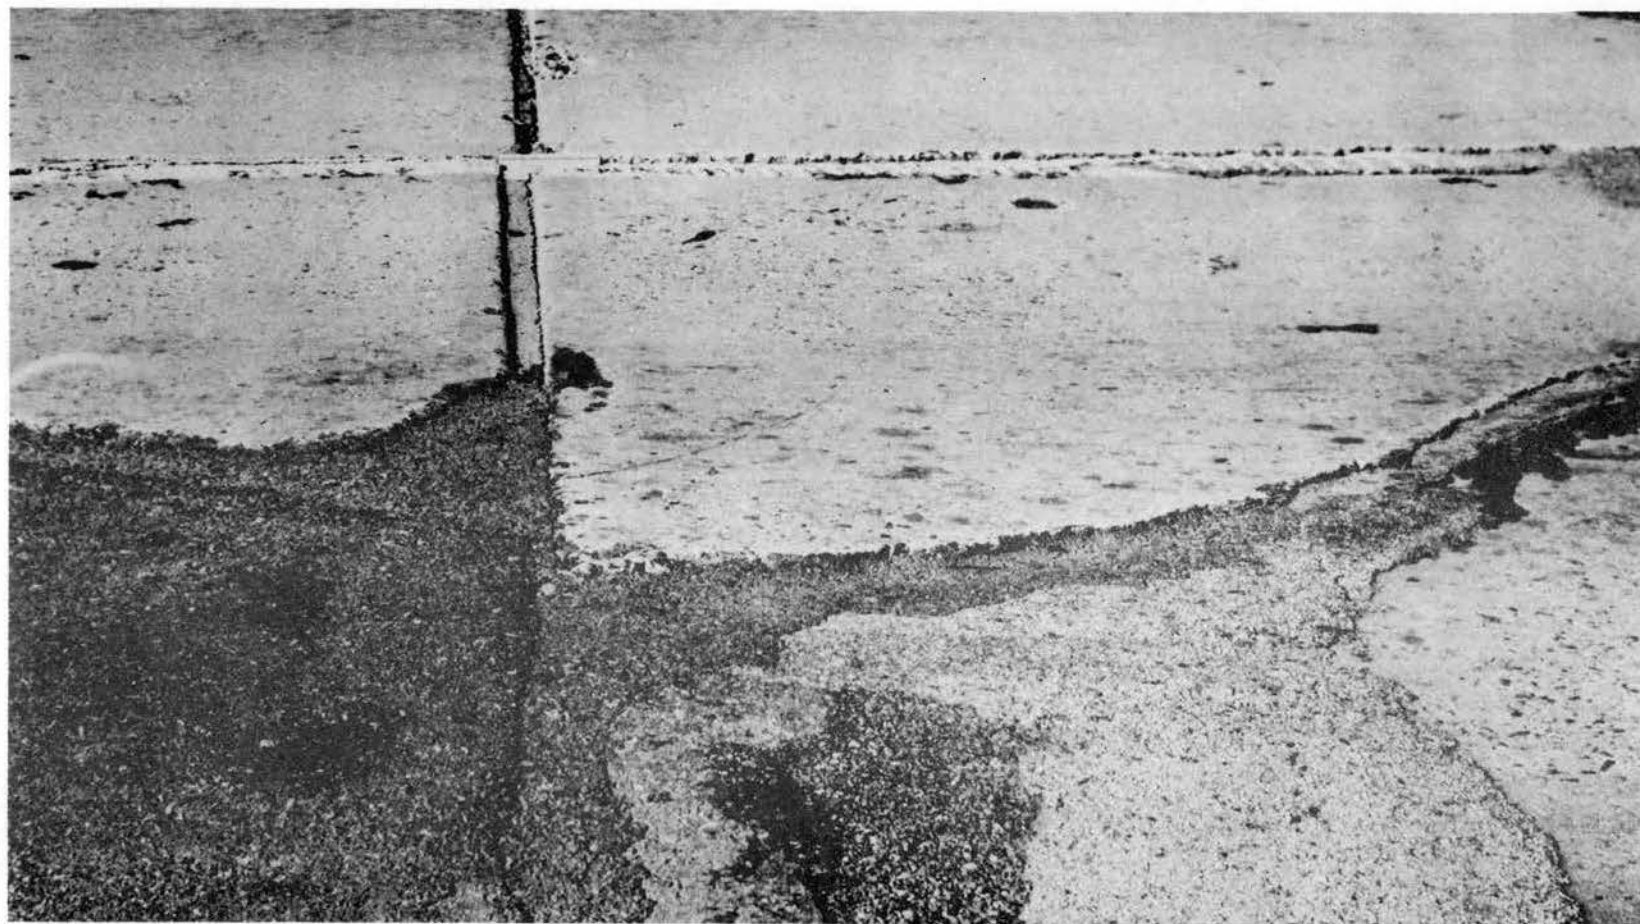
Figure 5.25. Close-up of Cracks and Joints in Figure 5.24

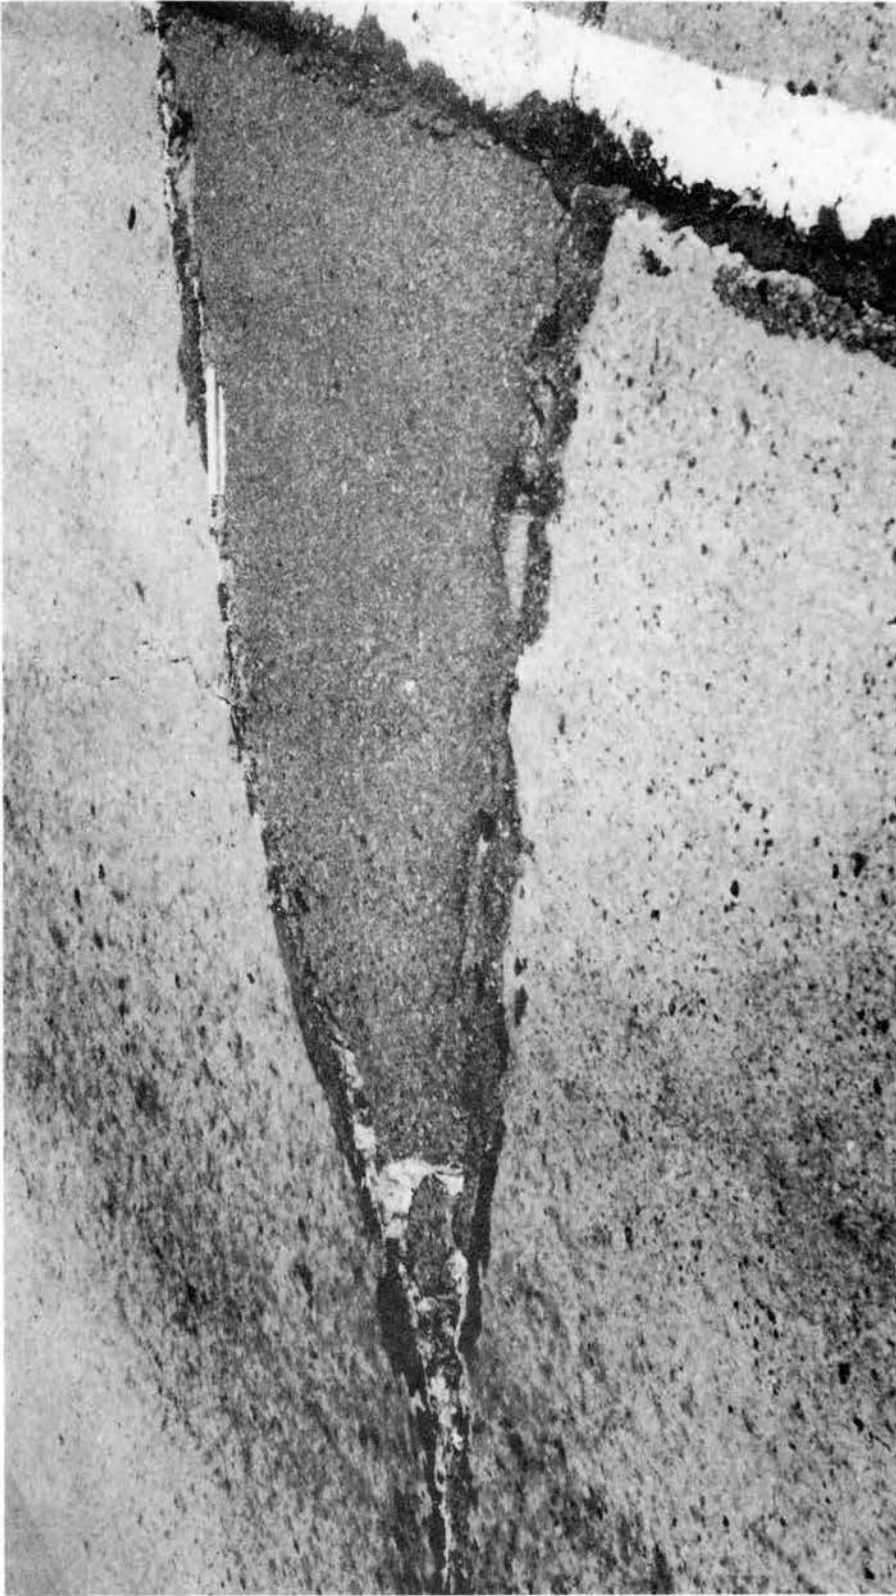
Figure 5.26. Open Centerline Joint and Corner Crack
