# EVALUATION OF SILICA FUME HIGH DENSITY THIN BONDED OVERLAYS

**Final Report  
September 2002**

**Wilson B. Brewer, Jr.  
Project Manager  
Gary Williams, P.E.  
Engineering Manager**

**Planning & Research Division  
Oklahoma Department of Transportation  
200 N.E. 21<sup>st</sup> Street, Room 3A7  
(405)522-3794  
FAX (405)521-6528**

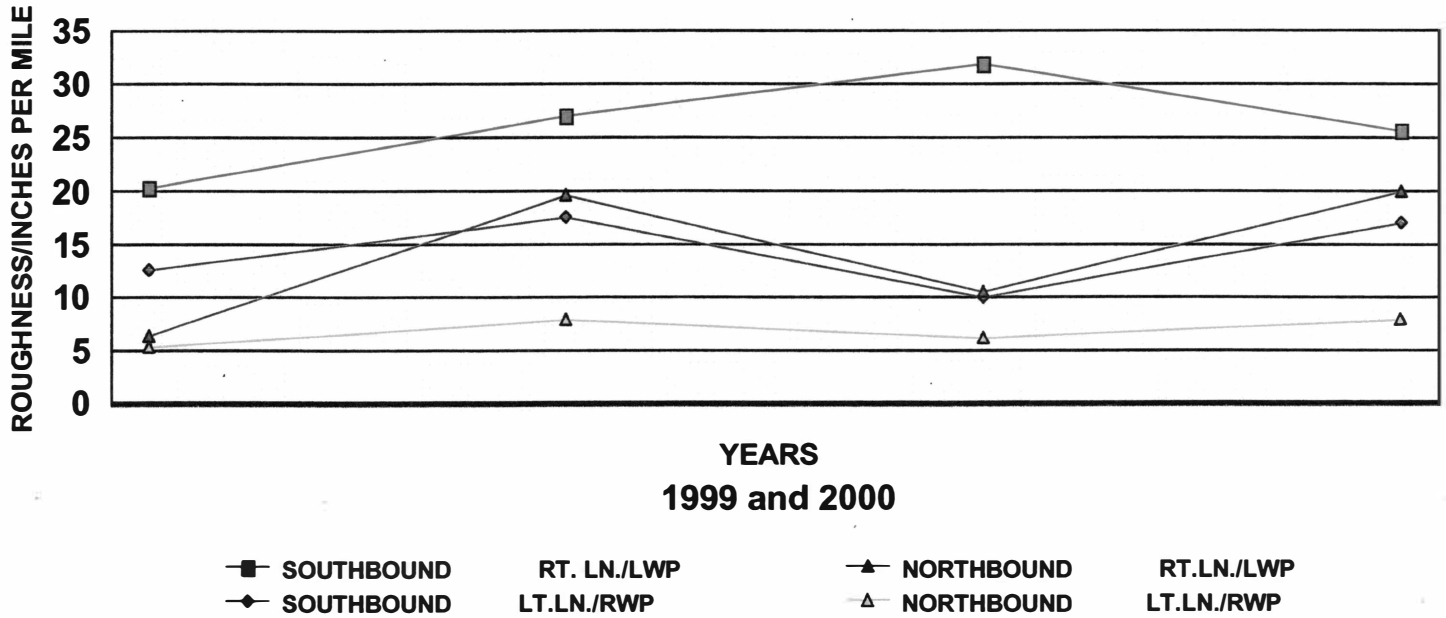
Figure 1. Profilograph testing of the total project which includes 200 ft (61 m) on each side of the bridge deck and on the bridge deck for the years 1999 and 2000. Locations 1 and 3 are results of testing on the bridge decks and locations 2 and 4 results of testing the length of the total project.

According to smoothness measurements shown on the line graph, three out of the four readings show the entire project being slightly rougher than the bridge deck and there was no noticeable increase in roughness for 1999 to 2000. Profilograph testing was not done in year 2001 but the ride quality felt approximately the same as previous years. Both bridges still have smooth riding surfaces.

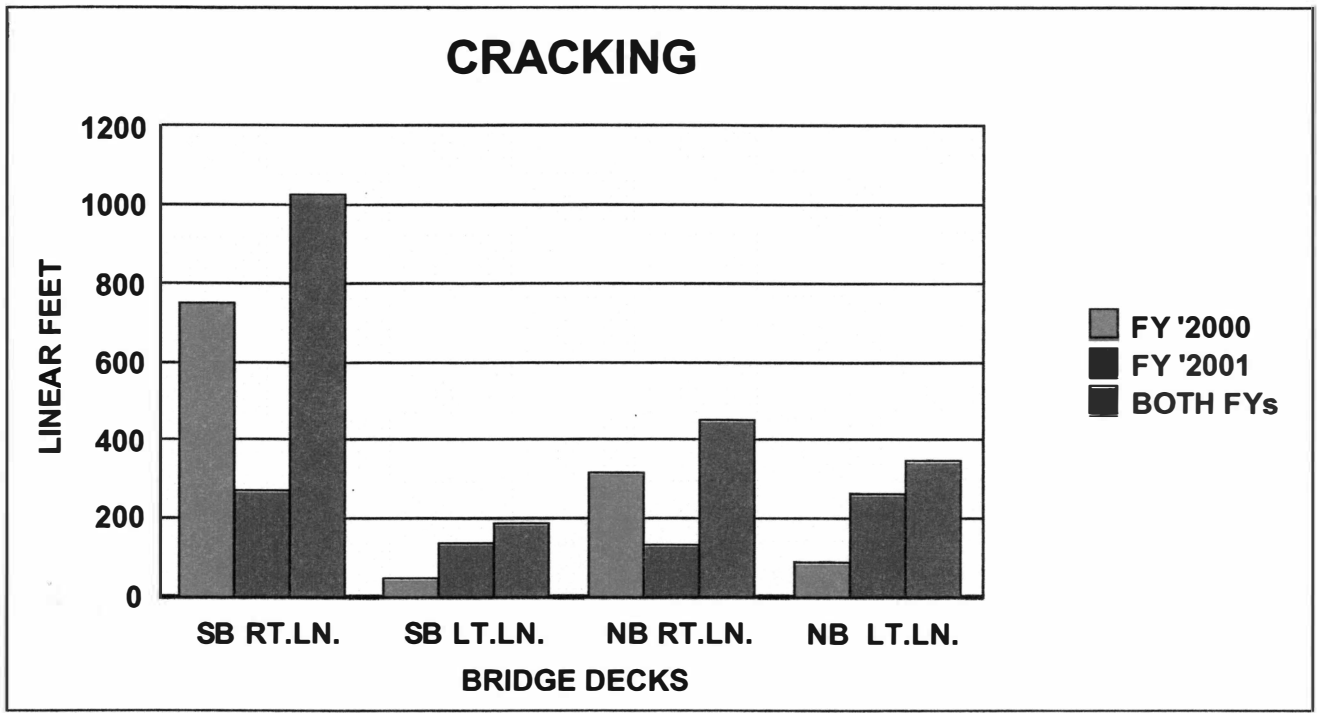
The southbound expressway bridge right lane in year 2000 had 751 ft ( 226 m)of cracking. Most of this was random cracking, but a construction joint crack of 148 ft (45 m) that runs the length of the bridge deck is included. Year 2001, 274 ft ( 84 m) of random cracks, in addition to those measured in 2000 were observed. The total amount of cracking for year 2000 and year 2001 is 1025 ft (312 m). Cracking in the left lane has the smallest amount. In the year 2000, the linear feet of cracking was 48 ft (15 m) and it increased to 138 ft (42 m) in the year 2001.

Cracking in the northbound lane has been less severe. In year 2000, the right lane cracking totaled 263 ft (80 m). Of that, 124 ft (38 m) was a longitudinal construction joint crack that runs the length of the bridge deck. Left lane cracking has been moderate. In year 2000, 86 ft (26 m) of random cracks were recorded. Two hundred and sixty three feet (80 m) of cracking was measured in 2001. Both construction joint cracks had a width opening of 1/4 in (6 mm) and the random cracks are still hairline size (2). The linear feet of cracking is graphed in figure 2. from the years 2000 and 2001, the graph shows the new cracking observed each year and a combined amount from both years. Each year, chain-drag testing was performed on both bridge decks and no delimitations were found.

Figure 2. Bar graph of linear feet of cracking on the bridge decks in the years 2000 and 2001 in both lanes.

Cracking has an effect on the amount of ions passing to the reinforcement bars. The hairline size cracks have increased each year. The southbound right lane has more than double the amount of cracking as the northbound right lane. While the northbound left lane has more cracking than the southbound left lane. There is no pattern with regards to traffic which would account for the great difference in cracking. The cracking problem should be examined with a goal of determining any connection to air entrainment and curing during construction.

Cracking continues to be a major concern which could affect the life of this project. It has increased each year and should continue to be observed and evaluated to determine its rate. Although the ride is currently smooth, and the overlays are performing well, an additional three years of investigation to observe cracking, ride quality and surface distress is recommended.

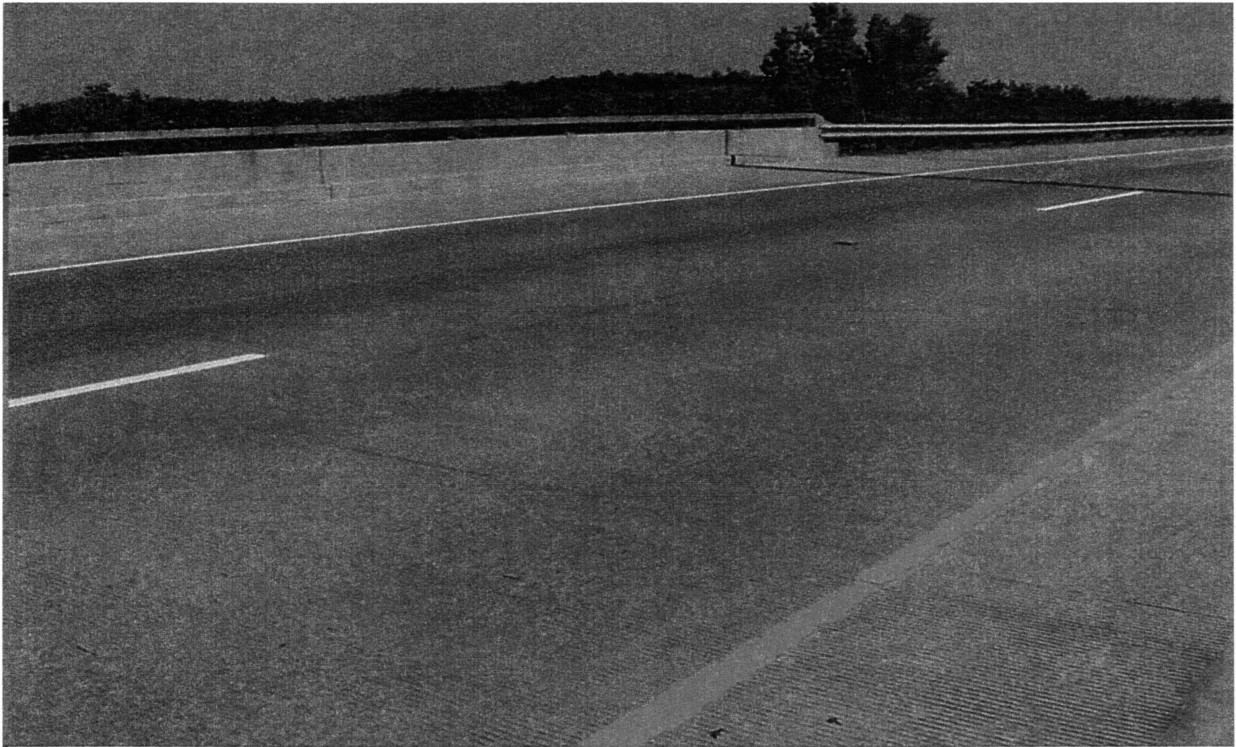
Figure 4. Overlaid Deck, No Distress Present Other Than Cracking.

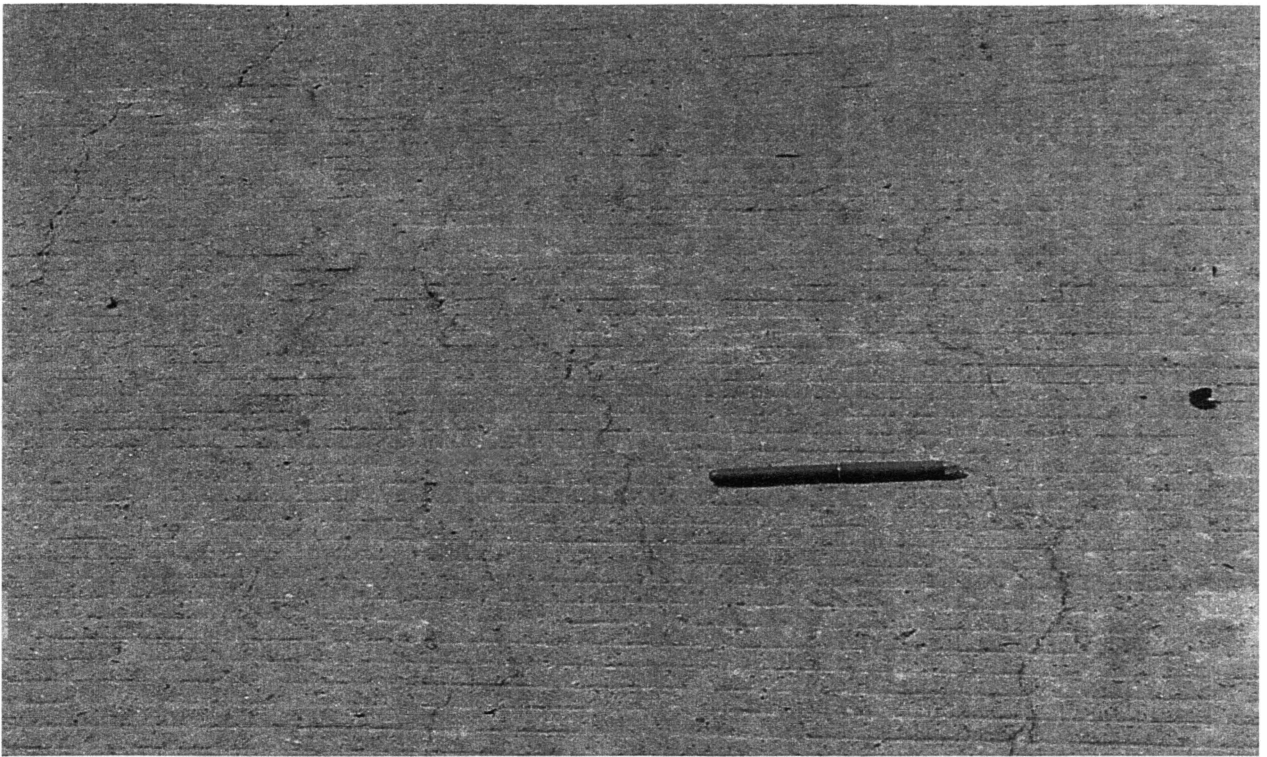
The October 2000 survey showed hairline cracking as the major distress found on both bridge decks. Approximately 10% of the northbound bridge deck had random hairline size cracks while the southbound bridge deck had similar distress over approximately 25%. No delaminations were detected during chain-drag testing. All half cell readings were in the lowest potential class (ASTM C 876). The southbound bridge had only 7% and the northbound bridge had 2.9% class "A" range readings. Skid values were measured on the southbound right lane at 43 and 52, and the northbound right lane at 42 and 46, which indicates good skid resistance. See Figure 1 for a graph of the profilograph test results from 1999 to 2000.

Figure 5. Hairline Size Random Cracks.

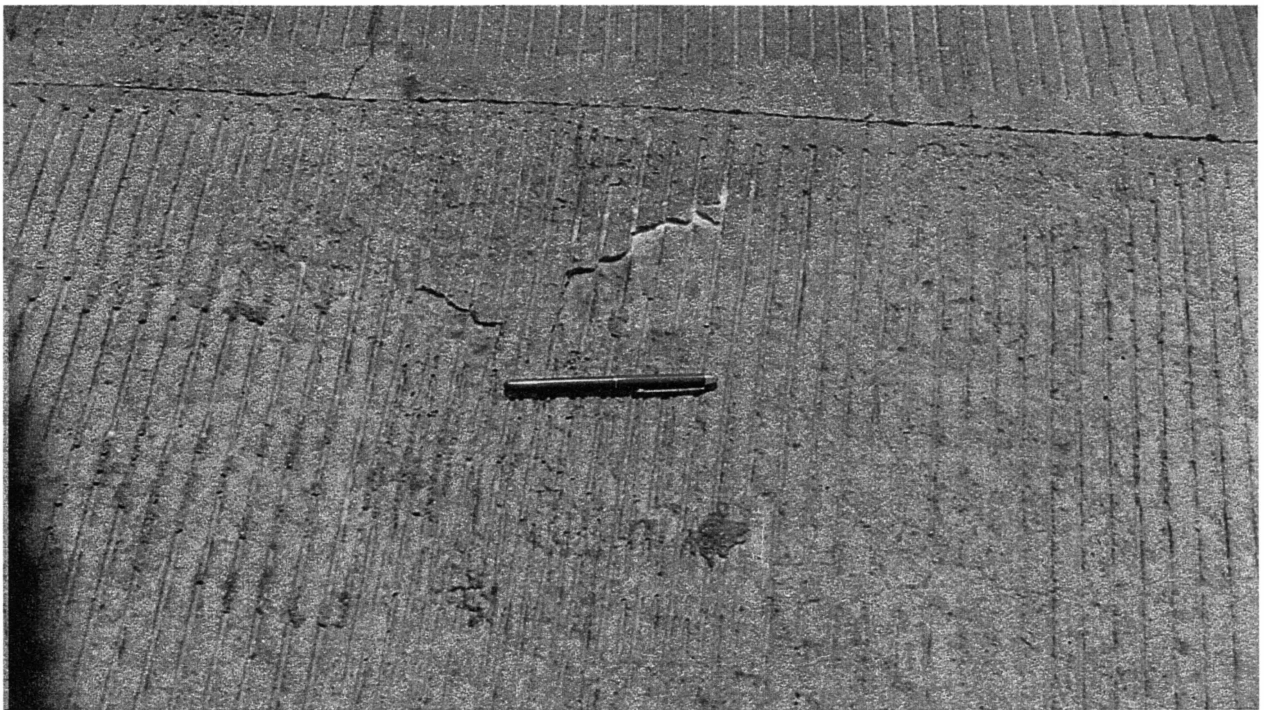
Figure 6. Longitudinal Construction Joint Crack.
