EVALUATION OF SILICA FUME HIGH DENSITY THIN BONDED OVERLAYS

**Interim Report
February 2001**

1. REPORT NO. FHWA/OK 00(03)	2. GOVERNMENT ACCESSION NO.	3. RECIPIENT'S CATALOG NO.	
4. TITLE AND SUBTITLE EVALUATION OF SILICA FUME HIGH DENSITY THIN BONDED OVERLAYS -INTERIM REPORT		5. REPORT DATE FEBRUARY 2001

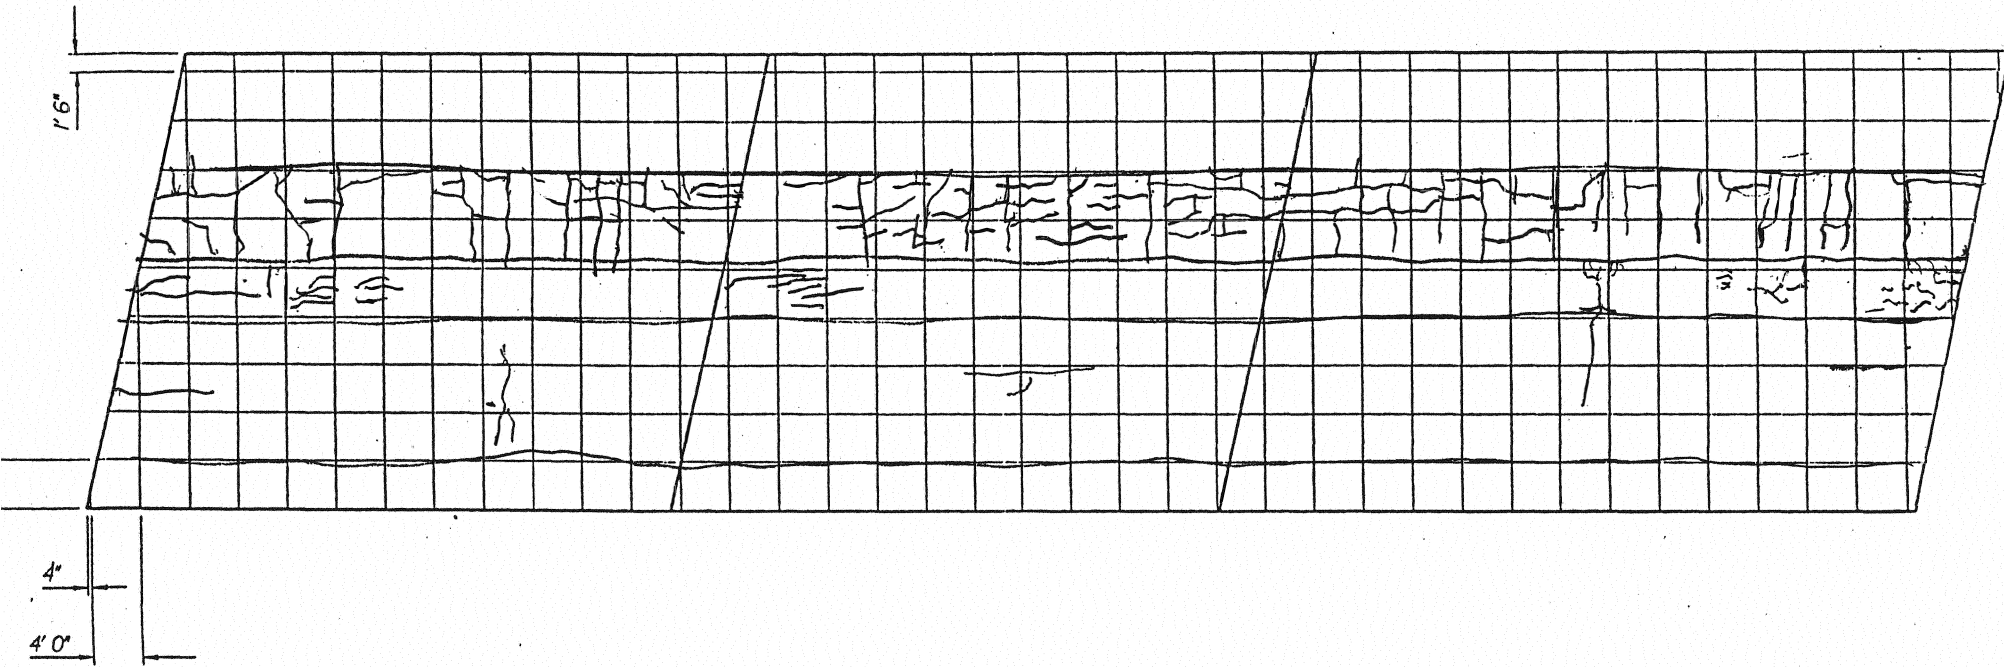
CRACK MAP OF SOUTH BOUND BRIDGE

The south bound bridge has a longitudinal construction joint which travels the length of the project. The joint is located on the inside half of the outside (west) lane. A crack formed over this joint which has a maximum width of 6 mm ($\frac{1}{4}$ inch). All other cracks were randomly spaced over approximately 10 percent of the bridge deck of the southbound bridge. These are "hairline" cracks size in accordance with SHRP-3-338 manual, a fracture that is very narrow in width, less than 3mm ($\frac{1}{8}$ inch).

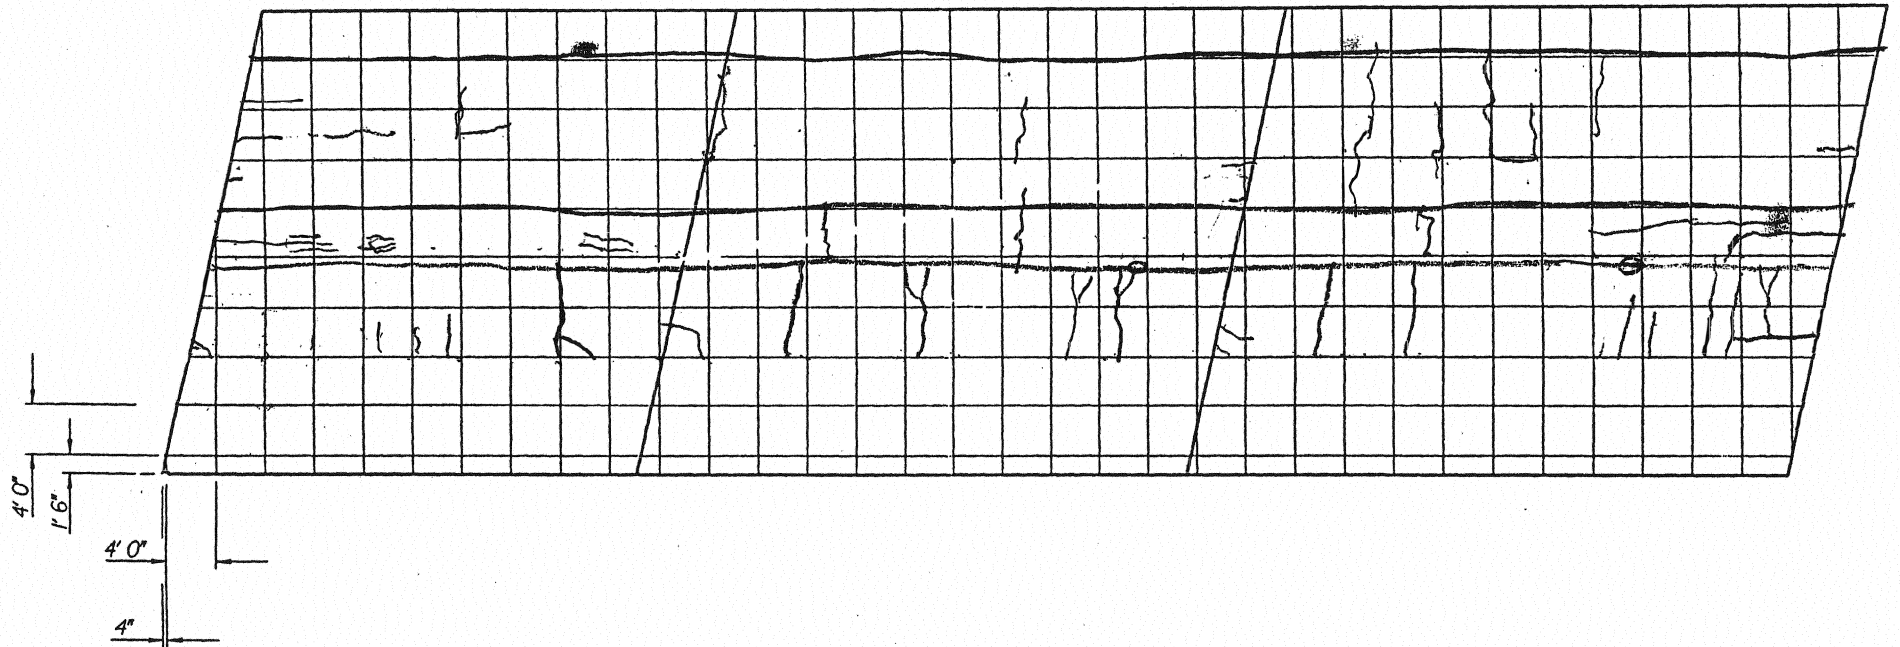
CRACK MAP OF NORTH BOUND BRIDGE

The north bound bridge also had a construction joint in the corresponding location (inside half of the outside, or east, lane). Maximum width of the crack over this joint was 3 mm ($\frac{1}{8}$ inch). Hairline cracks were randomly located over approximately 25 percent of the northbound bridge. Crack maps of each of the two bridges are included in Appendix A.

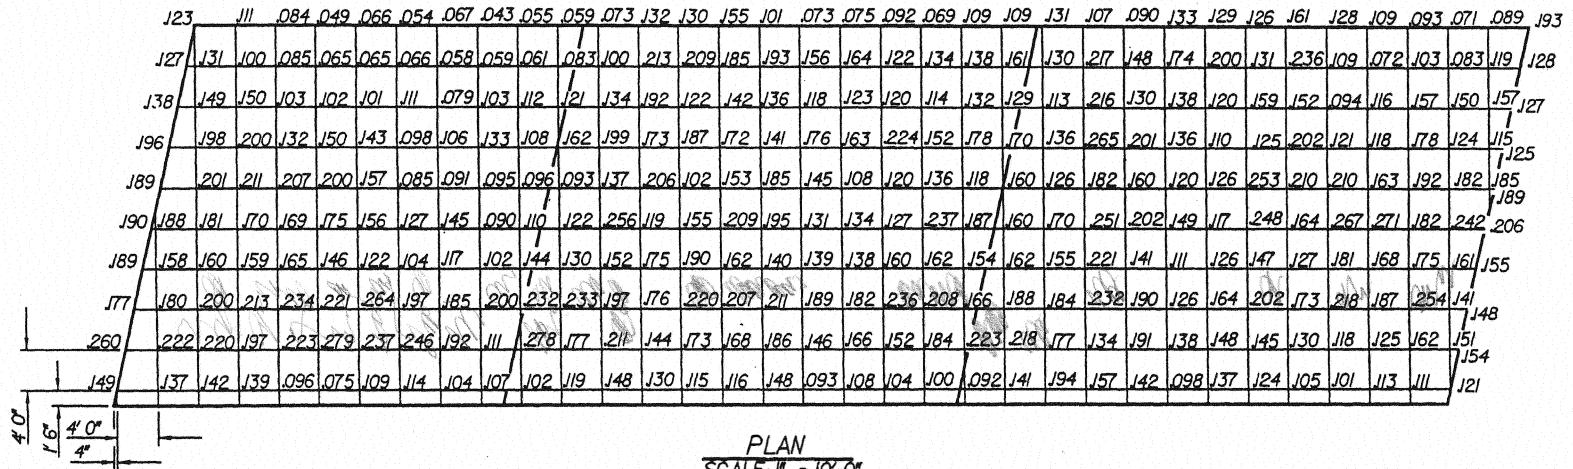
I-35 Northbound		Carter County	Design
SILICA FUME DECK ANALYSIS			Field
			Check
STATE OF OKLAHOMA			Sign
			Exp.
DEPARTMENT OF TRANSPORTATION		FILE NO. 2132	13

The results of this analysis shows that there was only 2.9% Class "A" readings on the Northbound bridge and no Class "B" or "C" data. The testing on the Southbound bridge indicated 7.0% of Class "A" readings and no Class "B" or "C" indications, Class "C" being the most critical. The 1999 results indicated 2.6% for the Northbound and 4.2% for the Southbound.

CLASS "A" % : 29%
 CLASS "B" % : 0 %
 CLASS "C" % : 0 %
