EVALUATION OF PYRAMENT BRIDGE DECK OVERLAY

**Final Report
November 1996**

**Research, Development & Technology Transfer
Oklahoma Department of Transportation
200 N.E. 21st Street, Room 2A2
Oklahoma City, OK 73105
(405) 521-2671
FAX (405) 521-6528**

EVALUATION OF A PYRAMENT BRIDGE DECK OVERLAY

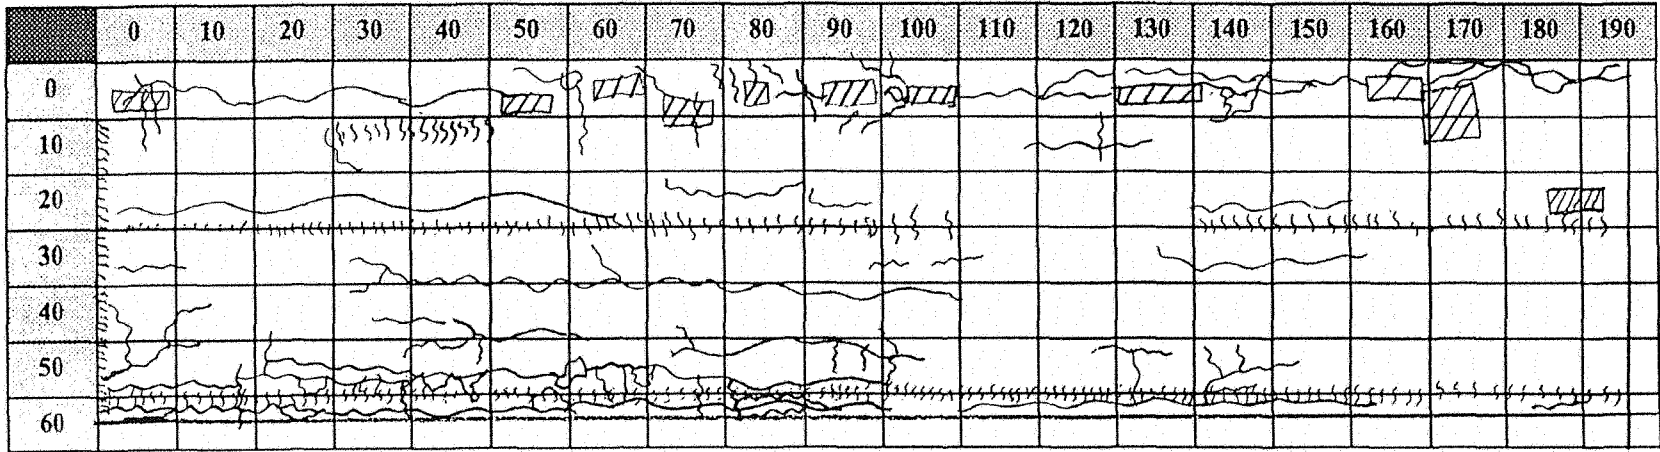
Figure 2. Visual Survey and Crack Map of North Bridge.

The crack map surveys for each structure are shown in feet. The northwest corner of the north structure treated with the silane penetrating water sealer is located on the top left corner of the crack map. Deteriorated areas that were patched during reconstruction are listed in the table above numbered from left to right. Patch five, for example, is located at approximately 0 x 60 on the survey grid and measures 0.88 meters (2.90 feet) in length and 0.76 meter (2.50 feet) in width. The patches are located near the outside lane on the shoulder.

Most of the longitudinal and block cracks on this structure are located on the shoulders. Transverse cracks generally show up near the edge of the lanes.

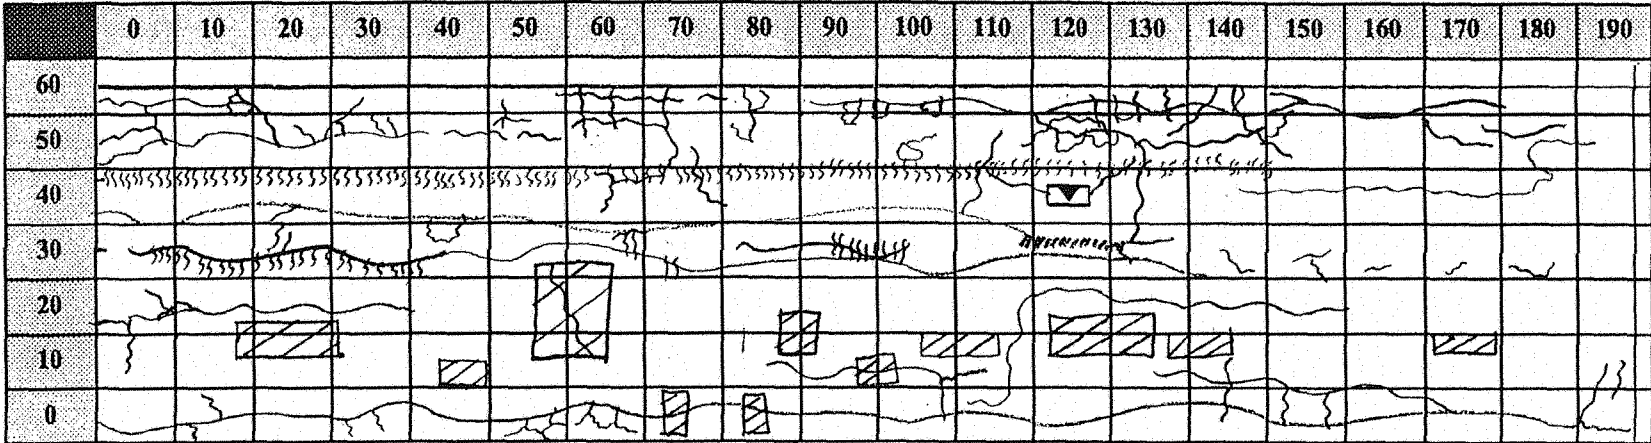
Figure 3. Visual Survey and Crack Map of South Bridge.

The grid on the survey is numbered differently from the grid on the north structure. Patch 10 is located in the southeast, or bottom right corner of the grid at the 10 x 170 location. The patches are near the wall on the outside shoulder.

There is one delamination on this deck at approximately 40 x 120 on the survey grid. Generally speaking, the cracking trends for this deck are the same as for the north structure; however, there is more longitudinal cracking in the driving lanes for this deck.

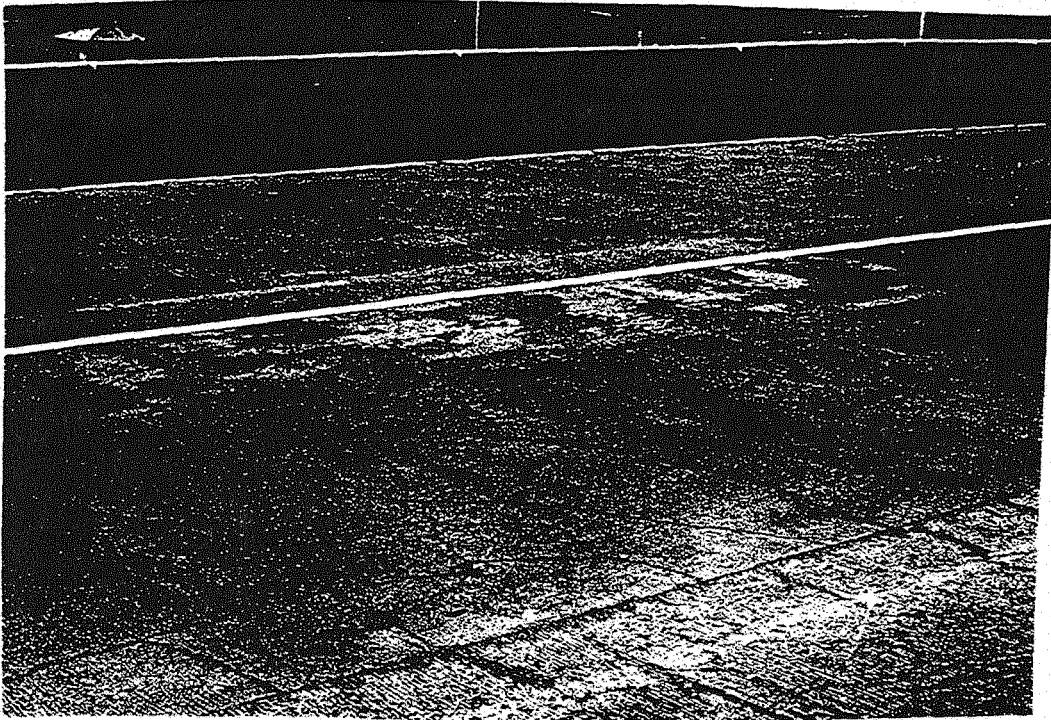
Figure 4. Cracks in Pavement.

The only particularly noticeable problems with this product were associated with the physical appearance. Cracking in both structures was evident. This could have been the result of application techniques, product performance over time, or a combination of two factors. There is no accurate and precise way to measure product performance in this respect.

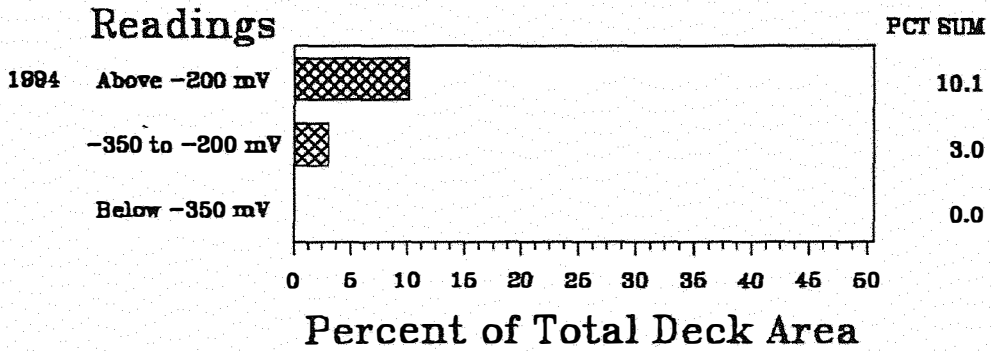
Figure 9. Percentage of Deck Corrosion on North Structure.

The graphs in Figures 9 and 10 indicate that a very small percentage of the deck is showing signs of corrosion activity. Increases in the level of corrosion activity from the time that the decks were reconstructed until 1994 are less than 0.5 percent, shown in Figure 11, for each structure when only readings lower than -350 mV are considered.

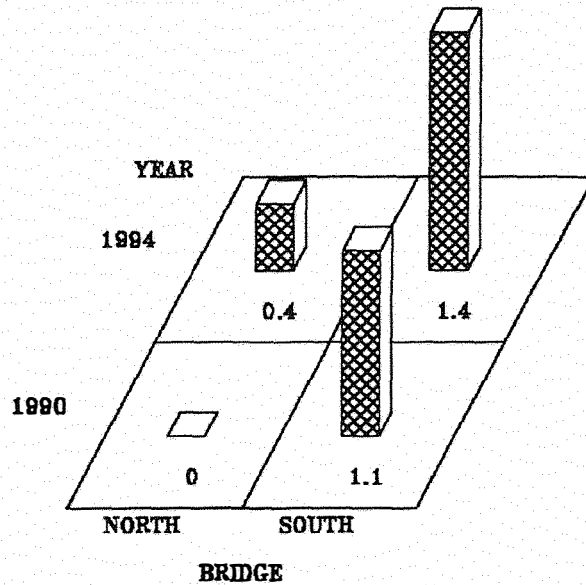
Figure 11. Change in Corrosion Levels between 1990 and 1994.

Less than two percent of both bridge decks surveyed in this study had half-cell readings below -350 mV, the generally accepted standard for deck corrosion. There was a 0.3% increase in corrosion levels between 1990 and 1994. Readings were lower, below -300 mV, near the joints on the deck and higher, above -200 mV, where the outside lanes were widened during reconstruction.
