NONDESTRUCTIVE EVALUATION OF OKLAHOMA
STATE UNIVERSITY COLVIN CENTER ANNEX
DECAYED TIMBER ARCHES

Submitted to the Faculty of the
Graduate College of the
Oklahoma State University
in partial fulfillment of
the requirements for
the Degree of
MASTER OF SCIENCE
December, 2001

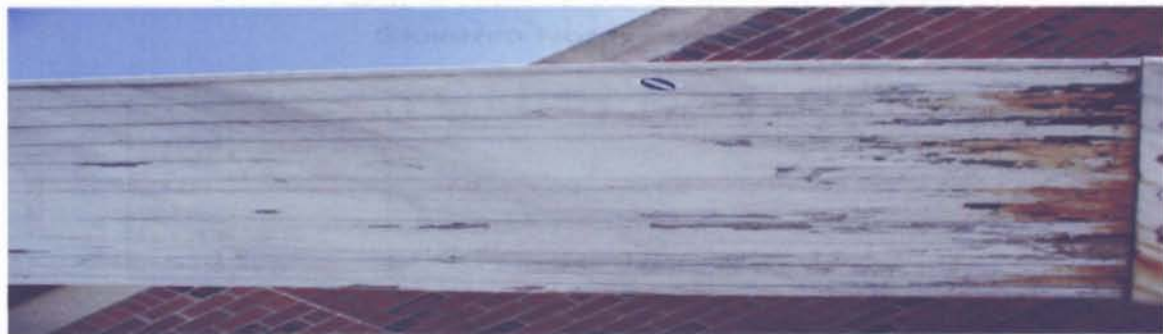
Figure 4.1.1: Field picture of Glulam 0.

In Glulam 0, a small amount of decay is present throughout most of the member. In the first eight inches, a pocket of advanced decay exists. This critical area can be seen as completely decomposed areas in the field picture. This advanced area is surrounded by regions of moderate and early decay and should be flagged since the connection between the member and the ground is made in this locale. Throughout the remainder of this component, early to moderate decay is often present, but few areas of concern exist. Lamination O is an exception, though, because moderate decay exists throughout the mid-section of the entire piece up to about 20-inches from the top. This decay is indicated on the color contour diagram as a light blue region just above the 10-inch vertical mark. Sometimes these middle areas of slower travel time indicate a natural knot in the wood, but, in this case, the entire lamination is affected, so decay is most likely present.

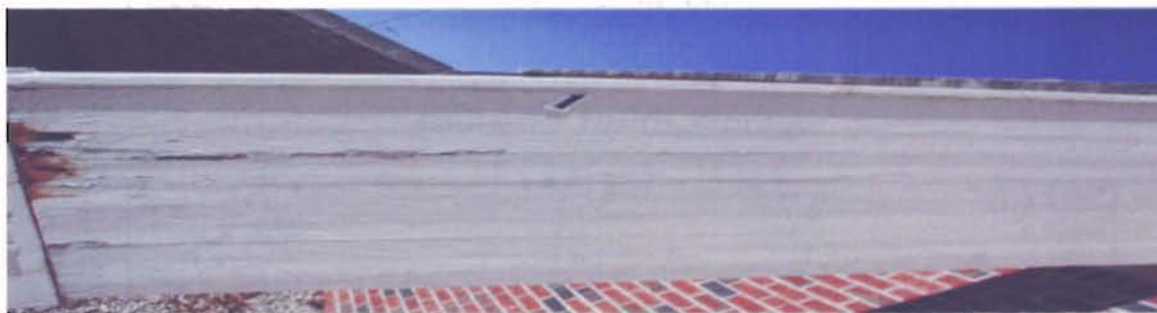
Figure 4.2.1: Field picture of Glulam 1.

Glulam 1 seems to have very little decay throughout, with patches of early to moderate decay present only in the top half of the member and not extending much past 16-inches from the base of the arch. No advanced or severe decay exists throughout any of the glulam. The location of this member is such that it is protected on both sides by brick walls. These structures have helped in deterring weather from glulam 1 and have, in turn, decreased the amount of decay in the constituent. From the field picture, it is seen that the paint remains on most of the exposed arch area, and this sign indicates little or no decay, since the paint peeling is the first step to allowing moisture to reach the depths of the beam. The contour diagrams for this member show decay throughout its entirety, which is misleading. The maximum travel times reach only to 400- μ s, which is relatively small, so every little change in travel time is magnified, since there are no large times present.

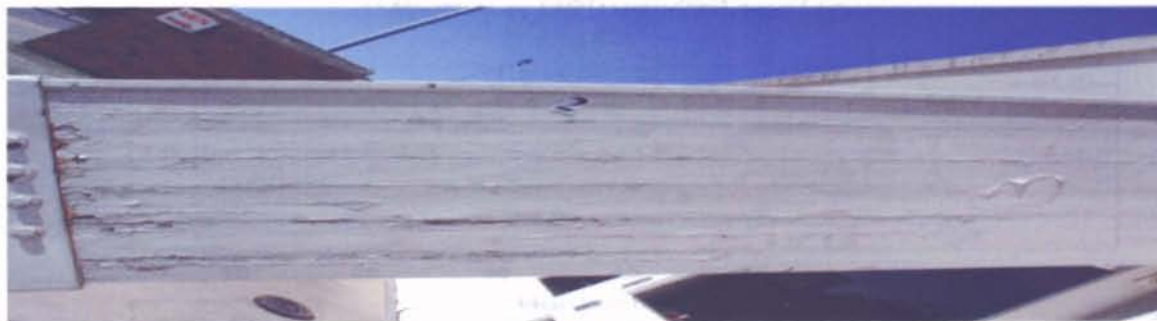
Figure 4.3.1: Field picture of Glulam 2.

Early to moderate decay exists throughout areas of Glulam 2, but no major areas of concern, containing either advanced or severe decay, subsist. The maximum travel time did not exceed 300 microseconds, which indicates most of the wood in these laminations is sound. This satisfactory state can be seen in the field picture below. As mentioned in Glulam 1, a similar situation of little to no paint peeling occurs in Glulam 2. This indicates, in conjunction with the Excel worksheets, that little or no decay exists throughout this entire member. The normalized graph of this glulam shows a green area along the bottom 8-inches of the beam. This area correlates with lamination T, where moderate and early decay exist throughout the entire beam. This demonstrates the accuracy of the normalized graphs. Another reason the normalized graph contains several areas of green coloration is because the variance of the time travels is so slight, similar to glulam 1, that the normalized graph has very little change from one area to the next. Therefore, the smallest change results in a colored area signaling an area of decay, when the entire beam actually contains only a slight amount of moderate and early decay.

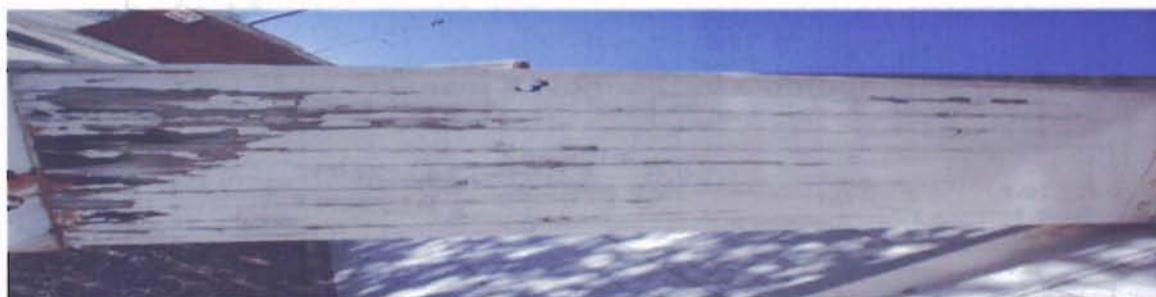
Figure 4.4.1: Field picture of Glulam 3.

Glulam 3 has a large concentration of moderate decay in the first 16-inches, although very few of the travel times approach or surpass 350- μ s. This value is comparatively low to travel times in other arches. Yet, the effects of weather and wood grain orientation could be the reason for this difference, which was discussed previously. Throughout this member, some areas of concern do exist. Laminations J and K have some moderate decay existing through most of the beam. This spot is too large to be considered a natural knot in the wood, so should be considered a problem area. Another region of concern is lamination T from 32-inches to 40-inches. Moderate decay is shown in this locale, but due to the relatively small size of the area, a natural knot in the wood is probably the cause of the large travel times. Overall, little decay occurs throughout the expanse of this member, but the first foot is of a primary concern. The graphs below show many areas of high decay, yet, as mentioned above, the travel times are relatively low, and the Excel worksheets indicate otherwise.

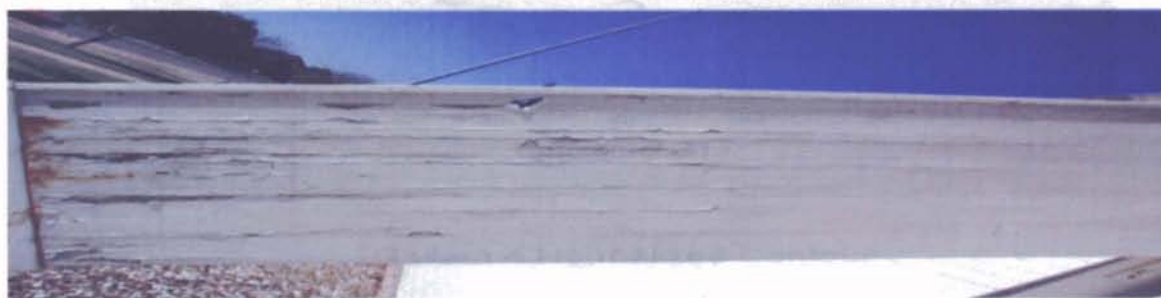
Figure 4.5.1: Field picture of Glulam 4.

Glulam 4 has solid amounts of early and moderate decay throughout the first 12-inches of the arch. The location of the beam is in the middle third of the glulams, which are the least sheltered from the environment members supporting the building. Although the color contour diagram of this member does not show a large portion of orange and red zones, the travel times are much larger than any of the previous beams. A wider expanse of numbers is occurring, making the diagram deceptively blue. Yet the black-and-white contour shows the locations of the high travel times. Laminations E and F have a consistent amount of moderate decay throughout the first 44-inches of the beam, with a concentration in the first 20-inches, which is indicated by the red and orange areas on the normalized graph. Smatterings of early decay are prevalent throughout much of this member.

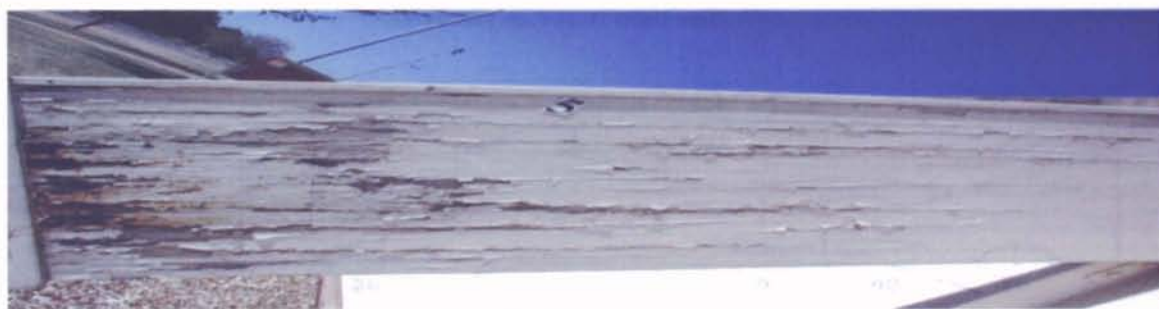
Figure 4.6.1: Field picture of Glulam 5.

Large pockets of severe decay occur in the first 8-inches of glulam 5. Actual holes exist in the wood, which is where a travel time of 5000- μ s is recorded. Surrounding the pockets of severe decay, early, moderate, and advanced decay is also rampant. Yet, past 20-inches, nothing more than early and some moderate decay exists, although moderate decay is quite prevalent in this area. Primary spots of advanced and severe decay are restricted to the first foot or foot-and-a-half of the glulam. As mentioned in glulam 4, this member is in a prime location where no protection from the weather exists. This factor has a large effect on the decay present. The widespread and large values of travel time can be seen in the black-and-white contour diagram. Other than the 5000- μ s recording, a travel time of up to 600- μ s is present, and this area is indicated in reds and oranges on the color contour diagram. The normalized graphs are similar to the regular graphs, yet more light blue exists throughout the member, representing the moderate decay. Although decay occurs throughout this entire member, most of the decomposition is early or on the low end of the moderate decay.

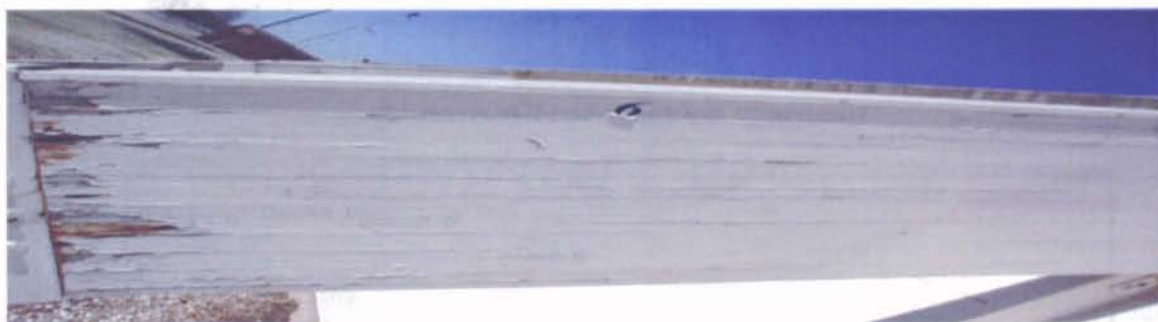
Figure 4.7.1: Field picture of Glulam 6.

In glulam 6, only moderate and early decay exist, with little or no decay subsiding beyond 20-inches of the beam. This data is dissimilar to previous conjectures that the members located in the middle third of the structure have large amounts of decay throughout. Yet, the first 8-inches has a solid mix of early and moderate decay, similar to all other members. Laminations E and F contain a slight amount of moderate decay throughout the first 56-inches, or almost 5-feet, but this area is of little concern since the rest of the beam is in such good condition structurally. These laminations should be taken into account, since the pocket of decay is larger than merely a knot in the wood. Yet, since little other decay exists throughout the arch, one small decayed area should not cause too much structural instability. This glulam's normalized graph is similar to the regular graph but with more light blue scattered about the whole. This indicates the small amounts of moderate decay throughout the length of the member, but not enough for the beam to be a primary concern.

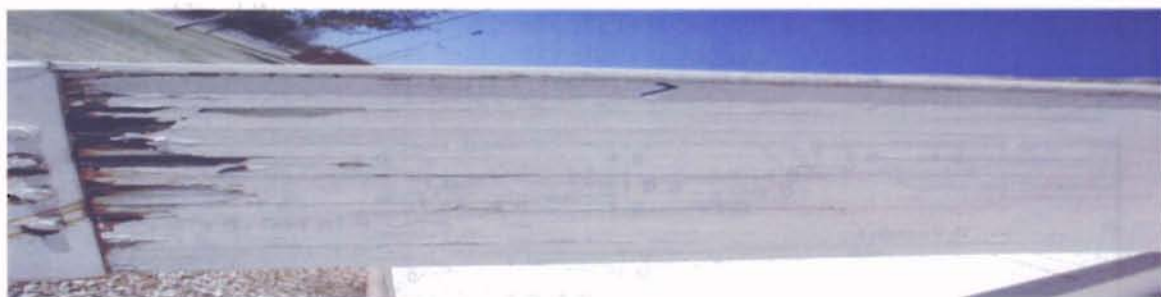
Figure 4.8.1: Field picture of Glulam 7.

Following in a typical manner as previous arches, glulam 7 also has a concentration of moderate decay in the first 16-inches with a few areas of severe decay, where the wood is actually nonexistent due to complete rotting. After this area, only minimal amounts of moderate and early decay exist, and the decomposition diminishes as the test spots become closer to the building. Two areas to look at include lamination O between 20- and 28-inches and lamination R between 28- and 36-inches. These areas indicate moderate decay, when the rest of the beam only shows minor amounts of early decay. Yet, since the areas are so small, the regions could be, and probably are, natural knots in the wood. The severe decay areas are identified in red and orange and are obviously located before the 10-inch marking on the horizontal axis. After this range, a solid blue color exists with interspersed areas of light blue, all of which indicate moderate or early decay. Overall, this beam does not have a continual problem throughout, but merely at the connection with the ground, which is the critical area.

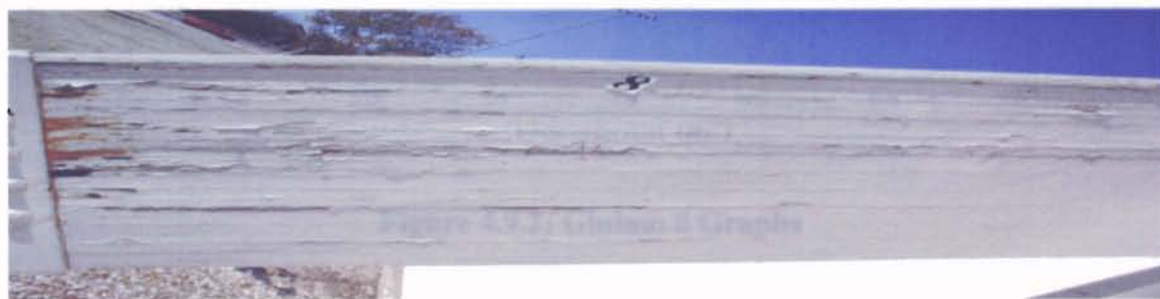
Figure 4.9.1: Field picture of Glulam 8.

Glulam 8 does not have much decay throughout the laminations. Moderate decay is limited primarily to the first 8-inches. From this point of decomposition, scatterings of moderate decay diminishing to decay levels continue scattered throughout the member, but few areas of concern exist other than laminations N and T. These laminations have a continual amount of moderate decay, which, since both areas are relatively small, this region could merely be a natural knot in the wood. Even if the area was decayed, since these two laminations are surrounded by 19 other structurally sound components, the member should not fail. A light blue streak extends through 20- to 25-inches, and a reason for this light blue streak through laminations could be due to the material properties of the particular wood utilized in that lamination. Glulams often have varying wood grain orientations throughout, and these differing patterns can cause an alteration in the stress wave sent through the individual lamination, resulting, in this case, in a larger travel time and a slower velocity. Although, this discontinuity should be fixed in the normalized graph, but the area still occurs. Another reason this might be happening is the relatively small travel times which appear to be drastic in the graphs, when, actually, the largest time is 400- μ s, a relatively small time.

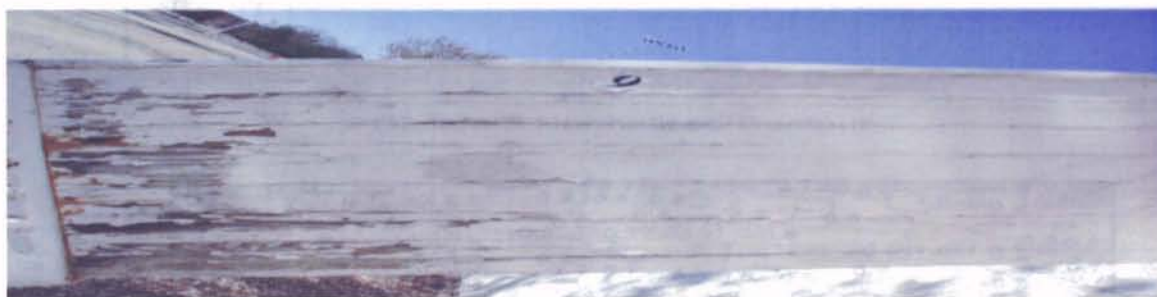
Figure 4.10.1: Field picture of Glulam 9.

The first 12-inches of glulam 9 has a high concentration of damaging moderate decay interspersed throughout the laminations with a small amount of early decay. The next 4-inches have half moderate decay and half early decomposition. The remainder of the member has relatively small amounts of moderate decay interspersed with early decay, except lamination S, which has moderate decay throughout the first 44-inches of the beam. This decay can be seen throughout the glulam in the color contour diagram as the green and light blue area along the entire length of the bottom. Some form of decay is present throughout this entire lamination up to the last foot. Yet, as mentioned in previous glulam discussions, one decayed lamination will not fail the member. The load can be transferred to the other surrounding laminations for support. The appearance of the normalized graph seems to have a large concentration of decay throughout the beam, indicated by the green areas, but this glulam only reaches travel times of 350- μ s, which is relatively low giving varying results from other glulams.

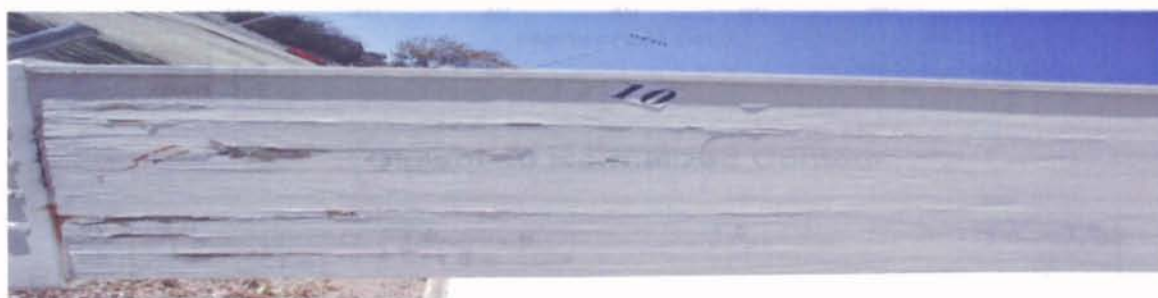
Figure 4.11.1: Field picture of Glulam 10.

As found in all others, glulam 10 also has a high concentration of moderate decay in the first 12-inches of the member, with no advanced or severe decay existing throughout the entire member. Beyond this region, a high concentration of early decay with interspersed moderate decay exists throughout the next 16-inches. From this point, only small amounts of early decay exist with no moderate decayed regions. This decay can be seen on the color contour diagram in the left side of the graph. Beyond this area, no coloration other than blue exists, indicating no decay throughout. Once again, the normalized graph is misleading because this graph shows green and dark areas throughout the entire beam, but the highest travel time is 400- μ s, which is relatively low, causing erroneous graph portrayals. Overall, this beam is in good condition, which is apparent in the field picture, Figure 4.11.1. Little paint has peeled off the beam, which is a good indication of little decay.

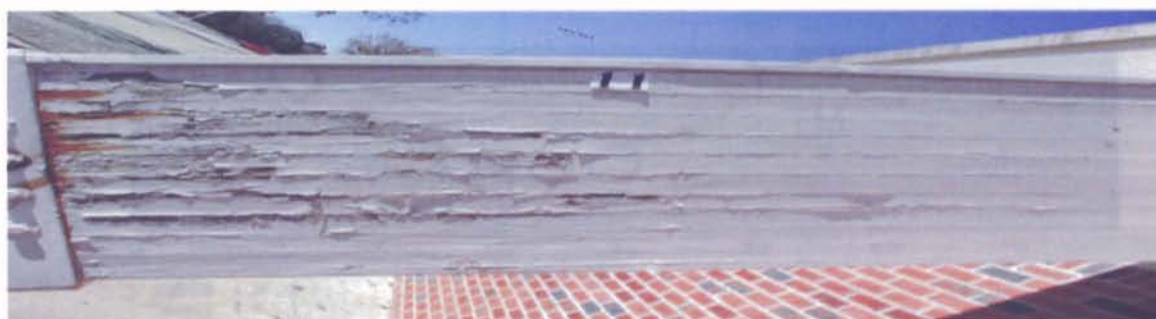
Figure 4.12.1: Field picture of Glulam 11.

A large concentration of moderate decay is limited to the first 12-inches of glulam 11. At grid location E1, a hole exists where the wood is completely decomposed. Extending on into the member, the usual early and low moderate decay subsists, except for laminations J and Q. Lamination J has moderate decay throughout the entire first 52-inches, which an area larger than a natural knot in the wood. Lamination Q has decay starting at 52-inches and ending at about 60-inches. This area could be a natural knot in the wood since it is relatively small, and, therefore, should not be flagged as a prime spot of concern. Other than these specific areas, no key areas of decomposition exist beyond the usual scattering of early decay.

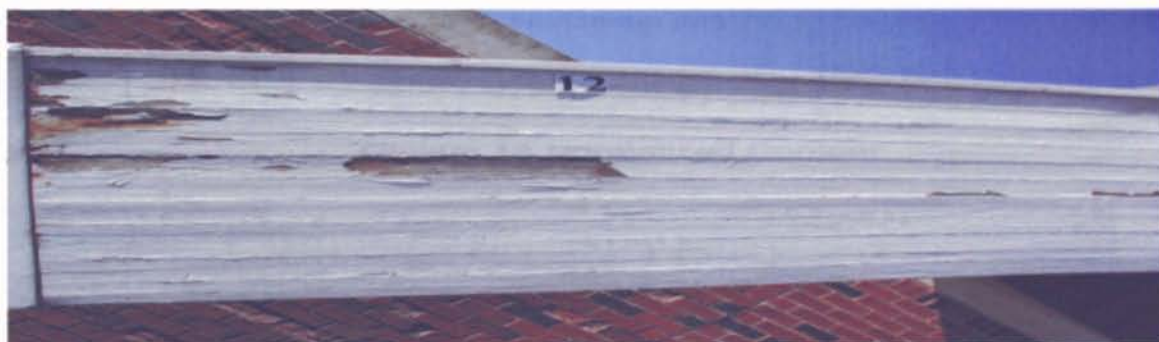
Figure 4.13.1: Field picture of Glulam 12.

Glulam 12 is protected on both sides from the environment. One side has a brick wall, and, on the other, the Oklahoma State University tennis courts' bleachers are situated. For this reason, very little decay exists in this member. The color contour diagram is misleading, because the green areas usually represent areas of large decay due to the high travel time. Yet, since all the travel times are relatively low, the most significant being 280- μ s, the range from low to high travel time is reduced, causing the colors to represent lower travel times than normal. For this reason, large amounts of decay seem to be present throughout the entire member, while, actually, no decay higher than moderate exists at all, and only early decay exists past the first 12-inches. This glulam is not one of major concern, although the color contour diagram appears to be that way. Throughout the member, some early decay is present, yet nothing to be concerned about due to the scattered nature of the decay.

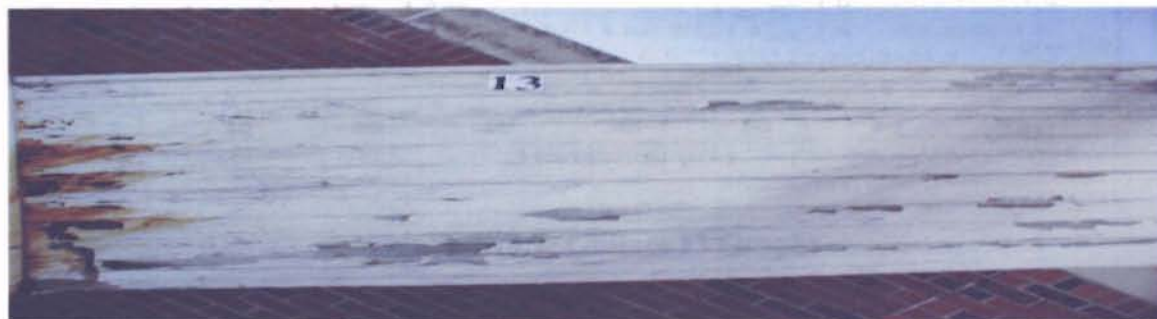
Figure 4.14.1: Field picture of Glulam 13.

The location of this glulam is on the northwest corner, where weather is the worst.

Because of that, the condition of this member is poor. Glulam 13 has some major areas of concern in the first 4-inches, with a high concentration of moderate decay extending through the first 16-inches of the member. Severe decomposition is located in lamination F, with laminations E and G containing advanced decay, all in the first 4-inches. These areas can be clearly seen on the color contour diagram in the orange and red zones and in the field diagram on the left side. Also, the travel times reach up to and past 500- μ s, which is relatively high compared to other glulams. Laminations E, F, and G contain moderate decay throughout most of the glulam, with this region stopping at 52-inches. In lamination O, at about 50-inches, a small pocket of apparent decay exists, and due to the small nature of the area, this spot could be a natural knot in the wood, but may not be. A light blue area surrounds the green region, which is usually present when decay subsists. Therefore, this area should be treated as a decay spot, and precautions should be taken to treat or to fix the area. Other than these problem areas, nothing more than scattered early decay exists.

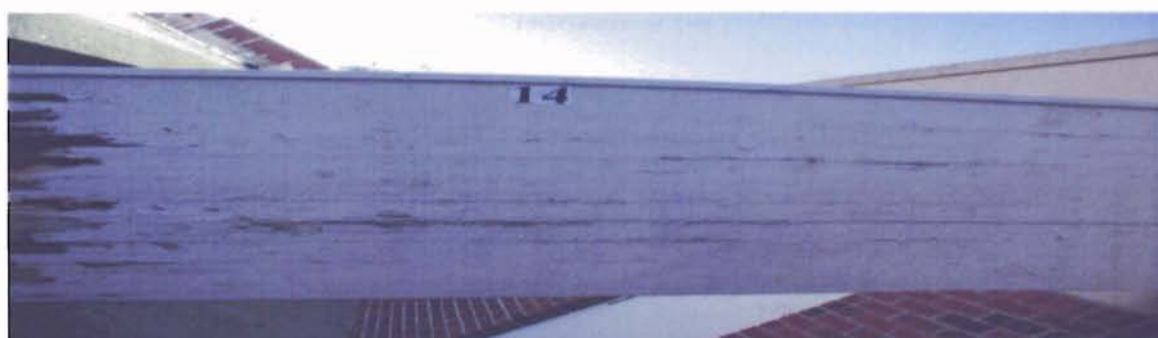
Figure 4.15.1: Field picture of Glulam 14.

Glulam 14 contains 4-inches of severe decay in lamination G and advanced decay in the first 4-inches of lamination L. The severe decay is actually completely rotted wood, so a value was merely assigned to it. These areas are indicated with the orange and red hues on the color contour diagram. Besides this, a high concentration of moderate decay exists in the first 12-inches, and beyond this, small amounts of moderate and early decay exist. Yet, laminations G and S have moderate decay in areas throughout the beam. Lamination G's decay extends through the first 48-inches, and this region should be taken into account and treated. Lamination S only contains decay between 60- and 70-inches, which can be seen as a red area in the normalized color contour diagram. This area is most likely a natural knot in the wood, due to the small nature of the apparently decayed region. Past the first 12- or 16-inches, nothing more than scattered early decay exists, other than the aforementioned areas.

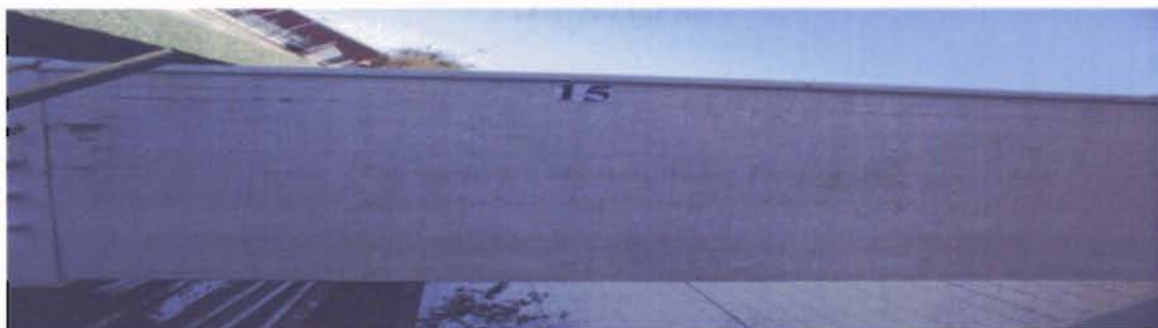
Figure 4.16.1: Field picture of Glulam 15.

Glulam 15 contains no areas of severe or advanced decay. All of the travel times were relatively low compared with other glulams, the largest being just over 200- μ s. For this reason, the color contour diagram has apparent areas of decay throughout the entire member, but these green areas are merely caused by the minor changes in travel times. Lamination A is the only actual part that may be of any concern, since moderate decay exists primarily through the entire lamination. Yet, the remainder of the glulam is in great condition, only containing scattered early and moderate decay. The reason for the lack of decay in the member could be the location. Glulam 15 is located on the north side of the building, with a hill just north of this location shielding the member from major weather environments. As seen in the field picture, very little paint has peeled from this member, also providing protection and indicating little decay.

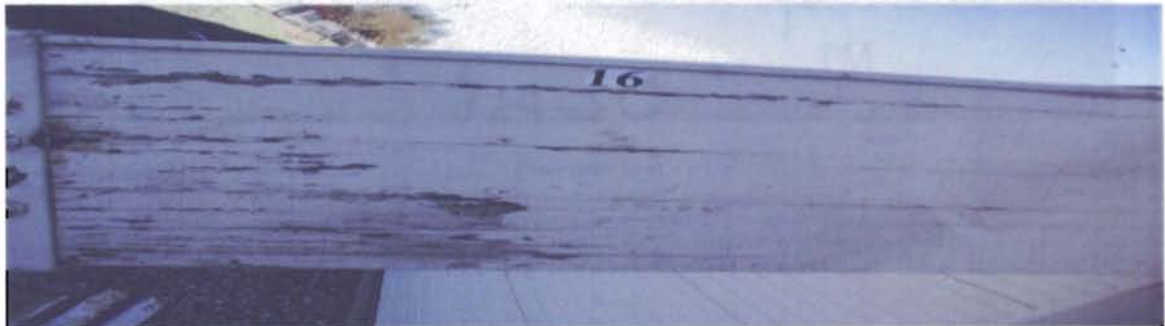
Figure 4.17.1: Field picture of Glulam 16.

In glulam 16, moderate decay exist throughout the entire depth of the beam in the first 8-inches, with most of the moderate decay diminishing after the first foot of the member. One spot of concern is the moderate decay extending through 44-inches in lamination T, almost 3-feet of the member, with low moderate and early decay subsiding throughout the remainder of the glulam up to the last foot. Other than these areas of concern, the usual early and low moderate amounts of decay exist throughout the member, but no major regions of decomposition. When looking at the graphs, many areas of decay seem to exist, but the highest travel time is only 300- μ s, which is relatively small, so causes erroneous graph results. The field picture in Figure 4.17.1 seems to show a lot of decay, but this apparition is merely due to paint peeling.

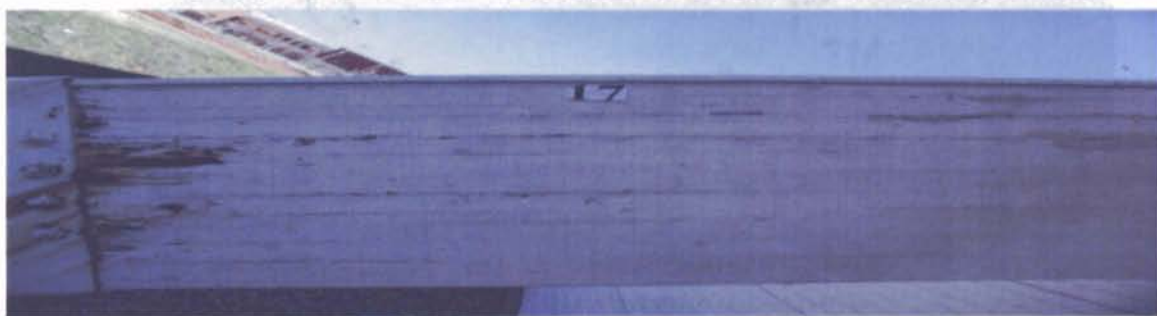
Figure 4.18.1: Field picture of Glulam 17.

The primary area of decay in glulam 17 is in the top 10-inches of the first 2-feet of the member. This region is made apparent in the color contour diagram by the orange and red hues within that one concentrated area. In the first 8-inches, a high concentration of moderate decay exists throughout the depth of the member, but in this glulam, the bottom half of the depth lessens to early decay. Extending past the first 8-inches, only the top half of the member's depth is of any concern, although, past 24-inches, only miniscule scatterings of moderate and early decay exist in any of the member, both of little apprehension. Overall, this glulam follows the usual problems of decay in the first foot, with little or no decomposition extending further into the member. The field picture in Figure 4.18.1 shows this result.

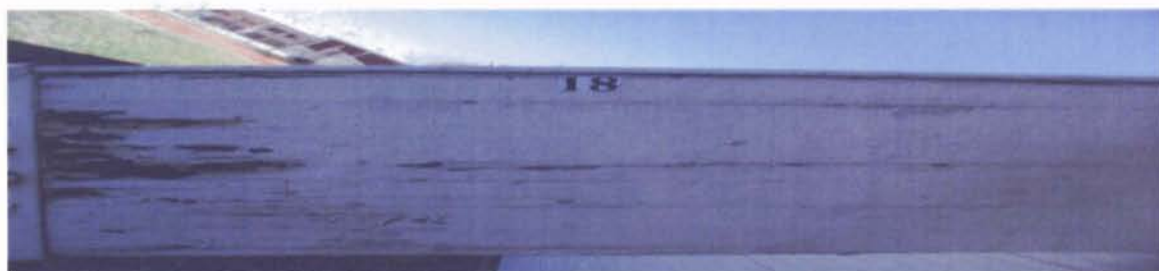
Figure 4.19.1: Field picture of Glulam 18.

Glulam 18 contains a high concentration of moderate decay, with areas of severe and advanced decay in the first 4-inches. Lamination K is completely decomposed, resulting in severe decay, while lamination J contains advanced decay. The entire first foot contains a high concentration of moderate decay, with a few exceptions in the top half of the member's depth. Past the first foot of glulam 18, the decay somewhat subsides, with the exceptions of laminations K, N, O, P, and Q. Each of these laminations contains moderate decay through the first 2-feet of the member. The largeness, and continuity of the region indicates something more than a natural knot in the wood, so measures should be taken at this spot to avoid further decomposition. All of these high decay areas are easily seen on the color contour diagram in orange, red, yellow, and green hues and on the field picture in Figure 4.19.1. Primary emphasis should be placed on these laminations, especially since the decay is extending further than previously mentioned glulams. Other than the specific areas mentioned, no major regions of concern exist.

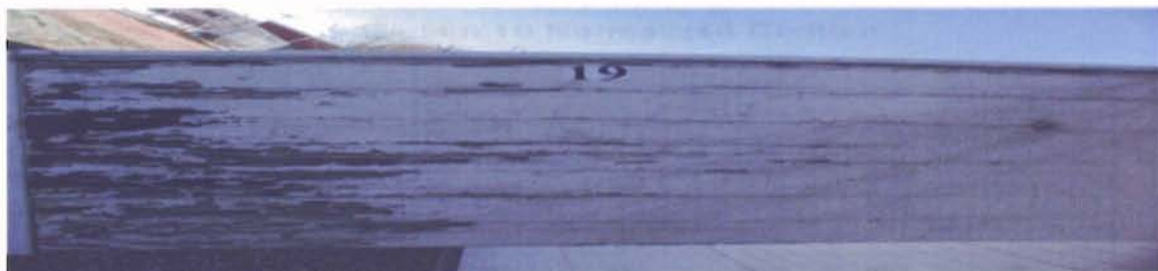
Figure 4.20.1: Field picture of Glulam 19.

Glulam 19 possesses more severe and advanced decay through the first 4-inches of the member than previous glulams. This area of decay is limited to laminations G and H with severely decomposed pockets and to lamination M with advanced decay, rather than spread through the entire depth of the member, with total decomposition occurring in spots G1 and H1. Past this region, a high concentration of moderate decay exists through the first 16-inches, with no moderate decay existing past the first 2-feet of the member. The area in light blue around the 5-inch mark on the color contour diagram indicates this lamination's decay. Also, the field picture in Figure 4.20.1 shows this area of decay as rotted wood on the left side of the picture. Other than the above-mentioned areas, no major concerns exist. The cause for the serious decay in this member is the location of the arch. A pattern has developed with the decay being more prevalent in the middle third of the glulams, such as glulams 4 through 8 on the south side and glulams 17 through 20 on the north side. Little to no protection for these members exists, resulting in more decay.

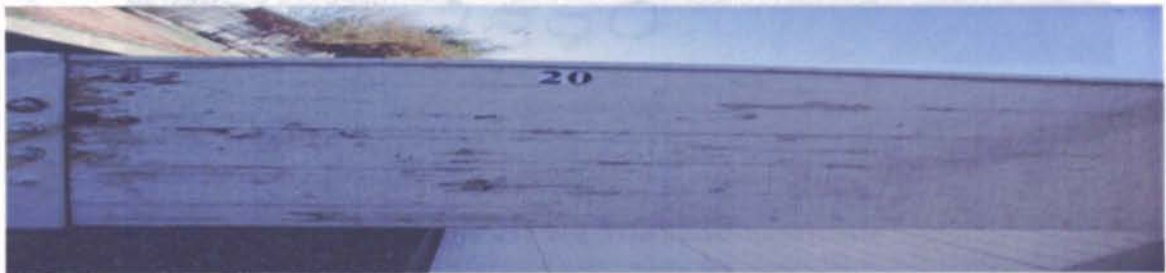
Figure 4.21.1: Field picture of Glulam 20.

In glulam 20, decay does not persist through the entire depth of the member at any point. Actually, the first 8-inches have considerable amounts of moderate decay, but most of the laminations have decomposition limited to laminations F through M. Laminations F through I have moderate and early decay ranging from the ground connection up to 5-feet. This region is the largest amount of decay in the entire member. Lamination M also has moderate decay up to 3-feet of the member. These problematic areas are somewhat delineated on the contour diagram, but not fully. Also, lamination A has a green area around the 30-inch horizontal measurement, which, after referencing the excel worksheets, indicates moderate decay. The remainder of the member does not have any prime concern areas outside of the usual early decay, which can be seen in the field picture in Figure 4.21.1 in the good quality of the paint.

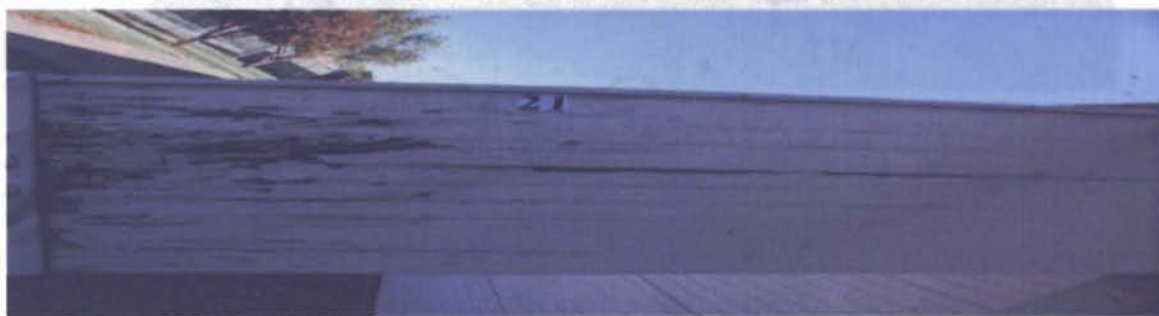
Figure 4.22.1: Field picture of Glulam 21.

Glulam 21 follows a similar decay structure as previous glulams in that high concentrations of moderate decay is primarily located in the central third of the depth, and limited to the first 8-inches of the length. Throughout the entire glulam, no severe or advanced decay exists, and the only crucial laminations are G and T. Moderate decay is present in this component through 3-feet of the member's length. From here, decay diminishes scatterings of early levels. The rest of the glulam is in good condition, with early decay existing haphazardly throughout the member's length. The poor condition of the beam's first 8-inches can be seen in the color contour diagram, as well as in the field picture in Figure 4.22.1. Also, the extended decay can be seen in the regular contour diagram in the light blue streaks throughout the member.

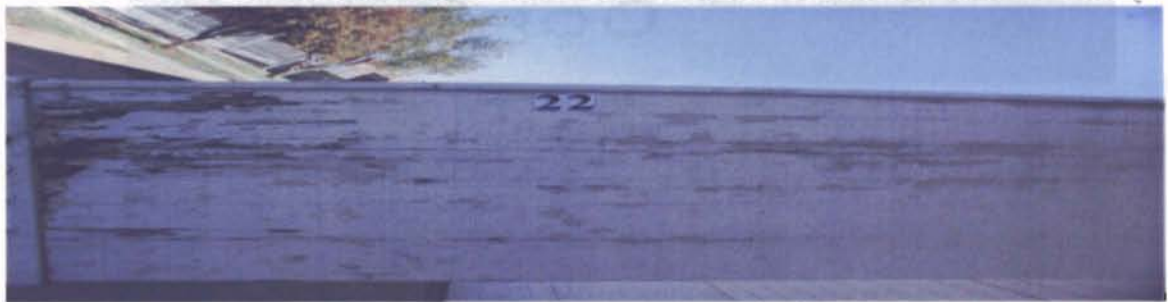
Figure 4.23.1: Field picture of Glulam 22.

Glulam 22 has very little amounts of decay, with the primary area limited to the top third of the member's depth and the first 12-inches of the member's length. This region contains high concentrations of moderate decay, which is expected in trend with the other glulams. Yet, beyond this area, no decay exists above early, and most of that decomposition is spaced sporadically throughout the laminations, with few pockets of concentrated decay. One exception is lamination L between 5 ½- and 6-feet. A small pocket of moderate decay is indicated in this location and can be seen on the color contour diagram as a small, light blue area; but the area could be, and most likely is, a natural knot in the wood. Other than these limited regions of decay, glulam 22 is in excellent condition, despite what is indicated in the field picture in Figure 4.23.1. The peeling paint is misleading, since little decay actually occurs.

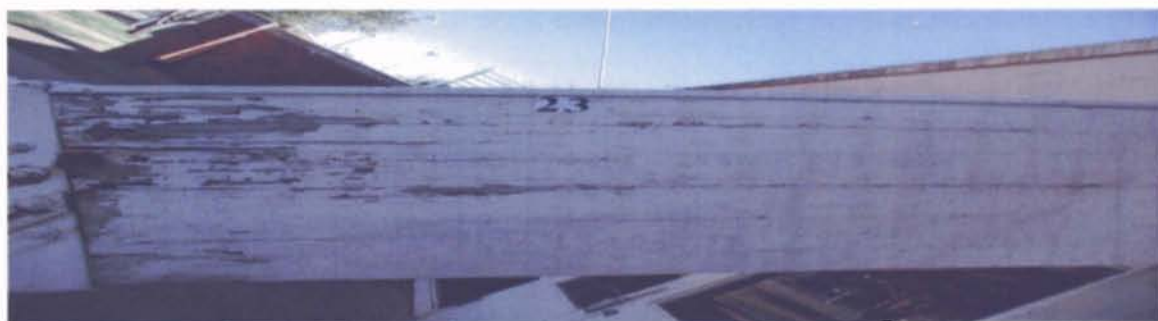
Figure 4.24.1: Field picture of Glulam 23.

Glulam 23 has a high concentration of moderate decay limited to the first 12-inches of the member's length, similar to previously discussed glulams, but this decay is located primarily in the top half of the beam. Extending further into individual laminations F and G, the decay areas can be seen as a light blue coloring, between 20- and 30-inches on the vertical scale. Yet, this decomposition ceases at about 20-inches on the horizontal scale in lamination F, and ends at 3-feet, or 36-inches on the horizontal scale for lamination G. This area can be seen in the field picture in Figure 4.24.1 on the far left side. Another problematic area is lamination K, at about 28- to 36-inches, on the horizontal scale. This area is identifiable by a small green spot at about 15-inches on the vertical scale. This pocket of moderate decay could merely be a natural knot in the wood, and most likely is since no major decay exists around the region. Other than these flawed areas mentioned, glulam 23 is in good condition and is easily treatable.

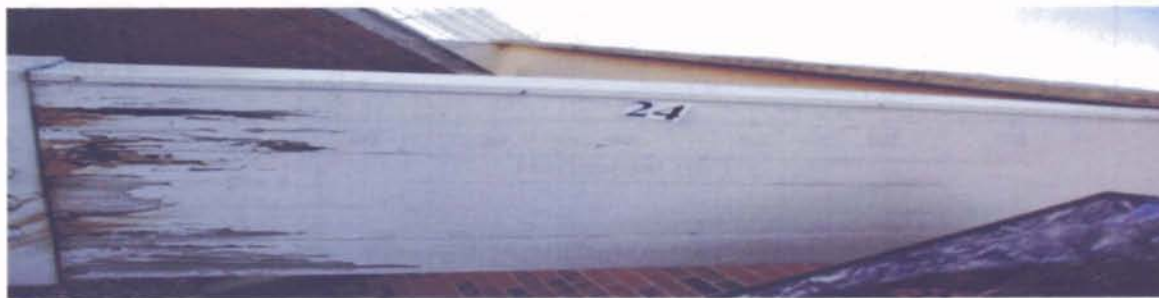
Figure 2.25.1: Field picture of glulam 24.

Glulam 24 contains the usual amount of moderate decay in the first 8-inches of the member's length, extending through the entire depth. Beyond this area, the next 2-feet contain sporadic concentrations of moderate decay. Lamination U contains moderate decay in the first 2-feet of the member. This bottom lamination is a primary support component, so decay in this area needs special consideration and treatment. Other problematic regions include laminations K and O. Lamination K has an indication of randomly placed moderate decay at spot K9, which is most likely a natural knot in the wood due to the small nature of the area. Also, the decay does not slowly dissipate into the wood around the decayed area. Lamination O contains moderate decay in the first 3-feet of the member's length, which then diminishes to early decay for another foot. None of these areas can be seen well on the color contour diagram or the field picture outside of the first 8-inches of decay, except lamination U. Green and orange hues can be seen in the first 20-inches on the horizontal scale at the bottom of the member, which indicate the above-mentioned decay. Other than these problem areas, no major regions of concern exist in glulam 24.

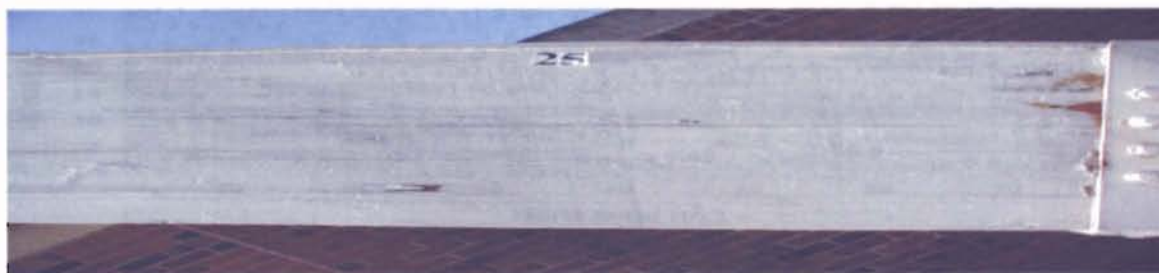
Figure 4.26.1: Field picture of Glulam 25.

In glulam 25, small concentrations of moderate decays exist in the first 12-inches, with major amounts of decay diminishing after this point. Exceptions include laminations C, G, and H. In lamination C, a possible natural knot in the wood may be present between the first and second foot, as indicated in the color contour diagram by a small green pocket between 25- and 30-inches on the vertical scale and at 10-inches on the horizontal scale. Since no diminishing areas surround this region, decay is probably not the reason for the coloration. Lamination G has moderate decay extending from the base through the first 2-feet of the member. The red, orange, and green hues at about 20-inches on the vertical scale indicate this area. From here, G has another pocket of decay that parallels with decay in lamination H. This location is in the middle of the contour diagram, and represents high moderate decay from 3- to 4-feet of the member's length. Other than these areas, no major problematic regions exist in glulam 25. This member is in good condition because its location is between a brick wall and the OSU tennis courts. This coverage is the reason for the quality of the paint, showing little to no decay in the field picture.
