IMPLEMENTING FIBER-REINFORCED, SELF-CONSOLIDATING  
CONCRETE AS A REPAIR MATERIAL FOR AASHTO PRESTRESSED  
CONCRETE GIRDERS

A THESIS

JACOB G. CHOATE  
Norman, Oklahoma  
2018

A THESIS APPROVED FOR THE  
SCHOOL OF CIVIL ENGINEERING AND ENVIRONMENTAL SCIENCE

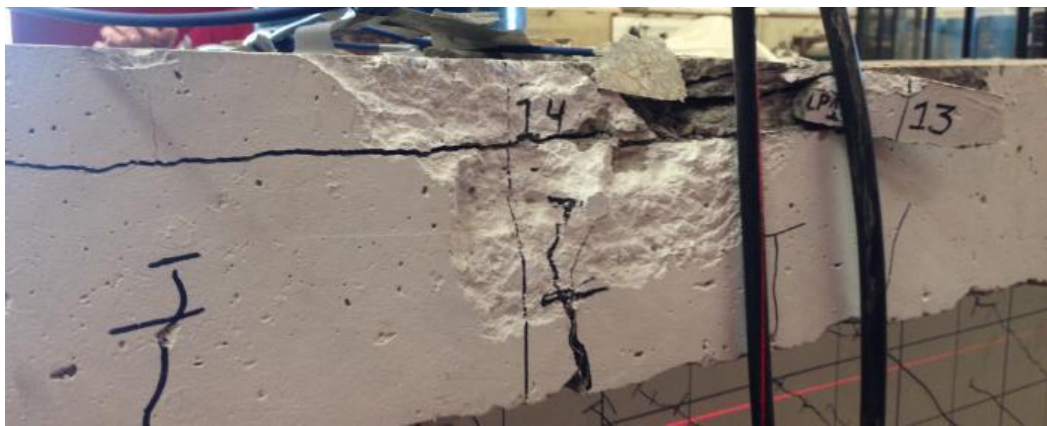
**Figure 4.6 Deck Compressive Failure & Wearing Layer Delamination**

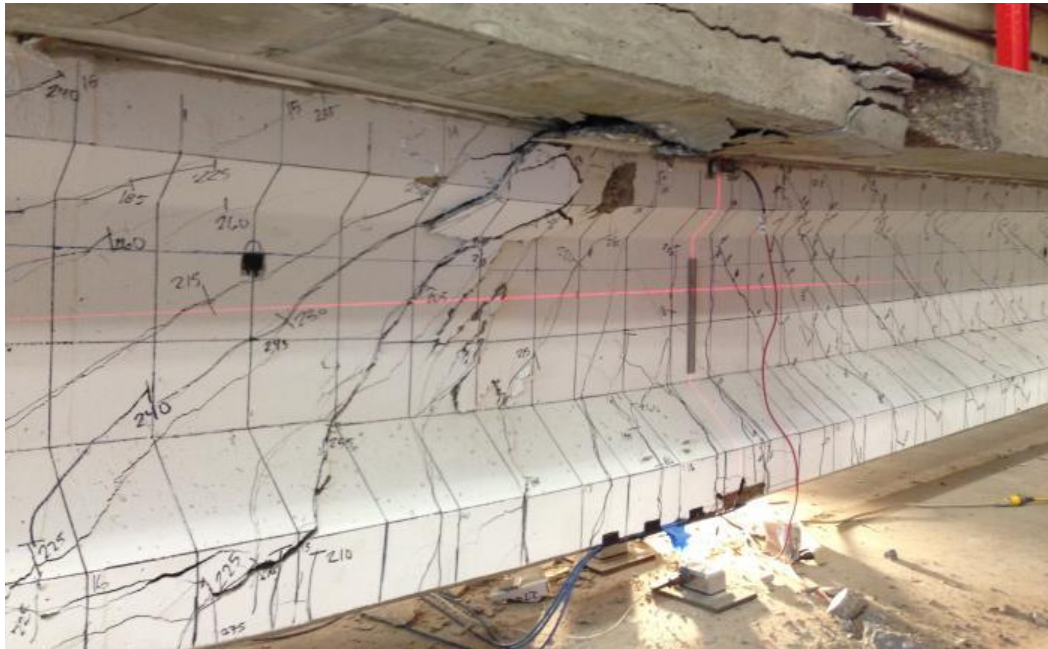
The second test (C2) featured a loading location at the quarter-span of the original girder length. This location was predetermined to be the critical section for shear, although, with an  $a/d$  ratio of 3.83, flexural failure was anticipated to be a controlling factor. Cracking was initially recorded at 150 kips of load in the form of web shear cracks at a location approximately 2 feet from the north support. Flexure cracks first propagated at a load of 160 kips and continued to develop until reaching the deck at a load of 190 kips, roughly. Shear cracks in the web started to expand into the bottom flange forming flexure-shear cracks at 195 kips of applied load. A number of these cracks began to traverse laterally, in the direction of the strands as more load was applied, suggesting bond failure along the tendons. Figure 4.8 illustrates the various types of cracking behaviors in test C2. Load was continuously applied until ultimate failure at which the compressive forces in the deck caused the longitudinal steel to buckle (Figure 4.9), the two-inch overlay to delaminate, and the deck itself to buckle. Murray noted this as either a compression-shear failure, which is the result of shear cracks entering the compressive zone leading to failure by compression, or simply a flexural failure. The extent of the damage caused by test C2 is shown in Figure 4.10.

**Figure 4.8 Cracking During Test C2**

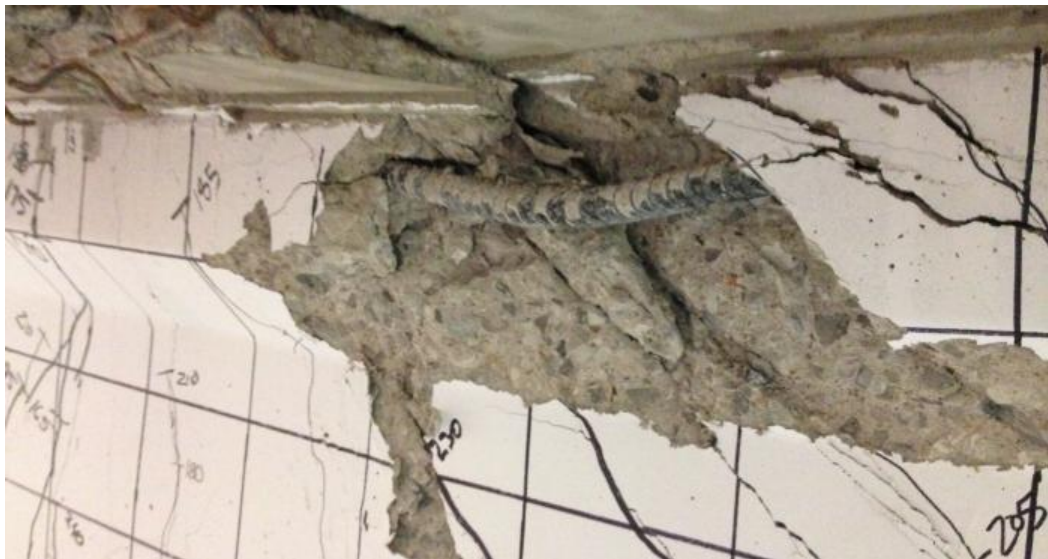
**Figure 4.9 Buckled, Longitudinal No. 8 Reinforcing Bar in the Top Bell of the Girder**

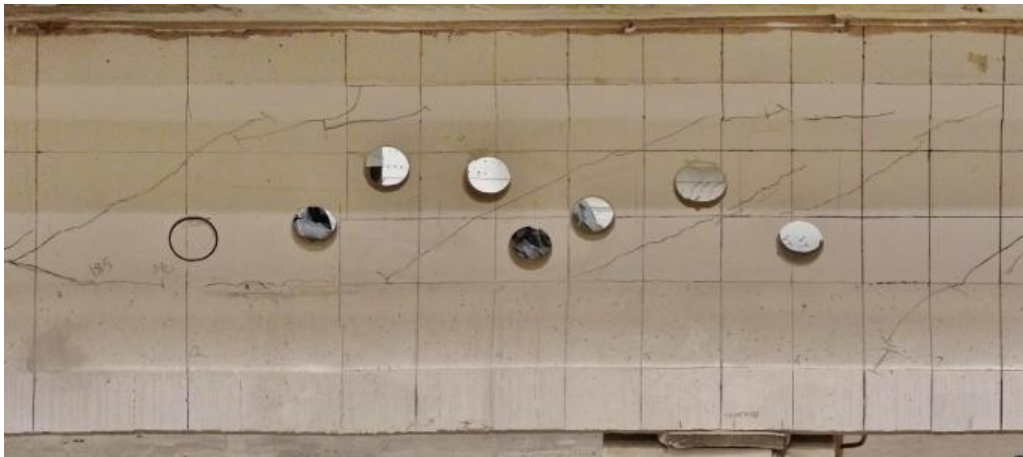
to allow for proper splice lengths for the reinforcing steel that was severed. Some of the corings did not fully sever some of the reinforcing bars. The damaged area of these bars were removed by grinding just above and below the damaged area. The final removal area measured 4 feet, 7 inches in length and the total height of the web section, 1 foot, 3 inches, with seven damaged stirrup legs.

**Figure 5.1 West Elevation of Core-Sampled Web Section**

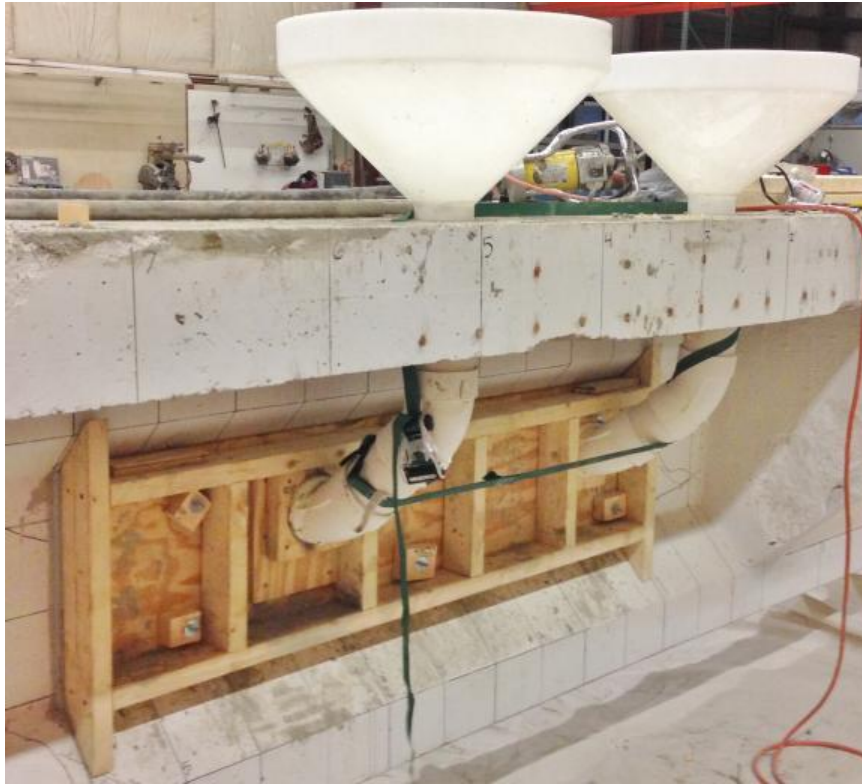
**Figure 5.2 Assembled Formwork, Core-Sampled Web Repair**

could escape and the concrete level could be monitored during the pour. The plywood surface exposed to the repair concrete was coated with polyurethane to help preserve the formwork. After the polyurethane dried for 24 hours, they were braced against the repair area to determine placement for the threaded rods that would fasten the forms together. The threaded rods were 18 inches long, 1/4-inch diameter stainless steel with matching nuts and washers. Wooden blocks were cut and drilled to act as an additional washer and to keep the formwork from deforming around the rods. To place the new concrete into the formwork, 4 inch diameter PVC was selected as the fill neck for the formwork (Figure 5.2). This PVC size was chosen based on the mix design study discussed in Chapter 3. A single section of pipe with an angle joint at each end was used as the fill neck. A wooden base was constructed around the lower end of the fill neck so that it could be fastened to the formwork using screws. A bead of silicone was added to the edges of the formwork and top end of the PVC fill neck to maximize containment of the concrete.

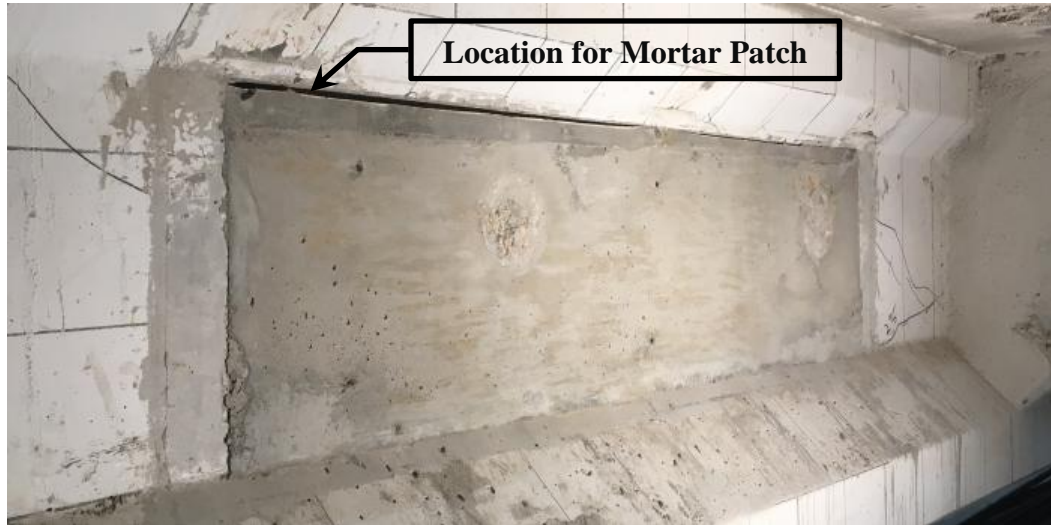
**Figure 5.6 Core-Sampled Finished Repair (Without Mortar Patch)**

excess mortar flat, matching the surface of the beam. No additional test specimens were made at the time of casting.

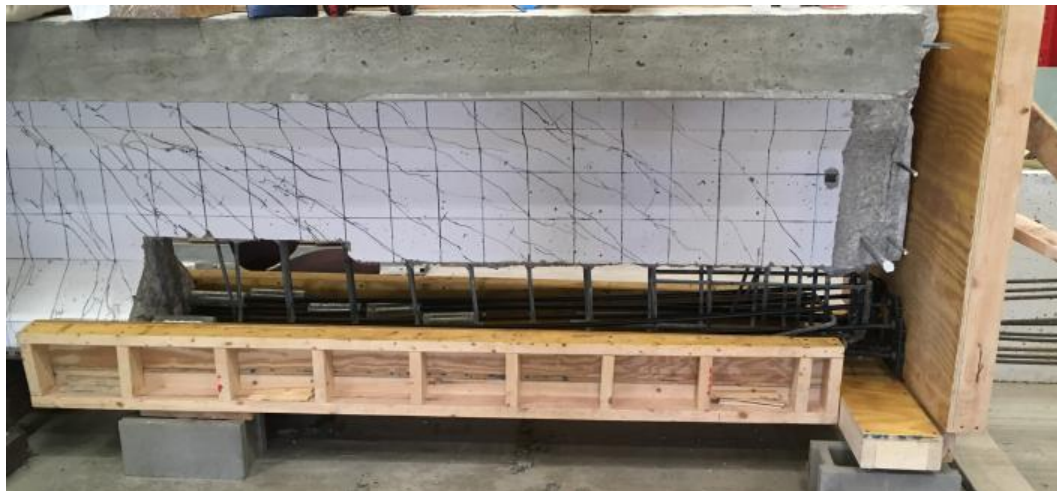
**Figure 5.13 Fully Installed Post-Tensioning with Partial Formwork**

face of the splice chuck to the inside face of the post-tensioning anchors. Following the greasing and sleeve placement on the existing strand, one of the foam pieces were slid over the sleeve and one end of the splice chuck was attached and seated to the end of the existing tendons. The shaft of the splice chuck was then assembled to the end of the splice chuck that was attached to the existing tendon and the replacing strand with the other end of the splice chuck was subsequently attached to the splice chuck shaft. Tongue-and-groove pliers were required for tightening the two ends of the splice chuck due to the internal, spring-loaded mechanics of the splice chucks, but, consequently, ensured proper seating of the wedges on both strands before tensioning. Grease was applied to the replacing strand and sleeved before the acrylic tube and other foam piece was slid over the sleeve and splice chuck, completing the housing assembly. Figure 5.13 shows the full post-tensioning assembly.

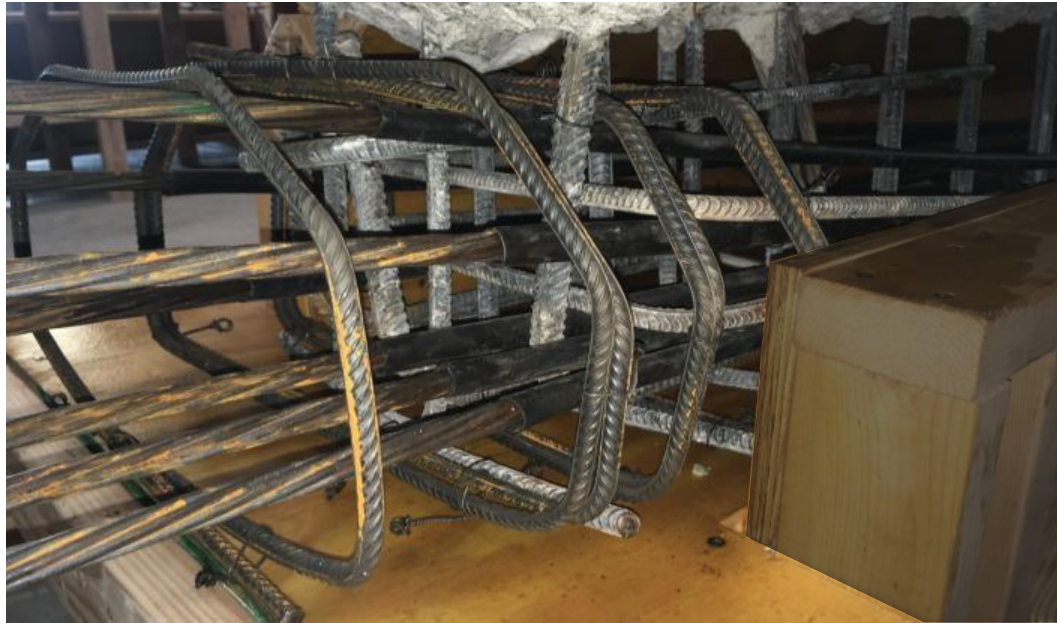
**Figure 5.14 Bursting Steel for Post-Tensioning**

The final preparation before assembling the formwork and pouring the repair section was to add bursting steel. Bursting steel is used to resist the Poisson's effect that can lead to failure during the post-tensioning of a section. As opposed to pretension applications where the stress from the tendons is transferred to the concrete throughout the length of the member, post-tension applications collectively apply the full force of the tendons at the anchored ends. High concentrations of compressive stresses in a single direction causes expansion in the perpendicular directions, which has the ability to be somewhat explosive for concrete applications. Thus, the use of additional, confining reinforcement just inside of the anchored regions is essential. Using various iterations of strut-and-tie modeling, a conservative calculation for the appropriate amount of steel was selected. Four pairs of closed loop, No. 3 bars with two inches of clear spacing were added to the section for a total of eight bars. To maximize the area of confinement, the bars were bent in the same shape as the bottom bell while permitting for one inch of cover on all sides. Addition of the bursting steel, shown in Figure 5.14, marked the completion for reinforcing the interior of the south end. The final preparation step for the prestressing tendons involved installation of monostrand anchorages for each strand, which were threaded over the strands and nailed to the inside face of the form end.

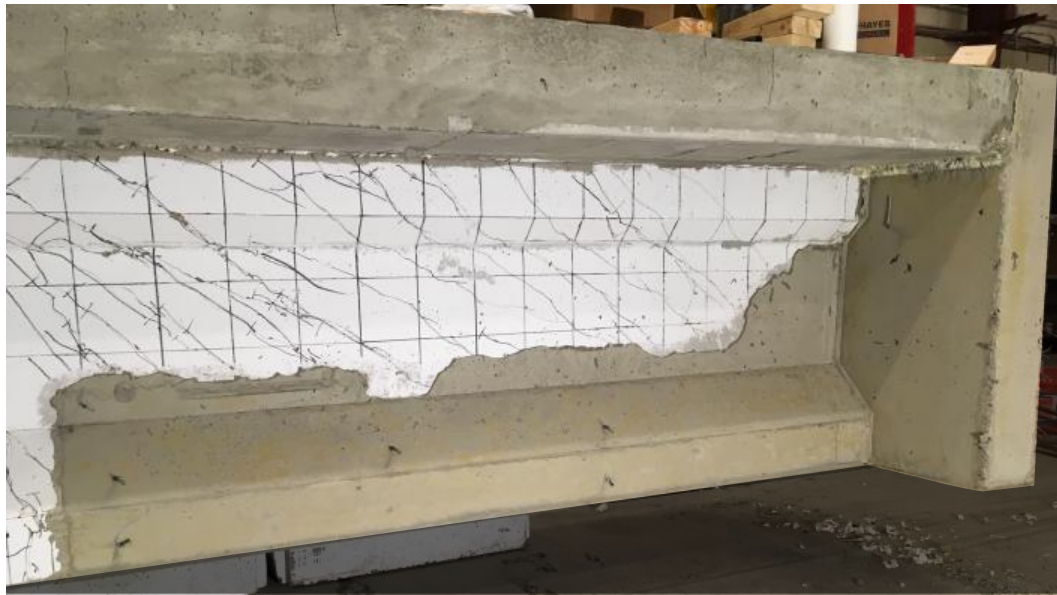
**Figure 5.17 South End Repair with Forms Removed**

concrete. The slump flow results yielded a 26.5 inch slump flow and the cylinders were set aside for compression testing when the repaired girder was tested. Upon completion of casting, the top of the form and the small specimens were covered with a plastic sheet for seven days, then the forms were removed. Figure 5.17 shows the seven-day-old repair section following form removal.

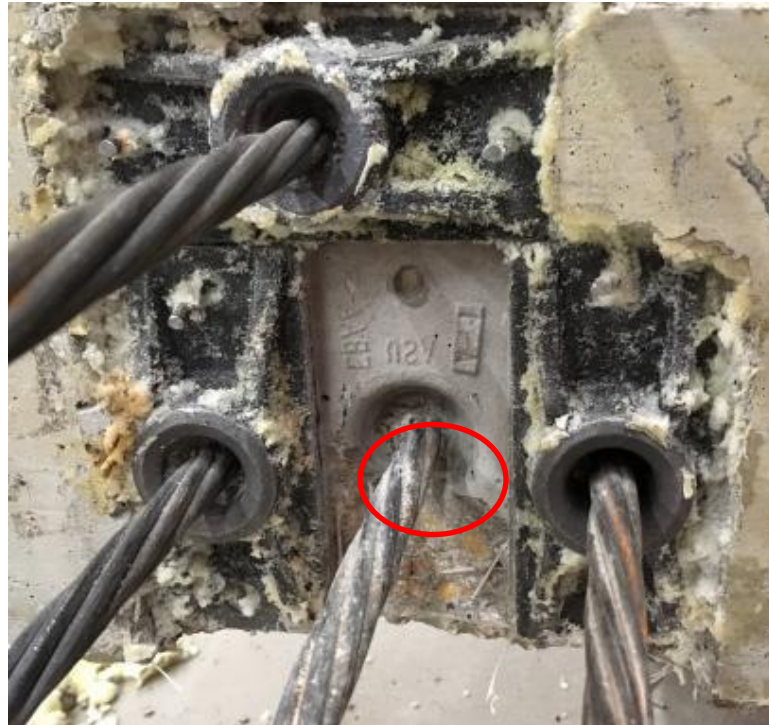
**Figure 5.19 Damaged Area After Removal of Anchor Plate**

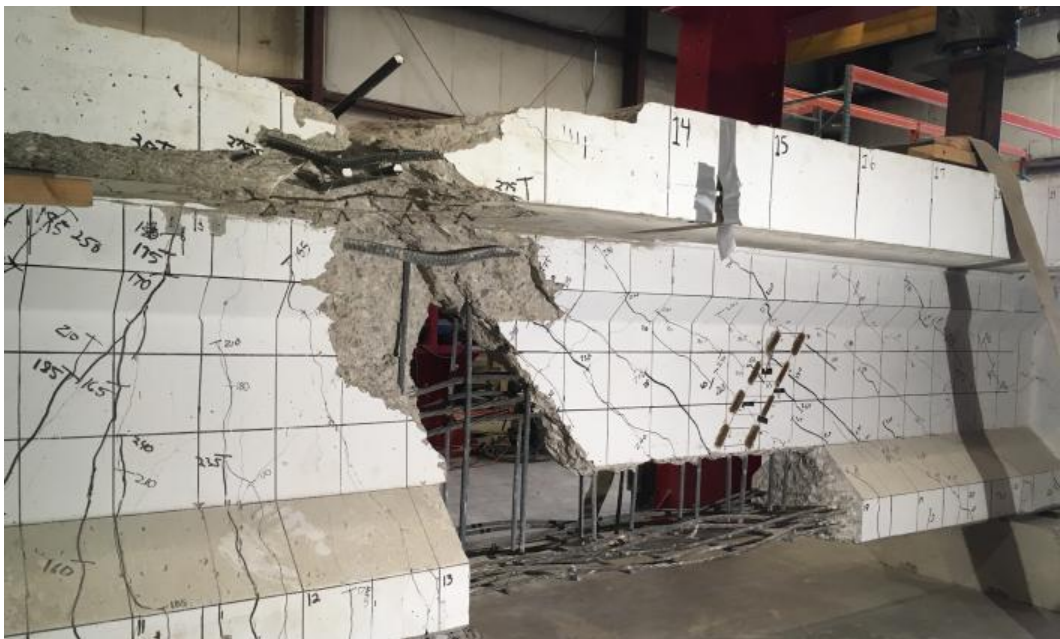
**Figure 5.23 Further Damaged Concrete Uncovered During Demolition**

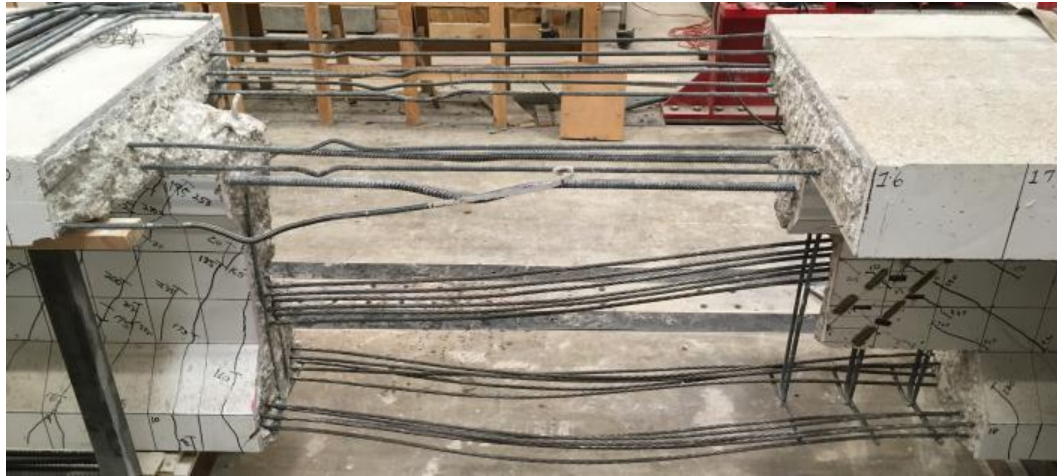
**Figure 5.24 North End with Damaged Concrete Removed and Loose, Existing Reinforcing Steel**

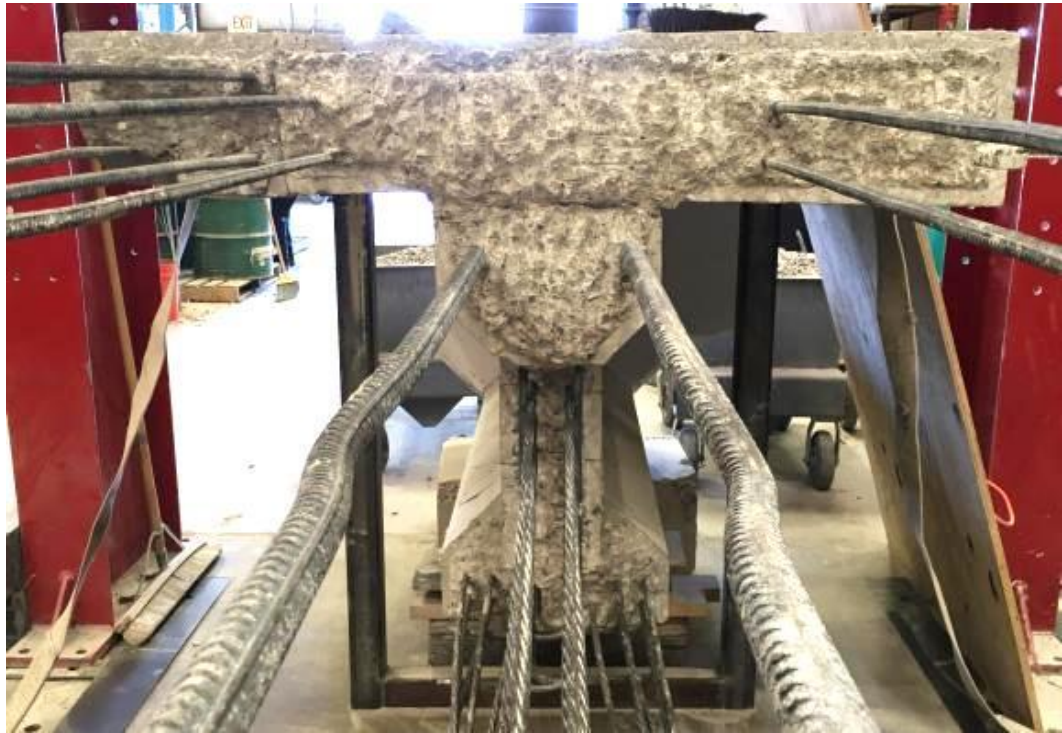
Figure 5.27 shows the north boundary of the repair with the longitudinal bars of the deck and girder. The transverse bars, according to ODOT's drawings, were alternating bar shapes that were No.5 bars spaced at 10 inches on center (5 inches on center between bar types). The two bar types were one grouping of two straight No. 5 reinforcing bars, one at the bottom of the deck and the other placed at the top of the deck in line with the bottom bar. The second bar type was a bent No. 5 bar where the shape allowed for the bar to be a top bar over the girder and a bottom bar in the span between girders. A diagram for the layout of a typical section of the deck is shown in Figure 5.28, and Figure 5.29 illustrates a partially demolished deck portion with the original transverse reinforcement.

Figure 5.27 North Boundary of North End Repair

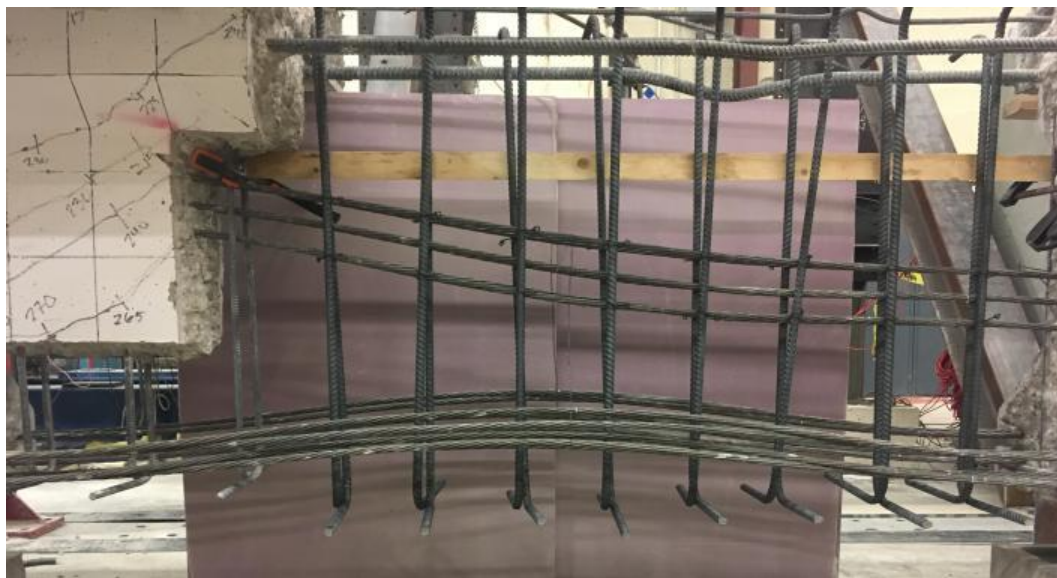
**Figure 5.30 Prestressing Tendons in Compression**

for approximately 14 3/4 inch section of strand to be cut away and for the strand to be test-fitted into the “anchor body” of the assembly without the wedges in place so as to mark where the outer face of the “anchor body” lines up on the strand. That extent was marked on the strand and used as a datum to place the wedges. Once the wedges were placed, the spring was added and the threaded rod screwed into the “anchor body.” The threaded coupler and other threaded rod were added to the assembly and installed to the manufacture’s specified spacing and the “anchor body” for the other end was screwed into the threaded rod. This process was repeated for each of the ten straight strands. Once installed the assembly was tightened in the same sequence that the post-tensioning was applied in Section 5.3.6 until snug-tight.

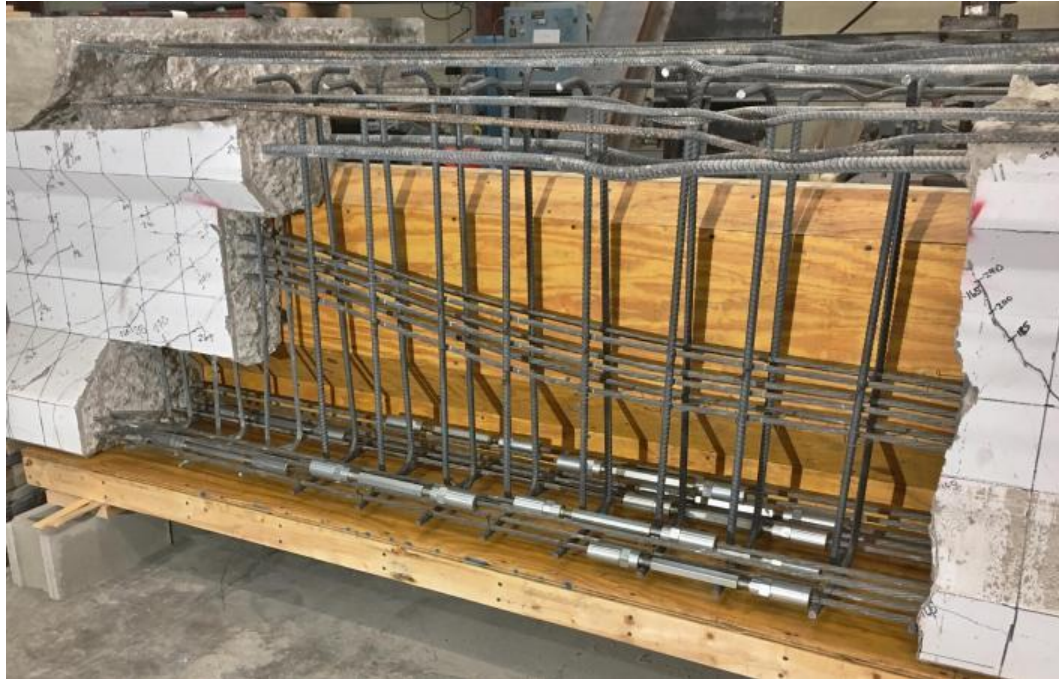
**Figure 5.32 North End Girder Internal Reinforcing**

original stirrup shape, at 7 and 1/2 inches on center. The final arrangement of stirrups is shown in Figure 5.32.

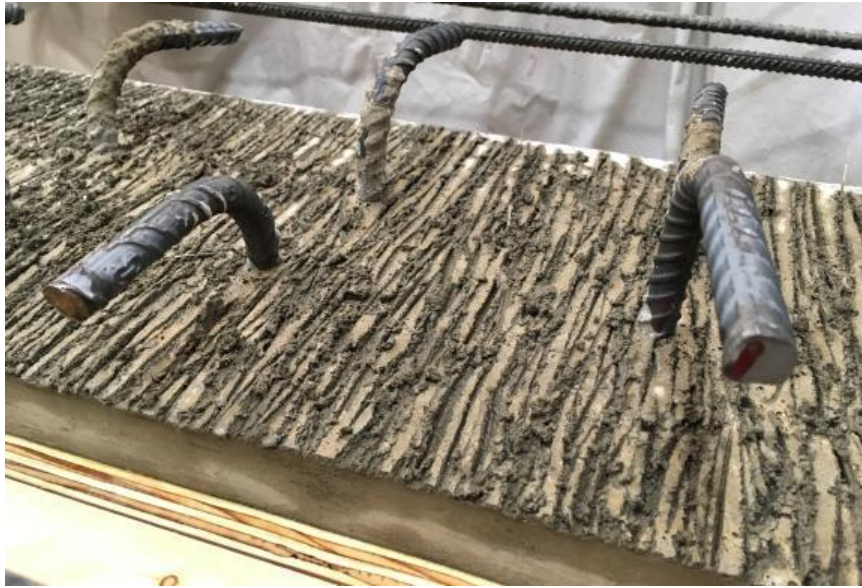
**Figure 5.33 Roughened Surface of North End Girder Portion**

In an effort to keep the original geometric properties of the girder, it was decided to cast the girder portion of the north end separate from the deck section. Originally, the deck was cast onto girders once they were in place and the top inch of the girder and the top of the Z-bars also extended into the deck. To mimic this process, the girder would be cast first, then the deck a few days later. The total volume of the girder repair is approximately 15.6 cubic feet of concrete, not accounting for the internal reinforcing. A total volume of 18 cubic feet was decided for casting day so that small scale cylinders could be cast in addition to the repair. Just as with the south end repair, all the materials were pre-batched and representative moisture samples were collected from the aggregates. All materials were sealed in their containers until mixing. The mixing procedure follows the steps previously outlined in Section 5.3.5 and conforming to ASTM C192. The formwork for the girder is open at the top, providing for easy access to pour the FR-SCC into the form. After the concrete was added to the repair section, six 6 inch by 12 inch cylinders were cast and a slump flow test was performed. The slump flow yielded 28.5 inches, which was the closest value to the target slump flow achieved in this study. At approximately one hour after casting, the top surface of the girder was roughened using masonry trowels to provide for improved bond between the girder and the deck (Figure 5.33).

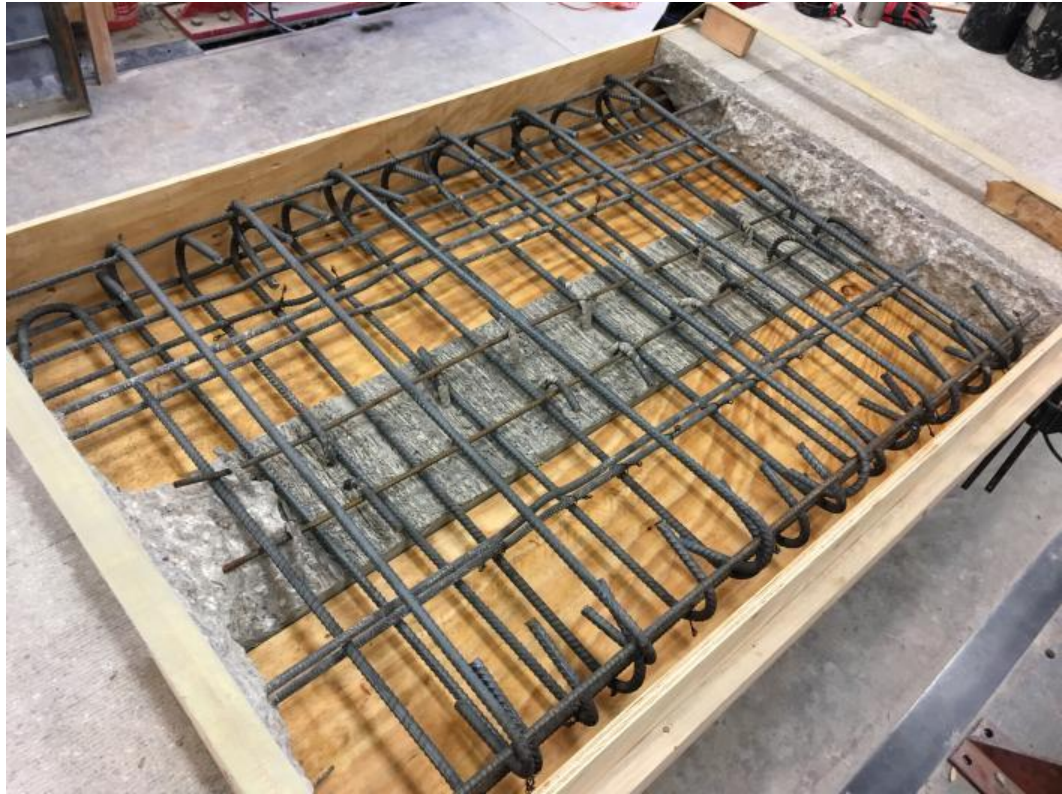
**Figure 5.34 Deck Reinforcing of North Repair**

As the girder portion of the north repair was curing, the deck was prepared for casting. Using the formwork that was currently still attached to the girder as a brace, the deck form was attached and secured to the girder using threaded rods and two-inch-wide tow straps. The original transverse reinforcement was removed from the section and new No. 5 bars were their replacement. These new bars followed the same spacing as the original reinforcement; however, they featured 180° hooks at each end as opposed to being terminated at the face of the concrete as they were previously. On the east side, two longitudinal No. 4 bars were added in the corners of the transverse reinforcing bars. Figure 5.34 shows the final arrangement of internal reinforcing for the deck portion of the north repair.

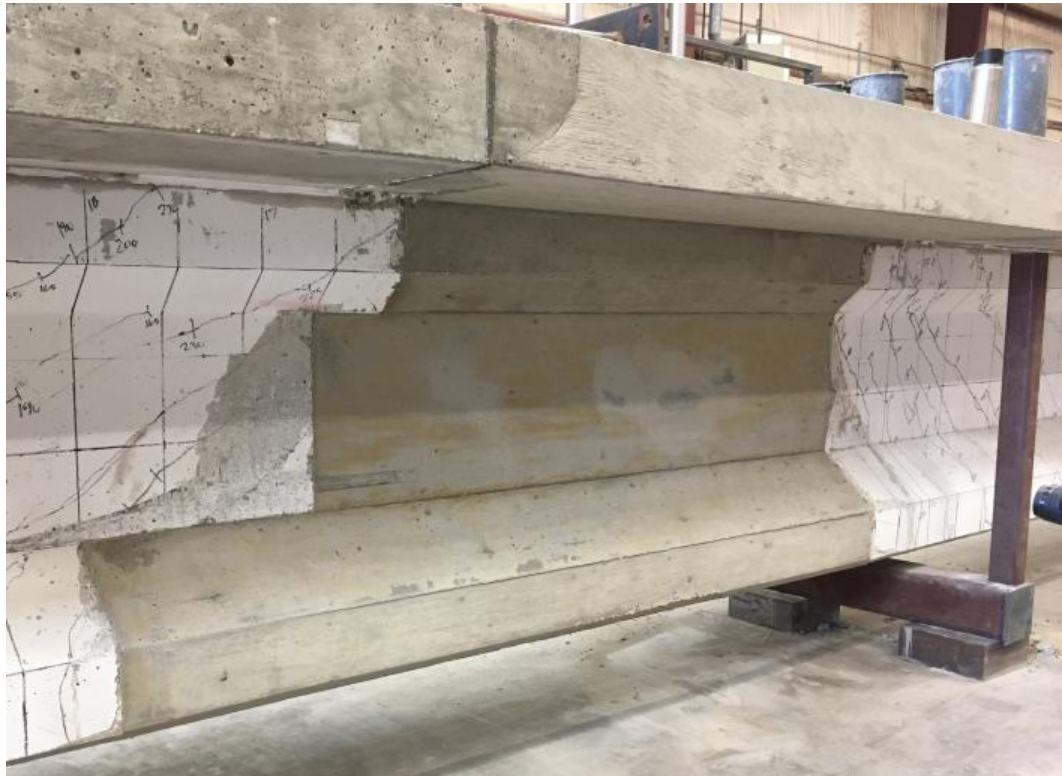
**Figure 5.35 West Side of Completed North End Repair**

wet burlap over the deck and a tarp over the burlap. This allowed the deck to moist cure for seven days, at which point the burlap was removed as well as the forms. Figure 5.35 shows the repair after removal of the formwork for the deck and girder.

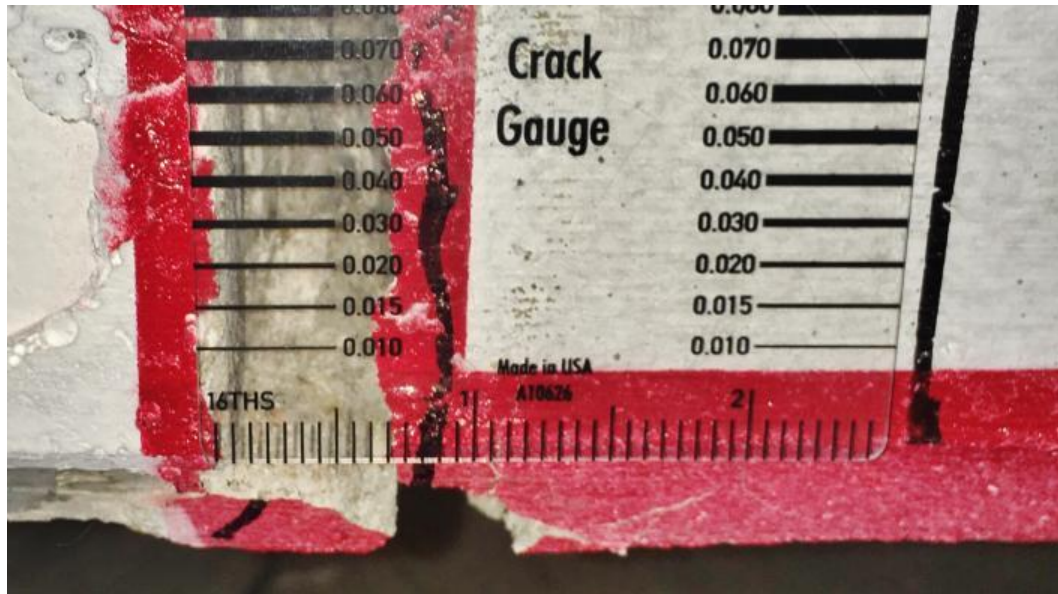
**Figure 6.6 Crack Width of Repair Interface**

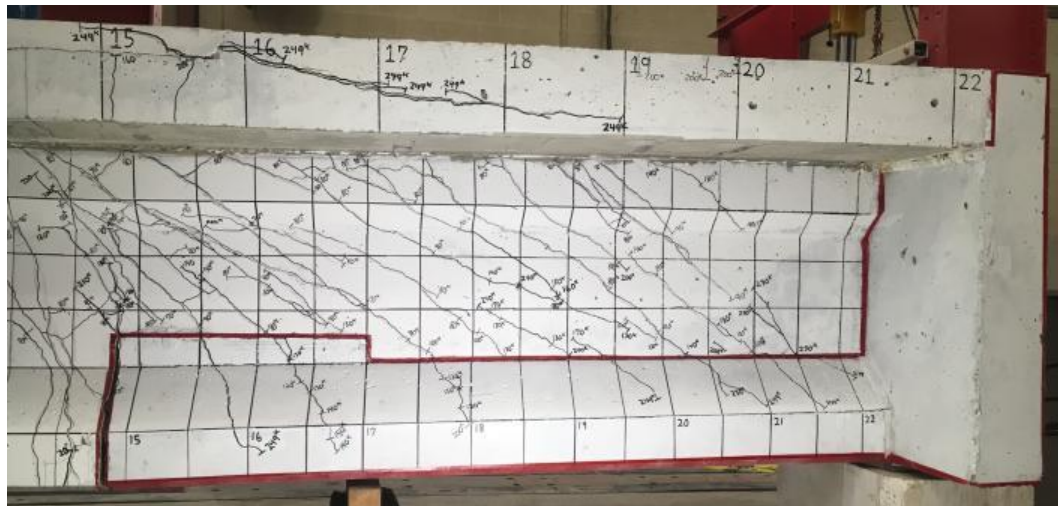
**Figure 6.7 Extent of Damage for South End Repair**

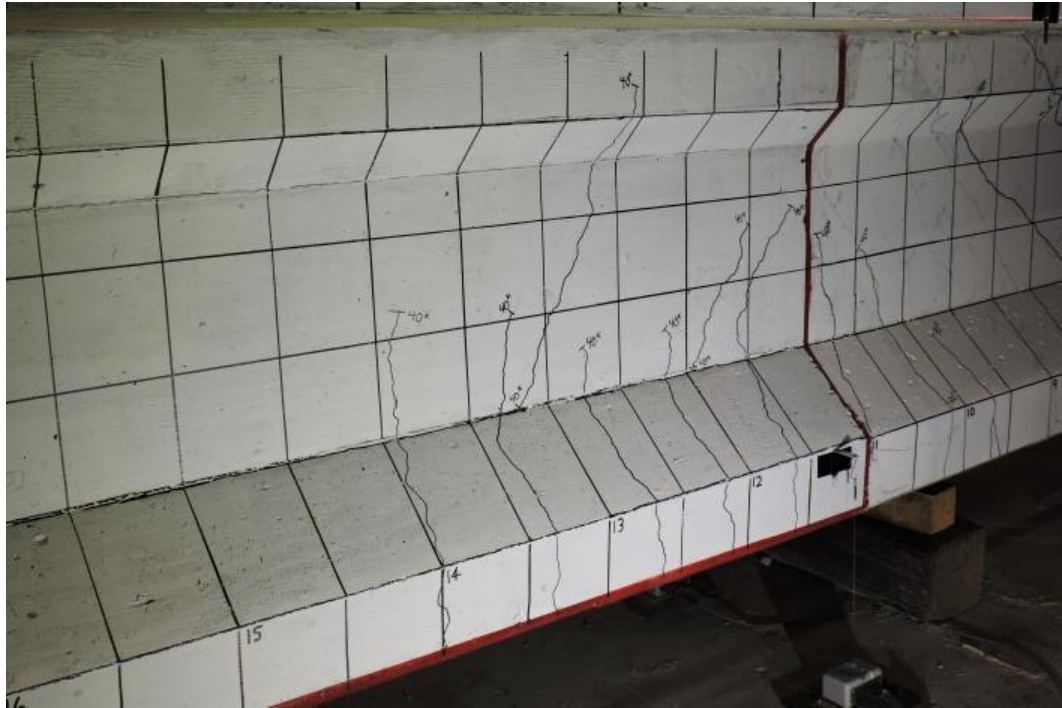
**Figure 6.11 First Cracks in the Repair Zone**

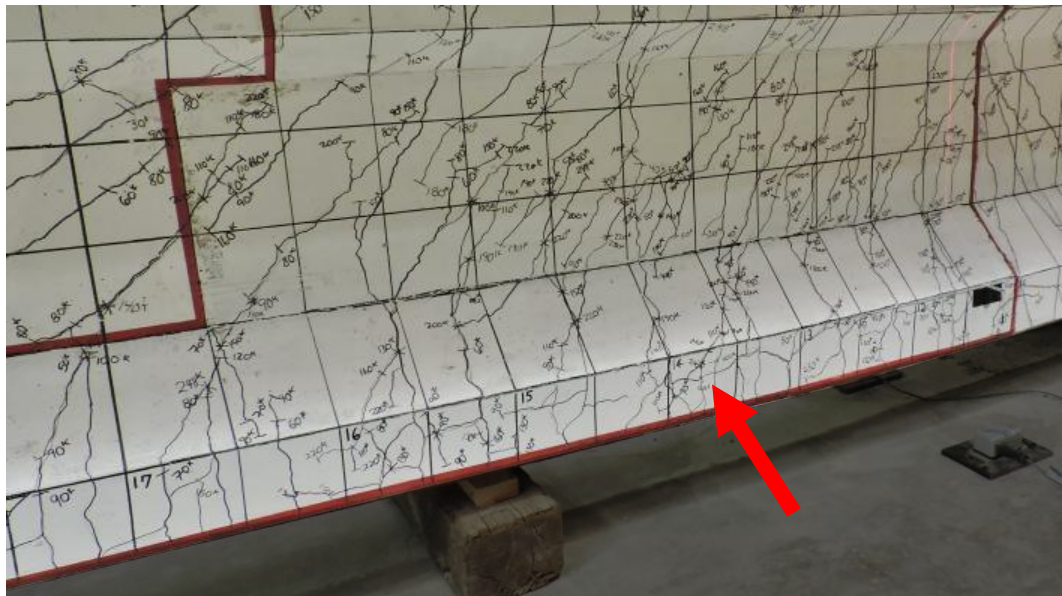
**Figure 6.12 Shear-Bond Cracking in North Repair**

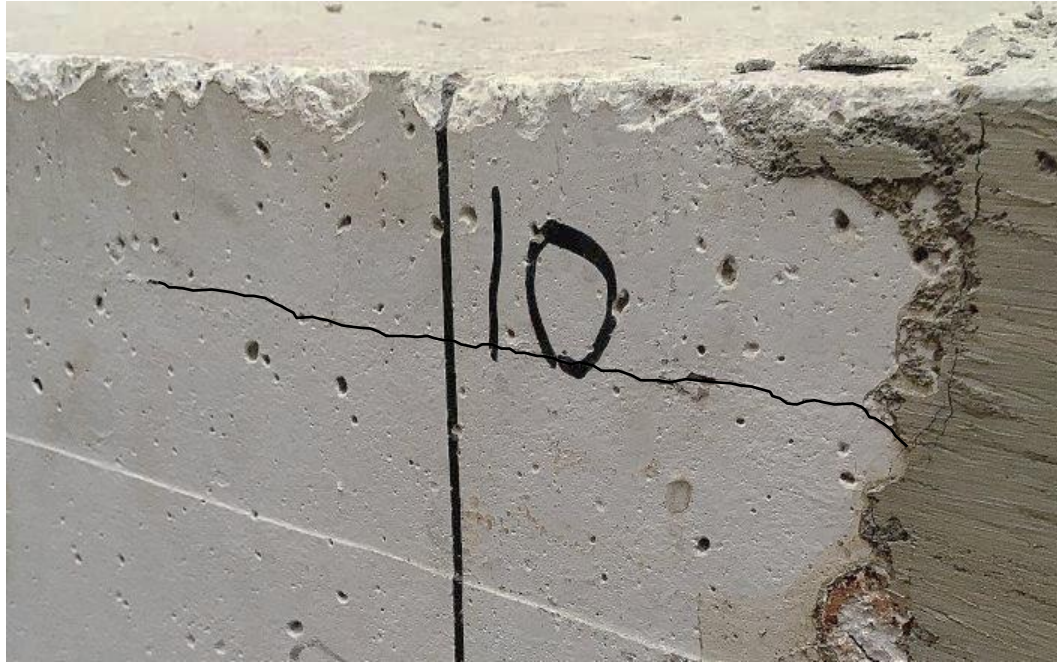
**Figure 6.13 Delamination of Wearing Layer During Repair Testing**

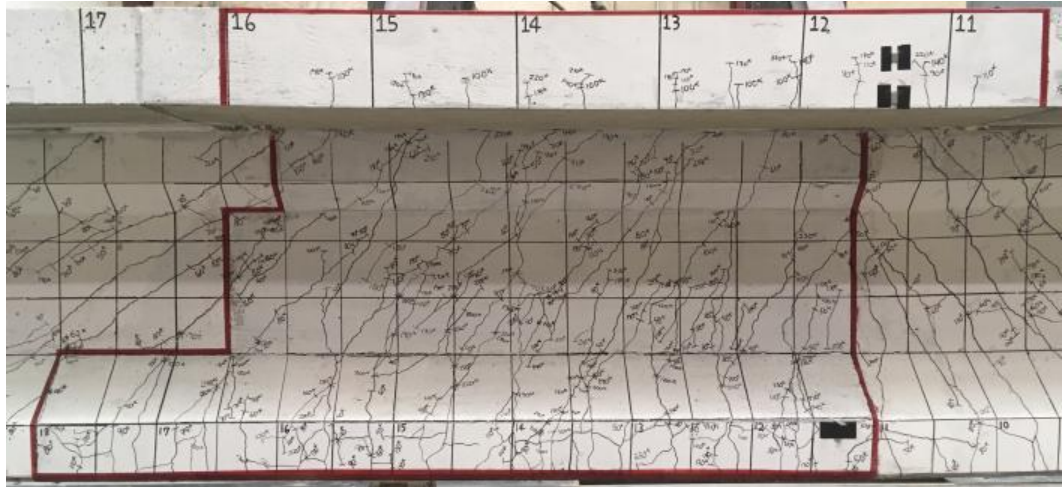
**Figure 6.14 Post-Testing West Elevation of North End**

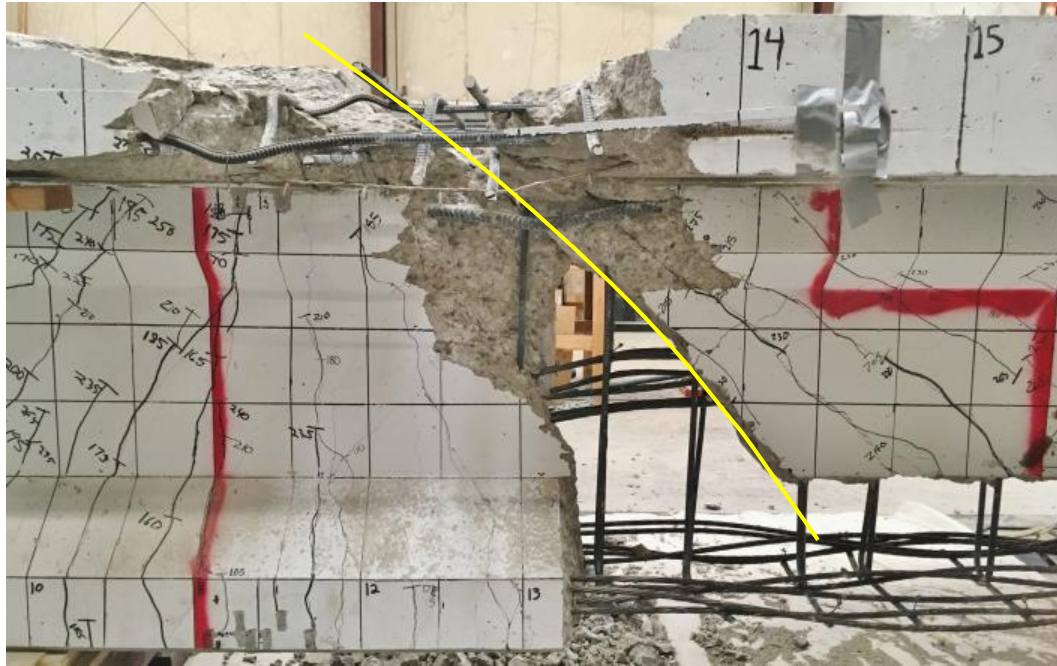
**Figure 7.4 North End Shear Plane (Yellow Line) Discovered Mid-Demolition**

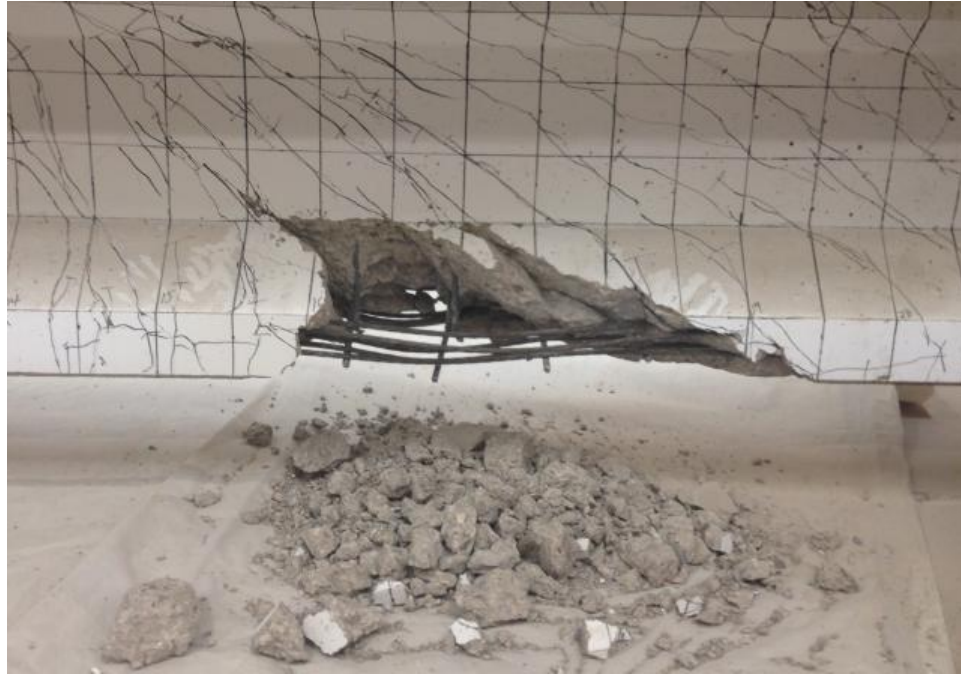
**Figure B.1 Loose Concrete Removed From South End With Hammer**

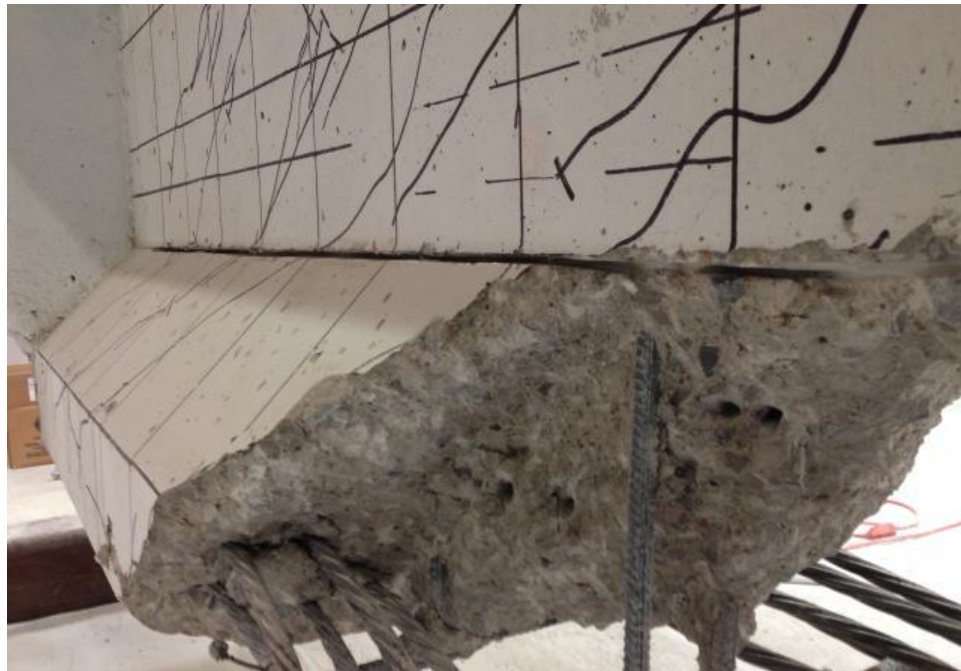
**Figure B.2 One-Inch Boundary Line Cut With Hand Grinder (South End)**

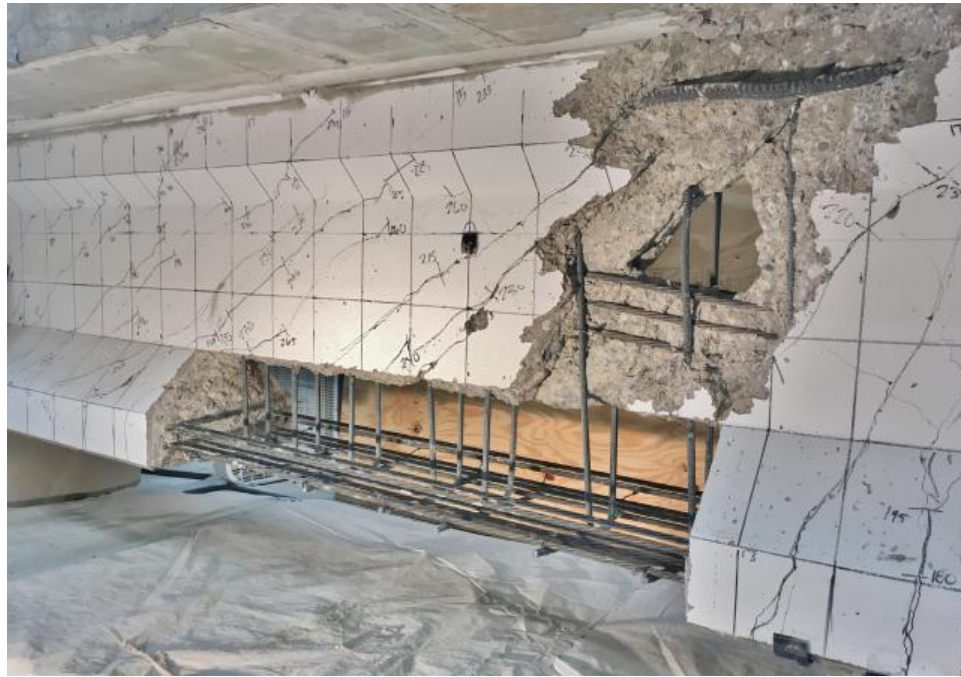
**Figure B.3 North End Bottom Bell & Loose Concrete Removal**

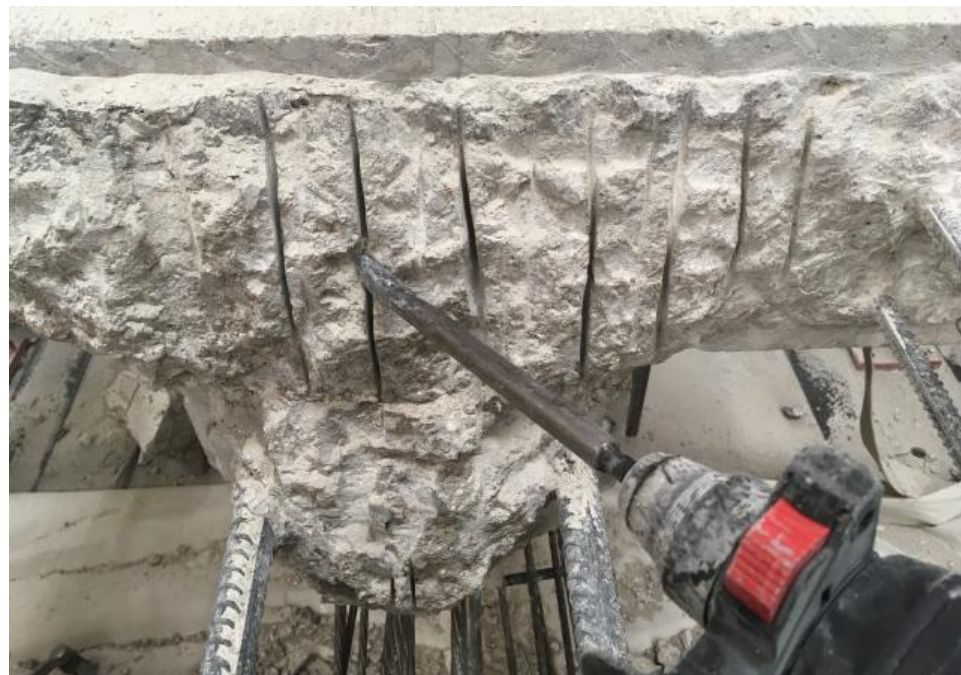
**Figure B.4 Removal of Deck Concrete Using an Impact Hammer**

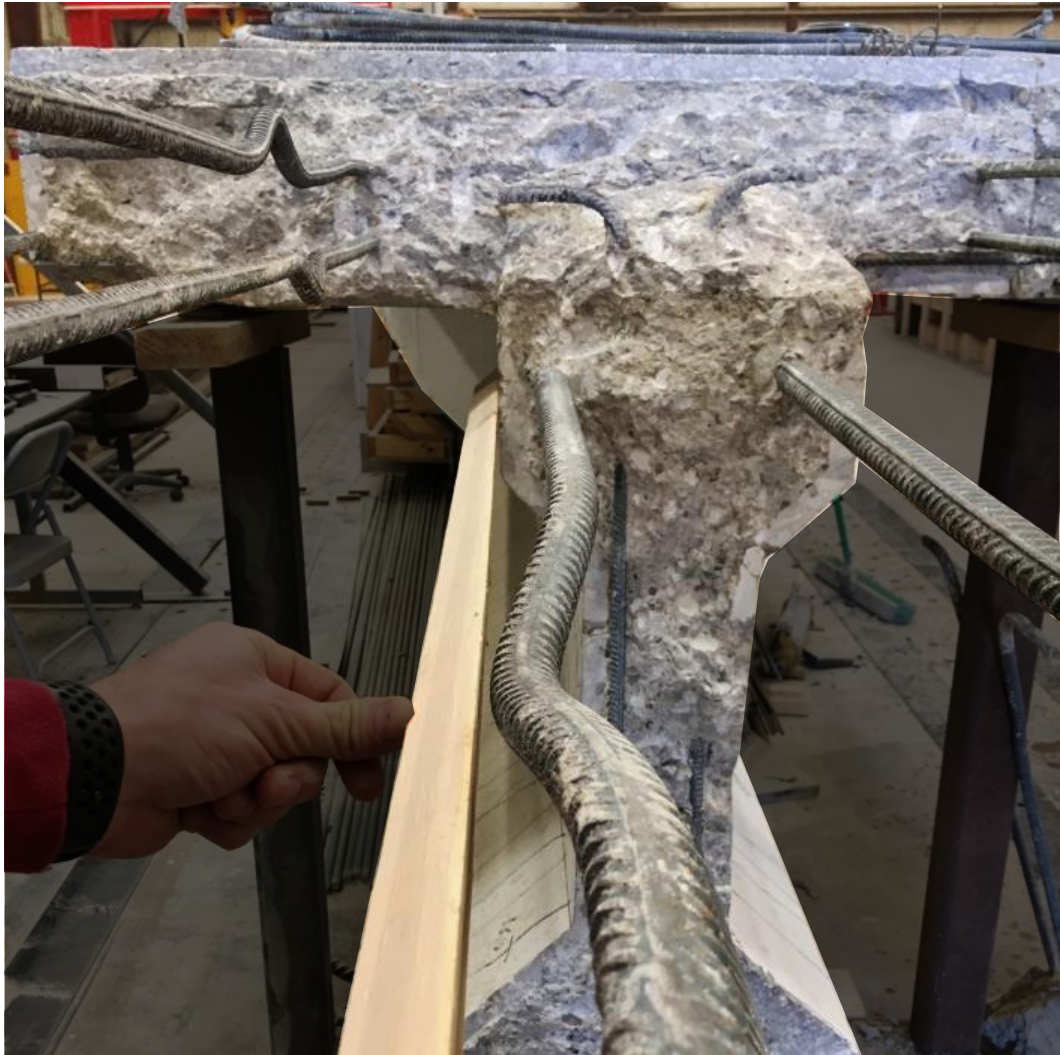
**Figure C.3 Bent Longitudinal Reinforcing of North End Repair**
