BRIDGE STEEL COATINGS TOLERANT OF MINIMAL SURFACE PREPARATION

**Construction Report
June 1996**

**Kimberly L. Gordon
Research Project Manager**

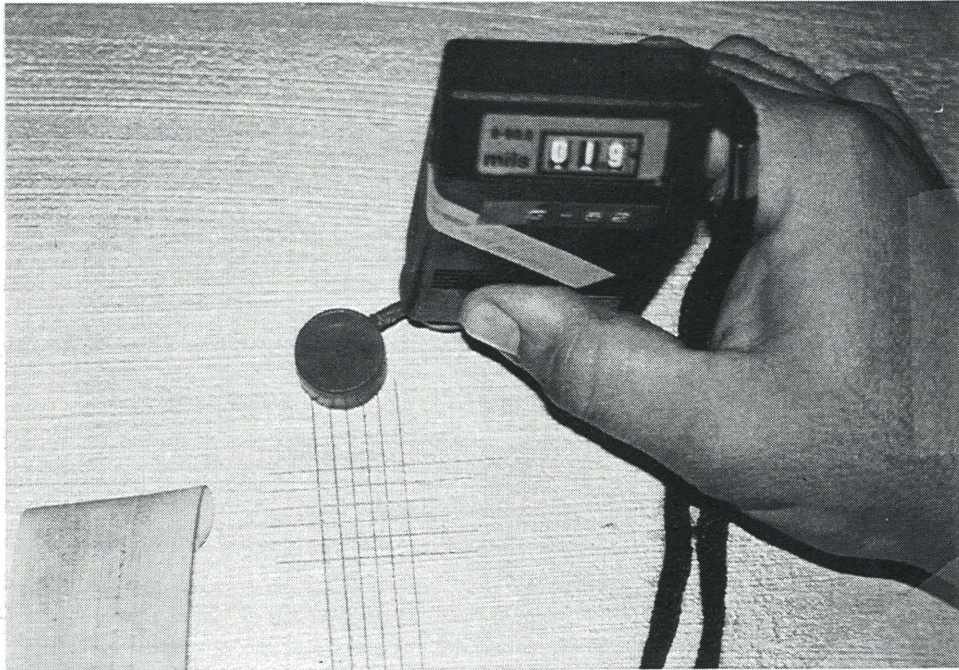
Figure 2. Compatibility Test

To perform test method B, a minimum of three test patches measuring at least 0.93 square meters (10 square feet) was selected, cleaned, painted, then allowed to dry for at least 7 days. After the curing period, several incisions 20 mm (0.75 in) long and 2 mm (0.8 in) apart are made through the new and old paint to the bridge steel. Several more incisions are made perpendicular to the first set of cuts. A semitransparent tape is placed firmly over the incisions then pulled back. Figure 2 shows an example of the grid cut for the test patch. The visual appearance of the paint on both the tape that has been removed and on the beams is noted and a rating is assigned. Normally, if the systems are not compatible, the new paint will be left on the tape while the old paint will remain on the substrate.

Compatibility tests results are rated from 0 to 5. A rating of 5 indicates no peeling or removal between the new and old coatings. A rating of 4 indicates trace peeling or removal along the incisions or at their intersections between the new and old coating. The ratings continue to decrease as the amount of paint that is removed or peels away increases. A rating of zero indicates that more than sixty-five percent of the new paint has peeled away from the old paint. Table 3 lists the average test results for each bridge.

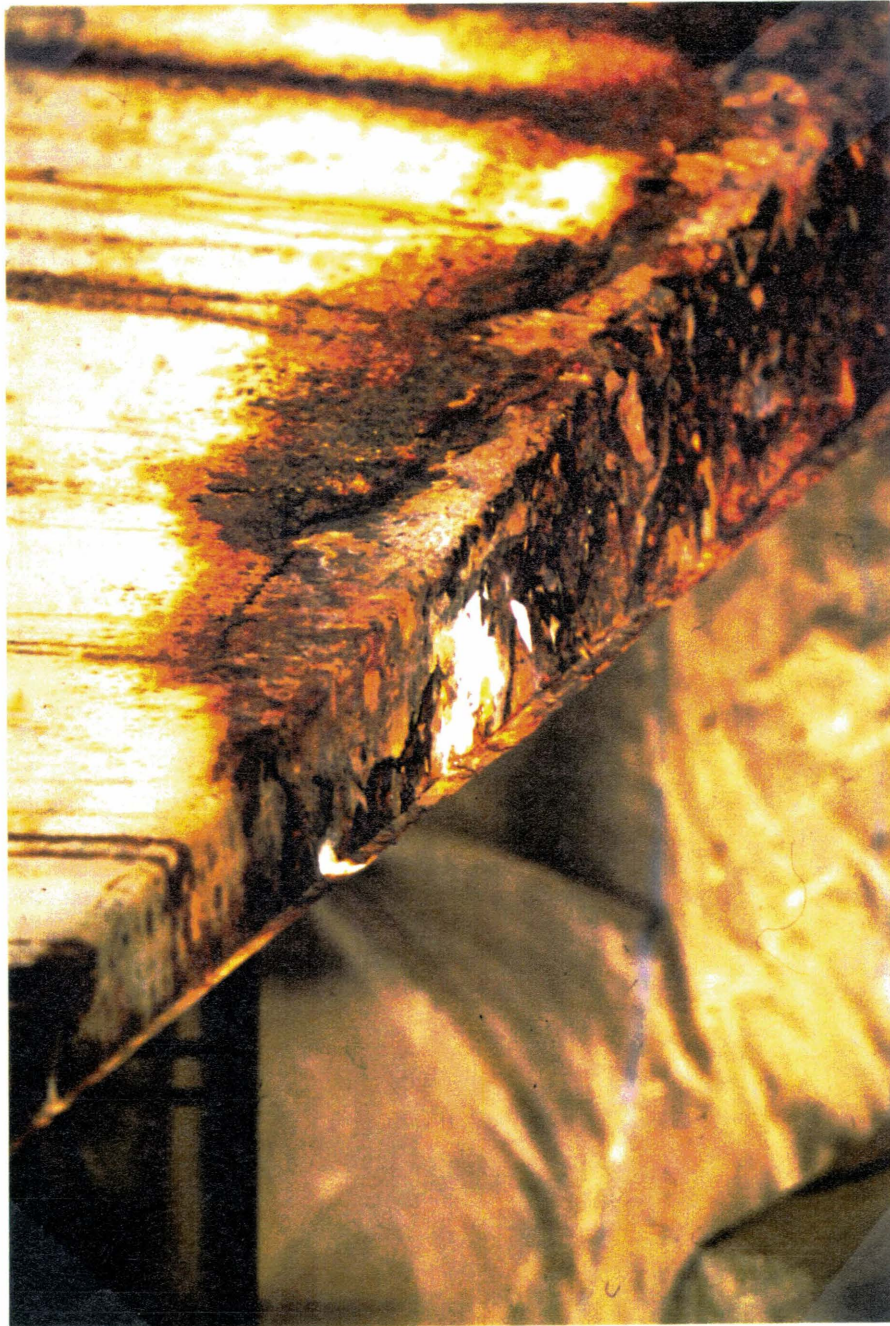
Figure 3. Rust and Calcium Deposits

The bridges in this evaluation were cleaned in accordance with one of the SSPC cleaning standards listed in Table 4. A tarpaulin was used to collect debris and wash water. Bridges were enclosed when blast cleaning was necessary. An example of the debris and rust on the bridge steel beams before cleaning is shown in Figure 3.

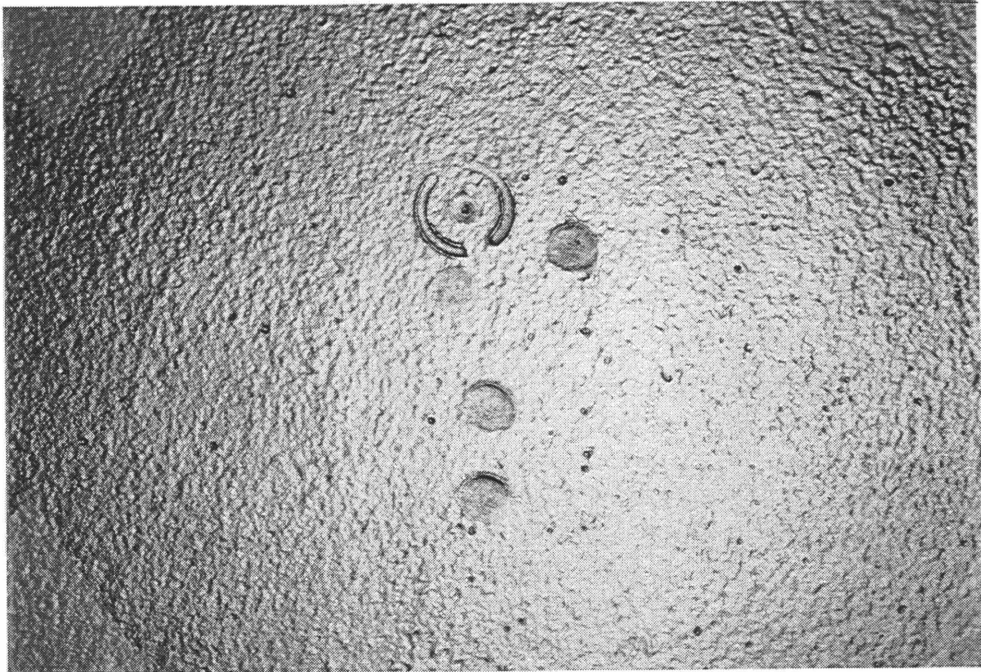
Figure 5. Bridge 3 - Alumanation Coating

At the final inspection of the bridge a few weeks after application, the parties participating in the inspection were not pleased with the appearance of the coating systems, particularly the Alumanation. It was difficult to get an even coating from this paint system. When applied, the paint appeared to have shadows and looked as if it were several different shades of gray. The contractor agreed to touch-up the bridge with paint in several problems spots to the engineers' specifications before the project was finished. The contractor went over the beams with a fine mist of the Alumanation paint for the center and west spans approximately 0.10 mm (4 mils) thick when wet.

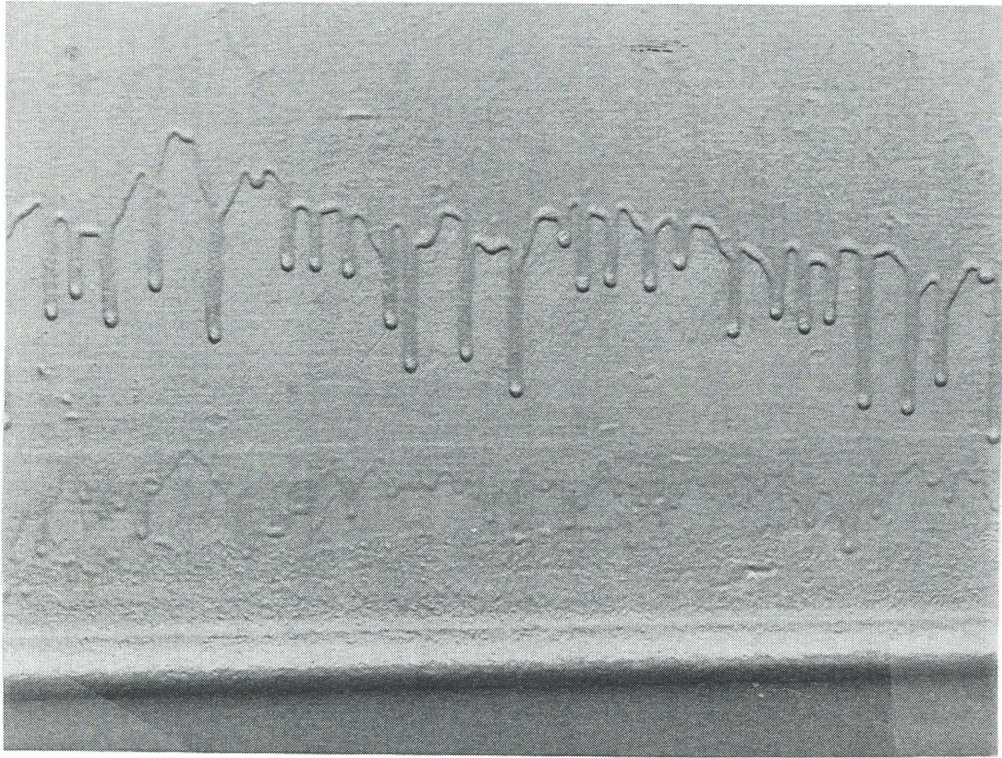
Figure 6. Bridge 5 - Top Coat of Rust Grip

The center span of this bridge was painted first then the remaining two spans. The contractor used a 0.432 mm (0.017 in) diameter tip to apply the paint. Rust Grip ran easily when applied, shown in Figure 6, and took four coats of paint for complete coverage. The manufacturer's representative suggested a larger size tip, 0.533 mm (0.021 in) diameter, for better coverage and fewer runs. A size 0.635 mm (0.025 in) diameter airless paint tip was used but this seemed to make little difference in the coverage and paint still ran.

When the coating system dried, it was very difficult to remove or scrape a section of the paint off even with the edge of a key. With the exception of the train schedule and runs, the operation proceeded with little incident. Figure 7 depicts the appearance of the bridge during application.

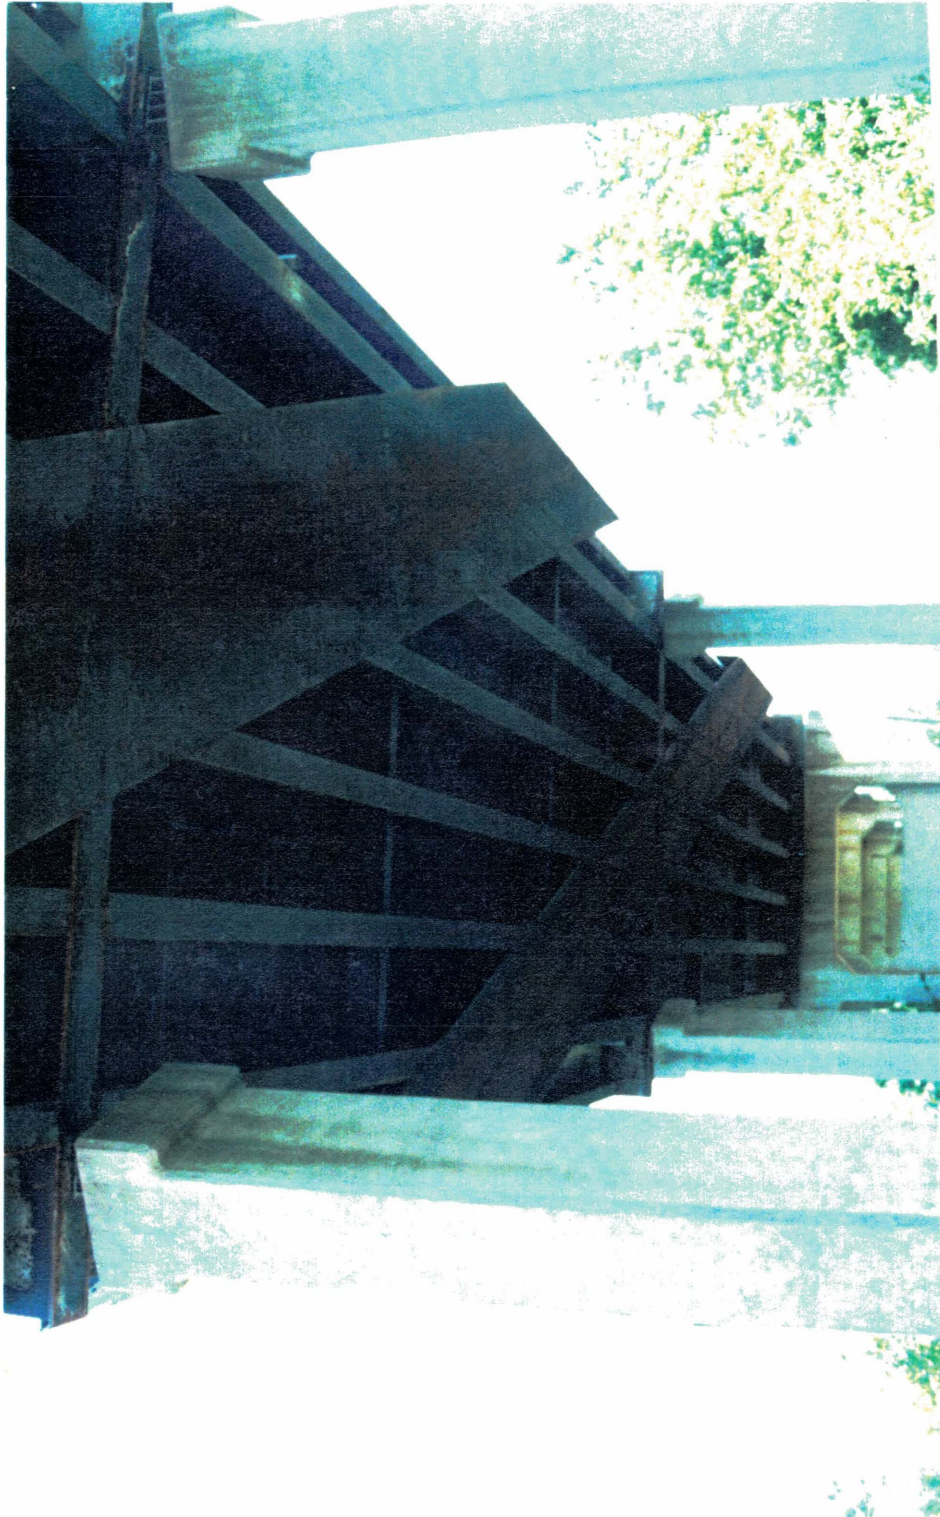
Figure 8. Bridge 7 - Blast Plates

This bridge had two blast plates, shown in Figure 8, that were removed from the steel beams. There was a lot of rust, debris, and animal nests between the blast plates and the steel beams. The areas were cleaned according to the standards and painted. The blast plates were not replaced.
