# ESTABLISHMENT OF UNDERDRAIN MAINTENANCE PROCEDURES

<b>1. REPORT NO.</b> FHWA/OK 95(04)	<b>2. GOVERNMENT ACCESSION NO.</b>	<b>3. RECIPIENT'S CATALOG NO.</b>	
<b>4. TITLE AND SUBTITLE</b> ESTABLISHMENT OF UNDERDRAIN MAINTENANCE PROCEDURES		<b>5. REPORT DATE</b> May 1995	
		<b>6. PERFORMING ORGANIZATION CODE</b>	
<b>7. AUTHOR(S)</b> Steven Sawyer, Project Manager		<b>8. PERFORMING ORGANIZATION REPORT</b>	
		<b>10. WORK UNIT NO.</b>	
<b>9. PERFORMING ORGANIZATION ADDRESS</b> Oklahoma Department of Transportation Research & Development Division 200 Northeast 21st Street, Room 2A2 Oklahoma City, OK 73105		<b>11. CONTRACT OR GRANT NO.</b> Item 2183	
		<b>13. TYPE OF REPORT AND PERIOD COVERED</b> Final Report May 1991 to May 1995	
<b>12. SPONSORING AGENCY NAME AND ADDRESS</b>  Oklahoma Department of Transportation 200 Northeast 21st Street Oklahoma City, Ok 73105		<b>14. SPONSORING AGENCY CODE</b>	
		<b>15. SUPPLEMENTARY NOTES</b>	
<b>16. ABSTRACT</b> Project #2183 analyzed the condition of underdrains and developed a method of classifying, maintaining, and, when necessary, replacing underdrain outlets.  The project encompassed every region of Oklahoma and many different climates and ge

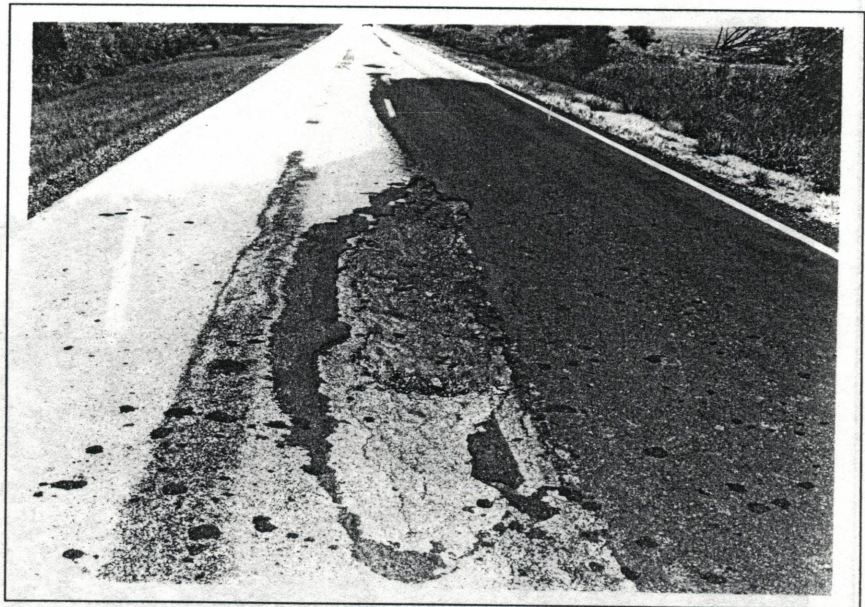
The devastating toll exacted by the cyclical and/or continuous presence of water is illustrated in Figure 3. This kind of damage is attributable to such water related processes as pumping, stripping, and erosion of the aggregate fines essential to the strength and integrity of bases and pavements.

Figure 3 *Water related pavement damage.*

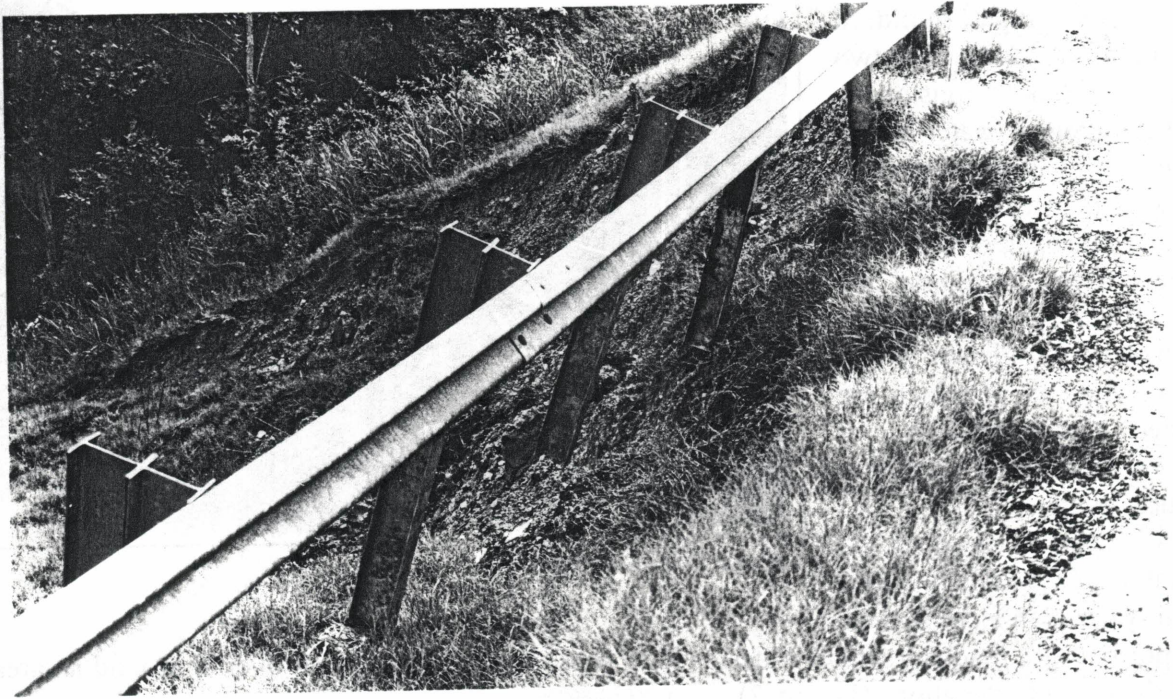
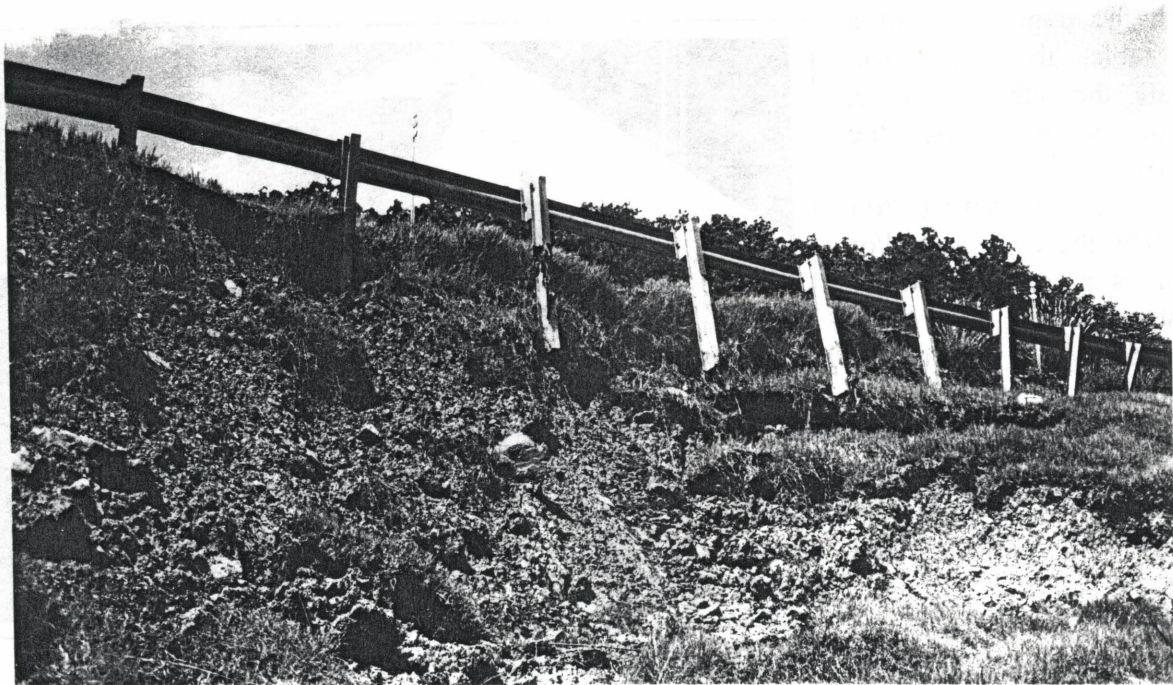
Figure 4 *Landslide.*

If embankments are very steep, excessive moisture may cause the soil material to shear. These troublesome and dangerous *landslides* (Figure 4) are all too common in mountainous terrain.

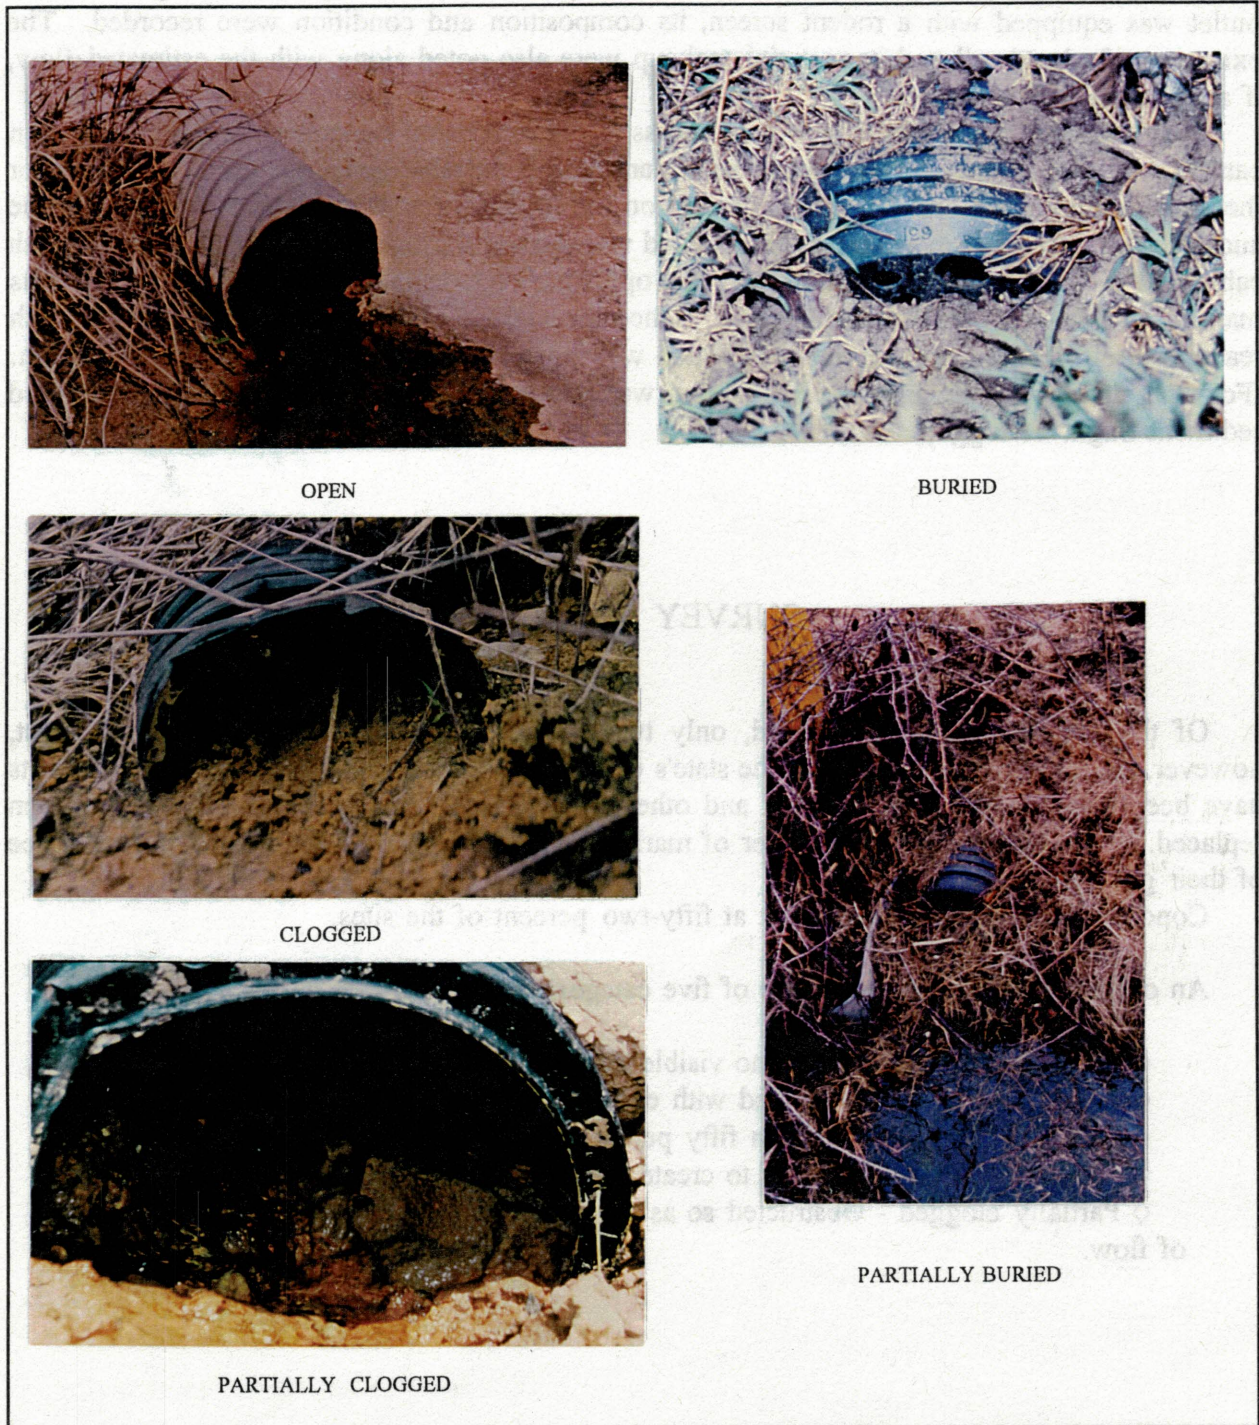
Photos of outlet conditions appear in figure 12.

Figure 12 Outlet conditions.

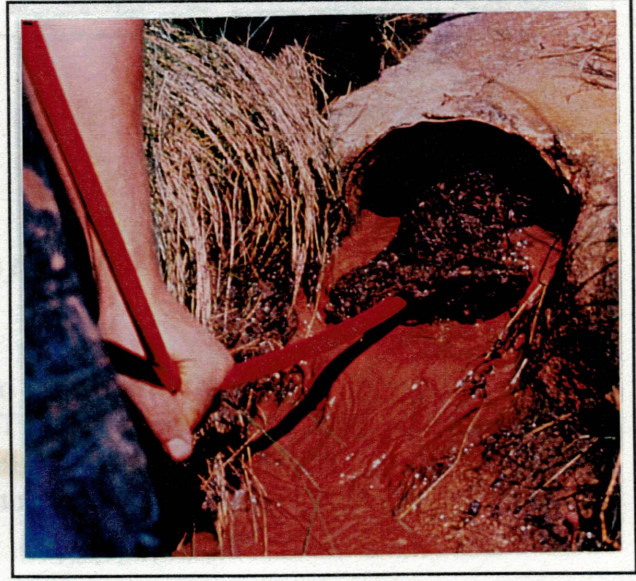
the hose through the pipe. The operator swabs the pipe with an oscillating motion until the obstructing material is carried to the outlet opening. (Figure 23)

**Figure 23** Operator clearing obstruction.

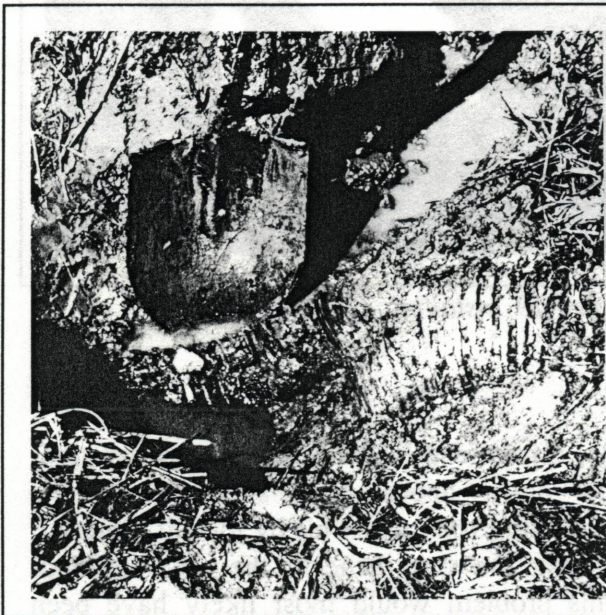
The pipes had been crushed, bent, and otherwise mutilated (Figure 26), presumably during installation. After estimating the proper size and length of pipe needed, the old outlet was exhumed with a backhoe. The pipe was carefully uncovered in increments of several feet and the severity of the damage examined. When a relatively sound section was exposed, the pipe was severed and inspected internally with the camera. If yet another deformation was encountered, the crew resumed exhumation. In the particular case of this demonstration, the pipe was spliced at the point where the outlet and paved shoulder intersected. Although there was still some deformation beyond this point, it was not deemed a significant deterrent to flow and, therefore, did not warrant the disturbance of the shoulder.

**Figure 26** Damaged drain pipe.

The pipe was easily cut with a small keyhole saw and the trench was layered with chips per ODOT 703.04(a) - Cover Material for Pipe Underdrains - Coarse Cover Aggregate (6) which was worked into a smooth, gentle grade. The new pipe was installed using standard coupling inserts.

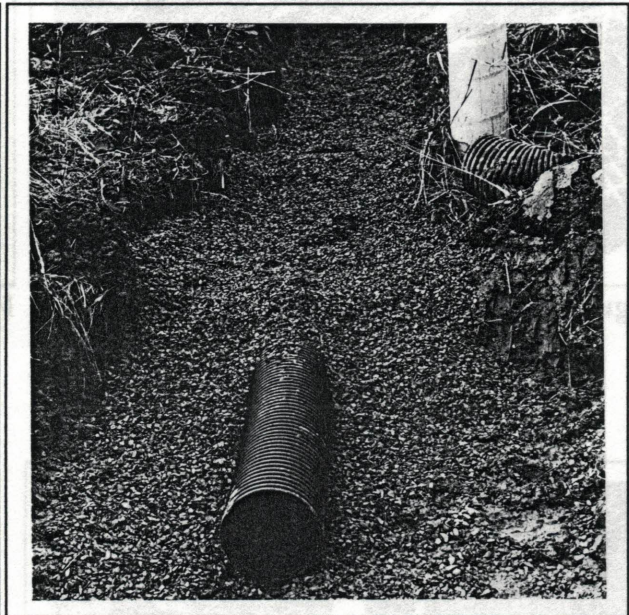
**Figure 27** Chips surrounding new outlet.

Two 6.1 m (20 ft) joints were needed on each outlet. The new outlet was covered with another layer of chips (Figure 27) before the trench was filled and the site finished.

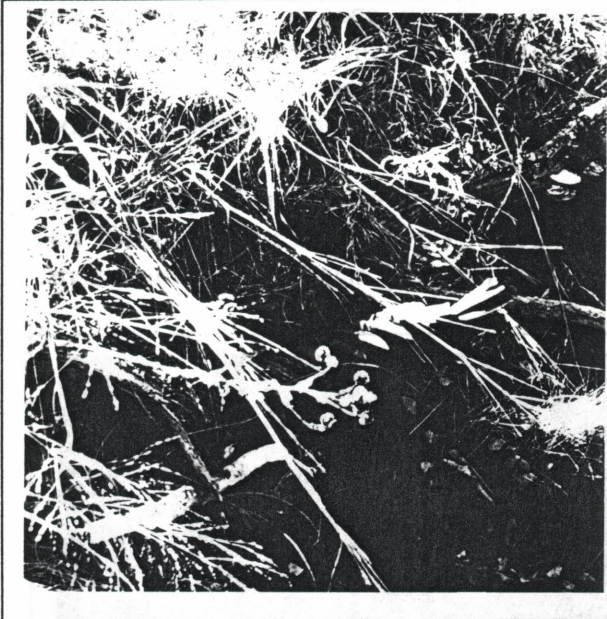
The second demonstration was conducted on a 15 cm (6 in) CGMP outlet (Figure 28). As with the HDPE, the severely damaged section was uncovered and a suitable splicing point chosen. The pipe was severed with a cutting torch and hacksaw.

Figure 28 *CGMP replacement site.*

Before installing the new pipe, the outlet was examined with the inspection camera. It was necessary to clear the outlet of sediment with the jetter before inspecting the interior. The observation ended at the junction of the outlet and the main underdrain because the connection had been made at too sharp an angle for the camera to negotiate.

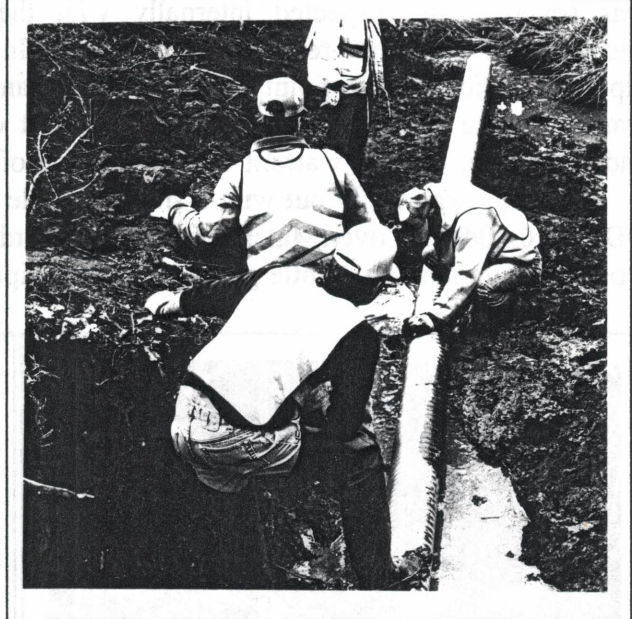
Figure 29 *Installing CGMP outlet.*

Two 6.1 m (20 ft) sections of new pipe were then installed. The joints were fastened with standard band couplings and extended to the existing ditch liner. (Figure 29) The pipe was supported only at the splice and the terminal end. A large rock was used as a center support at the band coupling but no bedding material was used.

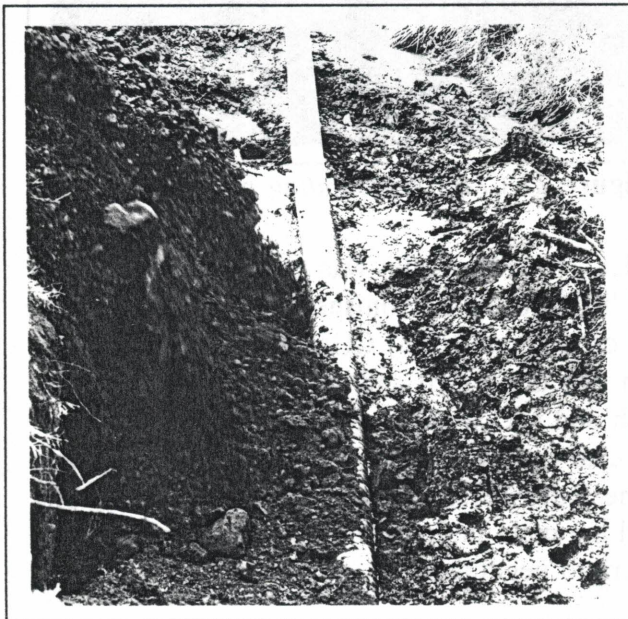
Figure 30 *Pipe sliding off center support.*

A front-end loader refilled the excavation. The outlet appeared to slide off of the supporting rock when hit by the fill material, leaving the void beneath the pipe unfilled. This problem would most likely have been avoided by stabilizing the pipe with chunks of earth, then bedding and backfilling with aggregate cover material. (See maintenance recommendations on page 24.)

Some outlets may need to be replaced. Replacement procedures should conform closely with those discussed in the REPLACEMENT chapter of this report. **Special attention should be paid to the achievement of a smooth, gentle grade of standard bedding material around all outlets - plastic and metal.**
