Video inspection of wells in open loop ground source heat pump systems in Norway.

Sondre Gjengedal, Randi K. Ramstad, Bernt Olav Hilmo, Bjørn Frengstad

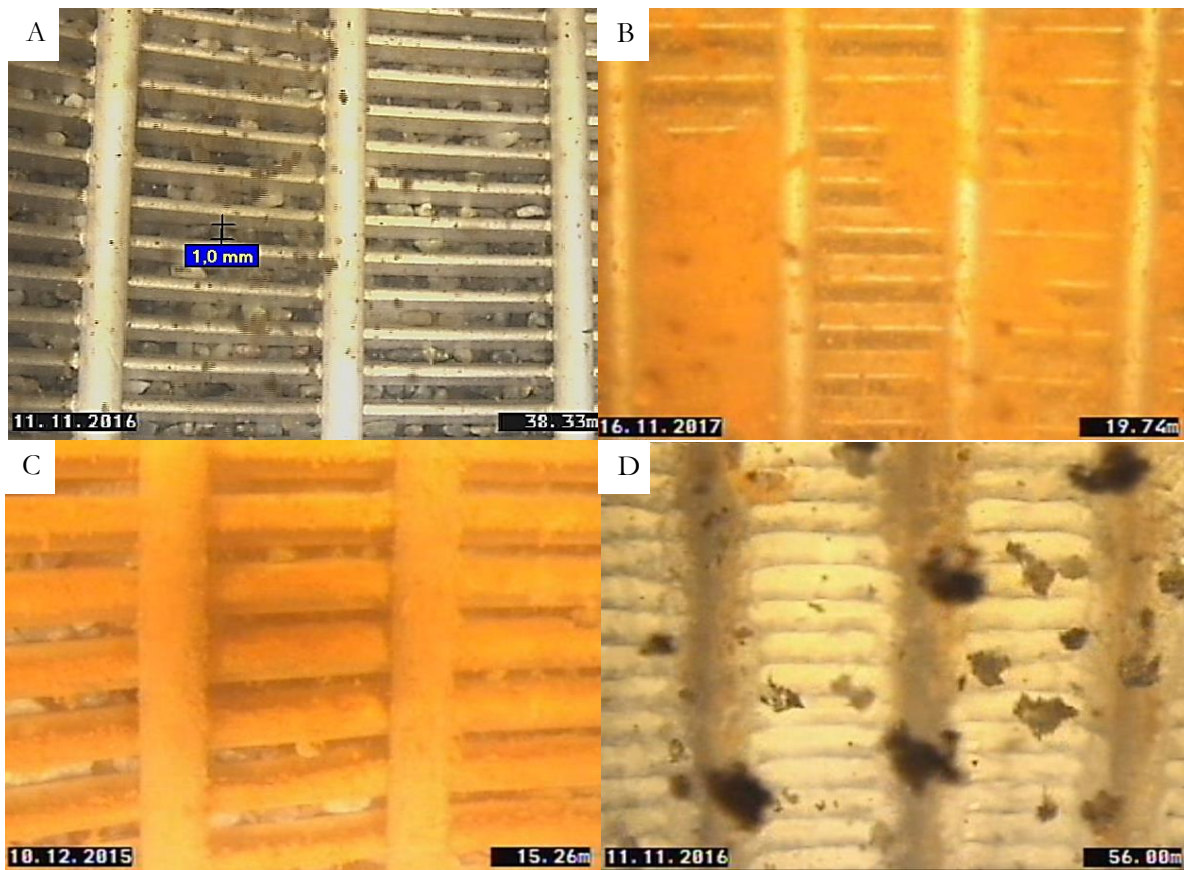
In groundwater wells, the usefulness of the method relies on the clarity of the water. Performing a flushing of the well and allowing particles to settle is in some cases recommended before the inspection, especially when inspecting new wells. Figure 1A shows a new well that had been pumped for 14 days and where the pumping ended one week before the video inspection. The 1 mm screen slot openings were measured to confirm that the well was constructed in accordance to the specifications given in the tender document. The lodged sand grains and the clarity of the water indicate that the well was constructed in good agreement with the local soil conditions.

The clarity of the water might be a good indication of a well`s current condition and an inspection without pre-flushing might be useful in itself. Figure 1B shows a production well in Elverum where the well screen is clogged by a biofilm of iron bacteria. This particular production well is less than 1 year old and had not yet been connected to the heat pump system. It was not flushed before the inspection. In this case the bacterial growth seems to favor specific parts of the screen and builds on the screen surface in a foam-like structure, effectively clogging some of the openings. These observations might not have been possible if the well was flushed before the inspection. Disinfection with chlorine and cleaning were necessary before the well could be connected to the system.

Precipitated iron and manganese hydroxides is a common problem in Norwegian open loop systems (Riise, 2015). Often these particles accumulate in the injection well, after a journey through the rest of the system. But some examples of hydroxide precipitation is also found in production wells in Melhus. The production well screen in figure 1C is incrustated with precipitated iron hydroxides at the location of the pump inlet. The drawdown in the well was not monitored during operation and the water table was lowered below the suction inlet section of the pump. Mixture of air into the screen area allowed the chemical reaction to occur. Unlike the iron bacteria in figure 1B the precipitated hydroxides seem to evenly cover the screen slots. This well had functioned for 15 years before the problem was discovered and the well had to be abandoned because of faulty design.

The injection well in figure 1D is clogged by fine silt and clay particles. The particles originate from the sedimentary formation around the production well, where they are carried through the production well screen by the flow of water. The particles are unable to infiltrate back through the injection well screen and effectively clog the slots. Before the inspection the well was taken out of service and the suspended particles were allowed to settle. The picture shows some small particles of black manganese hydroxides still settling in the well. The problem was discovered 1.5-2 years after the plant was set in operation. The problem was solved by installing a filter on a part of the pipe section in the machinery room before reinjection of the groundwater back into the aquifer. The filter is regularly cleaned.

Figure 1 Video inspections of well screens. A: a newly constructed well in Melhus. The 1 mm slots were measured with a built-in laser tool. B: iron bacteria have infected this production well in Elverum. C: precipitated iron hydroxide incrustations on a production well screen in Melhus. D: sand and silt clogging an injection well screen in Melhus. Photos: Gjøvaag AS (part of the ORMEL project).

The cost of a video inspection is a function of the actual inspection time and transportation cost to the site. The actual inspection time required for a single well depends mainly on the well depth and clarity of the water. For example, the depth of the wells shown in figure 1A-1D are 40 (A), 22 (B), 24 (C) and 58 (D) meters, respectively. The time needed for the inspections ranged from 15 (A), 15 (B), 23 (C) and 30 (D) minutes, respectively. The total cost of the individual video inspections ranged from 5000-5700 NOK (\approx 520-590 €) per well. By comparison, similar numbers have been reported by Banks (1992), where an average cost of 2500-6000 NOK (\approx 260-620 €) was registered in 1991.
