EVALUATION OF THE GILCREASE EXPRESSWAY DYNAMIC COMPACTION

FINAL REPORT

June, 1992

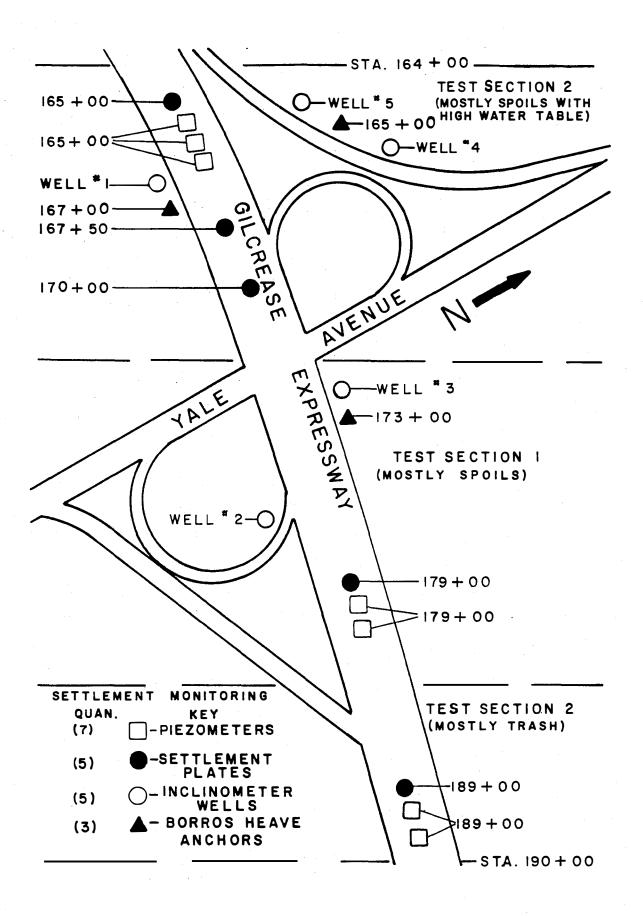
Figure 1. Location of the Instrumentation

Since there were three types of material encountered at the site, instrumentation was installed so that each area could be monitored. Consult Figure 1 to see the instrumentation layout relative to the test sections. Test Section No. 1 represents the conditions that exist between Stations 172+00 and 181+00. Borings from Test Section No. 1 indicated the presence of mine spoil, consisting of a silty clay with shale fragments, from the surface down to bedrock in this area. The water table was not encountered in the borings.

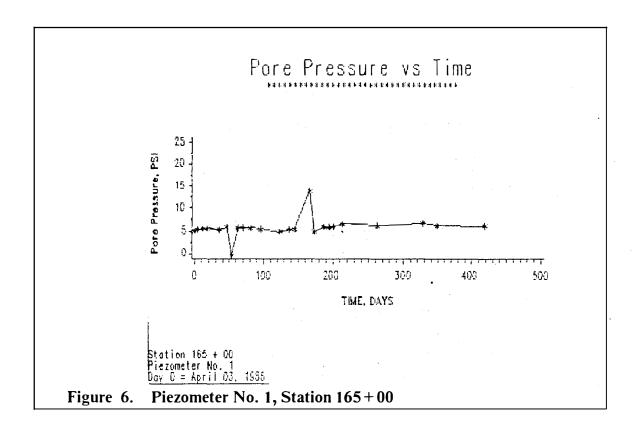
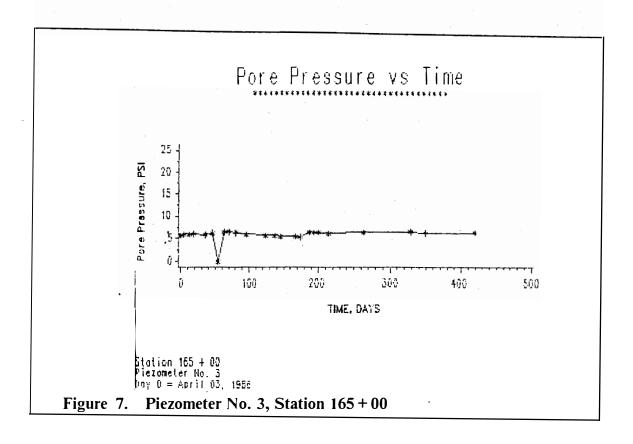
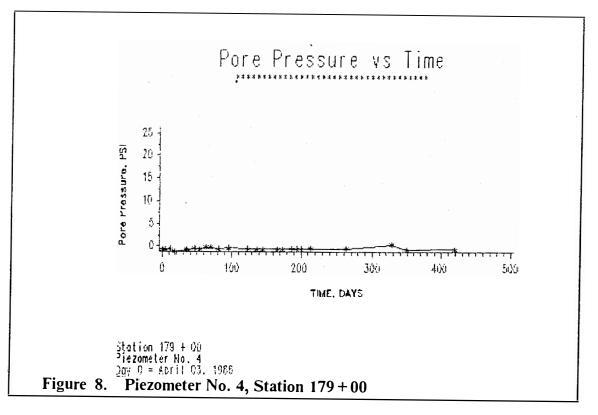
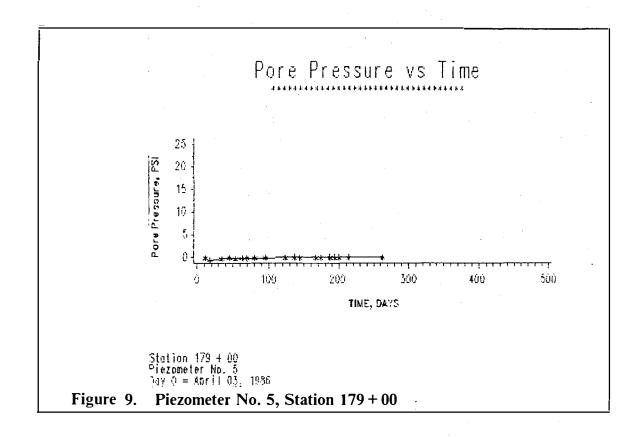
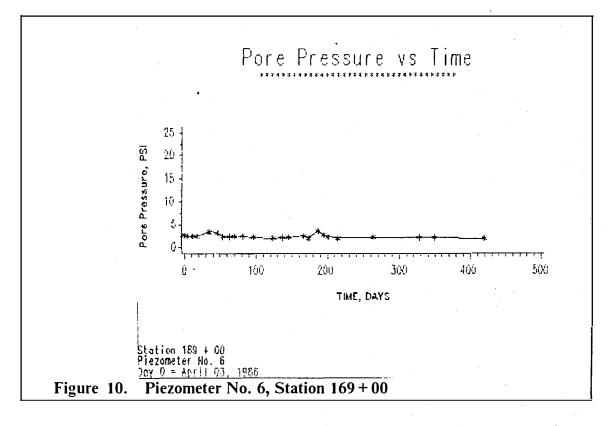
Five of the 7 piezometers that were installed in 1986 to measure the pore water pressure, worked effectively. Piezometers No. 2 and 7, located at Stations 165+00 and 189+00, showed inconsistent data and were abandoned. The pore water pressures of the working instruments were constant throughout construction. No indication of change in the pore water pressure was noted. Even the piezometers located in the high water table (Test Section No. 3), showed no appreciable change. Figures 6 to 11 show graphs of the pore water pressures vs. time for the five working installations. Day zero was when embankment construction began. By day 180, the construction of the embankment was completed. Traffic was allowed on the expressway 867 days (August 22, 1988) after the beginning of data collection.

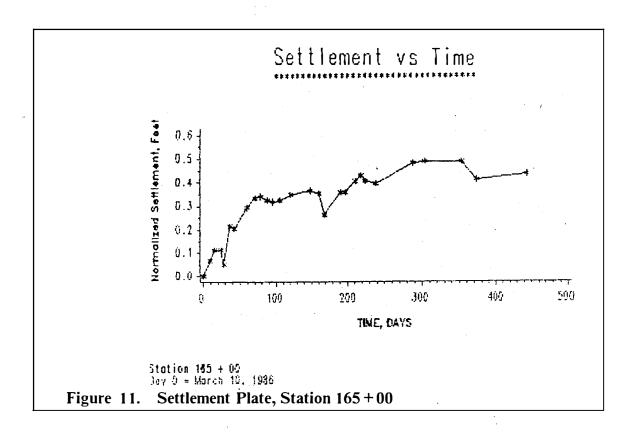
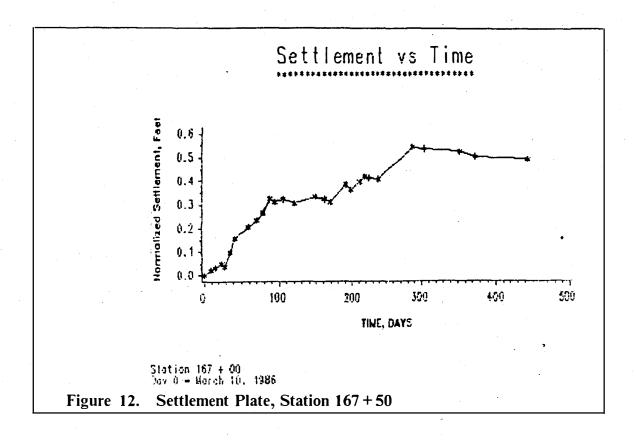
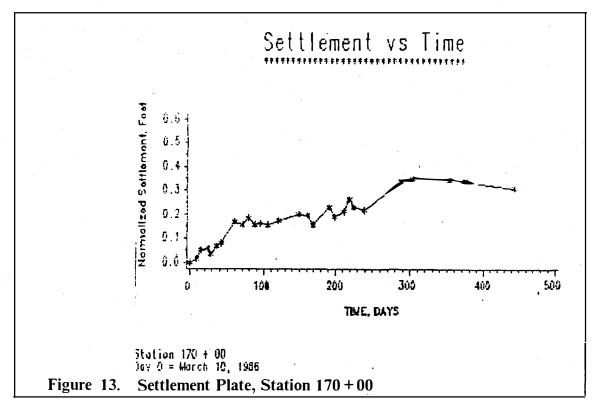
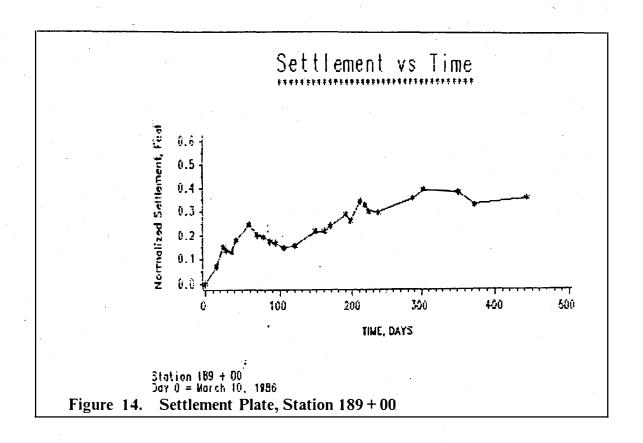
Four of the 5 settlement plates that were installed in 1986 to measure settlement worked effectively. The settlement plate reservoir and tubing at Station 179 + 00 were damaged during embankment construction and were abandoned. The 4 plates that operated correctly, indicated settlement.

Roughly 0.4 to 0.6 tenths of a foot of settlement occurred during and shortly after construction of the fill. On the average, 105 days after the start of embankment construction, the settlement had stopped, although two of the plates indicate continuing creep-like settlement. No appreciable settlement has occurred since that time. By day 180, the embankment was completed. Figures 11 to 14 show graphs of the settlement plate data that was recorded through 1987. Data has been recorded since then, but has shown no further settlement.

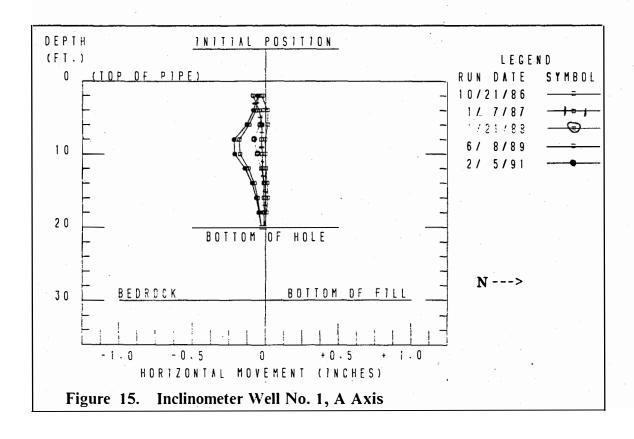
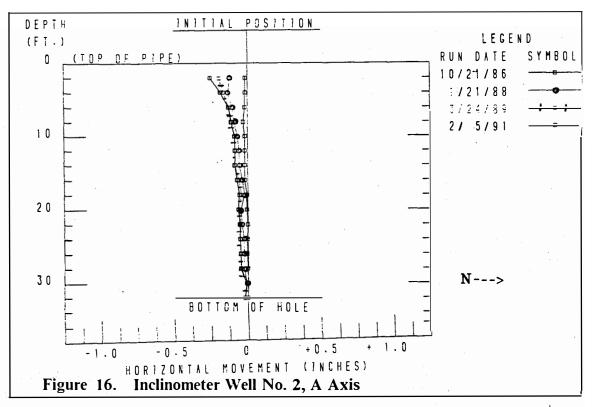
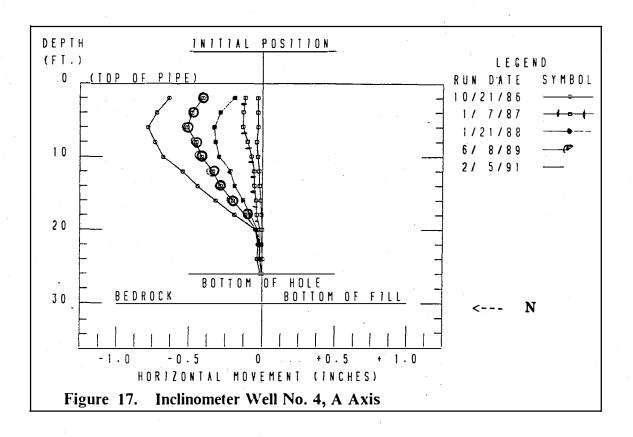
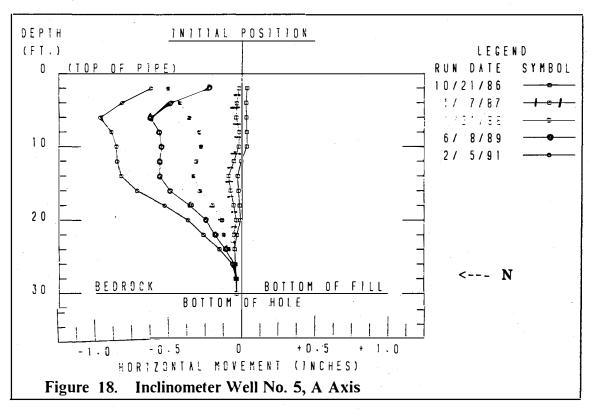
Four of the 5 inclinometer wells worked throughout the investigation. Well No. 3 (Test Section 1) was left inoperable after being crushed by a vehicle. The remaining 4 wells functioned properly. Since the inclinometer wells were installed in 1985, there has been virtually no significant movement. Well No. 2 (Test Section 1) has shown little movement. The inclinometers located in Test Section No. 3 (Wells No. 4, 5 and 1) have shown some slight movement.

Inclinometer wells No. 4 and 5 are located north of the expressway. Consult Figure 1 for the locations of the wells. Inclinometer Well No. 4 has shown a maximum movement of 0.75 inch outward from the embankment. Well No. 5 has had a maximum movement of 1.0 inch outward. This slight movement may be the result of two things. The first being that the water table is higher north of the expressway, averaging 4 feet below the surface. Secondly, the wells are placed at the toe of the embankment, which is the outer limit of the compacted area. The soft, wet, clayey soils adjacent to the 30 foot embankment, appears to be yielding due to the stresses applied by the embankment weight.

Well No. 1, also in Test Section No. 3, is located on the south side of the expressway in an area of compaction. The densification process extended 15 feet beyond the embankment toe. Well No. 1 indicates 0.25 inch of lateral movement outward from the embankment. Figures 15 to 18 show graphs of the inclinometer well data taken from 1986 to 1991.
