KOCH BRIDGE JOINT SYSTEMS

Gary G. Williams, P.E.
Research Project Manager

FINAL REPORT

June, 1993

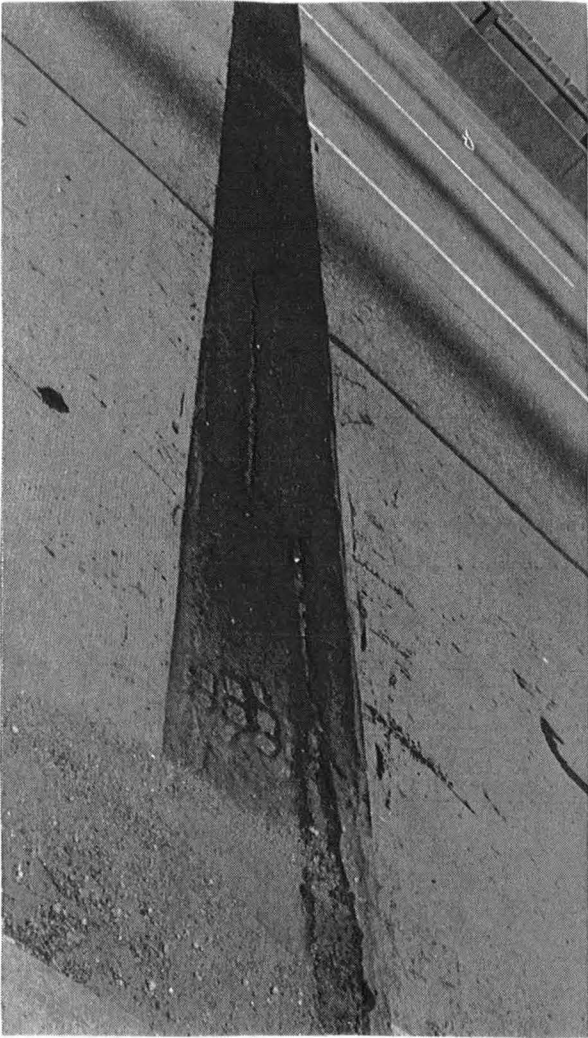
Of the twenty-seven BJS Units, nine (33 percent) had some cracking at the time of this survey (Figures 2 - 4). Crack lengths ranged from half of the bridge width to full width. All of the cracks appeared to be located over the outside edges of the bridge plates. Due to the high ADT in this area, it was not practical to close lanes to test water-tightness of the joints with a water truck. Visual inspection indicated that cracks extended at least down to the bridge plate. The asphaltic plug in the expansion gap is directly below the bridge plate, so there is a possibility that the BJS Units may still have been functioning as water tight seals on the survey date.

Every winter, Oklahoma City has freezing rain, sleet, and other weather conditions which require bridges to be sanded or salted. Some of this material goes into open cracks (Figures 2 - 4). It was thought at the time of the survey that the cracks might close up (at least to some extent) in warmer weather, as thermal expansion of the decks occurs. However, the sand and salt would still be in the crack, and it was expected that they would crack more easily the next winter.

Figure 2. Typical Cracks in BJS Units,
January 9, 1992.

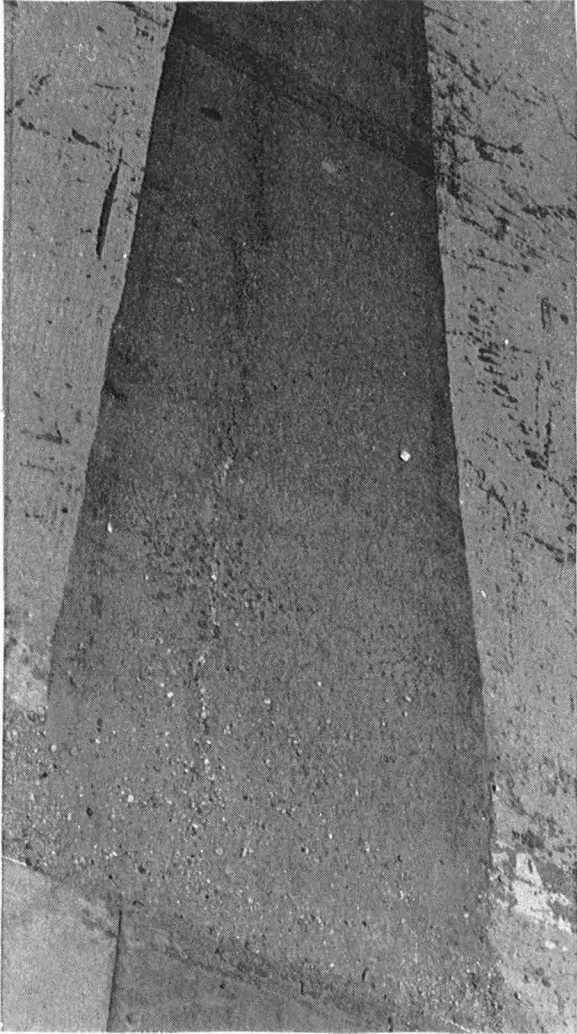
Figure 3. Cracks in BJS Units,
January 9, 1992.

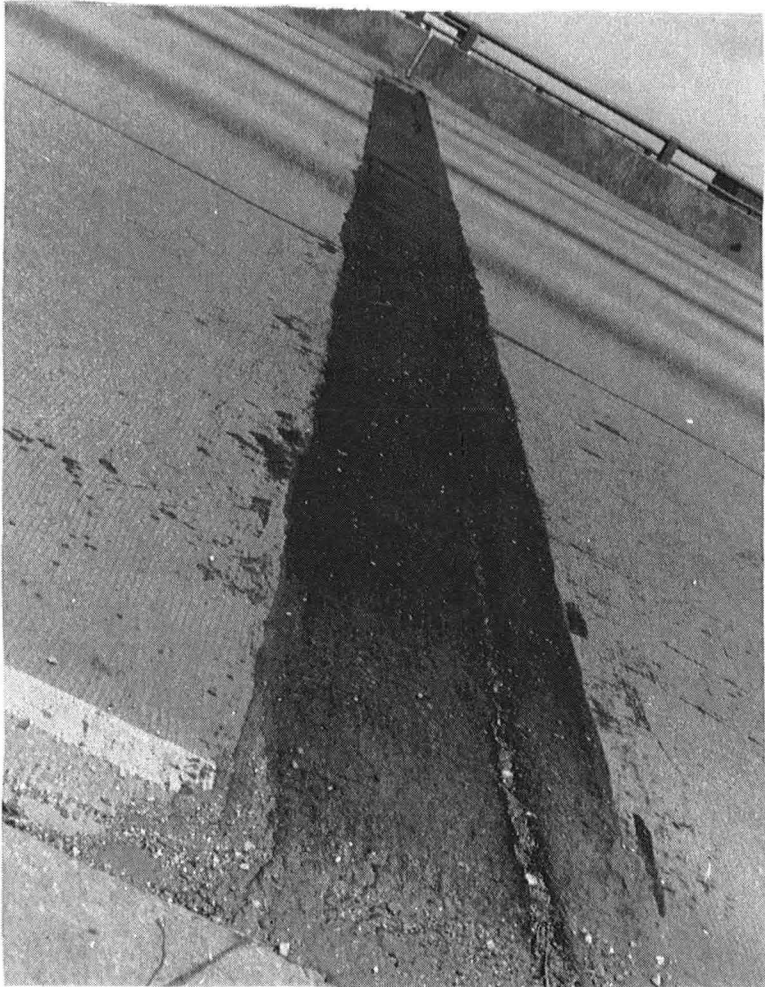
Figure 4. Cracks in BJS Units. January 9, 1992

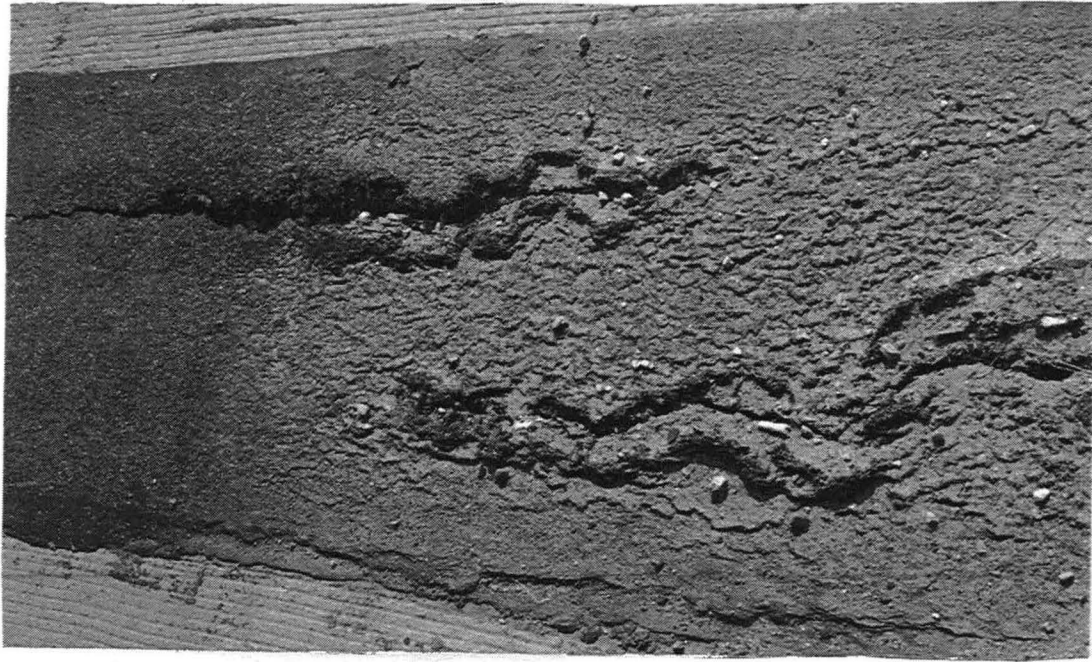
When this survey was done, all but two of the cracks noted during the two previous surveys appeared to have closed. A check with the Oklahoma City Maintenance Branch Manager confirmed that no work had been done on the BJS units, either by ODOT forces or the installation contractor's employees. Temperature at the time of this survey was higher than the previous surveys (Table 4). Because of this, the expansion gaps in the joints were closed relative to the January and April Surveys. The cracks appeared to have "healed". This was probably due to a combination of two actions, the expansion gaps closing and the action of the tires on the BJS units. On some of the units, the previous cracks could be seen as depressed areas (Figure 5). On others, sand, rock, and other foreign material could be seen compressed into the previously cracked area (Figure 6).

**Figure 6. Previously Cracked BJS Unit.
Rock compressed into crack.**

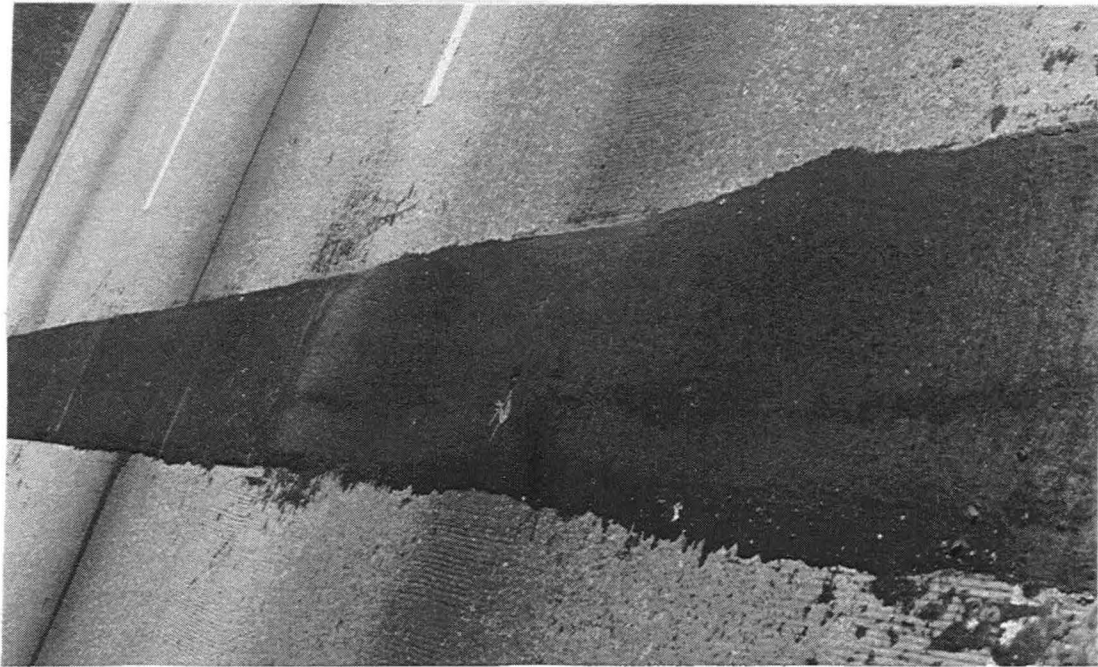
**Figure 5. BJS Unit with "healed" crack
(depressed area).**

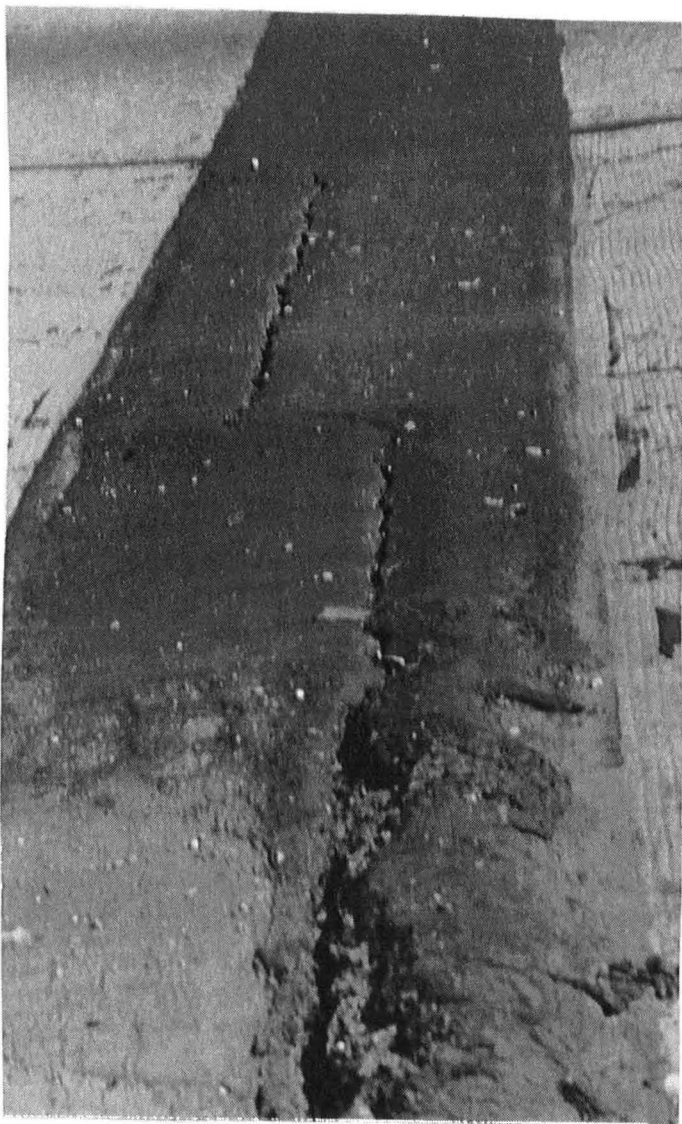
Figure 7. Cracked BJS Unit, 7-10-92.

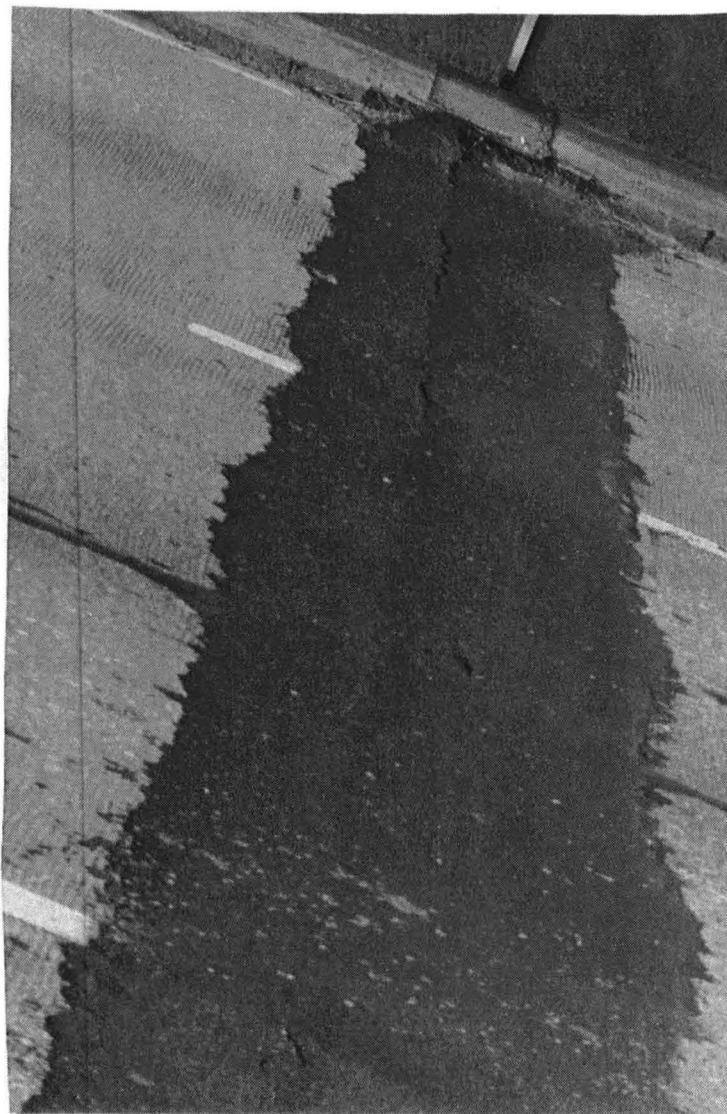
Figure 8. Cracked BJS Unit, 7-10-92.

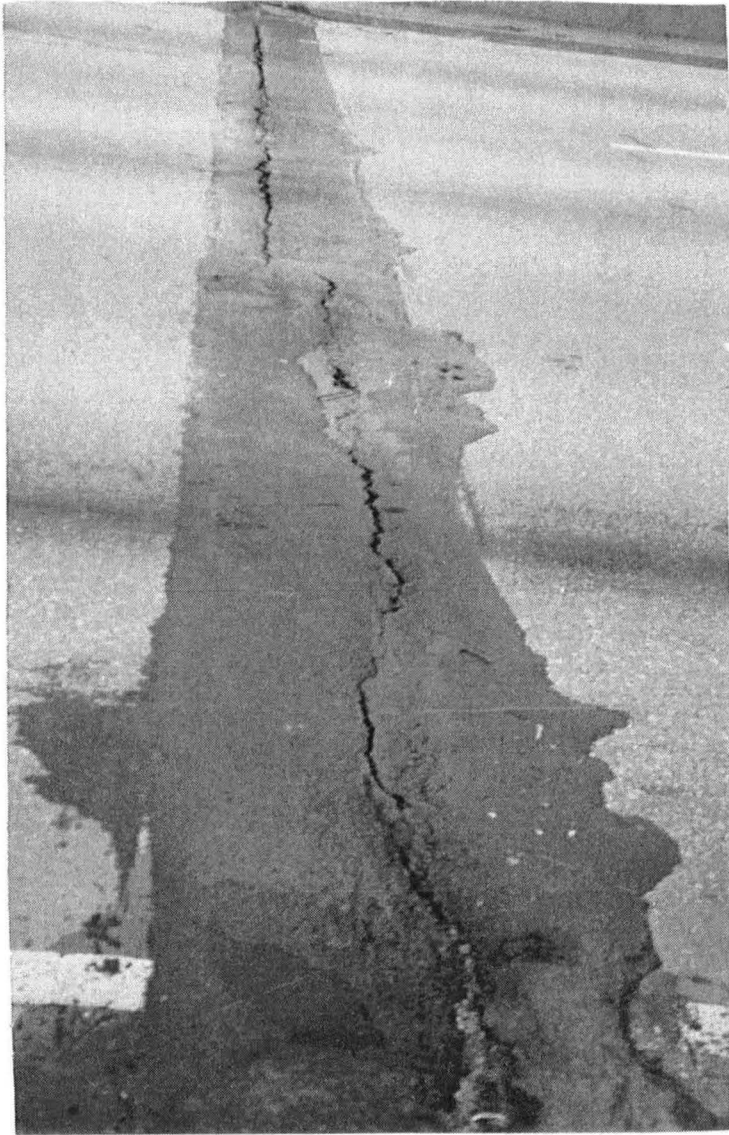
Nineteen of the twenty-seven BJS units (70 percent) were observed to be cracked during the survey. Also, there were two units where the bridge plate was either missing or moved out of position for part of the joint length, resulting in a joint without anything in that part of it (Figure 13). The other 17 cracked joints might (possibly) still be functioning as water-tight joints, but these have definitely failed. Cracking appears to be more severe than in previous surveys. Also, chunks of the KOCH Modified Asphalt Concrete making up the units have spalled along the cracks (Figures 10 and 11). Some spalls were also observed on the outside edges of the units (Figure 12).

Figure 9. Typical cracked BJS Unit, March 4, 1993

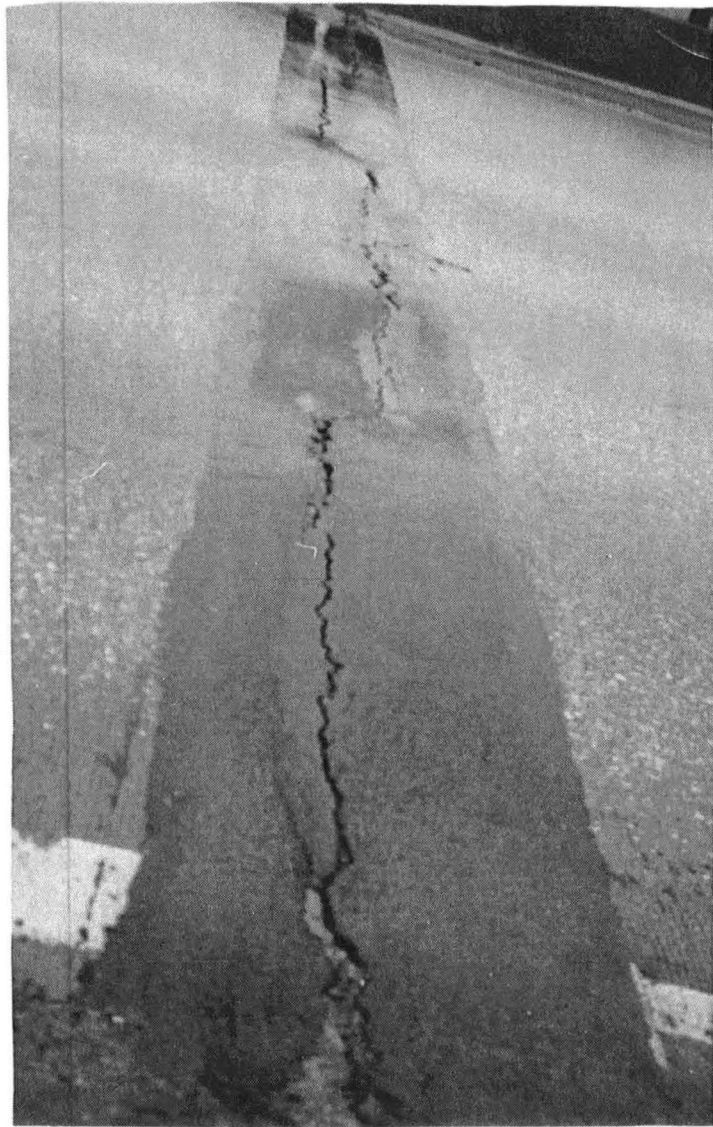
Figure 10. Typical cracked BJS Unit, March 4, 1993

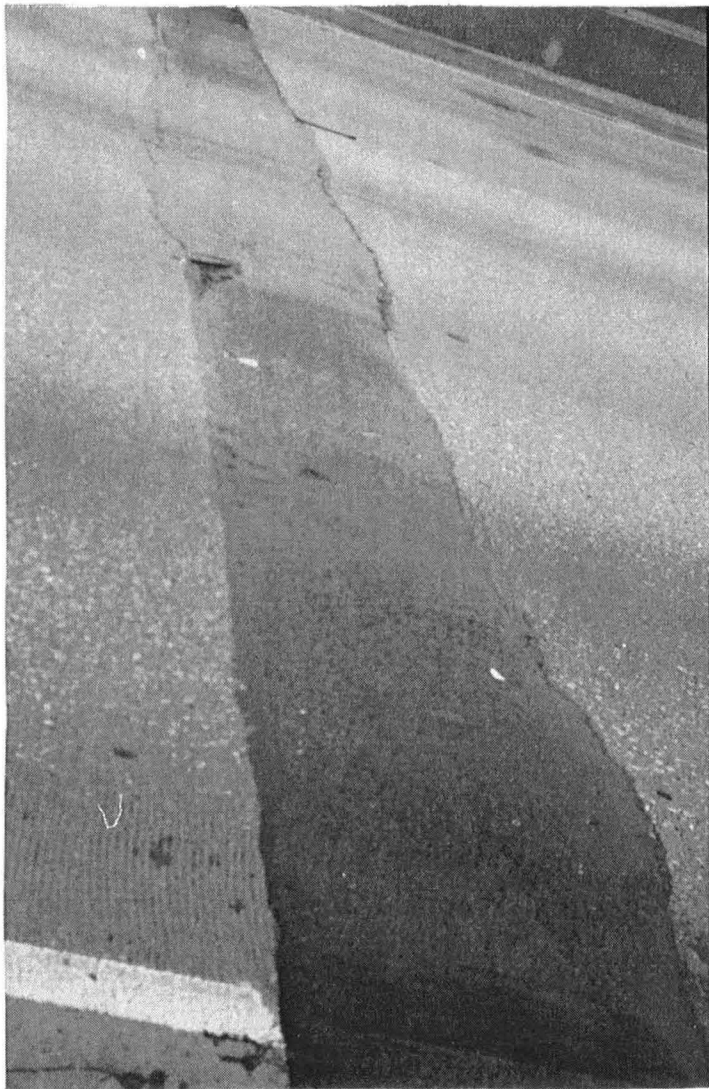
Figure 11. Spalling at edge of BJS Unit,
March 4, 1993

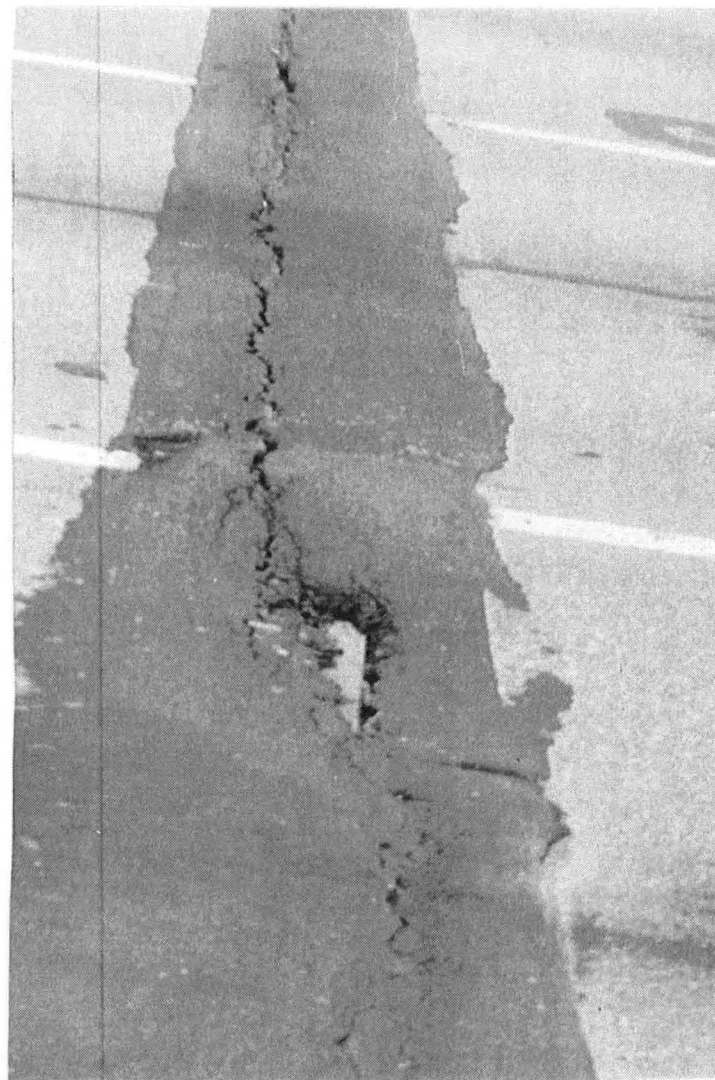
Figure 12. Spalls at Edge of Unit and Along
Crack, March 4, 1993

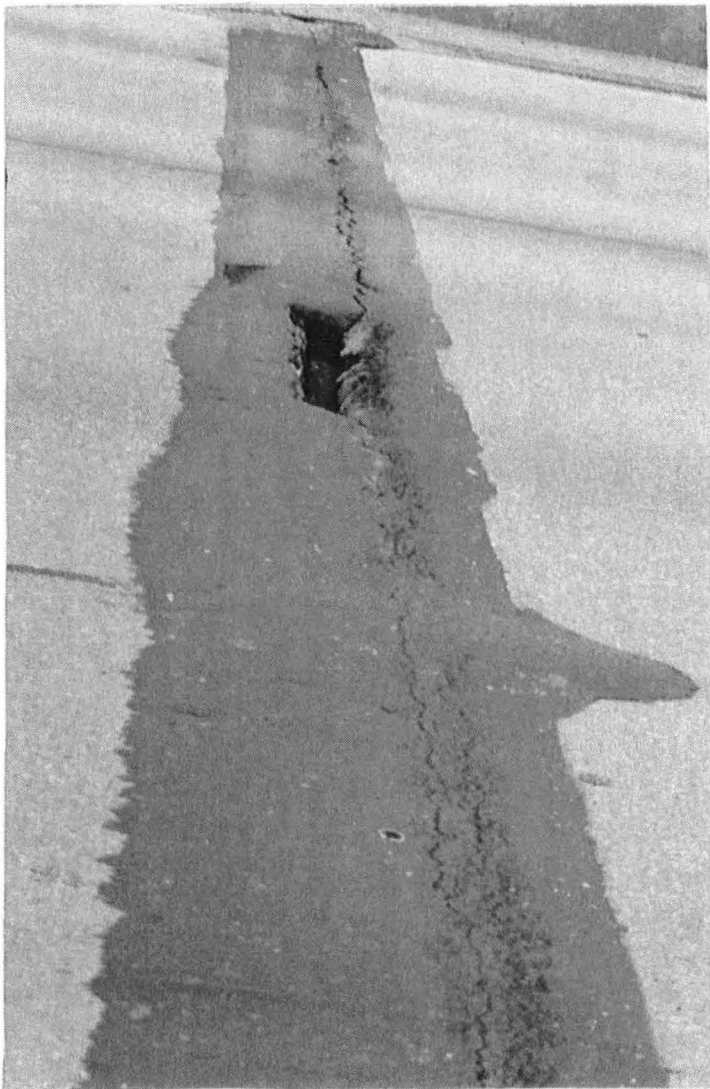
**Figure 13. Hole through BJS, Part of Bridge
Plate Missing, March 4, 1993.**

Installation of the BJS Units was completed in August, 1991. The units are still in the two-year warranty period. It may be worthwhile to have them replaced or repaired under warranty. In a high ADT area such as this, user costs associated with repairs would also be high. This may indicate using another type of sealing system, with a longer demonstrated life, if the units are replaced.
