**FIELD PERFORMANCE  
EVALUATION  
OF  
SELF-LEVELLING SEALANTS  
DOW CORNING 888-SL AND 890-SL**

Gary G. Williams, P.E.  
Research Project Manager

Research & Development Division  
200 N.E. 21st Street, Room 2A2  
Oklahoma City, Oklahoma 73105

April, 1995

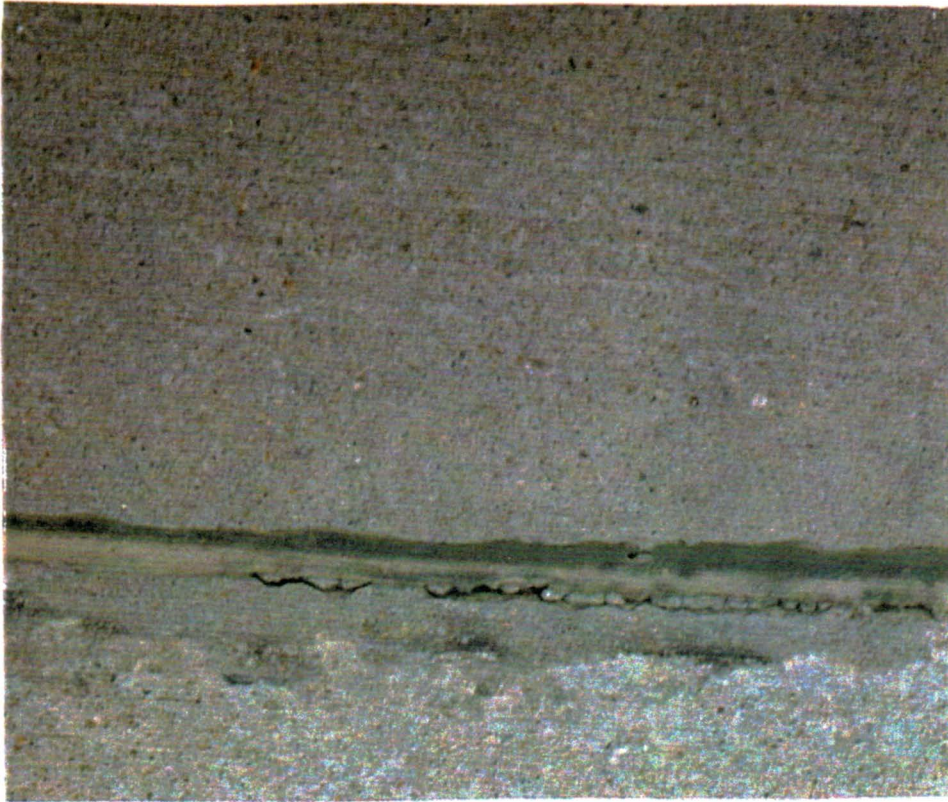
The formation of small cracks, with spalls along the sawed joints (Figure 8), was a common condition on this project. The cracks extended below the sealant, causing the joints to be unsealed where this occurred. The sealant was generally in good condition and adhering to the concrete in these cases.

**Figure 8. Crack next to Joint, Leaving an Unsealed Joint with no Sealant Failure.**

8. All projects in the study had numerous areas where small cracks formed parallel to joints or where small amounts of concrete spalled off of the edge of the saw cut. Where these conditions occurred, their effect was the same as that of sealant failure.

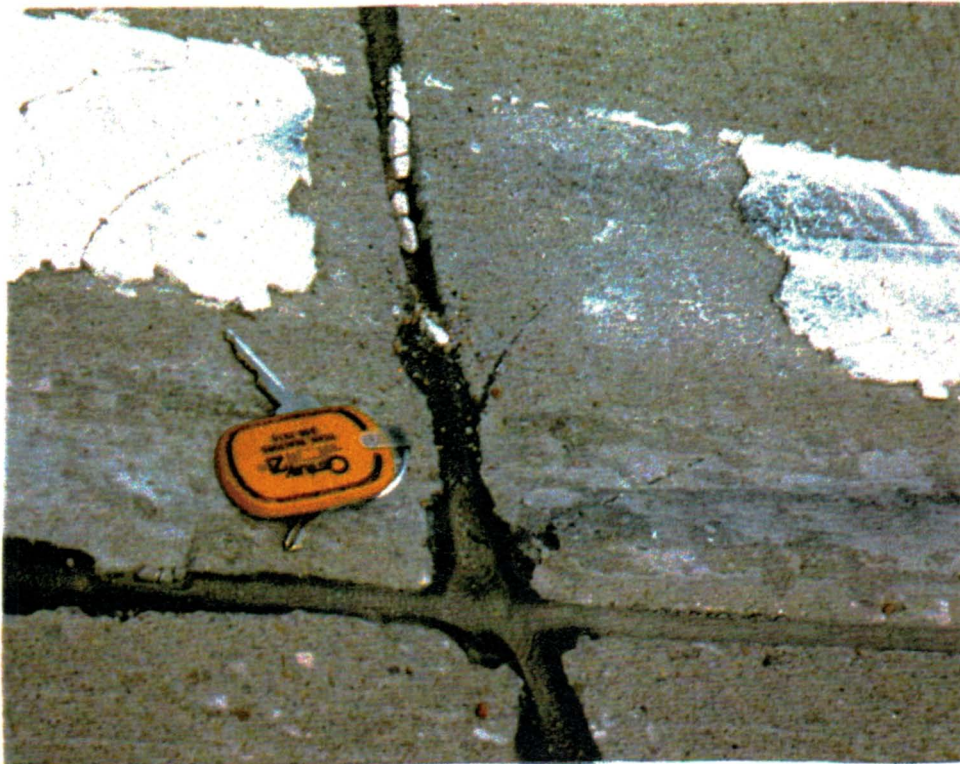
At the time of the final survey on this project (June 3, 1994), this section had seven adhesion failures (no other types of failure observed). Lengths of failures ranged from one inch to six inches. Four of these had failed on both sides of the sealant. This allowed the sealant to drop down into the joint in the failed area (Figure 13). All of the failures in this section were in locations where thermoplastic striping crossed a sealed joint (Figure 14). The failures were first observed when the sealant had been in service three and one half years.

Figure 13. Sealant Dropped into Joint Due to Adhesion Failure on Both Sides.

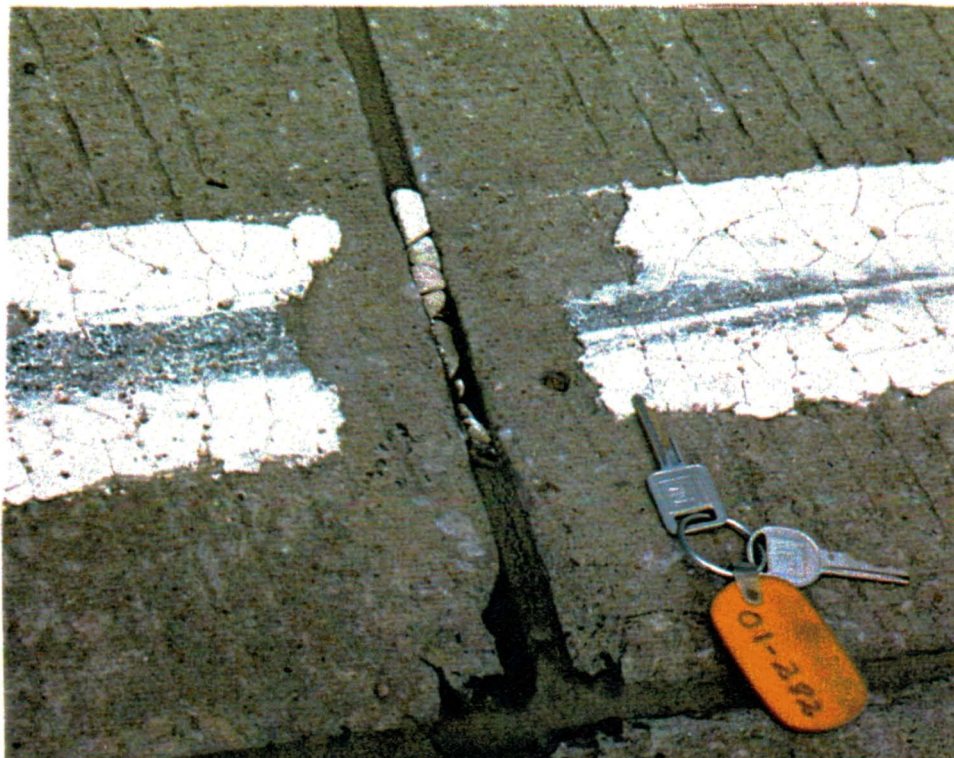
Figure 14. Adhesion Failure Where Thermoplastic Striping Crosses Joint Sealed with 890-SL.

1. On Project MAF-521(035), numerous failures occurred where Thermoplastic traffic striping crossed joints sealed with 890-SL. This was most common, and the effects most severe, where the outside edge stripe crossed transverse joints.

It may be possible to reduce the number of failures of the type involving thermoplastic striping. This could possibly be done by temporarily covering the part of the joint that will be crossed during striping with some type of fabric cover material. Another possibility would be scheduling striping to be done before joint sealing. Further research would be required to determine the effectiveness of actions of this type, and what effect they might have on construction operations.

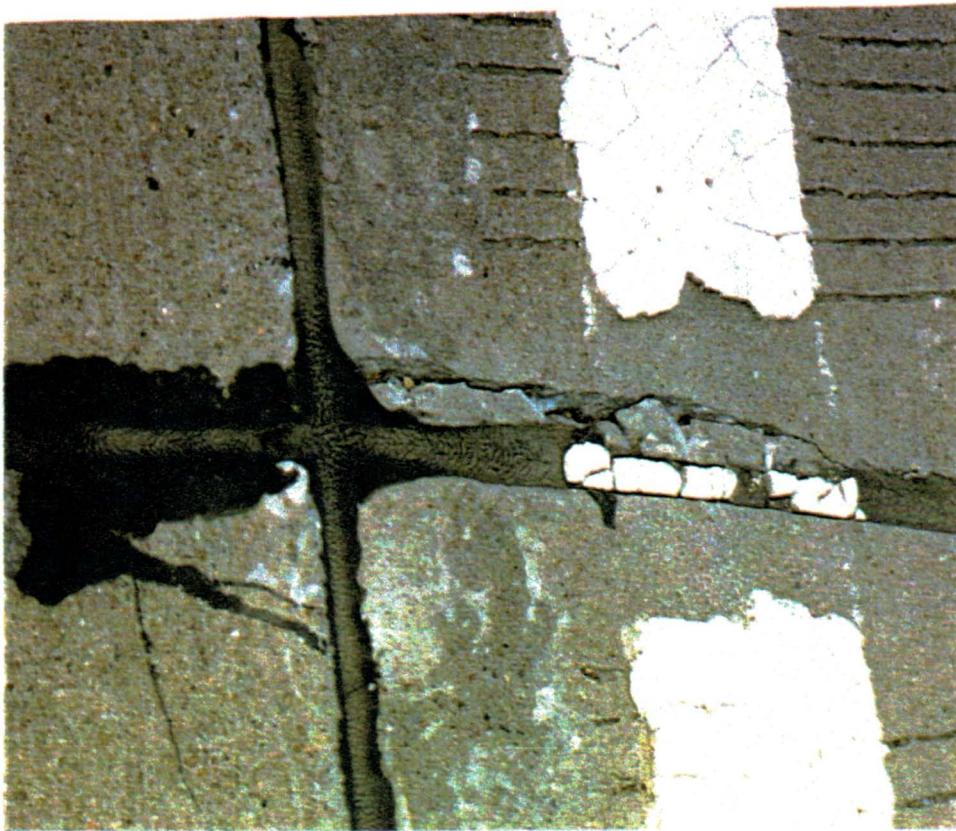
Eleven failures had occurred in this section by the time of the final survey. Five of these were cohesion failures, appearing as 3/8 inch (0.9525 cm) diameter holes through the sealant). All of the failures of this type occurred at the intersection of transverse joints and longitudinal edge line joint. One failure was a three-inch-long cohesion failure that had the appearance of a split in the sealant. The other three were adhesion failures occurring where thermoplastic striping crossed joints (Figure 15).

**Figure 15. Adhesion Failure Where Thermoplastic Striping Crosses Joint Sealed with Accepted Sealant.**

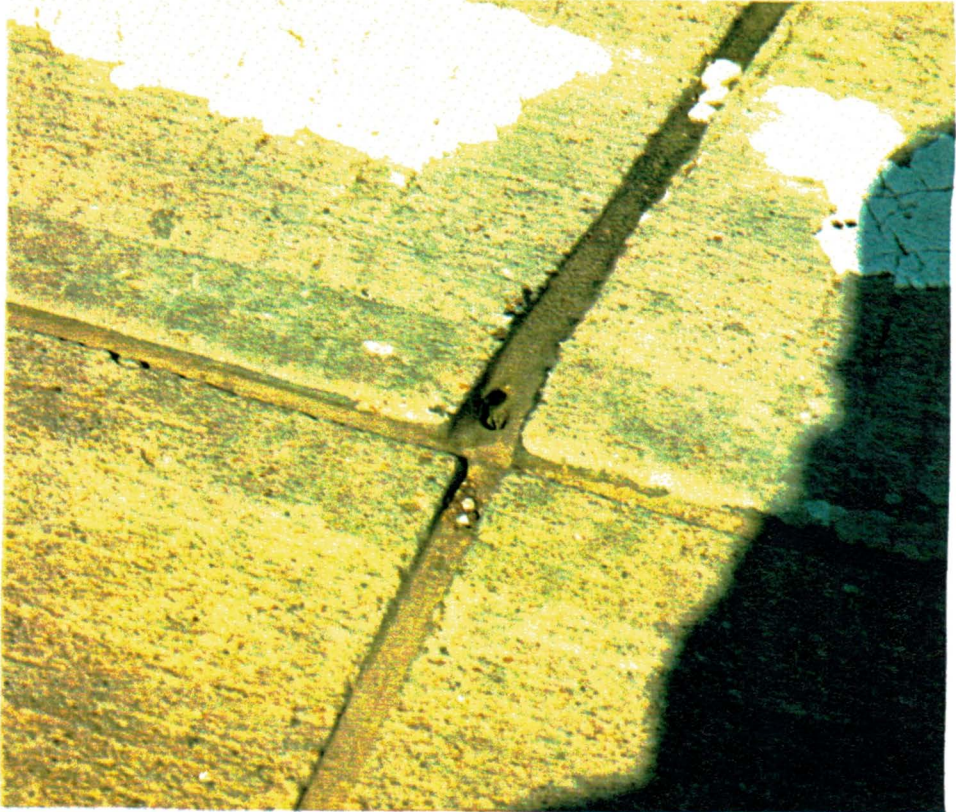
**Figure 16. Cohesion Failure Appearing as "Hole" in Sealant.**

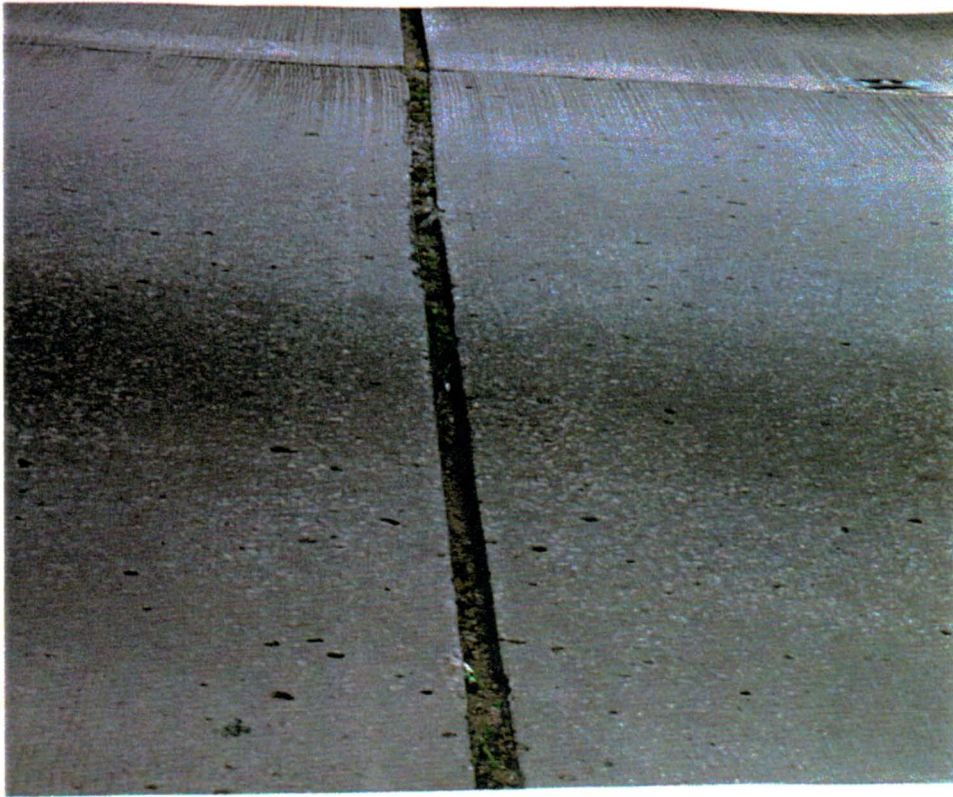
The joint between the bridge and the adjacent approach slab was sealed with hot pour sealant as in Sections 1, 2, and 3. The result was also similar. Only small traces of hot pour sealant remain in the joint. The other two-inch-wide joints, sealed with 890-SL, have adhesion failures in the wheel paths and show "polishing" where the sealant has been pushed up above the roadway surface when thermal expansion closes the joints (Figure 23). There were no failures in the 300-foot CRCP Section.

**Figure 18. Expansion Joint Formerly Sealed With Hot Pour Sealant.**

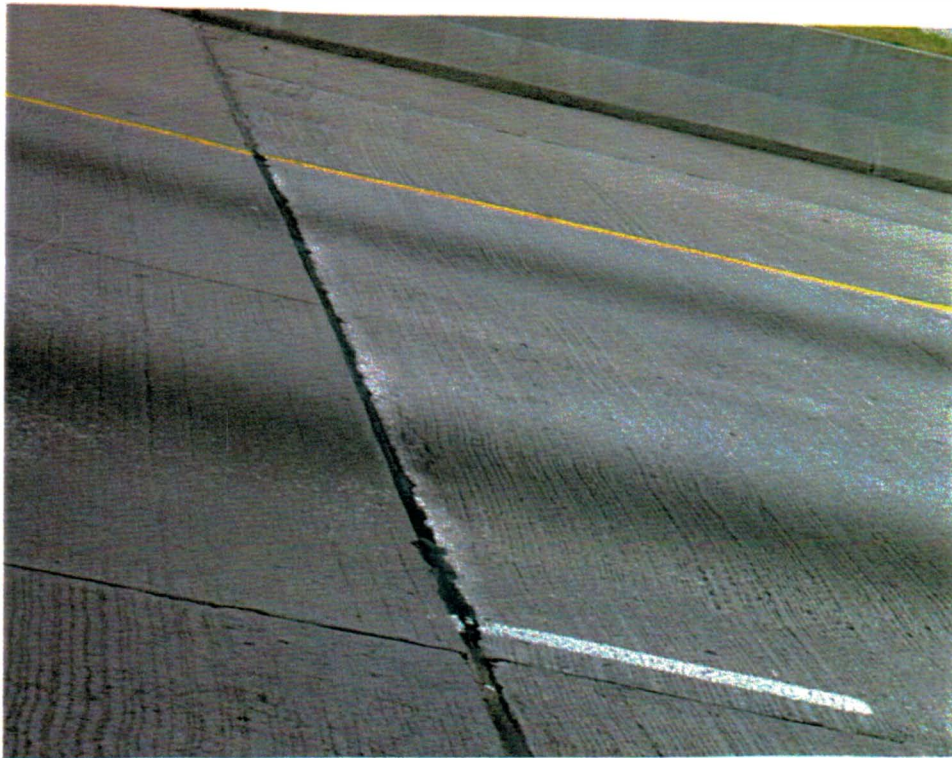
**Figure 19. Expansion Joint Sealed with Self-Levelling Sealant.**

Where self-levelling sealants were used to seal 1 1/2 inch (3.81 cm) wide expansion joints on Project MAF-521(075), they were considerably more successful than the hot pour sealant that they replaced.

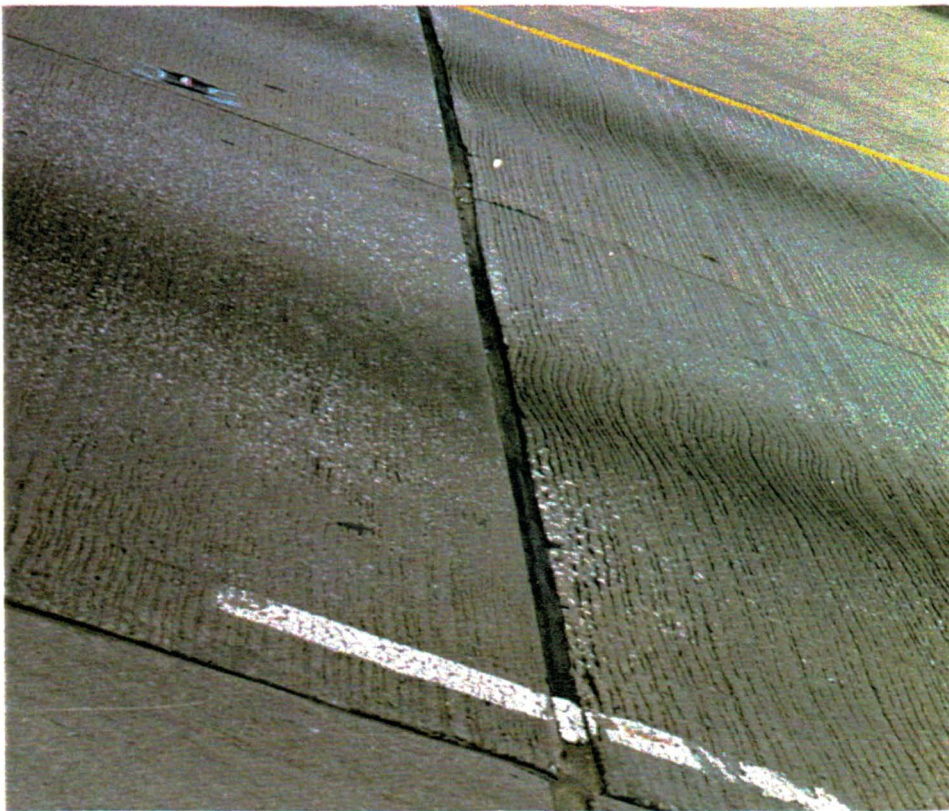
**Figure 20. Expansion Joint Sealed with 890-SL with Adhesion Failures in Wheel Paths.**

10. The self-levelling sealants used to reseal the 1 1/2 inch (3.81 cm) expansion joints on Project MAF-521(075) were installed so that the top of the sealant was 1/2 inch below the roadway surface. This recess distance appears to be inadequate, since sealant "polishing" in the wheel paths indicates that the sealant is being forced above the roadway surface during joint closure from thermal expansion of the deck. Installing sealant during hot weather, when joints are in a relatively closed position, would be another possibility for preventing this.
11. Results of this Field Performance Evaluation indicate that both 888-SL and 890-SL should be accepted for use on ODOT Projects.

1. Both self-levelling sealants (888-SL and 890-SL) should be accepted for use on ODOT projects.
2. Where joints are to be resealed with self-levelling sealants the old sealant should be completely removed and joints thoroughly cleaned.
3. Further research should be done on protecting self-levelling sealants from damage where thermoplastic traffic striping is applied over the sealant.
4. Where self-levelling sealants are used to seal 1 1/2 inch (3.81 cm) wide expansion joints, the distance the sealant is recessed below the roadway surface should be increased (beyond the 1/2 inch (1.27 cm) distance now used).

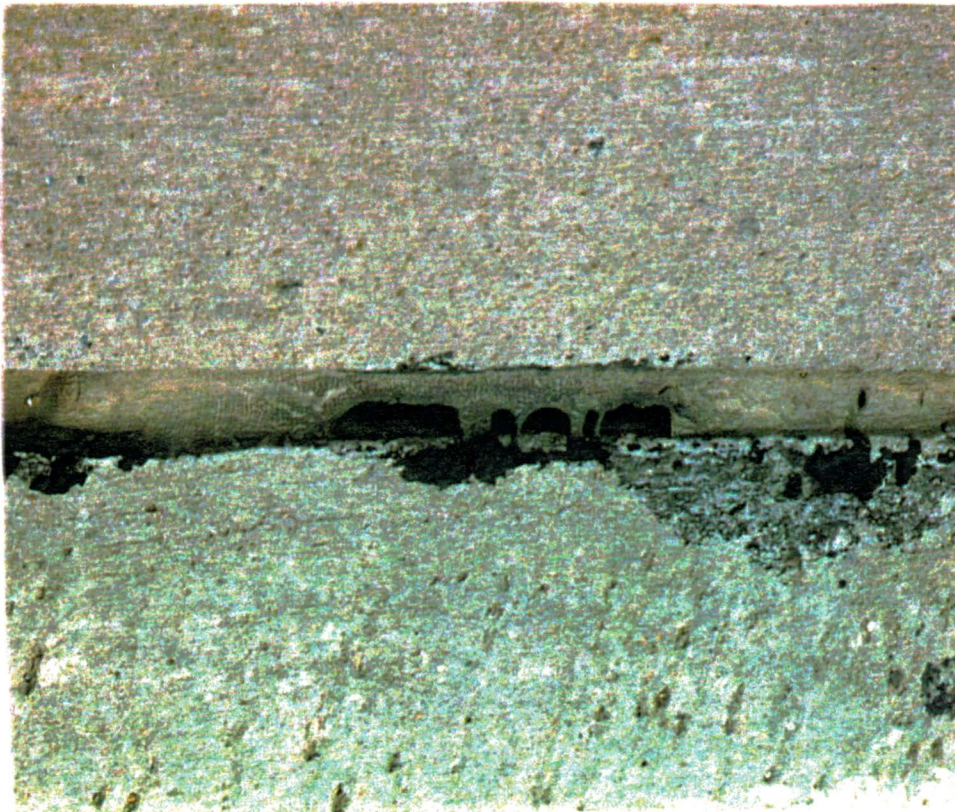
This test section had two failures in the sealed edge joint, and five in the two sealed terminal joints at the ends of the 51st Street overpass. The failures in the edge joint were cohesion failures consisting of series of connected "holes" (Figure 21). The sealant on both sides of these failures was intact and adhering to the pavement. The hot pour sealant originally used in the 1 1/2 inch joint between the bridge deck and the first slab had completely failed. Only small traces of it could be found in the joint (Figure 18). The next 1 1/2 inch wide joint was sealed with 890-SL. That seal was in good condition (Figure 19). South of this, there is another 30 foot long approach slab and another 1 1/2 inch wide joint, sealed with 890-SL. This joint has one six inch long adhesion failure at the outside edge line stripe.

**Figure 21. Cohesion Failures in Edge Line Joint.**

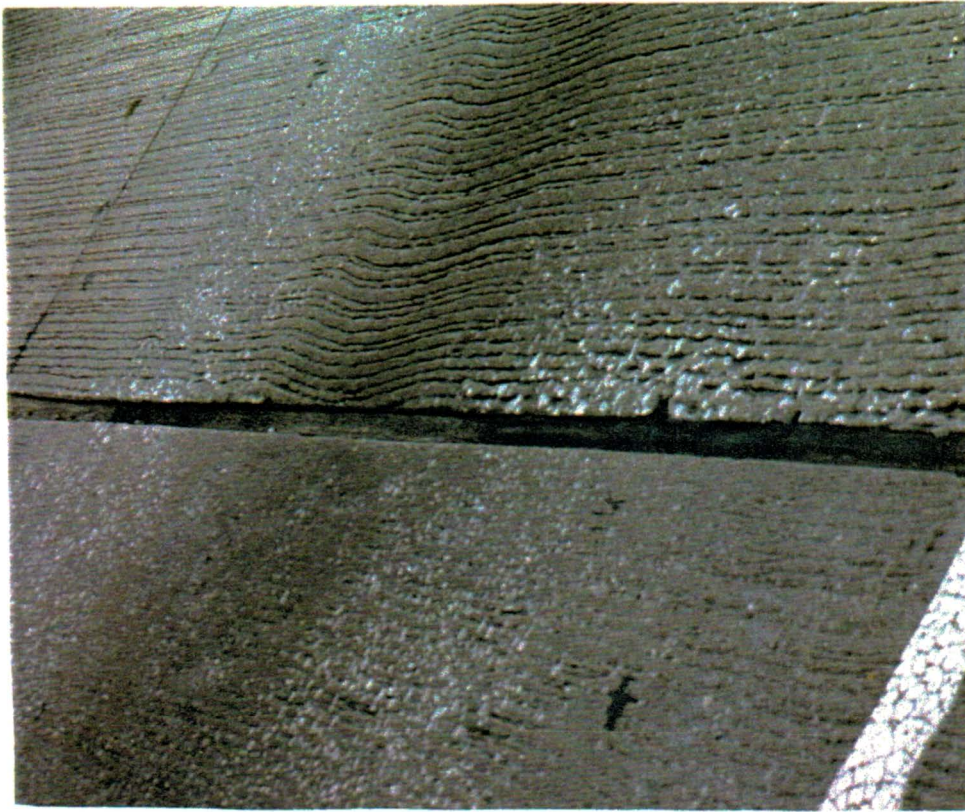
**Figure 22. Adhesion Failures Occurring Where Wheels Contact Sealant.**

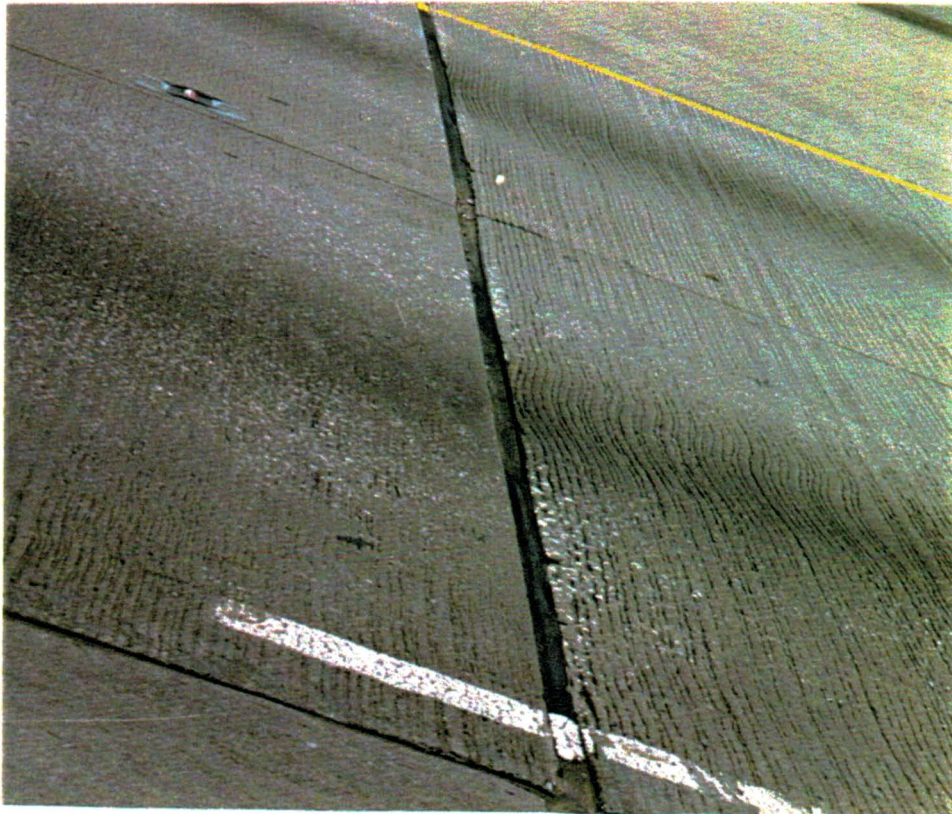
**Figure 23. "Polished" Sealant in Wheel Path.**

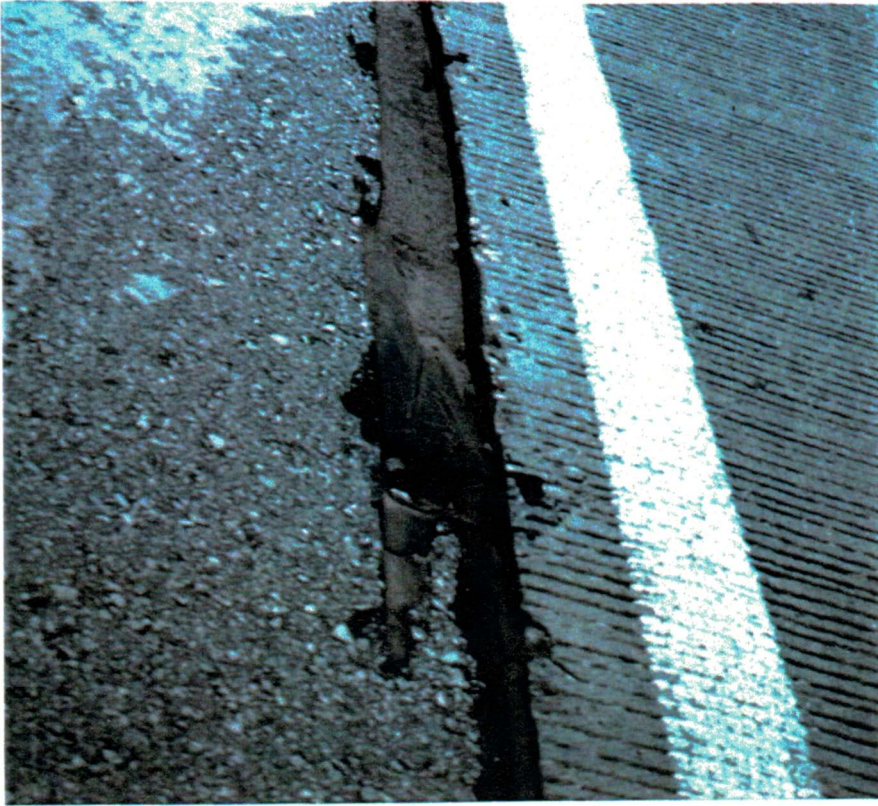
**Figure 26. Sawed Joint Between PCC Roadway and AC Shoulder.**

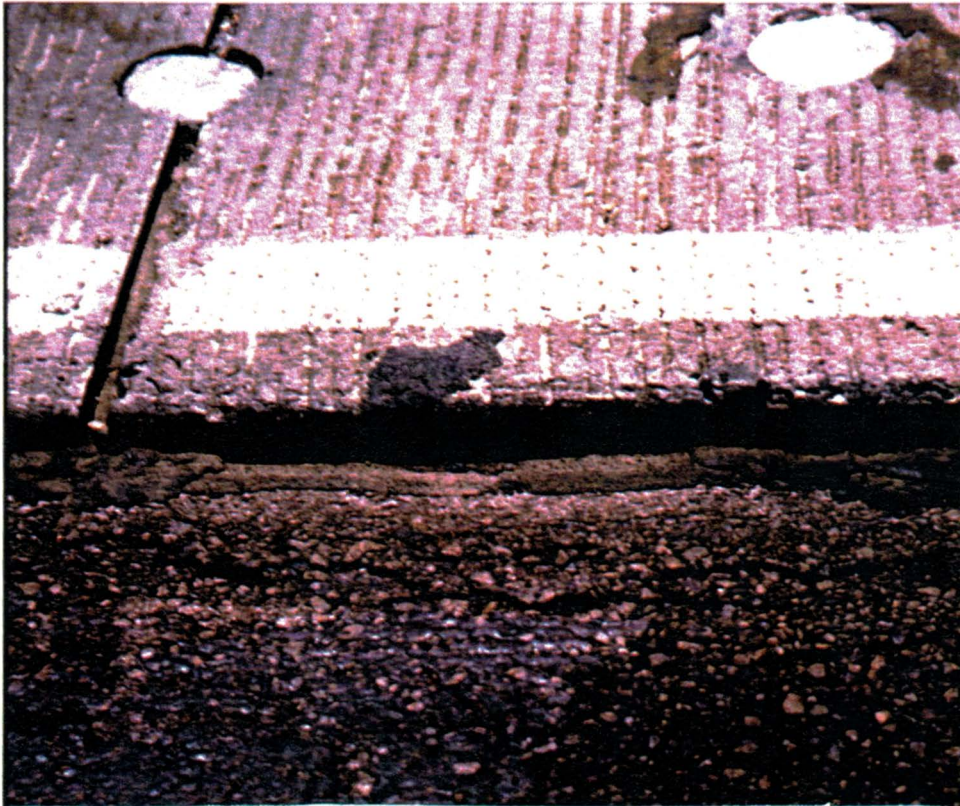
**Figure 27. Difference in Elevation Between PCC Roadway and AC Shoulder.**

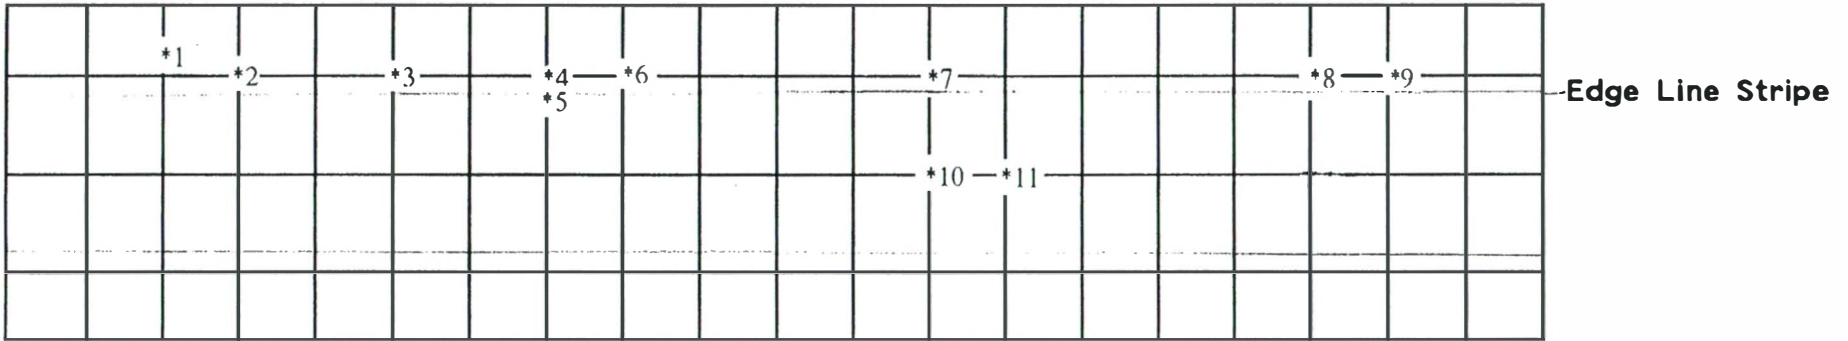
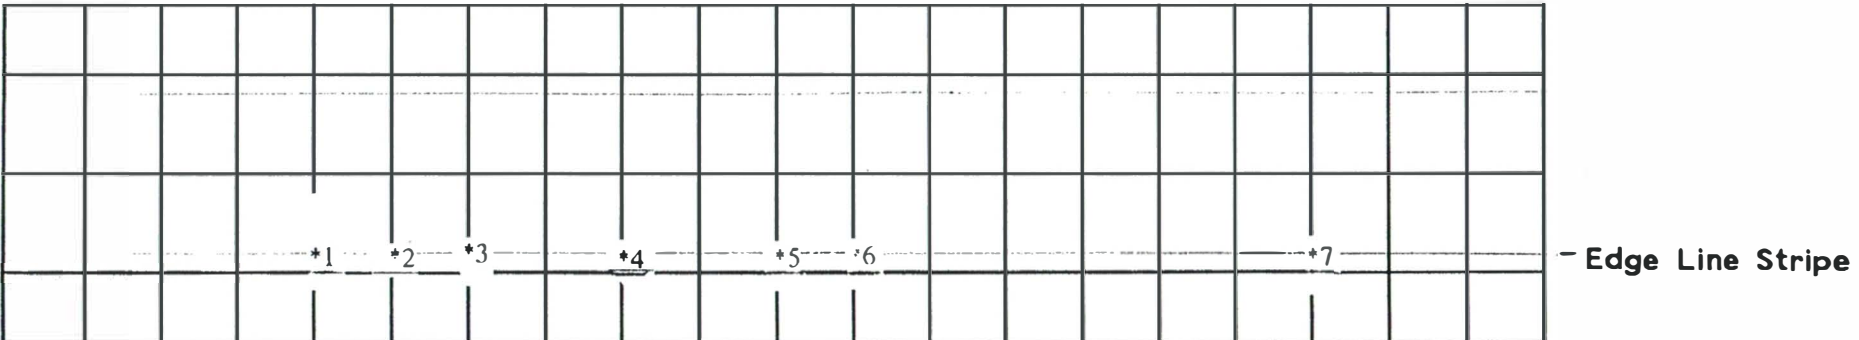
Test Section 1.

NUMBER	DESCRIPTION
1.	Four inch long adhesion failure. Located where thermoplastic edge line striping crosses transverse joint.
2.	Three inch long adhesion failure. Located where thermoplastic edge line striping crosses transverse joint.

3.	Three inch long adhesion failure. Located where thermoplastic edge line striping crosses transverse joint. the joint (1/2 inch).
4.	Five inch long adhesion failure. Located where thermoplastic edge line striping crosses transverse joint. Sealant is not attached to the joint on either side and has dropped (sagged) one inch below the surface.

5.	Four inch long adhesion failure. Located where thermoplastic edge line striping crosses transverse joint.
6.	Five inch long adhesion failure. Located where thermoplastic edge line striping crosses transverse joint. Sealant has sagged 1 inch below the surface as described in No. 4.
