Final Report O.R.A. 157-622

# EFFECTIVENESS OF RIVERBANK PROTECTION AND RIVER CONTROL IN OKLAHOMA

By  
Jimmy F. Harp, PhD  
Professor  
and  
Mathew Thomas  
Research Assistant

August 15, 1989

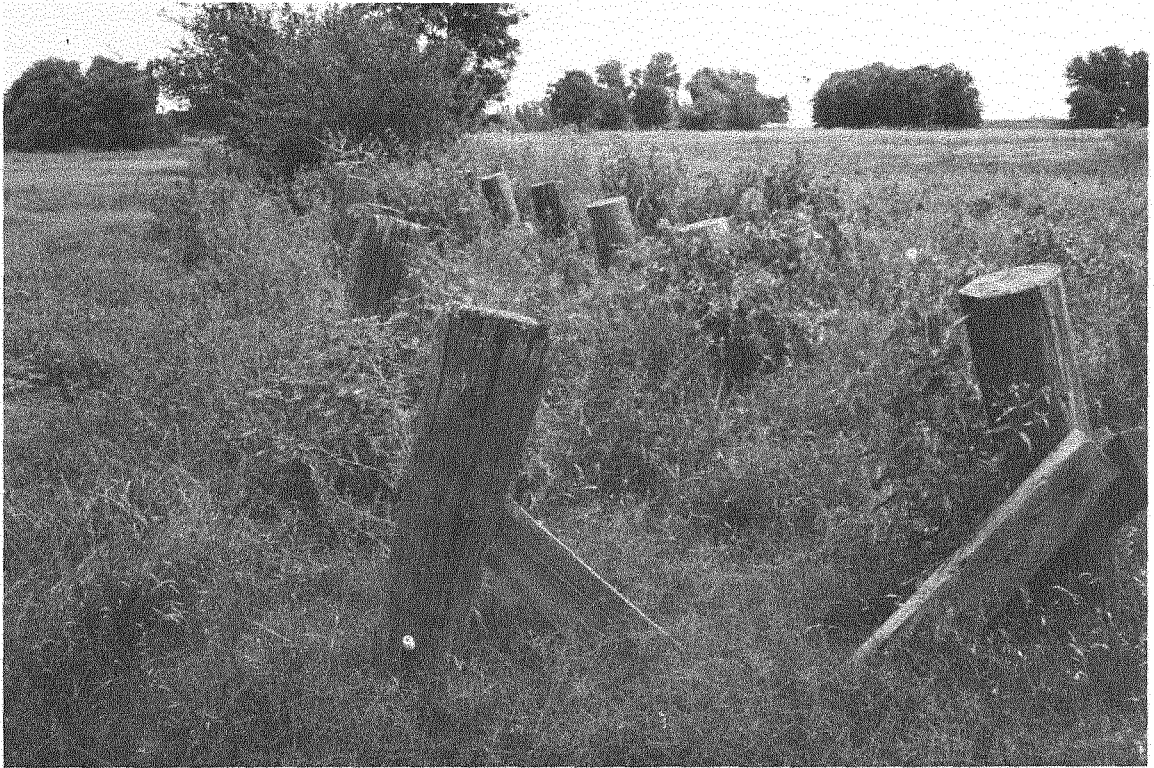
VIEW OF DAMAGED PILE DIVERSION  
FIGURE 31c

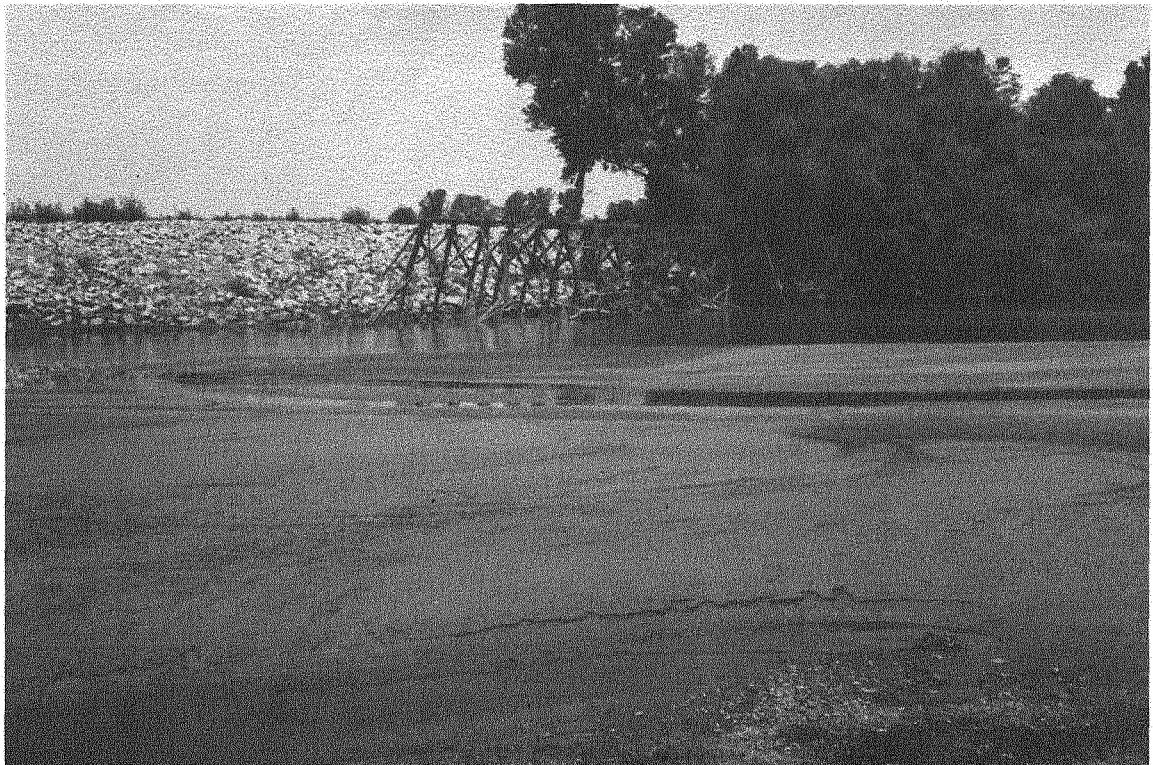
FIGURE 31d

RIPRAP AND PILE DIVERSION ON WESTERN BANK

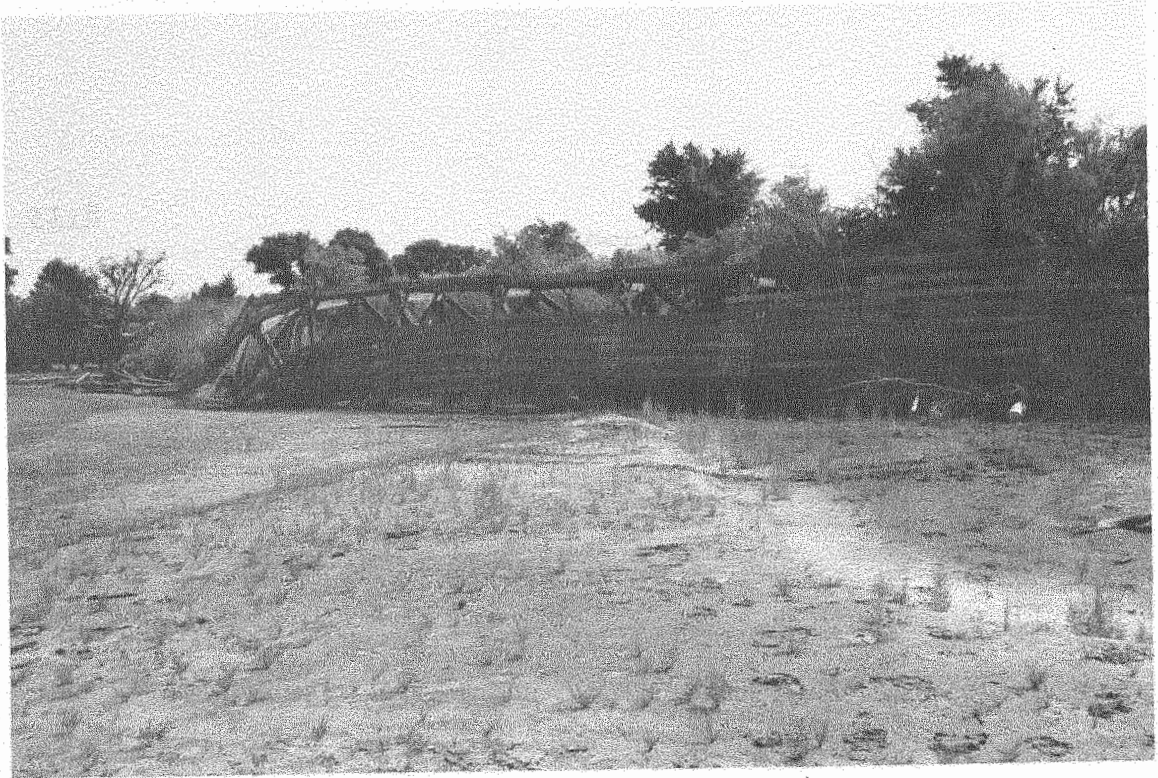
FIGURE 37c

Pile Diversion with Missing Face Planks

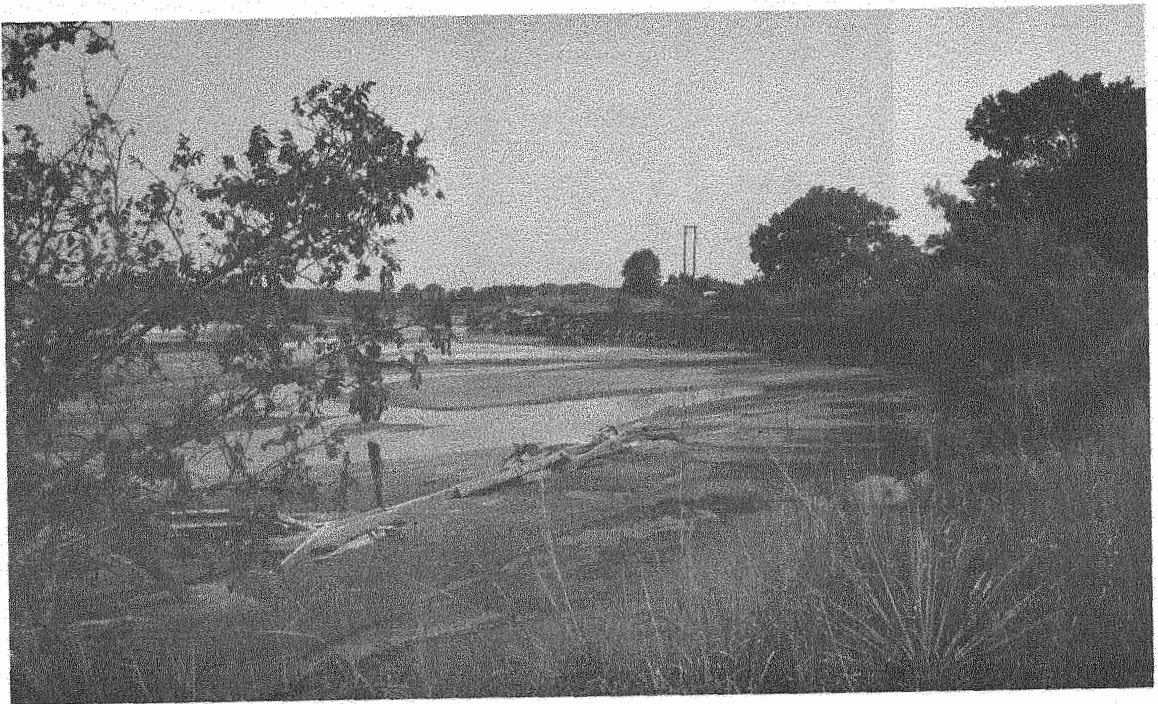
FIGURE 37d

Another View of Damaged Pile Diversions

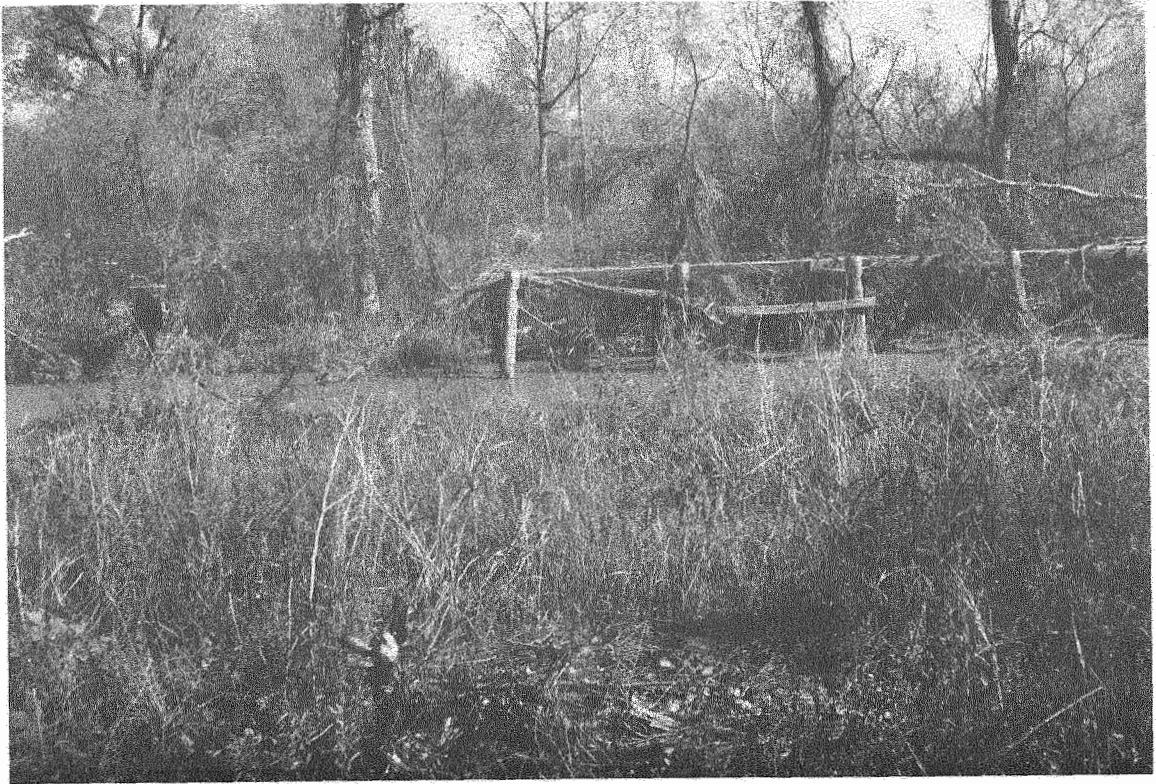
FIGURE 43a

Pile Diversion standing in a Scour Pool

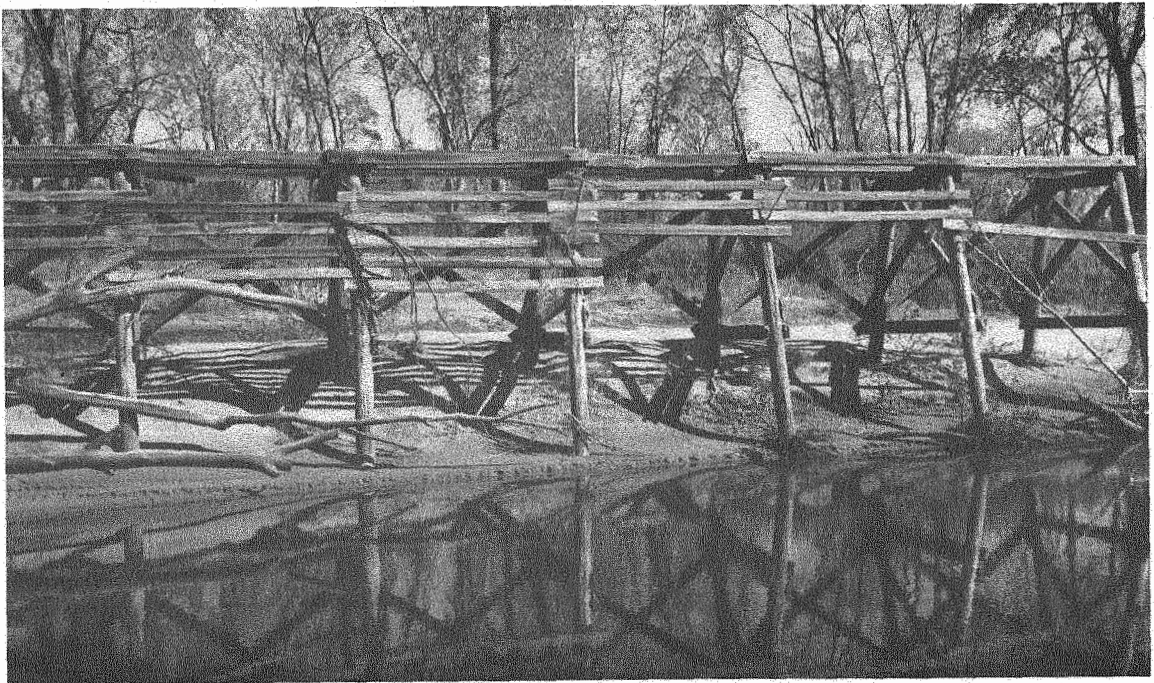
FIGURE 43b

Pile Diversion with Missing Surface Planks

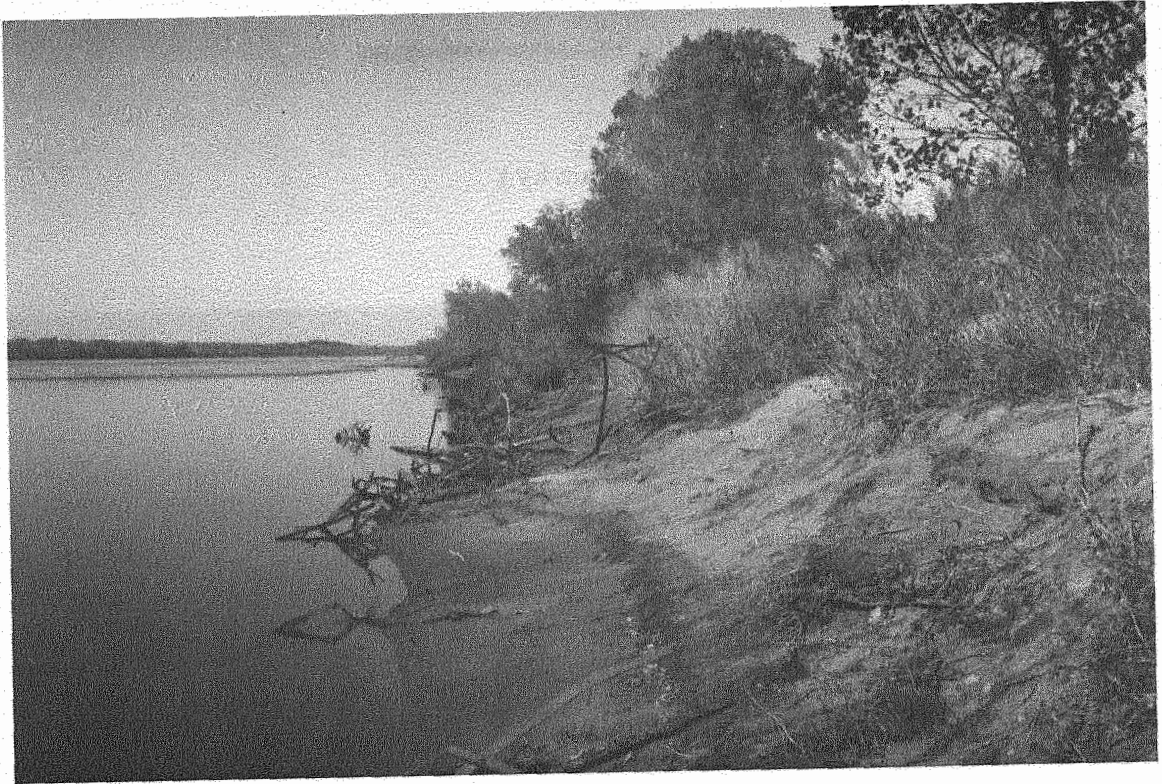
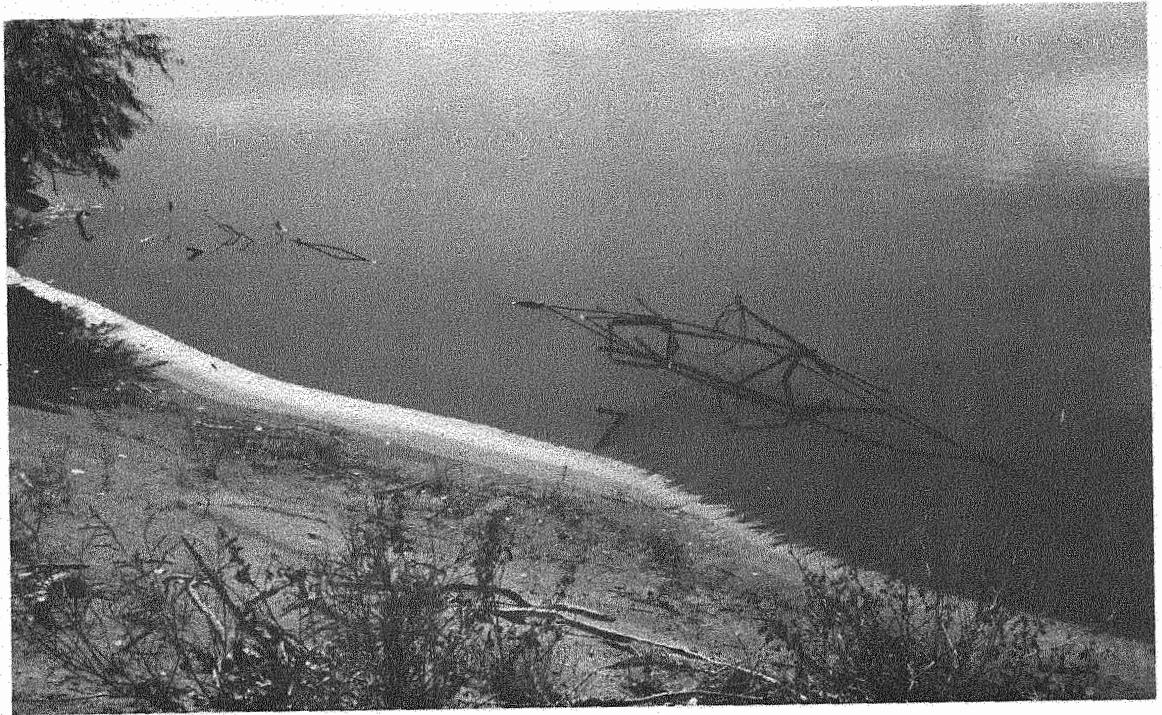
FIGURE 43c

Damaged jetty fields

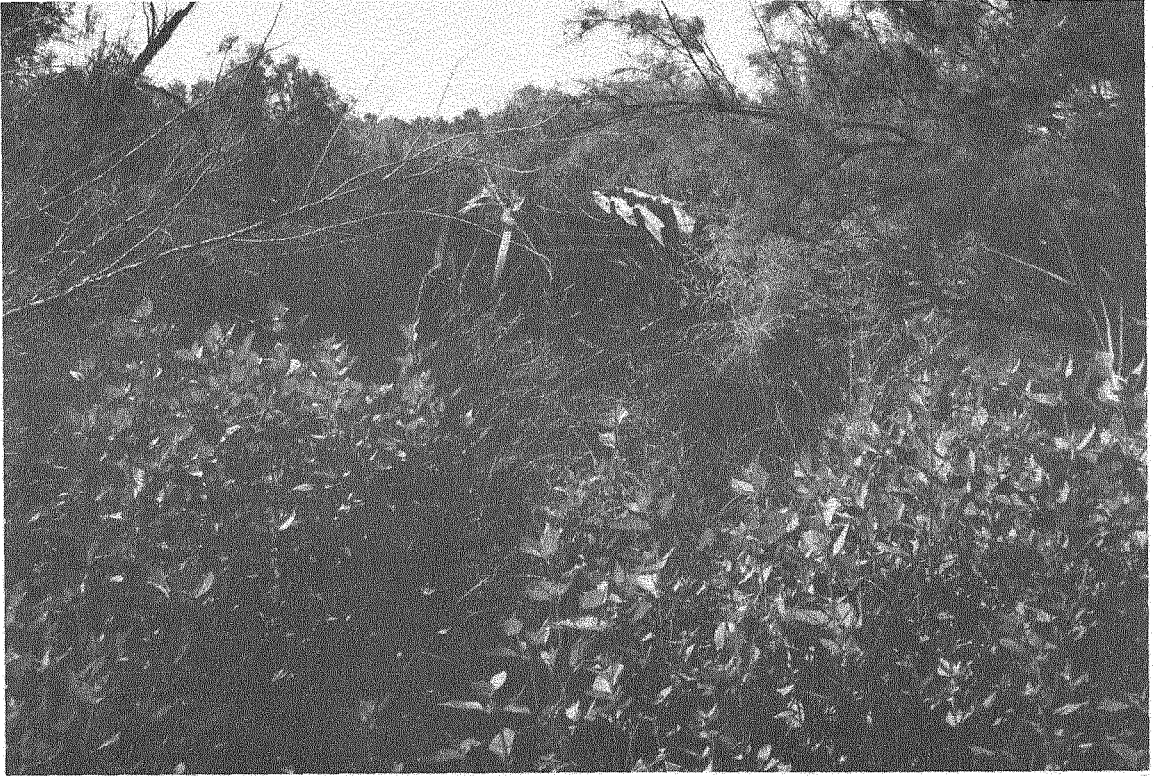
FIGURE 52a

Overgrown Damaged Pile Diversion

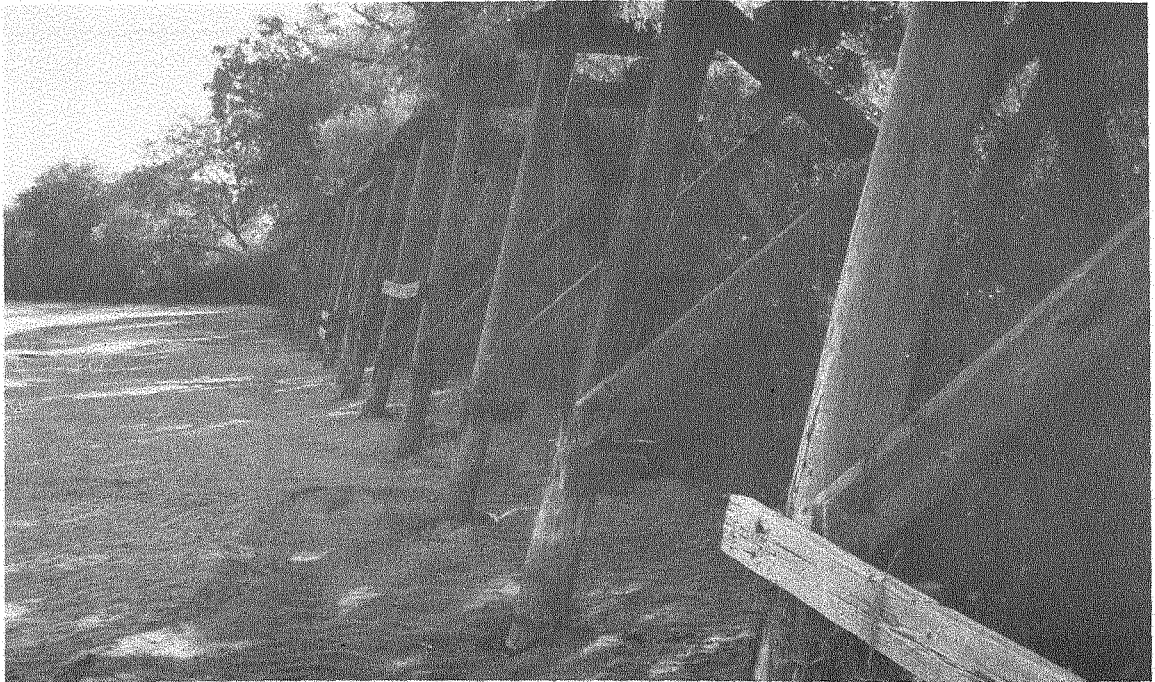
FIGURE 52b

Pile Diversion with few Surface Planks

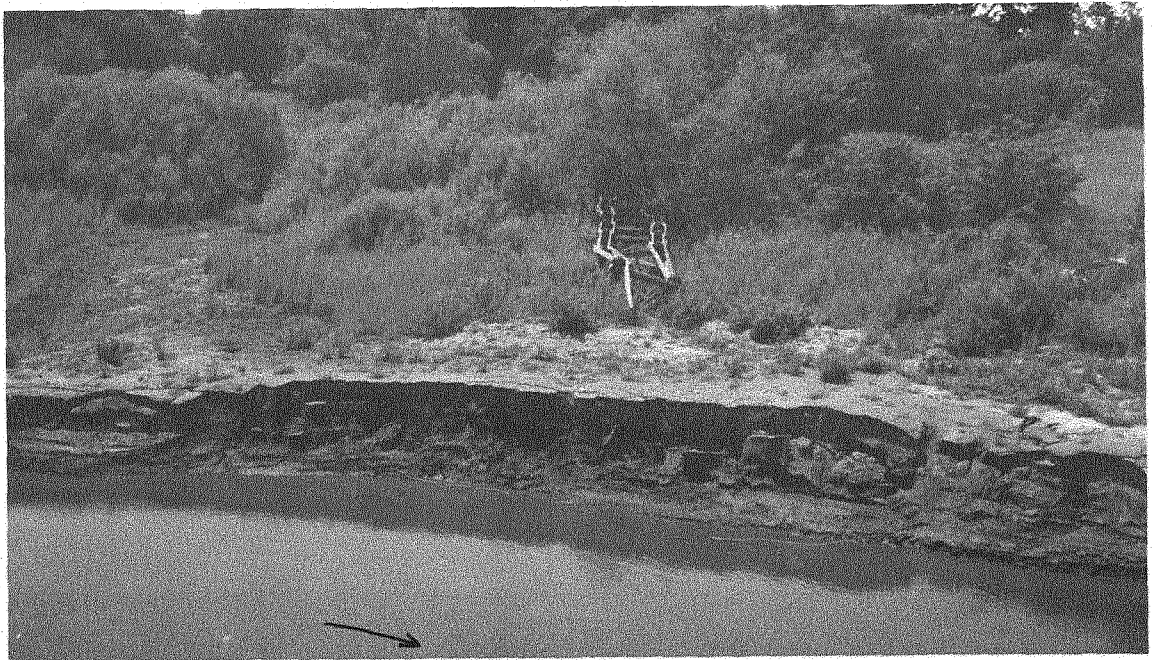
FIGURE 58b

View of Damaged Pile Diversion from Bridge

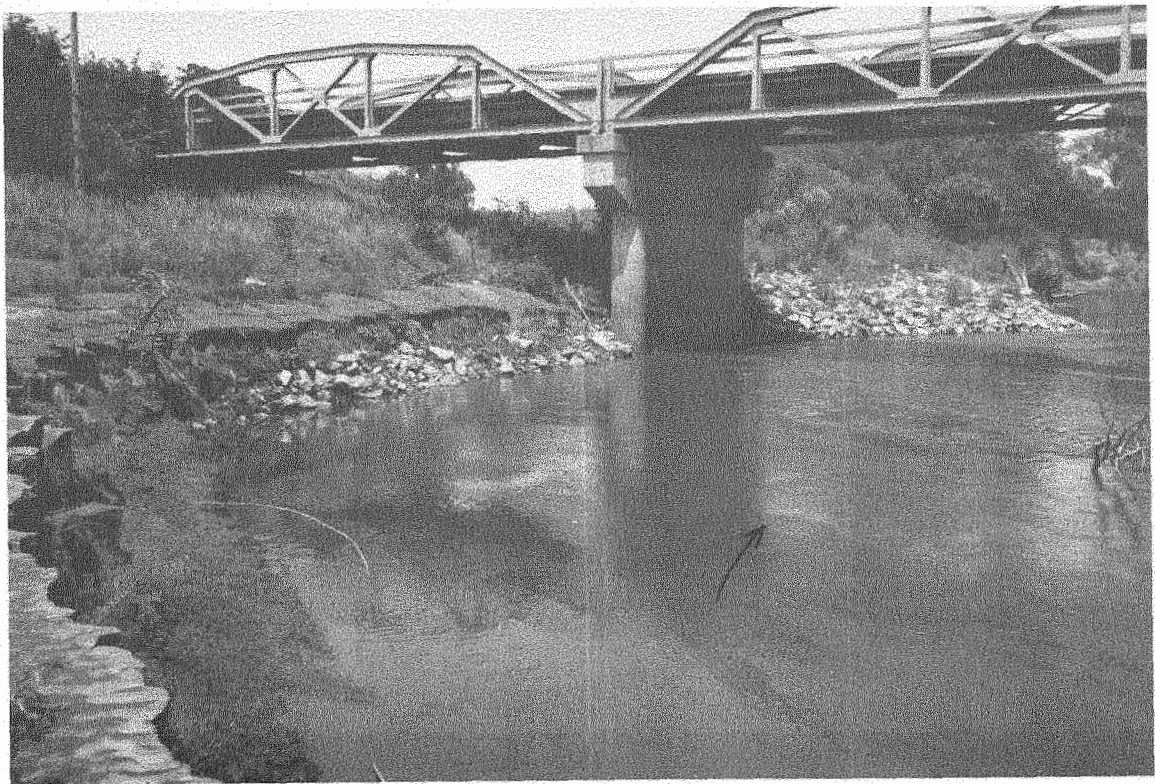
FIGURE 58c

Damaged Riprap on North Bank

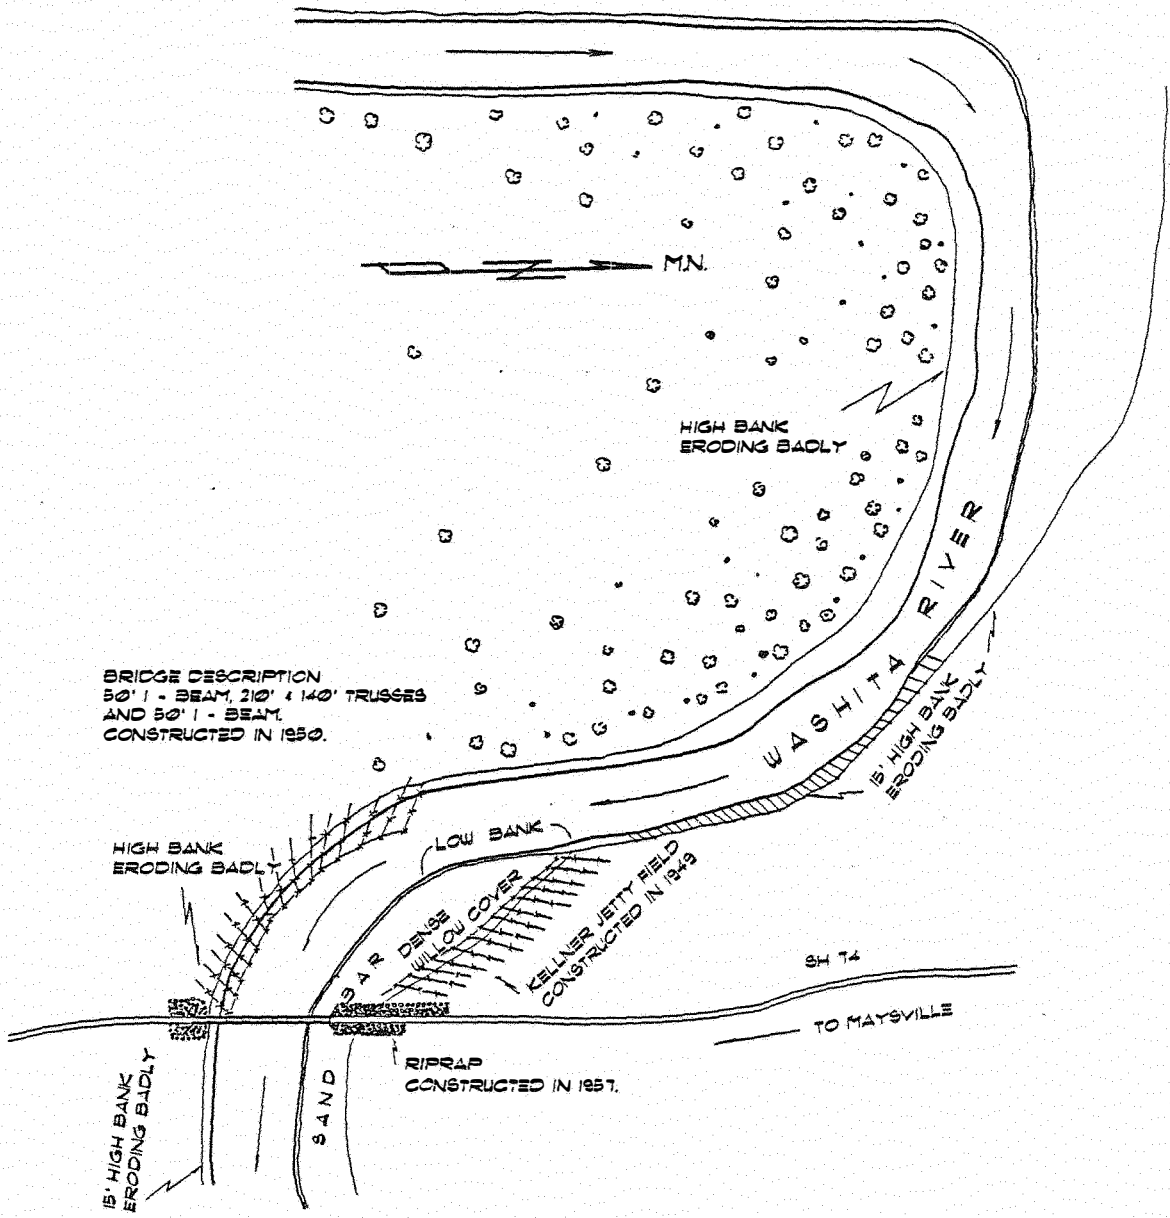
HIGH BANK  
ERODING BADLY

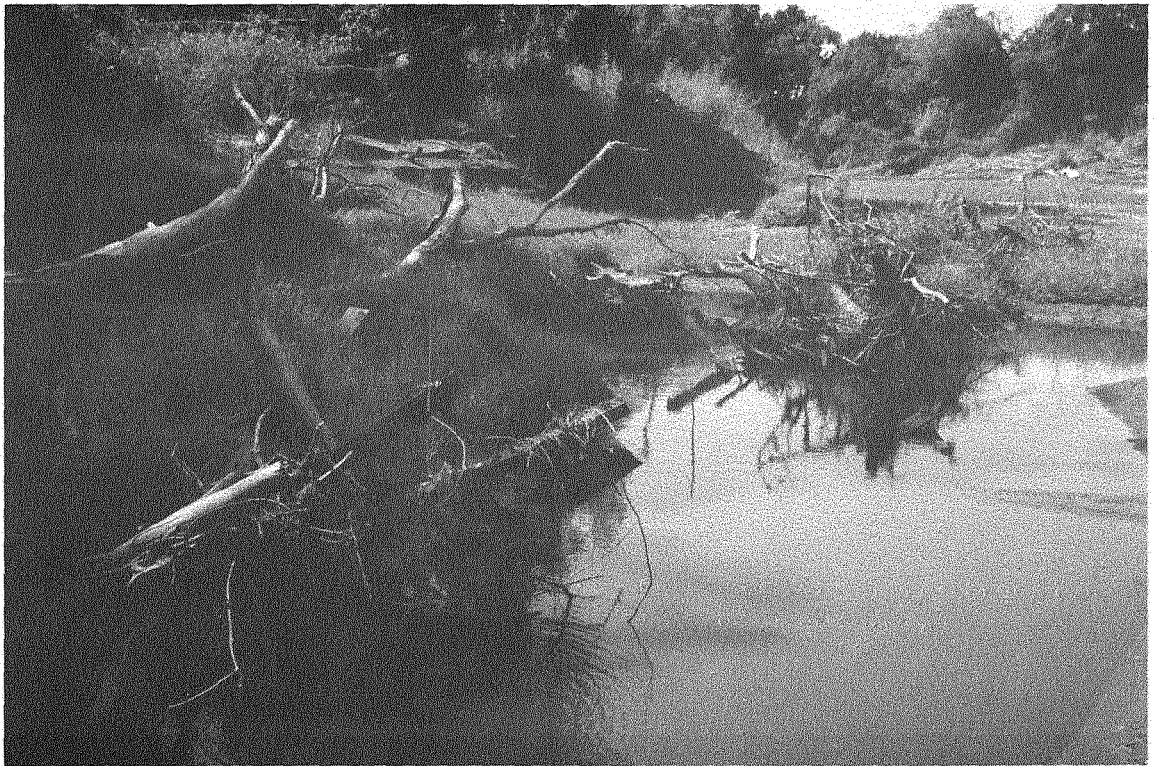
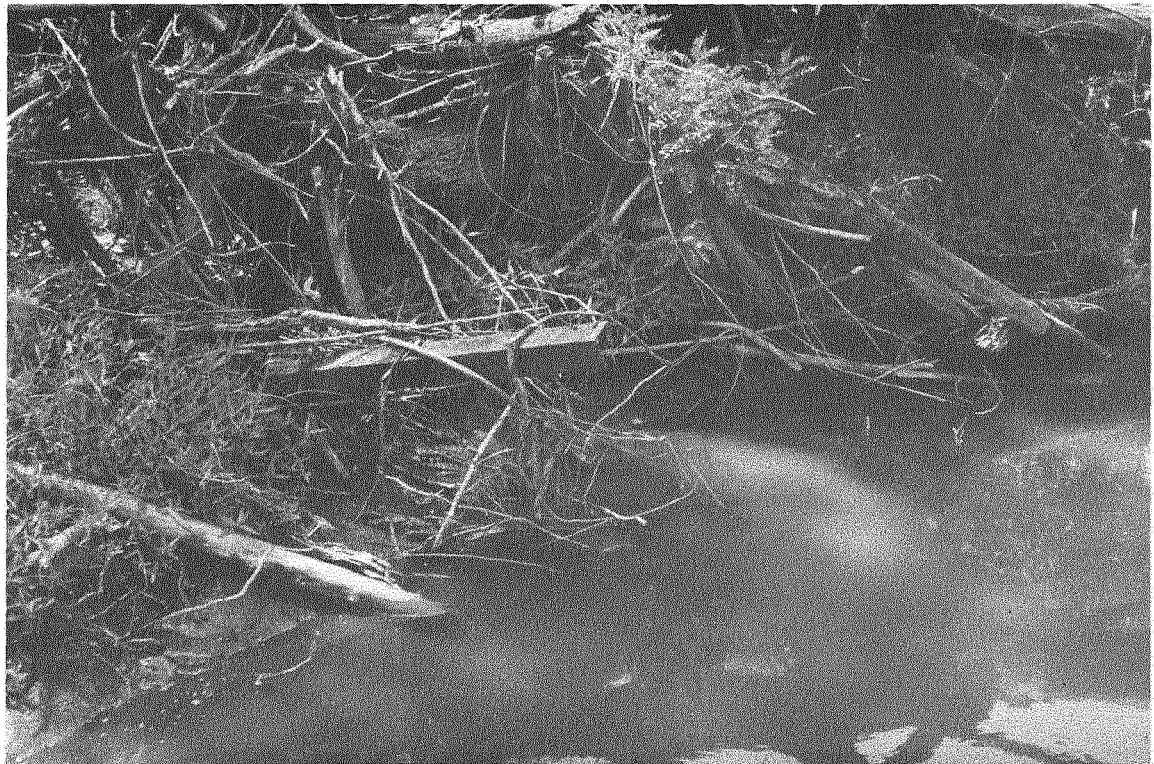
FIGURE 61c

Views of the Damaged Kellner Jetty Field

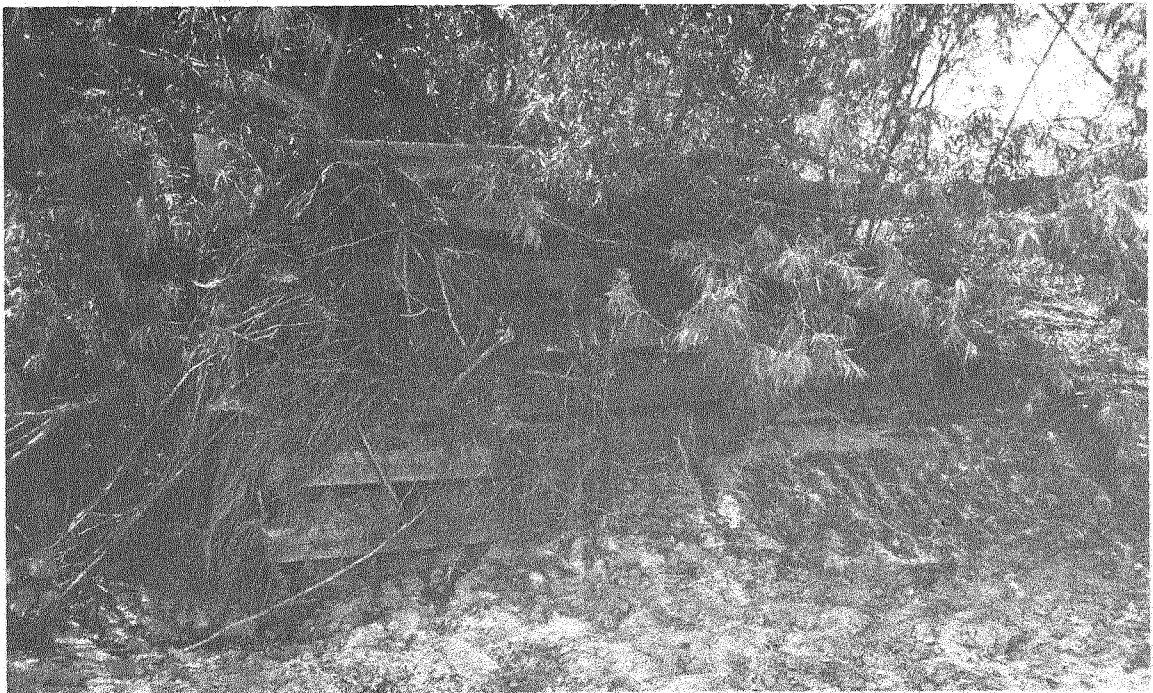
FIGURE 64d

Second Pile Diversion in a Deteriorated Condition

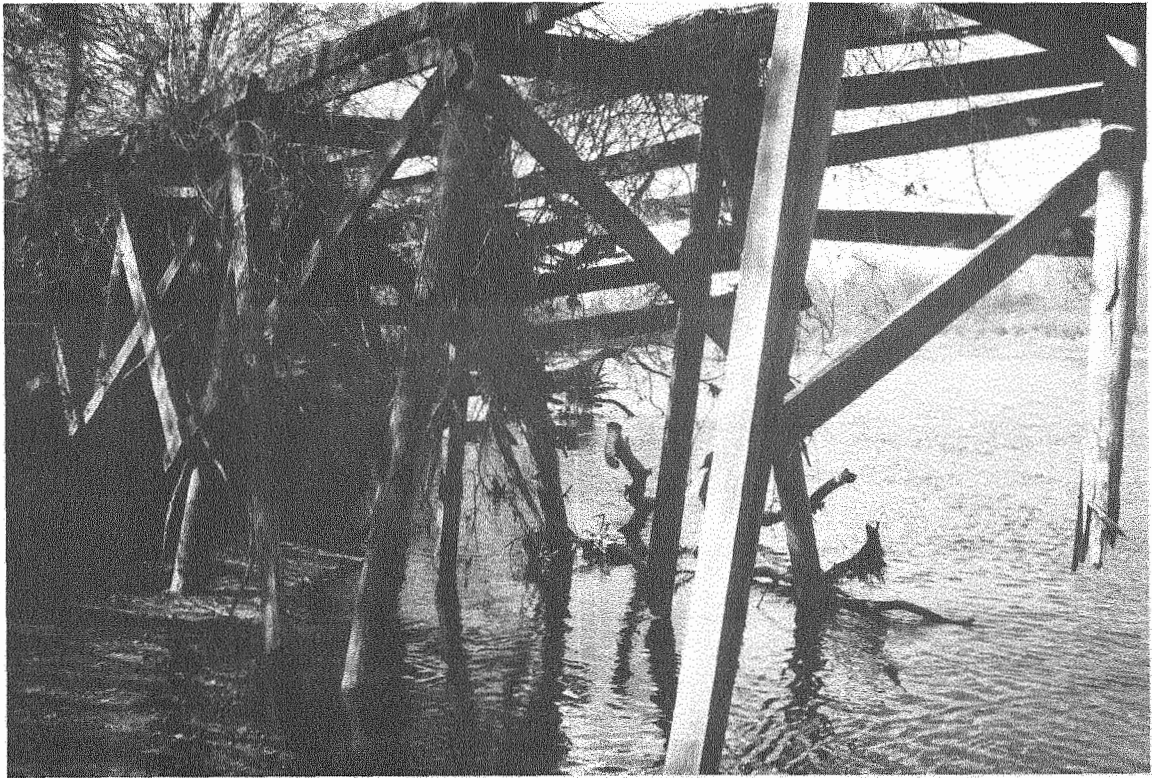
FIGURE 70a

View of Damaged Pile Diversion

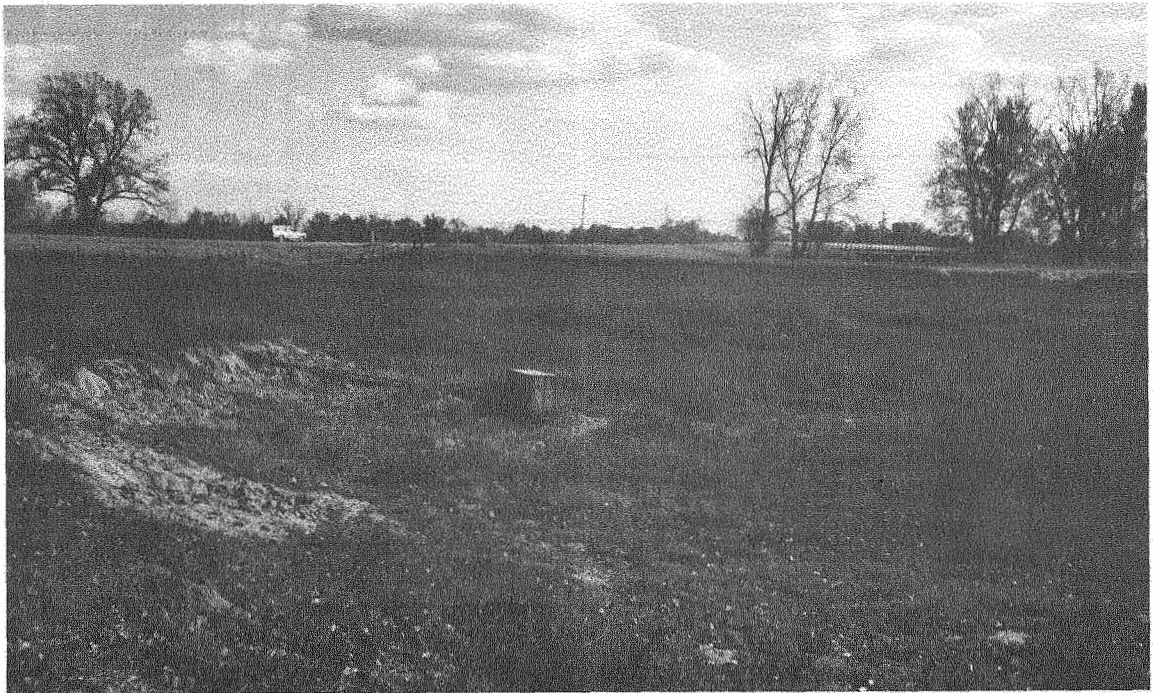
FIGURE 70b

Exposed Deadman of Kellner Jetty Field

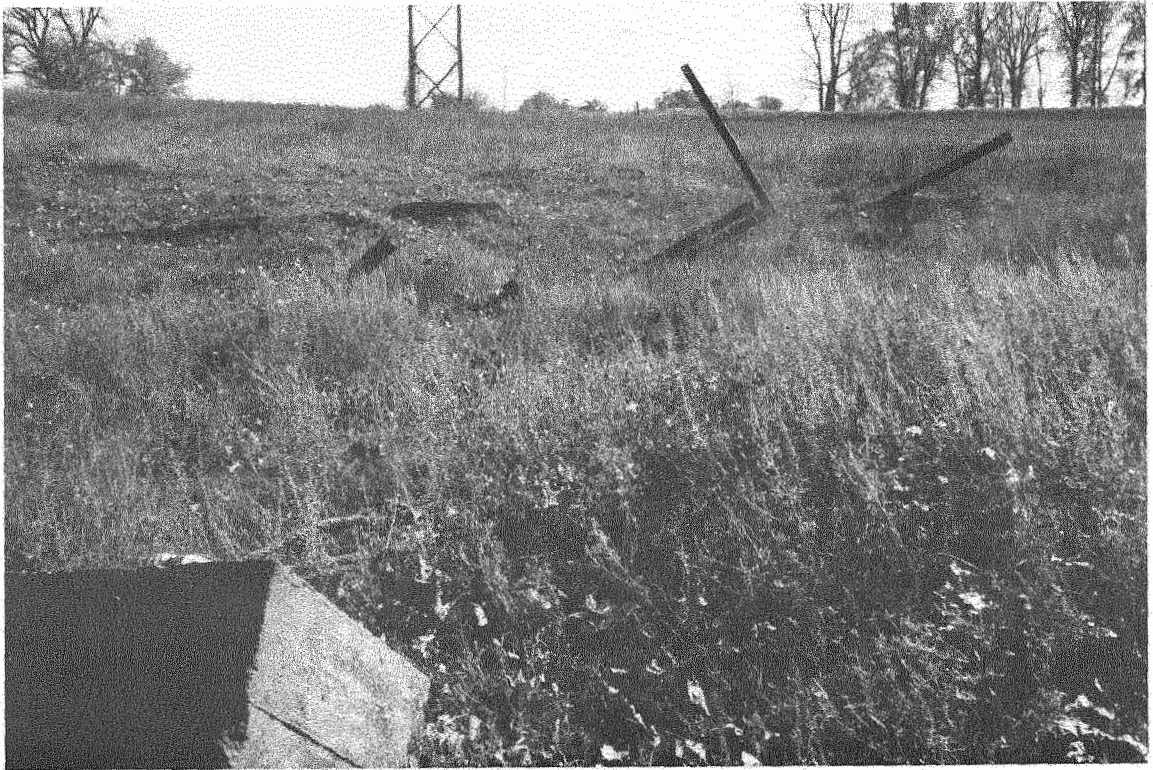
FIGURE 70c

Damaged Jetty Field

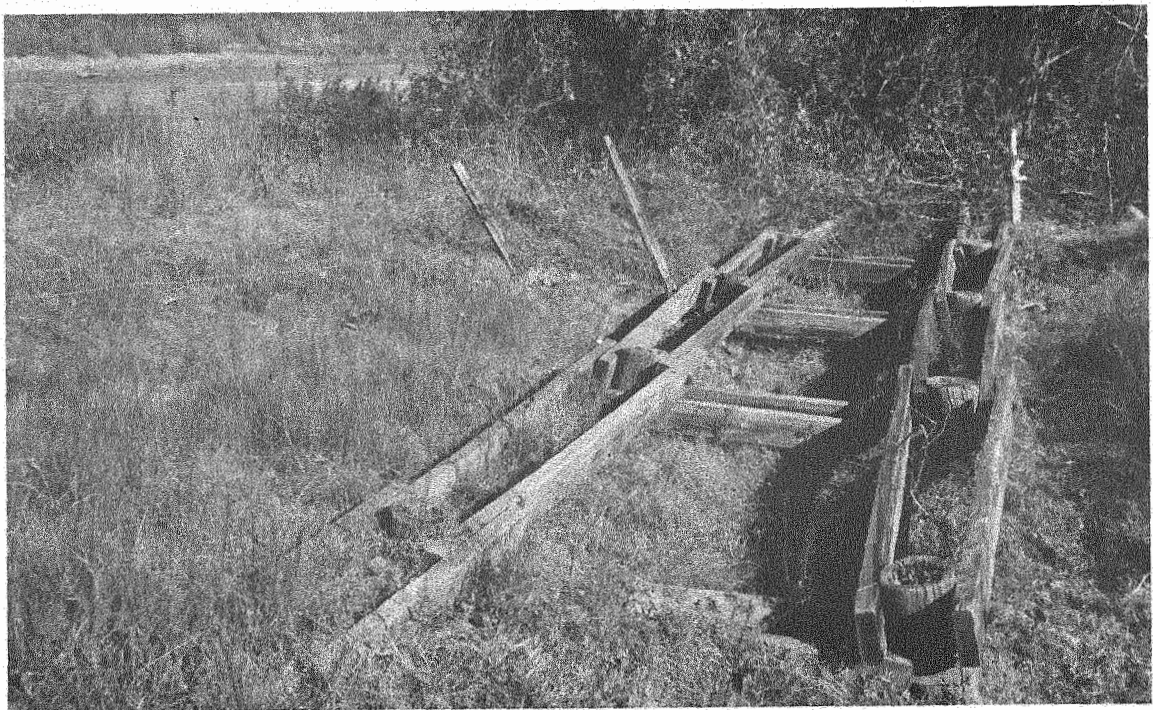
FIGURE 70d

A Buried Pile Diversion

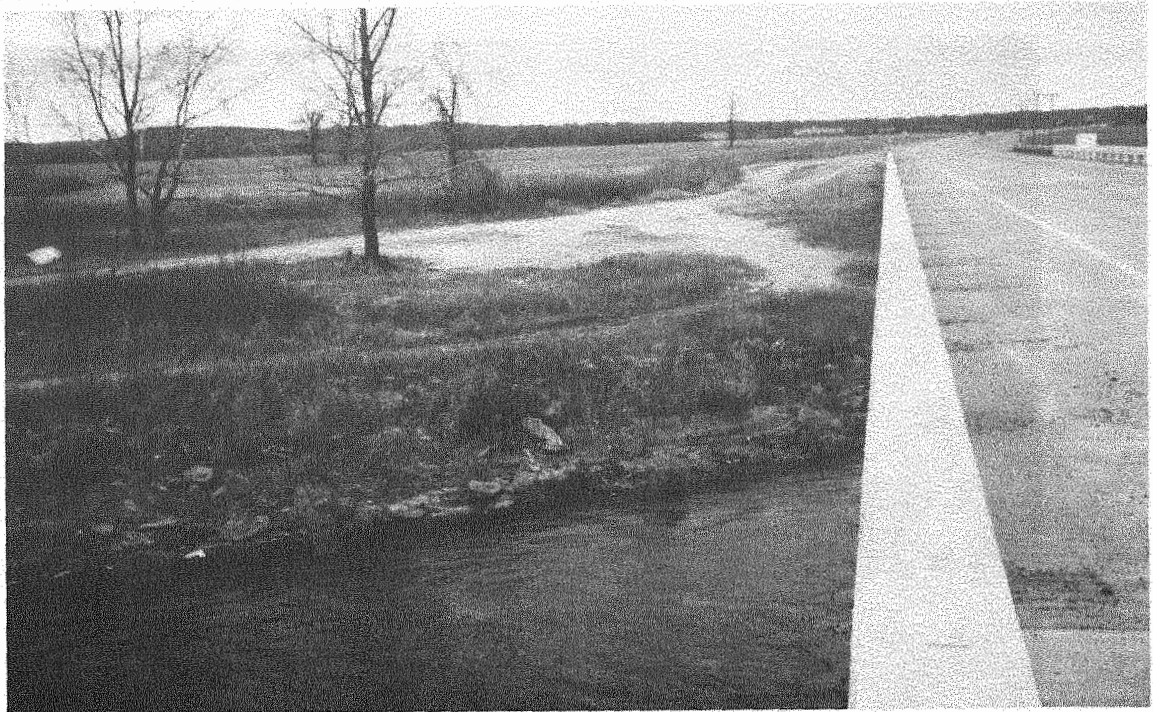
FIGURE 73b

Damaged Riprap at Bridge Abutment

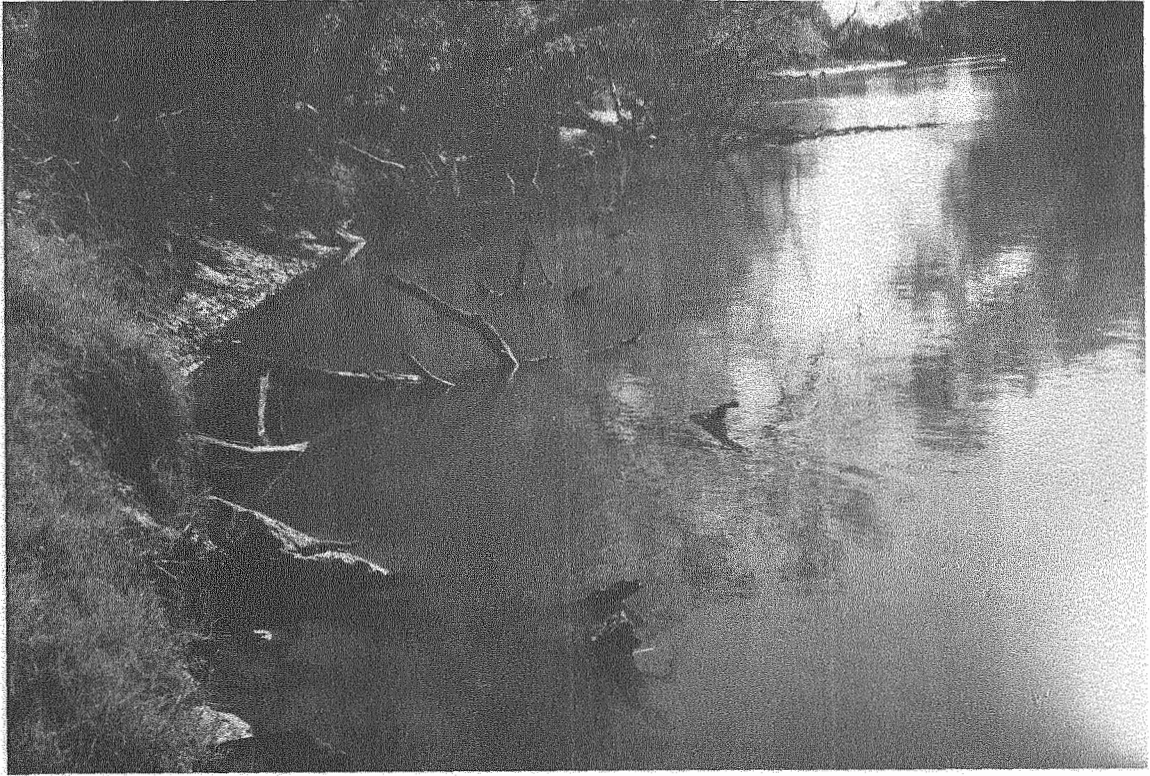
FIGURE 76c

Damaged Kellner Jetty Field
