SCHOOL OF  
CIVIL ENGINEERING  
OKLAHOMA STATE UNIVERSITY

FATIGUE DAMAGE TO STEEL  
BRIDGE DIAPHRAGMS,

Report No. FHWA/OK 89(10)

State Study No. 2156

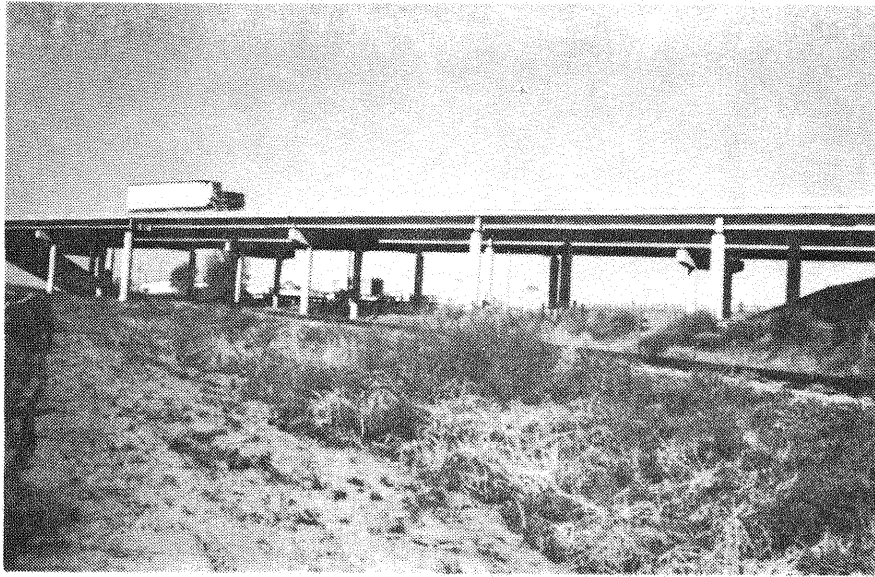
This research was conducted to identify the cause of diaphragm cracking in a steel girder highway bridge. The bridge, located on I-40 near Weatherford, Oklahoma, is shown in Figure 1. The bridge is about 20 years old and 60 of the 184 diaphragms in both the east and westbound spans are cracked, 5 of which have experienced a total section loss. A picture showing the position of several diaphragms on the bridge is presented in Figure 2, and two examples of fatigue damage are shown in Figure 3. In all but one case, cracks initiate at the lower flange and propagate up through the member. The one case where cracks were found in the upper cope is also the one case where cracks were found in diaphragms above pier caps. Locations of cracked diaphragms are indicated in Figure 4.

Figure 1. Bridge With Damaged Diaphragms,  
Structure No. 2004-1302SX

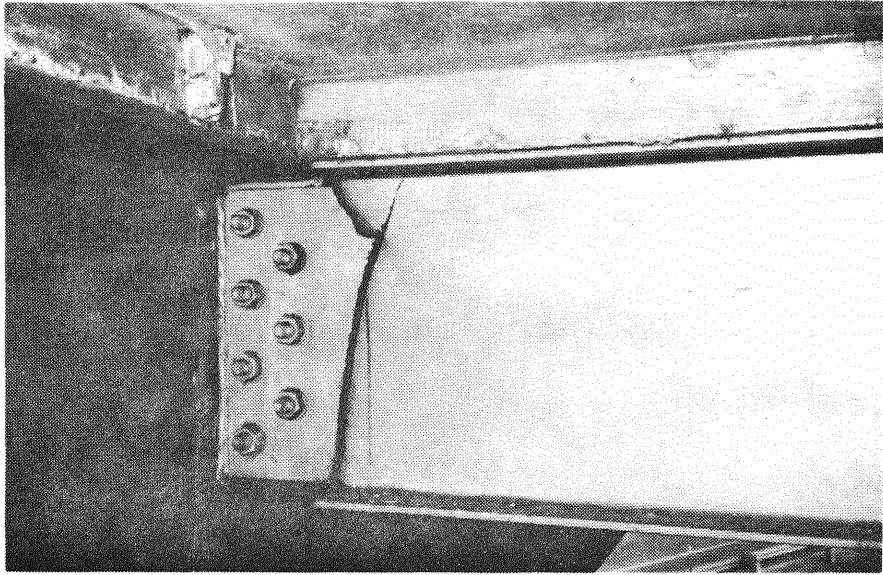
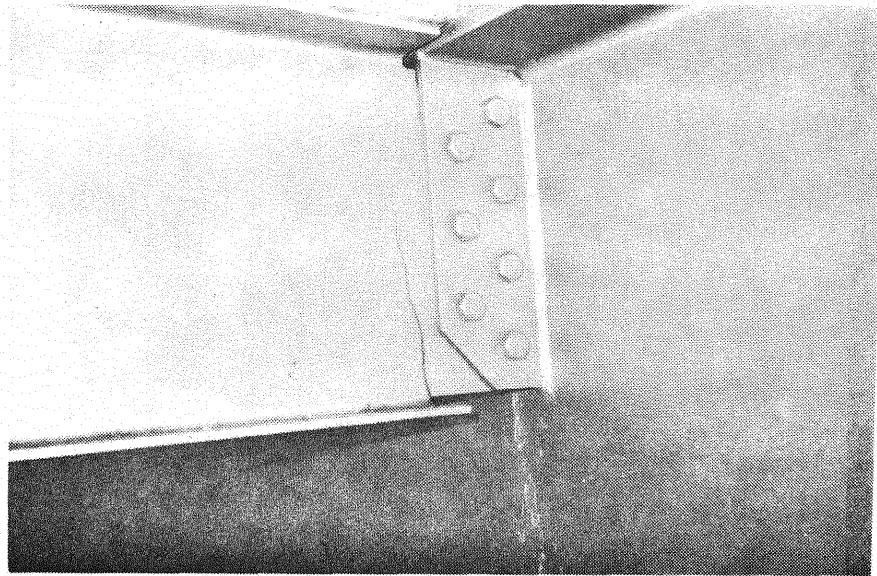
Figure 3. Examples of Cracked Diaphragms

The pattern of cracked diaphragms and the location of cracks in the diaphragms indicate that diaphragms at each transverse location between the piers are acting as continuous beams. In all but one case, the cracks originate in the bottom flange cope and grow up through the web. No cracks were found at connections to exterior girders. Taken as a whole, these observations indicate that the "continuous" diaphragms are being loaded by the differential deflections of the longitudinal girders.

It is recommended that for uncracked diaphragms and for diaphragms with cracks shorter than one inch, the bottom two bolts in the diaphragm-to-girder connection be removed. This recommendation is based on the effectiveness of this modification to increase fatigue life--even for diaphragms containing small cracks--and the relative ease with which this modification can be accomplished. Diaphragms containing cracks longer than one inch should be removed and replaced with diaphragms not coped at the bottom

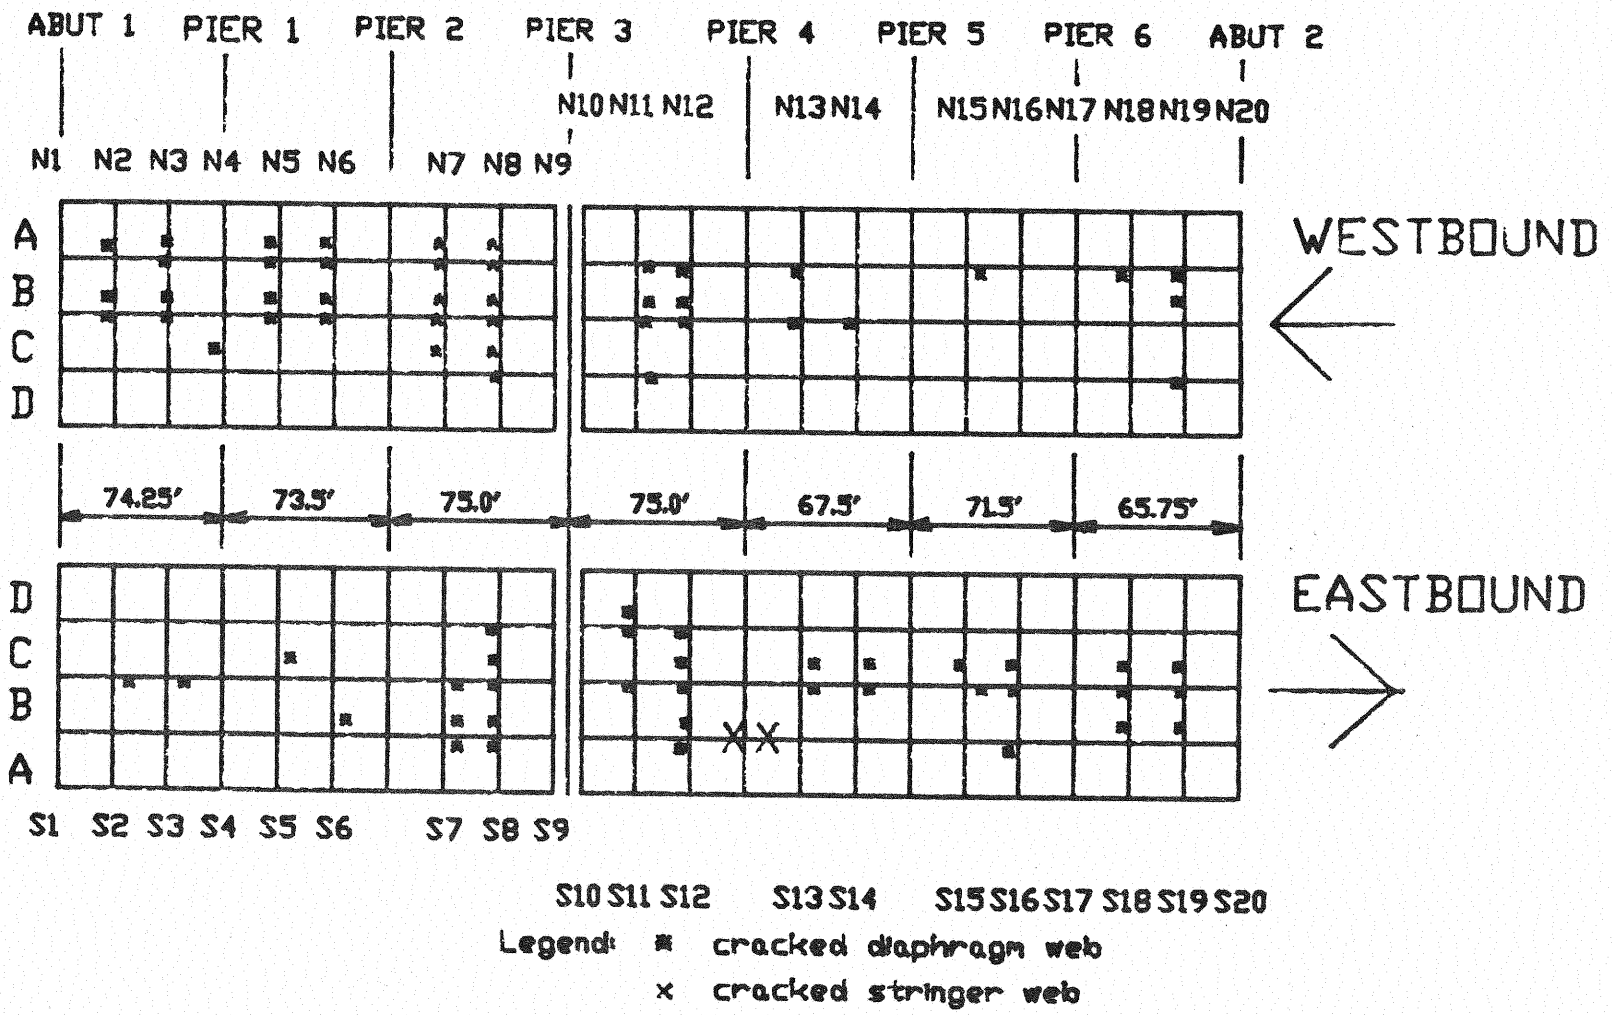
Figure 4. Plan View of Diaphragms and Stringers

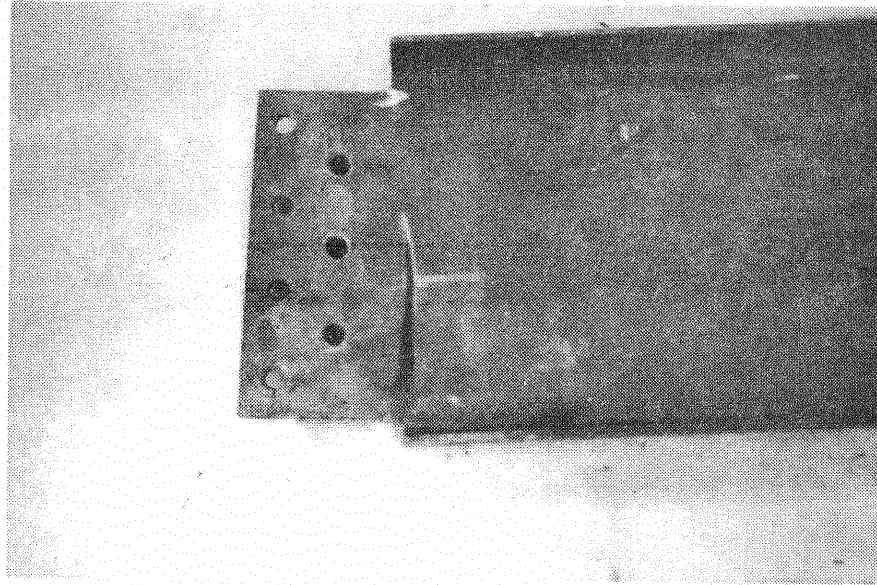
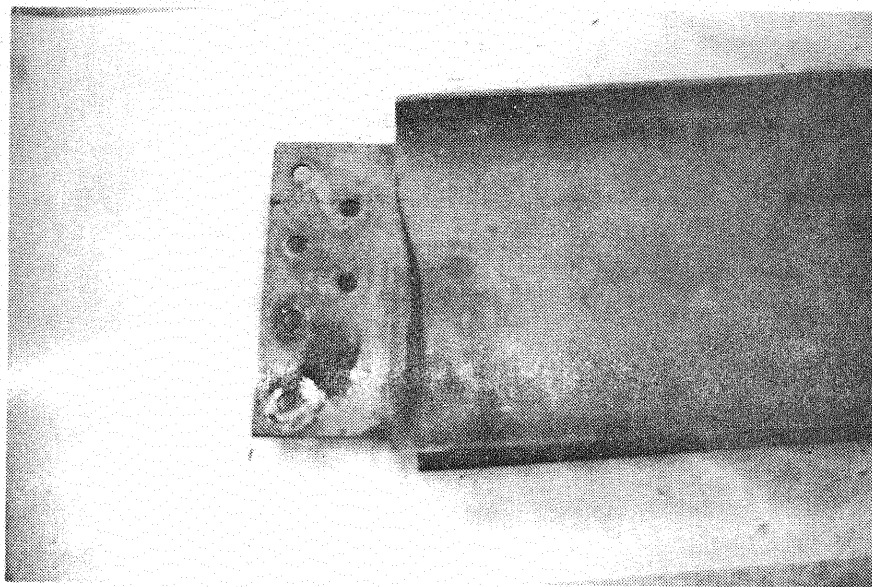
Failed specimens are shown in Figure 34. Specimens were considered to have failed when the crack had grown through half the web. It was found that very few cycles relative to the total number of cycles applied were necessary to propagate the crack from the web centerline through the upper half of the web. Stopping the tests when the cracks reached the web centerline was necessary to prevent the specimens from becoming so flexible that they would impact on the load frame during cycling. An important observation to be made from Figure 34 is that the crack shape is very similar to shapes observed on the bridge and that the crack plane is approximately perpendicular to the direction of the maximum principal tensile stress shown in Figure 31.

Figure 34. Typical Cracking Pattern in Laboratory Specimens

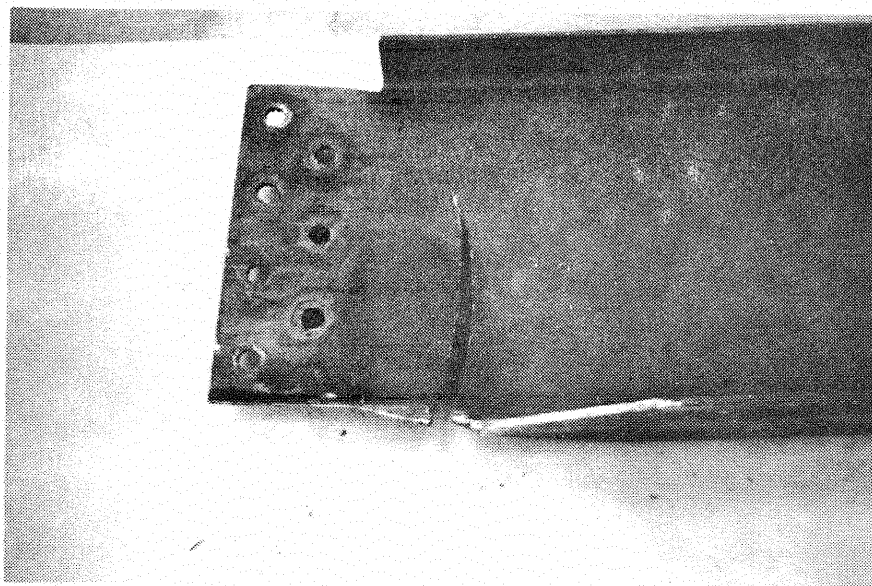
Tapered Cope. The fatigue life of the tapered cope detail was very dependent on how carefully cutting and grinding procedures were carried out. As can be seen in Table 3 and Figure 35, the two tapered cope specimens exhibited significantly different fatigue lives. One test resulted in a substantial increase over the life of the original detail while the other resulted in only a minimal increase. A failed specimen is shown in Figure 36. Cracks in these specimens originated at rough spots on the tapered surface and grew into approximately the same shape as on the original detail.

Figure 36. Failure of Tapered Cope Detail

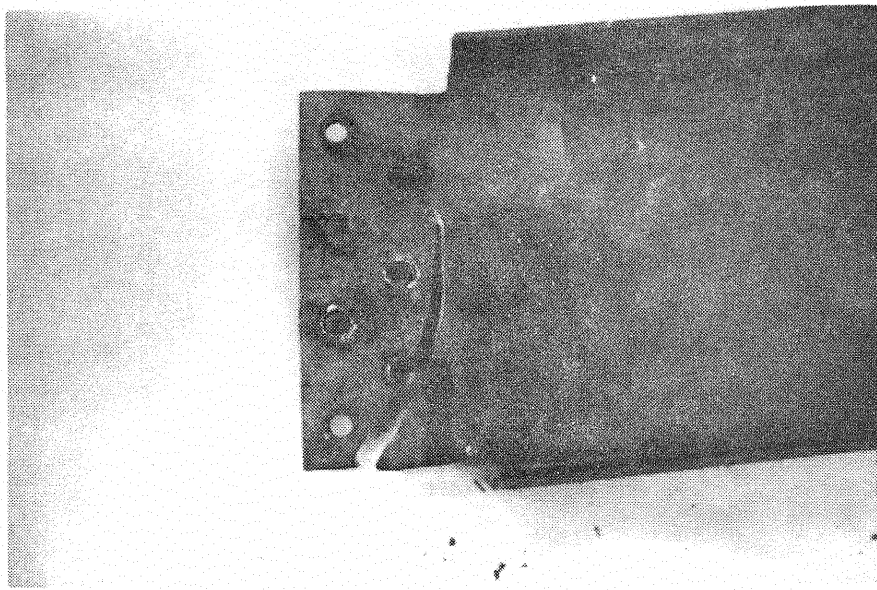
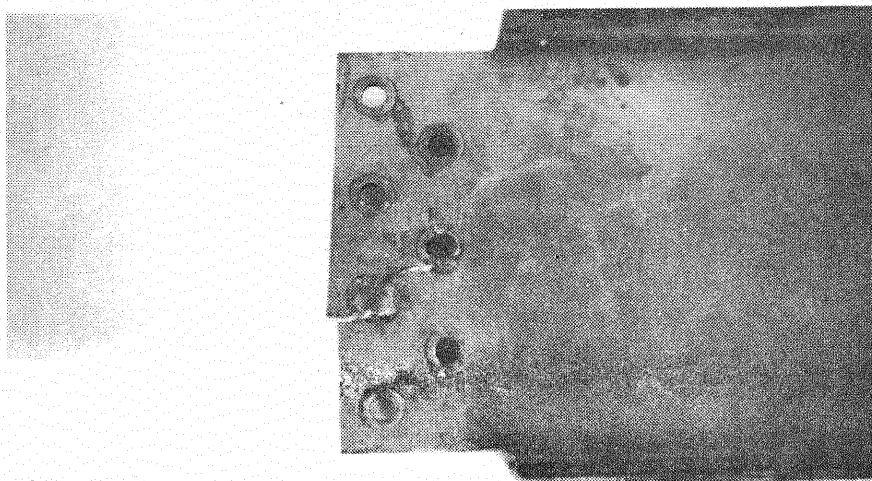
Failure in these specimens resulted from a crack originating in one of the lower bolt holes and growing out to the side or bottom of the diaphragm. Photographs of failed specimens are shown in Figure 38. The observed mode of failure may be partially the result of the loading system used in all the tests. Since the eccentricity at the diaphragm-to-column and diaphragm-to-actuator connections was fixed in the tests, removal of the bottom two bolts increased the eccentricity and therefore the moment on the connection. In the bridge, the moment is caused by differential deflections of the longitudinal girders, not by an eccentrically applied load. Removal of the lowest two bolts in the connections on the bridge may actually reduce the moment in the diaphragms by making them more flexible. The five remaining bolts will

Figure 38. Failure of Detail With Bolts Removed

Test results indicate that removing the bottom two bolts from the diaphragm-to-girder connection is an effective and reliable way of increasing diaphragm fatigue life. The method is effective even when small cracks are present in the diaphragm at the cope. Laboratory tests on this modification may be more severe than the detail would experience in actual service.

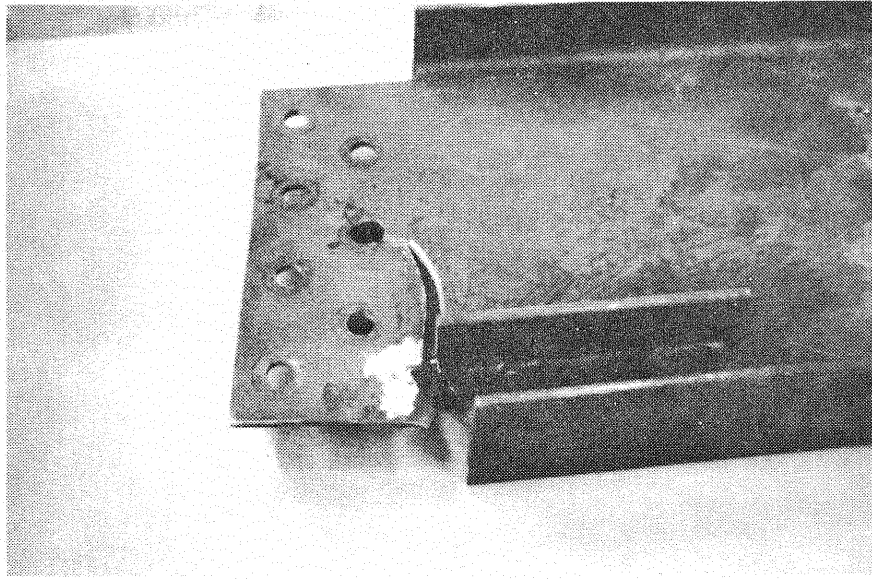
As can be seen in Table 3 and Figure 35, the modification did increase average specimen fatigue life, but there is a great deal of scatter in the data. In both tests, a short period of no growth after the modification was followed by propagation around the end of the auxiliary flange. A failed specimen is shown in Figure 39. The fact that the crack easily propagated around the auxiliary flange is an indication that the flange does not extend far enough ahead of the cope to be effective.

Figure 39. Failure of the Auxiliary Flange Detail
