SCOUR AROUND BRIDGE PIERS OF OVERFLOW
STRUCTURES AT I-35 BRIDGE
ON THE CIMARRON RIVER

Report No. 88-1
Water Resources Engineering
School of Civil Engineering

Oklahoma State University
Stillwater, Oklahoma 74078

April 1988

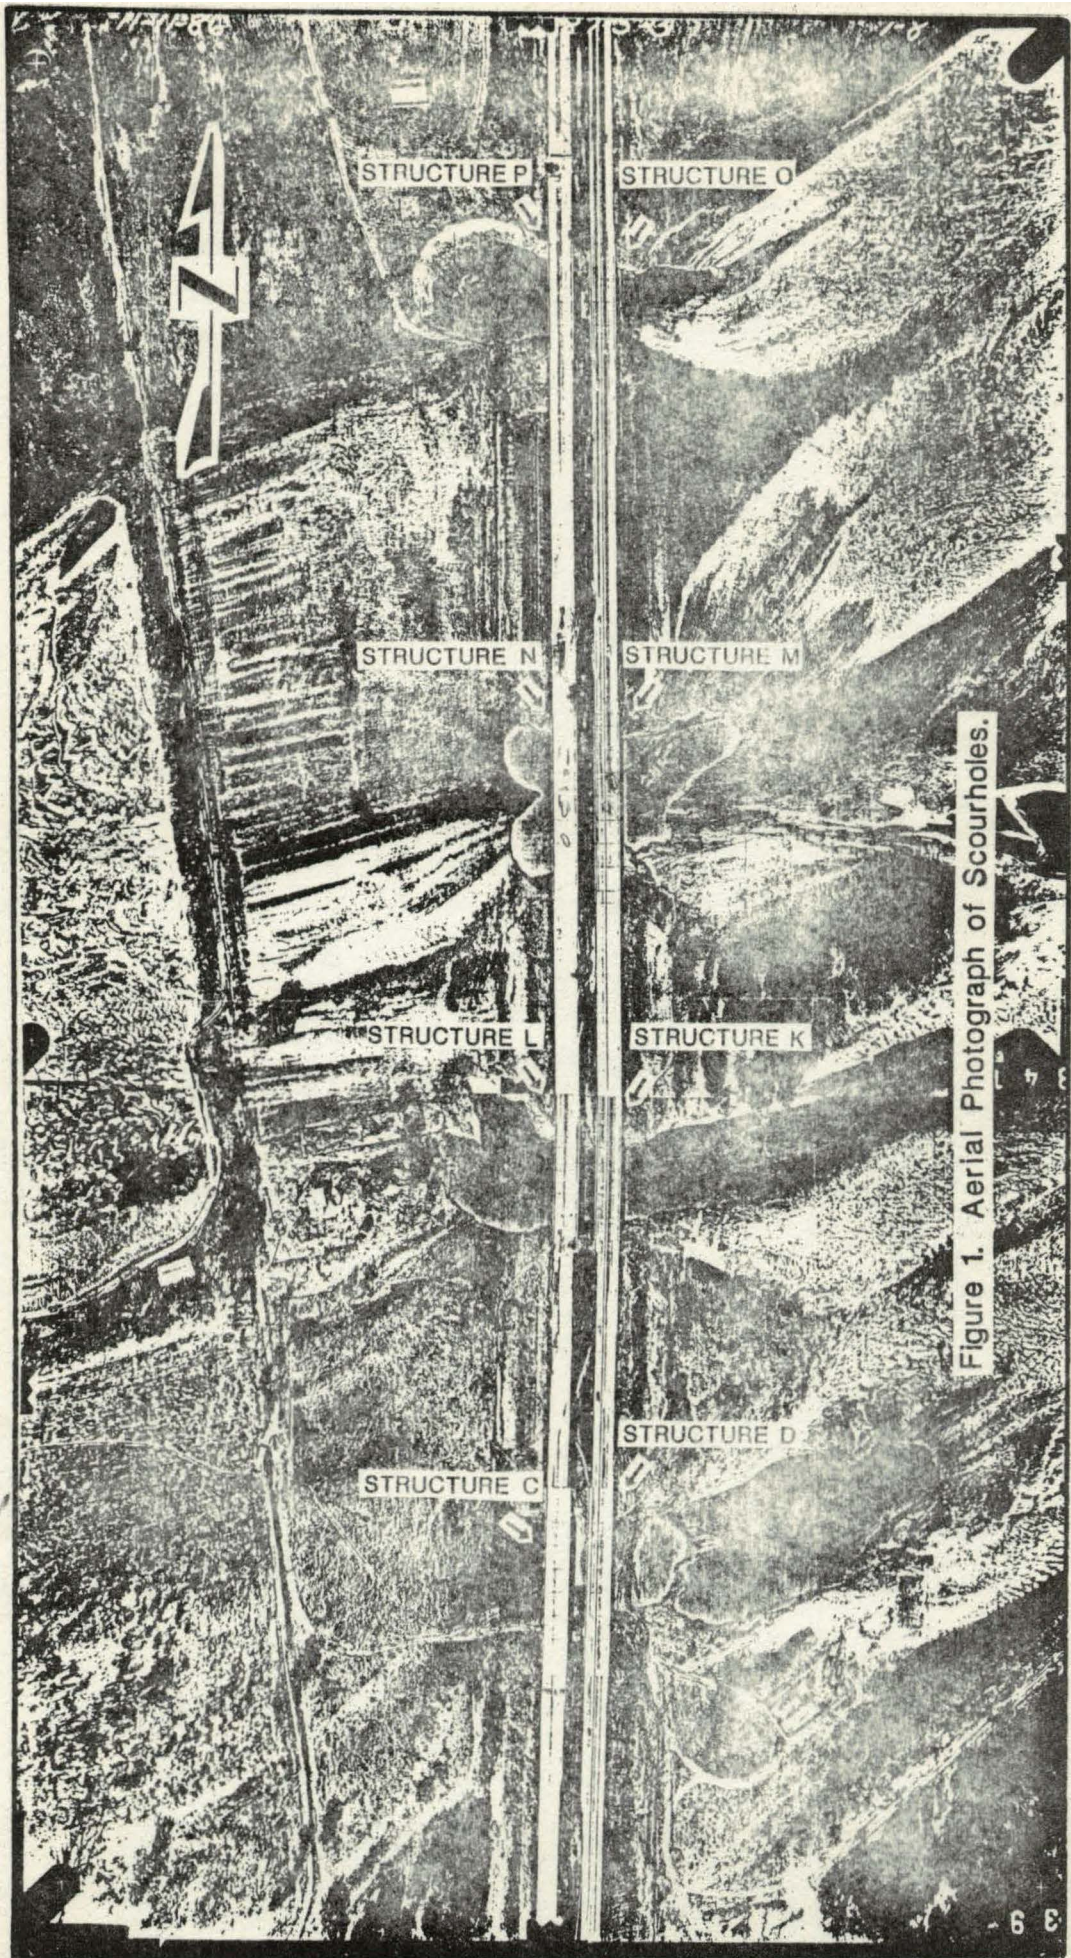
Figure 1. Aerial Photograph of Scourholes.

Figure 1 presents aerial view of scourholes near Overflow Structures C-D, L-K, N-M and P-O similar to those in Figures 2 through 17 based on actual field surveys. Even though the four sets of scourholes appear continuous in the aerial photograph, they sometimes contain two locations of maximum scour depths.

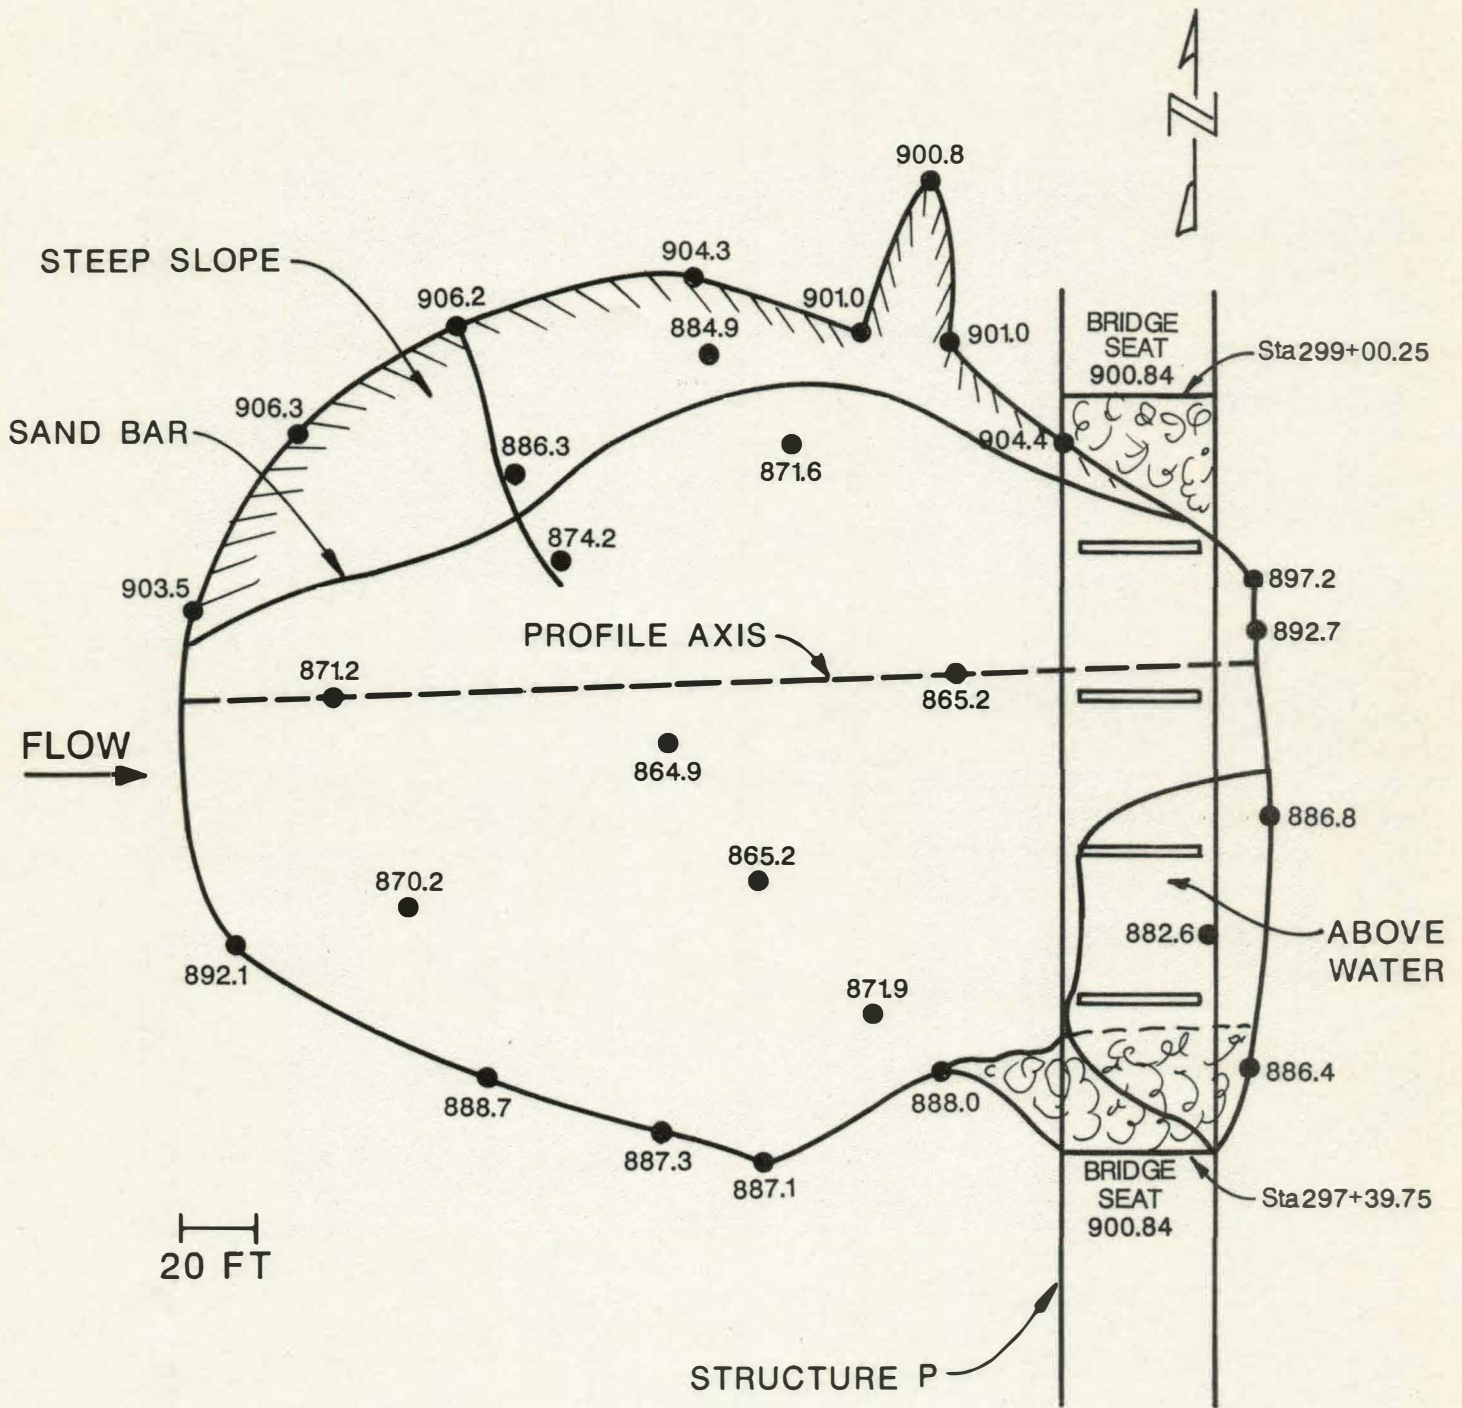
Figure 2. Location of Scour Hole Upstream of Structure P.

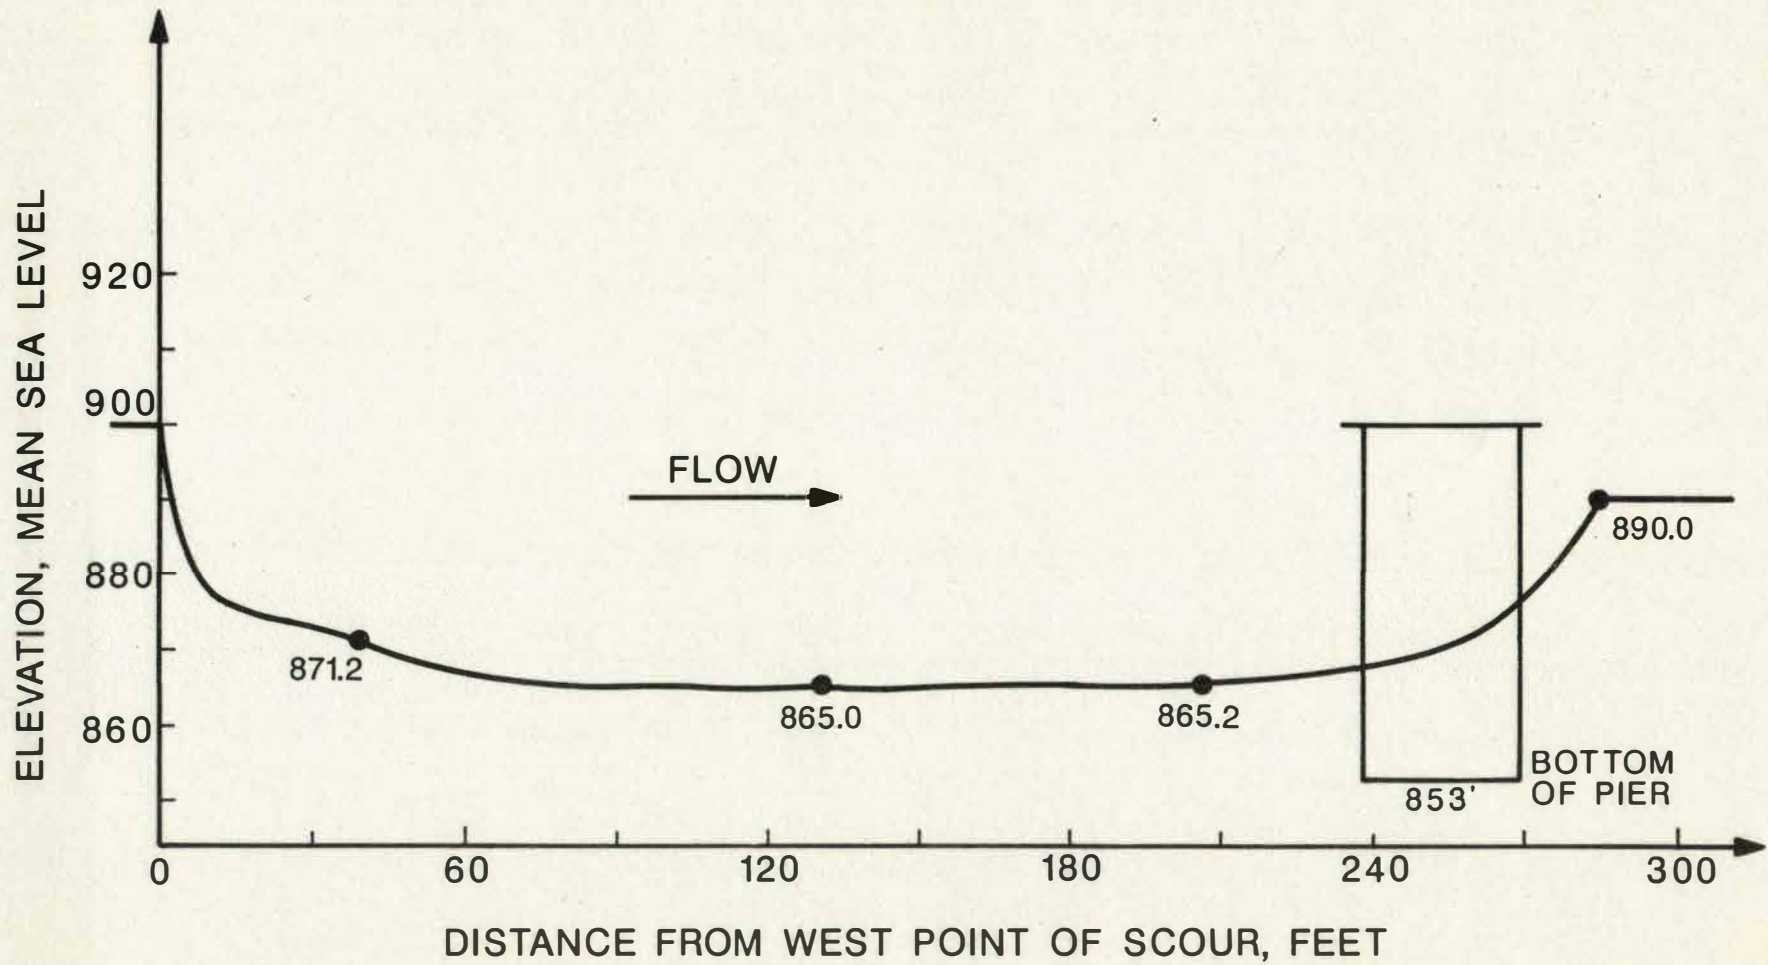
Figure 3. Profile of Scour Hole Upstream of Structure P.

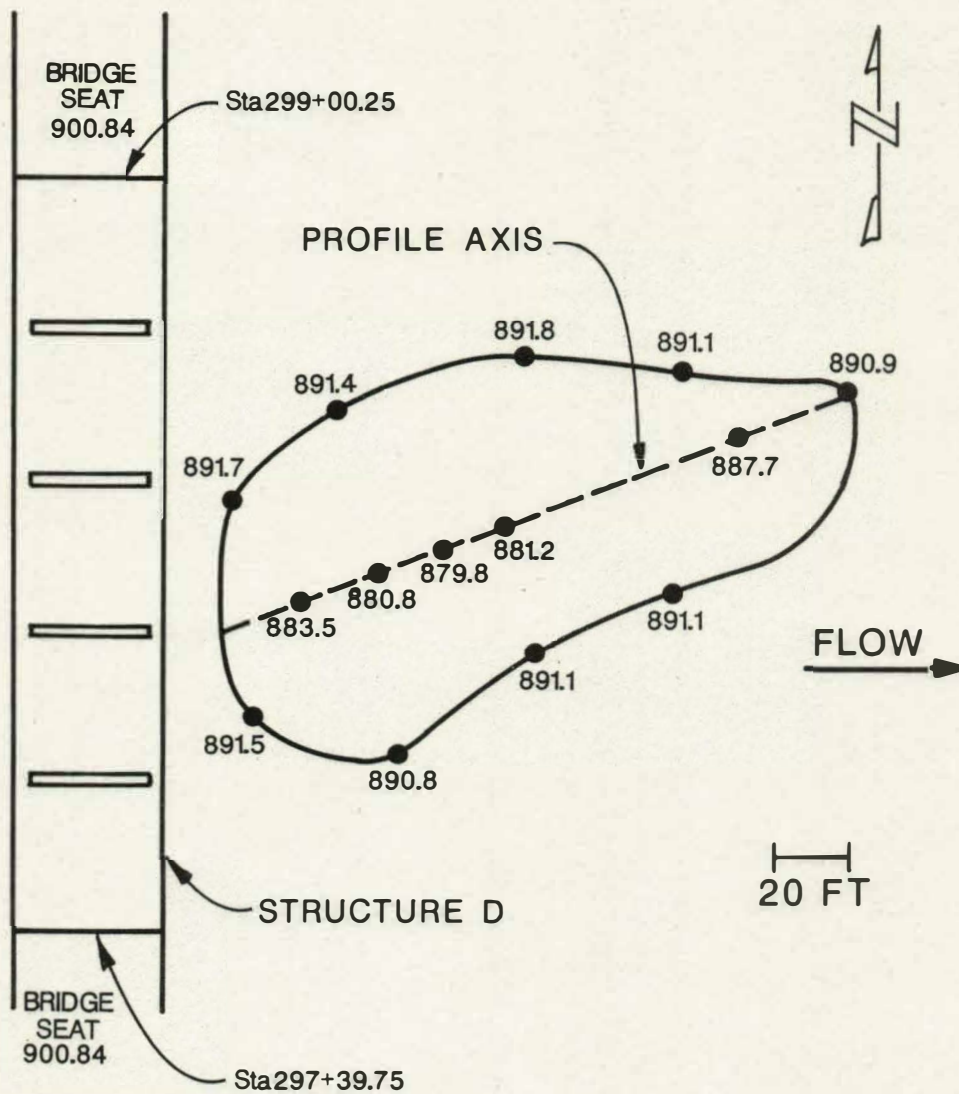
Figure 4. Location of Scour Hole Downstream of Structure O.

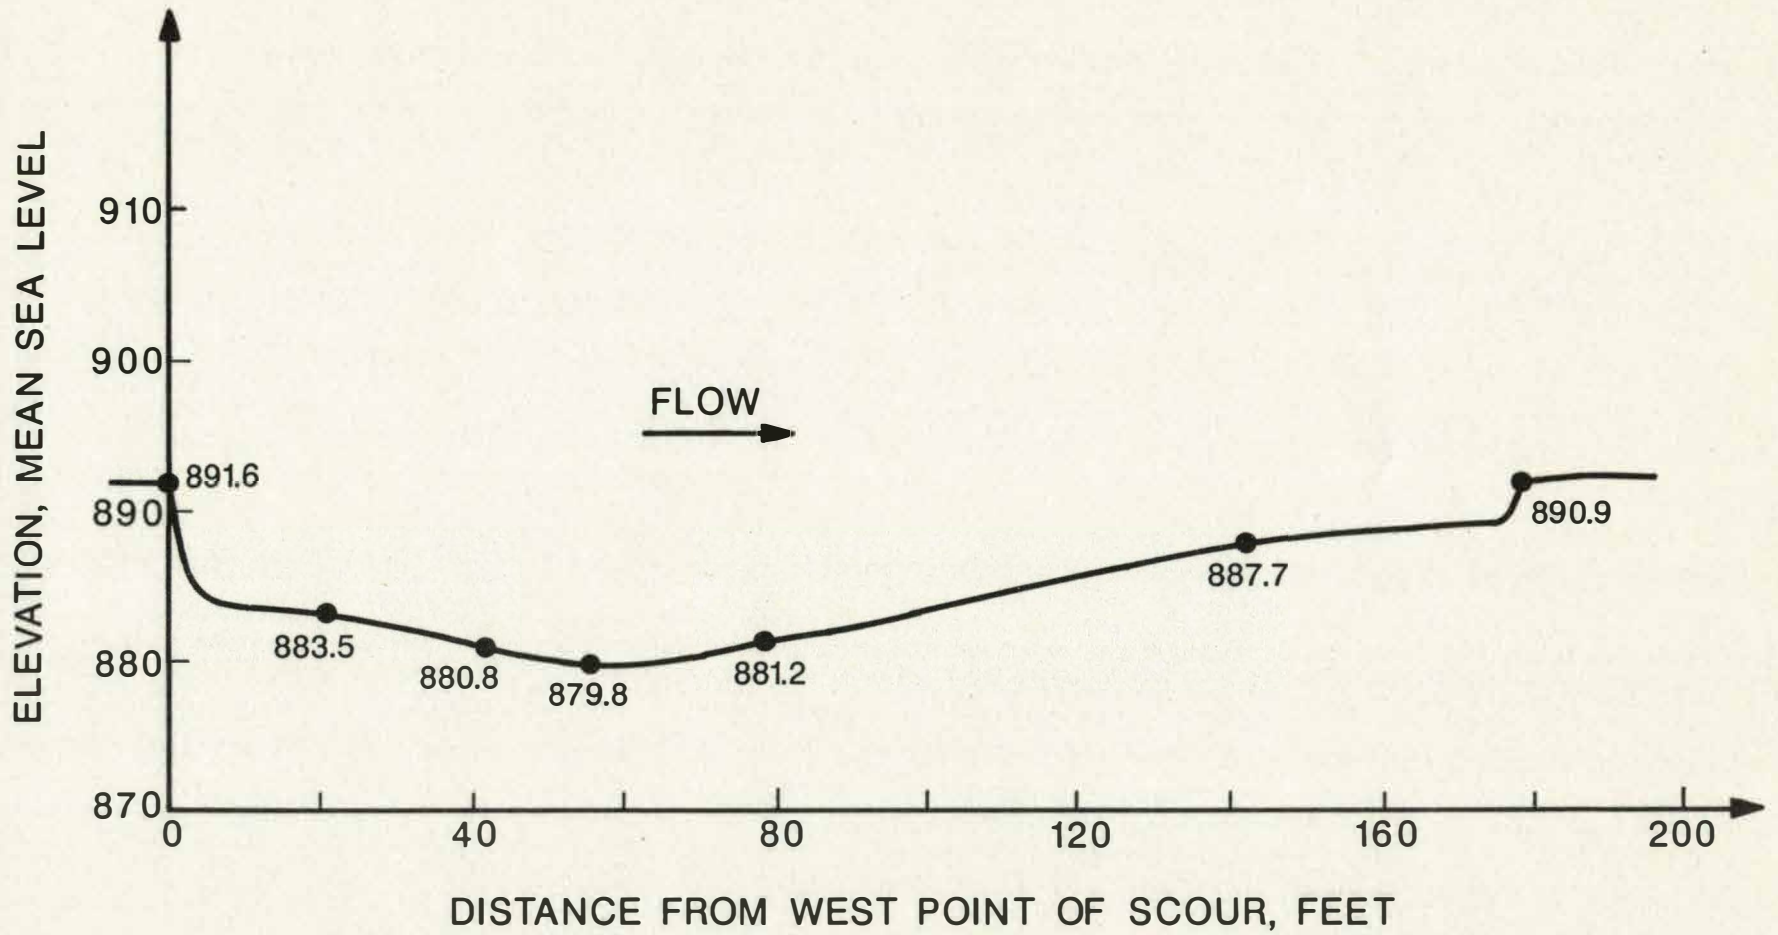
Figure 5. Profile of Scour Hole Downstream of Structure O.

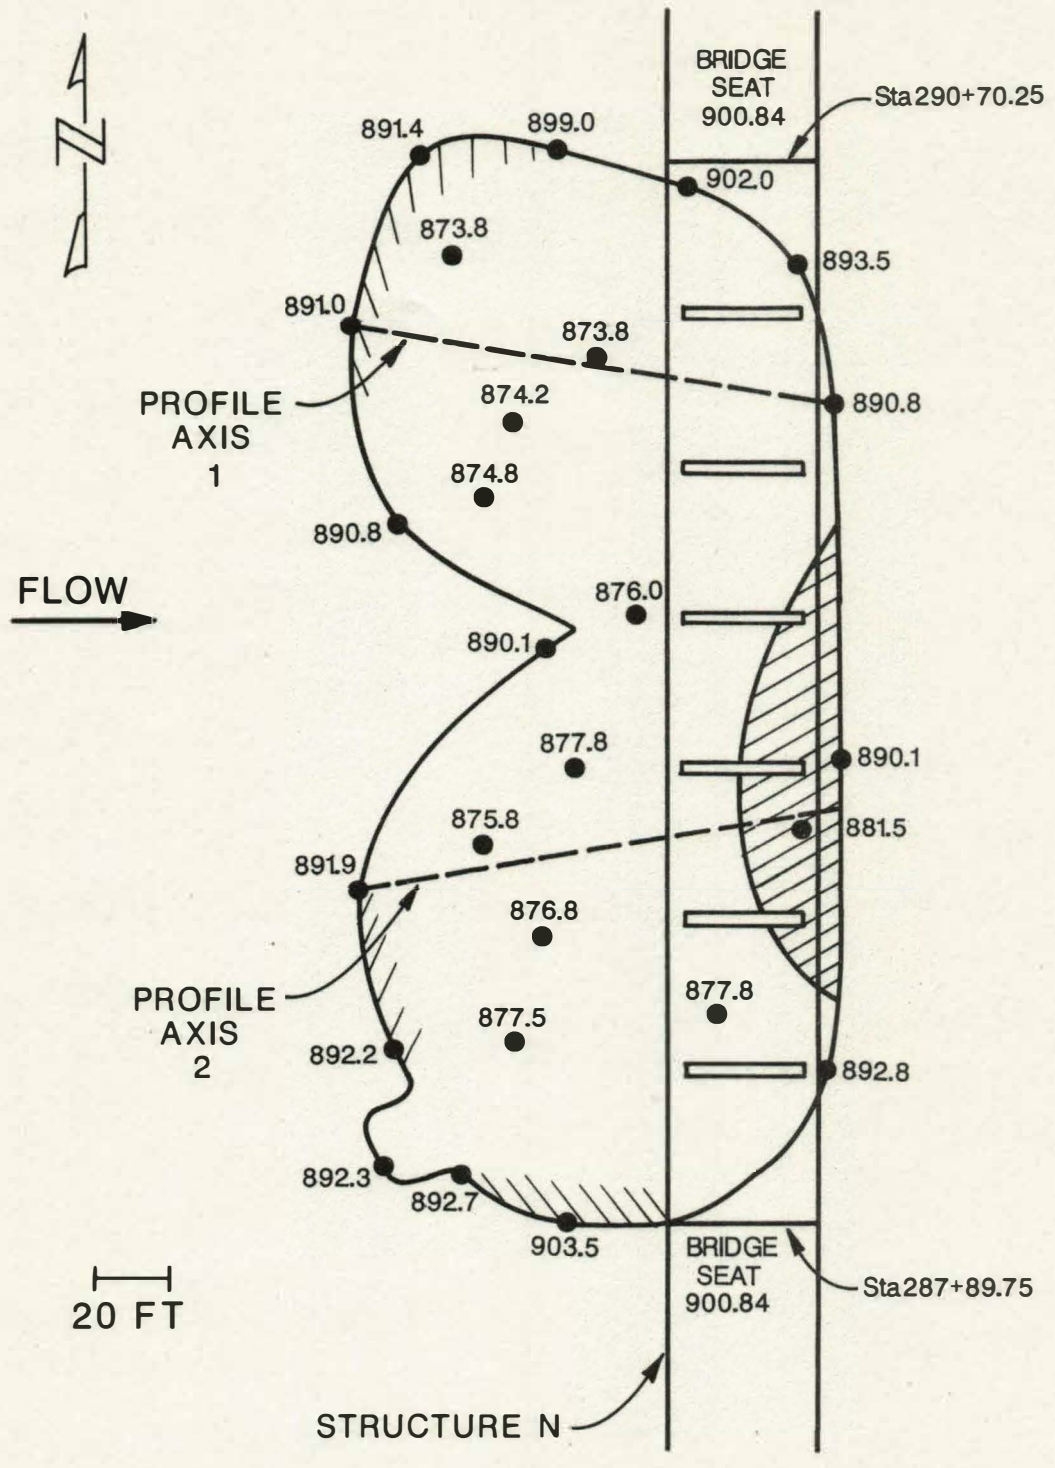
Figure 6. Location of Scour Hole Upstream of Structure N.

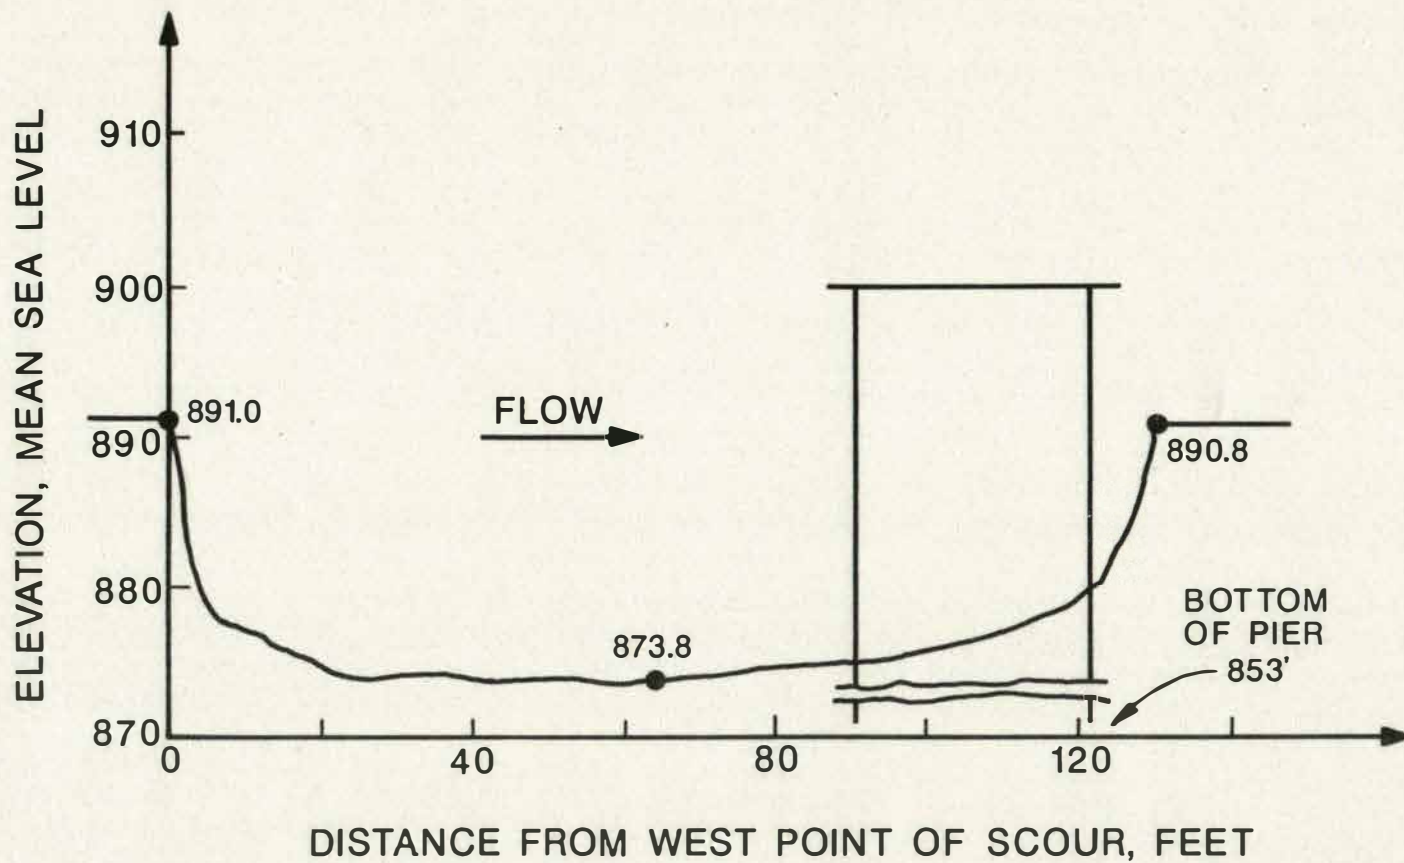
Figure 7a. Profile of North Scour Hole Upstream of Structure N.

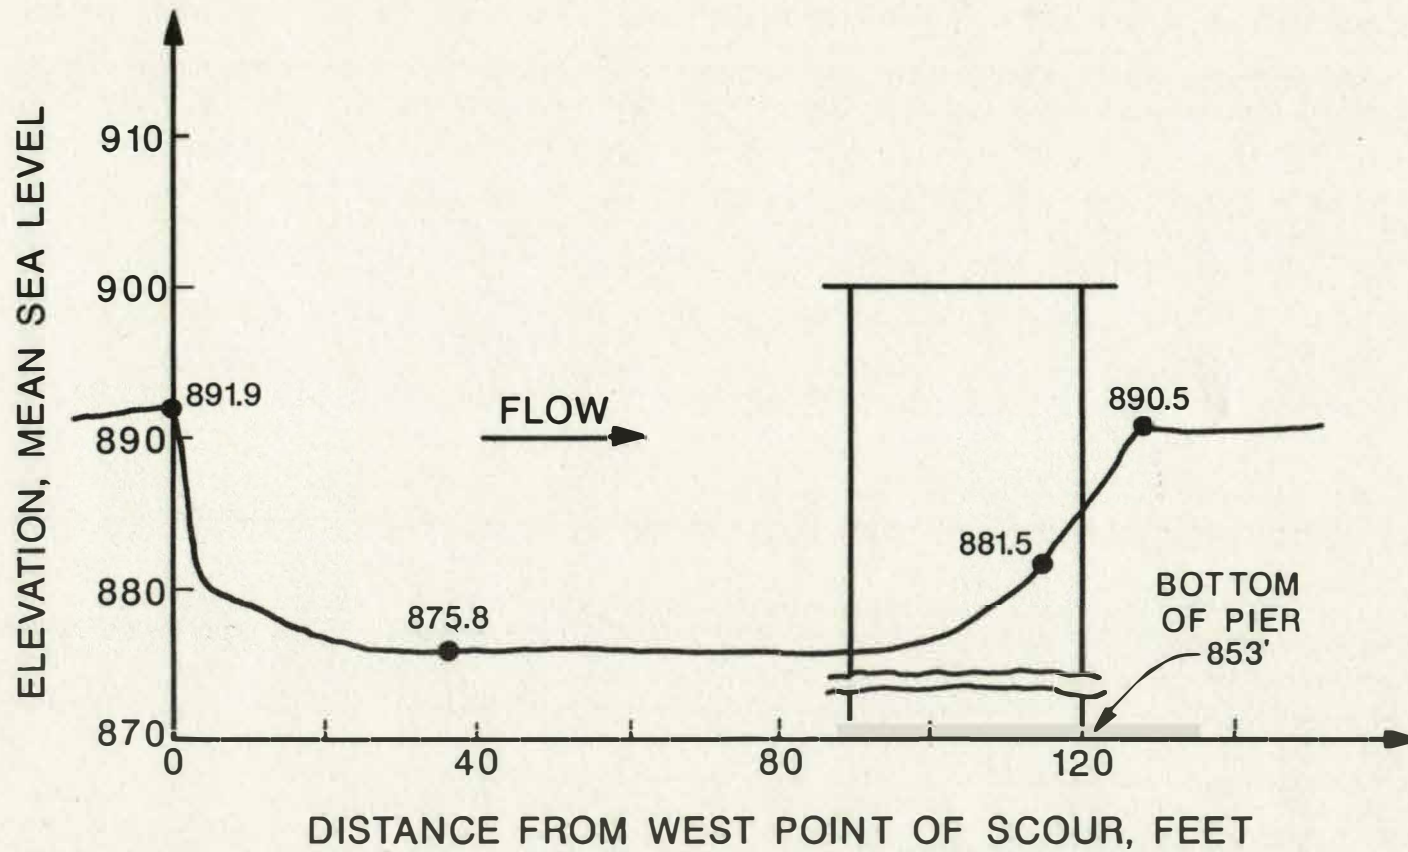
Figure 7b. Profile of South Scour Hole Upstream of Structure N.

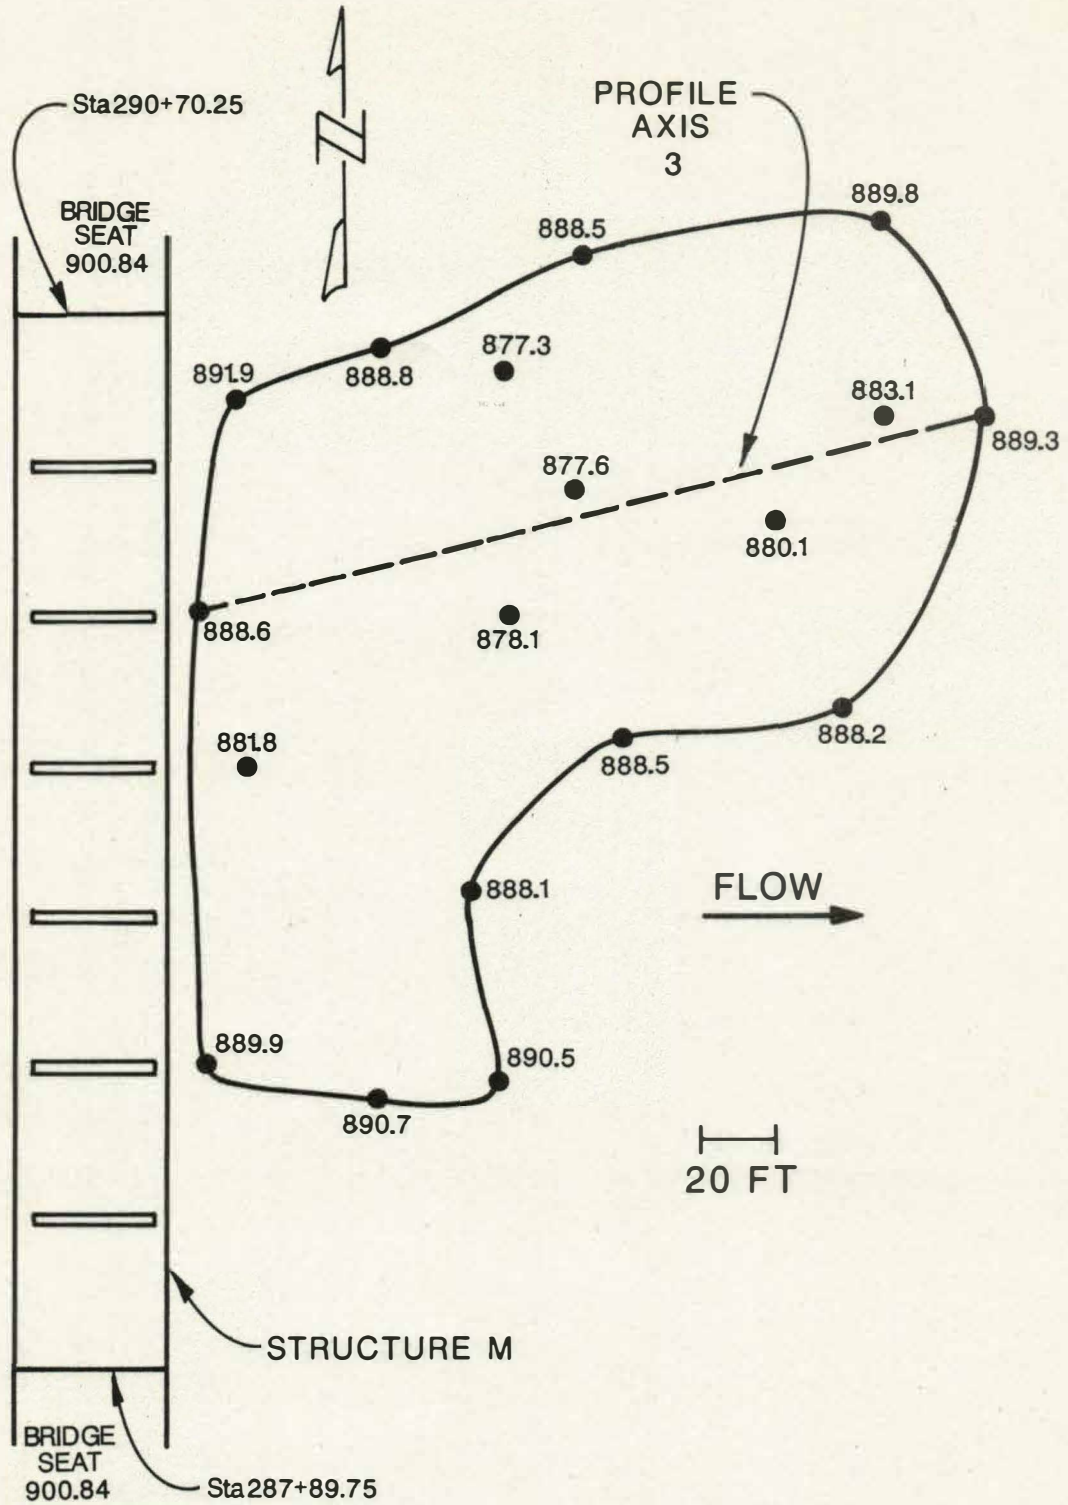
Figure 8. Location of Scour Hole Downstream of Structure M.

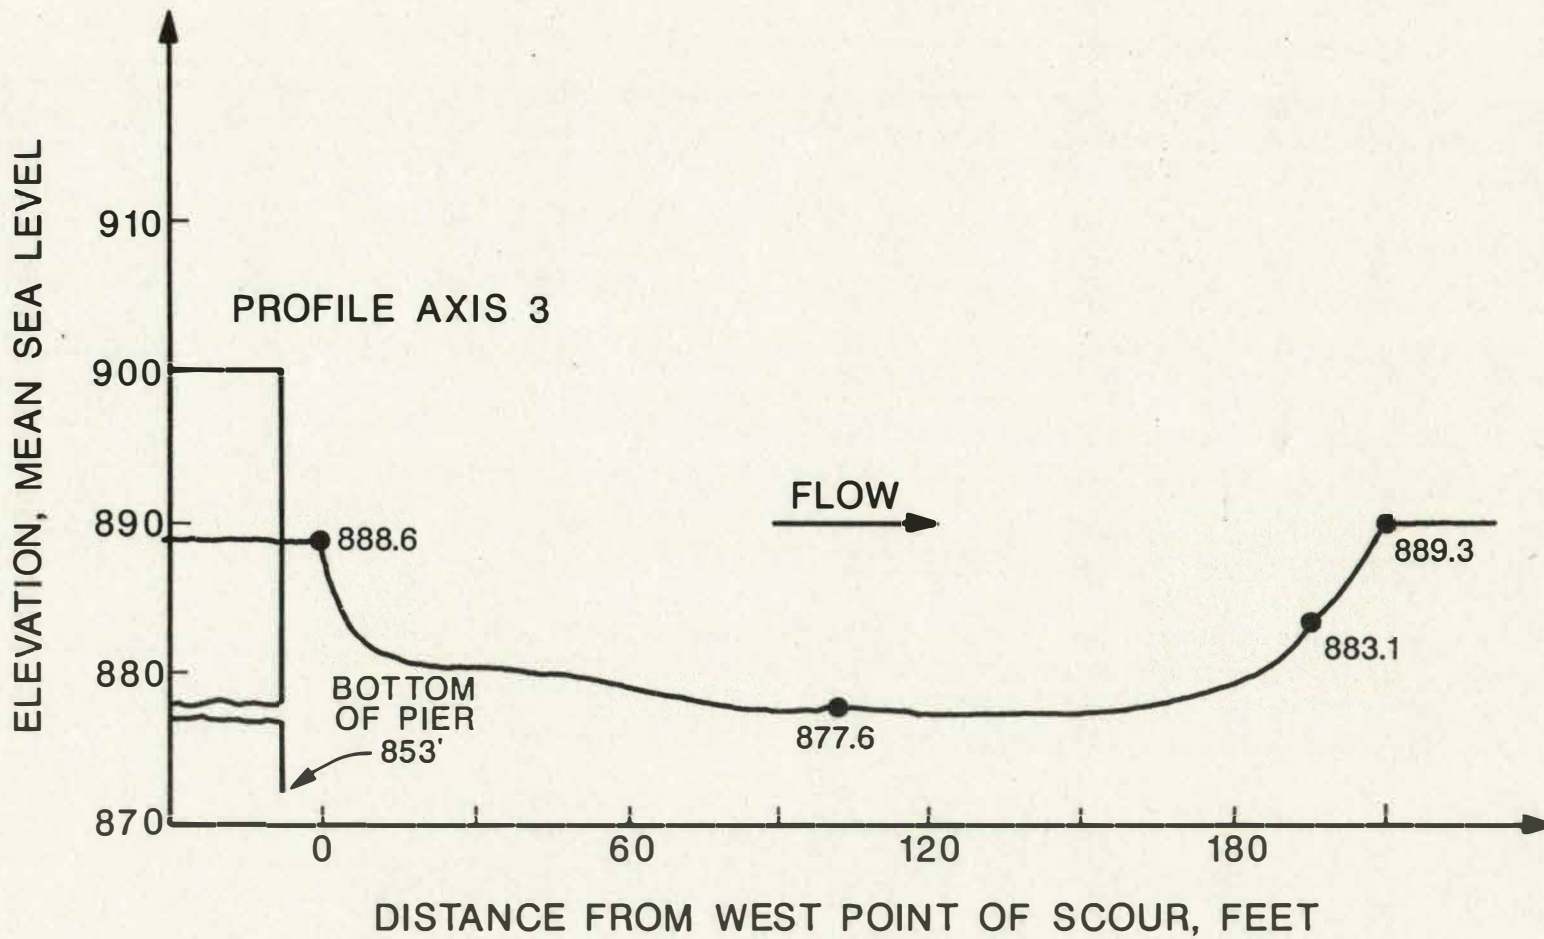
Figure 9. Profile of Scour Hole Downstream of Structure M.

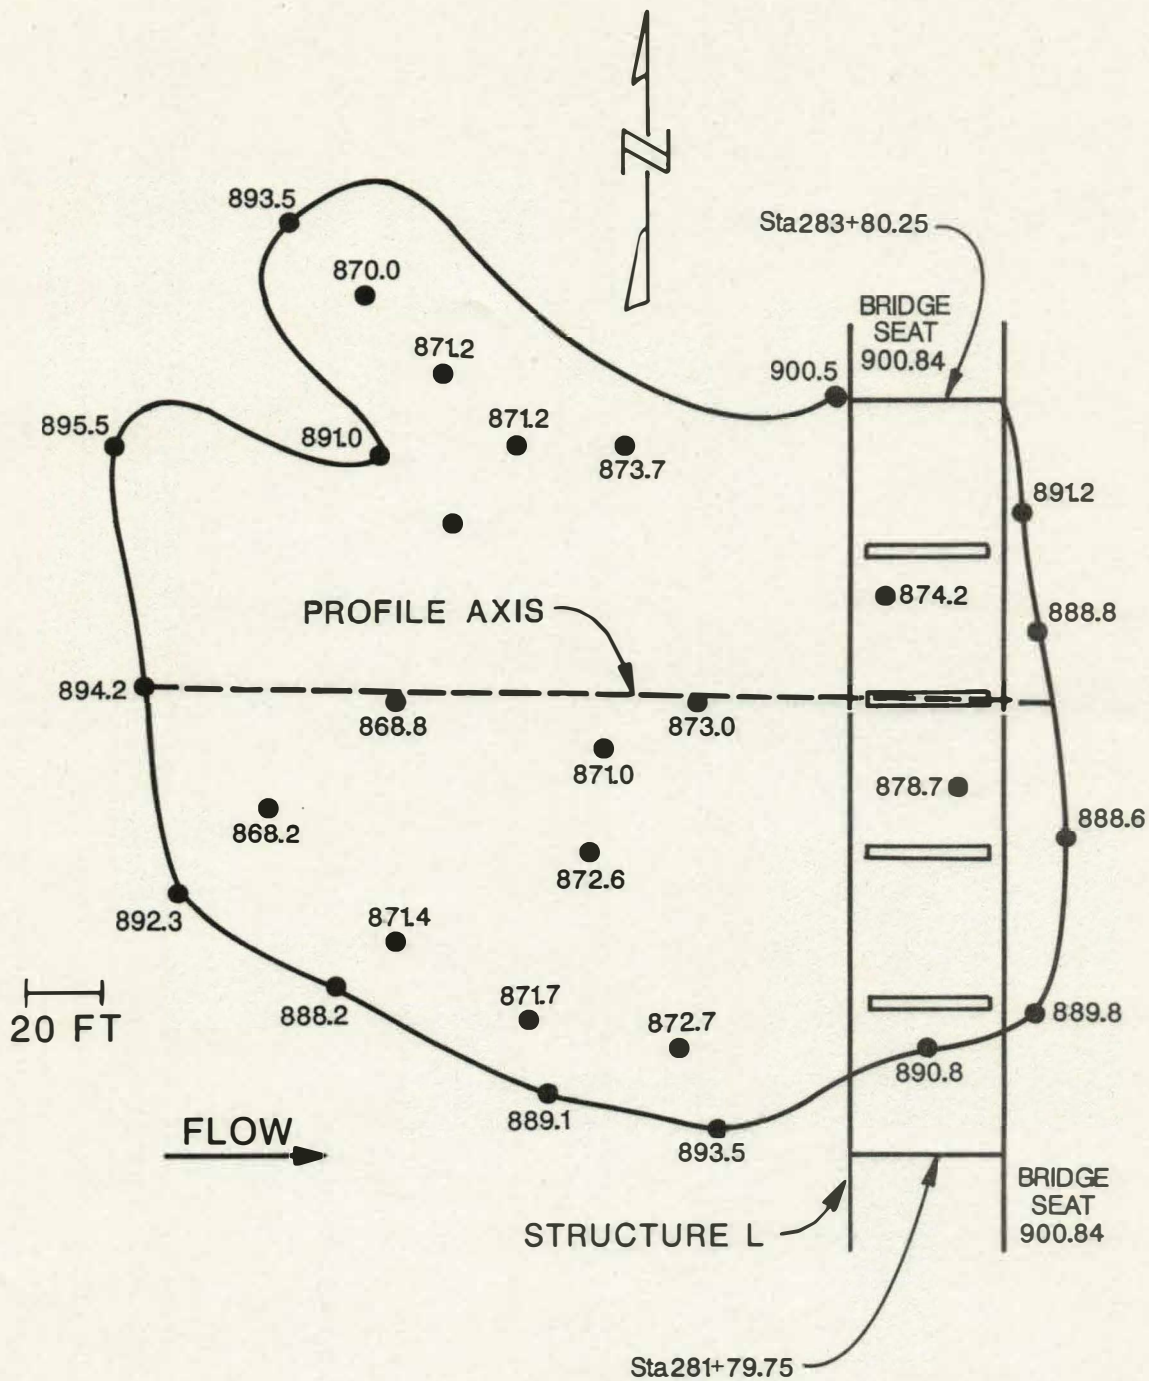
Figure 10. Location of Scour Hole Upstream of Structure L.

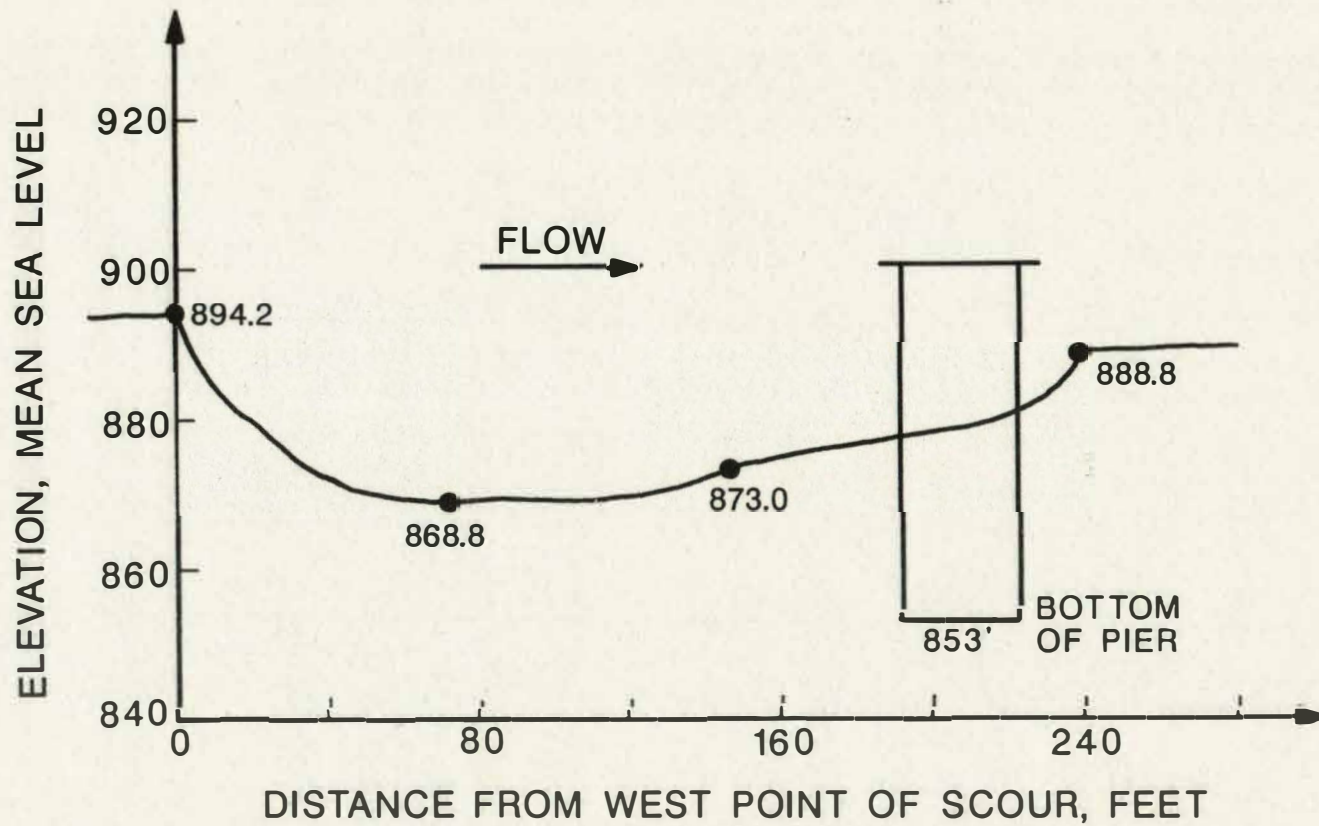
Figure 11. Profile of Scour Hole Upstream of Structure L.

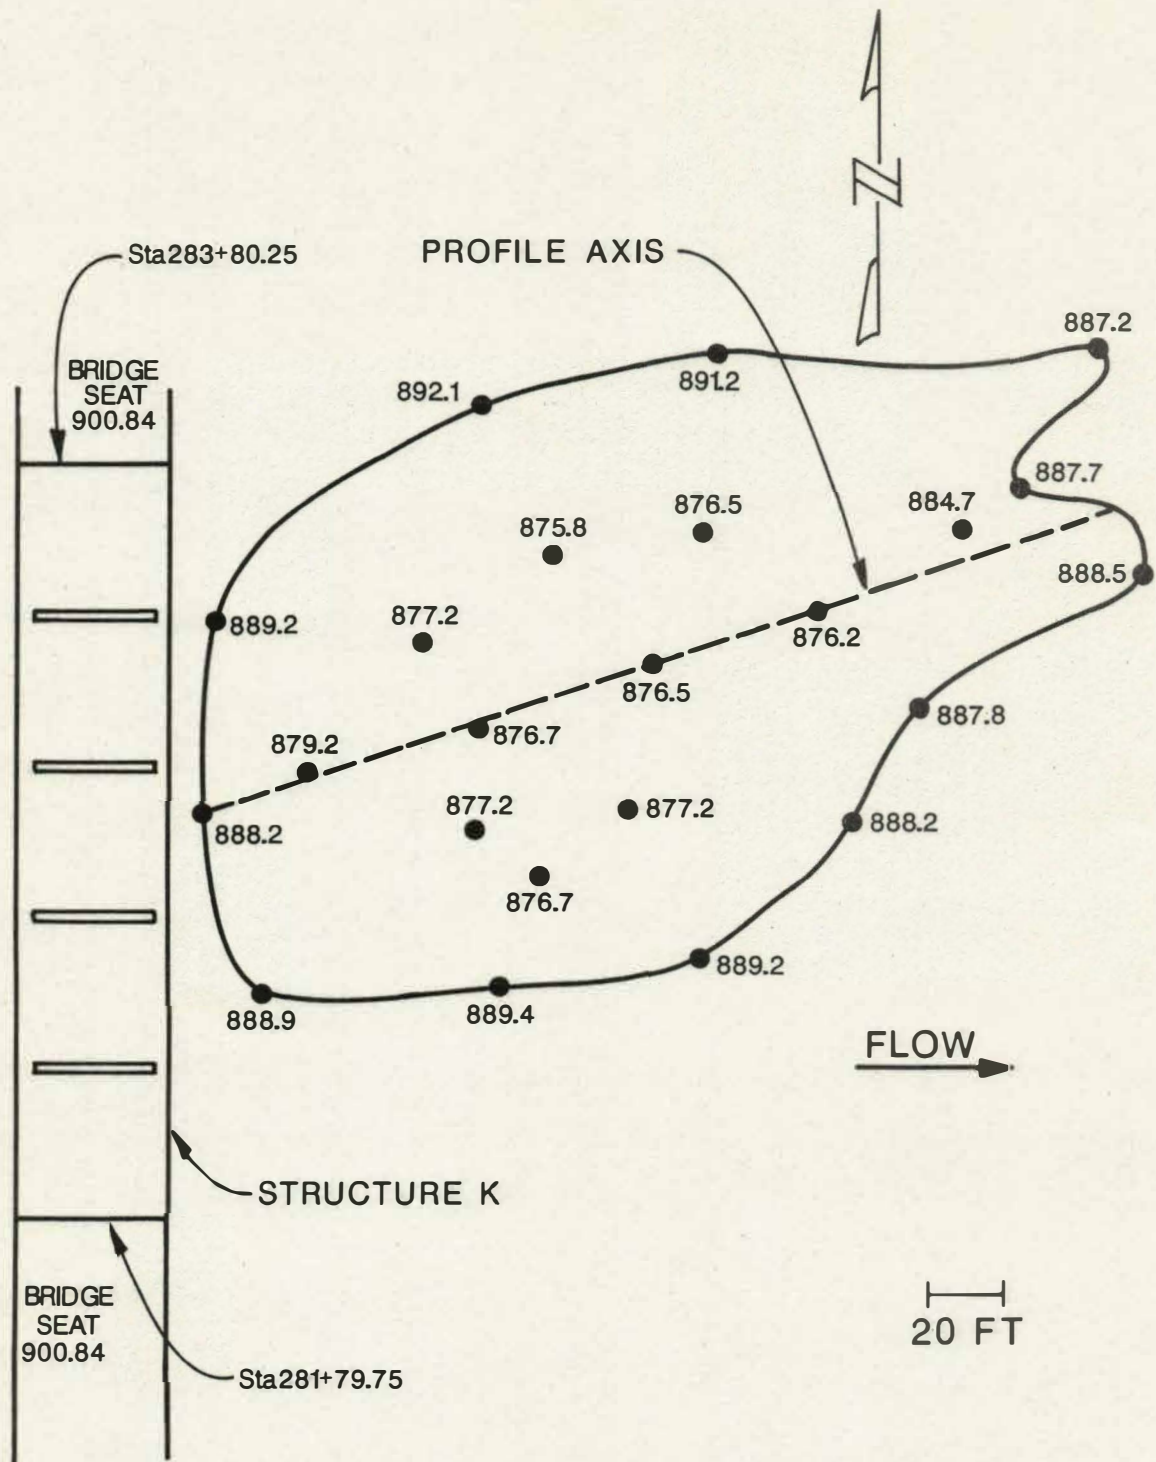
Figure 12. Location of Scour Hole Downstream of Structure K.

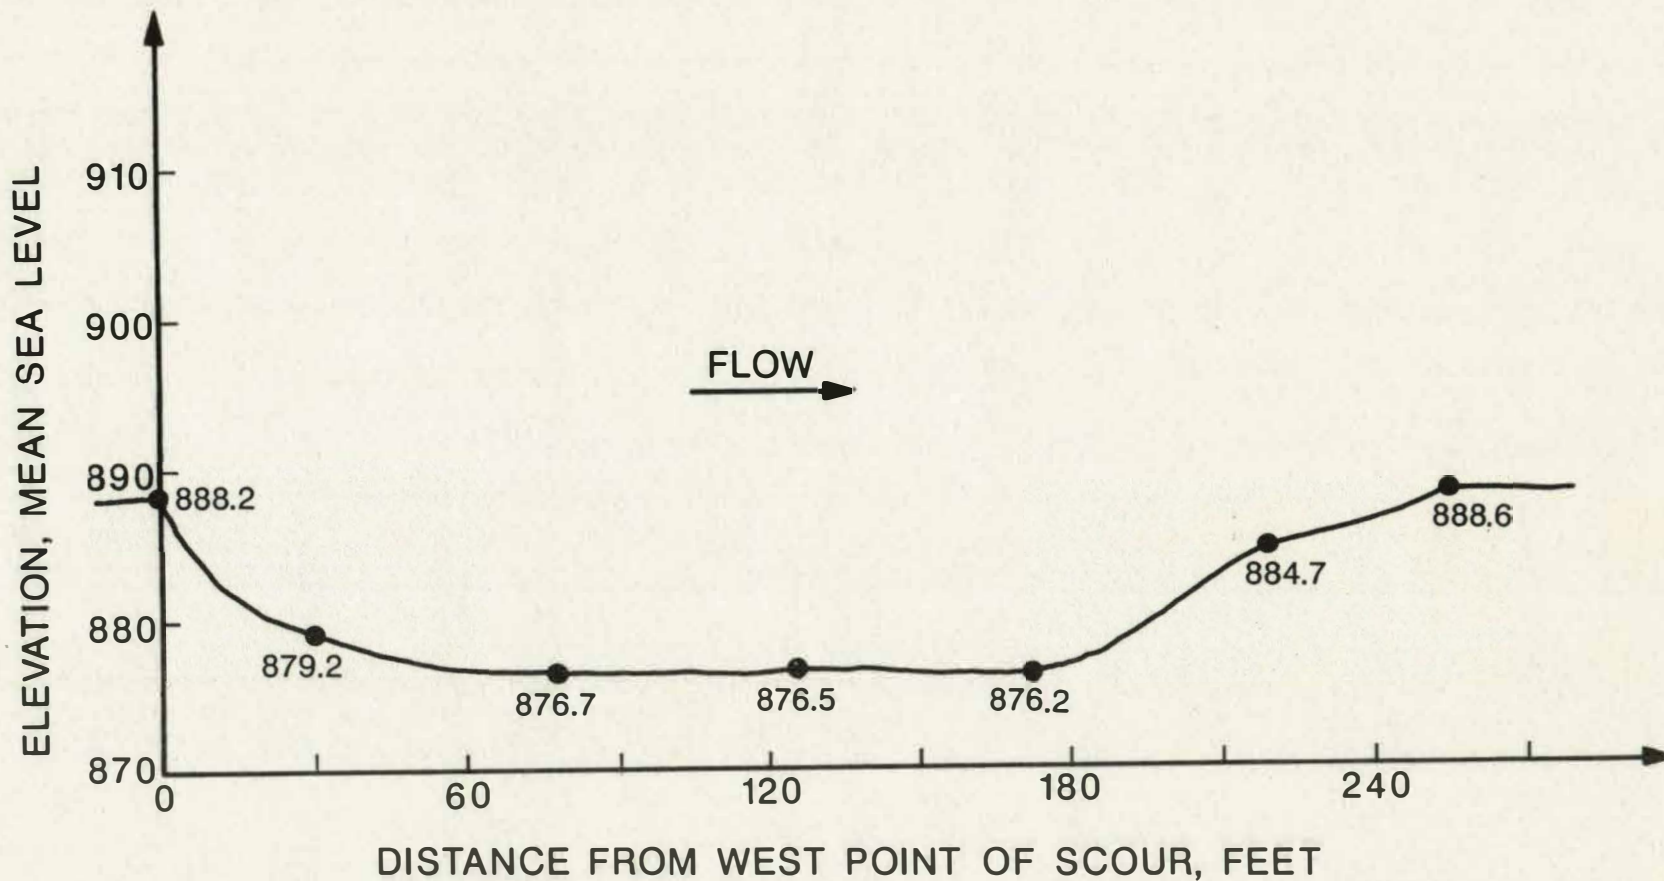
Figure 13. Profile of Scour Hole Downstream of Structure K.
