SCOUR AROUND BRIDGE PIERS OF OVERFLOW
STRUCTURES AT I-35 BRIDGE
ON THE CIMARRON RIVER

Report No. 88-1
Water Resources Engineering
School of Civil Engineering

Oklahoma State University
Stillwater, Oklahoma 74078

April 1988

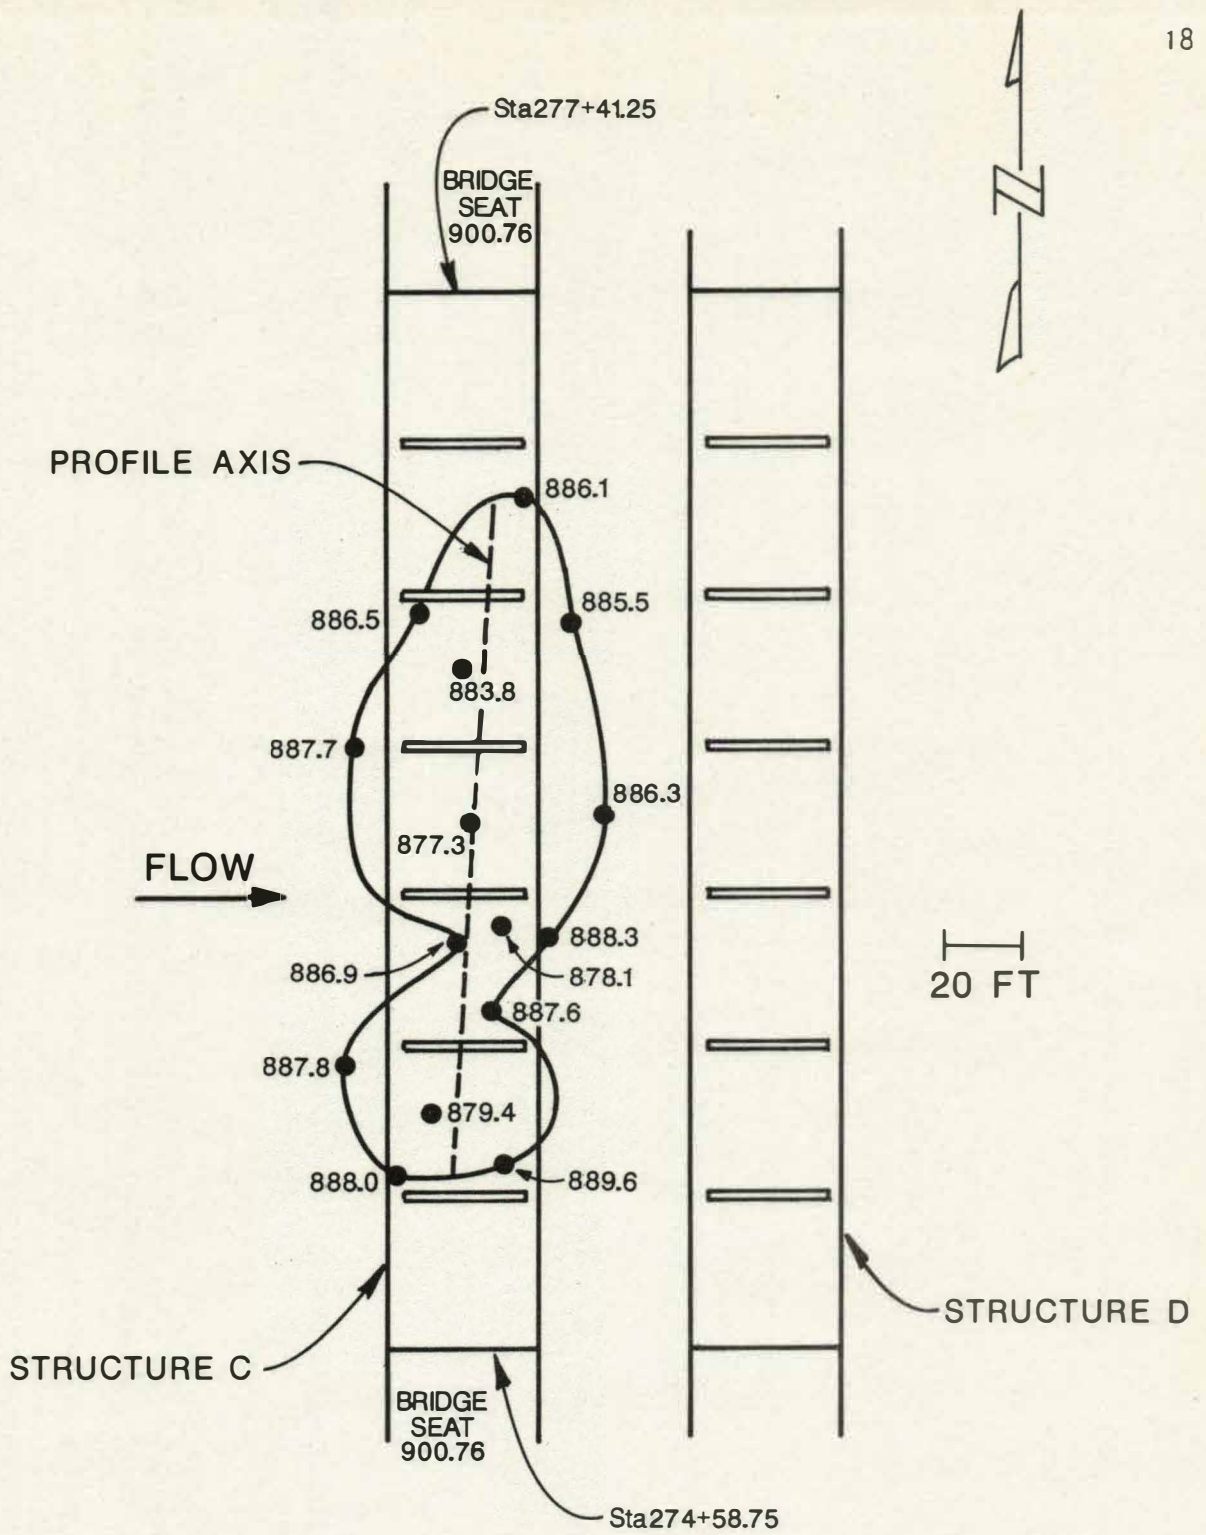
Figure 14. Location of Scour Hole Upstream of Structure C.

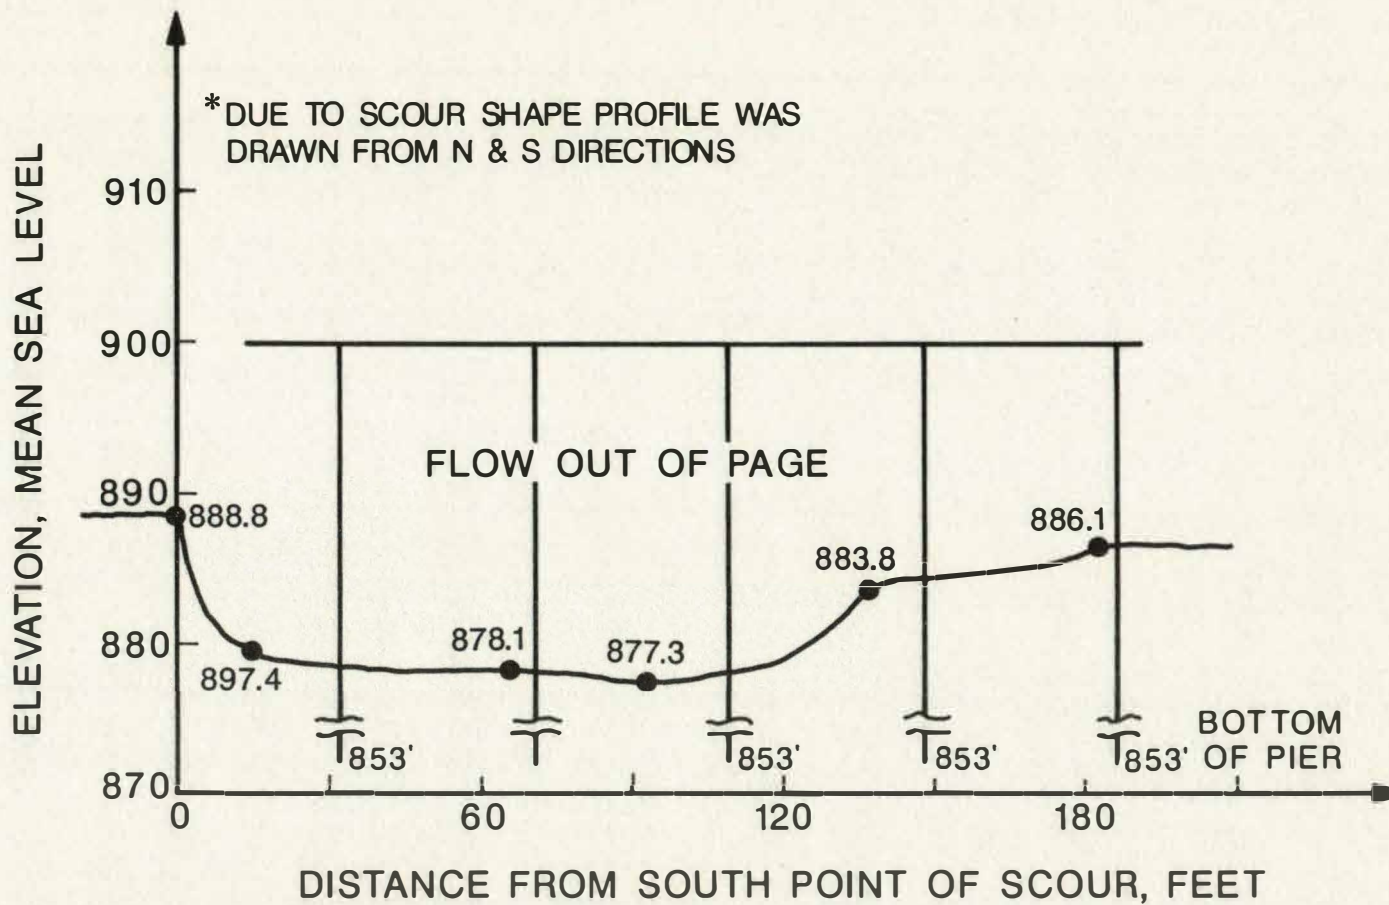
Figure 15. Profile of Scour Hole at Structure C.

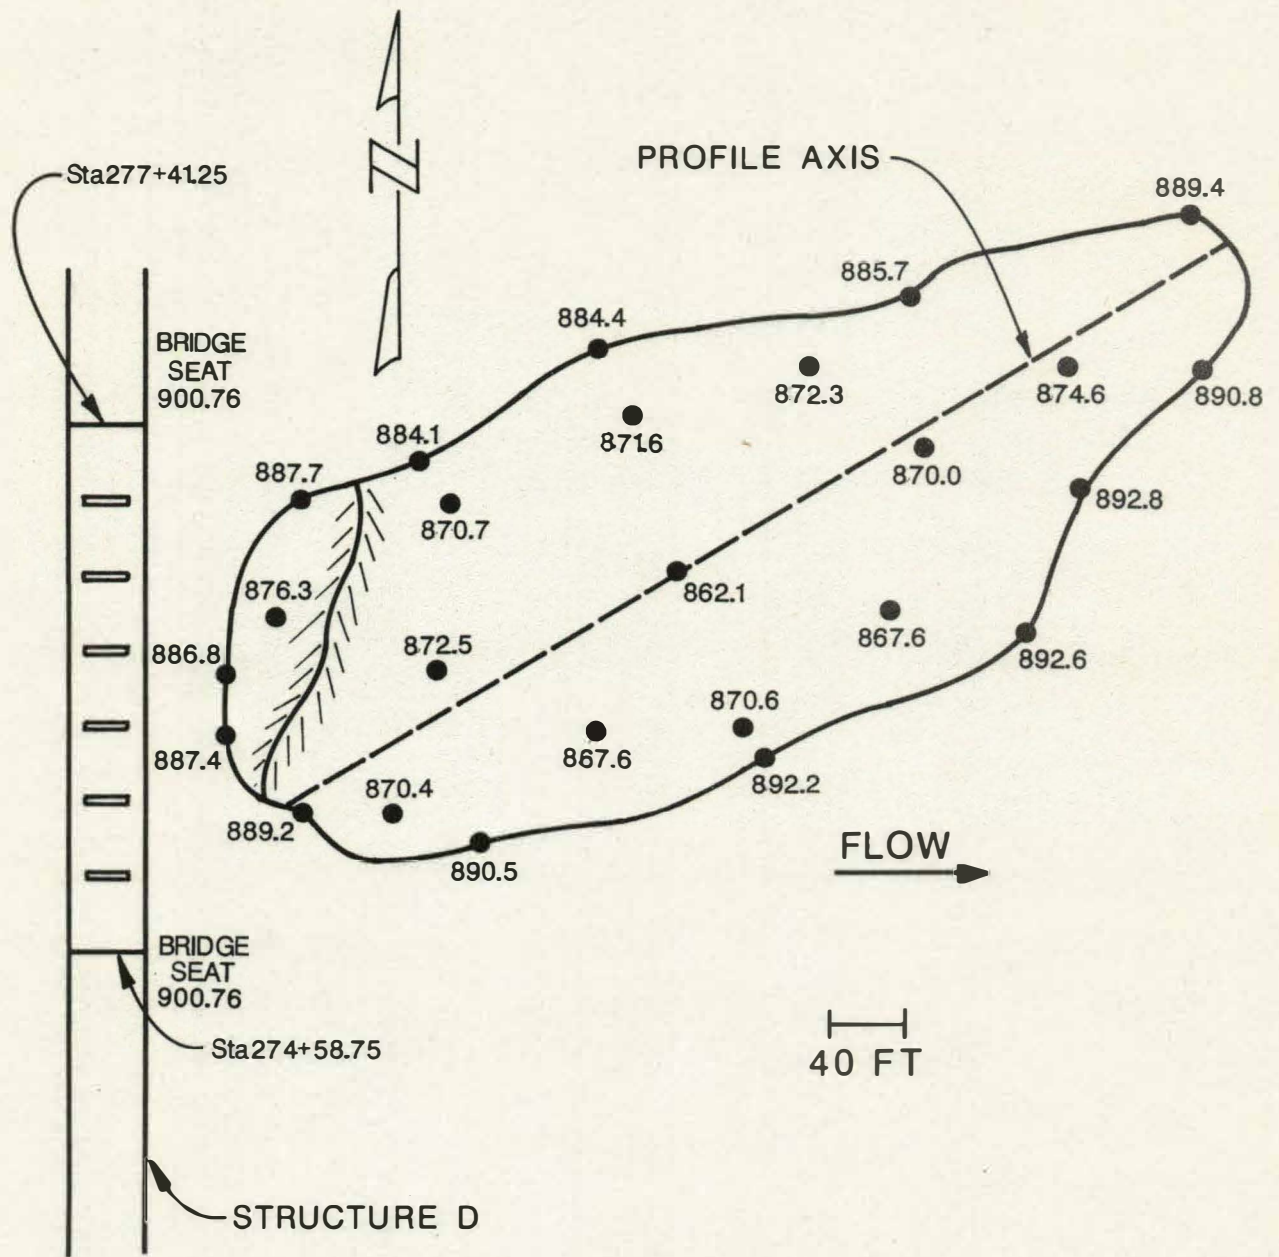
Figure 16. Location of Scour Hole Downstream of Structure D.

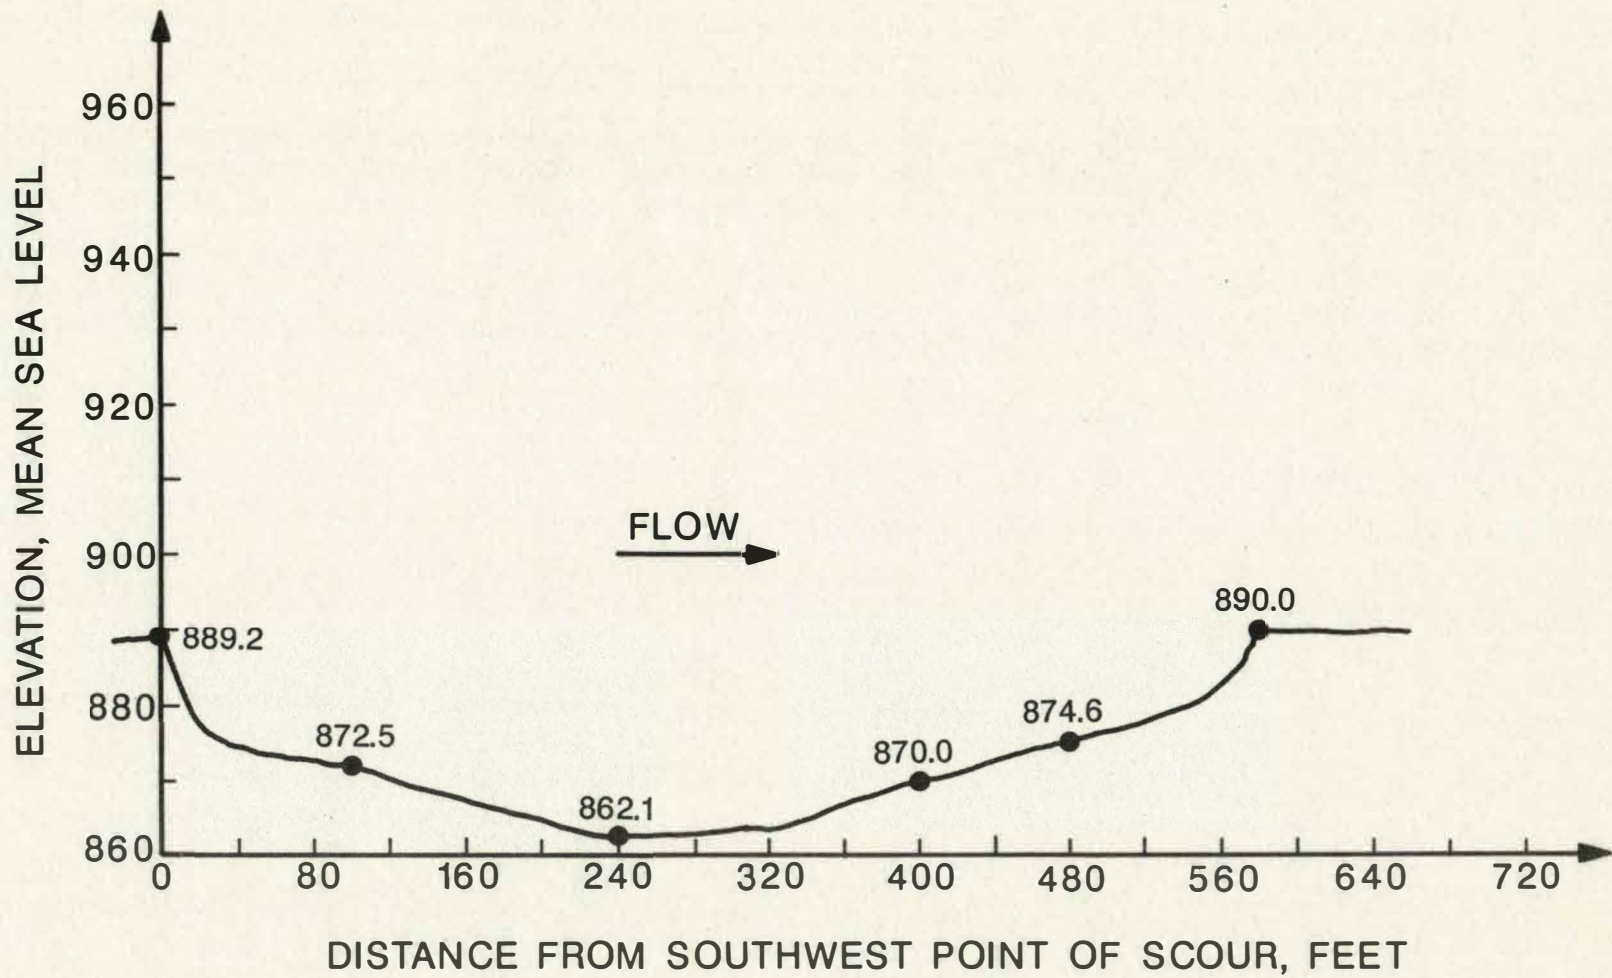
Figure 17. Profile of Scour Hole Downstream of Structure D.
