**THE EVALUATION  
OF  
NON-WOVEN FABRICS**

**PETROMAT & MIRAFI**

**MAY, 1982**

**Research and Development Division  
Oklahoma Department of Transportation**

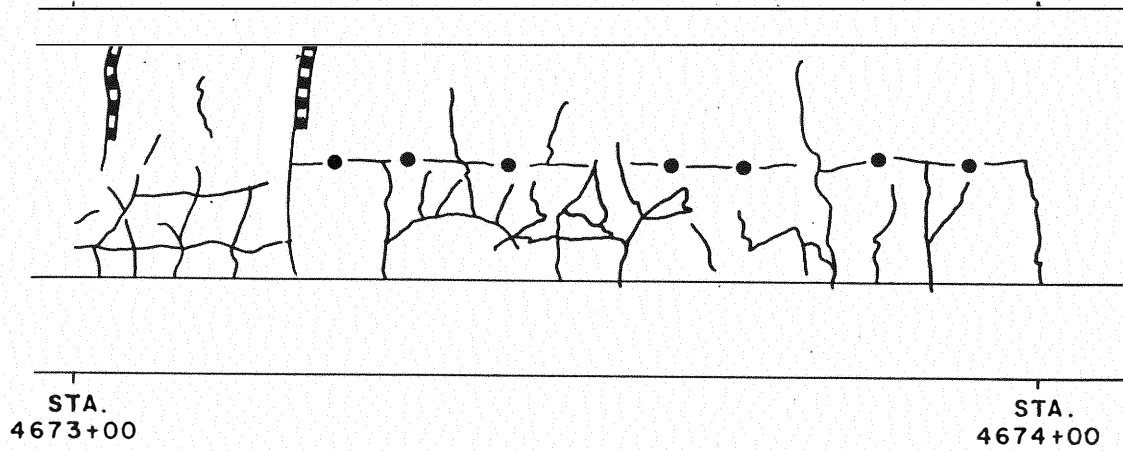
Figure 2. Typical Crack Evaluation Map for Petromat Test Section

The pre-construction evaluation was done during a two week period in September, 1976, The experimental sections were located and marked. The treated sections were chosen randomly. The existing system of reflective cracks was measured, classified, and drawn in detail, developing a detailed crack map. The width and length of each crack was measured, classified, and recorded. Figure 2 shows a typical crack evaluation map.

Figure 2 shows the development of reflected cracks during the six month and year evaluations.

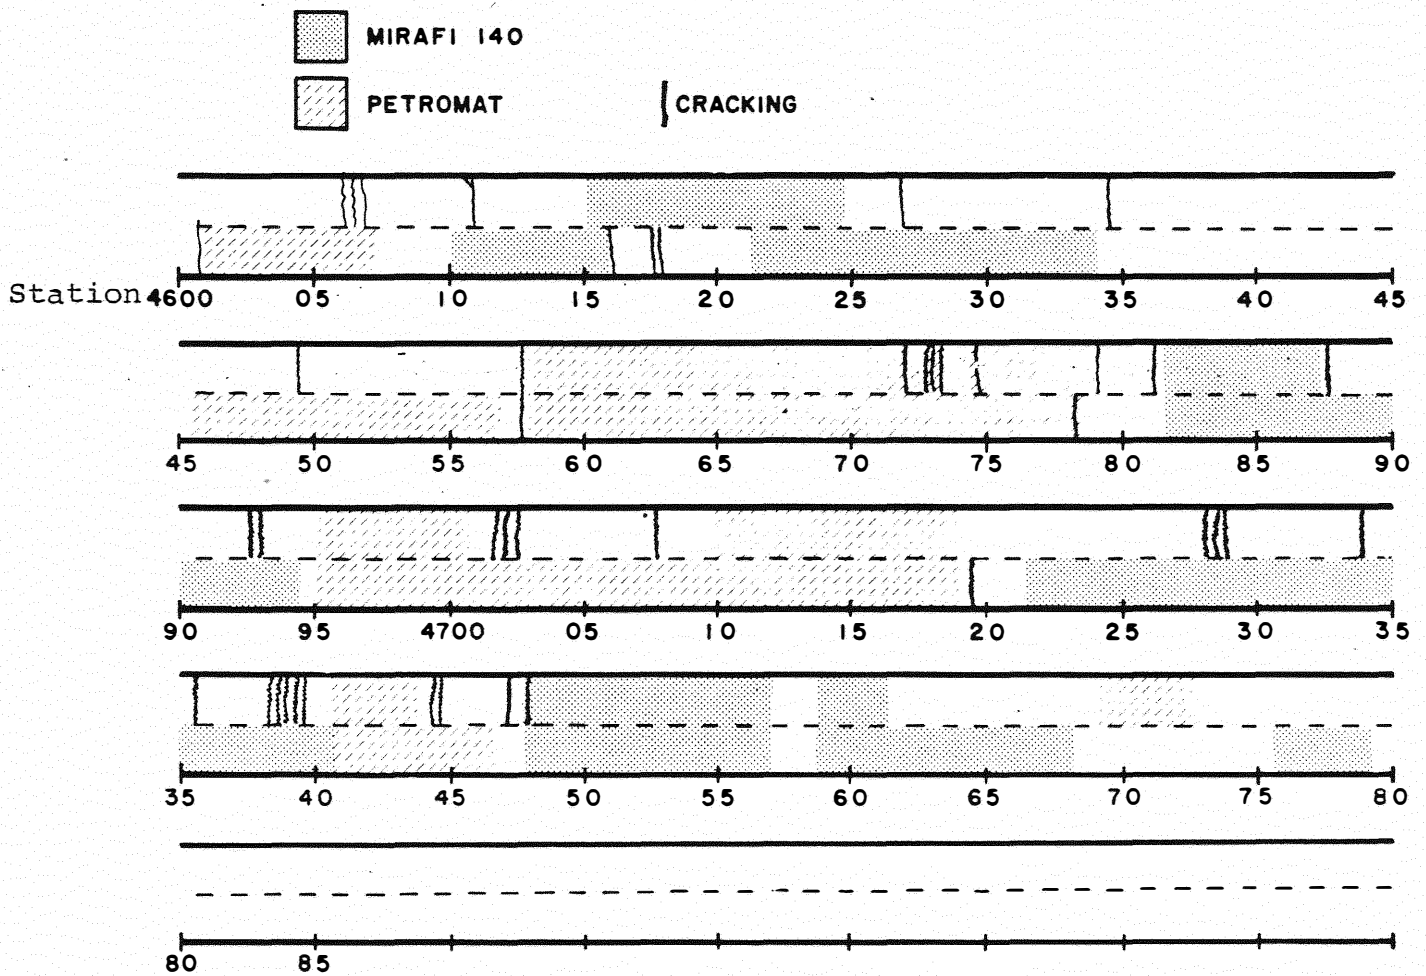
Figure 3. Transverse Cracks on Eastbound Section  
 30 Days after Construction

There were 42 transverse cracks within the project limits on the eastbound section (see Figure 3). Six of the cracks were located in Petromat between Stations 4672+00 and 4678+00. One crack was located in Mirafi (Station 4743+84) and one at the end of a Mirafi section at Station 4616+56. Only one crack ran the complete width of the road and it was in a control section. Most of the transverse

cracks began in the control sections opposite fabric sections and ran across the control section to the fabric edge. This occurred in control sections adjacent to both Petromat and Mirafi 140.

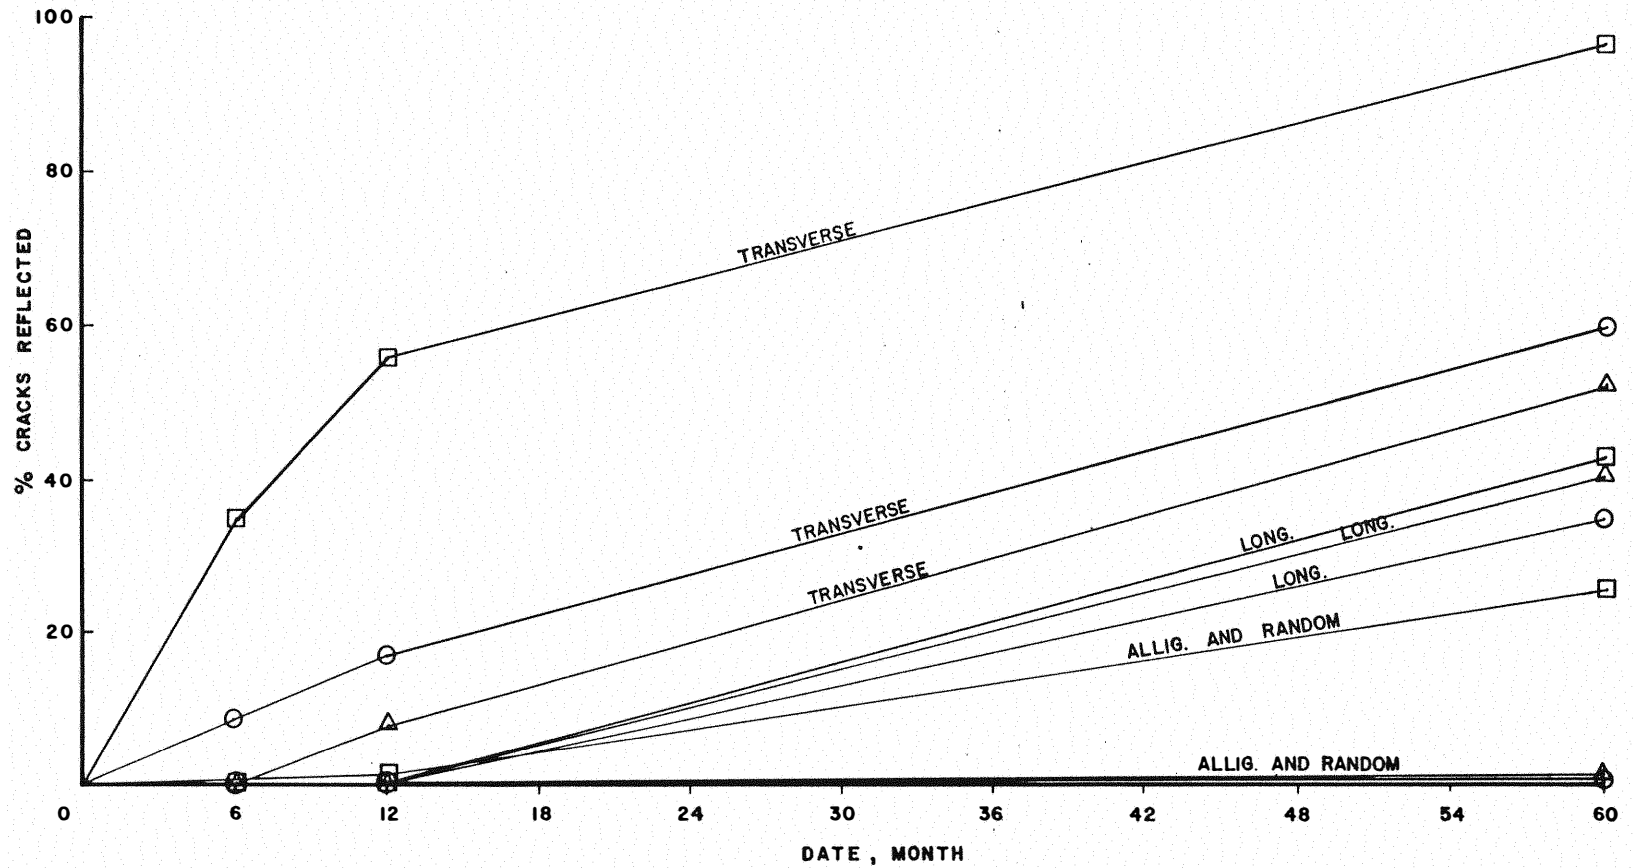
Figure 4. Crack Development for 1000 Foot Section

In the 1,000 ft. (305 m) Mirafi section, no cracks had reflected through in six months. Only 8 percent of transverse cracks had reflected through in one year. The longitudinal, random (block), and alligator cracks had not reflected through at the end of the year.

In the 1,000 ft. (305 m) Petromat section, 9 percent of the transverse cracks reflected through in six months with 17 percent of the cracks reflecting through at the end of the first year. Neither the longitudinal nor the alligator nor the random (large block) cracks had reflected through in the first year.

In the 1,000 ft (305 m) control sections, 35 percent of the transverse cracks had reflected through in six months and 56 percent of them had reflected through at the end of the year. There were no longitudinal cracks reflecting through in the first year. Only 0.2 percent of the random and alligator cracks had reflected through in six months and 8 percent at the end of the year. (See Figure 4.)
