CATHODIC PROTECTION FOR REINFORCED CONCRETE BRIDGE DECKS

Lawrence J. Senkowski, P.E.
Research Project Manager

SECOND ANNUAL REPORT

March, 1988

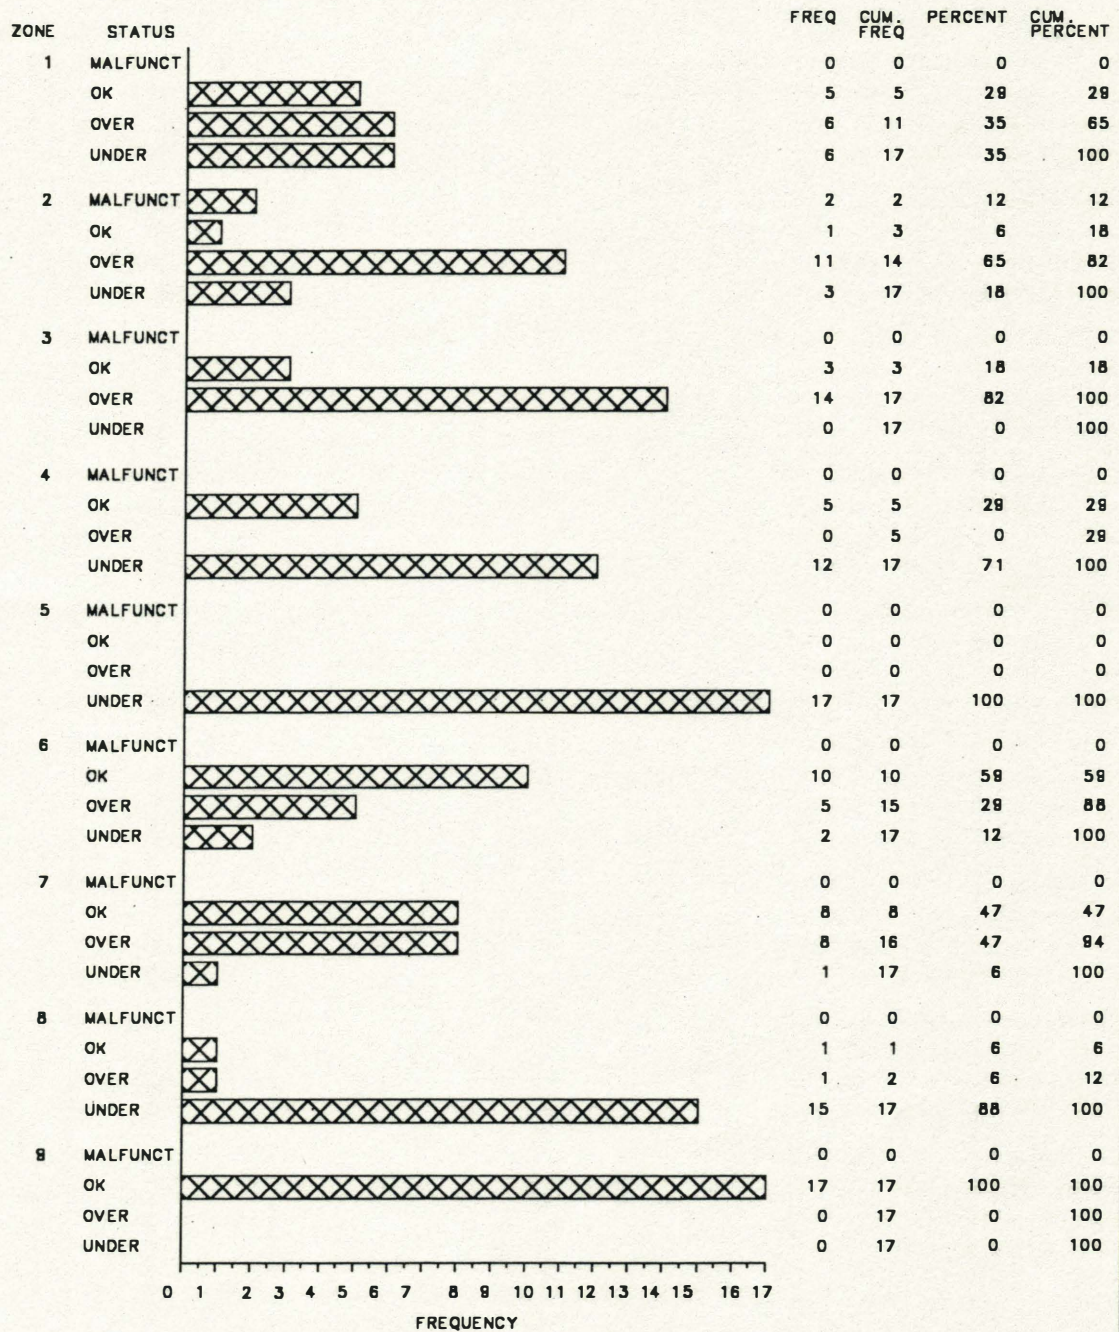
Figure 1. Bird Creek Status of Operation

It has been two and one half years (30 months) since the system was installed and put into operation. Six of those months the system was inoperable, and monthly data was not obtained. Figure 1. shows a summary of the status of operation for each zone while the system was in operation. The data represented in figure 1. is included in Appendix B.

Zone 1 has been classified as being "OVER" protected, "UNDER" protected, and "OK". The "OVER" protection was due to the problems with the reference cell. Since that was fixed it has been classified as either "OK" or "UNDER" protected and the current has been continuously discharging.

Zone 2 had the same as Zone 1 except it has two readings that were classified as "MALFUNCTIONING", which were a result of the reference cell's reading being higher than the meter could register. Therefore, no reading could be obtained. However, since the problem of the reference cells was fixed, Zone 2 has still been "OVER" protected. This is a result of Zone 1 constantly discharging current and the fact that these two zones interact on the same span, i.e. Zone 2 is receiving extra current from Zone 1.

Zone 3 has had a mixed status of either "OK" or "OVER" protected. This implies that sufficient current has been applied. Most of the zones that exhibit "OVER" protection are receiving current from an adjacent zone within the span. In this case Zone 3 is receiving extra current from Zone 4 which has been classified as being mostly "UNDER" protected, and like Zone 1, has continuously discharged current.

Zone 4, as previously mentioned, has consistently discharged current and has always been either "OK" or "UNDER" protected. The amount of "UNDER" protection, has not been significant.

Zone 5 has had a continuous status of "UNDER" protection throughout its entire operation. Although this is not inherently bad, it does mean that the system is not raising the reference cell reading to the desired level.

Zone 6 has had a mixed status of "OK", "OVER" protection, and "UNDER" protection. However, the potential of the reference cell has never deviated more than 78 millivolts from the set potential, and the current output has fluctuated on and off accordingly. Therefore, this zone has been performing satisfactorily.

Zone 7, like Zone 1 & 2, had a problem with the reference cell. Since the problem was corrected Zone 7 has been operating satisfactorily; one exception existed where the current from Zone 8 seemed to have influenced Zone 7.

Zone 8 has mainly been classified as being "UNDER" protected. However, the last reading that was obtained showed it to be "OVER" protected. Again, the location of Zone 7 & 8 on the same span allows these zones to interact with each other.

Zone 9 is the only zone that has had a continuous status of "OK" throughout its entire operation. Incidentally, this is the only zone that is not directly adjacent to another operating zone, i.e. it is in a span by itself.

In summary, all zones in the Bird Creek cathodic protection system have been operating satisfactorily since the power surge damage was repaired. The zones exhibiting "OVER" protection have potentials higher than the desired potential, but the potentials are well below that which would create hydrogen evolution. In the same manner, the zones exhibiting "UNDER" protection have potentials below the desired potential, but the potentials are significantly higher (at least 100 millivolts) than the static potentials, thereby protecting the steel cathodically. Finally, the ability of the controller to maintain the set potential within a zone has been hampered by the interaction of adjacent zones on a given span.

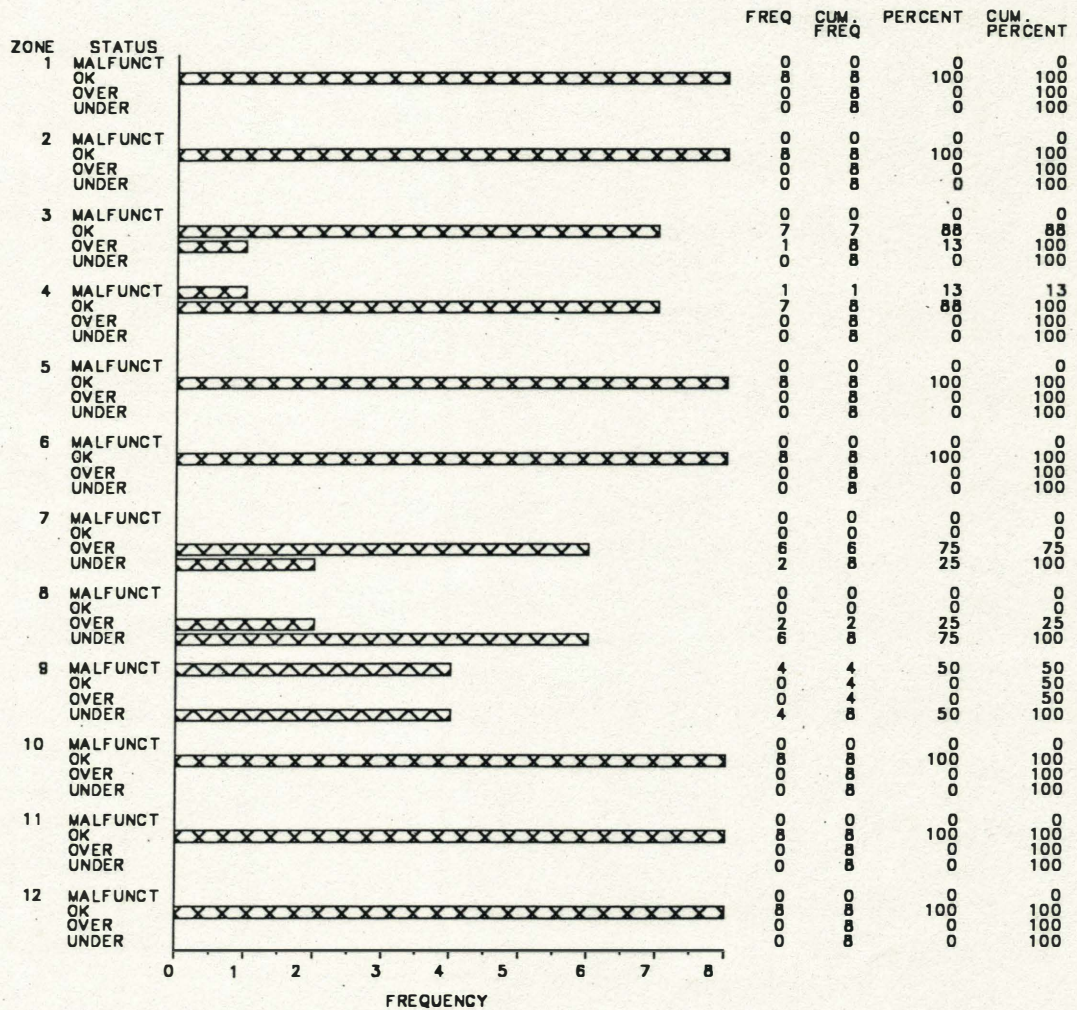
Figure 2. Overflow Status of Operation

The system was in operation for over 38 weeks. Figure 2. shows a summary of the status of operation for each zone while the system was in operation. The data represented in figure 2. is included in Appendix B.

Zone 1, 2, 3, 5, 6, 10, 11, & 12 all performed ideally up to the time of the power surge.

Zone 4 has performed satisfactorily except in one instance in which there was a blown fuse resulting in a "MALFUNCTION".

Zone 7 & 8 were either "UNDER" protected or "OVER" protected. This was due to the reference cells being crossed wired in these two zones. This problem has been corrected.

Zone 9 has malfunctioned several times due to a reccurring blown fuse.

In summary, the Overflow cathodic protection system has operated ideally with the exception of Zone 9 repeatedly blowing fuses. Zones 7 & 8 have not yielded enough information to determine the results since rewiring, and Zone 4 has not blown another fuse. The stability of the zones on the Overflow cathodic protection system can be attributed to the fact that there was one zone per span.
