PORTLAND CEMENT CONCRETE

PAVEMENT RESTORATION

FINAL REPORT

Under
Demonstration Project No. 69

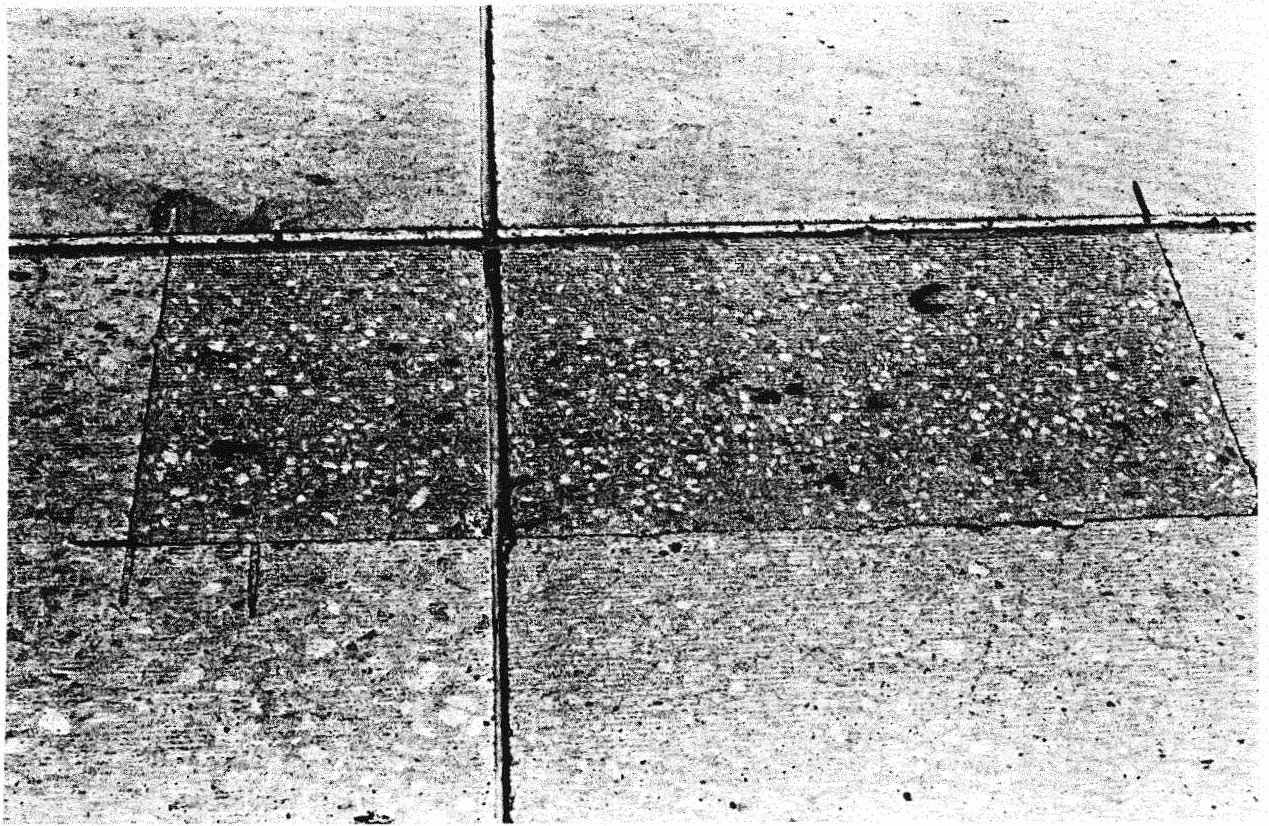
One year after installation, it appeared that the polymer concrete had debonded around the edges. However, the patch did not appear to be loose. After three years of service, the polymer concrete patch is still in place and exhibits no other signs of distress. See Figure 3.

Figure 3. Spall Repair

A spall located across a joint was repaired with a polymer concrete using the partial depth replacement technique. The area around the spall was sawed to a depth of 2 inches to provide clean vertical edges. The damaged concrete was chipped out with a jack hammer and sand blasted clean. Tape was applied to the longitudinal joint as a bond breaker, and a piece of plywood was used to form the transverse joint. A primer coat was applied and then the polymer concrete was placed. After the concrete hardened, the plywood was removed.

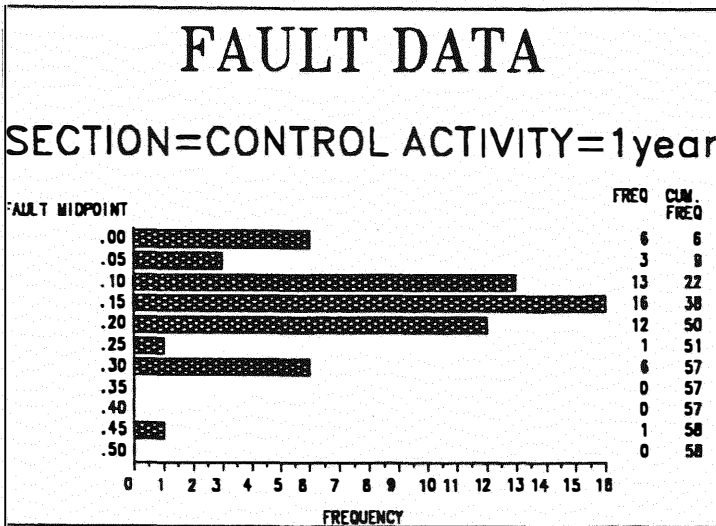
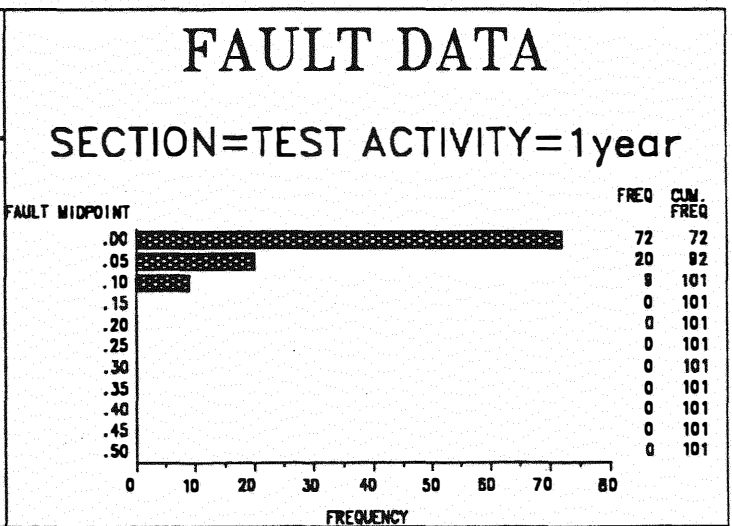
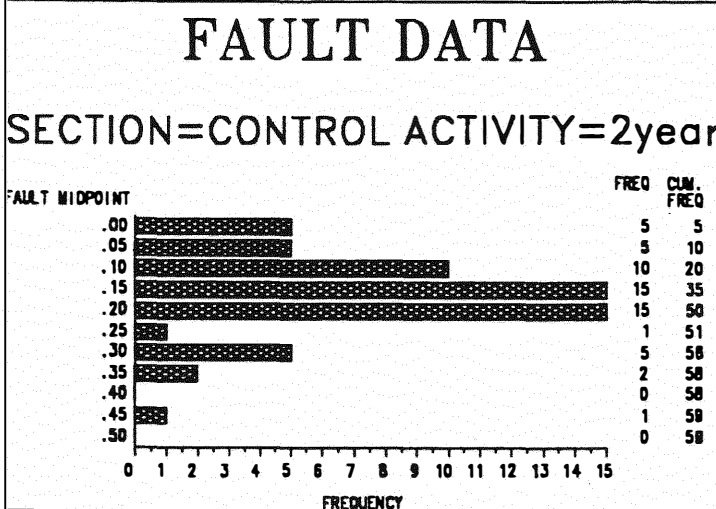
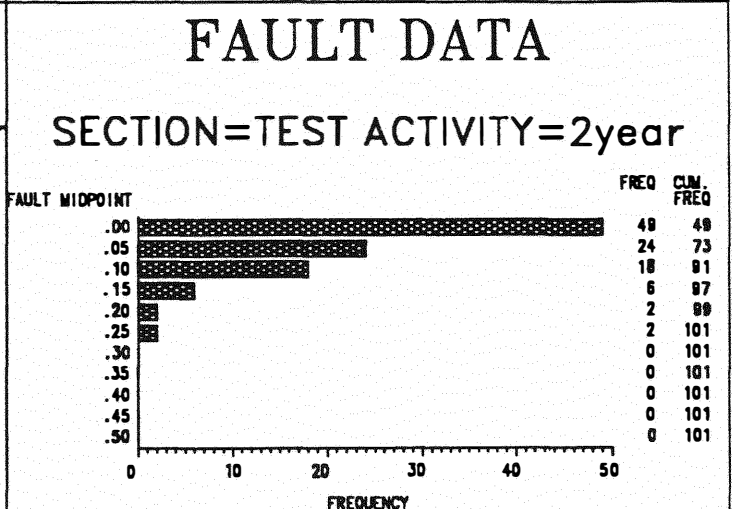
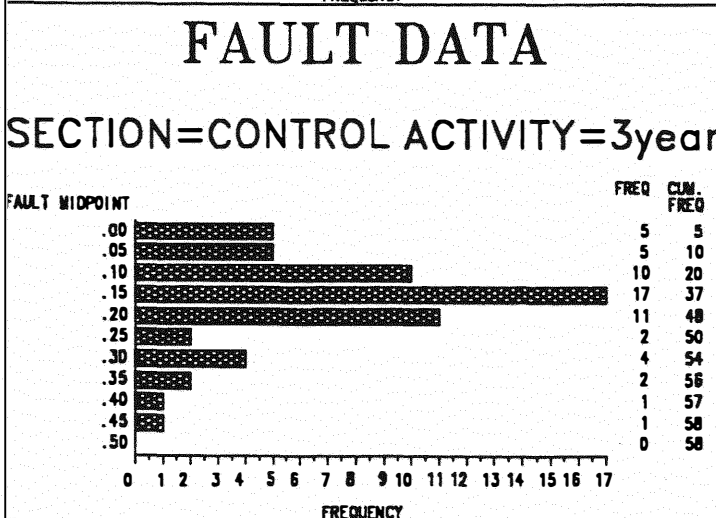
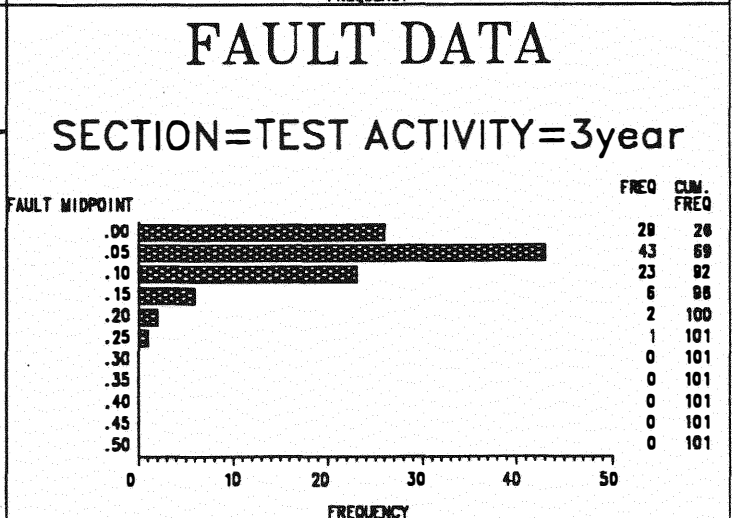
Figure 4. Fault Data

Fault data was collected every year since the restoration work was performed. The level of faulting in the test section has steadily increased. See Figure 4. After one year 29 percent of the slabs in the test section had a measurable fault at the joint. After two years, 52 percent of the slabs in the test section had a measurable fault. After three years, 75 percent of the slabs in the test section had a measurable fault.

A core investigation revealed the presence of "cone failure". Cores were taken on three randomly selected slabs. On each slab, one core was obtained directly over an injection hole, and each revealed the conical shattering of the bottom of the slab around the injection hole.

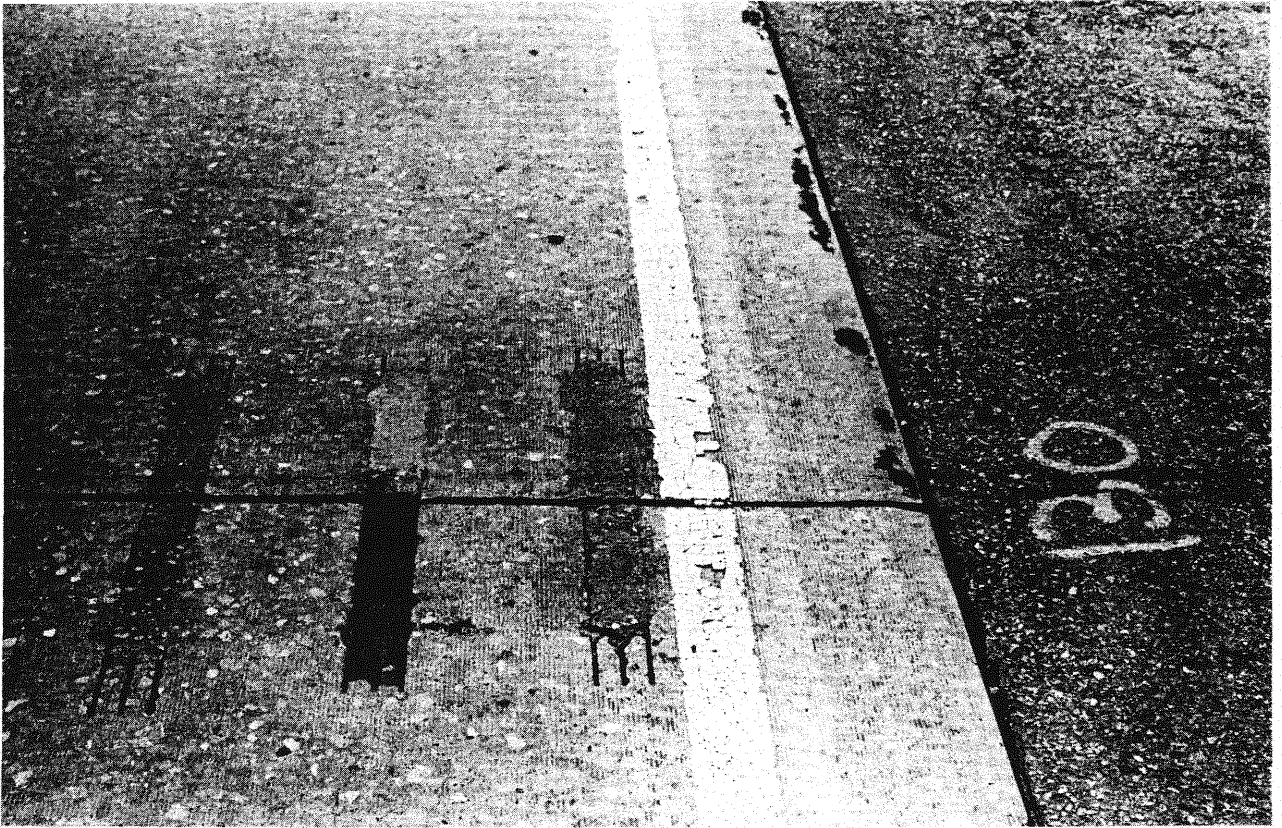
Three of the six joints retrofitted with dowel bars had failure of at least one unit. Two of the six joints had failure of two units. The backfill material for these units had cracked, debonded, and in one case totally popped out (Figures 7 & 8). It is important to note that these slabs were not stabilized.

Figure 7. Distressed Dowel Bar

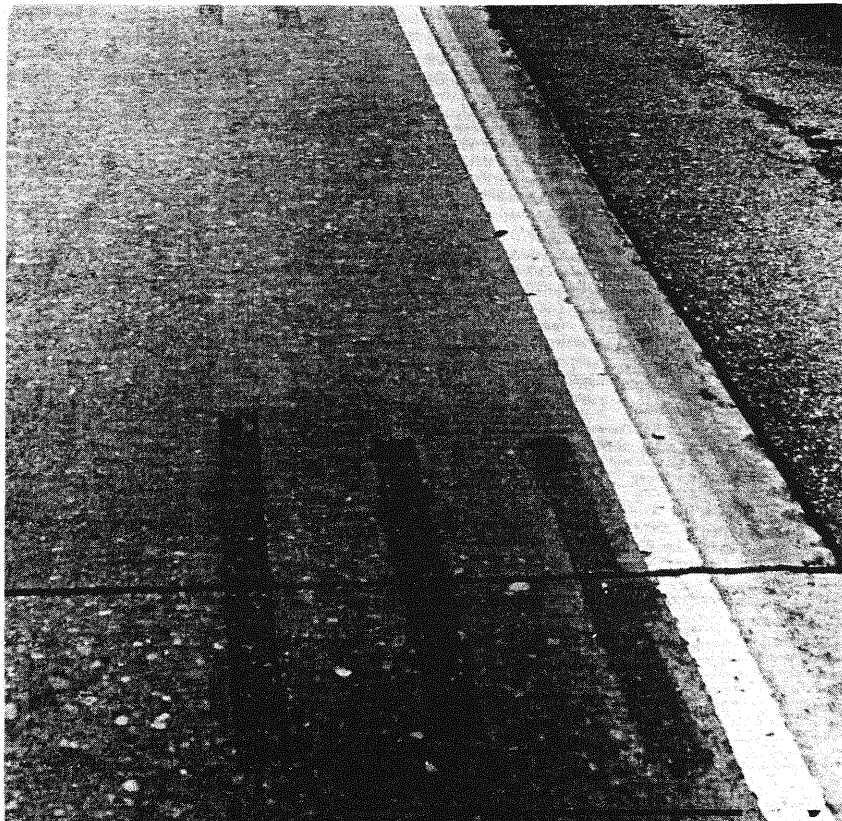
Figure 8. Distressed Dowel Bar

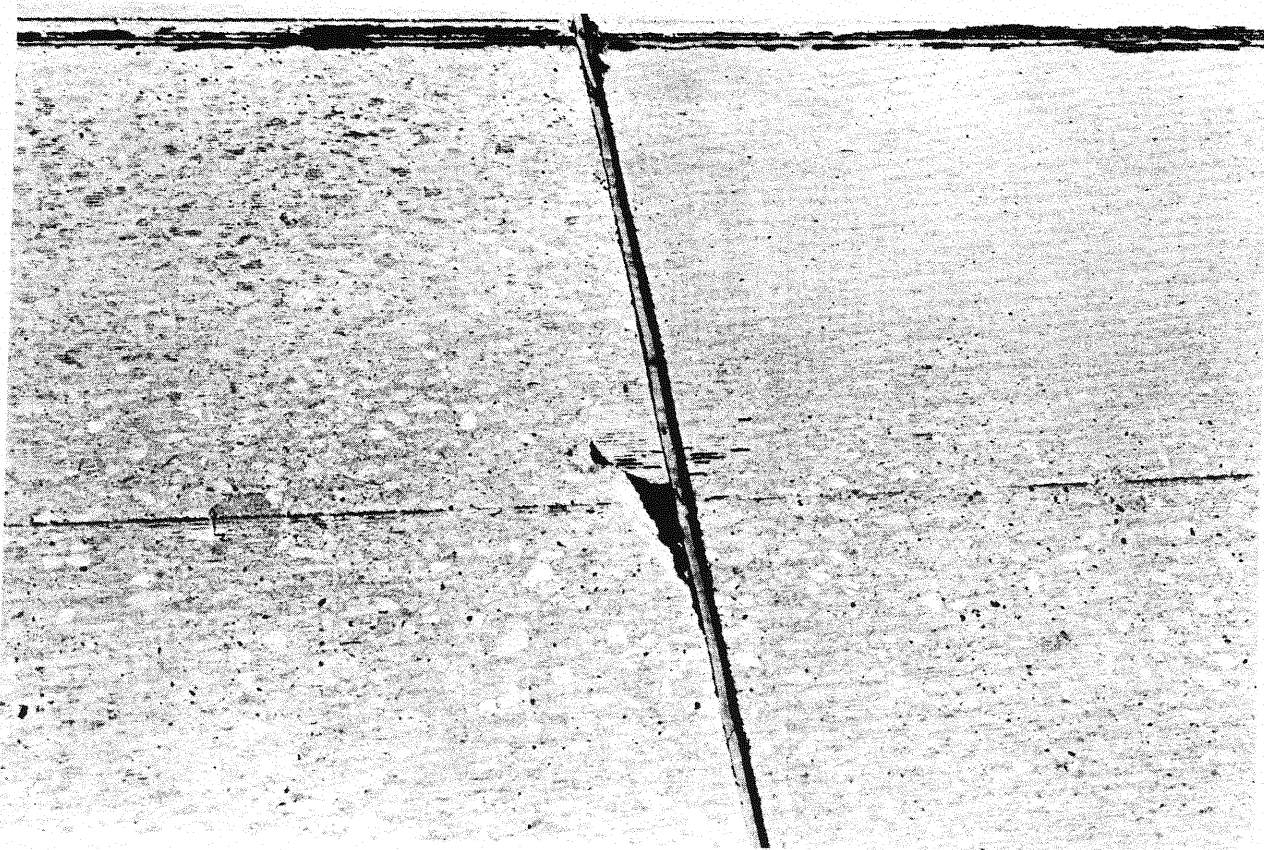
Of the six joints retrofitted with double-v load transfer devices, three joints had some kind of distress with at least one unit. Spalling occurred around three units over two joints, (Figures 9 & 10).

Figure 9. Spall Around Double - V Device

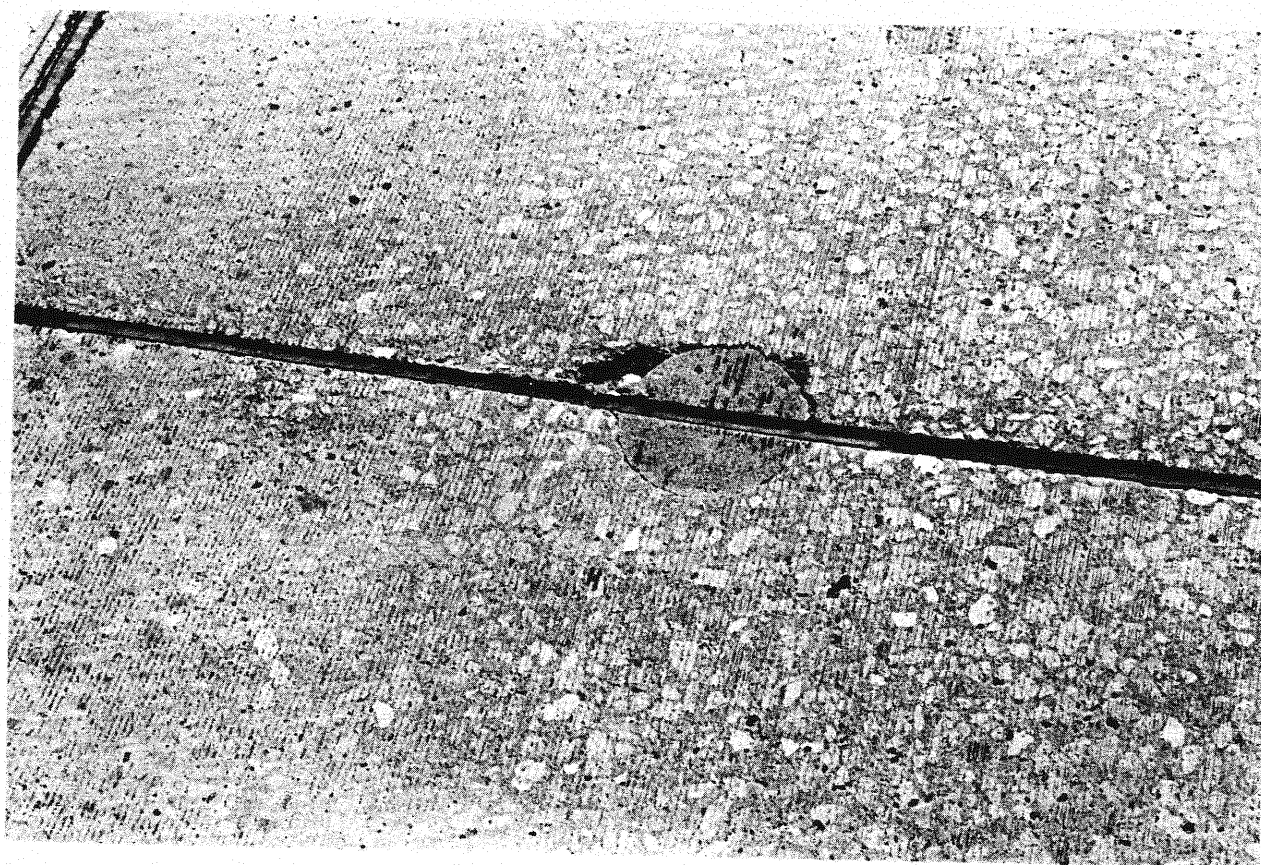
Figure 10. Spall Around Double - V Device

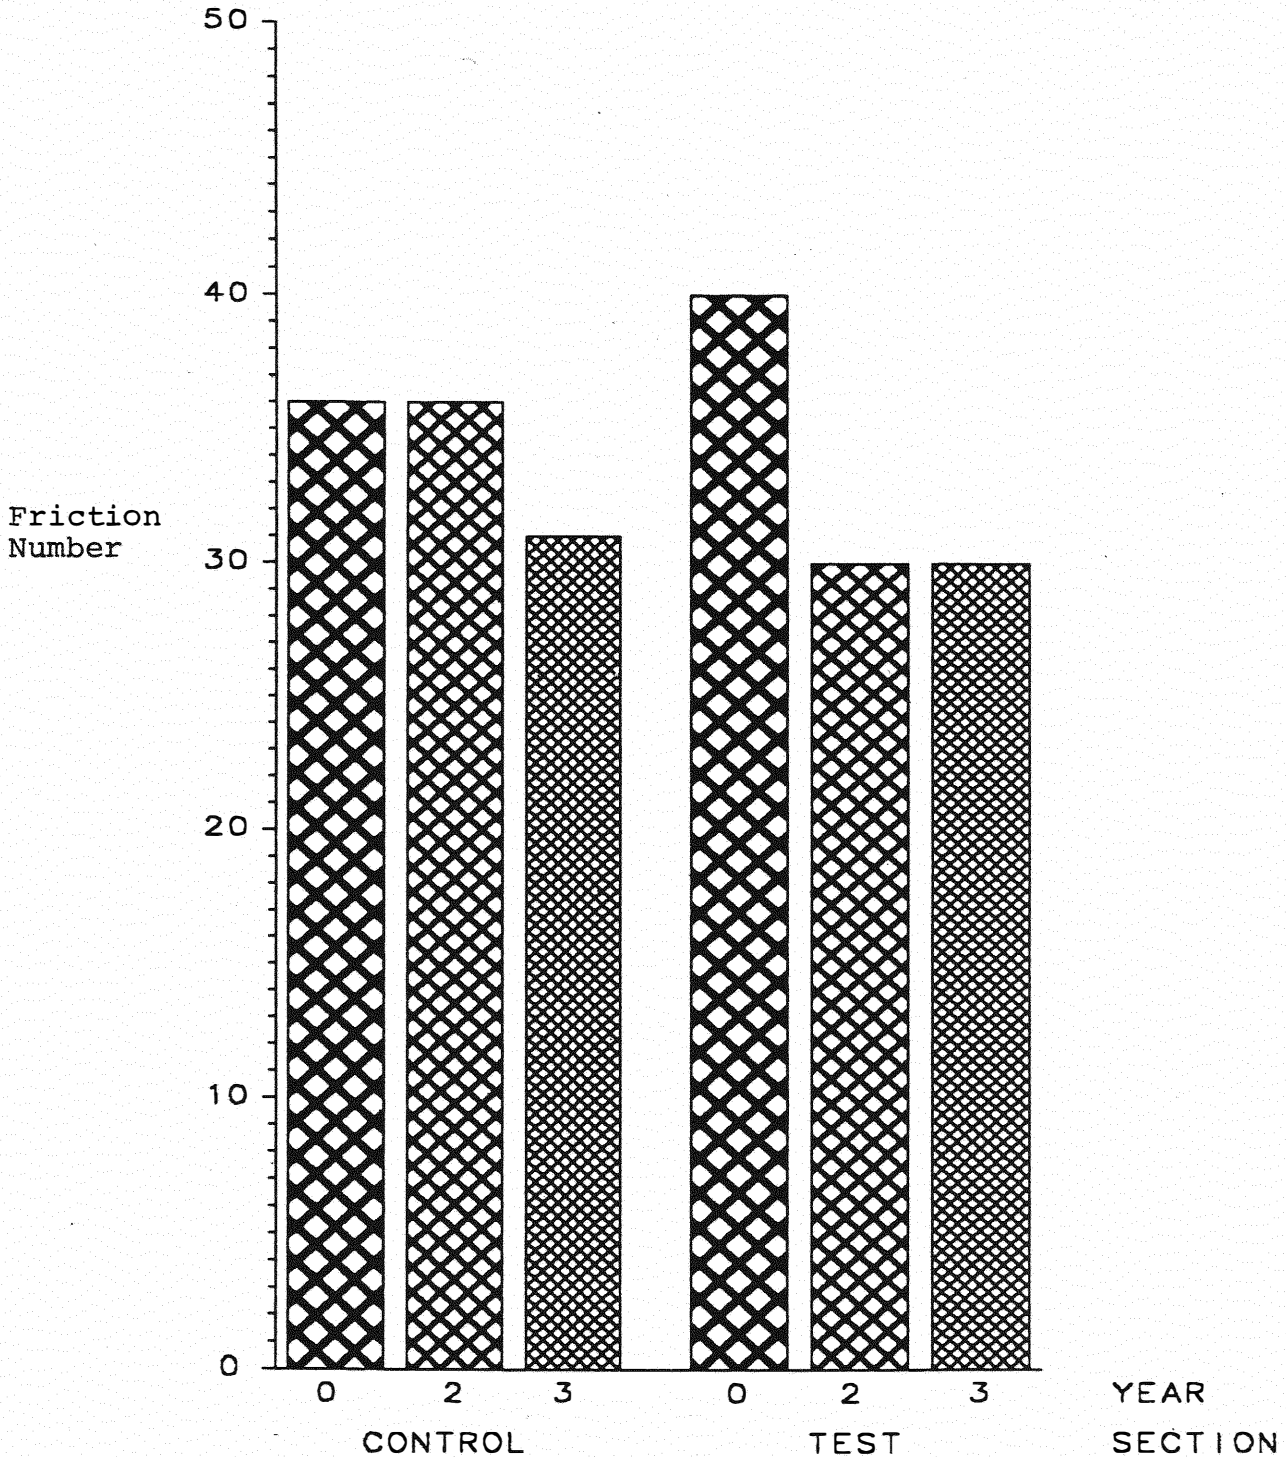
Figure 11. Friction Data

Diamond grinding initially improved the friction characteristics of the pavement. However, after three years of service, the friction characteristics of the test section have returned to the same level as that of the control section. See Figure 11.

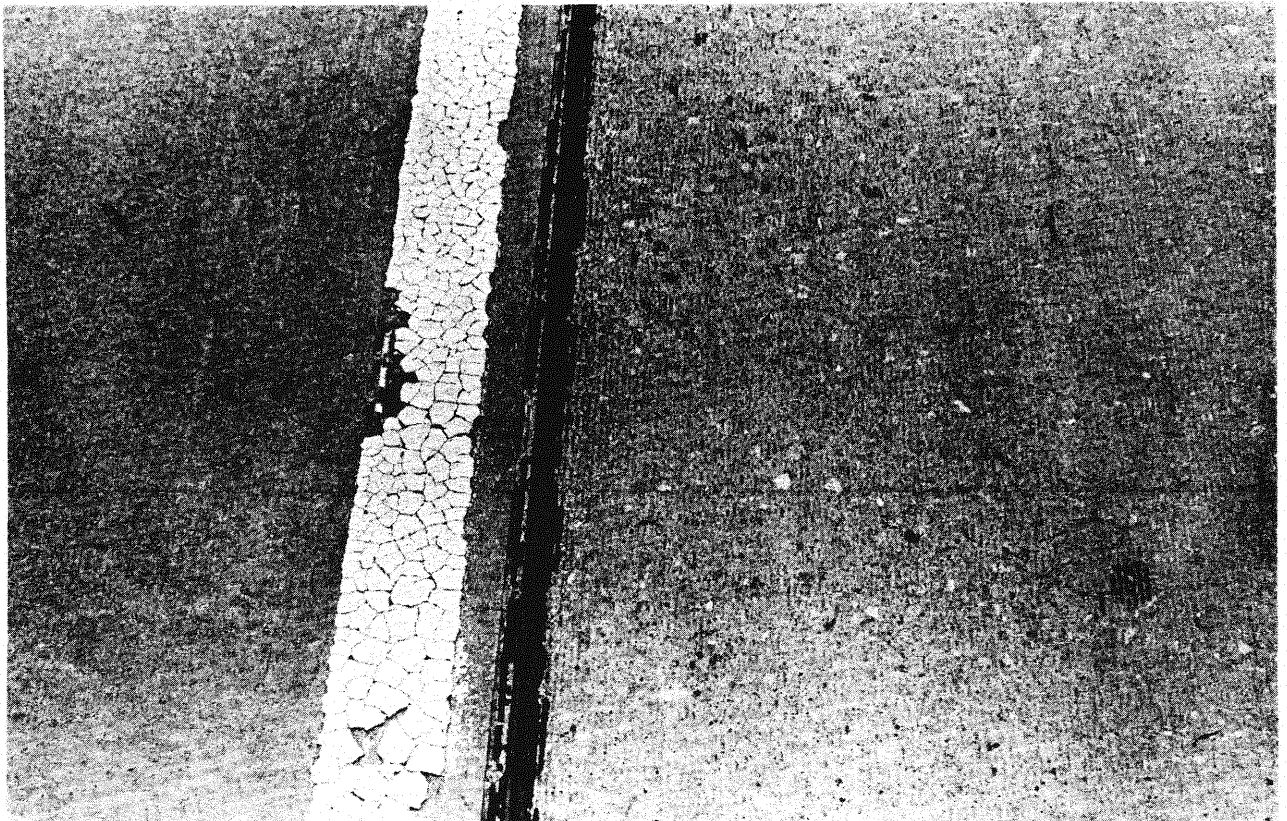
The transverse and centerline joints were filled with four different types of sealant. Most of the joints were filled with silicone sealants, using Dow Corning 888 or General Electric SCS 4403-N. The Dow Corning 888 performed satisfactorily. The General Electric SCS 4403-N had some failures. Although most joints were satisfactory, the SCS 4403-N exhibited cohesion failure in portions of the centerline joint and in one transverse joint. See Figure 12.

Figure 12. General Electric SCS 4403-N

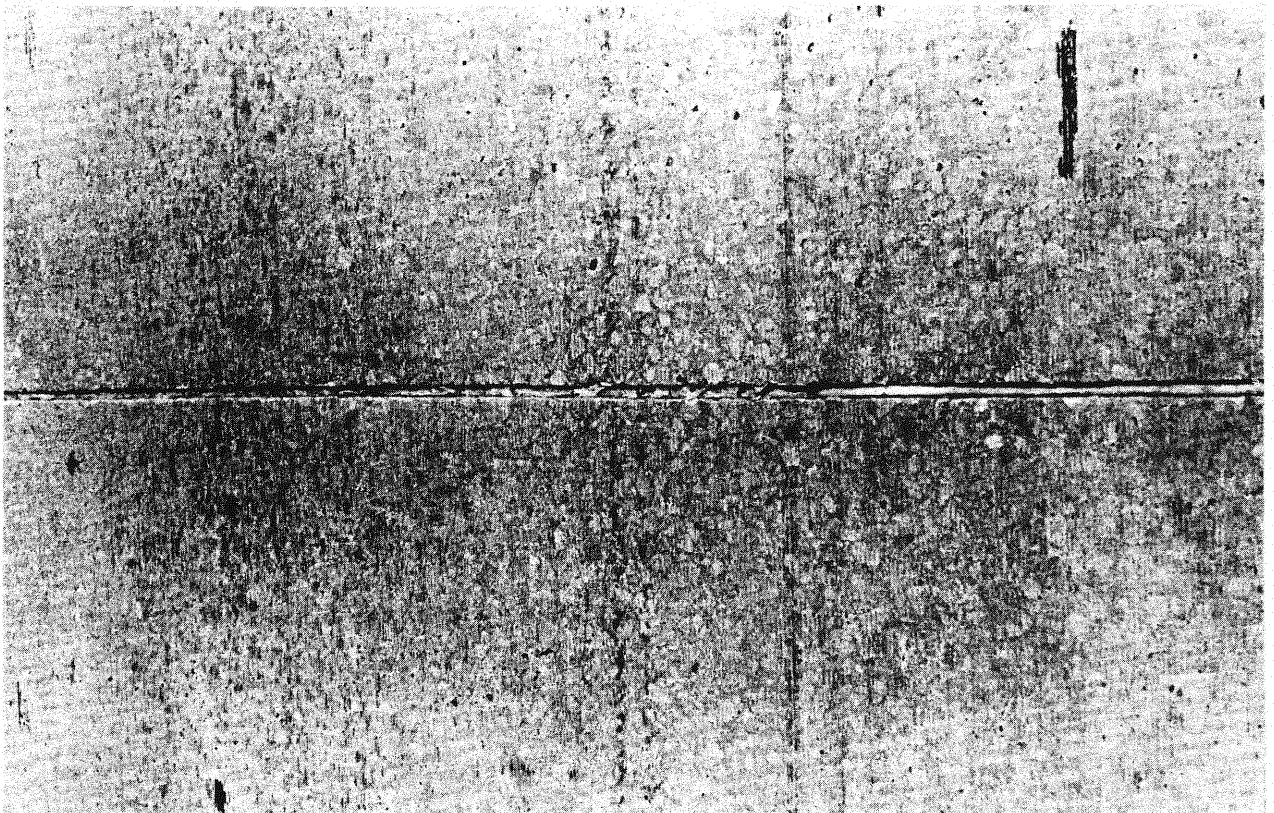
A fourth sealant, nitrile rubber (W.J. Ruscoe - Permanent Sealer) was used in a few of the transverse joints. This material failed early. It bubbled on initial installation, and after three years, portions are missing. See Figure 13.

Figure 13. Ruscoe - Permanent Sealer
