POLYMER CONCRETE OVERLAY ON SH-51 BRIDGE DECK

1. REPORT NO.	2. GOVERNMENT ACCESSION NO.	3. RECIPIENT'S CATALOG NO.	
4. TITLE AND SUBTITLE Polymer Concrete Overlay on SH 51, Bridge Deck		5. REPORT DATE June, 1982

6. PERFORMING ORGANIZATION CODE	
7. AUTHOR (S) Tim M. Borg, P.E.		8. PERFORMING ORGANIZATION REPORT 80-03-1, Item No. 2409	
9. PERFORMING ORGANIZATION NAME AND ADDRESS Oklahoma Department of Transportation Research & Development Division 200 N. E. 21st 2A2 Oklahoma City, OK 73105		10. WORK UNIT NO.

11. CONTRACT OR GRANT NO. DOT-FH-11-9124	
12. SPONSORING AGENCY NAME AND ADDRESS Federal Highway Administration Office of Development (HDV-22) Department of Transportation Washington, D.C. 20590		13. TYPE OF REPORT AND PERIOD COVERED Interim Report May 1980 thru March 1982

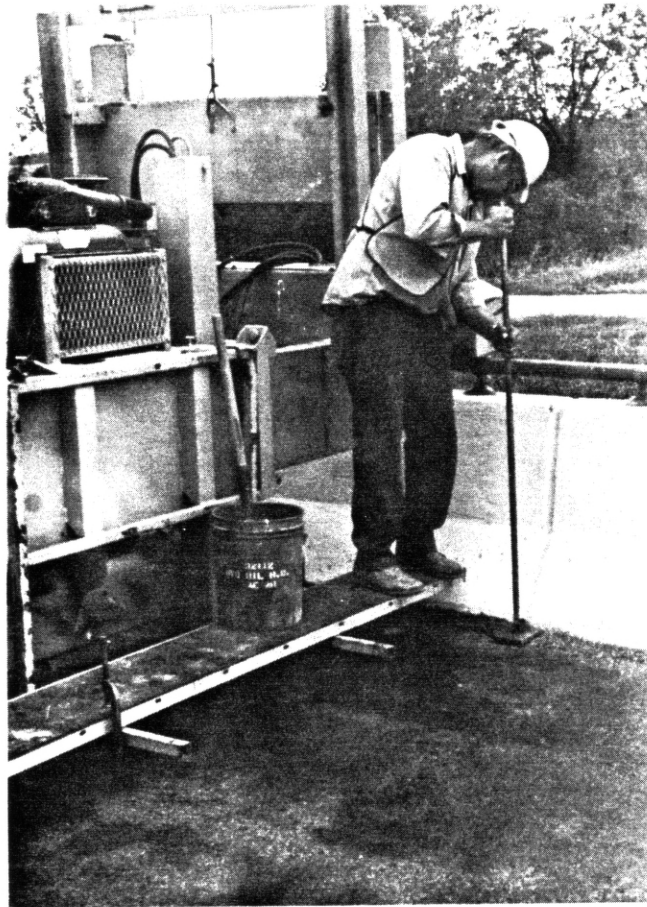
The vibrating screeds of the paver could not work directly against the parapet wall; therefore, a man with a tamping tool stood on the back of the paver, compacting and leveling a 4 in (100 mm) wide section of overlay along the parapet. The paver could not finish the last 3 ft (.9 m) of the lane because of the 45 degree skew. The parapet wall stopped before the paver could pass over the end of the lane. The remaining area in the right lane was placed and compacted by hand. After paving the right lane, the Concrete-Mobile was flushed with solvent along with the resin pumps. This removed residual catalyzed resin before it hardened.

Figure 12. The paving machine could not compact the last 4 in (10cm) against the parapet wall.

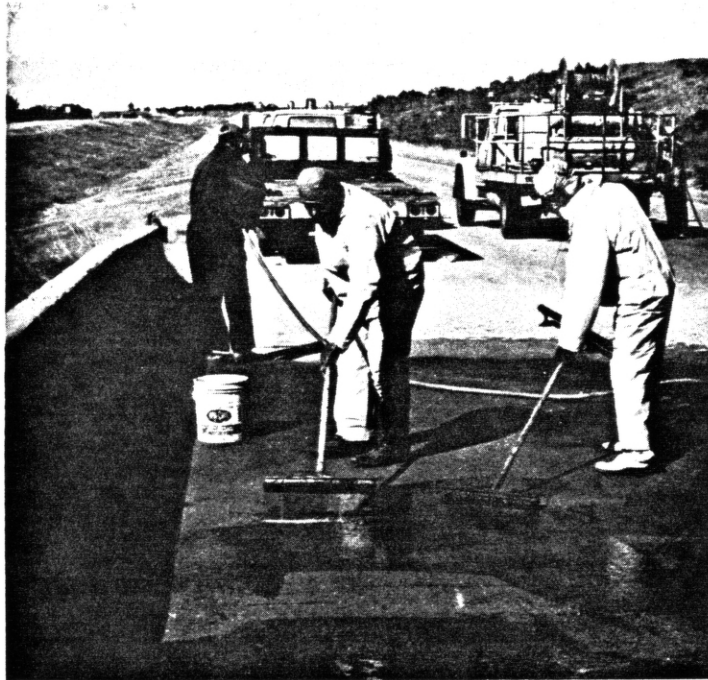
Quality control became a problem as work proceeded in this lane. The polymer concrete would alternate between being too rich or too lean. The lag time between adjusting the rheostat controlling the calibrated resin pump and the discharging polymer concrete was too great. The effect was to over compensate.

Figure 15. Areas having lean resin content were squeegeed with additional resin.

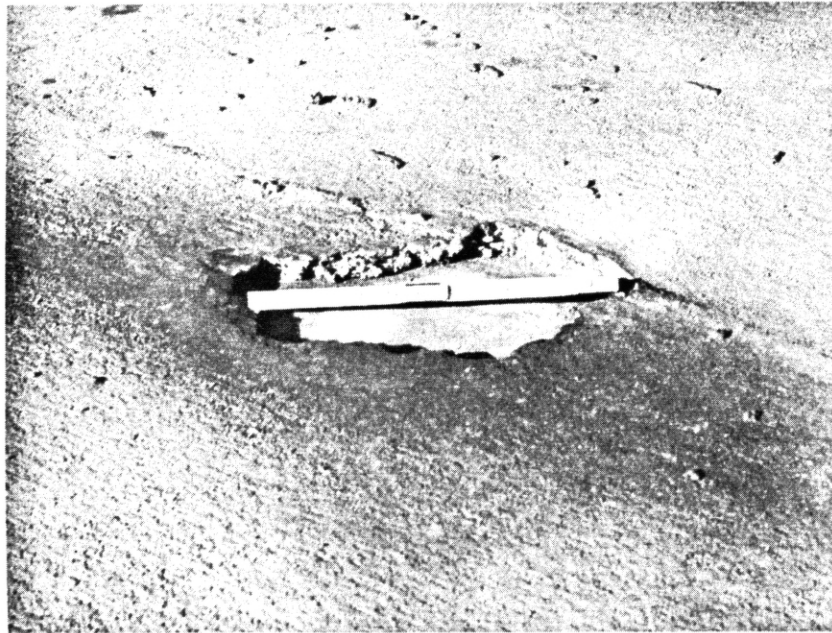
The week after completing the overlay, a delamination test revealed over 200 ft² (18 m²) of overlay that did not bond to the deck. Also, in the center pass about 10 ft (3 m) from the west end of the bridge, a portion of the overlay 8 ft (2.5 m) long failed to harden completely. However, skin about 1/4 in (6 mm) thick on top of the overlay did harden, probably due to ultra-violet radiation from the sun. A plan of the deck showing the location and relative size of the delaminated areas and resulting patches is shown in Appendix C.

Figure 18. Delaminations ranged from small to large.

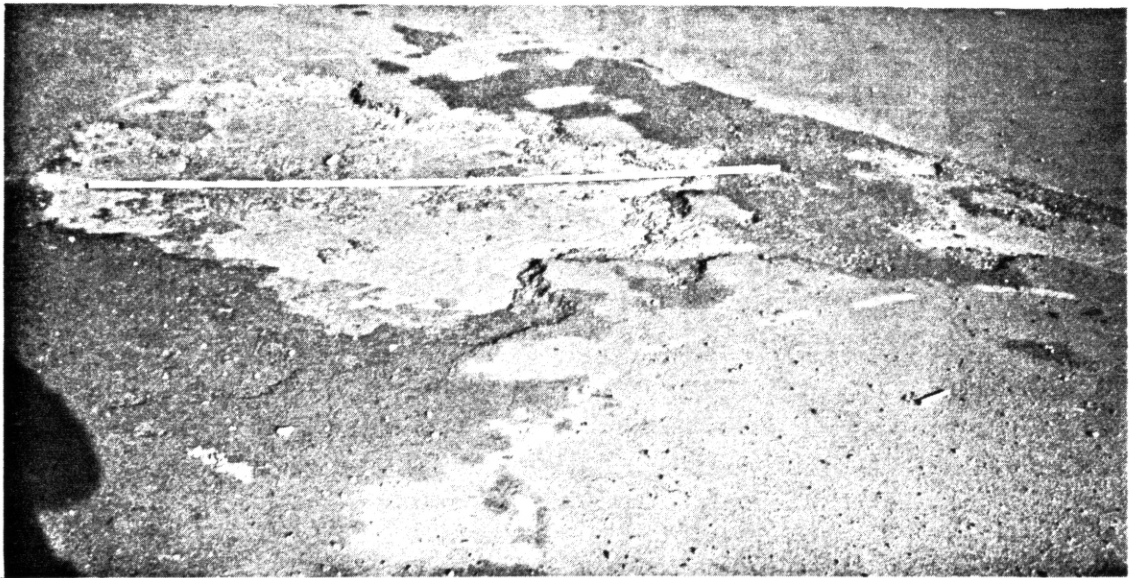
Figure 19. Some delaminations were very large; an 8 ft (2.4m) measuring stick.

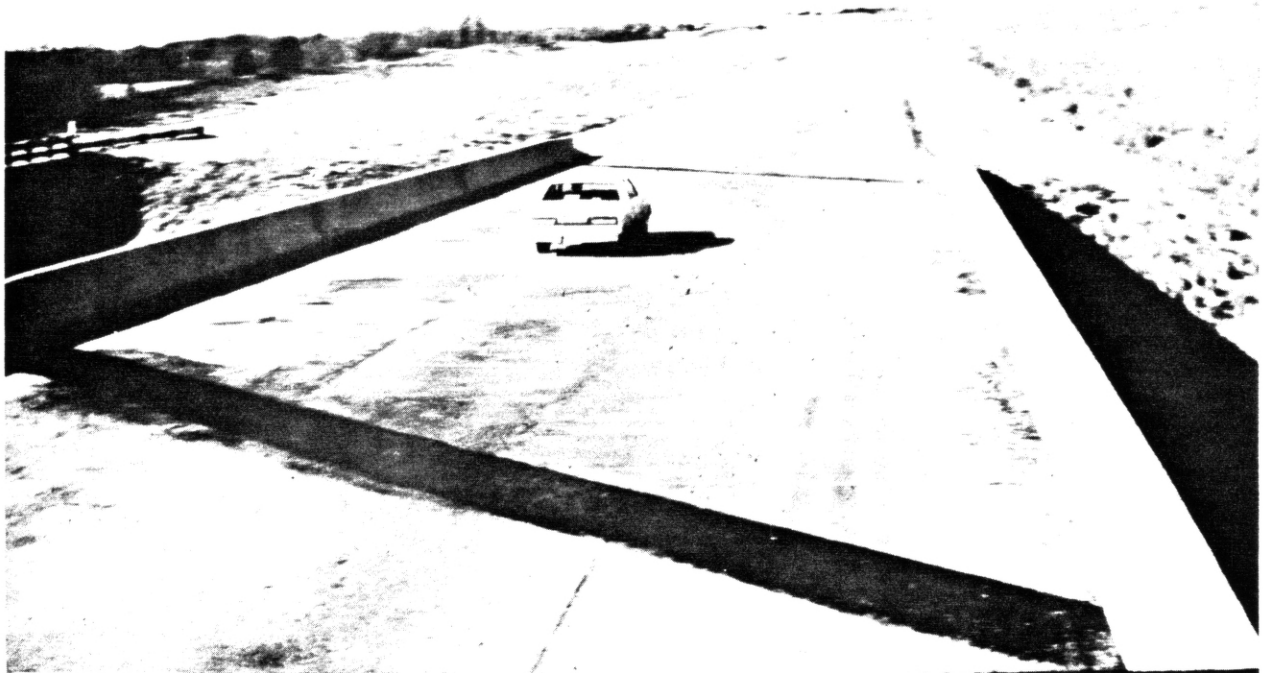
Figure 26. The bridge with its multi-colored patches as it appeared three months after initial construction.

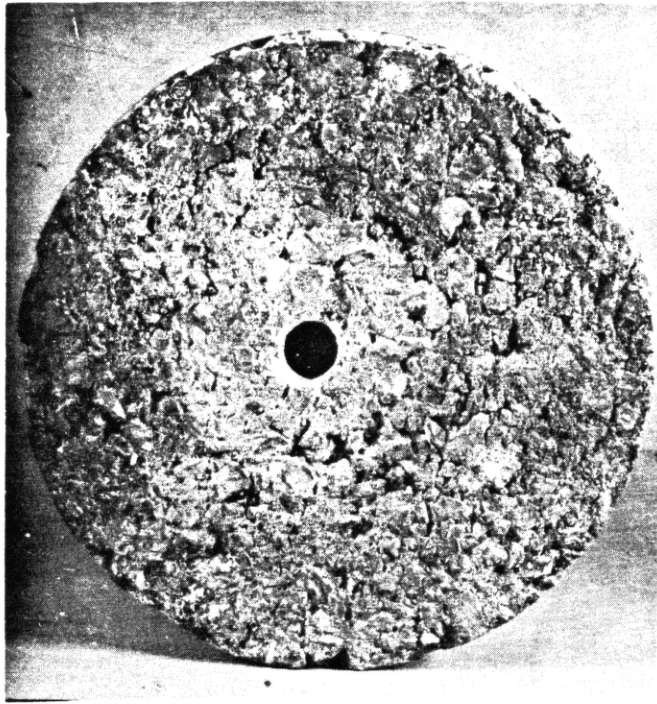
Figure 1. Resin Lean Polymer Concrete

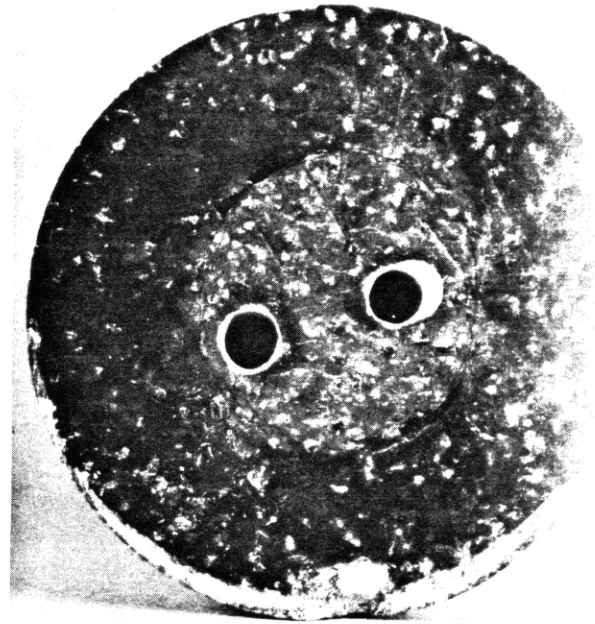
Figure 1. Resin Rich Polymer Concrete
