OKLAHOMA DEPARTMENT OF TRANSPORTATION

# PRECOATED MEMBRANES

March , 1986

PRECOATED MEMBRANES

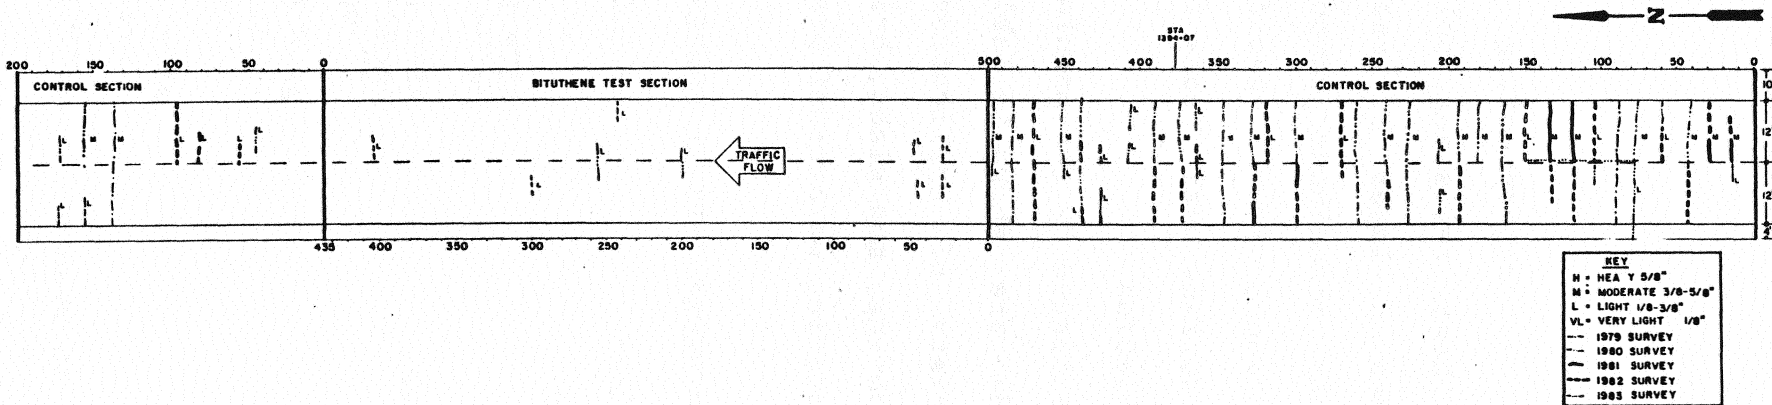
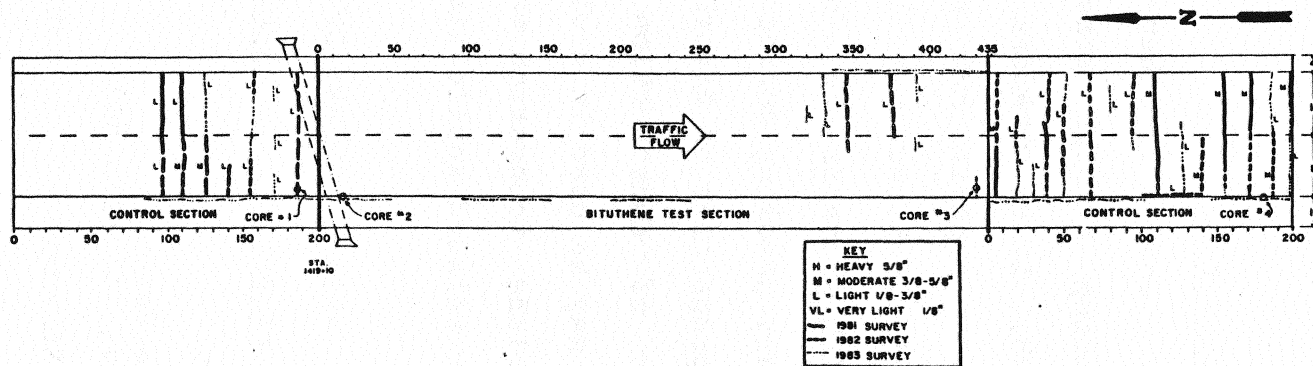
Figure 1. Crack reflection in Bituthene and control sections on I 35 southbound and northbound lanes at Ardmore.

The one year evaluation was made in August, 1979. There was no reflective cracking in either of the Bituthene sections. Five transverse cracks were found in the south control section of the northbound lane. One transverse crack was found in the north control section of the northbound lanes. Also no cracks were found in the southbound control section. See Figure 1.

The two year evaluation was conducted in July, 1980. No reflective cracks were found in either of the Bituthene sections. Twenty transverse cracks were found in the northbound control sections. No cracks were found in either of the southbound control sections. See Figure 1.

The three year evaluation was made in May, 1981. The Bituthene was performing very well. No reflective cracks were found in either of the Bituthene sections. Twenty-four transverse cracks were observed in the northbound control sections. Seven transverse cracks also were found in the southbound control sections. One longitudinal crack, 30 ft long, was found at the edge of the shoulder in the southbound control section. See Figures 1 and 2.

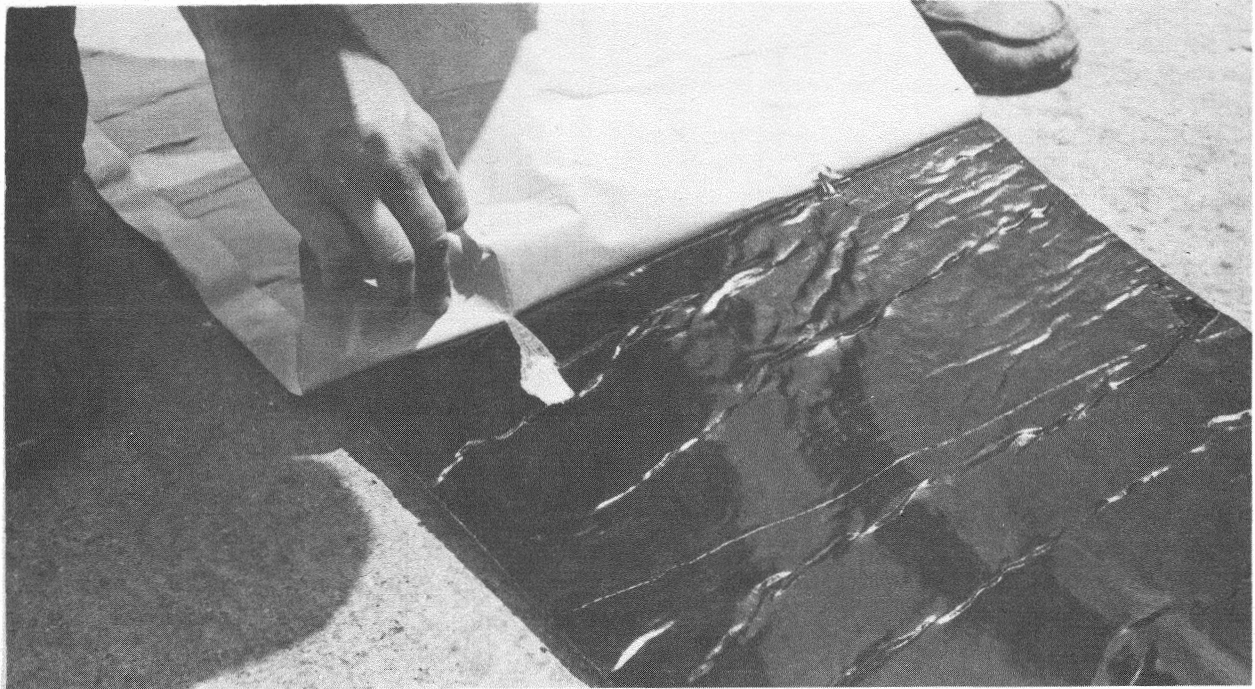
Problems were encountered in removing the release paper. A portion of the precoated fabric had been stored for about two years. When the air temperature approached 100°F (38°C) the heat caused the rubberized asphalt layer to become very sticky. This resulted in the release paper sticking and tearing many times. See Figure 7. Windy conditions often caused the material to flutter and stick to itself. See Figure 8. It was noted that the Bituthene stored for about one year was much more difficult to separate from the release paper than the recently delivered material.

Figure 7. Hot weather combined with a long storage time, allowed the rubberized asphalt layer to become very sticky, causing tearing of release paper.

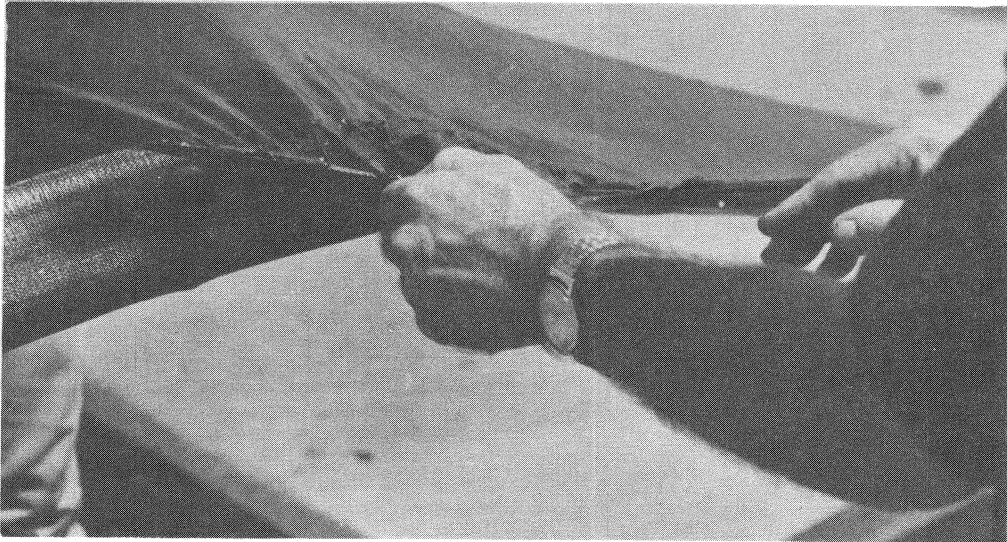
Figure 8. Windy condition often caused the material to flutter and stick to itself.

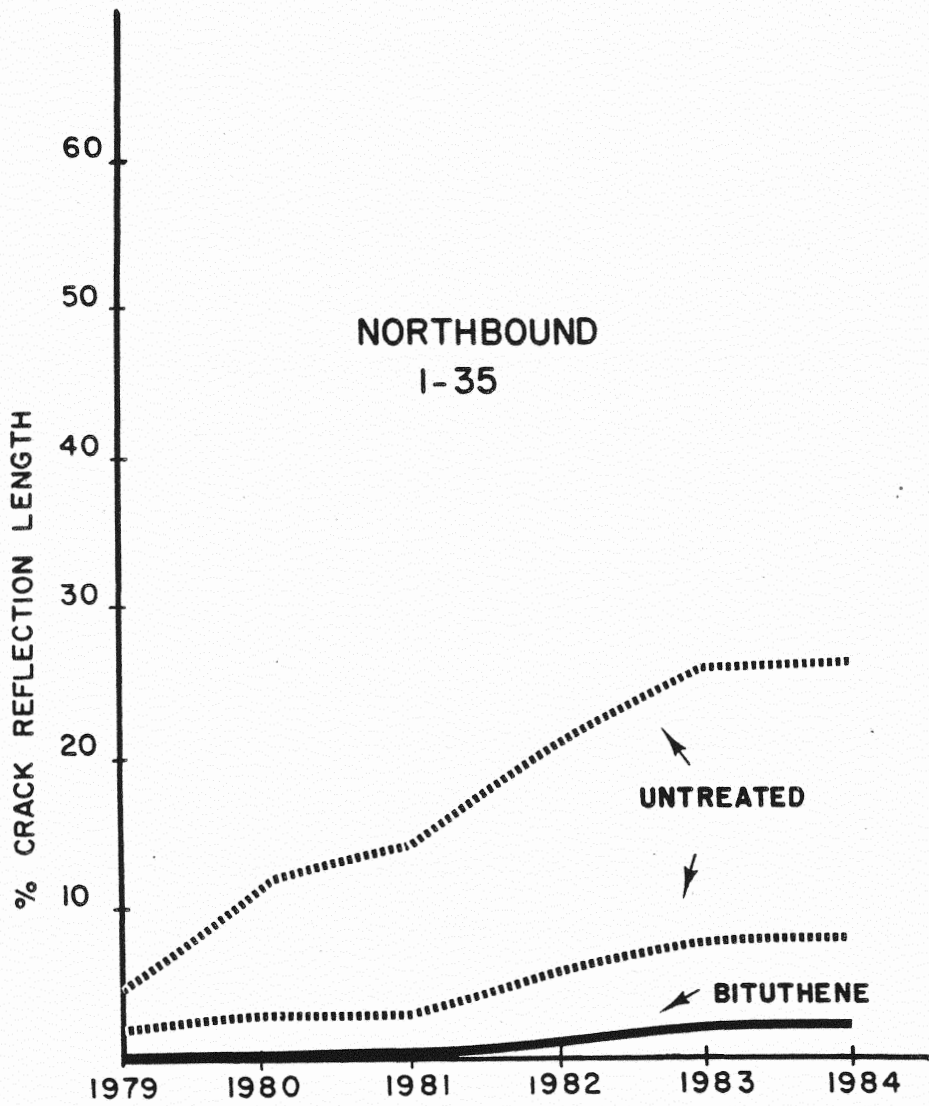
In the northbound lanes, only seven transverse cracks or 23 percent, have reflected through in the Bituthene section in five years. These cracks are in the wheel path and are about 3 to 4 ft (0.9 to 1.2 m) long. The remaining 23 transverse joints show no sign of any reflective crack. No longitudinal crack has developed in the treated section.

Ninety-seven percent of the transverse joints have reflected through in the south control section. The transverse cracks ranged from 3 to 24 ft (0.9 to 7.3 m) long. One longitudinal crack, 60 ft (18.3 m) long, also has reflected through in the centerline of the road.

The north control section showed 50 percent reflective transverse cracks. They ranged from 3 to 24 ft (0.9 to 7.3 m)

long. The remaining eight transverse joints have not reflected through yet. No longitudinal crack was found in the north control section.

Figure 9 shows the percent crack reflection length after five years. This is the total length of longitudinal and transverse crack reflections and should not be confused with the percent of reflective transverse cracks which were described previously.

Figure 9. Amount of crack reflection - Northbound.

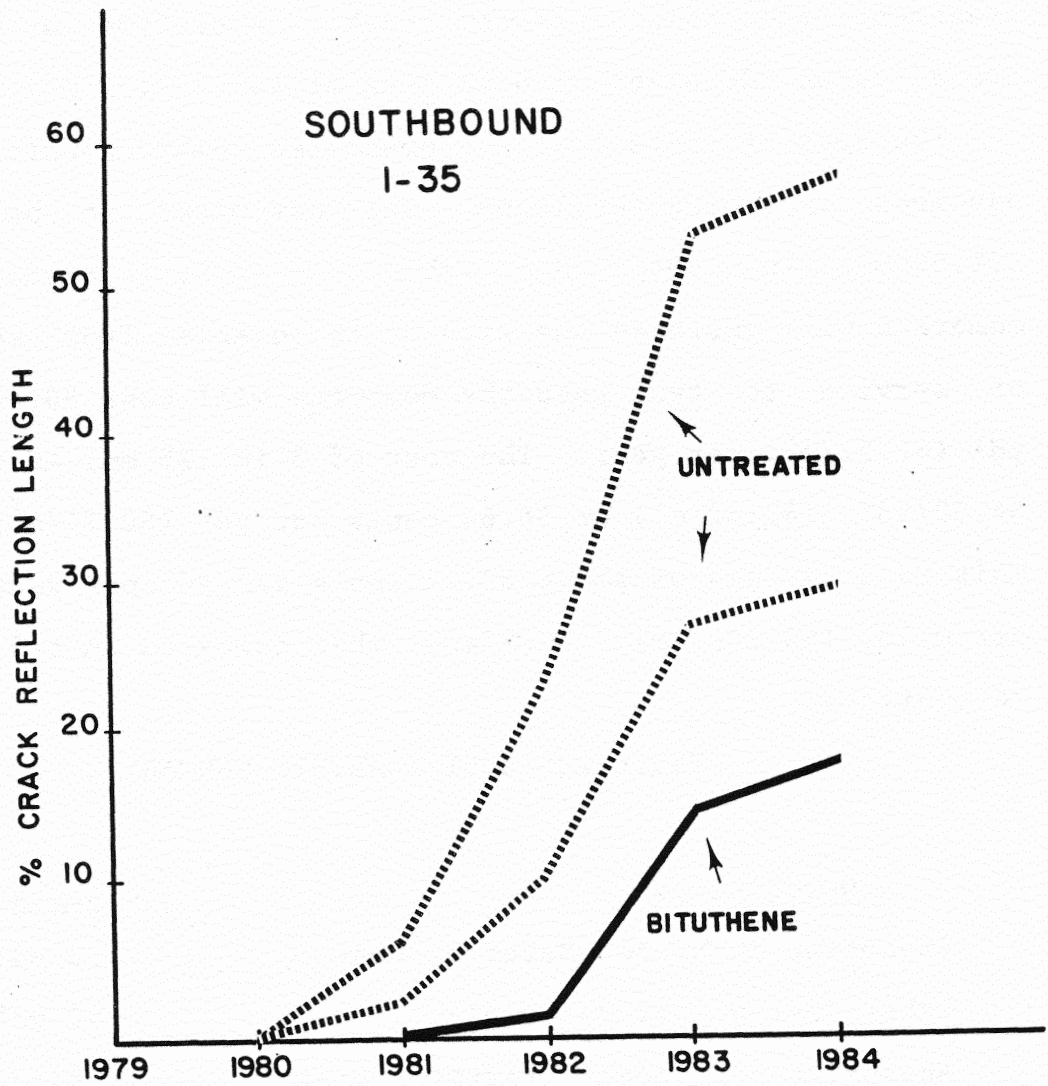
In the southbound lanes only 20 percent of the transverse cracks have reflected through in the treated section. The remaining transverse joints showed no cracking. One longitudinal crack, 100 ft (30 m) long, has reflected through at the edge of the inside shoulder. Also, two longitudinal cracks approximately 50 ft (15 m) long have reflected through at the edge of the outside shoulder.

All the transverse joints have reflected through, in the south control section. These cracks range from 3 to 24 ft (0.9 to 7.3 m) in length. One longitudinal crack, 200 ft (61 m) long, has reflected at the edge of the outside shoulder.

Approximately 50 percent of the transverse joints, have reflected in the north control section. These cracks range from 3 to 24 ft (0.9 to 7.3 m) in length. Also one 100 ft (30 m) long longitudinal crack has reflected at the edge of the outside shoulder.

The width of the transverse cracks in both the Bituthene sections were classified as "light", 1/8 to 3/8 in, (3 to 9 mm). The width of the transverse and longitudinal cracks in the control sections ranged from light to medium, 1/8 to 5/8 in, (3 to 16 mm). In one case, the width of a longitudinal crack in the south control section of the southbound lane exceeded 3/4 in (19 mm). This longitudinal crack was at the edge of the outside lane.

Figure 10 shows the percent crack reflection length after five years. This is the total length of longitudinal and transverse crack reflections and should not be confused with the percent of reflective transverse cracks which were described previously.

Figure 10. Amount of crack reflection - Southbound.

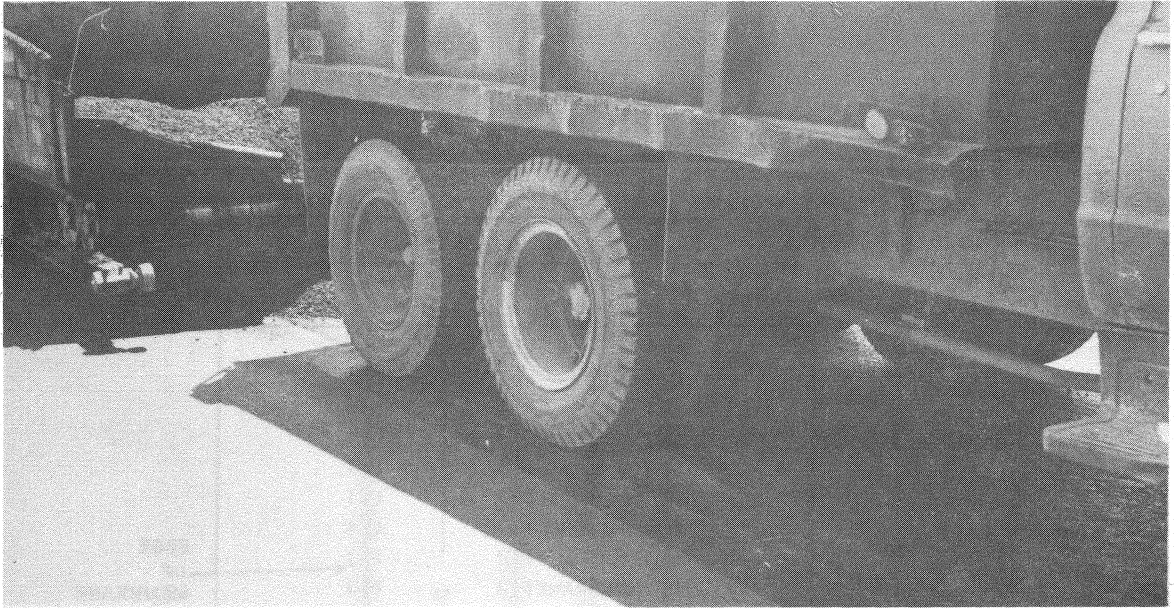
Asphalt tack sticking to the AC haul truck tires pulled the membrane up about 2 in (50 mm) from the surface in some instances. This problem occurred when the trucks backed over the

Figure 4. The tack on the truck tires pulled the fabric loose from the surface in some instances.

membrane. See Figure 4. The problem was corrected by sprinkling loose AC mix over the membrane prior to the AC overlay. See Figure 5.

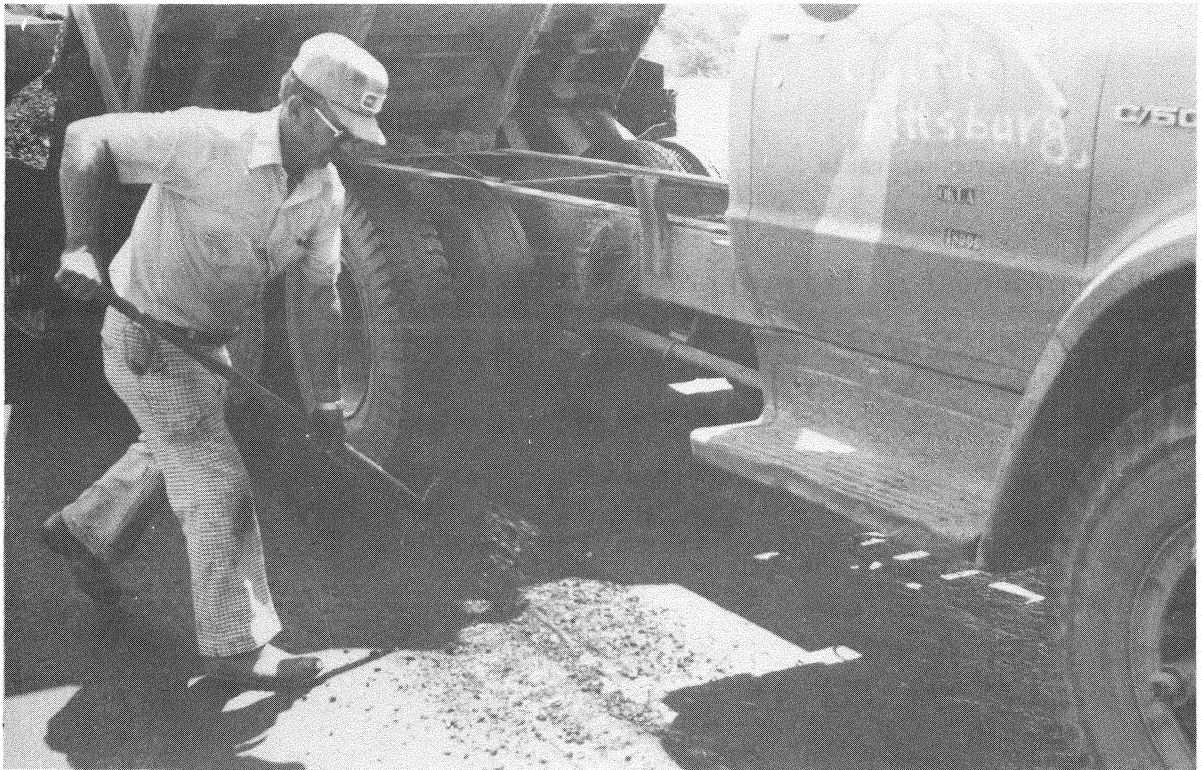
Figure 5. The asphalt concrete mix is sprinkled over the Polyguard to eliminate the fabric dislocation caused by the sticky tires.

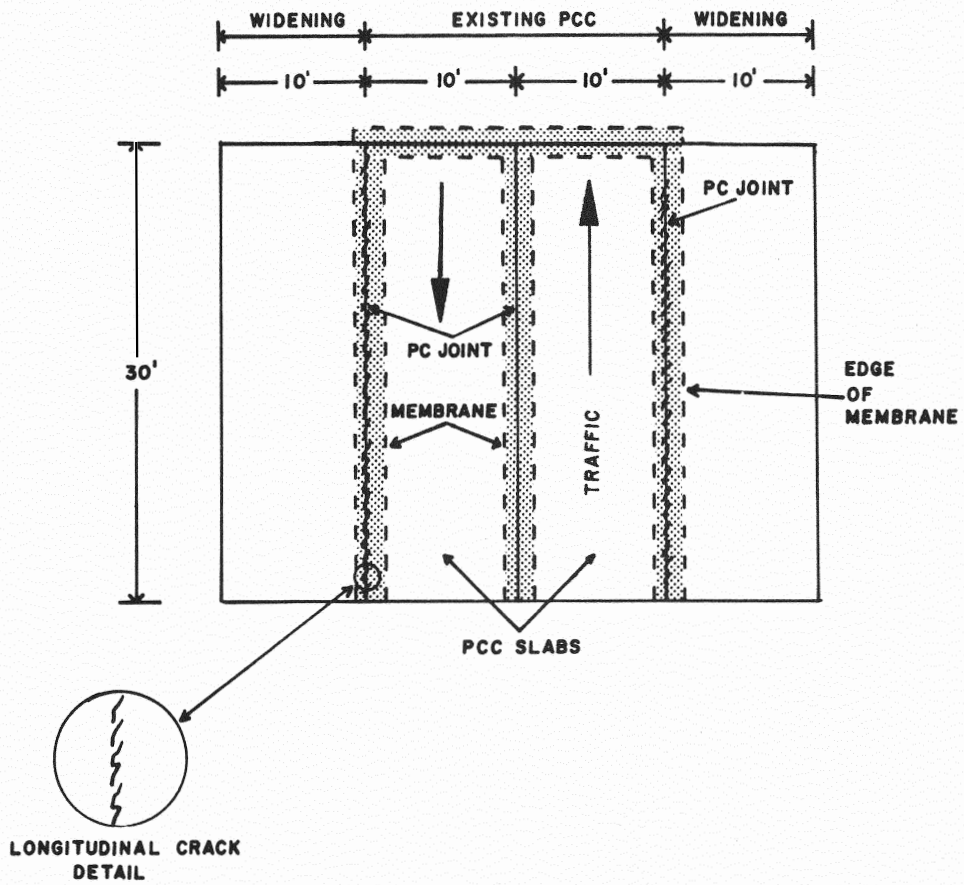
The three year evaluation was made on June 19, 1981. Additional longitudinal cracks had reflected through in both the treated and the control sections. See Figure 6 for typical longitudinal crack configuration. These cracks were along the pavement edge of the widened section and were located in the right wheel path.

Figure 6. Typical longitudinal crack reflection.

The longitudinal cracks had reflected in both treated and control sections. See Figure 6 for a typical configuration of longitudinal cracks.

There were longitudinal cracks over the new shoulder joints in both the treated and the untreated sections. This kind of crack appears to be the result of a combination of the horizontal, thermally induced movement of the underlying PCC slab relative to the AC shoulder and the vertical differential movement from heavy loads on the rigid PCC slab. This difference in materials and the weight of heavy vehicles causes the longitudinal pavement-shoulder edge joints to result in shear displacement.

Vertical joint movement due to dynamic load factors also could cause a crack at the longitudinal joint in the AC overlay. Another possible contributing factor may be the flexible properties of the AC shoulder section as compared to the rigid properties of the PCC slab.

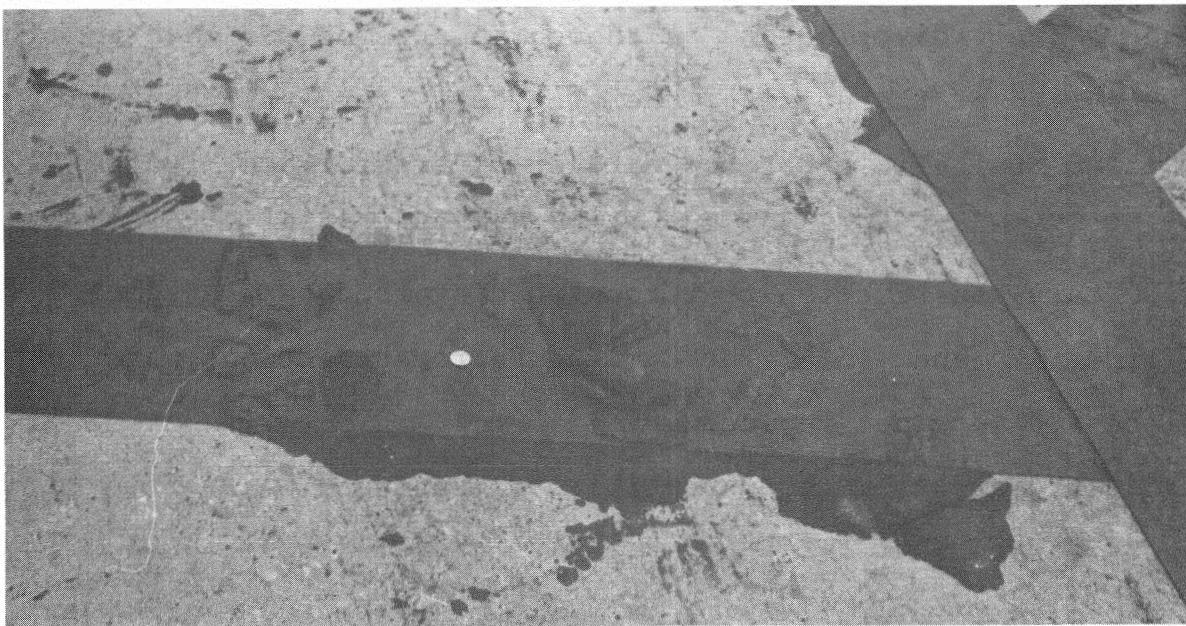
Figure 9. The disturbance of Petrotac was due to construction traffic.

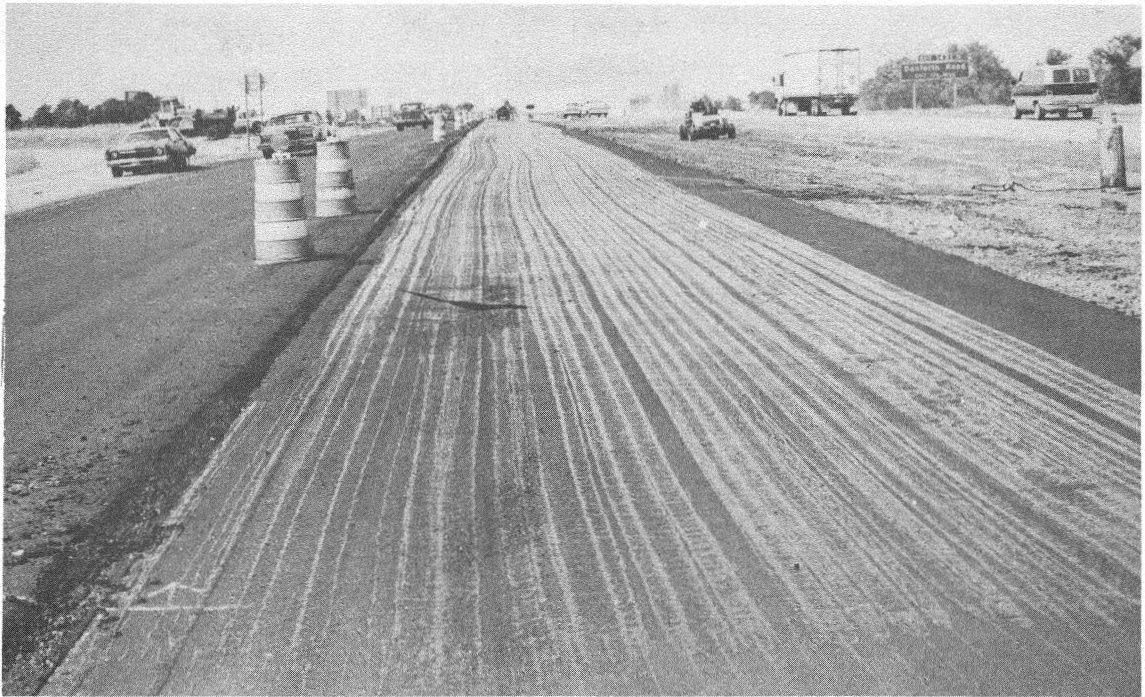
Figure 10. The tack coat was not spread uniformly due to a faulty asphalt distributor.

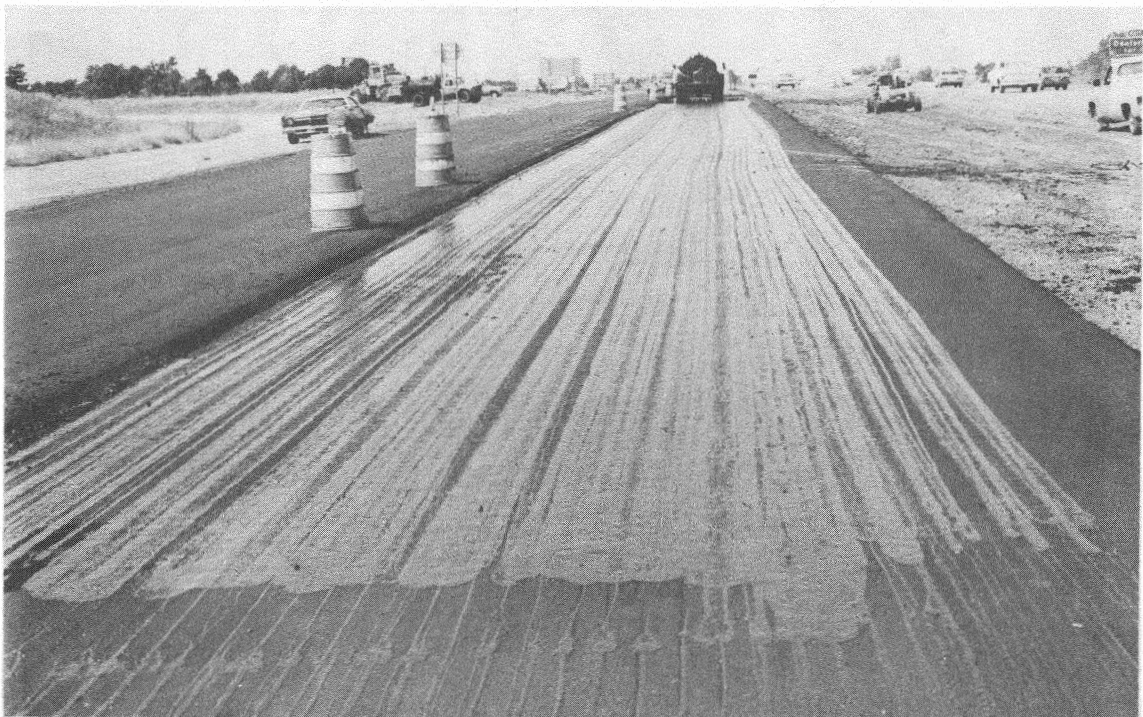
Figure 11. The tack coat for the Petromat was applied twice in order to get even coverage.

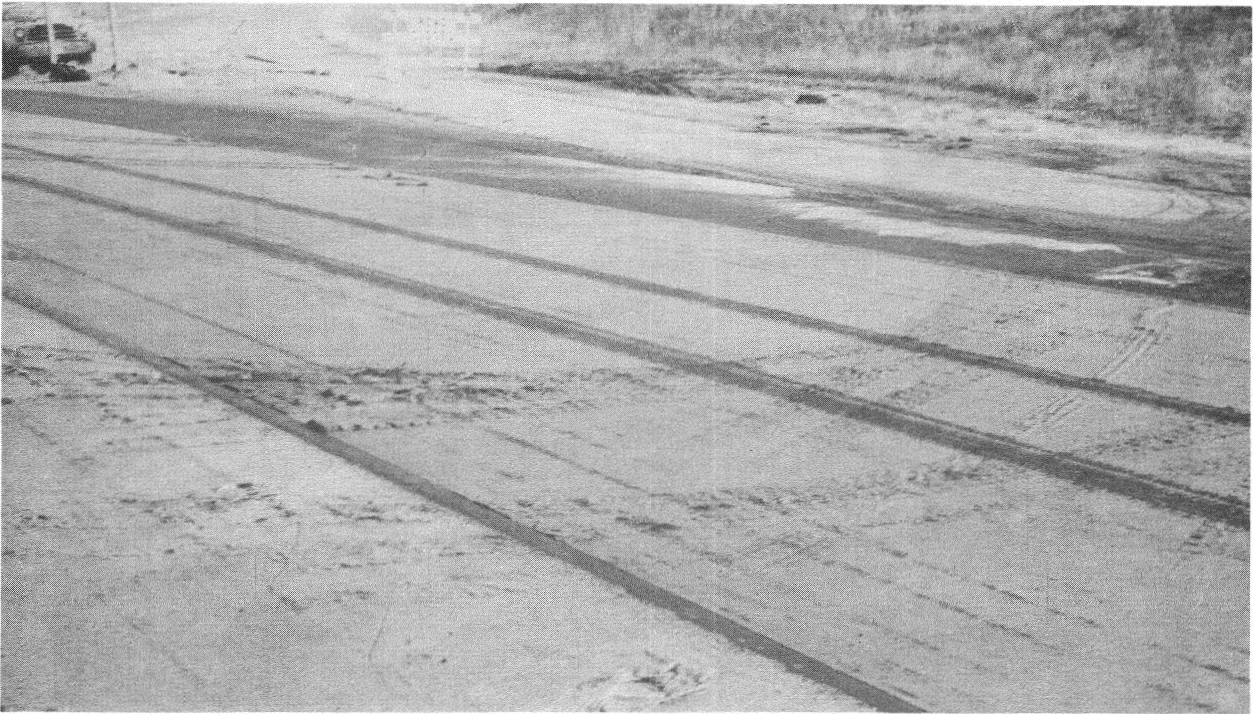
Heavy construction traffic also disturbed the Petromat. See Figure 12 and 13. The damaged Petromat sections were left in place and were not replaced.

Figure 12. Petromat disturbance caused by heavy construction traffic turning on the treated surface.

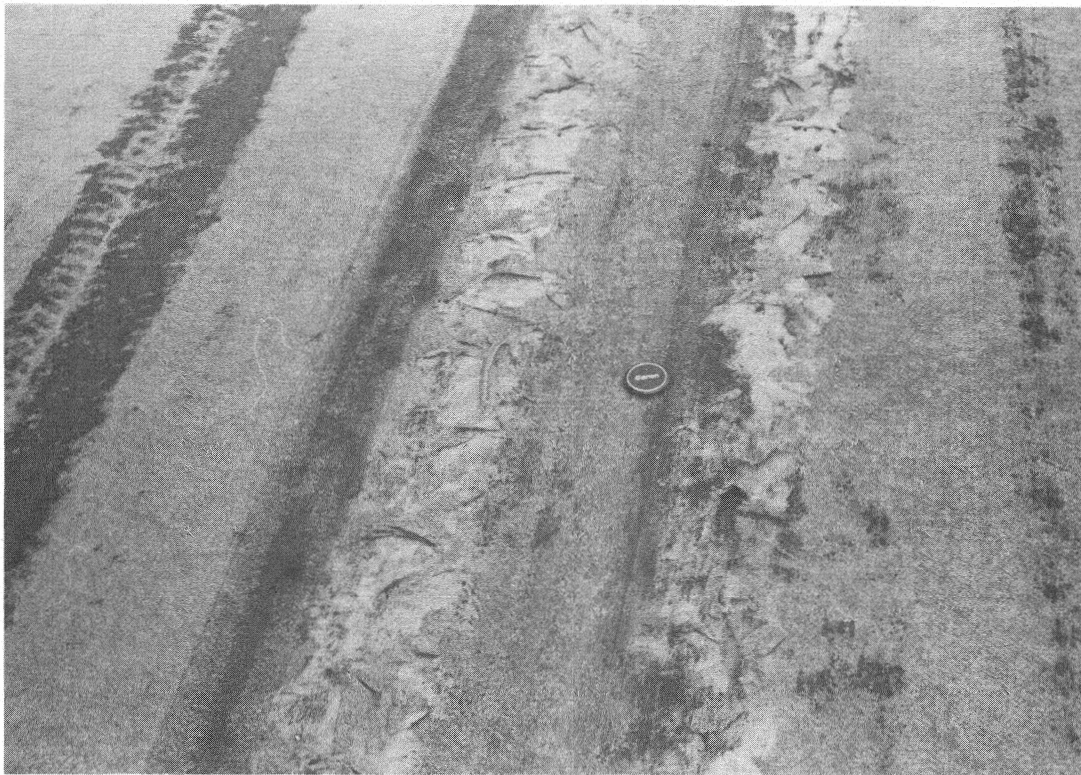
Figure 13. View of disturbed Petromat.

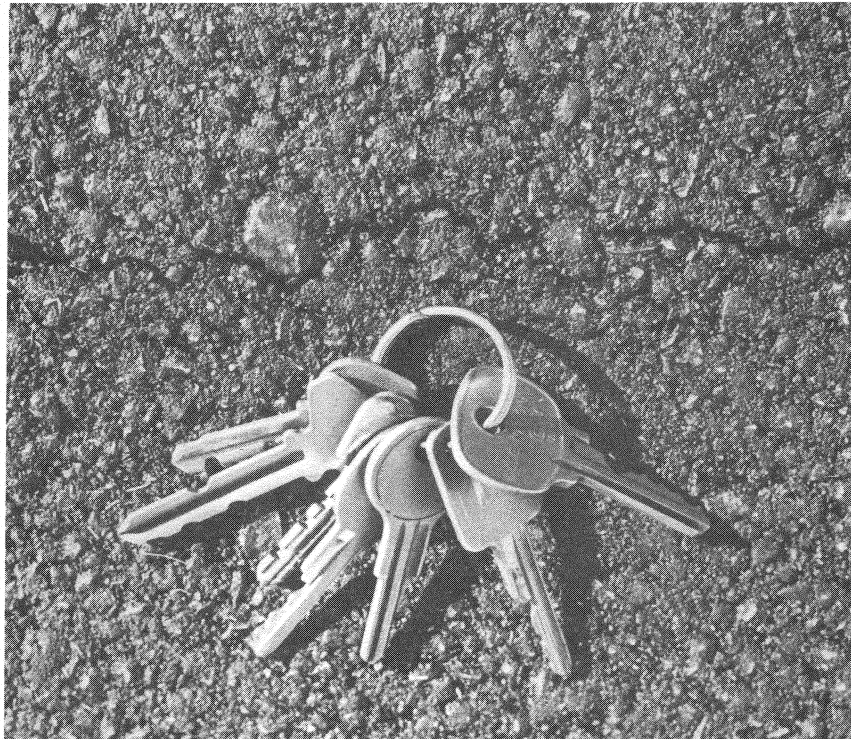
Figure 14. Close view of transverse crack over joint in Petrotac treated section - overlay less than 1 in. thick.

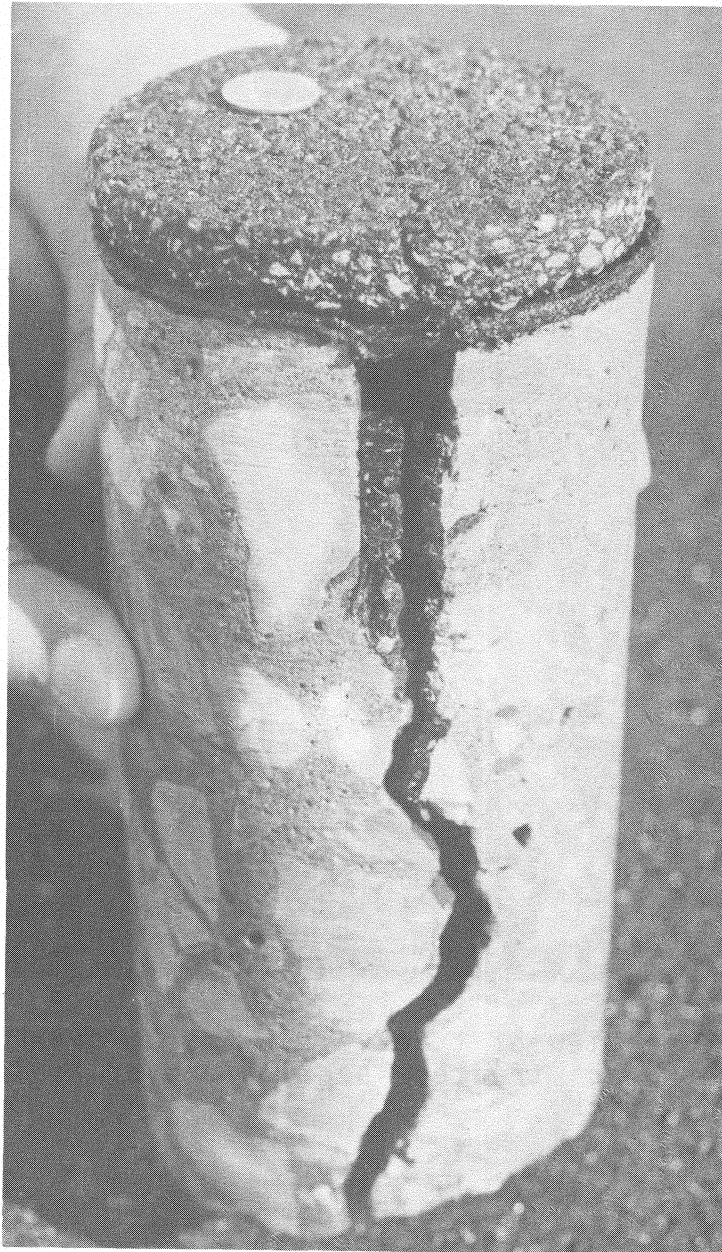
Figure 15. Core taken over the reflected transverse crack in the Petrotac section - overlay less than 1 inch thick. Note the "sealed" joint.

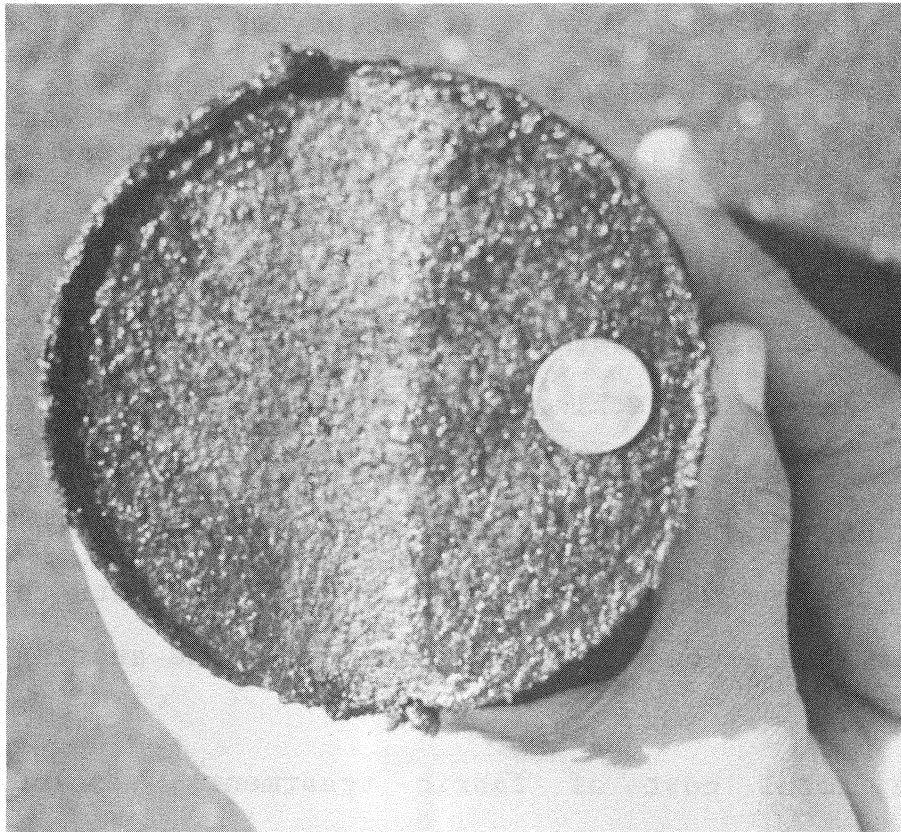
Figure 16. Four inch core taken over 1 inch joint, showing no damage to the Petrotac membrane.
