SHEAR WALL SILL PLATE BEHAVIOR IN WOOD  
FRAMES

Submitted to the Faculty of the  
Graduate College of the  
Oklahoma State University  
in partial fulfillment of  
the requirements for  
the Degree of  
MASTER OF SCIENCE  
July 2015

In this report, a summary review have been done to determine the failure causes for damaged houses that were observed by post tornado assessment team in Moore 2013. A further in-depth study of sill plate behavior in wood frames is a core focus of this report. Sill plate failure mode found throughout this and previous studies describes most of the actual failures that happened on the site during the Moore, 2013 tornado.

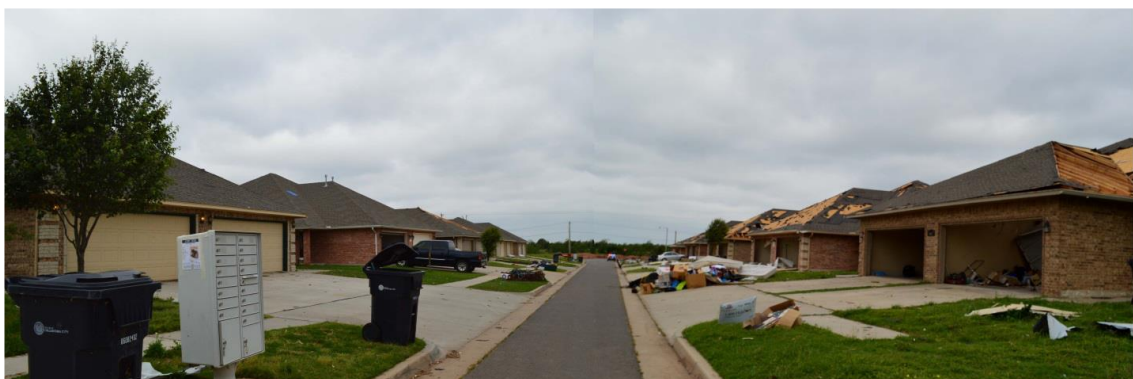
The outer band, Band 1, is the least intense pressure from the tornado, and in this band only horizontal wind pressure is applied to structures, more similar to hurricane winds. Buildings in this zone experience horizontal pressure on wind direction, in wood houses, mostly garage doors goes undergo the windward pressure and roof sheathings fails on leeward wind pressure.

Figure 1-6 Failure of Garage Doors (Tornado Damage Assessment in the aftermath of the May 20th 2013 Moore Oklahoma Tornado, 2014)

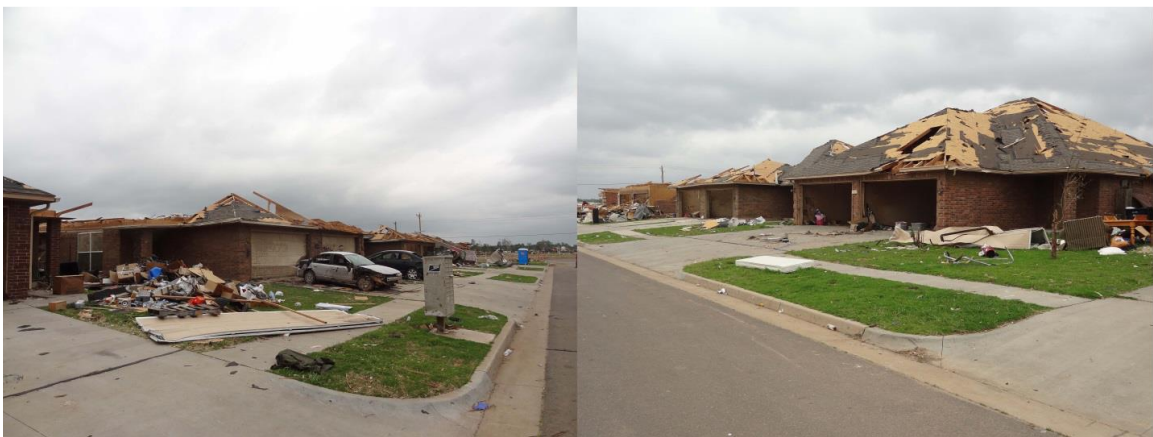
The band 2 is the location in between the core and outer band, and its characteristics contain both horizontal and uplift pressures. The horizontal wind pressure cause damage to the garage door in windward direction and the horizontal leeward wind plus the wind uplift pressure cause the roof sheathing to fall apart. Figure 1-7 is a good indicator of this band.

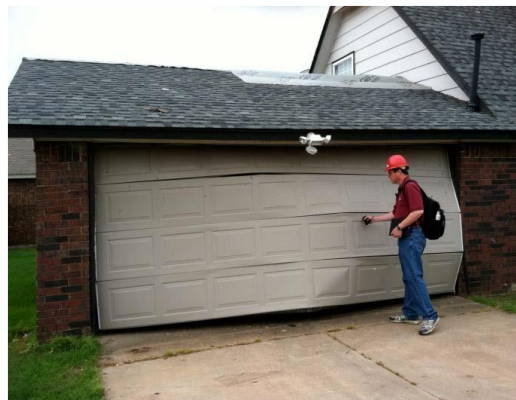
1. Failure of light-gage metal garage doors. Particularly on garages that extend out from the house. This type of garages led to pressurization on the roof, subsequently causes loss of a roof over the garage, and then to the collapse of the garage walls.

*Figure 1-8 Light Grage Door Failure (Tornado Damage Assessment in the aftermath of the May 20th 2013 Moore Oklahoma Tornado, 2014)*

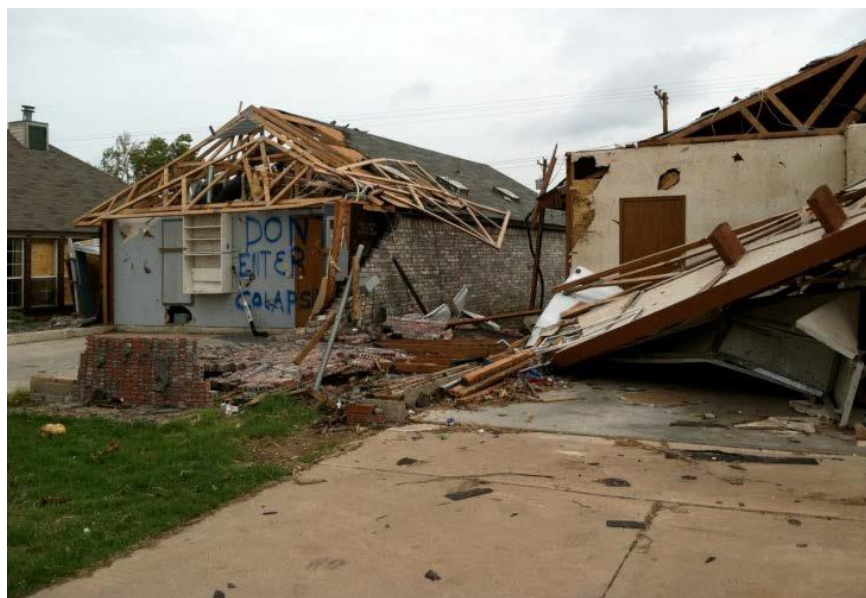
Damage to the roof can cause lateral disability to walls as roof structure is acting lateral bracing to the top of the wall. Figure 1-10 describes how the garages are destroyed, and walls are ripped-off together.

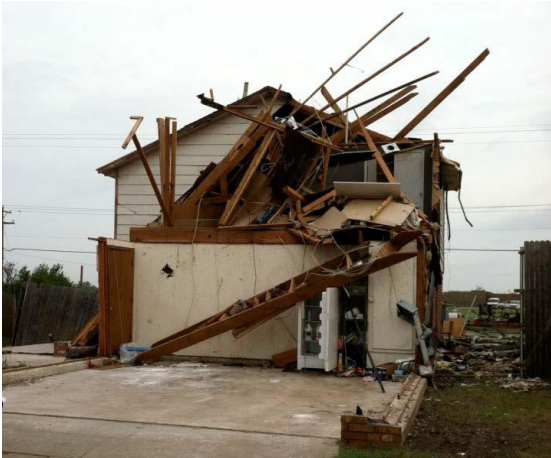
*Figure 1-12 (Tornado Damage Assessment in the aftermath of the May 20th 2013 Moore Oklahoma Tornado, 2014)*

In figure 1-12 the wall was anchored by sill plate to the concrete foundation. The Anchorage is useful to resist uplift forces, but not torsion plus uplift, this is the worse condition to fail in wall foundation. Further discussions on sill plate will be discussed in details in Chapter II.

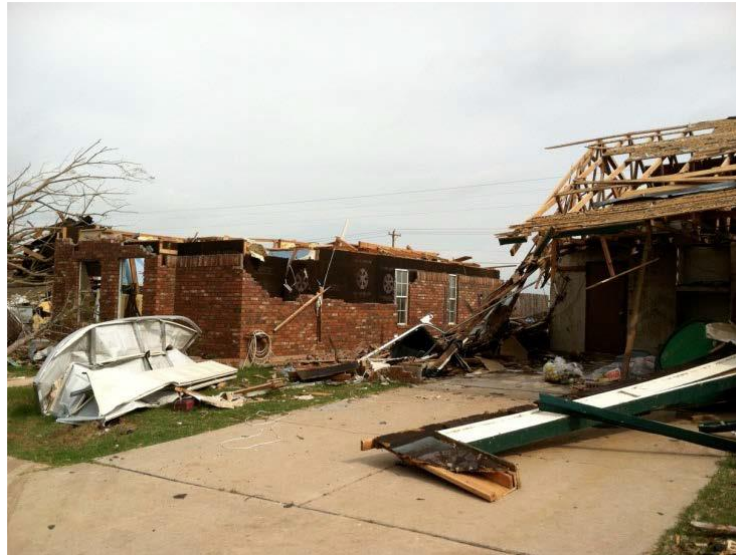
*Figure 1-13 (Tornado Damage Assessment in the aftermath of the May 20th 2013 Moore Oklahoma Tornado, 2014)*

The prefabricated left in a better condition in compare to other. The truss provides lateral support to top of the wall and rescues the wall from collapse.

The better performance of prefabricated trusses is because of the rigid connections.

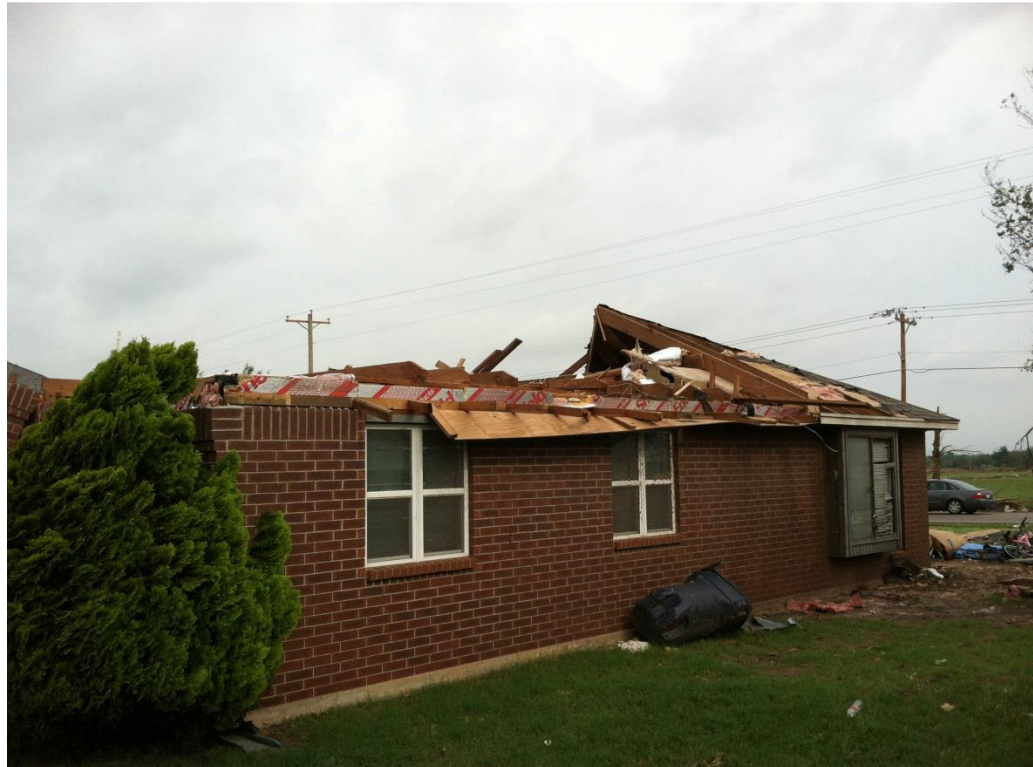
*Figure 1-14 (Tornado Damage Assessment in the aftermath of the May 20th 2013 Moore Oklahoma Tornado, 2014)*

3. Removal of roofs supported by prefabricated roof trusses left the tops of walls with little lateral support. On the other hand, removal of rafter/ridge-beam roofs typically left the separate ceiling joists in place, and thus the tops of the walls were still laterally supported. In the high-speed wind, it is favorable because prefabricated trusses are gone at all while Rafter/ridge beams still exist but in poor condition. Figure 1-14 shows the ceiling.

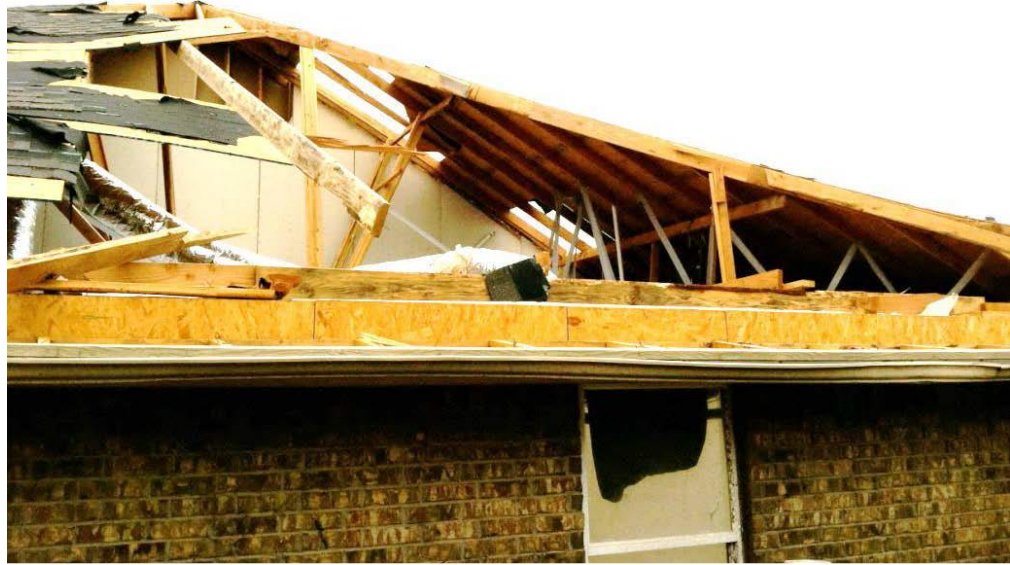
*Figure 1-15 (Tornado Damage Assessment in the aftermath of the May 20th 2013 Moore Oklahoma Tornado, 2014)*

4. “High profile” roofs had relatively long unsupported spans (compared to other roof types) leaving them more vulnerable to uplift. Fewer intermediate supports led to larger bending moments and shear forces in the rafters. Longer distances between lateral support to the rafter bottom edge (compression edge for uplift) decreased resistance to lateral torsional buckling of the rafters.

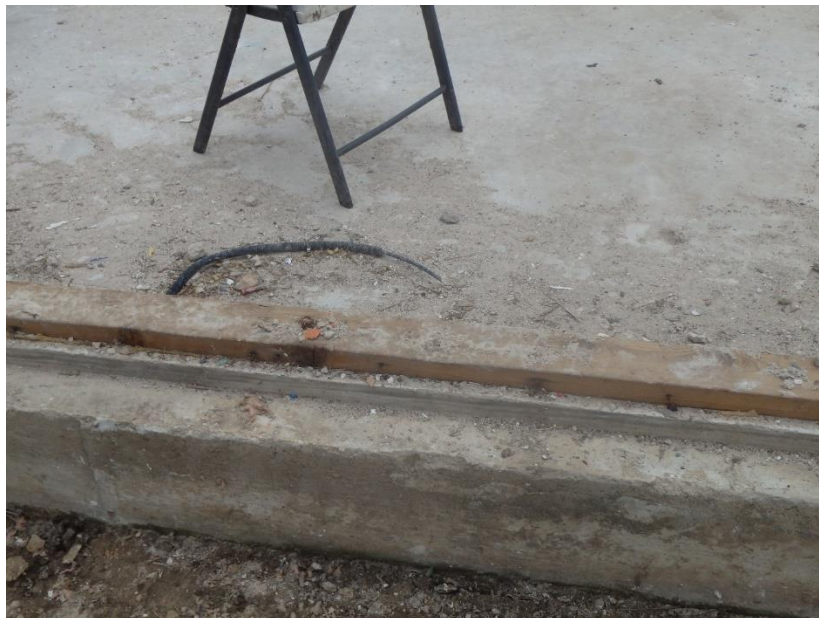
The post-tornado assessments photos show all failure scenarios mentioned above. It is observed that some houses were destroyed, and all walls collapsed, but the sill plate was remained undamaged. This type failure occurs when the failures are in cases 1 and 3. Figure1-20

*Figure 1-20 Undamaged Sill Plate (Tornado Damage Assessment in the aftermath of the May 20th 2013 Moore Oklahoma Tornado, 2014)*

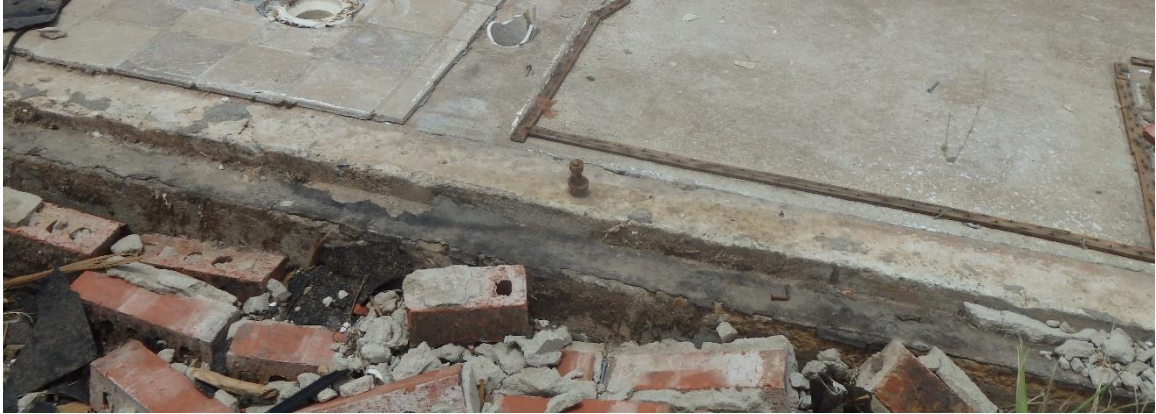
Case scenario one is also observed in Moore 2013 tornado. This scenario happens when the sheathing to sill plate fails. There can be many reasons for failure the size and spacing of

nails as well thickness of plywood. In this case, the sill plate is in its best's condition, and bolts are not deformed and damaged. Figures 1-21 and 1-22 are the photos taken from Moore 2013.

*Figure 1-21 Damaged Sill Plate (Tornado Damage Assessment in the aftermath of the May 20th 2013 Moore Oklahoma Tornado, 2014)*

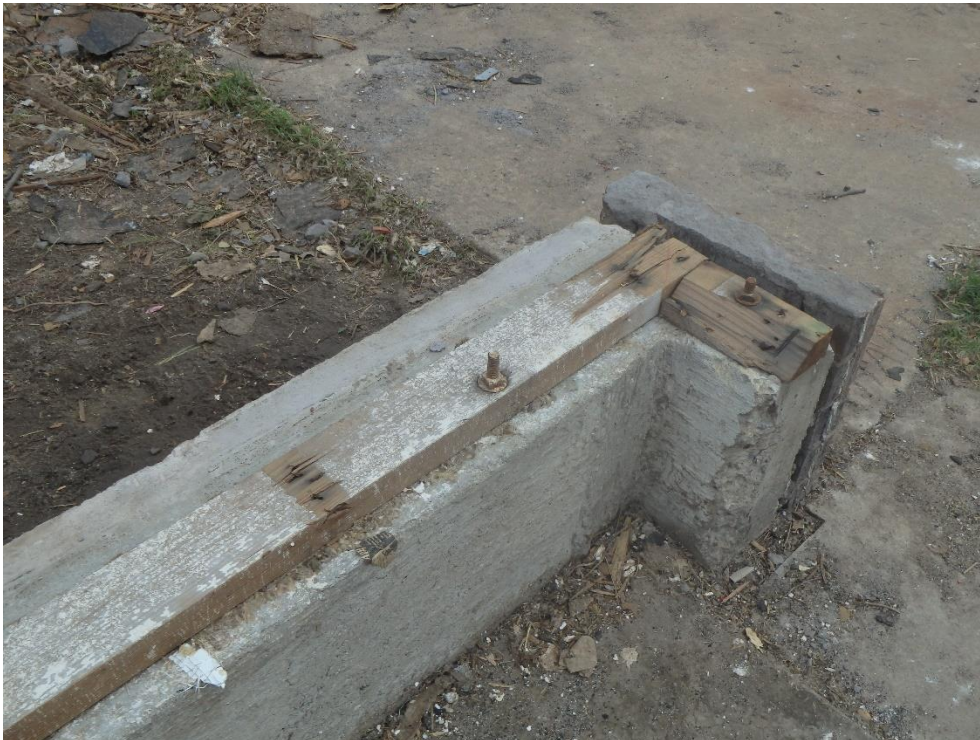
*Figure 1-22 Broken Sill Plate Along the Edge (Tornado Damage Assessment in the aftermath of the May 20th 2013 Moore Oklahoma Tornado, 2014)*

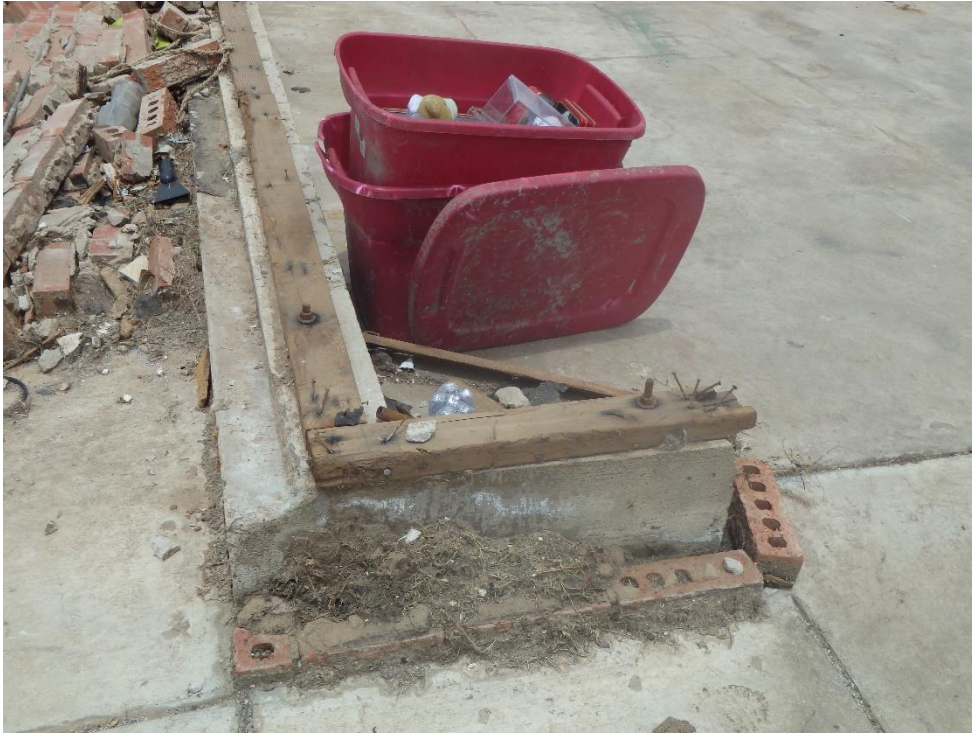
*Figure 1-23 Undamaged Sill Plate, Failure of Sheathing to Sill Plate (Tornado Damage Assessment in the aftermath of the May 20th 2013 Moore Oklahoma Tornado, 2014)*

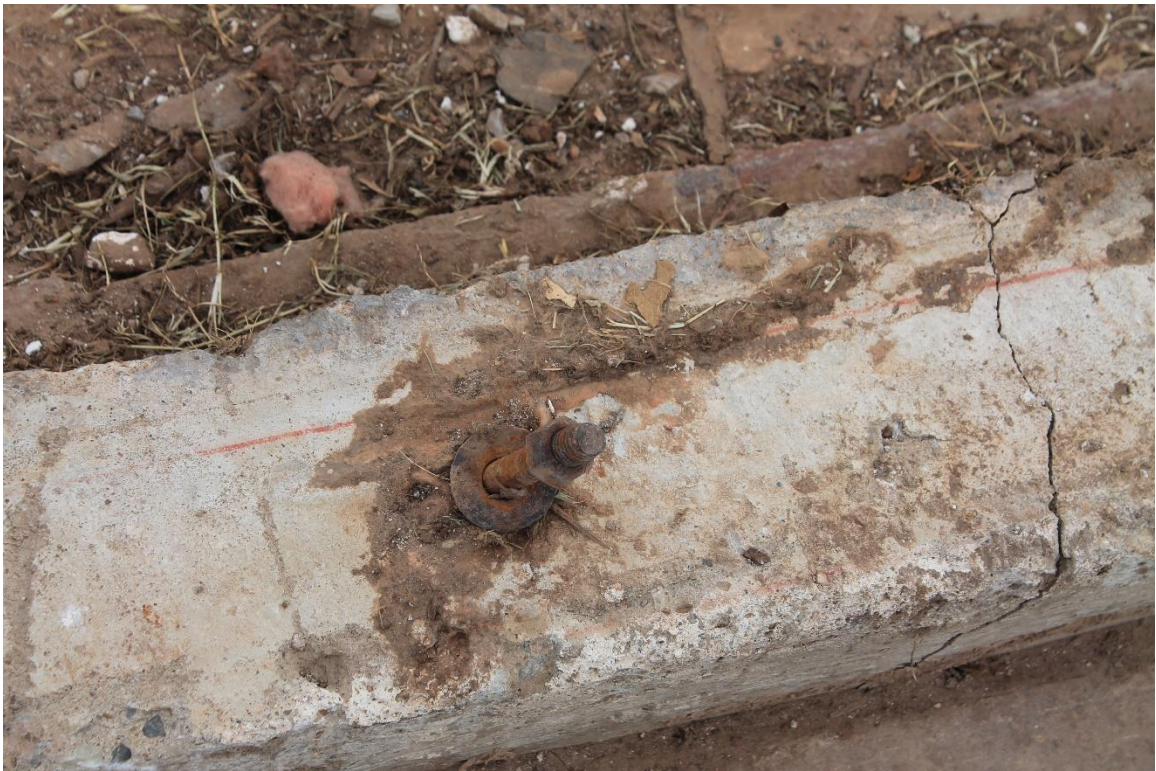
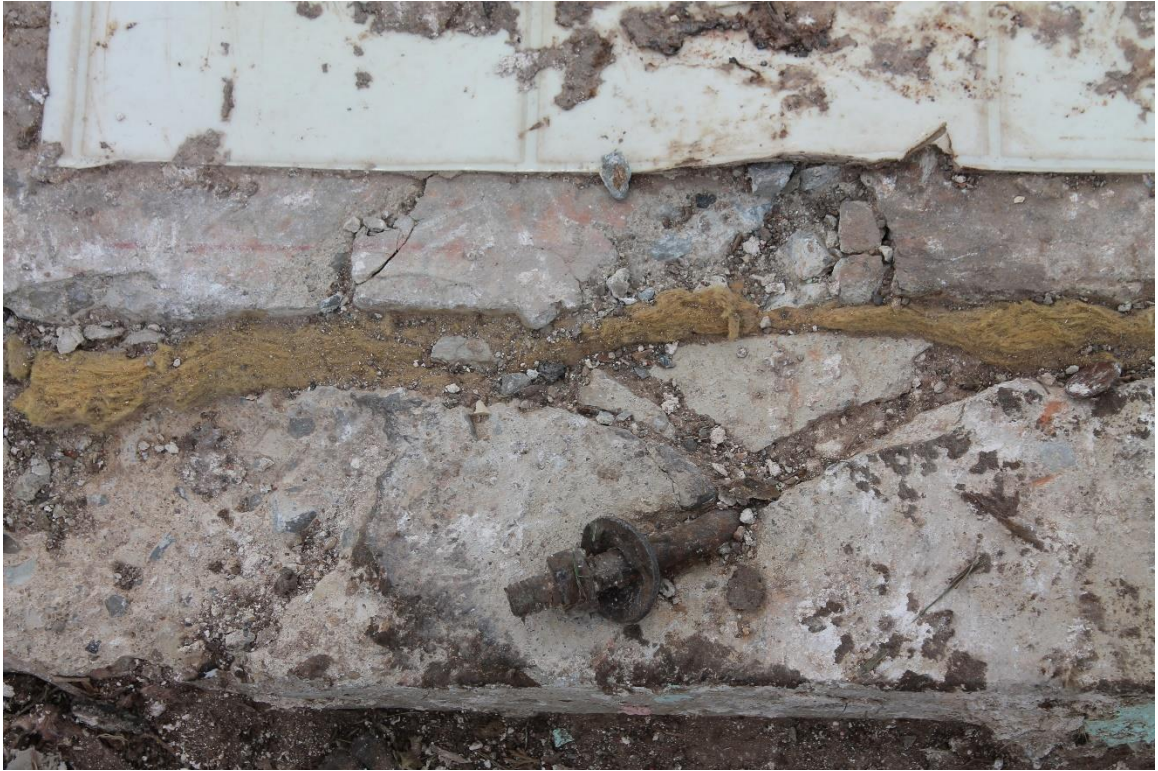
It has also been observed that the whole sill plate is gone, but the bolts are remained on its plate, but it is deformed, or nothing happened at all. When the plate splits then, anchor bolts can come in action to resist the loads. The split can be to the bottom of plate or side attached to sheathing. Figures 1-24 and 1-25 are photos taken in Moore 2013.

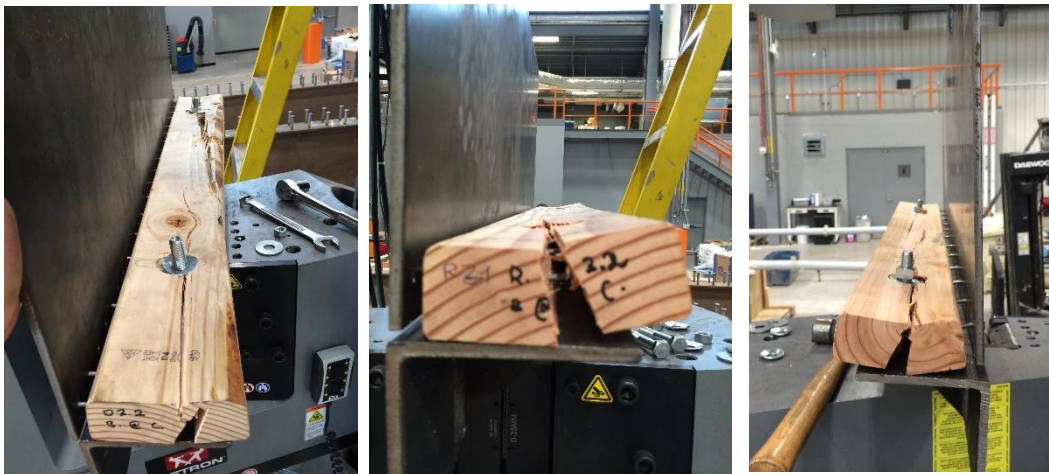
Figure 4-2 Fracture of SAMPLE#1 Specimens are all in bending.

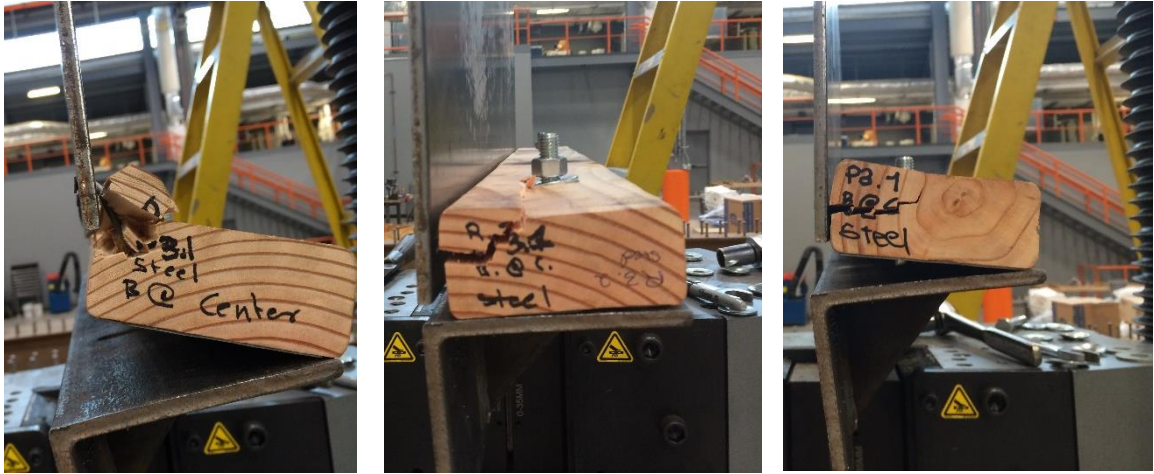
Figure 4-4 (a) Fracture of SAMPLE#2 Specimens along the Edge.

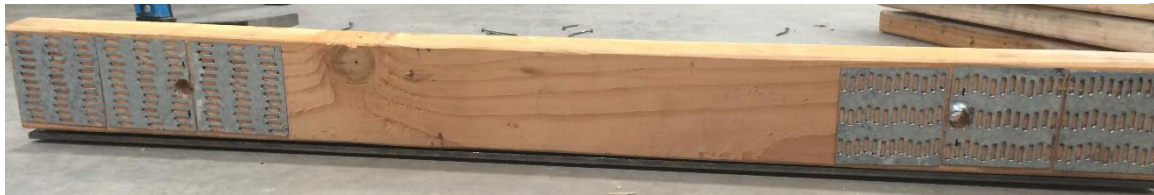
Figure 4-4 (b) Bottom Face of SAMPLE#2 Specimen. No Sign of Crack Or Any Damage Can Be Seen.

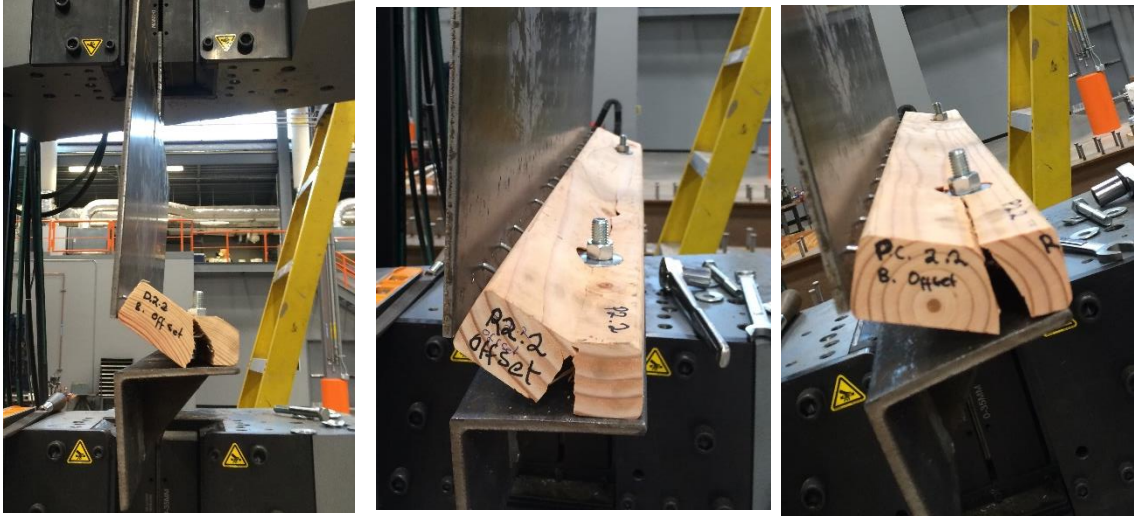
Figure 4-6 Fracture of SAMPLE#3 Specimens along bottom face.

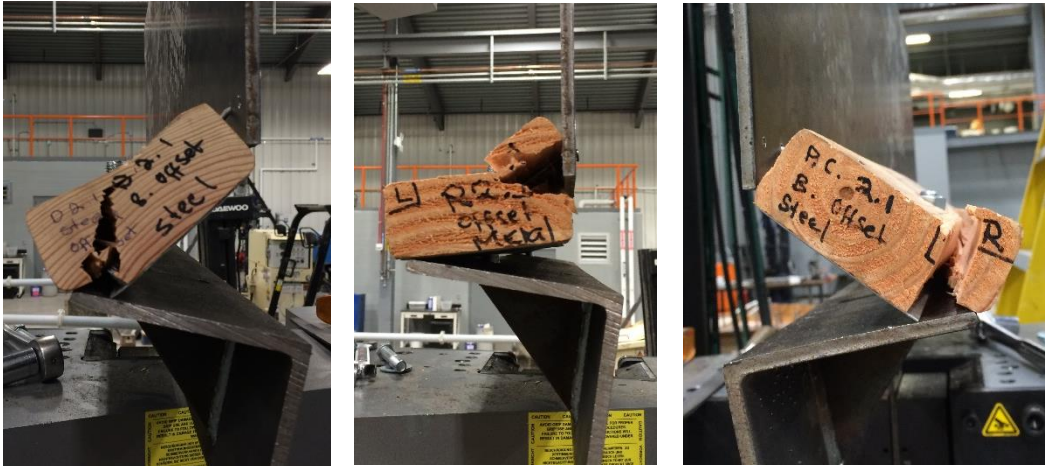
Figure 4-8 Fracture of SAMPLE#4 Specimens. D2.1 Crack goes from bottom in an angle to the line of bolts. R2.1 Fails along edge due to tensile perpendicular to grains. P2.1 splits apart.
