FINAL REPORT ~ FHWA-OK-13-09

APPLIED APPROACH SLAB SETTLEMENT RESEARCH, DESIGN/CONSTRUCTION

SCHOOL OF CIVIL ENGINEERING AND
ENVIRONMENTAL SCIENCE

August 2013

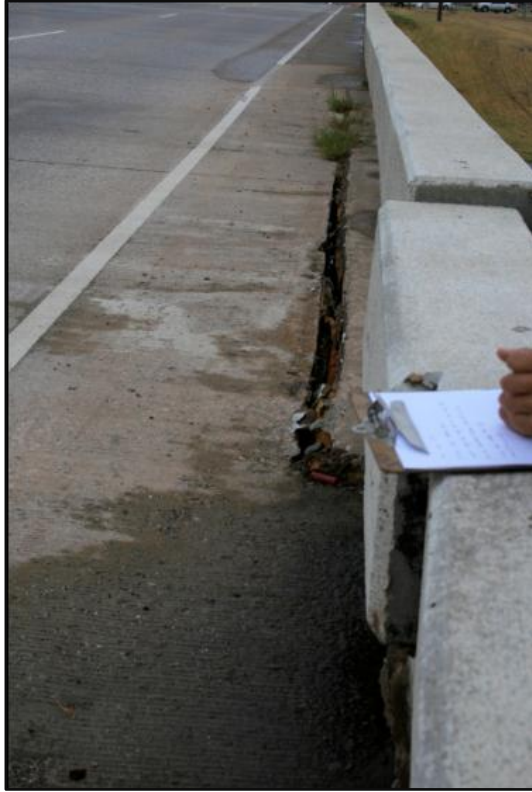
Examples of common problems are seen in Figure 4.4. A large gap can be seen between the wing wall, moving outwards, and the approach slab on Tecumseh Road over I-35. The developing bump on S.H. 6 over West Elk Creek has pulled the seal between pavement slabs apart. A concrete surface channel designed to carry water away from the embankment on S.H. 11 over I-35 failed and collapsed into a 3' deep void beneath the channel.

(a) Horizontal separation between wing wall and approach slab

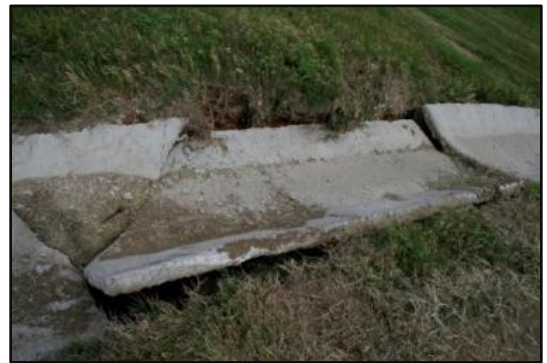
(c) Surface drain channel caving into 3' deep void

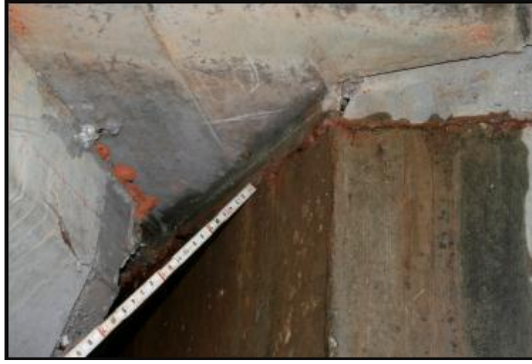
Some examples of erosion taking place through the abutment are shown in Figure 4.5. Soil stains could be observed on the abutment wall originating in these cracks suggesting that some soil loss is taking place through these cracks.

(a) Water and soil flowing through a cracked abutment on S.H. 59 B over Coon Creek, photographed May 21st, 2011

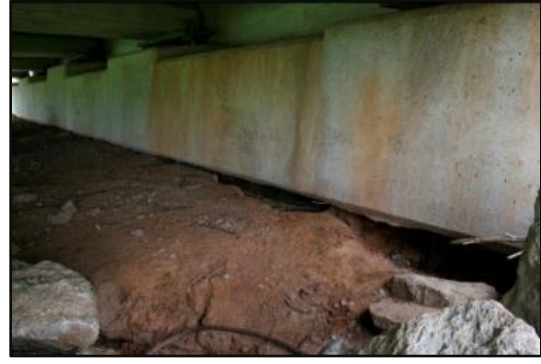
(b) Red stains on the abutment indicate the possibility of soil loss through U.S. 177 over the Salt Fork, photographed June 2nd, 2011

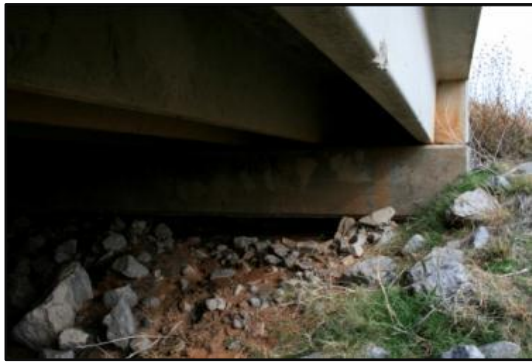
(c) Red staining on abutment at S.H. 152 over Lake Creek Overflow, photographed November 11th, 2011

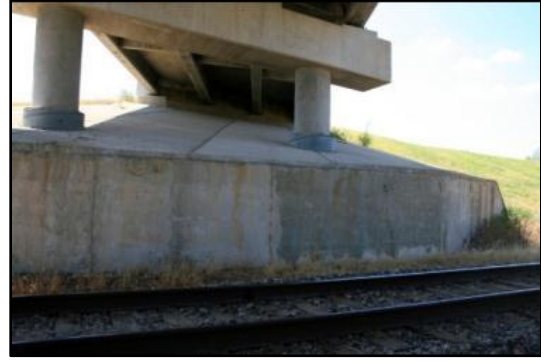
(d) Red stains originating from crack at S.H. 1 over BNSF, photographed August 26th, 2011

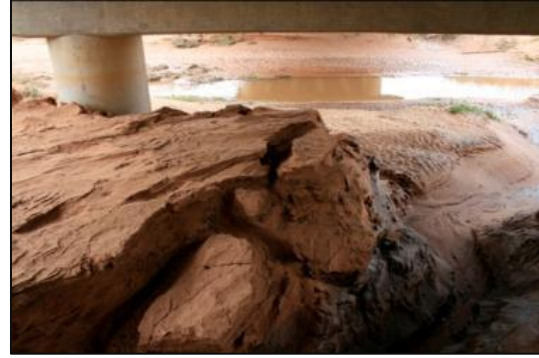
Figure 4.12 Erosion channel at S.H. 152 over Lake Creek continues

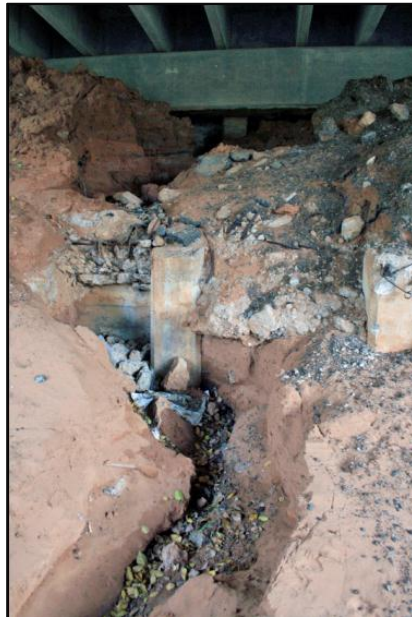
A similar channel was observed at S.H. 152 over Willow Creek and is shown in Figure 4.13. Expanding foam maintenance was used beneath S.H. 9 over Running Creek, but the erosion continued and a void is present even below the foam as seen in Figure 4.14. An example of erosion beneath the abutment is presented in Figure 4.15.

Figure 4.13 Erosion channel from beneath abutment at S.H. 152 over Willow Creek

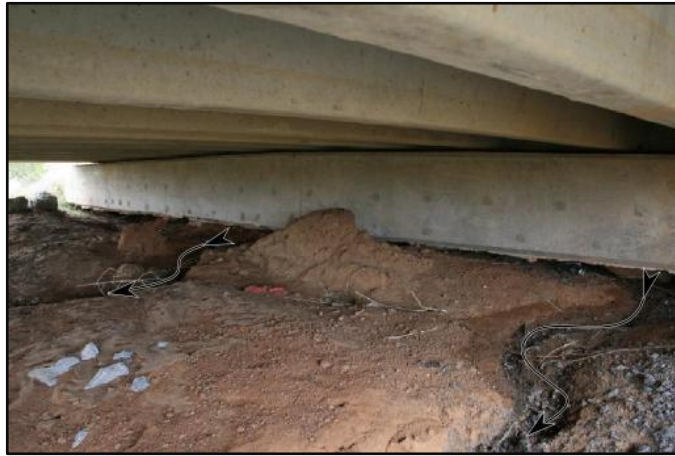
Figure 4.15 Erosion flow beneath abutment at S.H. 152 over Lake Creek Overflow

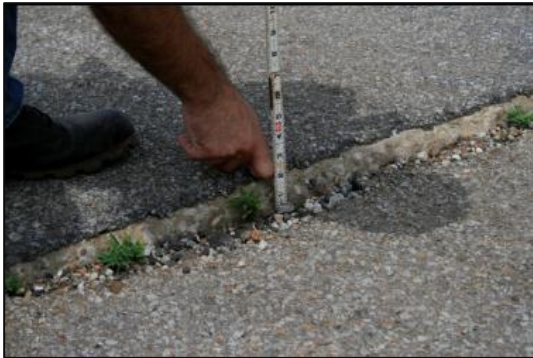
Figure 4.27 Bump at U.S. 177 over Salt Fork, Approach B-2

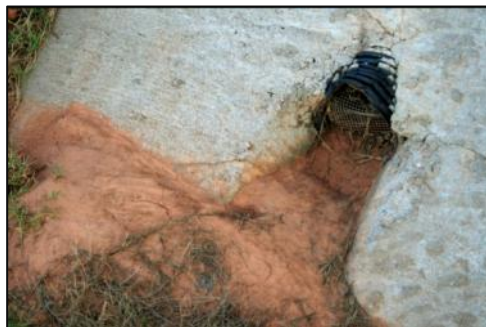
Another observed issue was soil being transported through drainage pipes. This indicates that improper filtering is allowing soil into the perforated pipes which are present in backfills and in slope walls. Shields Boulevard over I-35 provides an example of this. The pipes at this site are not only carrying water, but soil. Soil was observed to have flowed out of the outlets at this location, and voids were present at the abutment. This location has 8"-12" of settlement at the wing-walls, distress of the structure and approach slab, and a significant bump. The drainage outlet at the bottom of the slope wall is shown in Figure 4.32 and a developing void beneath the slope wall at the foot of the abutment is shown in Figure 4.33.

Figure 4.32 Soil flowing from underdrain outlet

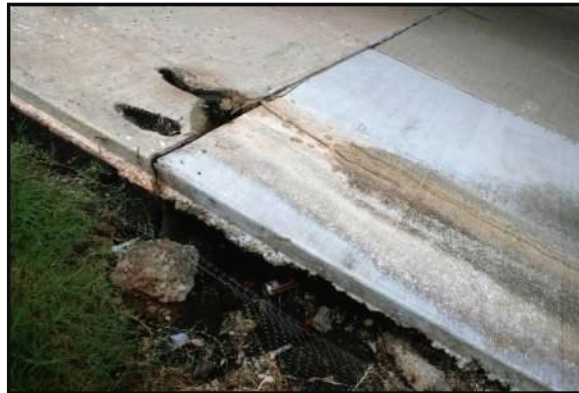
the slope wall. It is unclear which outlet serves the backfill and which serves the slope wall. Outlets are only on this side. The seal between the slabs had failed and therefore the water was poured directly back onto the embankment leading to erosion. The outlet and resulting 16" void is shown in Figure 4.34.

Figure 4.34 Water flowing from outlets into embankment, Tecumseh Rd. over I-35. (note large void under slope wall)

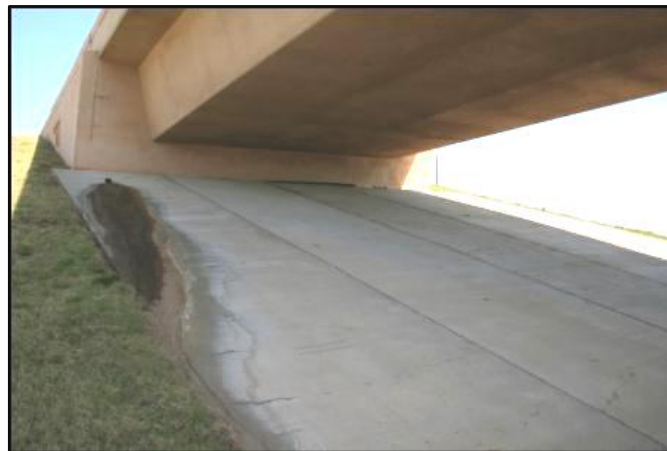
A similar situation was observed at Shields Boulevard over I-35. Though there were no cracks in the slope wall, the water flowed off the side of the slope wall. This led to water reentering the embankment and erosion. Figure 4.35 shows water flowing back into the embankment.

Figure 4.35 Outlet drain at Shields Boulevard over I-35, Embankment N-2

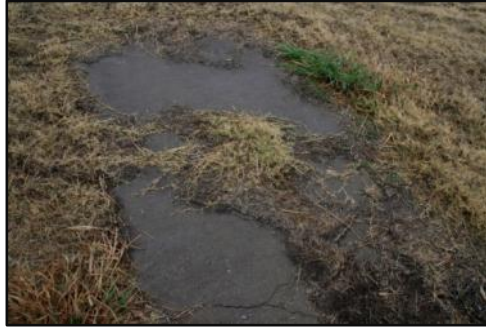
In many locations, the outlet drain is buried or crushed. The underdrain is useless if water cannot flow out of the outlet. Water becoming trapped in the embankment could have detrimental effects on the embankment performance. In Moore, bridges carrying 19th St. over I-35 and I-35 over Main Street have drains which are buried and blocked. No significant erosion was observed at either bridge, but the embankments were observed to have settled, as shown in Figure 4.36.

(a) Grass and soil blocks drainage outlets at 19th St. over I-35
