CRITICAL CORROSION PIT DEPTH FOR FATIGUE
CRACK INITIATION IN 2024-T3, 6061-T6 AND
7075-T6 ALUMINUM ALLOYS

Submitted to the Faculty of the
Graduate College of the
Oklahoma State University
in partial fulfillment of
the requirements for
the Degree of
MASTER OF SCIENCE
December, 2006

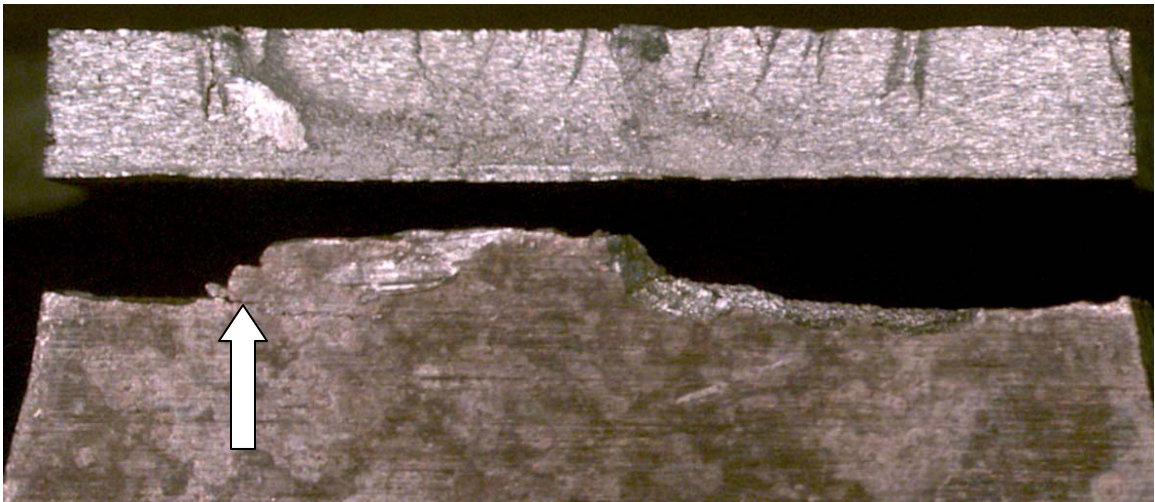
Figure 52 – Specimen T-7, 7075-T6, pre-corroded 60 minutes, exposed to 40/1 ratio 3.5% NaCl solution to H₂O₂ hydrogen peroxide, deflection = 13 mm (uncalibrated), N_f = 31,200 cycles. Cracks other than the primary fracture surface observable; one such is indicated by the arrow. Multiple ratchet marks indicate multiple cracks. (photo # TPS-005)

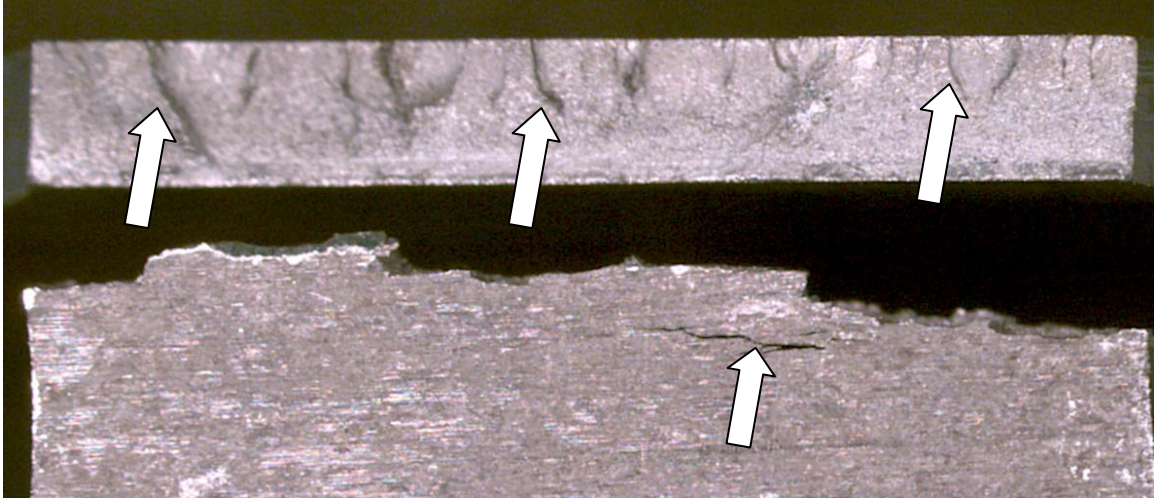
Figure 53 – Specimen T-8, 2024-T3 corroded during cyclic loading, exposed to 40/1 ratio 3.5% NaCl solution to H₂O₂ hydrogen peroxide, deflection = 17 mm (uncalibrated), N_f = 25200 cycles. Note the easily visible secondary crack (indicated by arrow) parallel to fracture surface; also there are many other less conspicuous secondary cracks. The end view of the fracture surface shows obvious signs of multiple ratchet marks (top arrows) indicating the cracks did not begin at the edges but is a result of multiple surface cracks linking together to form the fracture and thereby significantly reducing the fatigue life. (photo # TPS-004)

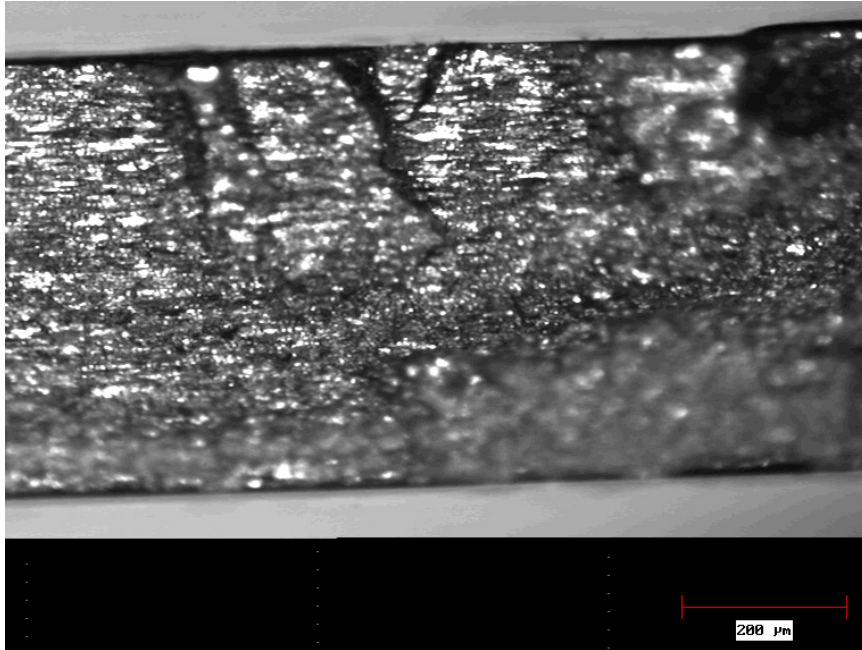
Figure 55 – Specimen T-7, 7075-T6 on edge showing closer view of ratchet marks, 50x, (photo T-7_2)

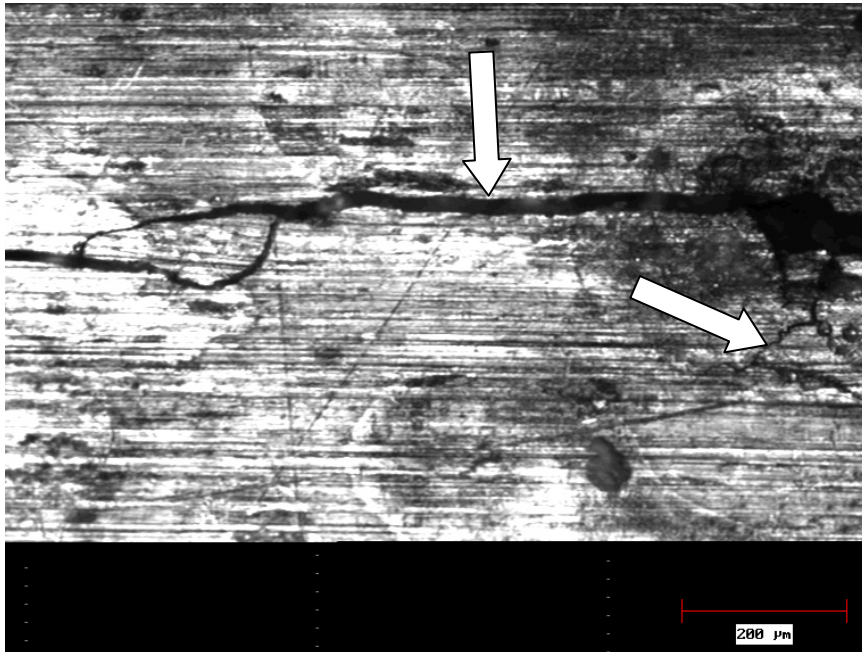
Figure 56 – Specimen T-7, 7075-T6, pre-corroded 60 minutes, exposed to 40/1 ratio 3.5% NaCl solution to H₂O₂ hydrogen peroxide, deflection = 13 mm (uncalibrated), Nf = 31,200 cycles. Cracks observed from a corrosion pit at right of frame. (photo # T-7_2DE)

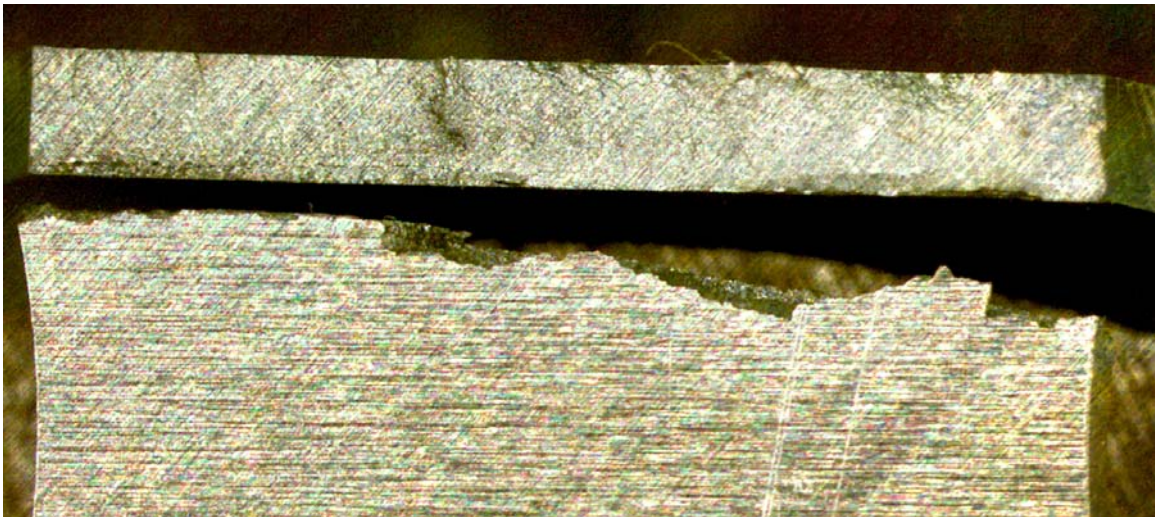
Figure 74 – Specimen T-60-3, (200x) 6061-T6, Defl = 17 mm, Nf = 42,500, corroded during in 3.5% NaCl. Note ratchet marks indicating multiple fatigue crack initiation sites. (photo S-014)

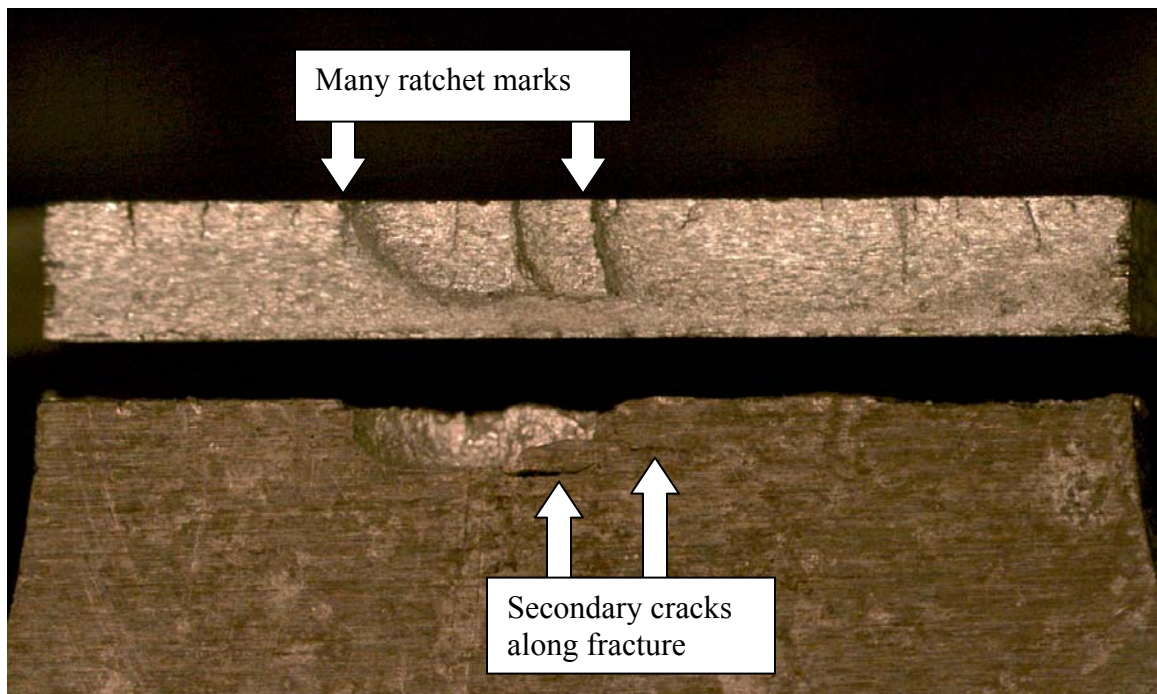
Figure 83 – Specimen 7PH-1, 7075-T6 pre-corroded 60 minutes in a 30/1 ratio of 3.5% NaCl solution to H₂O₂ hydrogen peroxide at 14 mm deflection, Nf = 31,700. Many secondary cracks can be seen along the fracture surface forming at pits, multiple ratchet marks (approximately 17 ea) can be seen originating at the top (tension) surface. (photo # PHS-009)

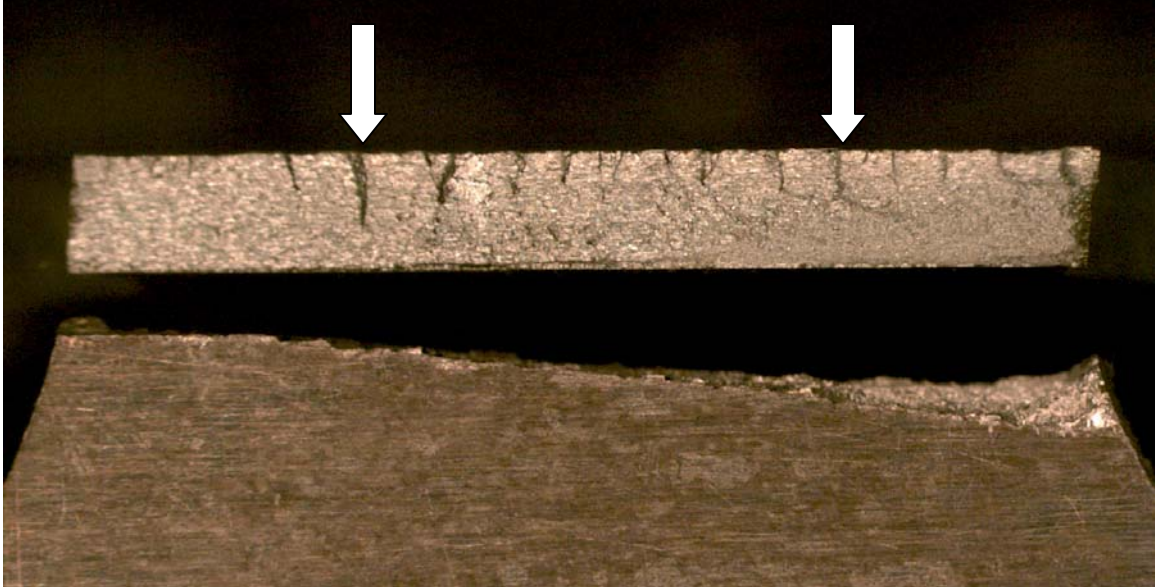
Figure 84 – Specimen 7PH-2, 7075-T6 pre-corroded 30 minutes in a 30/1 ratio of 3.5% NaCl solution to H₂O₂ hydrogen peroxide at 14 mm deflection, Nf = 30,000. Multiple ratchet marks (approximately 20 ea) can be seen originating at the top (tension) surface. (photo # PHS-010)

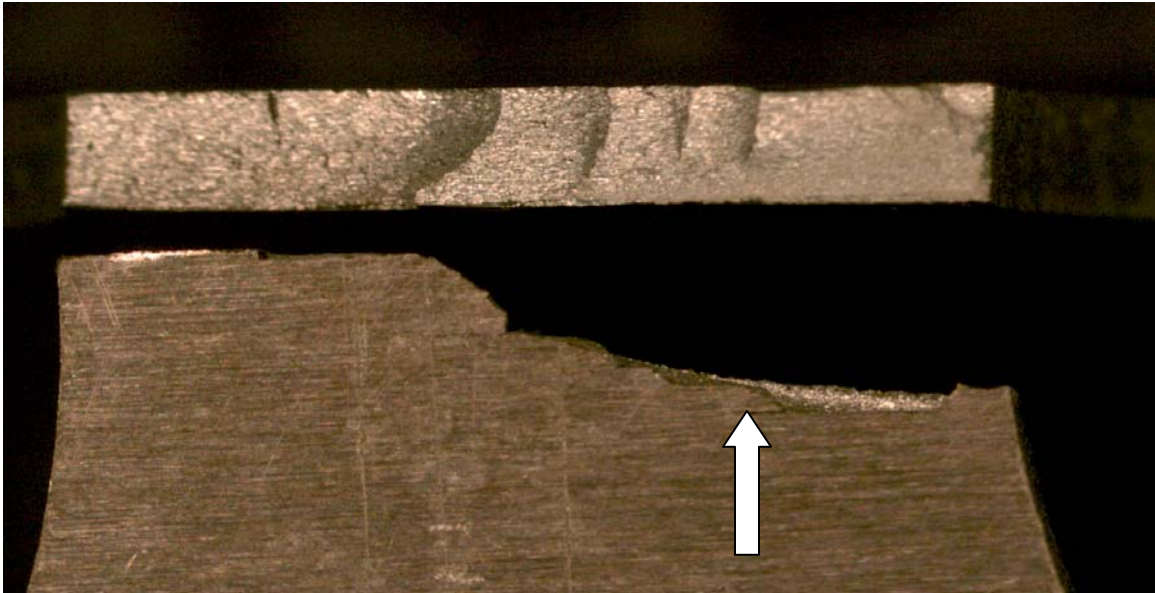
Figure 85 – Specimen 7PH-3, 7075-T6 pre-corroded 15 minutes in a 30/1 ratio of 3.5% NaCl solution to H₂O₂ hydrogen peroxide at 14 mm deflection, Nf = 41,300. A secondary crack can be seen along the fracture surface forming at pits, multiple ratchet marks (approximately 6 ea) can be seen originating at the top (tension) surface. (photo # PHS-011)

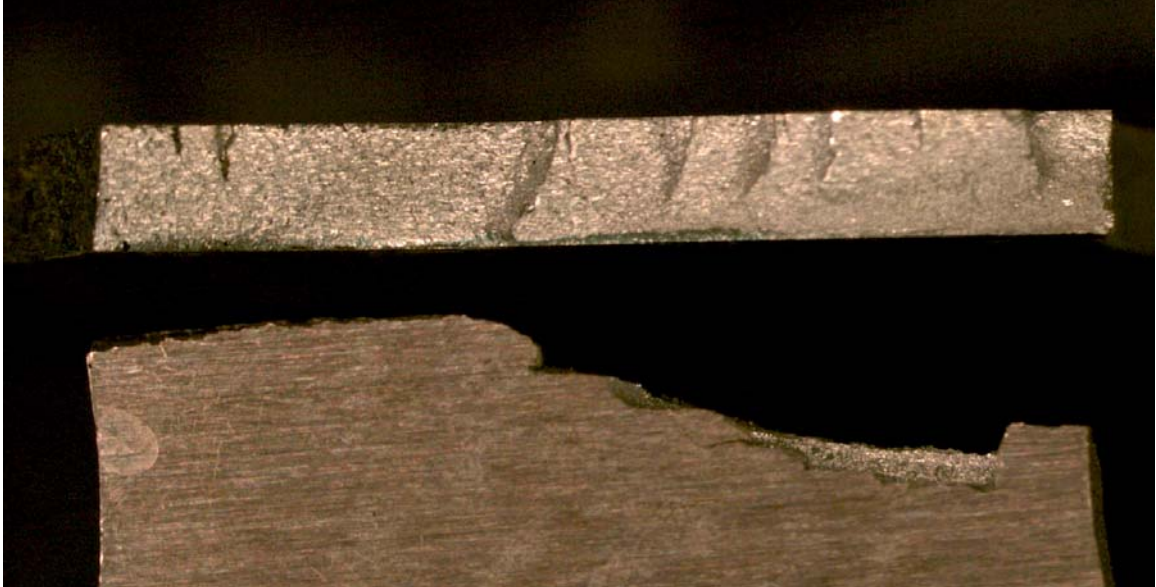
Figure 86 – Specimen 7PH-4, 7075-T6 pre-corroded 10 minutes in a 30/1 ratio of 3.5% NaCl solution to H₂O₂ hydrogen peroxide at 14 mm deflection, Nf = 34,800. Multiple ratchet marks (approximately 9 ea) can be seen originating at the top (tension) surface. (photo # PHS-008)

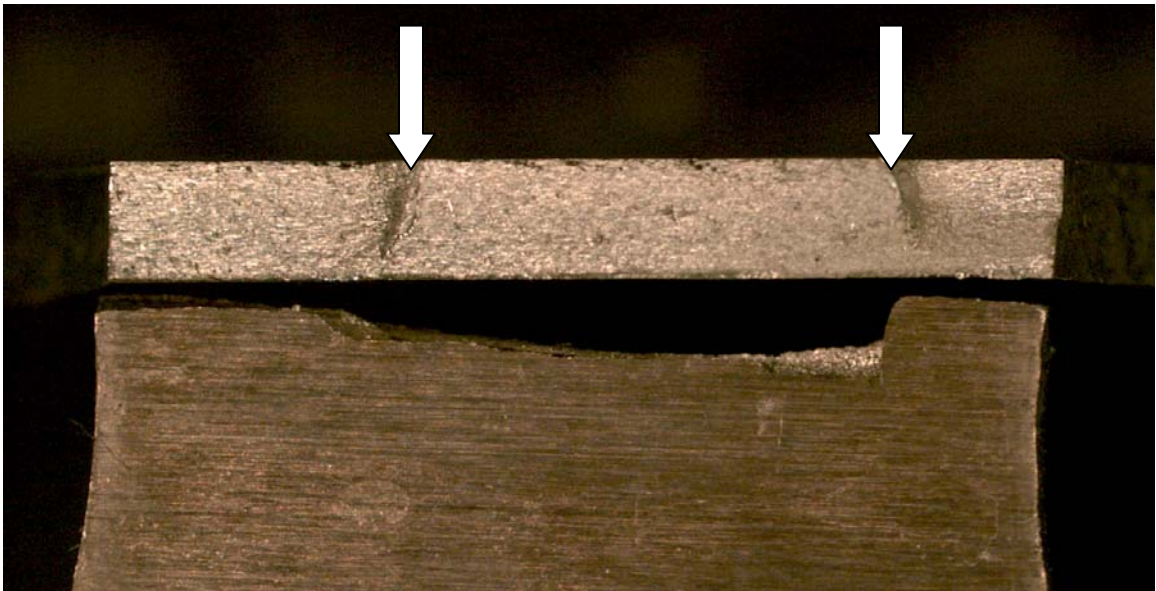
Figure 87 – Specimen 7PH-5, 7075-T6 pre-corroded 15 minutes in a 60/1 ratio of 3.5% NaCl solution to H₂O₂ hydrogen peroxide at 14 mm deflection, Nf = 47,900. Multiple ratchet marks (approximately 4 ea however the 2 obvious are indicated with arrows) can be seen originating at the top (tension) surface – this is greatly reduced from the previous specimens indicating the minimum corrosion pitting value is in close proximity. (photo # PHS-012)

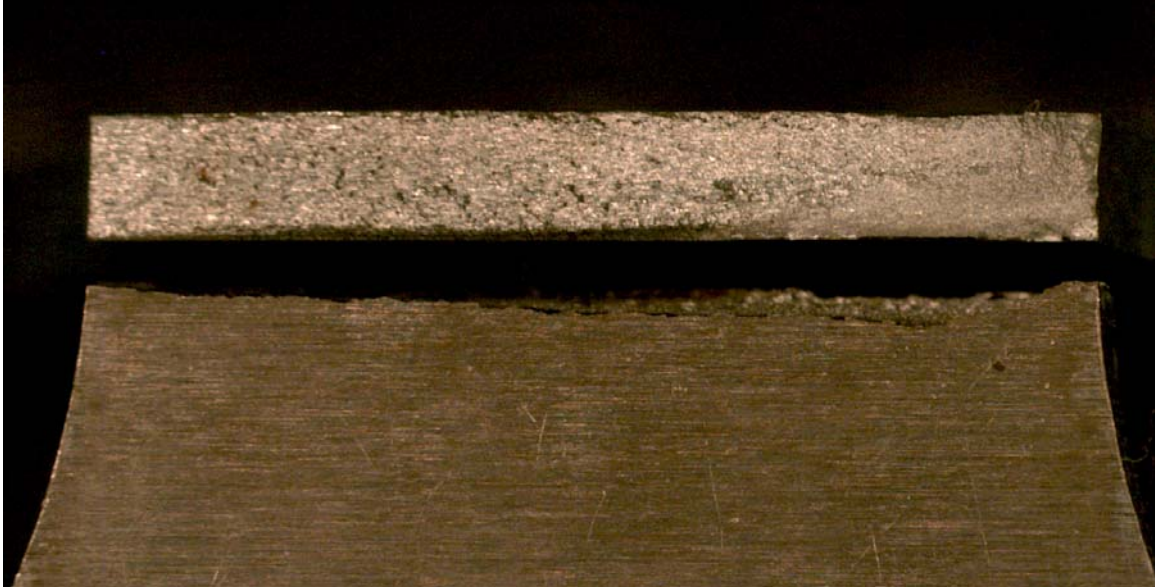
Figure 88 – Specimen 7PH-6, 7075-T6 pre-corroded 30 minutes in a 120/1 ratio of 3.5% NaCl solution to H₂O₂ hydrogen peroxide at 14 mm deflection, Nf = 64,200. No discernable ratchet marks can be seen originating at the expected top (tension) surface – this is greatly reduced from the previous specimens indicating the minimum corrosion pitting value required to generate ratchet marks must be more severe. (photo # PHS-013)

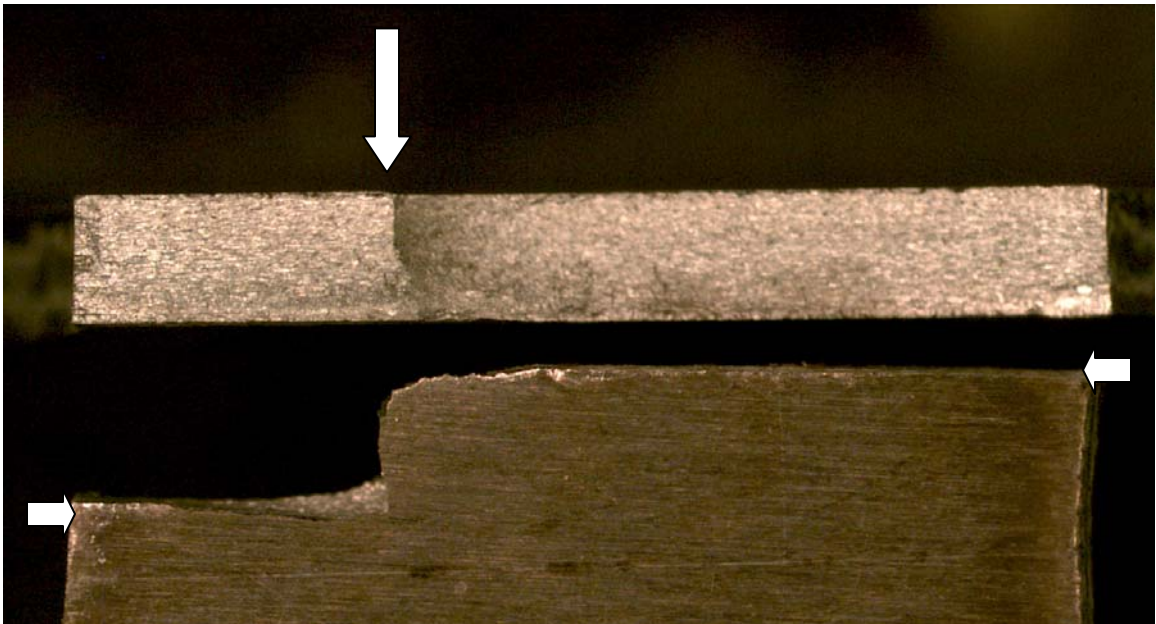
Figure 89 – Specimen 7PH-7, 7075-T6 pre-corroded 240 minutes in a 120/1 ratio of 3.5% NaCl solution to H₂O₂ hydrogen peroxide at 14 mm deflection, Nf = 51,900. Only one ratchet mark is apparent, however, it appears this is a result of cracks originating at each edge and meeting near center at the “ratchet” mark. (photo # PHS-014)

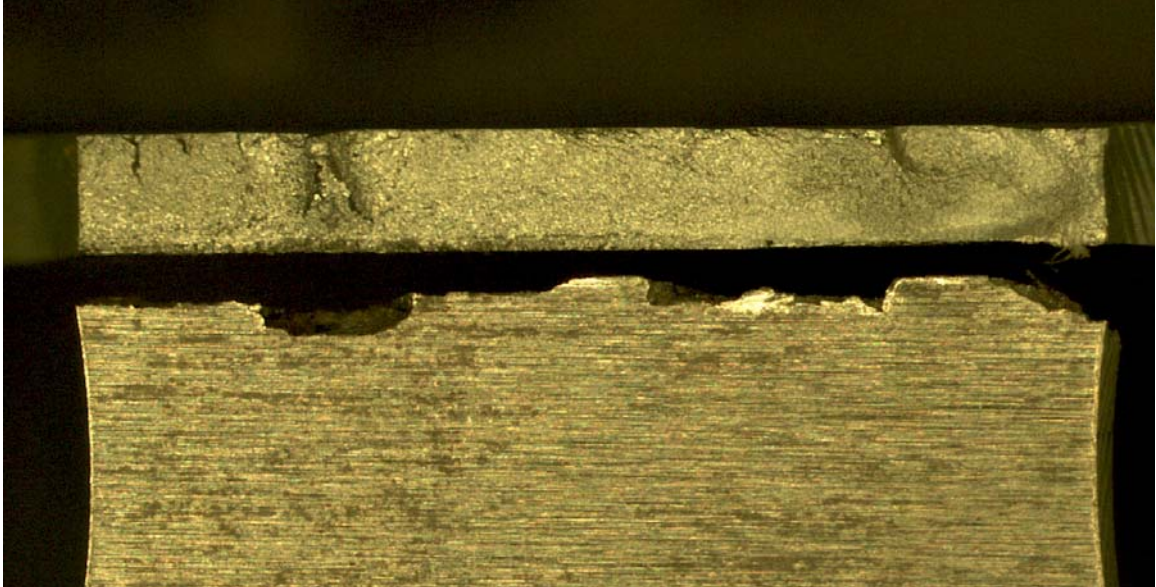
Figure 90 – Specimen 6PH-1, 6061-T6 pre-corroded 90 minutes in a 30/1 ratio of 3.5% NaCl solution to H₂O₂ hydrogen peroxide at 14 mm deflection, Nf = 84,200. Multiple ratchet marks (approximately 10 ea) can be seen originating at the top (tension) surface indicating multiple fatigue crack initiations. (photo # PHS-015)

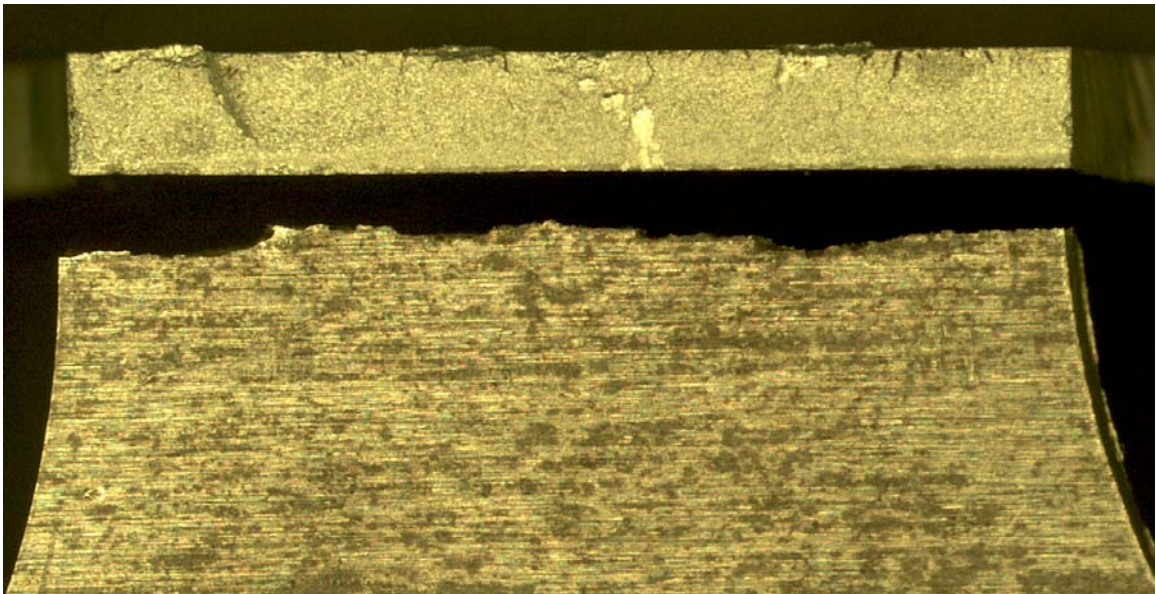
Figure 91 – Specimen 6PH-2, 6061-T6 pre-corroded 120 minutes in a 30/1 ratio of 3.5% NaCl solution to H₂O₂ hydrogen peroxide at 14 mm deflection, Nf = 47,200. Multiple ratchet marks (approximately 11 ea) can be seen originating at the top (tension) surface indicating multiple fatigue crack initiations. (photo # PHS-017)

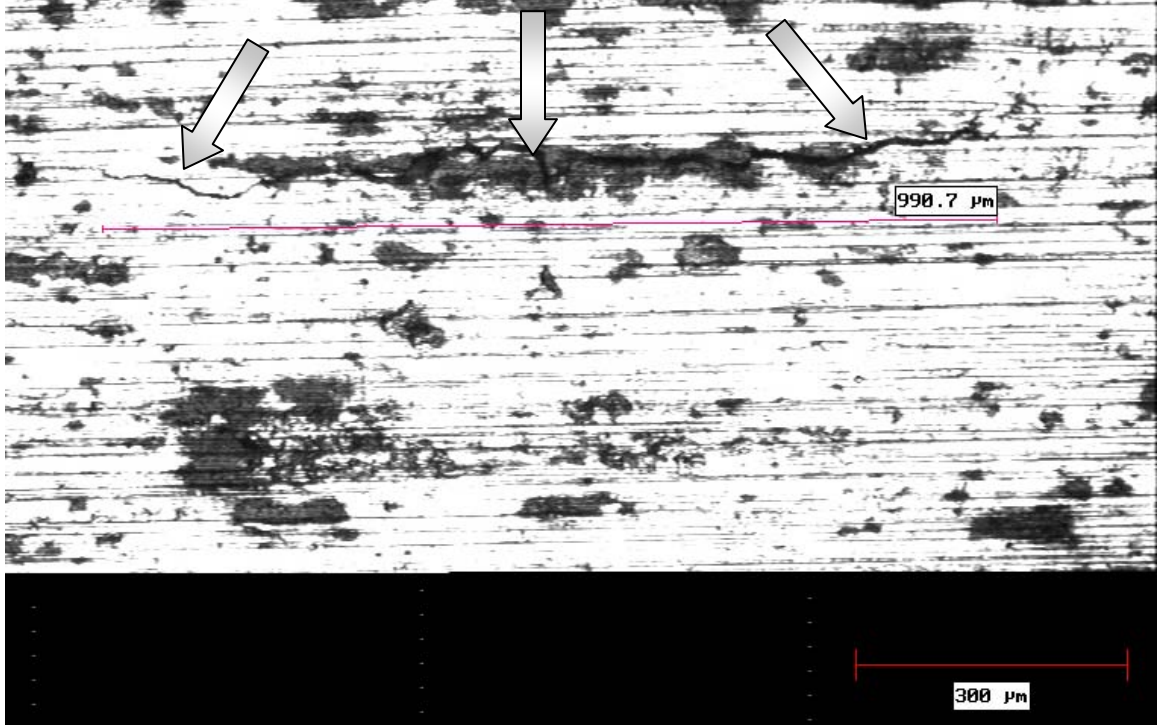
Figure 92 – Specimen 6PH-2, 6061-T6 pre-corroded 120 minutes in a 30/1 ratio of 3.5% NaCl solution to H₂O₂ hydrogen peroxide at 14 mm deflection, N_f = 47,200. An interior crack away from primary fracture surface initiating in a pitted region; again reinforcing the observation that visible corrosion pitting results in crack initiation and a subsequent reduction in N_f. (photo # PH-028)

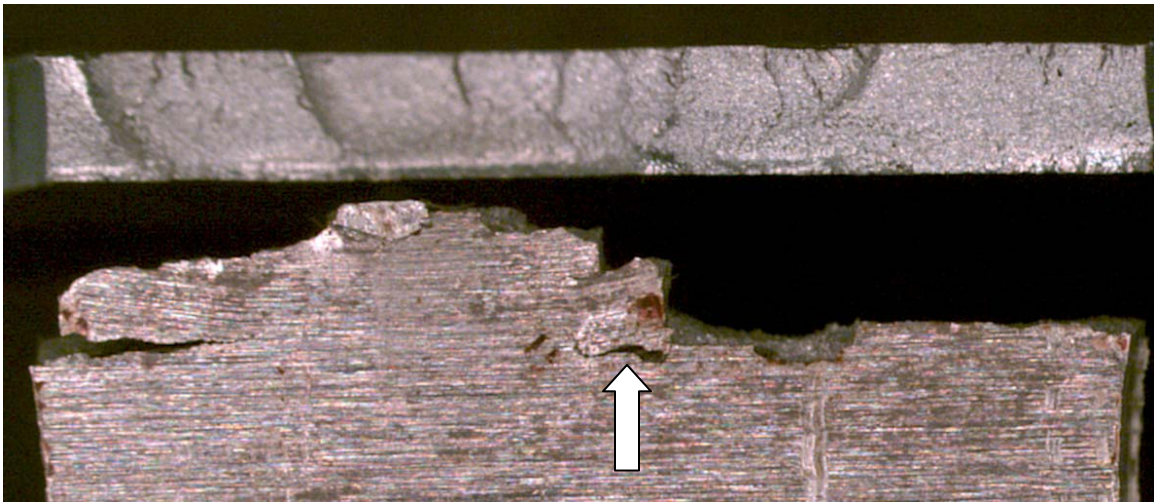
Figure 93 – Specimen 6PH-3, 6061-T6 pre-corroded 30 minutes in a 30/1 ratio of 3.5% NaCl solution to H₂O₂ hydrogen peroxide at 14 mm deflection, N_f = 110,000. Multiple ratchet marks (approximately 15 ea) can be seen originating at the top (tension) surface indicating multiple fatigue crack initiations. Arrow indicates an easily visible secondary crack. (photo # PHS-016)

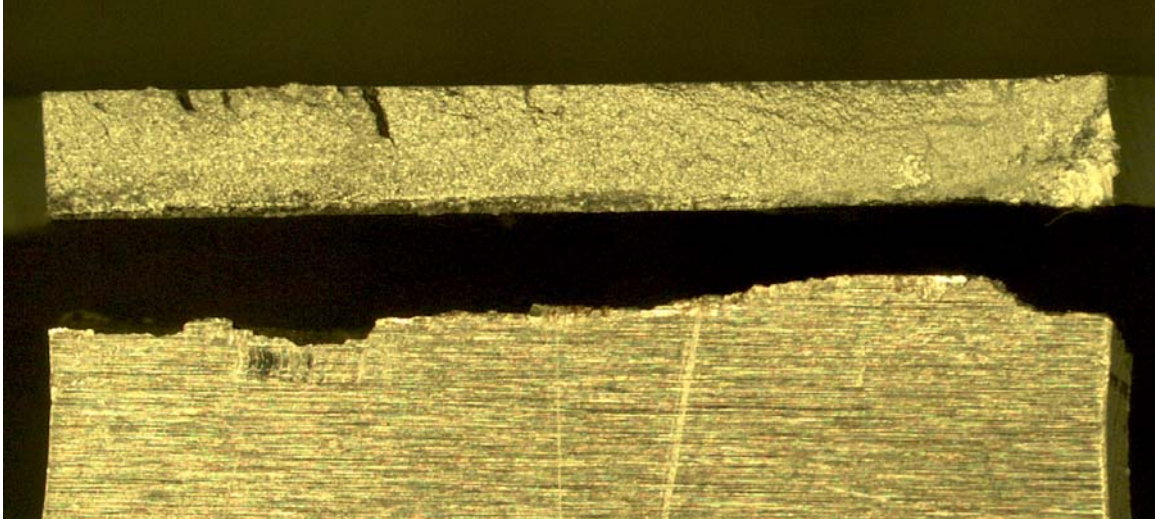
Figure 94 – Specimen 6PH-4, 6061-T6 pre-corroded 15 minutes in a 30/1 ratio of 3.5% NaCl solution to H₂O₂ hydrogen peroxide at 14 mm deflection, Nf = 76,500. Multiple ratchet marks (approximately 7 ea) can be seen originating at the top (tension) surface indicating multiple fatigue crack initiations. (photo # PHS-018)

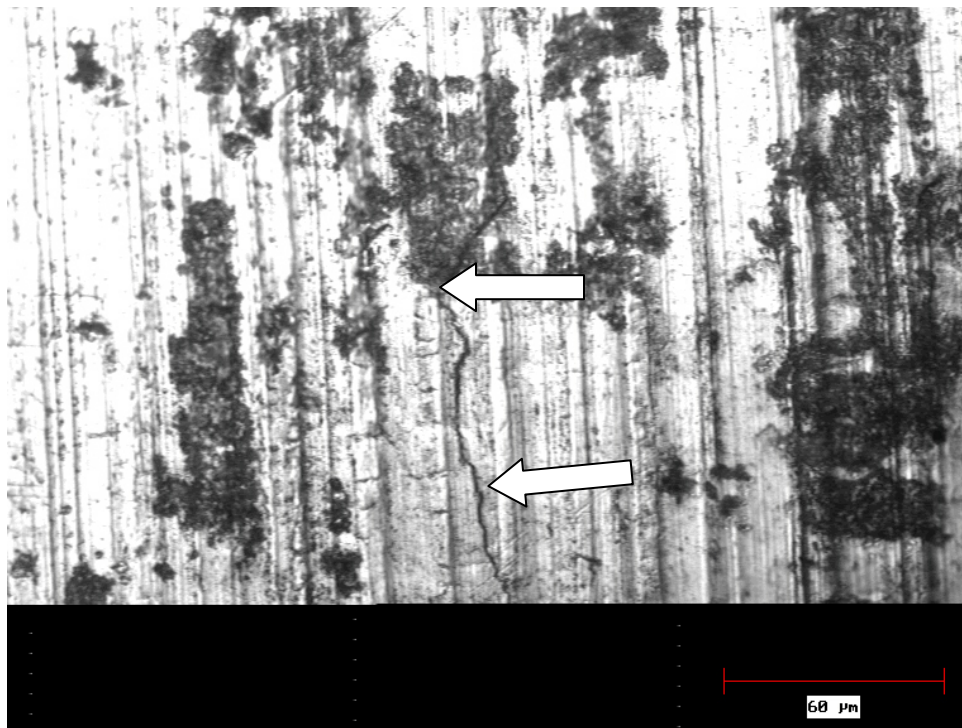
Figure 95 – Specimen 6PH-4, 6061-T6 pre-corroded 15 minutes in a 30/1 ratio of 3.5% NaCl solution to H₂O₂ hydrogen peroxide at 14 mm deflection, Nf = 76,500. Crack can be seen running through corrosion pits away from primary fracture surface. (photo # PH-030)

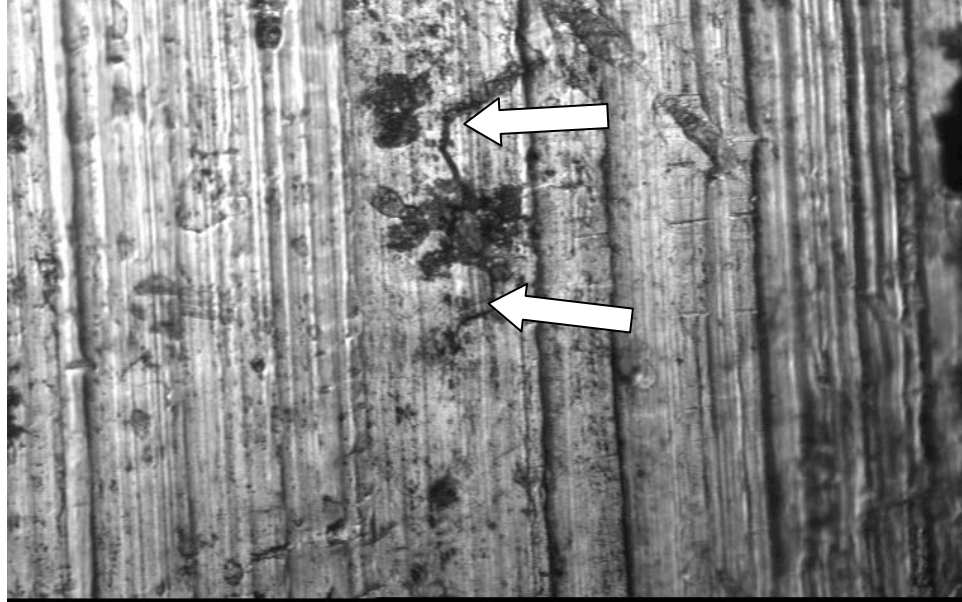
Figure 96 – Specimen 6PH-4, 6061-T6 pre-corroded 15 minutes in a 30/1 ratio of 3.5% NaCl solution to H₂O₂ hydrogen peroxide at 14 mm deflection, Nf = 76,500. Crack can be seen here beginning to initiate at a corrosion pit away from primary fracture surface; ample corrosion pitting is present in order to initiate secondary cracking as seen by ratchet marks in Figure 42. (photo # PH-031)

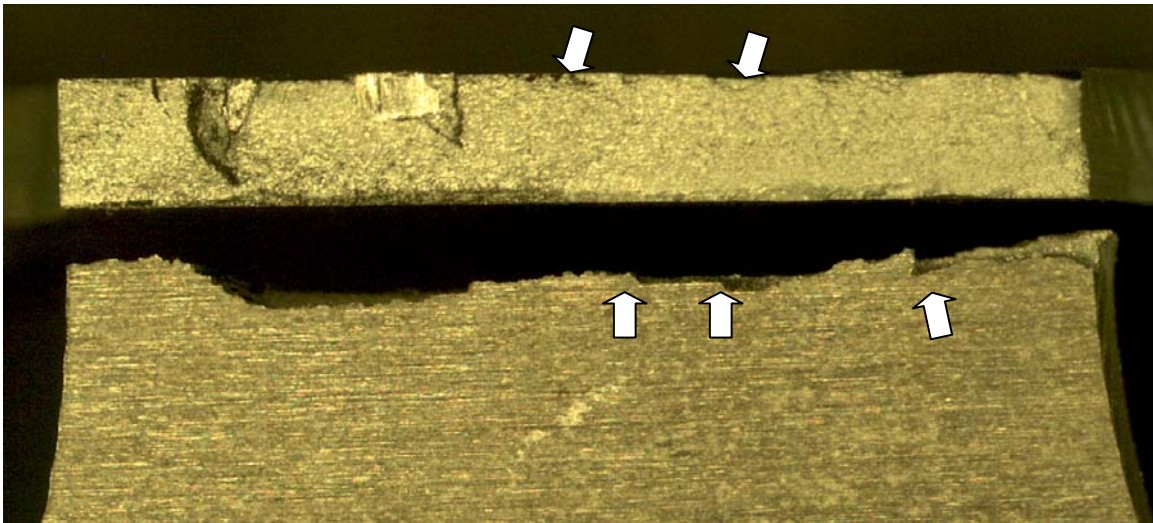
Figure 97 – Specimen 2PH-1, 2024-T3 pre-corroded 5 minutes in a 30/1 ratio of 3.5% NaCl solution to H₂O₂ hydrogen peroxide at 14 mm deflection, Nf = 128,600. Multiple ratchet marks (approximately 16 ea), most of them shallow, can be seen originating at the top (tension) surface indicating multiple fatigue crack initiations. The shallowness of the ratchet marks is a good indicator the degree of pitting is near a minimum. (photo # PHS-019)

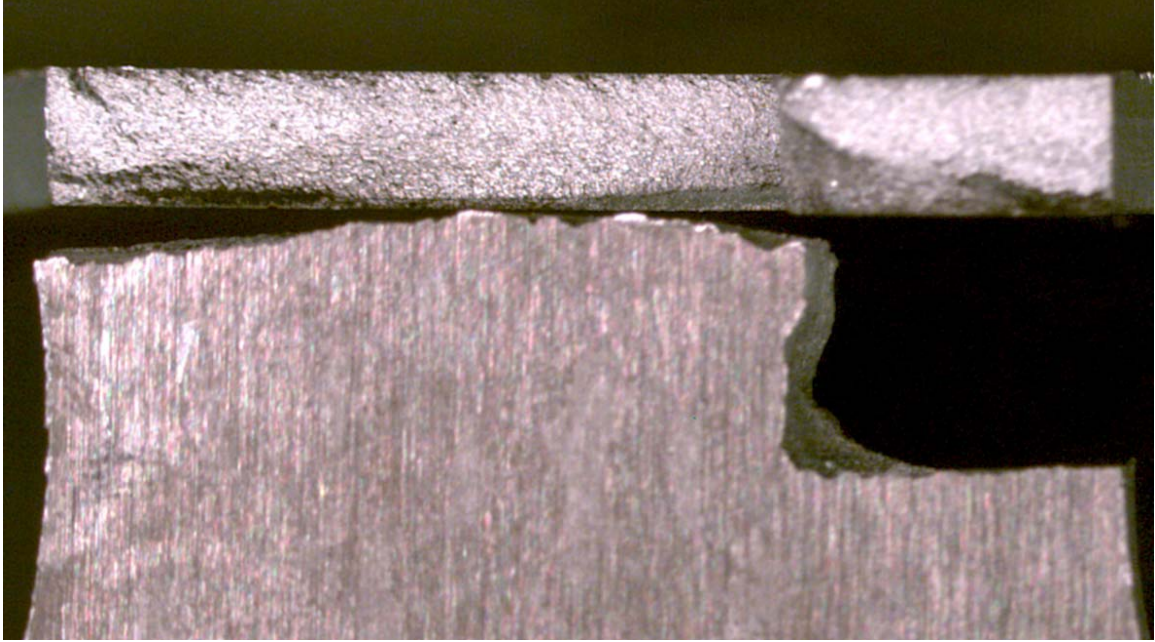
Figure 98 – Specimen LPH-1, 2024-T3 laser cut pre-corroded 15 minutes in a 30/1 ratio of 3.5% NaCl solution to H₂O₂ hydrogen peroxide at 14 mm deflection, Nf = 114,500. Possibly several small ratchet marks but main impression of this failure is that of two offset edge cracks that jogged near center to meet and complete the fracture surface. (photo # LPHS-002)

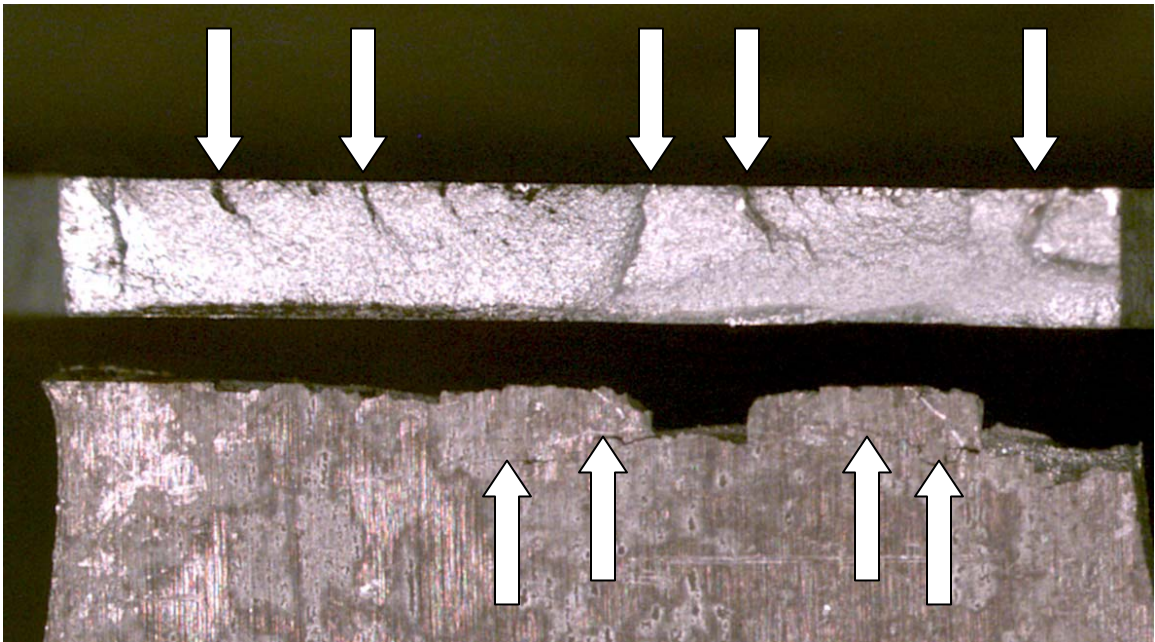
Figure 99 – Specimen LPH-2, 2024-T3 laser cut pre-corroded 70 minutes in a 30/1 ratio of 3.5% NaCl solution to H₂O₂ hydrogen peroxide at 14 mm deflection, Nf = 73,200. Multiple ratchet marks (approximately 14 ea) can be seen originating at the top (tension) surface indicating multiple fatigue crack initiations. Several cracks initiating from corrosion pits also observed running basically parallel to the primary fracture surface (lower section). (photo # LPHS-003)

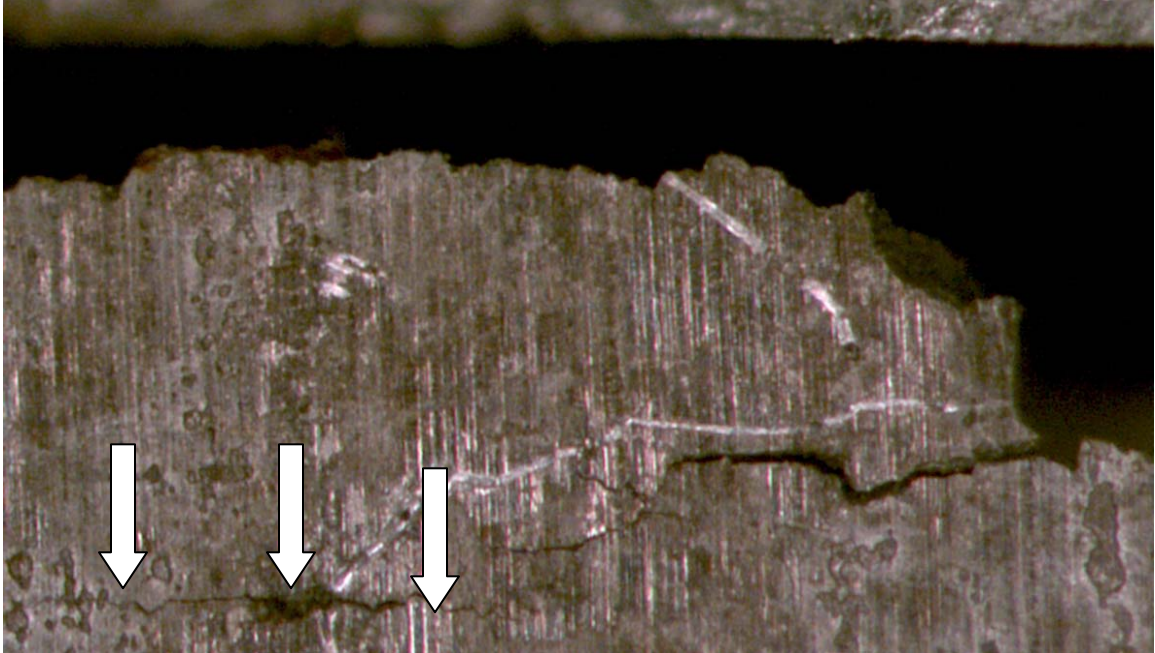
Figure 100 – Specimen LPH-2, 2024-T3 laser cut pre-corroded 70 minutes in a 30/1 ratio of 3.5% NaCl solution to H₂O₂ hydrogen peroxide at 14 mm deflection, Nf = 73,200. Closer view (50x) of secondary cracks, noted in Figure x above, running parallel to primary fracture surface – arrows indicate another fatigue crack traversing left and right from a pit (center arrow); crack has not yet linked to the larger crack at right. (photo # LPHS-004)

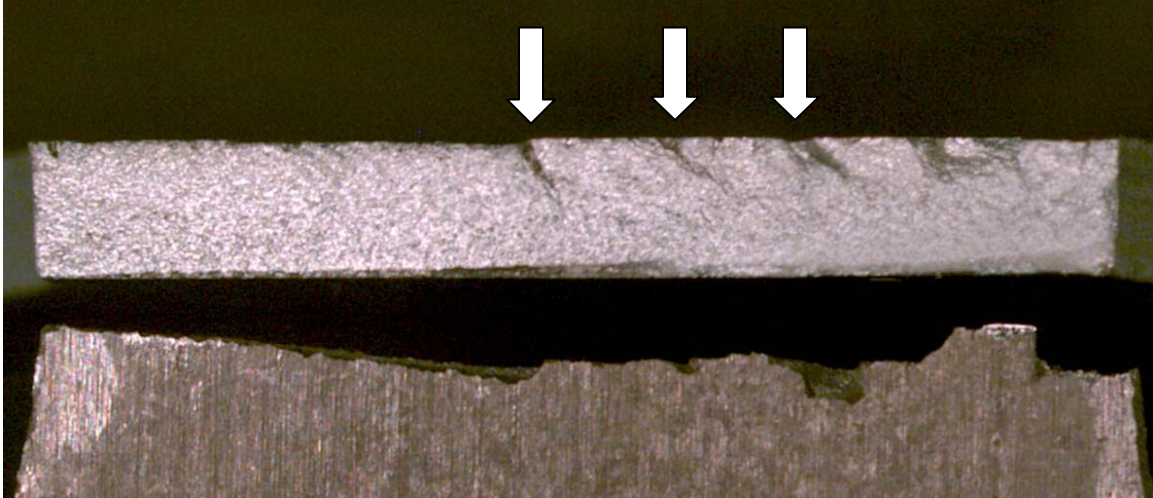
Figure 102 – Specimen LPH-3, 2024-T3 laser cut pre-corroded 45 minutes in a 30/1 ratio of 3.5% NaCl solution to H₂O₂ hydrogen peroxide at 14 mm deflection, Nf = 86,200. Multiple ratchet marks (approximately 10 ea) can be seen originating at the top (tension) surface indicating multiple fatigue crack initiations. (photo # LPHS-006)

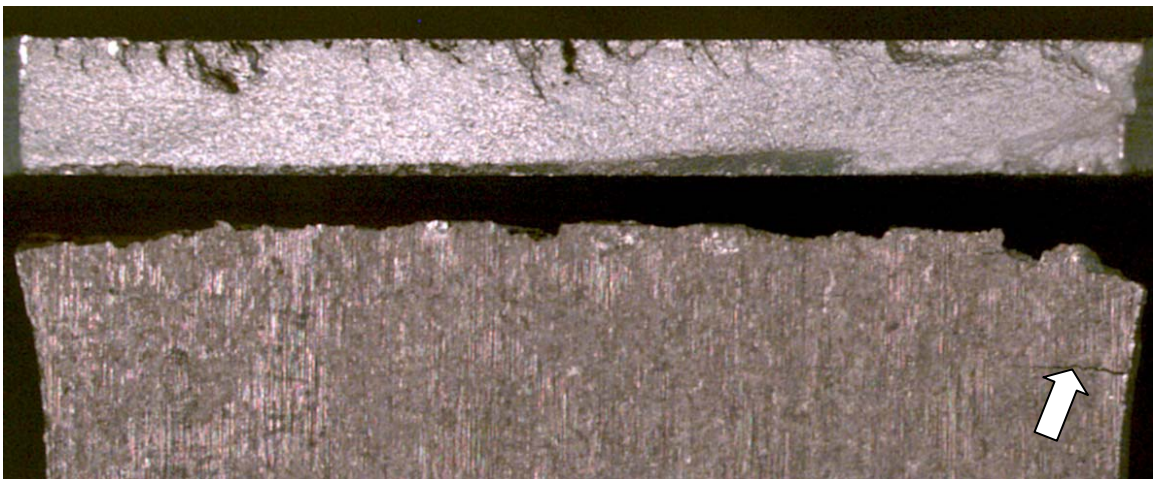
Figure 103 – Specimen LPH-4, 2024-T3 laser cut pre-corroded 10 minutes in a 30/1 ratio of 3.5% NaCl solution to H₂O₂ hydrogen peroxide at 14 mm deflection, Nf = 73,200. Multiple ratchet marks (approximately 23 ea) can be seen originating at the top (tension) surface indicating multiple fatigue crack initiations – ratchet marks penetrate the surface about 1/3 -1/2 of thickness. One crack noted originating at the right-hand edge. (photo # LPHS-007)

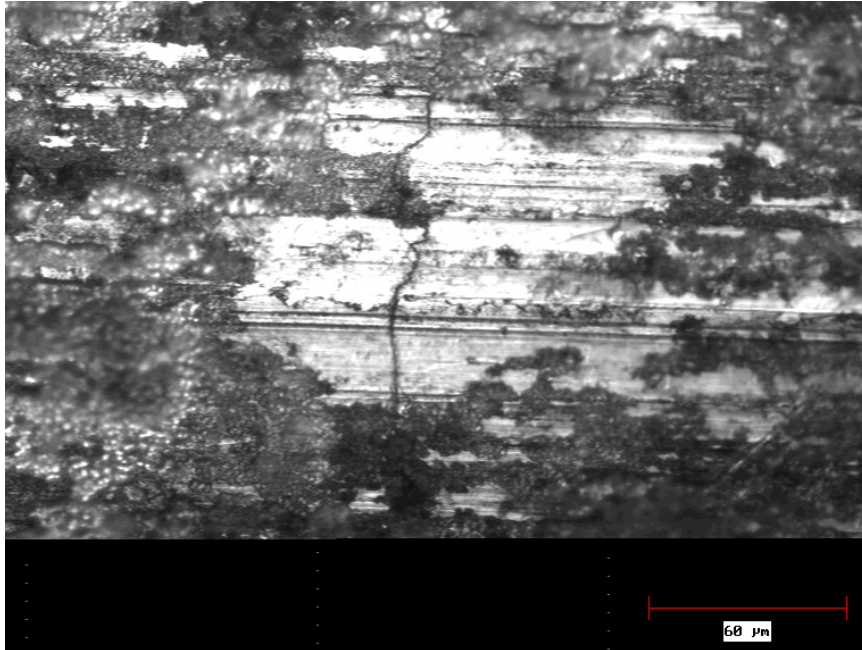
Figure 106 – Specimen LPH-4, 2024-T3 laser cut pre-corroded 10 minutes in a 30/1 ratio of 3.5% NaCl solution to H₂O₂ hydrogen peroxide at 14 mm deflection, Nf = 82,000. Cracking away from primary fracture surface (500x) – crack originates from a 4 μm deep corrosion pit well away from edges and propagates toward other pits. (photo # PH-034)

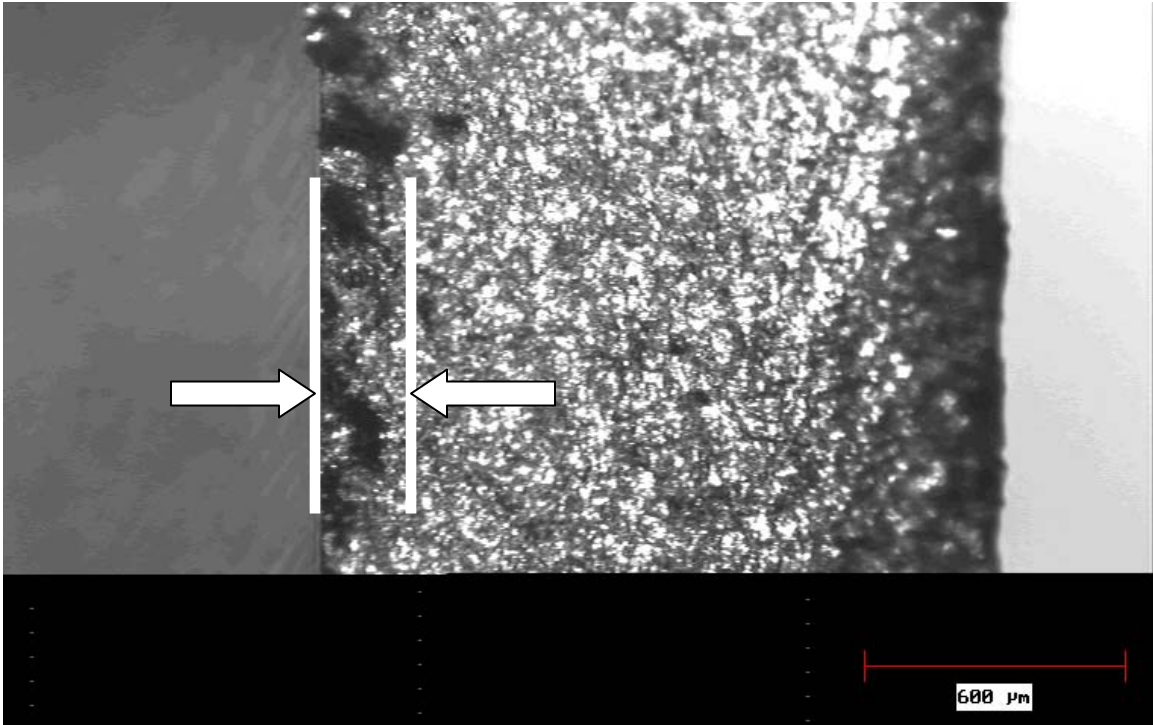
Figure 108 – Specimen LPH-5, 2024-T3 laser cut pre-corroded 5 minutes in a 30/1 ratio of 3.5% NaCl solution to H₂O₂ hydrogen peroxide at 14 mm deflection, N_f = 114,900. Close-up (50x) of several ratchet marks seen in Figure x above - ratchet marks can be seen originating at the left-hand (tension) surface; each indicating multiple fatigue crack initiations. Ratchet marks are relatively shallow and penetrate, as seen here, vertically into the surface only about 10% of the thickness. (photo # LPHS-014)

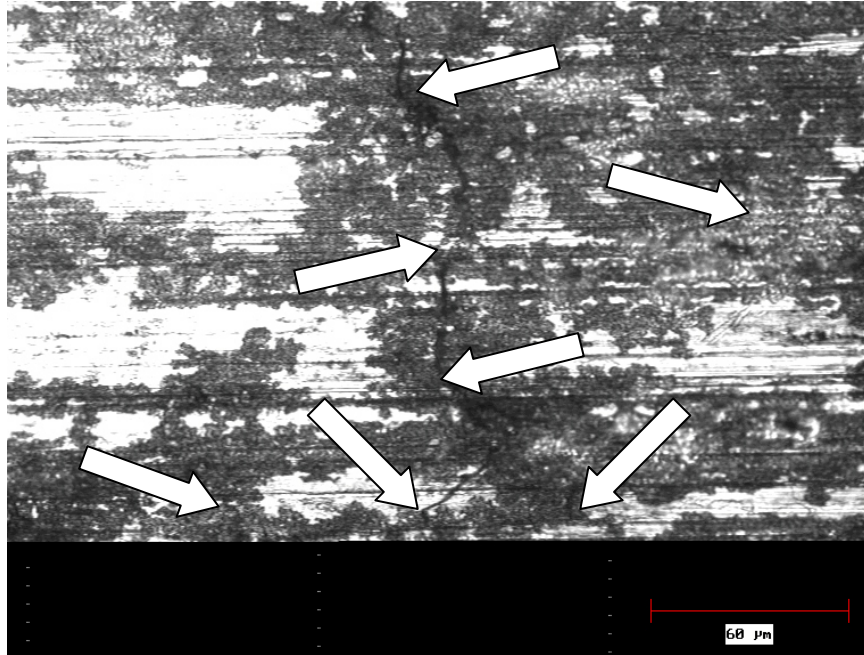
Figure 109 – Specimen LPH-5, 2024-T3 laser cut pre-corroded 5 minutes in a 30/1 ratio of 3.5% NaCl solution to H₂O₂ hydrogen peroxide at 14 mm deflection, Nf = 114,900. Close-up (500x) of several cracks originating from pits away from the primary fracture surface. (photo # LPHS-013)
