OKLAHOMA DEPARTMENT OF TRANSPORTATION

# SILANE PENETRATING WATERPROOFING SEALERS

**Final Report**  
**November 1996**

**Kimberly L. Gordon**  
**Research Project Manager**

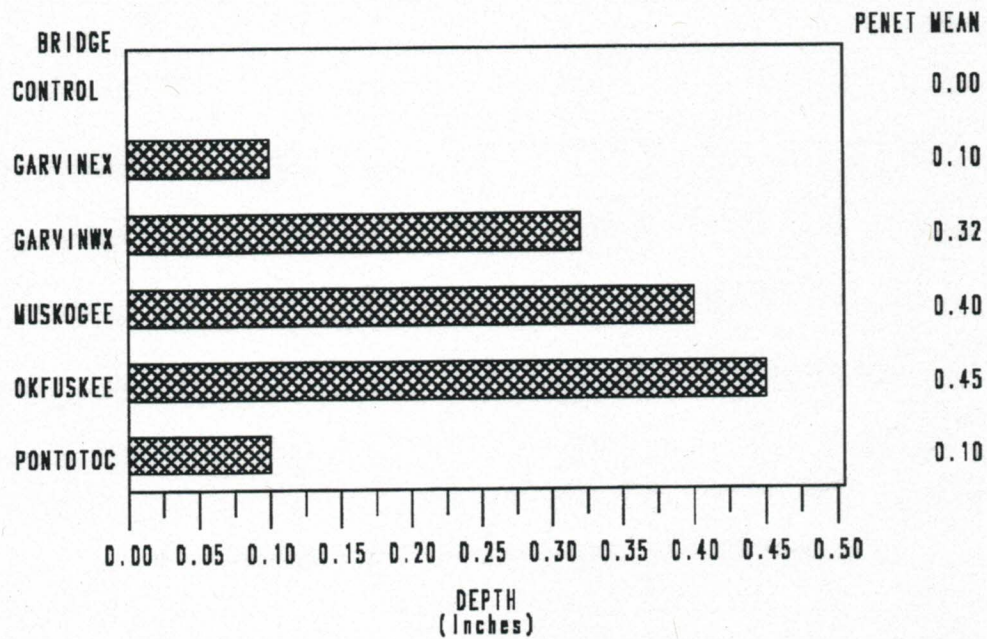
Figure 3. Depth of Penetration.

At least two cores were taken from bridges in Garvin, Muskogee, Okfuskee and Pontotoc Counties in 1993 for indications of silanes. One core is cut, broken, or split across the diameter and dipped in a tinted solution. Areas that have been penetrated by the silanes retain their original color. The rest of the core retains the color of the dye used in the testing procedure. Then the core is photographed and measured with a planimeter to determine the depth of penetration. The second core is used to measure the 48 hour water absorption.

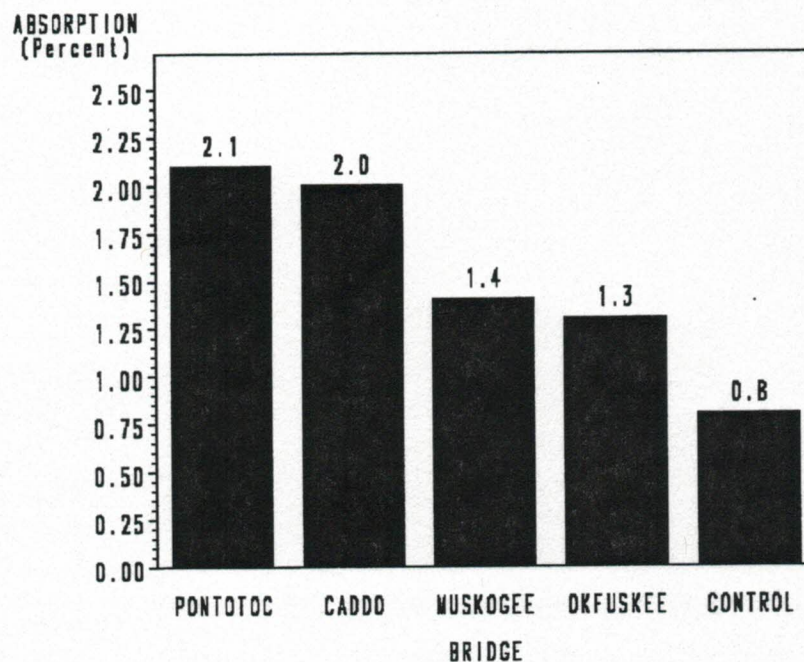
Figure 4. Moisture Absorption.

The current ODOT standard for the maximum amount of water acceptable at the time of silane application to new bridge decks is 1%. Unfortunately, the water absorption test results at the time of silane application are not available and like the depth of penetration tests, little information is available on changes in the water absorption over time although an increase in the percentage of moisture absorbed may be expected.

Figure 4 presents the results of this test. The numbers at the top of each bar are the percent of moisture absorption absorbed by each core. None of the cores treated with a silane met the current initial standard for maximum water absorption when tested in 1993. The bridge deck that was not treated, the control bridge, had the lowest water absorption. Laboratory results are given Appendix B.

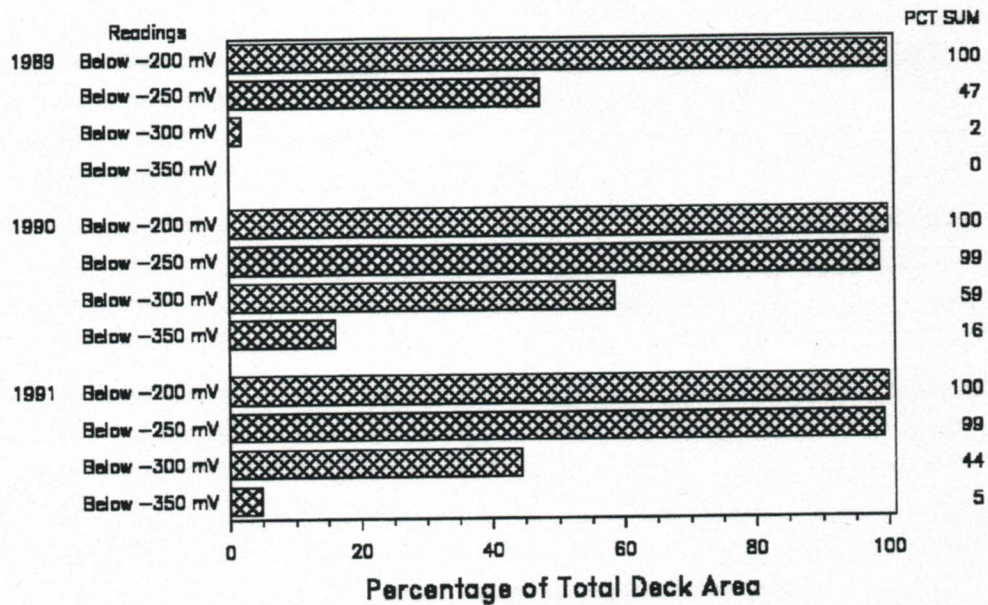
Figure 10. Corrosion Readings: Okfuskee

There are some erratic readings for the Okfuskee bridge deck that indicate increased corrosion activity for three of the four years tested. The most recent test results show no signs of corrosion activity.

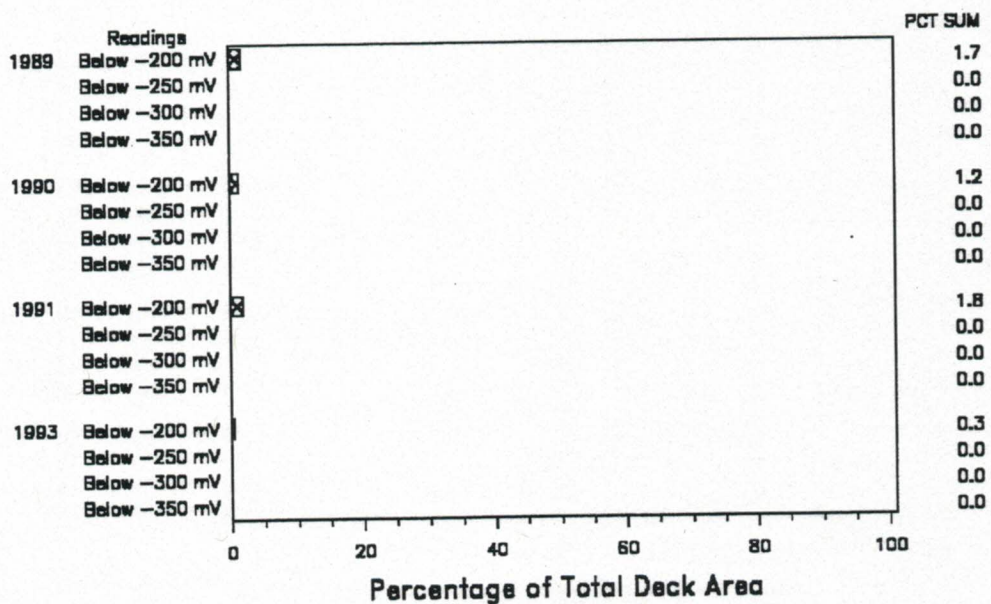
Figure 13. Corrosion Readings: Control

Neither the control nor treated bridge in Pontotoc County is showing signs of corrosion. A complete graphical representation of the annual readings for each bridge is located in Appendix A.

| BRIDGE | VISUAL INSPECTION NOTES | LAST EVALUATION |
|---|---|---|
| CONTROL | Minor, random, shallow, narrow cracks; good condition. (4) | 1993 |

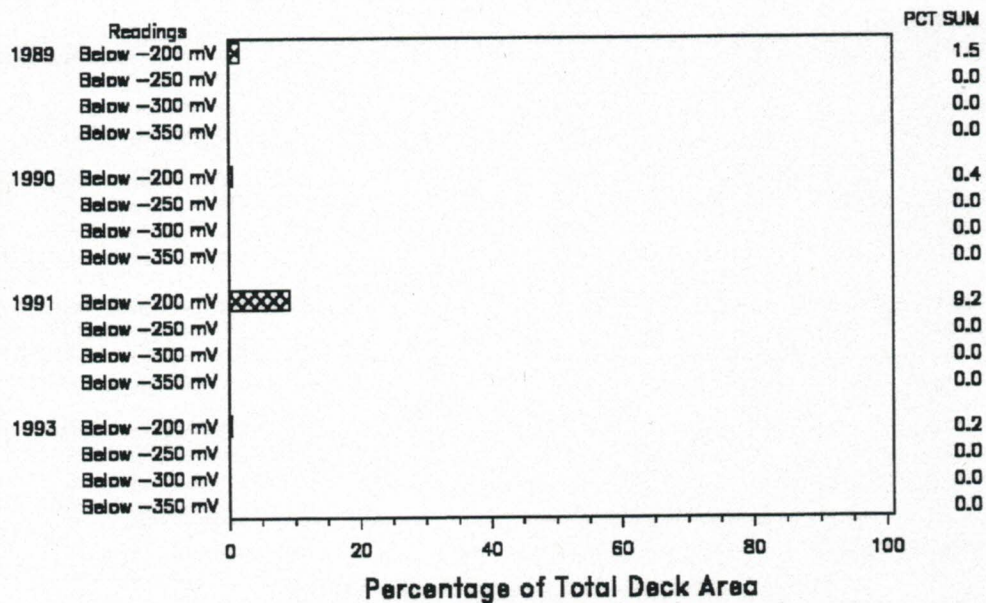
Figure 14. Corrosion Readings: Pontotoc

| BRIDGE | VISUAL INSPECTION NOTES | LAST EVALUATION |
|---|---|---|
| PONTOTOC | Minor scattered cracks; good condition. (4) | 1993 |

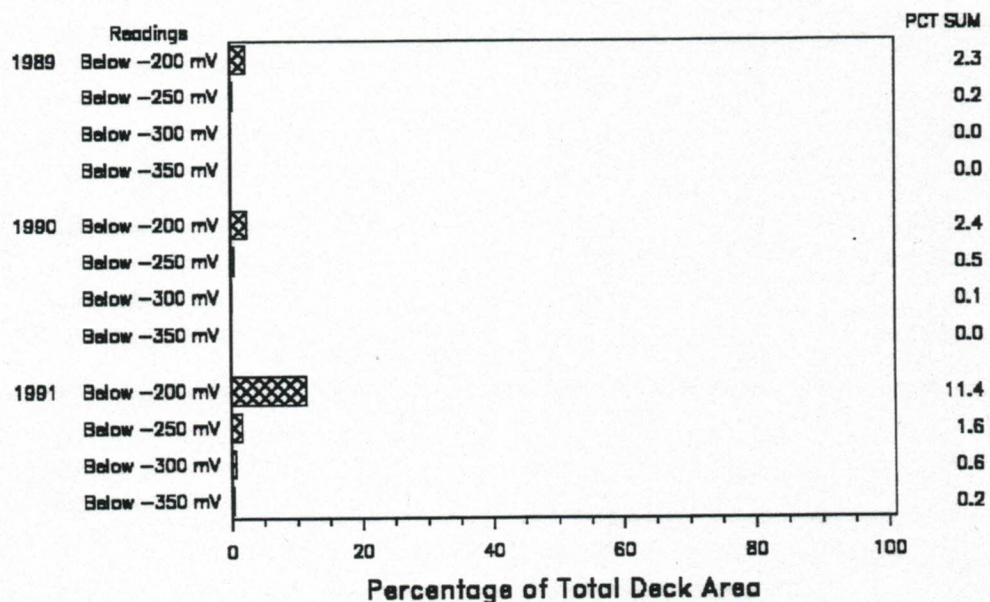
Figure 15. Corrosion Readings: Rogers

The Rogers bridge had as much as twenty-two percent delamination in 1990, the last year of evaluation for this deck. Electrical half cell readings indicate little corrosion on this bridge deck and chloride readings are low.

| BRIDGE | VISUAL INSPECTION NOTES | LAST EVALUATION |
|---|---|---|
| ROGERS | Delaminations, cracking, exposed steel. (2) | 1991 |
