**FINAL REPORT ~ FHWA-OK-22-02**

# **A SYSTEMS APPROACH FOR DESIGN, CONSTRUCTION, AND MAINTENANCE OF BRIDGES AND ADJACENT ROADWAYS**

**School of Civil Engineering and Environmental Science (CEES)**  
**The University of Oklahoma**  
**Norman, Oklahoma**

**January 2022**

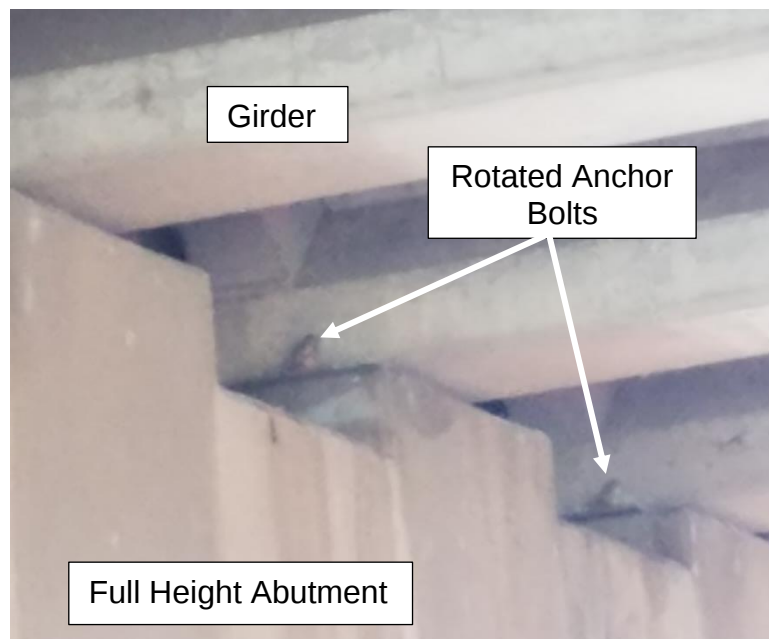
bridge. Due to the full height abutments the bridge abutment was not able to be inspected up close. However, from the roadway elevation it was observed that the Oklahoma River bridge is experiencing similar types of distress. A photograph taken in September of 2019 is shown in Figure 25. The image shows that the anchor bolts are angled away from the abutment backwall indicating that the pavement was pushing on the bridge deck.

**Figure 25. Shields Boulevard over the Oklahoma River: North Abutment**

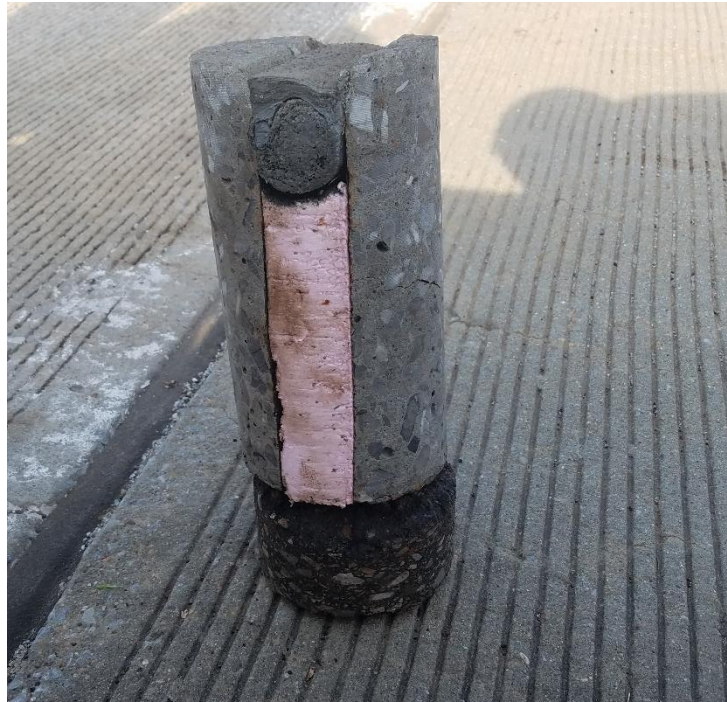
A site investigation was performed by the geotechnical branch of ODOT. Initially a pavement core was taken along the I-40 bridge pressure relief joint. The joint was expected to contract under the observed conditions at the bridge. A photograph of the pavement core through the pressure relief joint is shown in Figure 26.

**Figure 26. Shields Boulevard over I-40: Expansion joint pavement core**

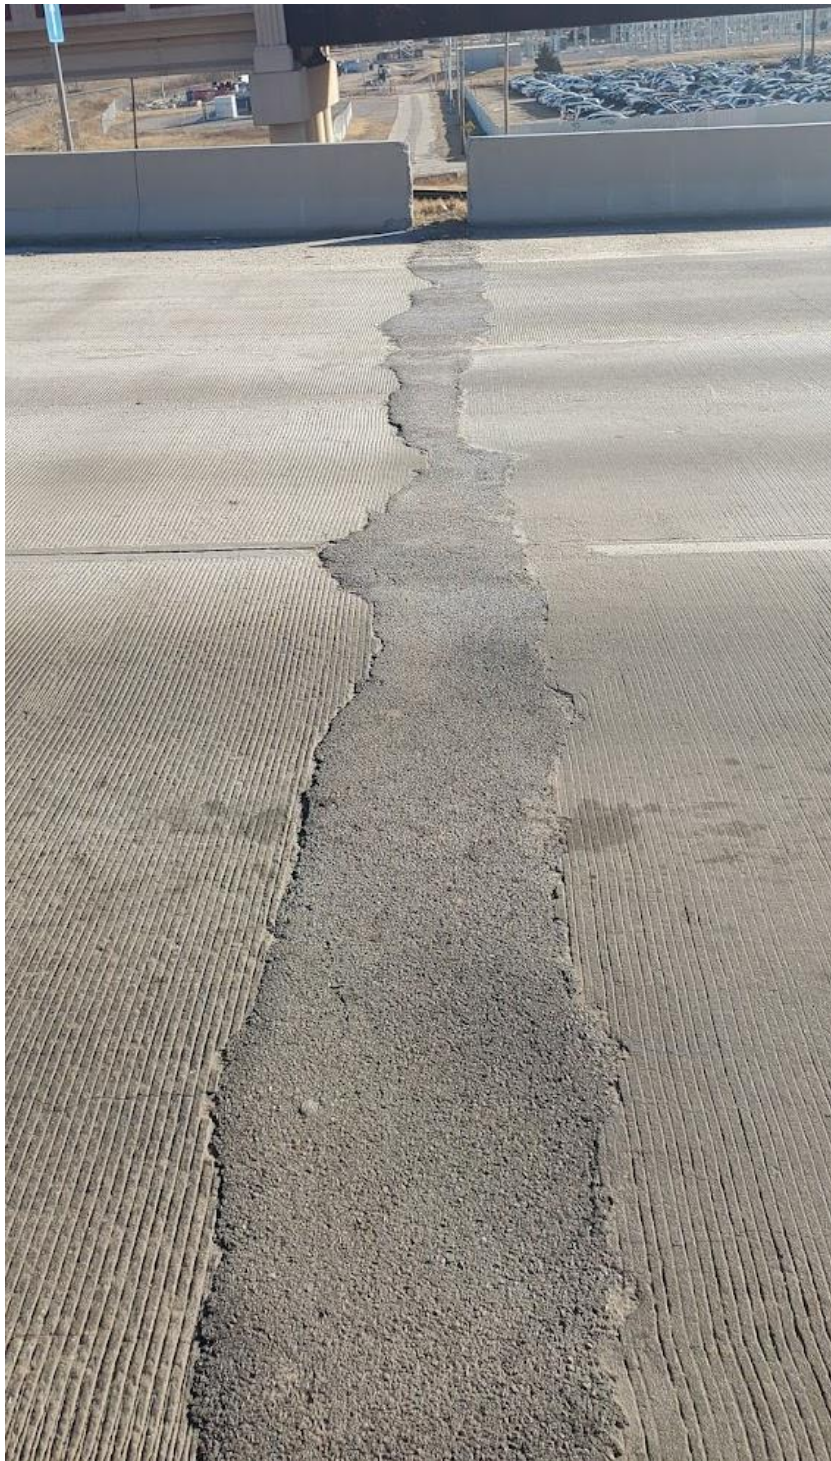
**Figure 27. Shields Boulevard over I-40: Full depth asphalt pressure relief joint**

Since excessive pavement pressure was determined to be the cause of the approach slab shoving into the bridge, a full depth joint was placed adjacent to the approach slab. A single 12-inch full depth asphalt joint was placed at the end of the approach slab. The joint was installed in April 2020 by ODOT. A photograph of the completed joint is shown in Figure 27. The photograph was taken in December 2020.

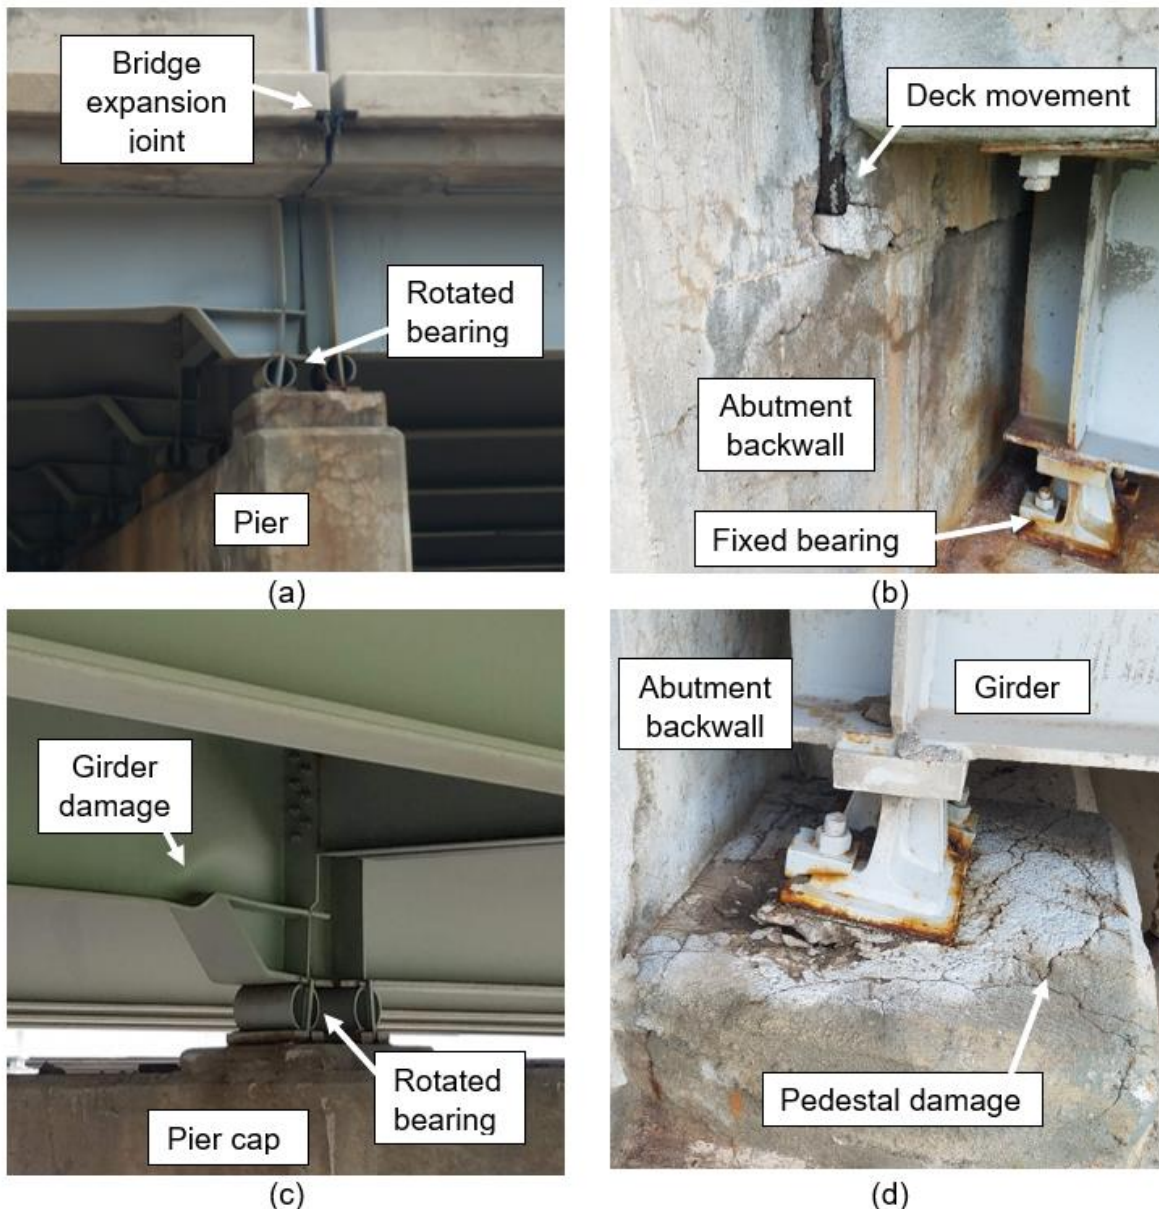
the bridge expansion joints. The beam ends were shortened to allow the bridge room for thermal movement. Following the shortening of the beam ends the bridge relaxed into the bridge expansion joints. When this happened the roller bearings supporting the shortened beams rotated. Photographs of the observed bridge distress are shown in Figure 33. The photographs were taken in May 2019.

**Figure 33. I-40 over SH-81: (a) closed expansion joint, (b) deck shoving, (c) rotated bearing, (d) pedestal damage**

To prevent further damage to the bridge from excessive pavement pressure, four pressure relief joints were installed. One pressure relief joint was installed adjacent to each abutment. The joint was approximately 4 inches wide at the time of installation. The Bridge Expansion Joint System (BEJS) from EMSEAL® was used as the pressure relief joint. The BEJS joint is a compression joint made from foam that is covered in a layer of silicone for the surface exposed to the elements (EMSEAL 2021). The joint is attached to the concrete bridge deck ends using epoxy. A bead of silicone is then used to seal the top edge of the joint to the bridge deck. The BEJS joints used for this project was in 5 feet sticks. Silicone was used to seal the top of the joint at the stick connections. A photograph of the joint used for this project from the EMSEAL product sheet is included in Figure 34.

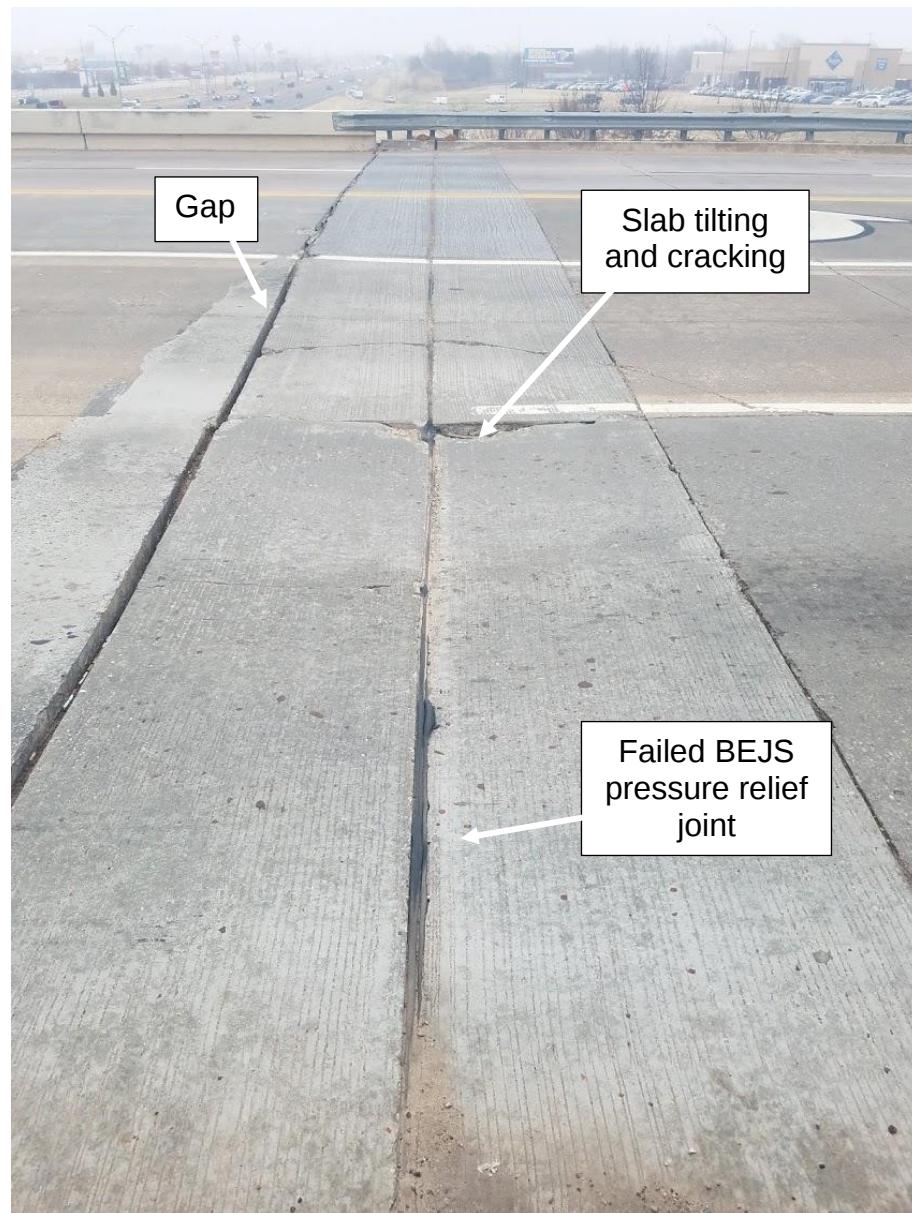
tilted into the area where the subgrade failed. As a result, the approach pavement was left with a large bump.

**Figure 41. 19th Street over I-35: Pressure relief joint in 2019**

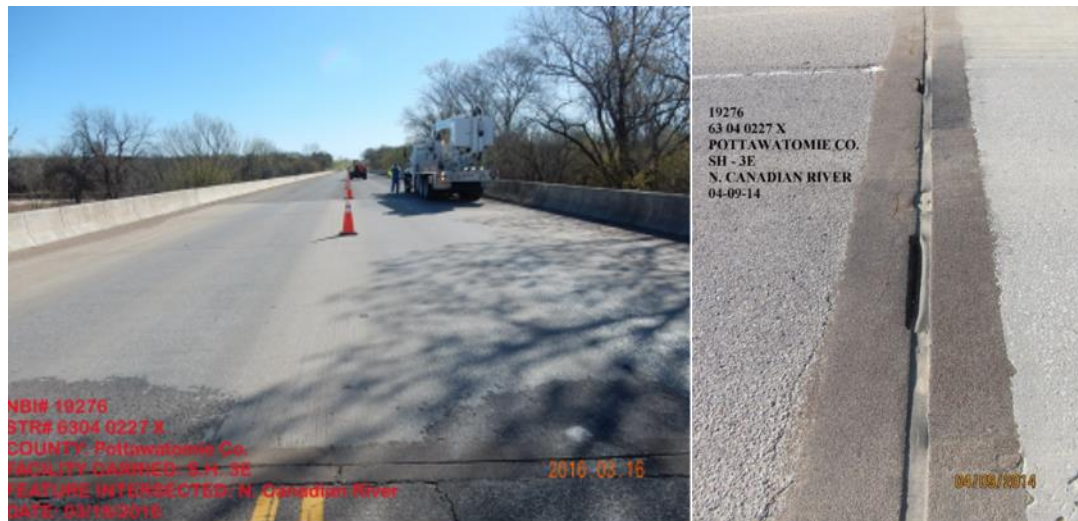
**Figure 66. SH-3 bridge over N. Canadian River (left)  
and expansion joint to be replaced (right)**

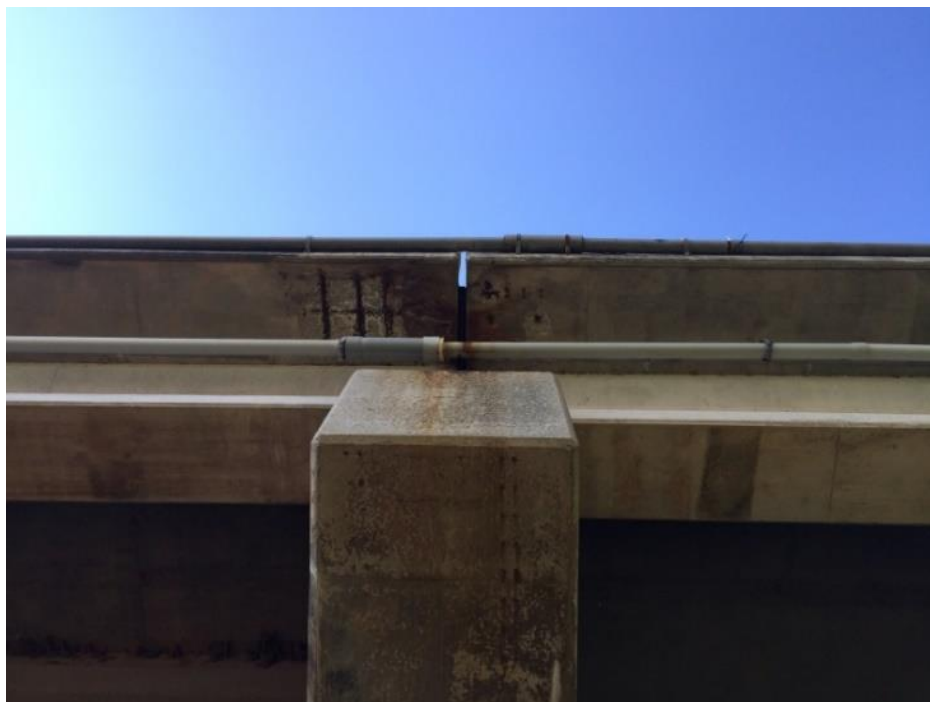
**Figure 67. Underside of the SH-3 bridge over N. Canadian River at  
the candidate joint showing concrete deterioration**

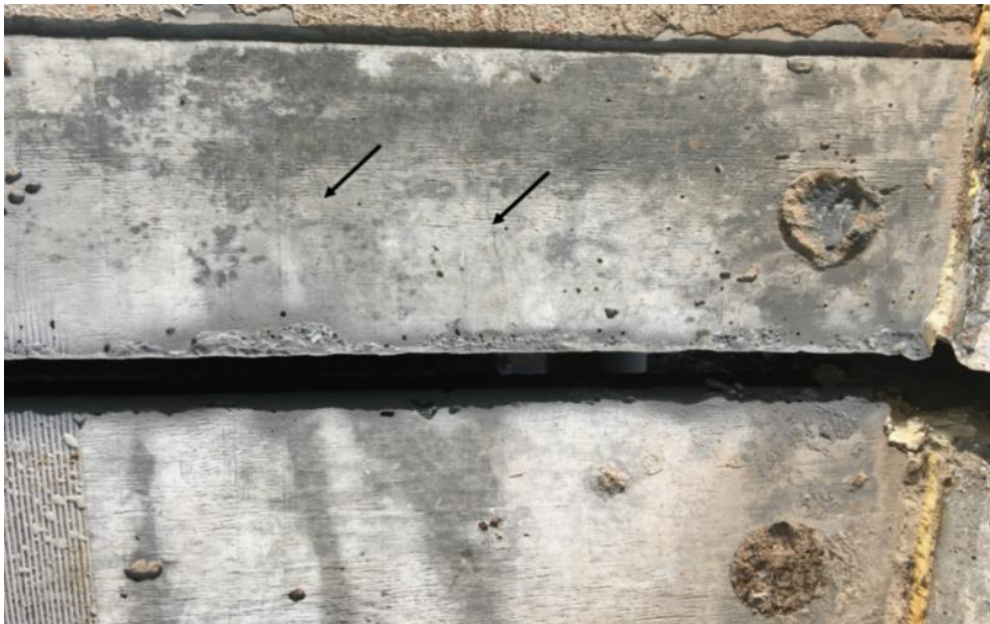
**Figure 78. UHPC joint headers on SH-3E bridge before joint sealant was placed and showing hairline cracks**

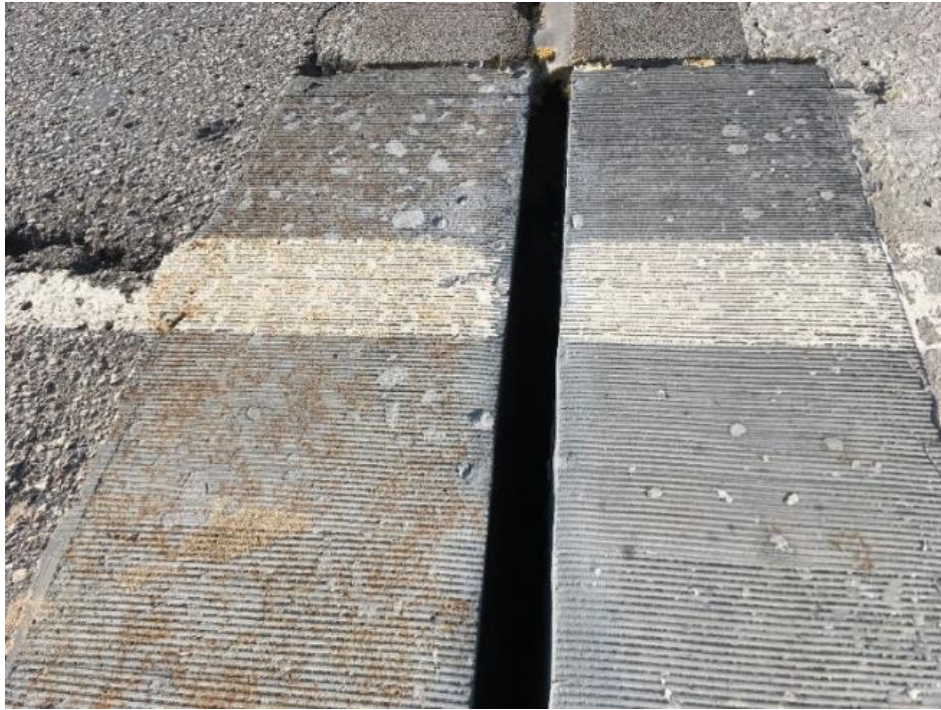
**Figure 79. UHPC joint headers on SH-3E bridge before joint sealant was placed and showing surface rusting of the exposed steel fibers**

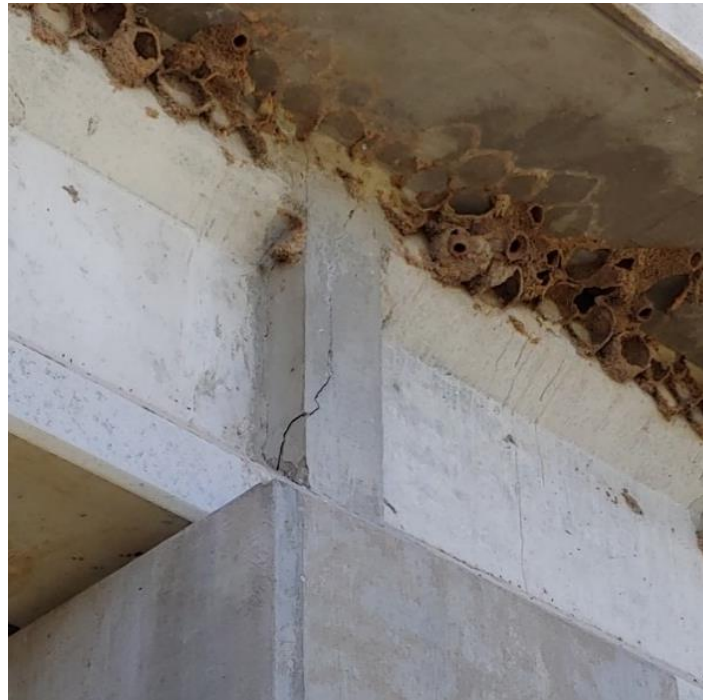
**Figure 82. Example of positive moment cracking in a continuity joint of the U.S. 183/412 bridge over Wolf Creek**

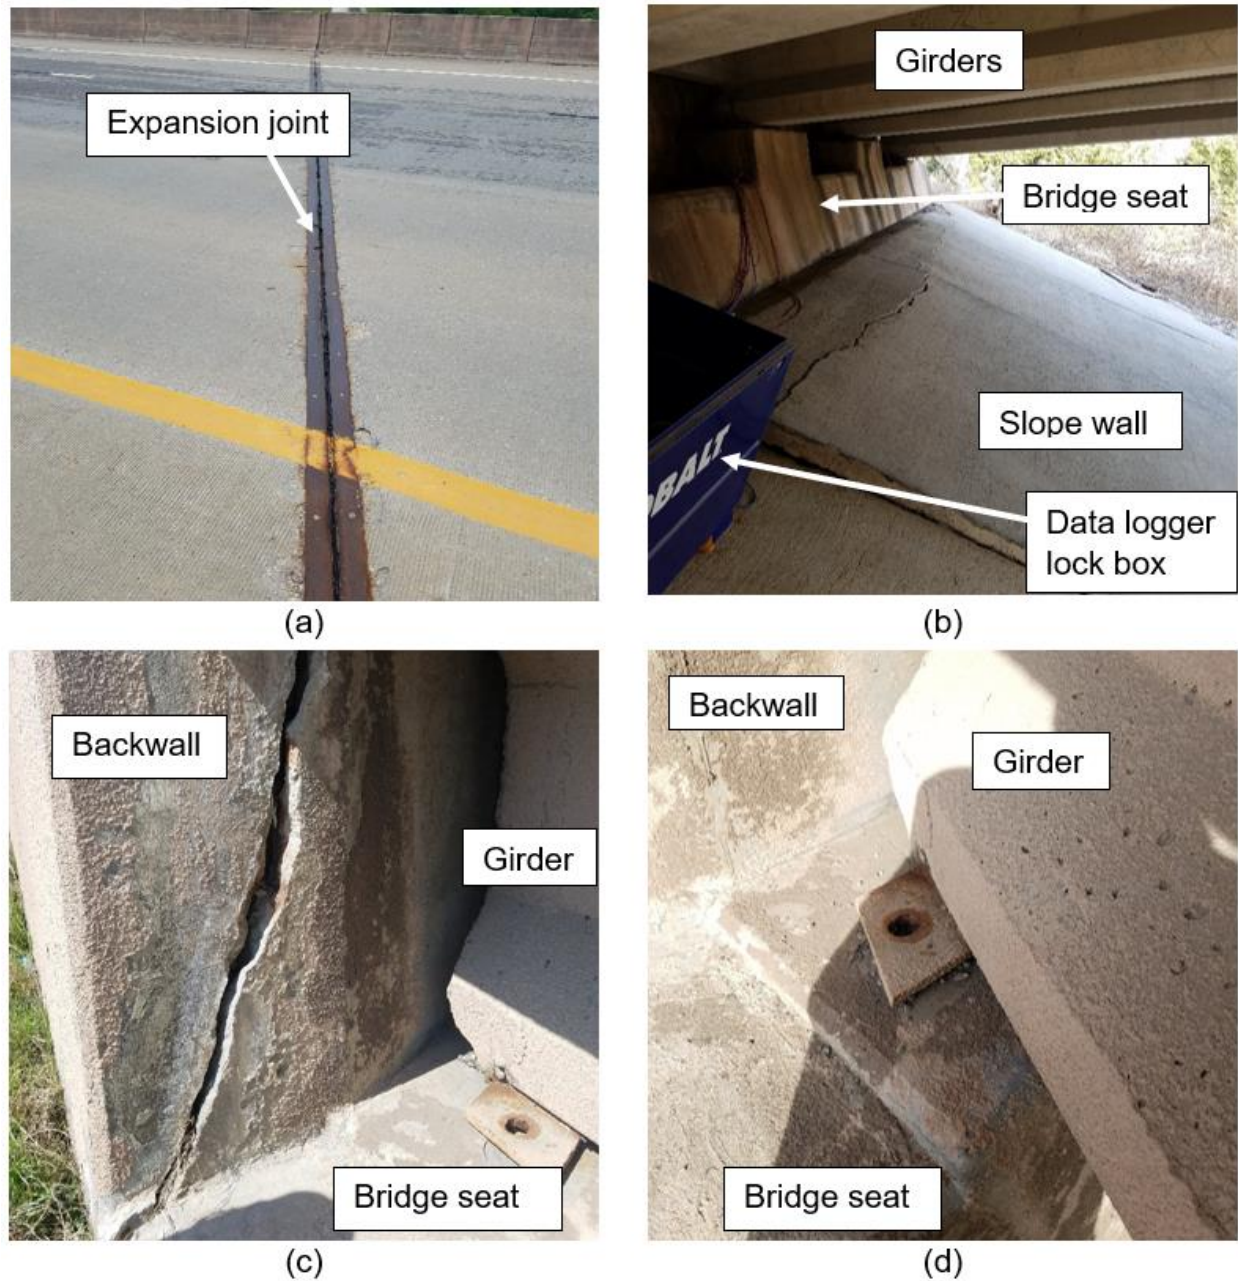
**Figure 101. SH-3 over BNSF: Bridge distress (a) closed expansion joint, (b) buckled slope wall, (c) cracked backwall, (d) sheared anchor bolt**

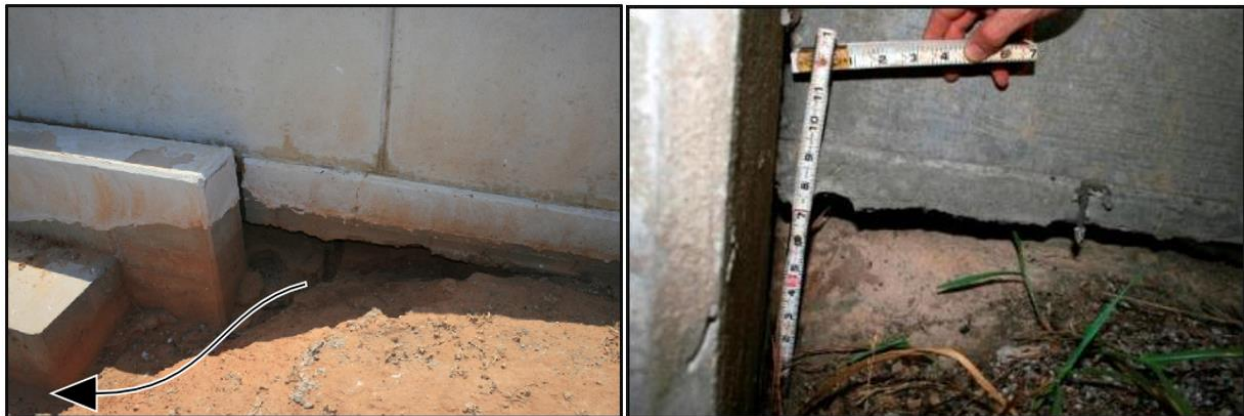
**Figure 111. Void beneath approach slab and possible path for water flow (black arrow) at bridge over Sadler Creek (left photo), and another under the approach slab at SH59A over Big Creek (right photo)**

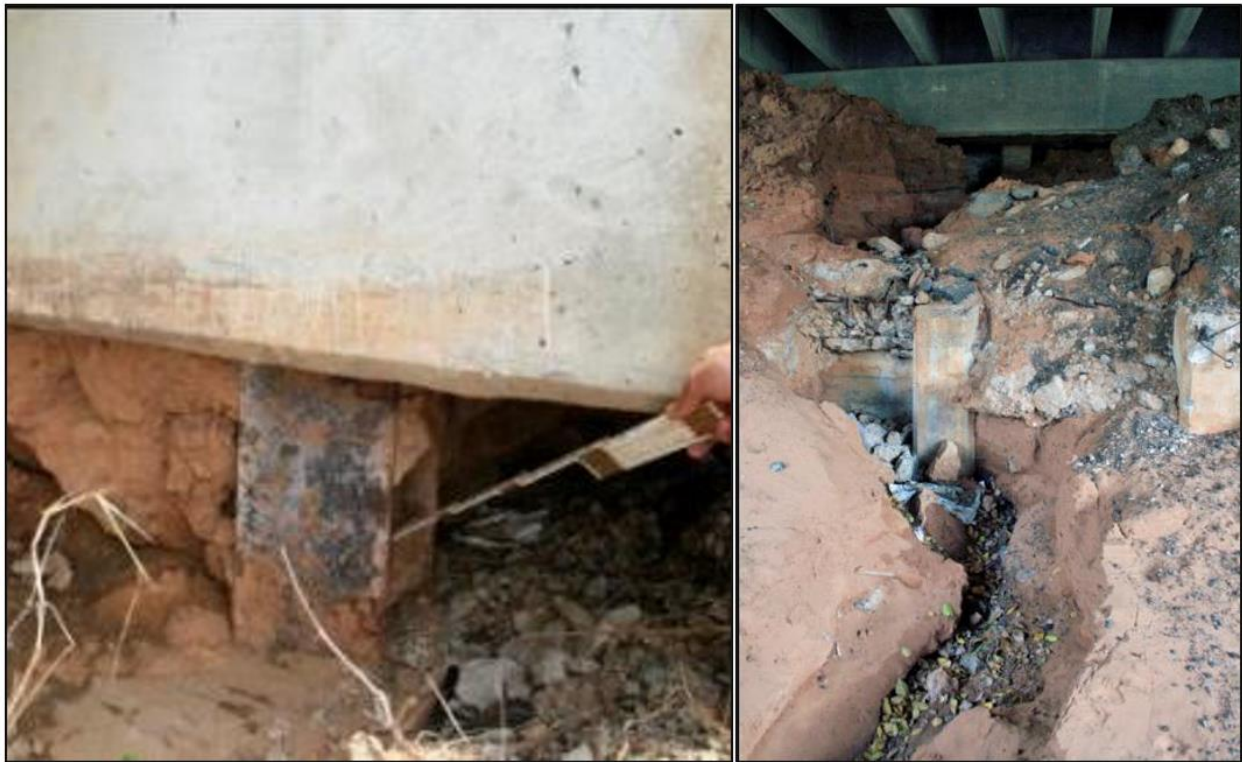
**Figure 112. Erosion observed under abutment at Bridge B on US177 over the Salt Fork River (left photo) and at the bridge on SH152 over Willow Creek (right photo)**

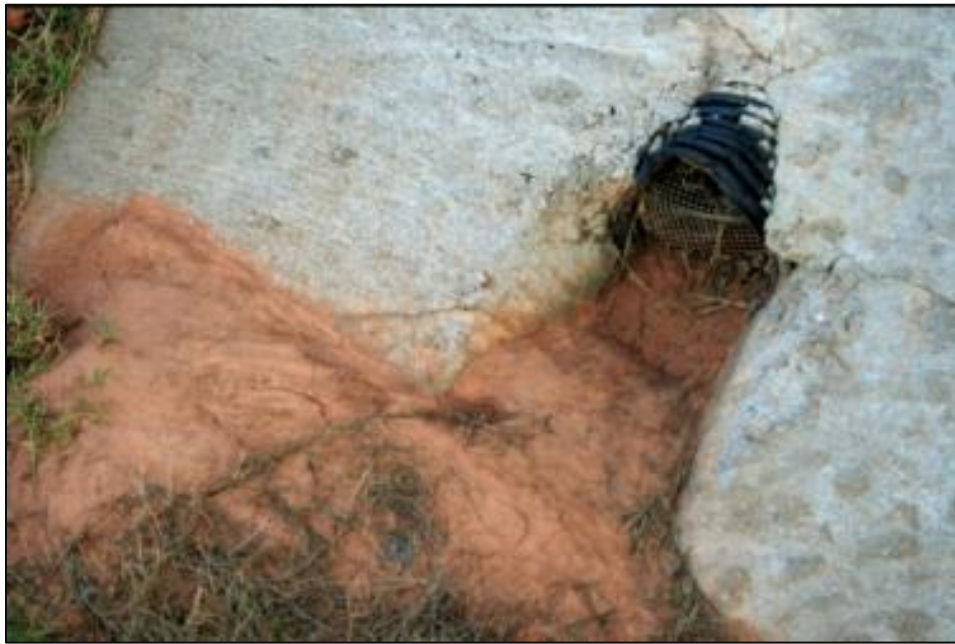
**Figure 121. Soil flowing out of underdrain outlet.**

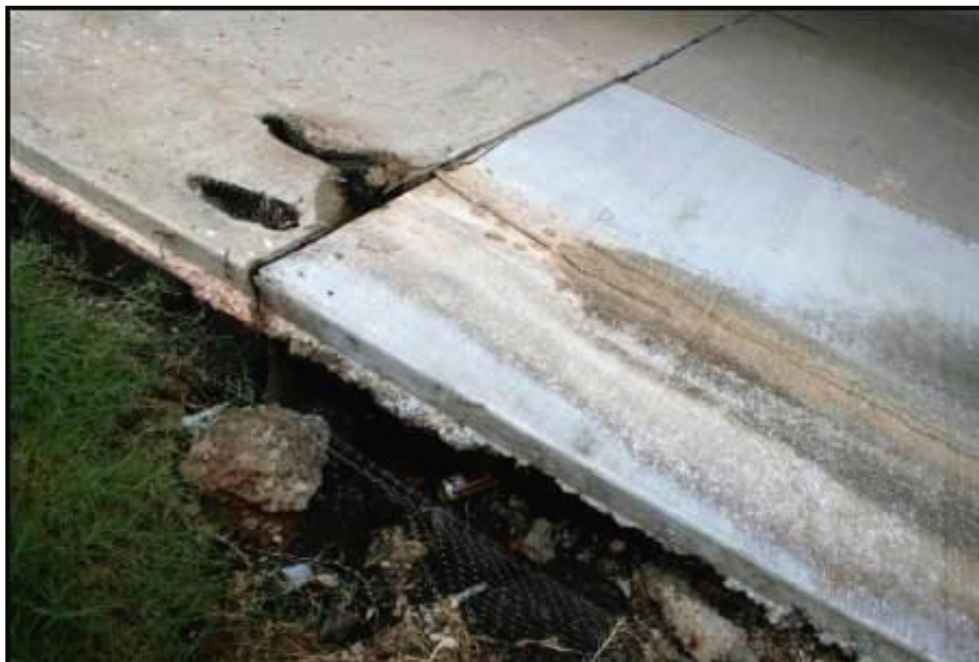
**Figure 122. Water flowing from underdrain outlets onto slope wall, Tecumseh Rd. over I-35. (note large void under slope wall)**

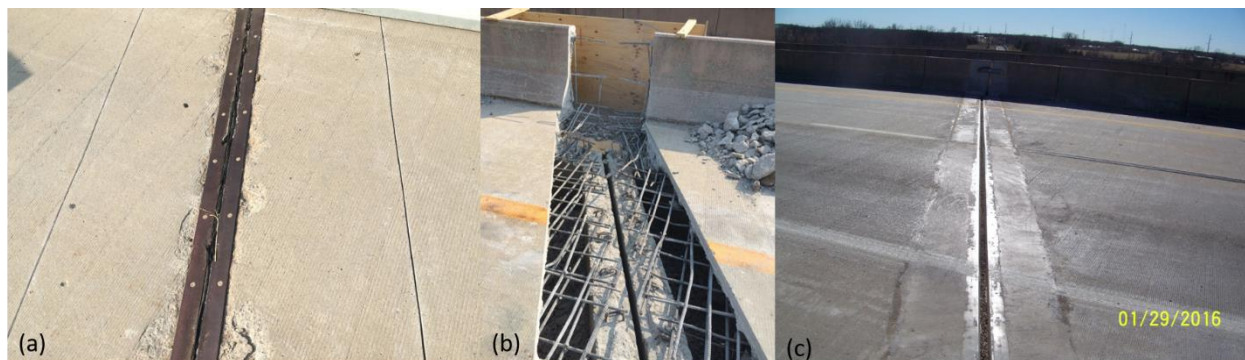
**Figure 126. Retrofit of bridge deck expansion joint using conventional concrete  
(a) before retrofit, (b) after demolition, and (c) after retrofit completion**
