SOIL FACTORS IN THE FAILURE OF

EARTHEN DAM STRUCTURES

GORDON PATRICK KING

Submitted to the Faculty of the Graduate College of the Oklahoma State University in partial fulfillment of the requirements for the Degree of MASTER OF SCIENCE May, 1973

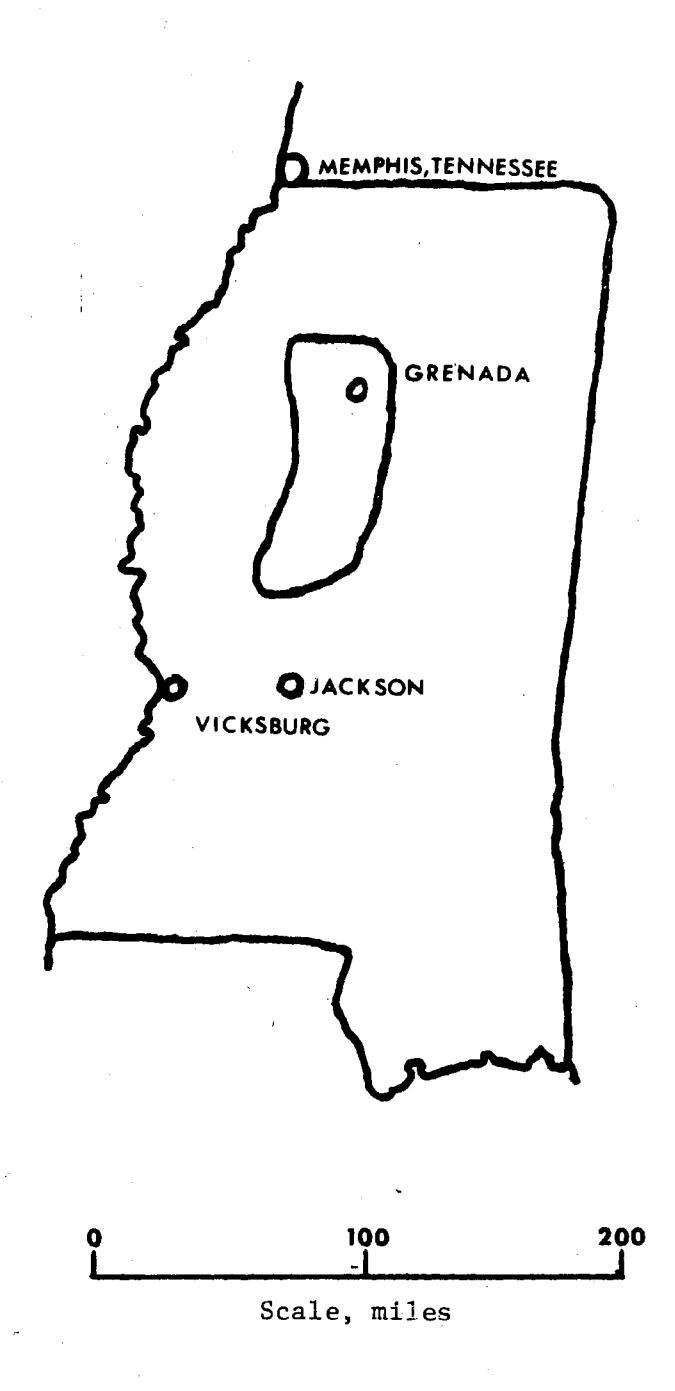
Figure 1. Approximate Geographic Area of Severe Erosion Damage from Rainfall to SCS Flood Control Dams in Mississippi.

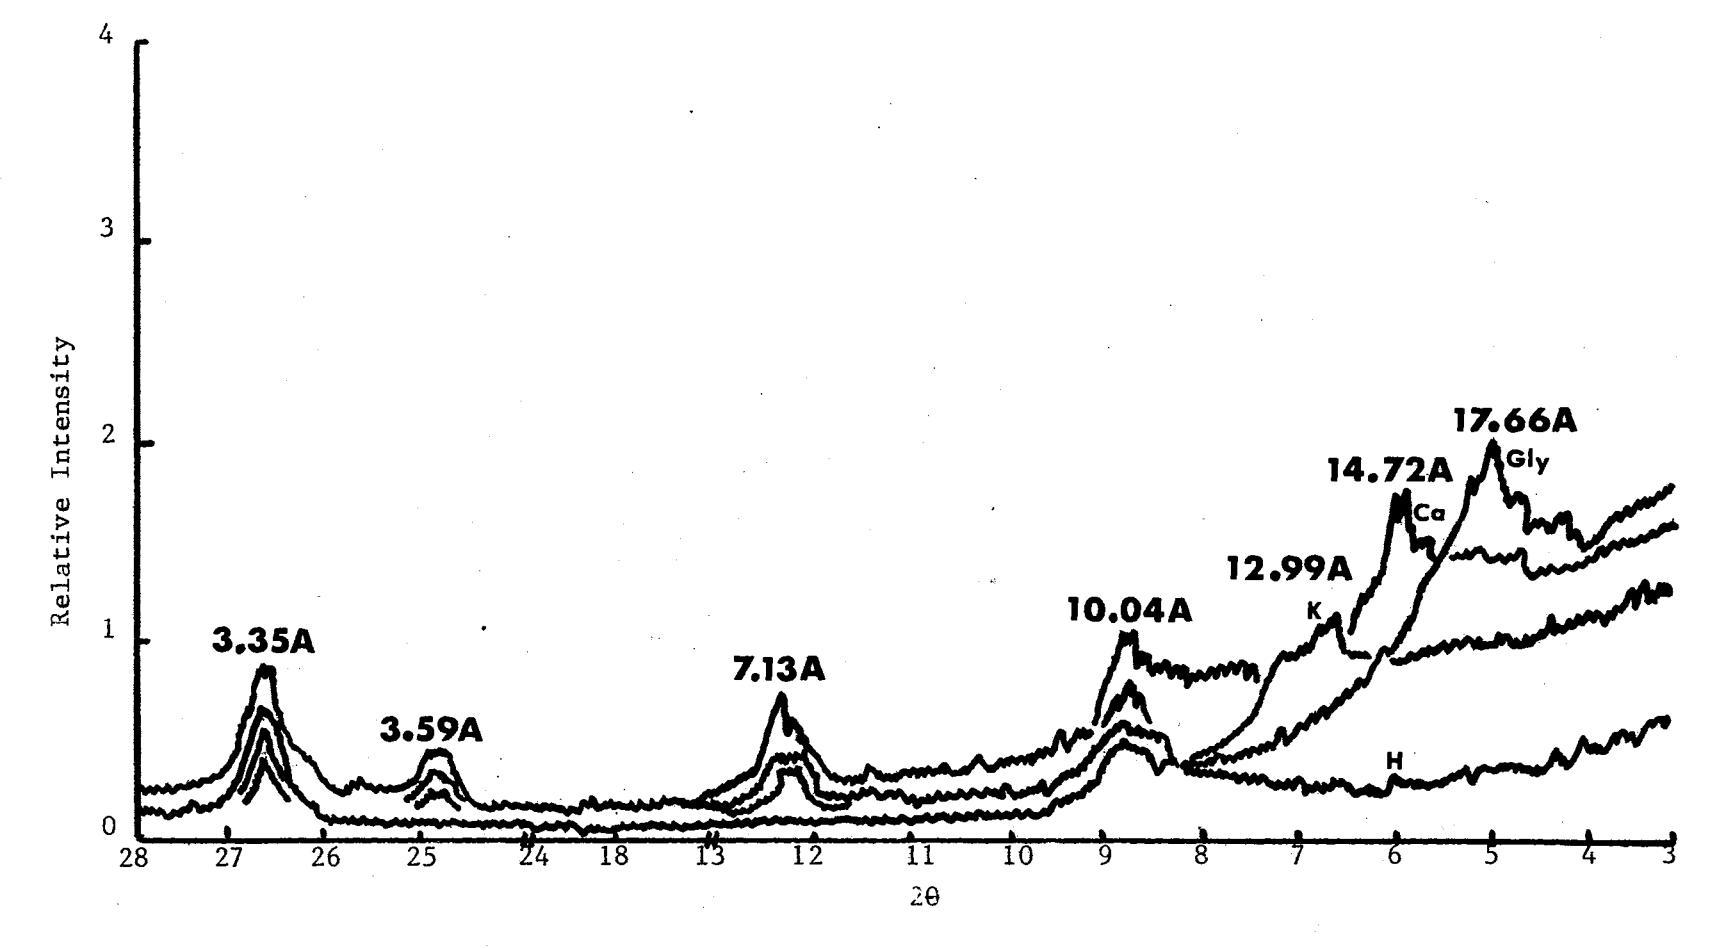
Figure 7. X-ray Diffraction Pattern and c-spacings in Angstroms of the Coarse Clay Fraction of S-75

in Figures 7 and 8. The coarse clay fraction of S-75 (Figure 7) contains a moderate amount of montmorillonite and illite and lesser amounts of kaolinite. The fine clay fraction of S-75 (Figure 8) contains a large amount of montmorillonite and is essentially monomineralic. The montmorillonite spacings are braod and upon heating the montmorillonite collapses completely, thus indicating amorphous material may be present on the clay surfaces.

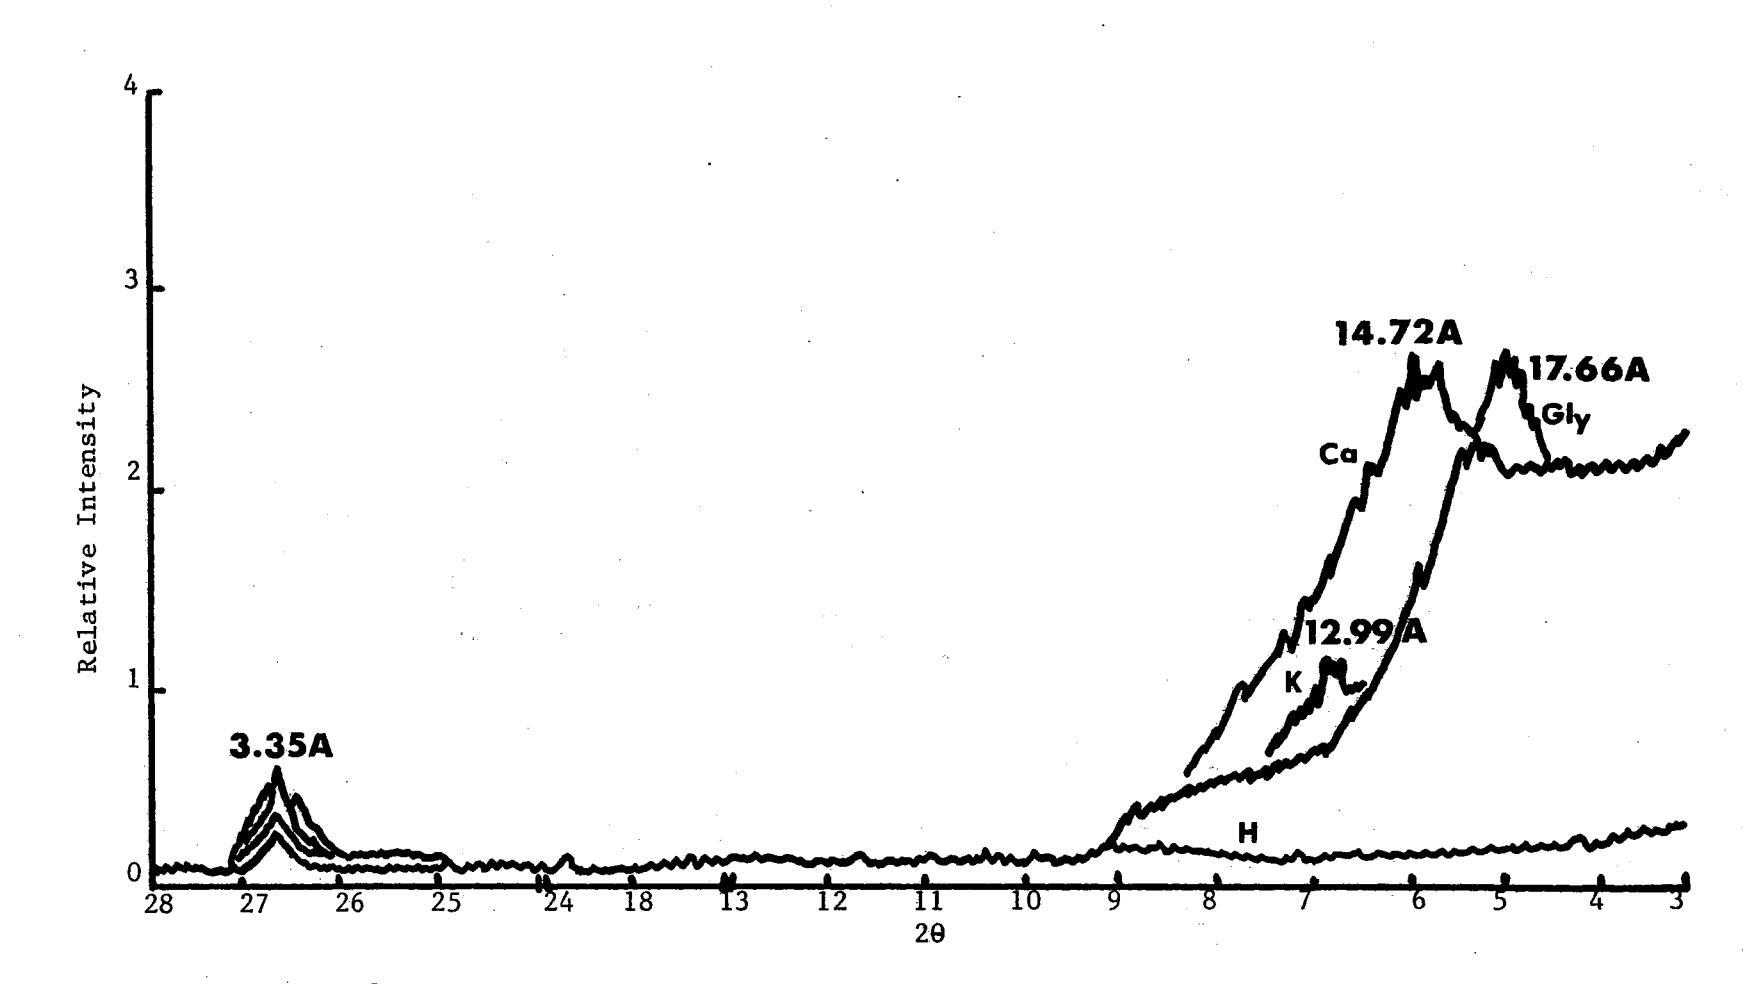
. Figure 8. X-ray Diffraction Pattern and d-spacings in Angstroms of the Fine Clay Fraction of S-75.
