EVALUATION AND DEVELOPMENT OF
COST EFFECTIVE TIMBER PILE
REPAIR TECHNIQUES

Submitted to the Faculty of the
Graduate College of the
Oklahoma State University
in partial fulfillment of
the requirements for
the Degree of
MASTER OF SCIENCE
May, 2004

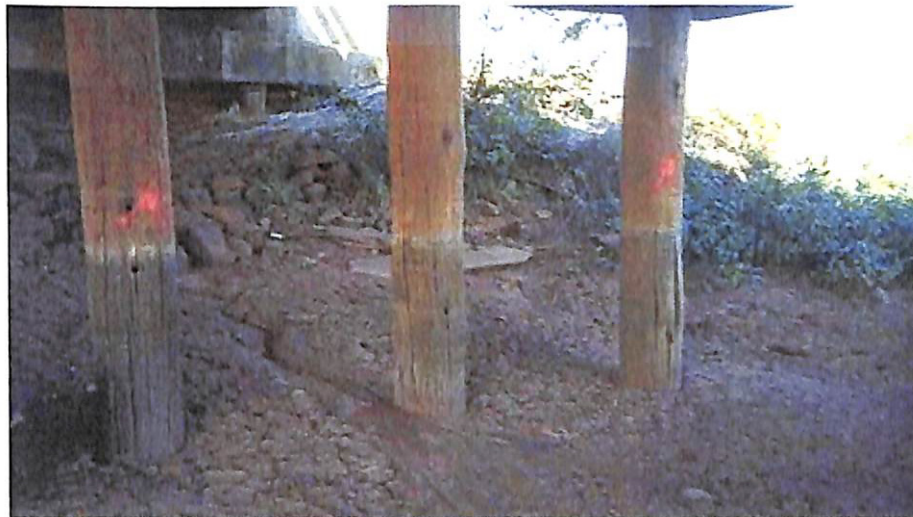
FIG. 1.1. Decayed Timber Piles in Service

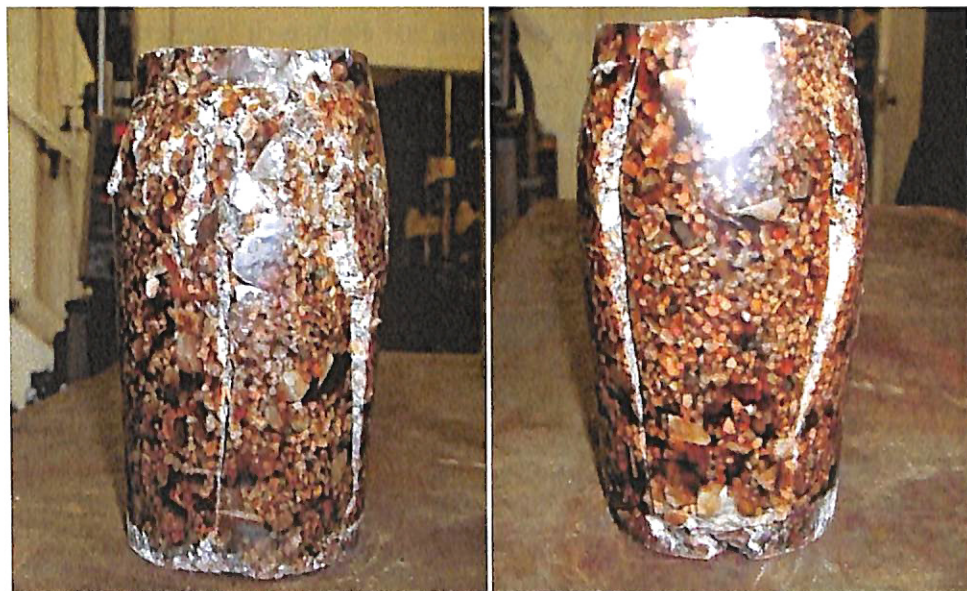
The unreinforced cylinders failed at an average maximum compressive stress of 7460 psi. Fig. 5.1 shows the load versus displacement diagram for the unreinforced cylinders. All three cylinders underwent post-yielding displacement and experienced excessive spalling and splitting as shown in Fig. 5.2. Under axial compression, they expanded normal to the loading direction due to the Poisson's effect and splitting.

FIG. 5.2. Compression Failure of Unreinforced Laboratory Fabricated Cylinders

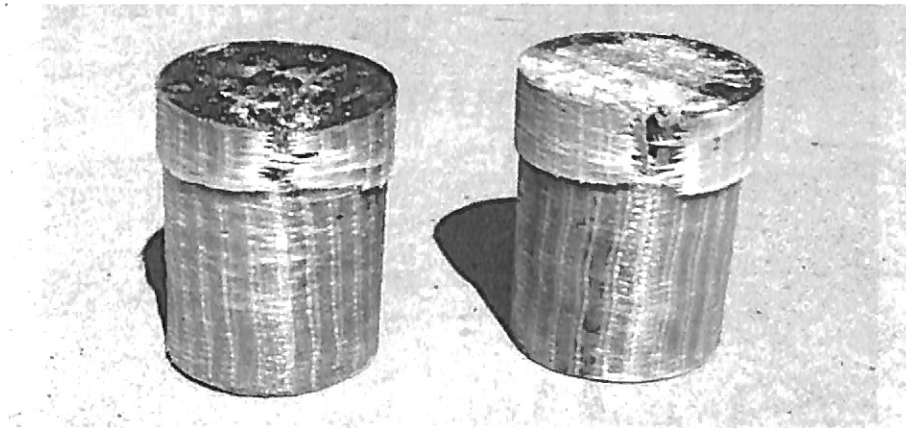
The presence of fiberglass reinforcement increased the compressive strength of the unreinforced cylinders by 70 percent. The load-displacement diagram for transversely reinforced cylinders is shown in Fig. 5.3. The stiffness of the specimens increased with the loading. The transverse reinforcement effectively controlled the radial expansion of the cylinders. The spalling of the unreinforced cylinders was replaced by the breaking of glass fibers as shown in Fig. 5.4. It was caused by the hoop stress acting on the fiberglass under compression loading.

FIG. 5.4. Compression Failure of Laboratory Fabricated Cylinders with Transverse Fiberglass Reinforcement

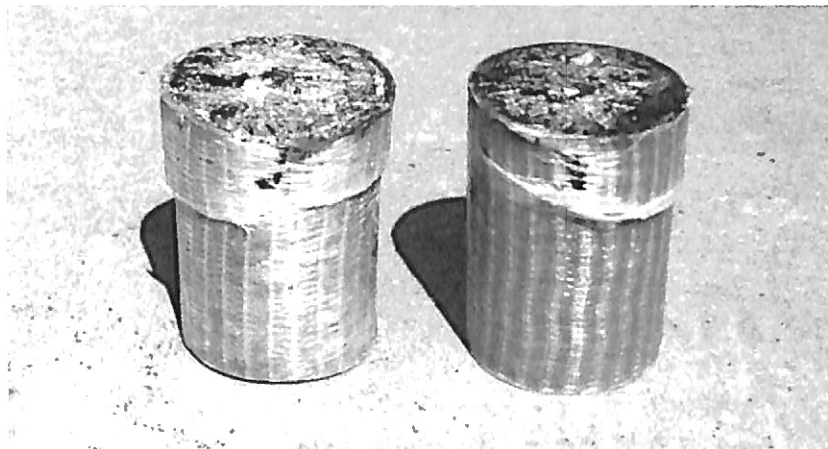
An 84 percent increase in compressive stress over unreinforced specimens was found when both transverse and longitudinal fiberglass reinforcement were used. Fig. 5.5 shows the load vs. displacement diagram for cylinders with transverse and longitudinal reinforcement. The same failure phenomenon as the cylinders with only transverse fiberglass reinforcement was observed as shown in Fig. 5.3. Figure 5.6 shows the cylinders with transverse and longitudinal fiberglass reinforcement after they reached ultimate load.

FIG. 5.6. Compression Failure of Laboratory Fabricated Cylinders with Transverse and Longitudinal Fiberglass Reinforcement

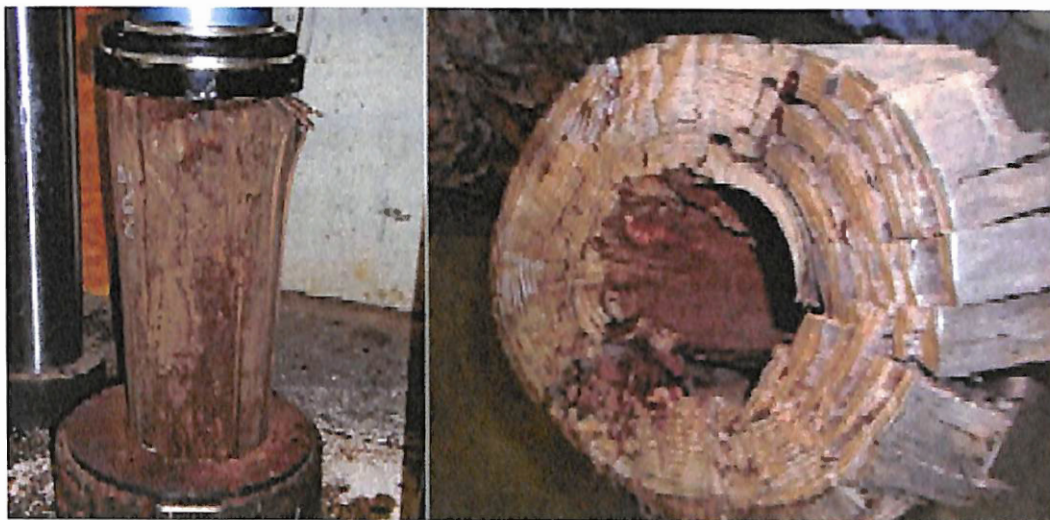
The control specimens failed at an average maximum compressive stress of 1507 psi. The load versus displacement diagram for the control specimens is shown in Fig. 5.7. Both specimens failed as the wood shell crushed as shown in Fig. 5.8.

FIG. 5.8. Failure of Control Specimen under Compression

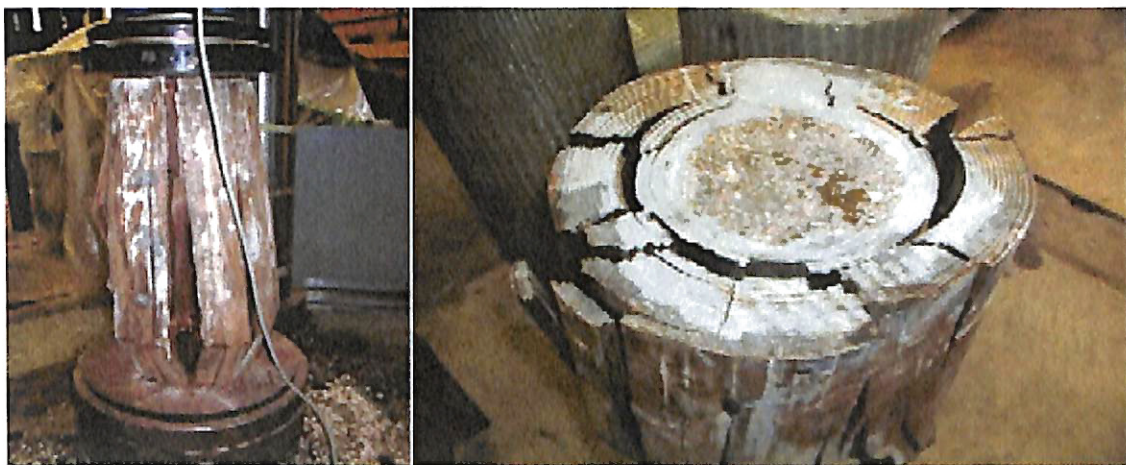
The repaired core provided a 127 percent increase in compression strength over the control specimens. They failed at an average maximum compressive stress of 3416 psi. The load versus displacement diagram is shown in Fig. 5.9. Both specimens experienced a similar failure as the control specimens. The wood shell spalled under loading. It caused the wood shell to separate from the core, followed by excessive splitting of the wood shell as shown in Fig. 5.10.

FIG. 5.10. Compression Failure of Core-repaired Timber Piles

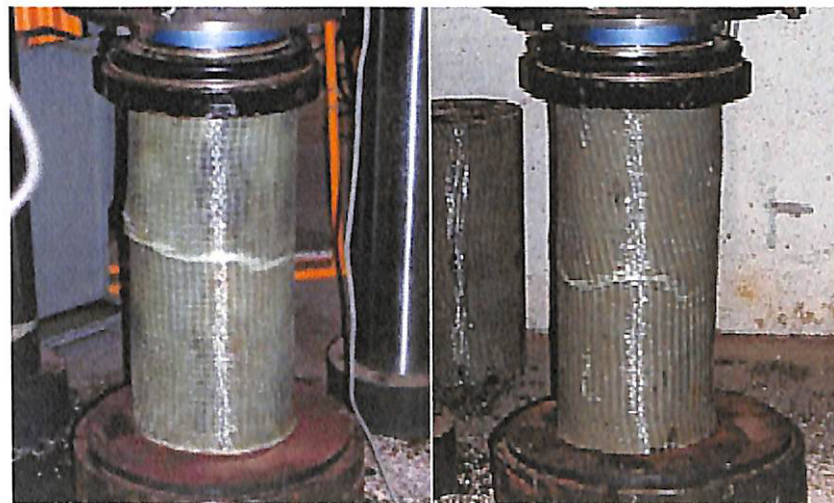
The specimens with repaired core and transverse reinforcement failed at an average compressive stress of 6256 psi. The transverse reinforcement improved the compressive strength of the unreinforced specimens by 317 percent. There was no sign of debonding between the wood shell and the repaired core. The load-displacement diagram shows in Fig. 5.11 indicated a ductile failure while the specimens experienced post-yielding displacement. Rupture of the fiberglass reinforcement is shown in Fig. 5.12.

FIG. 5.12. Compression Failure of Core-repaired Timber Piles with Transverse Reinforcement

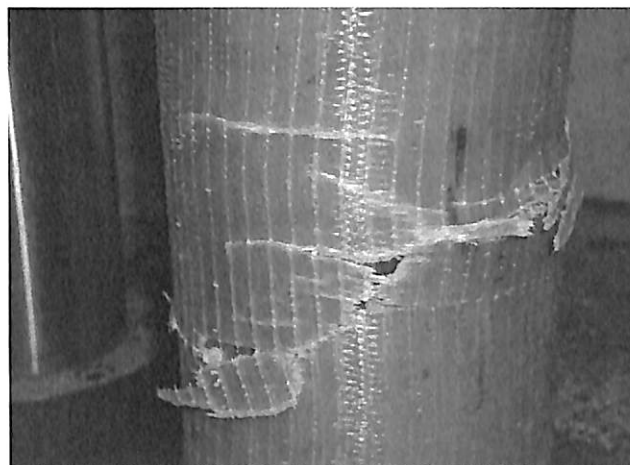
The piles with repaired core, and transverse and longitudinal fiberglass reinforcement displayed a behavior similar to the specimens with only transverse fiberglass reinforcement. The addition of the longitudinal fiberglass reinforcement provided a strength enhancement of 11 percent to the pre-existing transverse reinforcement. Fig. 5.13 shows the load versus displacement for the specimens. The hoop stress acting against the fiberglass caused peeling of the fiber all around the pile perimeter as shown in Fig. 5.14.

FIG. 5.14. Fiber Rupture of Core-repaired Timber Piles with Transverse and Longitudinal Reinforcement

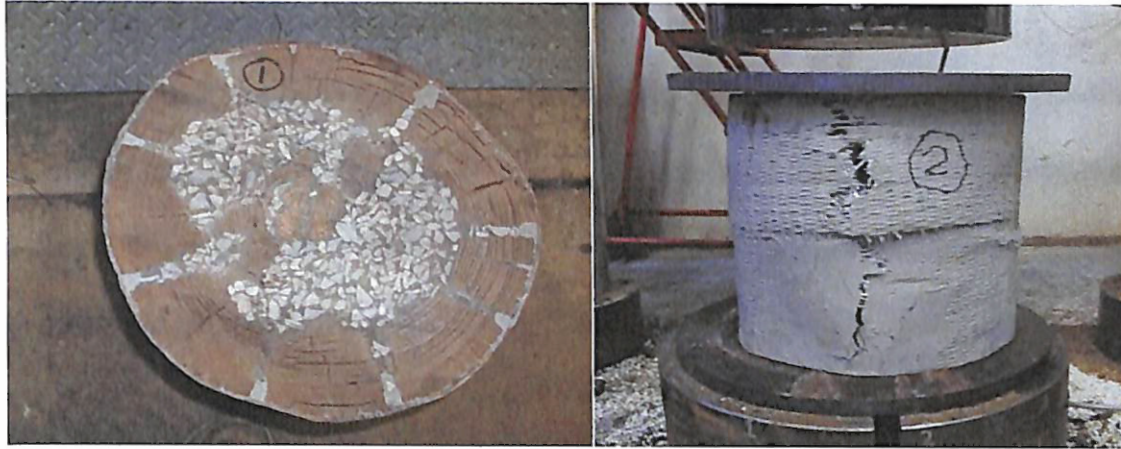
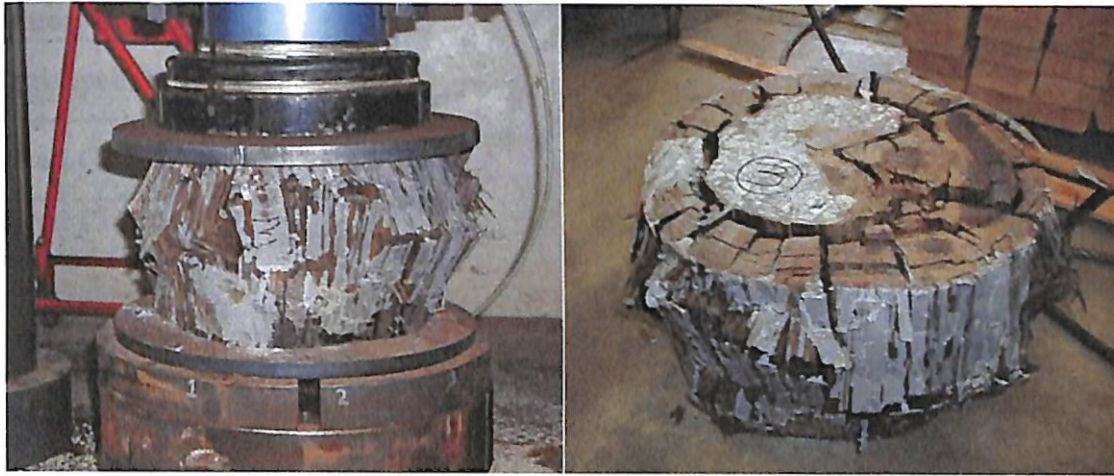
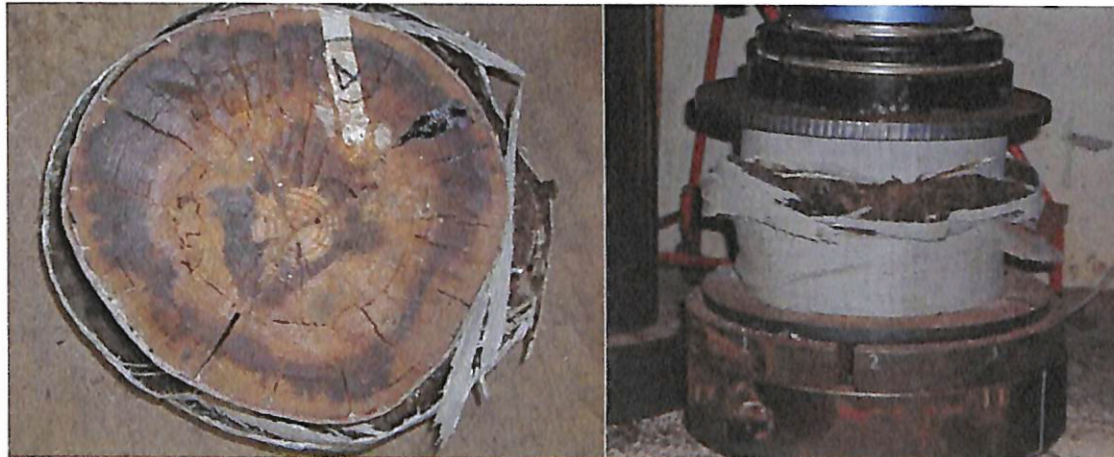
FIG. 5.16. Compression Failure of Field Repaired Timber piles: (a) Fiber Rupture of the Transverse Reinforcement; (b) Debonding of Wood Shell and Repaired Core; (c) Fiber pullout and rupture

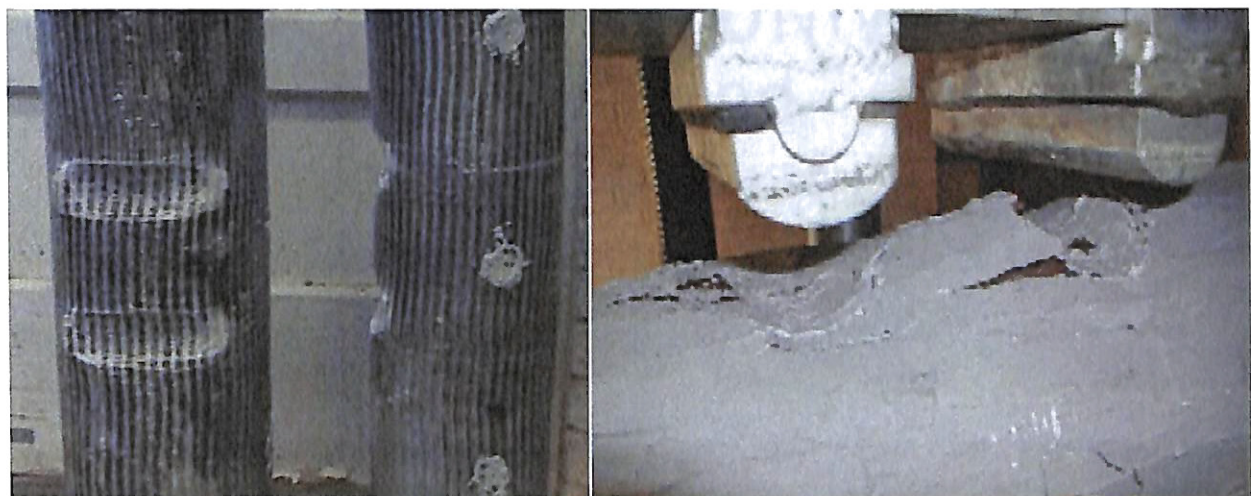
FIG. 5.17. Localized Crushing at Loading Points on Flexural Specimens

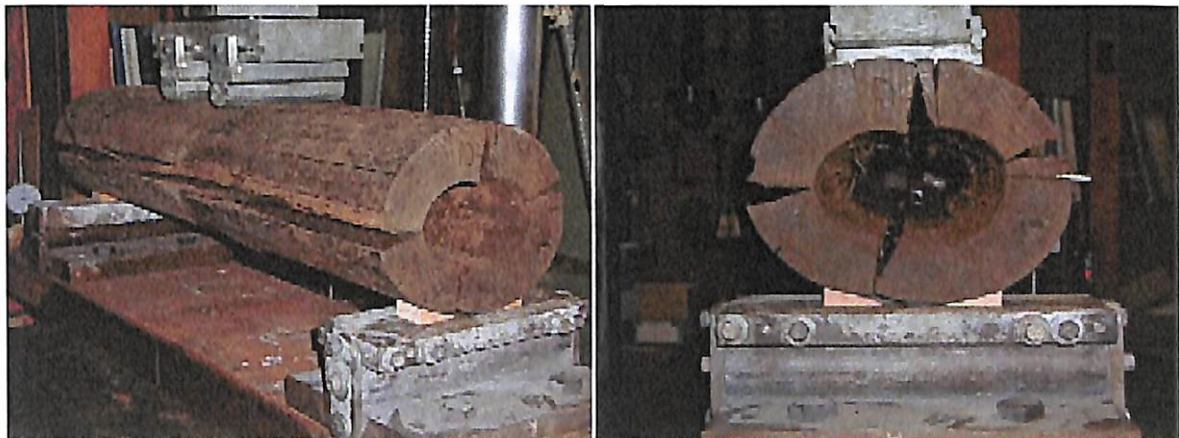
Specimen C3 and D3 crushed at a low average stress of 607 psi. The load versus displacement diagram for the control specimens is shown in Fig. 5.18. Splitting of the wood along its length as shown in Fig. 5.19 was caused by tension acting perpendicular to the grain. The real flexural strengths of specimens C3 and D3 are undetermined.

FIG. 5.19. Splitting of Control Specimen under Four Point Bending

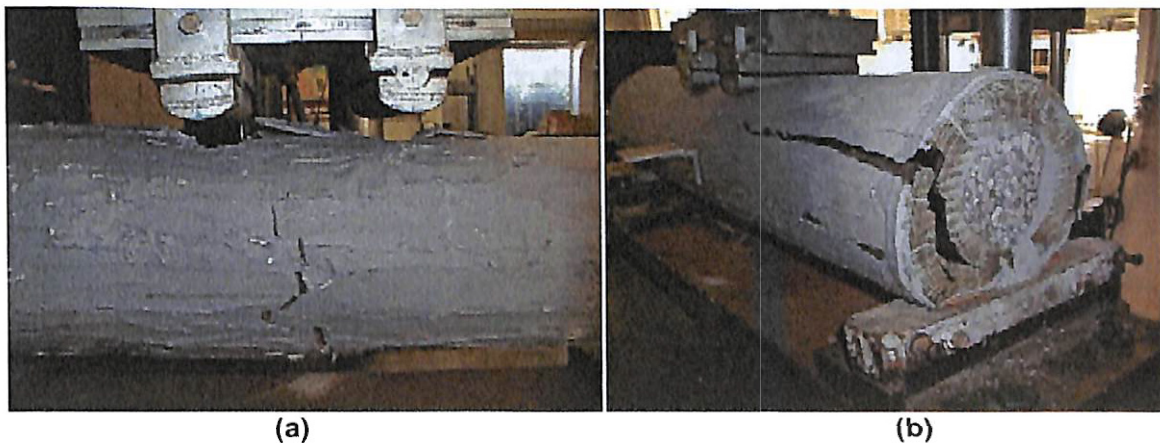
The core-repaired timber piles failed at an average stress of 4980 psi. The load versus displacement diagram is shown in Fig. 5.20. There is no evidence to identify which specimen represented the actual behavior of the core-repaired timber piles. These specimens experienced different failure as shown in Fig. 5.21. Flexural failure occurred on specimen C4, while cracks propagated at its midspan along with the loading. Conversely, specimen D4 failed in shear that caused the wood shell to split. There is no indication of interfacial debonding between the core and the wood shell in either specimen. The bonding for the composite was considered sufficient.

FIG. 5.21. Failures of Timber Piles with Repaired Core: (a) Flexural Failure on Specimen C4; (b) Shear Failure on Specimen D4

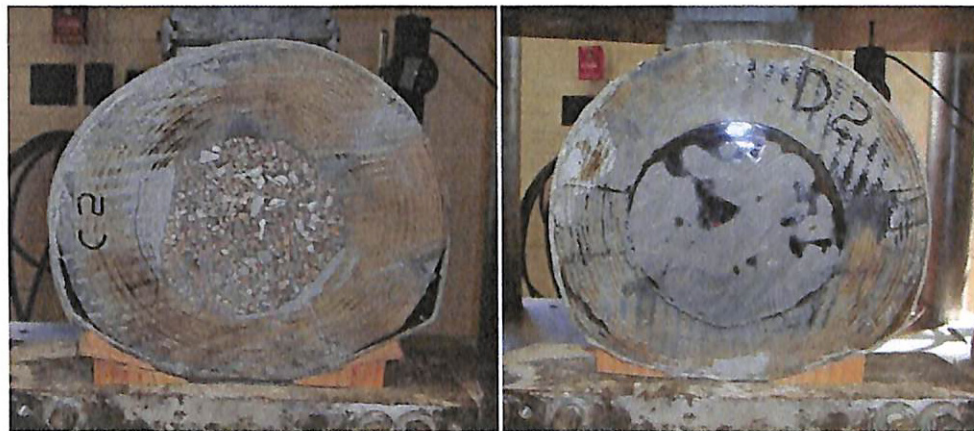
The addition of transverse fiberglass reinforcement enhanced the strength of specimens C2 and D2 compared to the specimens with a repaired core but no fiberglass reinforcement. The load-displacement diagram shows that the specimens underwent post-yielding displacement as shown in Fig. 5.22. Failure occurred at an average stress of 6580 psi and both specimens failed in a similar fashion, i.e. bond failure between fiberglass reinforcement and wood shell as shown in Fig. 5.23. Bond slip at the interface of the repaired core and wood shell occurred in these specimens, thus affecting their performance. There was no significant fiber rupture in either specimen.

FIG. 5.23. Delamination of Fiberglass Reinforcement

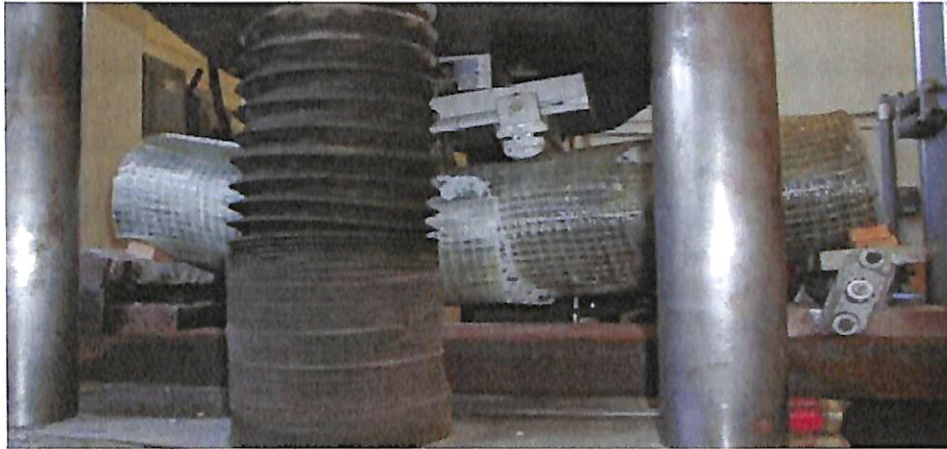
FIG. 5.25. Fiber Rupture at Midspan of Specimen D1

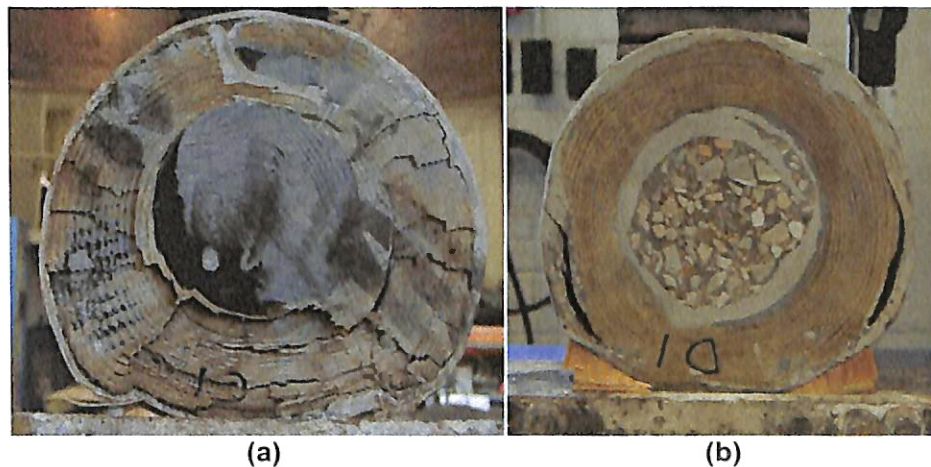
Localized slippage of the repaired core within the wood shell was observed in both specimens. It led to visible protrusion of the core. Interfacial bond failure between fiberglass reinforcement and wood shell was found in both specimens. Fig. 5.26 shows the bond failure for specimen C1 and D1. The separation of all the interfaces led to the conclusion that shear was critical and the bonding between the core and surrounding wood needed to be improved.

FIG. 5.26. Bond Failure: (a) Bond Slip of the Core; (b) Delamination of Fiberglass Reinforcement
