Ultrahigh Resolution Pulsed Laser-Induced Photoacoustic Detection of Multi-Scale Damage in CFRP Composites

Siqi Wang ¹

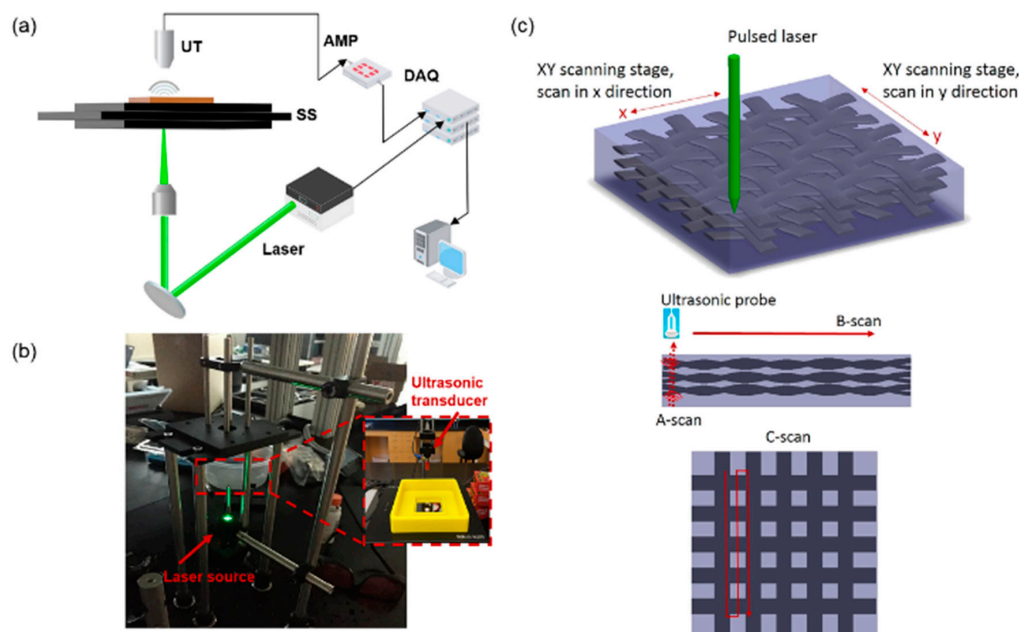
Figure 1. Developed photoacoustic non-destructive evaluation (pNDE) system. (a) A schematic of the pNDE system, showing the following key components: UT, ultrasonic transducer; SS, scanning stage; OL, objective lens; AMP, amplifiers; DAQ, data acquisition card; Laser, green laser (532 nm). (b) Experimental setup of the pNDE system, the transducer and the 3D-printed water container are further magnified to demonstrate the sample set up. (c) A schematic of A-scan, B-scan, and C-scan for ultrasonic signal presentation.

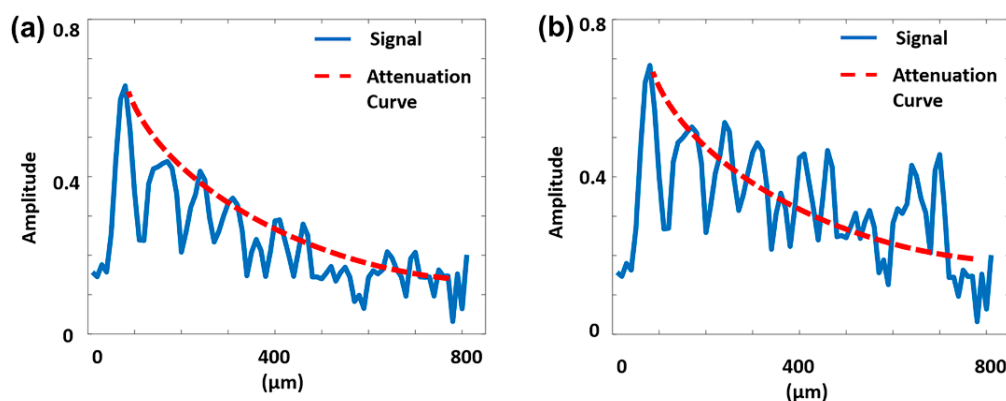
Figure 2. Photoacoustic A-scan signal. (a) Typical full bandwidth signal with an assumed signal attenuation function (red dashed curve) and (b) corrected A-scan signal by normalizing using the exponent of Equation (3).

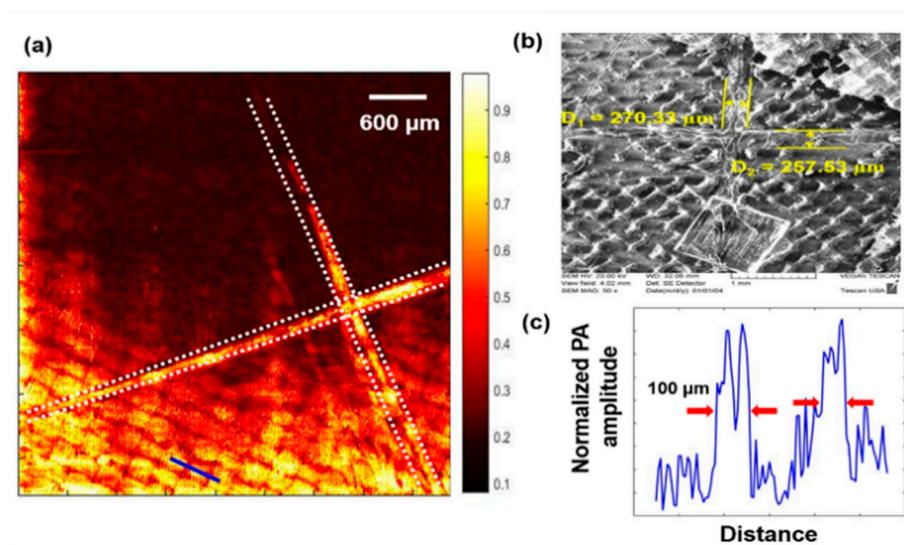
Figure 3. X-Y plane image. (a) pNDE X-Y plane image; the ‘X’ marking is highlighted. (b) SEM image; the width of the ‘X’ marking is calculated. (c) Full width at half maximum (FWHM) measurements along the blue line on the pNDE image, which are taken as the lateral resolution of the image.

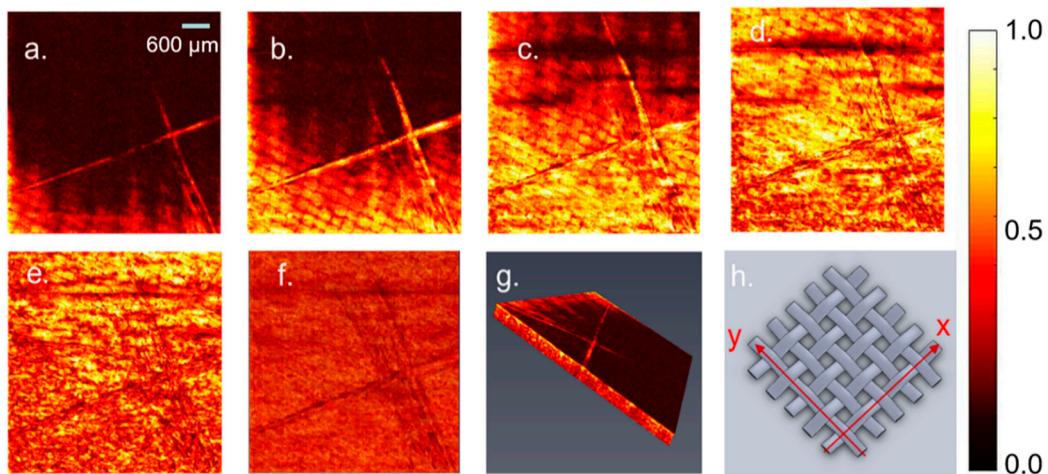
Figure 4. The 3D C-scan images of micro-scale damage in composites. (a–e) X-Y plane slices at a depth of 0.001, 0.025, 0.05, 0.065, and 0.15 mm, respectively. (f) The photoacoustic maximum-amplitude image projection (average) from the top of the carbon fiber-reinforced plastic (CFRP) composites. (g) A 3D C-scan image of a rotating 3D model. (h) Grid pattern explanation image.

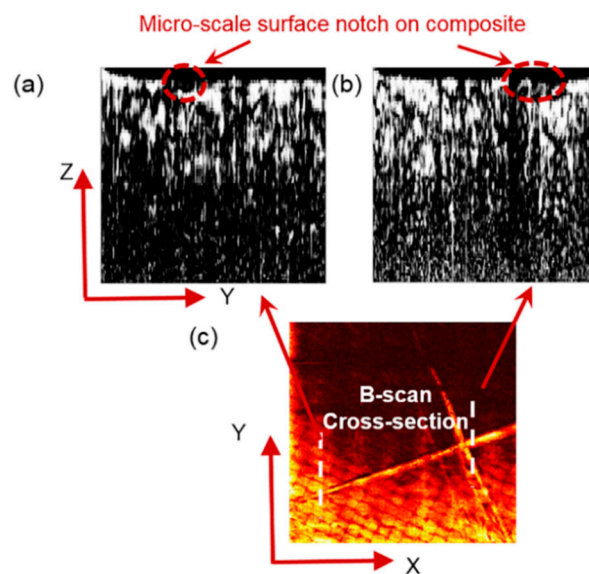
Figure 5. (a,b) Typical B-scan images showing the vertical cross-section of the detected notch in the composite plate, at positions: $x = 1.6$ and 4.1 mm, respectively (from left to right). (c) C-scan image showing the position of B-scan images in the X-Y plane.

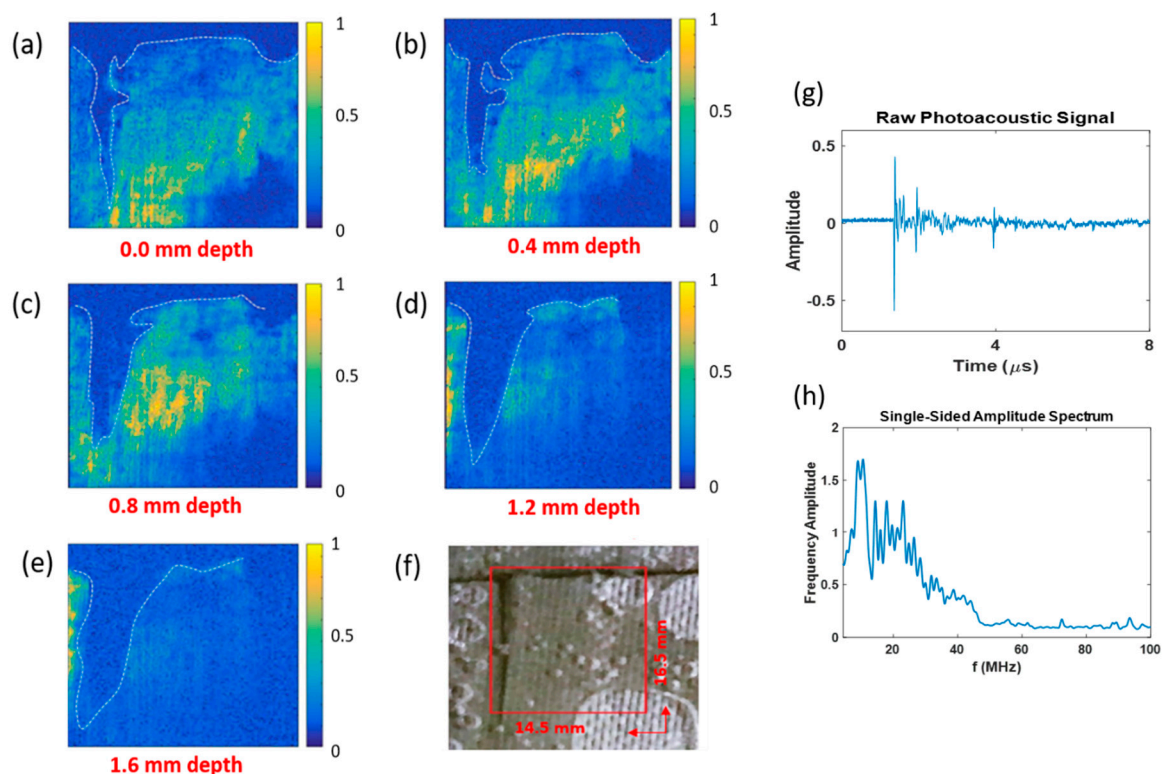
Figure 6. A pulsed laser-induced pNDE system to detect macro-scale delamination and transverse ply cracks in composites. (a–e) The 2D C-scan images showing the size of delamination and transverse ply cracking. (f) Optical images using the detected impact damage of composites. (g) A plot of the raw photoacoustic signal. (h) Single-sided photoacoustic signal frequency amplitude spectrum plot.
