UNIVERSITY OF OKLAHOMA
GRADUATE COLLEGE

EVALUATION OF LONG-TERM PERFORMANCE OF IN-STREAM CHANNEL
STABILITY STRUCTURES FOR PROTECTING OKLAHOMA BRIDGES AND ROADS

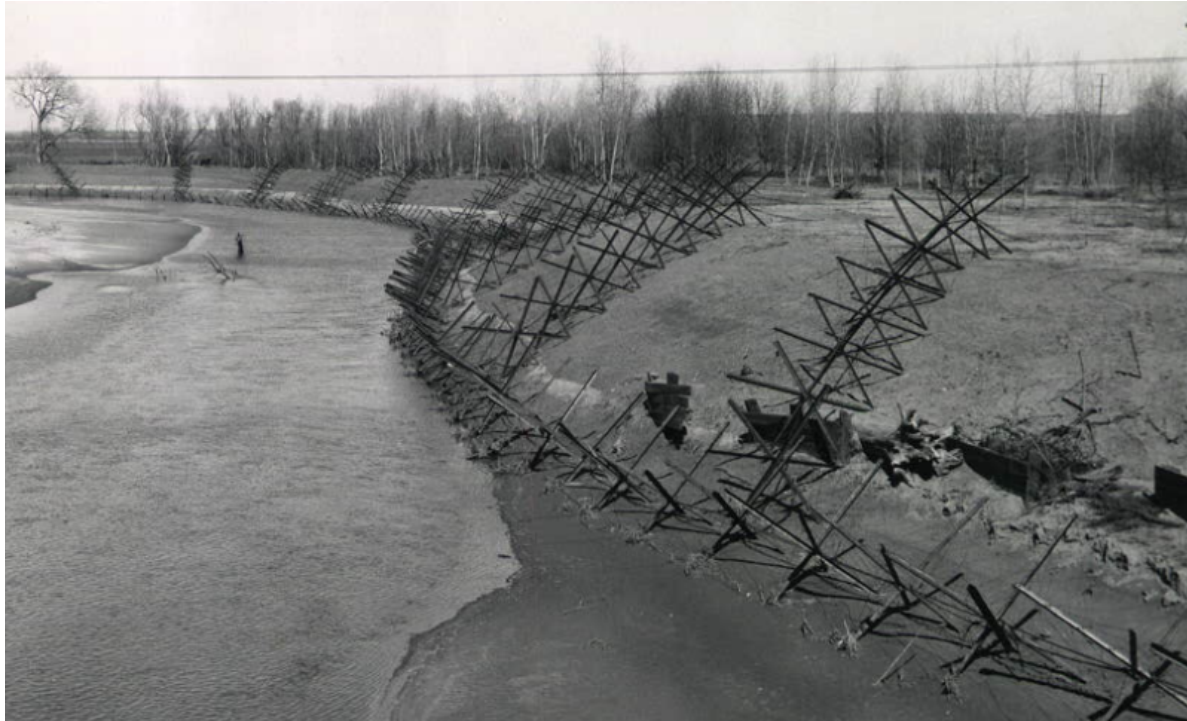
Figure 1. Example of a Kellner jetty field on the Washita River in Oklahoma, taken in 1950 (Lewis 2020).

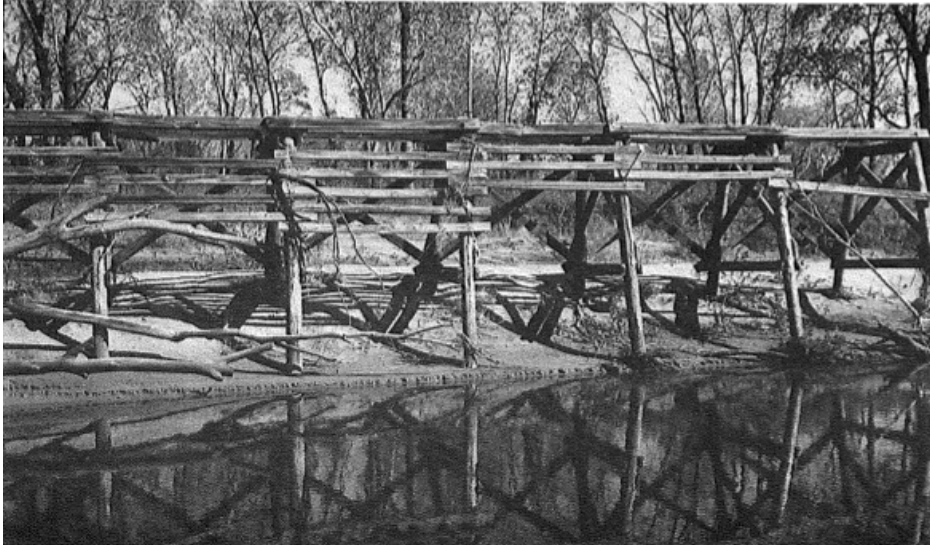
Figure 3. Image of pile diversion on the Arkansas River north of Bixby, Oklahoma, taken in 1988 (Harp and Thomas 1989).

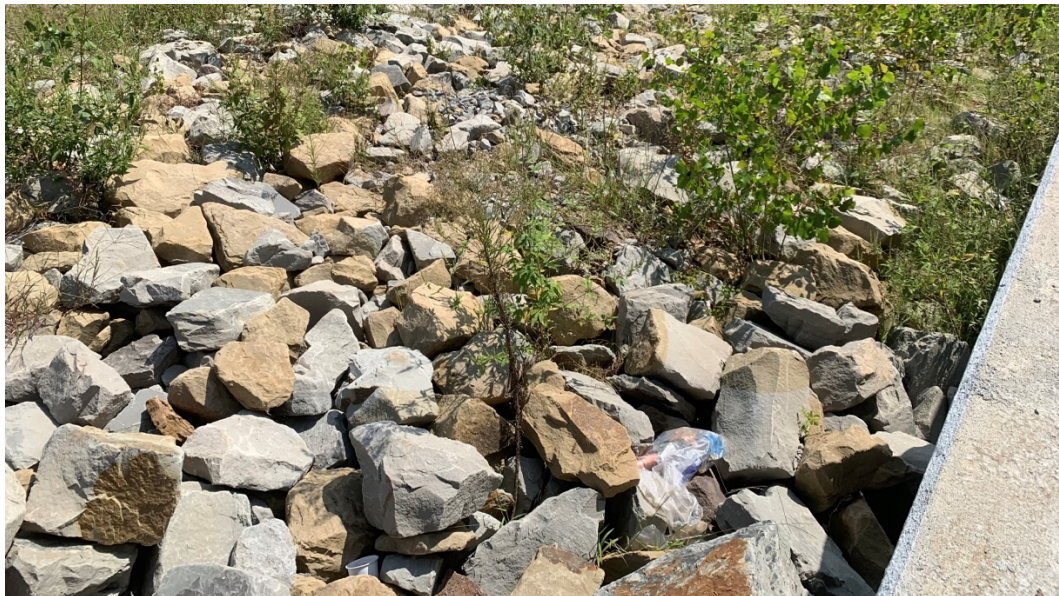
Figure 4: Rip rap along bridge abutment in good condition, taken near Laverne, Oklahoma, in 2020.

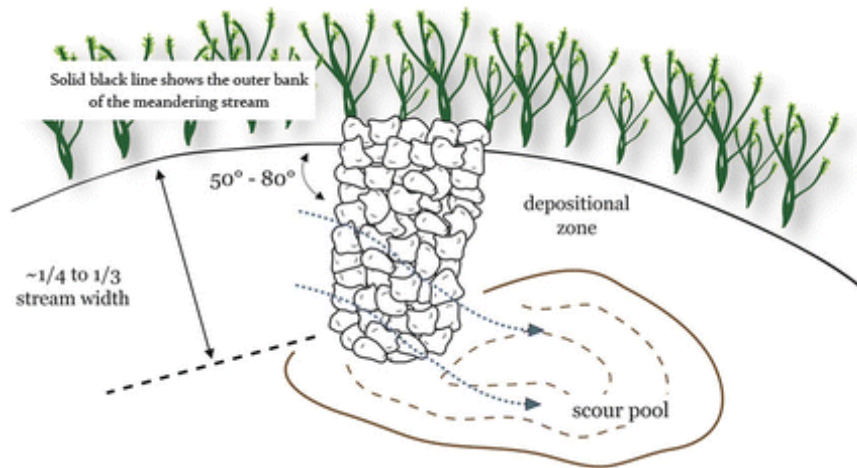
Figure 6: Standard bendway weir design (Khosronejad et al. 2017).

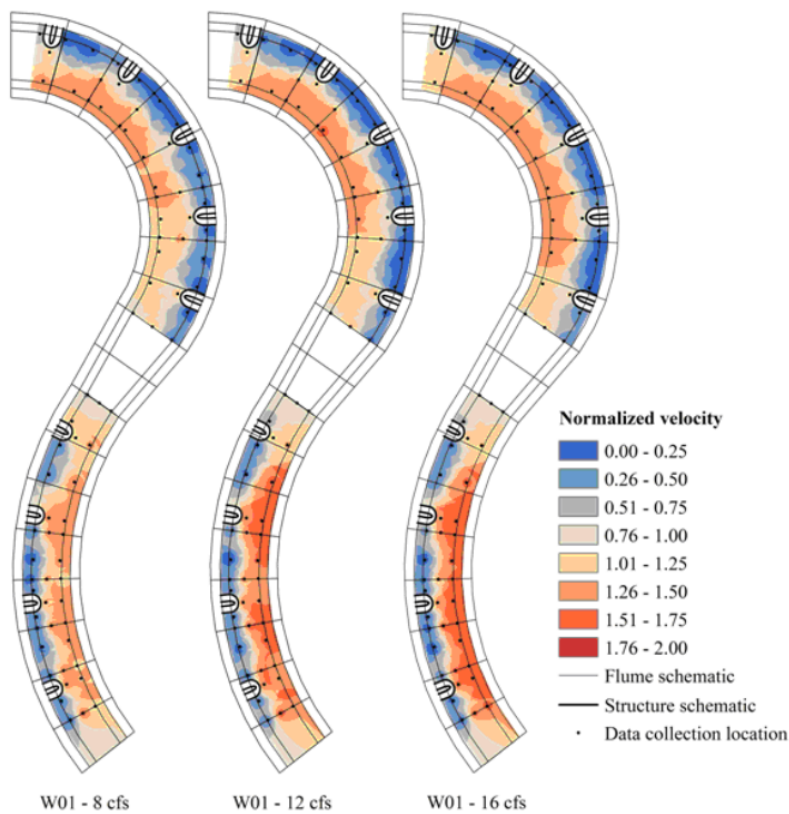
Figure 7: Normalized water velocities in stream meanders with bendway weirs (Scurlock 2014).

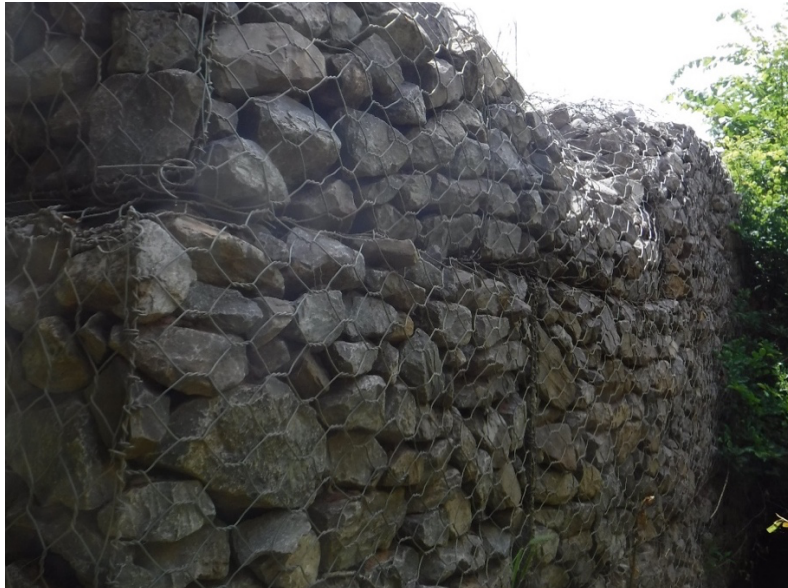
Figure 9: Photo of gabion baskets near Hydro, OK.

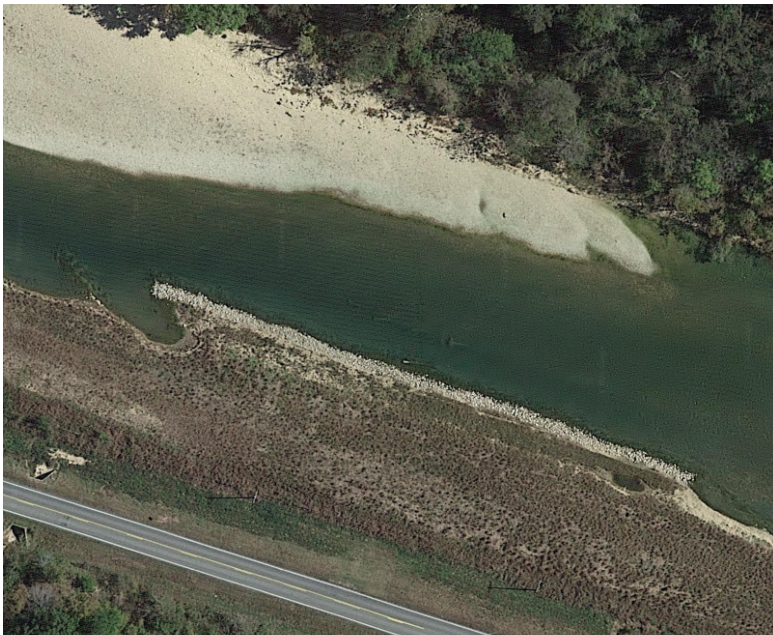
Figure 10: Aerial photo of rock vane in the Illinois River near Tahlequah, OK (GoogleEarth 2020).

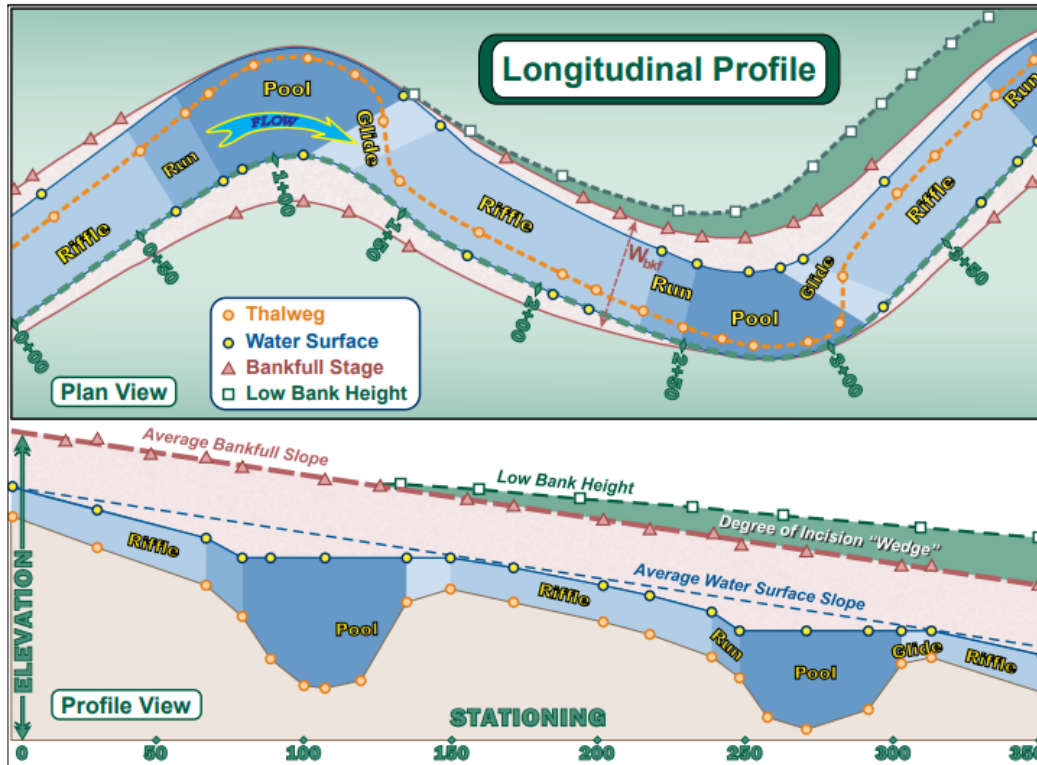
Figure 11: Riffle-pool pattern in longitudinal profile (Rosgen 2014).

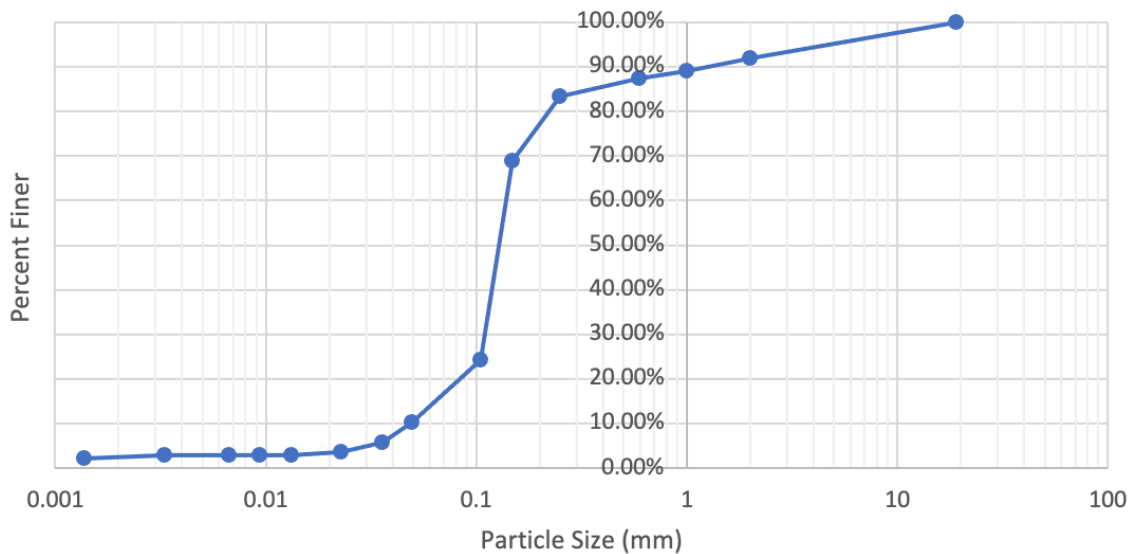
Figure 34: Site 24, Red River and U.S. 259 south of Harris in McCurtain county left bank particle size distribution.

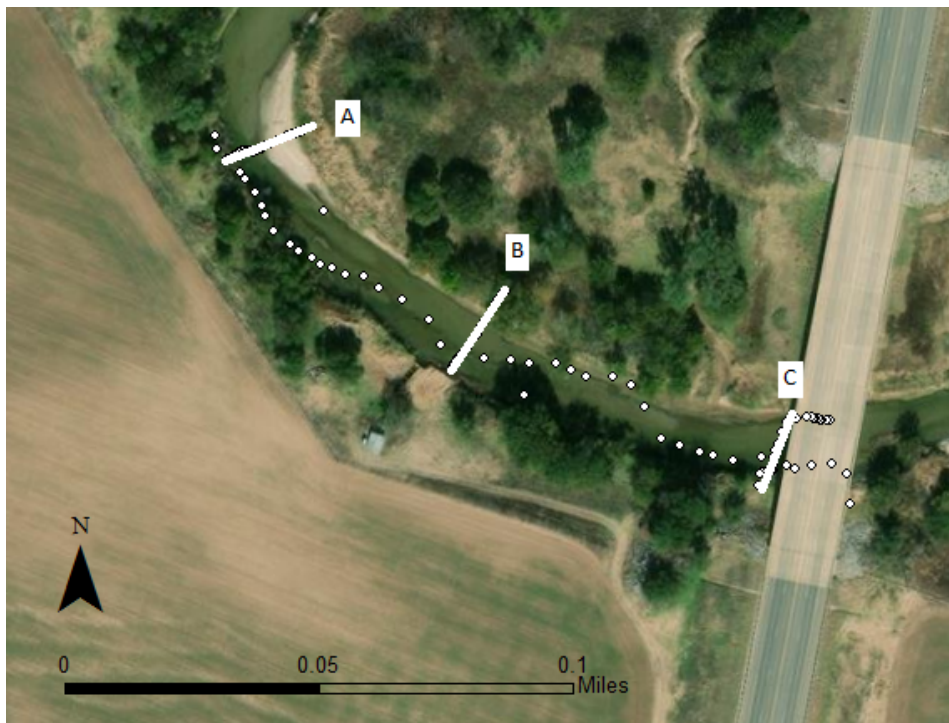
Figure 35: Site 6, North Canadian River and U.S. 281 near Watonga, cross section locations.

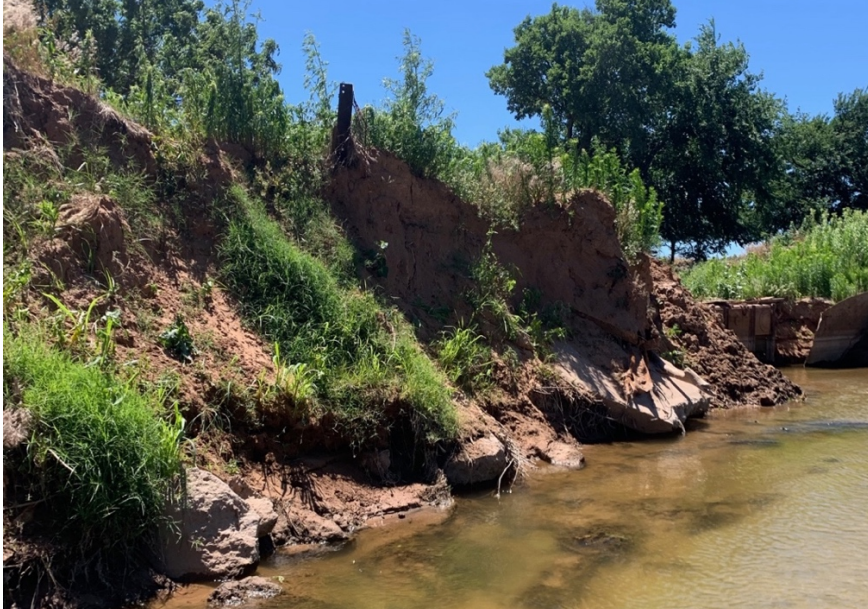
Figure 39: Site 6, North Canadian River and U.S. 281 near Watonga right bank with Kellner jetties.

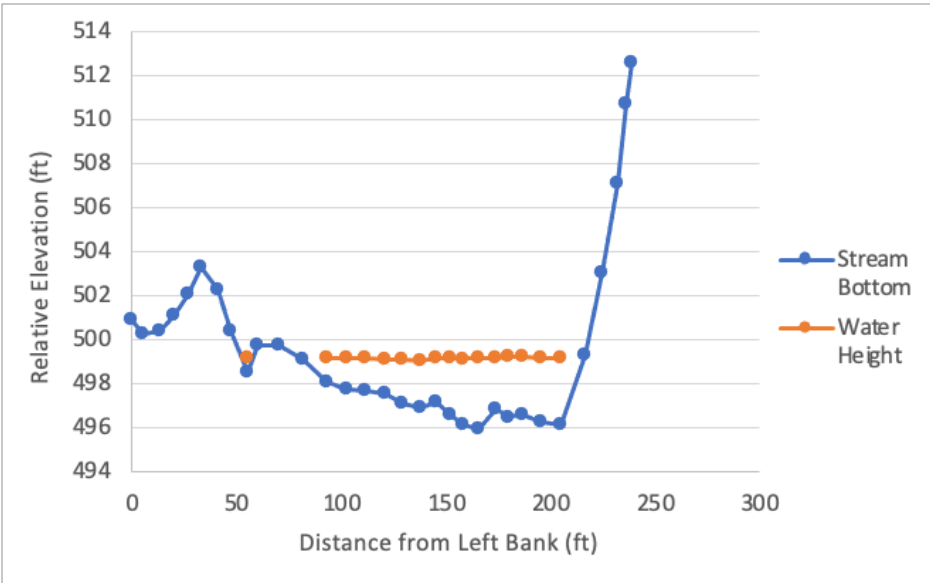
Figure 42: Site 32, Washita River and S.H. 7 west of Davis in Murray county, cross section at Kellner jetties facing downstream.

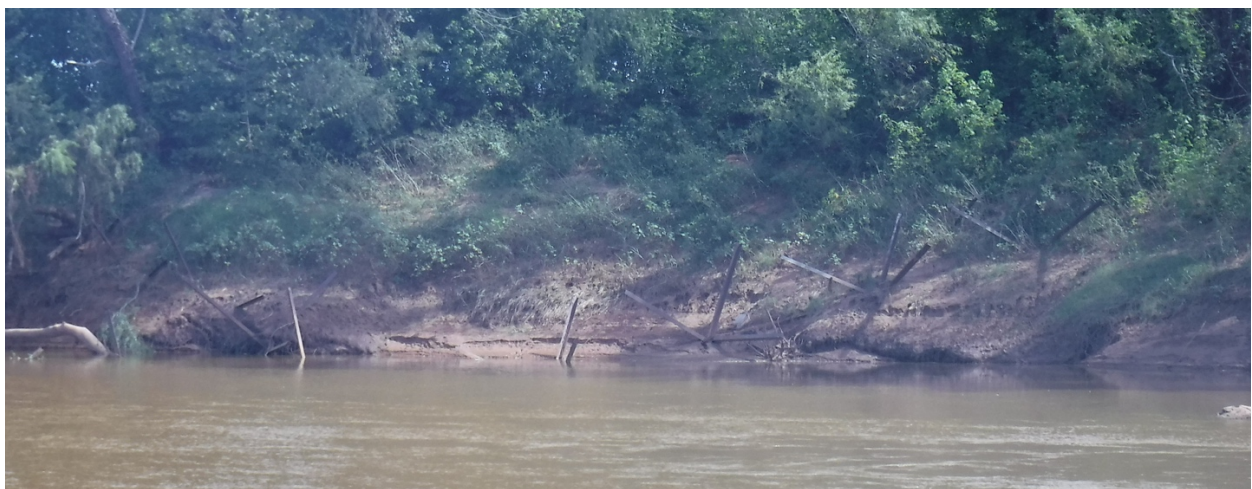
Figure 43: Site 32, Washita River and S.H. 7 west of Davis in Murray county, left bank with Kellner jetties.

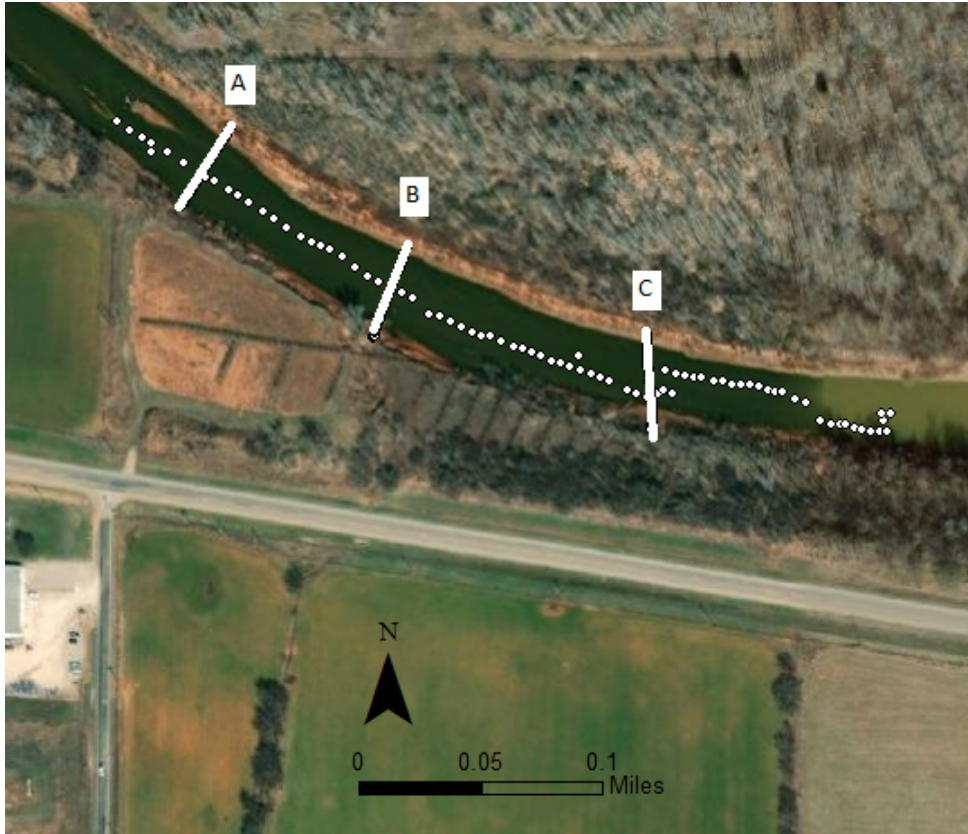
Figure 44: Locations of velocity profiles at site 29, Washita River at S.H. 19 South of Lindsay in Garvin county.

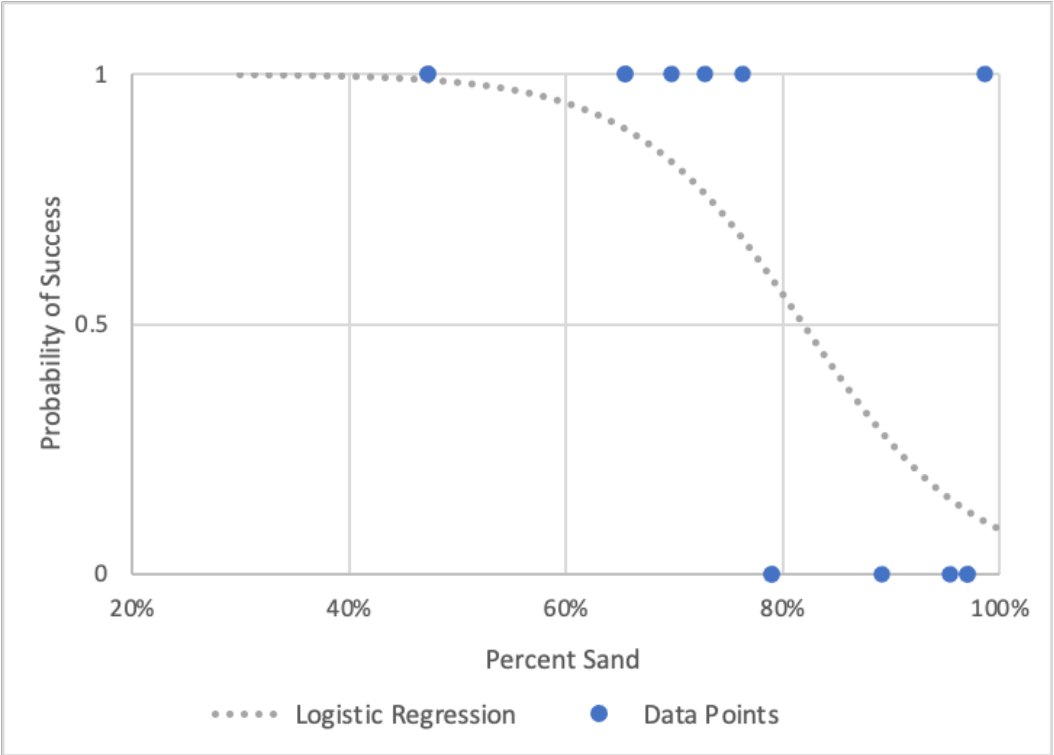
Figure 54: Pile diversion logistic regression with percent sand ($p < 0.1$).

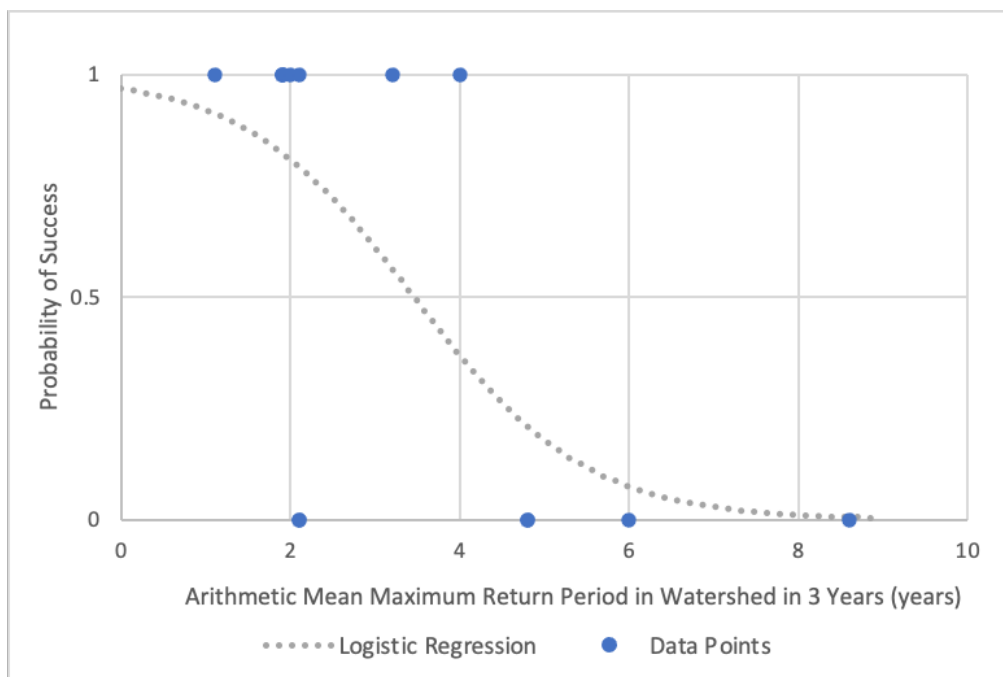
Figure 55: Pile diversion logistic regression with arithmetic mean maximum return period in the watershed within three years of installation ($p < 0.1$).

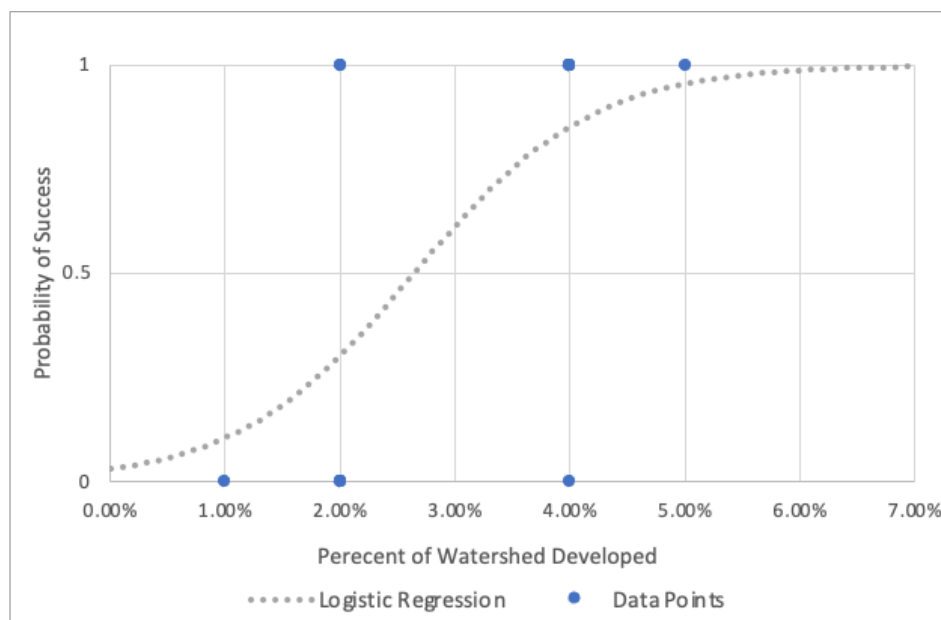
Figure 56: Pile diversion logistic regression with percent watershed developed ($p < 0.1$).

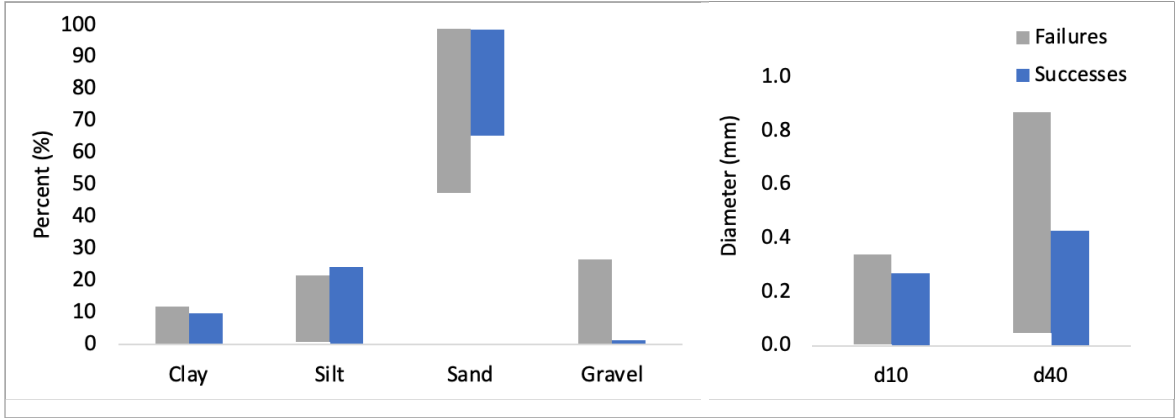
Figure 57: Ranges of sediment factors at sites with rip rap, separated by failures and successes.

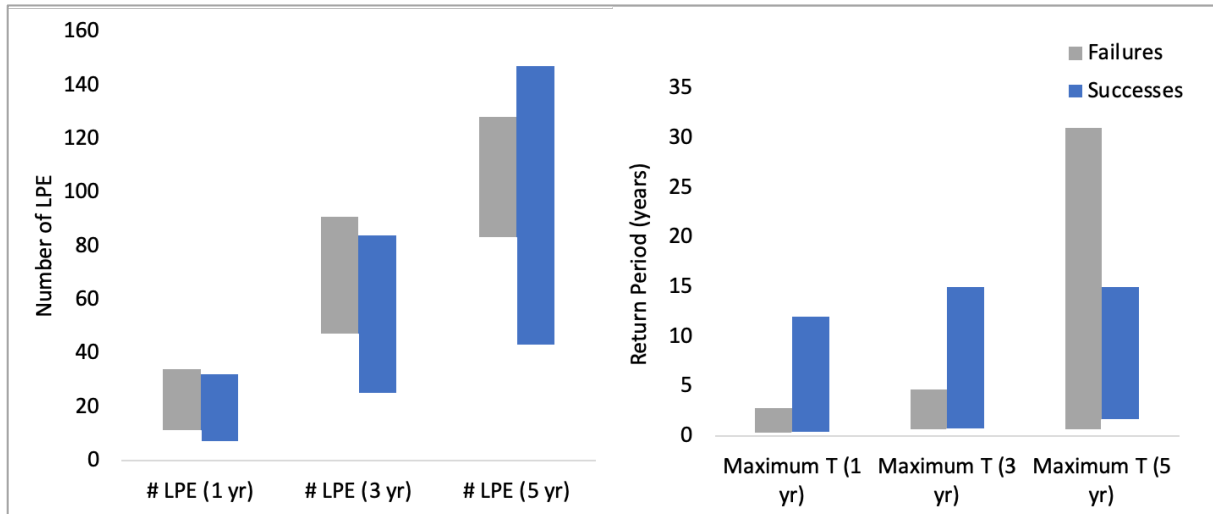
Figure 58: Ranges of precipitation data at sites with rip rap, separated by failures and successes (LPE = large precipitation events, T = return period).

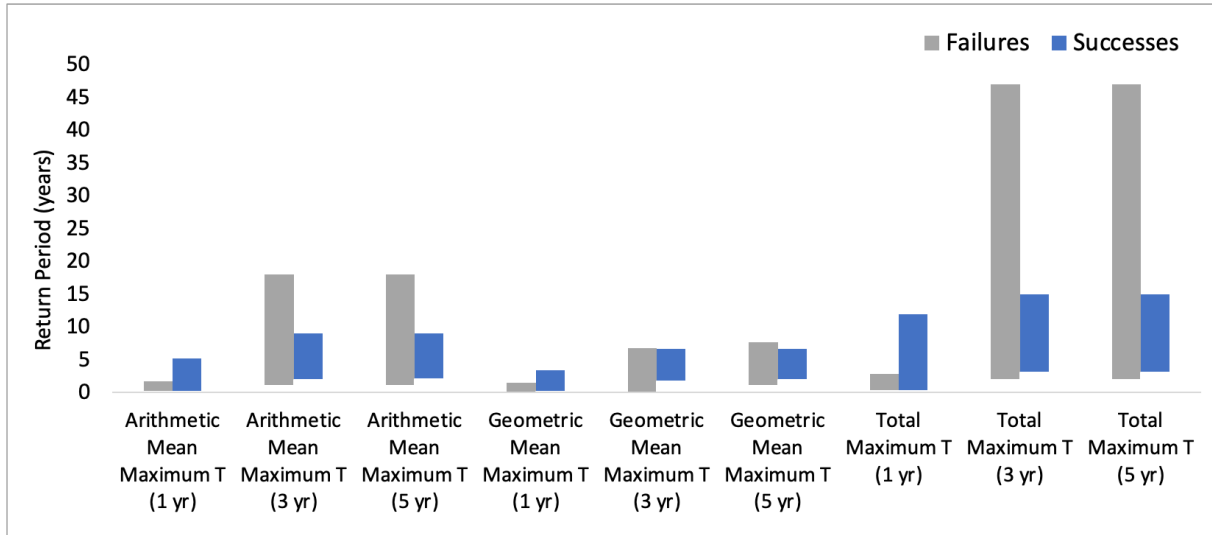
Figure 59: Ranges of arithmetic mean, geometric mean, and total maximum return periods (T) within the watersheds of sites with rip rap, separated by failures and successes

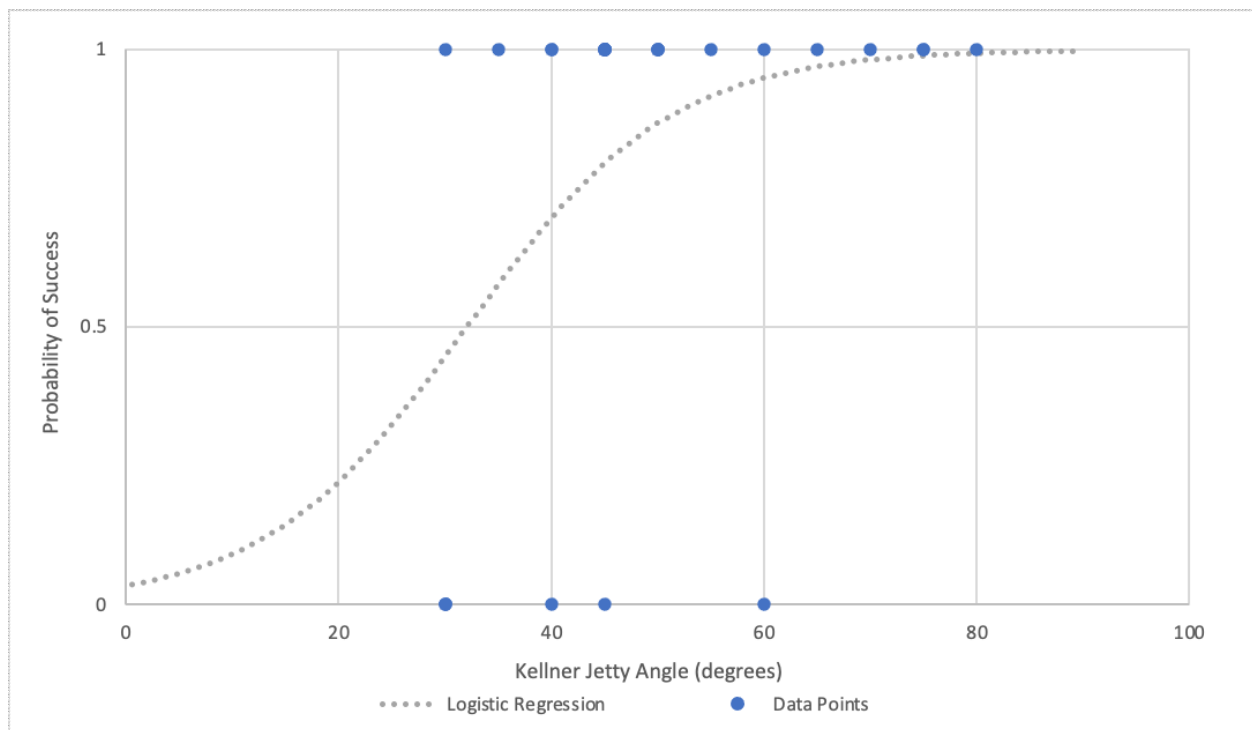
Figure 60: Kellner jetty logistic regression with oldest Kellner jetty angle ($p < 0.1$)

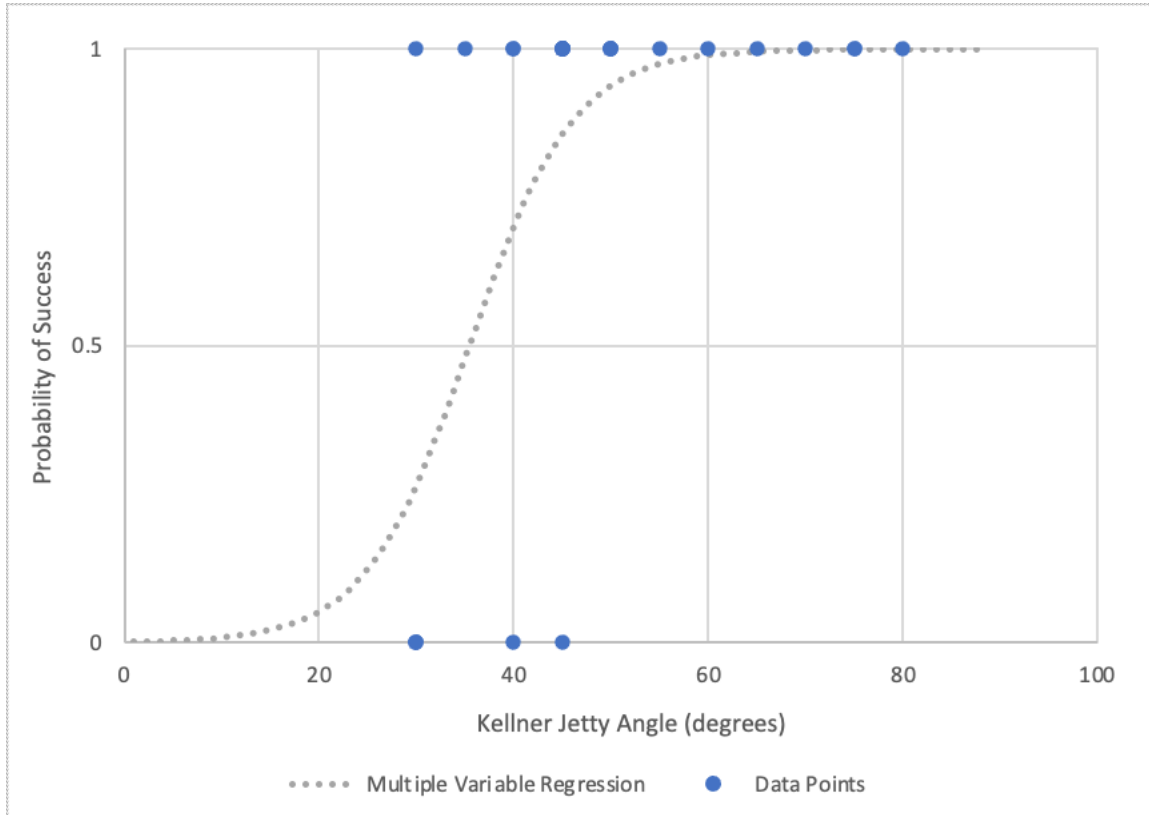
Figure 61: Kellner jetty multiple variable logistic regression in respect to Kellner jetty angle ($p < 0.1$)

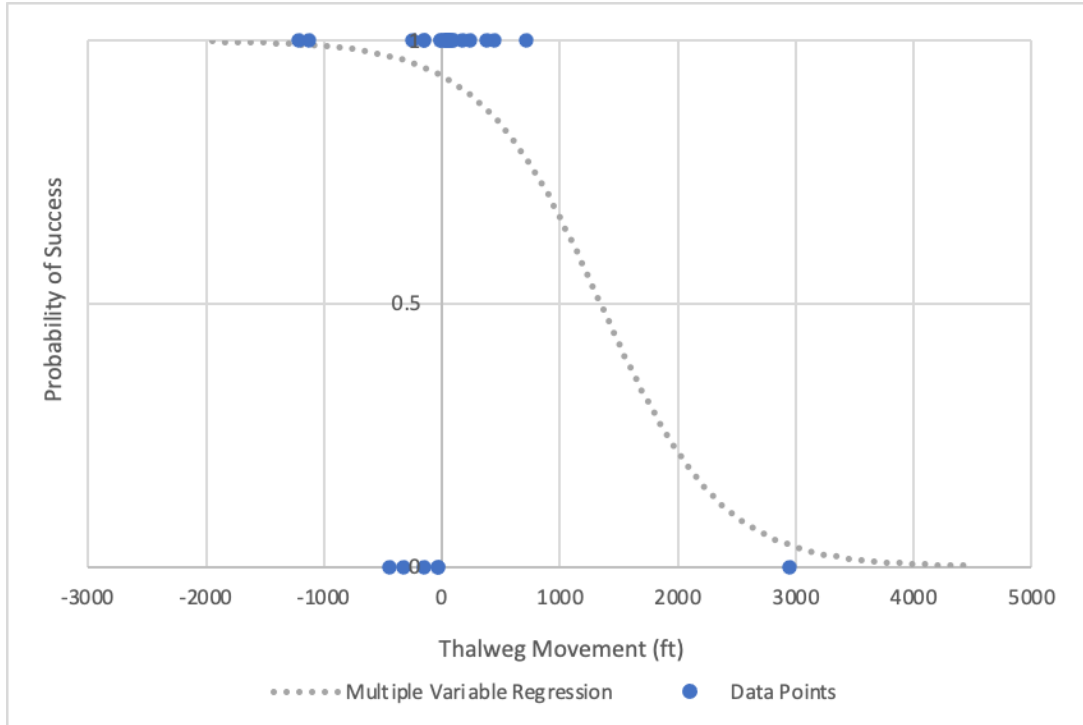
Figure 62: Kellner jetty multiple variable logistic regression in respect to thalweg movement ($p < 0.1$)

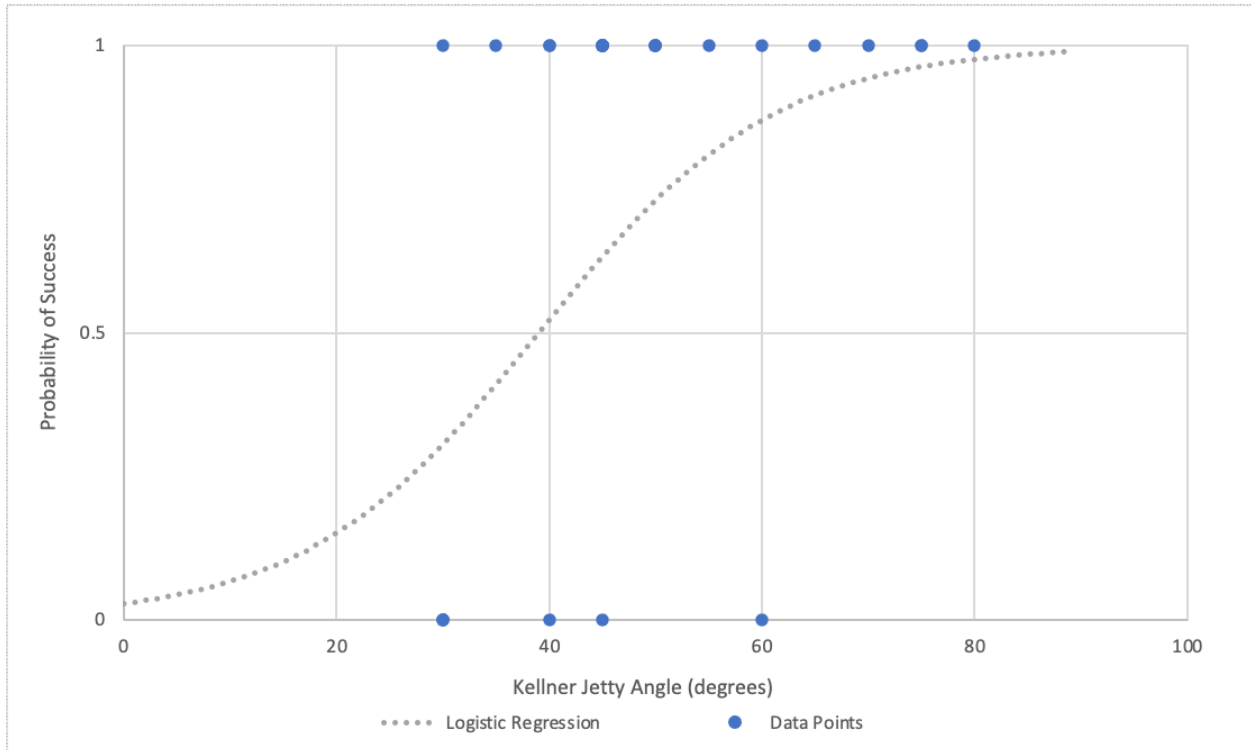
Figure 64: Kellner jetties logistic regression with oldest Kellner jetty angle without site 21 ($p < 0.1$)

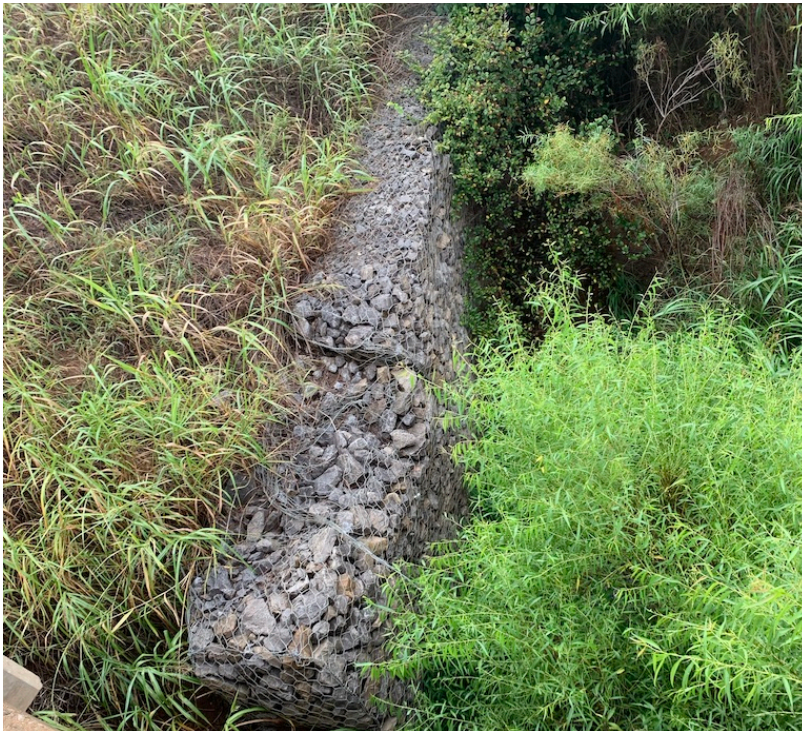
Figure 65: Gabion baskets at site 31

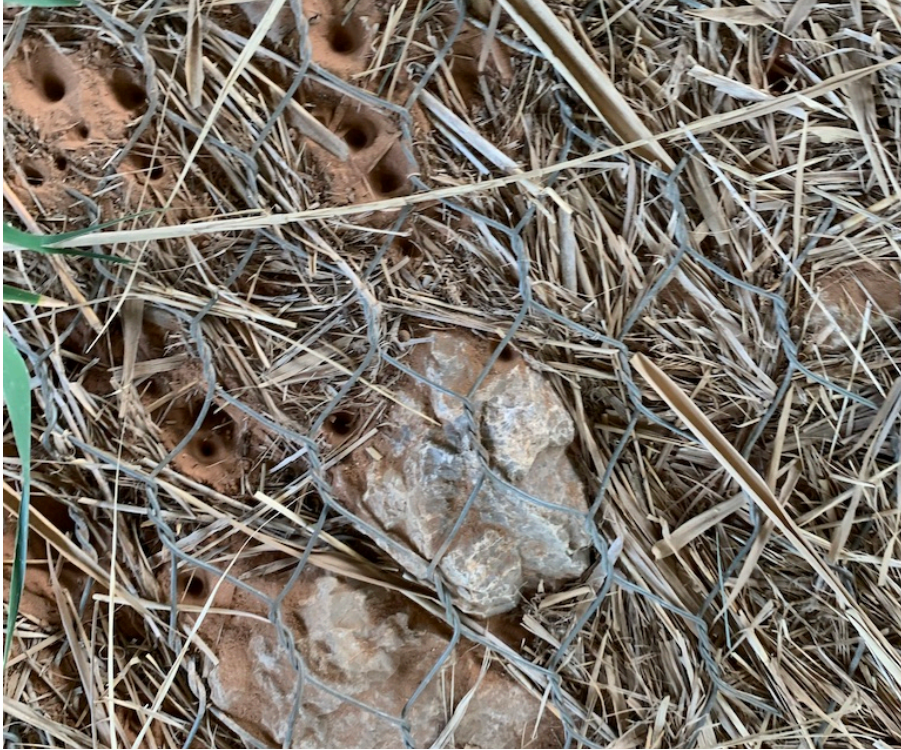
Figure 66: Sunken gabion baskets at site 26

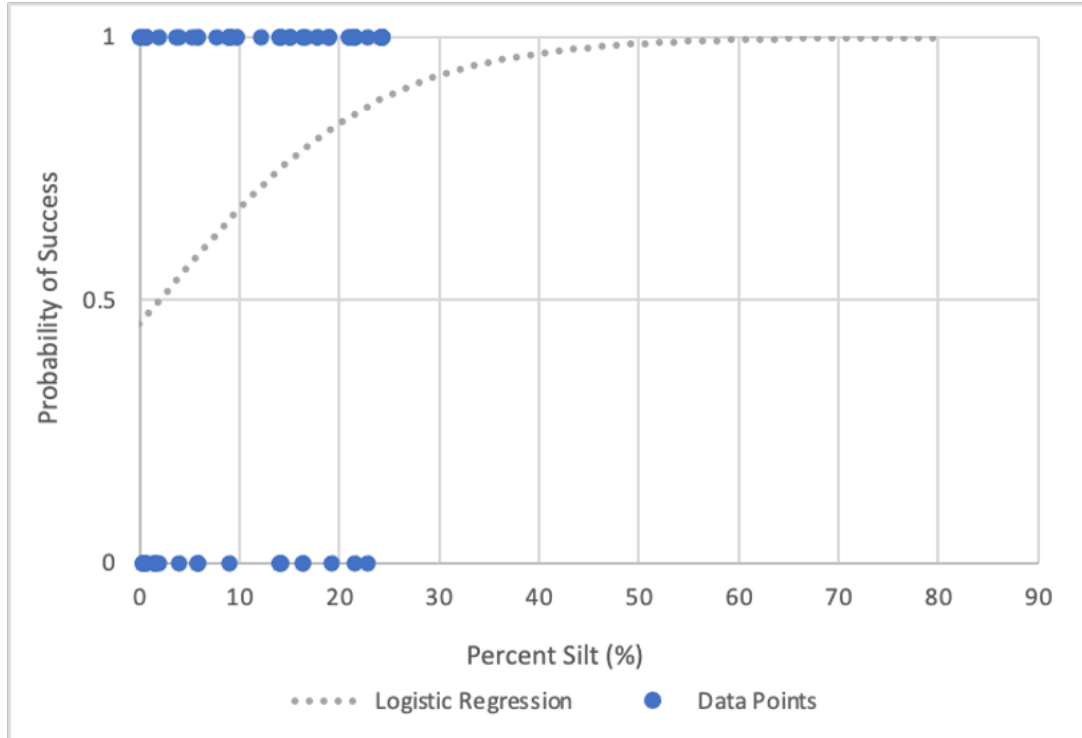
Figure 70: All structures logistic regression with percent silt ($p < 0.05$)

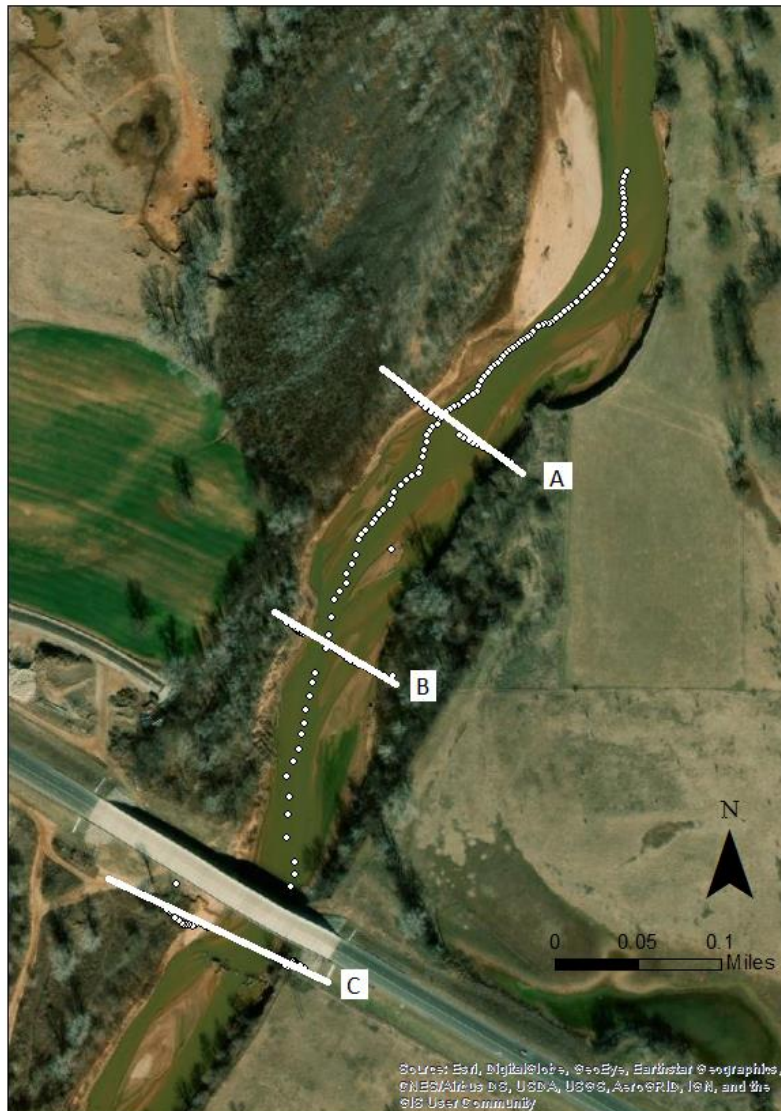
Figure A1: Site 1, Washita River and U.S. 77 north of Wynnewood in Garvin county, thalweg data points and cross section locations.

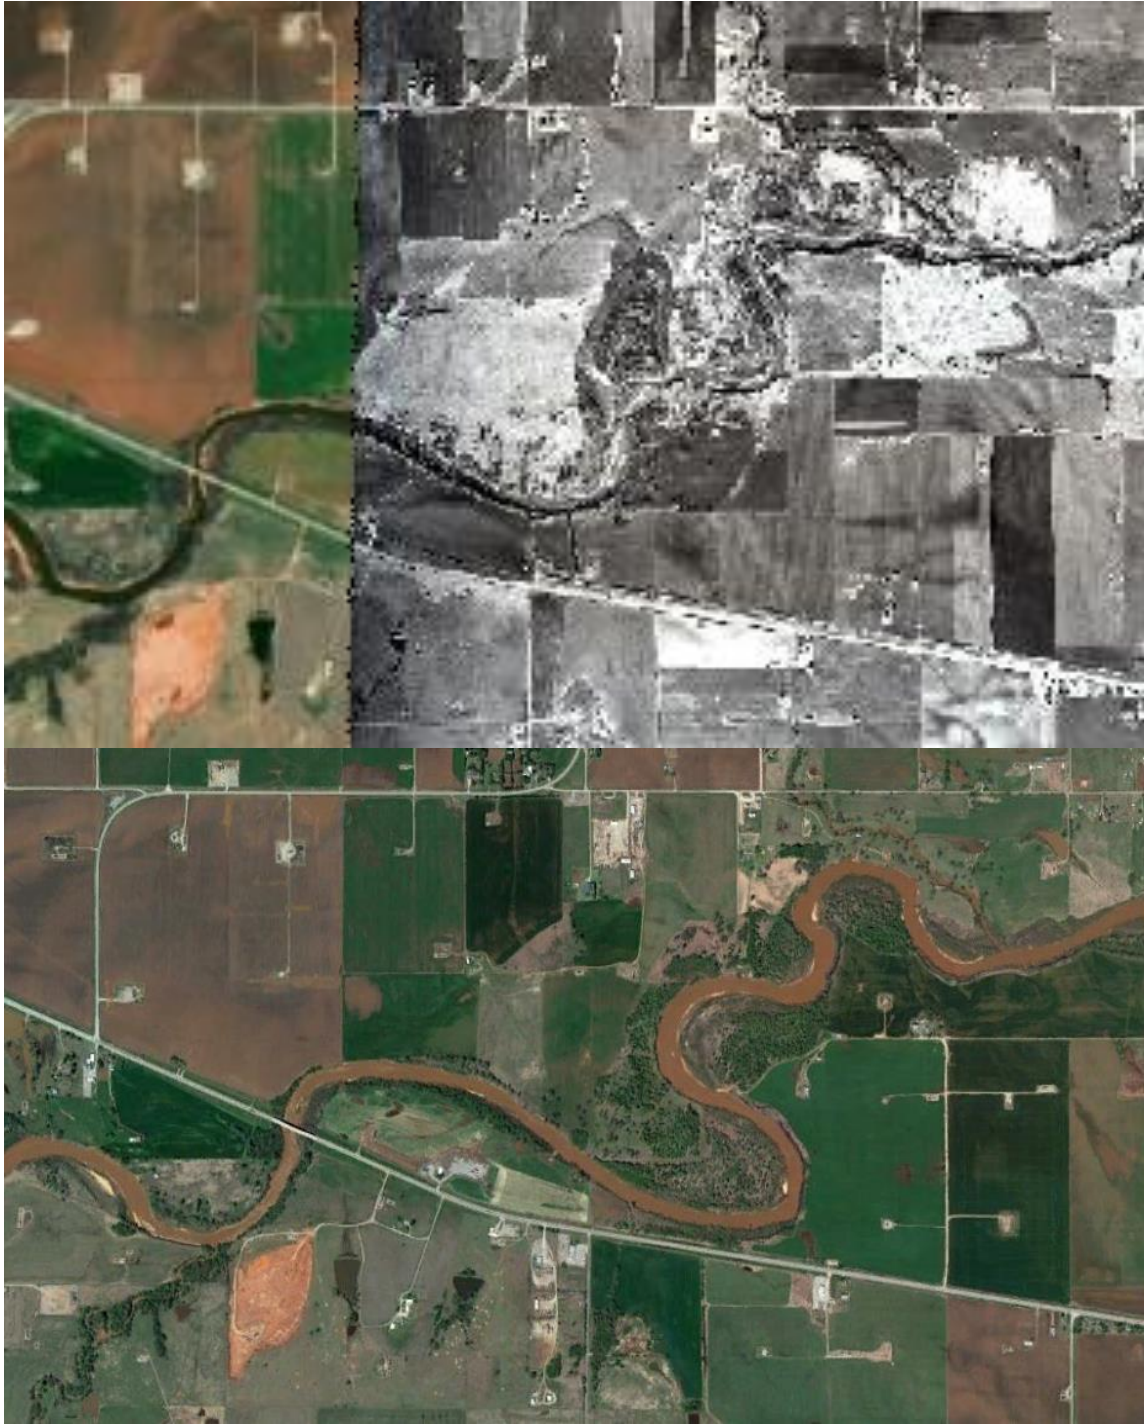
Figure F14: Site 29, Washita River and S.H. 19 east of Lindsay in Garvin county, in 1969 (top) and 2020 (bottom).
