FINAL REPORT ~ FHWA-OK-21-03

EVALUATION OF ULTRA-HIGH PERFORMANCE CONCRETE, FIBER REINFORCED SELF-CONSOLIDATING CONCRETE, AND MALP CONCRETE FOR PRESTRESSED GIRDER REPAIR

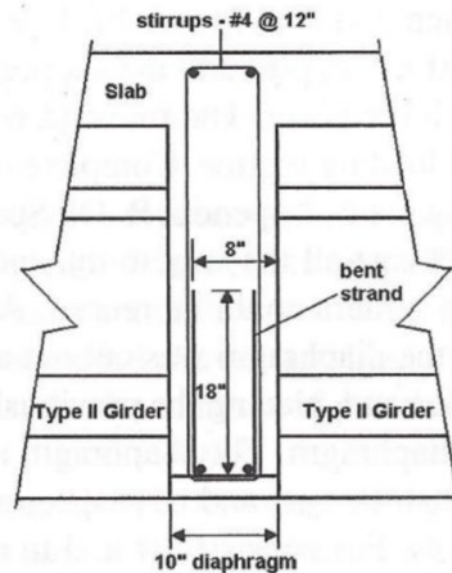
Figure 2.1. Bent bar continuity joint specimen (Miller et al. 2004)

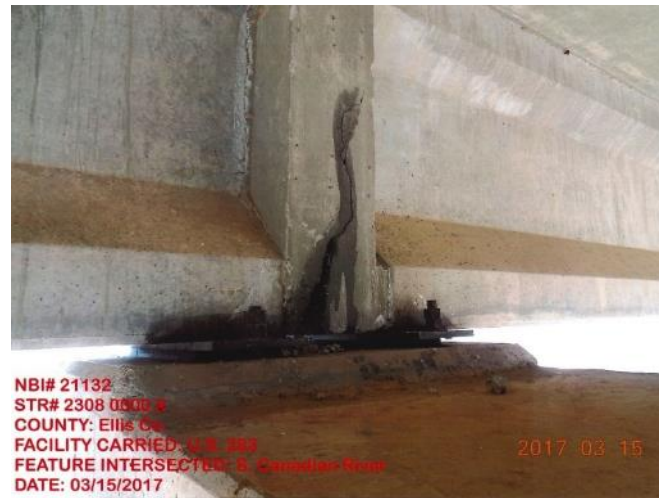
Figure 2.2. Cracking in continuity linkage block (photo courtesy of Walt Peters)

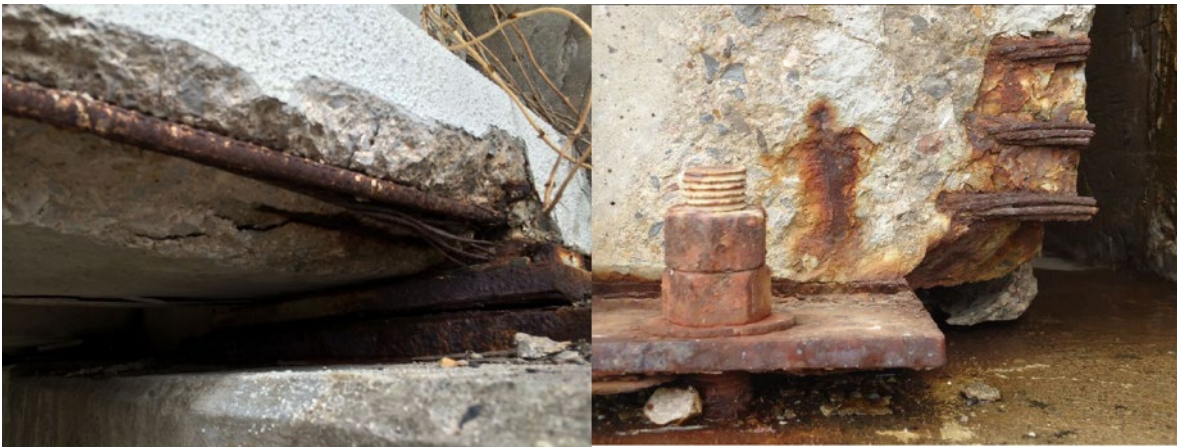
Figure 2.3. Corrosion damage to a precast, prestressed concrete girder end region

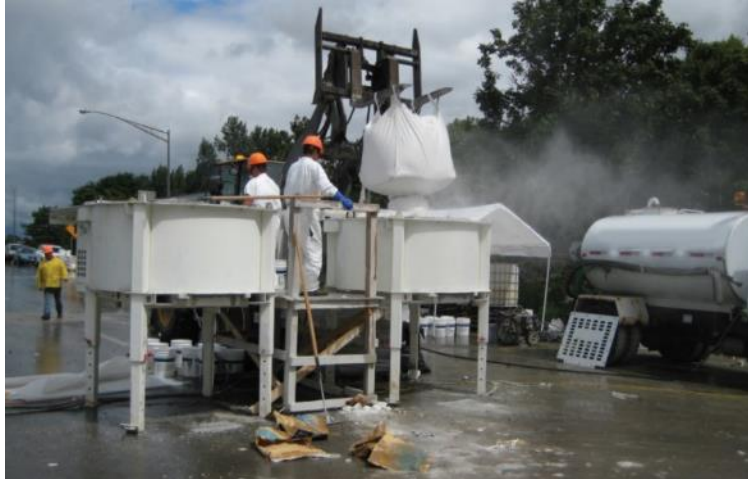
Figure 2.4. UHPC field mixing operations using high shear mixers (Graybeal 2014)

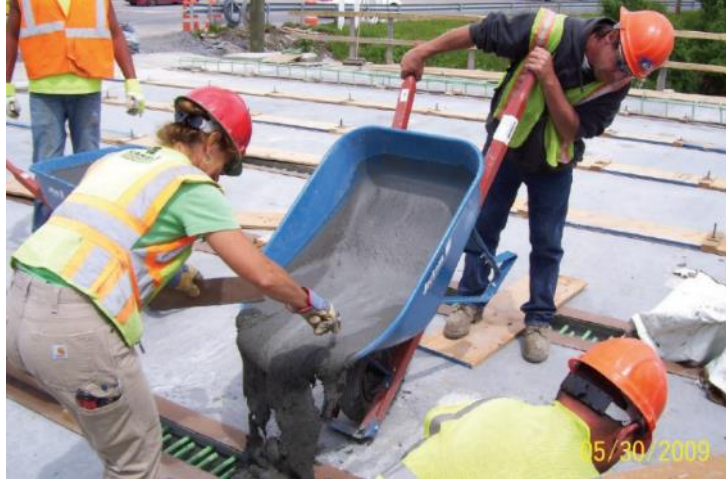
Figure 2.5. UHPC placement into a longitudinal connection of bridge elements (Graybeal 2014)

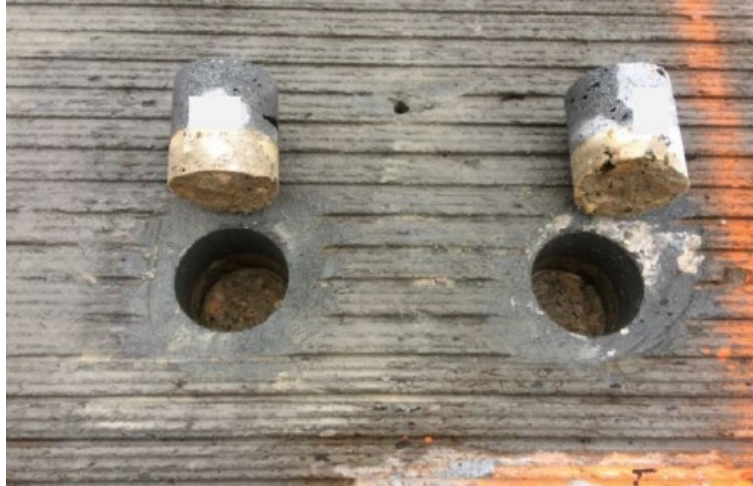
Figure 2.7. Direct pull-off test cores (Graybeal 2017)

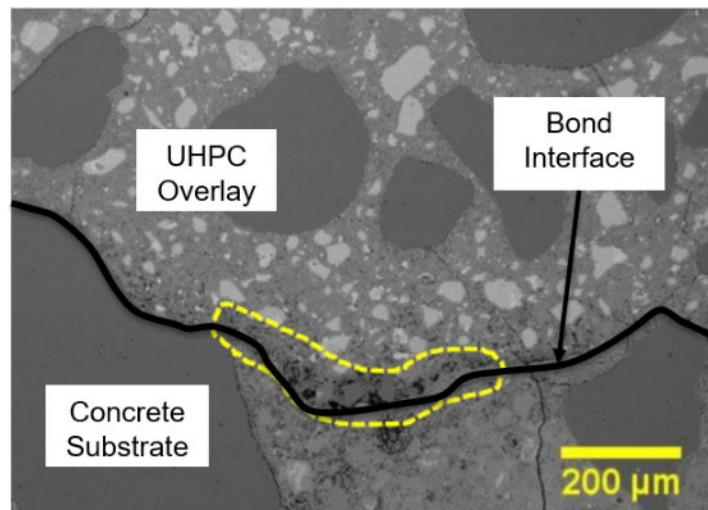
Figure 2.8. Area of bond interruption at UHPC-conventional concrete interface (Graybeal 2017)

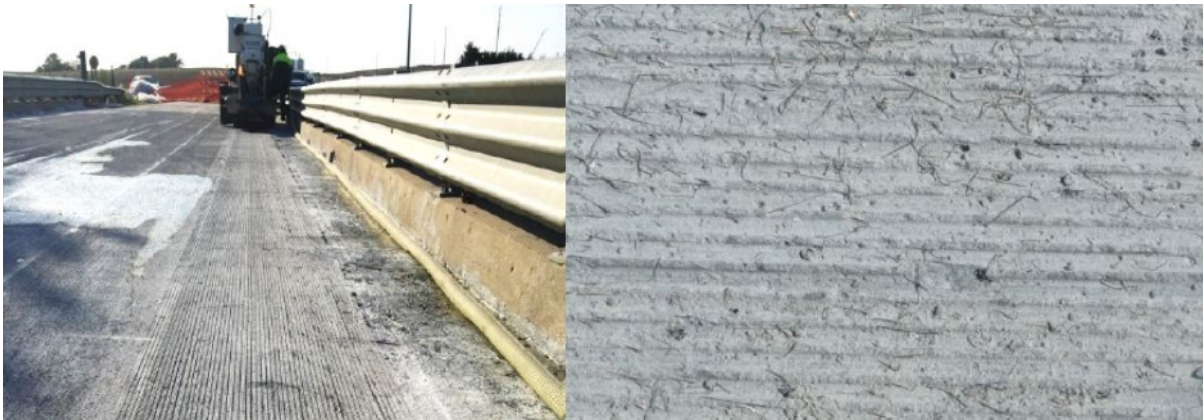
Figure 2.9. Finished overlay on the Mud Creek bridge (Wibowo and Sritharan 2018)

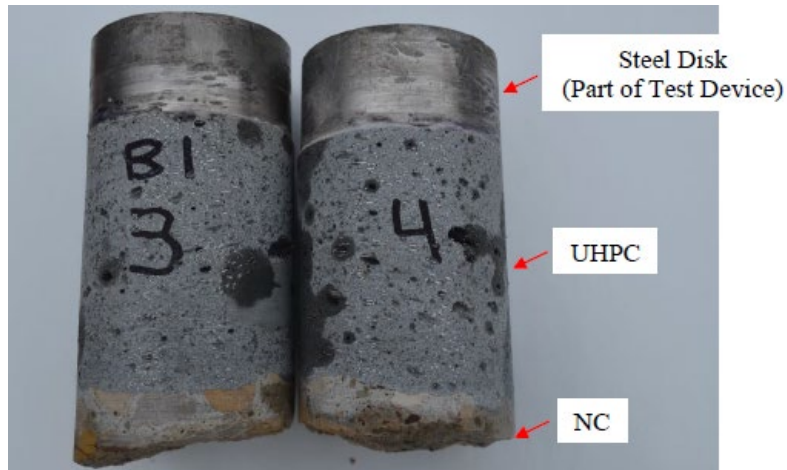
Figure 2.10. Typical direct pull-off test failure for the Mud Creek bridge overlay (Wibowo and Sritharan 2018)

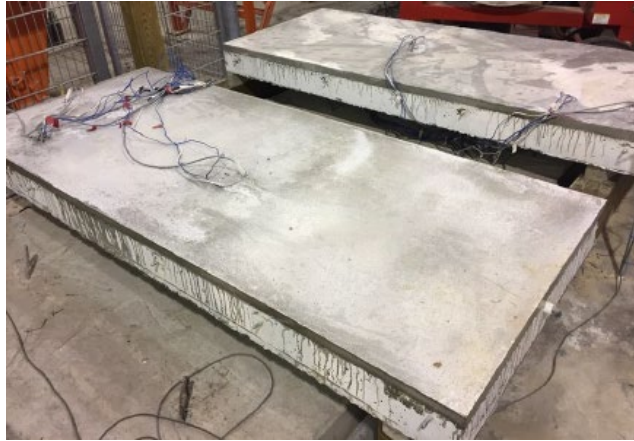
Figure 2.11. Final experimental panel with UHPC overlay used by Khayat et al. (2018)

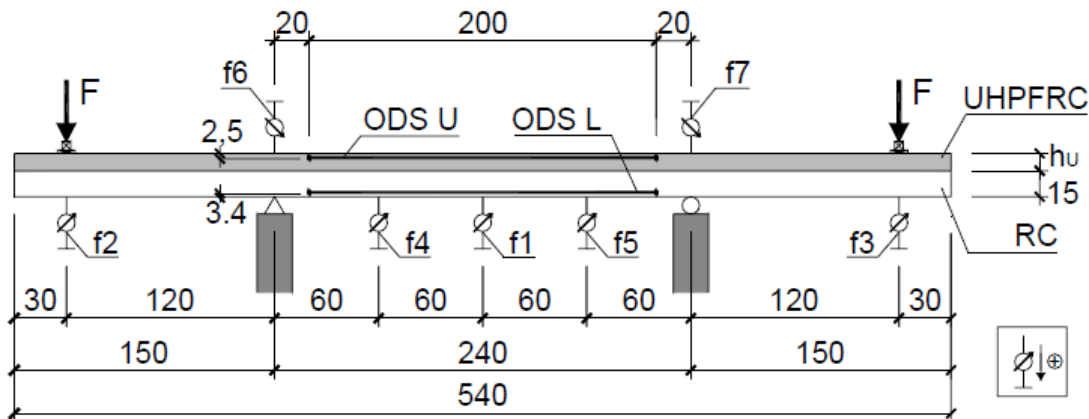
Figure 2.12. Four-point loading system for Habel et al. (2004) experiments. Notations f1-f7 are LVDT locations, and dimensions are given in cm.

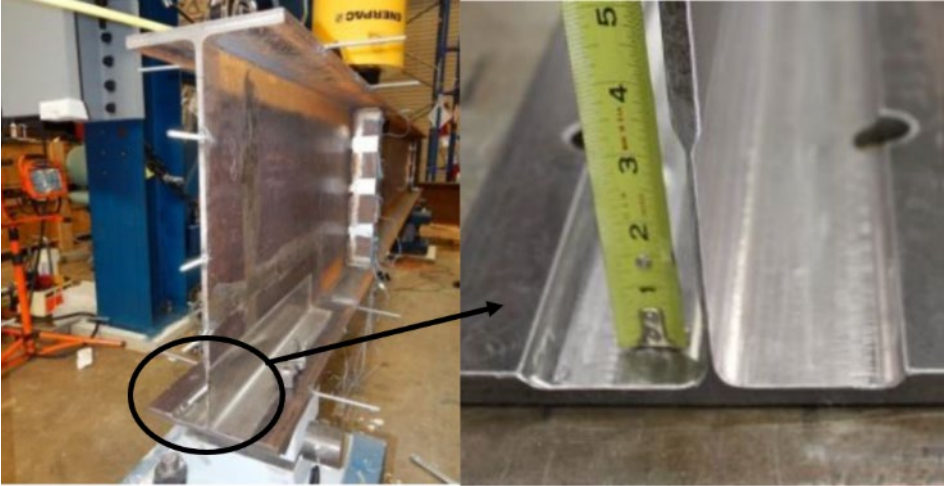
Figure 2.13. Damaged girder end (Zmetra 2015)

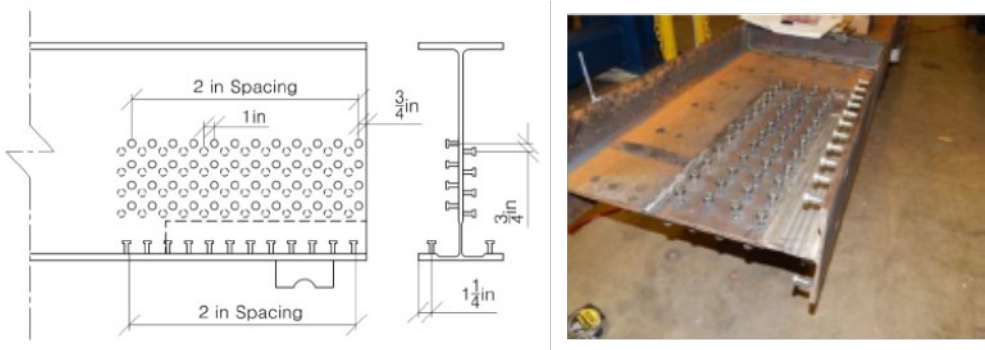
Figure 2.14. Shear stud layout on the repaired girder (Zmetra 2015)

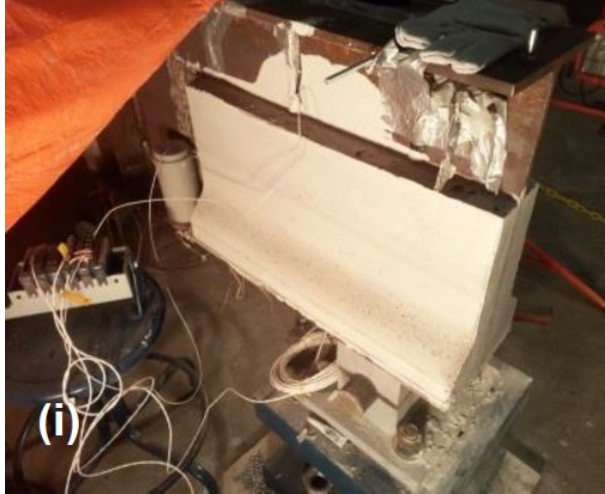
Figure 2.15. Final repaired girder (Zmetra 2015)

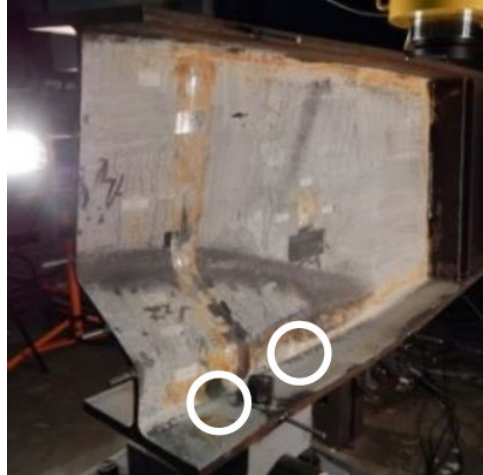
Figure 2.16. Undamaged girder failure (Zmetra 2015)

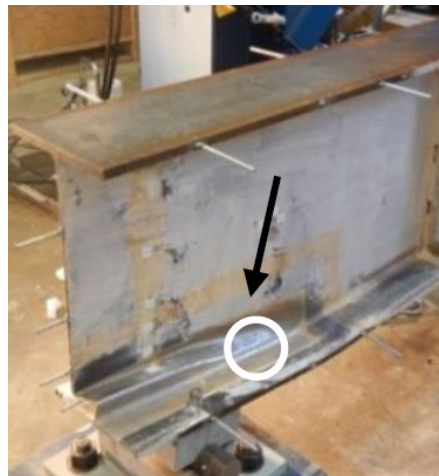
Figure 2.17. Damaged girder failure (Zmetra 2015)

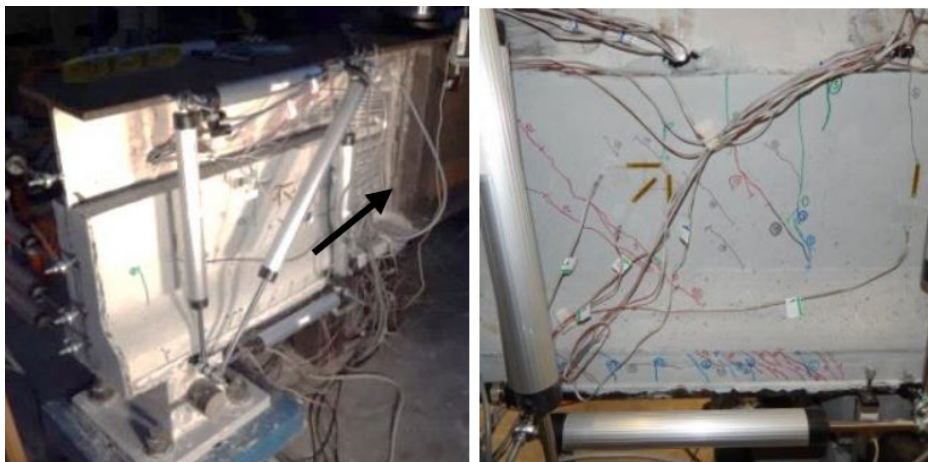
Figure 2.18. Repaired girder failure (Zmetra 2015)

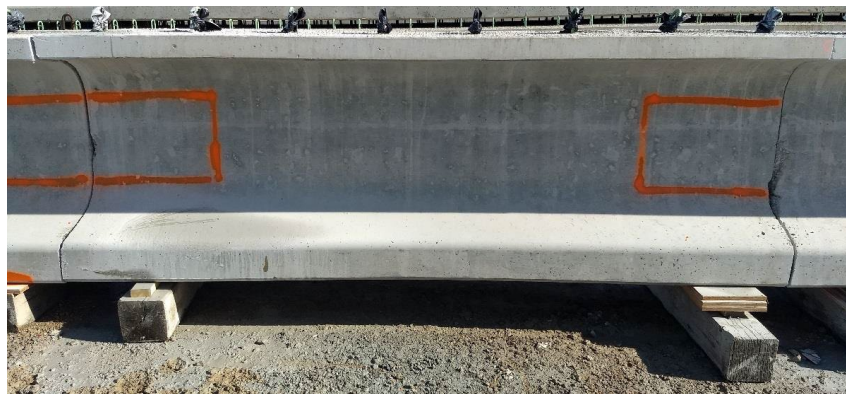
Figure 2.19. Cut beam segment marked for controlled damage (Shafei, 2020)

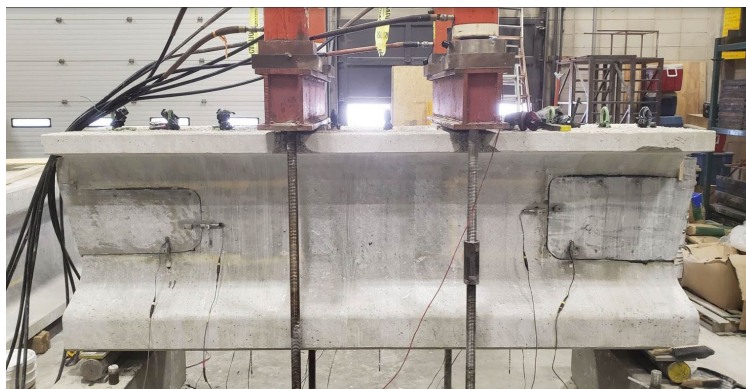
Figure 2.20. Loading setup for beam with UHPC patch (Shafei, 2020)

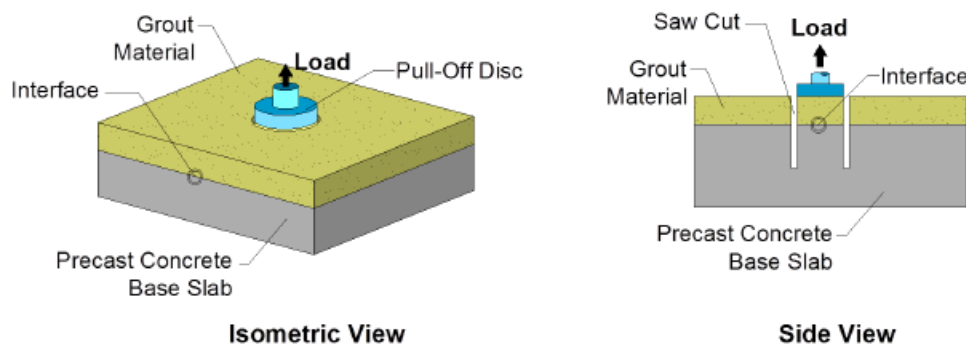
Figure 2.21. Direct tension pull-off test setup (Graybeal 2016)

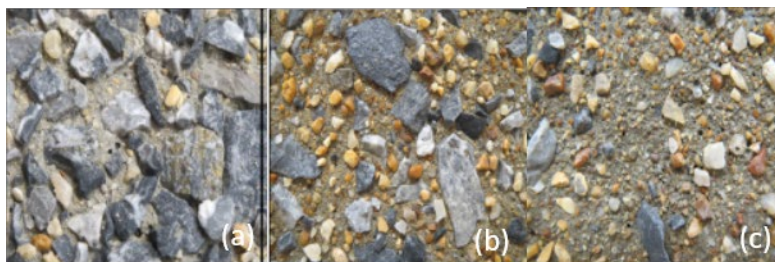
Figure 2.22. (a) High, (b) medium, and (c) low aggregate exposure levels (Graybeal, 2016)

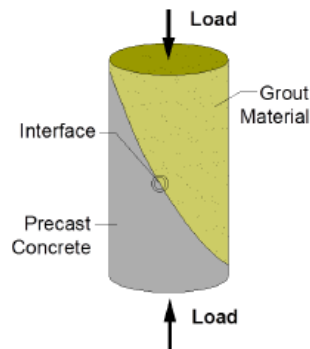
Figure 2.23. Slant shear compression test (Graybeal 2016)

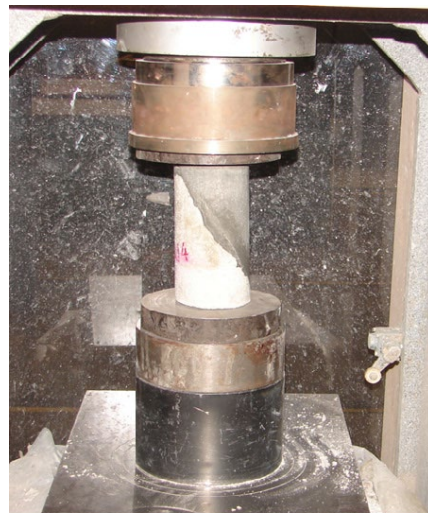
Figure 2.25. Cylindrical specimen and testing setup for Sarkar (2010) experiments

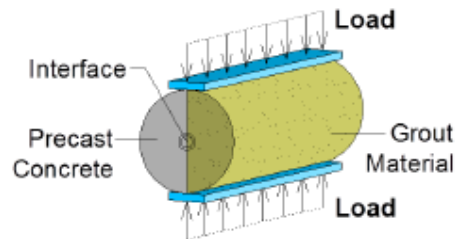
Figure 2.26. Splitting cylinder test (Graybeal 2016)

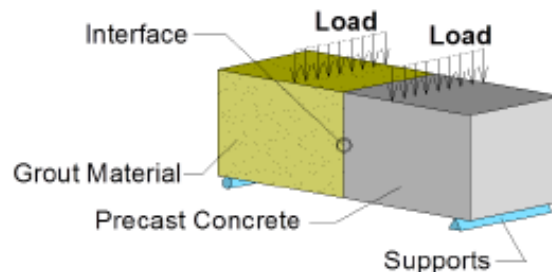
Figure 2.27. Flexural beam bond test (Graybeal 2016)

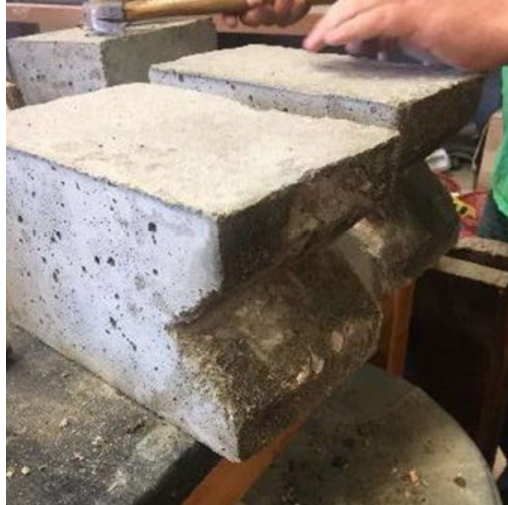
Figure 2.28. Shear key conventional concrete substrate (Funderburg 2018)

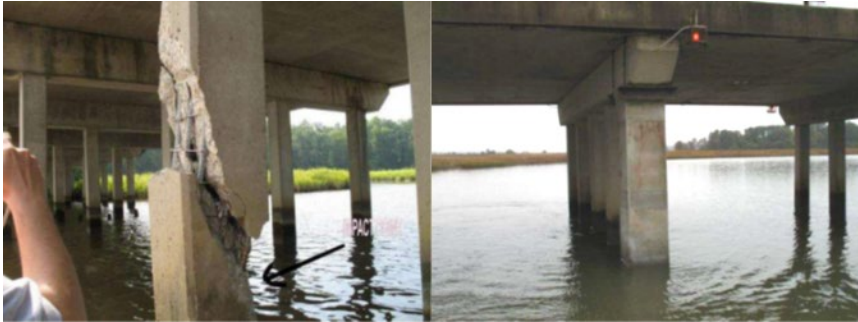
Figure 2.29. Damaged (left) and SCC repaired bridge pier (right) (Ozyildirim 2013)

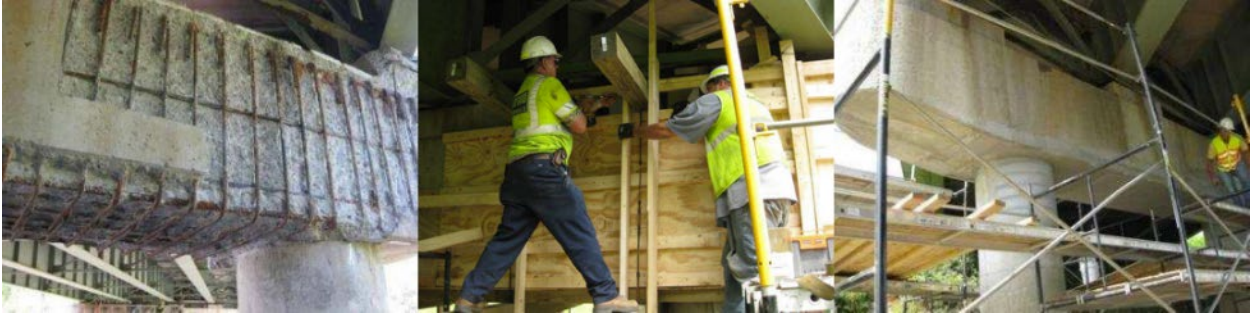
Figure 2.30. SCC repaired column and pier cap (Ozyildirim 2013)

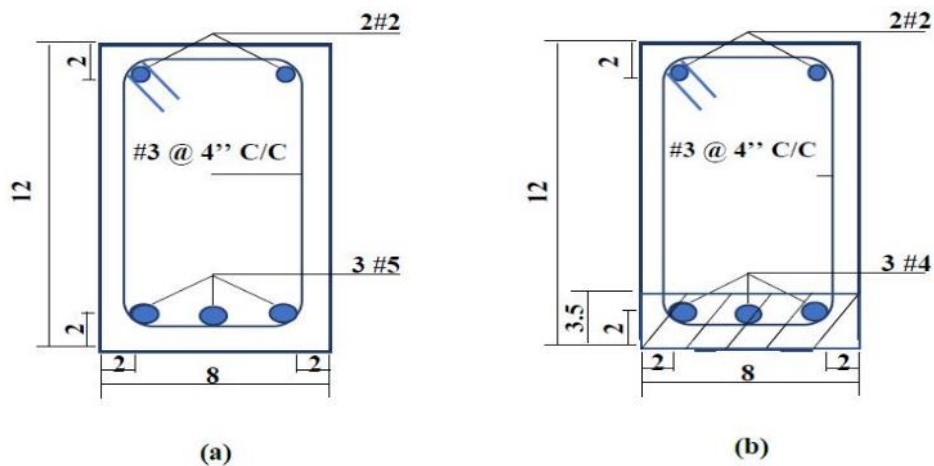
Figure 2.31. (a) Undamaged control beam and (b) damaged beam (Abdulhameed 2018) (all dimensions are in in.)

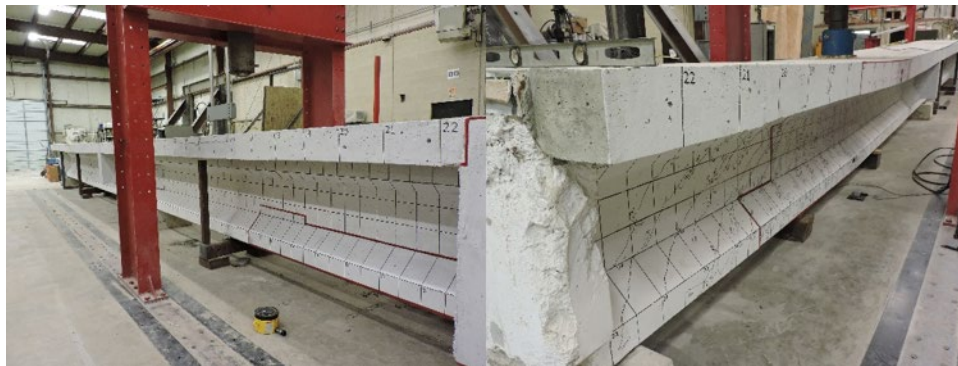
Figure 2.32. FR-SCC repaired girder before (left) and after (right) testing

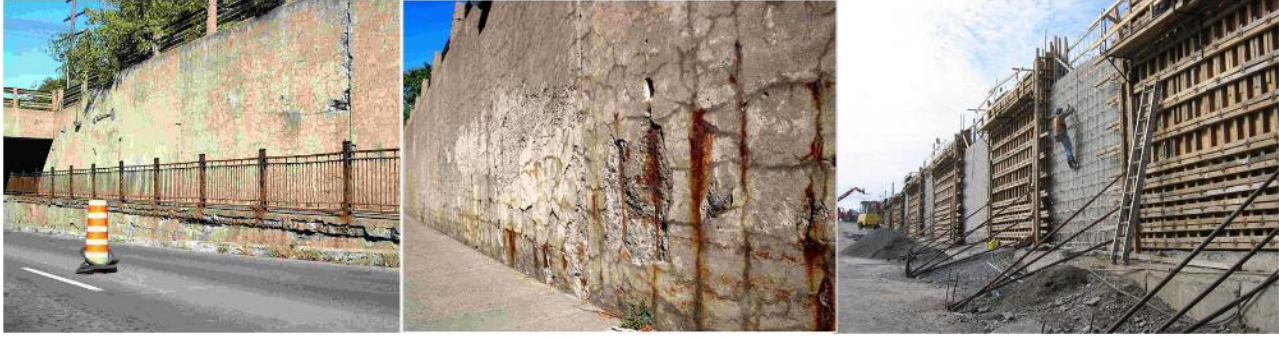
Figure 2.33. Application of FR-SCC in Jarry/Querbes underpass, Montreal (Khayat et al. 2005)

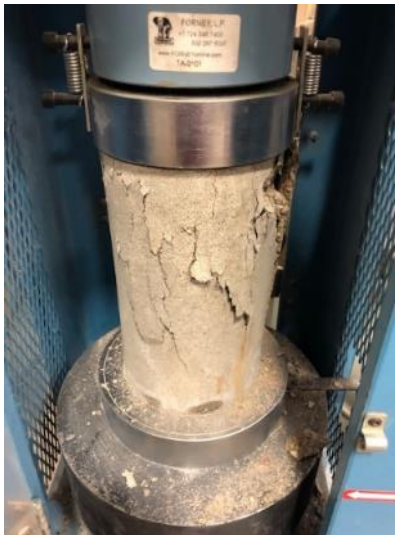
Figure 3.6. Failure of an FR-SCC compressive strength specimen

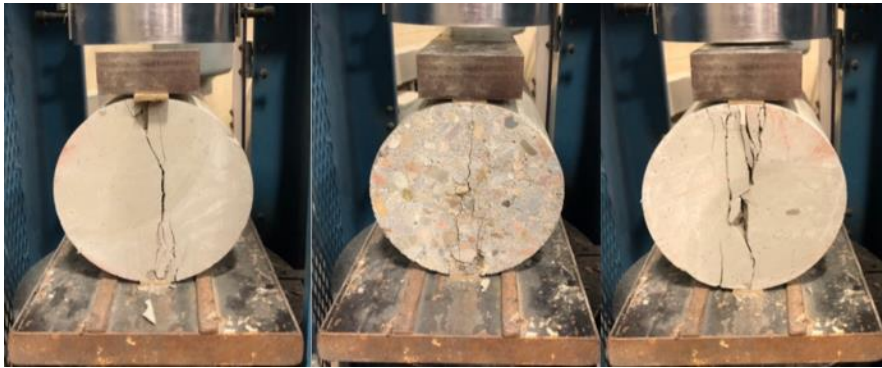
Figure 3.7. Splitting tensile strength specimens

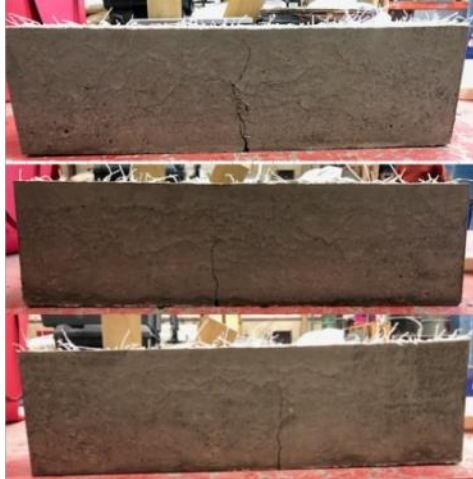
Figure 3.8: FR-SCC modulus of rupture specimens after testing

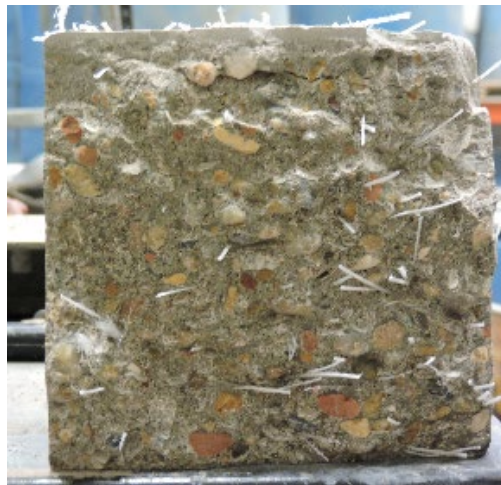
Figure 3.9. Typical FR-SCC modulus of rupture specimen failure surface

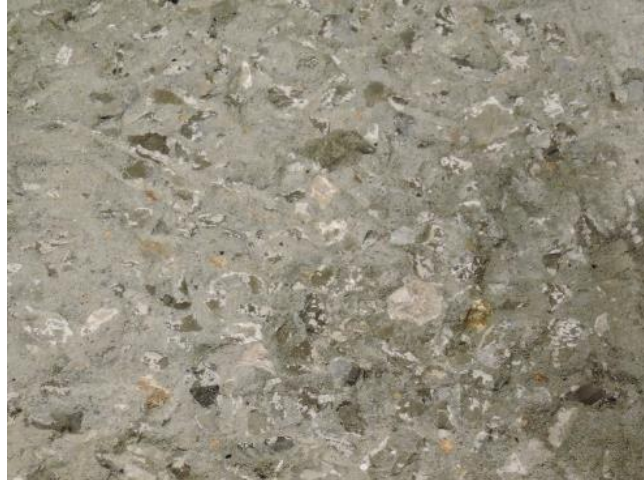
Figure 3.11 Chipped top surface of substrate (ODOT AA pull-off slabs)

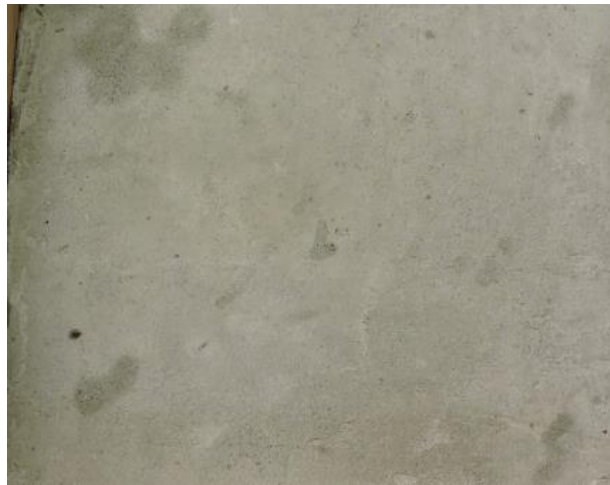
Figure 3.12. Sandblasted top surface of substrate (ODOT AA pull-off slabs)

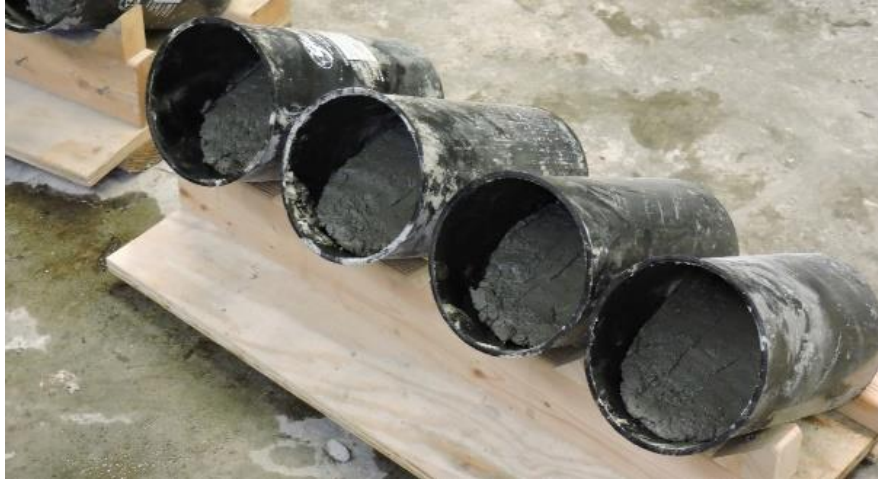
Figure 3.13. Slant shear cylinders prior to pouring FR-SCC Overlays

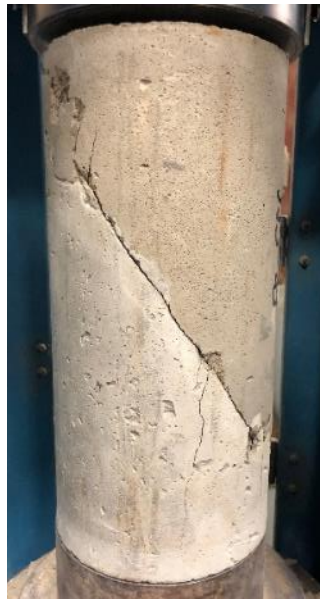
Figure 3.17. FR-SCC low flow slant shear failure

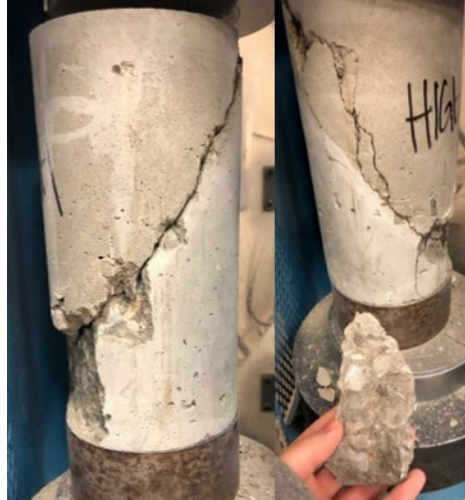
Figure 3.18. FR-SCC high flow slant shear failure from two sides

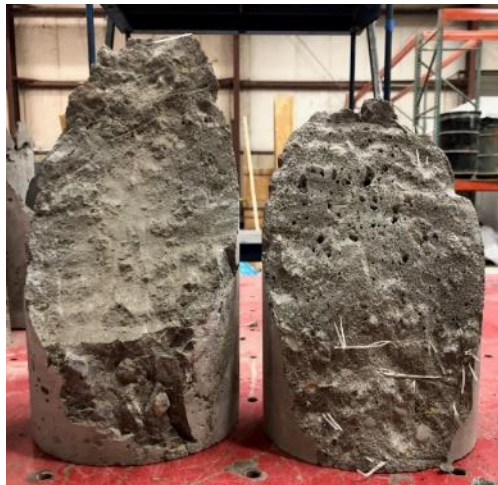
Figure 3.19. FR-SCC slant shear test sudden separation of materials

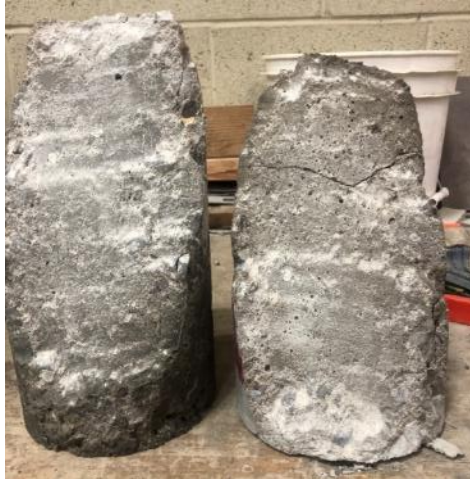
Figure 3.20. ODOT AA slant shear failure

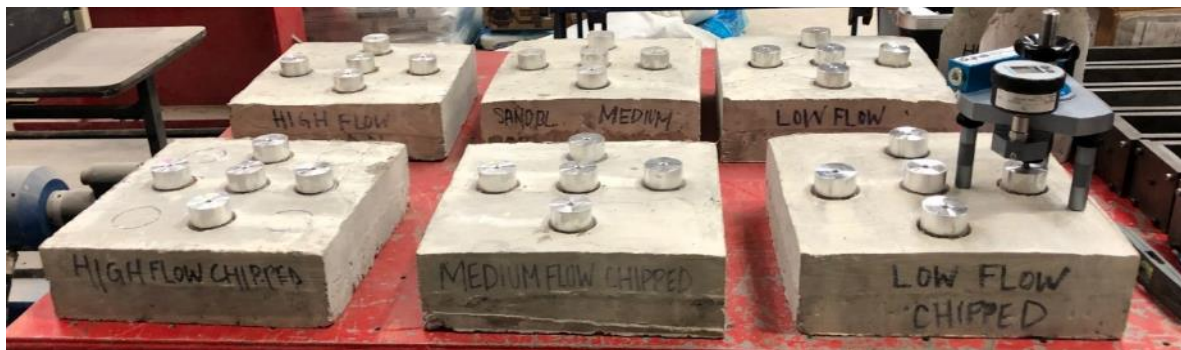
Figure 3.21. Configuration of pull-off specimens for bond testing

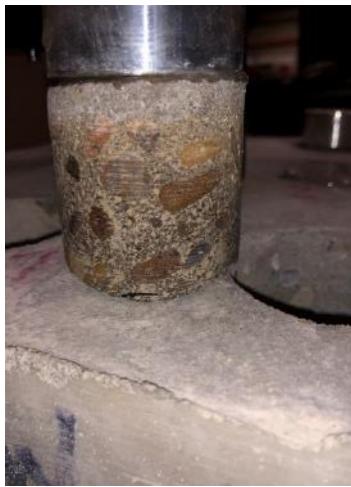
Figure 3.22. Interface failure

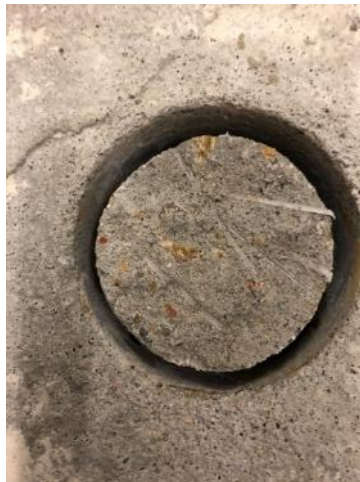
Figure 3.23. Overlay failure

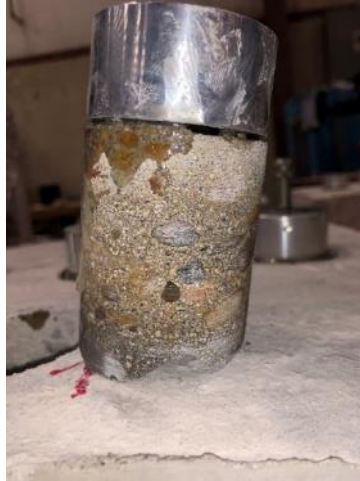
Figure 3.24. Substrate failure

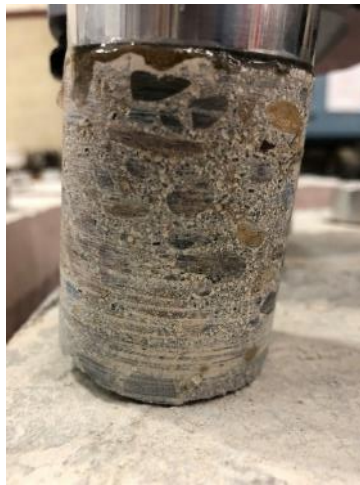
Figure 3.25. Interface failure that enters substrate

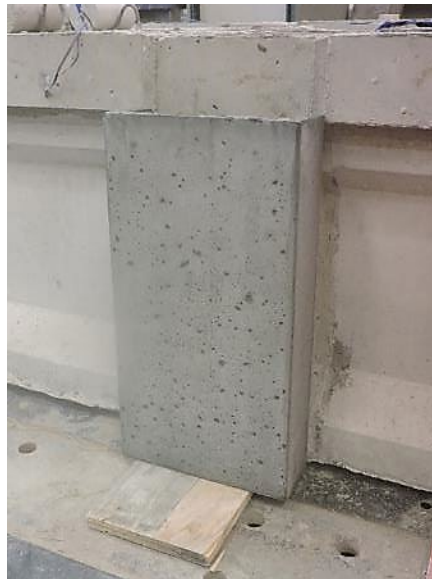
Figure 3.30. J3 UHPC continuity joint repair mock-up specimen

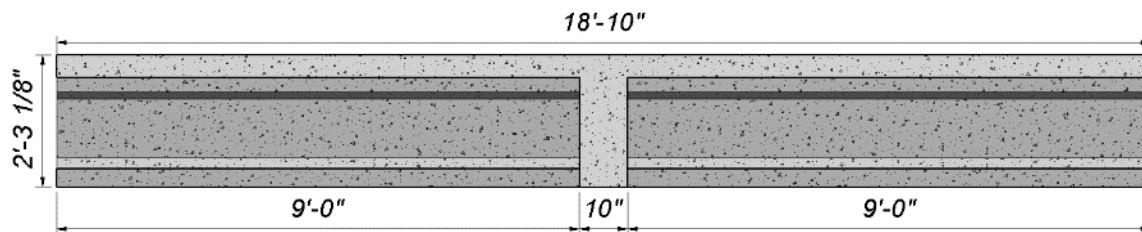
Figure 4.3. Girder-joint-girder specimen dimensions

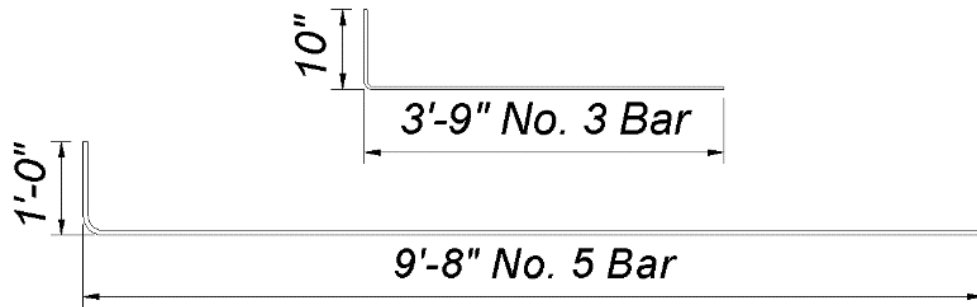
Figure 4.4. Hooked end bar dimensions used for continuity connection

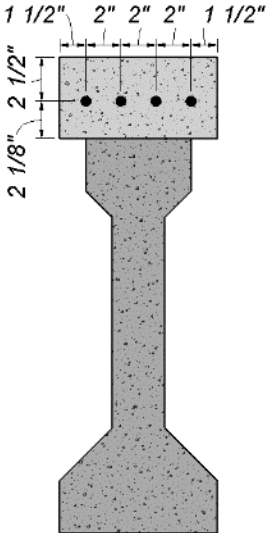
Figure 4.8. Deck reinforcement placement

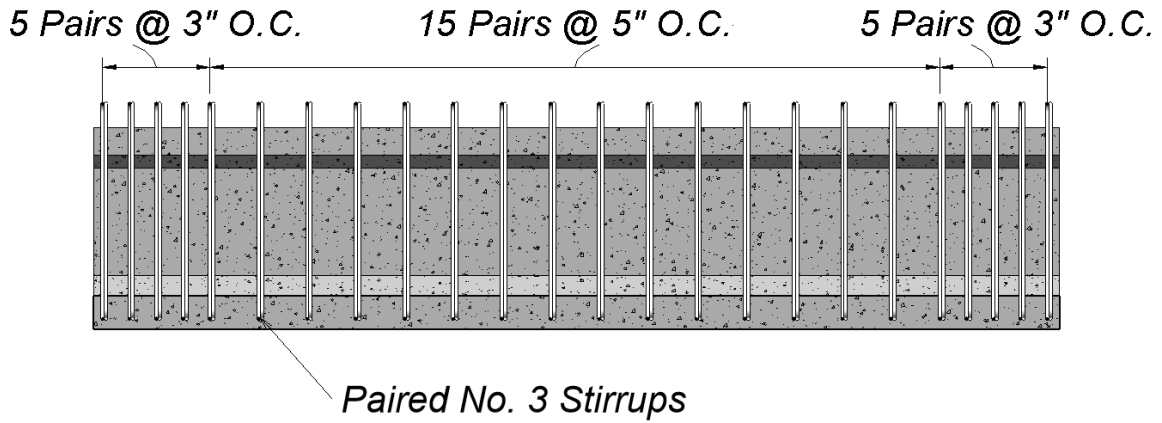
Figure 4.9. Half-length specimen stirrup spacing

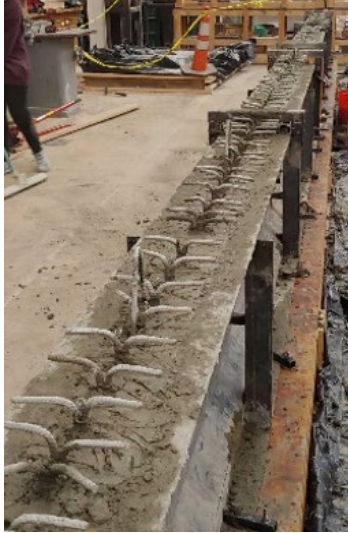
Figure 4.21. Completed girder specimens immediately after casting

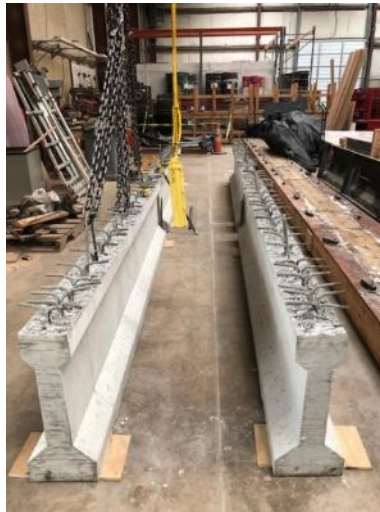
Figure 4.22. Half-length girder specimens after moist cure

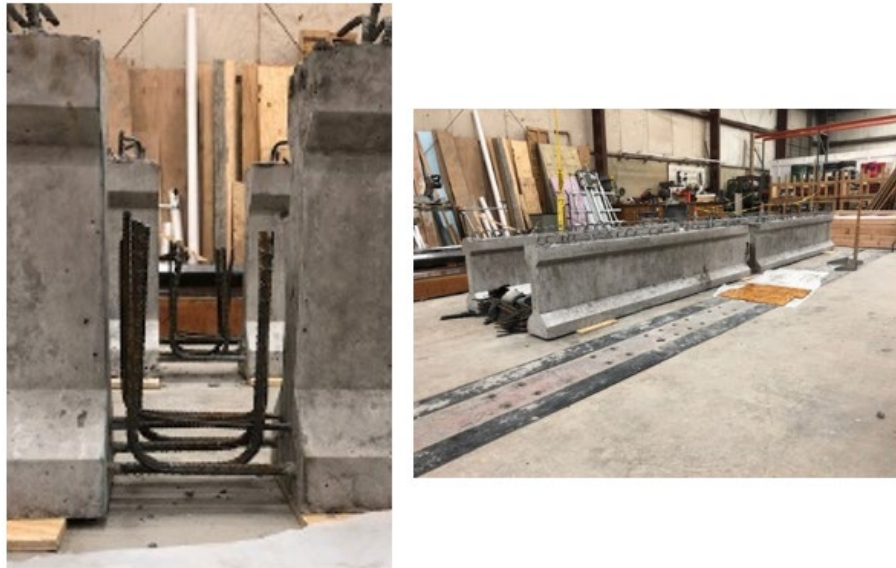
Figure 4.23. Orientation of half-length girders prior to deck/joint casting

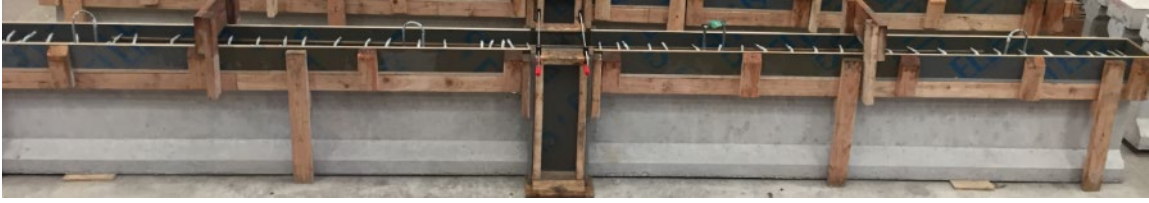
Figure 4.25. Deck formwork

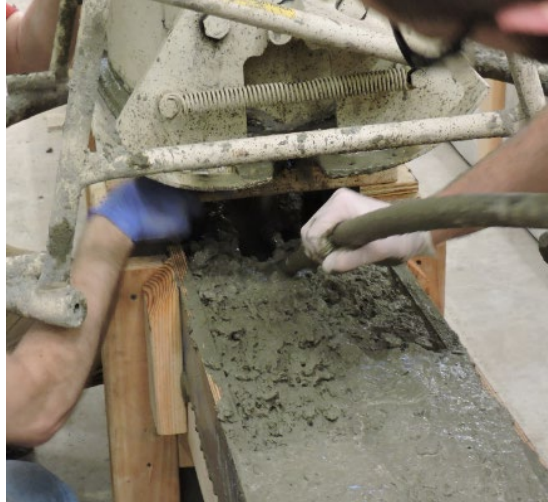
Figure 4.32. Vibrating the continuity joint during casting

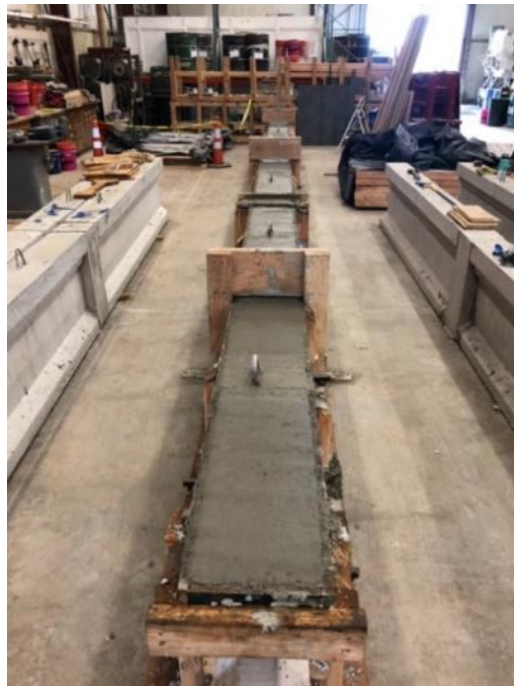
Figure 4.33. Girder-joint-girder specimen after final casting

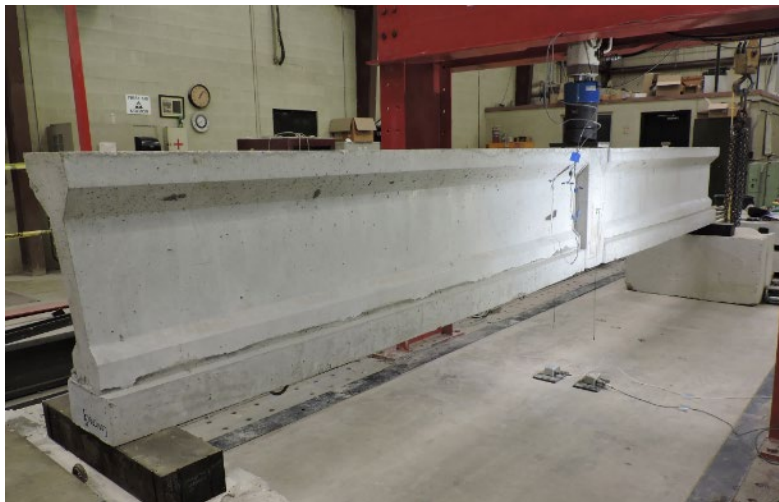
Figure 4.37. Control beam test setup for negative moment bending

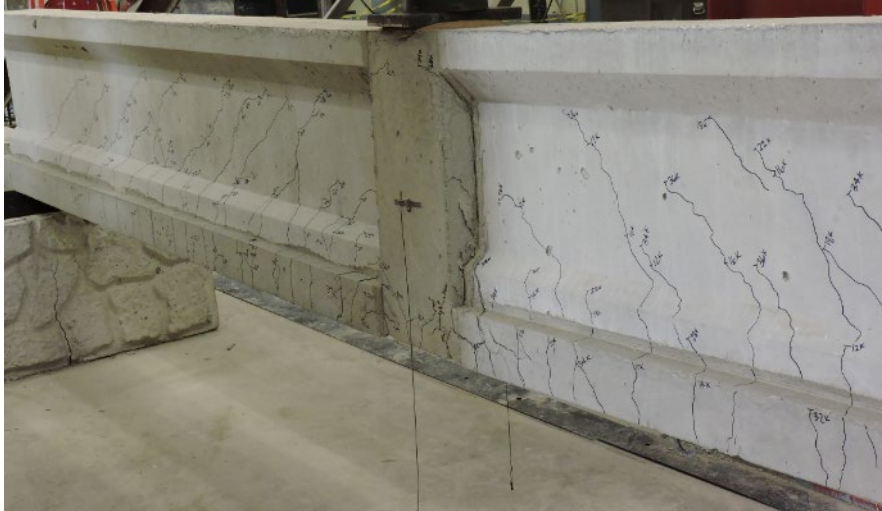
Figure 4.38. Specimen C1 shear cracking

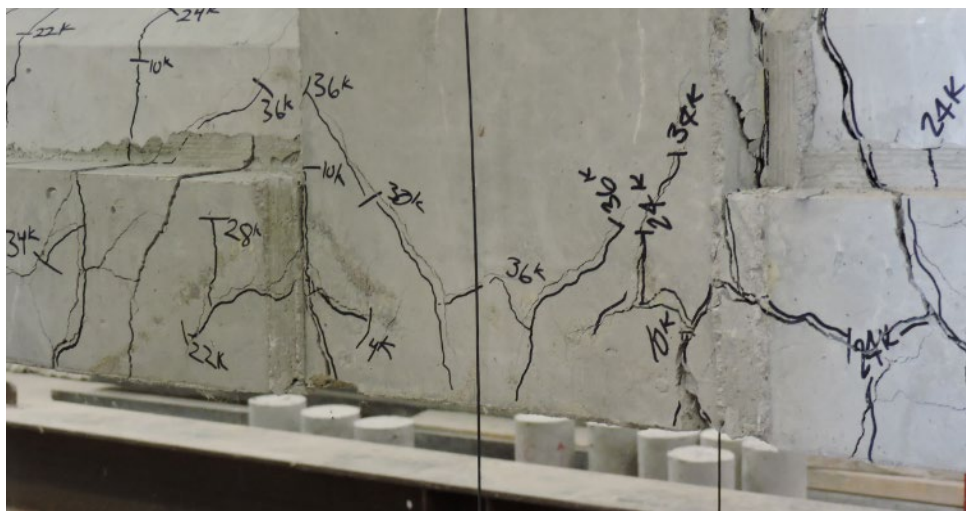
Figure 4.39. Specimen C1 flexural cracking in the continuity joint

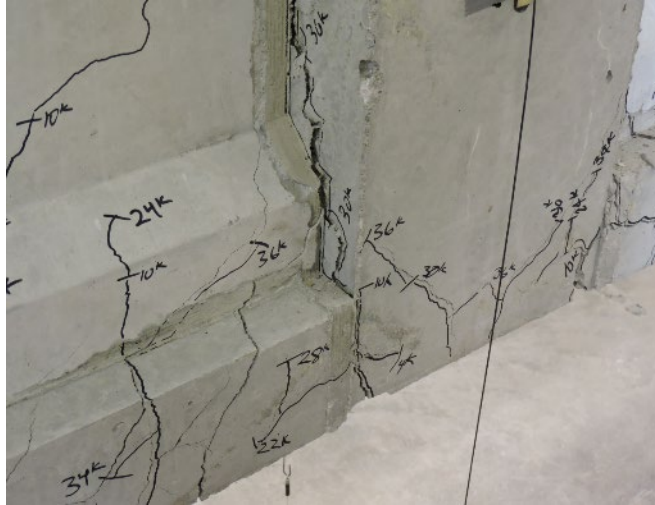
Figure 4.40 Specimen C1 cracking at girder-joint interface (left side)

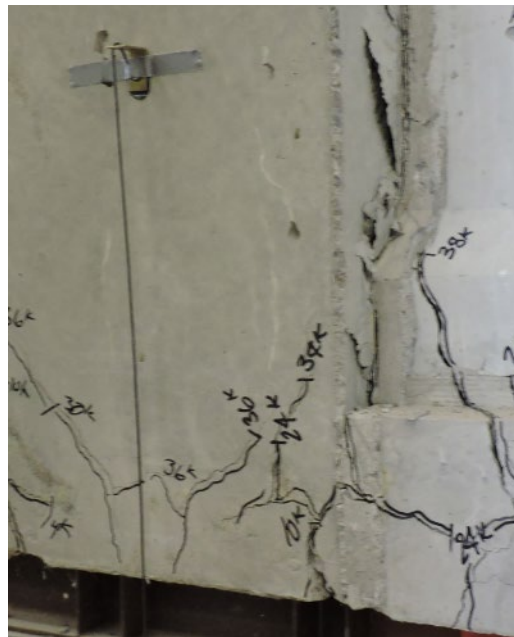
Figure 4.41. Specimen C1 cracking at girder-joint interface (right side)

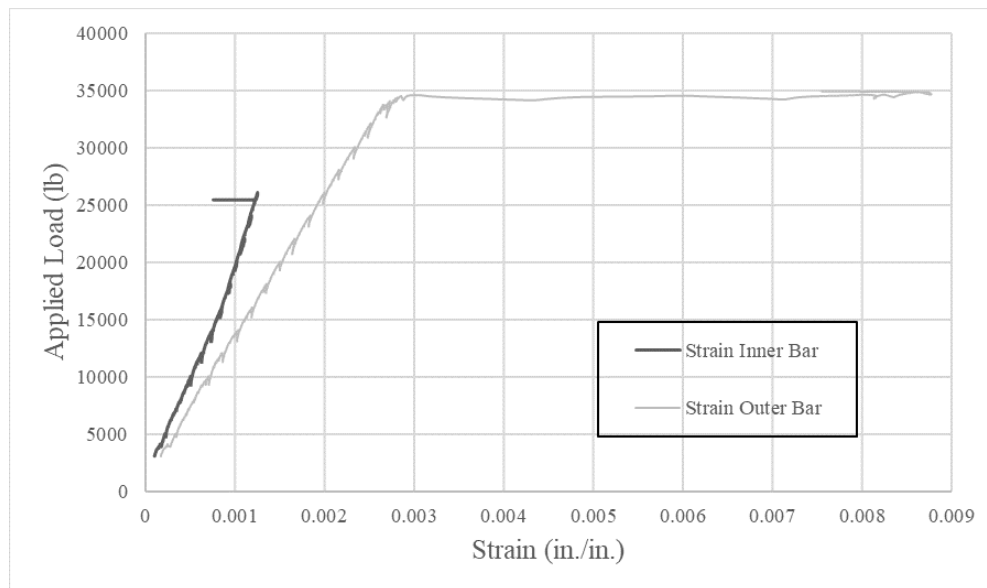
Figure 4.45. Specimen C1 load-strain curve

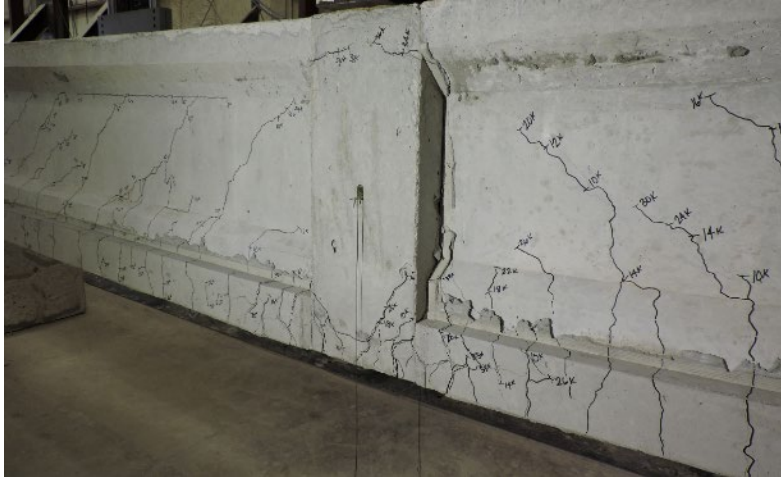
Figure 4.46. Specimen C2 shear cracking

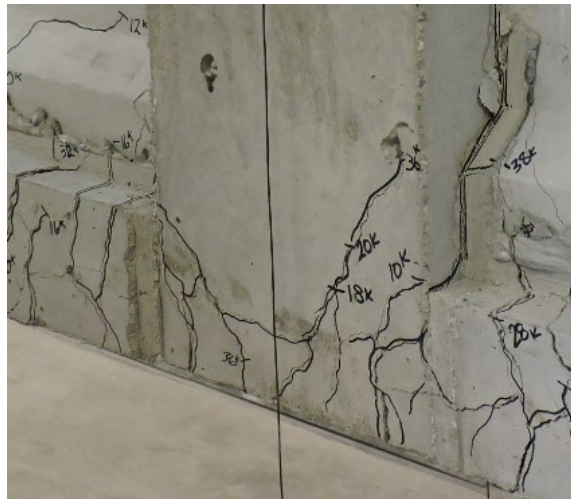
Figure 4.47. Specimen C2 flexural cracking in the continuity joint

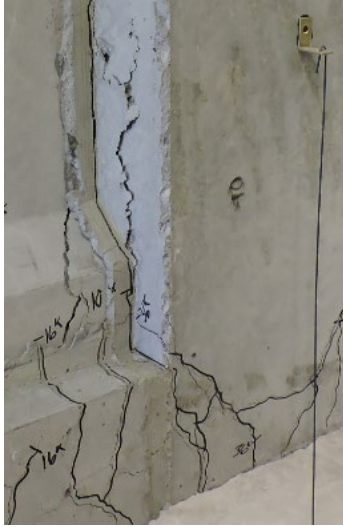
Figure 4.48. Specimen C2 cracking at girder-joint interface (left side)

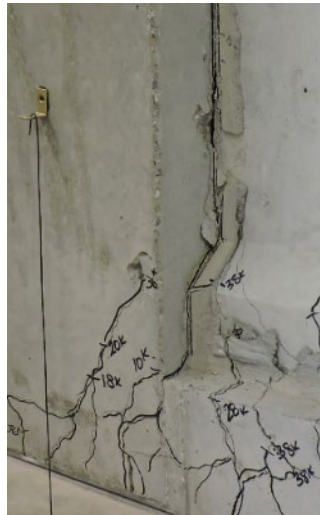
Figure 4.49. Specimen C2 cracking at girder-joint interface (right side)

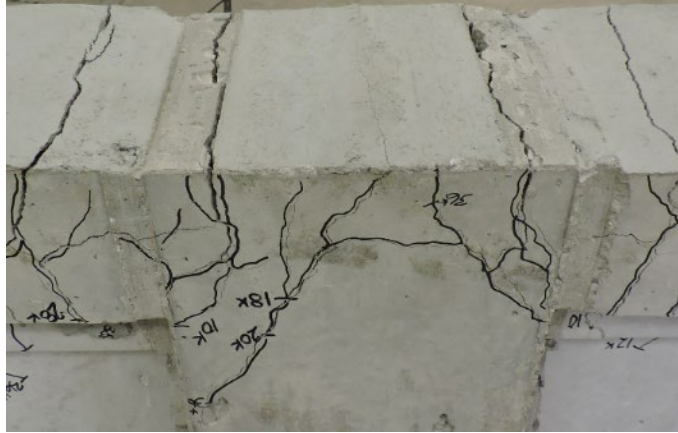
Figure 4.50. Specimen C2 girder-joint interface cracking across the deck

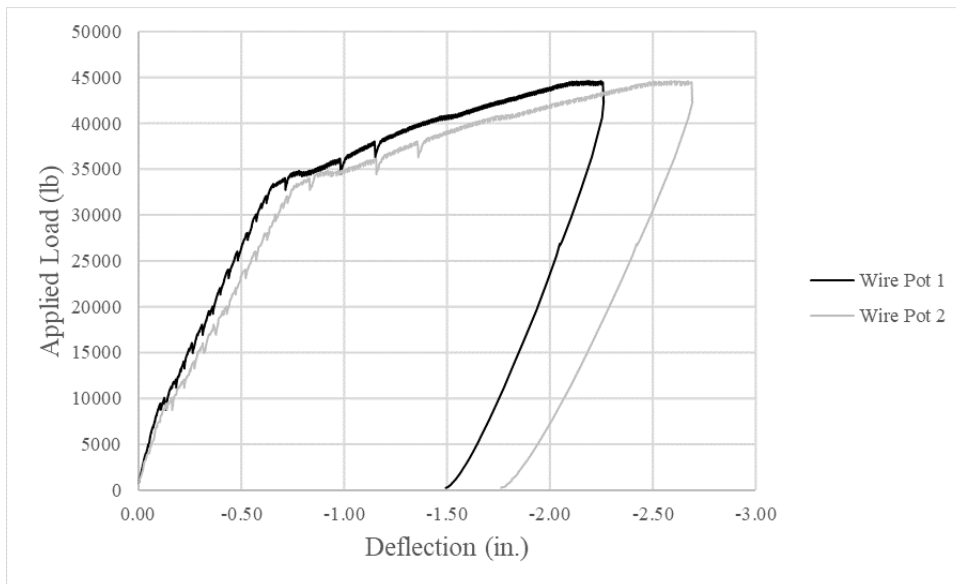
Figure 4.52. Specimen C2 load-deflection curve
