FINAL REPORT ~ FHWA-OK-21-03

EVALUATION OF ULTRA-HIGH PERFORMANCE CONCRETE, FIBER REINFORCED SELF-CONSOLIDATING CONCRETE, AND MALP CONCRETE FOR PRESTRESSED GIRDER REPAIR

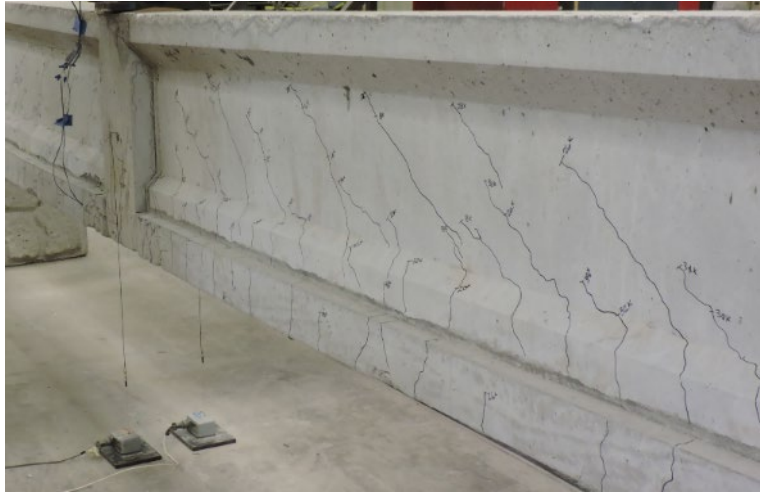
Figure 4.54. Specimen C3 shear cracking

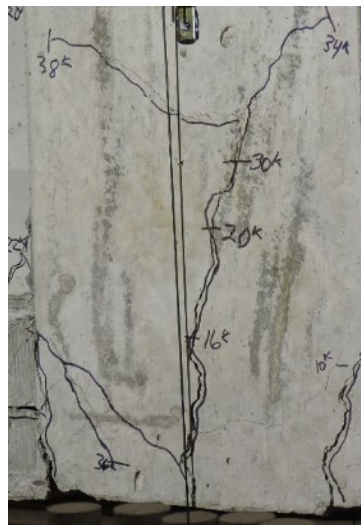
Figure 4.55. Specimen C3 flexural cracking in the continuity joint

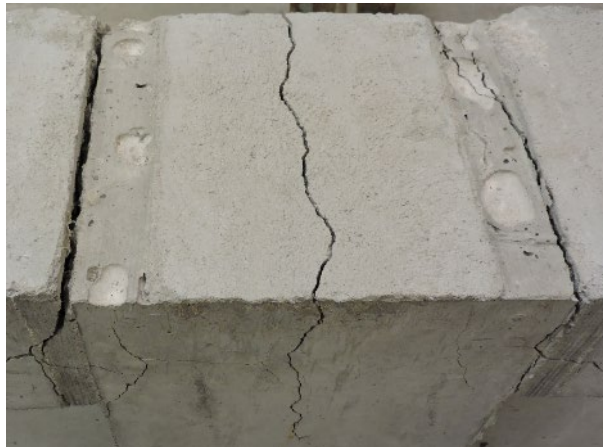
Figure 4.56. Specimen C3 girder-joint interface and centerline cracking across the deck

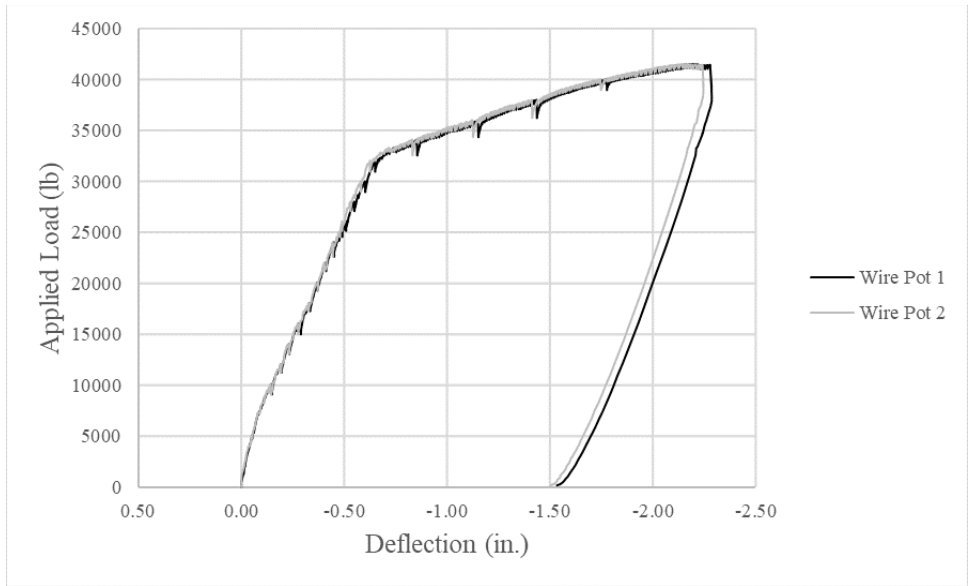
Figure 4.58. Specimen C3 load-deflection curve

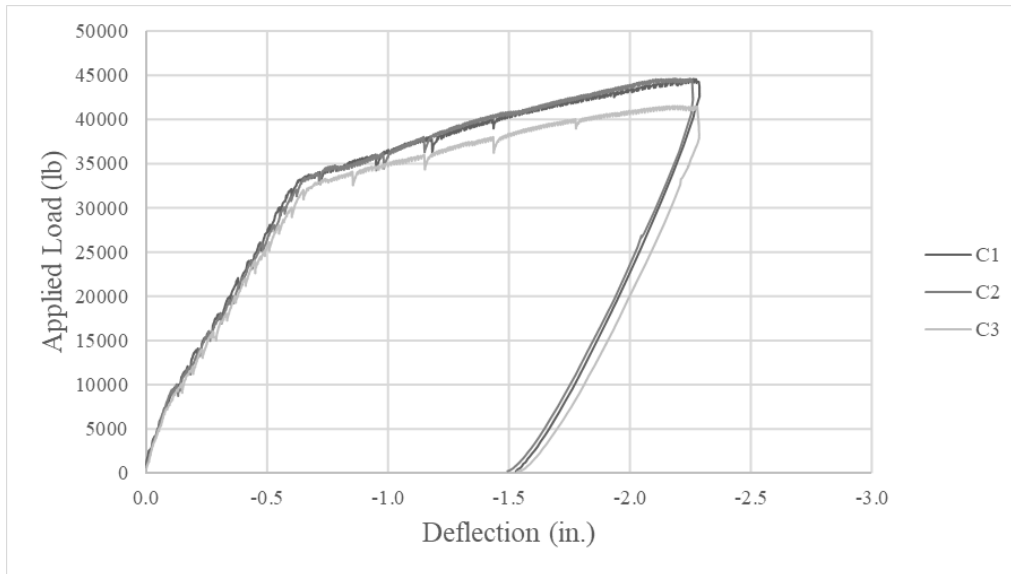
Figure 4.60. Load-deflection curves for control girder specimens

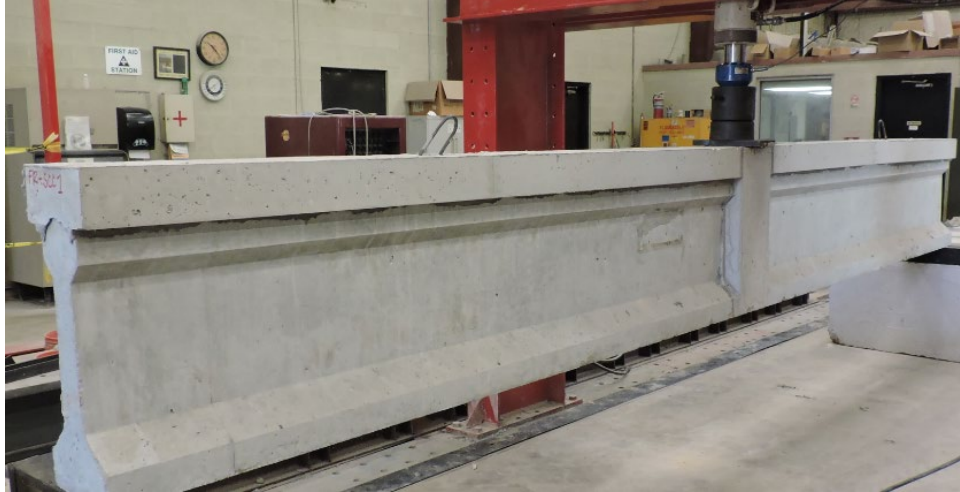
Figure 4.61. Setup for testing girders specimens to be repaired

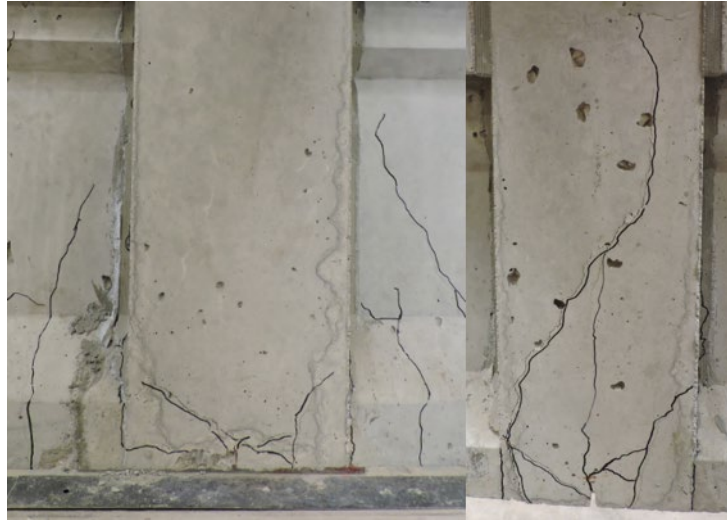
Figure 4.62. Initial cracking of specimen R1-J3 on the front (left) and rear (right) of the joint face

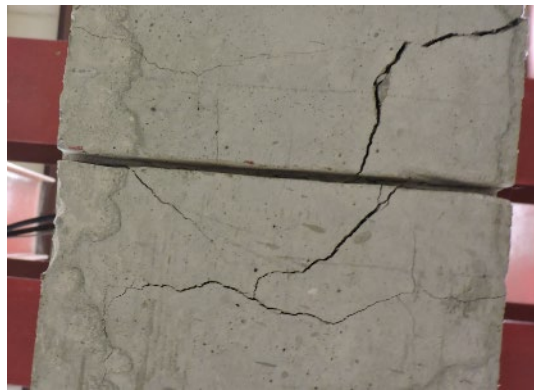
Figure 4.63. Initial cracking of specimen R1-J3 on the bottom joint face

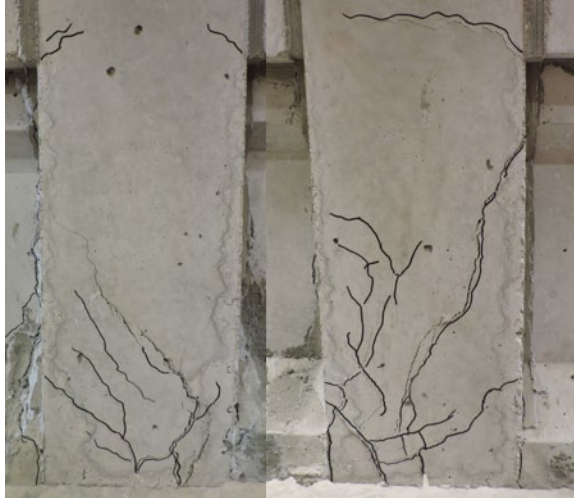
Figure 4.64. Initial cracking of specimen R2-J3 on the front (left) and rear (right) of the joint face

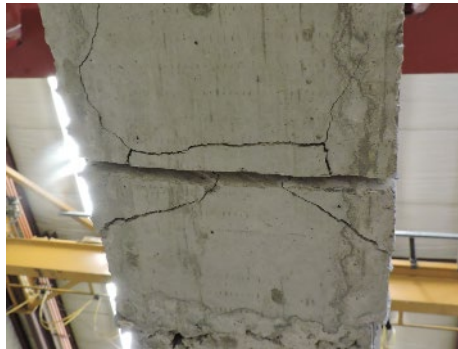
Figure 4.65. Initial cracking of specimen R2-J3 on the bottom joint face

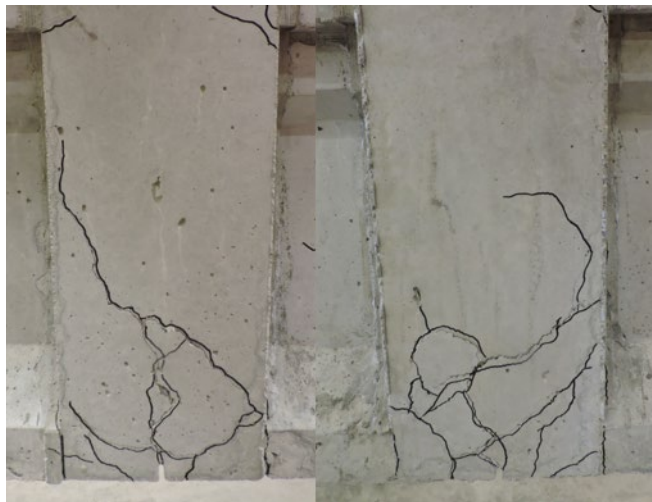
Figure 4.66. Initial cracking of specimen R3-J3 on the front (left) and rear (right) of the joint face

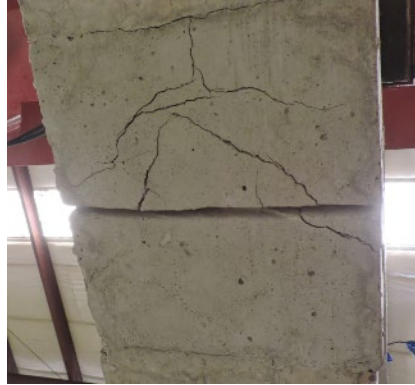
Figure 4.67. Initial cracking of specimen R3-J3 on the bottom joint face

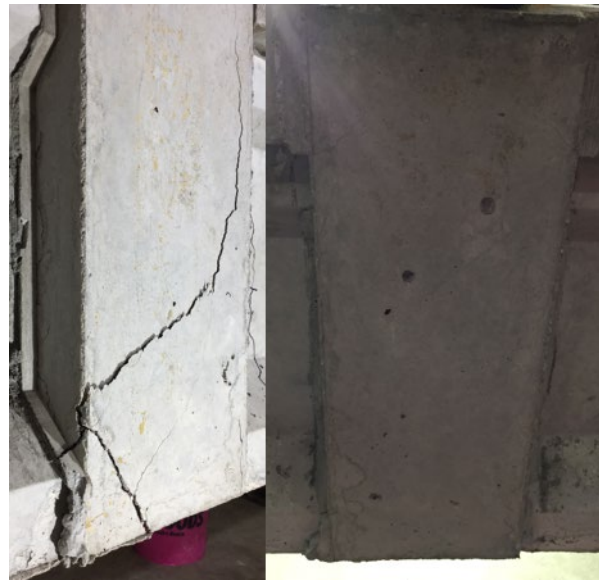
Figure 4.68. Initial cracking of specimen R1-FRSCC on the front (left) and rear (right) of the joint face

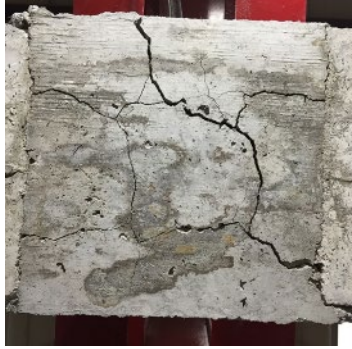
Figure 4.69. Initial cracking of specimen R1-FRSCC on the bottom joint face

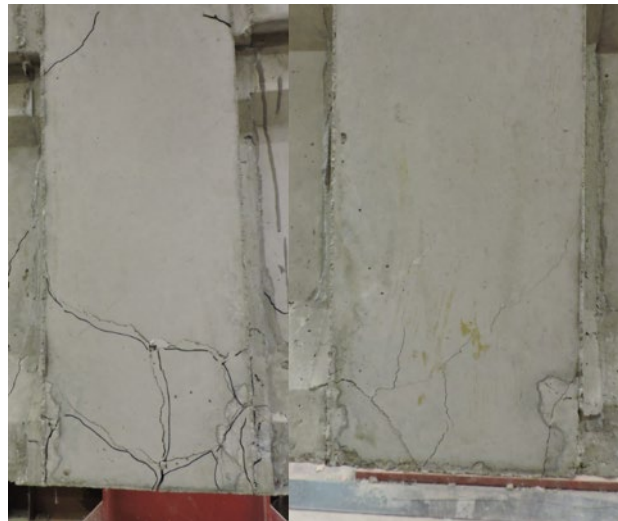
Figure 4.70. Initial cracking of specimen R2-FRSCC on the front (left) and rear (right) of the joint face

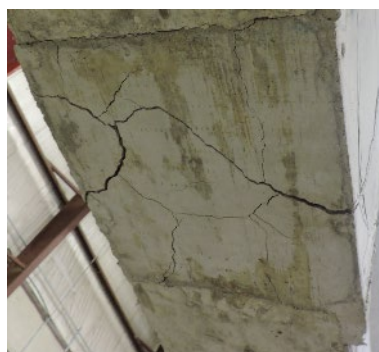
Figure 4.71. Initial cracking of specimen R2-FRSCC on the bottom joint face

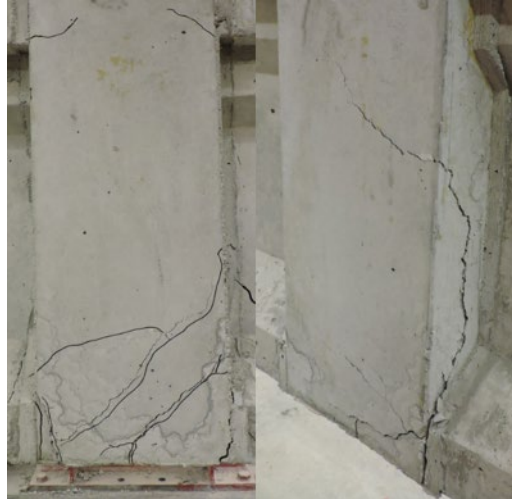
Figure 4.72. Initial cracking of specimen R3-FRSCC on the front (left) and rear (right) of the joint face

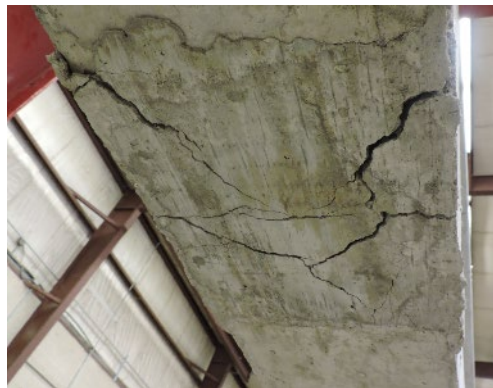
Figure 4.73. Initial cracking of specimen R3-FRSCC on the bottom joint face

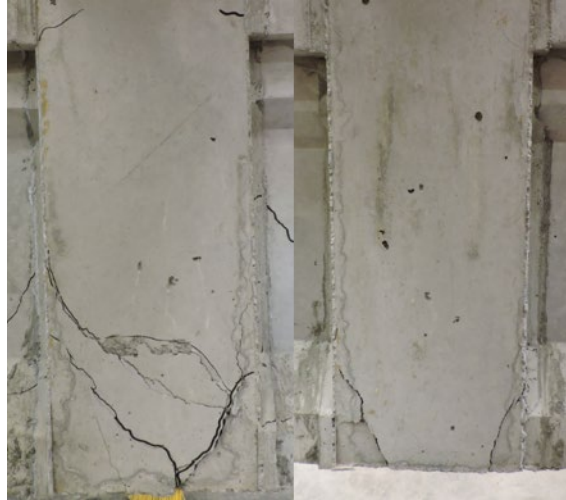
Figure 4.74. Initial cracking of specimen R1-PHOS on the front (left) and rear (right) of the joint face

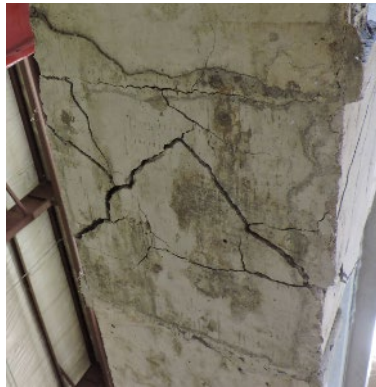
Figure 4.75. Initial cracking of specimen R1-PHOS on the bottom joint face

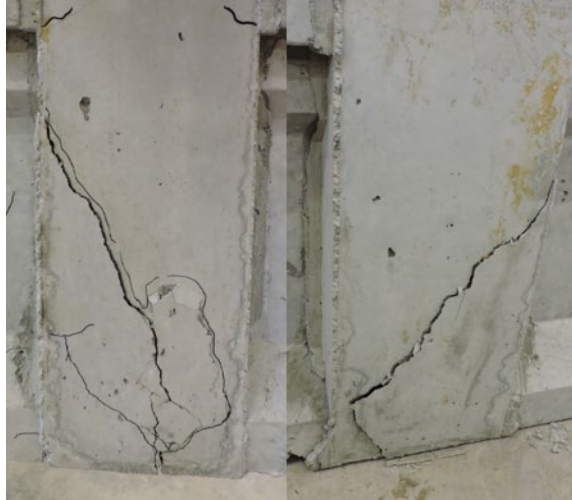
Figure 4.76. Initial cracking of specimen R2-PHOS on the front (left) and rear (right) of the joint face

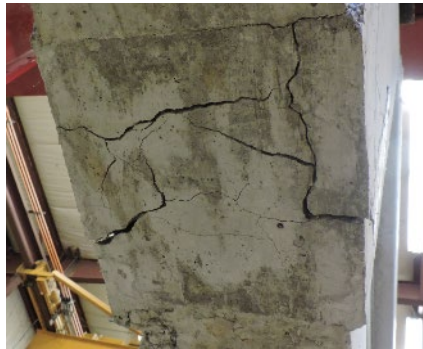
Figure 4.77. Initial cracking of specimen R2-PHOS on the bottom joint face

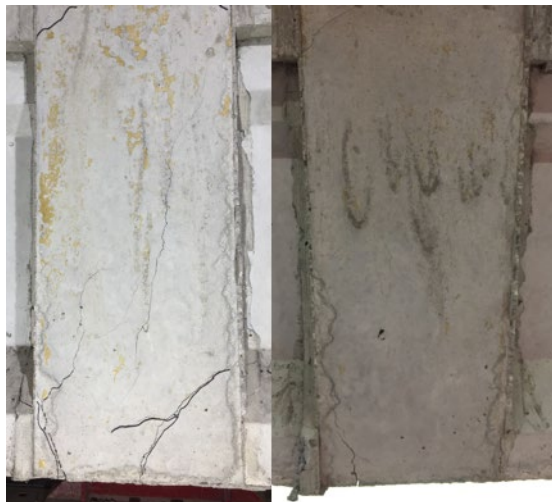
Figure 4.78. Initial cracking of specimen R3-PHOS on the front (left) and rear (right) of the joint face

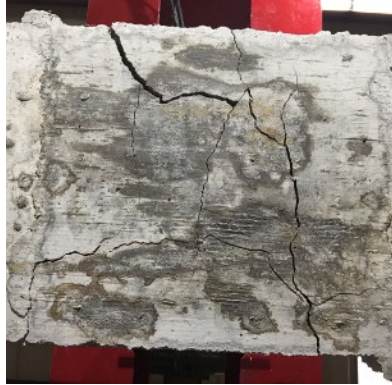
Figure 4.79. Initial cracking of specimen R3-PHOS on the bottom joint face

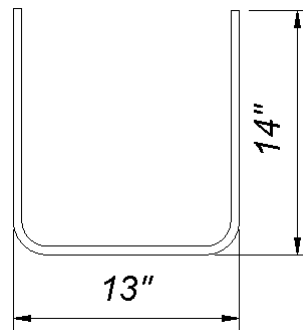
Figure 4.80. Top repair reinforcement shape and dimensions

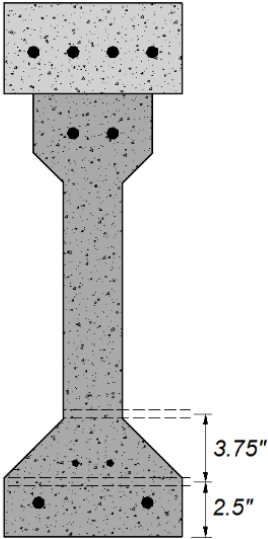
Figure 4.82. Vertical location of drilled holes for anchoring repair reinforcement

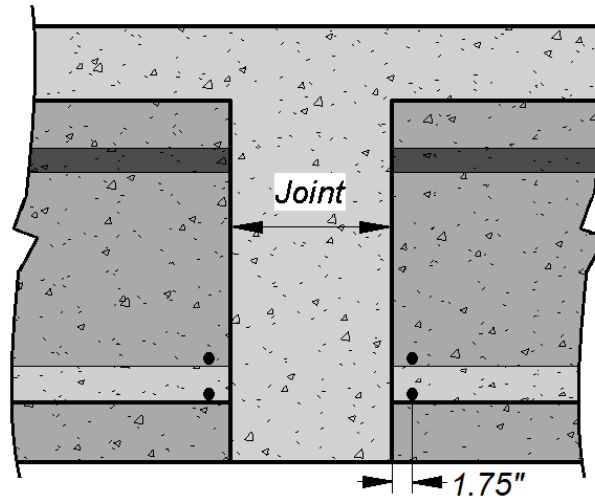
Figure 4.83. Horizontal location of drilled holes for anchoring repair reinforcement

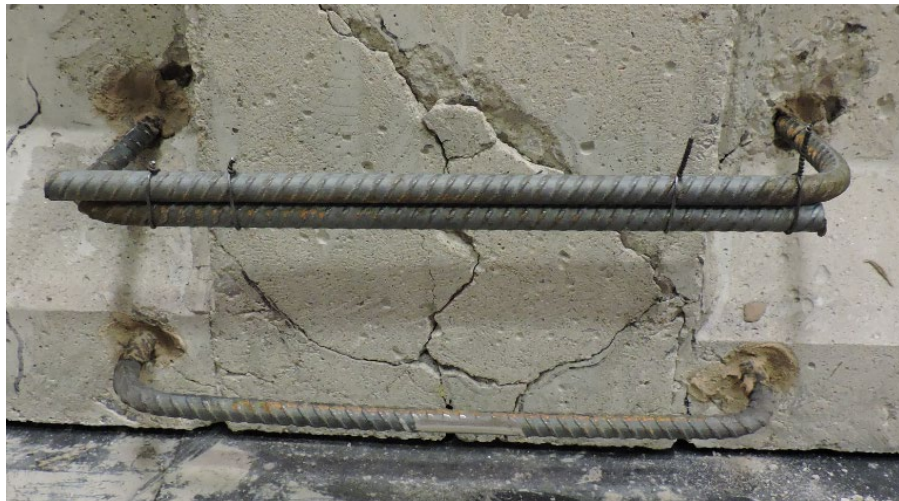
Figure 4.84. Installation of repair reinforcement

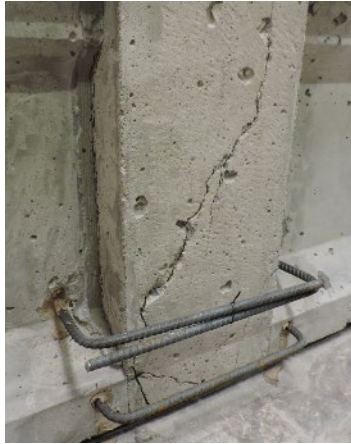
Figure 4.85. Roughened surface of continuity joint to be repaired

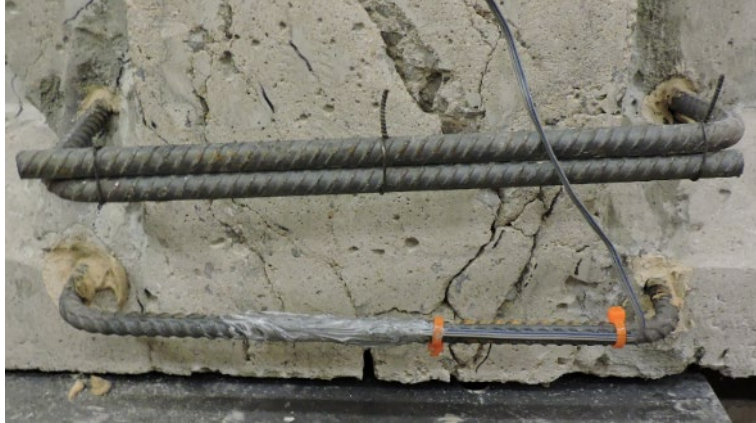
Figure 4.86. Strain gauge installed on repair reinforcement

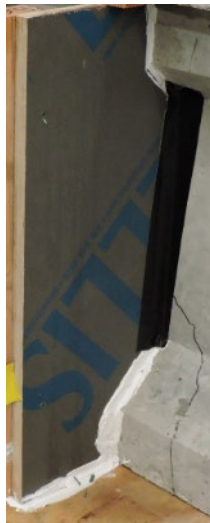
Figure 4.87. Repair formwork for side face of the continuity joint

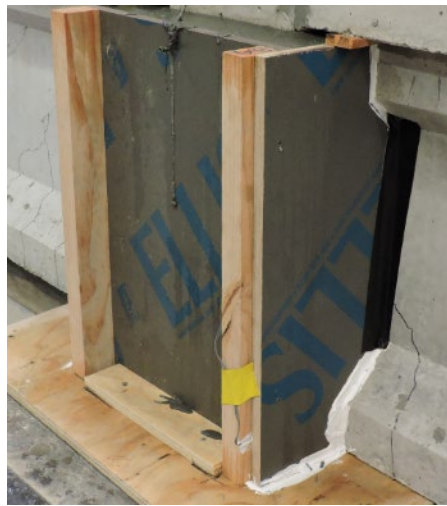
Figure 4.88. Joint repair formwork

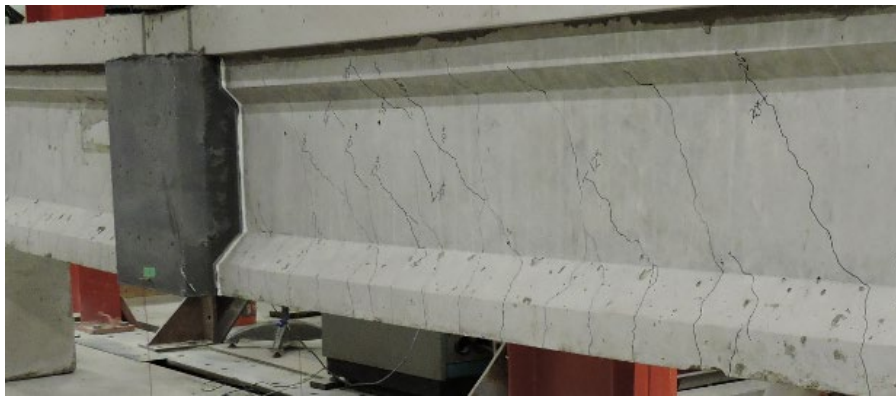
Figure 4.89. Specimen R1-J3 shear and flexural cracking

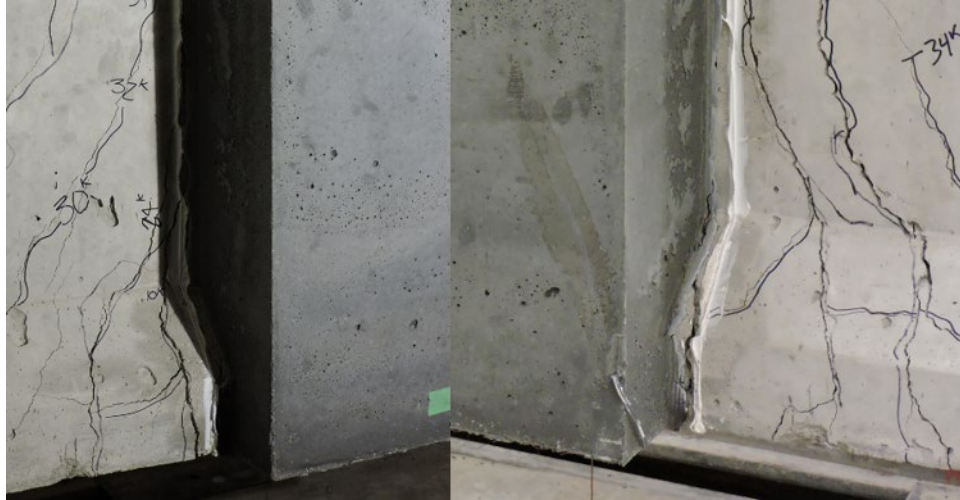
Figure 4.90. Specimen R1-J3 girder-joint interface crack on the left (left) side and right (right) side

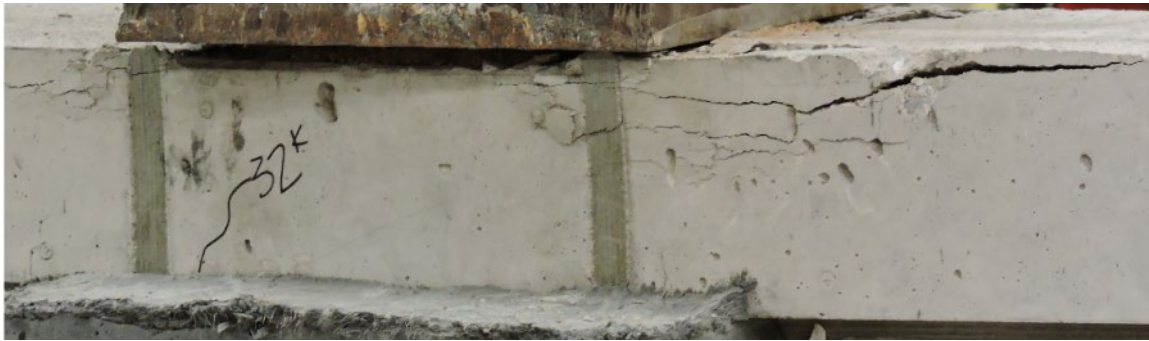
Figure 4.91. Specimen R1-J3 deck crushing at failure

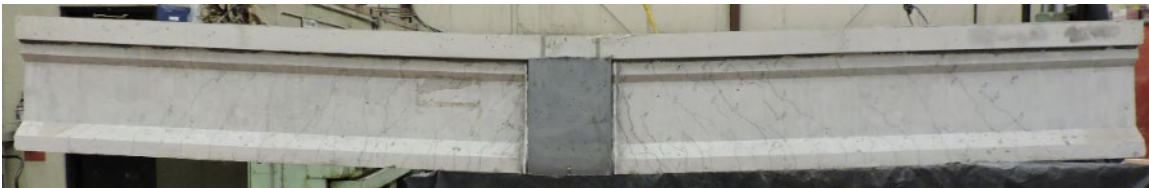
Figure 4.92. Deflected shape of specimen R1-J3 after testing

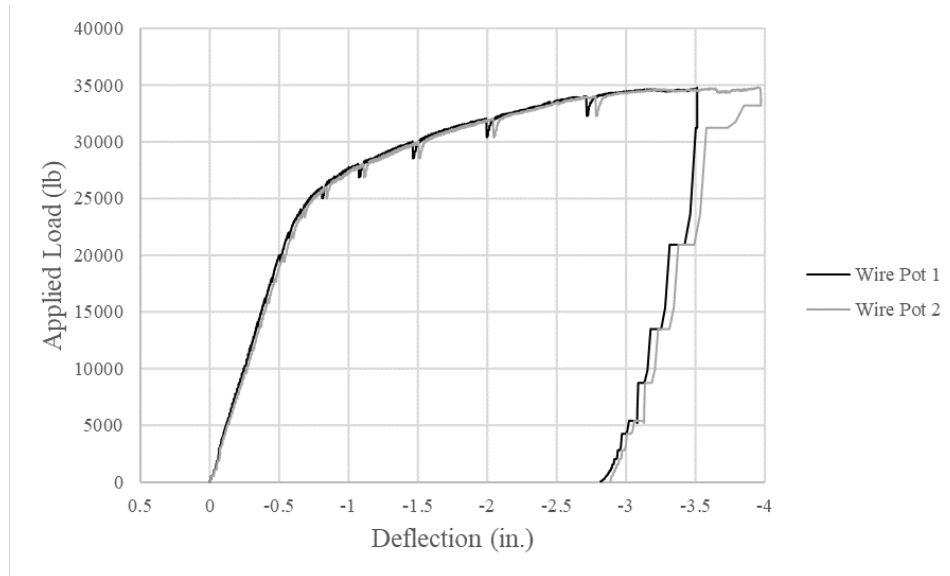
Figure 4.93. Specimen R1-J3 load-deflection curve

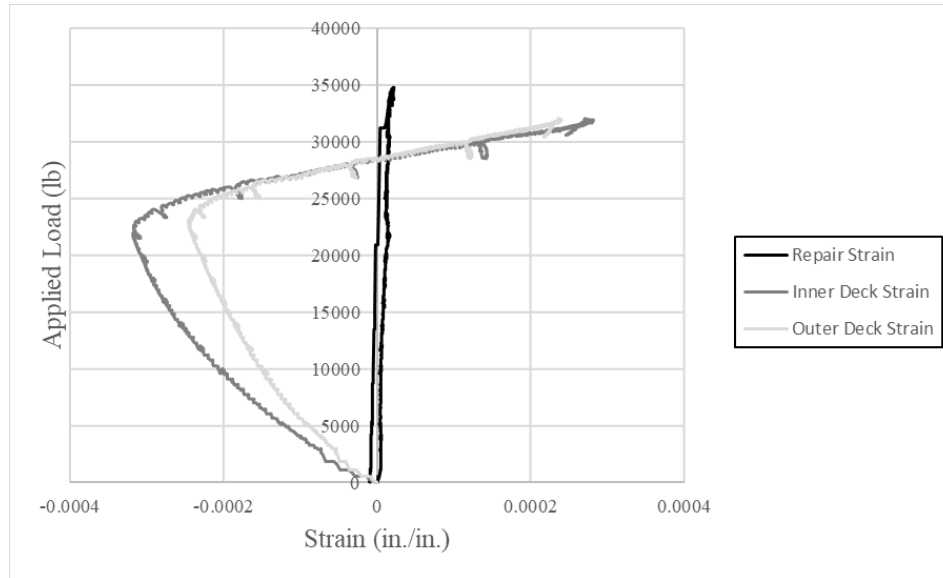
Figure 4.94. Specimen R1-J3 load-strain curves

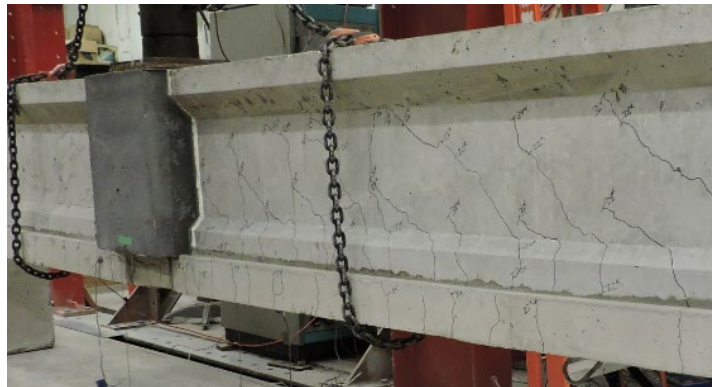
Figure 4.95. Specimen R2-J3 shear and flexural cracking

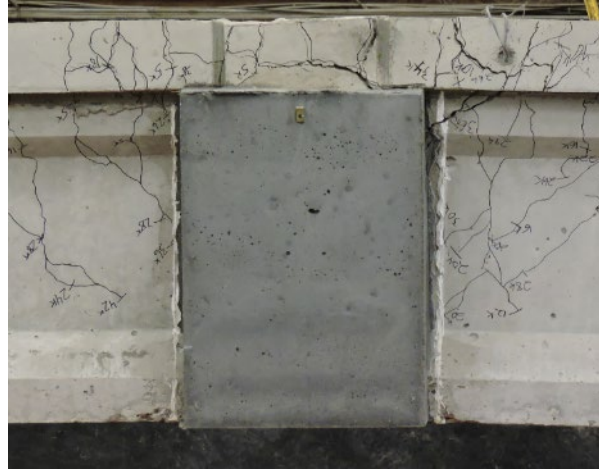
Figure 4.96. Specimen R2-J3 continuity joint repair after testing

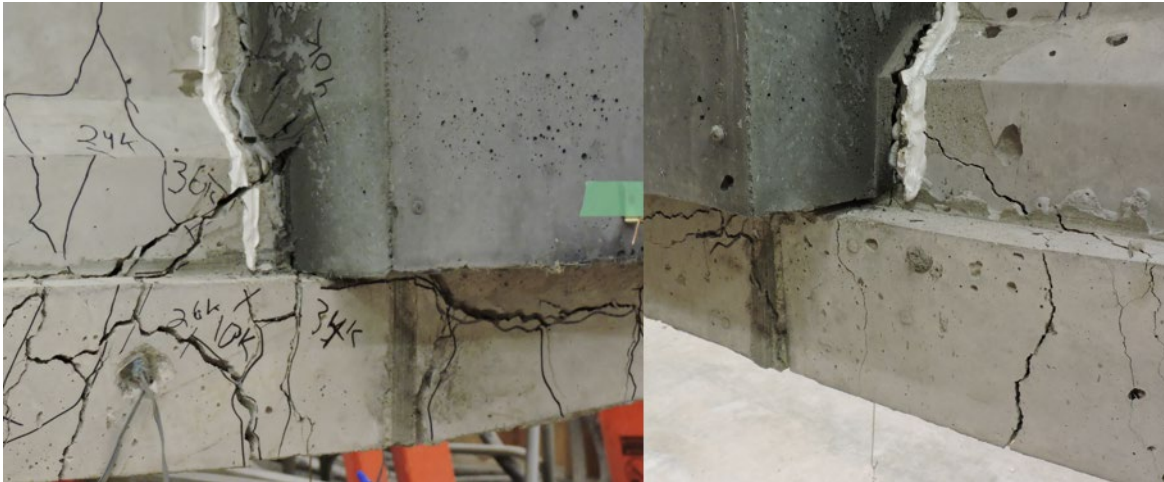
Figure 4.97. Specimen R2-J3 girder-joint interface cracking on the front left (left) and front right (right)

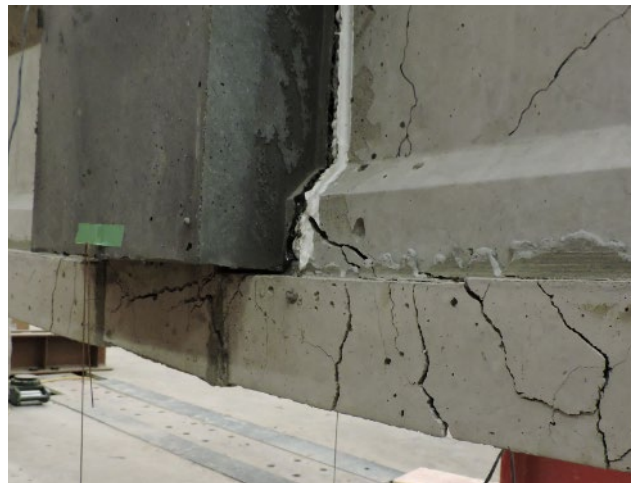
Figure 4.98. Specimen R2-J3 girder-joint interface cracking on the back right

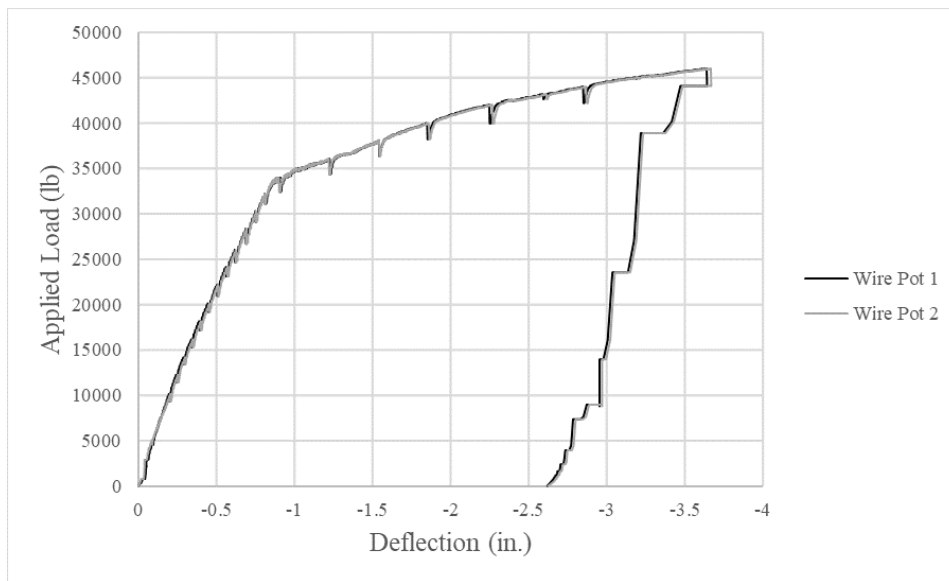
Figure 4.100. Specimen R2-J3 load-deflection curve

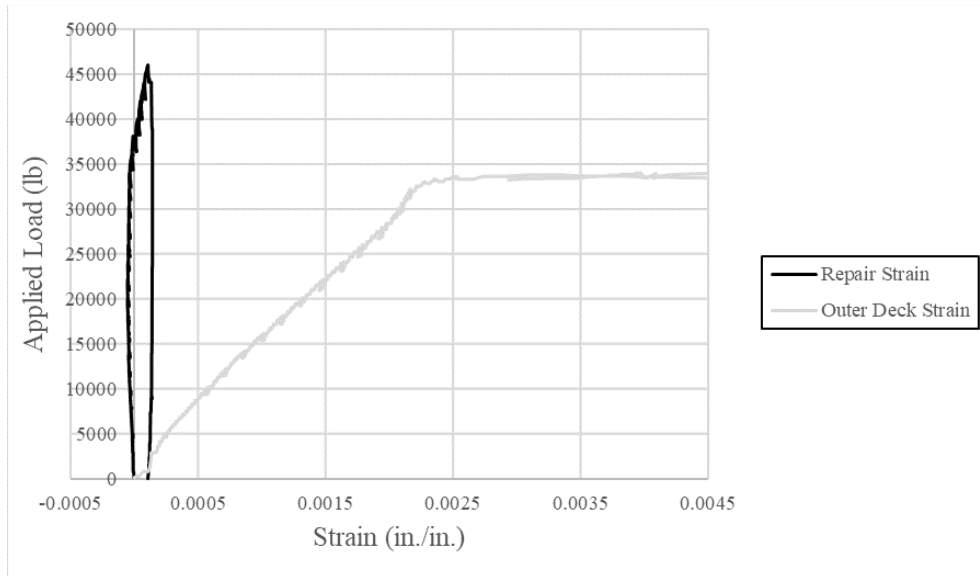
Figure 4.101. Specimen R2-J3 load-strain curves

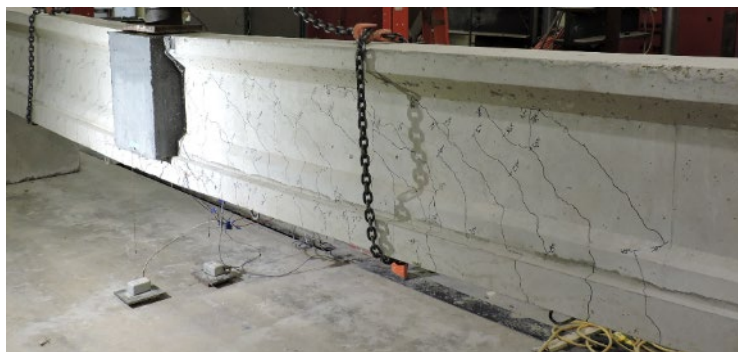
Figure 4.102. Specimen R3-J3 shear and flexural cracking

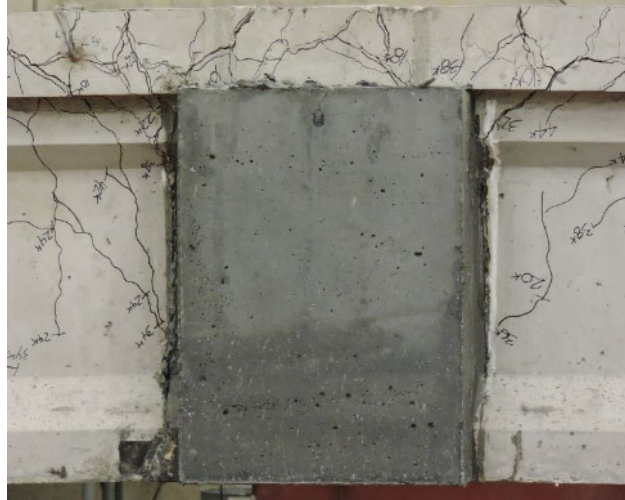
Figure 4.103. Specimen R3-J3 continuity joint repair after testing

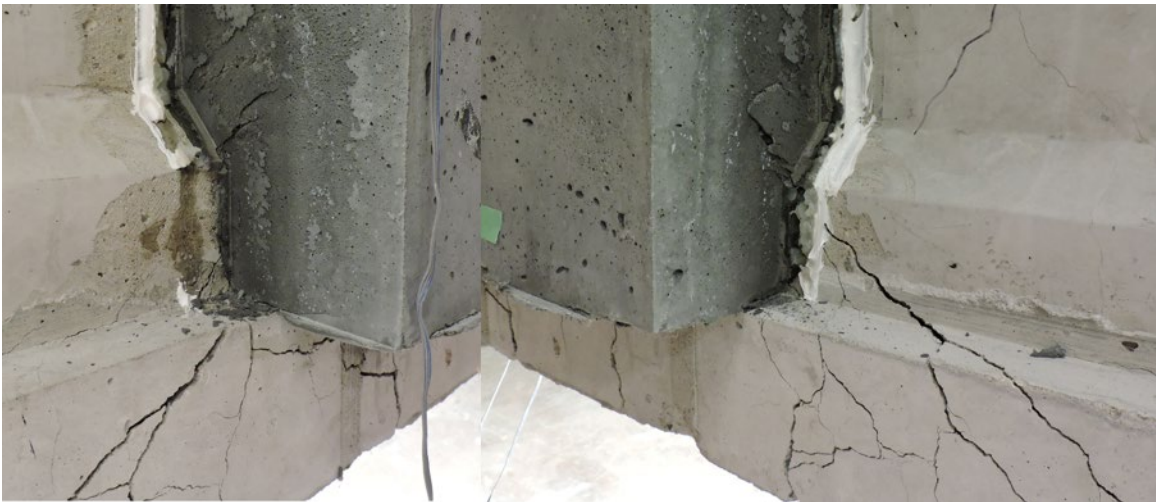
Figure 4.104. Specimen R3-J3 girder-joint interface cracking

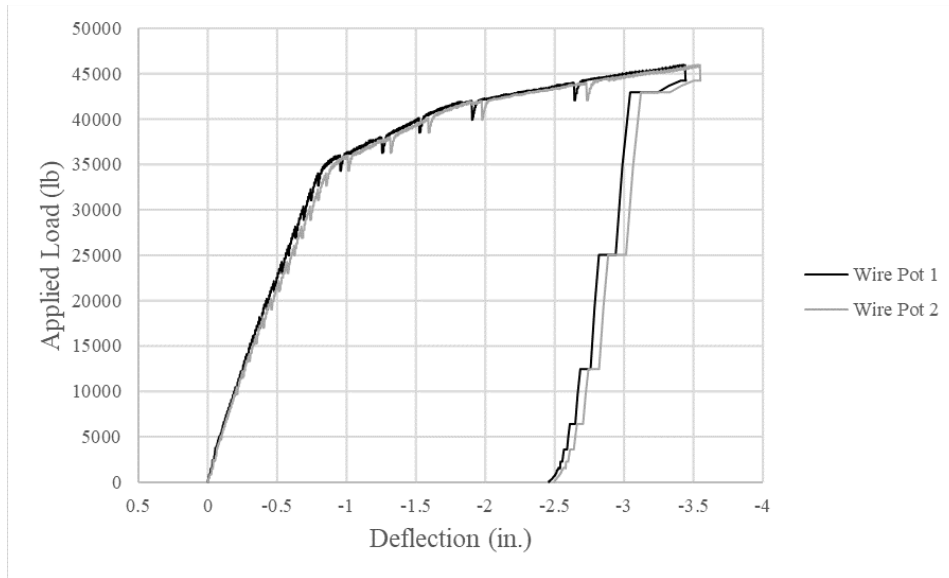
Figure 4.106. Specimen R3-J3 load-deflection curve

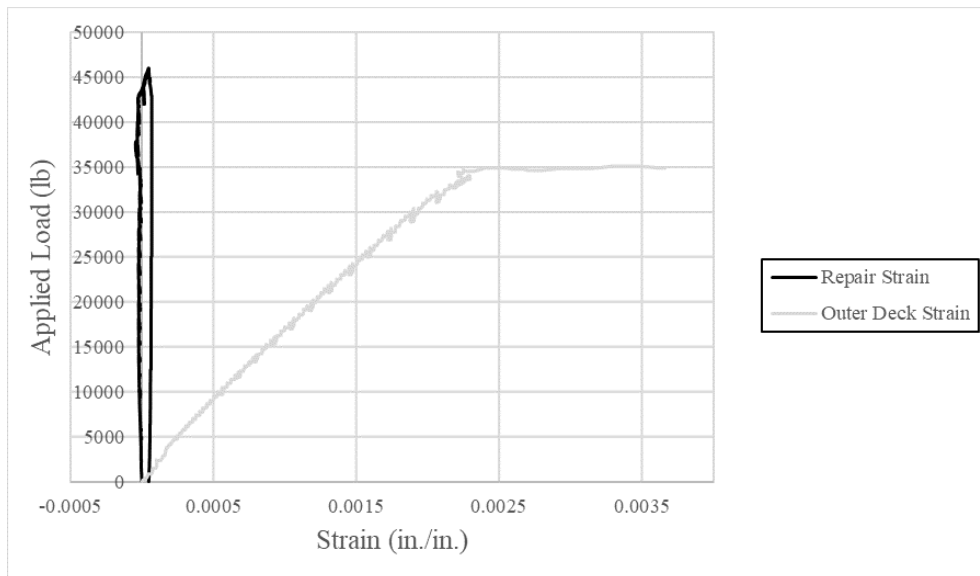
Figure 4.107. Specimen R3-J3 load-strain curves

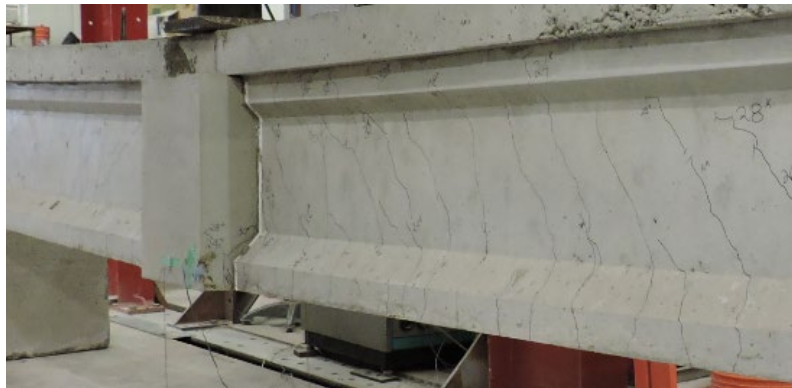
Figure 4.108. Specimen R1-FRSCC shear and flexural cracking

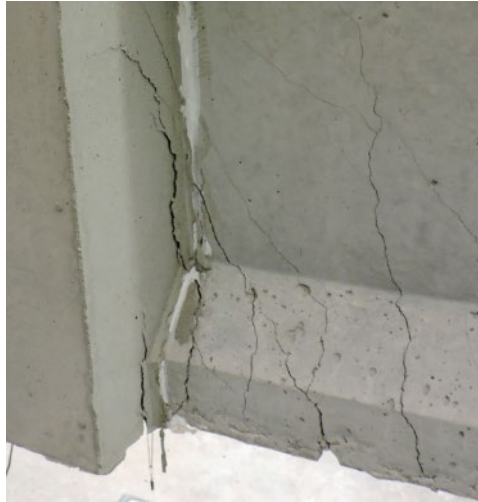
Figure 4.109. Specimen R1-FRSCC back right joint transverse face cracking

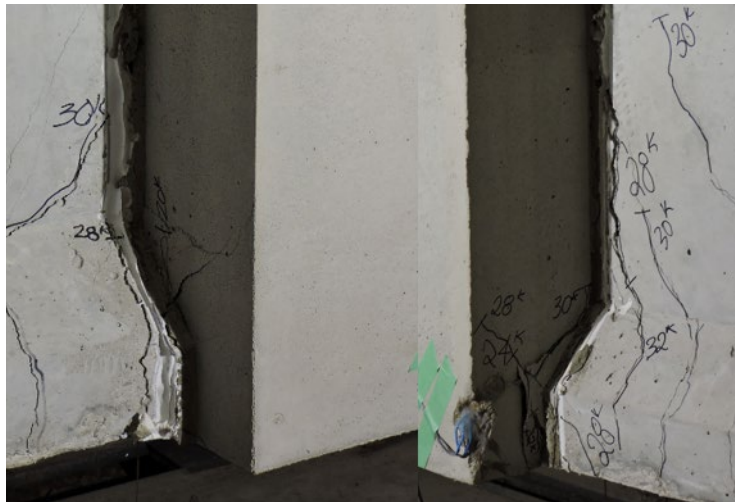
Figure 4.110. Specimen R1-FRSCC girder-joint interface cracking on the front left (left) and front right (right)

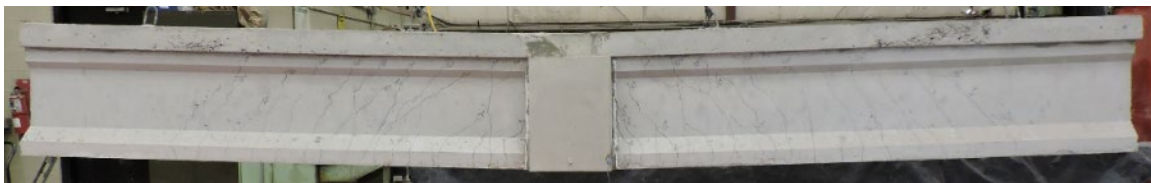
Figure 4.111. Deflected shape of specimen R1-FRSCC after testing

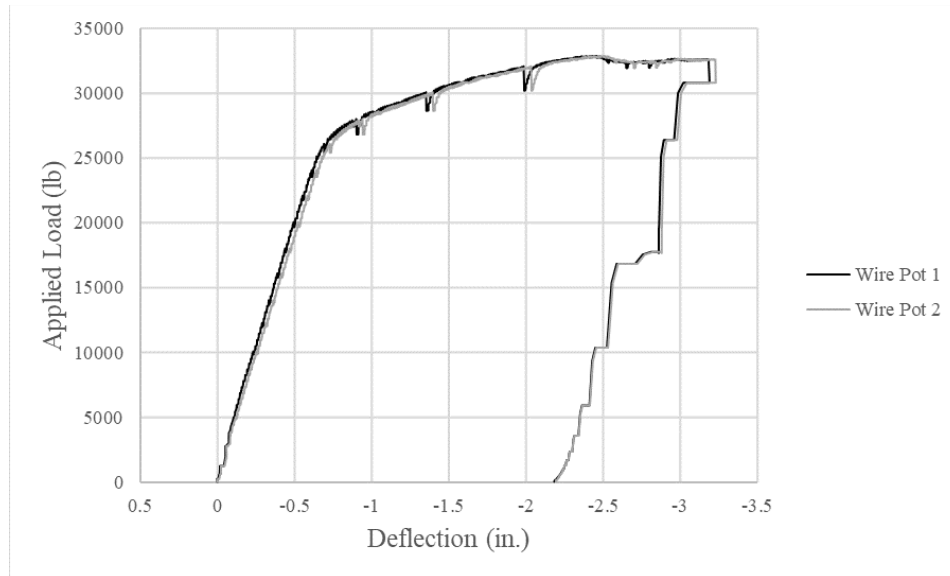
Figure 4.112. Specimen R1-FRSCC load-deflection curve

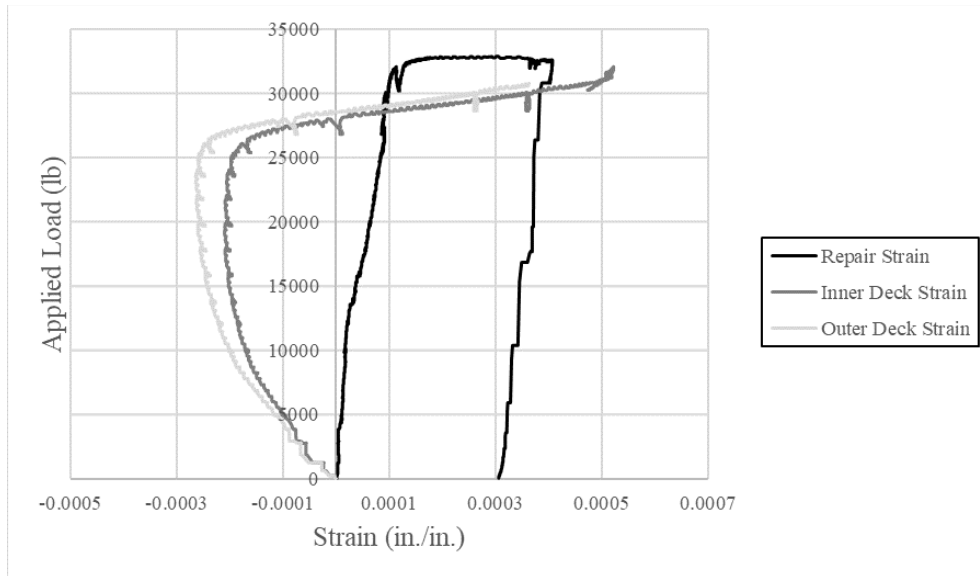
Figure 4.113. Specimen R1-FRSCC load-strain curve

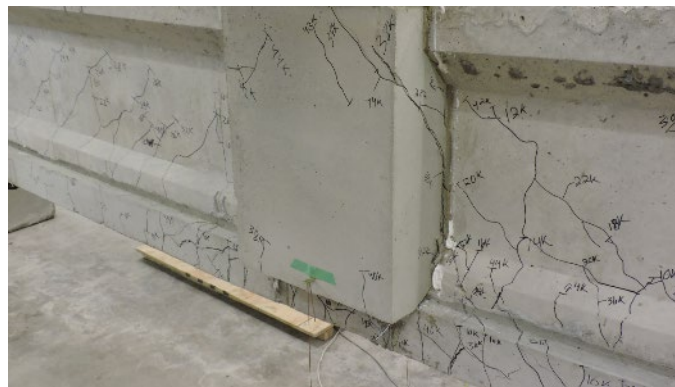
Figure 4.114. Specimen R2-FRSCC shear and flexural cracking

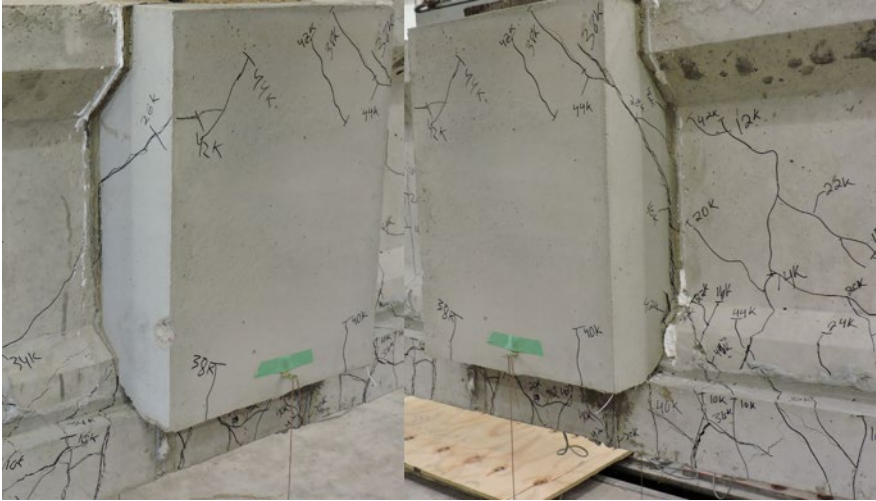
Figure 4.115. Specimen R2-FRSCC joint cracking on longitudinal and transverse faces from the front left (left) and front right (right)

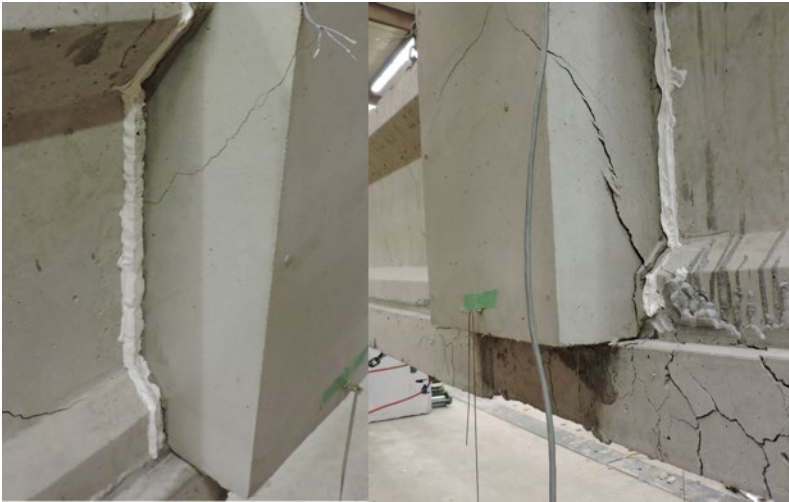
Figure 4.116. Specimen R2-FRSCC joint cracking on longitudinal and transverse faces from the back left (left) and back right (right)

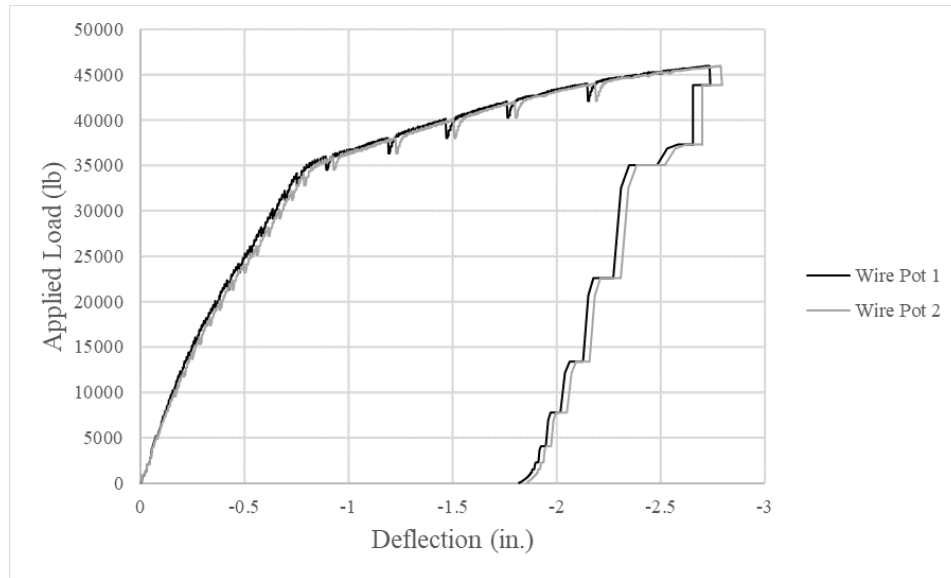
Figure 4.118. Specimen R2-FRSCC load-deflection curve

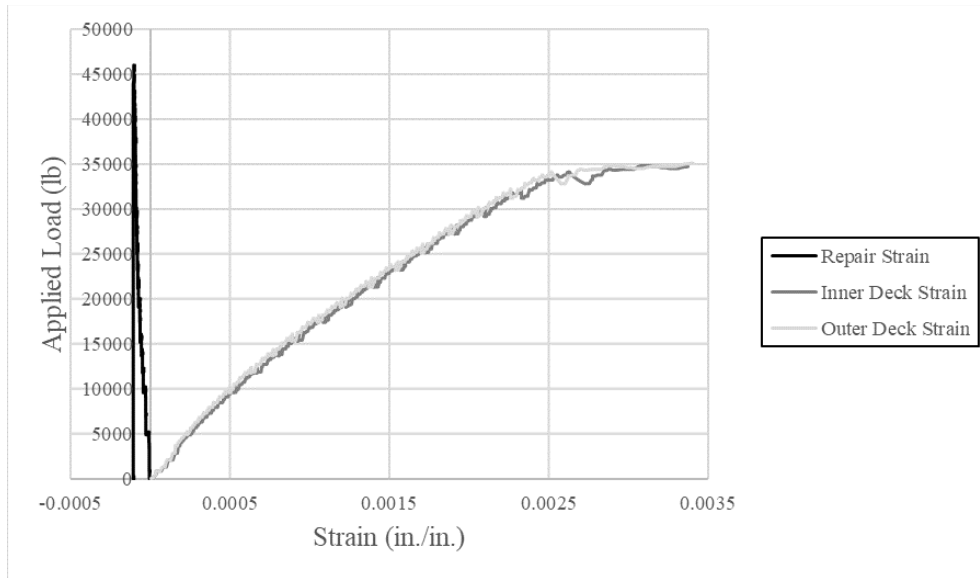
Figure 4.119. Specimen R2-FRSCC load-strain curve

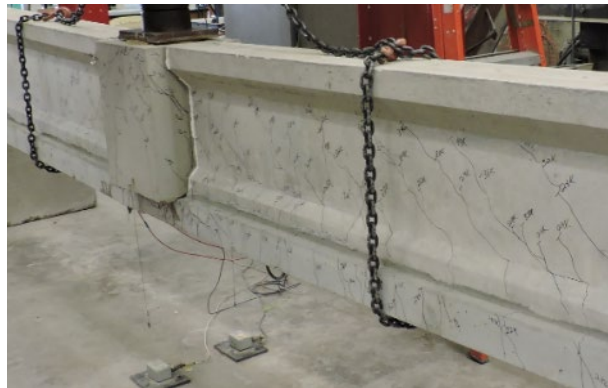
Figure 4.120. Specimen R3-FRSCC shear and flexural cracking

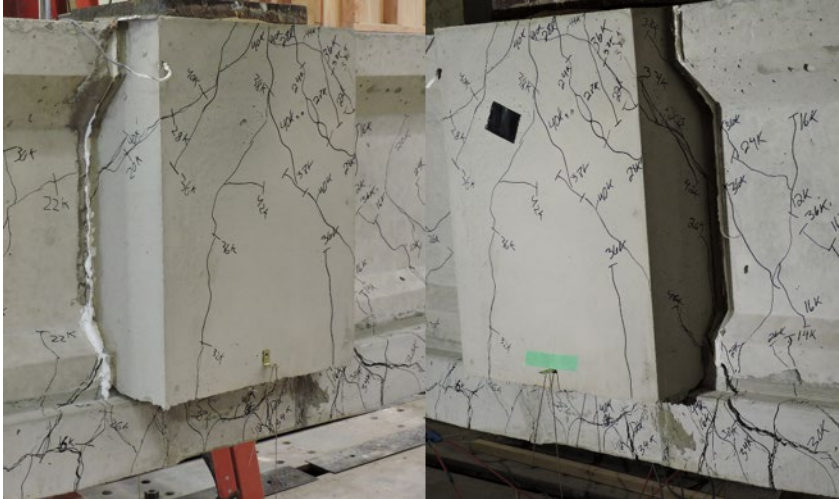
Figure 4.121. Specimen R3-FRSCC joint cracking on the longitudinal and transverse faces from the front left (left) and front right (right)

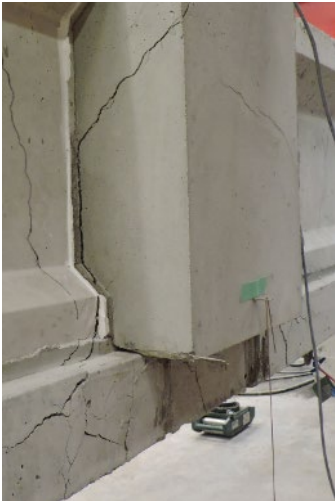
Figure 4.122. Specimen R3-FRSCC joint cracking on the longitudinal and transverse faces from the back left

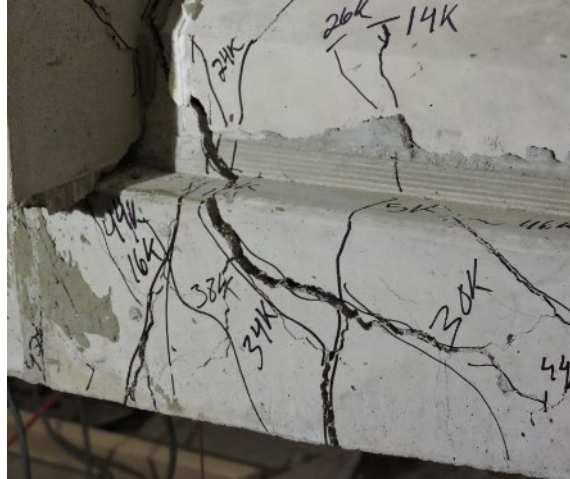
Figure 4.123. Specimen R3-FRSCC deck cracking

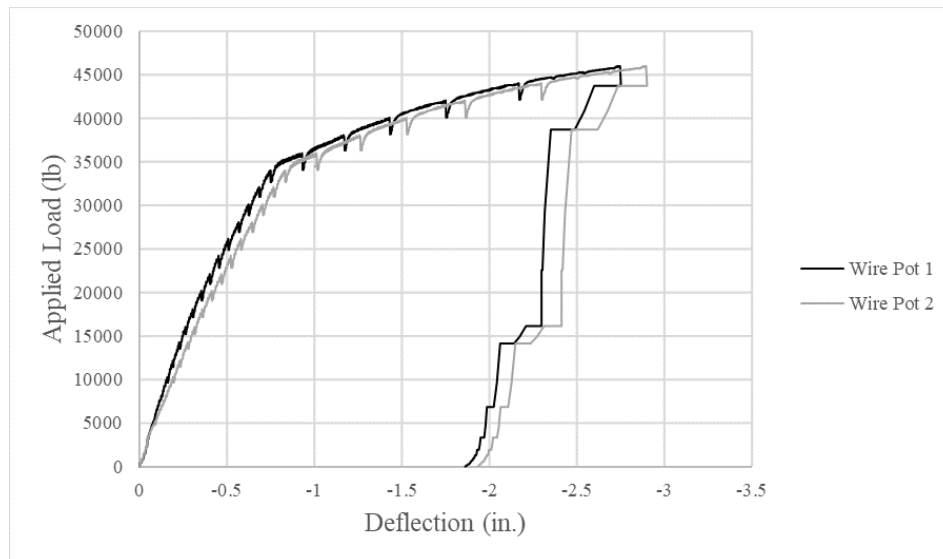
Figure 4.124. Specimen R3-FRSCC load-deflection curve
