FINAL REPORT ~ FHWA-OK-21-03

EVALUATION OF ULTRA-HIGH PERFORMANCE CONCRETE, FIBER REINFORCED SELF-CONSOLIDATING CONCRETE, AND MALP CONCRETE FOR PRESTRESSED GIRDER REPAIR

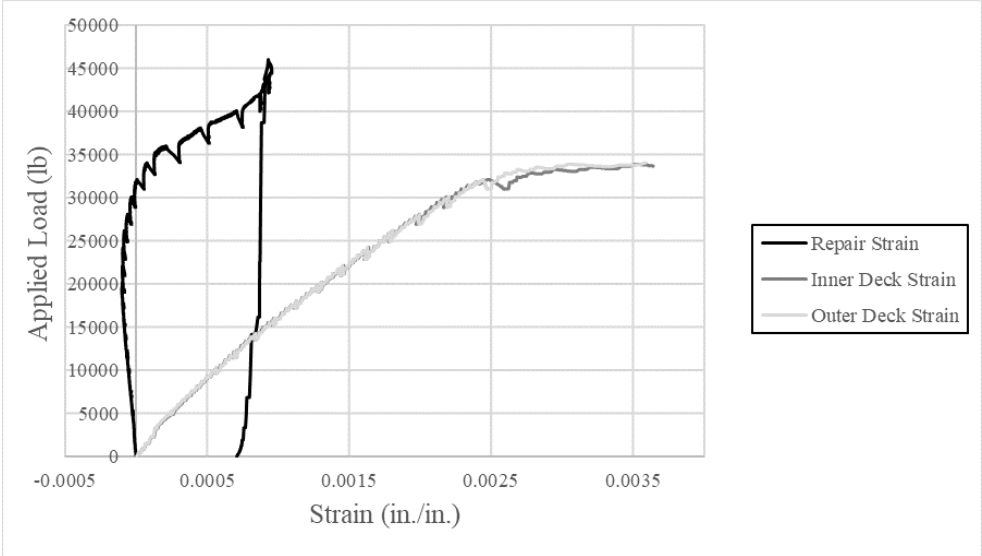
Figure 4.125. Specimen R3-FRSCC load-strain curves

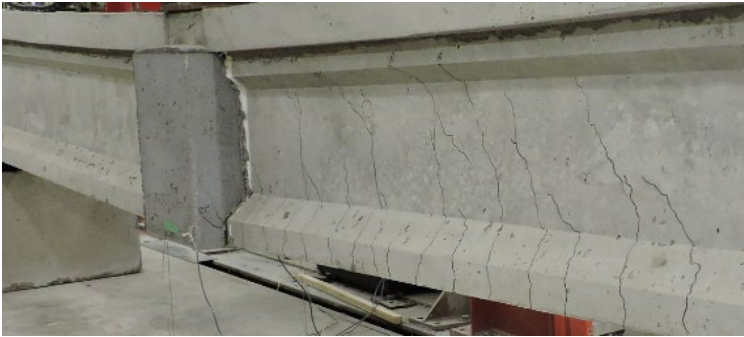
Figure 4.126. Specimen R1-PHOS shear and flexural cracking

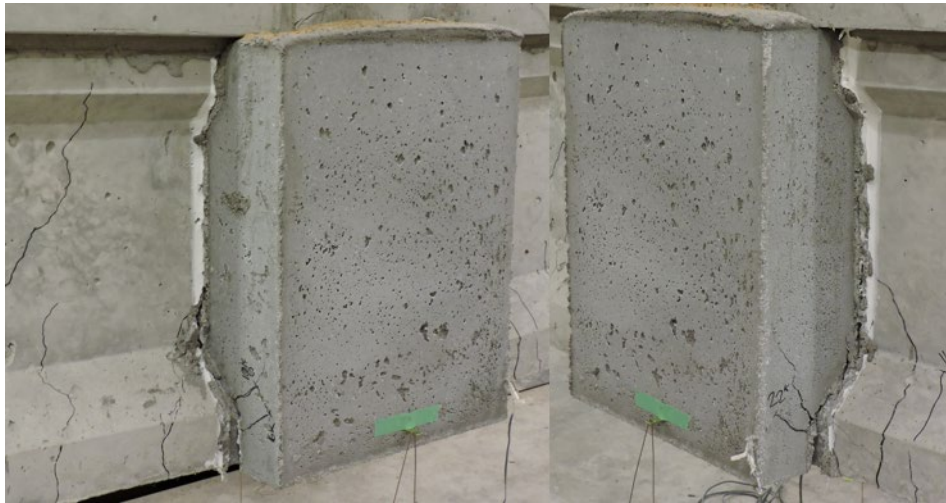
Figure 4.127. Specimen R1-PHOS girder-joint interface and joint transverse face cracking from the front left (left) and front right (right)

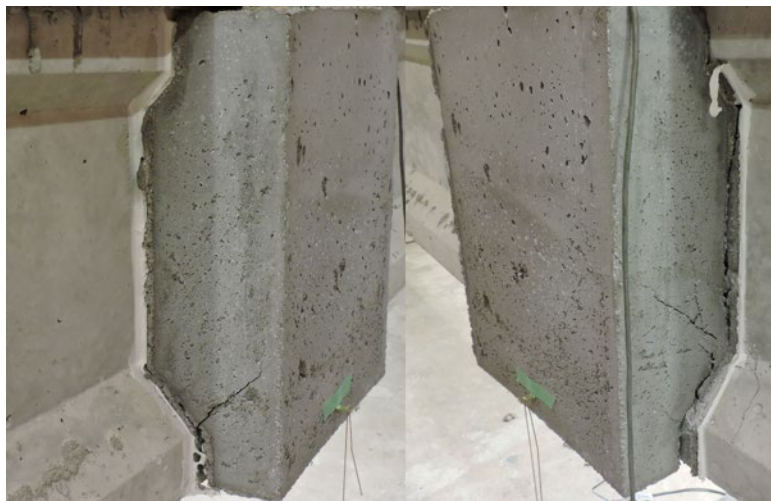
Figure 4.128. Specimen R1-PHOS girder-joint interface and joint transverse face cracking from the back left (left) and back right (right)

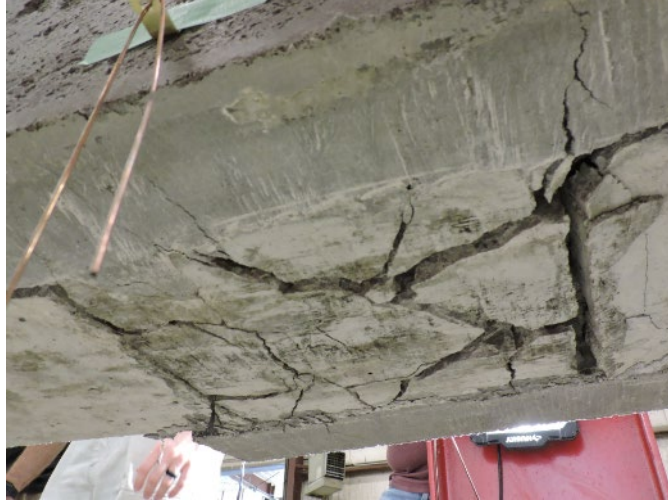
Figure 4.129. Specimen R1-PHOS girder-joint separation

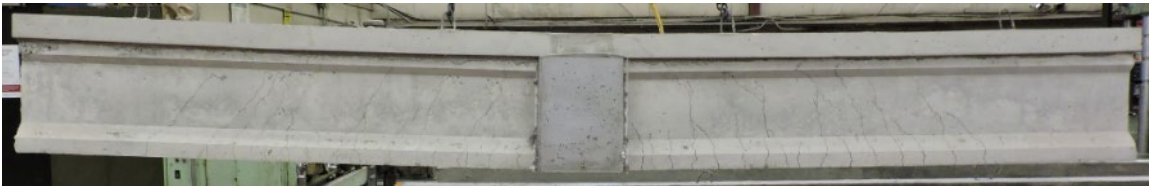
Figure 4.130. Deflected shape of specimen R1-PHOS

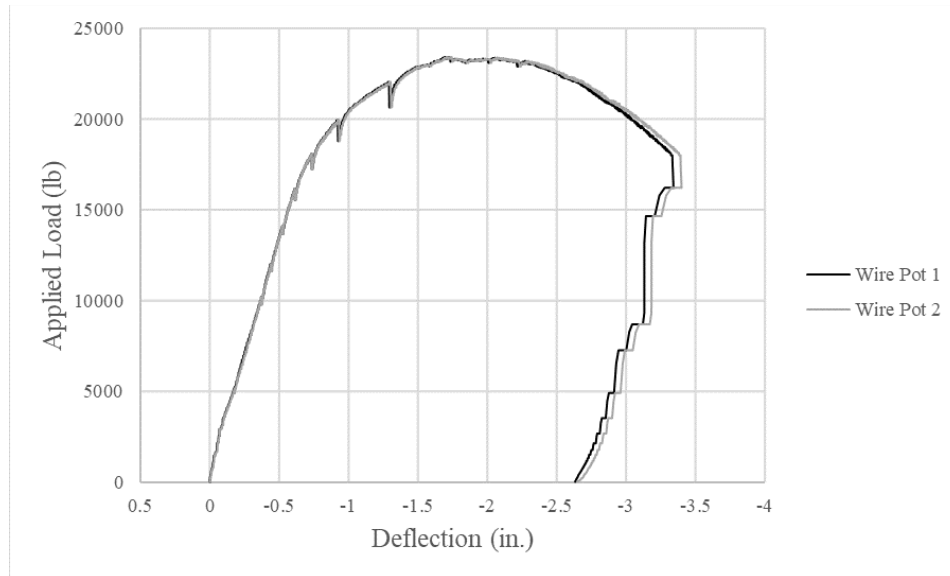
Figure 4.131. Specimen R1-PHOS load-deflection curve

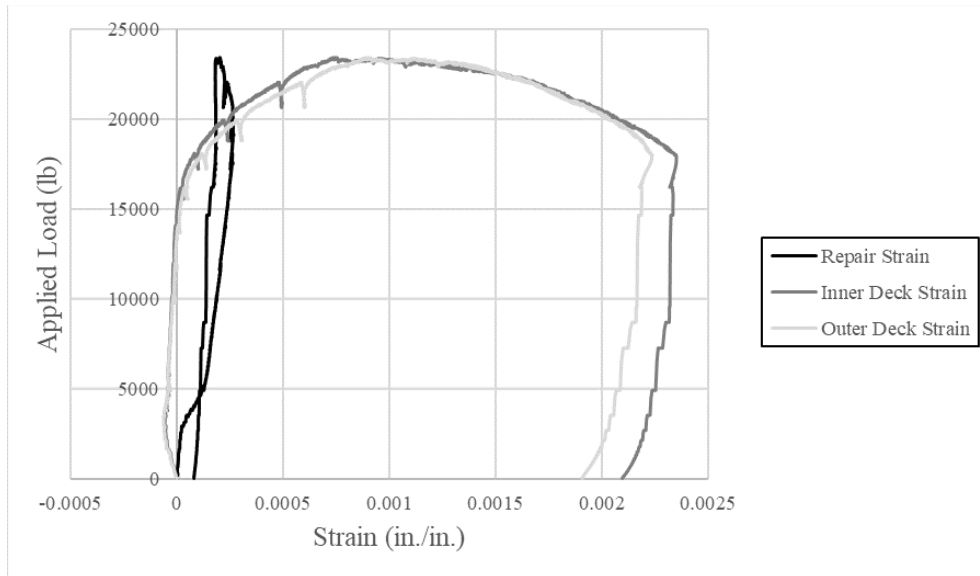
Figure 4.132. Specimen R1-PHOS load-strain curves

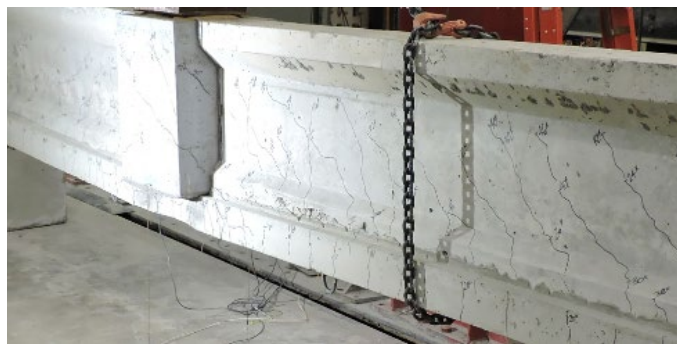
Figure 4.133. Specimen R2-PHOS shear and flexural cracking

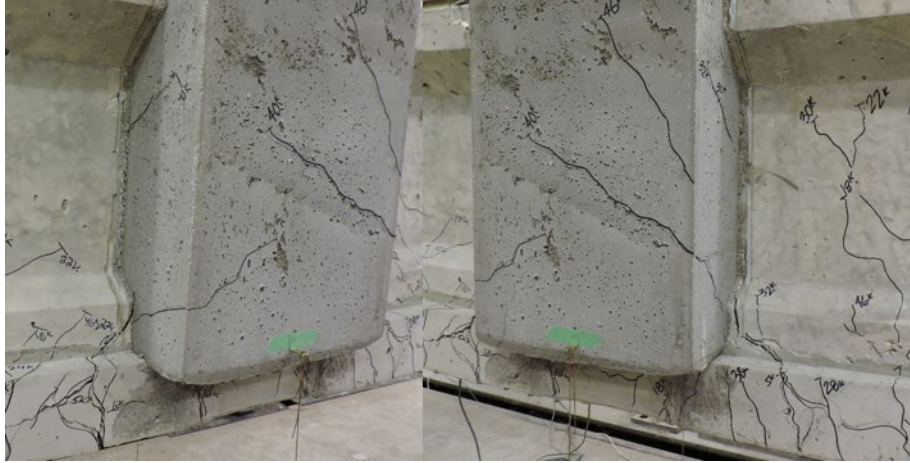
Figure 4.134. Specimen R2-PHOS joint cracking on the longitudinal and transverse faces from the front left (left) and front right (right)

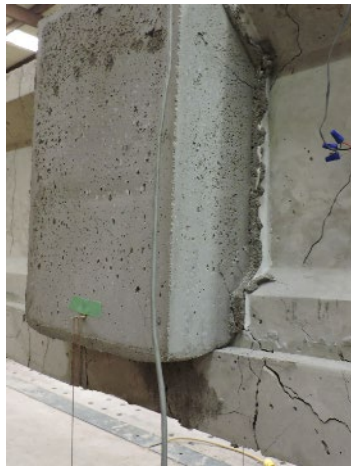
Figure 4.135. Specimen R2-PHOS joint cracking on the longitudinal and transverse faces from the back right

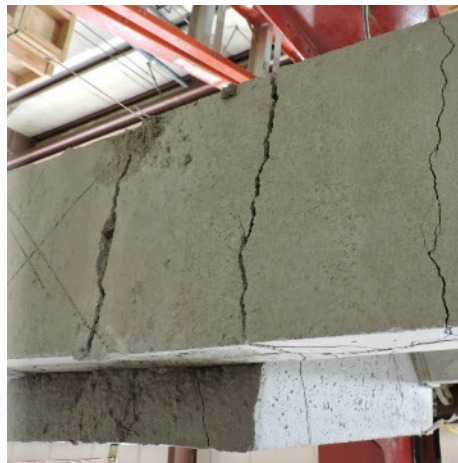
Figure 4.136. Specimen R2-PHOS deck cracking

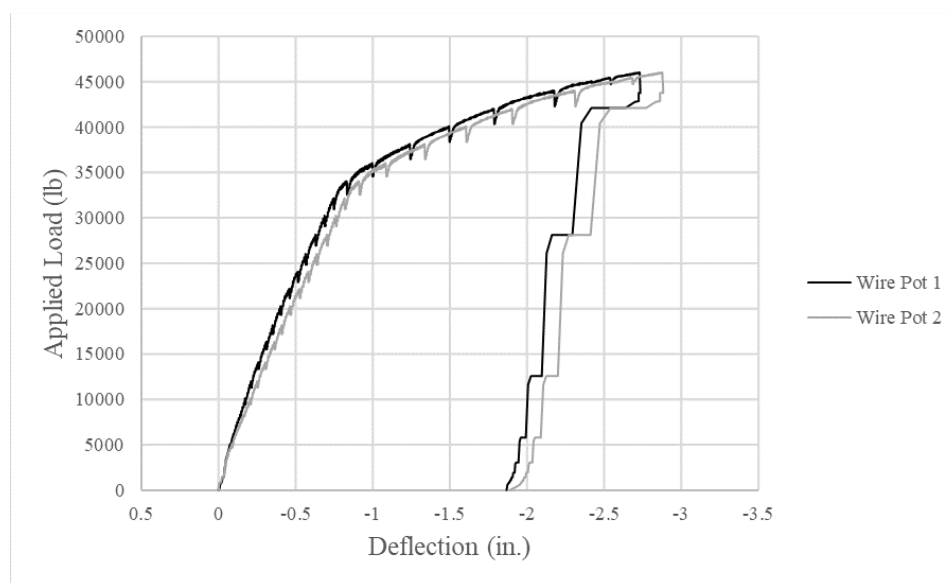
Figure 4.138. Specimen R2-PHOS load-deflection curve

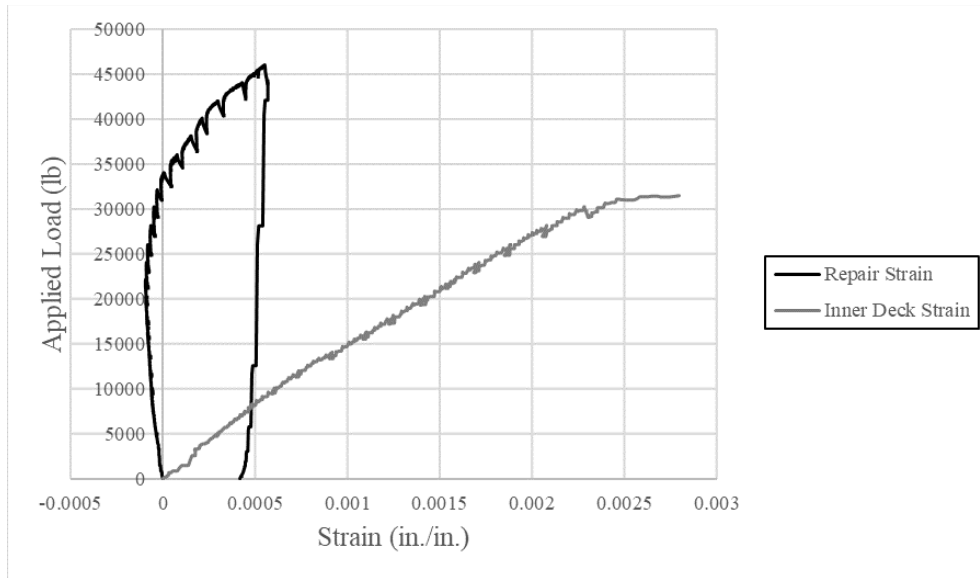
Figure 4.139. Specimen R2-PHOS load-strain curves

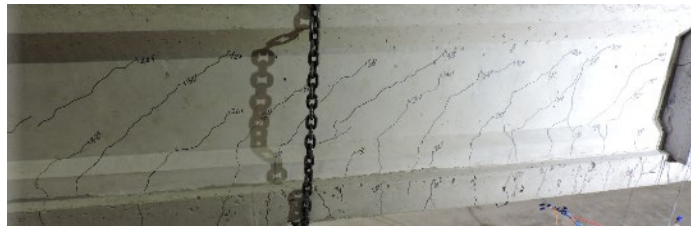
Figure 4.140. Specimen R3-PHOS shear and flexural cracking

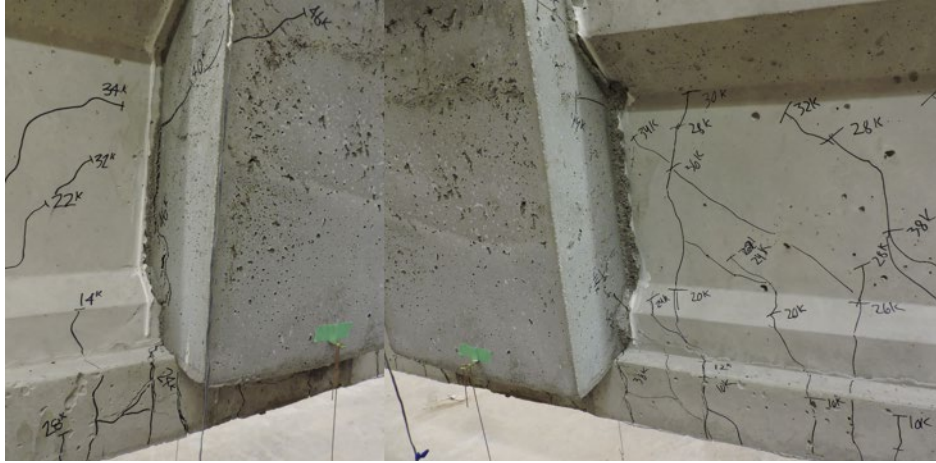
Figure 4.141. Specimen R3-PHOS girder-joint interface and joint transverse face cracking from the front left (left) and front right (right)

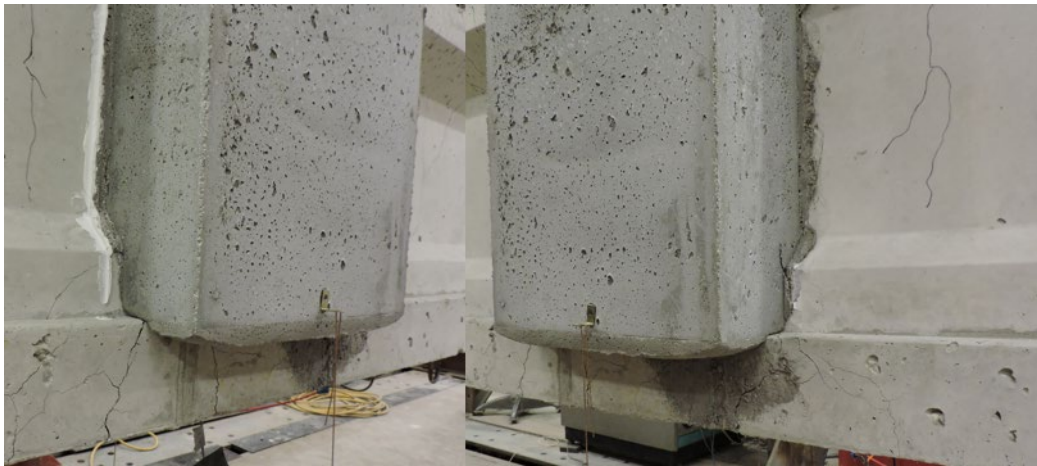
Figure 4.142. Specimen R3-PHOS joint transverse face cracking from the back left (left) and back right (right)

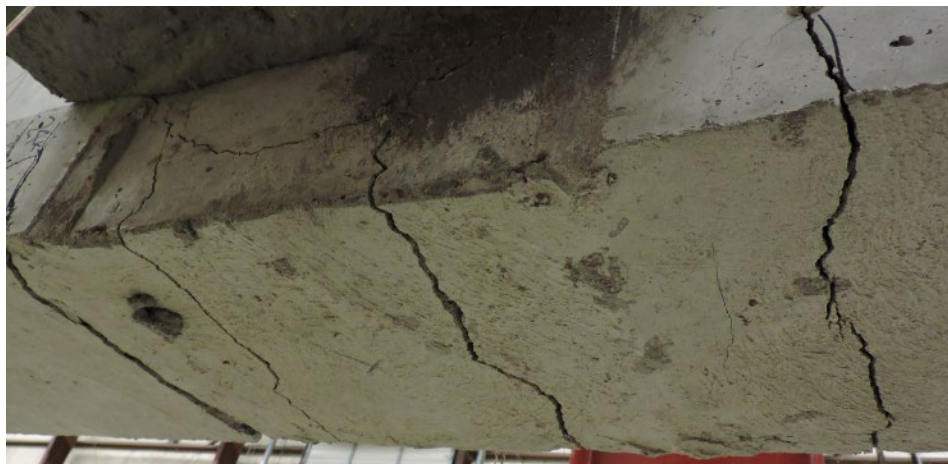
Figure 4.143. Specimen R3-PHOS deck cracking

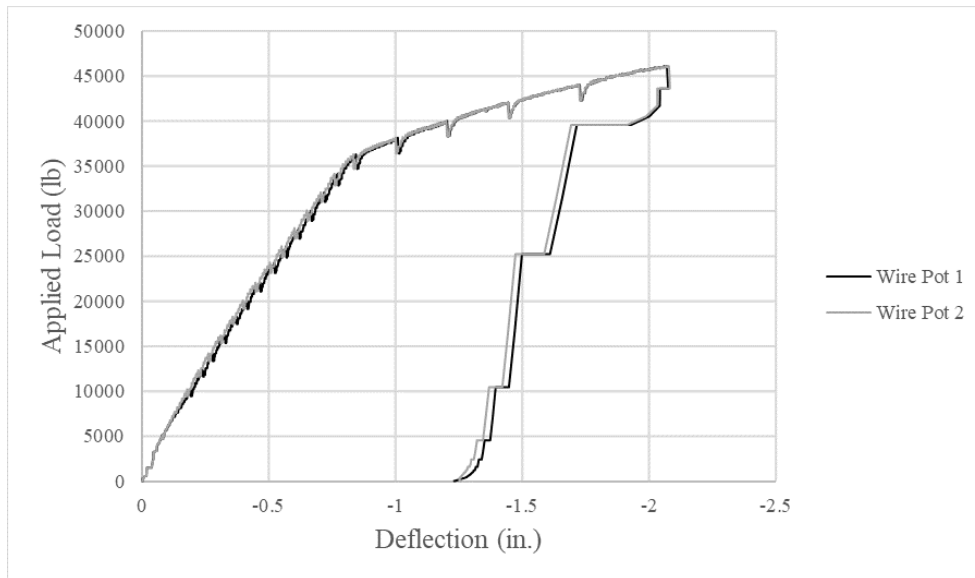
Figure 4.145. Specimen R3-PHOS load-deflection curve

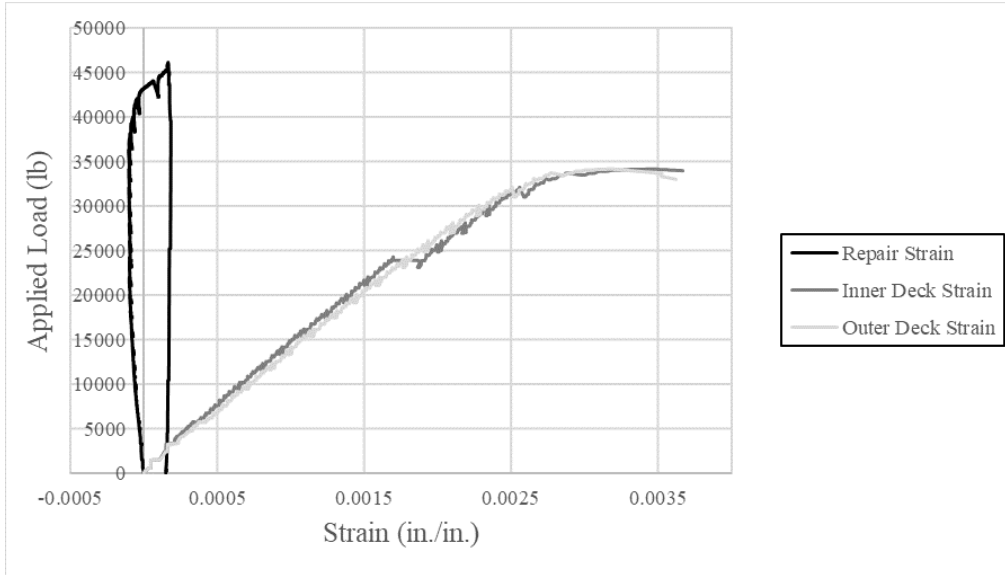
Figure 4.146. Specimen R3-PHOS load-strain curves

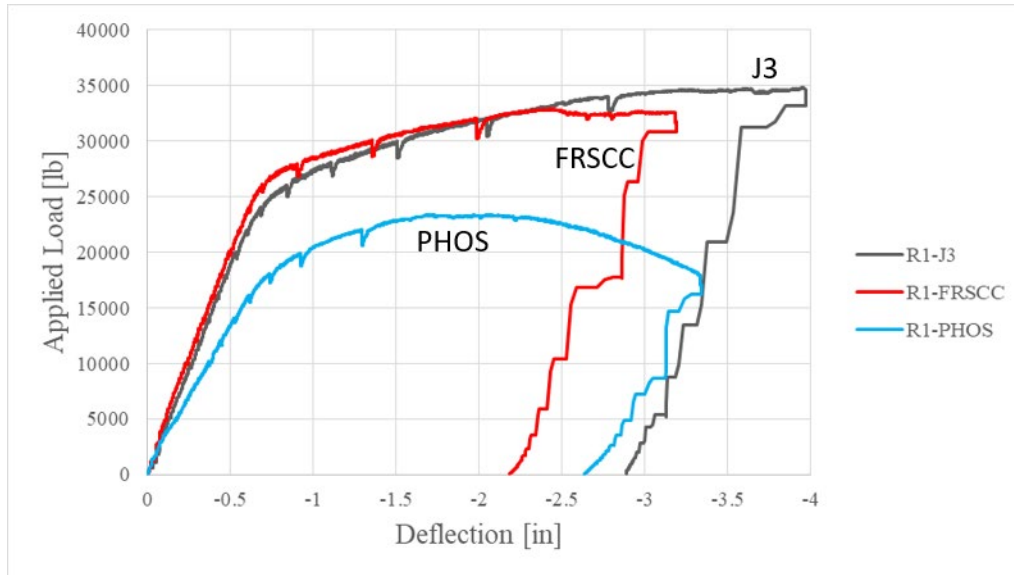
Figure 4.147. Summary of positive moment repair specimen load-deflection curves

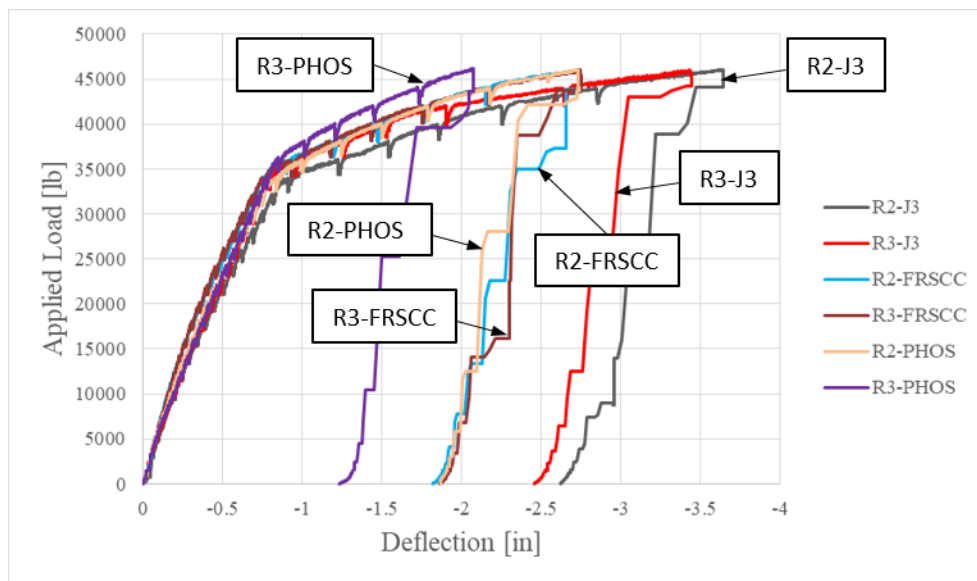
Figure 4.148. Summary of negative moment repair specimen load-deflection curves

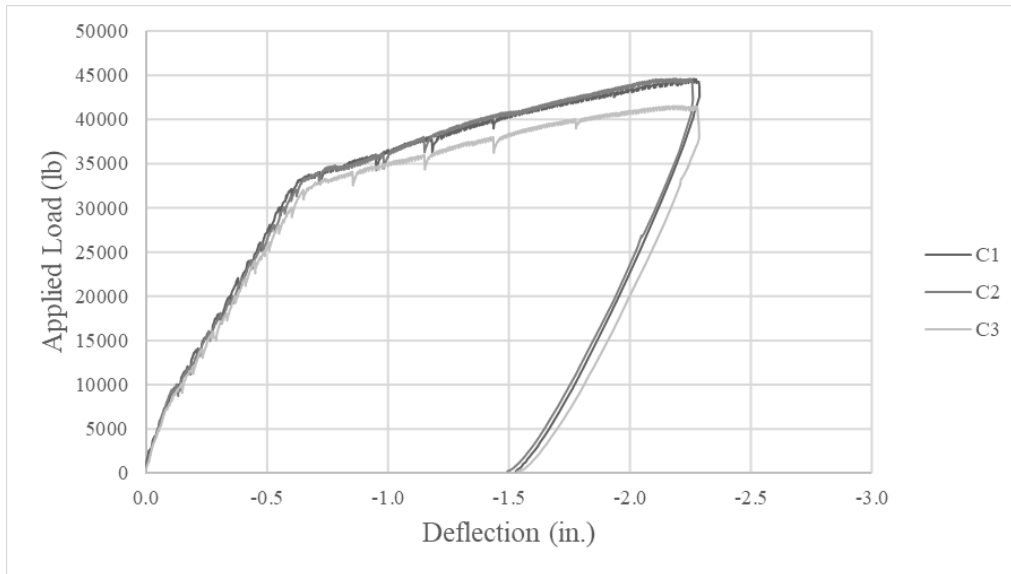
Figure 4.149. Summary of negative moment control group load-deflection curves

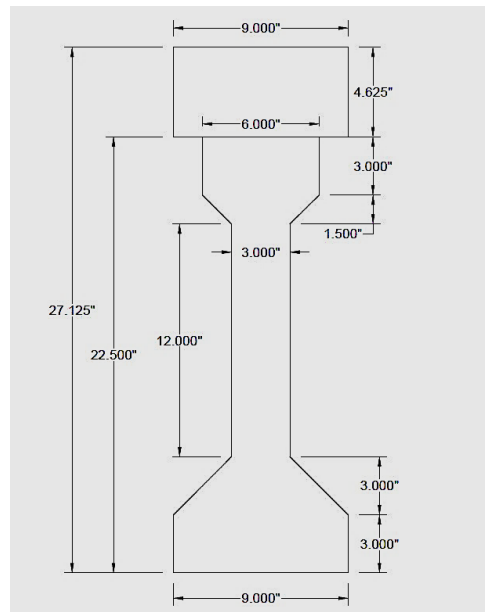
Figure 5.1. Prestressed beam specimen cross-section

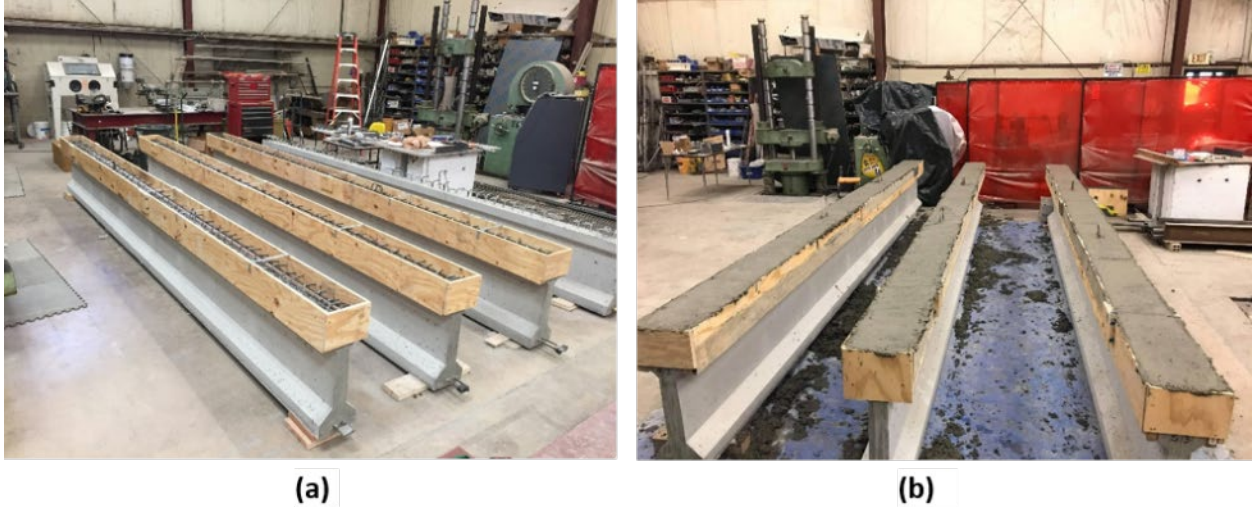
Figure 5.6. (a) Deck formwork and (b) deck concrete immediately after casting

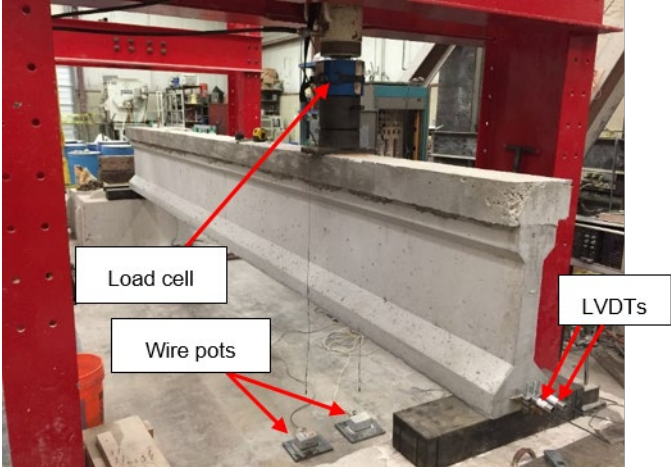
Figure 5.7. Un-cracked girder arranged in the test setup

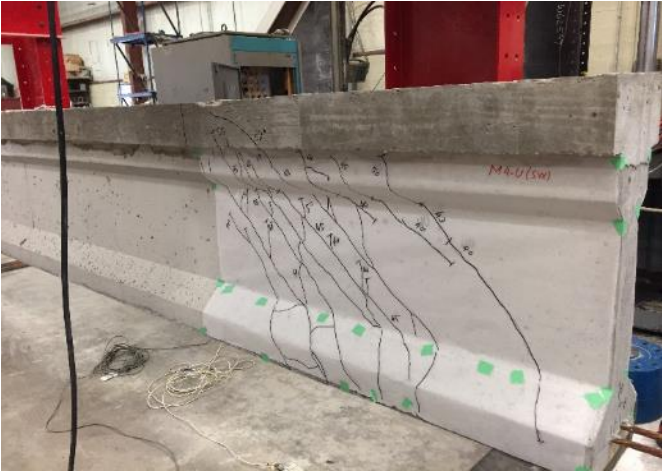
Figure 5.8. Tracing paper on one side of the cracked girder to copy the crack locations after testing

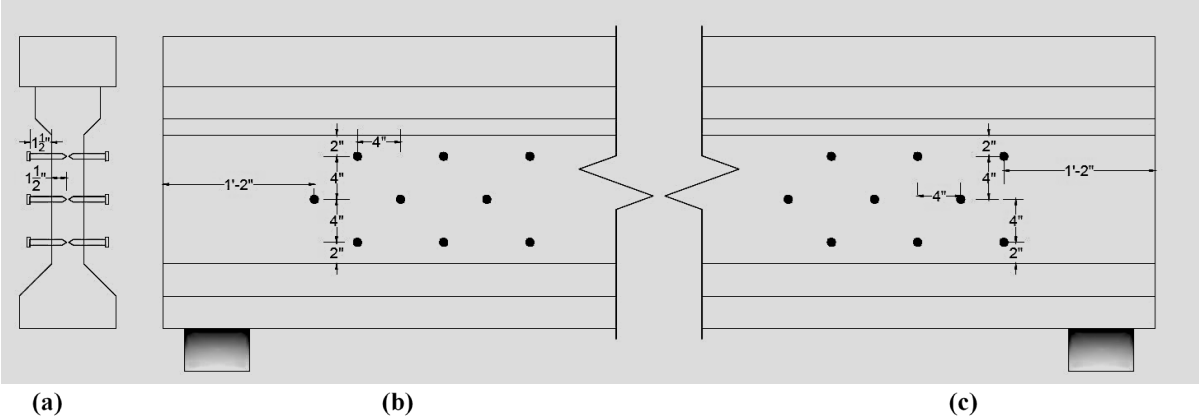
Figure 5.9. (a) Cross-sectional view of concrete anchor locations, (b) front face showing distribution of anchors, (c) back face showing distribution of anchors

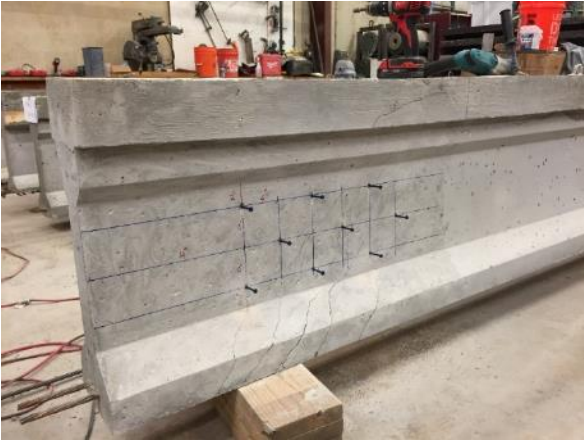
Figure 5.10. Concrete anchors used for shear studs in the web of a girder specimen ready for repair

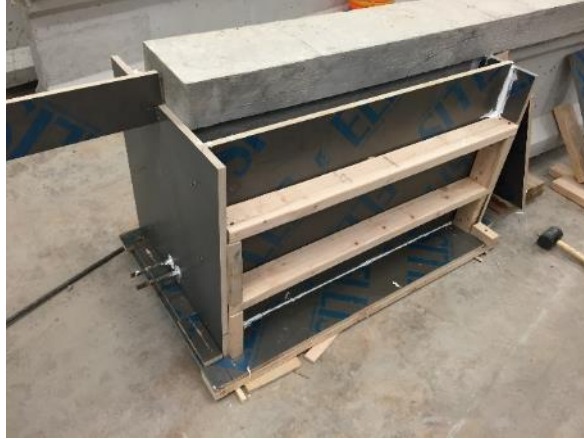
Figure 5.11. Repair formwork

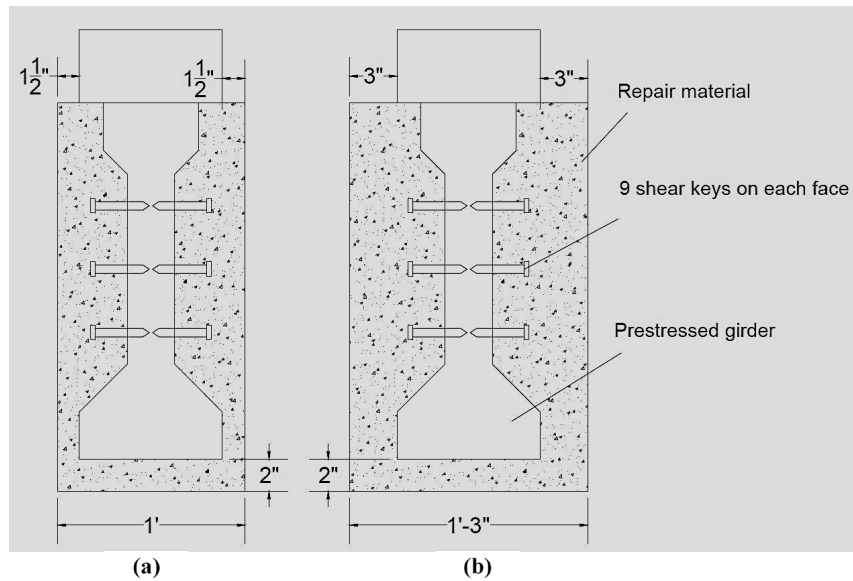
Figure 5.12. (a) Repair dimensions for UHPC and (b) repair dimensions for FR-SCC and MALP concrete

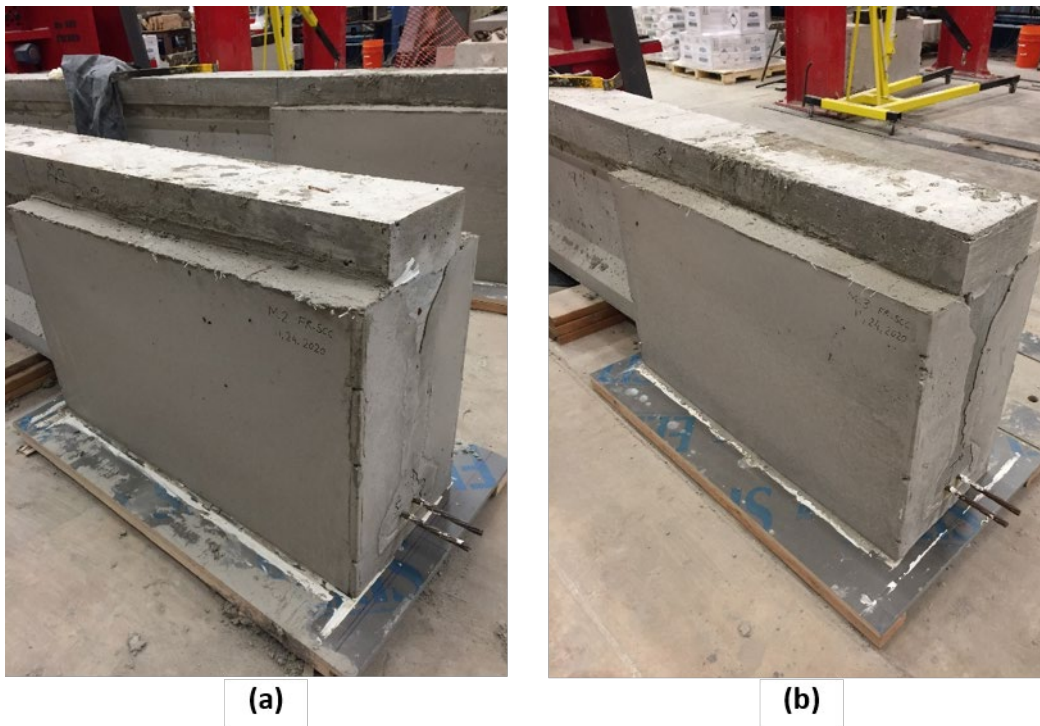
Figure 5.13. (a) FR-SCC repair for beam M-2 and (b) FR-SCC repair for beam M-3

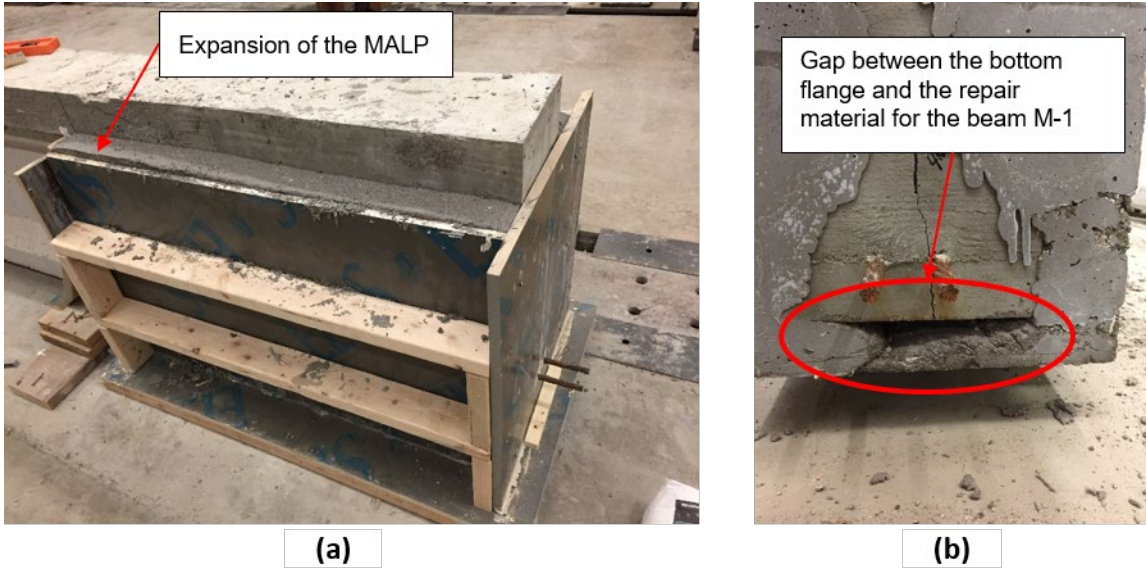
Figure 5.14. (a) Expansion of the MALP above the formwork and (b) gap under the beam resulting from poor workability of the new MALP

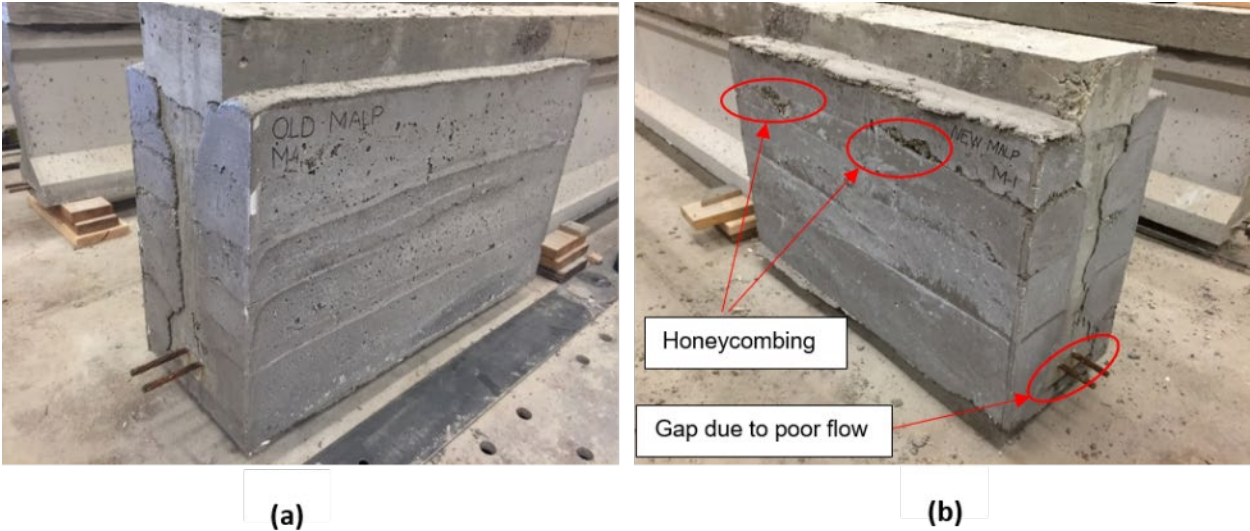
Figure 5.15. (a) Old MALP repair for beam M-4 and (b) new MALP repair for beam M-1

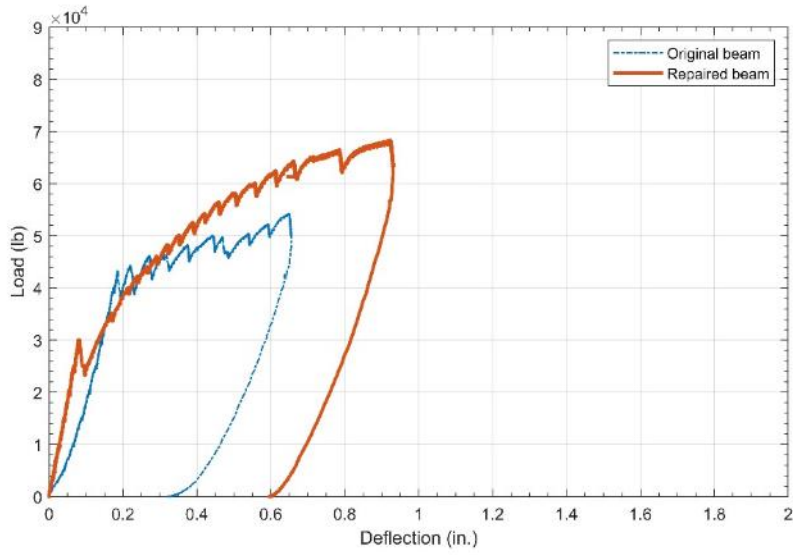
Figure 5.16. Load-deflection curves for the initial and post-repair shear tests of specimen M2-FRSCC

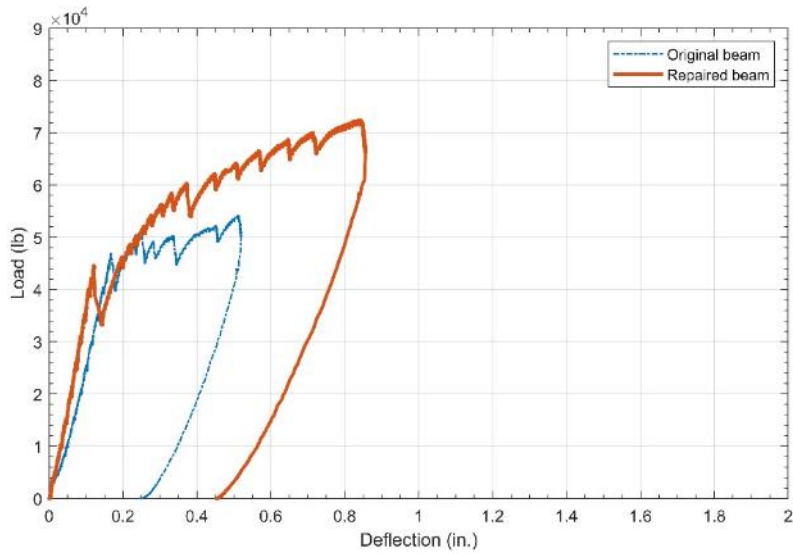
Figure 5.17. Load-deflection curves for the initial and post-repair shear tests of specimen M3-FRSCC

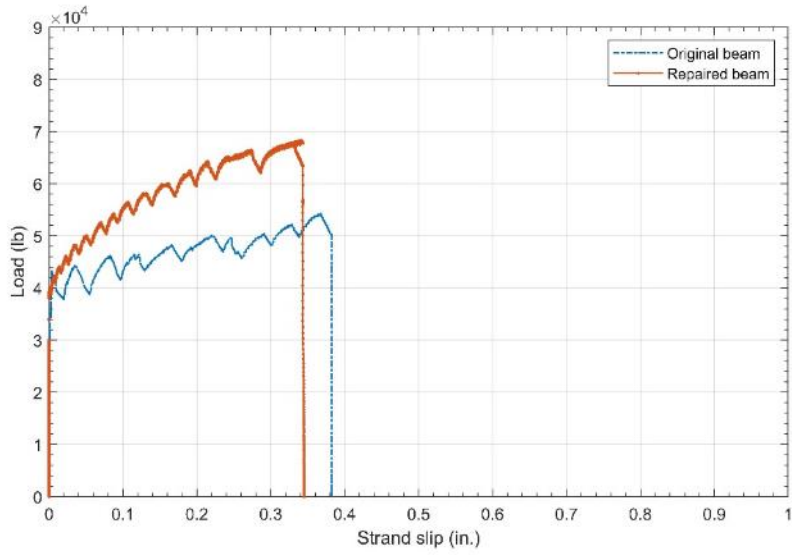
Figure 5.18. Load-slip curves for the initial and post-repair shear tests of specimen M2-FRSCC

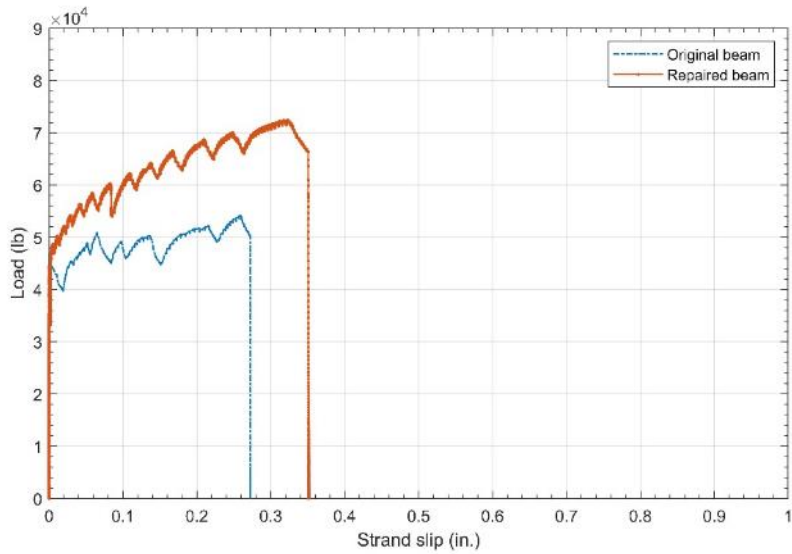
Figure 5.19. Load-slip curves for the initial and post-repair shear tests of specimen M3-FRSCC

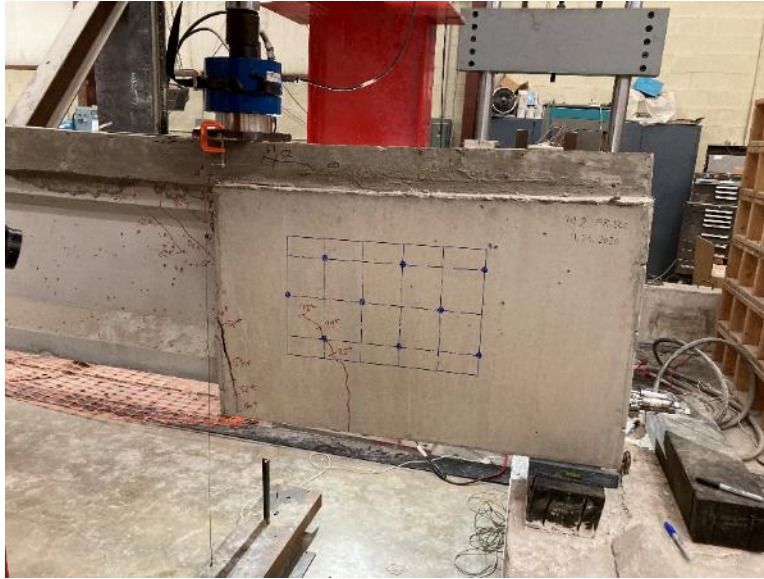
Figure 5.20. Specimen M2-FRSCC at failure showing cracking in the specimen and concrete crushing at the load point

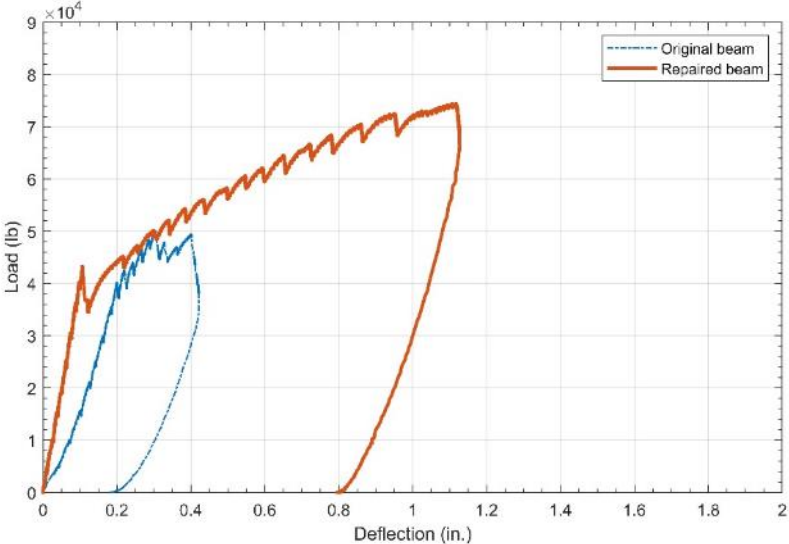
Figure 5.21. Load-deflection curves for the initial and post-repair shear tests of specimen M1-MALP

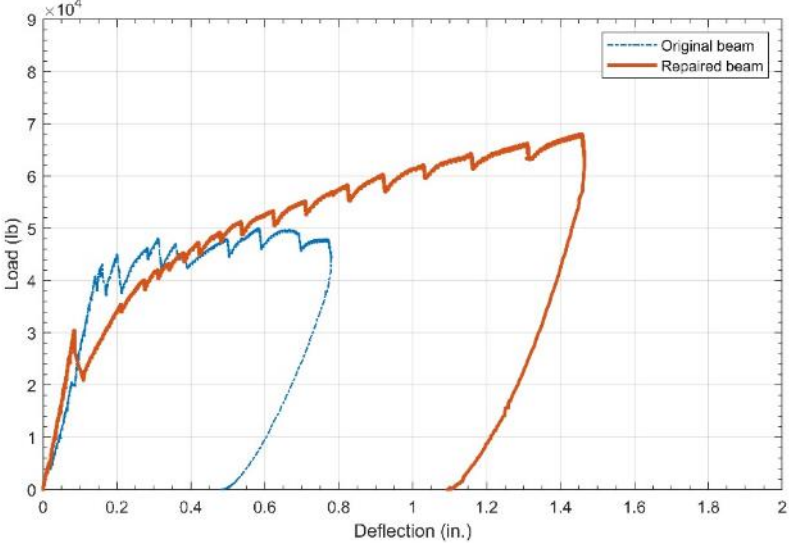
Figure 5.22. Load-deflection curves for the initial and post-repair shear tests of specimen M4-MALP

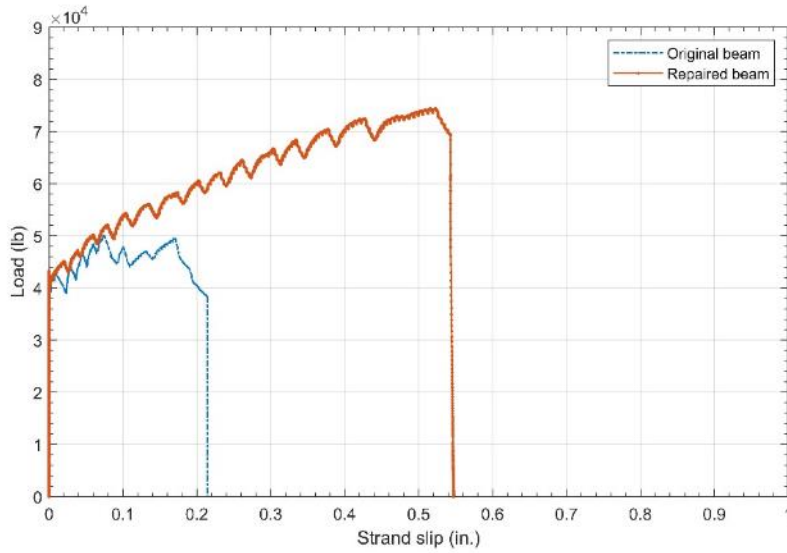
Figure 5.23. Load-slip curves for the initial and post-repair shear tests of specimen M1-MALP

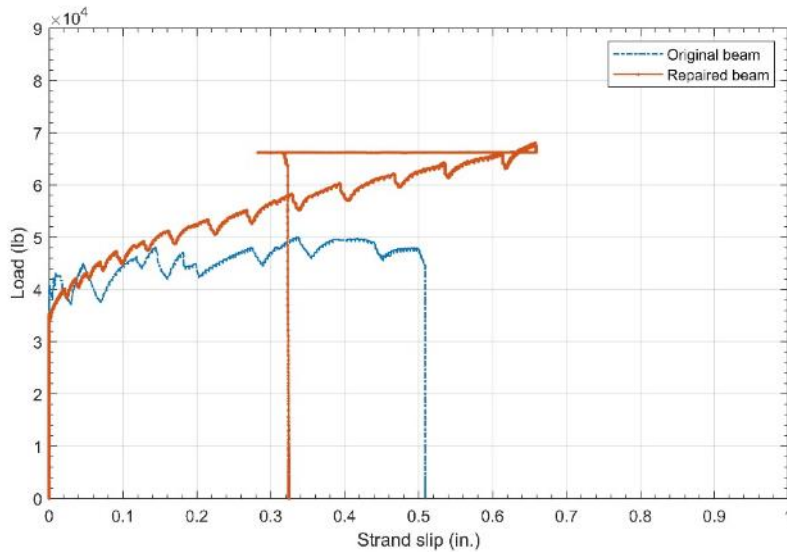
Figure 5.24. Load-slip curves for the initial and post-repair shear tests of specimen M4-MALP

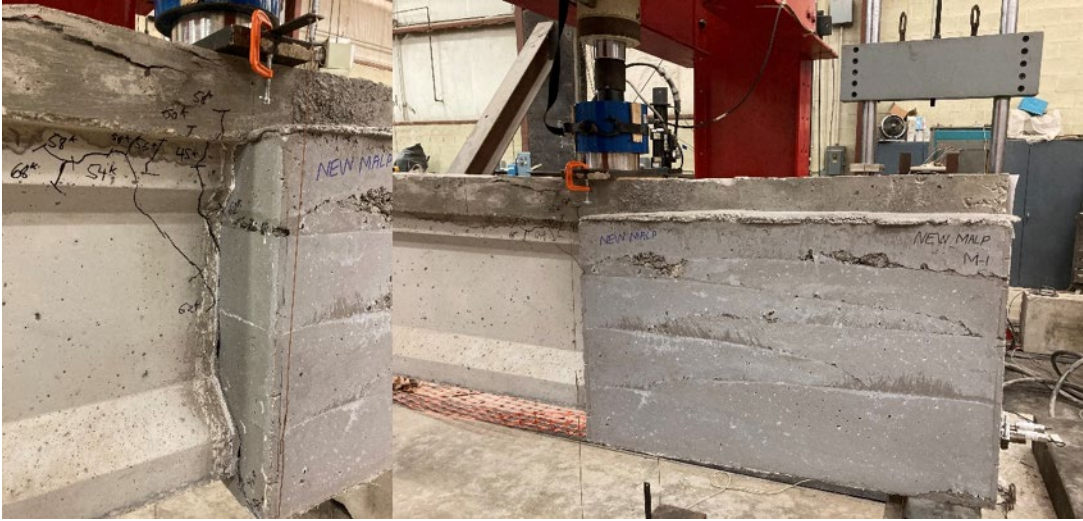
Figure 5.25. Specimen M1-MALP at failure showing cracking in the specimen and concrete crushing at the load point

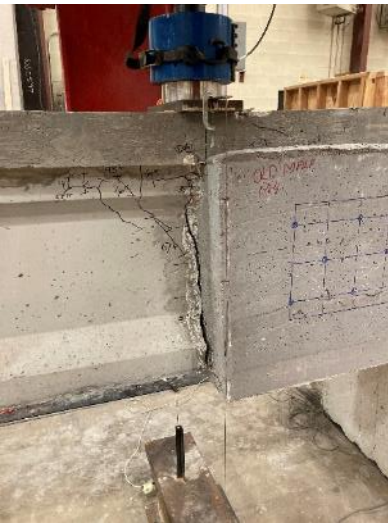
Figure 5.26. Specimen M4-MALP at failure showing cracking in the specimen and concrete crushing at the load point

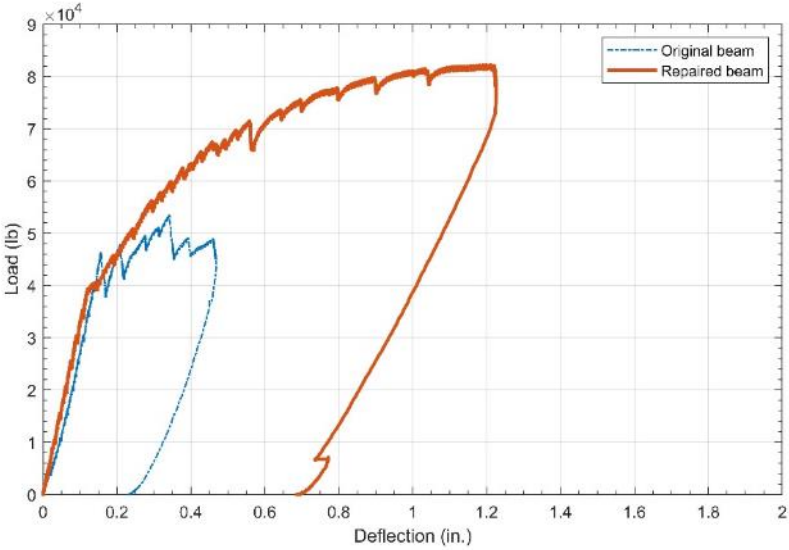
Figure 5.27. Load-deflection curves for the initial and post-repair shear tests of specimen M5-UHPC

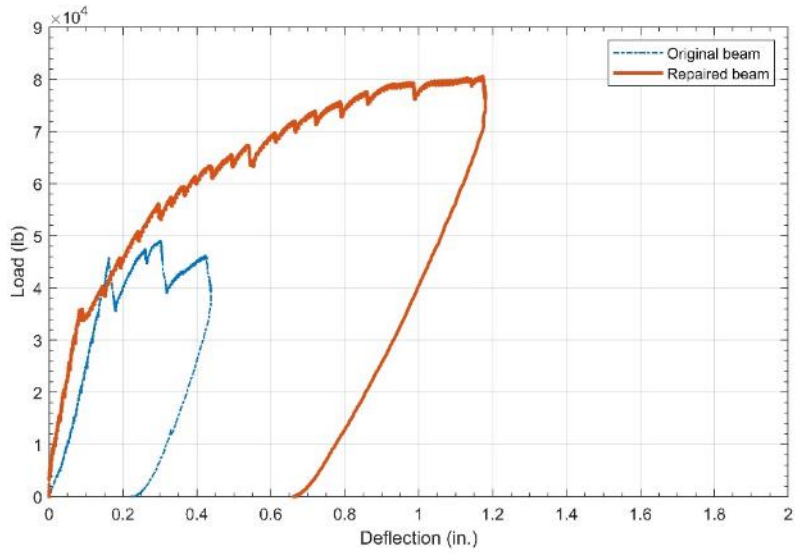
Figure 5.28. Load-deflection curves for the initial and post-repair shear tests of specimen M6-UHPC

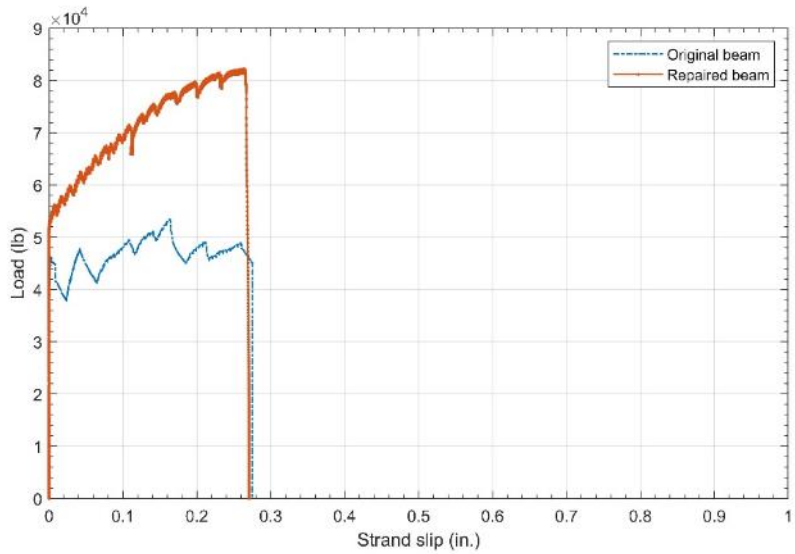
Figure 5.29. Load-slip curves for the initial and post-repair shear tests of specimen M5-UHPC

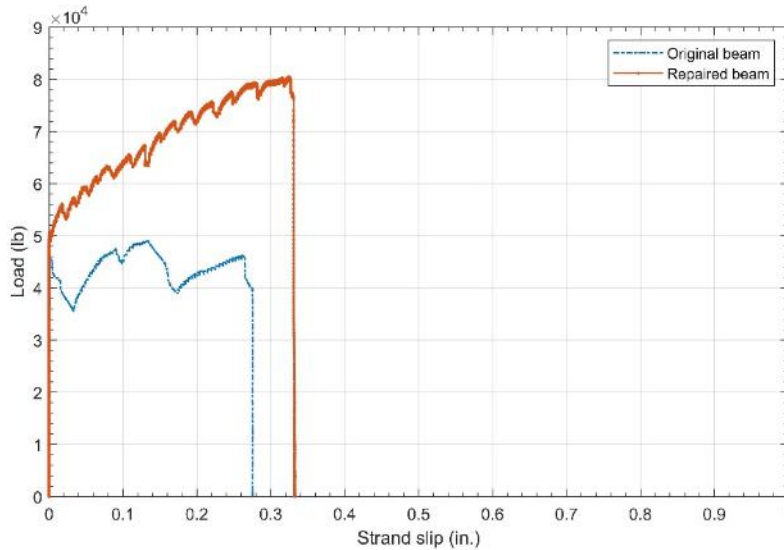
Figure 5.30. Load-slip curves for the initial and post-repair shear tests of specimen M6-UHPC

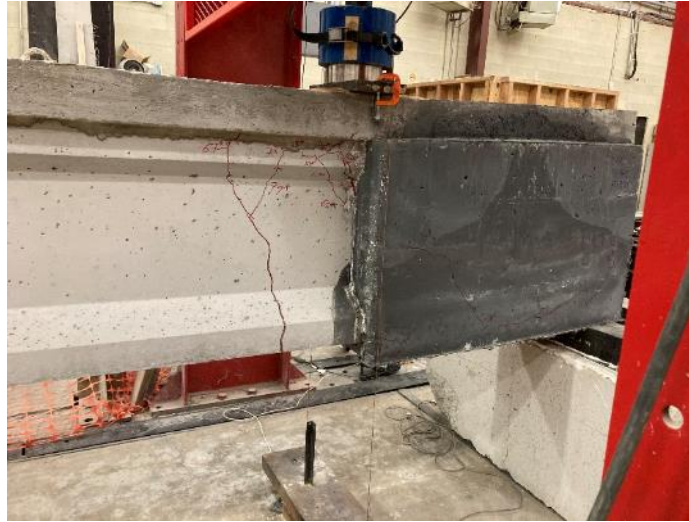
Figure 5.31. Specimen M6-UHPC at failure showing cracking in the specimen and concrete crushing at the load point
