FINAL REPORT ~ FHWA-OK-21-03

EVALUATION OF ULTRA-HIGH PERFORMANCE CONCRETE, FIBER REINFORCED SELF-CONSOLIDATING CONCRETE, AND MALP CONCRETE FOR PRESTRESSED GIRDER REPAIR

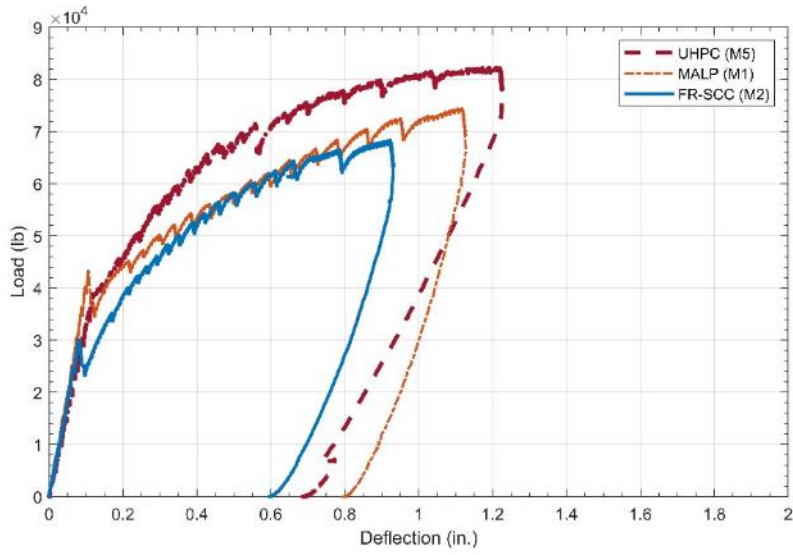
Figure 5.32. Comparison of load-deflection curves for the post-repair shear tests of specimens M2-FRSCC, M1-MALP, and M5-UHPC

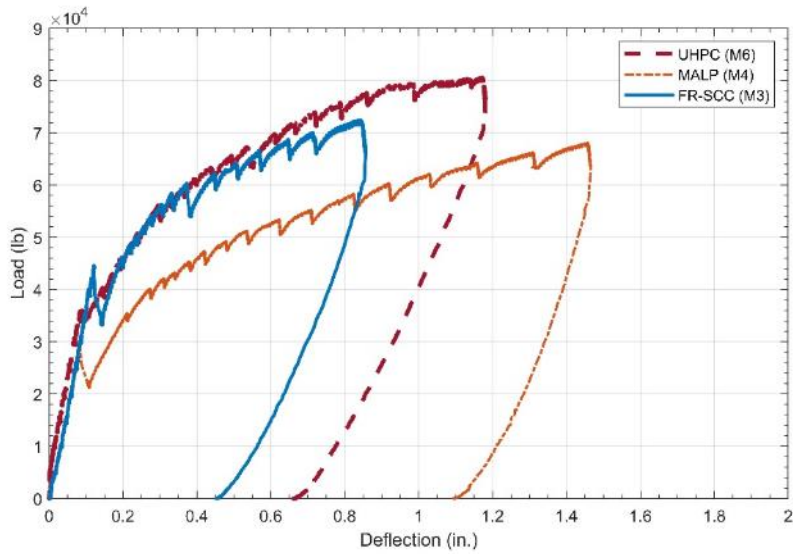
Figure 5.33. Comparison of load-deflection curves for the post-repair shear tests of specimens M3-FRSCC, M4-MALP, and M6-UHPC

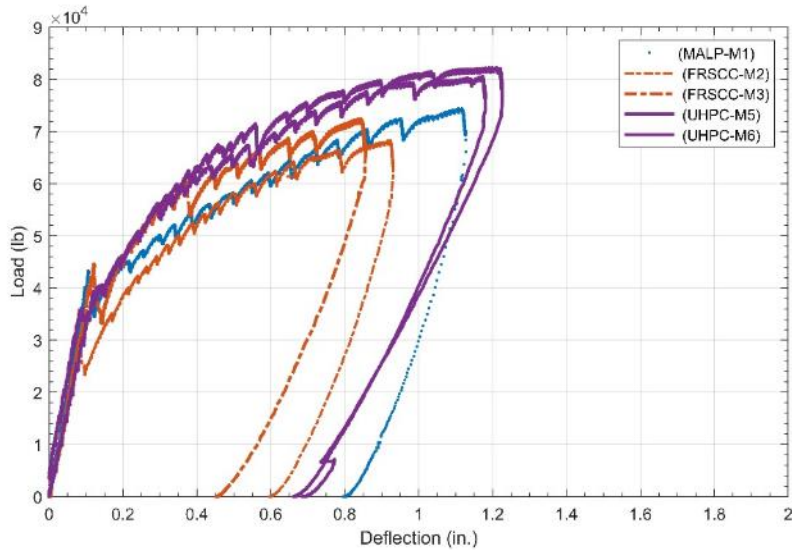
Figure 5.34. Comparison of load-deflection curves for the post-repair shear tests of all specimens except M4-MALP

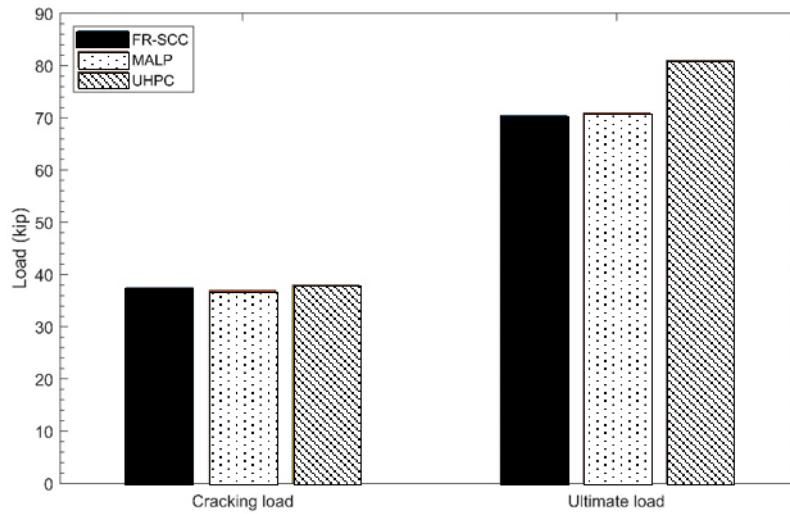
Figure 5.35. Comparison of average cracking and ultimate loads for specimens with all repair materials

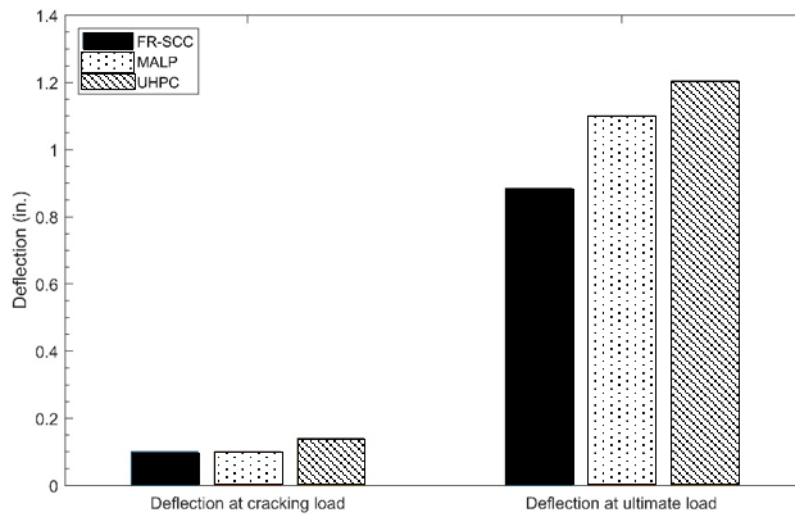
Figure 5.36. Comparison of average deflection at cracking and ultimate loads for specimens with all repair materials

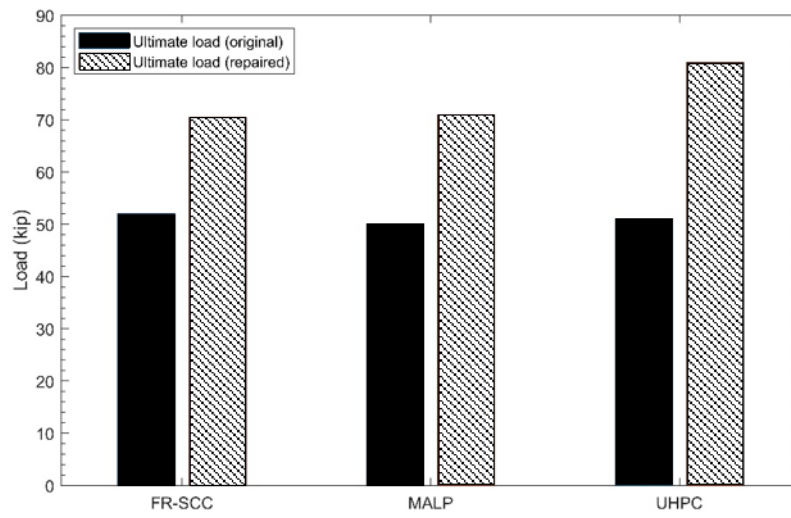
Figure 5.37. Comparison of ultimate load before and after repair

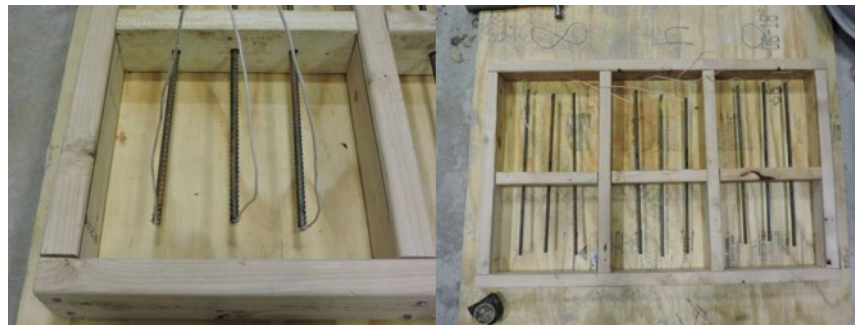
Figure 6.1. Small-scale corrosion specimen molds

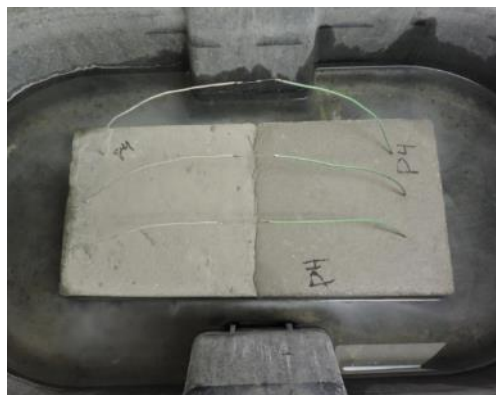
Figure 6.2. Typical small-scale corrosion testing specimen in the chloride solution

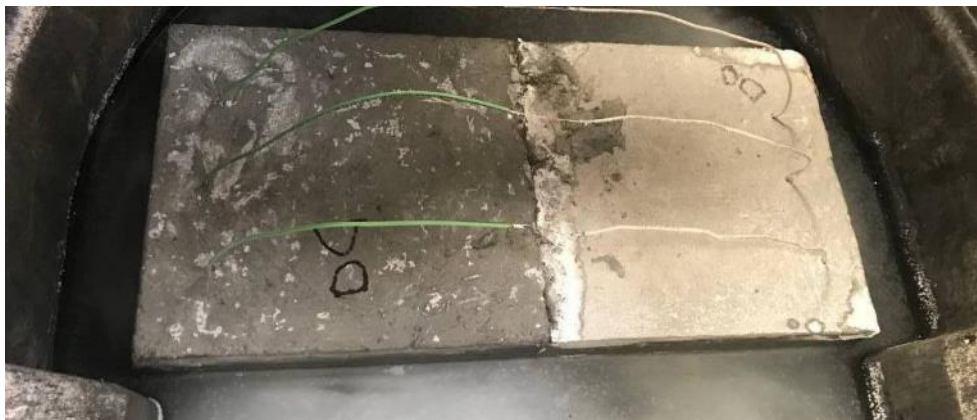
Figure 6.3. Initial joint corrosion in Ductal® small-scale corrosion testing specimen D0 - patching

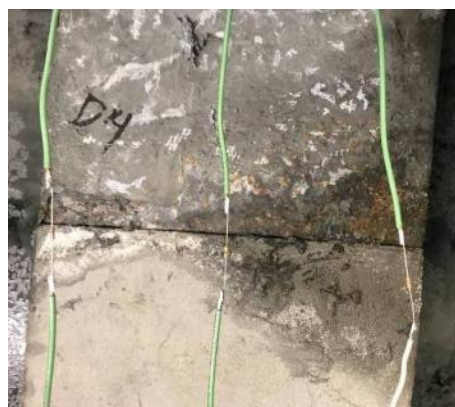
Figure 6.4. Initial joint corrosion in Ductal® small-scale corrosion testing specimen - corrosion spotting

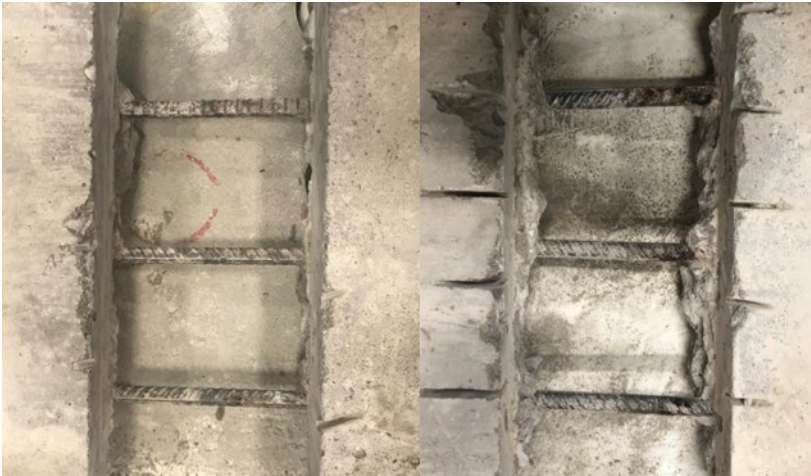
Figure 6.5. Corrosion state of rebar reinforcing at joint of ODOT Class AA small-scale corrosion specimens with 4% NaCl (left) and 8% NaCl (right)

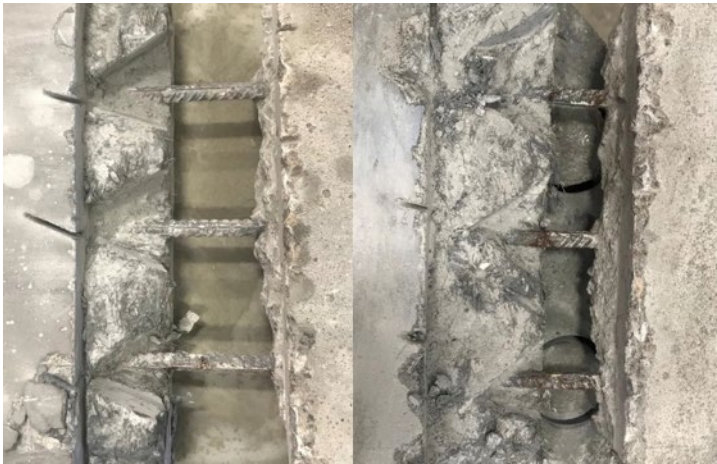
Figure 6.6. Corrosion state of rebar reinforcing at joint of J3 small-scale corrosion specimens with 4% NaCl (left) and 8% NaCl (right)

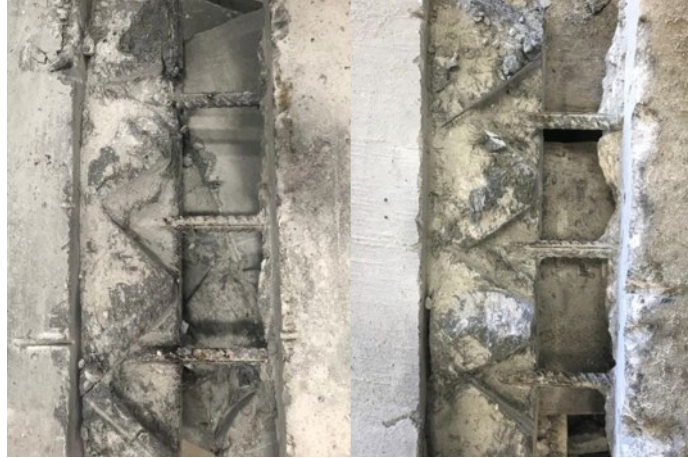
Figure 6.7. Corrosion state of rebar reinforcing at joint of Ductal® small-scale corrosion specimens with 4% NaCl (left) and 8% NaCl (right)

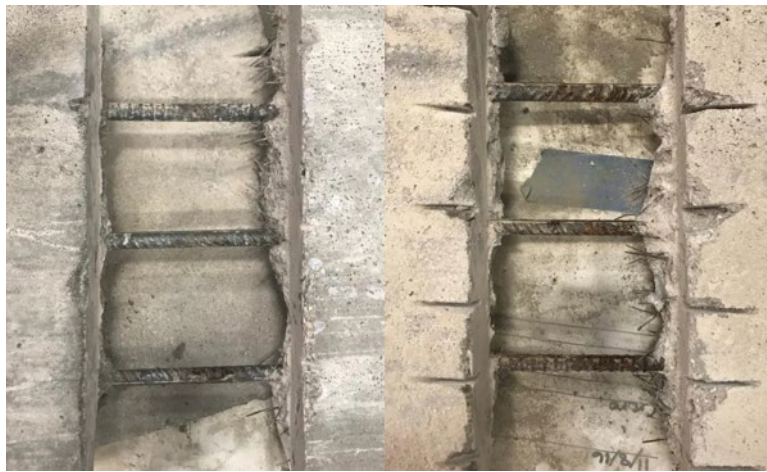
Figure 6.8. Corrosion state of rebar reinforcing at joint of Phoscrete® small-scale corrosion specimens with 4% NaCl (left) and 8% NaCl (right)

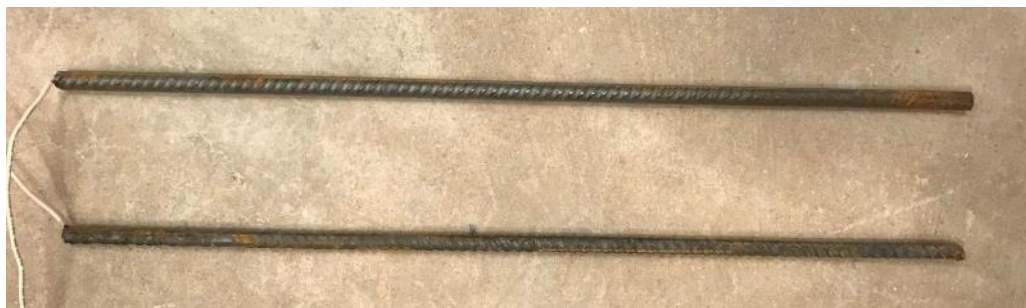
Figure 6.9. Steel rebar before testing - typical

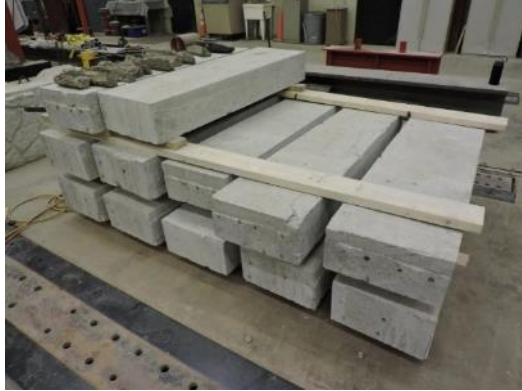
Figure 6.10. Large-scale corrosion joint specimens before chipping

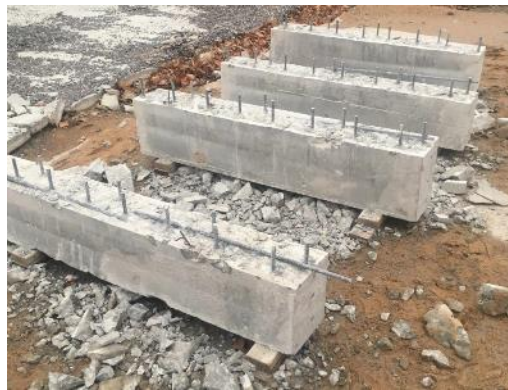
Figure 6.11. Large-scale corrosion joint specimens after chipping

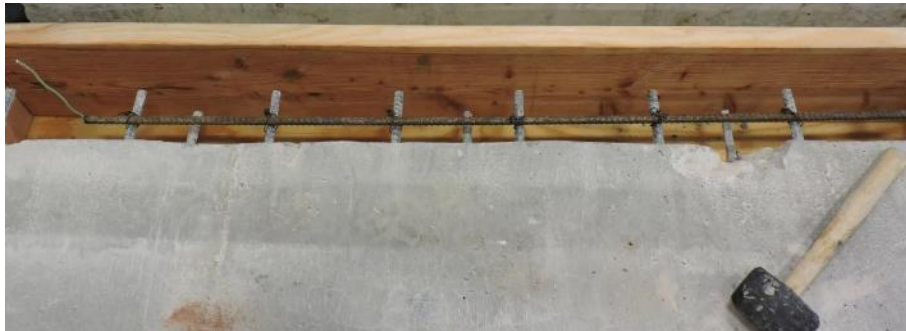
Figure 6.12. Large-scale corrosion joint specimen with longitudinal connection bar in place

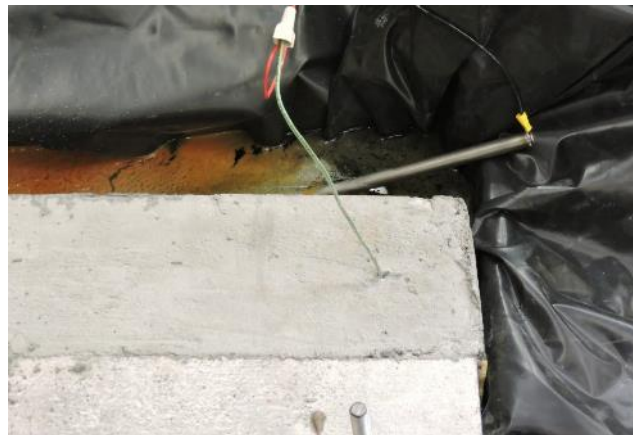
Figure 6.13. Stainless steel rod and electrical wiring for large-scale corrosion testing

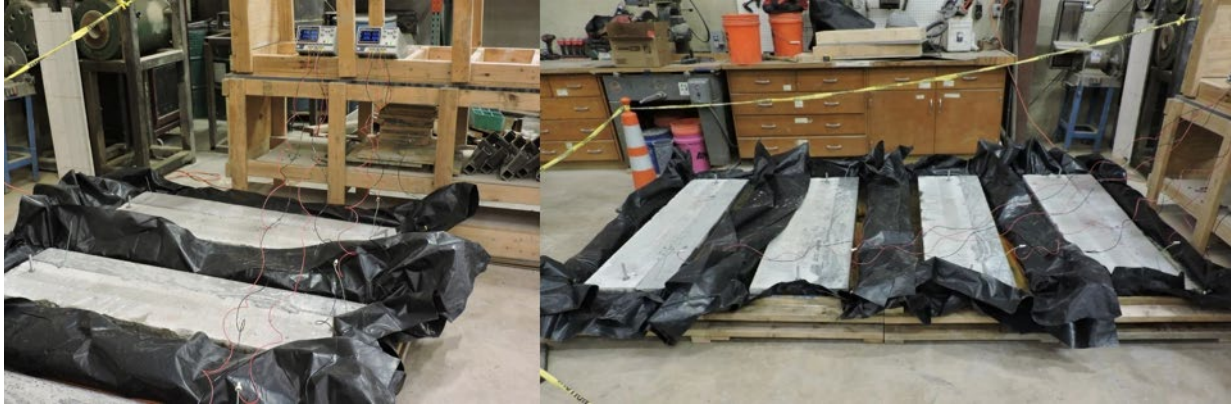
Figure 6.14. Large-scale corrosion testing setup showing power supplies (left) and all specimens in place (right)

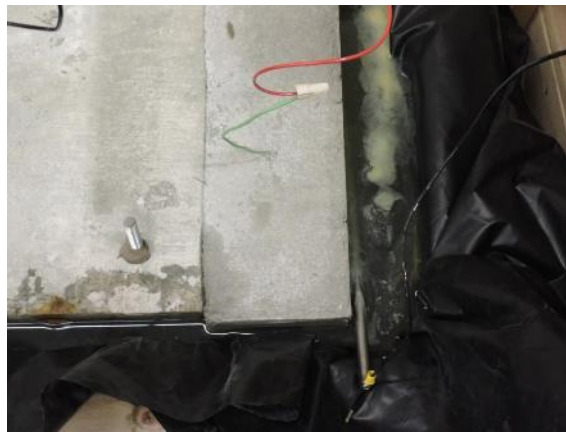
Figure 6.15. White film in water of Phoscrete large-scale corrosion specimen

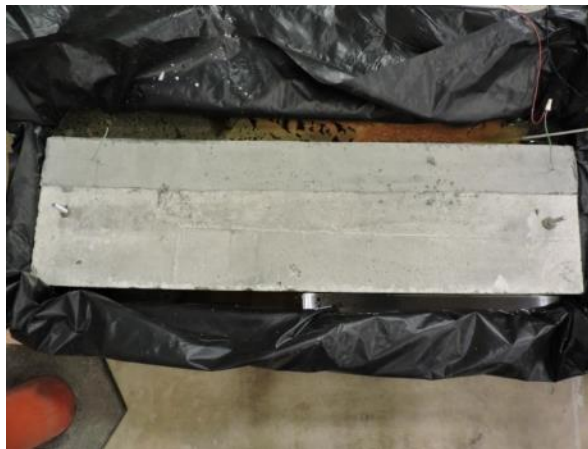
Figure 6.16. Corrosion in water of typical large-scale corrosion specimens

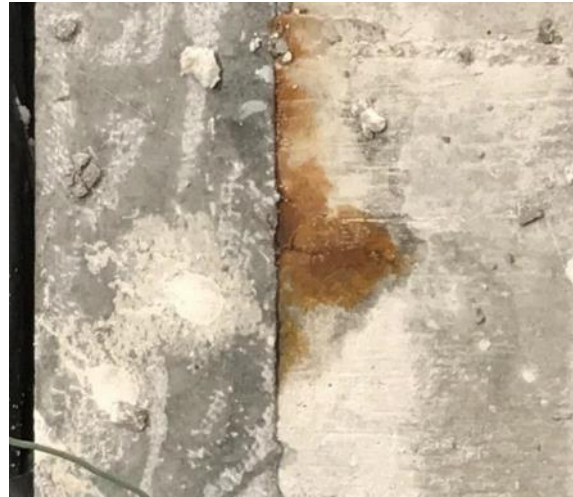
Figure 6.17. Joint corrosion in Ductal[®] large-scale corrosion testing specimen during week 2 of testing (Ductal[®] on left side of image)

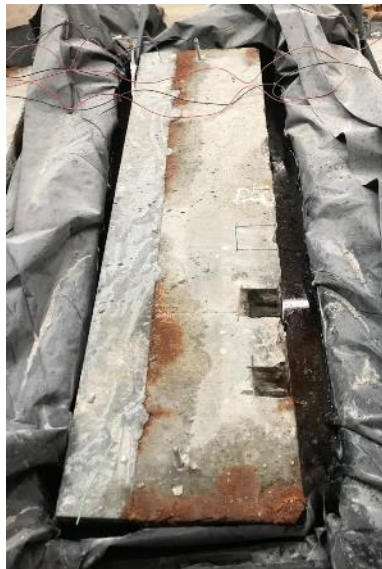
Figure 6.18. Joint corrosion in Ductal[®] large-scale corrosion specimen during week 5 of testing

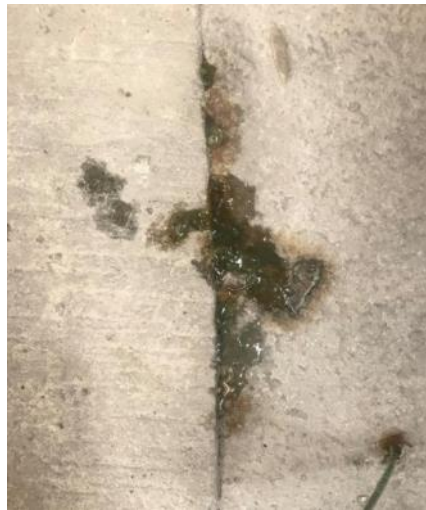
Figure 6.19. Green liquid in joint of Phoscrete large-scale corrosion specimen during week 7 of testing

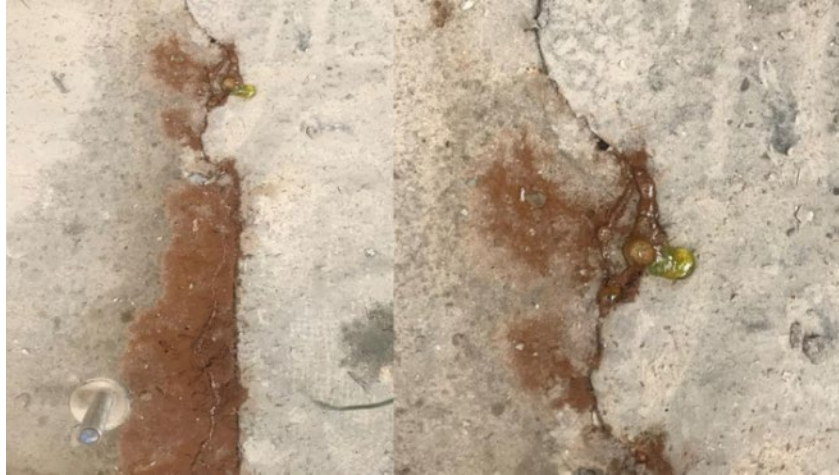
Figure 6.20. Green liquid in joint of Ductal® large-scale corrosion specimen during week 8 of testing

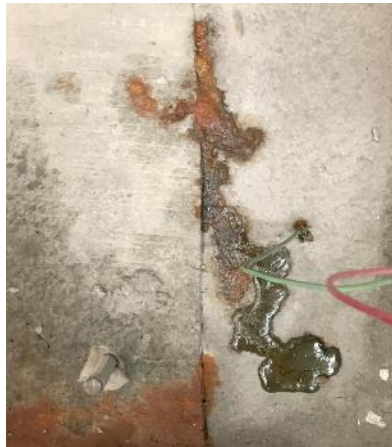
Figure 6.21. Green liquid in joint of Phoscrete® large-scale corrosion specimen during week 10 of testing

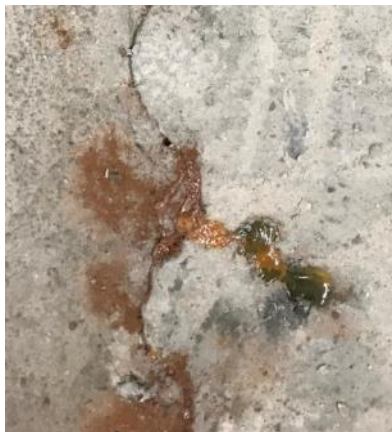
Figure 6.22. Green liquid in joint of Ductal® large-scale corrosion specimen during week 10 of testing

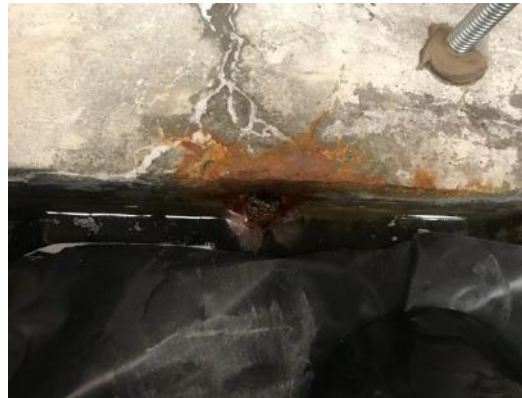
Figure 6.23. Visible confirmation of reinforcing bar corrosion during week 1

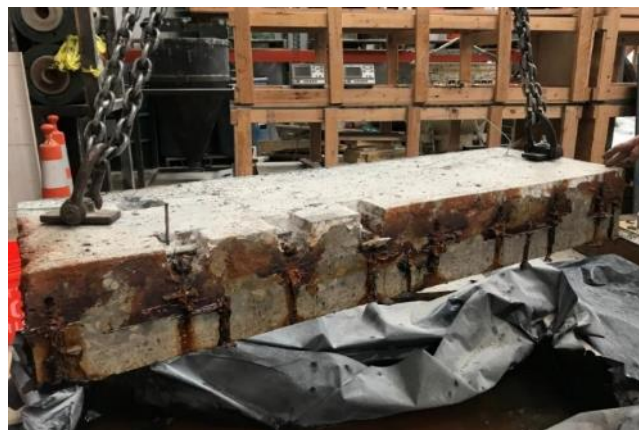
Figure 6.24. Typical reinforcing bar corrosion at the conclusion of testing - week 10

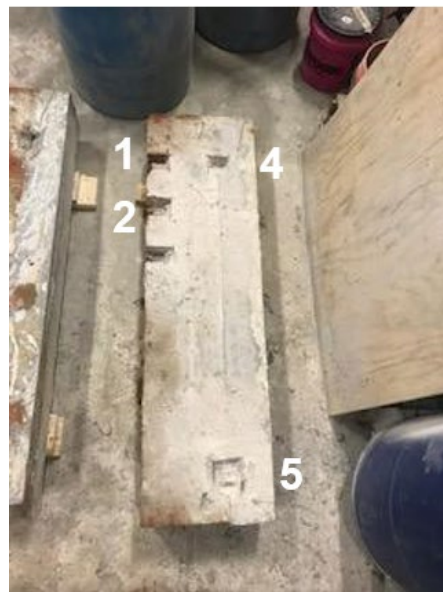
Figure 6.25. Chipping sequence of large-scale corrosion specimens

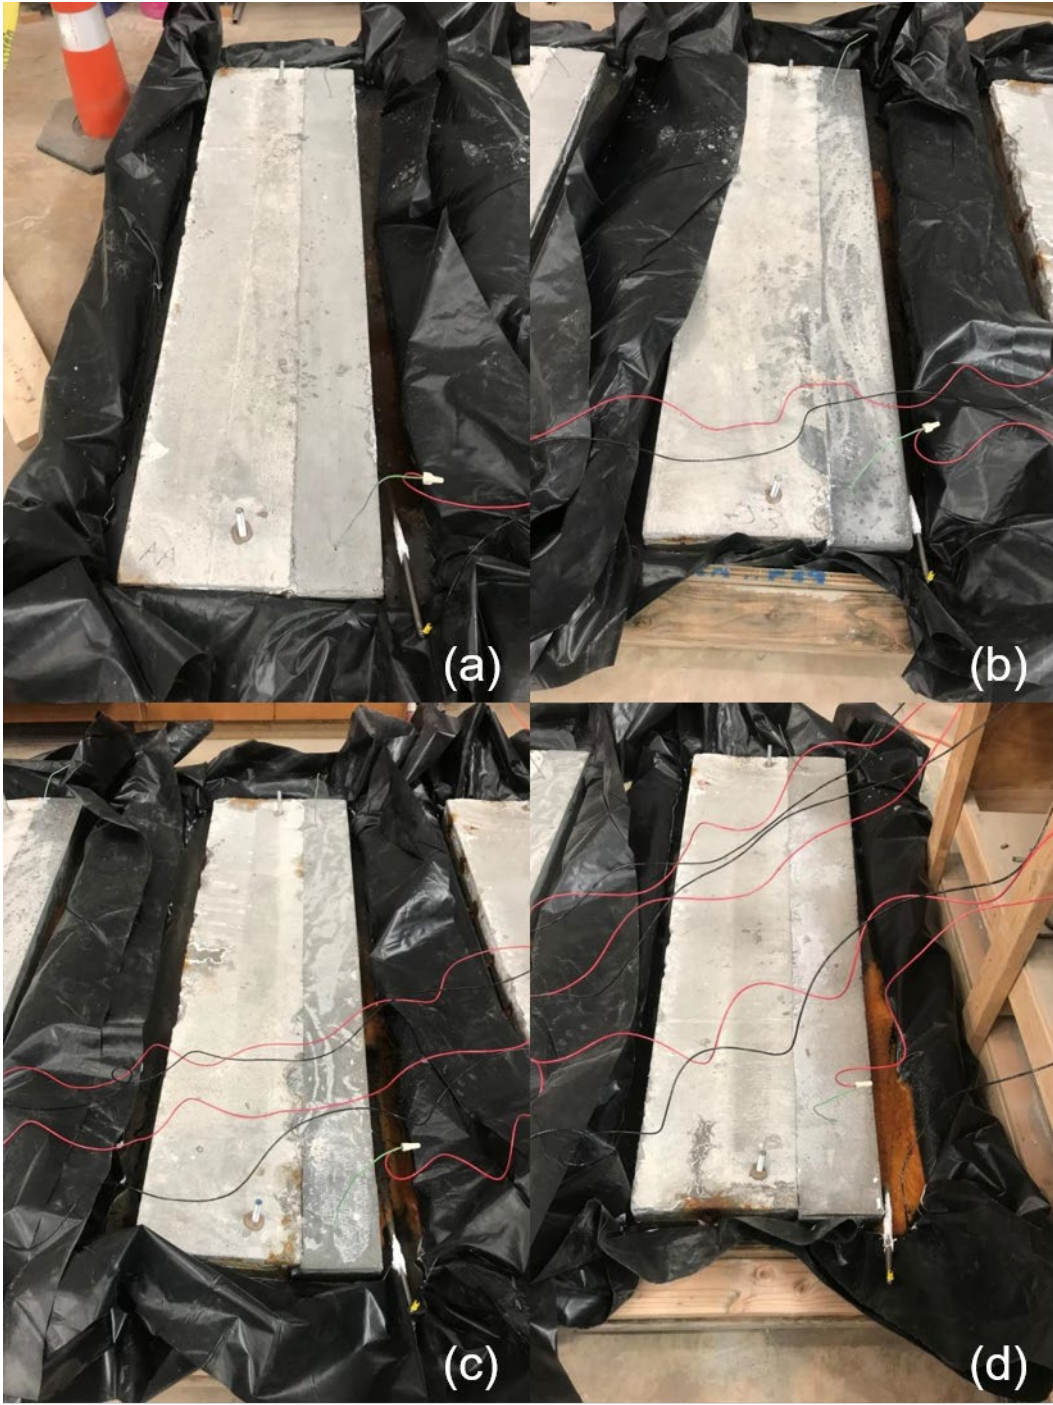
Figure 6.26. Week 1 update for large-scale corrosion specimens using (a) ODOT AA, (b) J3, (c) Ductal®, and (d) Phoscrete®

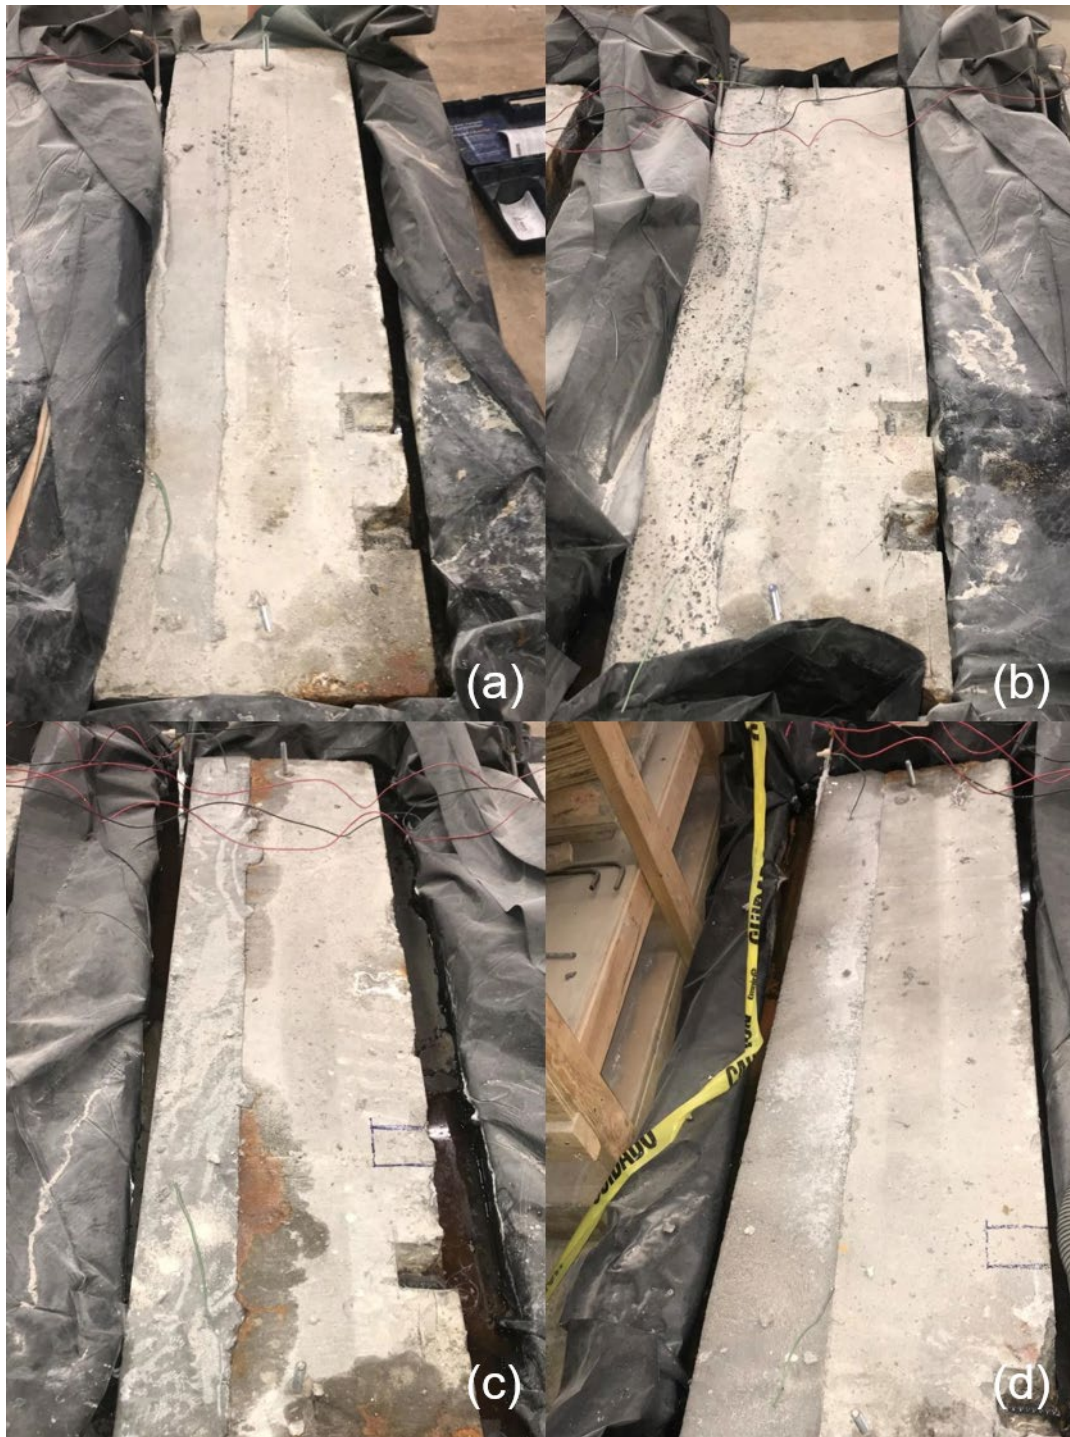
Figure 6.27. Week 3 update for large-scale corrosion specimens using (a) ODOT AA, (b) J3 (c) Ductal®, and (d) Phoscrete®

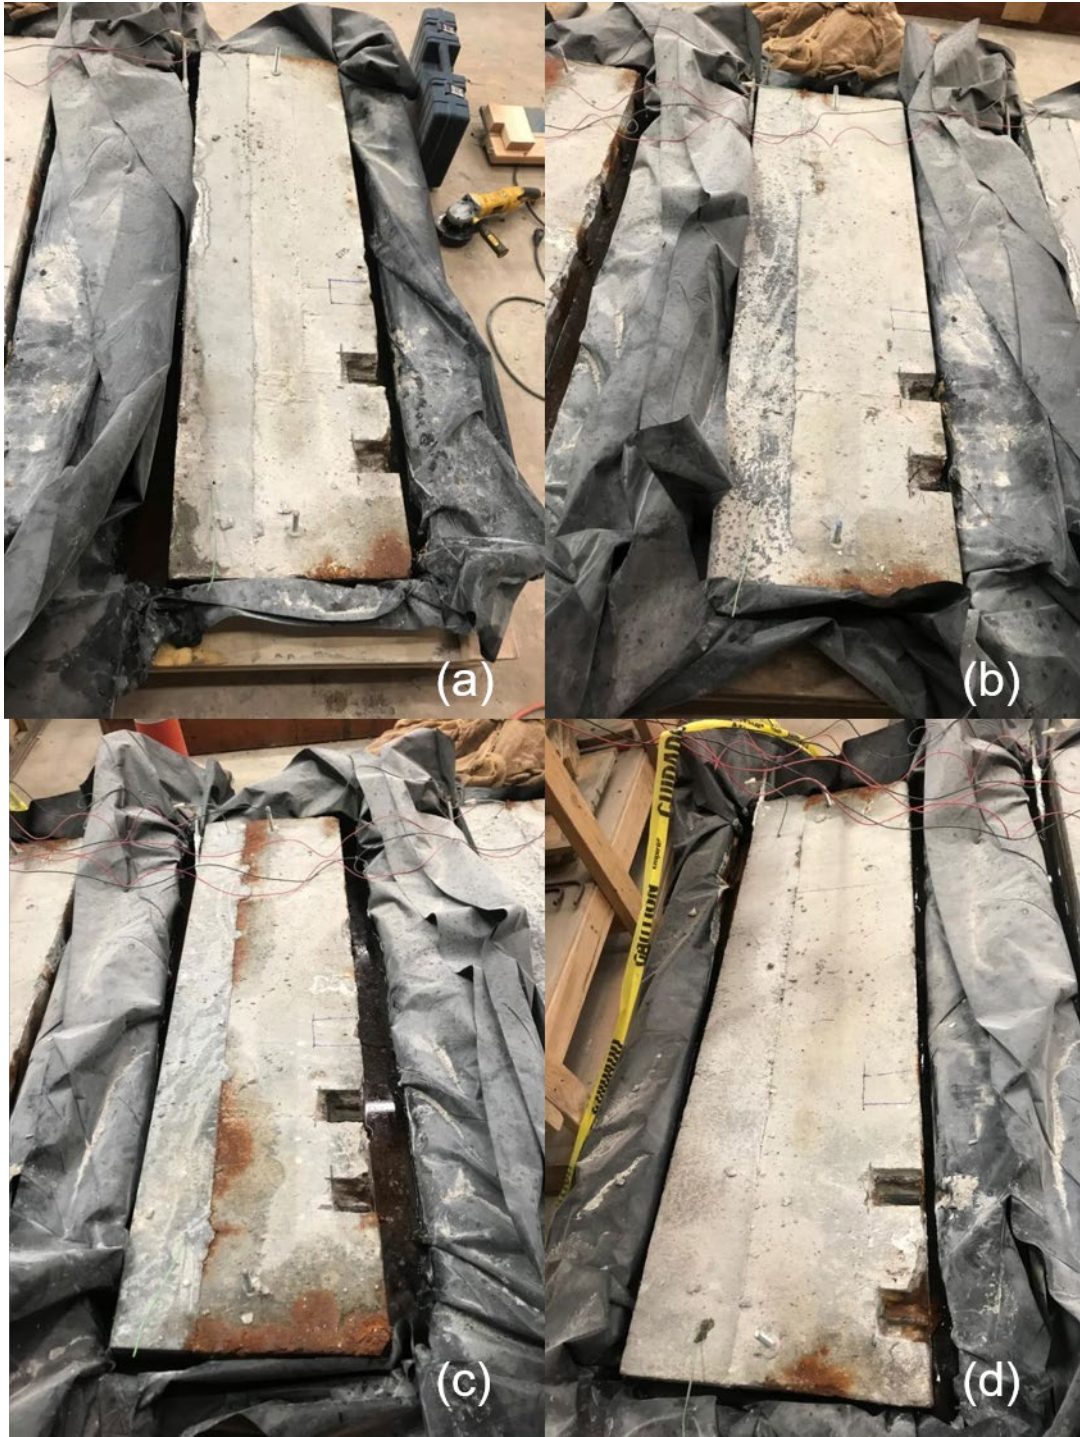
Figure 6.28. Week 6 update for large-scale corrosion specimens using (a) ODOT AA, (b) J3, (c) Ductal®, and (d) Phoscrete®

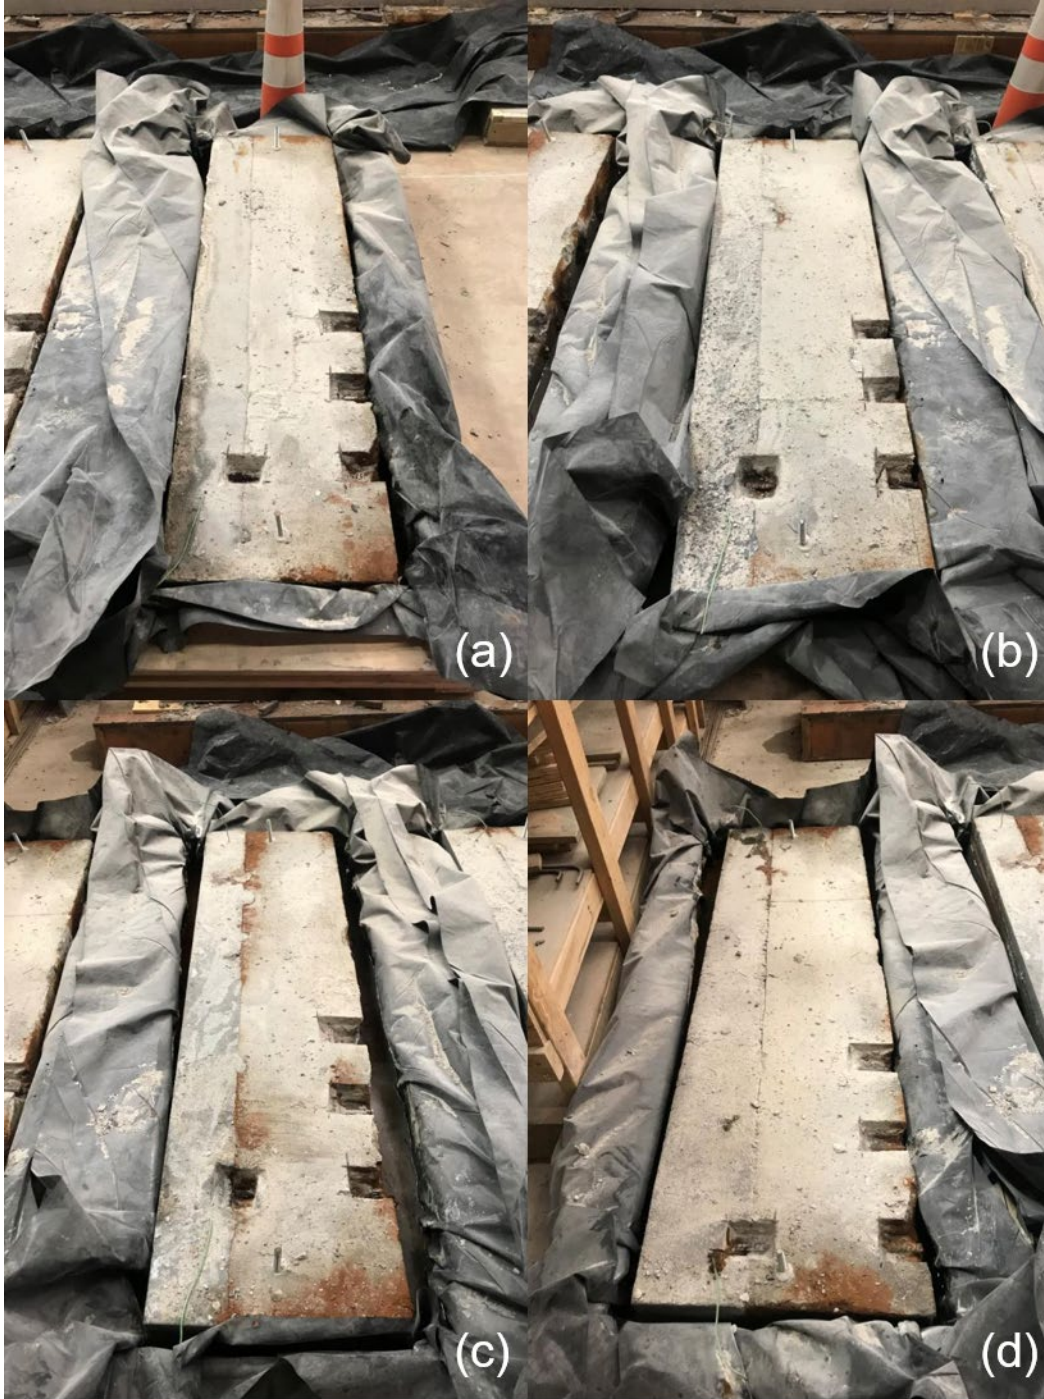
Figure 6.29. Week 10 update for large-scale corrosion specimens using (a) ODOT AA, (b) J3, (c) Ductal®, and (d) Phoscrete®

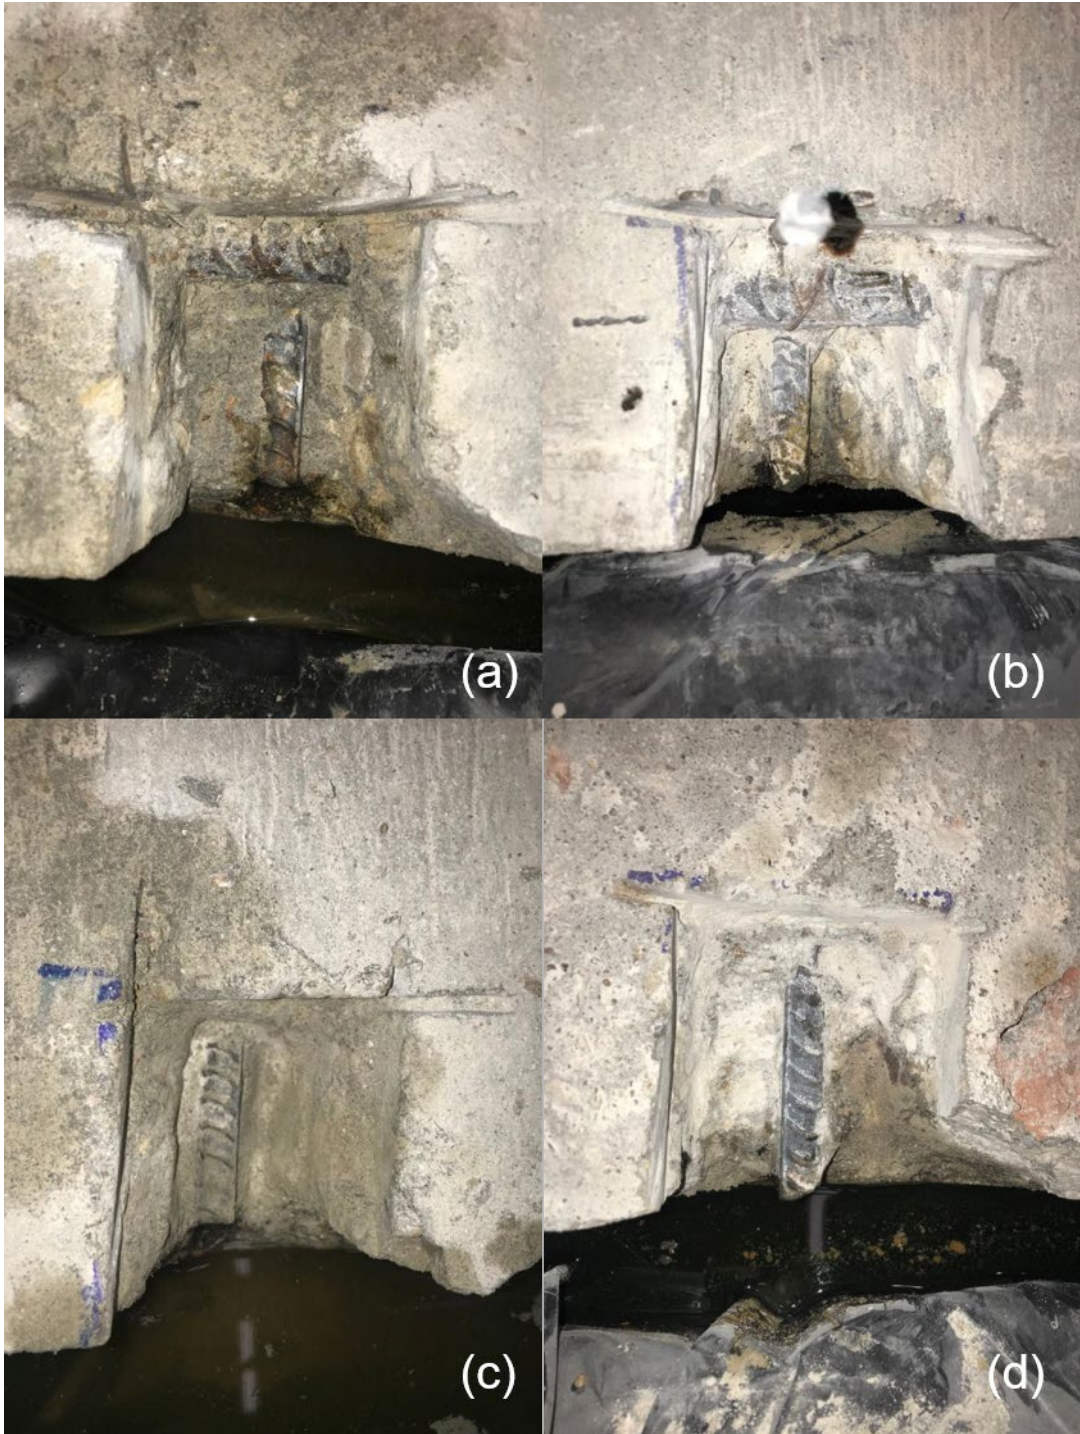
Figure 6.30. First rebar excavation for large-scale corrosion specimens using (a) ODOT AA, (b) J3, (c) Ductal®, and (d) Phoscrete®

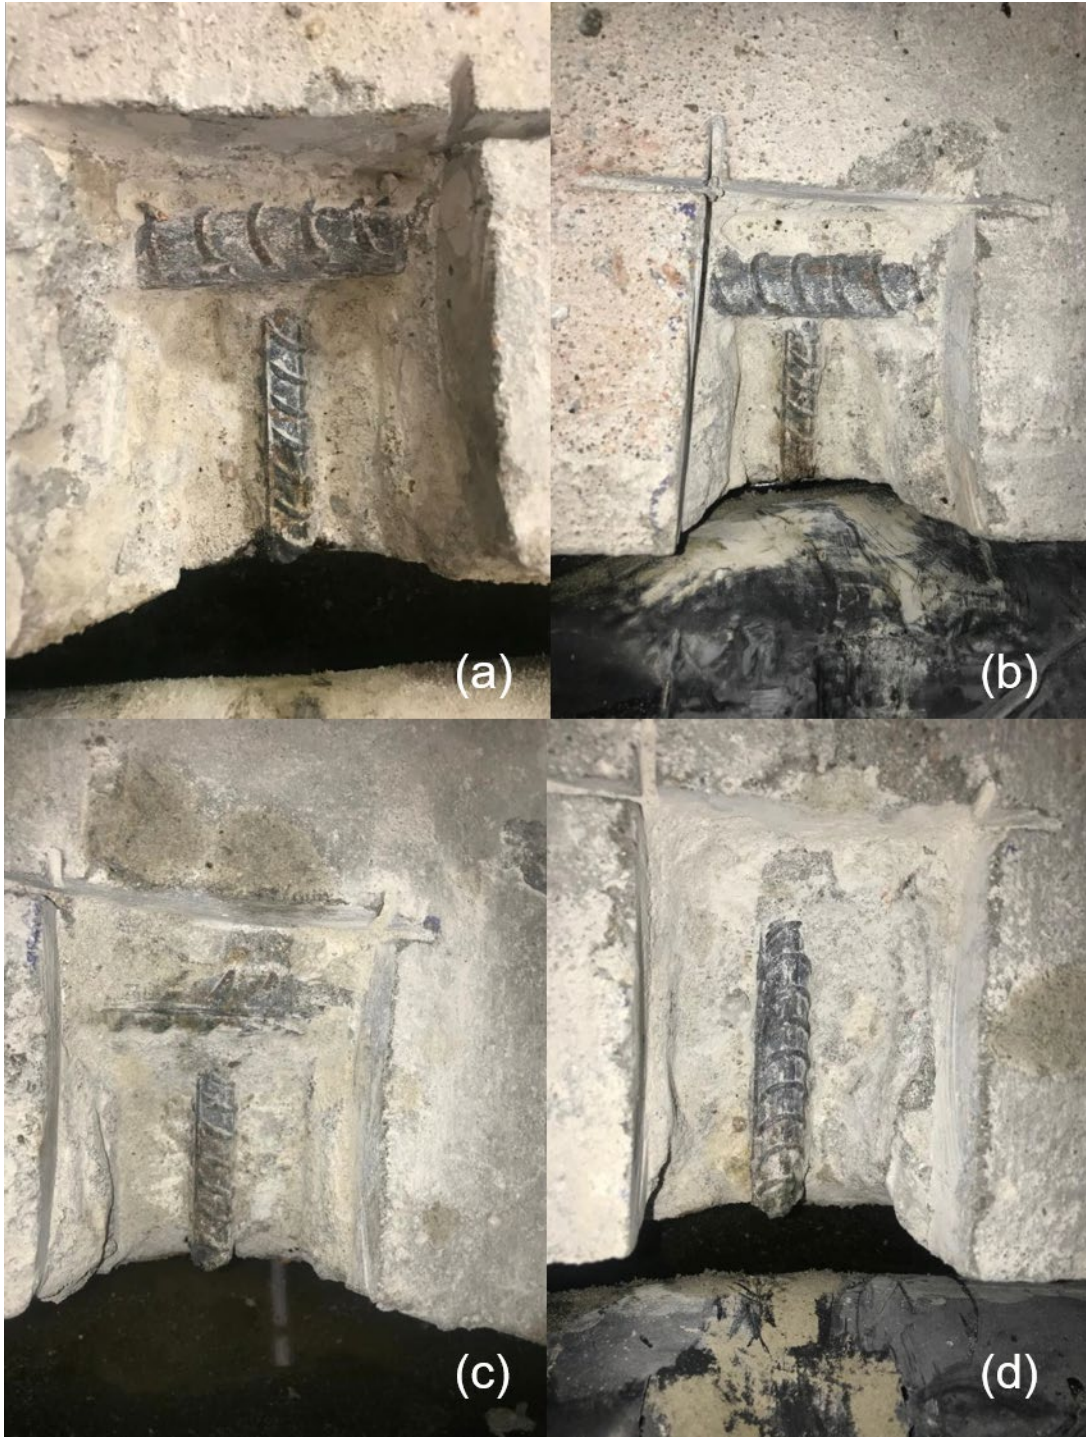
Figure 6.31. Second rebar excavation for large-scale corrosion specimens using (a) ODOT AA, (b) J3, (c) Ductal®, and (d) Phoscrete®

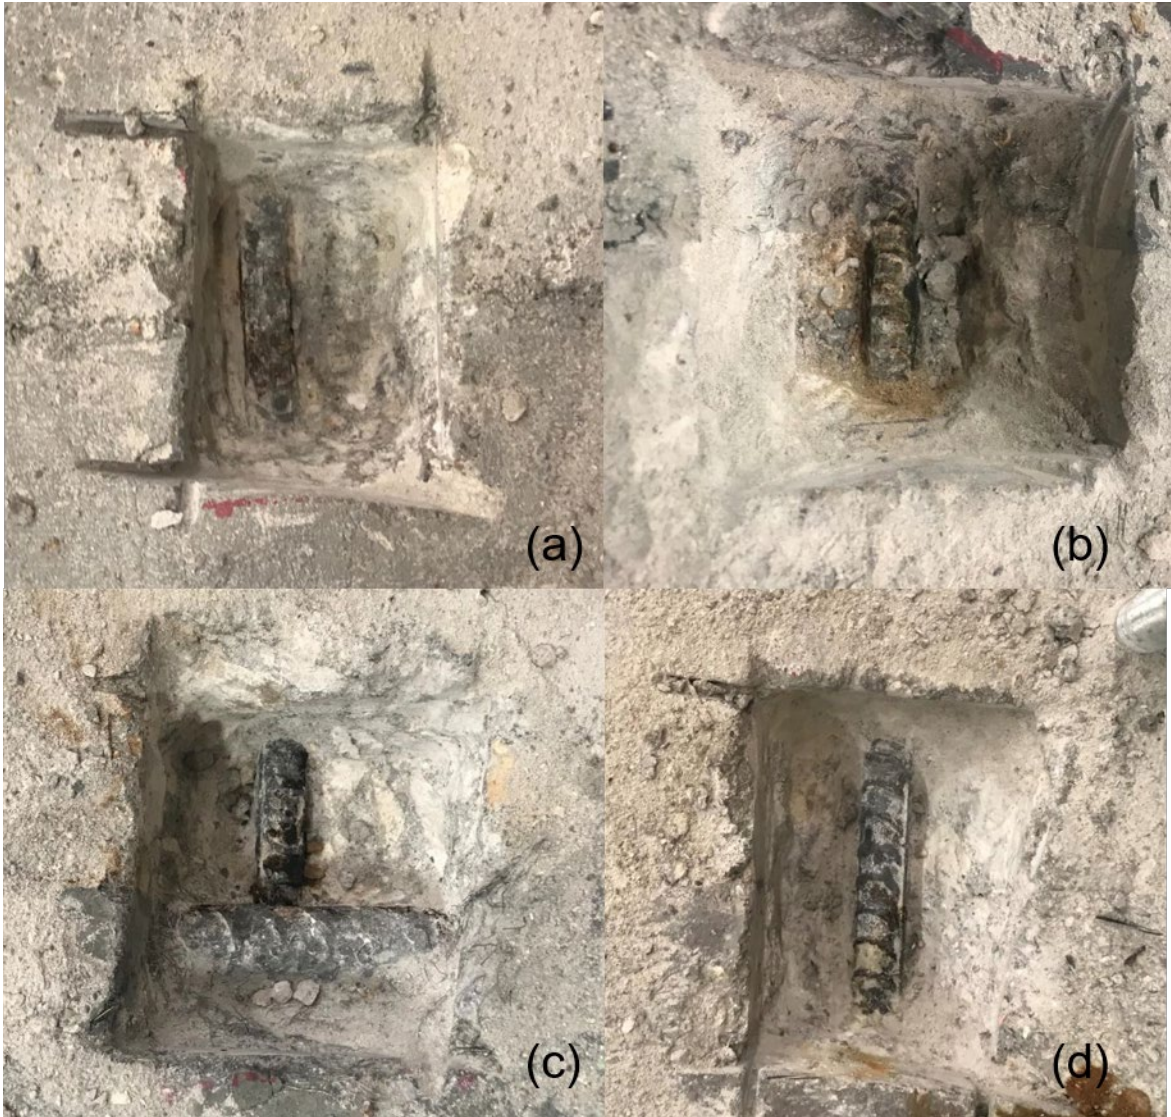
Figure 6.32. Fourth rebar excavation for large-scale corrosion specimens using (a) ODOT AA, (b) J3, (c) Ductal®, and (d) Phoscrete®

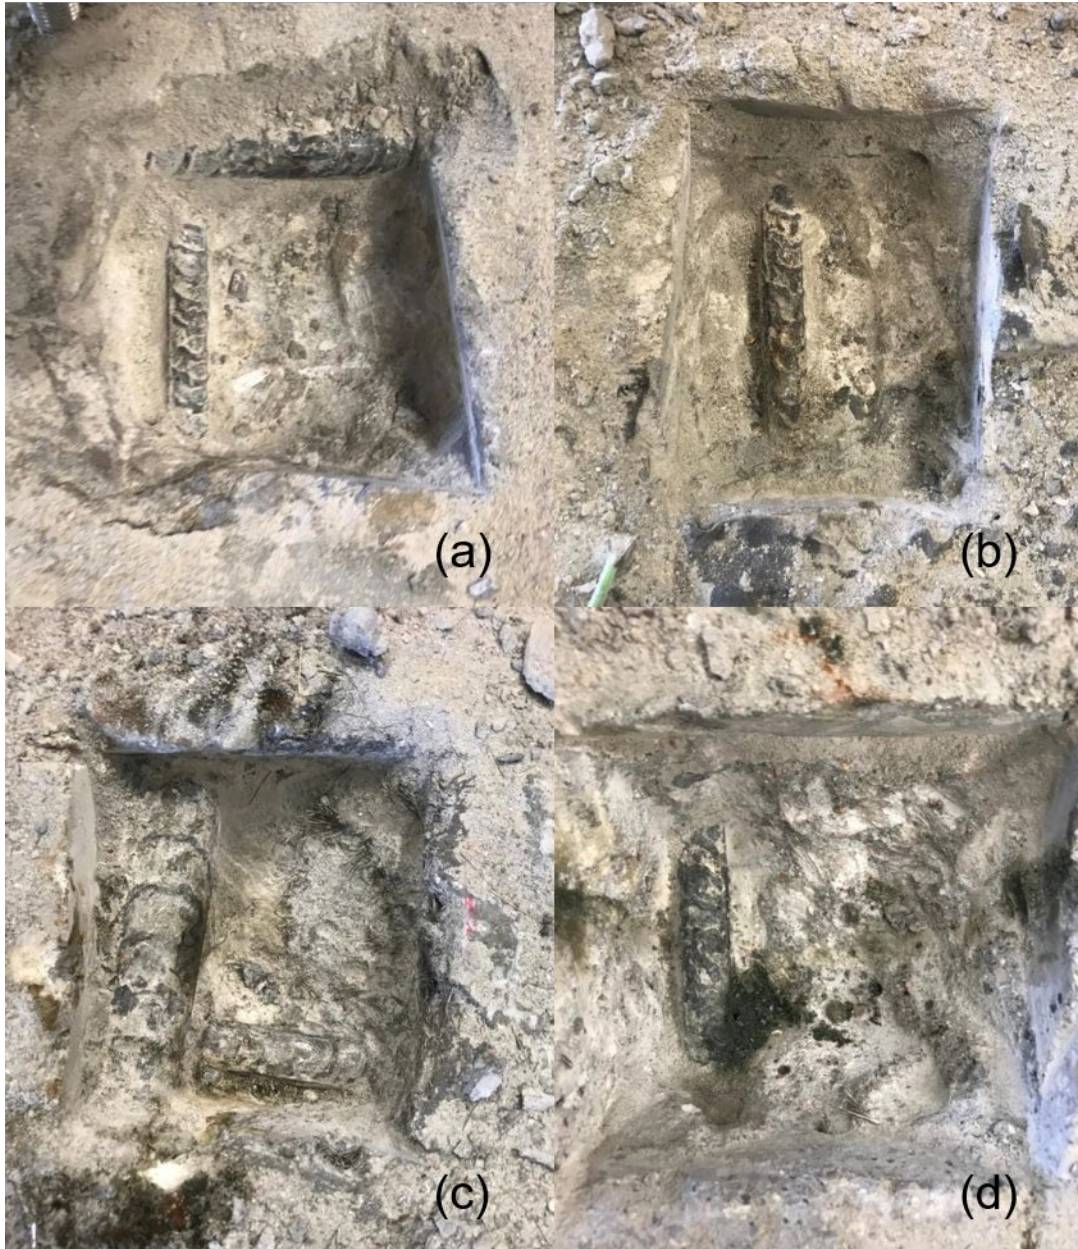
Figure 6.33. Fifth rebar excavation for large-scale corrosion specimens using (a) ODOT AA, (b) J3, (c) Ductal®, and (d) Phoscrete®
