FINAL REPORT ~ FHWA-OK-21-03

EVALUATION OF ULTRA-HIGH PERFORMANCE CONCRETE, FIBER REINFORCED SELF-CONSOLIDATING CONCRETE, AND MALP CONCRETE FOR PRESTRESSED GIRDER REPAIR

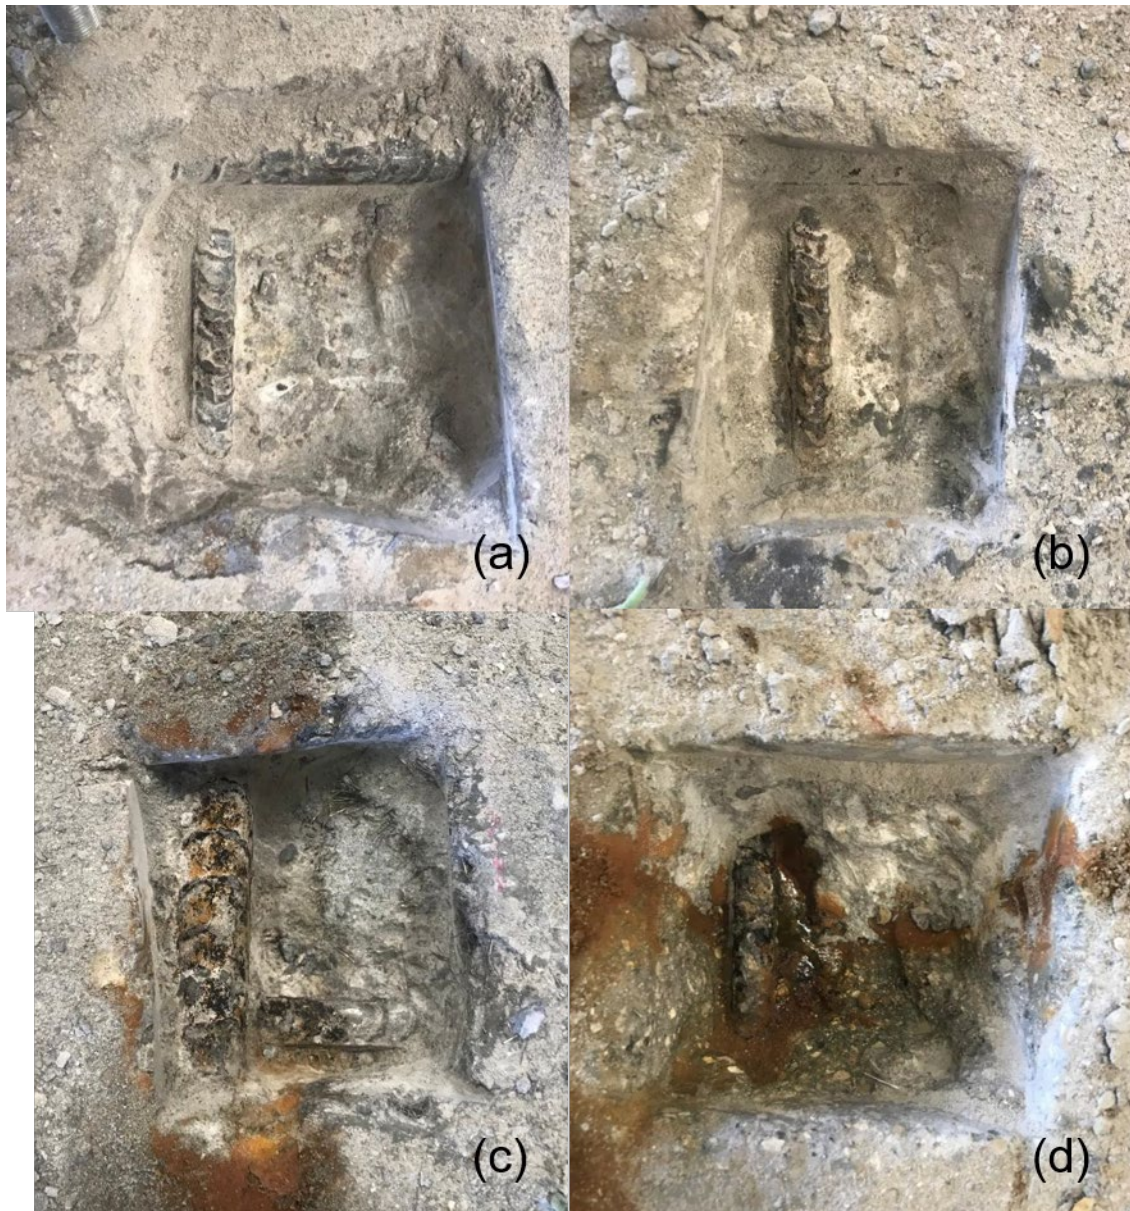
Figure 6.34. Fifth rebar excavation for large-scale corrosion specimens using (a) ODOT AA, (b) J3, (c) Ductal[®], and (d) Phoscrete[®] after 24 hours

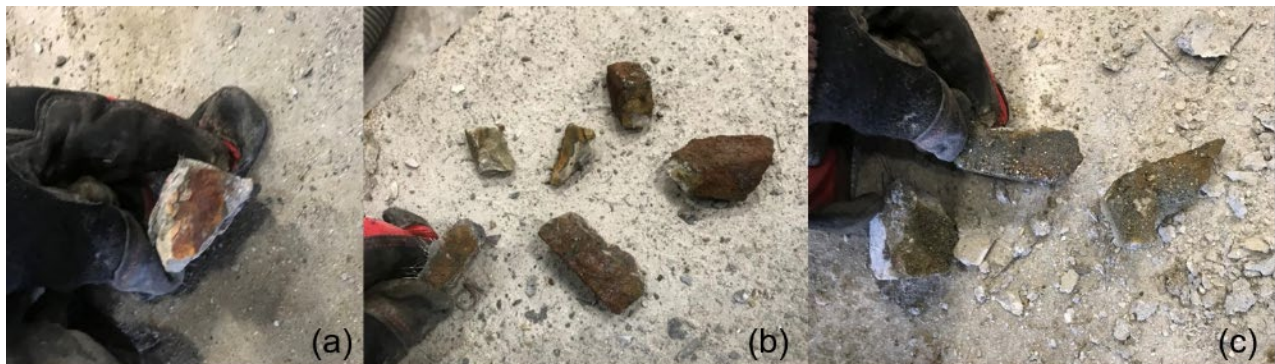
Figure 6.35. Evidence of surficial corrosion on large-scale corrosion specimens using (a) J3, (b) Ductal[®], and (c) Phoscrete[®]

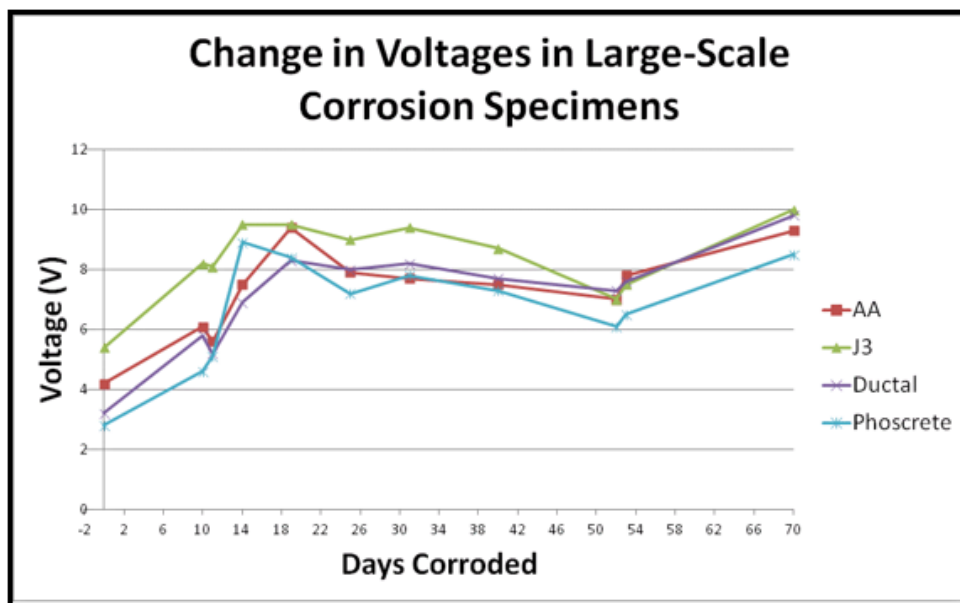
Figure 6.36. Change in voltage over time for all large-scale corrosion specimens

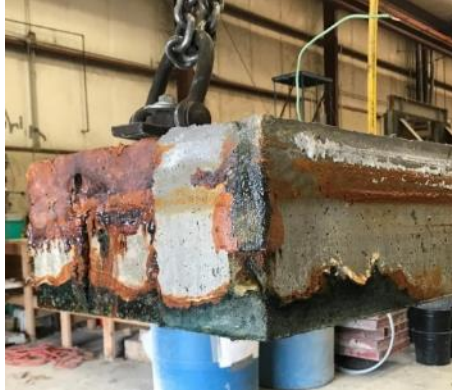
Figure 6.37. Final state of Phoscrete® large-scale corrosion specimen after week 10

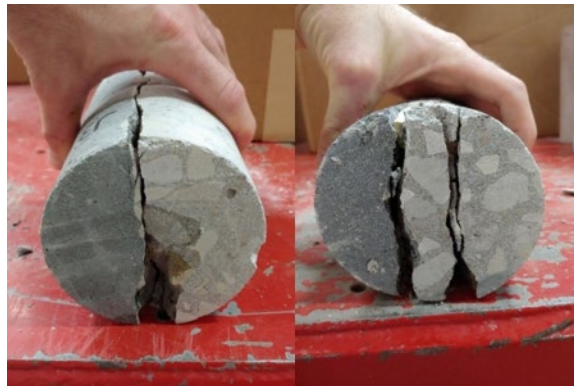
Figure 6.38. J3 (left) and Ductal® (right) split cylinder test specimens

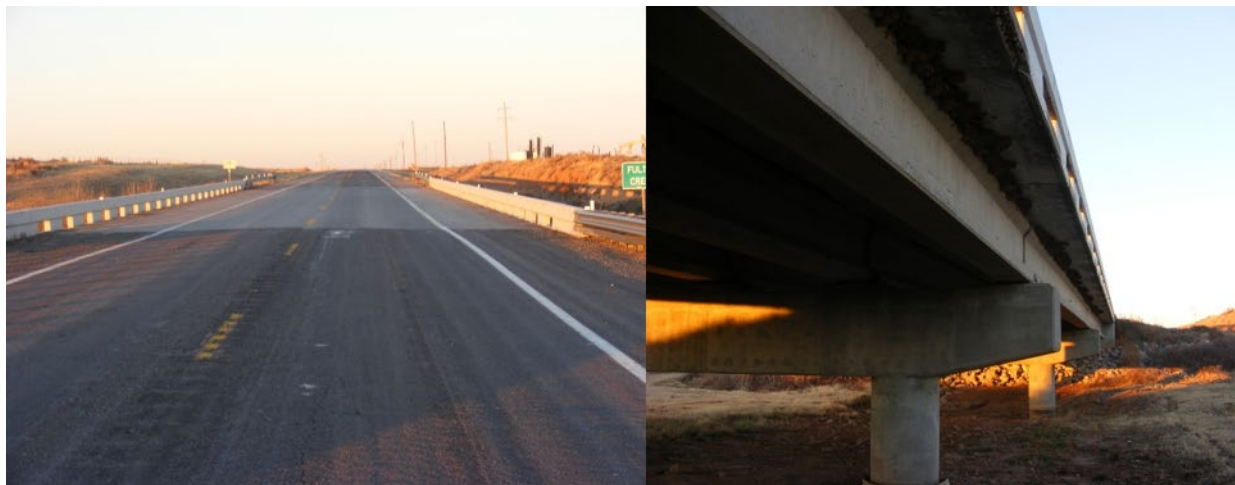
Figure 7.1. S.H. 3 bridge over Fulton Creek (NBI No.: 21700)

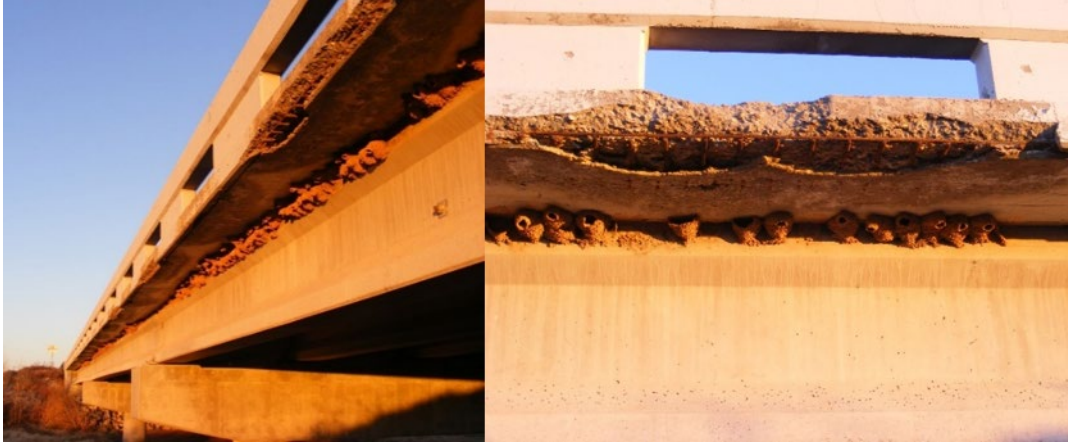
Figure 7.2. Typical spalling on slab cantilever of Fulton Creek bridge

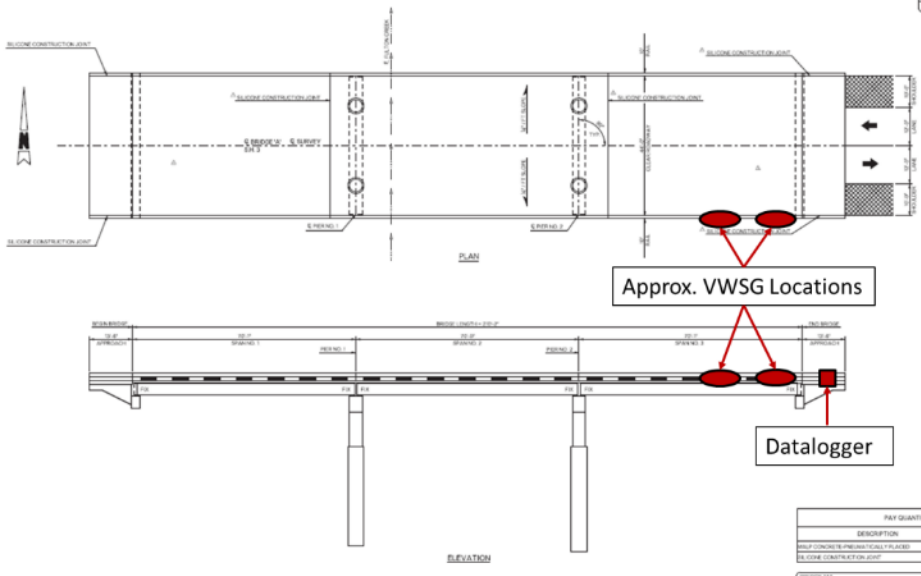
Figure 7.3. Approximate location of vibrating wire strain gauges for monitoring temperature and shrinkage of MALP concrete repair on SH-3 over Fulton Creek bridge

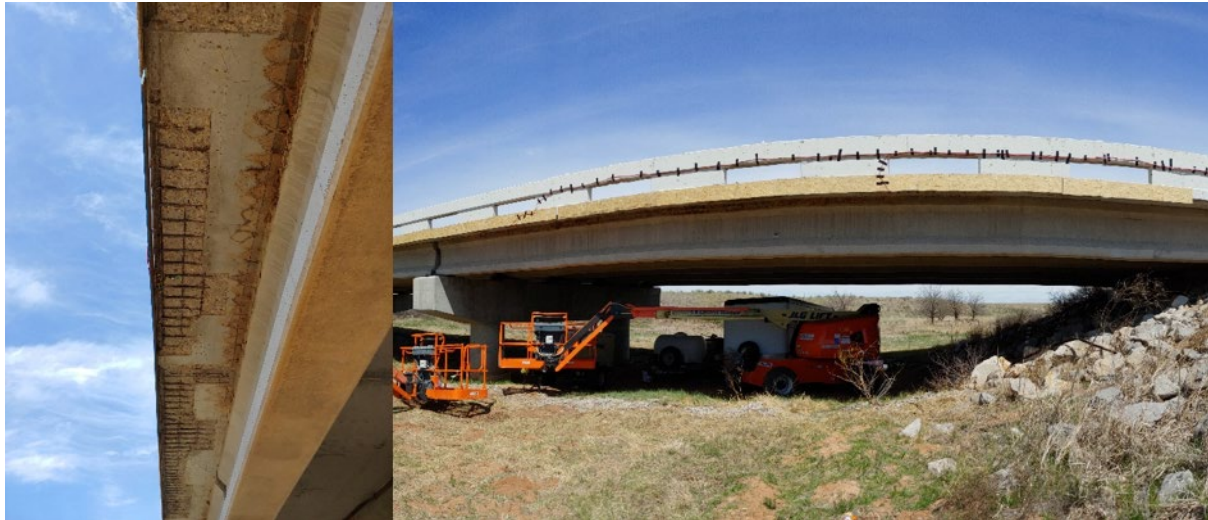
Figure 7.4. Slab cantilever section after removal of loose material (left) and forms in place for the repair (right)

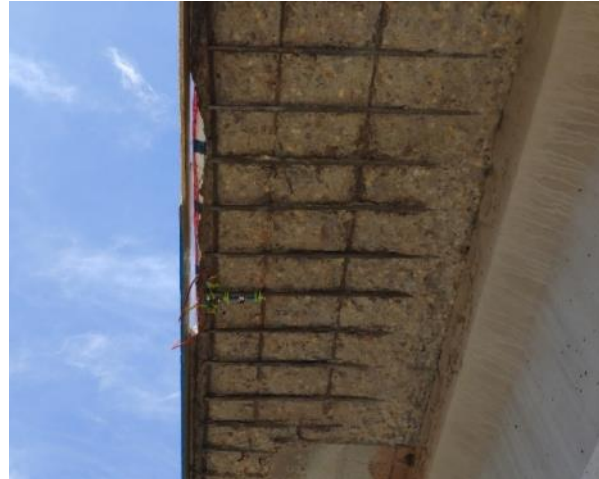
Figure 7.5. Strain gauge placement within the area to be repaired on the south side of span 3 of the S.H. 3 bridge over Fulton Creek in Beaver County

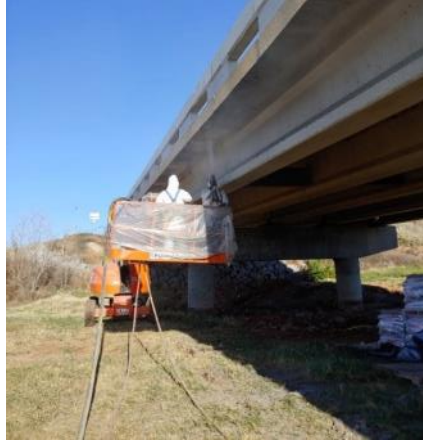
Figure 7.6. Placement of MALP mortar on the S.H. 3 bridge over Fulton Creek in Beaver County

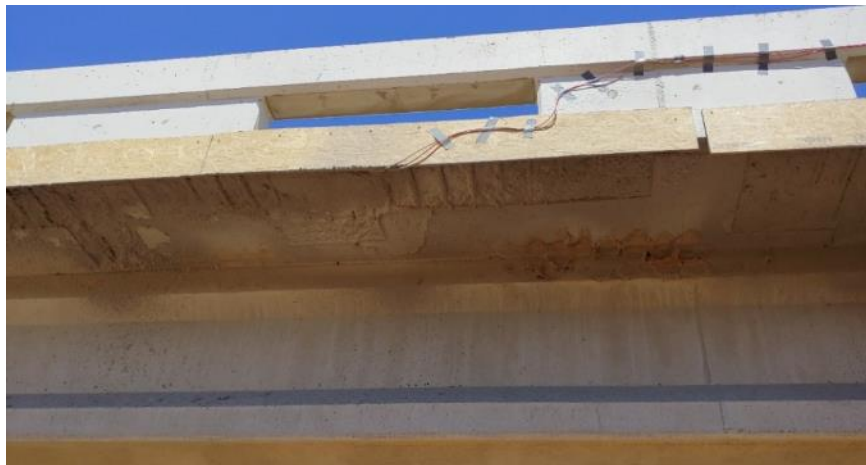
Figure 7.7. Repaired section at the location of the westernmost strain gages (Figure 7.4) after the first layer of MALP was placed

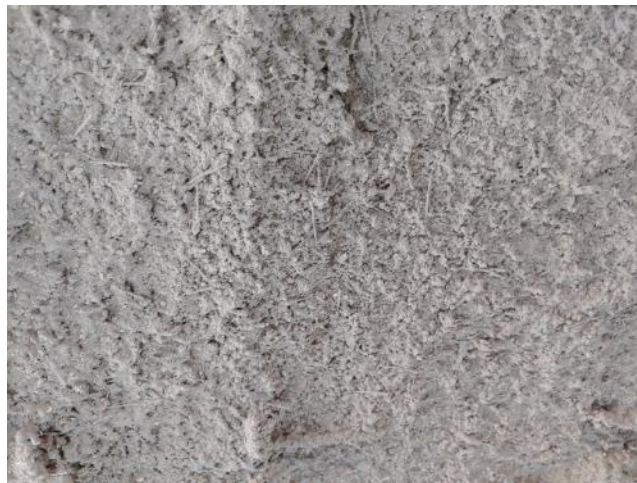
Figure 7.8. Close-up of MALP repair after placement of the first layer

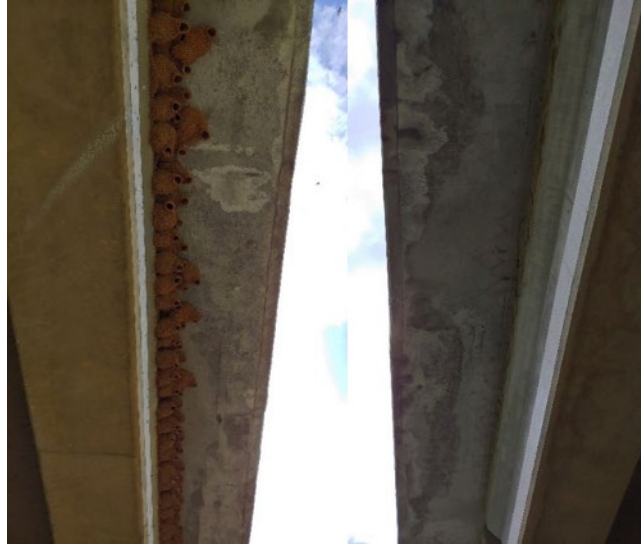
Figure 7.9. Close-up initial MALP placement on the southeast side (left) and later MALP placement on the northeast side (right) showing difference in surface finish of repair

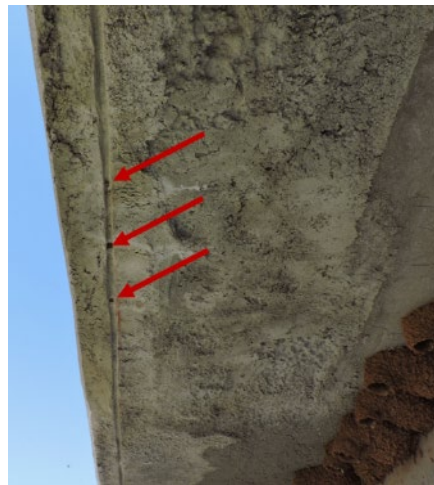
Figure 7.10. Rust spot in this section of MALP repair where drip edge was cut on the south side of the bridge

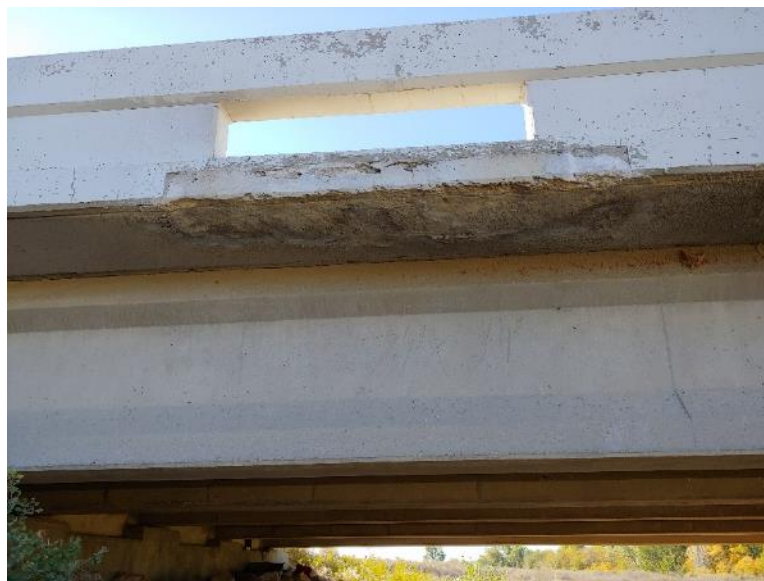
Figure 7.11. Repair spalling on the northeast side of the bridge 18 months after repair

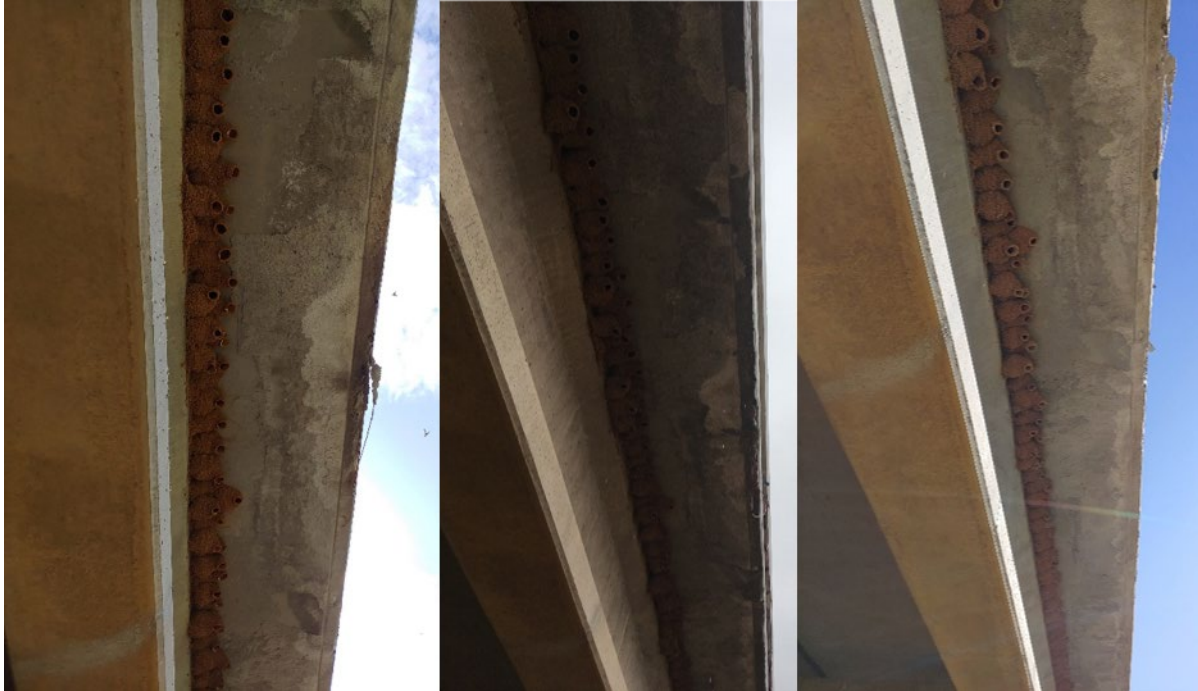
Figure 7.12. Section of completed MALP mortar repair on south side of span 3 of the S.H. 3 bridge over Fulton Creek in Beaver County near the west end of the span 3 months (left), 8 months (middle), and 18 months (right) after placement

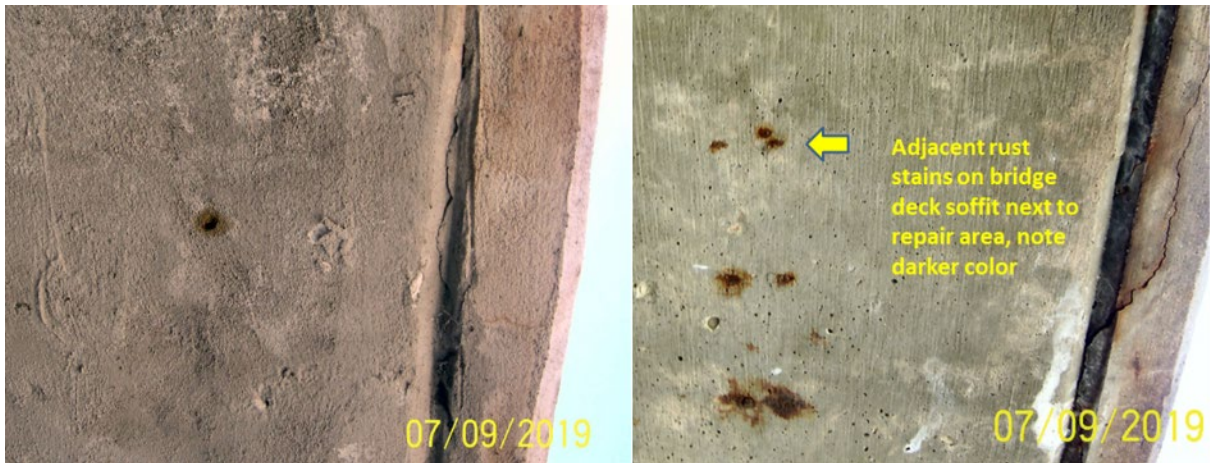
Figure 7.13. Rust spot within the MALP repaired area on the Packsaddle Bridge (NBI 21132) (left) and rust spots outside but near the repaired area (right). Photo courtesy of Walt Peters.

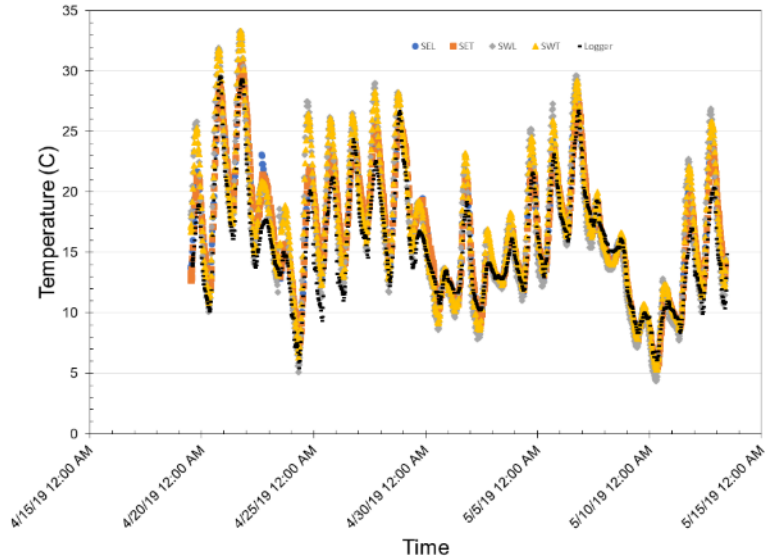
Figure 7.14. Temperature history of MALP repair material on Fulton Creek bridge over the first month in service.

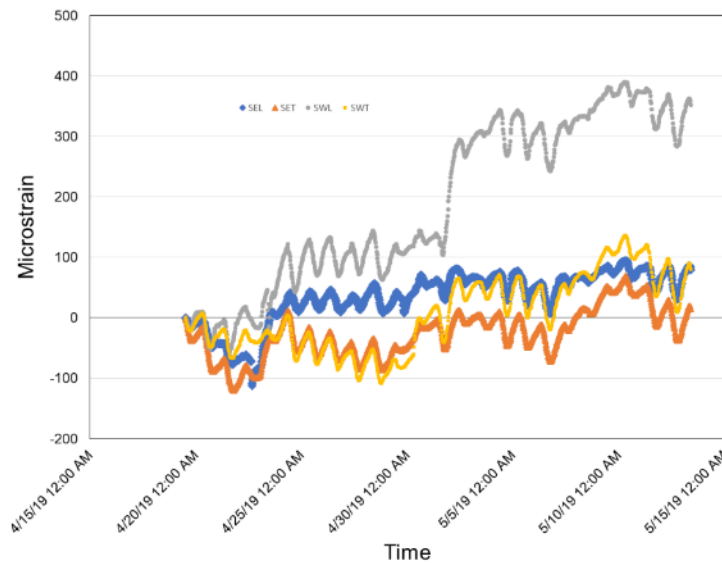
Figure 7.15. Measured strain over time for MALP repair material on Fulton Creek bridge over first month of service

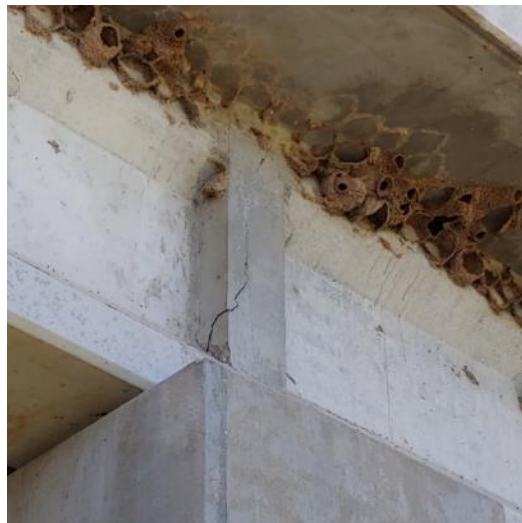
Figure 7.16. Example of positive moment cracking in a continuity joint of the U.S. 183/412 bridge over Wolf Creek

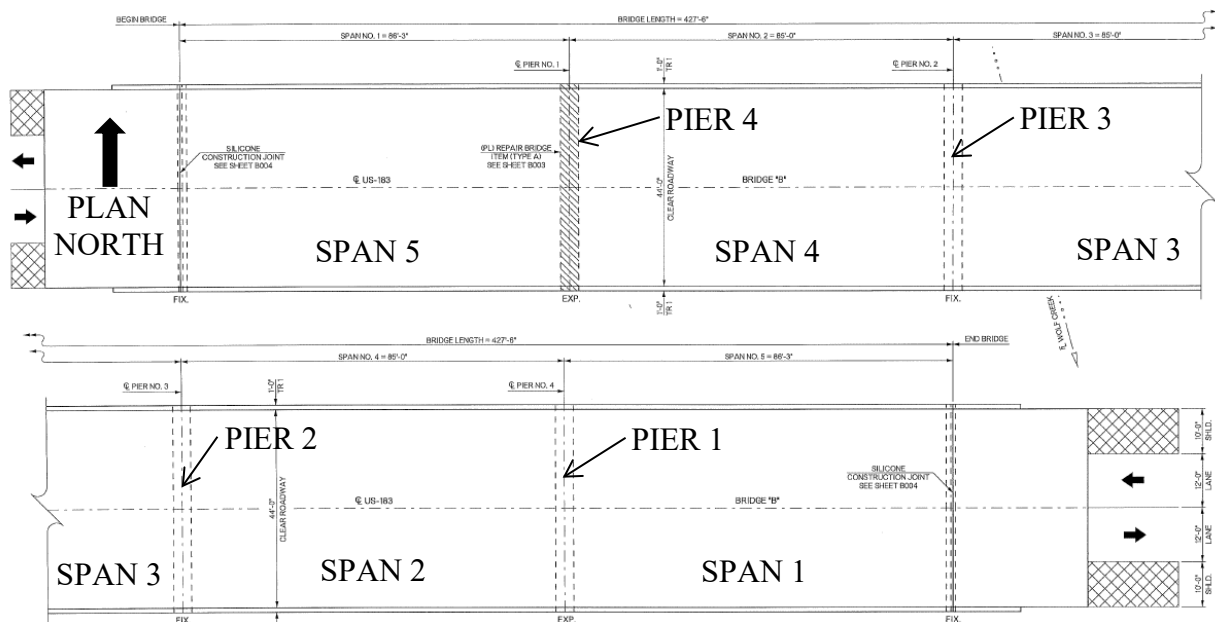
Figure 7.17. Plan view of U.S. 183/412 over Wolf Creek bridge

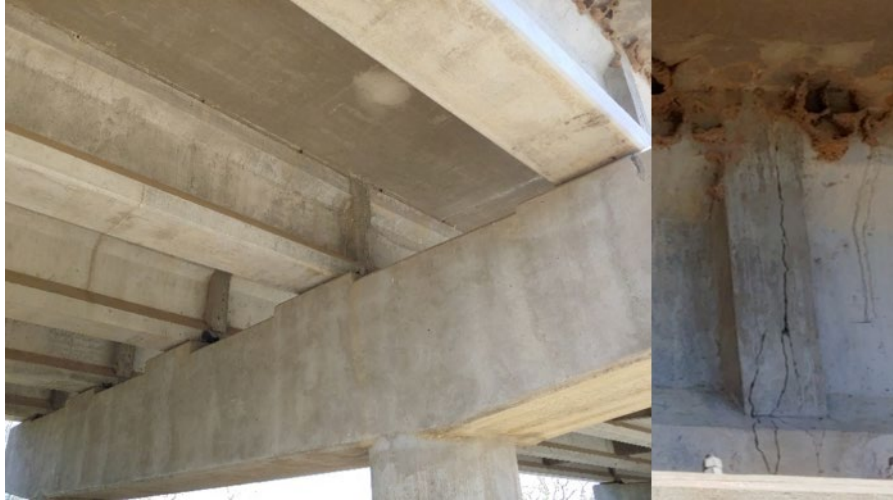
Figure 7.19. Joints at pier 3 prior to repair (left) and typical damage (right)

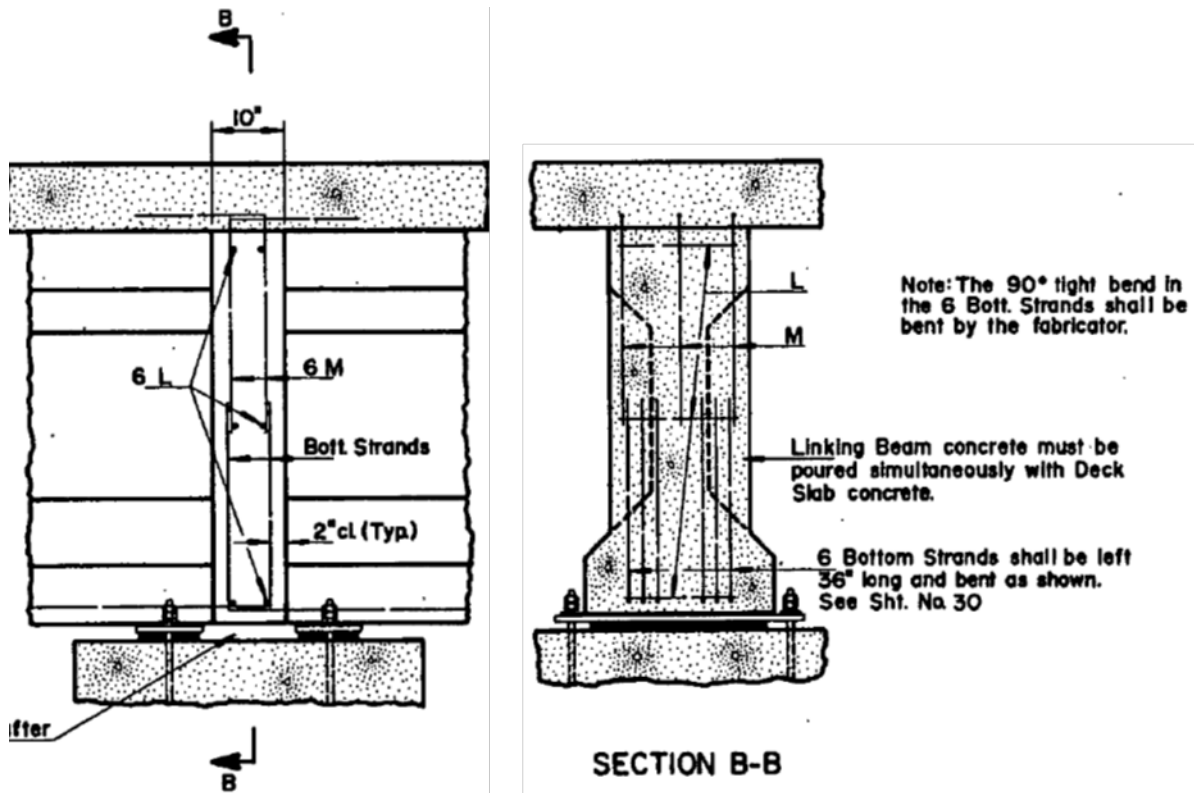
Figure 7.20. U.S. 183/412 over Wolf Creek continuity joint details from original drawings

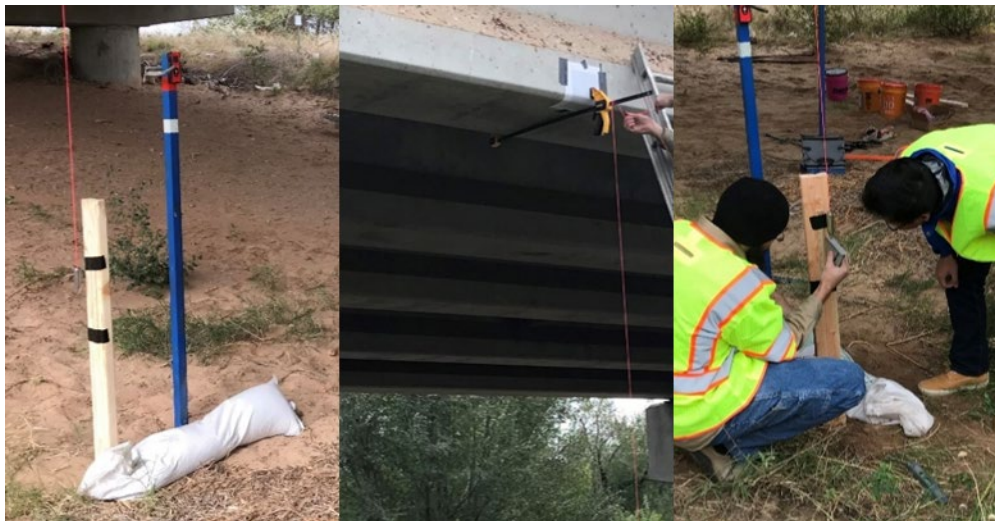
Figure 7.21. Laser measurer and plumb bob setup (left), clamp on the girder bottom (middle), and method used for measurement with the plumb bob (right)

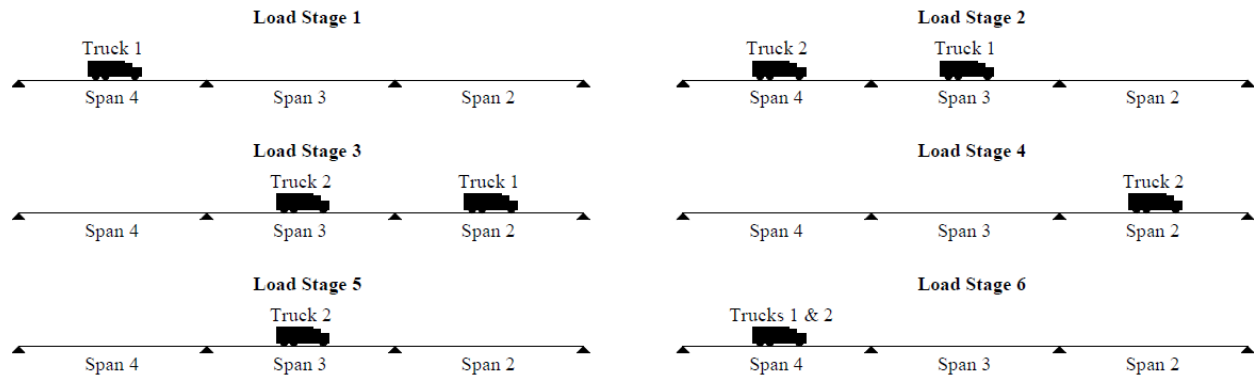
Figure 7.22. Truck locations for each load stage

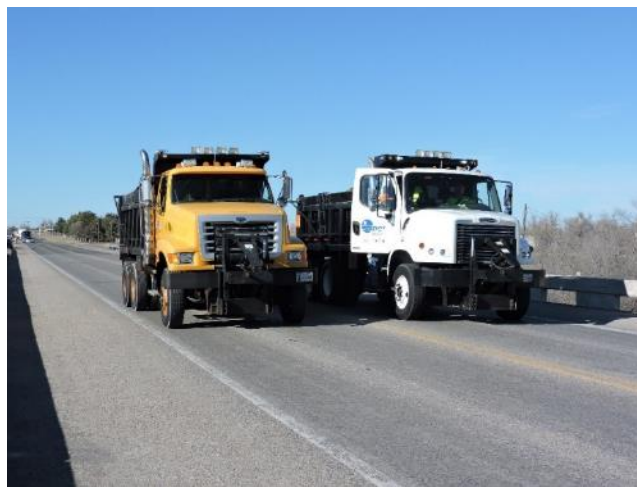
Figure 7.23. Trucks located for Load Stage 6

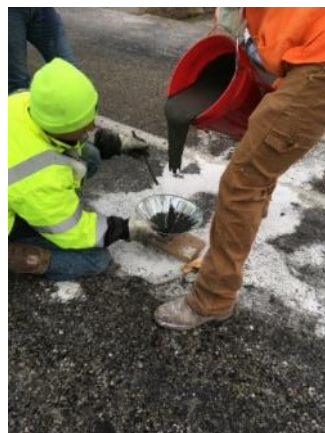
Figure 7.27. Placement of UHPC into fill hole in the bridge deck

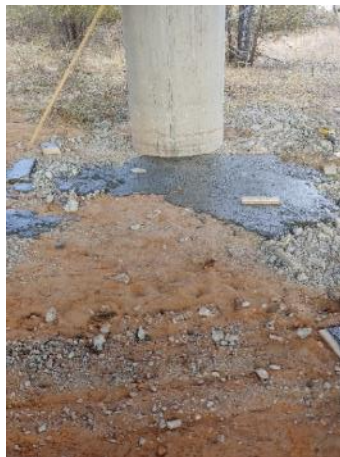
Figure 7.28. UHPC from failed formwork

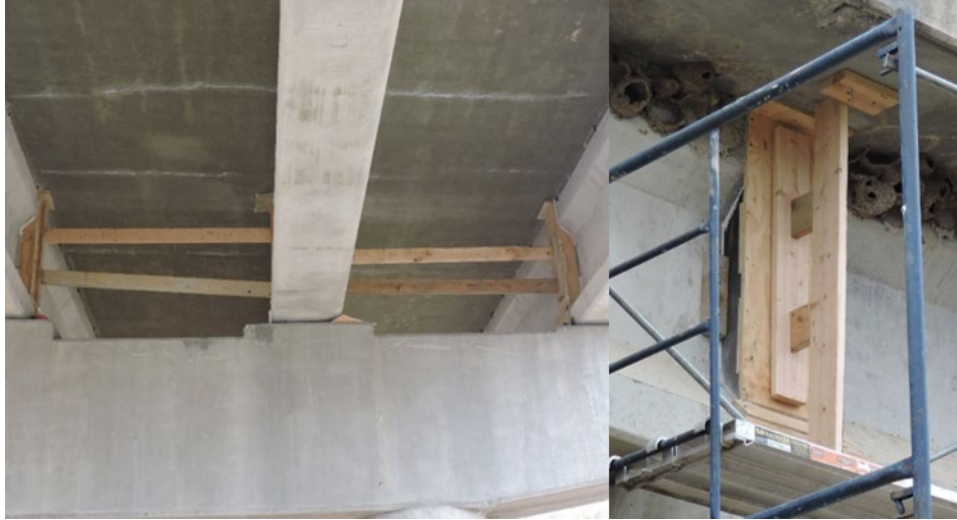
Figure 7.29. Final joint forms after adding bracing

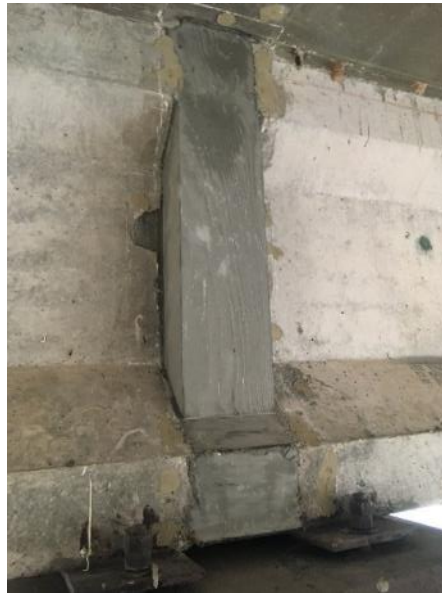
Figure 7.30. Completed UHPC continuity joint after form removal

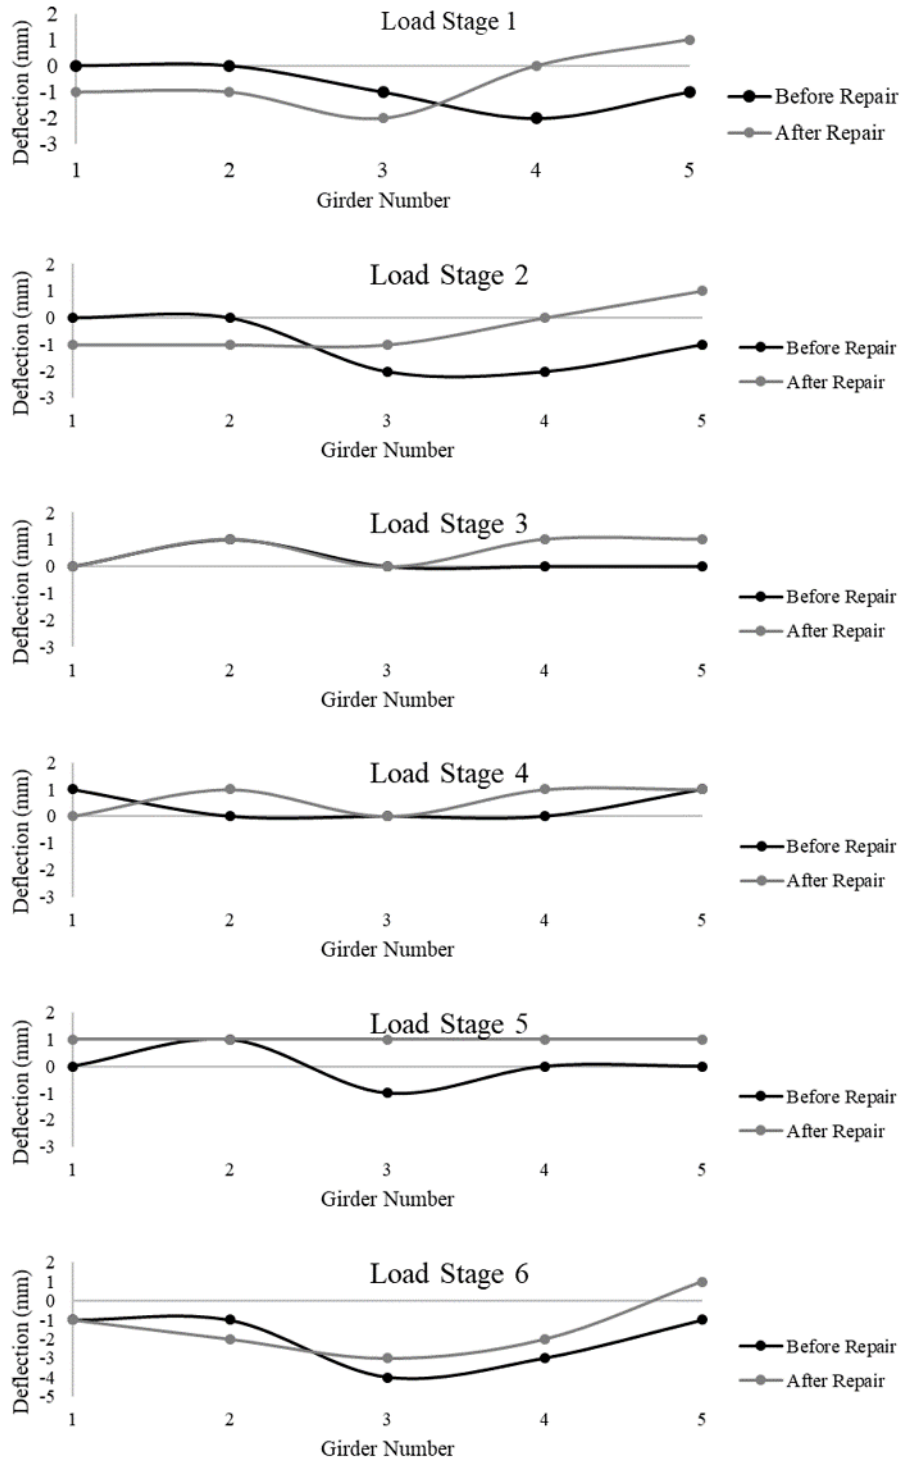
Figure 7.32. Span 4 midspan deflections during each of the six load stages

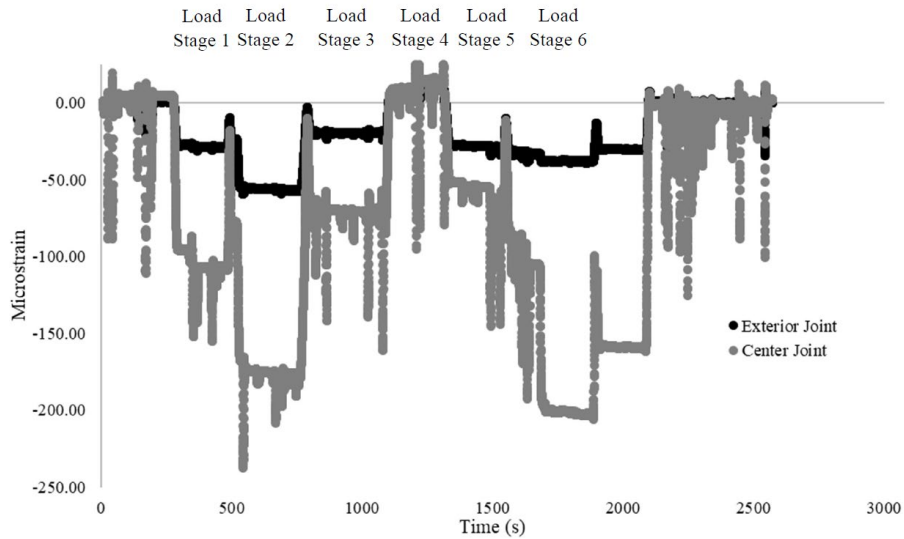
Figure 7.33. Foil strain gauge data for post-repair load test

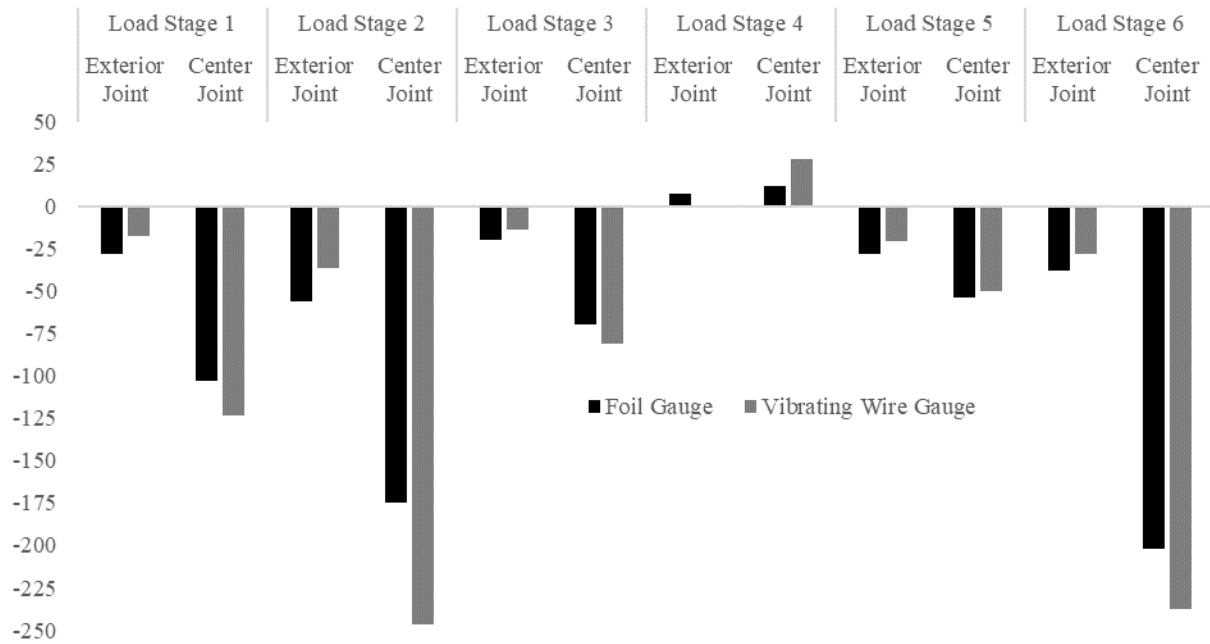
Figure 7.34. Collected average strain gauge readings

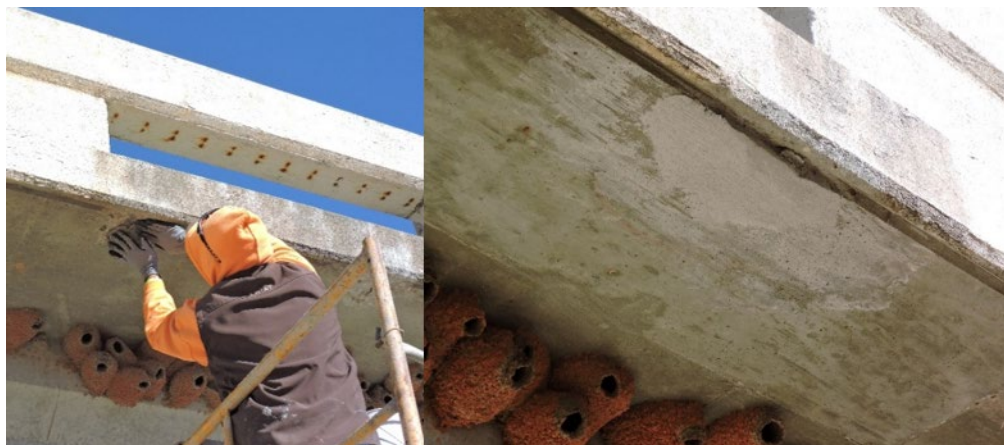
Figure 7.35. Placement of a representative MALP concrete patch (left) and completed patch (right)
