REPORT ON OPERATION OF 60 KV TRANSMISSION SYSTEM IN THE FORT WORTH AREA 1940 - 45

Submitted to the Department of Electrical Engineering Oklahoma Agricultural and Mechanical College In Partial Fulfillment of the Requirements For the Professional Degree of Electrical Engineer 1948

Prepared by Texas Electric Service Company Power Department April, 1945

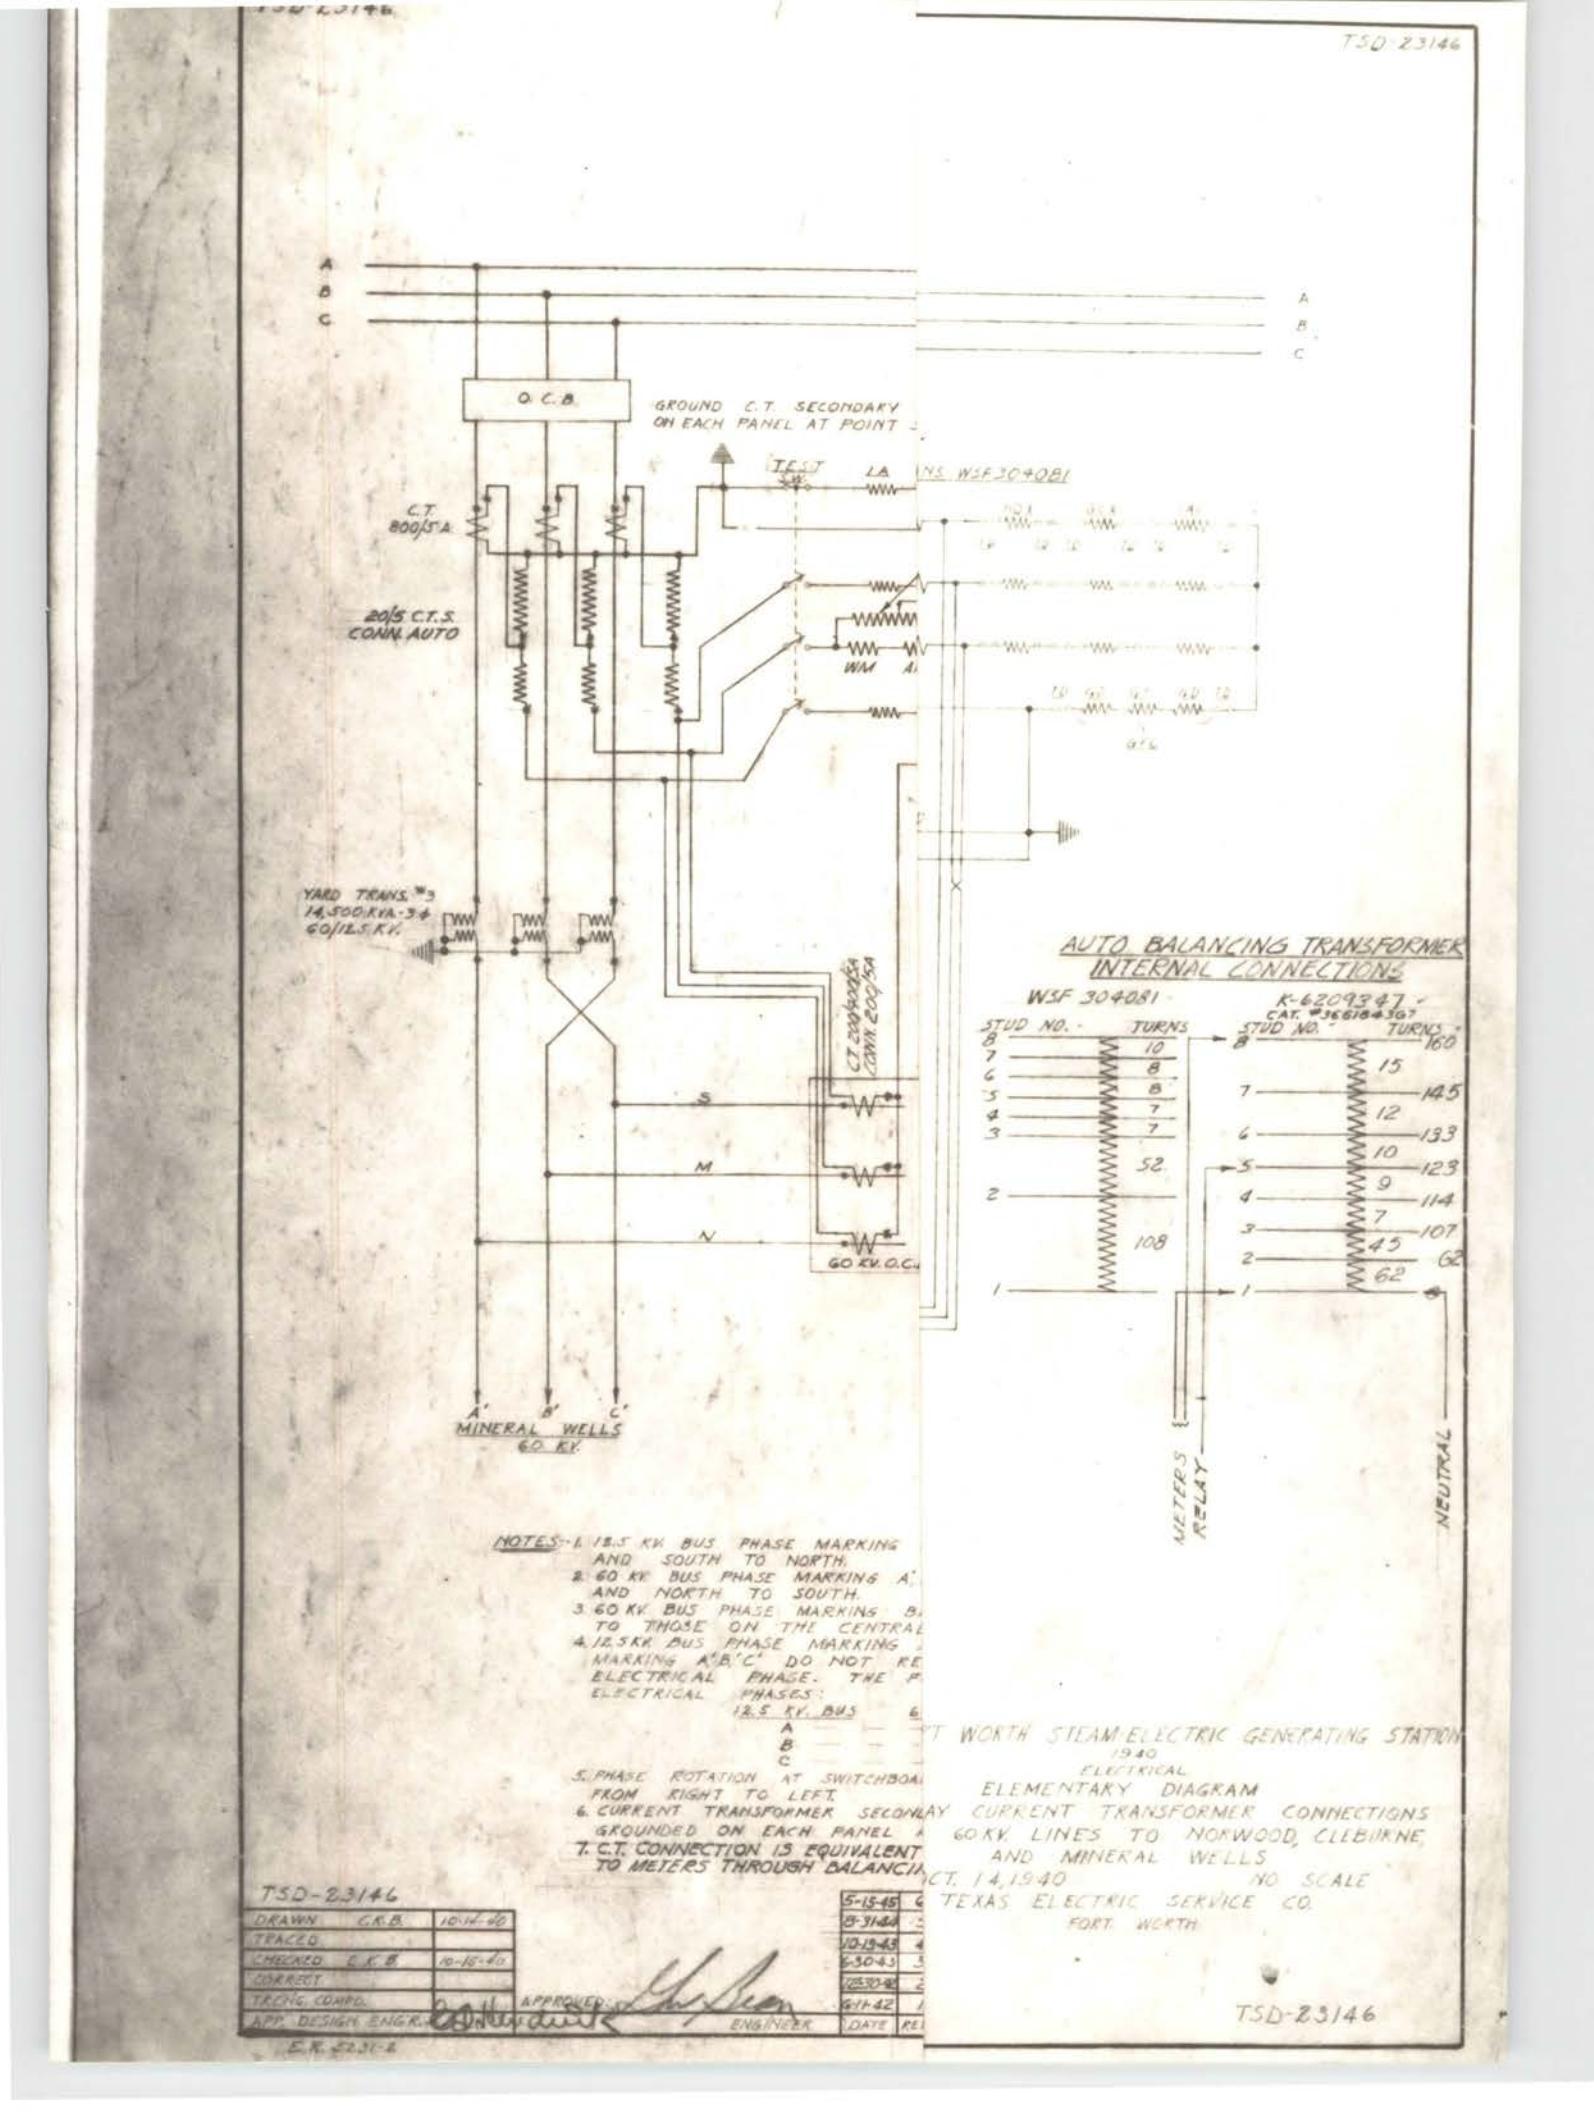
Plate III

This plate is included to show the complex interconnection of current transformers of various kinds and at different voltages.

Reference is made, at various points throughout the report, to this application of current transformers and balancing transformers. It is definitely true that current transformers have been the cause of a great amount of incorrect operation.

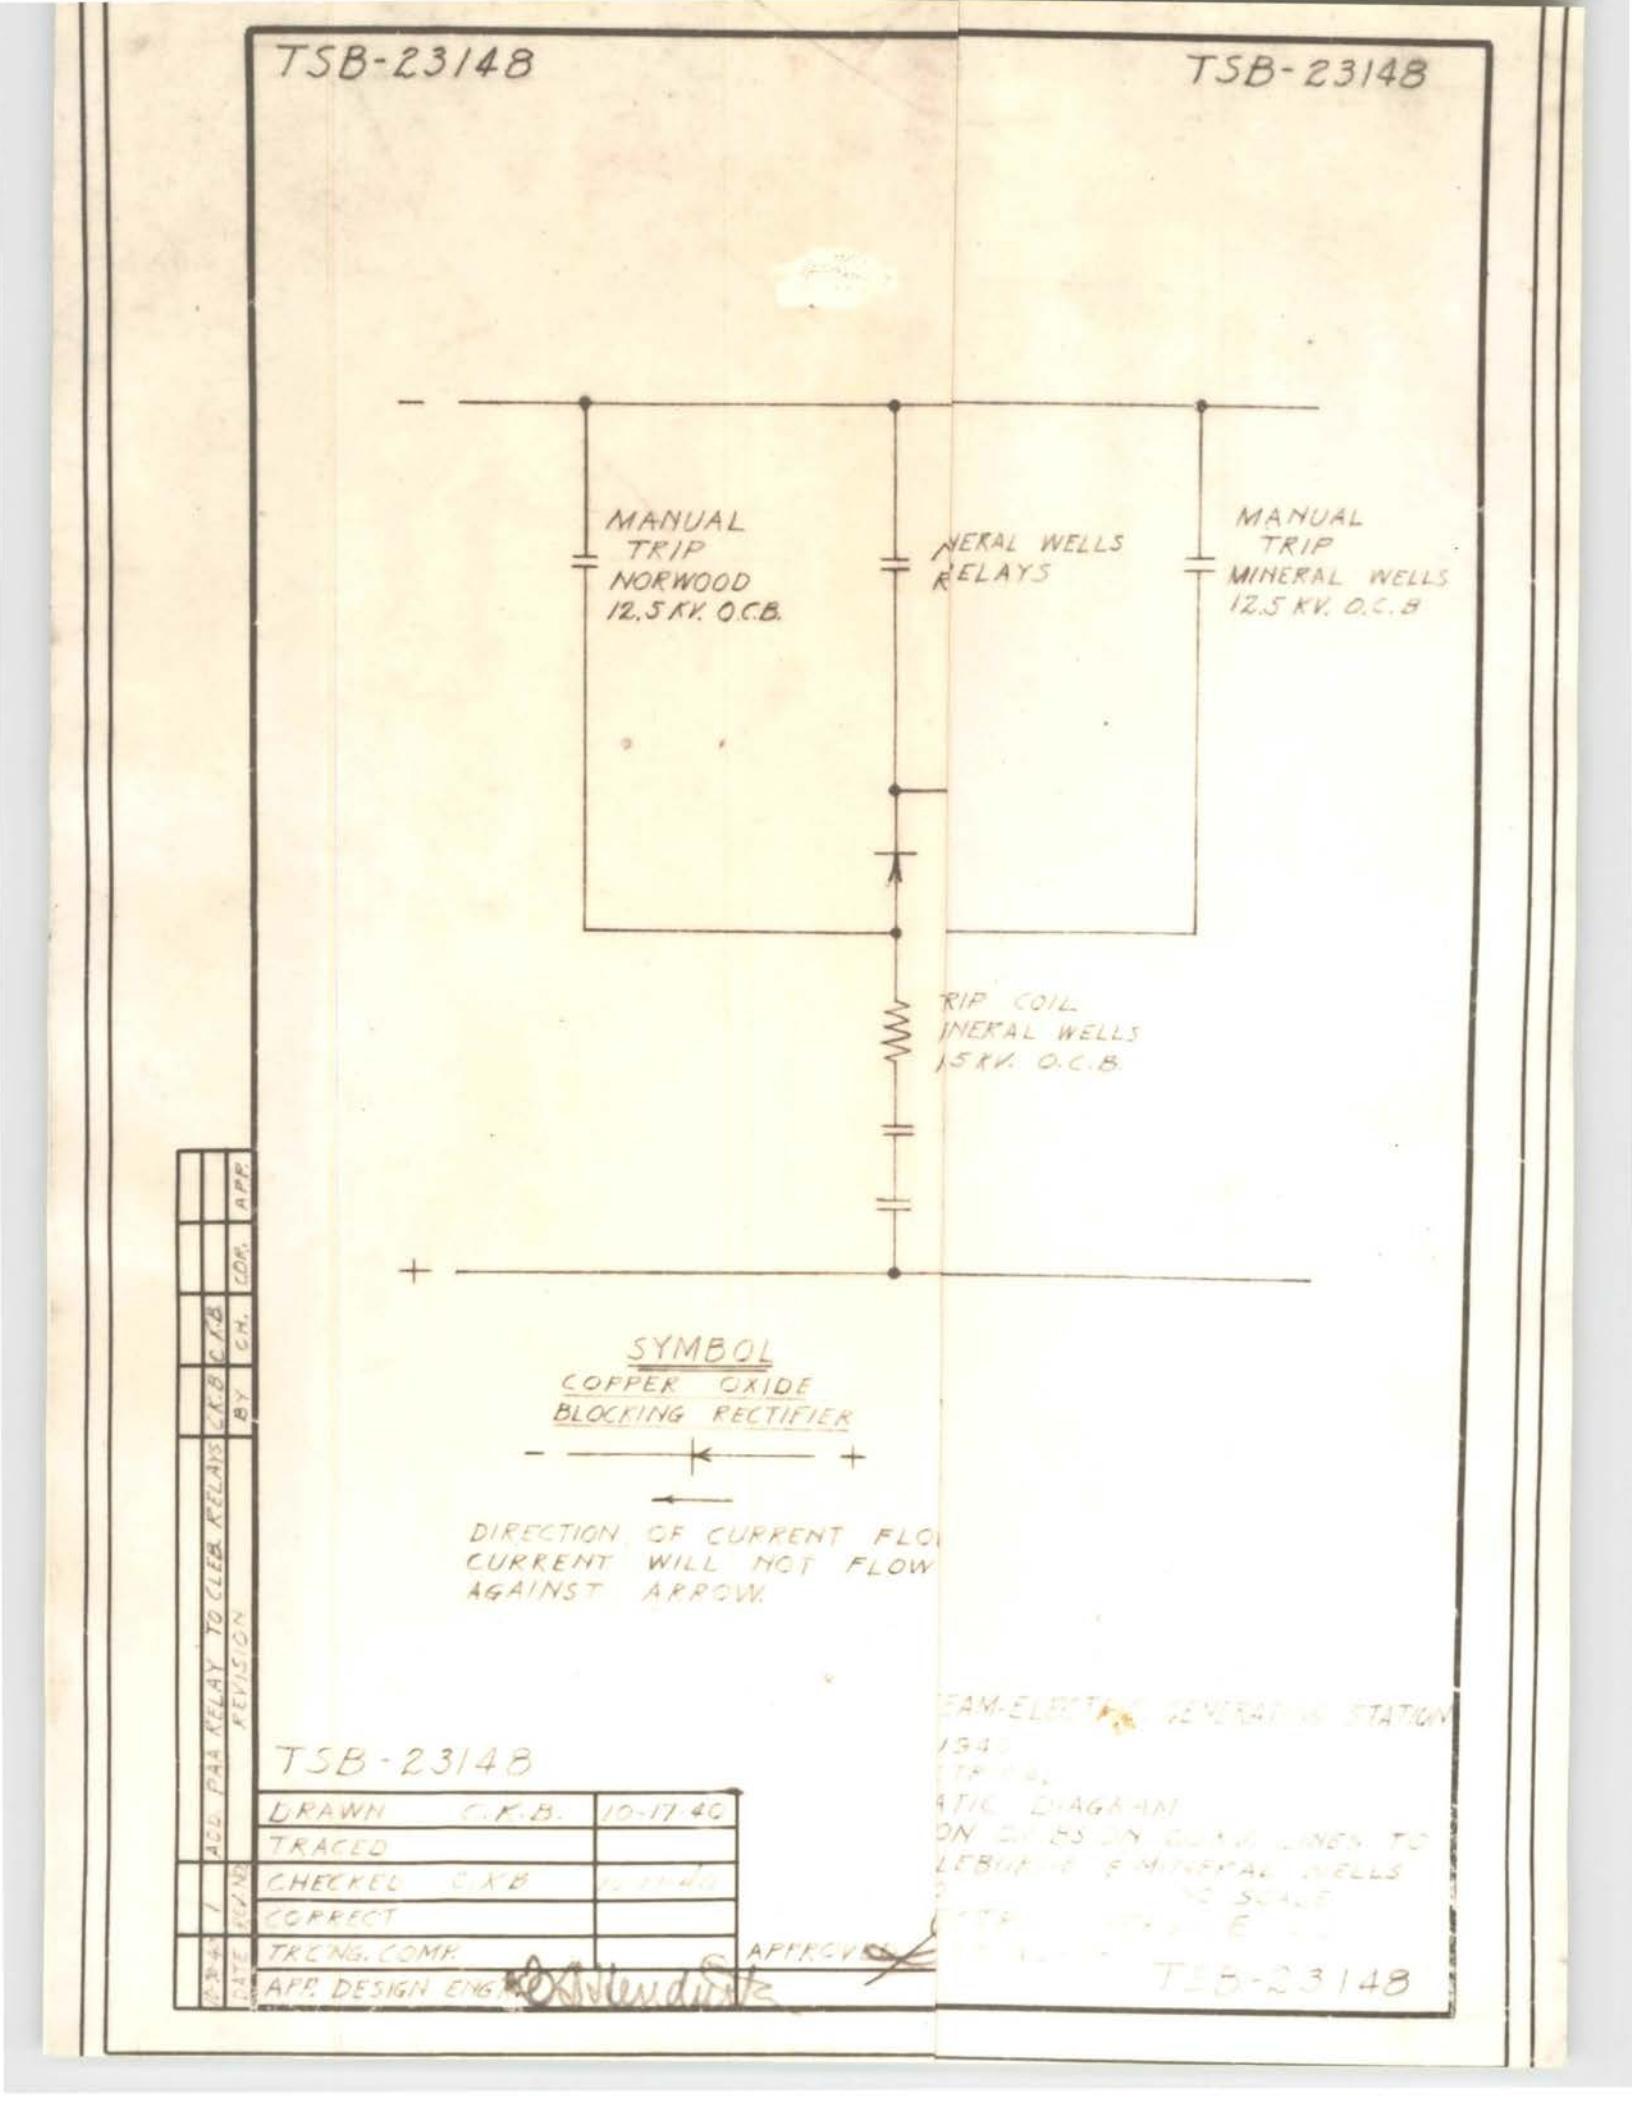
Plate IV

Schematic Diagram of Trip Circuits Showing Use of Blocking Rectifiers

The PAA bellows type relay was provided to furnish a time delay bypass on the Cleburne relay contacts and seal in coil.

There is some lack of confidence in this whole arrangement for the following reasons: (1) No provision is made for bypassing the Norwood or Cleburne relay contacts. (2) The PAA relay is a bellows type relay. (3) The life of the copper oxide rectifiers may be short when subjected to heat and vibration. (4) Some damage was done to rectifiers in 1940, when the relays sealed in on two or three occasions, the rectifiers became overheated before the trouble was discovered.

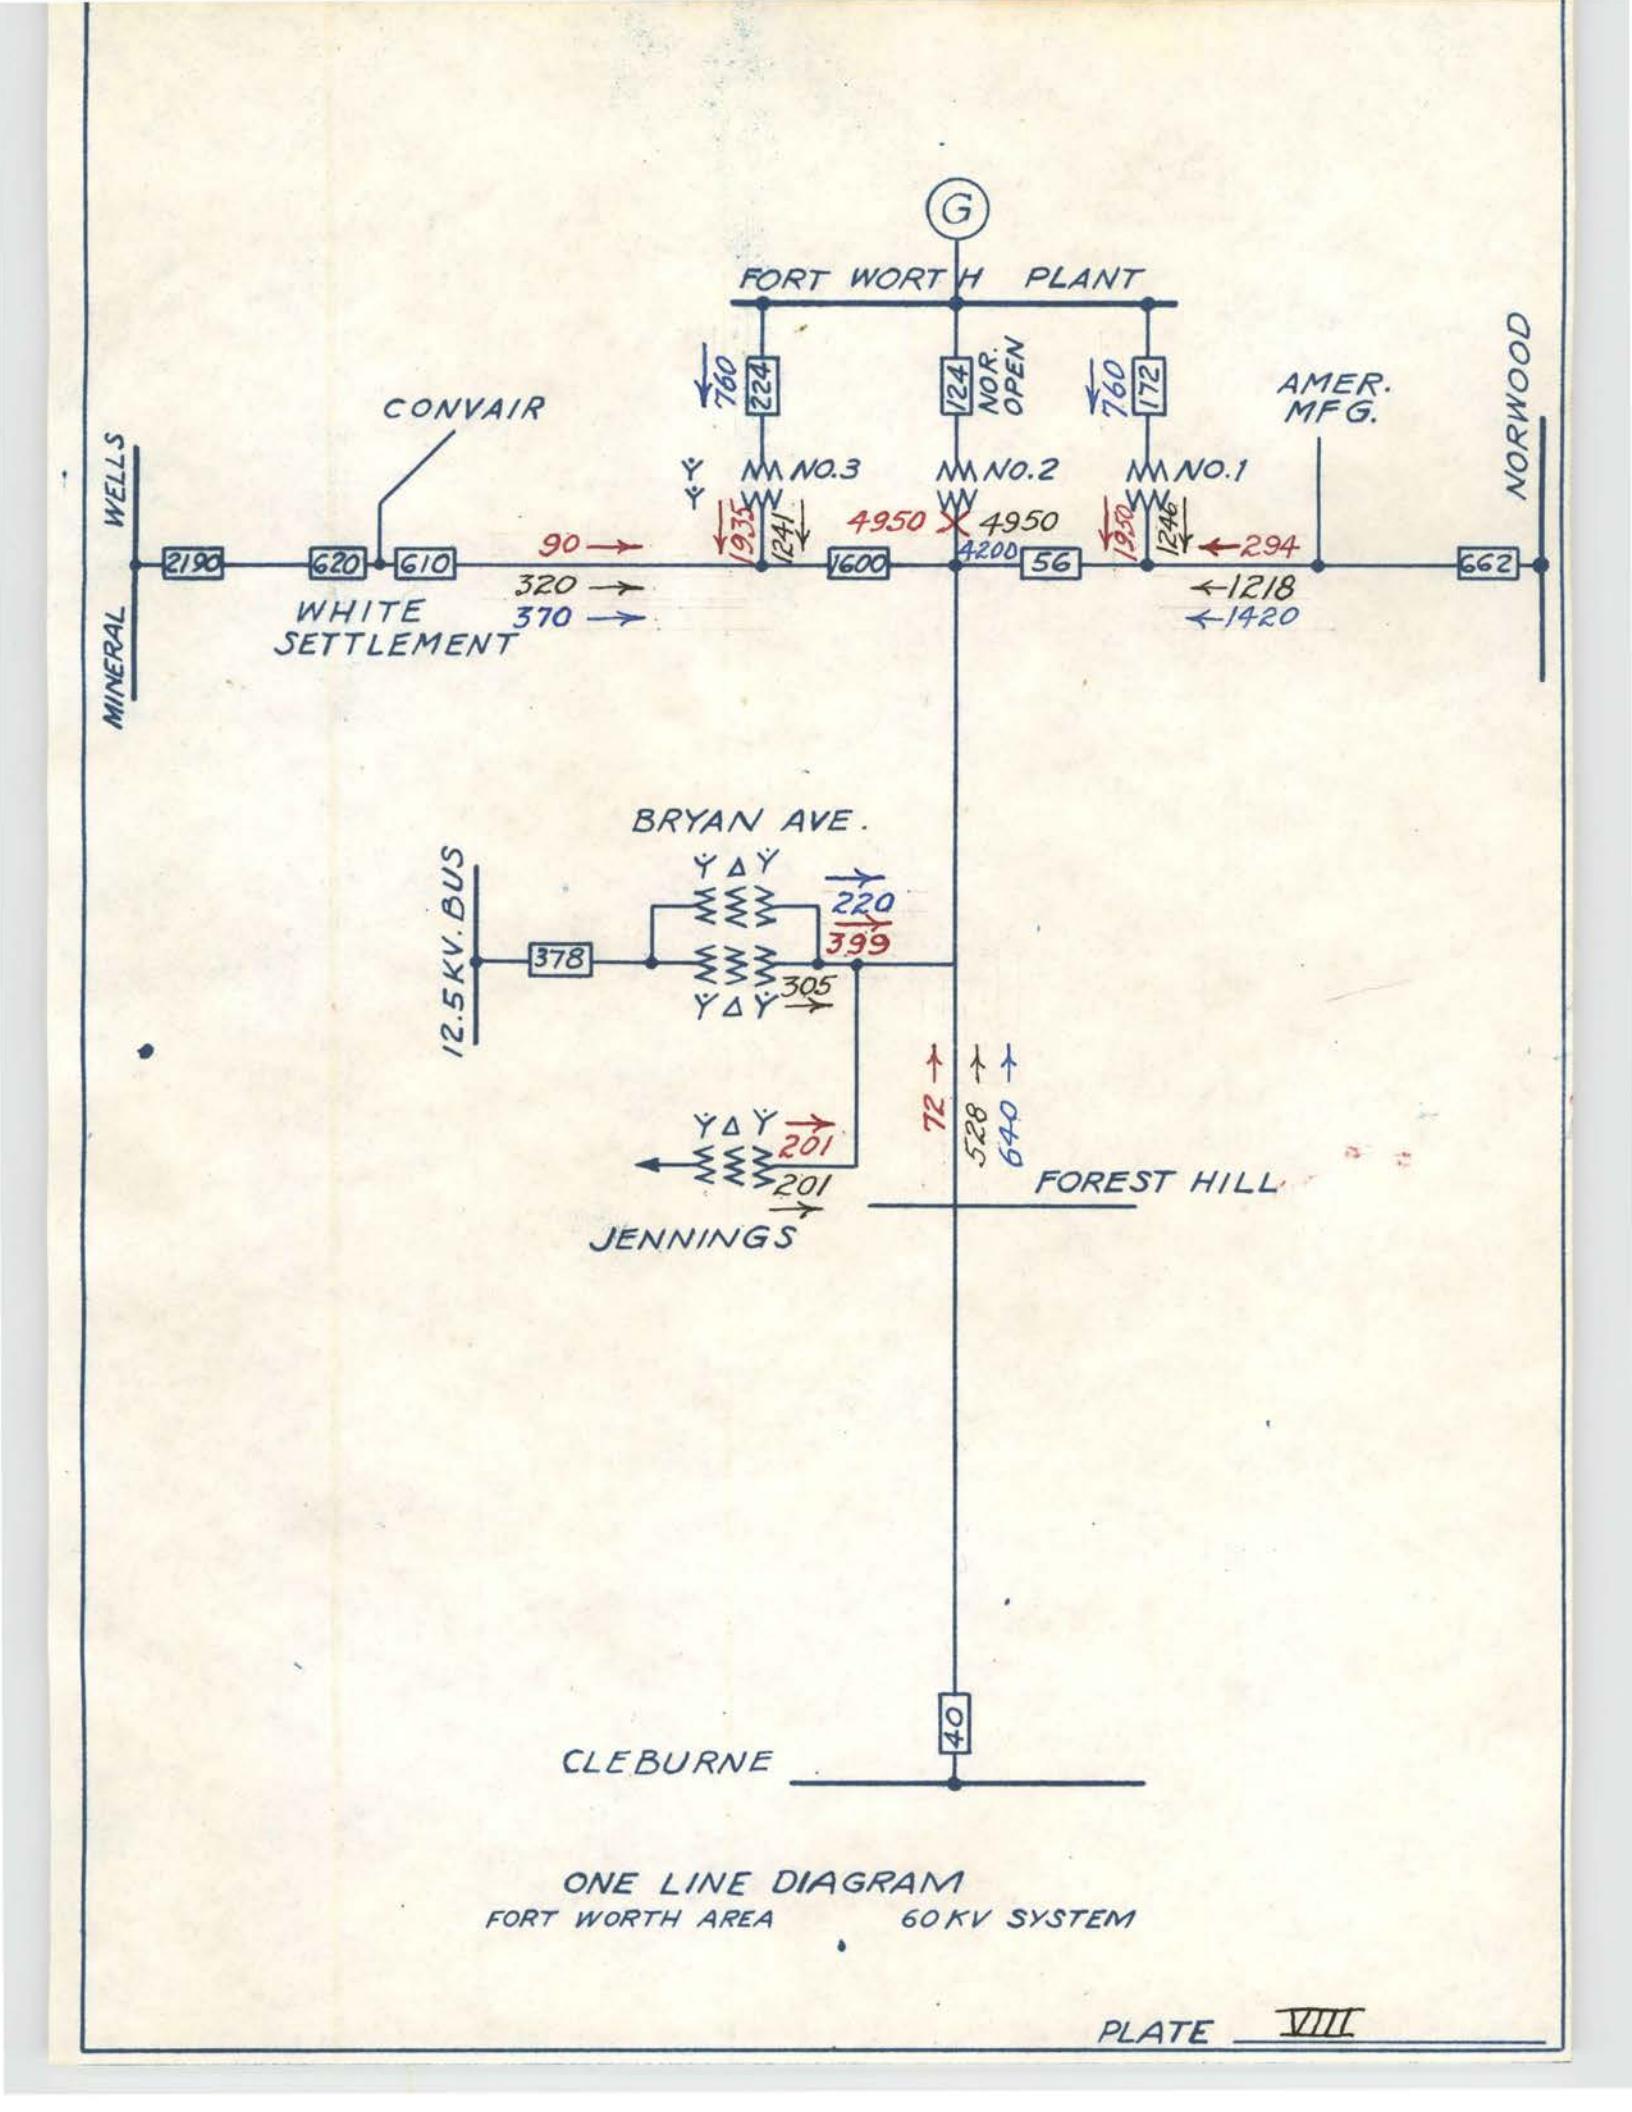
Plate VIII

Short Circuit Current Distribution for Three Phase and Single Phase Faults on Cleburne Line at Fort Worth Plant

The 399 amperes from Bryan Avenue is sufficient current to cause instantaneous tripping of OCB #378, since installation of the 60 kv neutral current transformers at Bryan Avenue. However, the opening of OCB #378 does not remove the principal sources of zero sequence current which originates in the Bryan and Jennings transformers.

It will be beneficial to open the neutrals at Bryan and Jennings to the extent that the residual current coming from Bryan and Jennings will be reduced to zero. Other problems will be introduced as a result, and the Cleburne line will remain multiple ended.

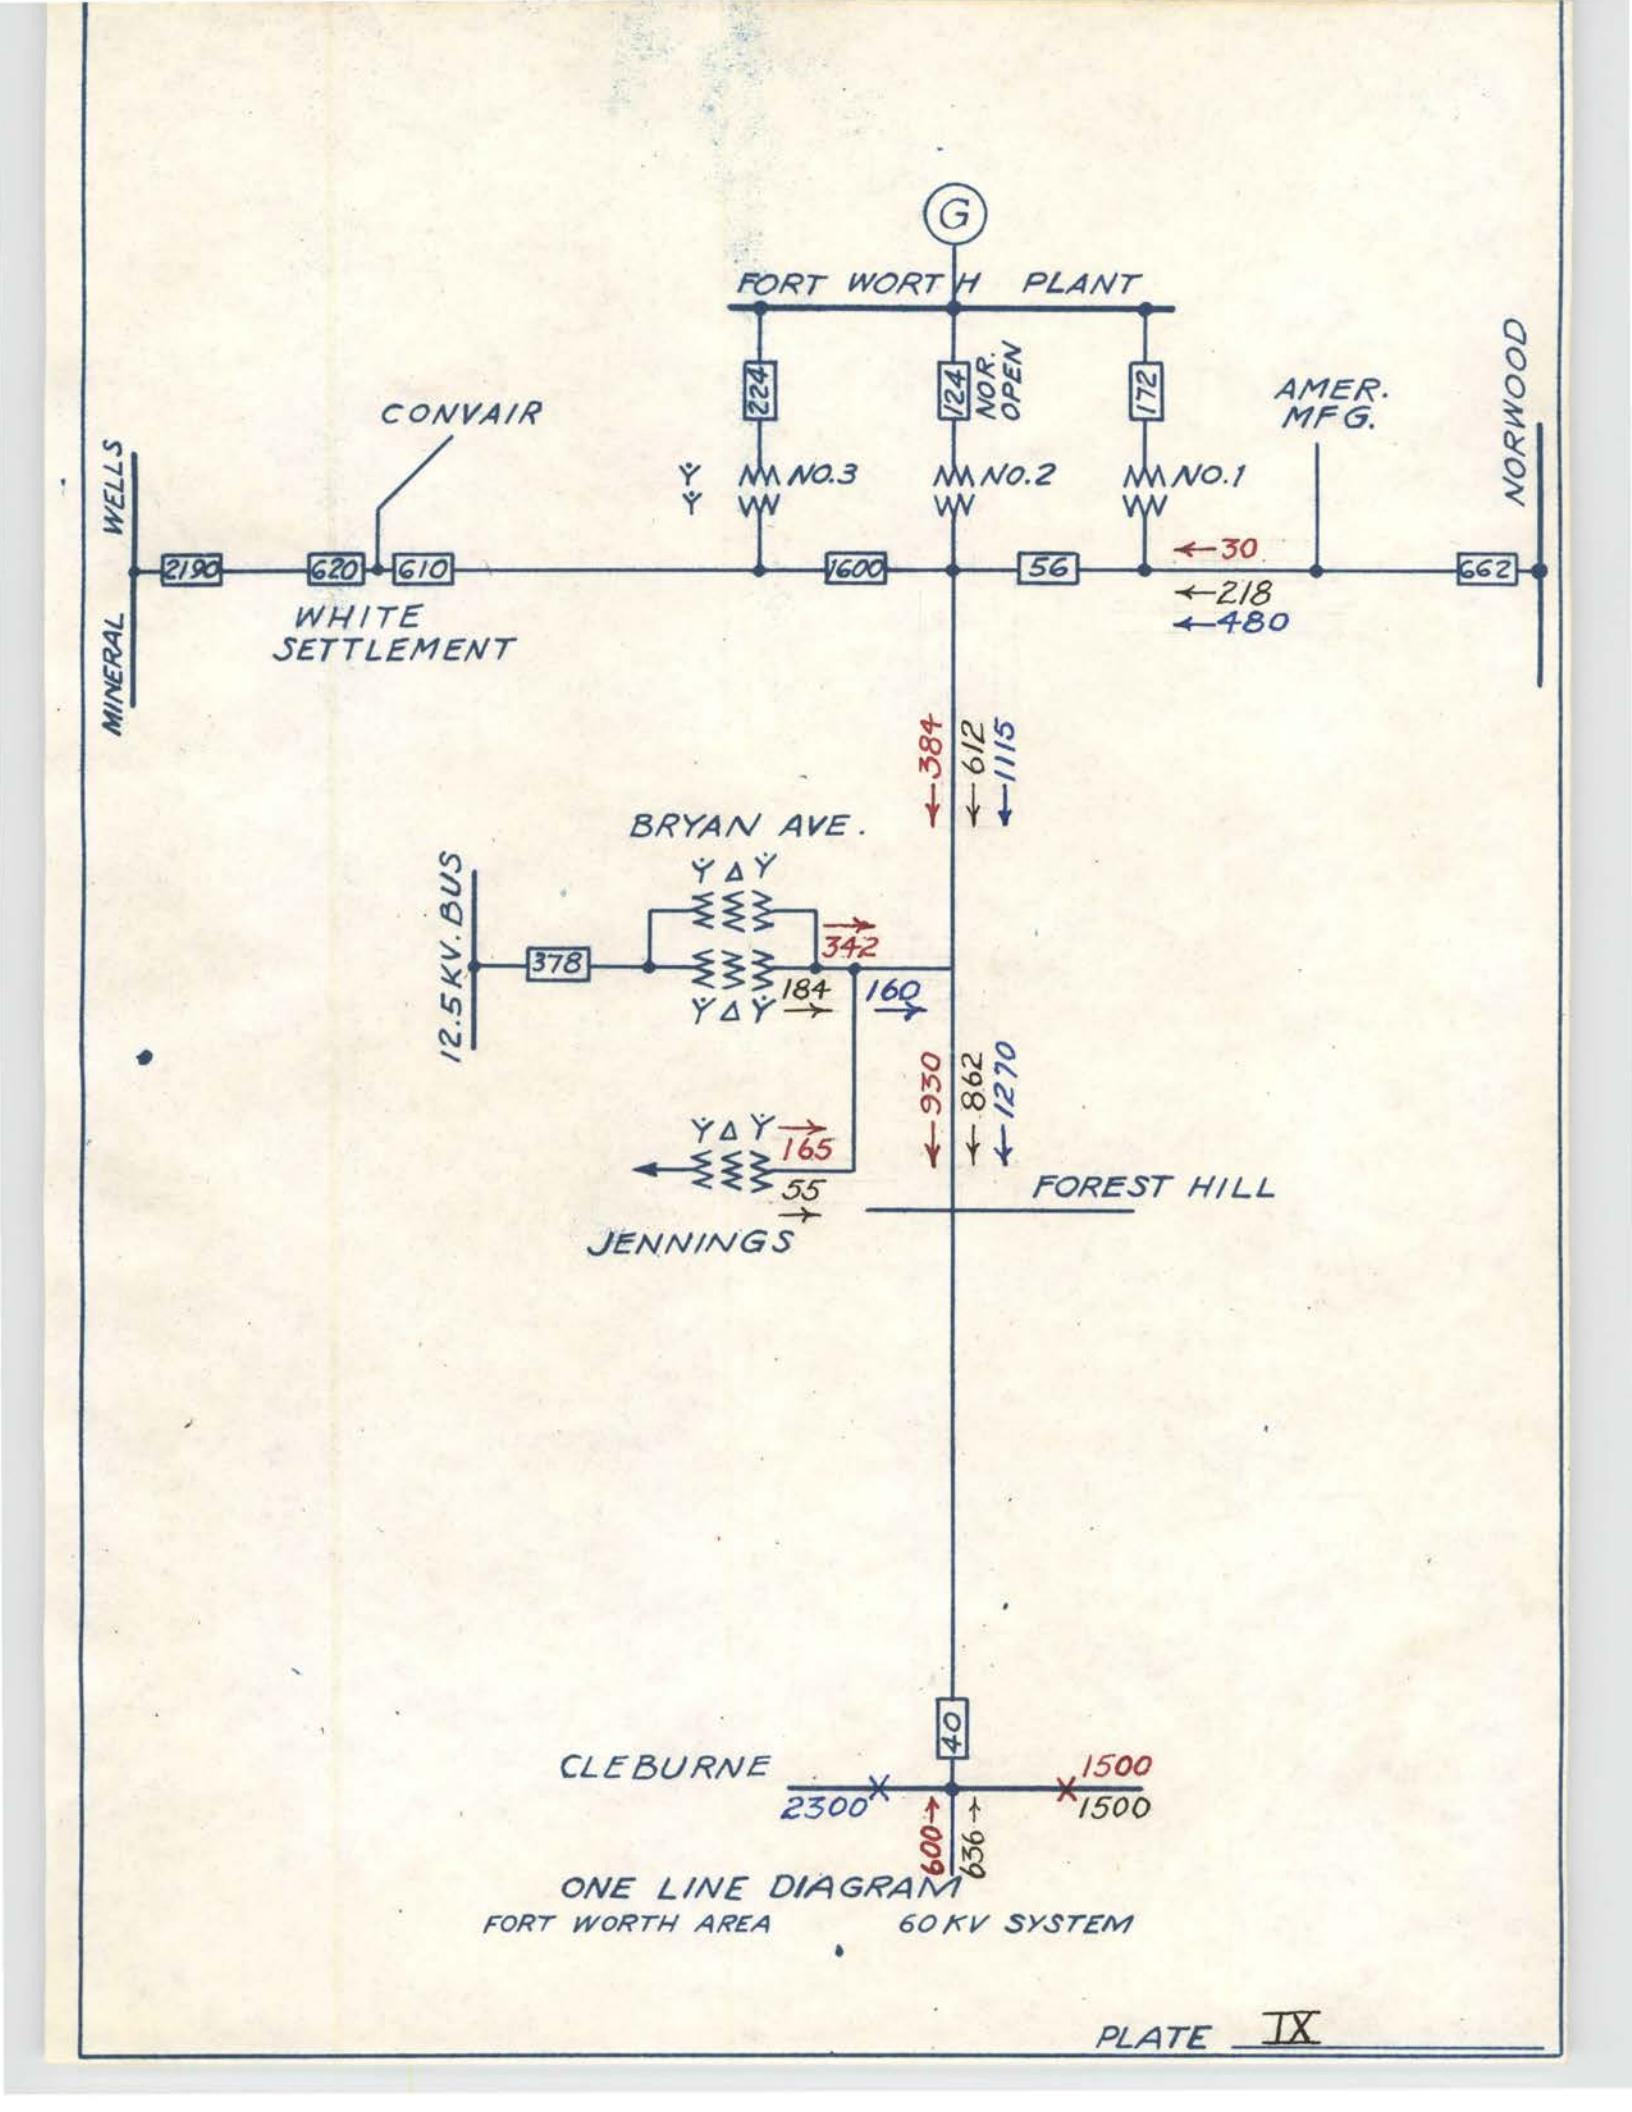
Plate IX

Short Circuit Current Distribution for Faults on Cleburne Bus

These faults cannot all be cleared by fast relaying without a breaker to the south of the Bryan Avenue tap. With any appreciable time delay #3 copper would be expected to burn down. Operating records show that it does burn down for almost one third of the flashovers.

As pointed out elsewhere, it seems evident that 60 kv transformer neutrals should be ungrounded at Bryan and Jennings Avenue Substations.

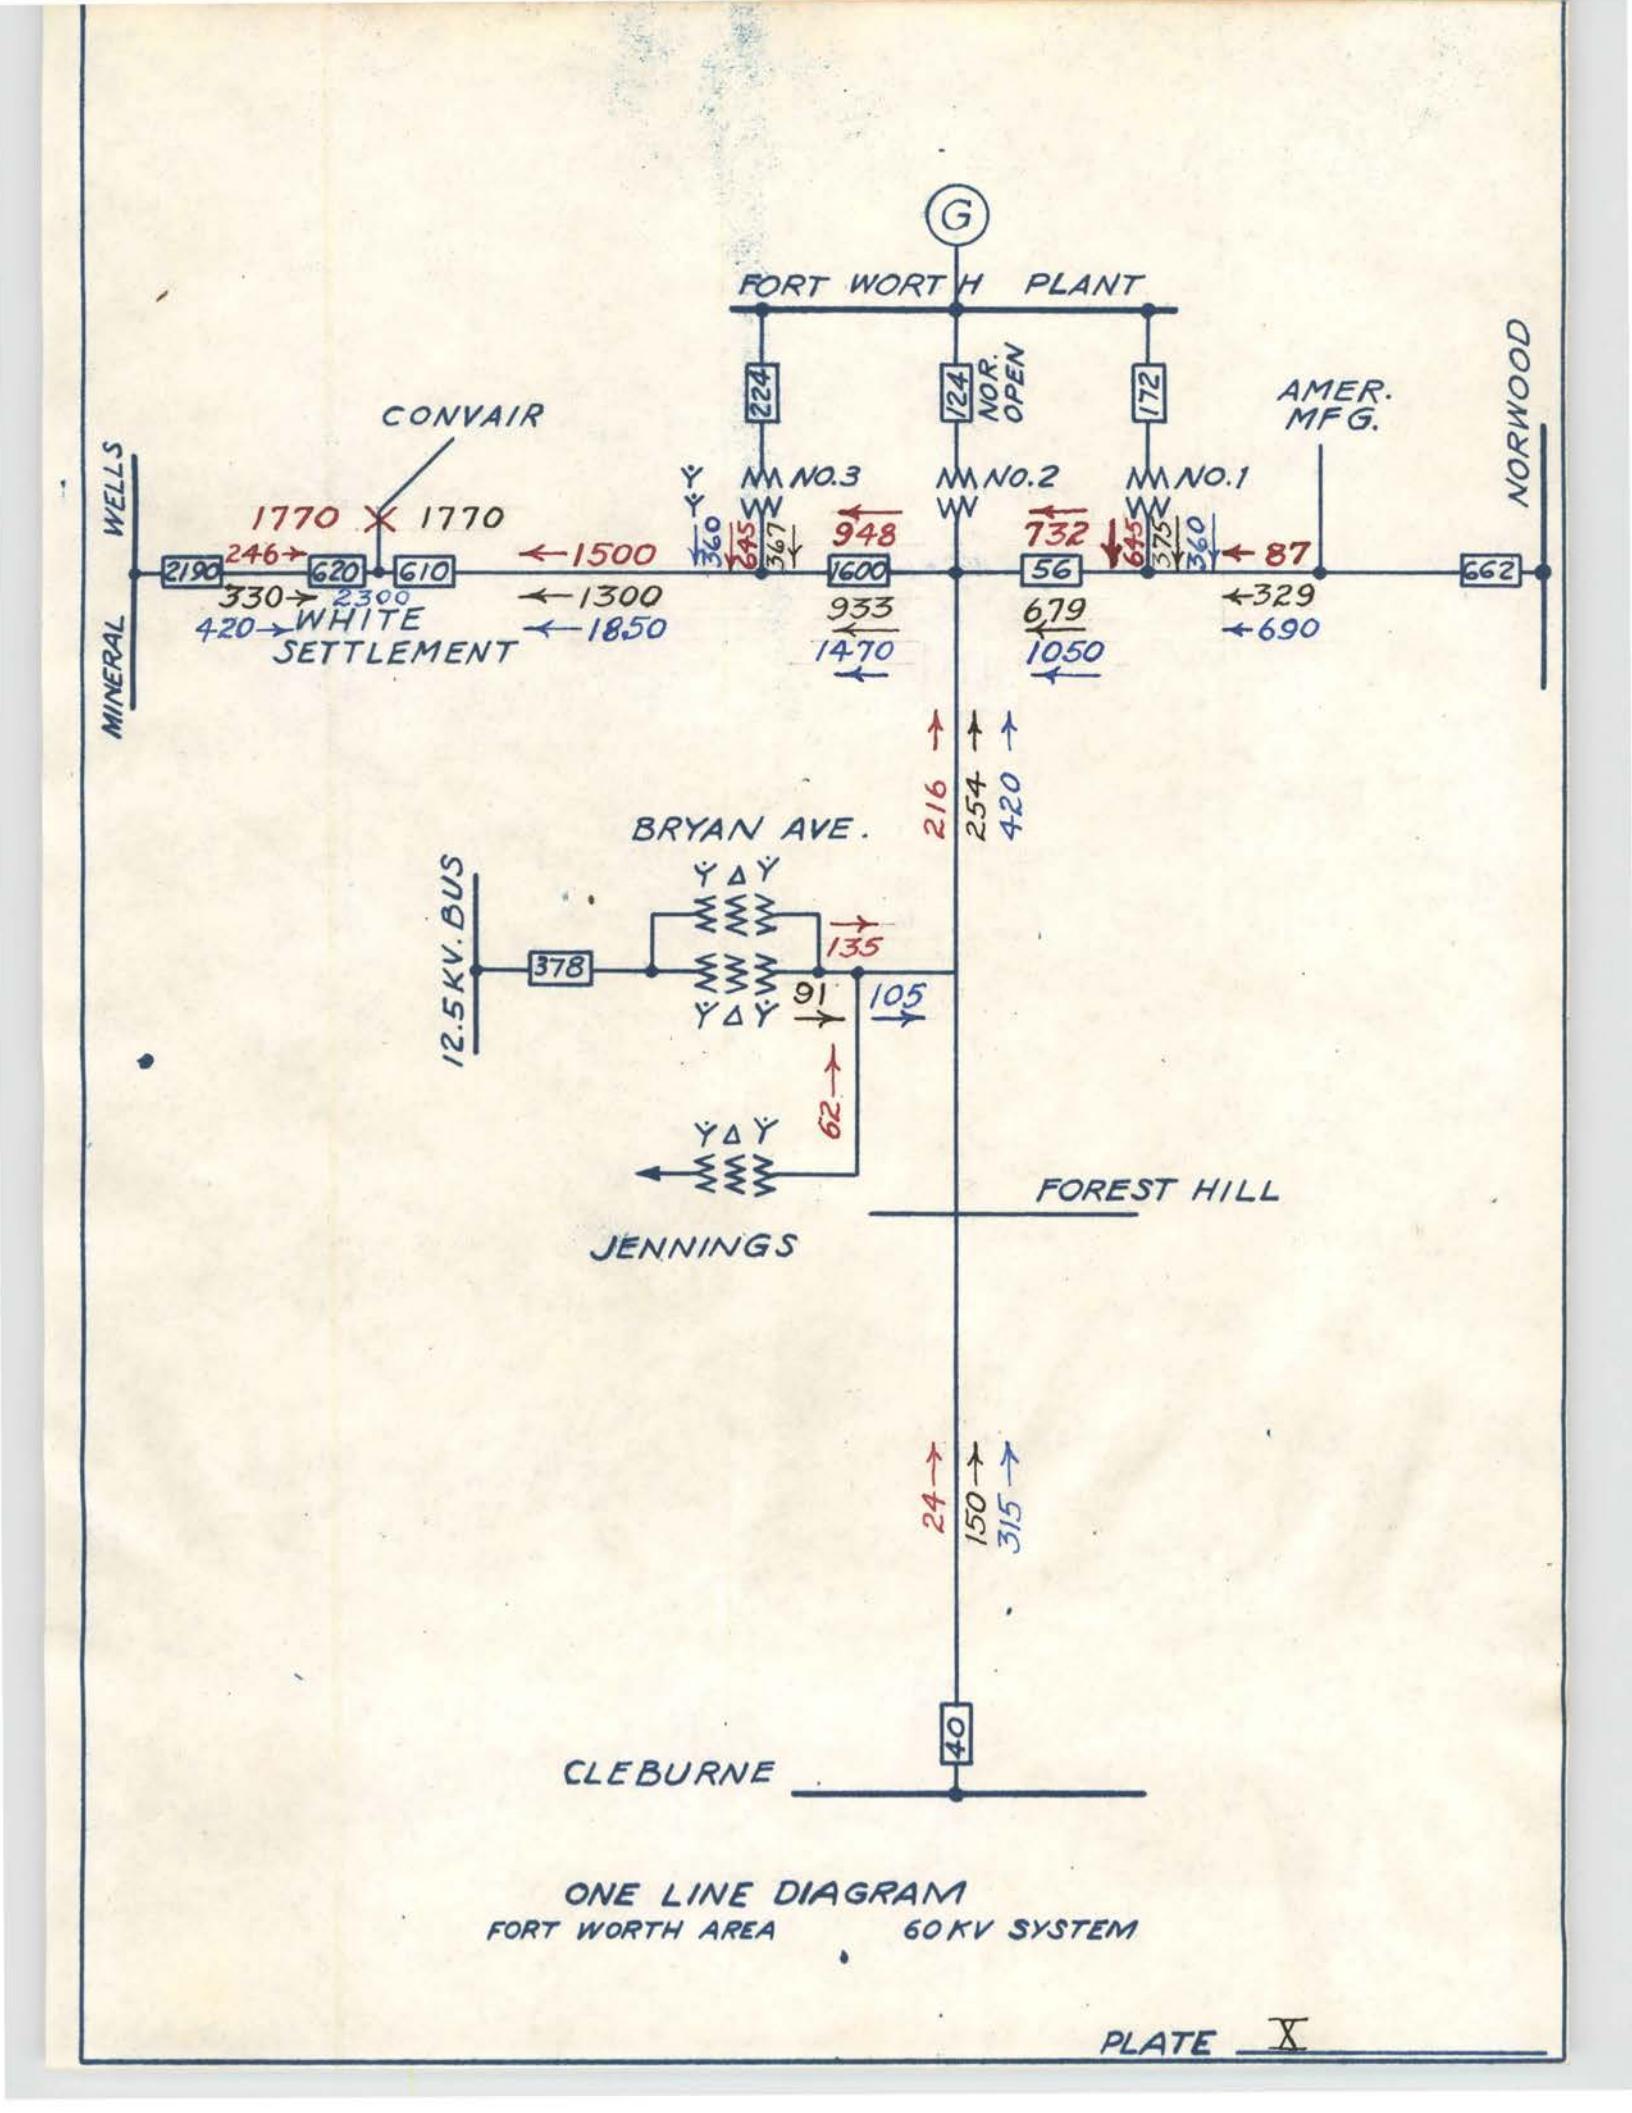
Plate X

Fault Current Distribution For Faults on White Settlement 60 kv Bus

It may also be seen that when OCB #1600 recloses on a permanent fault, the fault current is only about 60% of the original fault since 948 amperes come through OCB #1600 and 640 amperes through Bank #3 which is already open when OCB #1600 recloses automatically. These values are for residual amperes, and the other values are of similar proportion.

Various other information may be obtained from this and the previous distribution charts, such as the following: (1) 135 amperes, residual, flow from Bryan for a bus fault at White Settlement or 399 amperes for fault at Fort Worth and 342 amperes for fault at Cleburne. It is considered good practice to reach the full length to Cleburne and Fort Worth lines but not reach beyond White Settlement with instantaneous tripping. This means that the Bryan Avenue instantaneous ground relay should be set above 135 amperes but not over 342 amperes. (As mentioned elsewhere, the tripping of OCB #378 for faults beyond Fort Worth and Cleburne is considered a necessary evil.) (2) A study of this and Cleburne fault current distribution charts along with Plate XIII indicates that normal current transformer saturation should be no problem for faults at Cleburne and White Settlement, etc.

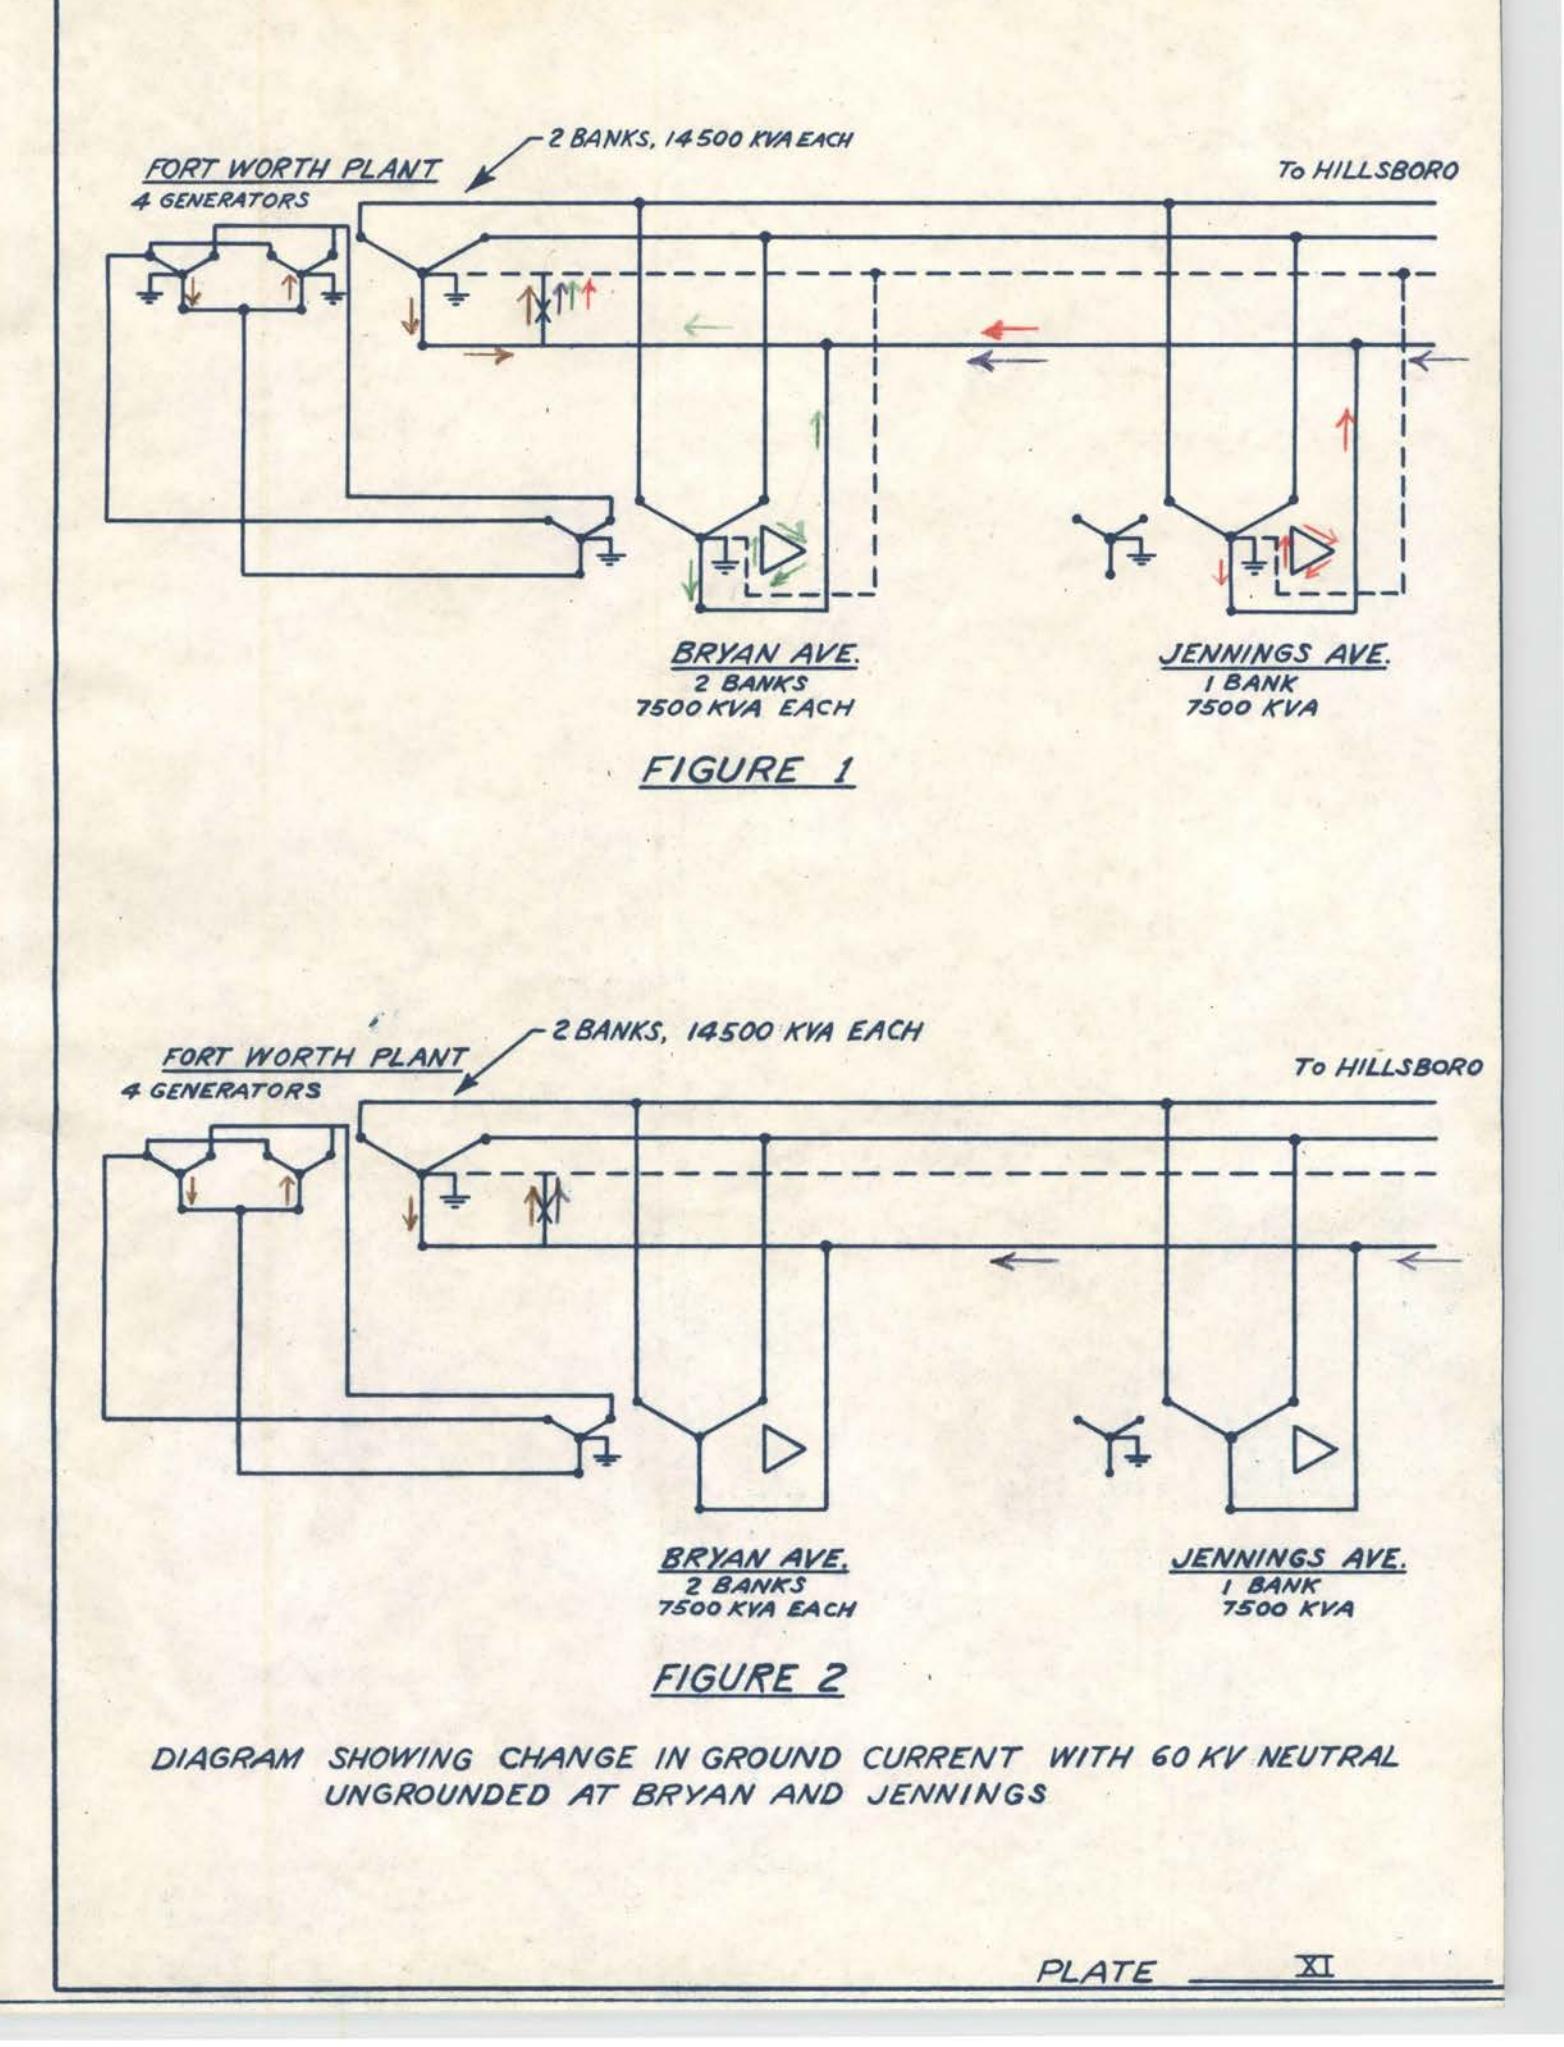
Plate XI

Plate XI, Figure 1, shows the normal condition of ground current flowing from Bryan and Jennings with arrows showing flow also from Cleburne.

Diagram Showing Change in Ground Current on Cleburne Line

Figure 2 shows no ground current from these transformers. Removing the neutral connection will improve relay action at Fort Worth and Cleburne, as well as remove this heavy source of ground current which burns down No. 3 stranded copper conductor in an extremely short time.

A 60 kv potential transformer and voltage relay may be considered desirable at Bryan Avenue for tripping OCB #378 on the low side of Bryan Avenue for permanent ground faults on the 60 kv line.
