REPORT ON OPERATION OF 60 KV TRANSMISSION SYSTEM IN THE FORT WORTH AREA 1940 - 45

Submitted to the Department of Electrical Engineering Oklahoma Agricultural and Mechanical College In Partial Fulfillment of the Requirements For the Professional Degree of Electrical Engineer 1948

Prepared by Texas Electric Service Company Power Department April, 1945

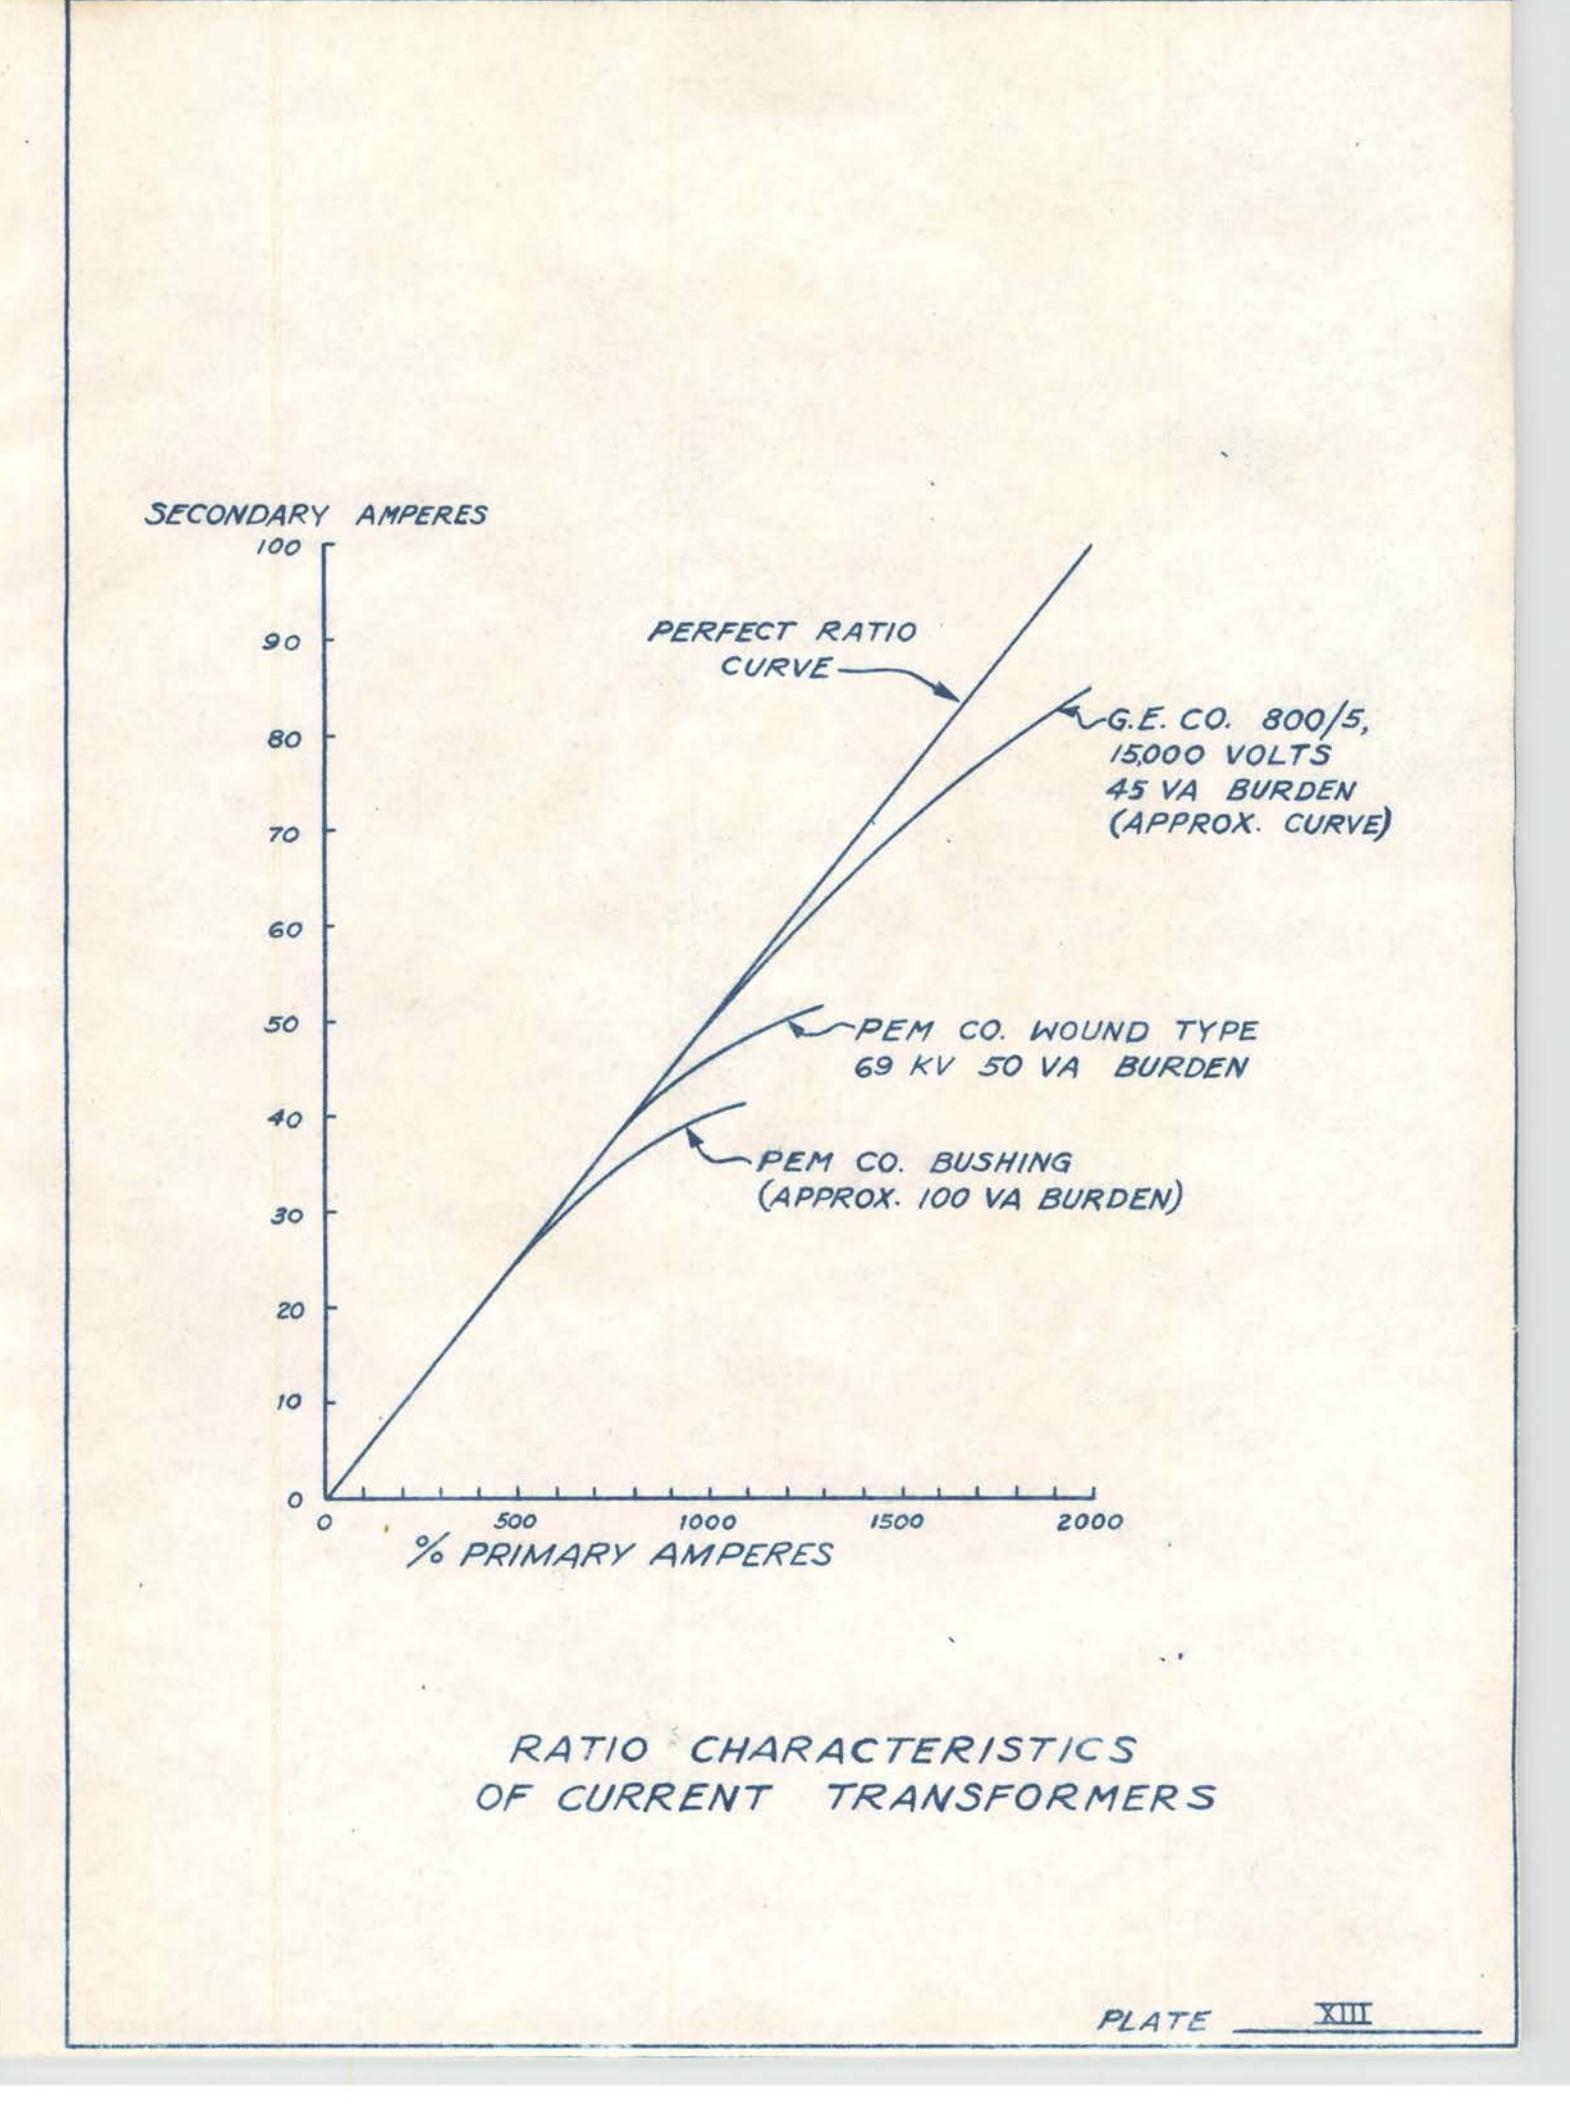
It appears that the bushing type current transformers level off at approximately 8 times normal, the Pacific Electric wound type at 11 times normal, and General Electric wound type at approximately 20 times normal.

The expected result of such variation in performances is incorrect and inconsistent action for paralleled current transformers which provide current for line faults near the Fort Worth plant.

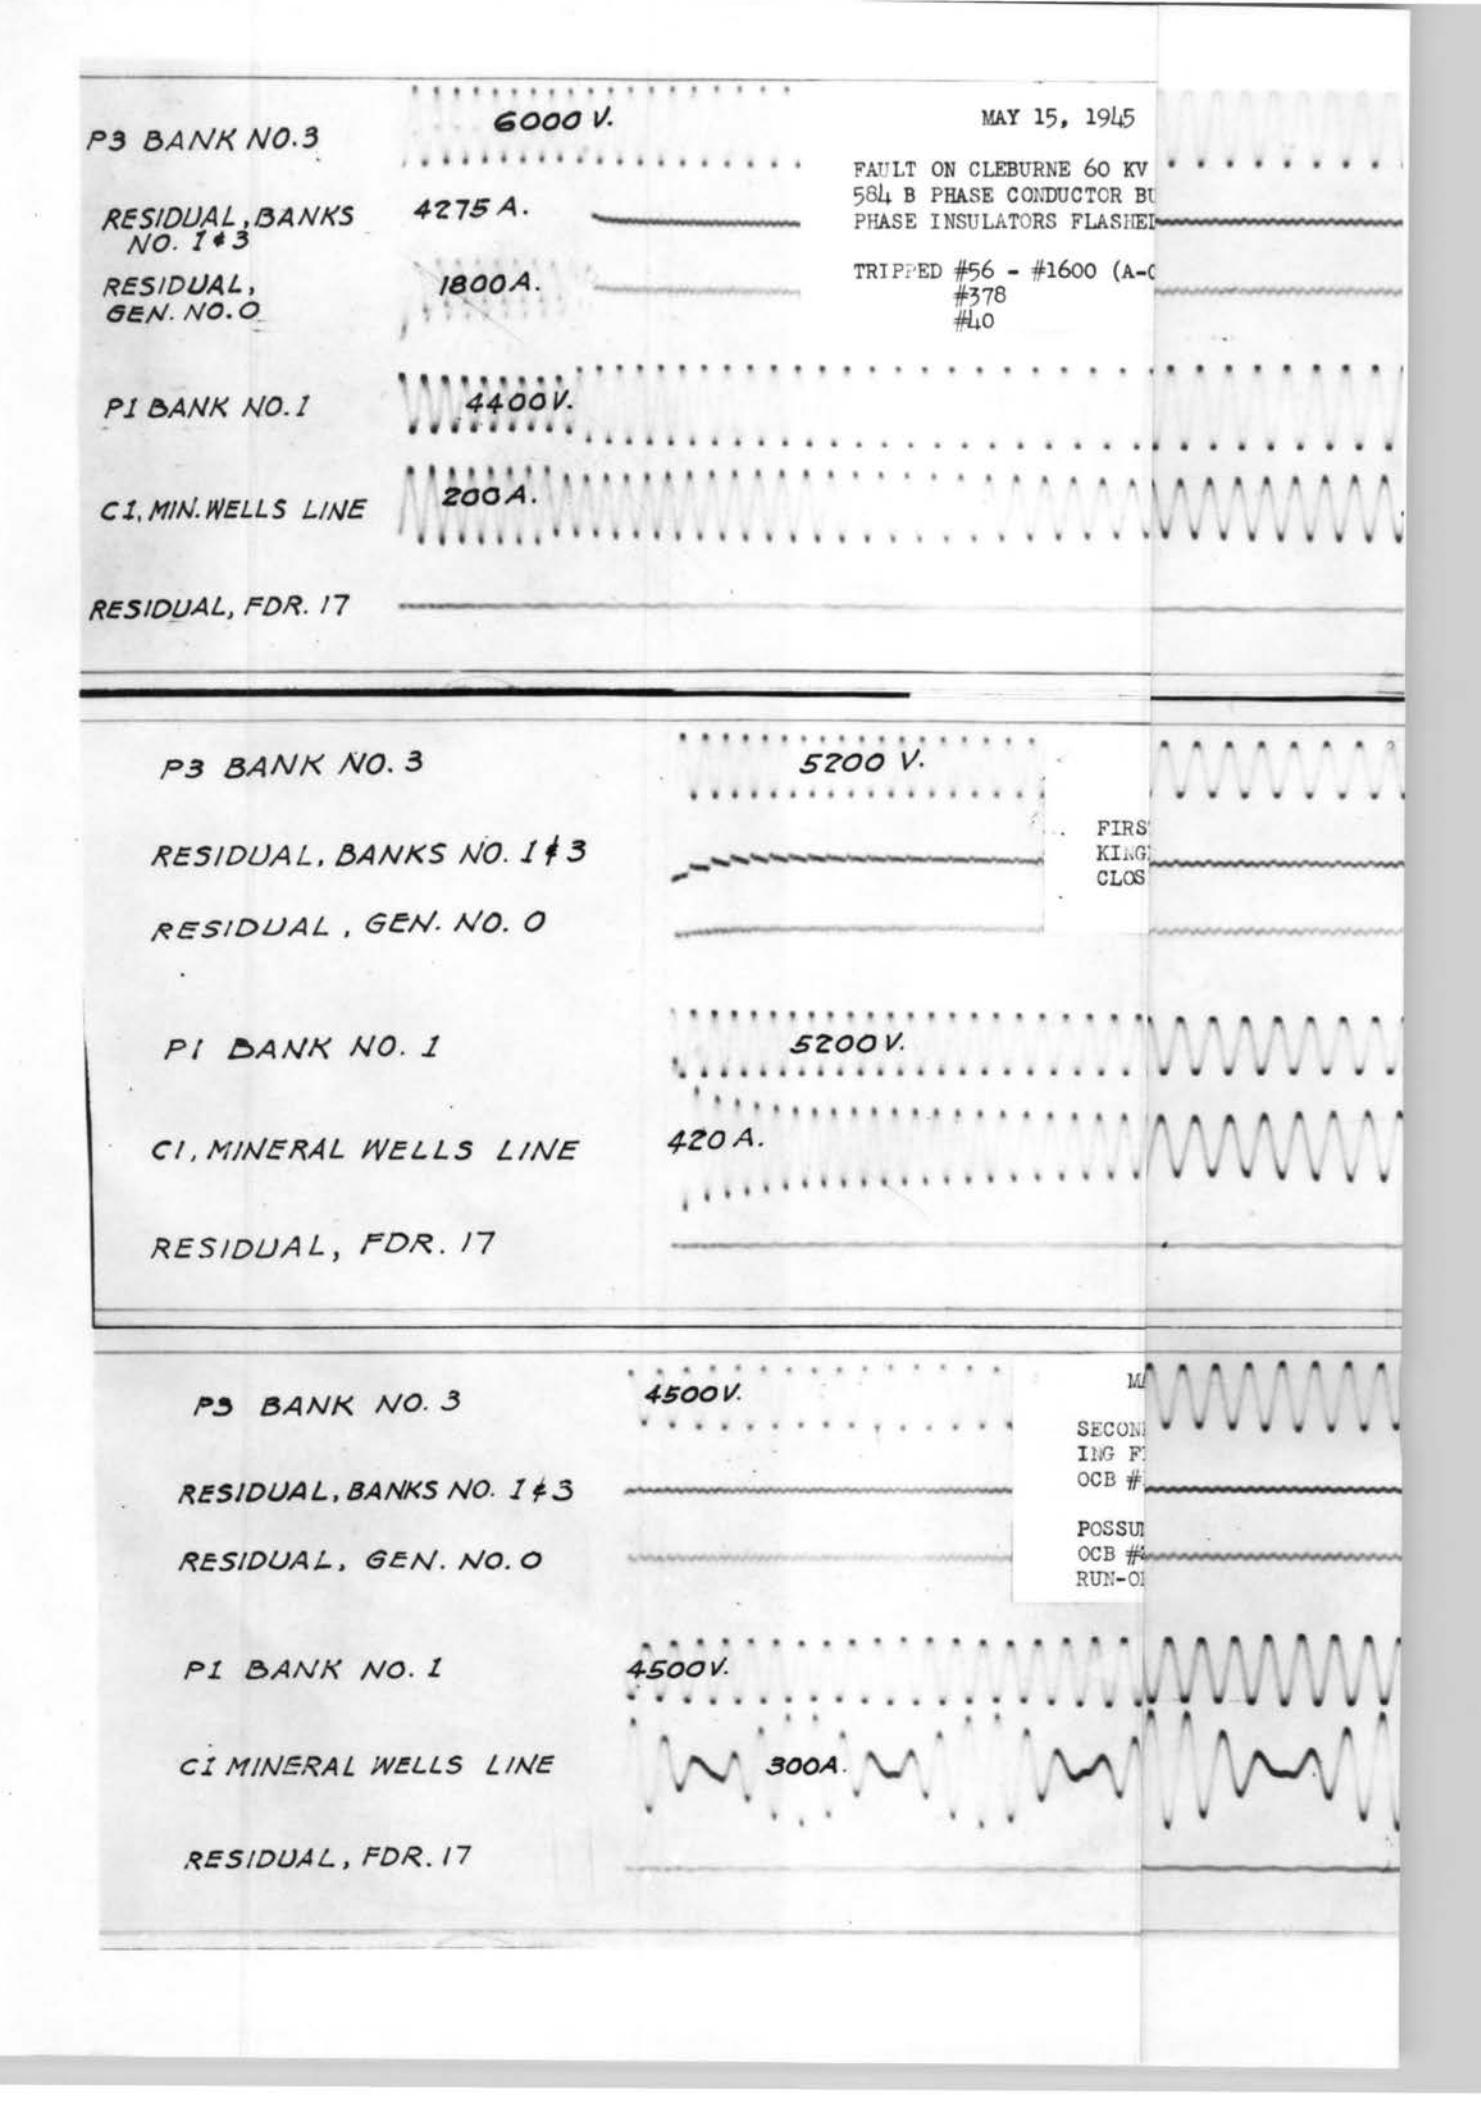
Plate XIV

Oscillograms Showing Instability of Possum Kingdom Following Permanent Fault on Cleburne Line and Test by Charging Line with 60 kv OCB #1600

When the line was tested at 5:03, using OCB #1600 to charge from #3 Bank and the Mineral Wells line, there was very little drop in 12.5 kv voltage or flow of ground current through Bank #3. In fact, there was insufficient current flow or voltage drop to start the oscillograph. However, the 60 kv voltage did drop sufficiently to cause Possum Kingdom to get out of step. This in turn dropped the voltage sufficiently to start the oscillograph at 5:03 for the second run off.

The third run off shown at the bottom of the sheet and indicated as 5:04 perhaps started the oscillograph immediately after the second run off. It shows definitely out-ofstep conditions which separated Possum Kingdom from the system by tripping OCB #203 at Oran.
