### CamTracker camera preview is completely white or blue.

**CamTracker quality checks are not all green and the sun intensity is reading low values or 'nan.'**

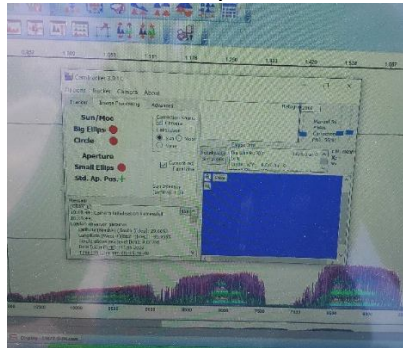
Blue screen example:

1. Laptops can easily overheat due to high ambient temperatures and excessive incident light. If the laptop is hot to the touch, move it into the shade if possible.
  - a. If there is no shade available, consider shutting the laptop down and leaving it in an air-conditioned building until it has cooled off before continuing.

2. Check the “Camera” box in the “Correction Sources” box under the “Image Processing” tab in CamTracker.
3. Wait for the motors to stop moving.
4. If the camera preview changes back to black, check the “Camera” box again, make any necessary motor adjustments, and continue taking data.

5. Uncheck the box labeled “Camera active if available”
6. Wait up to a minute to see if the camera preview changes.
7. Recheck the box.

8. If this does not help, put the tracker back in park position.
9. Restart CamTracker.
10. Make the tracker track the sun (see main Manual Operation procedure for more details).

11. If the camera preview is still white or blue, halt data collection.
12. Put the tracker in park.
13. Restart the computer.
14. Follow the steps for operating OPUS and CamTracker to begin taking data again (see the main Manual Operation procedure).

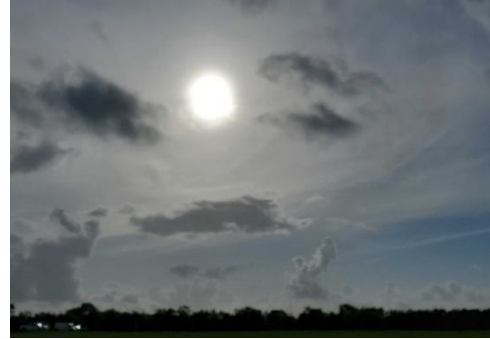
1. The sky may not be clear enough for data collection. Even cirrus clouds (thin clouds in the picture on the right) or relatively slow-moving cumulus clouds (smaller clouds in the foreground of the picture) can keep the EM27 from being able to track properly. Wait for more favorable sky conditions before re-aligning the mirrors and continuing to take data.
