THE IMPACT OF HIGHWAY CONSTRUCTION ON A FRESH WATER STREAM

A DEMONSTRATION PROJECT

Oklahoma Department of Transportation

December 1988

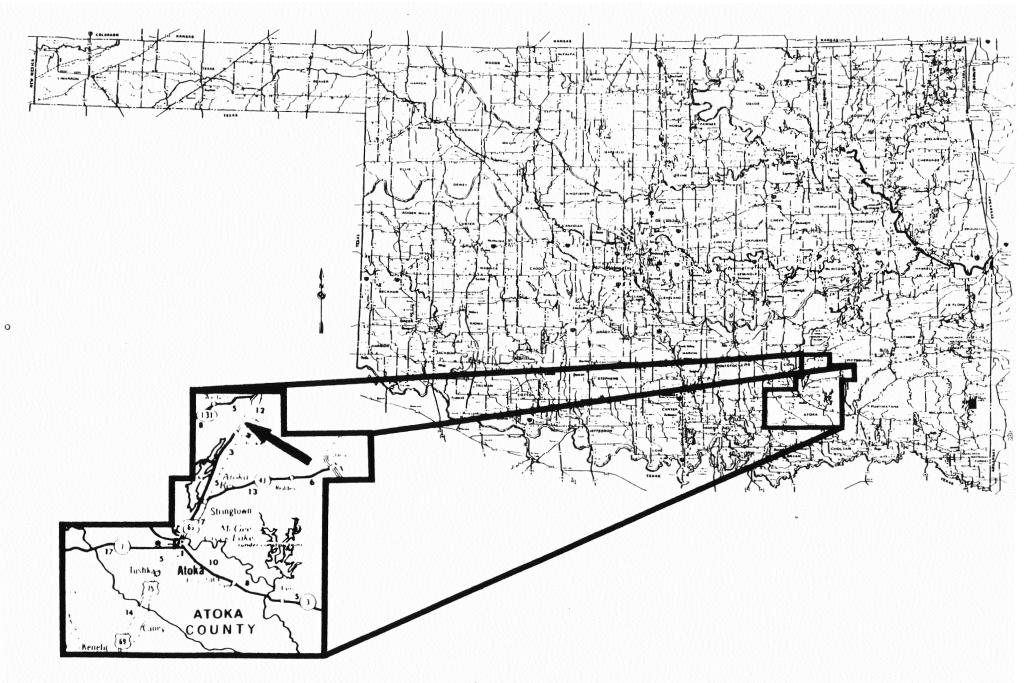
Figure 1. Project Location

selected for the demonstration study was chosen because of the clarity of the stream water and the magnitude of the proposed highway construction work, which involved extensive clearing, blasting and a high embankment in the immediate vicinity of the stream. Other considerations accessibility to sampling sites, contributed to the selection of the site. The place chosen for the demonstration is located approximately two miles north of Chockie, eight miles south of Kiowa along US highway 69 at a place called Limestone Gap in northern Atoka County, Oklahoma. Figure 1 shows the location of the demonstration site.

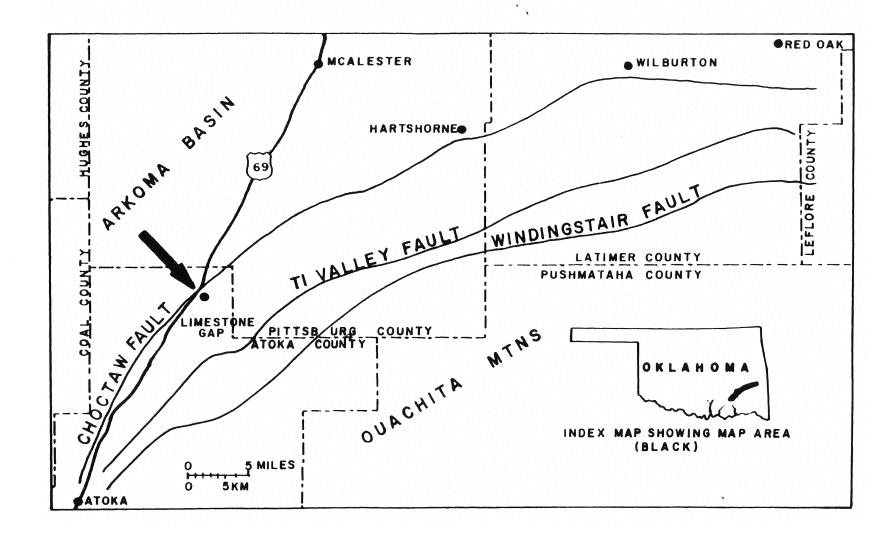
Figure 2. Regional Geologic Setting of Limestone Gap

Limestone ridge is significant geologically, because it represents the beginning of the frontal belt of the Ouachita Mountains. It is bounded on the west by the Choctaw fault and on the east by the Ti-Valley fault. Figure 2 shows the regional geological setting of Limestone Gap in respect to the two major faults of the Ouachita frontal belt.

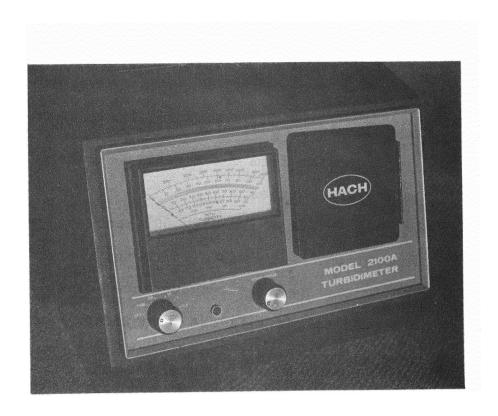
Figure 5. Turbidimeter

- B. Turbidimeter, model 2100A manufactured by HACH Chemical Corporation. It was used to make direct measurements of suspended particles in a liquid using the Nephlometric Turbidity Unit principle. Figure 5 shows the Hach turbidimeter.

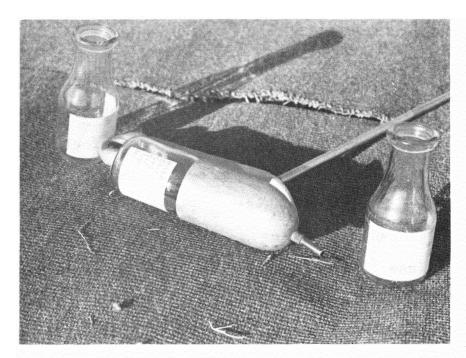
Figure 6. Water Sampler and Bottles

- C. Water Sampler, model USDH 48-2142, it was used to obtain water samples from the stream. Figure 6 shows the water sampler and bottles.
- D. Hydrolab "digital", model 4000 manufactured by Hydrolab Corporation. It was used to test water temperature, pH alkalinity, specific conductance dissolved oxygen and dissolved solids. Figure 7 shows the Hydrolab and a pair of required wading boots.

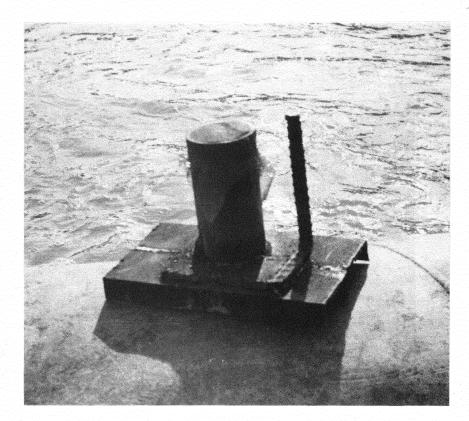
Figure 8. Sediment Collector Plate

- E. Sediment Collector Plate, was made by ODOT with a #10 screen placed across the top. It was used to collect settling stream sediment carried along the stream bottom. Figure 8 shows the sediment collector plate.

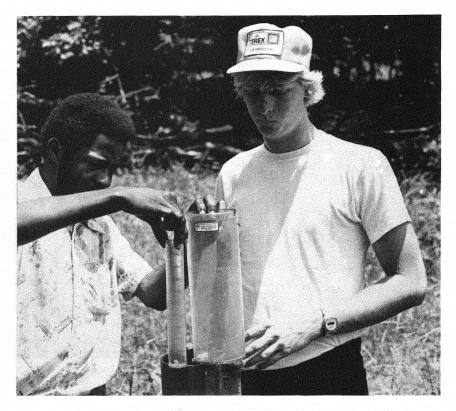
Figure 9. Rain Gauge

- F. Rain Gauge, model 5-780, manufactured by Universal Raingauge. It registers the amount of rainfall on a clock driven chart. Figure 9 shows part of the rain gauge.

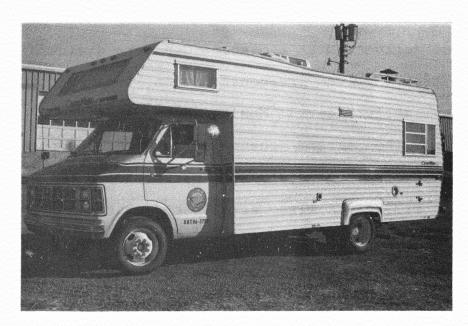
Figure 12. ODOT RV Mobile-lab

- I. Mobile-lab, it's an RV converted into a mobile-lab. It's used to transport equipment and personnel to remote testing sites. All chemical tests are conducted inside the mobile-lab at the site. Figure 12 shows the RV converted mobile-lab.

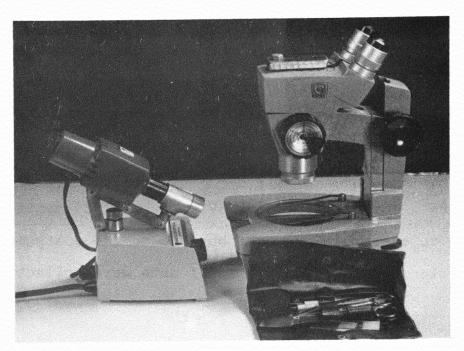
Figure 13. Binocular Microscope and Accessories

- J. Binocular Microscope, It was used to identify the aquatic insects collected at the sites. Figure 13 shows the microscope and associated tools.

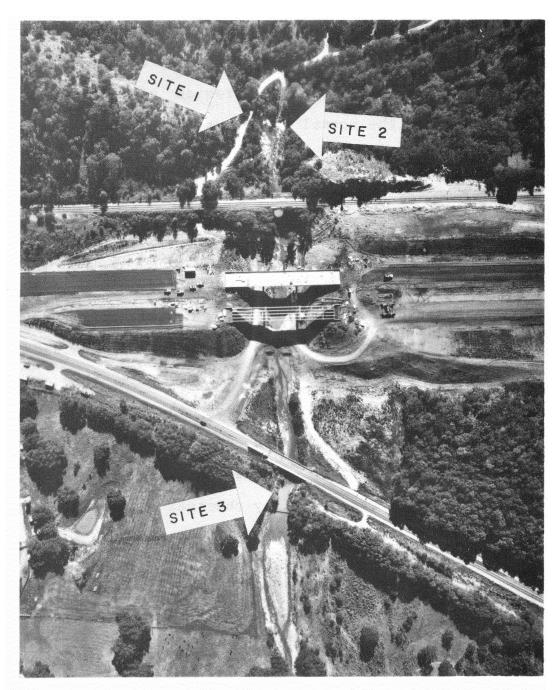
Figure 14. Water Quality Monitoring Sites 1, 2 and 3

A site approximately 250 yd downstream from the boundary of the construction area, under the US 69 bridge, was selected as a third monitoring site. This location was selected in order to observe the effects of the construction activities on the stream. Figure 14 shows the locations of the water quality monitoring sites.

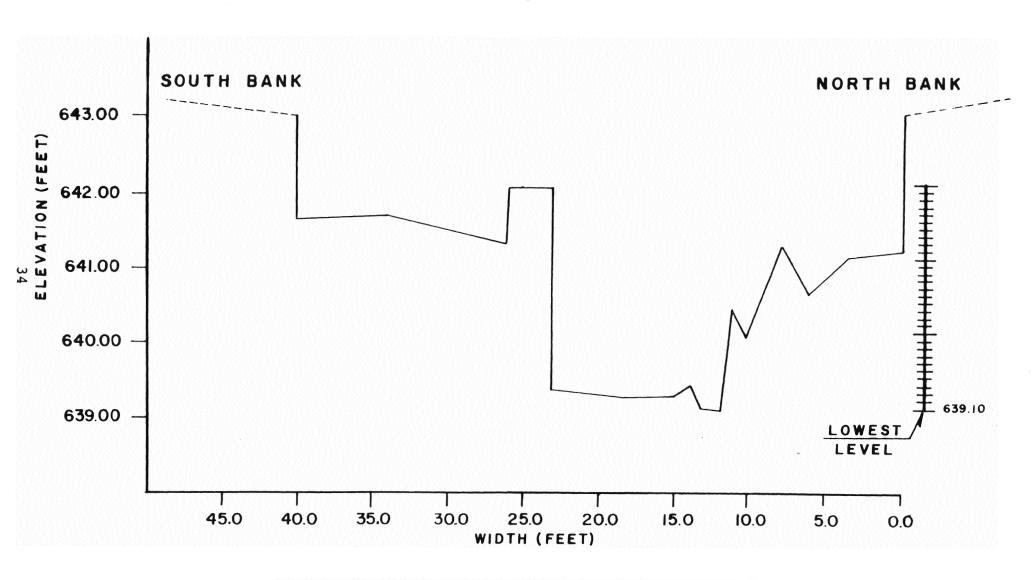
Figure 17. Cross Section of Limestone Creek, Site 1

This creek is a perennial stream with an average stream bed elevation of approximately 640 ft. The channel width is about 30 to 55 ft with an approximate length of 4.2 mi. Figure 17, 18 and 19 shows the cross section and the channel width for testing sites 1,2 and 3 respectively. The Limestone Creek channel bottom is rocky and gravelly with pools and riffles. Its banks are unstable, made up of fairly loose soil, shale and gravel. The stream is intermittently clogged at various points in the channel by natural debris such as rock, gravel and broken branches and fallen trees.

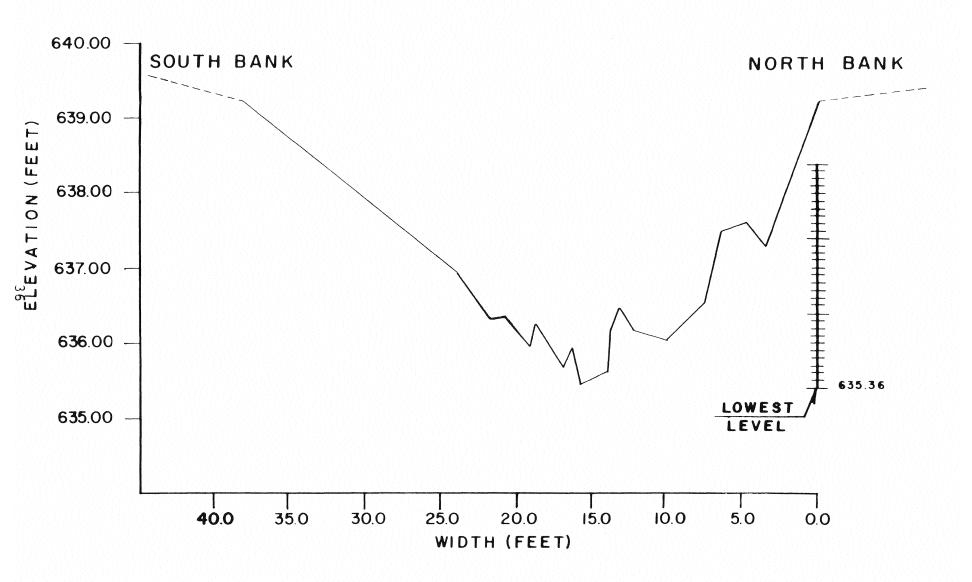
Figure 19. Cross Section of Limestone Creek, Site 3

A $\rm Q_{50}$ of approximately 7350 cfs and a $\rm Q_{100}$ of 8650 cfs with a $\rm V_{50}$ of 8.9 fps were calculated for Limestone Creek at site 3.

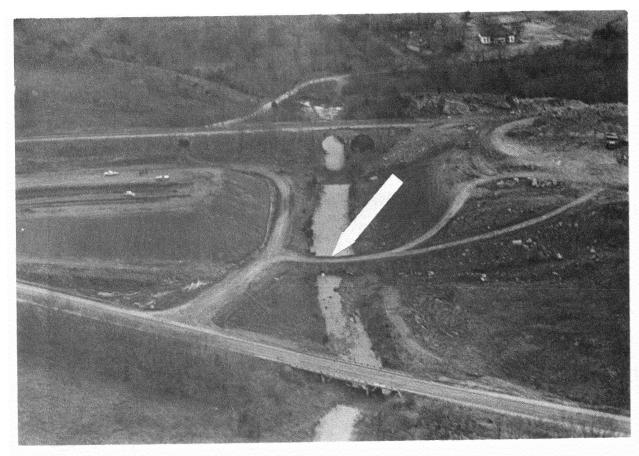
Figure 21. A View of Limestone Creek and the Temporary Dyke Looking East

At the construction site, Limestone Creek was dammed by the contractor. Two 48 in corrugated culverts were placed parallel

to the stream channel while a fill dyke was built over them to convey heavy trucks and equipment to and from the construction site. This installation created a water storage pond for the construction work at Limestone Gap. Figures 21 and 22 show the temporary dyke across Limestone Creek and, the pump used to pump water from the pond.

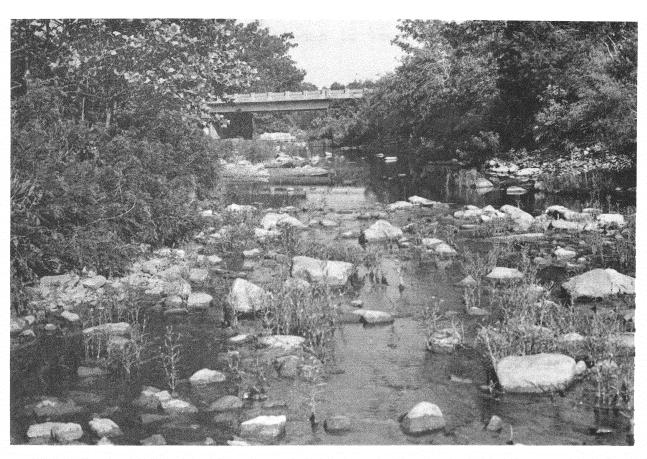
Figure 23. Pre-construction Condition of Limestone Creek

The pre-construction phase of research monitoring and testing activities ended in October of 1984, providing eight years of baseline data. Normally a year or two of baseline data would be adequate. Figure 23 shows the pre-construction condition along Limestone Creek.

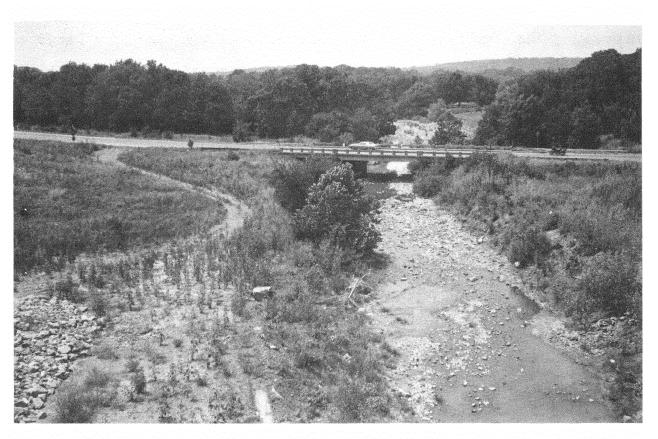
Figure 24. Cleared Area Along Limestone Creek

The clearing grubbing and grading operation started at the same time in all areas surrounding Limestone Creek. sediment collector plates were placed directly adjacent to disturbed areas where runoff entered the streams. An area approximately 1800 ft long by 400 ft wide was cleared along Limestone Creek alone. Figure 24 shows the cleared area along Limestone Creek.

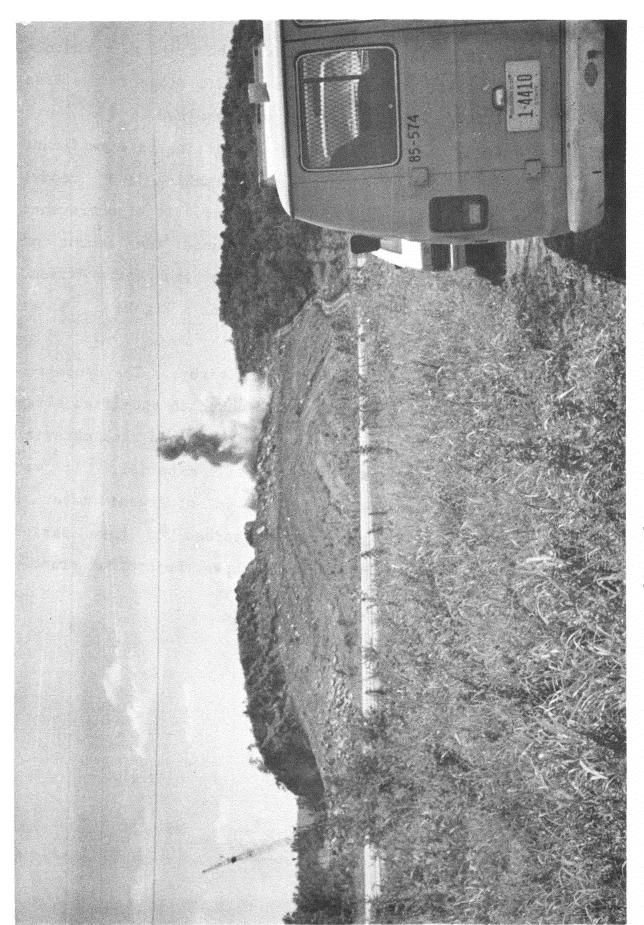
Figure 25. Blasting at Limestone Gap

2. <u>Blasting and Rock Crushing:</u> Blasting activities started on April 10, 1985. The contractor used the blasting technique of angle pre-splitting to produce a 1/2:1 slope in the area of the Gap where a new alignment was required.

This blasting technique of pre-splitting is significant because it reduces overbreakage, crushing and radial cracking of rock around the bore holes. It also prevents excessive flying debris. This reduced the amount of sediments that were introduced into the nearby stream. Blasting was completed in April of 1986. Figure 25 shows blasting at Limestone Gap.

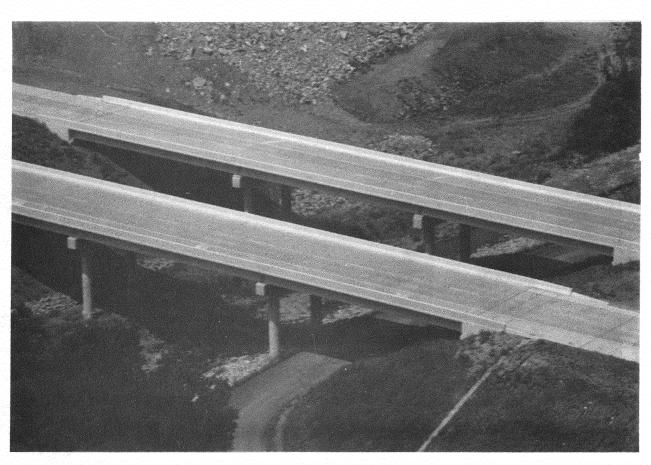
Figure 29. Completed New Twin Bridges at Limestone Gap

3. <u>Bridge and Roadway</u>: Bridge work over Limestone Creek began on April 14, 1986 and ended on December 17, 1986. It involved construction of 0.051 mi twin bridges on drilled shaft piles. It was done simultaneously with roadway surfacing.

To prevent erosion, the bridge abutments were protected with rip-rap. The literature reviewed indicated that the impact of bridge construction on aquatic communities is minimal, but researchers at ODOT monitored this activity to see if there would be any impact at Limestone Gap. Figure 28 shows roadway surfacing while Figure 29 and 30 show the completed new twin bridges across Limestone Creek.

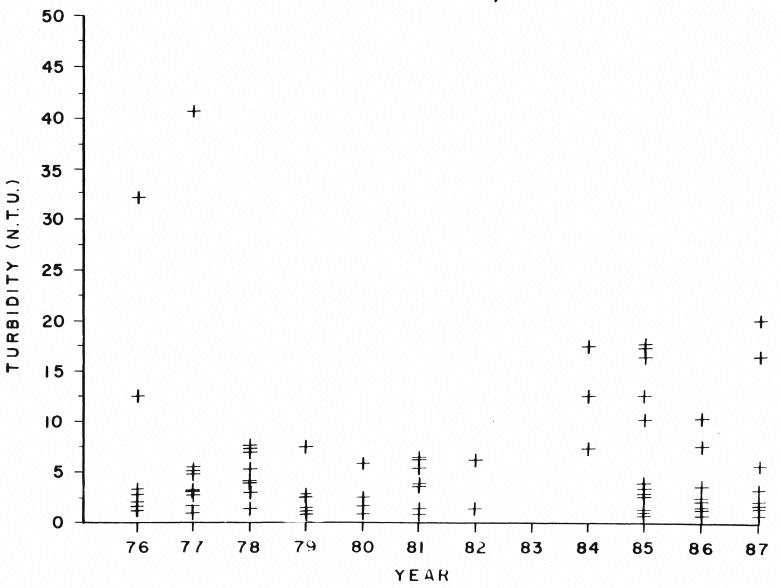
Figure 31. Turbidity Variation Plot from 1976 through 1987 for Site 1.

LIMESTONE GAP TURBIDITY GRAPH, SITE I

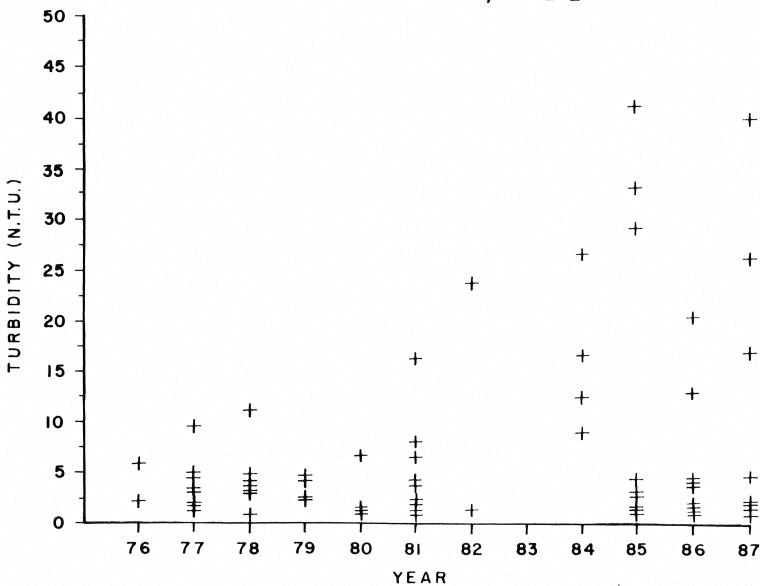
Figure 32. Turbidity Variation Plot from 1976 through 1987 for

LIMESTONE GAP TURBIDITY GRAPH, SITE 2
