SLIDING VANE PUMP SHAFT STRUCTURAL  
RESPONSE AND INTERMITTENT  
FAILURE INVESTIGATION

Submitted to the Faculty of the  
Graduate College of the  
Oklahoma State University  
in partial fulfillment of  
the requirements for  
the Degree of  
MASTER OF SCIENCE  
May, 2009

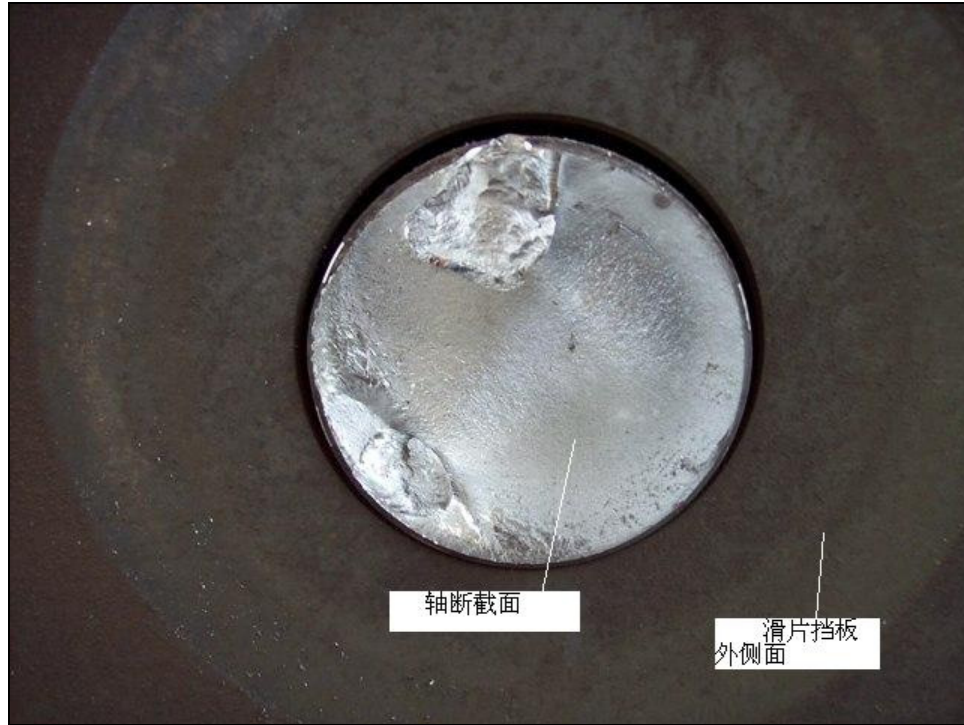
Figure 1.3 through 1.5 are photographs of the typical fracture surface associated with an intermittent pump shaft failure. The fracture surfaces exhibit signs of fatigue failure given the relatively smooth fracture surface and the relatively small final rupture zone. Many of the fractures surfaces were found to pass through or very near the seal drive pin hole that is drilled radially into the shaft. However, the question still remains regarding what are the specific conditions that lead to the intermittent failure of these pump shafts.

Figure 1.3: Photograph of Typical Pump Fracture Surface Rotor Side

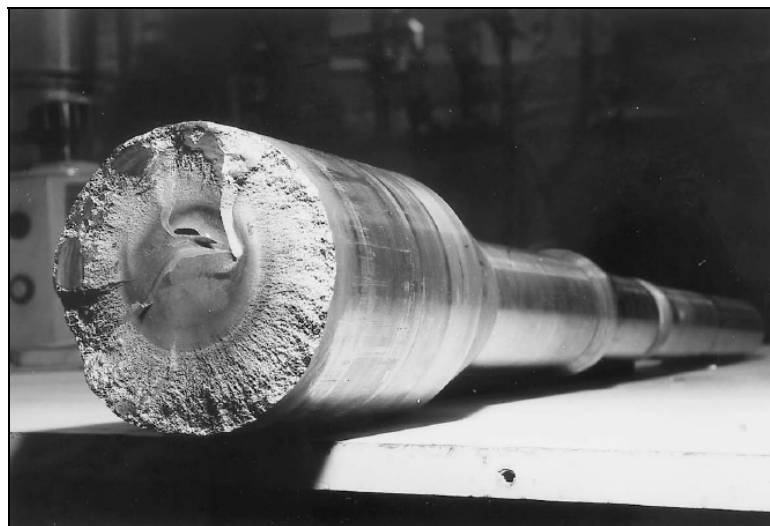
However, not all shaft failures stemming from wear and friction are the result of geometrical stress concentrations on the outer circumference due to scoring or other types of mechanical damage. Lancha, Serrano, and Gomez Briceno [3] conducted a failure analysis of a condensate pump shaft pictured in Figure 2.3 where the material located on the outer surface of the shaft was embrittled via thermal cycling due to friction from a failed shaft sleeve. The shaft sleeve was to serve as a protective barrier between the pump shaft outer surface and a bronze bearing. However, when the protective sleeve seized and relative motion began to occur between the sleeve and the pump shaft large amounts of friction began to occur, which subsequently generated a significant amount of heat. Periodic operational use of the pump resulted in thermal cycling on the outer surface of the shaft, which subsequently resulted in hardening of the shaft surface, grain growth, and the formation of subsurface cracks shown in Figure 2.4. The subsurface cracks and the reduced ductility served to facilitate intergranular crack growth until the crack front approached the more ductile center of the shaft where the crack growth became more transgranular in nature.

**Figure 2.3: Photograph of Nuclear Power Plant Pump Shaft Fracture**

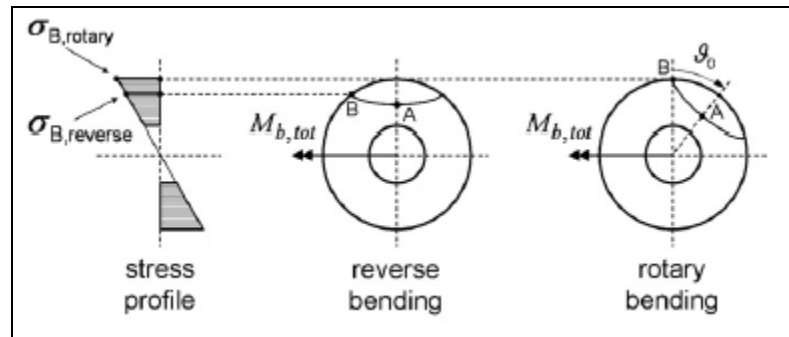
reversed bending acted to increase the stress intensity factors of the crack front near the outer surfaces as compared crack front within the interior of the shaft. Figure 2.7 provides an illustration given by Madia, Beretta, and Zerbst where the SIF at point B located on the outer surface of the shaft would be larger in magnitude as compared with the SIF at point A. As a consequence of this they noted that this tended to flatten the crack as it propagates through the body of the shaft when the cracks initial shape is assumed to be elliptical. This phenomenon was also shown analytically by Carpinteri, Brighenti, and Spagnoli [10], however their research did not take into account any effects from nearby interference fits. The flattening of the crack shape as it propagates transversely through the interior of the shaft can also be seen in the fracture surface schematics shown in Figure 2.6, specifically for cases of low nominal stress where there is either no outer surface stress concentration or the existence of a “mild” stress concentration.

**Figure 2.7: Illustration Denoting Point Locations Along Crack Front**

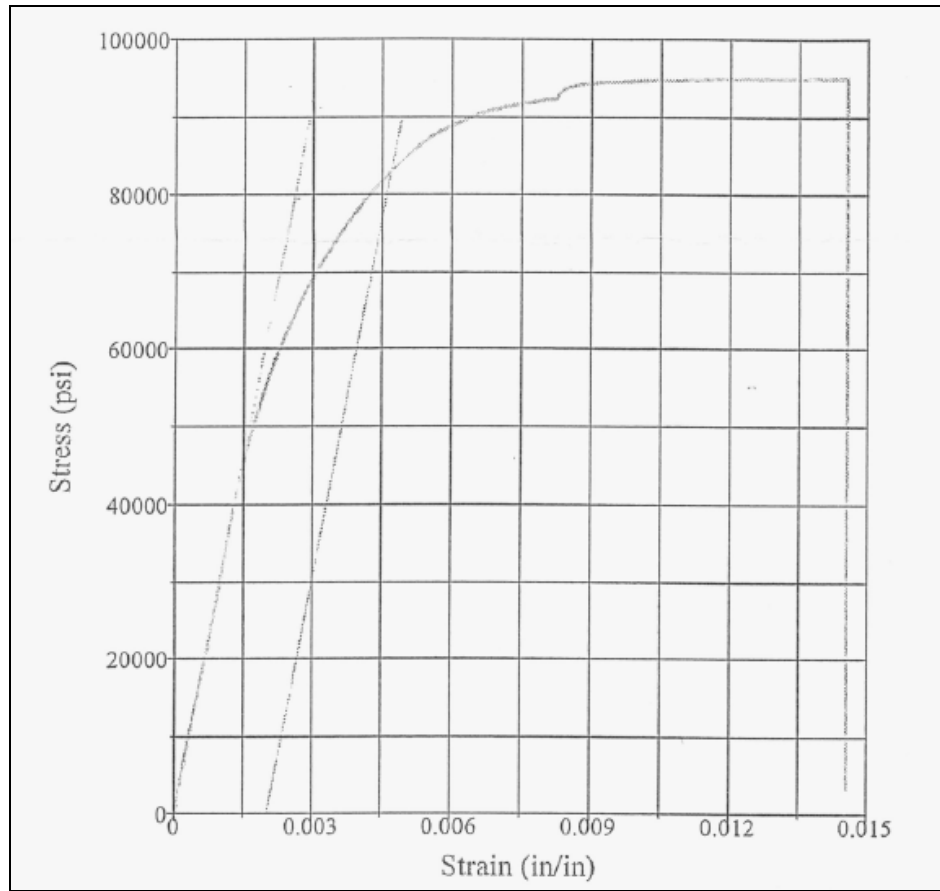
A second tensile test was conducted to generate an engineering stress-strain curve for the sample shaft material. Figure 3.1 shows the resulting stress-strain curve that was generated. This engineering stress-strain data was subsequently converted into true stress-strain data and used to model plastic deformation using the finite element method associated with the interference fit of the seal assembly pin into the pump shaft. The results from these analytical studies will be covered in Chapter IV.

**Figure 3.1: Engineering Stress-Strain Diagram of Sample Shaft Material**

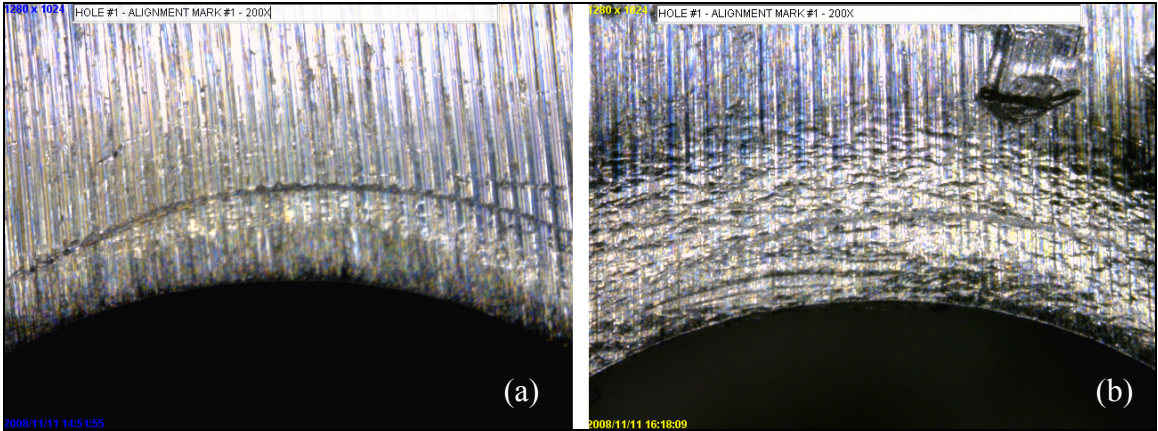
It can be seen from the photographs that there is an appreciable amount of plastic deformation in the area surrounding the seal drive pin hole after pinning. However, it can be seen that the plastic deformation is more highly concentrated at alignment marks #1 and #3, which are located transverse of the shaft axis. No visible cracks near or around the seal drive pin hole were observed.

**Figure 3.4: Photographs of Seal Drive Pin Hole at Alignment Mark #1 (a) Before Pinning, (b) After Pinning**

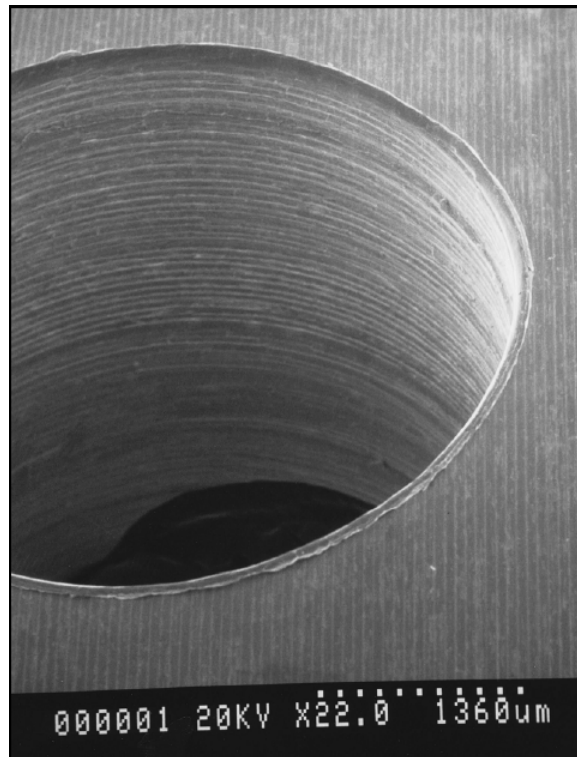
Figures 3.10 and 3.11 show two different views of the seal drive pin hole in the shaft prior to the press fit operation. Machining marks on the outer surface of the shaft can be visibly seen as well as the circular machine marks inside the seal drive pin hole. A small amount of plastically deformed metal can be seen around the perimeter of the seal drive pin hole. This small ring of material is attributed to the drilling operation.

**Figure 3.10: SEM Photograph of Seal Drive Pin Hole Prior to Pinning**

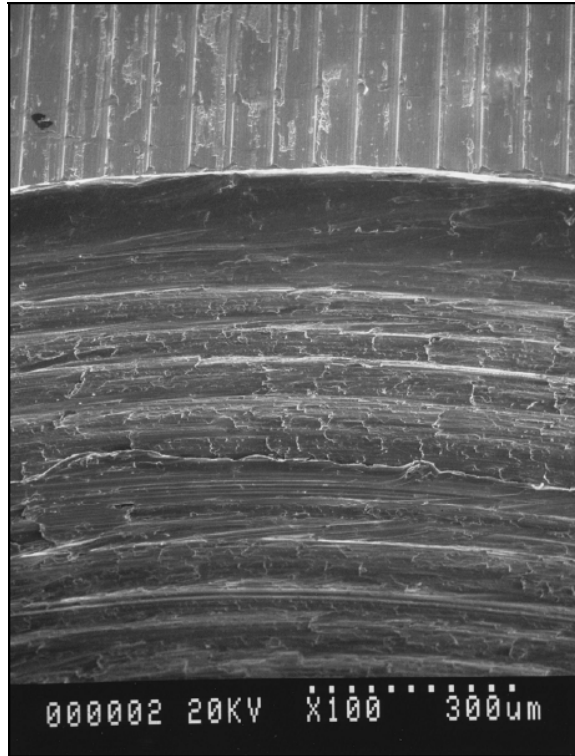
**Figure 3.11: SEM Photograph - Closer Examination of Seal Drive Pin Hole**

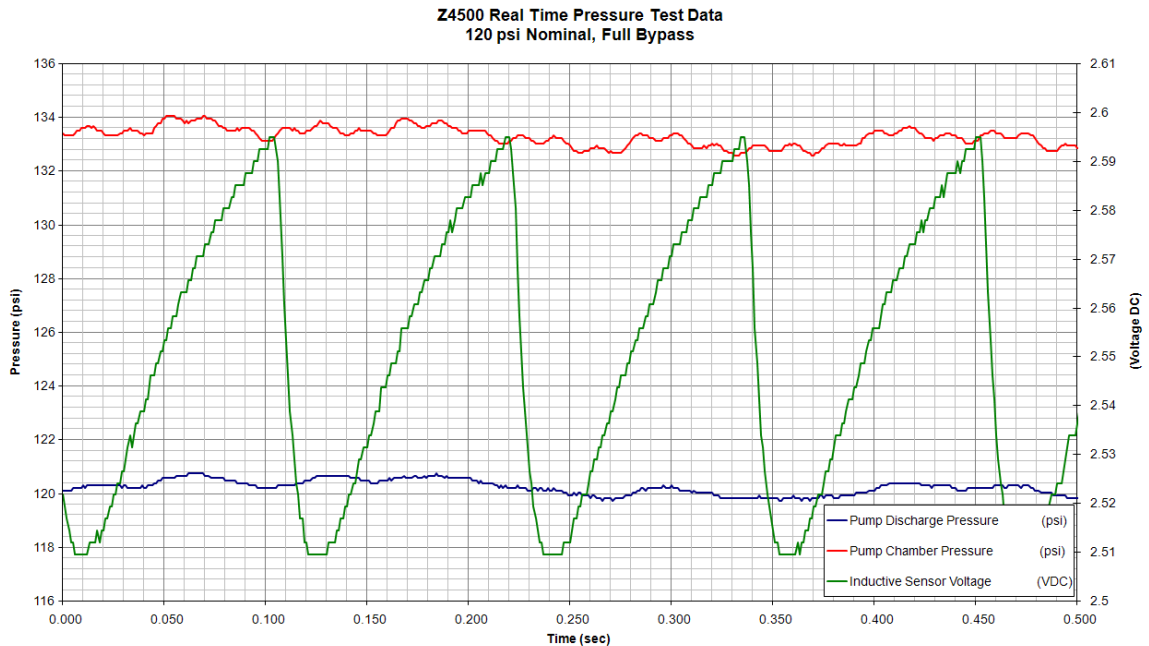
An excerpt of the data collected is shown in Figure 3.17. There was an obvious difference in mean value between the pump discharge pressure and the pump chamber pressure. In addition, the acquired data revealed pressure oscillations within the pumping chamber. The pump chamber pressure oscillations were noted as having six (6) peaks per revolution, which is identical to the number of vanes within the pump. A complete revolution of the pump is shown in the data presented in Figure 3.17 as the time between peaks of the inductive sensor voltage. The inductive sensor voltage signal was such that when the modified shaft key was present directly underneath the inductive sensor the inductive sensor output voltage would immediately drop.

The mean difference between the pump discharge pressure and the pump chamber pressure in conjunction with the pressure fluctuations observed within the pumping chamber appear to be related to the number of vanes in the pump and may indicate the possibility of liquid compression within the pump. Liquid compression within positive displacement pumps is viewed as being detrimental due to the magnitude of the resulting pressures, the loss in efficiency, and the subsequent torque variations which result in vibration. However, the mean difference between the pump discharge and the pump chamber pressure may simply be a function of the pressure losses as the fluid travels from the pumping chamber, through the cam outlet porting, and into the main volume of the discharge cavity.

**Figure 3.17: Pump Pressure Test Results**

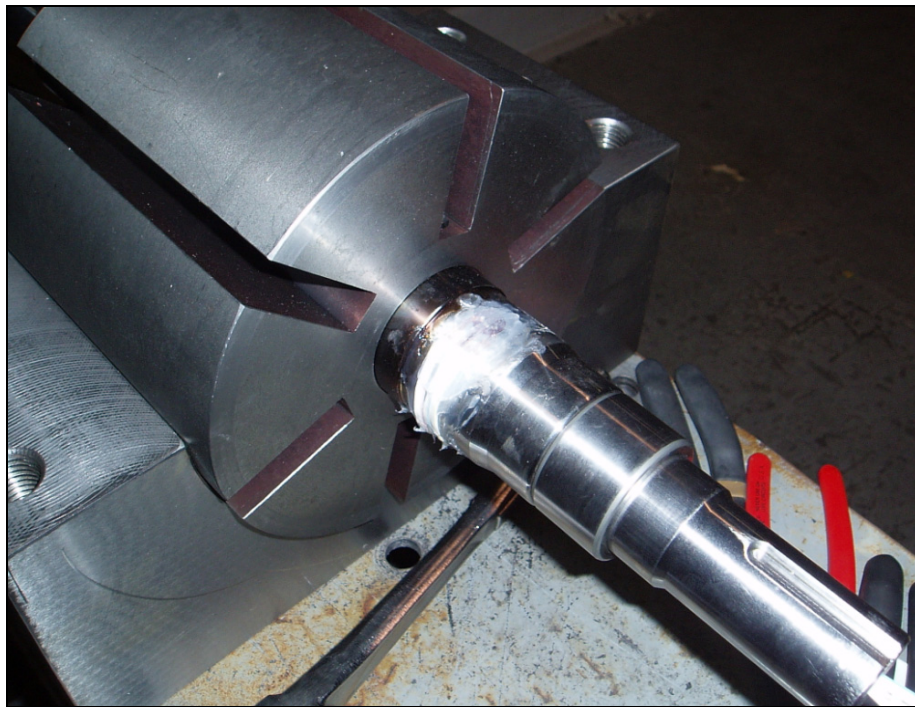
One final issue regarding the strain gauging was protection of the gauge and fine lead wires while submerged in pressurized fluid. The test fluid used by Corken, Inc. is clear Electrical Discharge Machining (EDM) oil. The first attempt at protecting both the gauge and the lead wires that were routed around the outer circumference of the pump shaft was to use commercially available clear silicone. However, during one of the experiments it was discovered that EDM fluid dissolves silicone. Therefore, a second attempt to protect both gauge and its lead wires was performed using several coats of commercially available cyanoacrylate adhesive. This protection method proved to be successful at both protecting the gauge from the EDM fluid and protecting the lead wires from incidental displacement. Figure 3.25 is a photograph of the rotor/shaft assembly with the protective coating over both the gauge and the lead wires routed circumferentially to the radially drilled hole.

**Figure 3.25: Photograph of Strain Gauge with Protective Coating**

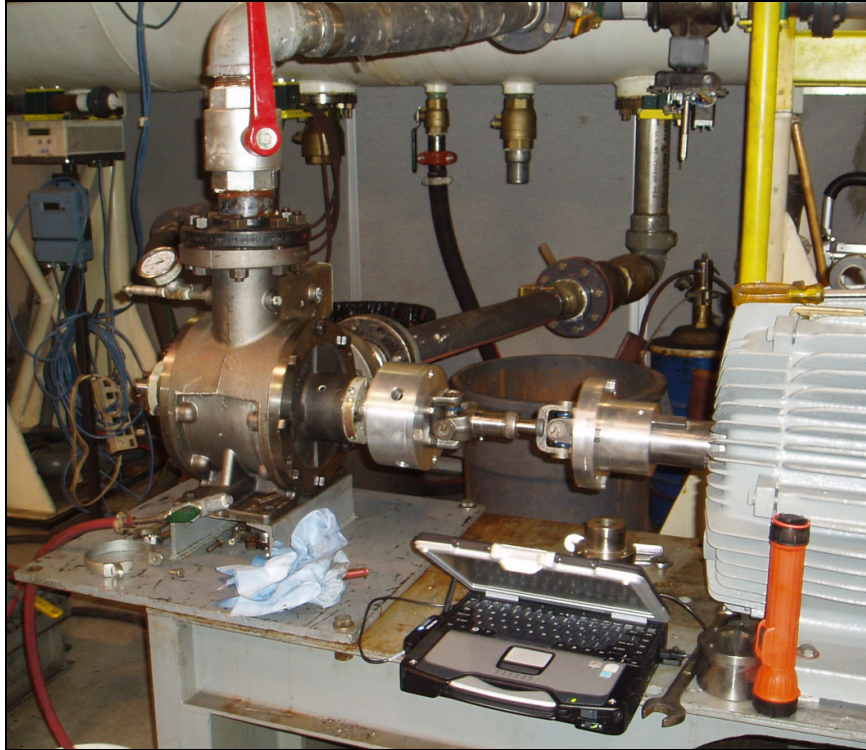
**Figure 3.37: Photograph of U-Joint Setup**

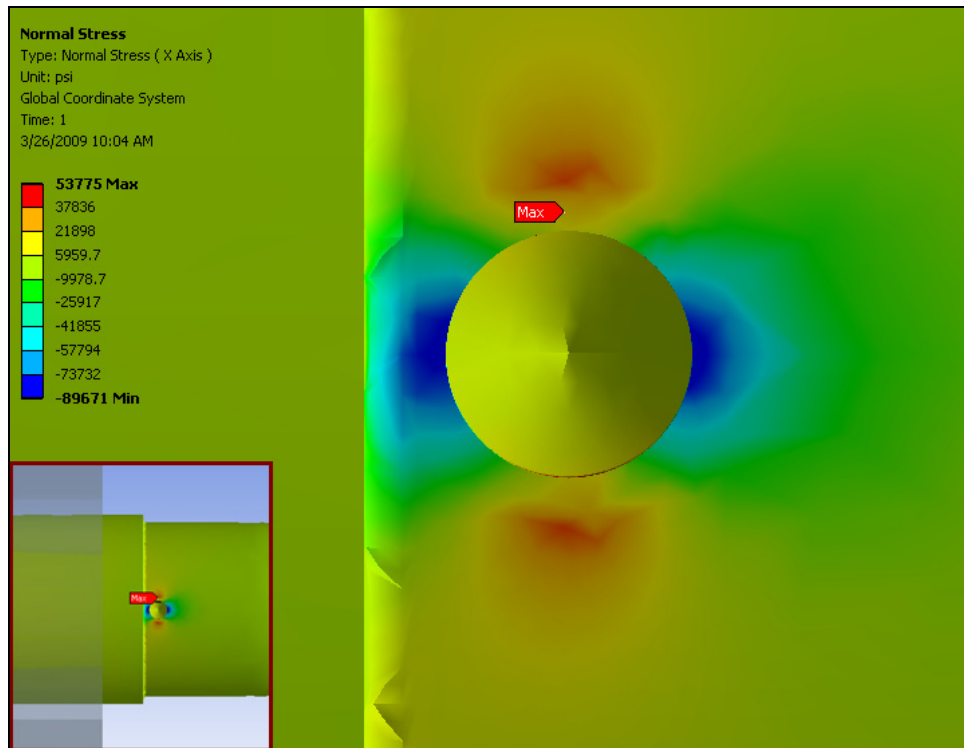
**Figure 4.22: Plot of Axial Stresses Near the Seal Drive Pin Hole Top View**

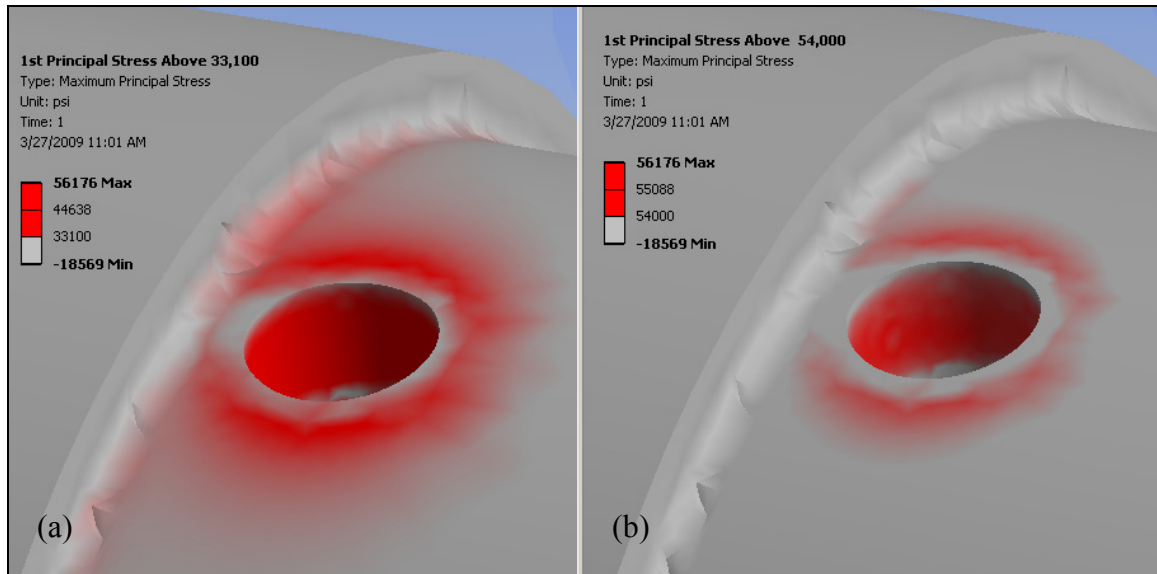
**Figure 5.9: Fringe Plot of the 1st Principal Stresses (a) Above 33,100 psi and (b) Above 54,000 psi**
