RECOMMENDATIONS FOR THE DEVELOPMENT
LENGTH OF PRESTRESSING STRANDS
INCLUDING THE EFFECTS OF
HIGH STRENGTH CONCRETE

By
AMOL SHRIDATTA GANPATYE
Bachelor of Engineering
University of Mumbai
Mumbai, India
2004

Submitted to the Faculty of the
Graduate College of the
Oklahoma State University
in partial fulfillment of
the requirements of
the Degree of
MASTER OF SCIENCE
December, 2006

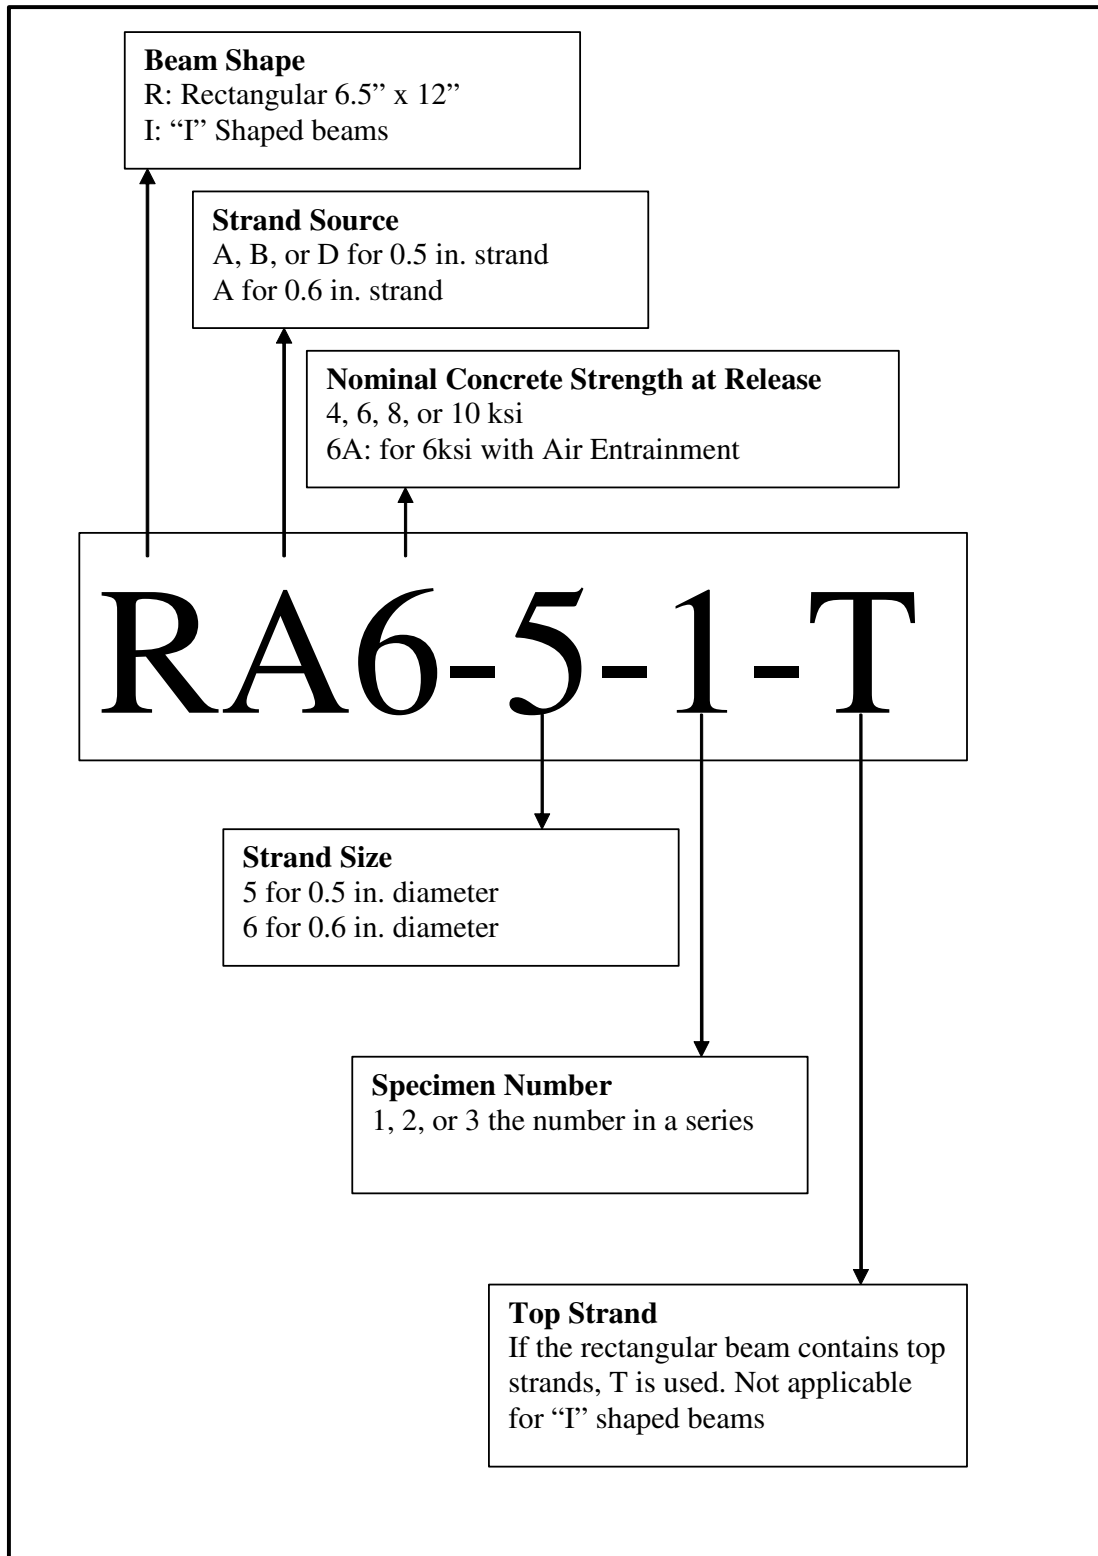
Figure 2.2: Nomenclature for beam specimens used adopted for the current research project. Adopted from Masters thesis of (Chandran 2006)

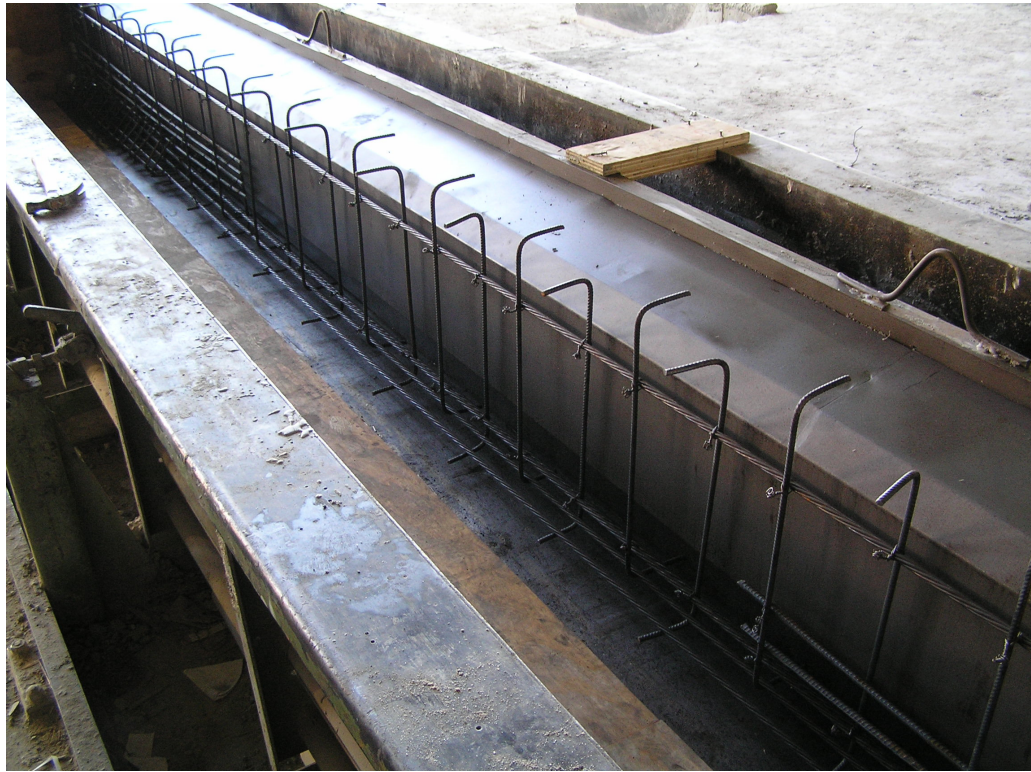
Figure 3.3: Arrangement of stirrups for I-shaped beams

Figure 3.2 shows the cross-section of the I-beams with the reinforcement details. Each beam had a length of 24 feet with 5 strands for the beams with 0.5 in. diameter strands and 4 strands for the beams with 0.6 in diameter strands. The central strand from the bottom most level of strands was removed keeping the remaining 4 strands in their respective positions. Top flange longitudinal reinforcement was 2 #3 bars throughout the length and the transverse reinforcement was # 3 bars at 9 in spacing throughout the length of the beams. Stirrups were # 3 bars with standard 90 degree bend and spaced 7 in. on-center. These stirrups were arranged such that the alternate stirrups faced in the opposite

directions as shown in Figure 3.3. In addition to these reinforcements, horizontal reinforcement of #4 bars with a standard 180 degree bend on one end were placed near the beam ends with 2 #4 bars on the South end and 4 #4 bars on the North end. To avoid concrete crushing in the bottom bulb, a reinforcement cage as shown in the Figure 3.4 was provided in all I-shaped beams. The vertical reinforcement of this cage was made of #3 bars bent into a triangular shape as shown in Figure 3.5 and the horizontal reinforcement of this cage was made of #3 bars stretched up to 72 in. from the ends of each beam.

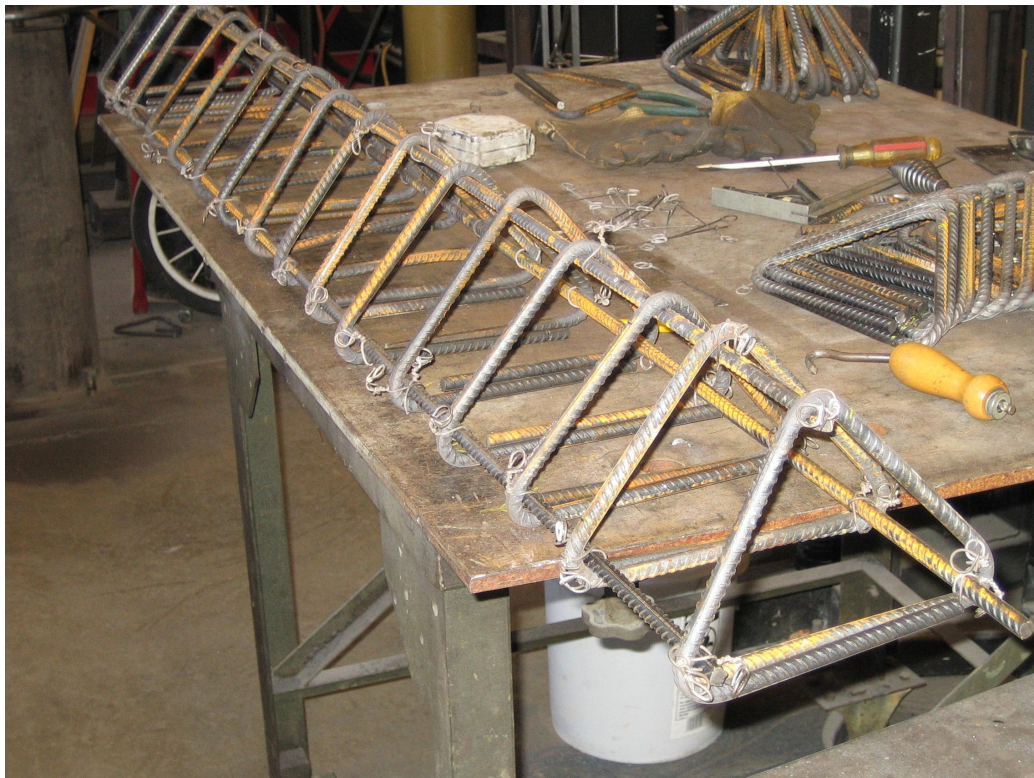
Figure 3.4: Bottom bulb confining reinforcement

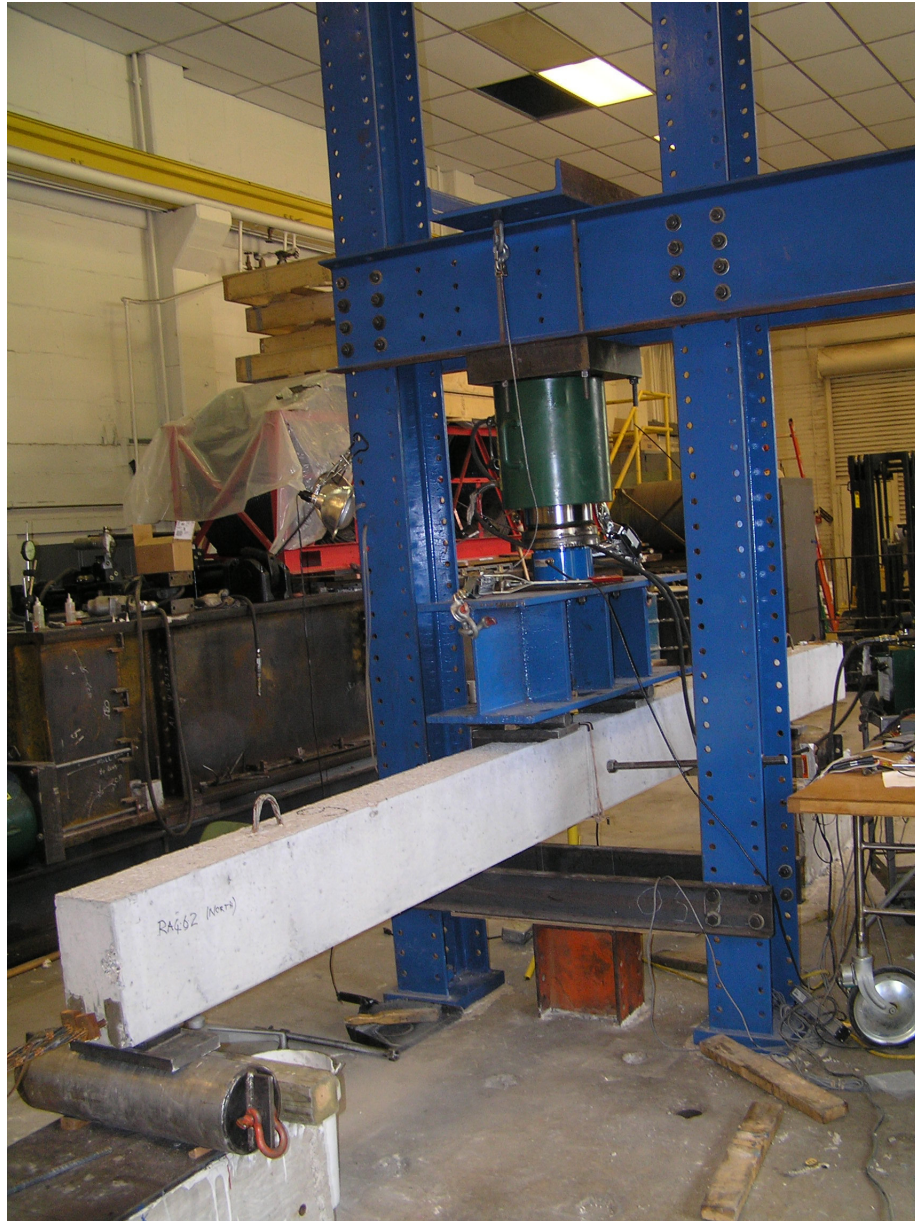
Figure 3.6: Test frame with one of the rectangular beams in place

The test frame was designed to perform flexural tests on the rectangular as well as on the I-shaped beams. Figure 3.6 shows a photo of the test frame with a rectangular beam in position. Test frame mainly consisted of two columns connected to the reaction floor and a crosshead which could be bolted at variable heights depending on different height requirements for rectangular and I-shaped beams. A hydraulic actuator was attached at the center of crosshead so that the line of loading was located at the midpoint between the two columns. A spherical head was attached to the hydraulic actuator which allowed for changes in the slope of the beam during loading. The load was distributed into two point loads by a spreader beam which rested on two small rollers. The position of these two

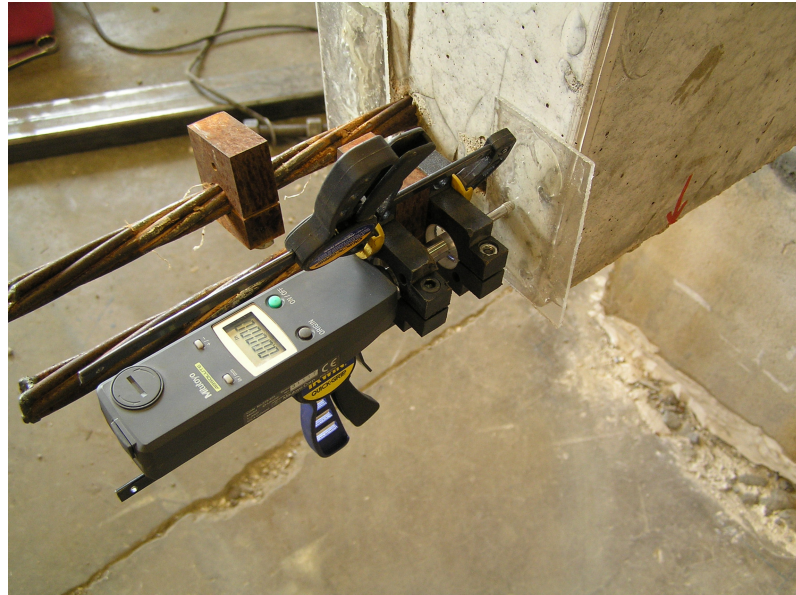
Figure 3.13: Photo showing digital dial gauge attached to the strands at the opposite end for one of the rectangular beams

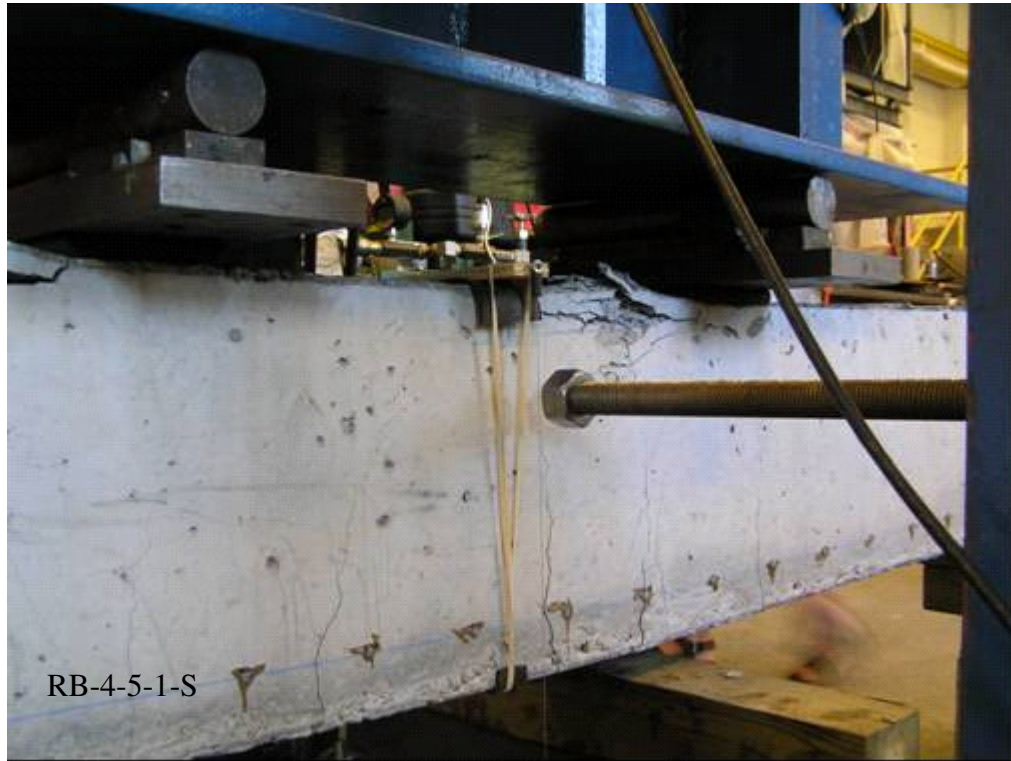
Figure 4.2: Concrete crushing at the top surface of concrete (Test – RB-4-5-1 S)

Figure 4.1 shows the variation of Moment and end-slip with deflection. Figure 4.2 presents a photograph of the crushed concrete.

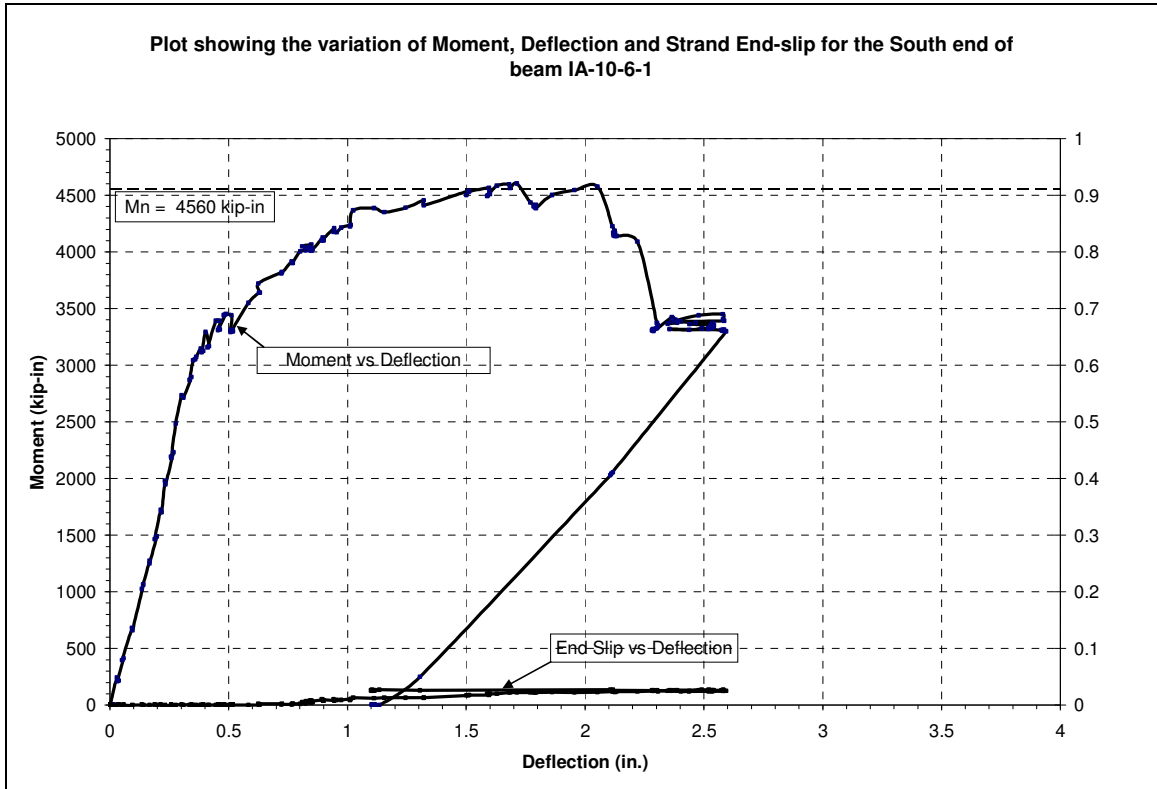
Figure 4.3: Photo of the South end of the beam IA-10-6-1 showing the first web shear cracking

Figure 4.3 shows the variation of moment, deflection and the strand end slip during the test on South end of the beam IA-10-6-1. The sudden drop in load at strand fracture can be clearly seen from the graph. Figure 4.4 shows the variation of shear vs. average shear strain measured on the web of the beam at Station 36 from the South end. Figure 4.5 displays a photograph taken as the first web shear cracking occurred. Also, Figure 4.6 shows a photograph of the South end of the beam just after strand fracture occurred. In Figure 4.7 we can clearly see the fractured strand.

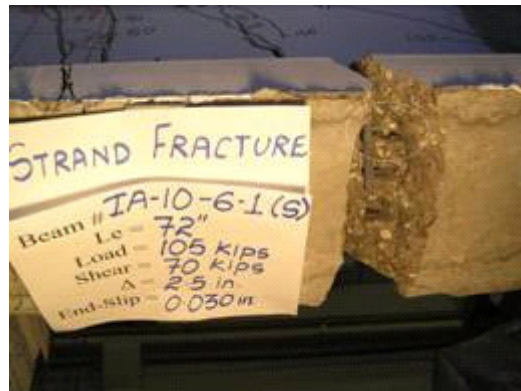
Figure 4.7: Photo showing the fractured strand (Test : IA-10-6-1-S)

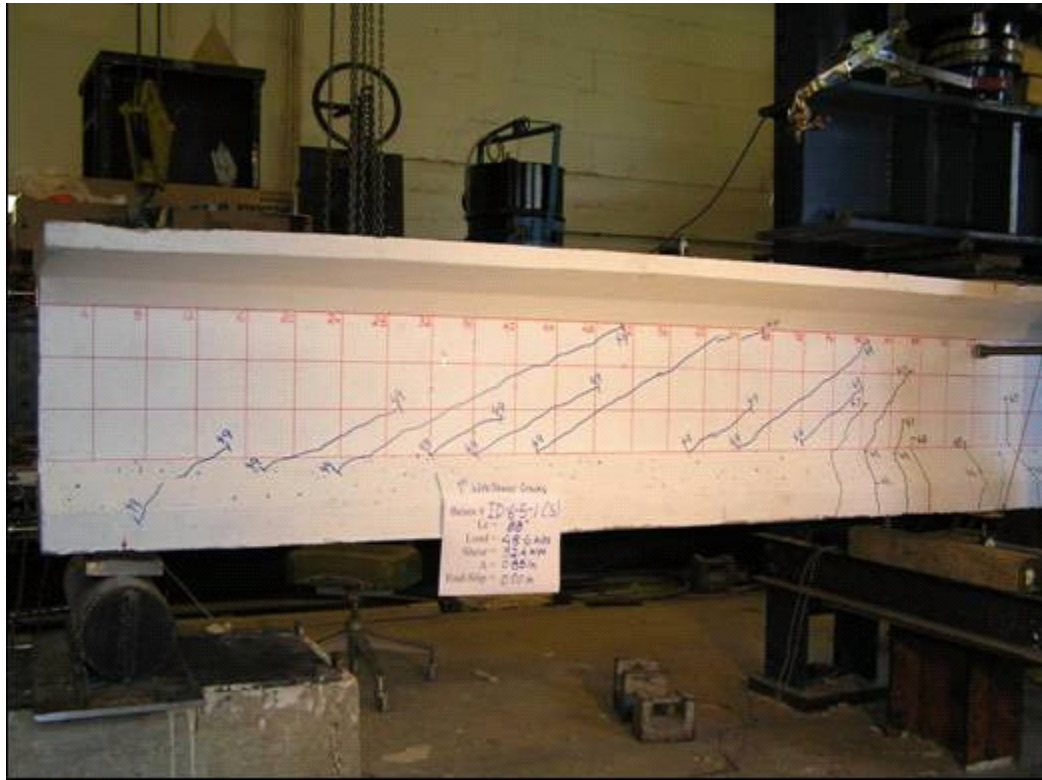
Figure 4.12: Photo of the South end of the beam ID-6-5-1 showing the first web shear cracking

Failure of this beam was classified as bond failure since the end slip values were large and the maximum moment attained was lesser than its nominal capacity by approximately 20%. From the result of this test, it was clear that the embedment length of 88 in. was insufficient for the strand to develop enough anchorage required to achieve nominal capacity. Figure 4.10 shows the variation of Moment and End-slip with deflection. The plot shows the rate of increase of load reduces as the strand started slipping. The plot becomes horizontal as strand slip increases sharply. The increase of strand slip corresponds to large deflections during the later stages, and indicates that the demand of bond strength had increased beyond the maximum value the strand could offer. It can be seen from the plot that the end slip did not start with the first flexural cracks, but that strand slip can be associated with the formation of first web shear cracks. Figure 4.11 shows the variation of shear vs. average shear strain measured on the web of the beam. Figure 4.12 and Figure 4.13 present photographs taken just after first web shear cracking and at maximum deflection respectively.

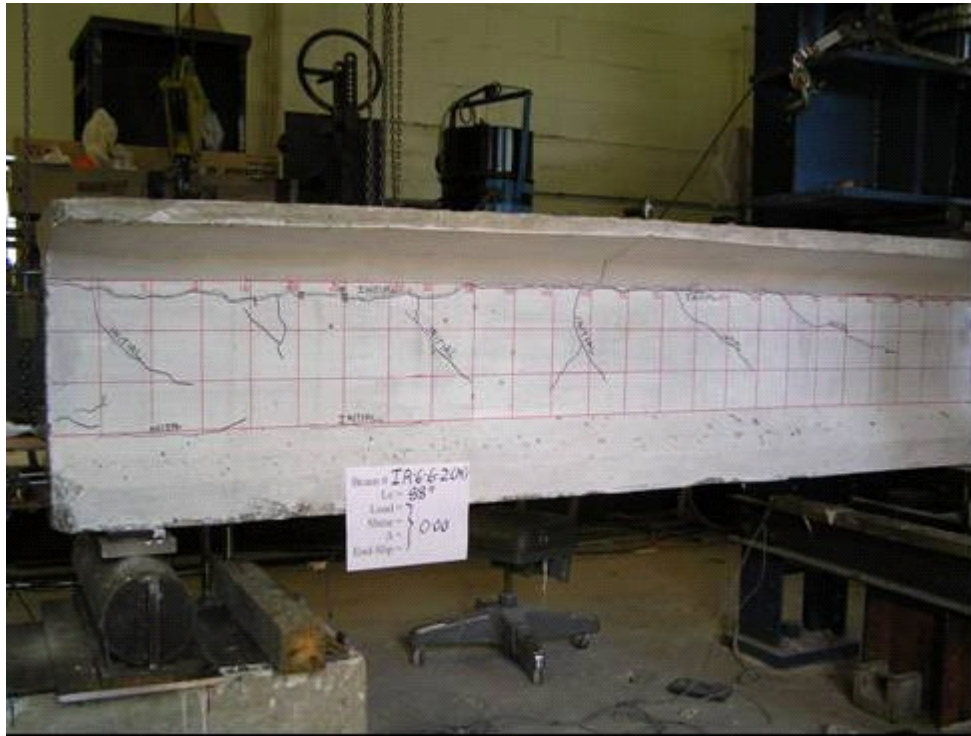
Condition of the beam before starting the test can be seen from Figure 4.14. There were several initial cracks present on the beam with a significantly long crack at the junction of flange and web. These cracks were caused during the handling of the beam at the precast/prestressing plant.

Figure 4.14: Photo showing the cracks present on the beam IA-6-6-2 before starting the test.

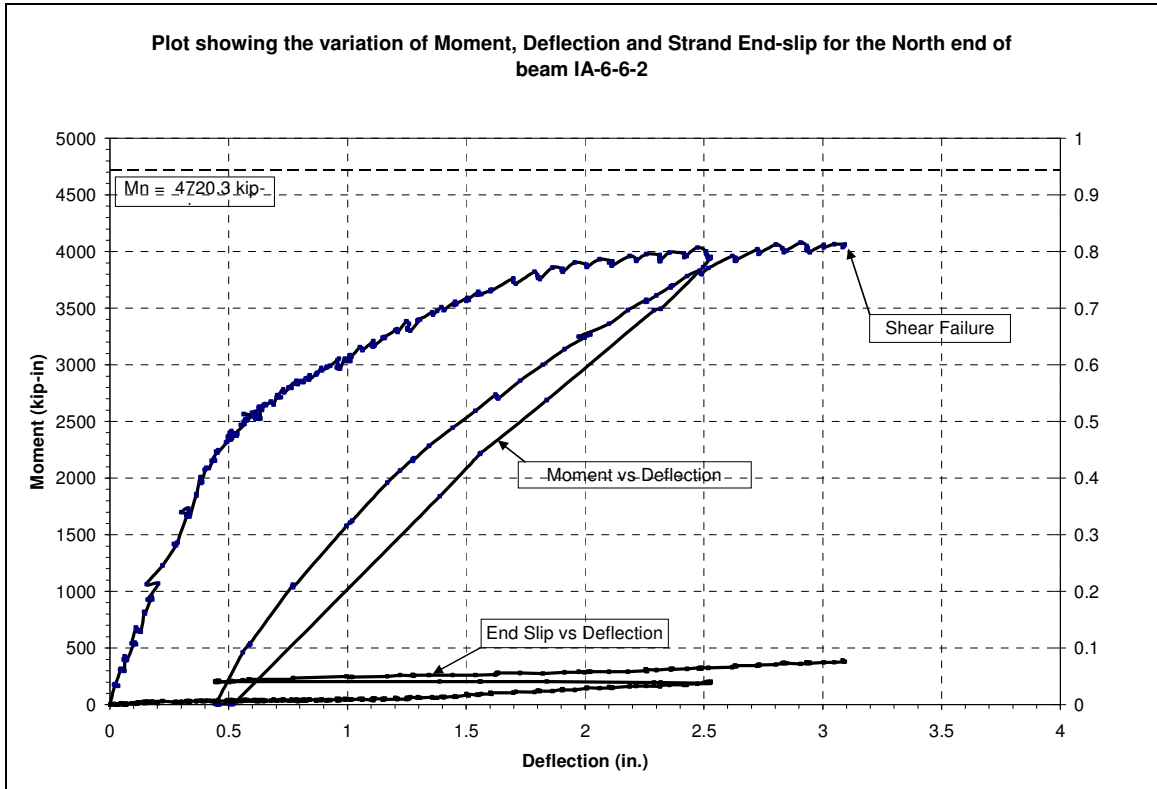
Figure 4.15: Moment-Deflection curve with end slips for the North end of the beam IA-6-6-2

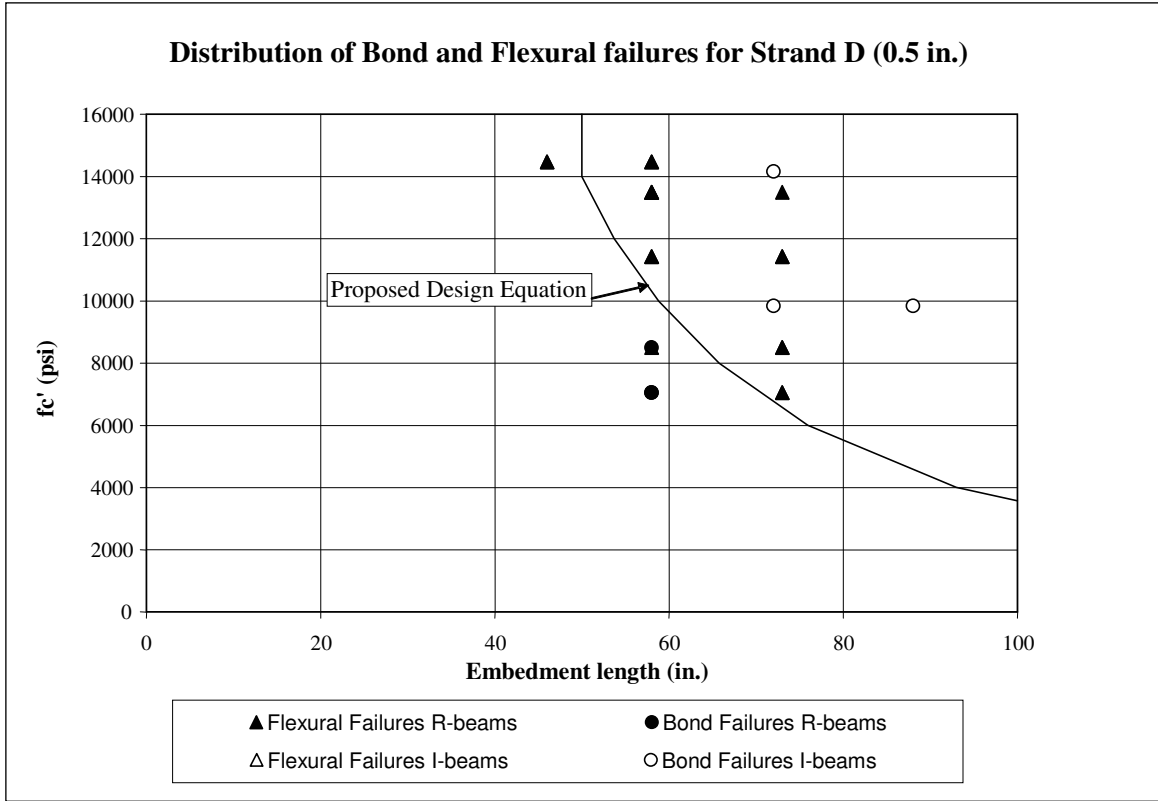
Figure 5.3: Distribution of Bond and Flexural failures for Strand D (0.5 in.)

Figure 5.3 shows the results of development length tests on Strand D. Strand D demonstrated below average bond performance with a relatively low NASP Bond Test result (6890 lbs), longer transfer lengths and longer development length requirements than Strand A/B. Figure 5.3 shows that bond failures occurred in rectangular beams with embedment lengths of 58 in. at the lower concrete strengths. More importantly the figure shows improvement in strand bond behavior as concrete strengths improve. Note, however, that bond failures occurred in I-beams cast with Strand D. Results of the tests demonstrate that the Strand D, with an NASP Bond Test value of only 6890 lbs. may not provide adequate bond-ability with concrete.

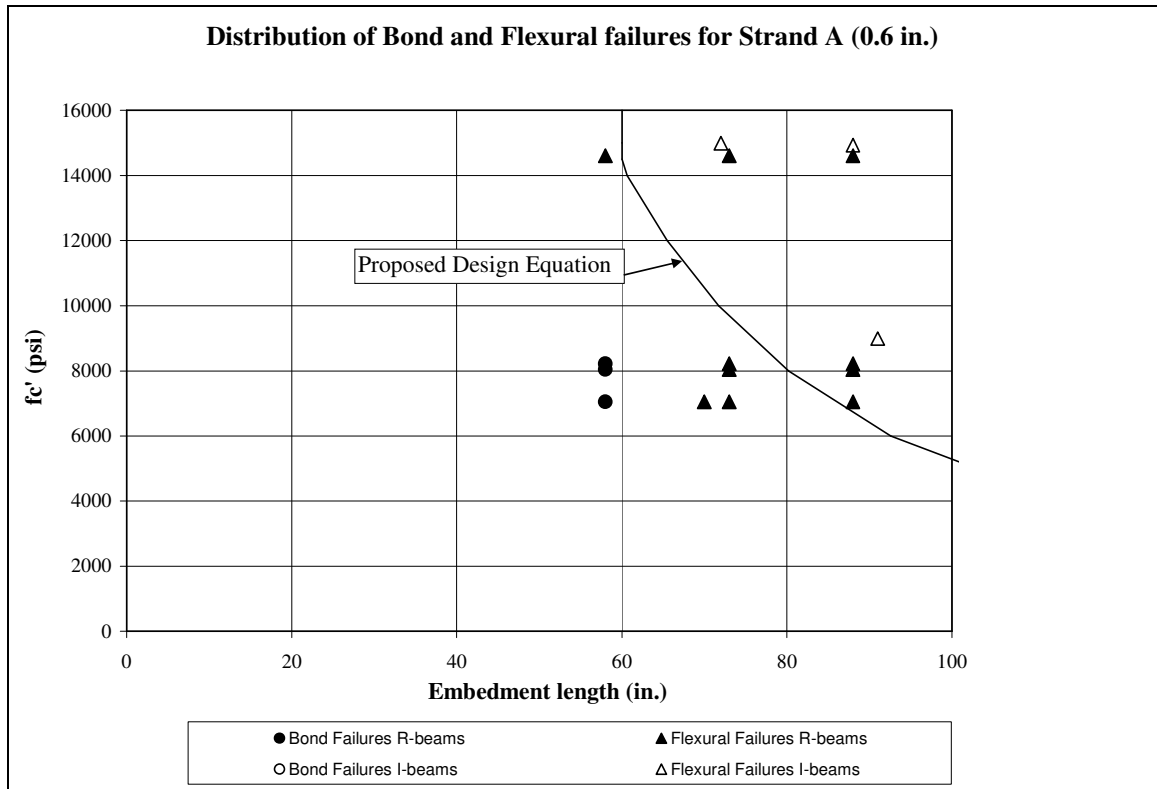
Figure 5.5: Distribution of Bond and Flexural failures for Strand A (0.6 in.)

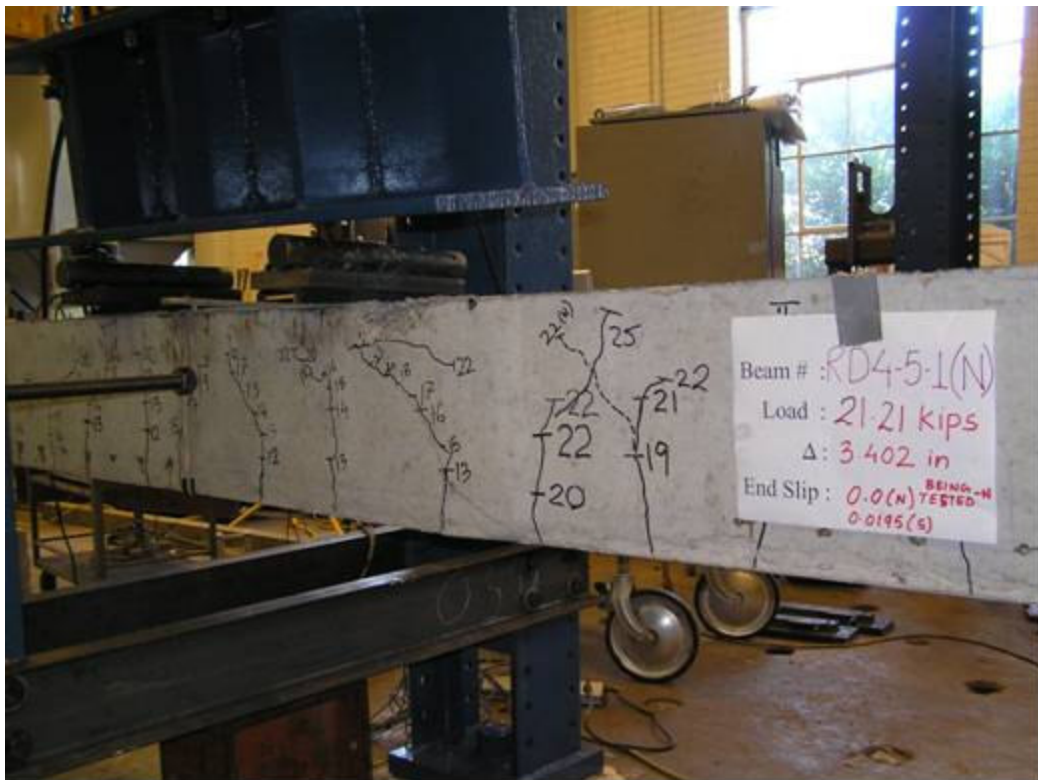
Cracking pattern included 9 cracks in the middle 60 in. span with average crack spacing of 7.5 in. No inclined flexural crack was noticed.

Cracking pattern for Beam RD-4-5-1 being loaded at North end.

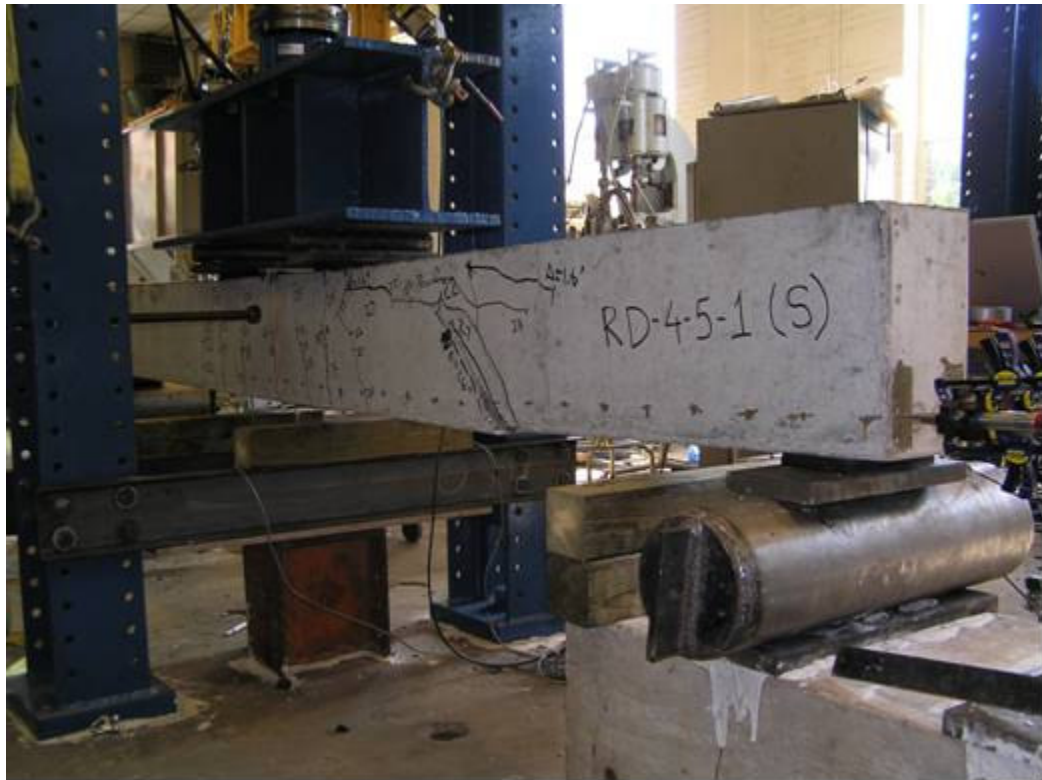
Crack pattern shows 7 flexural cracks in the middle 40 in. span with average crack spacing of 6.7 in. An inclined flexural crack was observed rising from Stn. 29 and Stn 32 and joining at approx. 3 in. from bottom to form a single crack.

Photo Showing cracking pattern for Beam RD-45-1 being loaded at South end.

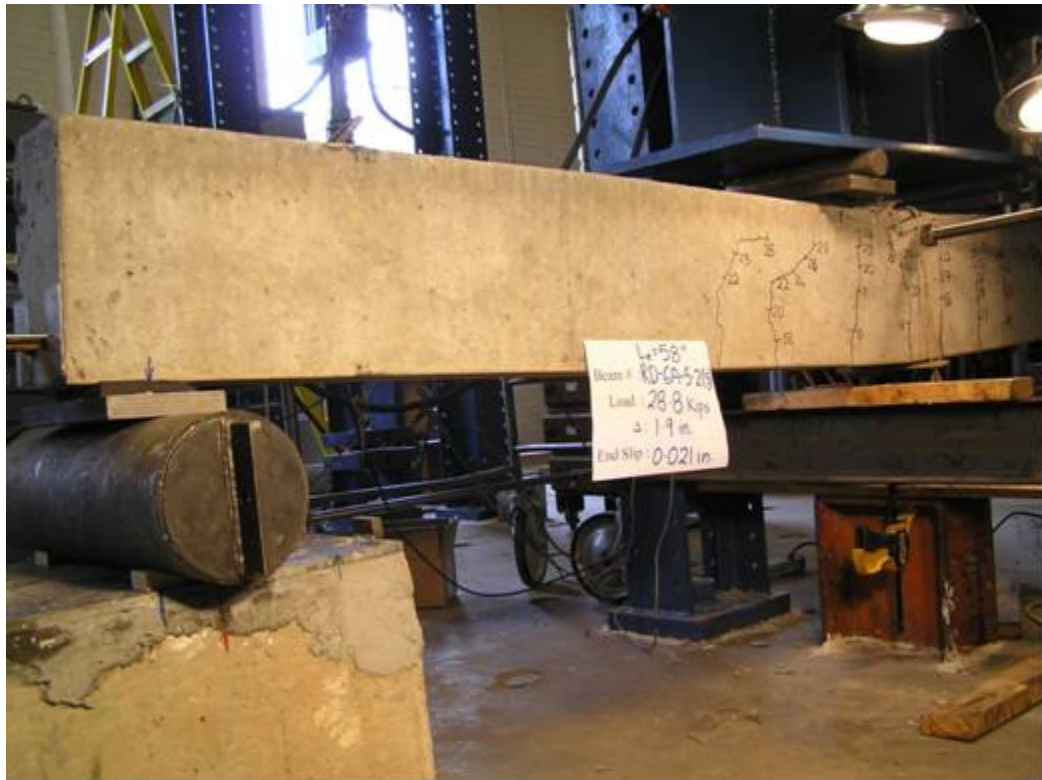
Cracking pattern shows 8 cracks formed in the middle 51 in span with average crack spacing = 6.4 in. No inclined flexural crack was observed in the shear zone. First flexural crack from the South end occurred at Stn. 42.

Cracking pattern for Beam RD-6A-5-2 being loaded at South end

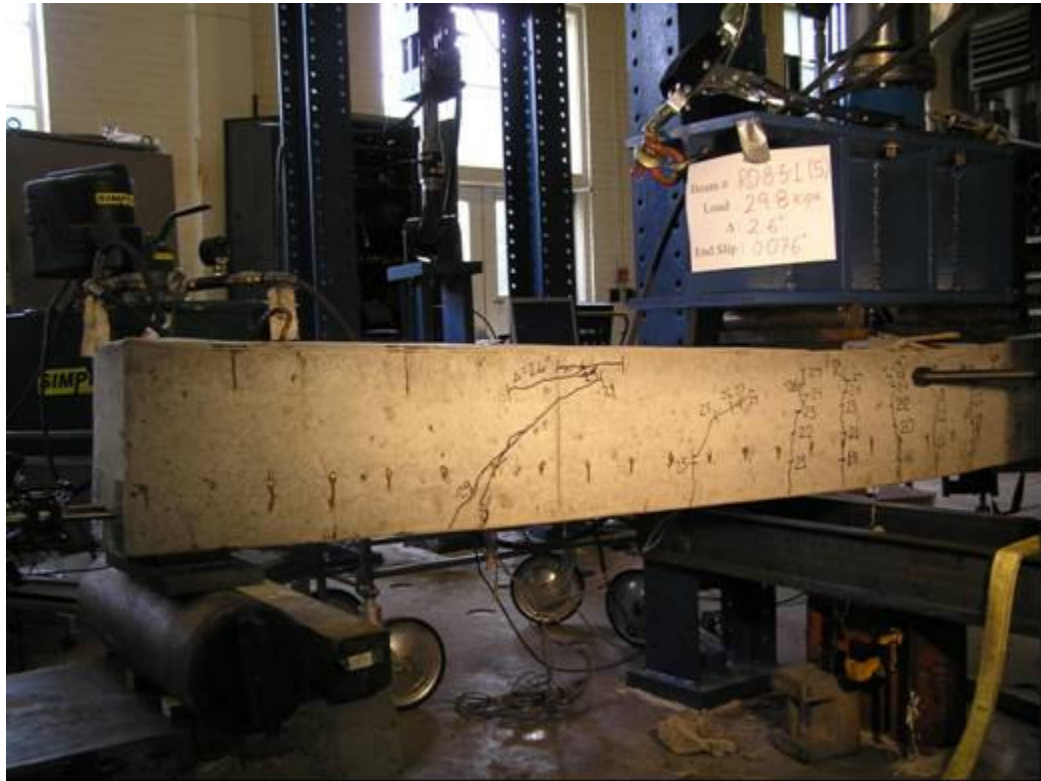
At 29 kips, a large inclined flexural crack was discovered, rising from Stn. 24 and Stn 21 and joining at 3 in. from bottom to form one single crack.

Loading was halted at 29.8 kips (deflection 2.6 in.) since cracking seemed to continue for a longer time at the same load. Suddenly drastic end-slip was noted at this point and approx. 5 seconds later concrete crushing was observed at the top surface. Moment at this load was 105% M_n which suggested flexural failure of the beam.

Cracking pattern for Beam RD-8-5-1 being loaded at South end

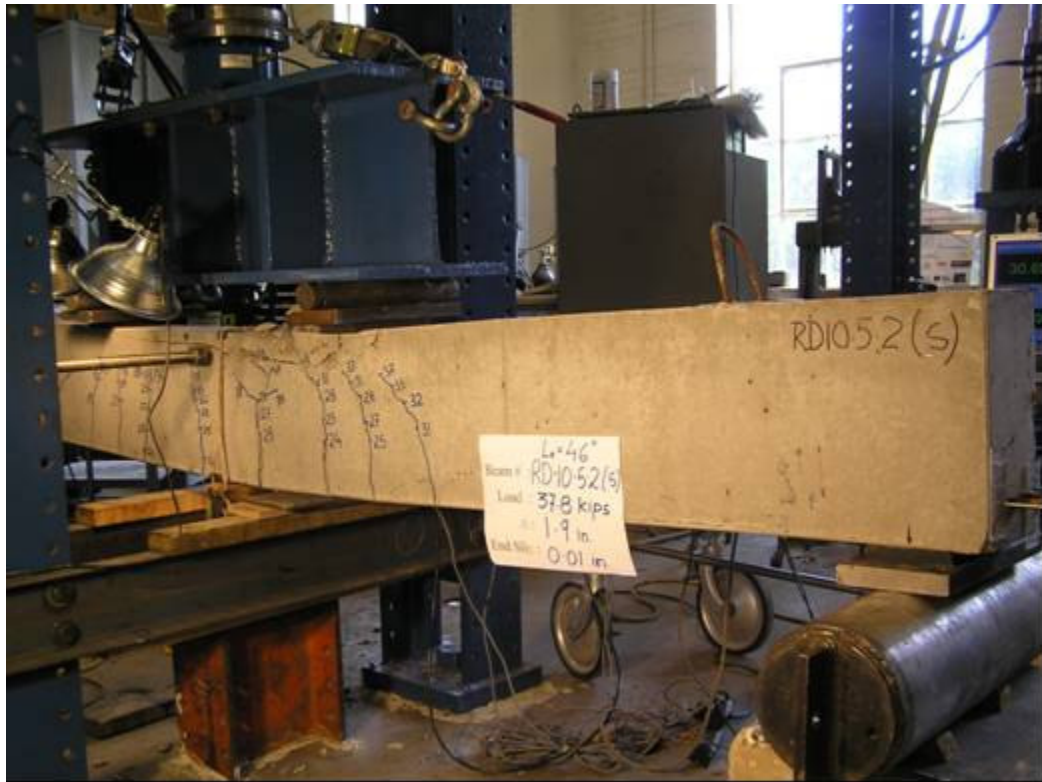
Cracking pattern included 9 cracks in the middle 58 in. span. No inclined flexural cracks were seen in the shear zone. Width of the central crack was 3/8th in. Location of the first flexural crack from the South end was 37 in.

Cracking pattern for Beam RD-10-5-2 being loaded at South end

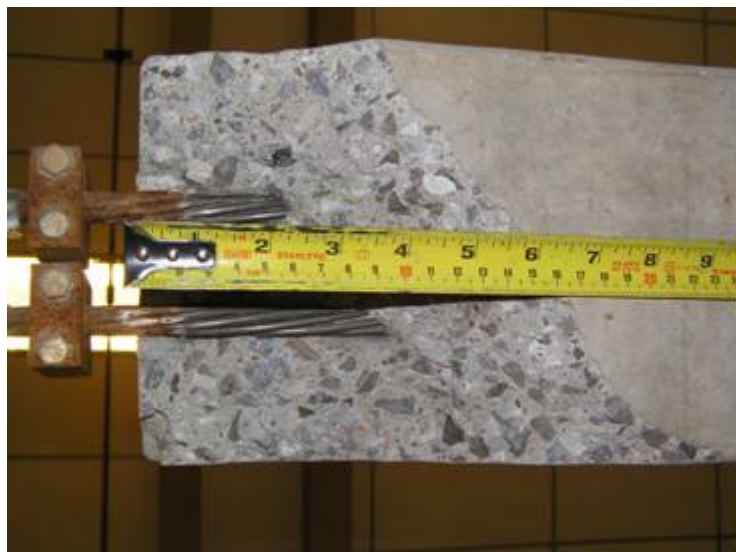
Before starting the test it was discovered that the region of concrete below the strands at the North end was damaged and the strands were exposed from under up to about 2.25 in. (East) and 3.75 in (West). Support point was fixed at 11 in. (instead of 4 in.) from the North end. To adjust the symmetry the constant moment region was changed from 24 in. to 27 in. and the total span was kept 120 in.

Damage caused during transportation at the North end (bottom).

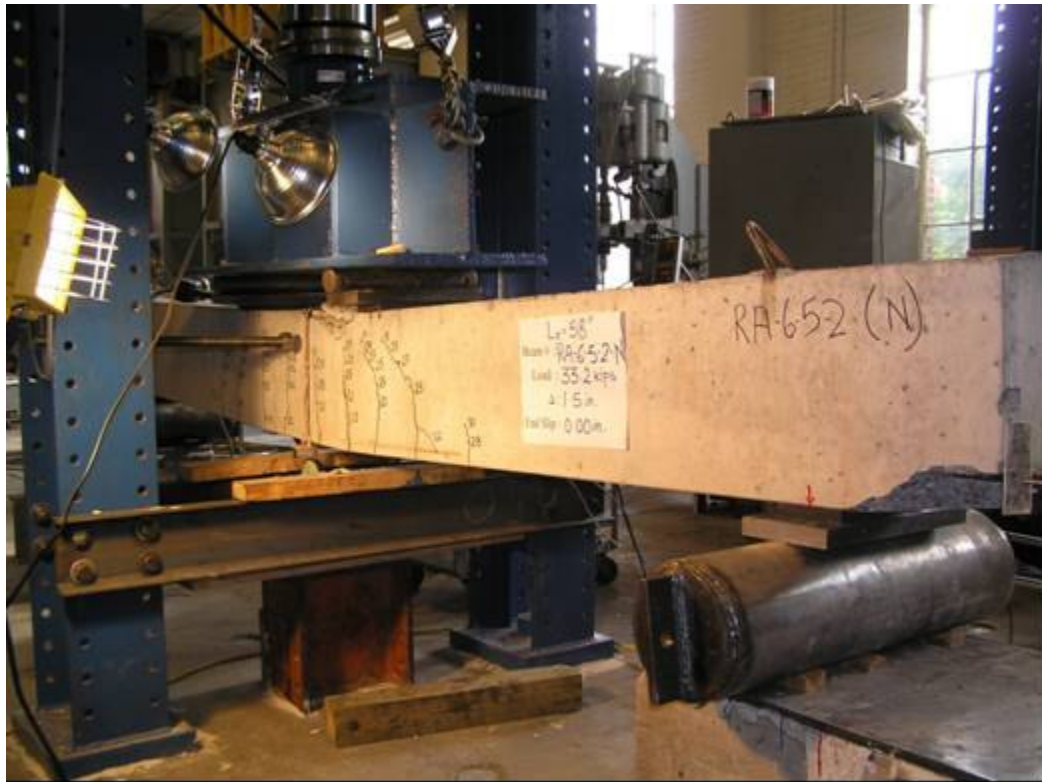
Cracking pattern demonstrated 9 cracks in the middle 50 in. span with average crack spacing = 6.3 in. Width of central crack at maximum deflection (2.5 in.) was $3/8^{\text{th}}$ in. First flexural crack was observed at Stn. 43 from the North end.

Cracking pattern for Beam RA-6-5-2 being loaded at North end

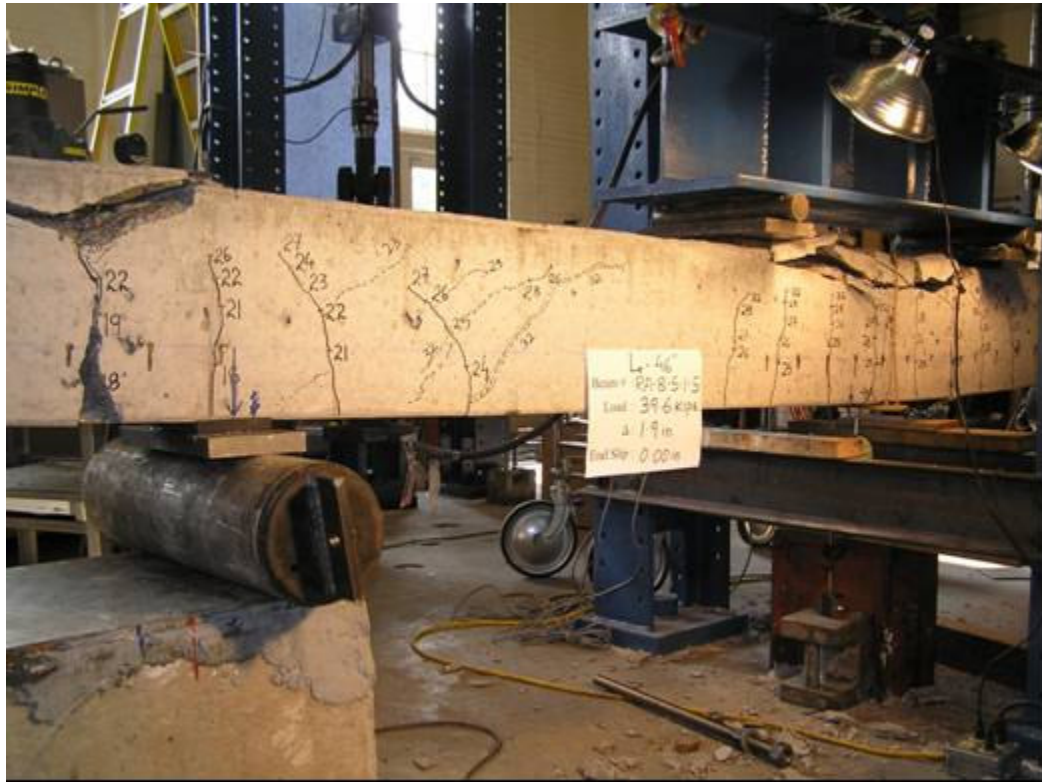
Cracking pattern at the North Support for Beam RA-8-5-1 (South side being tested)

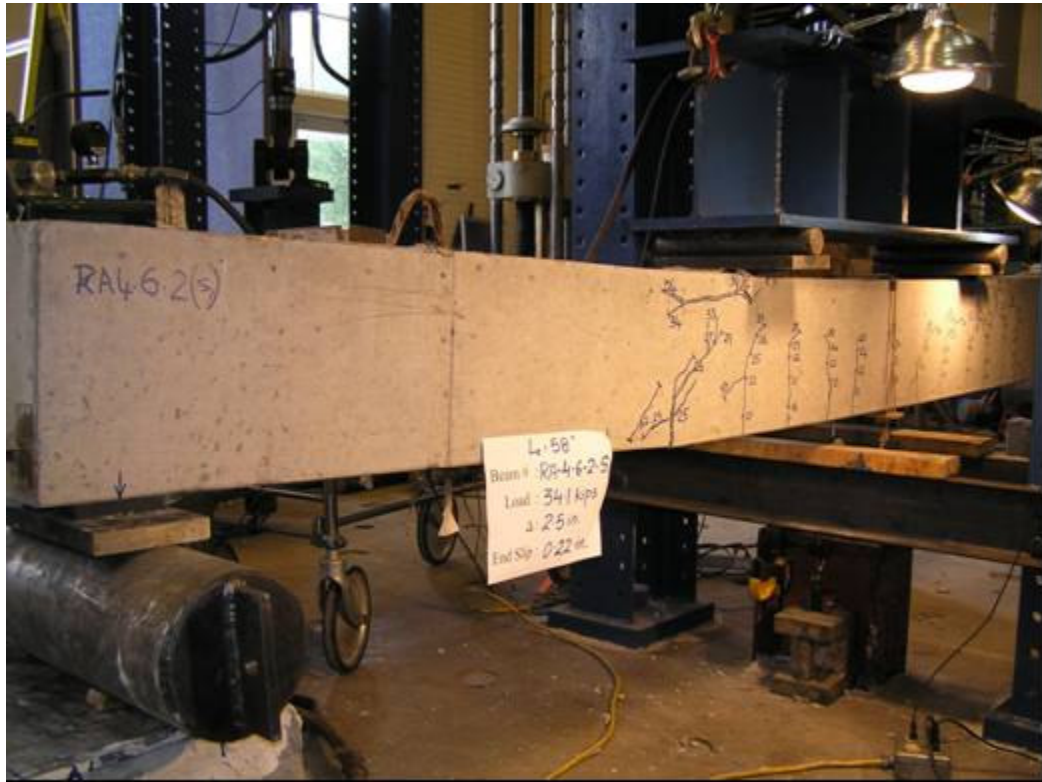
Cracking pattern for Beam RA-4-6-2 being loaded at South end

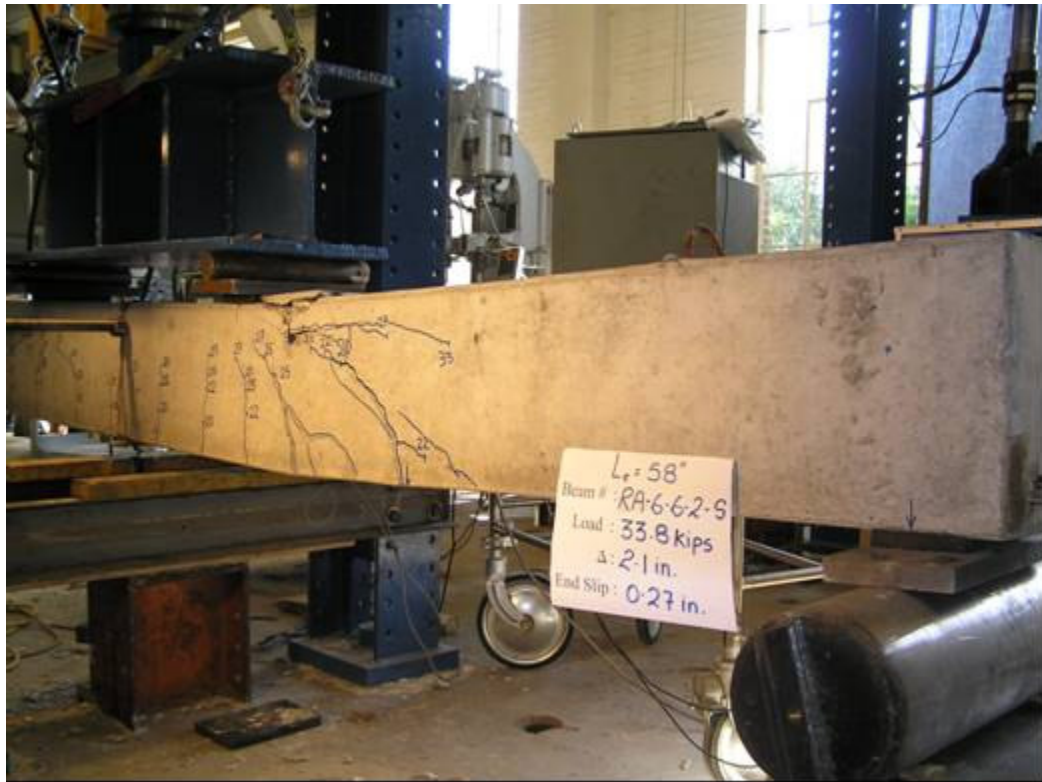
Cracking pattern for Beam RA-6-6-2 being loaded at South end

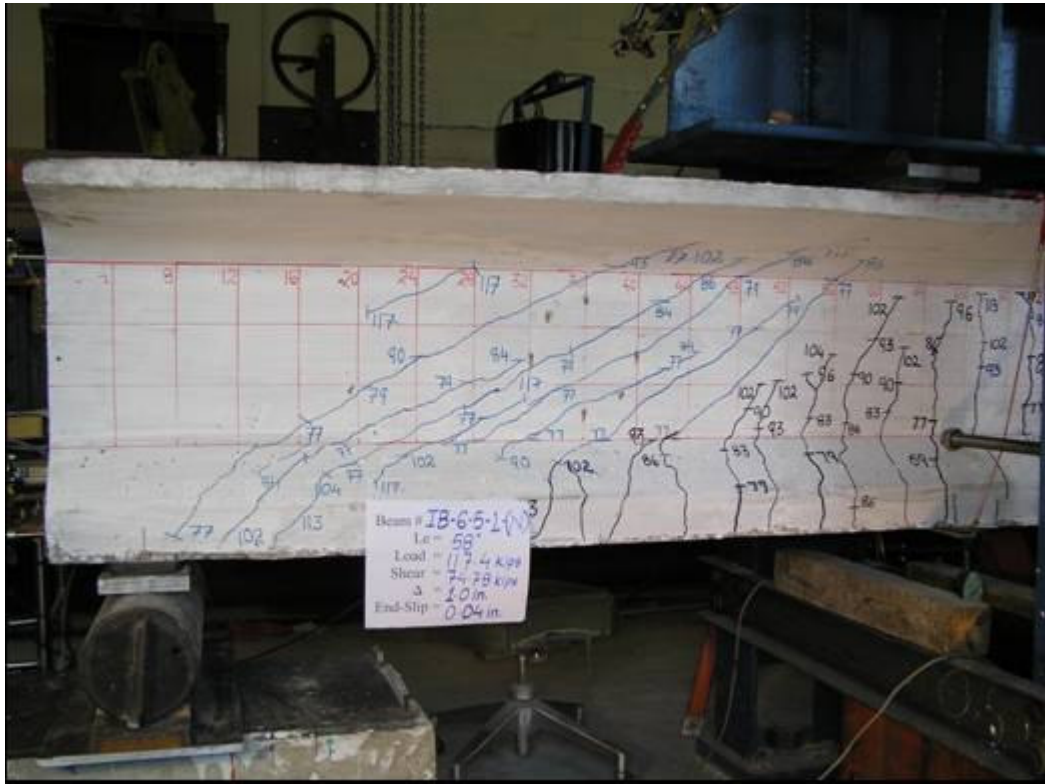
Photo of North end of beam IB-6-5-1 showing the cracking pattern at the maximum load

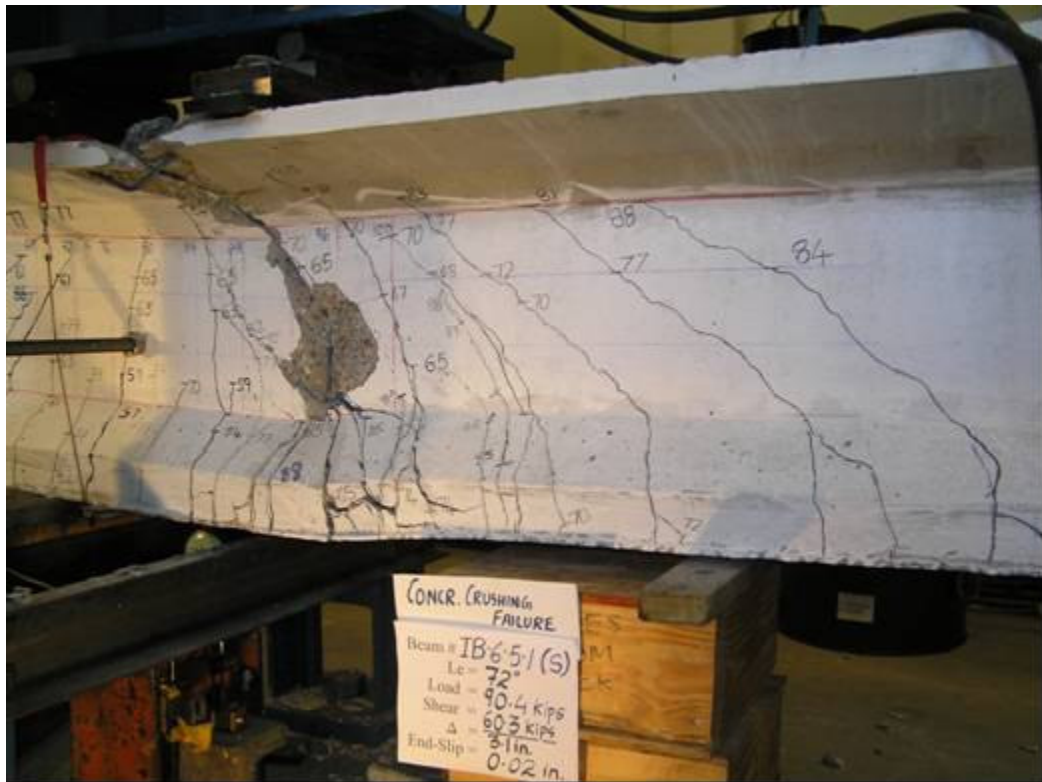
Photo of the crushed region of beam IB-6-5-1 (South end test)
