RECOMMENDATIONS FOR THE DEVELOPMENT
LENGTH OF PRESTRESSING STRANDS
INCLUDING THE EFFECTS OF
HIGH STRENGTH CONCRETE

By
AMOL SHRIDATTA GANPATYE
Bachelor of Engineering
University of Mumbai
Mumbai, India
2004

Submitted to the Faculty of the
Graduate College of the
Oklahoma State University
in partial fulfillment of
the requirements of
the Degree of
MASTER OF SCIENCE
December, 2006

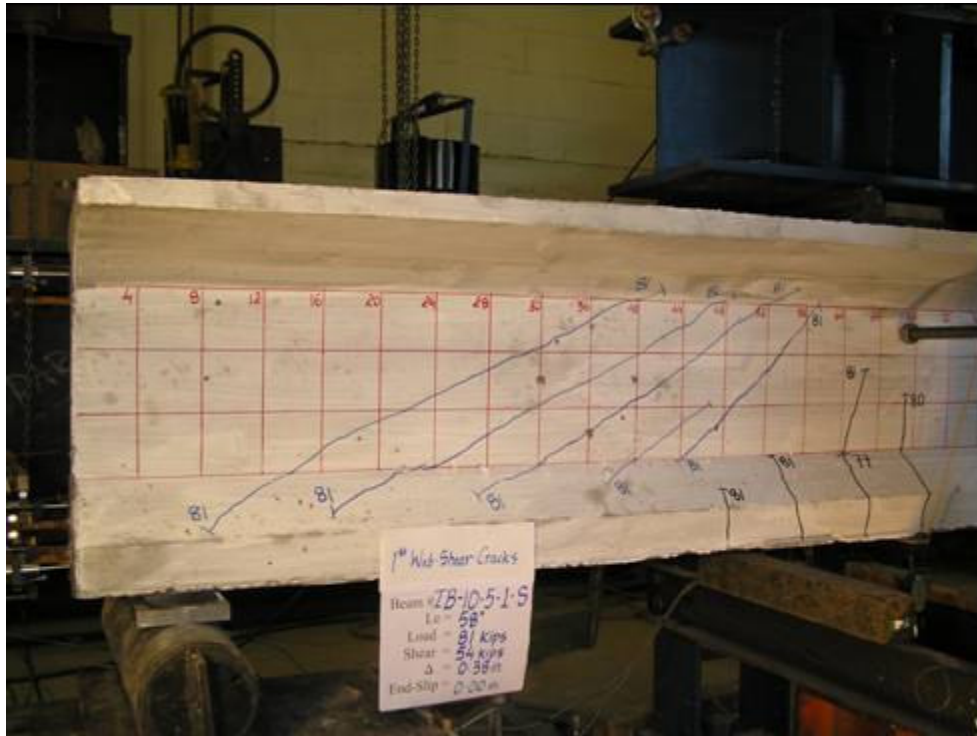
(In all the photographs presented below, cracks marked in black represent the ones originated as flexural cracks while those marked in blue represent the web shear cracks. Red color was used only for marking the grid lines and station points. Numbers written in red should not be confused with the load values.)

Photo of the South end of the beam IB-10-5-1 showing the first web shear cracking

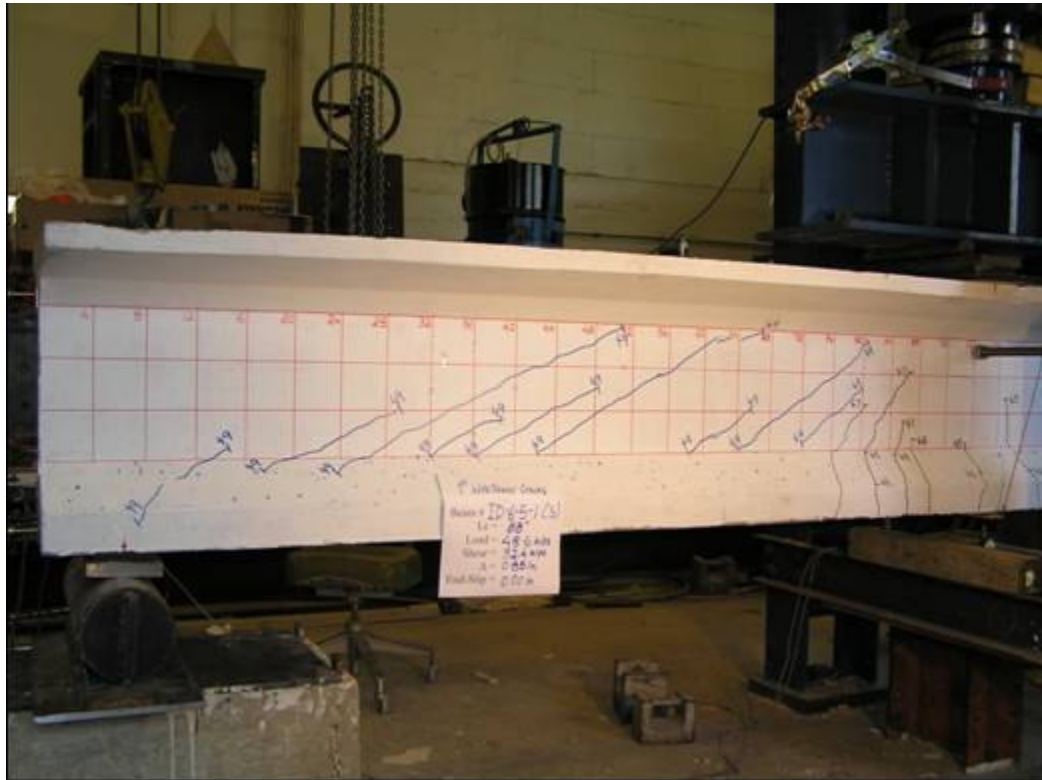
(In all the photographs presented below, cracks marked in black represent the ones originated as flexural cracks while those marked in blue represent the web shear cracks. Red color was used only for marking the grid lines and station points. Number written in red should not be confused with the load values.)

Photo of the South end of the beam ID-6-5-1 showing the first web shear cracking

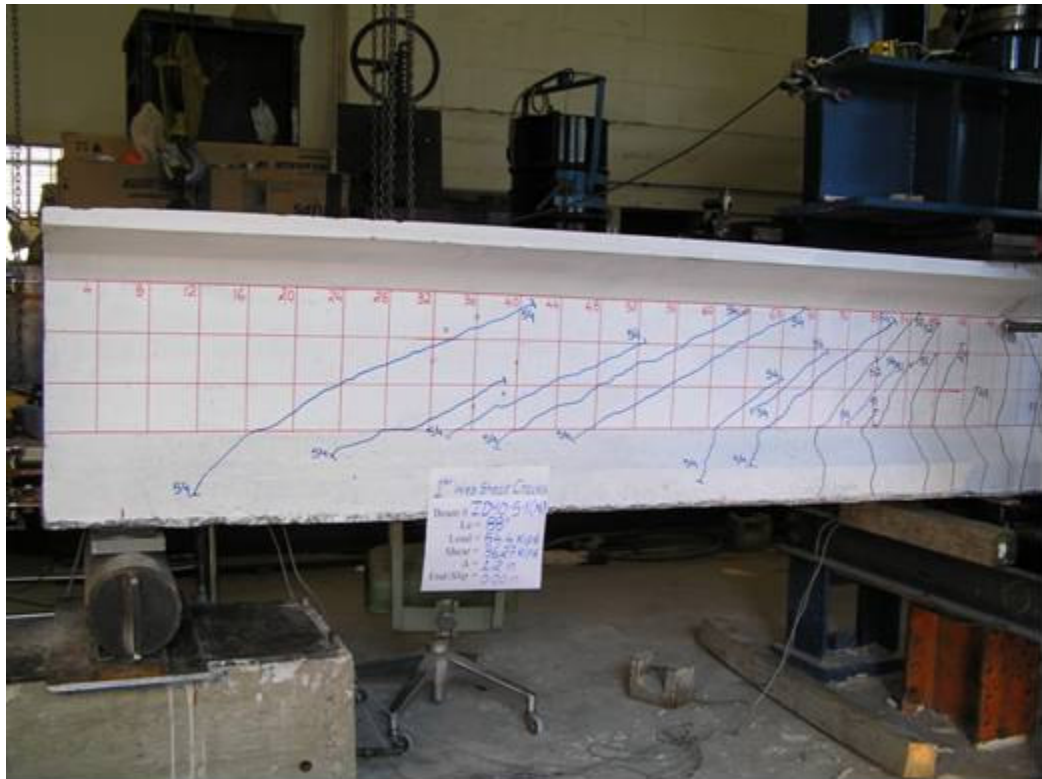
(In all the photographs presented below, cracks marked in black represent the ones originated as flexural cracks while those marked in blue represent the web shear cracks. Red color was used only for marking the grid lines and station points. Number written in red should not be confused with the load values.)

Photo of the North end of the beam ID-10-5-1 showing the first web shear cracking

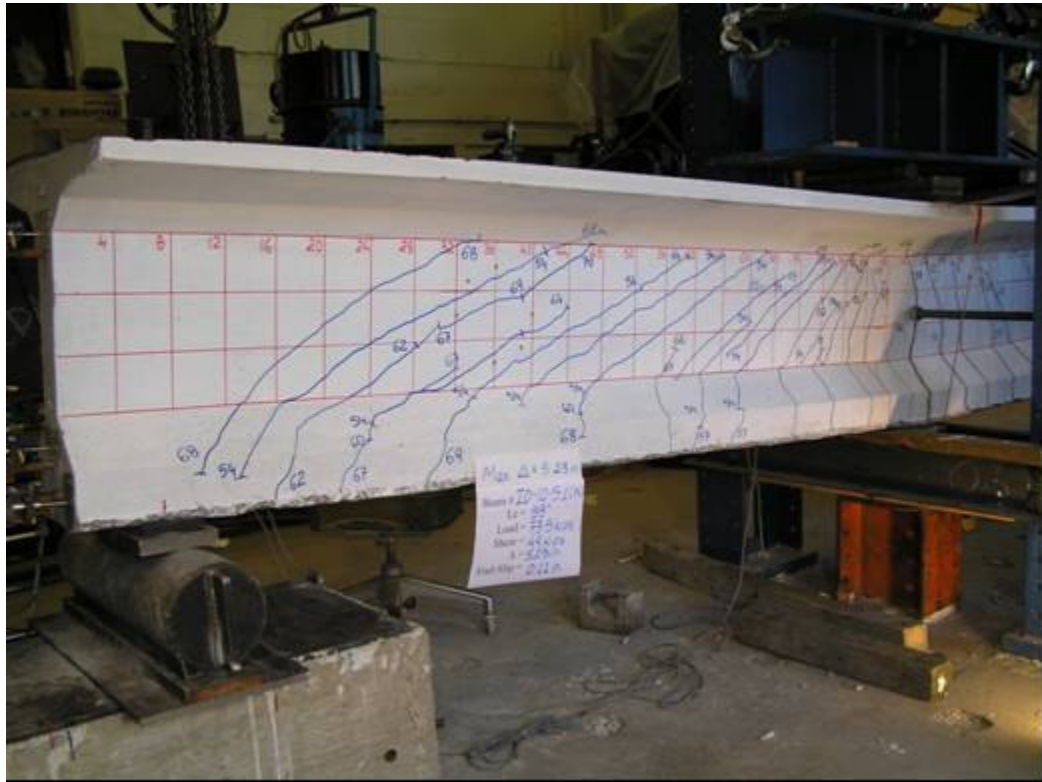
Photo of North end of beam ID-10-5-1 showing the cracking pattern at the maximum load

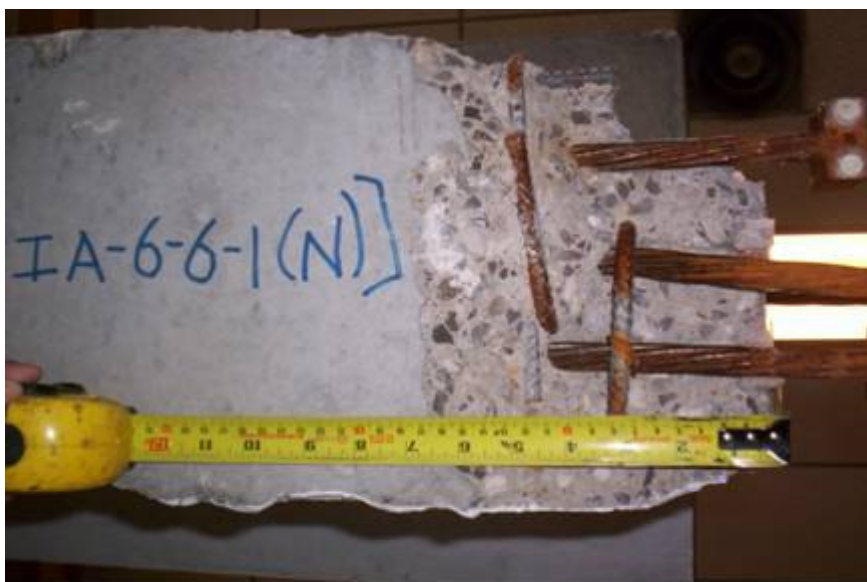
The bottom surface of concrete at the North end was damaged during transportation and the strands were exposed. As a result, the support point was moved to 9 in. from the end instead of 6 in.

Photo showing the damage at the Bottom surface of North end of beam IA-6-6-1

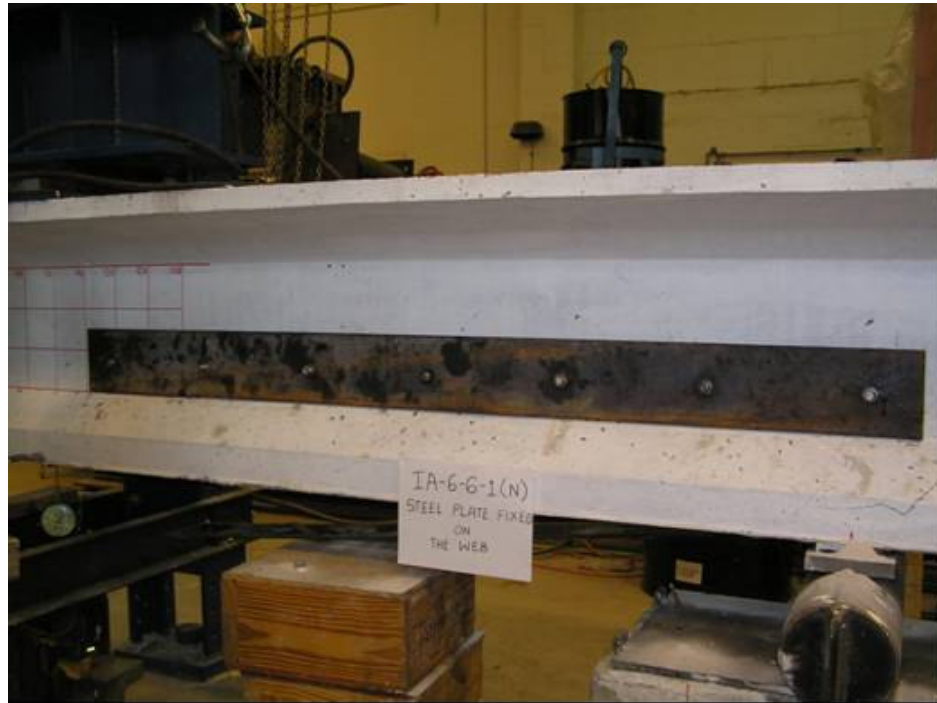
Before starting the test, the web was reinforced with externally connected steel plates on both sides of the beam in the South shear span. Dimensions of the steel plates were 6in. x 1/4 in. and they extended from the South support up to the first loading point from the South end. Holes were drilled through the web to allow the plates to be bolted to the web along with being glued. The purpose of attaching these plates was to compensate for the horizontal shear reinforcement at the South end.

Photo showing the external steel plate attached on the web for compensating the horizontal reinforcement at the North end.

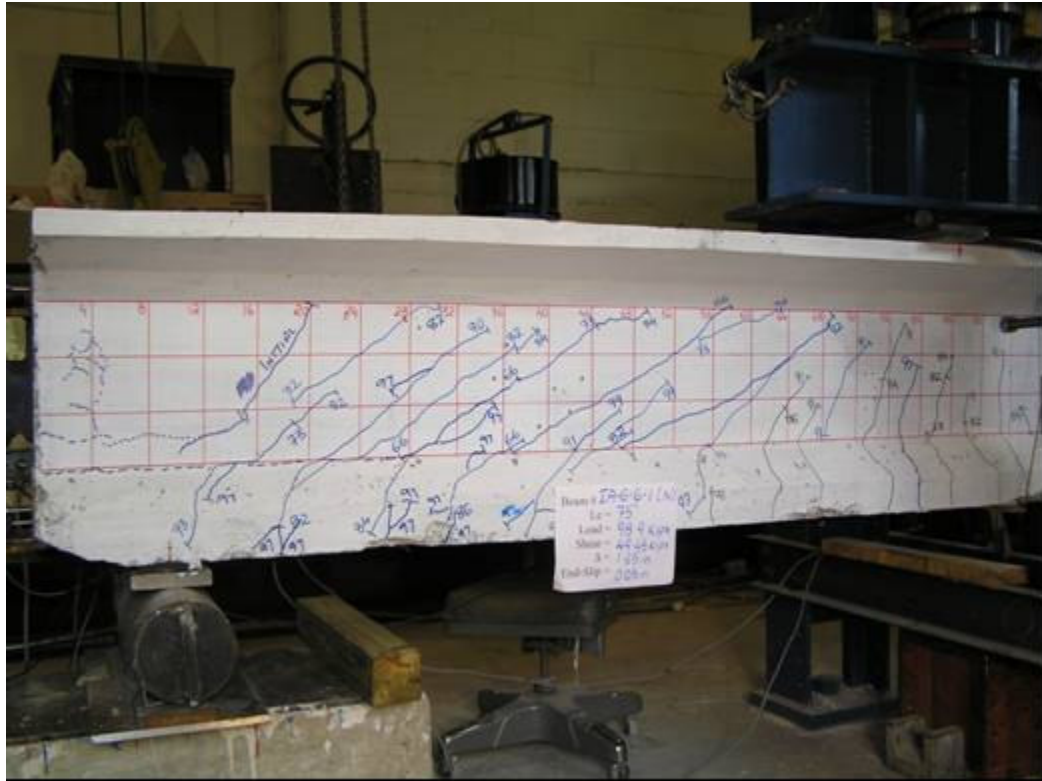
Photo of South end of beam IA-6-6-1 showing the cracking pattern at the maximum load

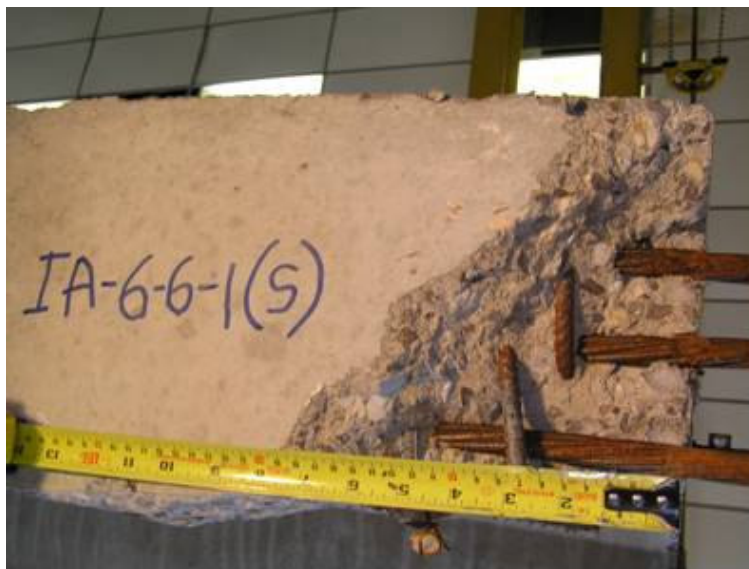
The bottom surface of concrete at the South end was damaged during transportation exposing the strands as seen in the photo below. The support p[oint] was thus moved to 9 in. from the South end instead of 6 in.

Photo showing the damage at South end caused during transportation

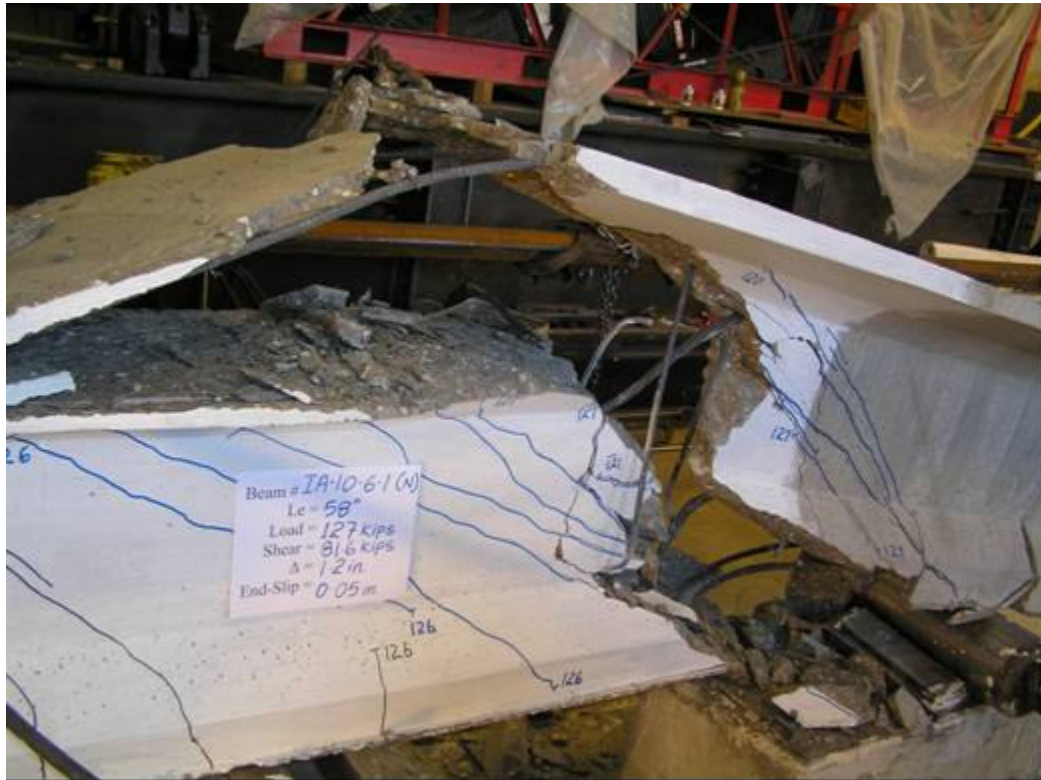
Photo showing shear failure at the opposite end for IA-10-6-1-N

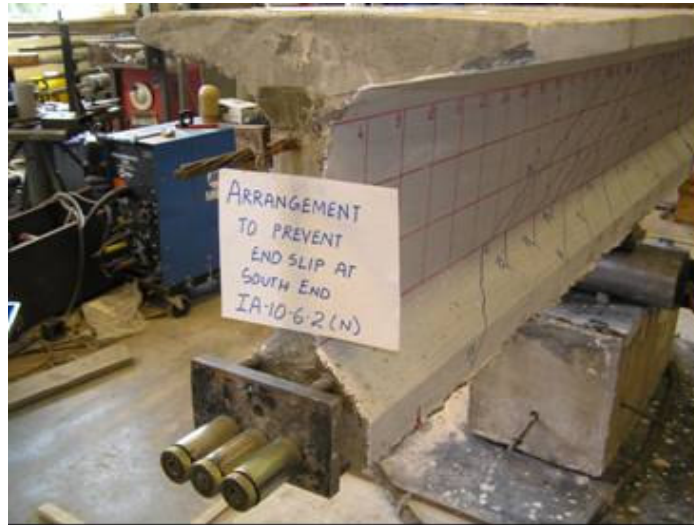
Before starting the test, strands at the South end were prevented from slipping with an arrangement of chucks as shown in the photo below.

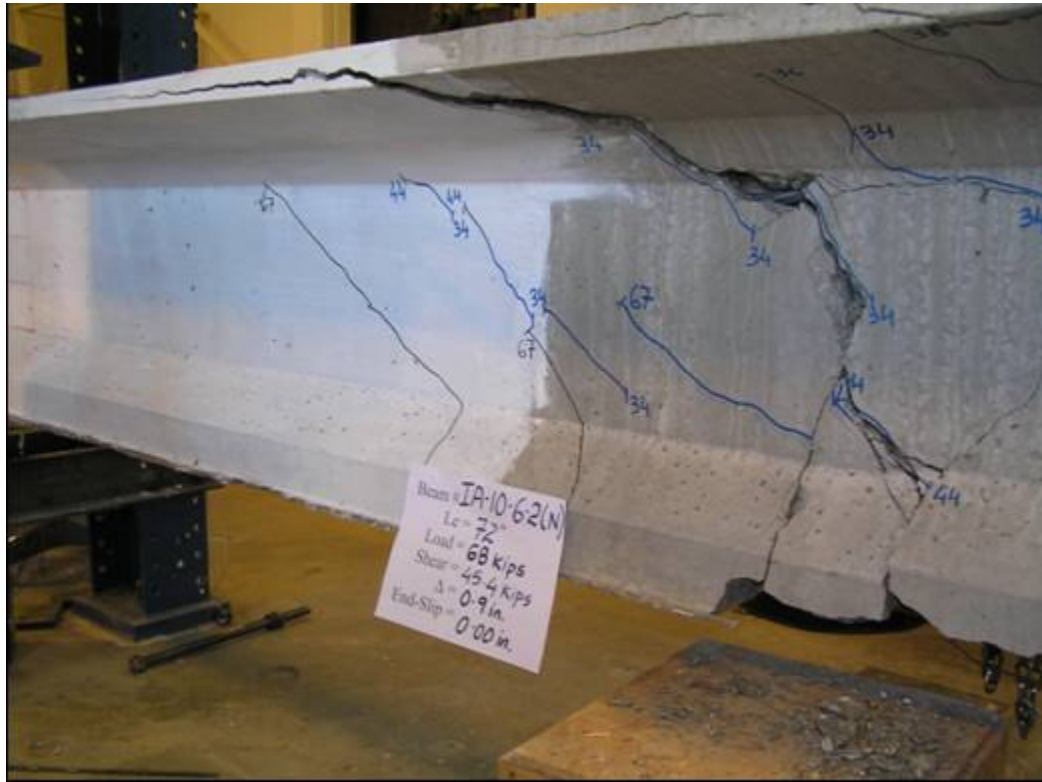
Photo of the North end of the beam IA-10-6-2 showing shear failure in the South side shear zone.
