FACTORS AFFECTING WILDLIFE-RELATED POWER
OUTAGES IN ELECTRICAL SUBSTATIONS

Submitted to the Faculty of the
Graduate College of the
Oklahoma State University
in partial fulfillment of
the requirements for
the Degree of
MASTER OF SCIENCE
May 1998

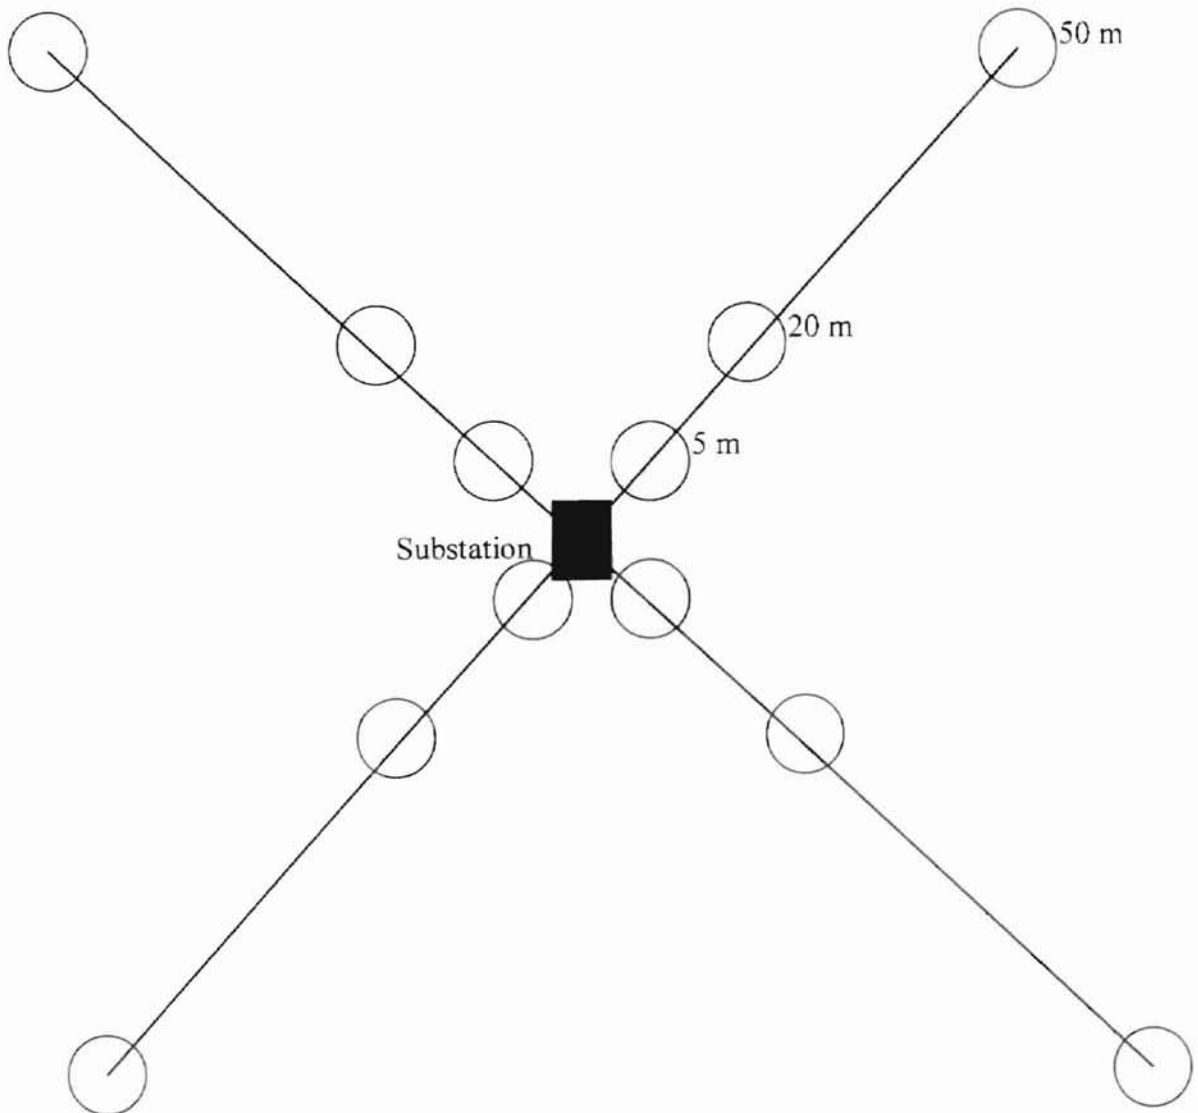
Figure 3. Layout for small-scale habitat sampling within 50 m of each substation, consisting of 12, 5-m radius circular plots.
