LIQUID METAL EMBRITTLEMENT OF
TYPE 304 STAINLESS STEEL
BY LIQUID MERCURY

Submitted to the Faculty of the
Graduate College of the
Oklahoma State University
in partial fulfillment of
the requirements for
the Degree of
MASTER OF SCIENCE
December, 1995

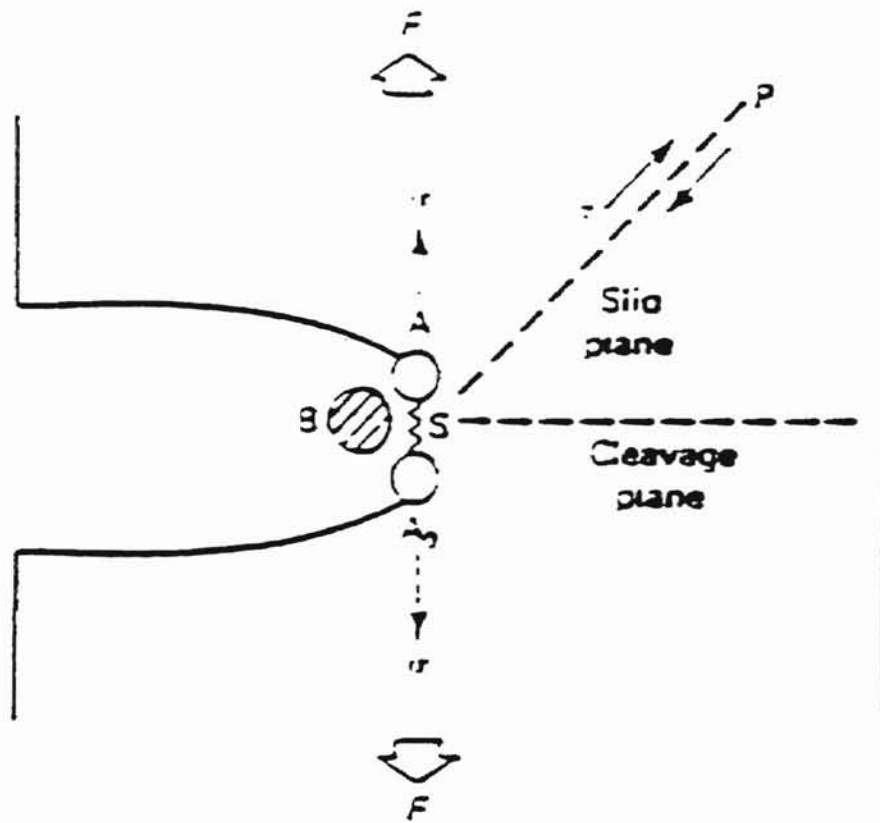
Figure 1. Schematic illustrating reduction of strength of atomic bond at crack tip by embrittler species [6].

Two principal mechanisms are widely accepted for liquid metal embrittlement [6]. The first is that adsorption of liquid metal atoms induces a localized reduction in the cohesive strength of atomic bonds in the solid metal. When this event occurs at a stress concentration on the solid metal's surface, a crack is initiated; the process continues by the weakening of atomic bonds at the crack tip, facilitating crack propagation. Figure 1 shows this phenomenon. Under applied load F , embrittler atom B can be seen weakening the bond between solid metal atoms A and A_0 at the crack tip. The second mechanism involves a reduction in shear strength of atomic bonds by the adsorption of embrittler metal atoms. This localized reduction in shear strength facilitates nucleation of dislocations or slip at low stresses at or near the crack tip. The resulting localized increase

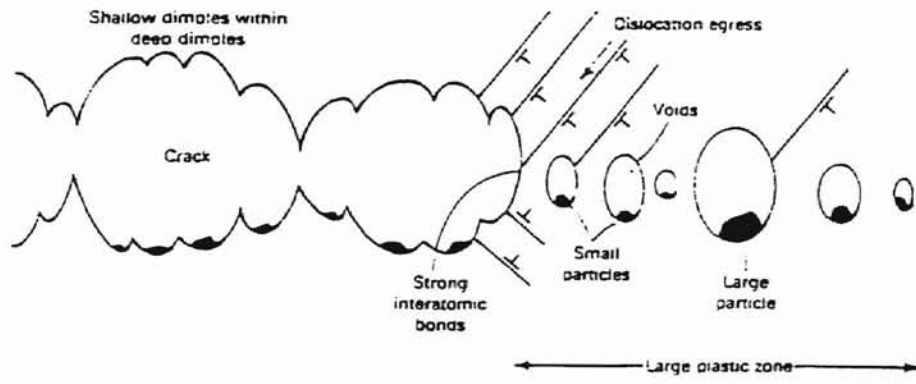
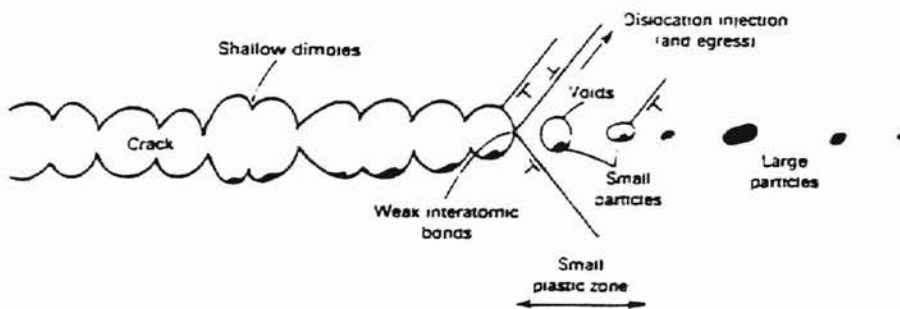
Figure 2. Schematic illustrating crack growth by microvoid coalescence and the reduction in shear strength of atomic bonds by embrittler species atoms [6].

in plasticity facilitates the nucleation of voids ahead of the crack tip; as these voids grow, crack growth occurs. Figure 2 shows this process. Note the presence of weakened atomic bonds in the liquid metal environment. While this is actually a ductile process, macroscopically the material still suffers a loss of ductility, and is embrittled. Typically, LMIE results in a brittle intergranular or cleavage fracture mode due to the localized reduction in cohesion of atomic bonds. However, ductile dimpled fracture, caused by reduction in bond shear strength and resulting void nucleation, results in a transgranular failure mode [6]. Similar mechanisms are believed to be responsible for various forms of embrittlement, i.e., HE, MIE, etc.

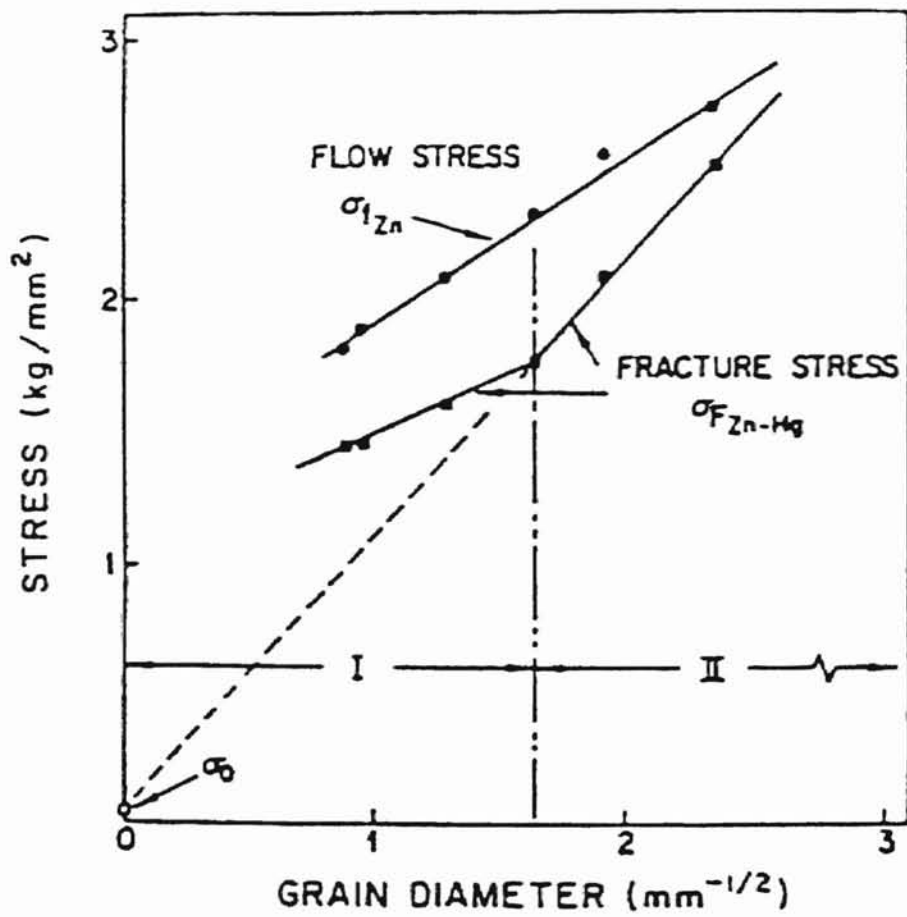
Figure 3. Variation of flow stress and fracture stress with grain size of zinc in liquid mercury [2].

to generate a high enough stress concentration for brittle fracture to occur [5]. Certain materials consequently exhibit a transition between nucleation- and propagation-controlled embrittlement as grain size decreases. Figure 3 shows this behavior in the zinc/mercury embrittlement couple. Note the linear relationship between fracture stress, σ_F , and grain diameter. Larger grain sizes in region I promote nucleation control, while smaller grain sizes of region II encourage propagation control. When tested in air, many ductile metals, e.g., copper, α brass, cadmium, and nickel, show the same fracture characteristics regardless of grain size. Sometimes, in appropriate liquid metal environments, σ_F is proportional to $d^{-1/2}$, and larger grain sizes require lower stresses to fracture [2].

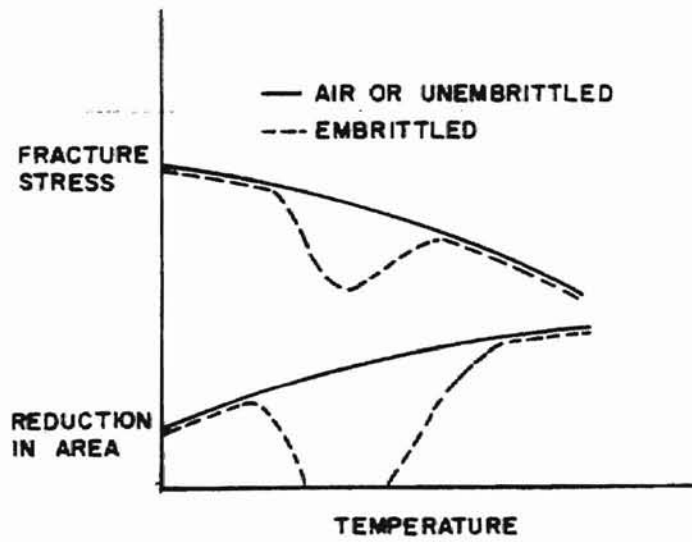
Figure 4. Typical embrittlement vs. temperature diagram [5].

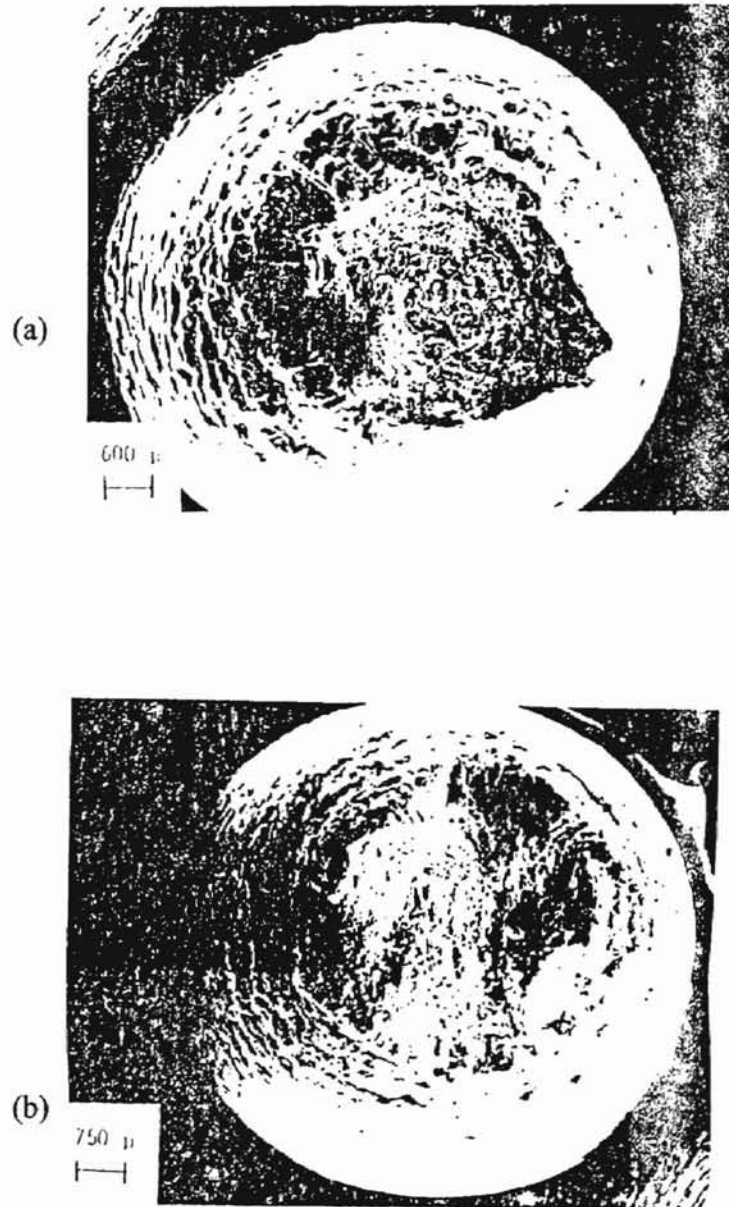
Figure 5. (a) The cup of ductile SSR failure of Nickel 200 in air.
(b) Nickel 200 failure in mercury; slant fracture with several origins, especially at lower edge [14].

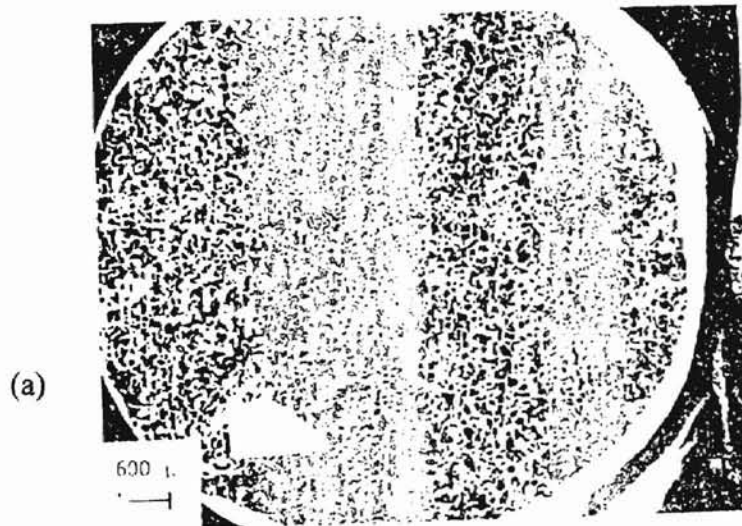
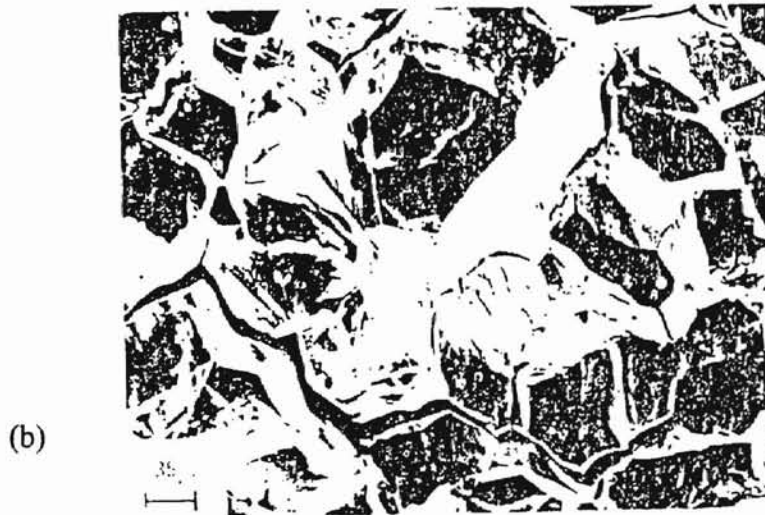
Figure 7. Alloy 400 fractured in mercury. (a) Totally intergranular nature of break.
(b) Close-up of intergranular break, typical throughout cross section [14].

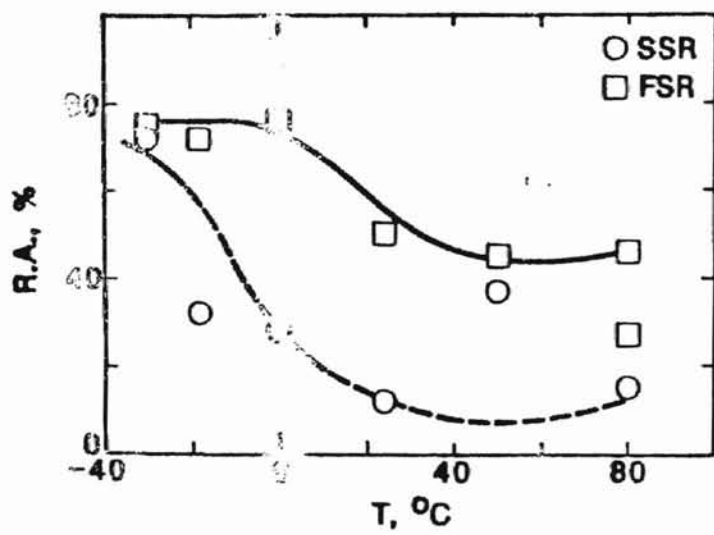
Figure 8. Reduction of area versus temperature, Alloy 400 fractured in mercury [7].

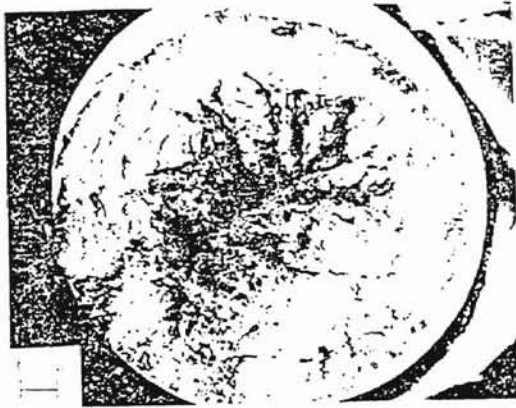
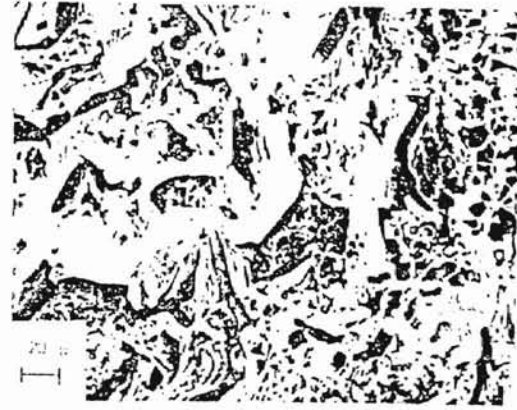
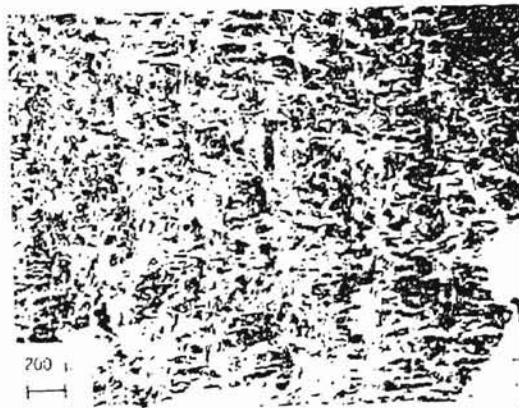
Figure 9. Alloy R405. (a) Note presence of some necking; no cup and cone, however. (b) In midsection, slip markings, tearing, possible dimple rupture, as opposed to transgranular edge zone. (c) Side view showing extensive surface cracking [14].

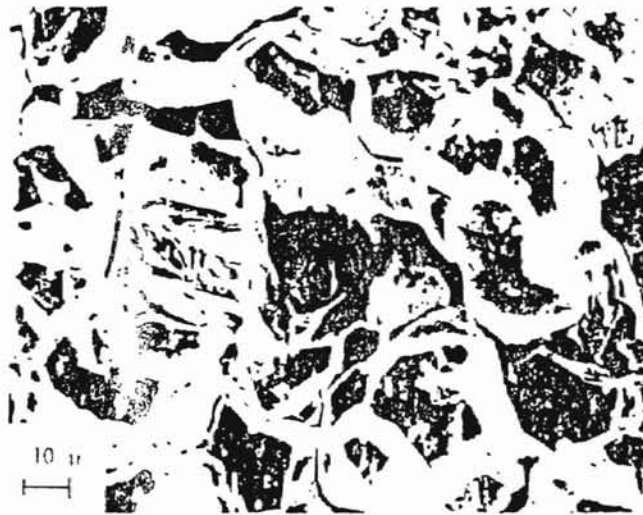
Figure 10. Typical fracture surface, Alloy K500. Similar to Alloy 400; note surface irregularities [14].

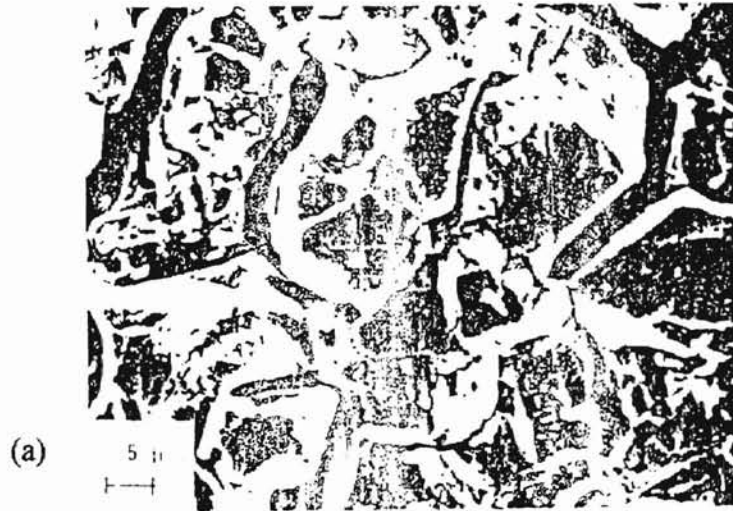
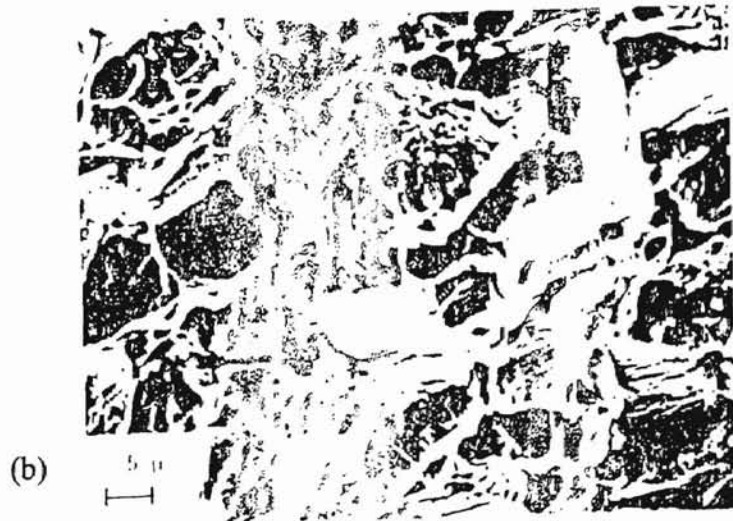
Figure 12. Fracture surface, Alloy X750. (a) Intergranular origin zone with relatively large amount of tearing. (b) Conglomeration of various effects in later stages of fracture

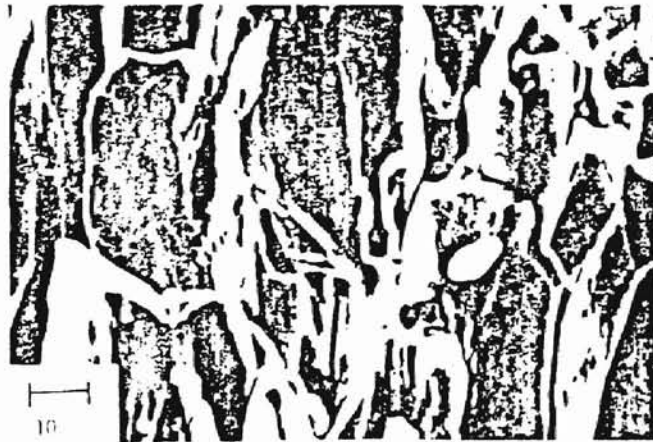
Figure 15. Opened out secondary crack in cold worked Alloy 400; note clean, elongated grains and intergranular cracking in the third orthogonal direction [12].

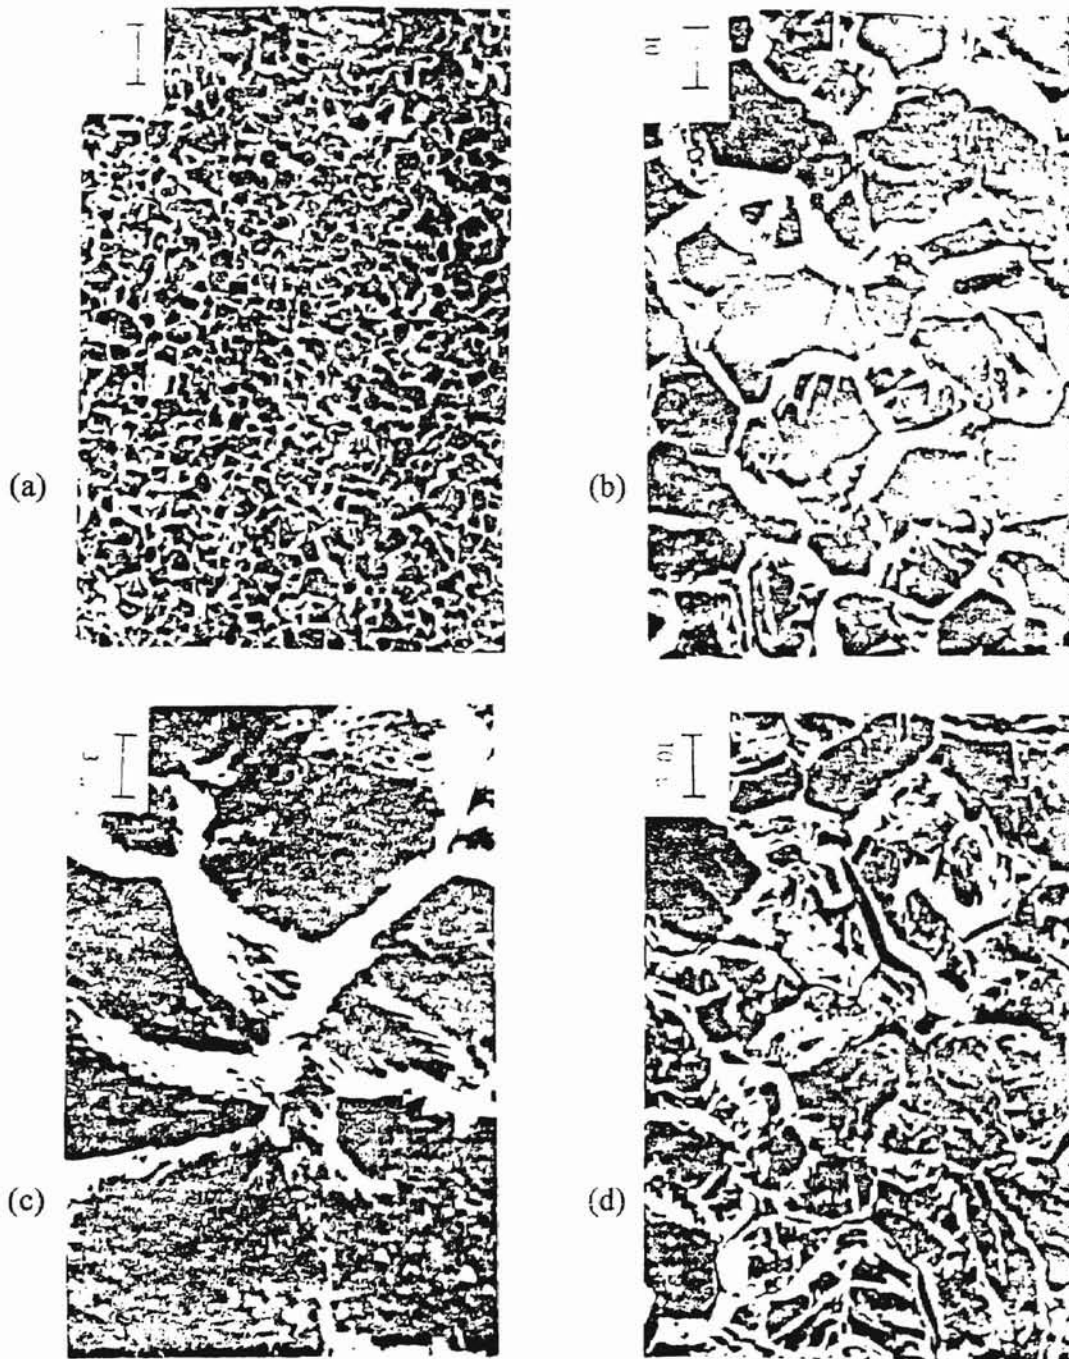
Figure 16. Alloy 600 fracture surface. (a) Predominately intergranular origin zone. (b) Detail of origin zone; note shear failures in minority of grains and occasional secondary cracking. (c) Detail of origin zone; note second phase particles and transgranular fracture of one grain. (d) Later stage of failure; primarily TG, but with some secondary IG cracking [12].

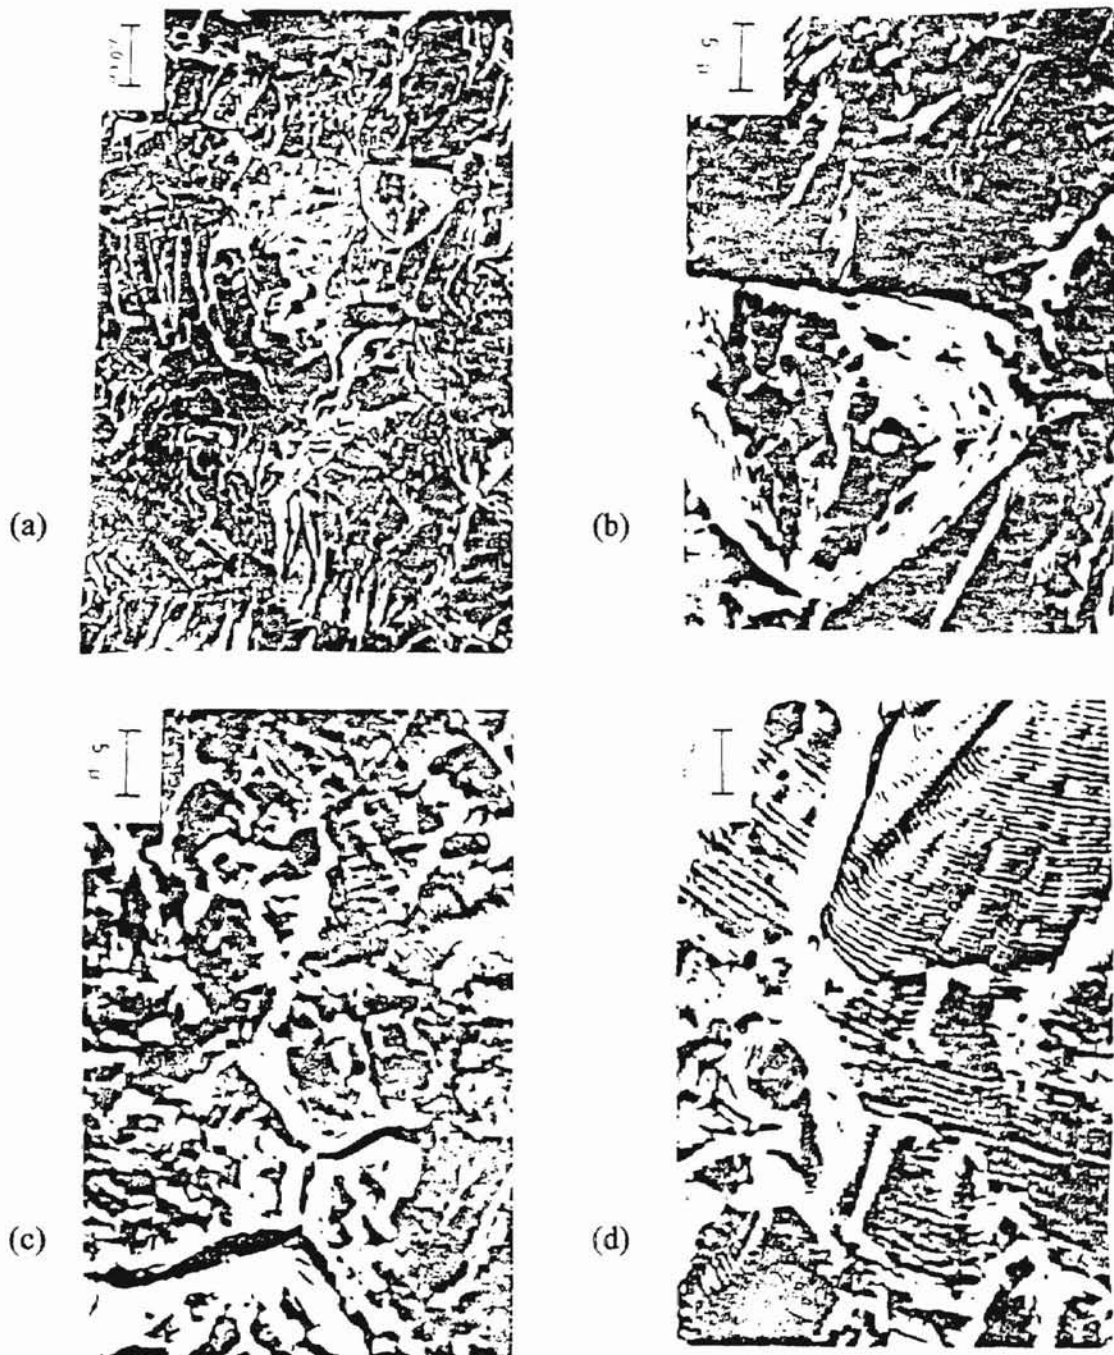
Figure 17. Alloy 718 fatigue fracture in mercury. (a) Transgranular cracking with traces of intergranular cracking. (b) Detail of (a) showing individual grain; note slip, or possible striation, markings on surrounding grains. (c) Intermediate stage of failure; note extensive secondary cracking of IG and TG nature. (d) Late stage of failure; note well defined striations and minimal secondary cracking [12].

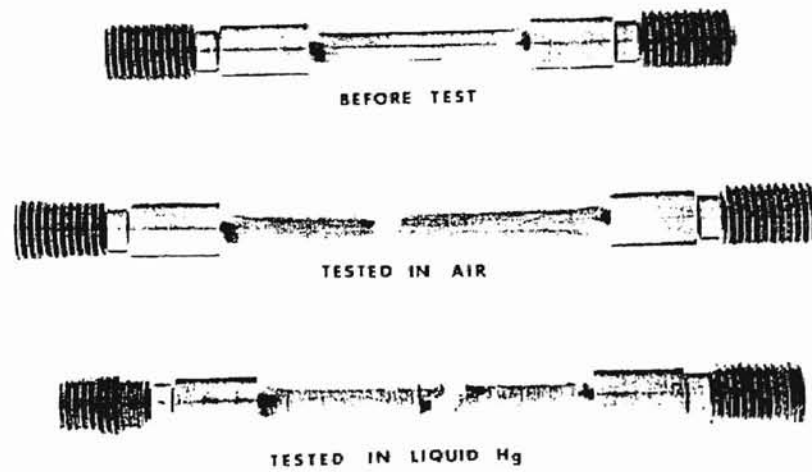
Figure 19. Typical Type 304 test specimen [15].

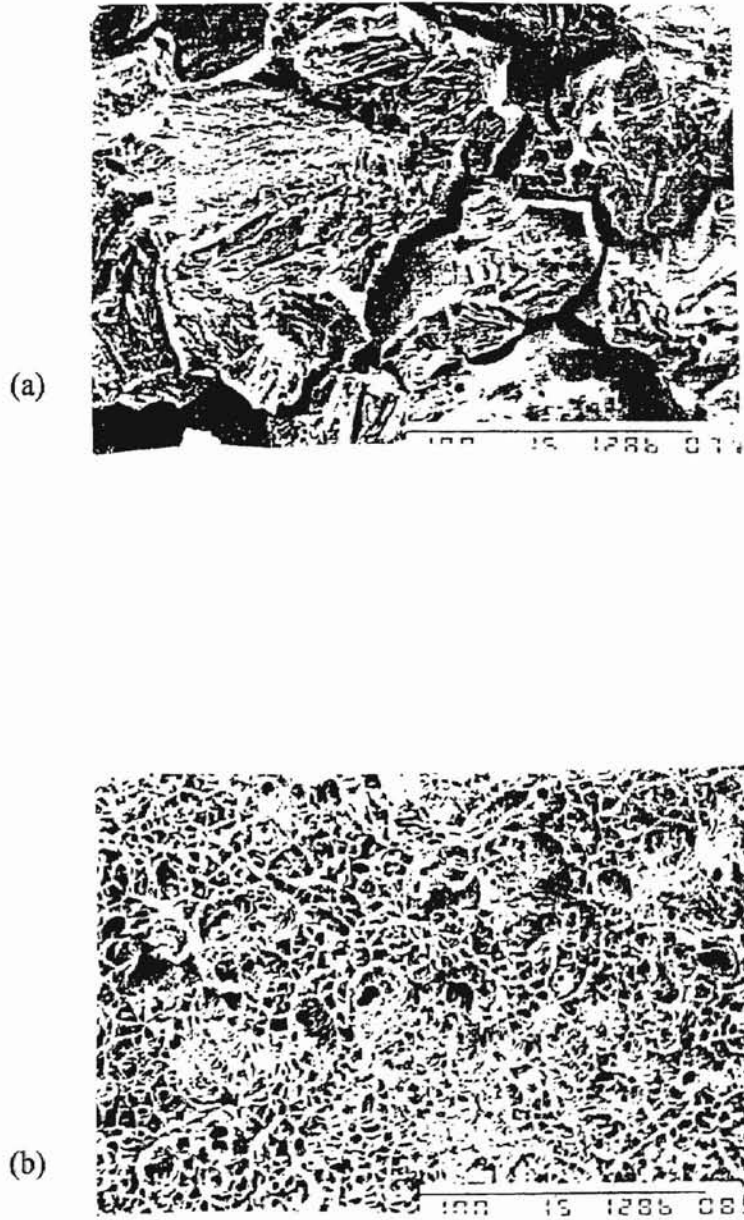
Figure 21. Fracture surface of Type 304 tested in mercury at $5 \times 10^{-6} \text{ s}^{-1}$. (a) Embrittled outer region. (b) Ductile central region [15].

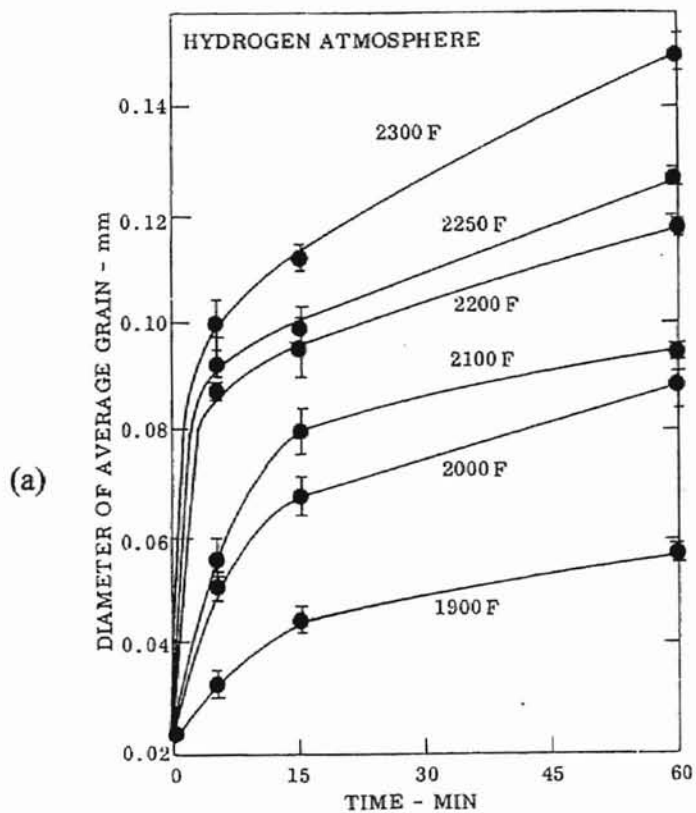
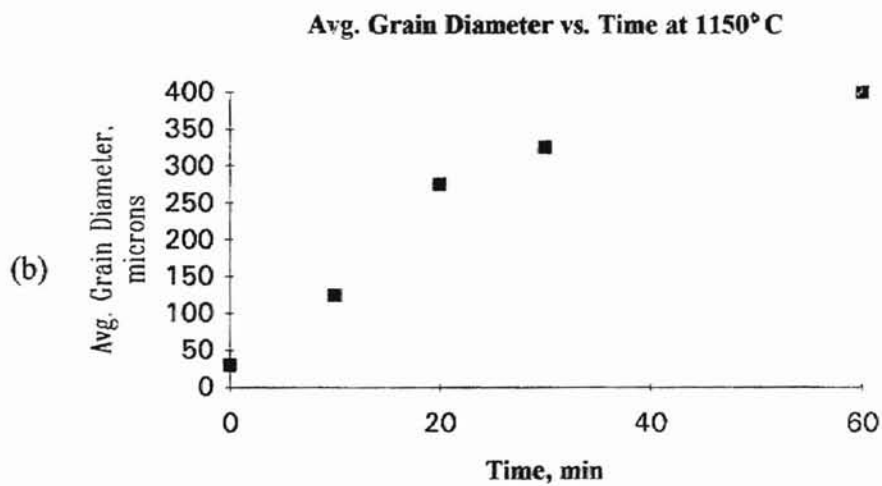
Figure 22. Grain growth vs. time. (a) Reference chart [20]. (b) Experimental results.

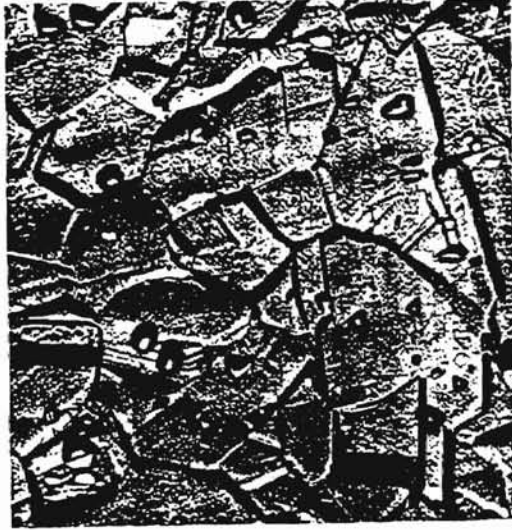
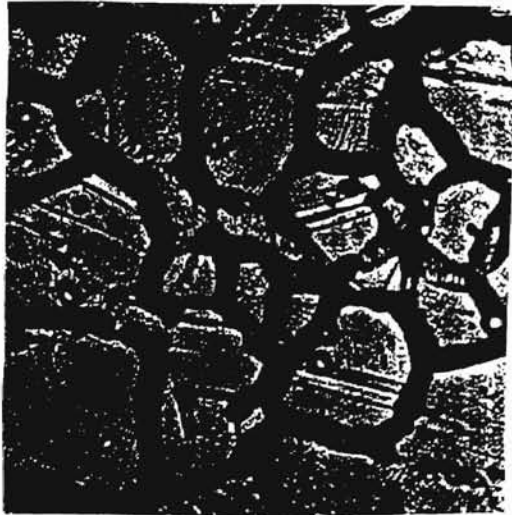
Figure 23. Typical microstructural appearance of (a) unsensitized (Step Structure) and (b) sensitized (Ditch Structure) stainless steel [22].

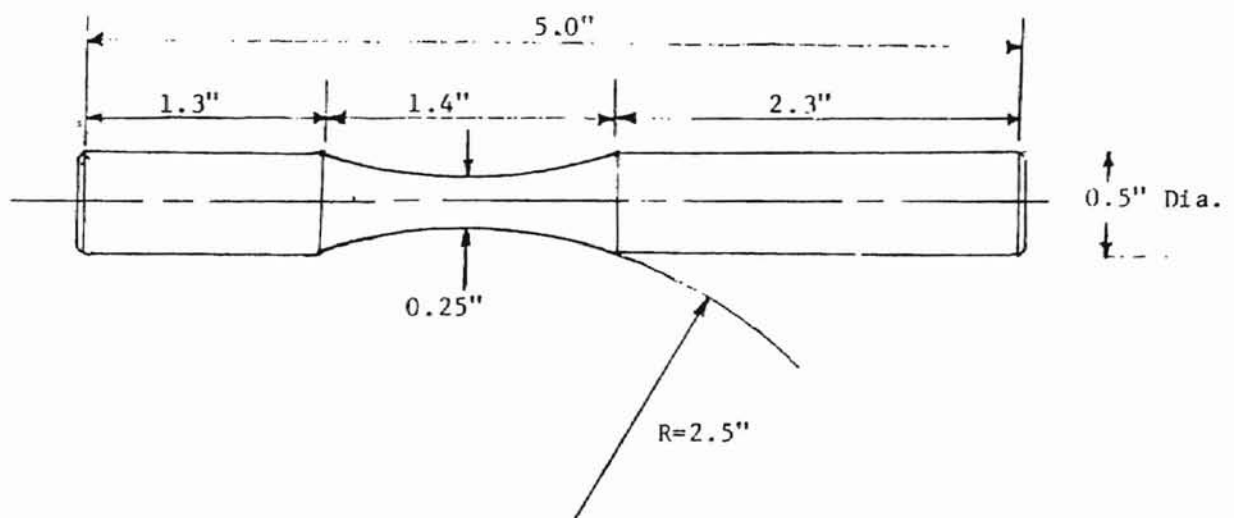
Figure 24. Specimen dimensions (actual total length 6 in.).

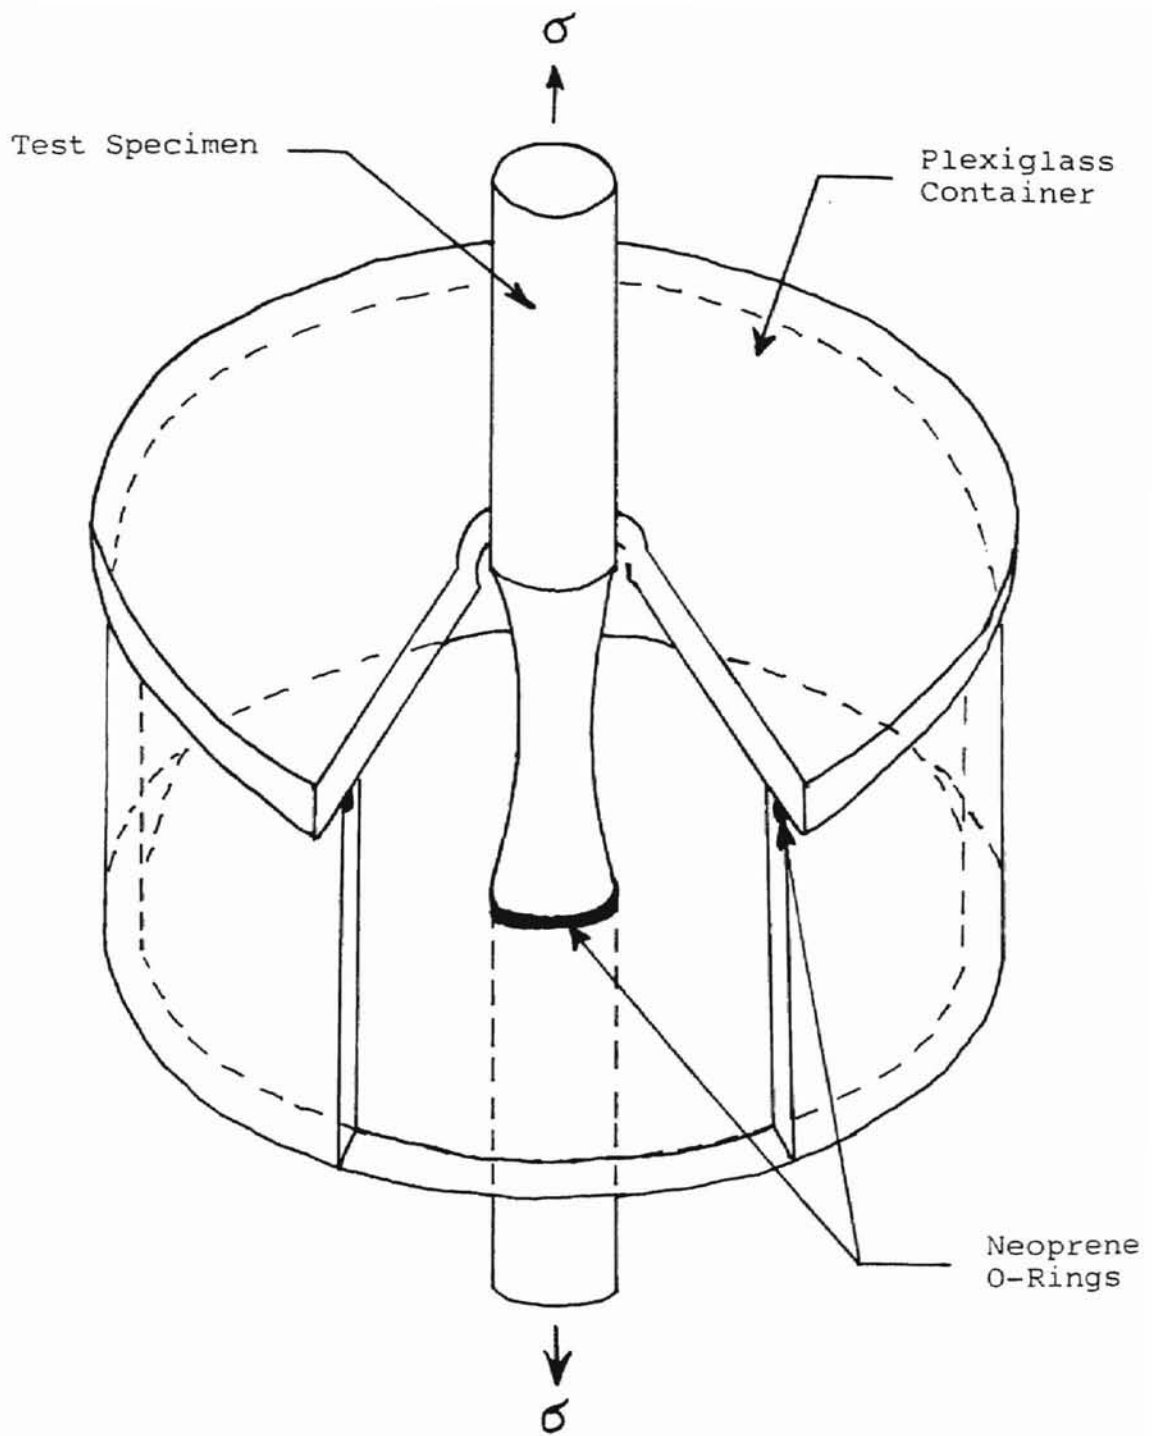
Figure 25. Apparatus for testing in mercury.

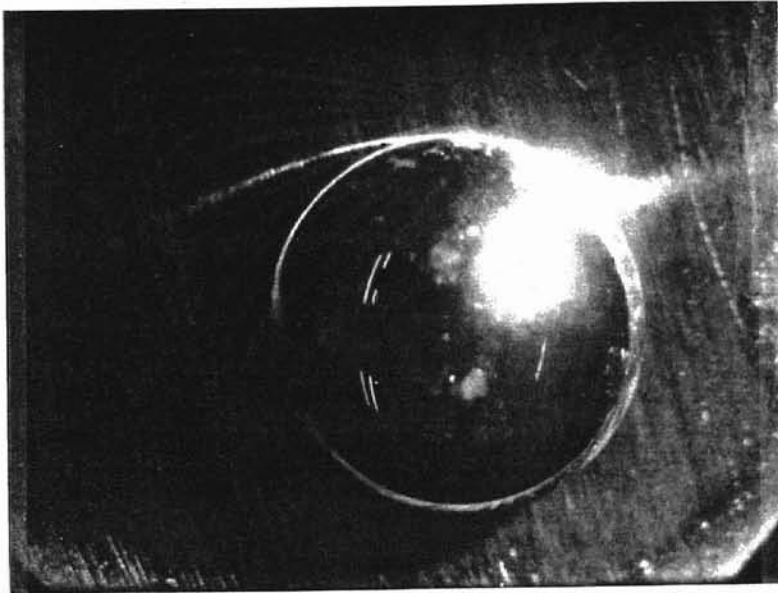
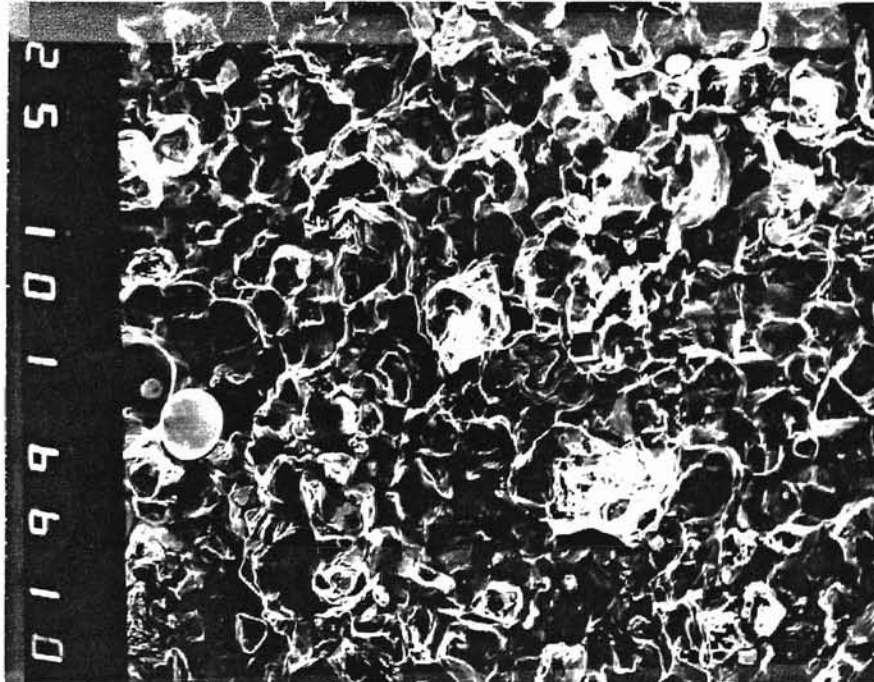
XX sessile drop on 600 grit surface

Figure 26. Unwetting drops of mercury on (a) 600-grit polished surface (SZM) and (b) fracture surface (SEM, 100 \times).

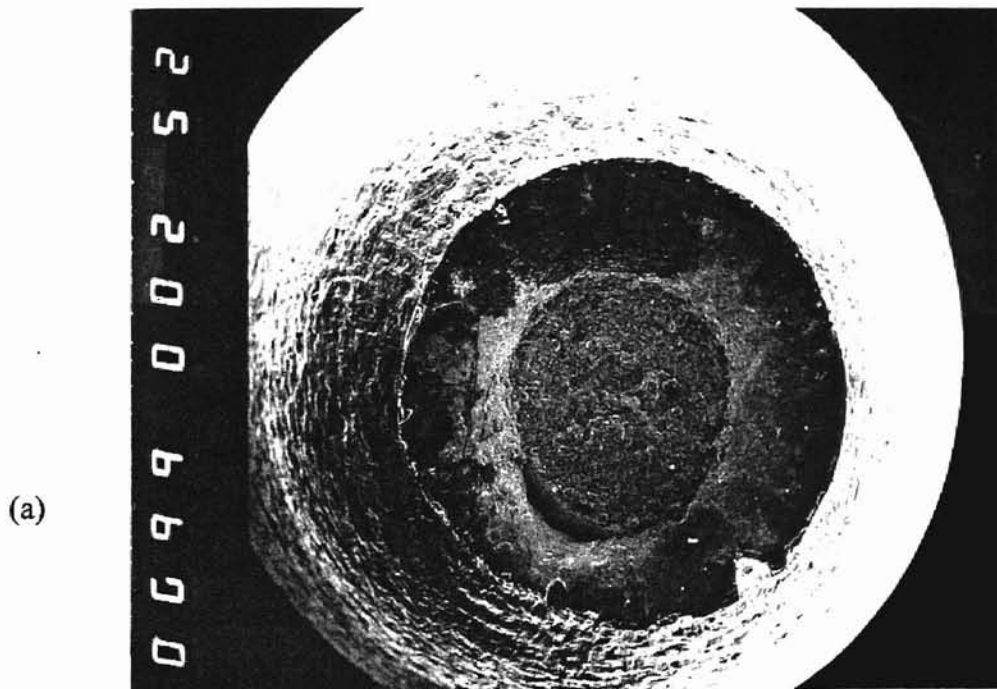
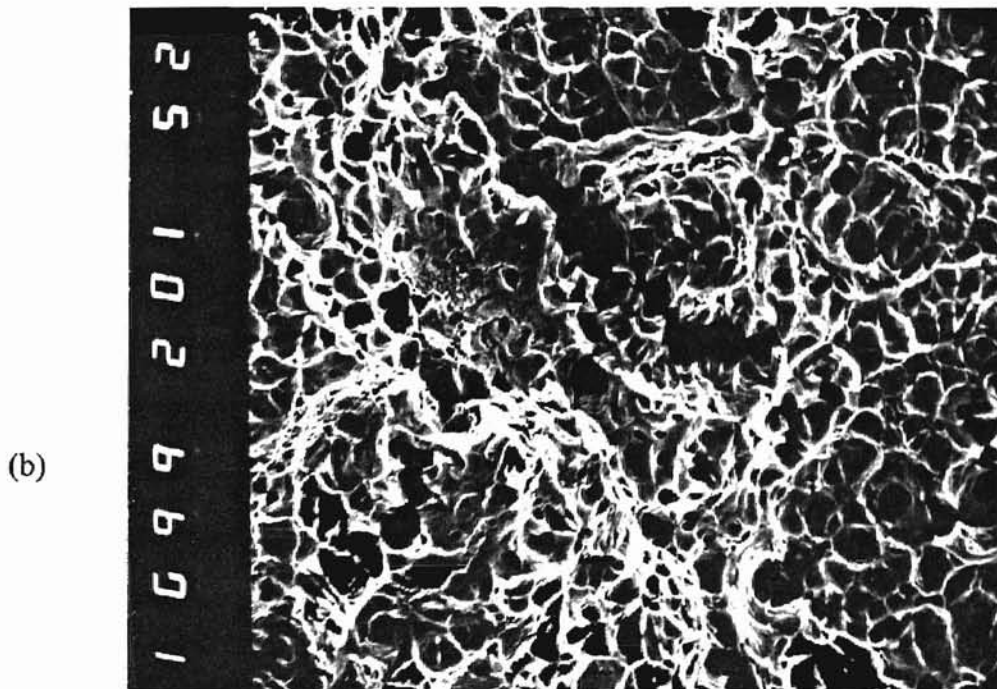
Figure 27. As-received specimen broken in air. (a) General specimen view, 20 \times . (b) Detail, showing microvoids as well as secondary MVC cracking, 1000 \times .

As can be seen from the table, the air-broken specimen had a typical (~80 %) high reduction of area figure for Type 304 [20]. This specimen was necked, with a classical cup/cone fracture. In mercury, the reduction of area was markedly lower for both as-received and annealed specimens. Both specimens were not necked, with jagged irregular fractures. SEM examination revealed that the air-broken specimen fractured, as expected, solely by microvoid coalescence. Figure 27 shows this fracture surface. The microvoid sizes, and irregularity thereof, as well as the secondary cracking, are akin to similar photographs in reference books [23]. In mercury, the as-received material fractured generally transgranularly, with a small bit of MVC at the fracture terminus. Many slip

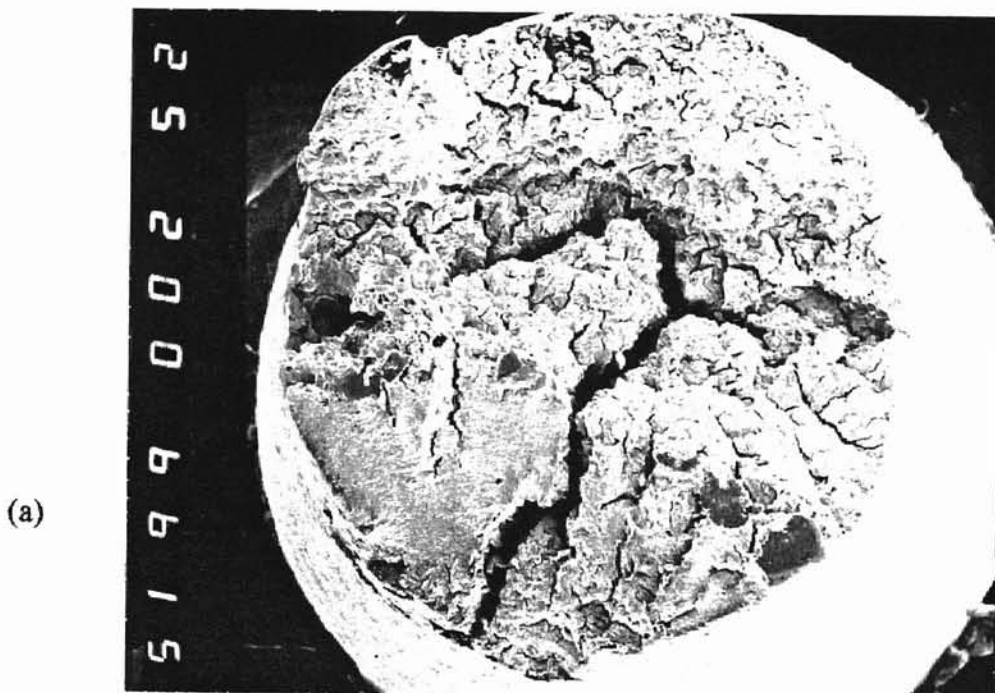
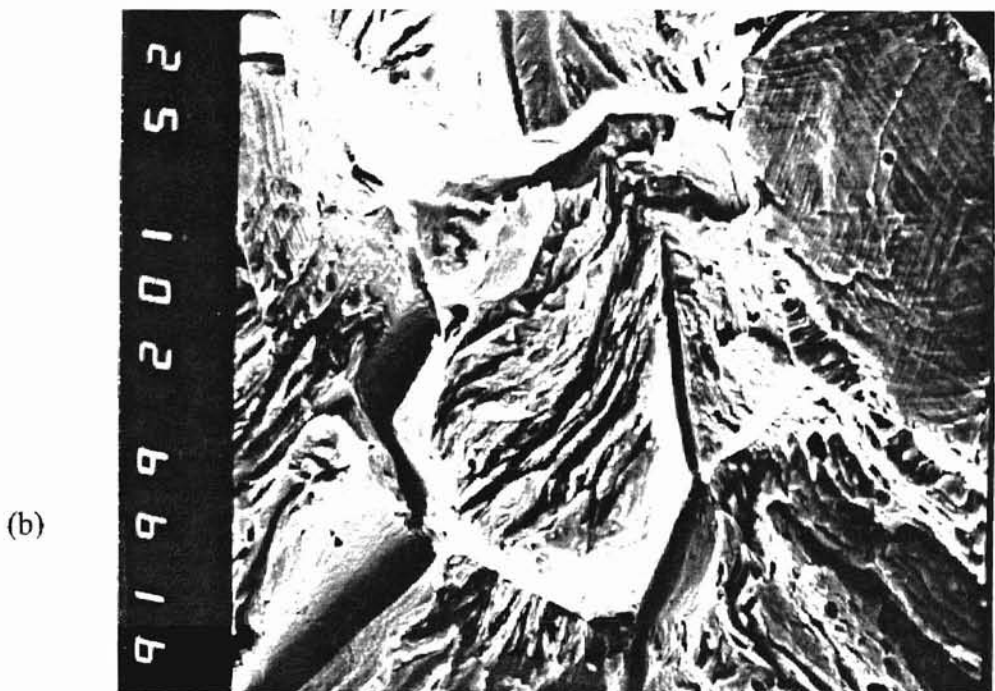
Figure 28. As-received specimen broken in mercury. (a) General specimen view, $20\times$. Note MVC smooth region, lower left. (b) Detail, $1000\times$. Note cleaved slip bands as well as some prominent slip bands on the sheared grain at the upper right.

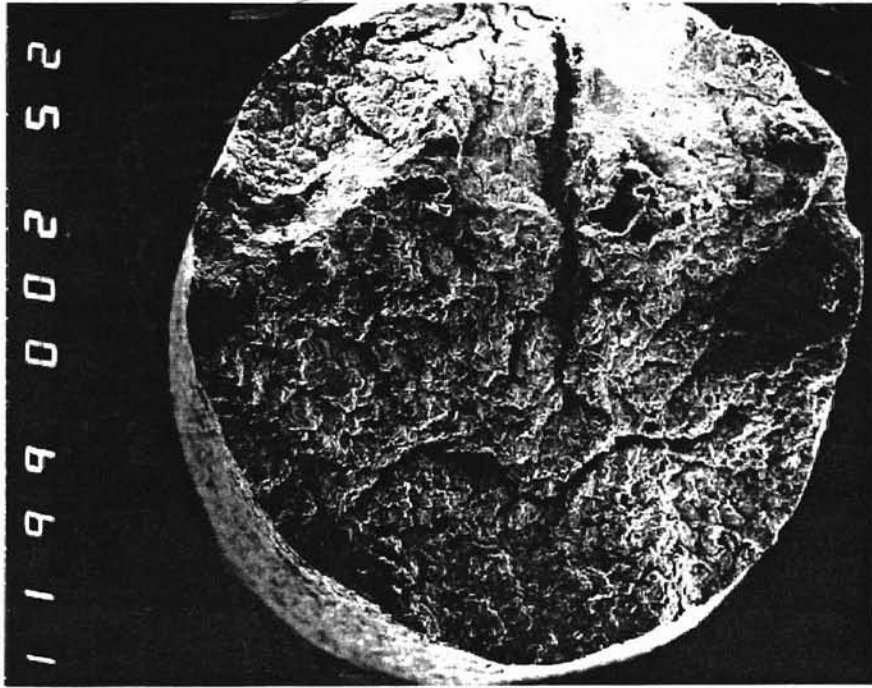
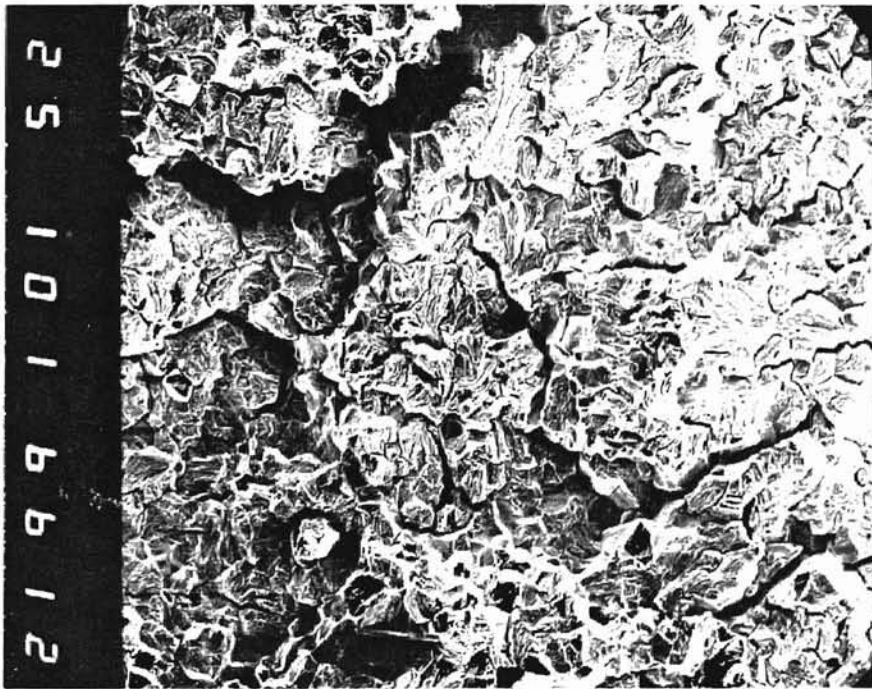
Figure 29. Annealed specimen broken in mercury. (a) General view, 20 \times . (b) Detail,

100 \times .

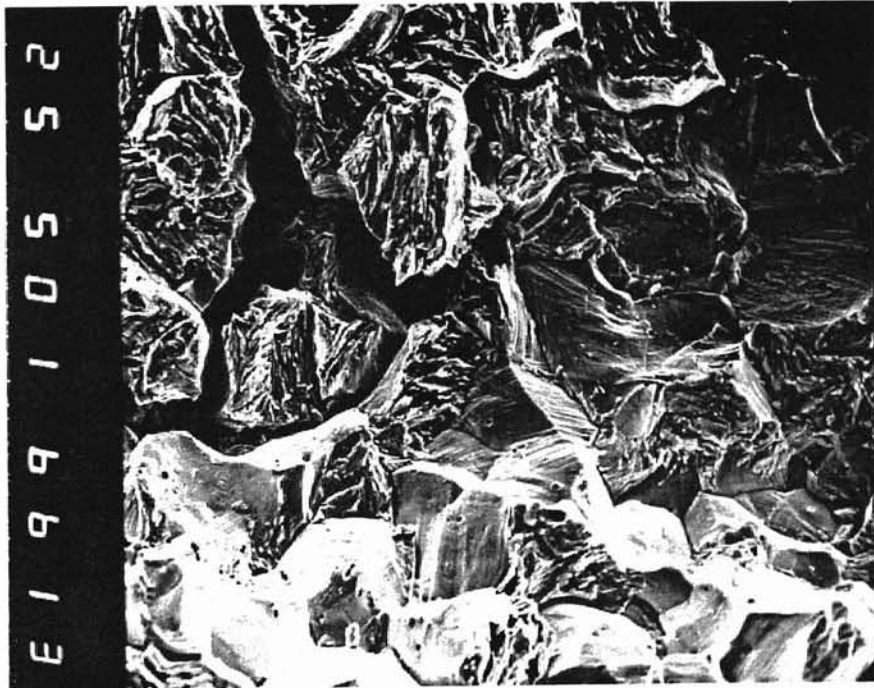
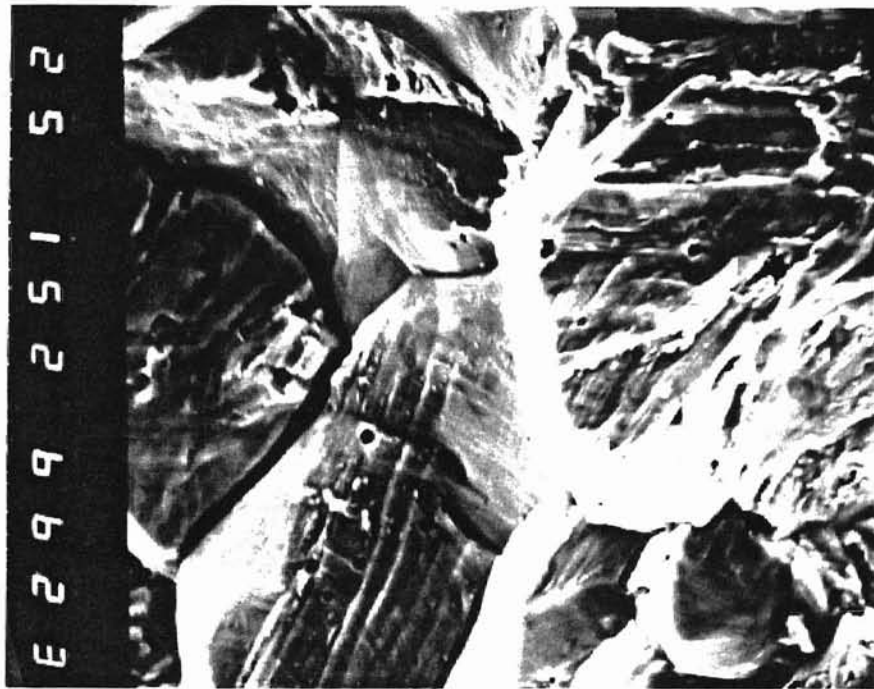
Figure 29, continued. (c) Detail, showing TG + IG mixed-mode cracking, $500\times$. This particular zone has an unusually high amount of IG contribution. (d) Detail of (c), $1500\times$. IG region; note slip on three systems, secondary cracking.
