LIQUID METAL EMBRITTLEMENT OF
TYPE 304 STAINLESS STEEL
BY LIQUID MERCURY

Submitted to the Faculty of the
Graduate College of the
Oklahoma State University
in partial fulfillment of
the requirements for
the Degree of
MASTER OF SCIENCE
December, 1995

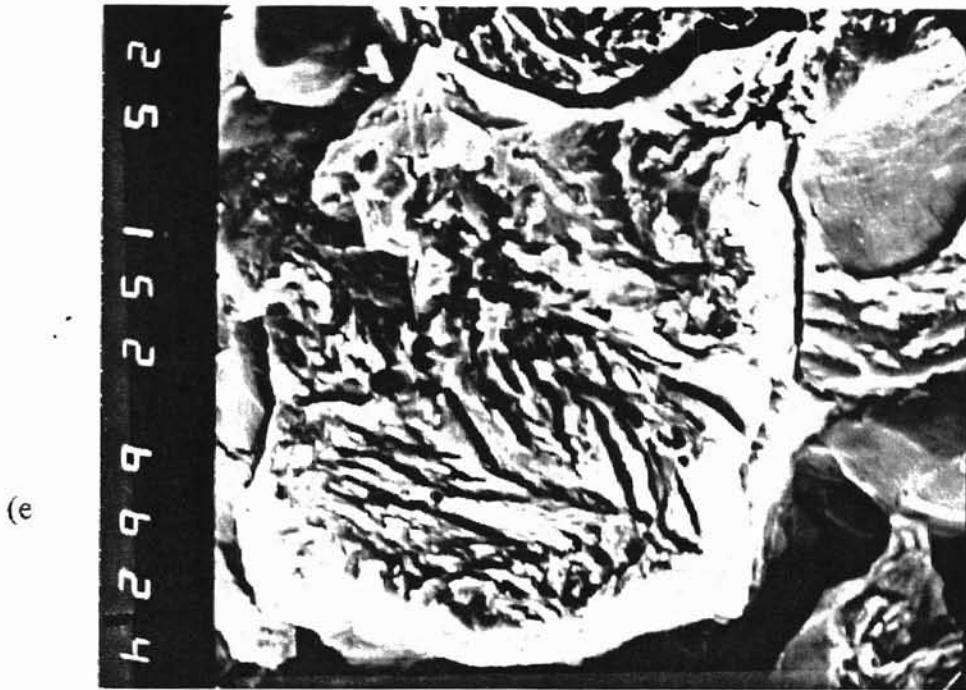
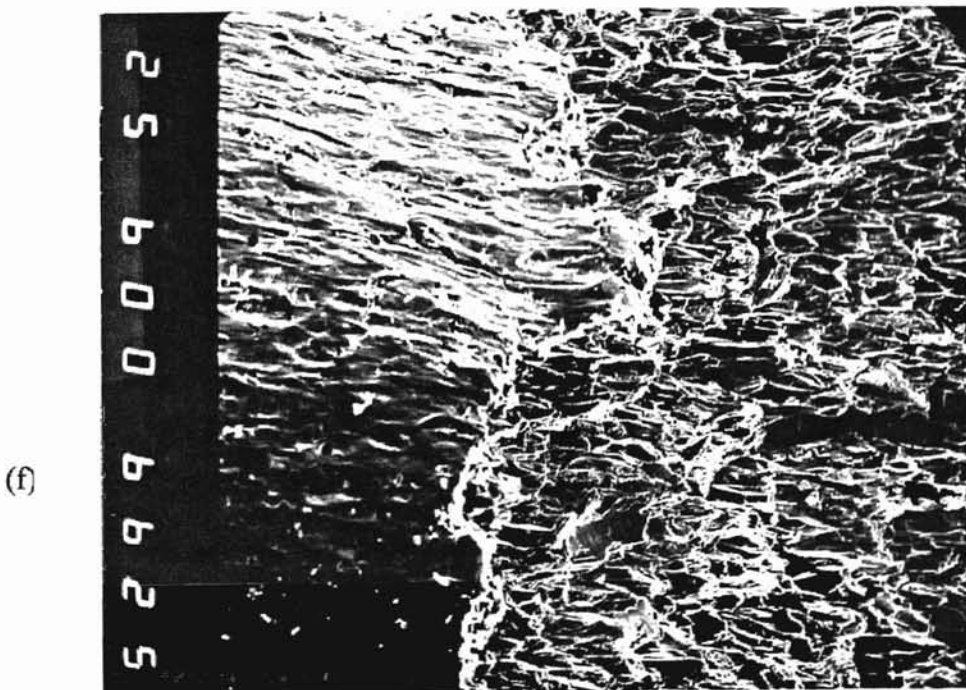
Figure 29, continued. (e) Detail of TG region of Figure 29 (c), 1500 \times . (f) Side view of fracture surface/specimen side interface, 60 \times .

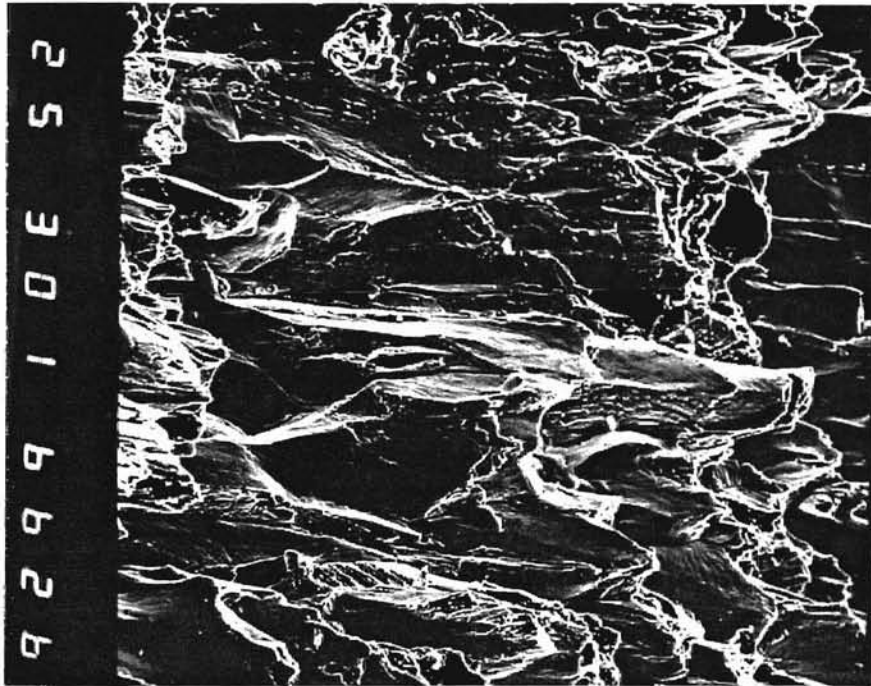
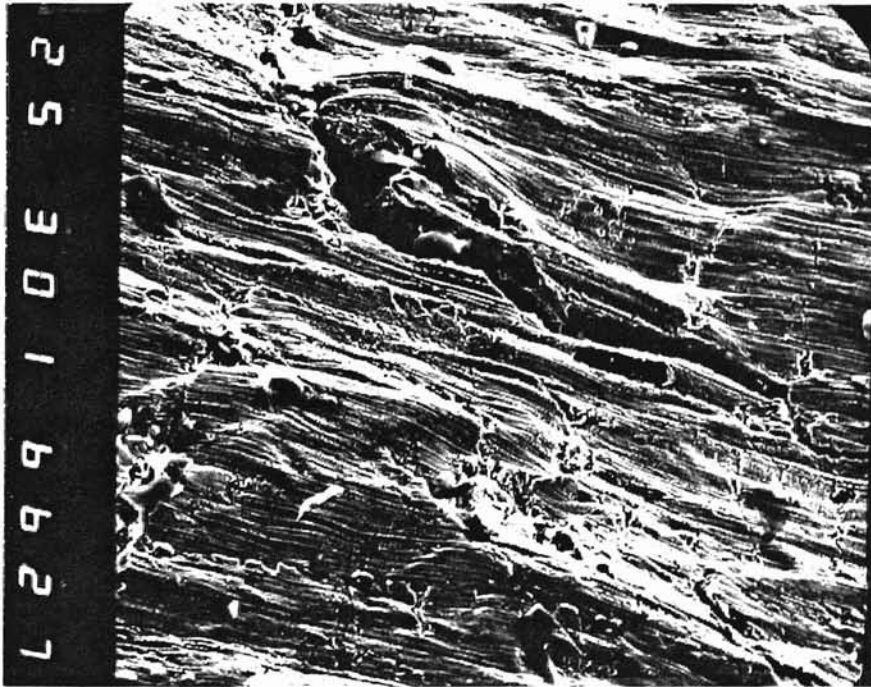
Figure 29, continued. (g) Side view of fracture surface, 300 \times . (h) Side of specimen near fracture, 300 \times .

specimen, near the fracture surface. Figure 29 (i) is a detail of the side 6-8 mm away from the fracture, showing a side crack, and Figure 29 (j) is an intermediate location. Note the progression from longitudinal to lateral secondary crack orientation with increasing distance from the fracture surface. The waisted gage length facilitates this effect; away from the gage length center, the diameter is larger and the strain experienced is less. Additionally, while side cracking such as that seen in Figure 29 (i) and (j) was most prominent in this particular specimen, it was present in all broken specimens. Even the sensitized specimen showed small side cracks when viewed in the SZM.

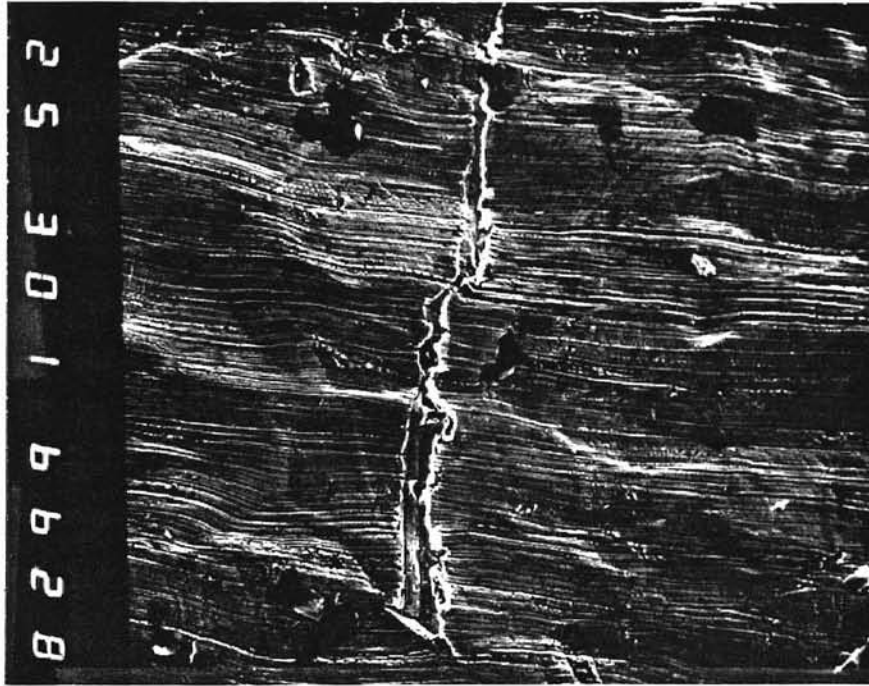
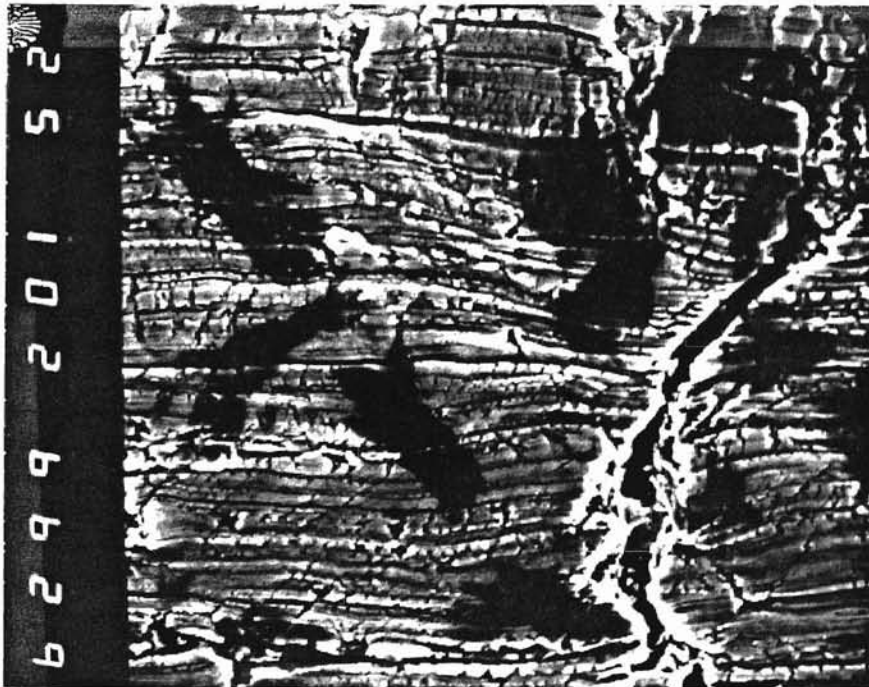
Figure 29, continued. (i) Side, 6-8 mm from fracture, $300\times$. (j) Side, between Figure 29 (h) and (i), $1000\times$.

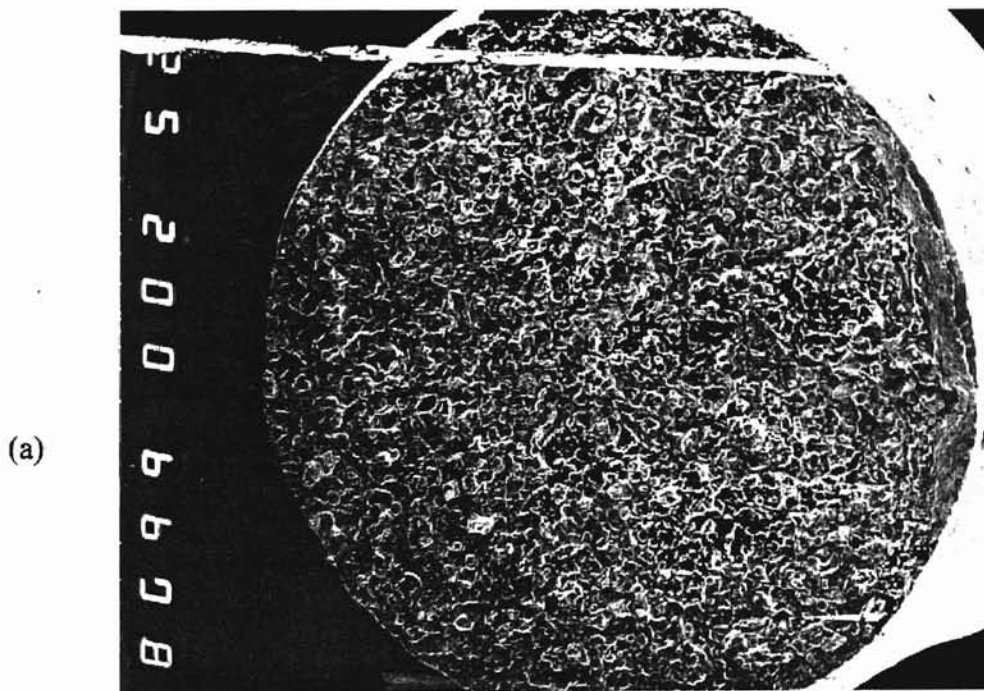
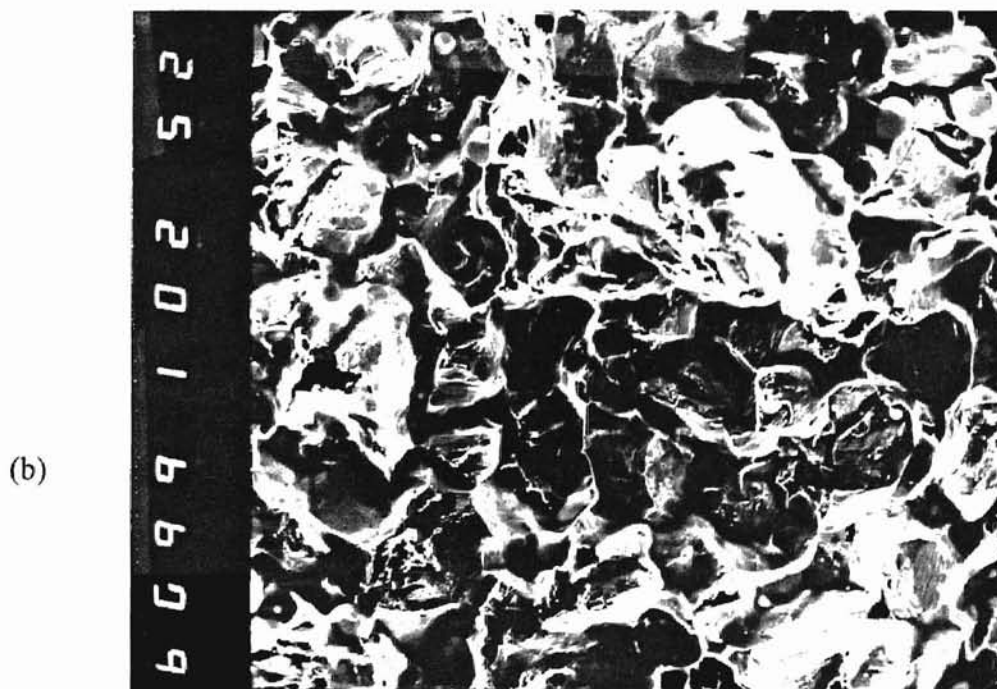
Figure 31. Fracture surface of sensitized specimen broken in mercury. (a) General specimen view, 20 \times . (b) Detail, 200 \times .

As mentioned above, the sensitized specimens fractured completely intergranularly, with the exception of the 25-35 μm grain size specimen, whose fracture was largely transgranular, with some microvoid coalescence in the final stages of fracture. Figures 31 and 32 show these fracture surfaces.

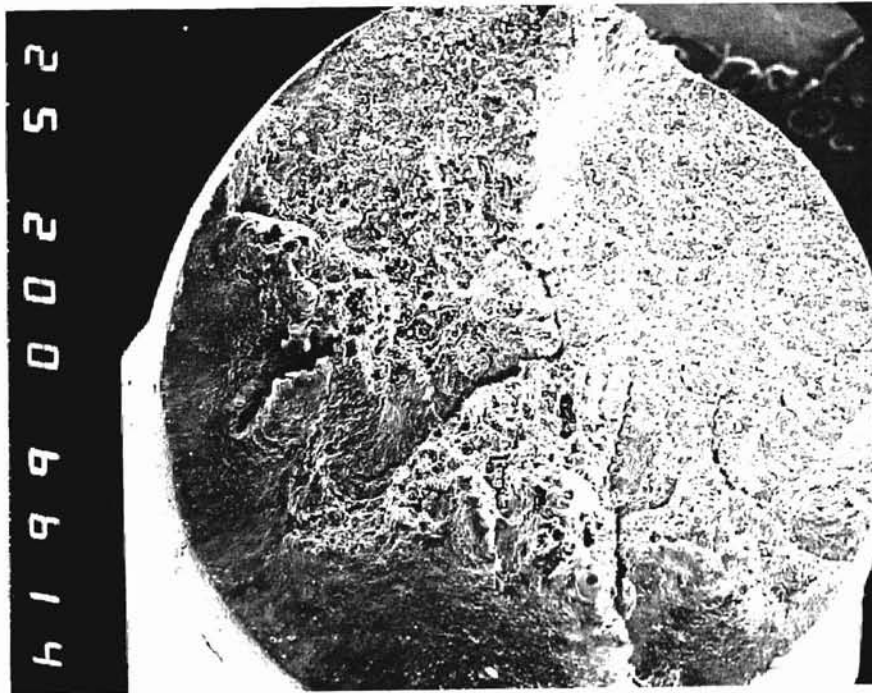
Figure 32. Sensitized small-grained specimen broken in mercury, 20 \times . Note MVC region at lower left. The origin is likely at upper right; note secondary cracking is much more conspicuous as the crack progresses.

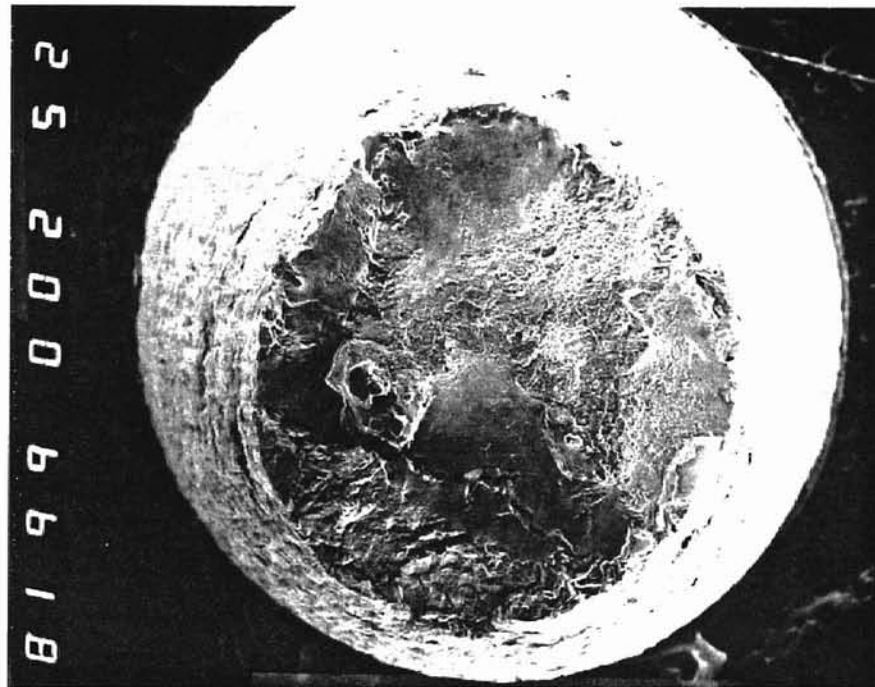
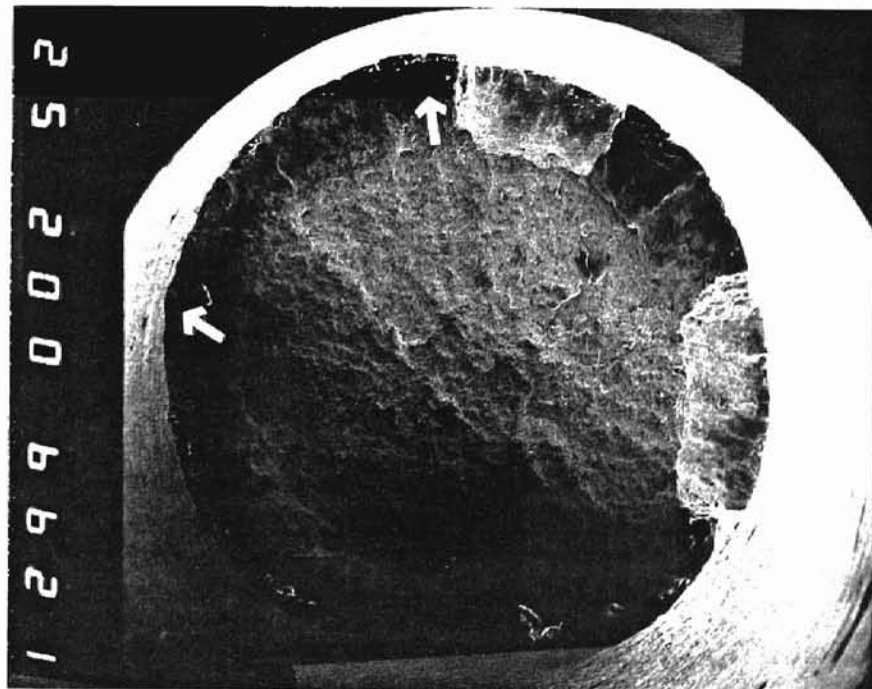
Figure 33. (a) 250-400 μm grain size specimen, broken in mercury, 20 \times . Note TG region at lower portion of fracture. (b) 25-35 μm grain size specimen, broken in mercury, 20 \times . Isolated small TG patches were found at 9 and 12 o'clock.

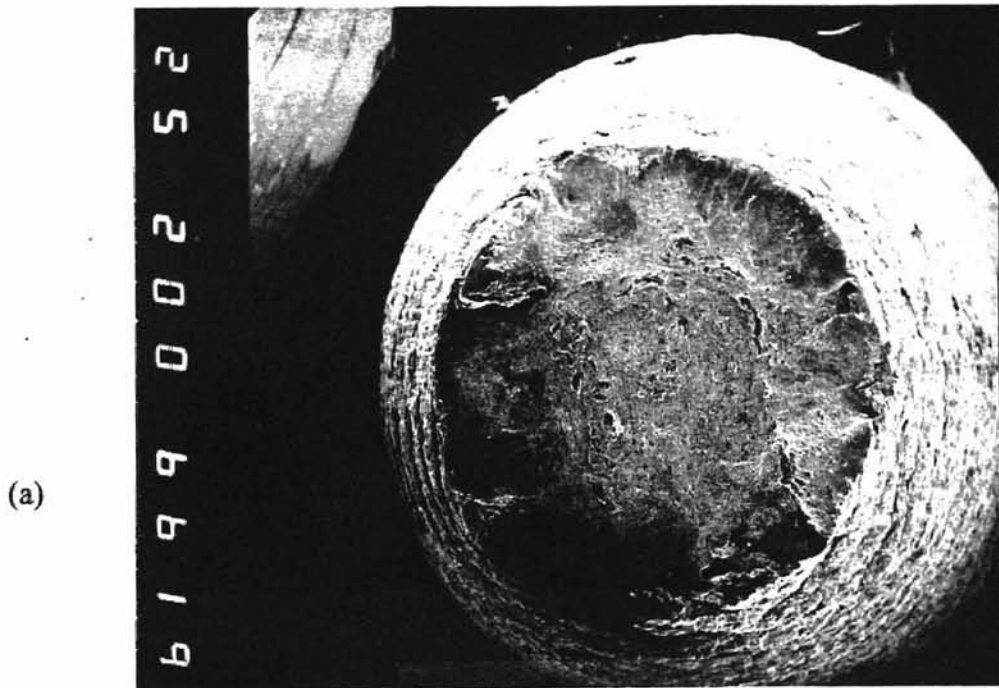
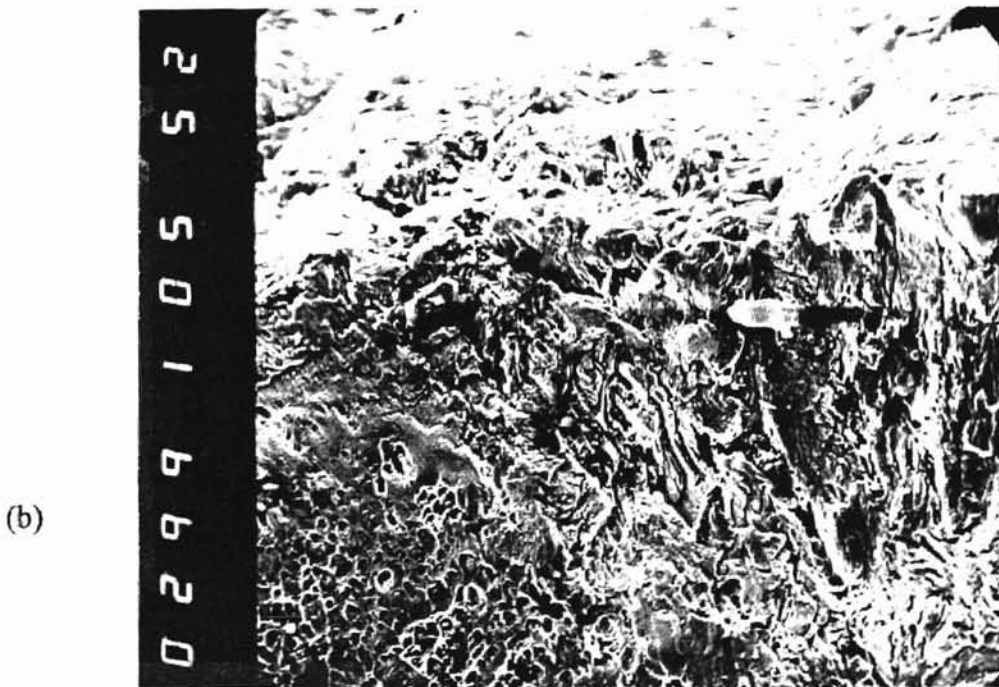
Figure 34. Fracture surface of annealed and cold-worked (to 70% of the tensile strength) specimen. (a) General view, 20 \times . (b) Detail, from 12 o'clock, showing TG origin zone and transition to MVC, 500 \times .

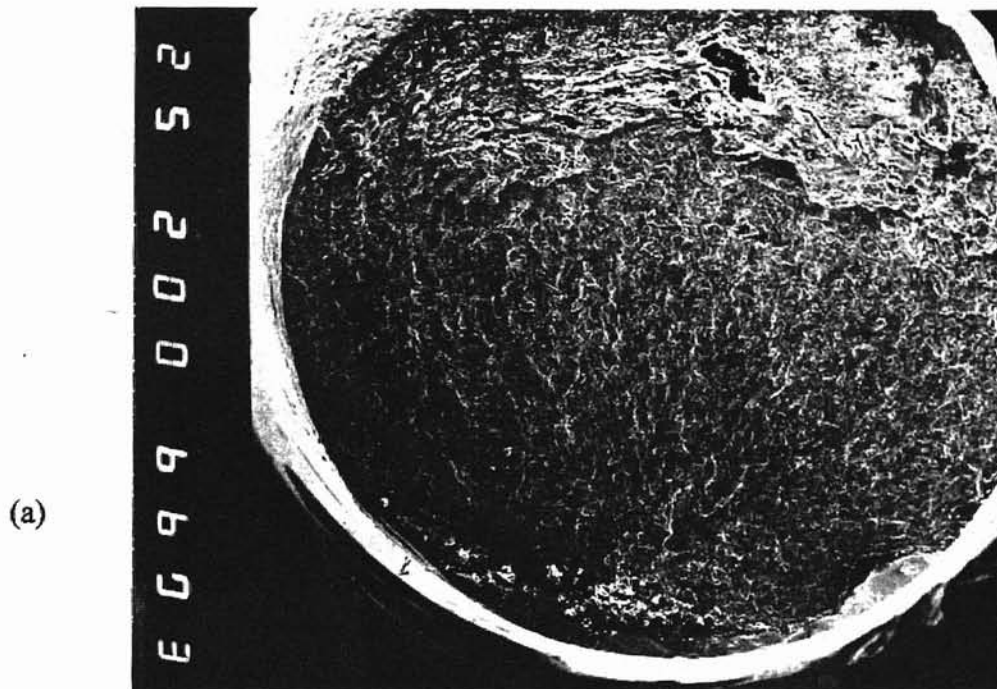
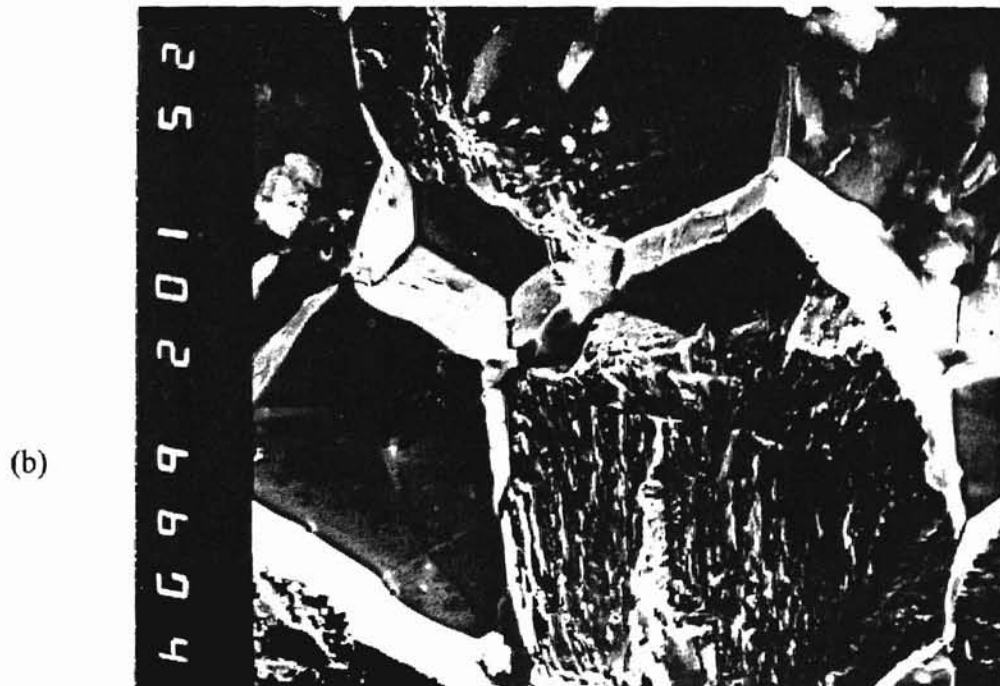
Figure 35. Annealed specimen broken in fatigue in liquid mercury. (a) General specimen view, 20 \times . (b) Mixed-mode origin, 1000 \times .

The fracture surface of the specimen fatigued in mercury was markedly different from the MVC that normally occurs in air [23]. The origin zone was mixed IG and TG, with a progression towards a greater proportion of TG contribution as the fracture progressed. At the end of the fatigue zone, cracking was totally TG with much plastic deformation. The overload zone was purely MVC. Figure 35 shows this fracture surface. The origin is at the lower edge of the specimen, as viewed in Figure 35 (a). Note that obvious secondary cracking is only evident in the transition to the overload zone.

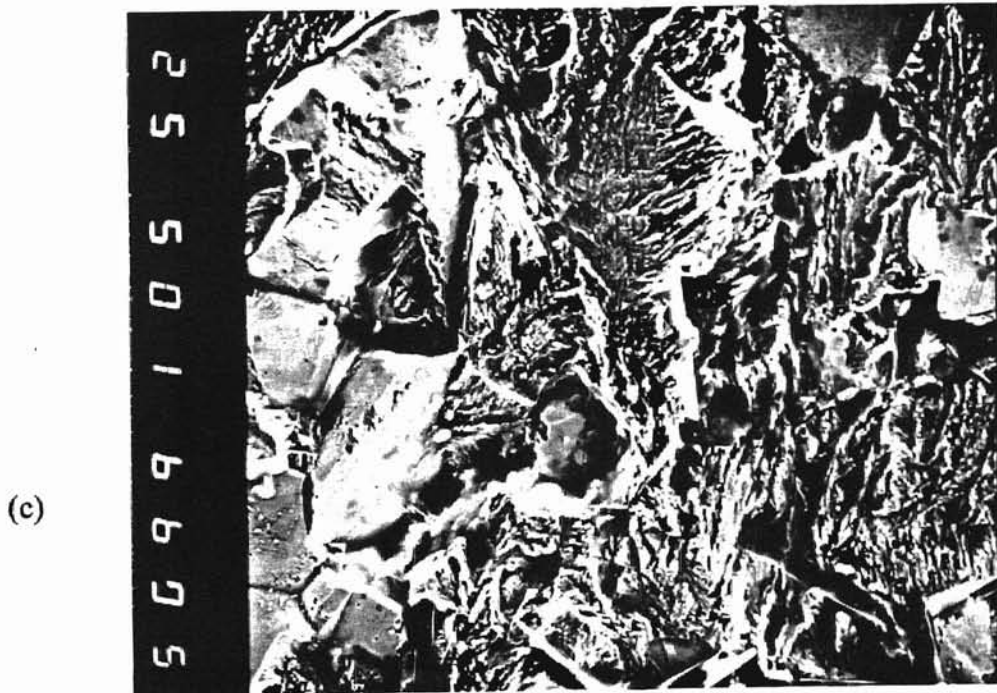
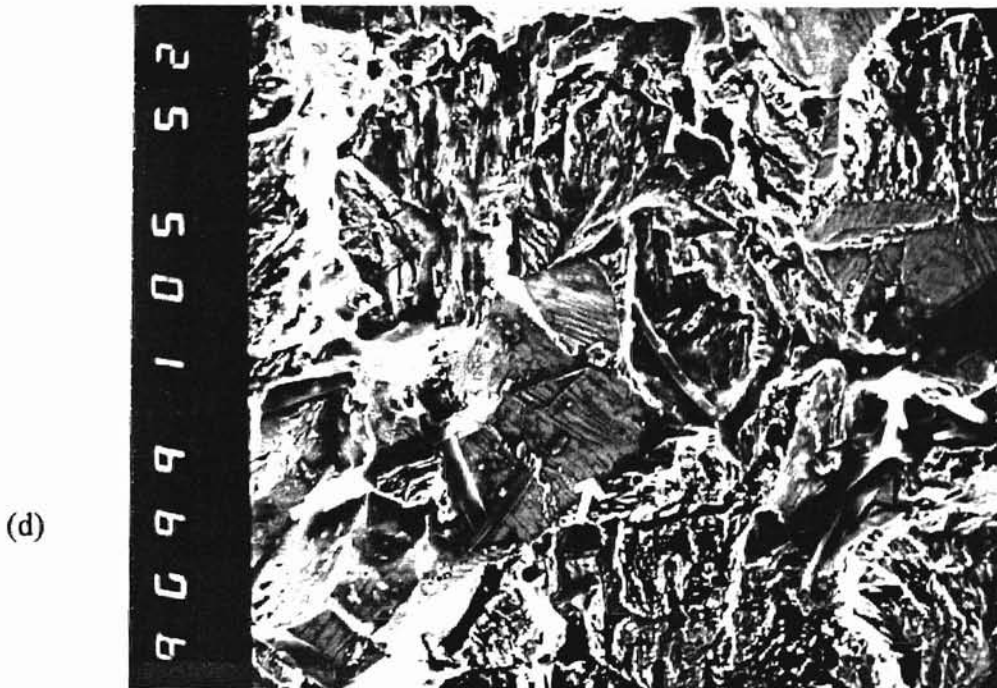
Figure 35, continued. (c) More advanced stage of fatigue crack, 500 \times . Note larger TG contribution. (d) Later stage of crack, 500 \times . Note more plastic deformation, TG cleavage, yet some IG. Note possible remains of striations, as indicated by arrow.

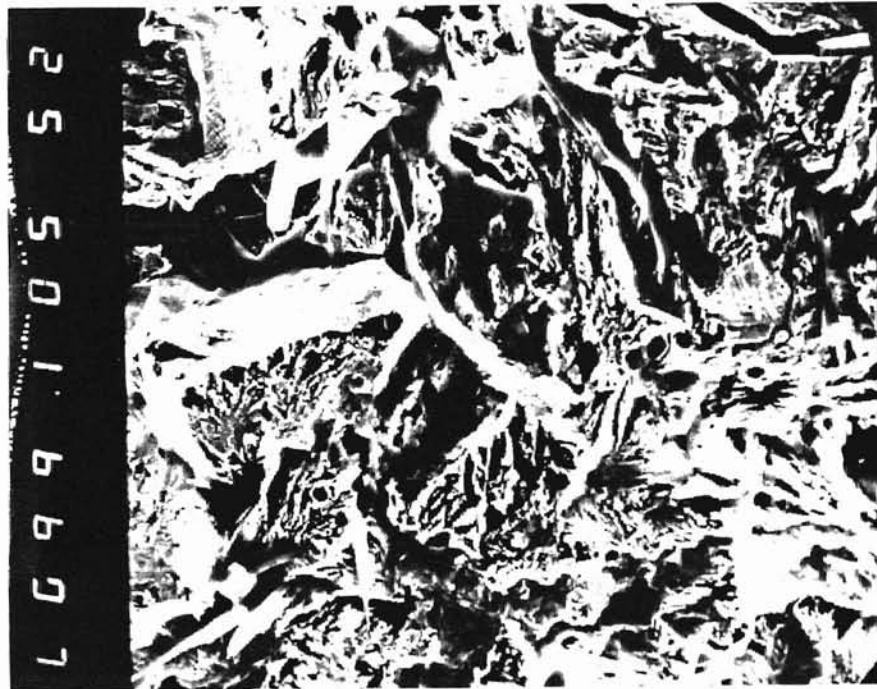
Figure 35, continued. (e) End of fatigue crack, 500 \times . Note large extent of PD and secondary cracking.
